# ASSESSMENT, RESTORATION, AND MANAGEMENT OF THE N PUYALLUP TRAIL, MOUNT RAINIER NATIONAL PARK

Taylor R Kenyon

A report prepared in partial fulfillment of the requirements for the degree of  
Master of Science  
Earth and Space Sciences: Applied Geosciences

University of Washington  
December 2016

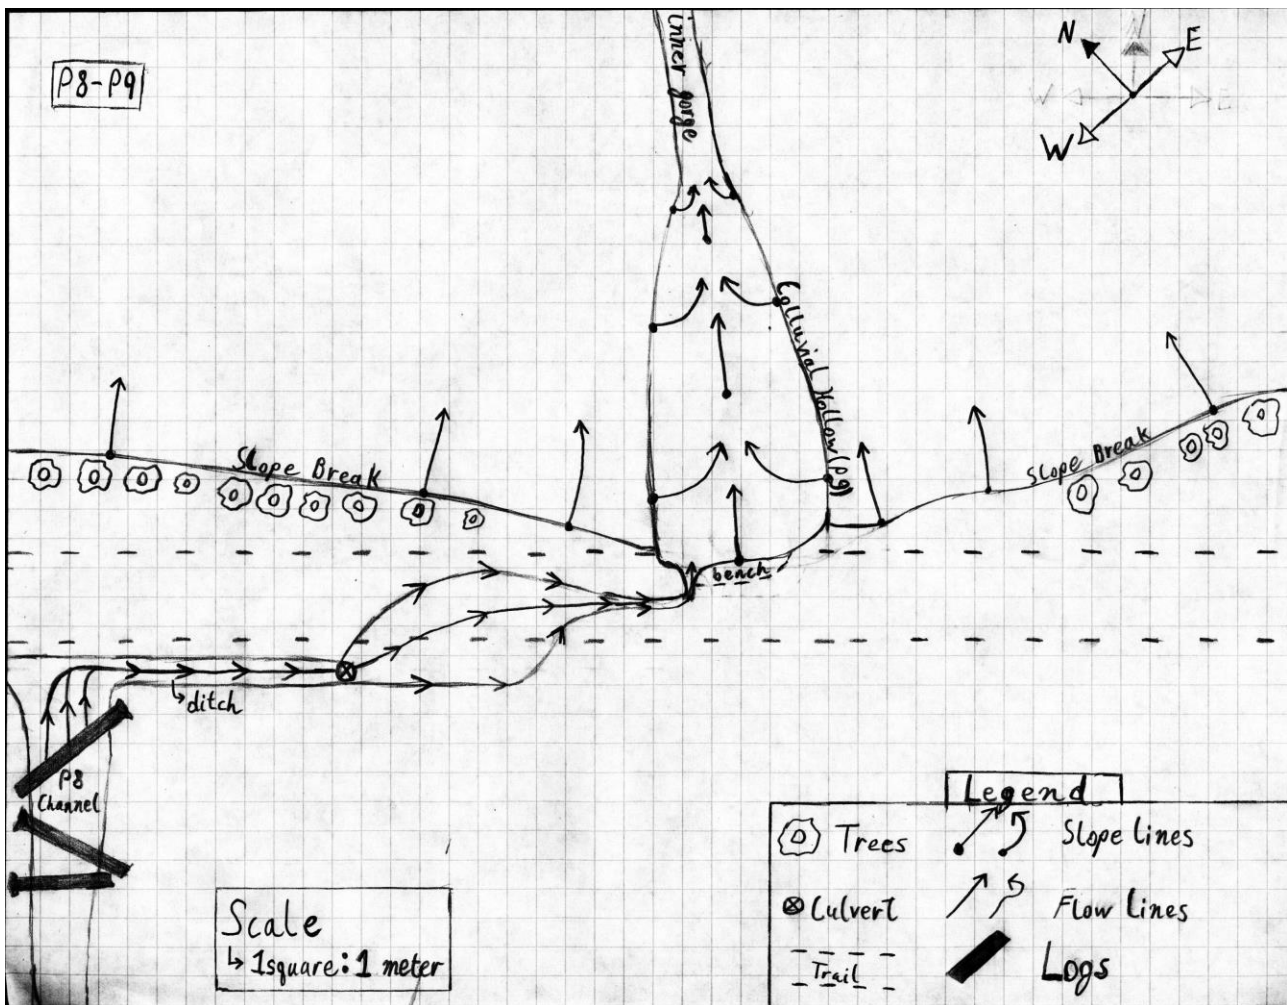
With a perennially flowing channel and an improperly functioning culvert, I think the flow of surface water is the primary concern here. The scour paths leading away from the culvert entrance shows that the culvert cannot handle high flows, allowing flows to spread out on the trail surface. Scouring paths converge heading toward the hollow and come in direct contact with the slumped block at the headwall, suggesting that water is the main source of erosion on the trail at these points, and likely created the hollow. The bare condition of the hollow is a sign of recent instability or continuous surface erosion, which fits if the damage is from surface water. With no exit all water entering the culvert must end as groundwater seepage. Seepage does not appear to cause any immediate concerns, but will likely lower stability over time.

Figure 4: Sketch of P8-P9. Field sketch detailing the plan view of the channel, culvert, and colluvial hollow at P8 and P9. Sketch shows how water paths from the culvert affect the colluvial hollow. Slope lines point in the steepest downslope direction.

Points 8-9 require water management designs, and will also benefit from alterations to the fill surface and soil reinforcements. The primary concern is the replacement of a culvert which currently inputs continuous flow to the subsurface, and allows for surface runoff leading directly into a colluvial hollow that has produced debris flows.

Culvert replacement is needed because the constant discharge of the channel requires a robust drainage to handle winter storm events. To make the new drainage capable of maintenance without machinery I recommend that the culvert be replaced by a structure similar to an open-top box culvert (US Forest Service, 2014), and made of stone for stability. The replacement must be larger to handle heavy winter rainfall. Minor ditch clearing will be needed to direct flow, and can be performed by hand. I also recommend that waterbars be used to make the repairs more effective and fail-safe.

Using waterbars in addition to a new culvert is an effective and relatively inexpensive reinforcement. Waterbars should be made of either stone or logs, and should be skewed 40-45 degrees from the trail to ensure that they are as self-cleaning as possible (US Forest Service, 2014). To provide drainage support that could function without the culvert for a year I think 6-8 waterbars should be installed, with the greater density of bars being west of the current culvert location. This way if the culvert fails the waterbars west of the culvert can still divert most of the flow away from the hollow. I also recommend installing 2-3 additional waterbars just east of the hollow where the valley slope becomes divergent. This allows for excess flow to be directed around the hollow to a stable slope. Installation around the culvert is preferable because the road tilts inward at point 8, making installation at the channel difficult.

To improve stability the colluvial hollow must be reinforced. Here the slumped bench should be removed by trail crews and replaced by wattle fences. The slump at the head of the failure will inevitably fall into the hollow and contribute sediment to the river. Removing the block will both decrease and unload the entry slope, making entering water less erosive. The space left by the block should be replaced by a series of 3 wattle fences with regular drops in height, and backfilled with organic soils (Figure 6). Bioengineering repairs will likely need maintenance, but can become a permanent source of stability if maintained for several years.

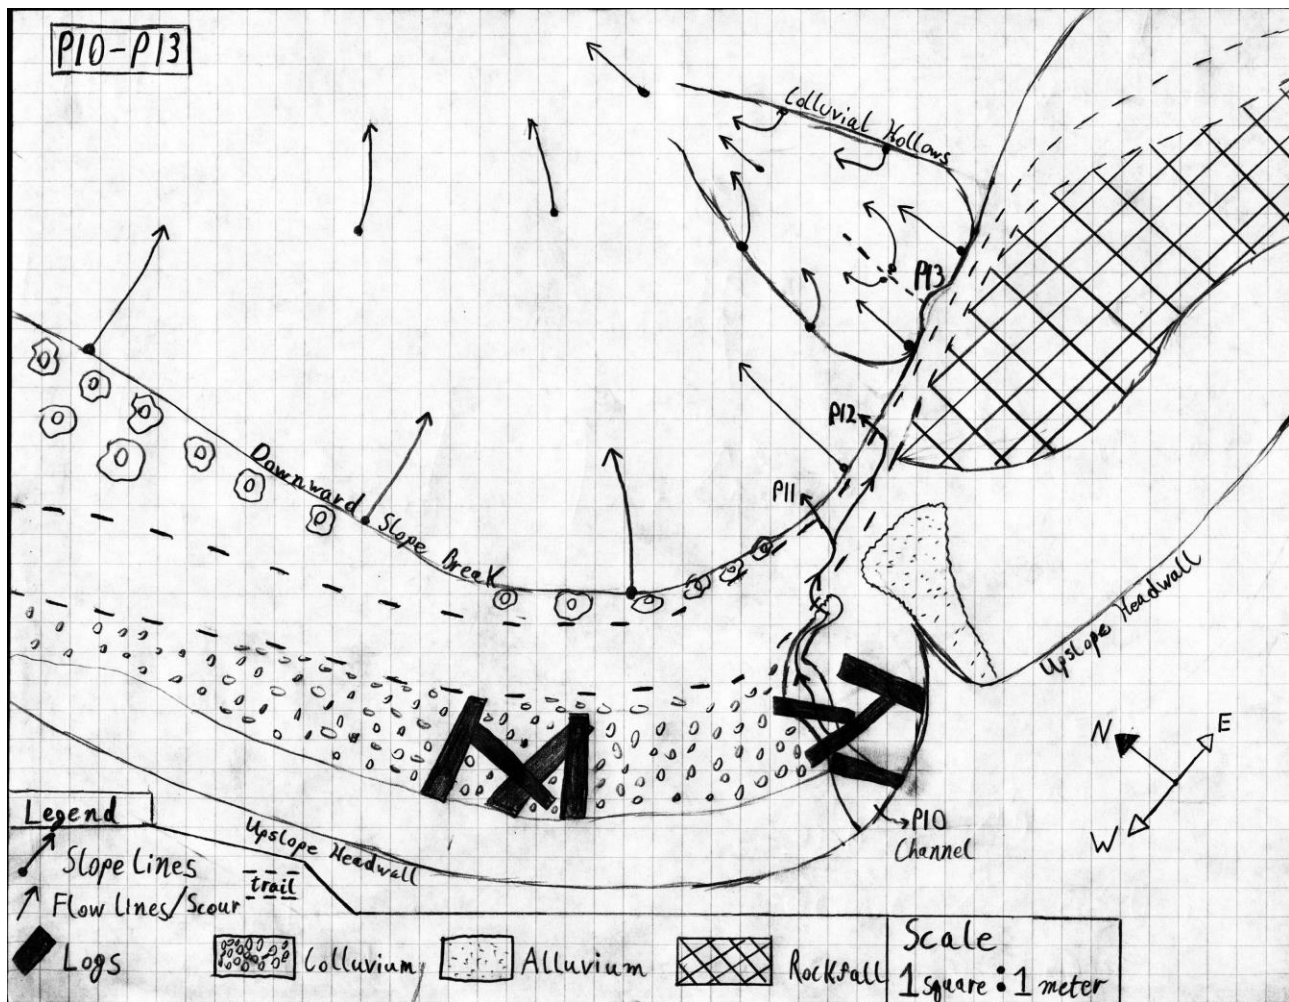
The pair of hollows appear to be a landslide that became a debris flow after travelling a short distance downslope. Here the flows don't encounter the same surface roughness as point 9, and the flow created a larger path as it headed downslope, seen by the presence of continuous levees that reach the river's edge (Hung et al., 2015). Flows here do reach the river, and the height difference of the deposit and the river suggest that slides here can deliver large amounts of sediment (Hung et al., 2015). Large slides are possible here, but conditions suggest that the channel is stabilizing and can handle surface water inputs.

Figure 5: Sketch of P10-P13. Sketch detailing the convergence, channel, and colluvial hollows of P10-P13. Trail narrowing is most significant where rockfall is also most significant. Slope lines point in the steepest downslope direction.

I propose buttressing of the rockfall slope and installation of wattle fences in the headwalls of both hollows at point 13. Since the rockfall seems to be at repose significant removal of rockfall materials could produce instability that will later re-fill the slope to its original condition, or cause a larger amount of rockfall than before. Buttressing would hold back rockfall on the slope, allowing for it to be removed periodically without seriously affecting stability. Buttressing here can be performed by live alder staking and weaving branches through for lateral support. Even if small sections fail they can be replaced and rely on the support of the other stakes which have strengthened. These strengthen over time as the plants grow and eventually provide a permanent support feature. I recommend wattle fences to provide crown support of the hollows. There is only enough room for 2-3 wattle terraces for each hollow. These designs may also require instances of repair until the structure is able to fully root and build cohesion. While these designs have already been developed (Polster, 2002), they were not specifically intended for these uses, making my designs experimental.

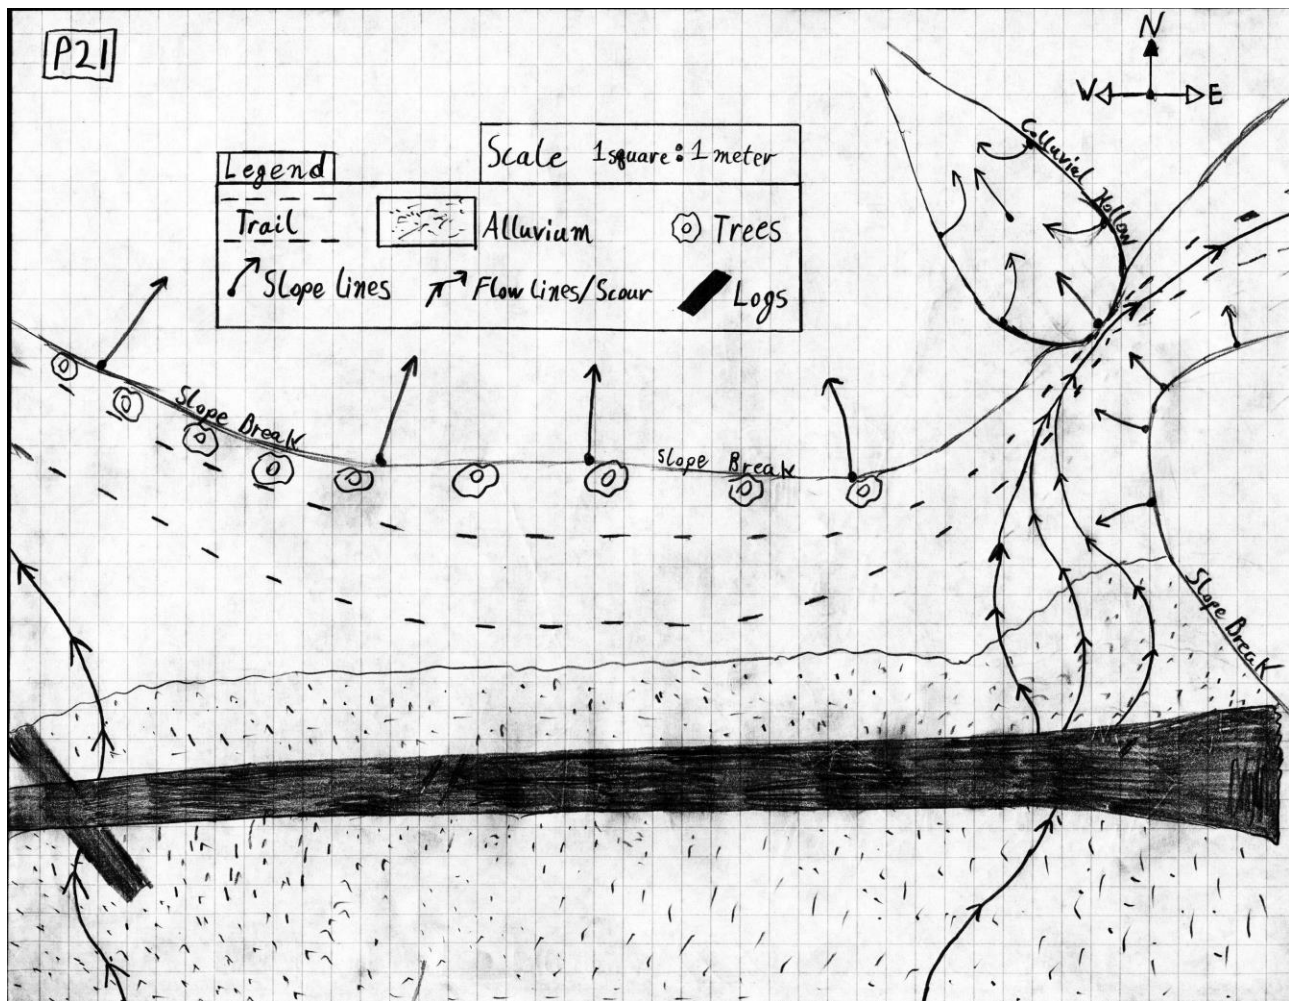
This scouring at point 21 occurs just above the local hollow, and erosional effects will likely accumulate until the scouring begins contributing to the headward retreat of the hollow. Since no surface scouring leads into the hollow I think this level of incision being directed into the hollow could cause permanent loss of this narrowed section within a few years. The channel here is certainly pre-construction, and this plus the availability of vegetation suggests to me that the safest option will be to direct water into the main convergence.

Figure 6: Sketch of P21. Field sketch detailing the plan view of the P21 channel, convergence, and colluvial hollow. Note that the graded surface is lost for a small section, and is replaced by scouring from surface water flows sourced on the east side of the channel. Slope lines point in the steepest downslope direction.

Point 21 has the most severe case of a fill-through section that is degrading rapidly and must be mitigated. I recommend directing water toward the channel convergence to re-occupy the natural flow path and avoid damaging the hollow. A failure on the hollow of point 21 significant enough to cause more headward retreat could mean the end of the trail, requiring drastic measures to restore a useable footpath. Soil bioengineering could also be used to provide slope cohesion, and help deal with water that reaches the fill slope.

Waterbars are likely the best option for this point, and remain preferable due to low cost and ease of maintenance, but must be approached with care. Here waterbars need to be up to 30 feet long to properly direct flow, and entrances to waterbars should be linked to the east scouring to ensure that as much of the flow is captured as possible. Here I recommend that a robust waterbar be installed as the entry and serve as the main flow path. This waterbar can then be used to make 4-5 branches that lead to the fill slope, diverting water before it reaches the hollow at point 21. The existing incision path should be filled in and a small soil berm be installed perpendicular to the trail to prevent flow from continuing beyond the waterbars. Up to 2-3 feet of fill should be removed to make an outlet for each waterbar. These pullbacks should be deep enough to provide a relaxed exit slope even after being filled with rock to resist surface erosion.

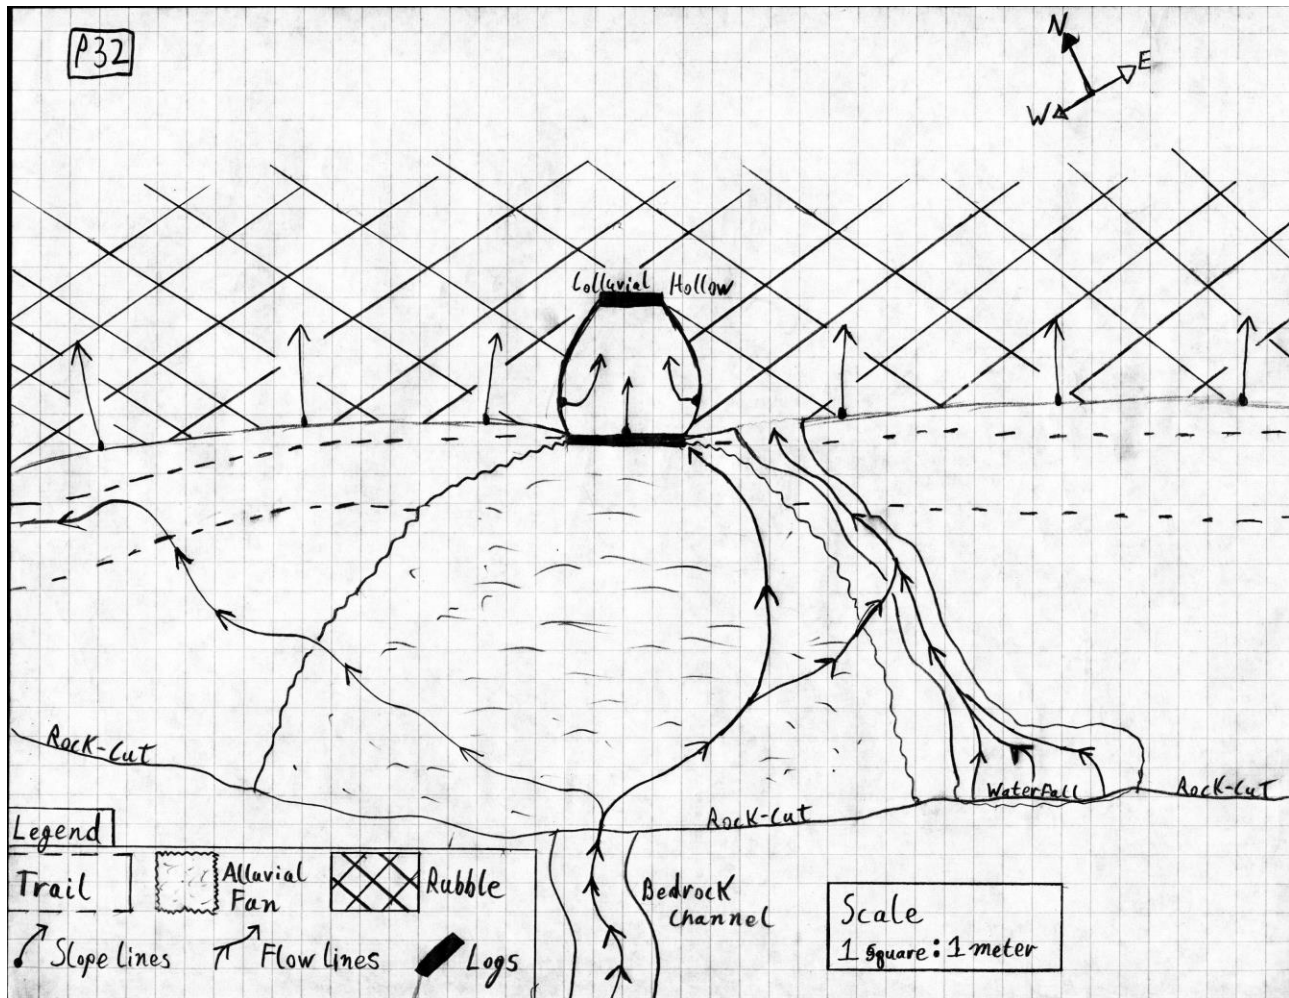
Here the road is roughly as wide as the original construction. The alluvial fan is likely to continue accumulating sediment, sending more downslope every year. The fill surfaces of the road are generally unstable unless in perfect design condition, so loading of material from this fan could eventually lead to instability. The other feature of interest here is a small colluvial hollow.

The condition of the small hollow feature seems to be stable based on the size of the feature and the wood that is currently holding the shape of the landform. Since both the top and bottom are reinforced it seems unlikely that the condition will change within 10 years. It is more likely that the hollow will eventually begin being filled by the outward progression of the alluvial fan, but this could lead to instability from loading.

Figure 7: Sketch of P32. Field sketch detailing the alluvial fan, bedrock channel, small hollow, and both surface flow paths sourced from P32. Shows how logs control the relief of the hollow, and the physical position of the fan on the trail surface. Slope lines point in the steepest downslope direction.

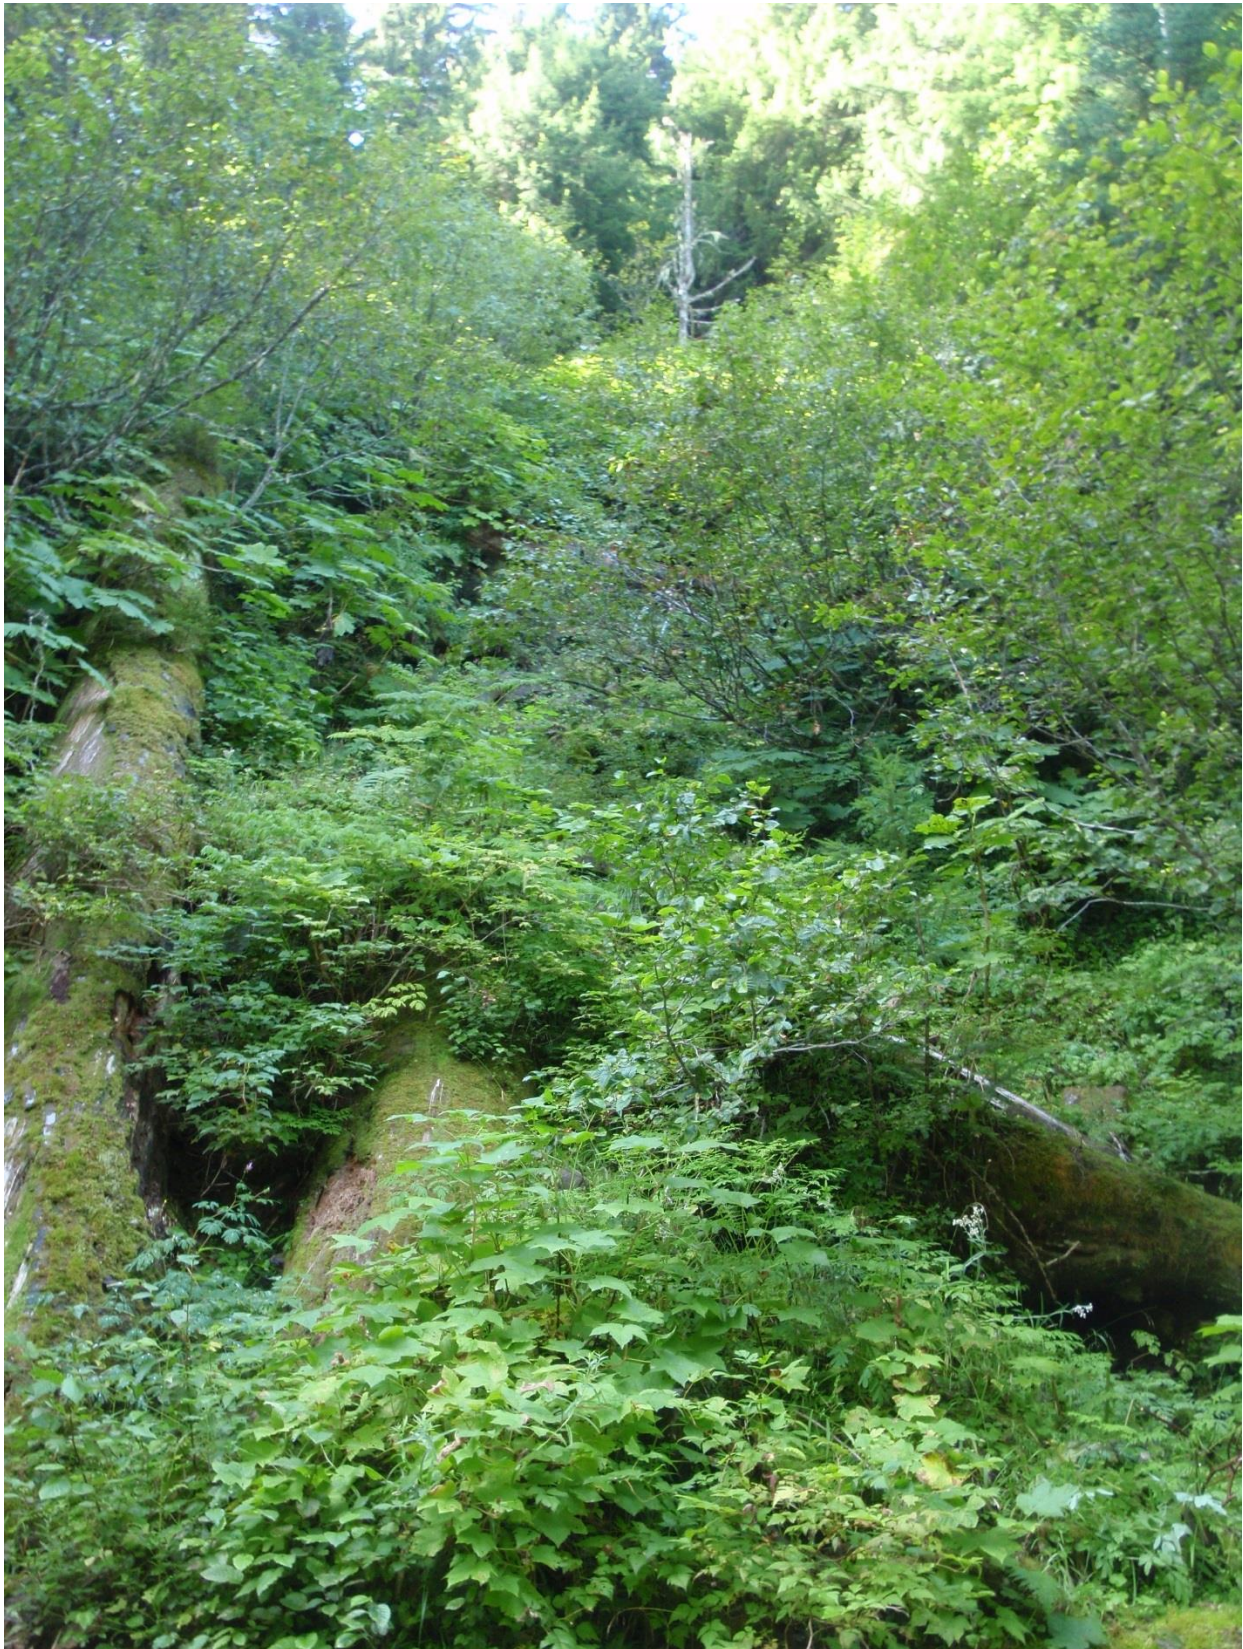
Appendix Figure 1: Point 8 Channel. Photo showing the channel that contacts point 8 from upslope and leads to the point 9 culvert.

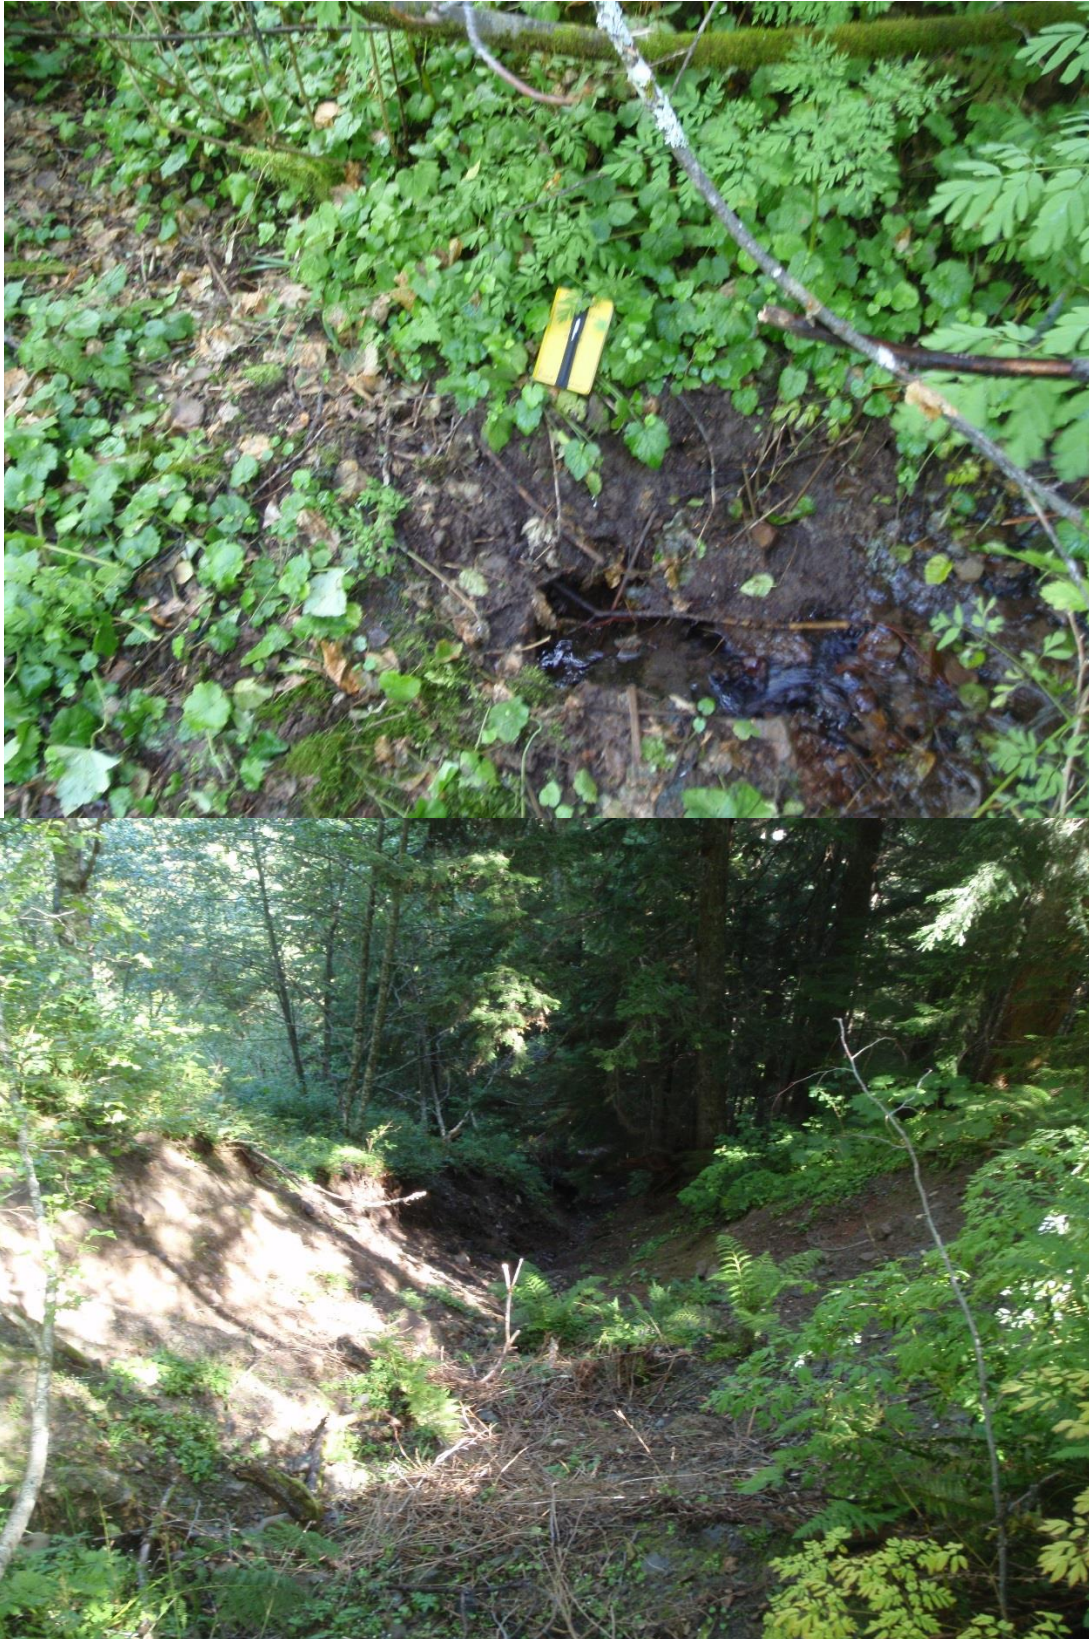
Appendix Figure 2: Photos of Point 9 Concerns. Upper photo shows the entrance to the point 9 culvert that has no exit. Lower shows the point 9 colluvial hollow emanating from the fill slope.

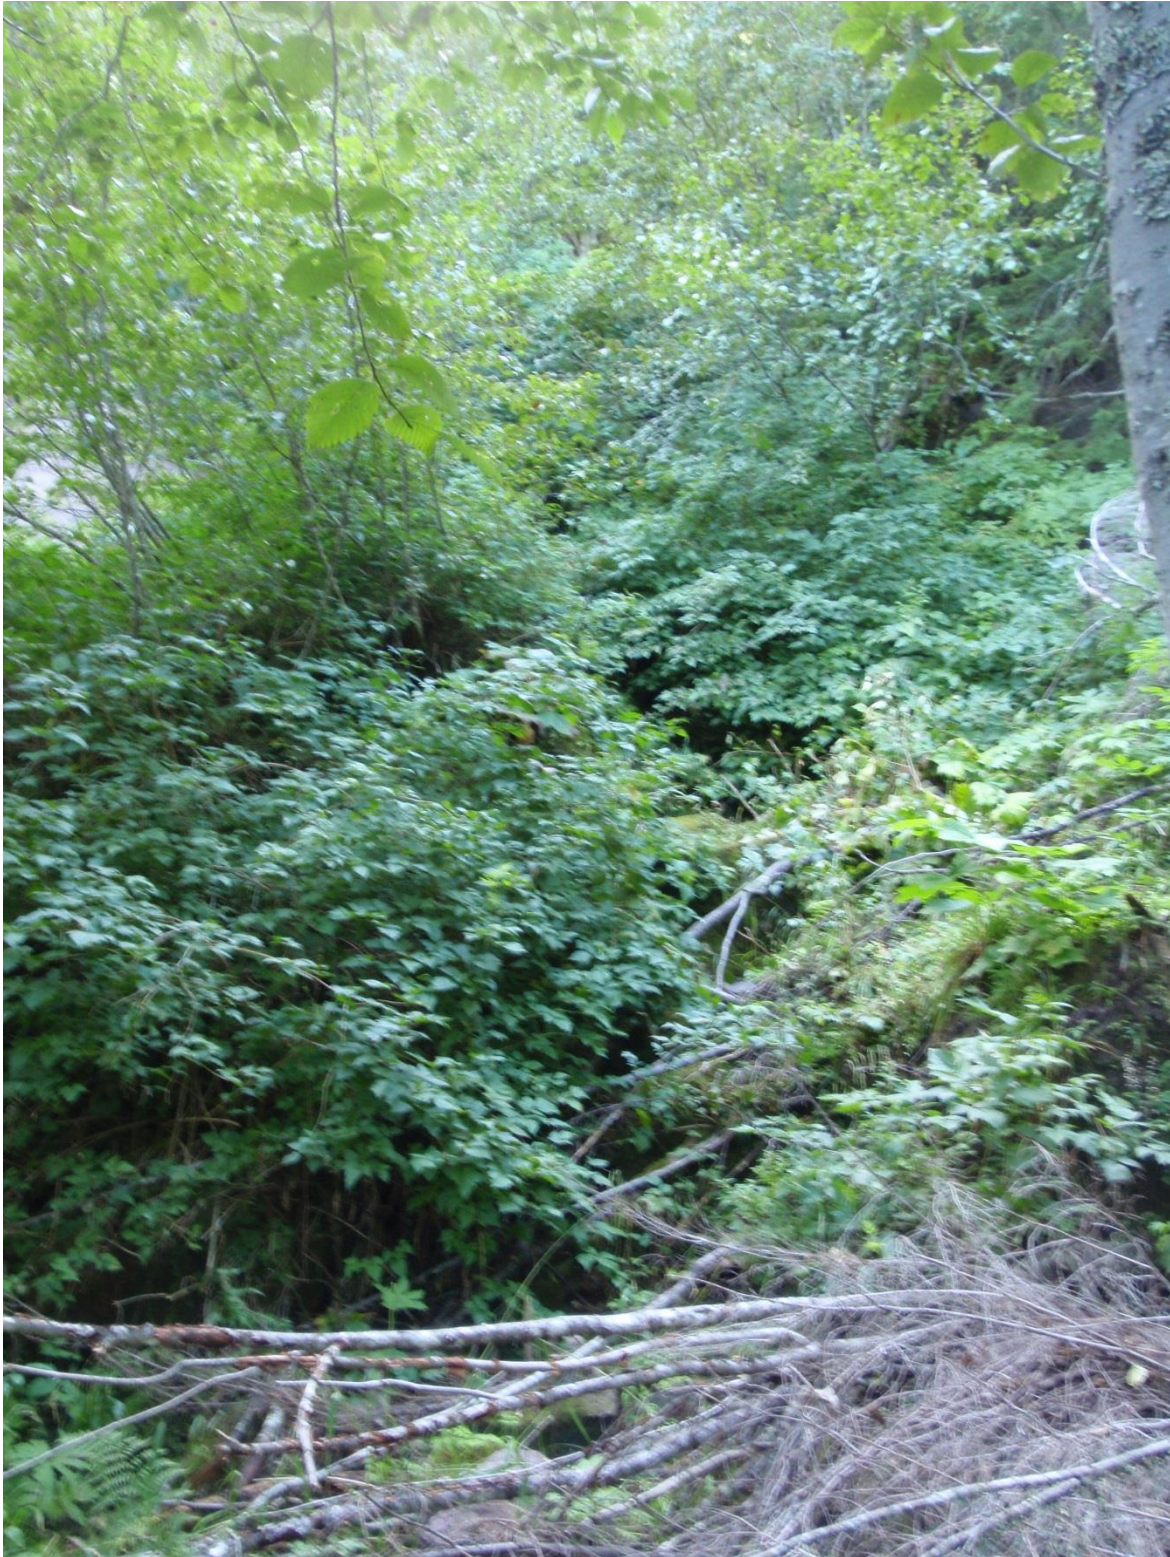
Appendix Figure 3: Point 10 Channel. Photo detailing the smaller clogged channel contacting the trail from upslope at point 10. This channel is constricted at its base and produces some ponding near the trail.

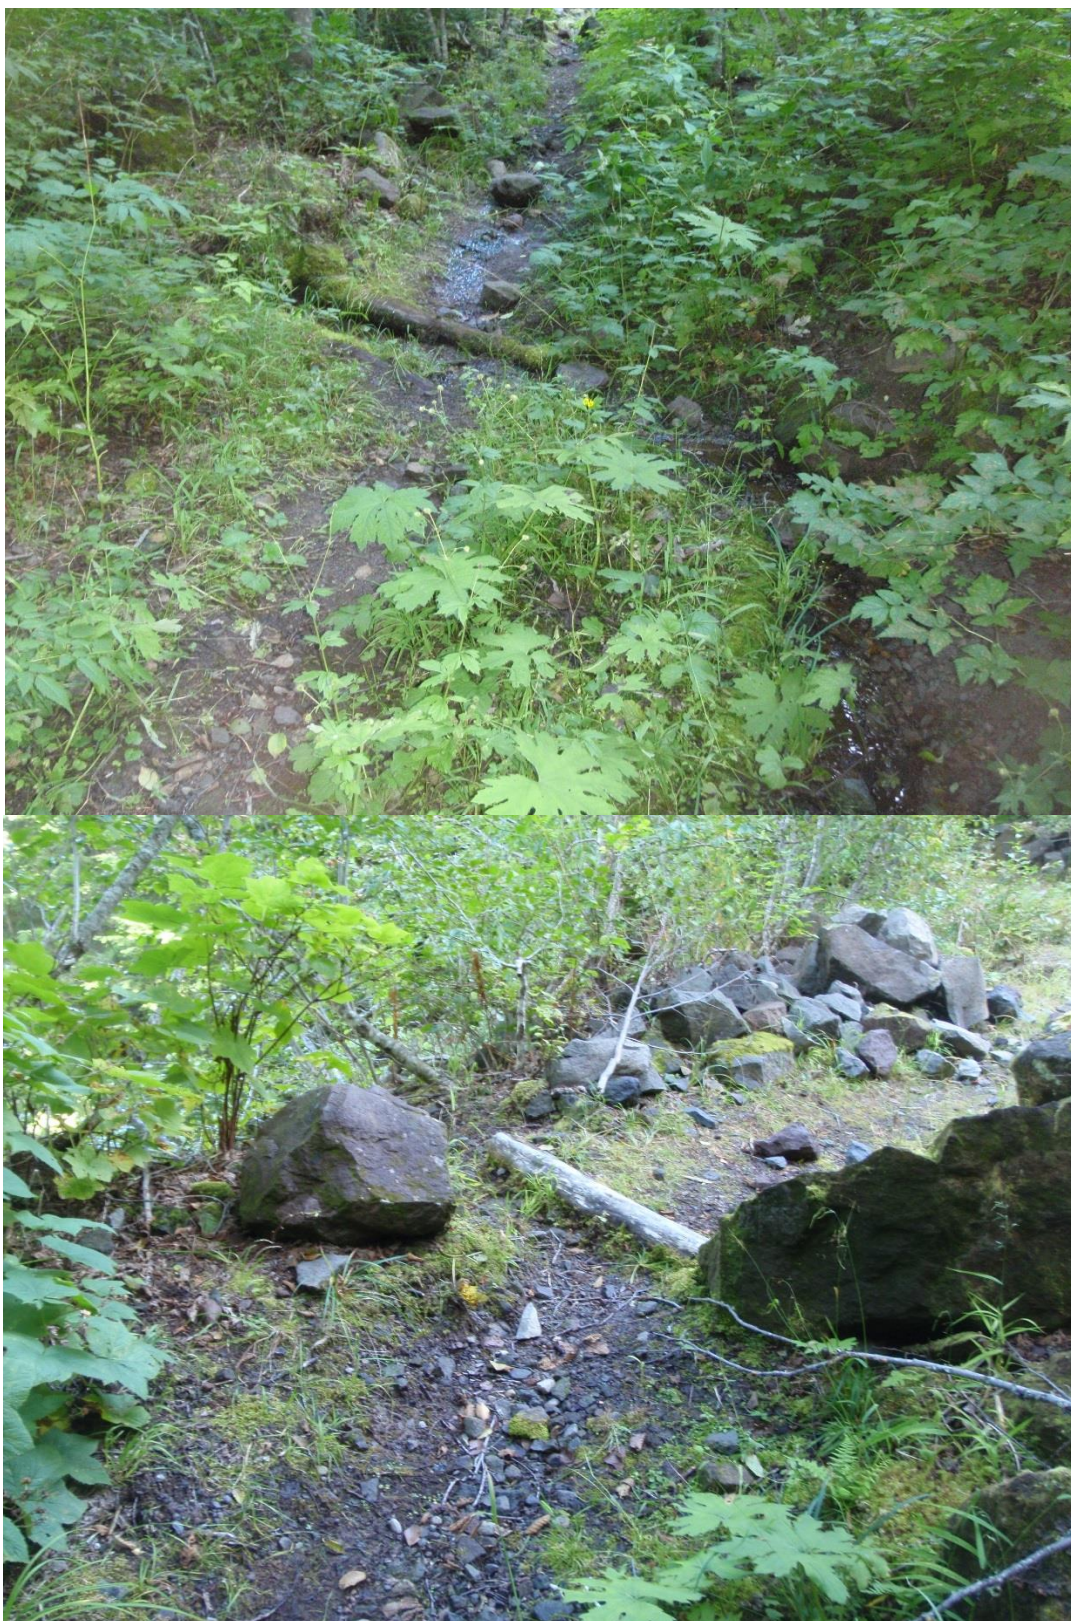
Appendix Figure 4: Point 11 and 12 Waterbars. Upper photo details the input and condition of the waterbar that I labeled as point 11. Lower photo shows the same for point 12. Note how point 12 is dry but still has scour sourced from point 11.

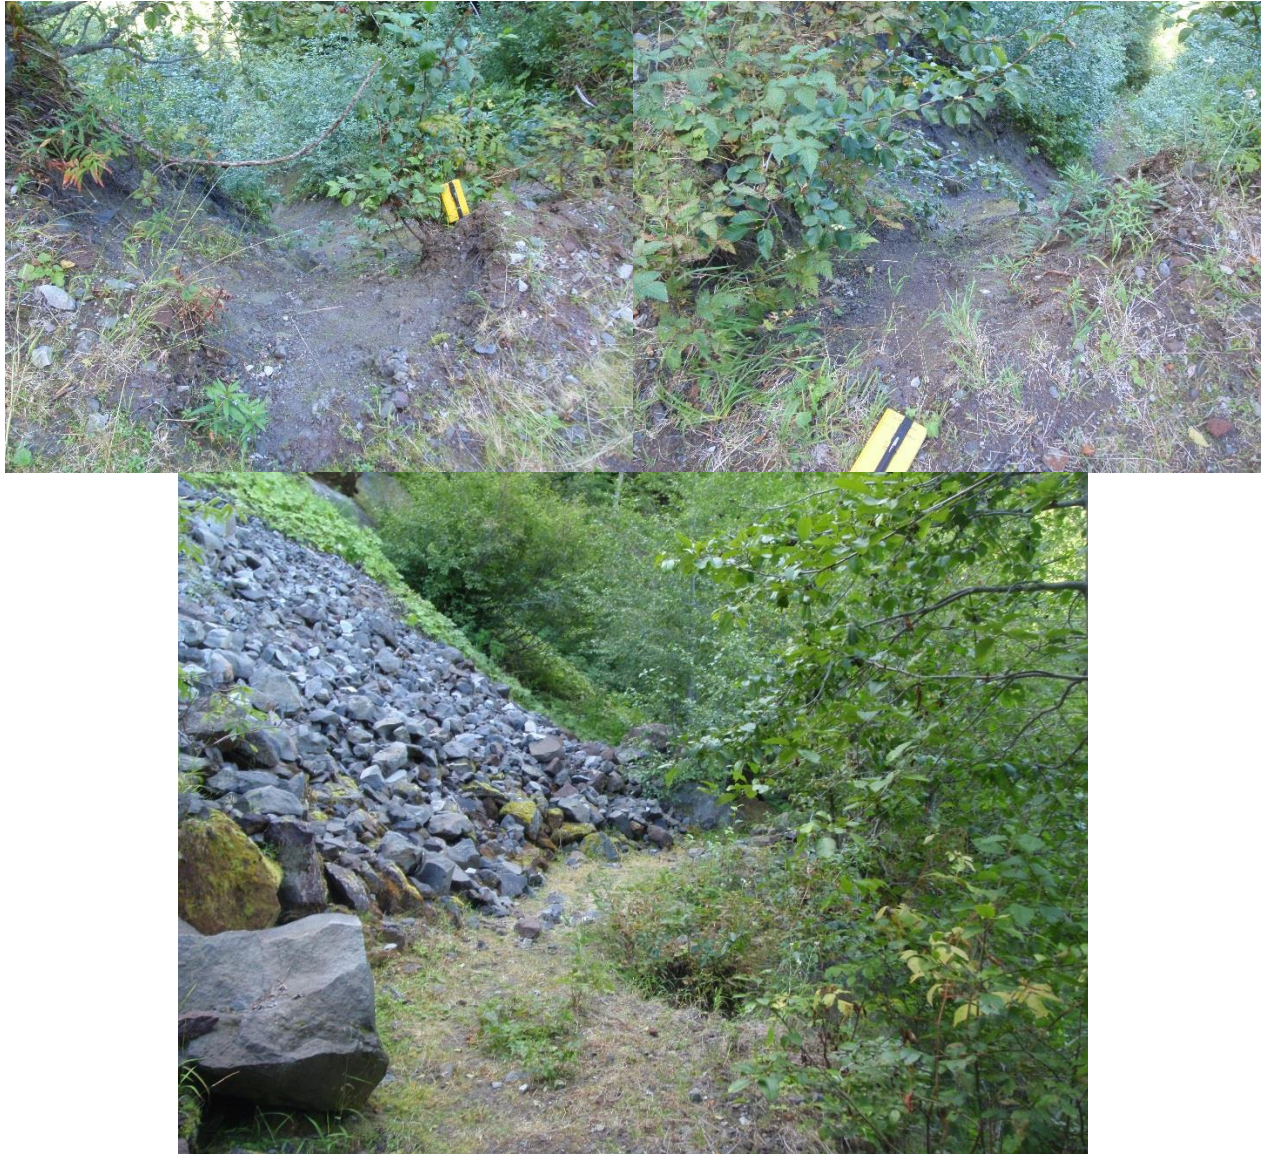
Appendix Figure 5: Point 13 Conditions. Upper left and right photos show the W and E colluvial hollow crowns, respectively. The lower photo is taken from the E edge of the point looking W, and shows the rockfall that contacts the trail.

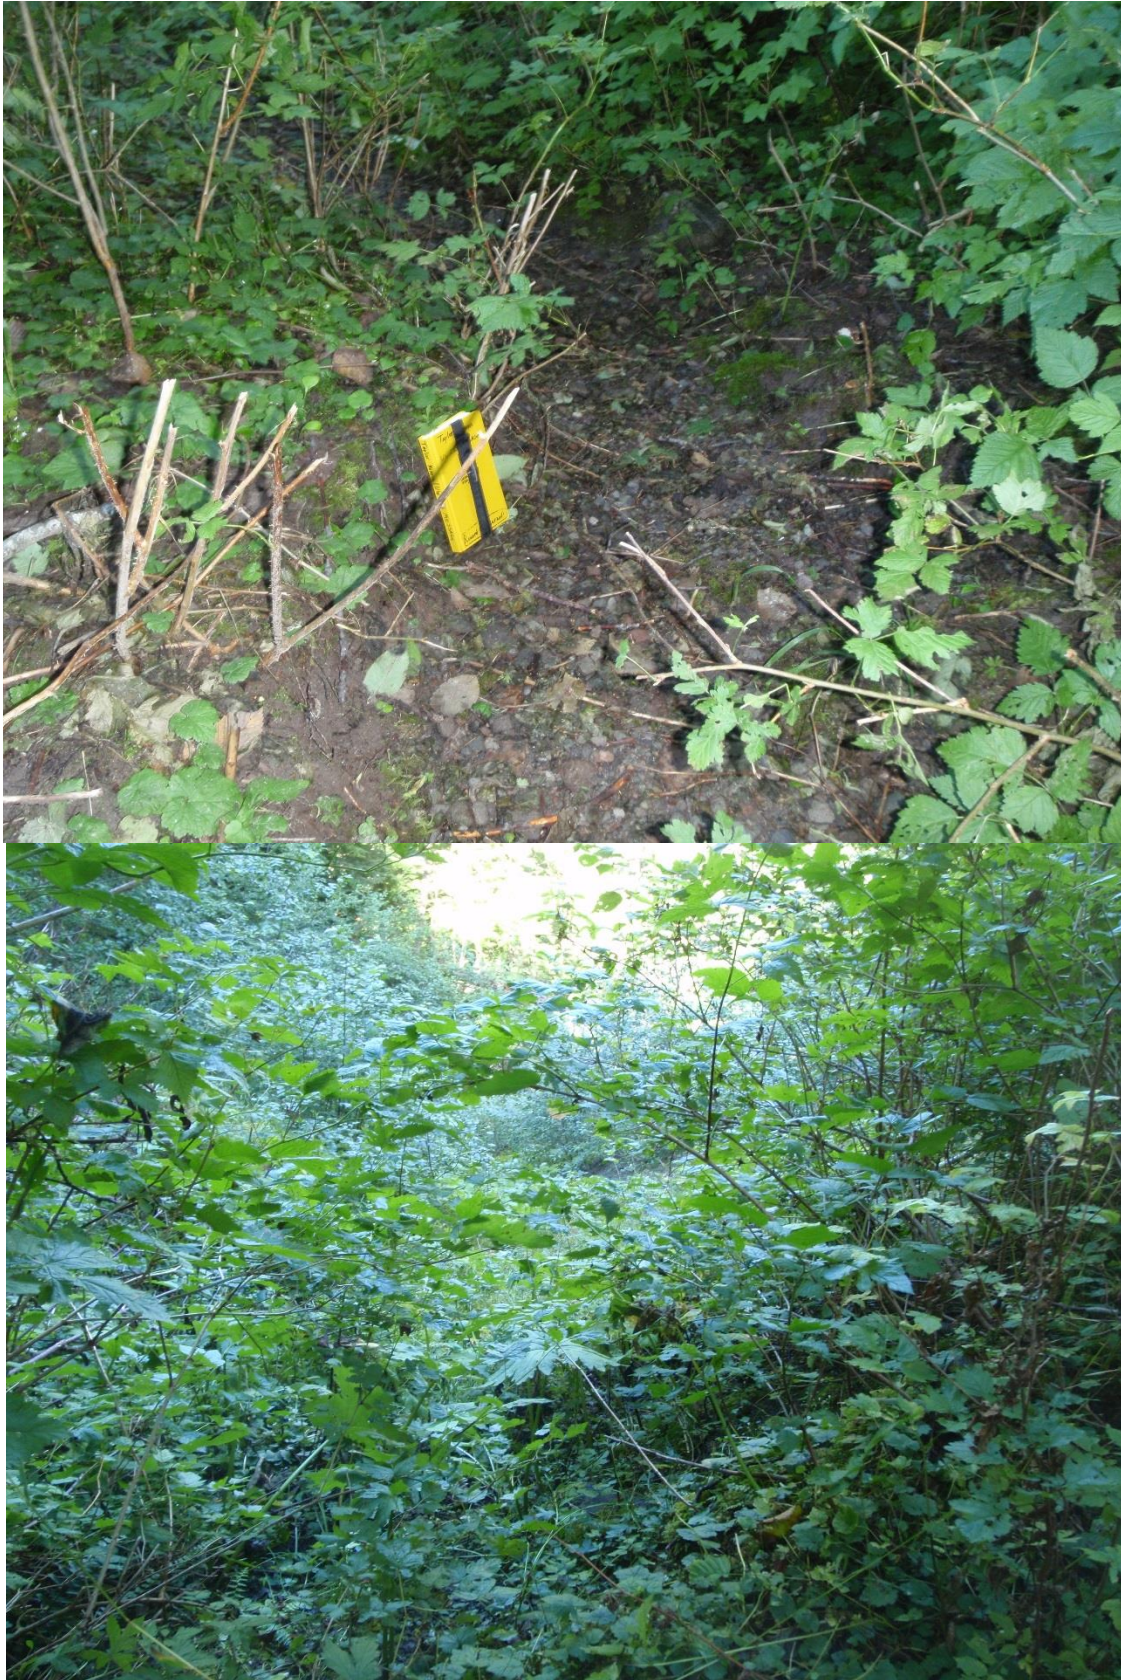
Appendix Figure 6: Point 21 Conditions. Upper photo shows the surface scouring that exists near the point 21 colluvial hollow headwall. Lower photo shows the condition of the interior of the hollow. The scour in the upper photo does not lead into the hollow.

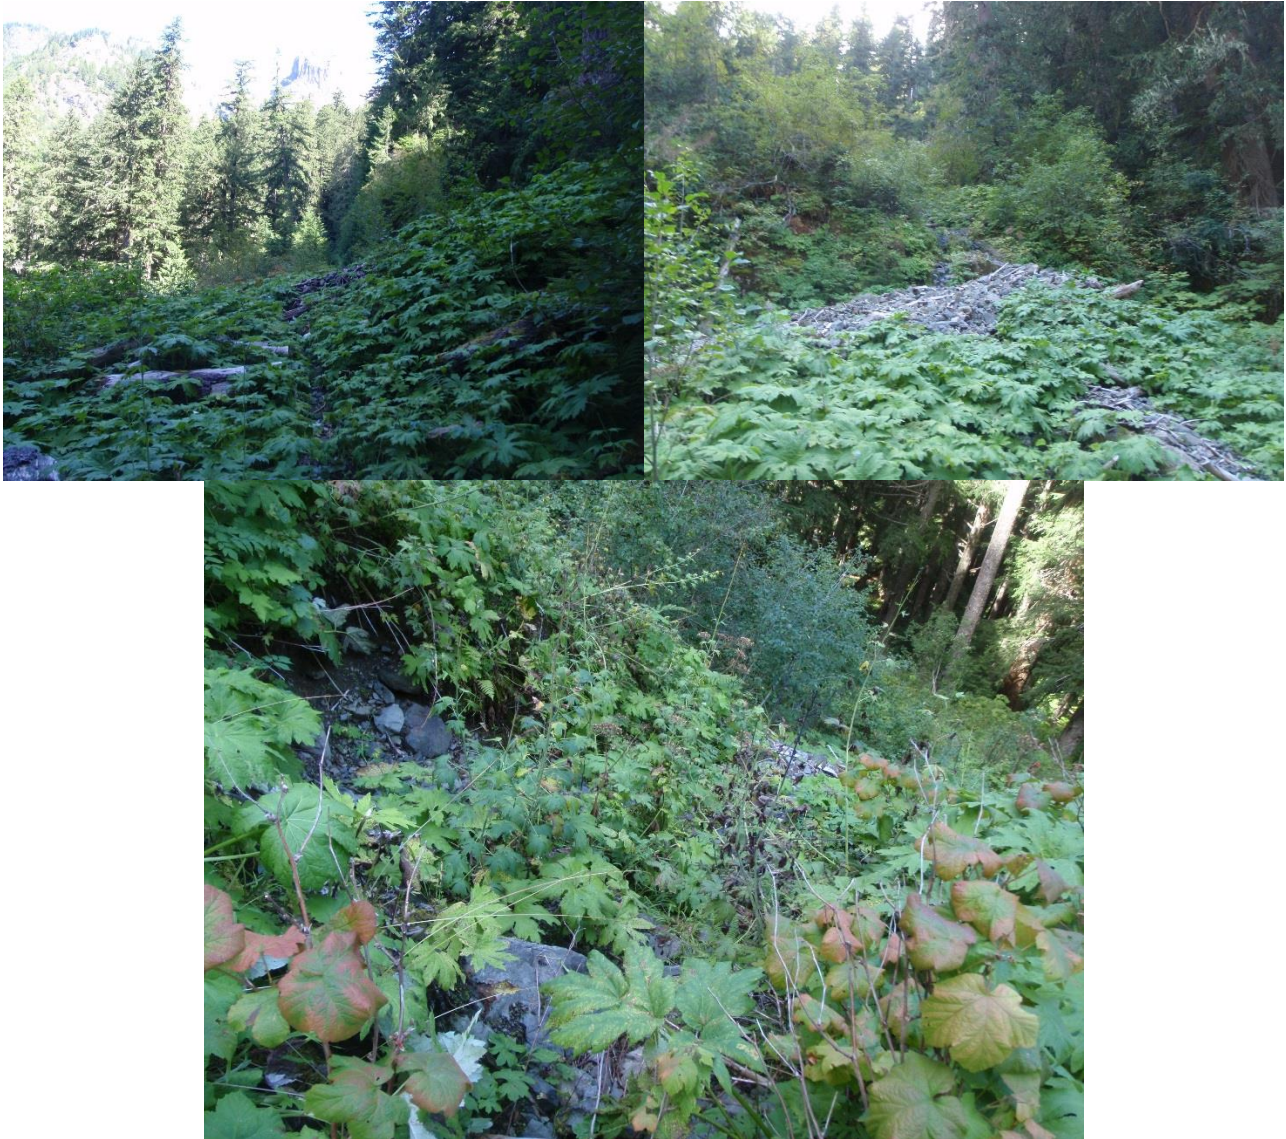
Appendix Figure 7: Point 32 Conditions. Upper left and right photos show the W side of the alluvial fan and the axis of the fan looking upslope at the channel, respectively. Lower photo shows the interior of the small hollow in the fill slope.

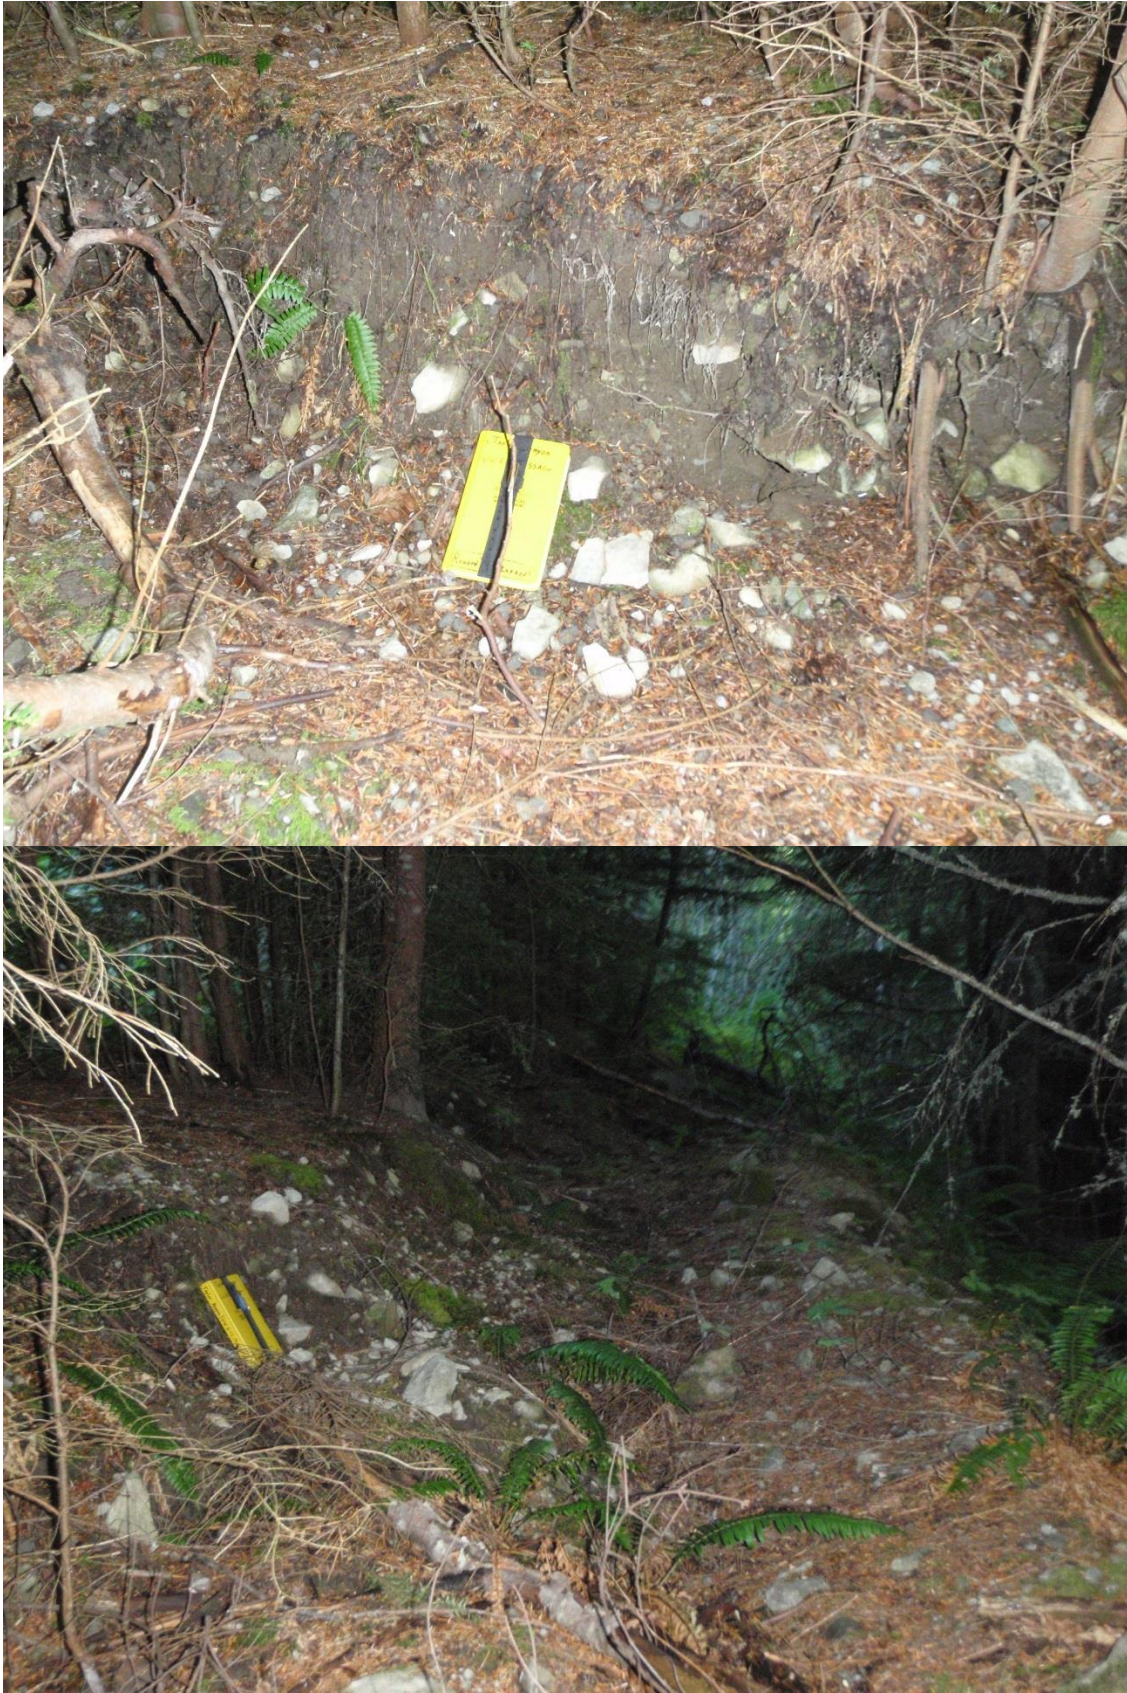
Appendix Figure 8: Deep-Seated Hazard Example. Upper photo shows an example of vertical offset above a bench within the hazard zone. Lower photo is a view of the same location looking W. These are just one example of benching and cracking that occur across this 280 meter zone of trail.
