**Using the Rockfall Activity Index to assess the impact of scaling on rock fall activity
at Glitter Gulch, Alaska**

Master of Science
Earth and Space Sciences: Applied Geosciences

University of Washington

May, 2019

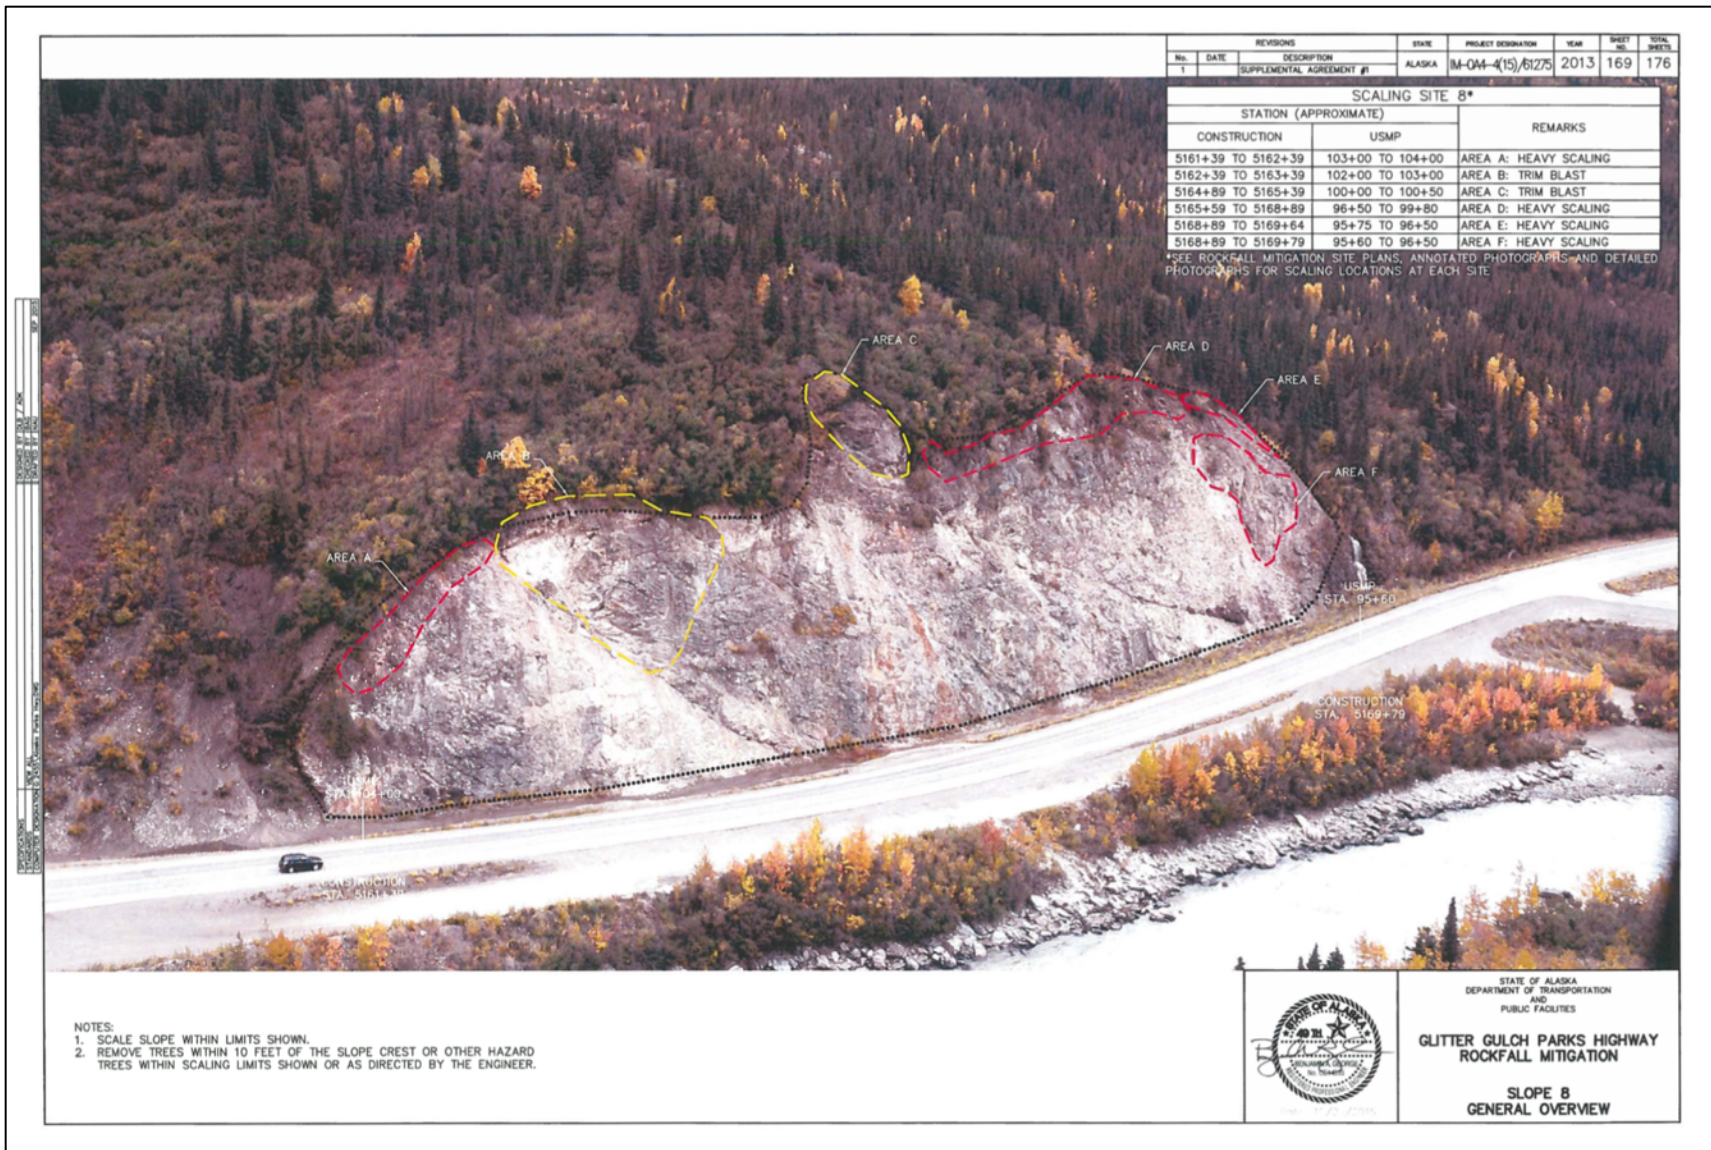
In 2016, ADOT&FS began a year-long scaling project at Glitter Gulch. The work was prompted when an engineer identified a larger than acceptable risk of rock fall during construction activities for a re-grading project from Mile Posts (MP) 239-252 (Jeff Curry, personal communication, 2018). A scaling crew, Landslide Technology, was hired to remove loose material from the five most hazardous of the eleven slopes along the stretch to be re-graded, by scaling and trim blasting as well as installing extensive barriers between the catchment ditches and the George Parks Highway where the ditch was determined to be insufficient to protect the roadway. The change orders delineating the extent of the ~\$15 Million slope maintenance project is attached as an appendix, and a map of the planned work for the slope in my study is shown on Figure 4.

Figure 4: Annotated oblique aerial image of the study outcrop generated by ADOT&FS denoting the planned areas for scaling (red) and trim blasting (yellow) for the 2016 maintenance project.

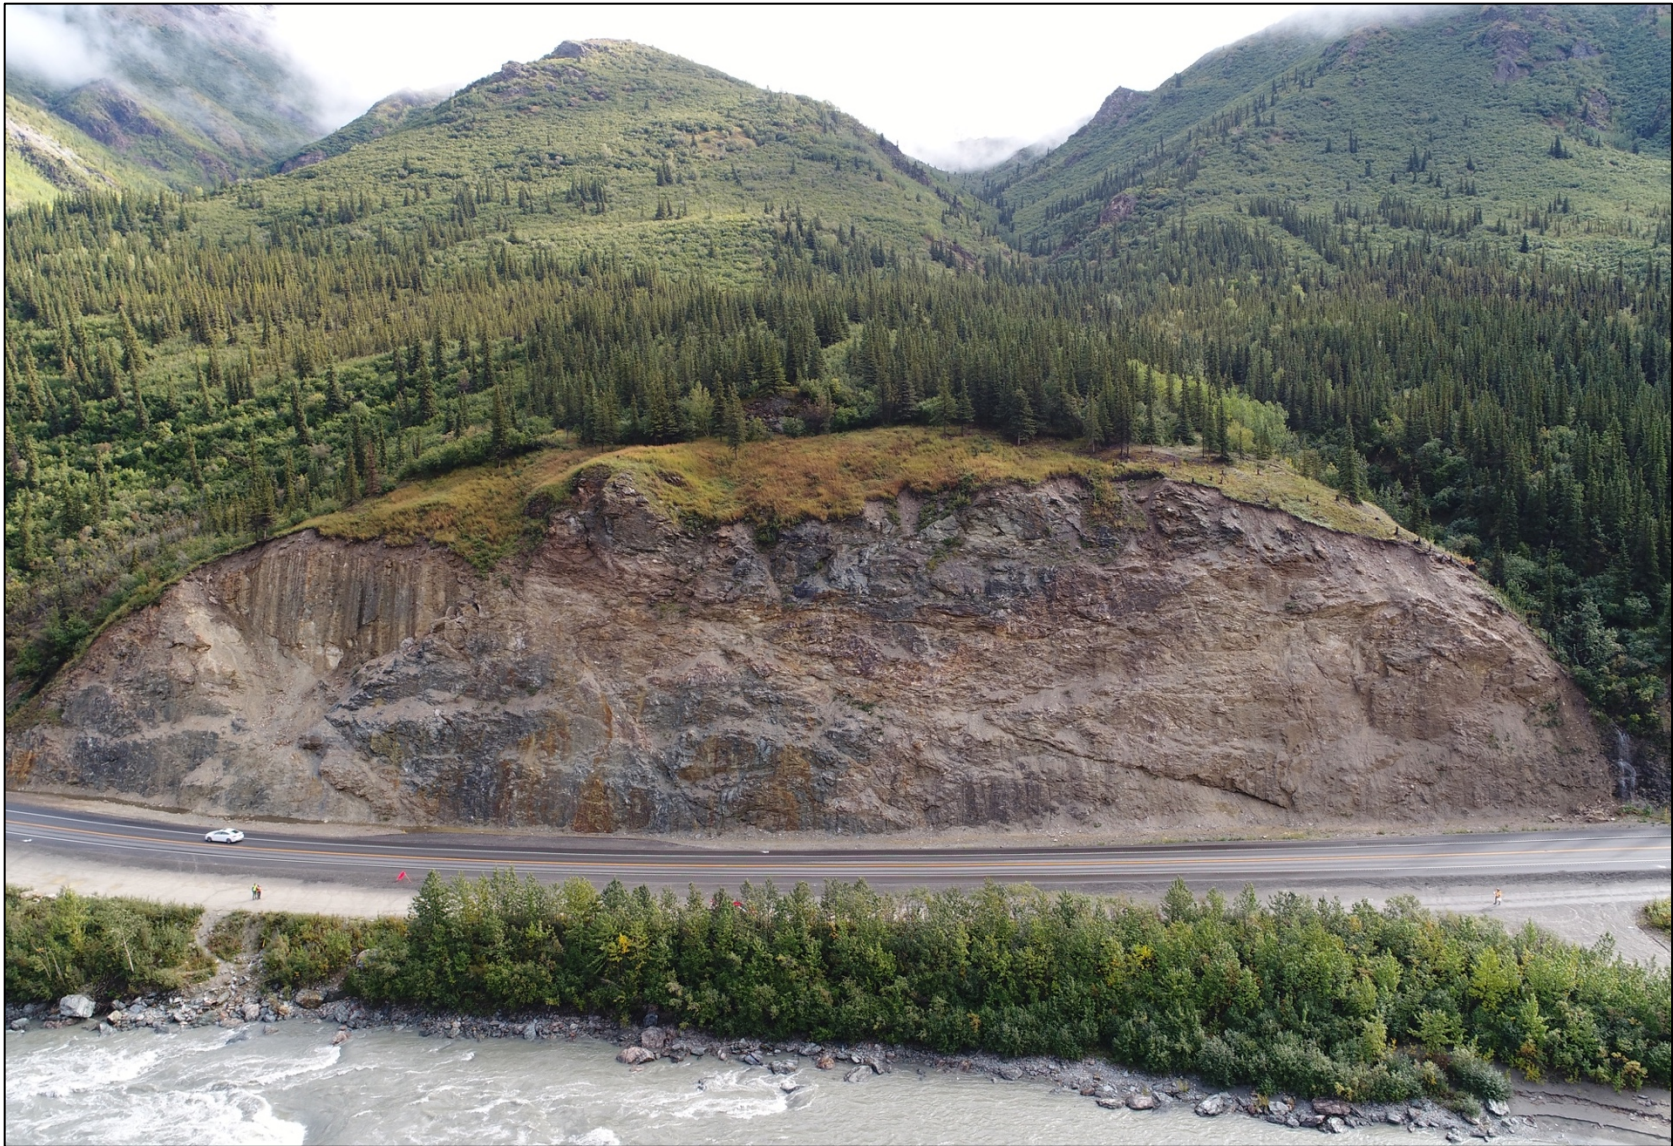
northbound traveling traffic (Figure 7). The slope is part of an arcuate hill that is a segment of Mount Healy that was separated by the Nenana River. I estimated the uniaxial compressive strength (UCS) of the rock in the field with blows of a standard rock hammer. The rock has a UCS of weak to very weak (<25 MPa) where schist dominated and strong to extremely strong (>25 MPa) where quartzite veining dominates. Micaceous talus clings to the slope above ledges and oxidization stains approximately 75% of the face. The schistosity is parallel/sub-parallel to the slope and there are a few, widely-spaced, intersecting joints with very high persistence.

The RHRS score is between 190 and 304. The dominant control of the score are the overall height of the slope and the very-high-persistence joints. At the time of the site visit, the minimal rock fall present was well within the ditch. However, visible track marks from heavy machinery indicated that the ditch had recently been cleaned. This made it difficult to classify the typical rock fall behavior. Yet, another of the high-hazard mitigated slopes that was not included in this study, had visible track marks as well as rock fall debris on the roadway so it is possible that sufficient time had passed since the ditch/road cleaning for rock fall to have accumulated.

Figure 7: Aerial photo taken in August 2018, of the study slope at MP 241 on the George Parks Highway near Glitter Gulch, Alaska. The image was captured with a DJI Phantom 4 drone flown by Jake Dafni. North is to the left; Sugar Loaf Mountain is in the distance and the Nenana River is in the foreground. Quartzite dominated regions of the outcrop present as grey while more micaceous regions appear brown in this image.

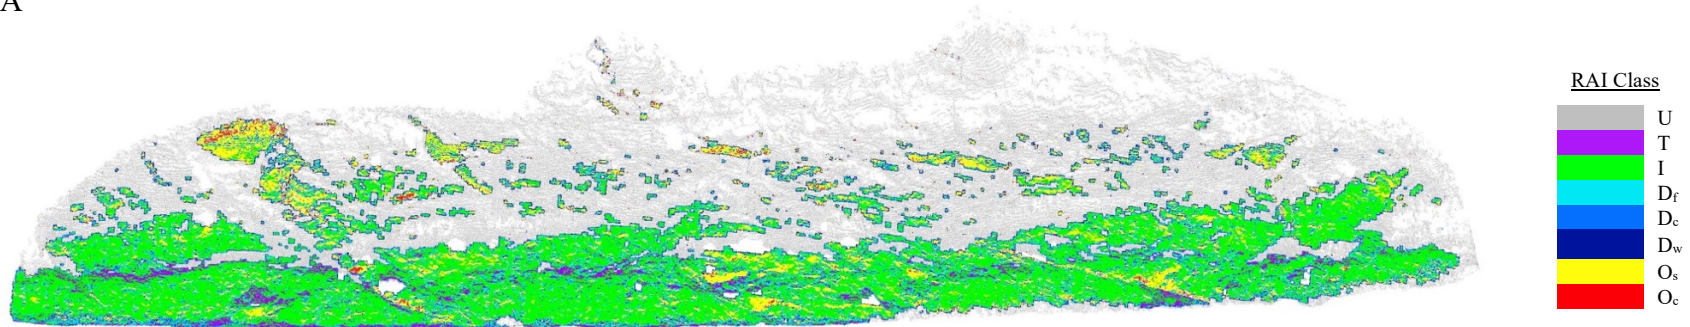
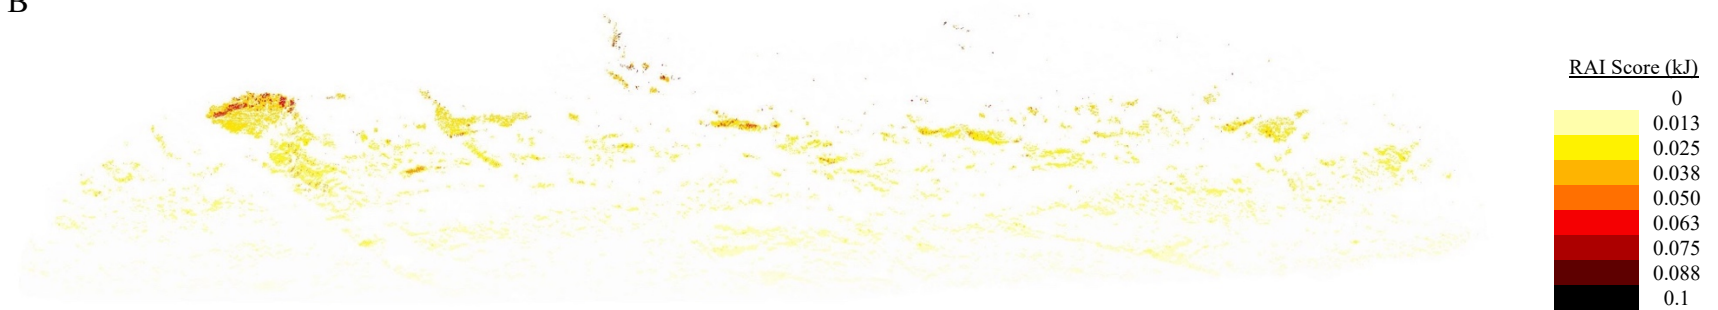
The portions of the slope that are mapped represent the morphology well (Figure 8A). The lower third of the slope was nearly sufficiently captured and overhangs along discontinuities are accurately identified. The middle, approximately third of the slope, is less than 15% mapped but significant hazards such as the large wedge on the upper-left are, at least in part, identified. The upper third of the slope is not well represented in the RAI analysis with the exception of small spots on the large knob in the upper-center of the slope.

With the caveat of the poor resolution, hazardous areas such as overhangs and small blocky sections around discontinuities are flagged as being significantly hazardous (orange and red in Figure 8B). Better resolution is needed to analyze further.

Figure 8: RAI Classes (A) and RAI Scores (B) for the 2012 scan of the study slope at MP 241 on the George Parks Highway near Glitter Gulch, Alaska. Refer to Figure 6 for a description of the RAI Classes. The white areas in A are holes in the data set and grey areas are where there is insufficient data for classification of a morphology type.

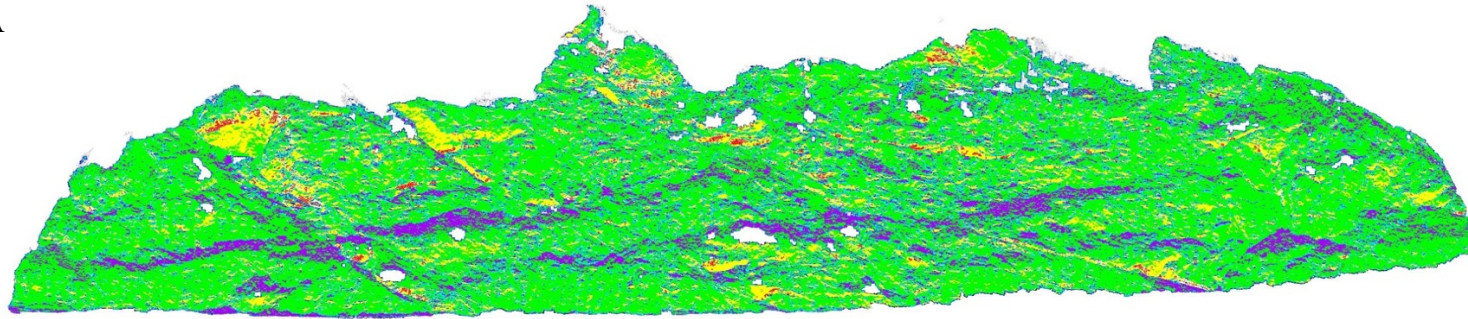
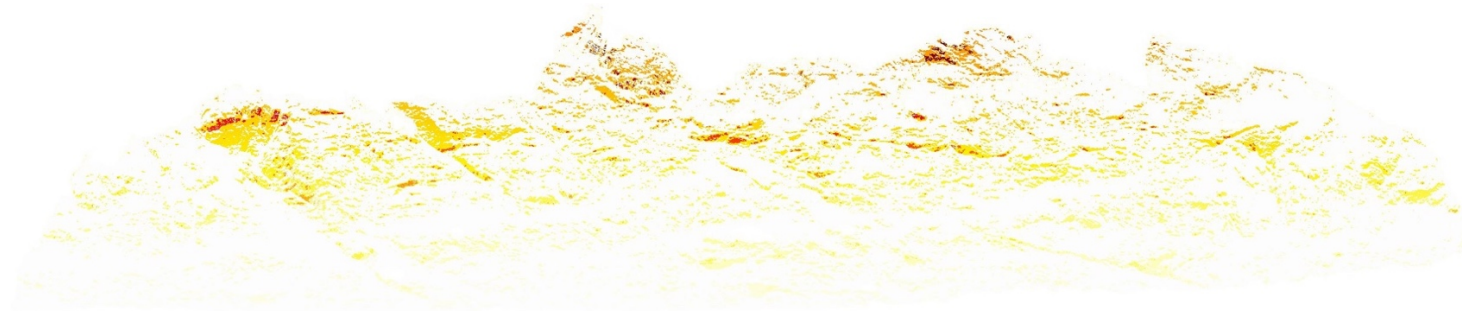
Mapped hazards are well highlighted but poorly scored (Figure 9B). Large protrusions high on the slope are only mapped as having a moderate hazard (orange) even though there are unfavorable discontinuities having the potential to create blocks up to 9 m in diameter, over 15 m high on the slope. Small block (<0.5 m) potential failures from atop ledges at the same elevation are given approximately the same kJ rating as the large protrusions.

Figure 9: RAI Classes (A) and RAI Scores (B) for the 2013 scan of the study slope at MP 241 on the George Parks Highway near Glitter Gulch, Alaska. Refer to Figure 6 for a description of the RAI Classes.

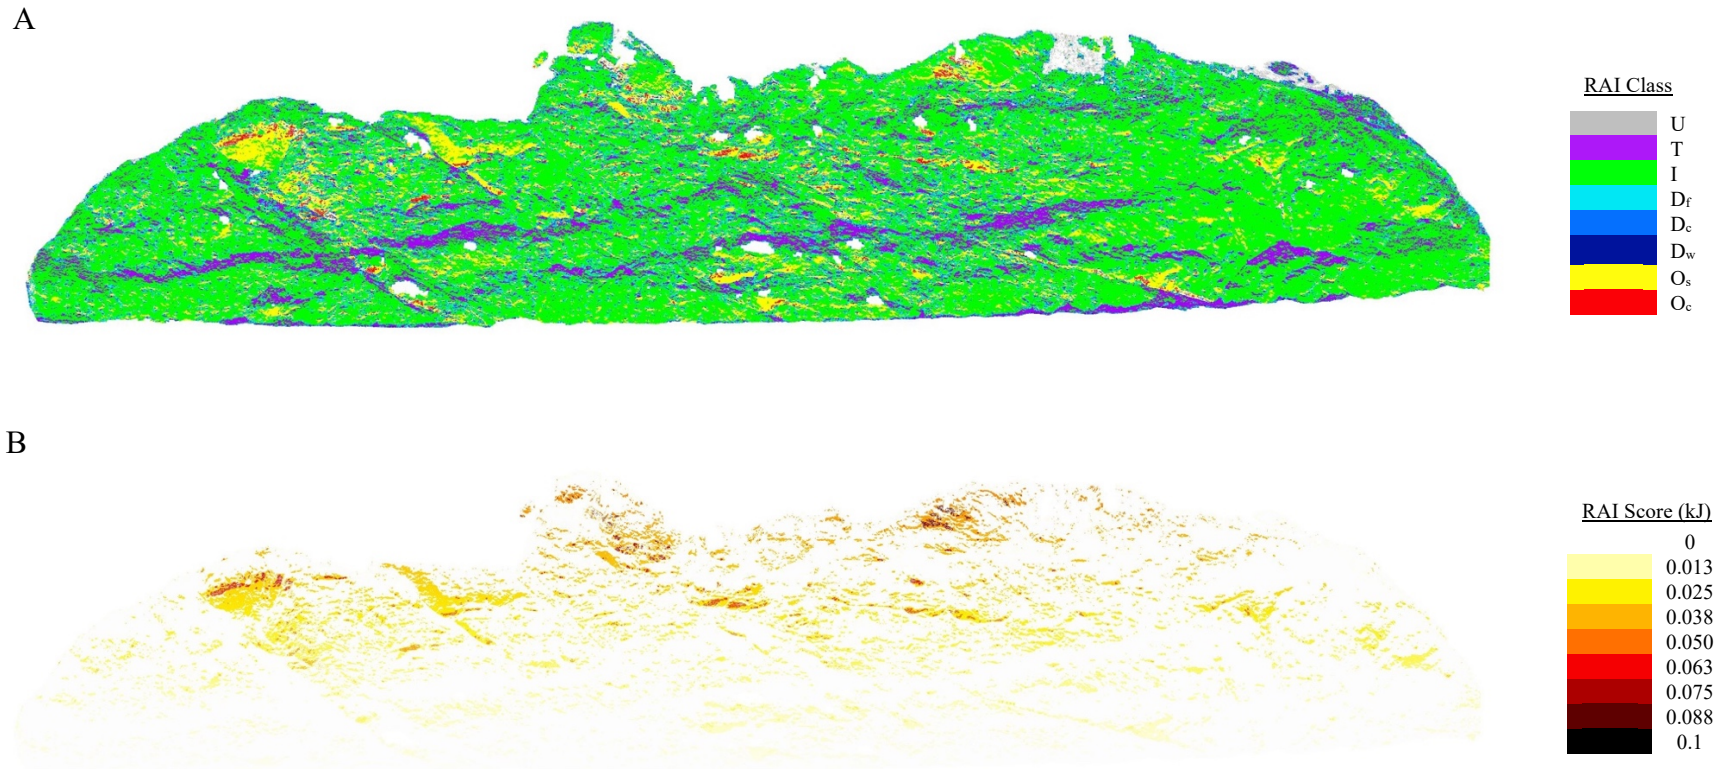
Mapped hazards also gained significant resolution from the previous year (Figure 10B). The color re-distribution from 2013 to 2014 suggests that the total RAI score for the slope likely did not increase though a larger portion of the slope is identified as at least a small hazard. Reclassifications from “Intact” to “Widely-Spaced Discontinuous” increased in hazard while reclassifications from “Widely-Spaced Discontinuous” to “Closely-Spaced Discontinuous” or “Fragmented Discontinuous” decreased hazard.

Figure 10: RAI Classes (A) and RAI Scores (B) for the 2014 scan of the study slope at MP 241 on the George Parks Highway near Glitter Gulch, Alaska. Refer to Figure 6 for a description of the RAI Classes.

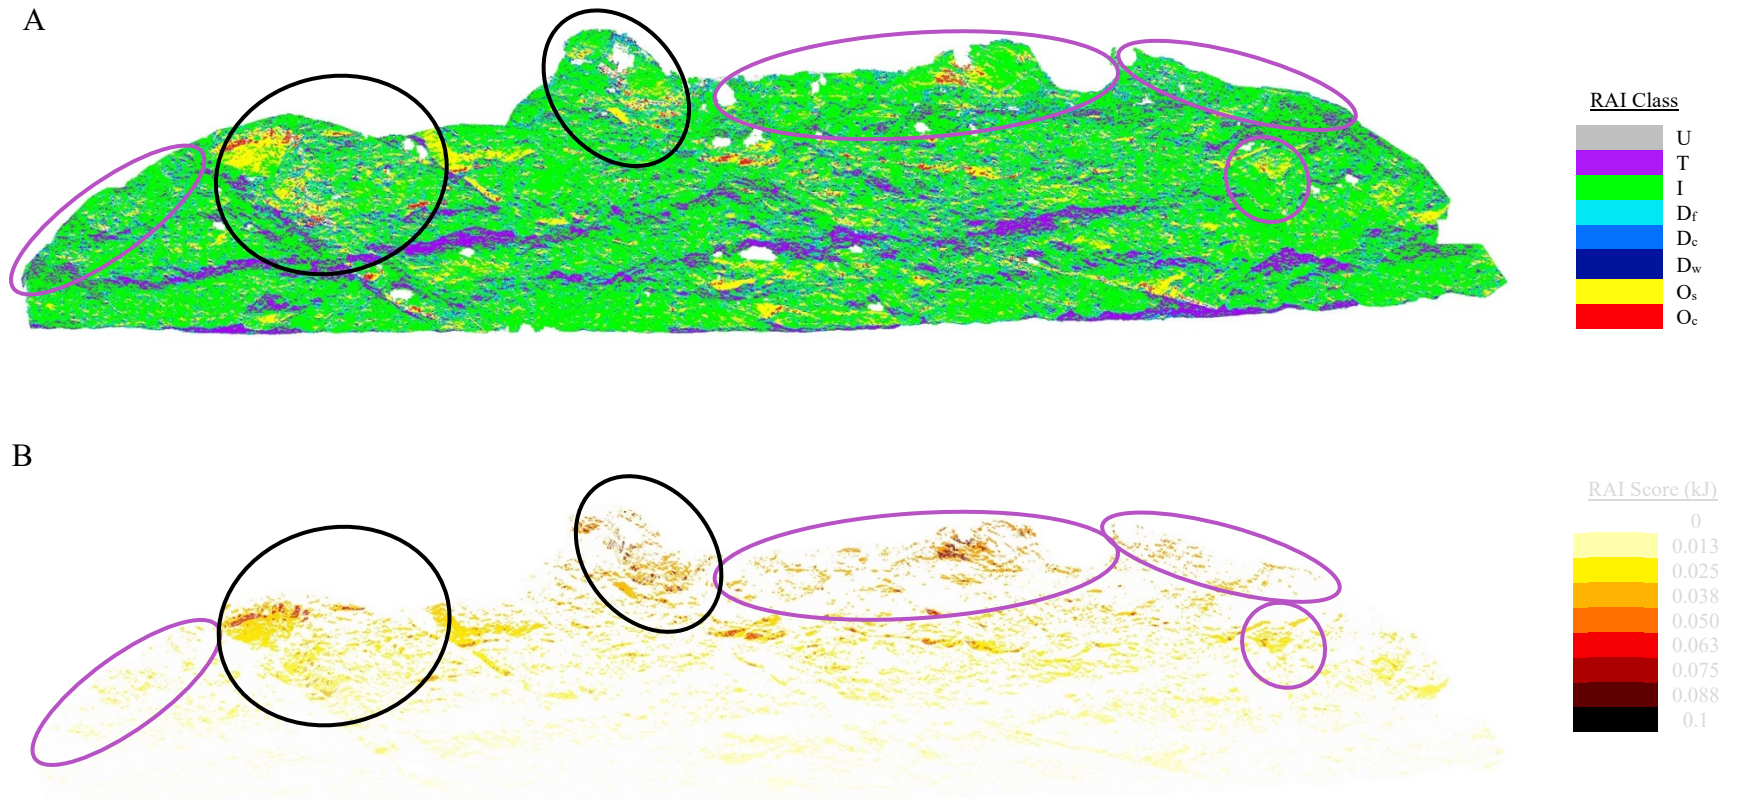
The morphology and hazard mapping patterns follow those listed for 2013 and 2014. Due to an increase in resolution, volumes of rock classified as “Intact” decreased while “Discontinuous” and “Talus” classified rock volumes increased (Figure 11A). Additionally, more of the slope is mapped as having some hazard while areas mapped as significant hazard have been further segmented into smaller areas of significant hazard surrounded by lower hazard or no hazard (Figure 11B).

Figure 11: RAI Classes (A) and RAI Scores (B) for the 2015 scan of the study slope at MP 241 on the George Parks Highway near Glitter Gulch, Alaska. Refer to Figure 6 for a description of the RAI Classes. Planned mitigation areas are circled in purple for scaling and black for trim blasting. (Compare to Figure 4.)

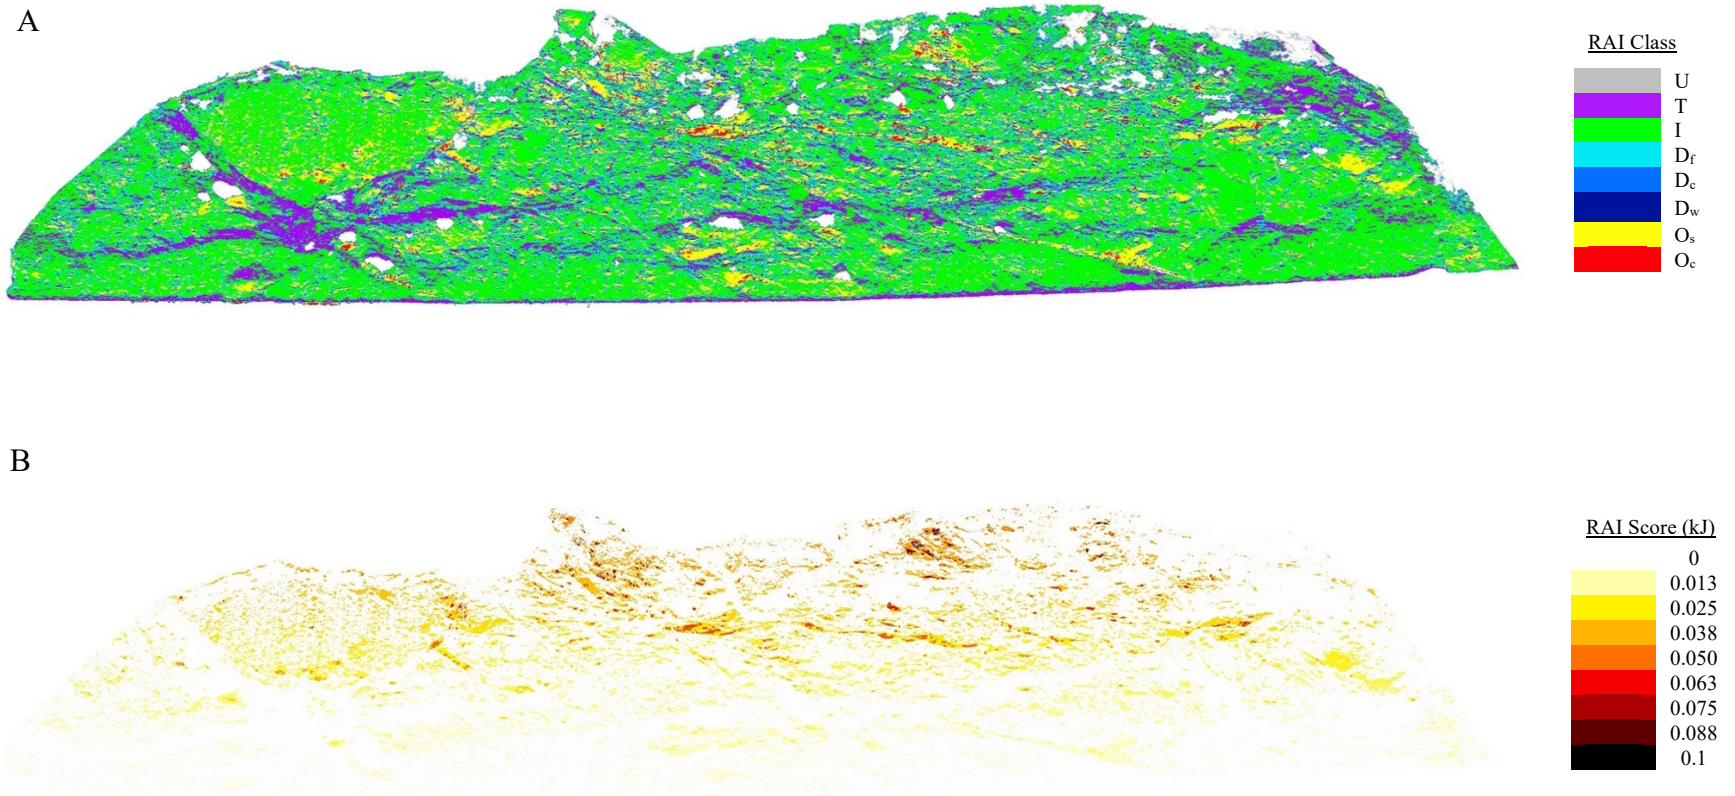
The hazard mapping identification patterns follow those indicated in 2013 and 2014 while the patterns of hazard changes follow that of the morphology changes (Figure 12B). The left third of the slope was downgraded significantly in maximum hazard from 2015, but a larger percentage of that section of the slope was re-mapped as having some hazard potential. The remainder of the slope actually increased in overall hazard with many new, small blocks (<0.5 m) being mapped as high hazard (red), and the upper third of the slope nearly doubling in volume mapped as moderate hazard (from zero).

Figure 12: Post-scaling RAI Classes (A) and RAI Scores (B) for the 2017 scan of the study slope at MP 241 on the George Parks Highway near Glitter Gulch, Alaska. Refer to Figure 6 for a description of the RAI Classes.

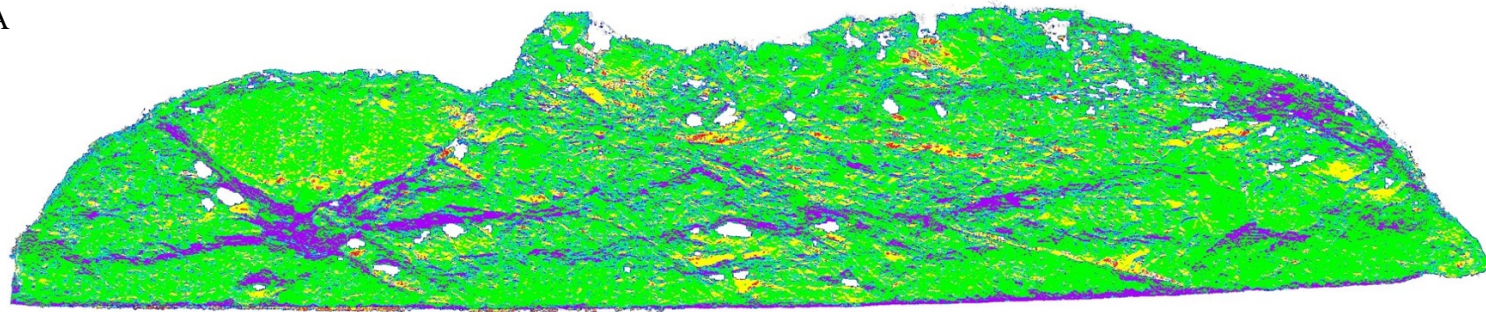
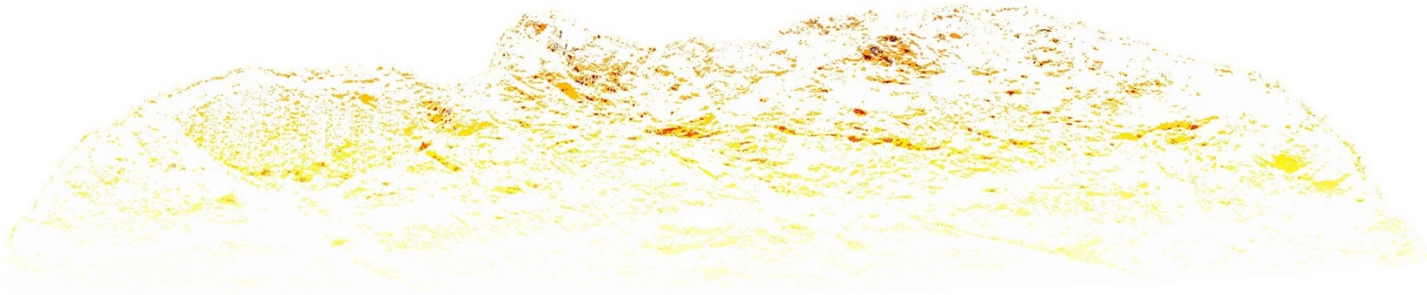
The overall hazard as indicated by the RAI score appears to have remained fairly constant as well (Figure 13B). The only notable changes are an increase in rock mapped as moderate hazard near the knob at the upper-middle region of the slope.

Figure 13: RAI Classes (A) and RAI Scores (B) for the 2018 scan of the study slope at MP 241 on the George Parks Highway near Glitter Gulch, Alaska. Refer to Figure 6 for a description of the RAI Classes.

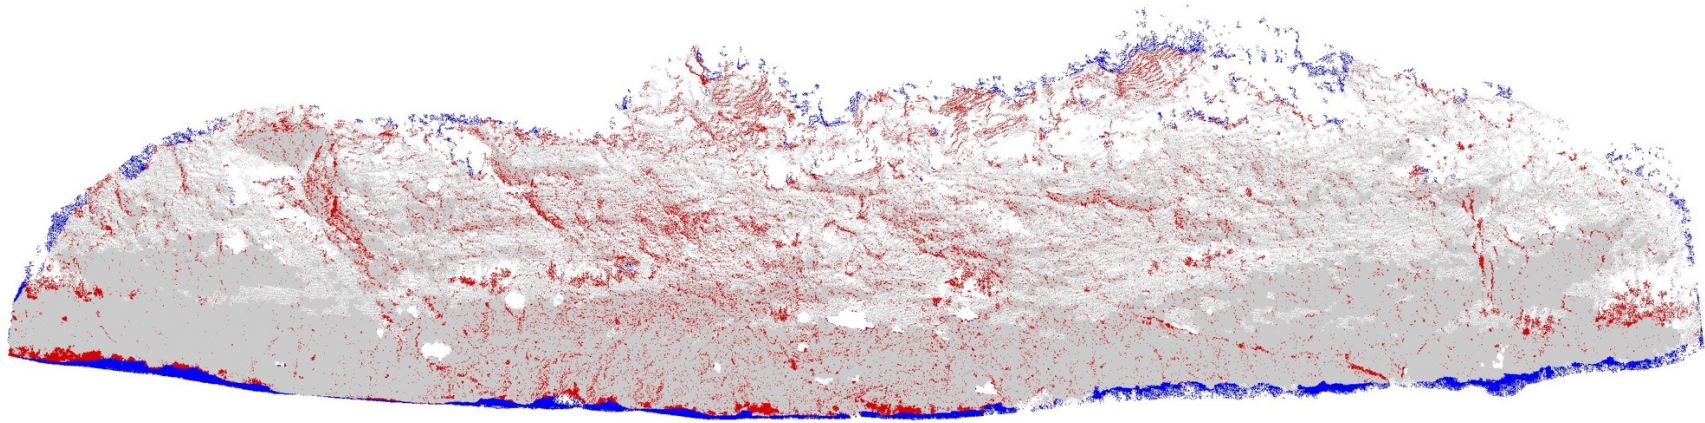
Even with significant hole filling due to the low resolution from the mobile scanner used to gather the 2012 data, change detection losses suggesting rock fall appear in the expected areas by visual inspection as well as those identified as hazardous by the RAI Score (Figure 14). Loss clusters follow expected areas of rock fall such as along major discontinuities, under overhangs, and in areas of talus accumulation. Each area identified as high hazard or moderate hazard by the RAI Score experienced a loss, at least partially. Significant losses lower in the slope were not predicted by the RAI Score map even though some were as high as 6 m from the base of the slope. Unfortunately, resolution was poorest in critical areas such as the highest points of the slope. Nearly all gains were points that were absent from the 2012 image (due to cropping) or were assigned an Unclassified morphology by the RAI software; the very few actual gains, at the base of the slope, were classified as Talus.

Figure 14: Change detection for Epoch 1 (2012-2013) of the study slope near MP 241 on the George Parks Highway near Denali, AK. The change from August 2012 to August 2013 is highlighted, with red representing apparent volume loss and blue representing apparent accumulation. Gains around the perimeter may represent differences in cropping of the point cloud data. The image shows the change data overlying the point cloud in grey with gradation due to changes in data density; the 2012 data was not colored RGB so an overlay with a true color image was not generated.

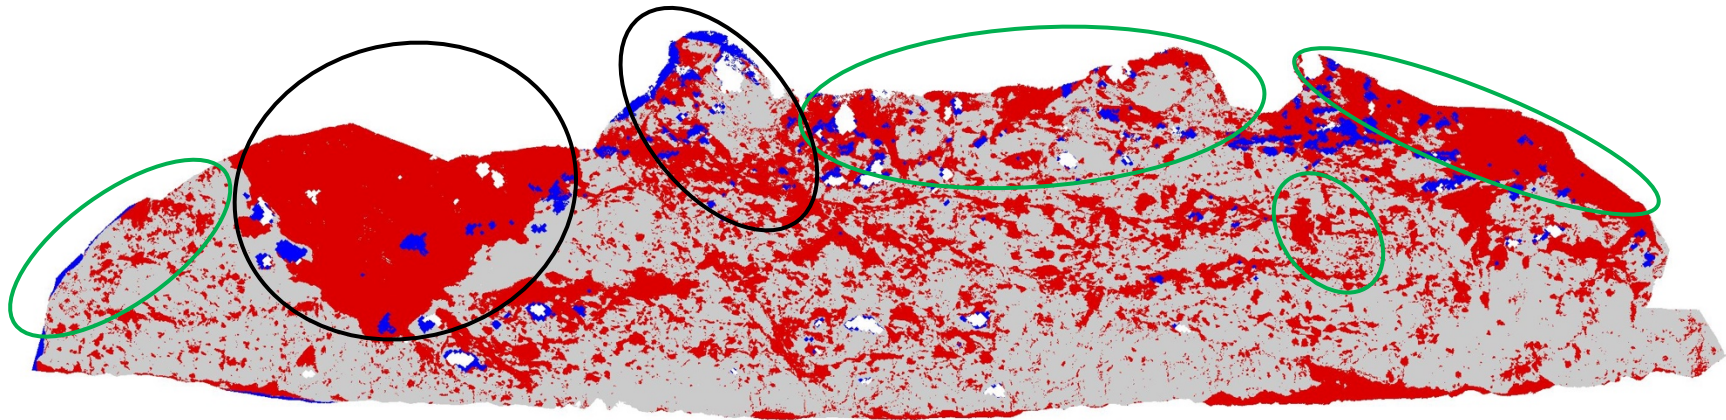
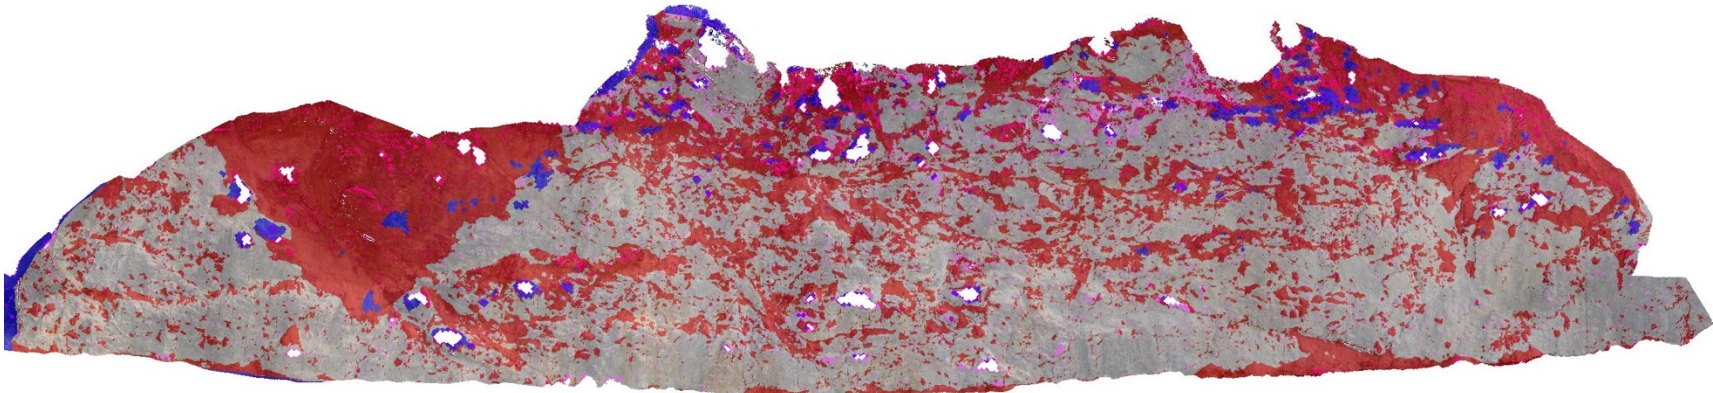
As expected, there were significant losses between these 2015 and 2017 (Figure 17), due to scaling operations on the slope. The large overhanging wedge in the upper left was removed as well overhanging massive section in the upper right. Much of the remaining losses follow lesser overhangs identified as high and moderate hazard, and ledges with significant “Talus” classified. Unexpected were the significant patches of gains appearing sporadically along the upper third of the slope, adjacent to significant losses.

Figure 17: Change detection for Epoch 4 (2015-2017) of the study slope near MP 241 on the George Parks Highway near Denali, AK. The change from August 2015 to August 2017 is highlighted, with red representing apparent volume loss and blue representing apparent accumulation. Points created by a hole-filling algorithm are fuchsia while significant data gaps are white. Image A shows the change data overlying the point cloud in grey, while image B shows the change data overlaying a true color point cloud from 2015 data. The large change is largely a result of a 2016 slope maintenance project of scaling and trim-blasting on the slope in conjunction with re-paving of the highway. The planned areas are circled in green: scaling and black: trim blasting. Gains around the perimeter of the slope may represent differences in cropping of the annual data.

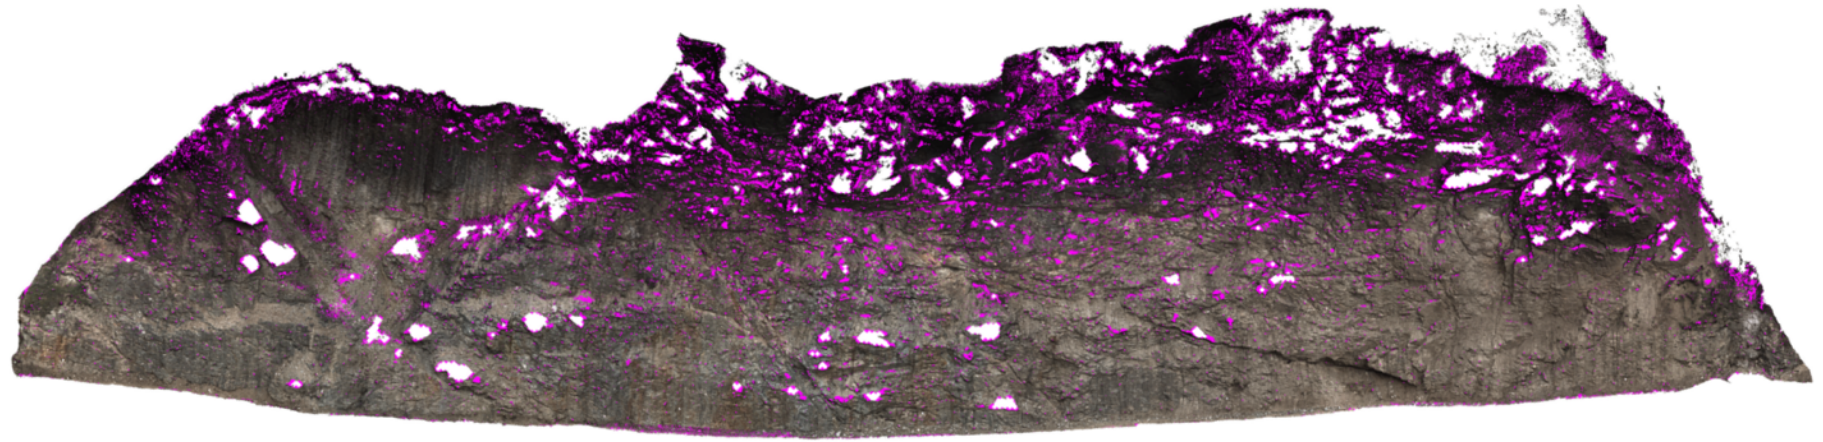
Errors (in the form of misidentification of change) arise due to a variation of the 3-D surface created from the point cloud in subsequent years that are independent of any actual change in the geometry of the slope face. Alignment errors are significantly less than the chosen threshold for change so any error present would be due to resolution or filtering. The most common cause of a misrepresented 3-D surface is vegetation that is incompletely removed being represented as part of the slope face; this may be partially corrected by a hole filling algorithm but may still result in mis-identification of slope failures (see Markus 2018). Hole filling can be significant, even in a very dense and well-cleaned data set (Figure 19).

Figure 19: Point cloud of the study slope using 2018 data with hole filling outputs colored fuchsia.
