Rockfall Reconnaissance and Stability Assessment: Frenchman Coulee, WA

A report prepared in partial fulfillment of  
the requirements for the degree of  
Master of Science  
Earth and Space Sciences: Applied Geosciences  
University of Washington

March, 2019

MESSAGe Technical Report Number: 071

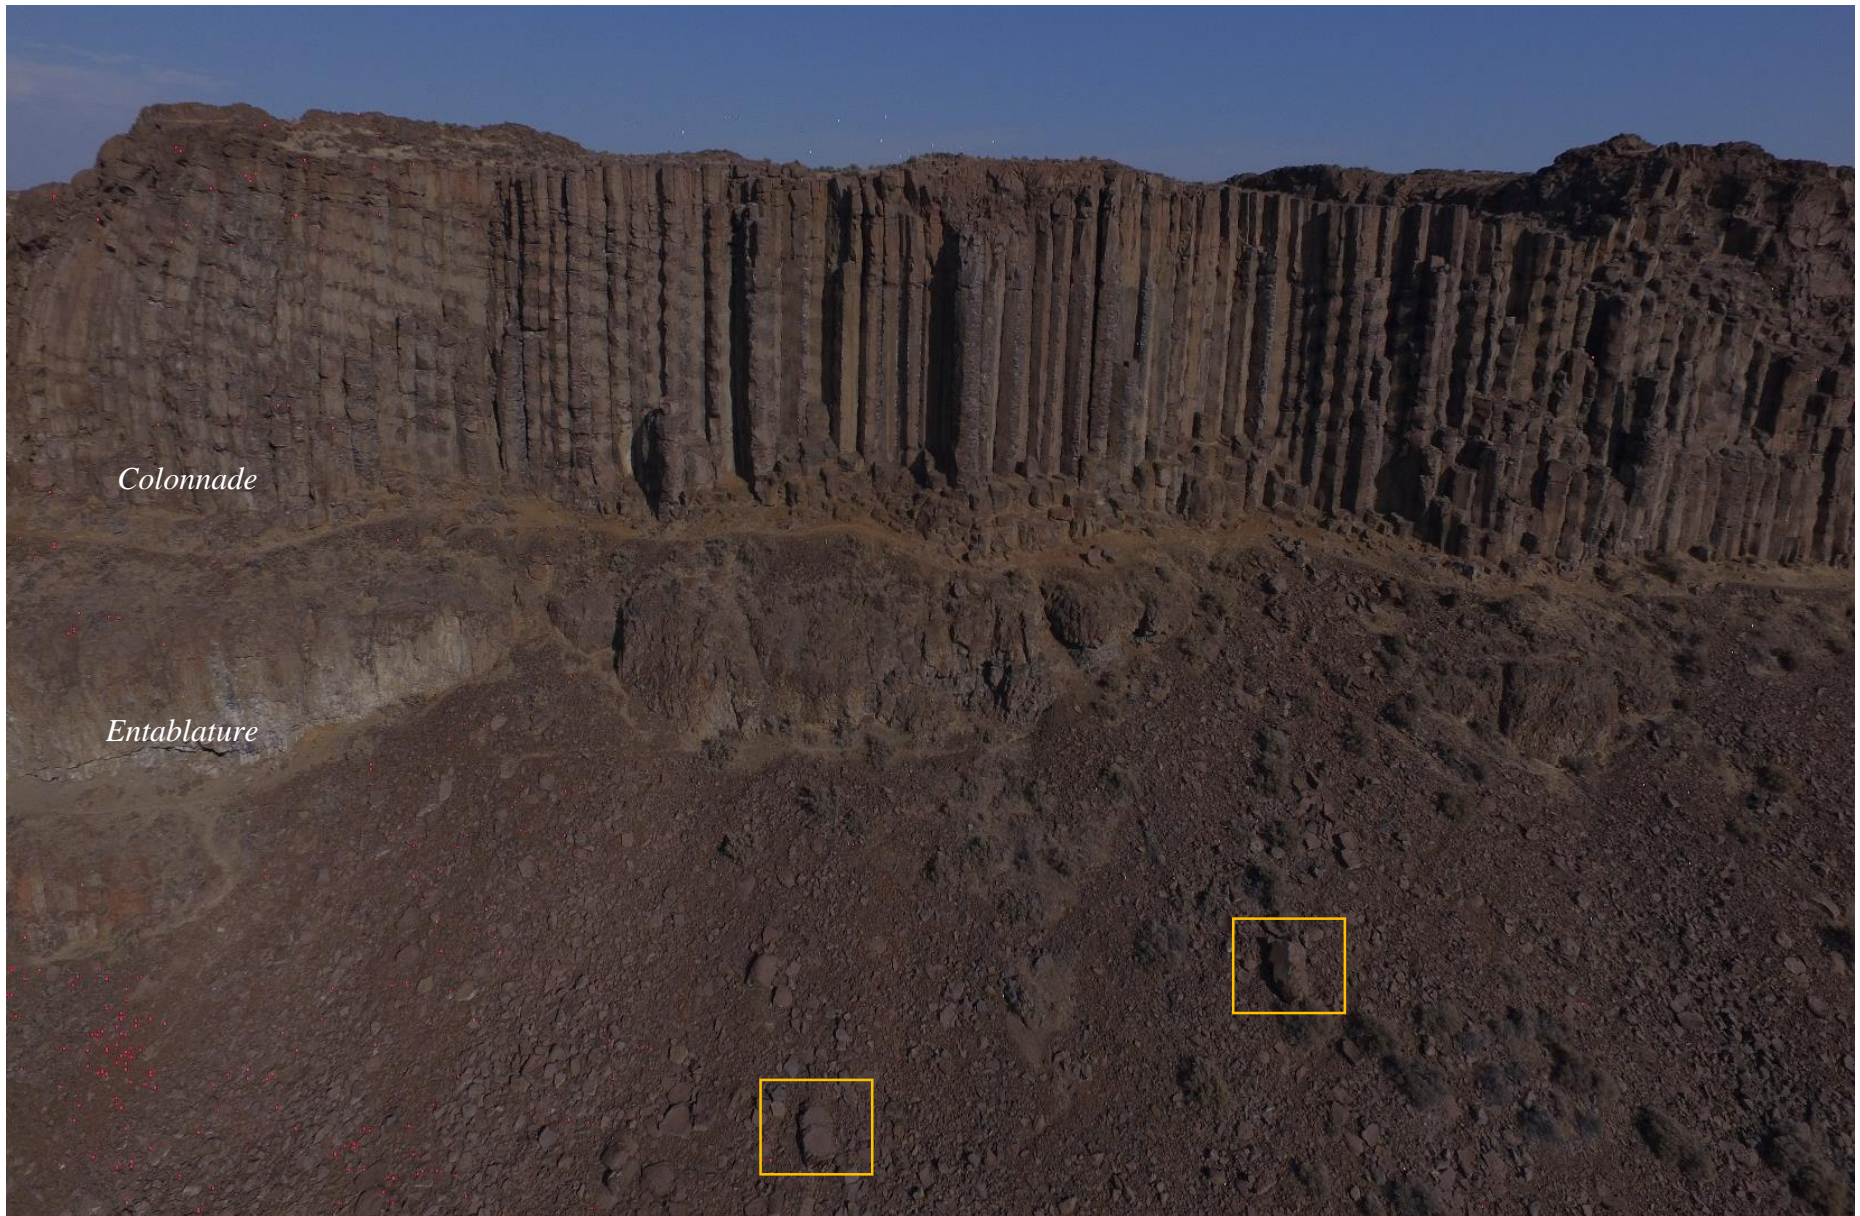
**Figure 3:** Oblique aerial image of the western extent of the Sunshine Wall. Camera is facing north. Basalt columns are approximately 1.7 meters wide and 22-30 meters tall. Below the colonnade, the entablature and the talus slope are shown. Note the presence of columnar shaped blocks on the talus slope (yellow boxes).

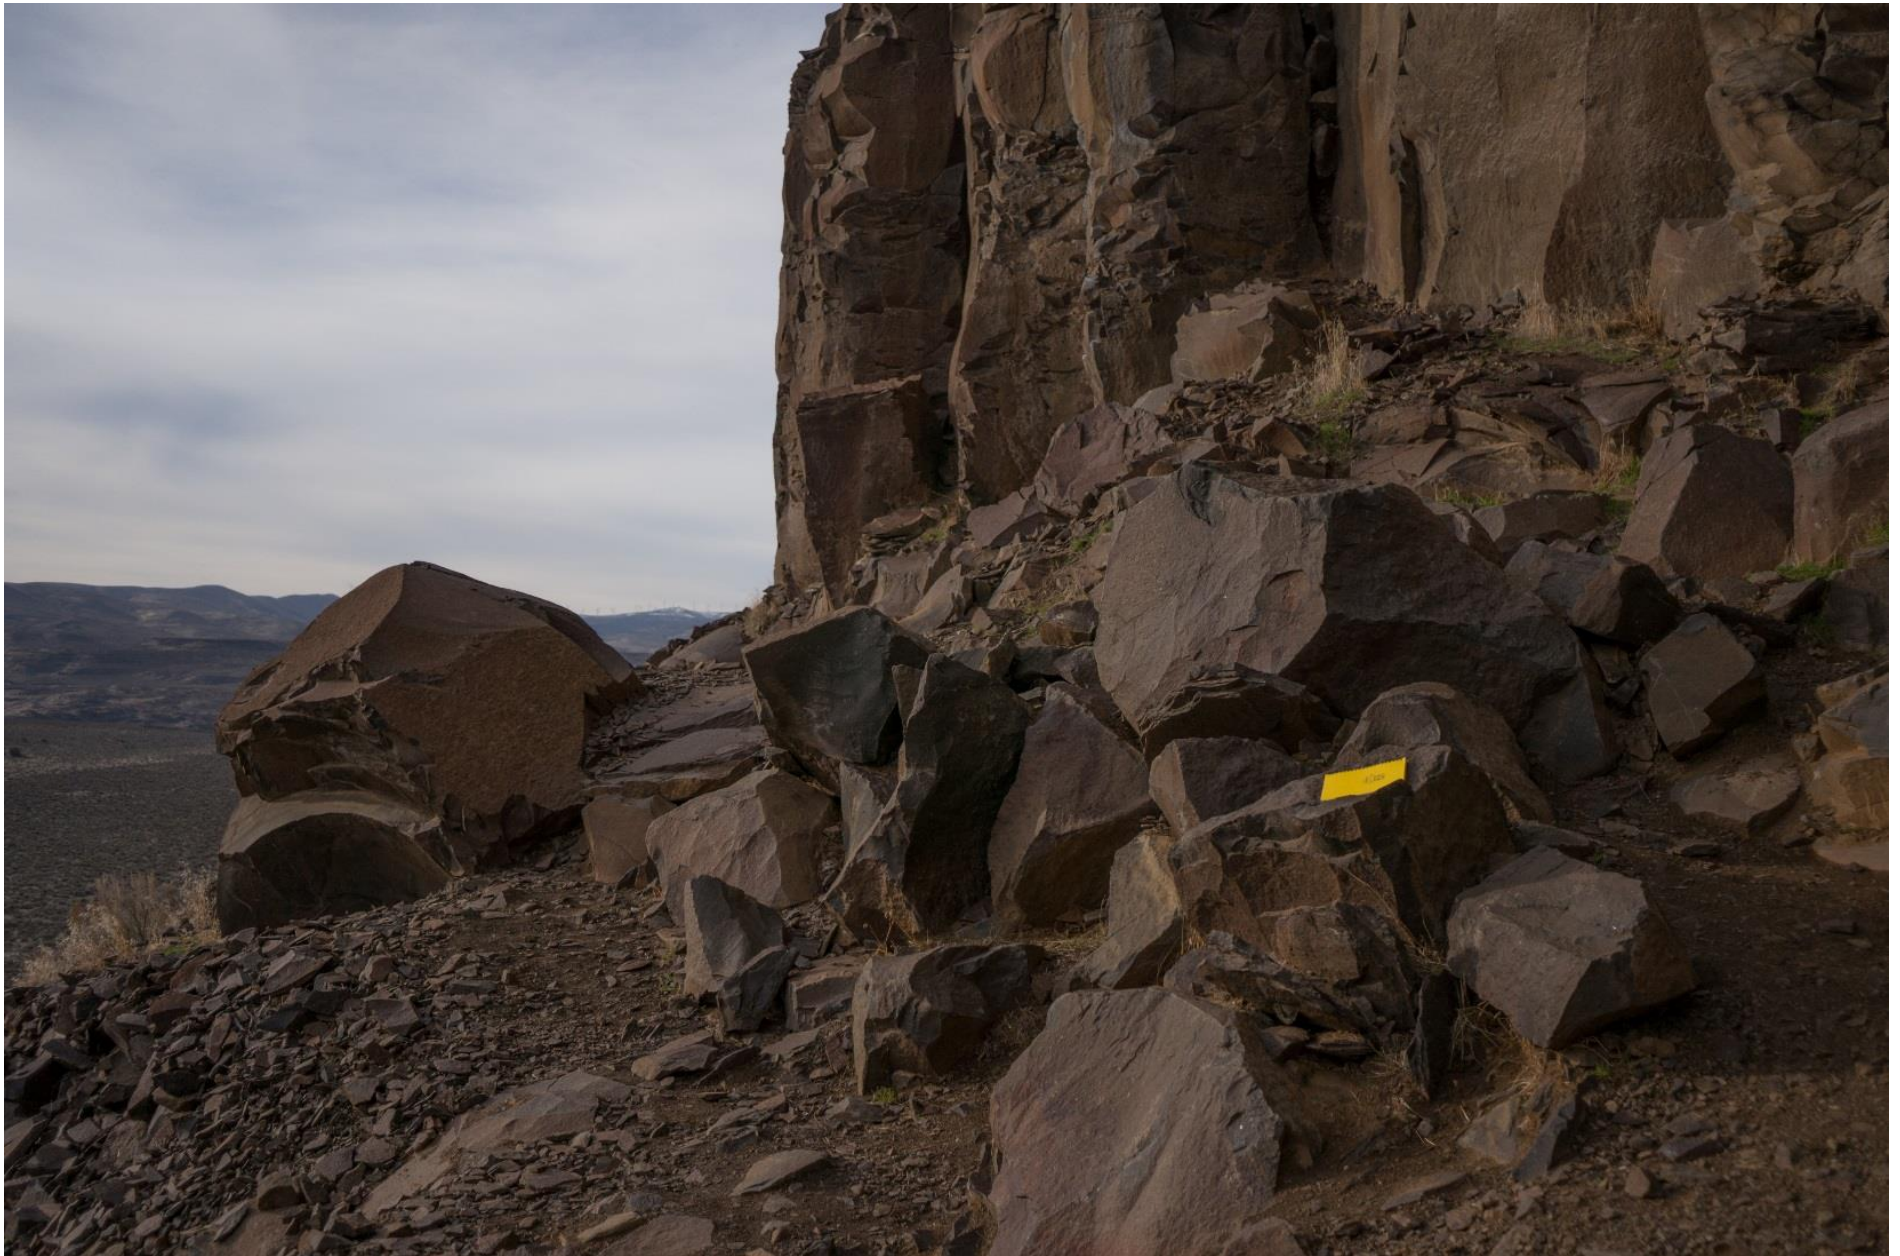
The talus slopes below the wall, along with the large boulders that rest at the base of the colonnade are direct evidence of how this slope has failed in the past (Figure 4). This is due to the toppling of precariously balanced columns. Climbers who are in possession of old guidebooks may find themselves looking for routes along the Sunshine Wall that no longer exist. One example of this, is the once precariously balanced column called "Herm's Tower" that was pushed over by unknown climbers in 2002 (Ford and Yoder, 2008).

**Figure 4:** Column-sized debris at the base of the colonnade, Sunshine Wall. Image of the climbing trail at the western extent of the study area. Similar to the talus slope, large column sized blocks have accumulated at the base of the wall.

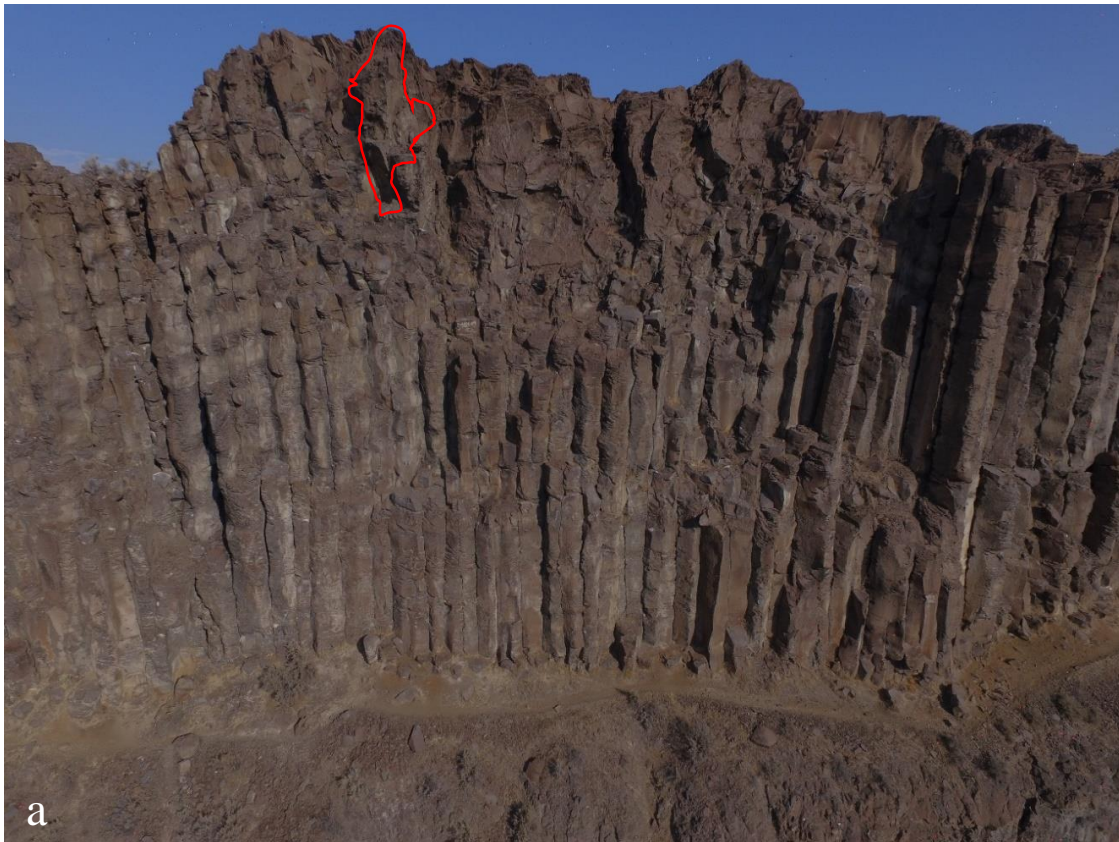
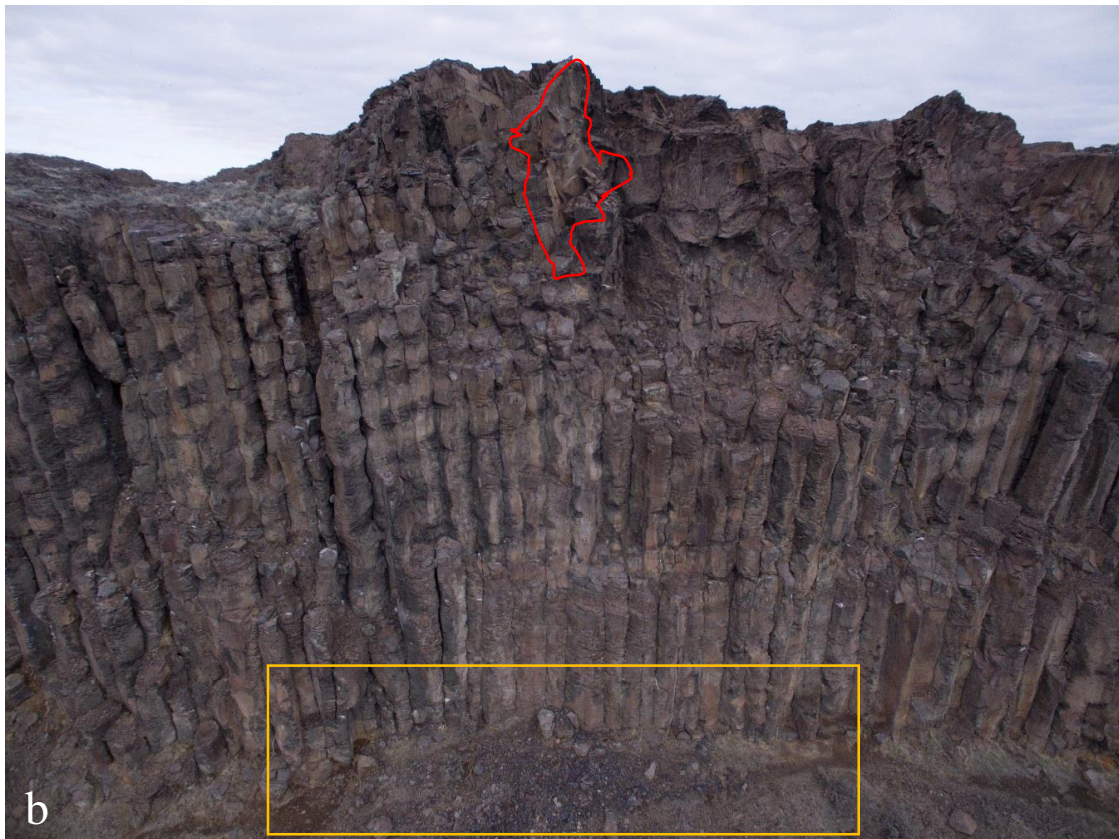
During the course of this investigation a significant rockfall event took place. In late November 2018, freeze-thaw processes likely lead to ~33 cubic meters of rock detaching from the slope face and landing on the climbers trail below (Figure 5 and Appendix A). Approximately 33 meters of trail was covered by boulders and cobbles with freshly broken surfaces. Small craters measuring 70 cm in diameter, and 20-30 cm deep, were found on the trail. A sage tree that had taken root at the base of the slope was destroyed. Although few routes exist in the area where the rockfall occurred, the trail experiences large volumes of foot traffic to access the western half of The Sunshine Wall. Fortunately, during November the area is less busy and no one was hurt during this rockfall event.

**Figure 5:** November 2018 Rockfall. These images show a specific section of the Sunshine Wall that was subject to rockfall in late November 2018. At the top of the page the specific block that detached from the rock slope is outlined in red. This picture was taken in October 2018 prior to the event. Below, is an image of the area after the rockfall event. Outlined in Red is the detachment zone. The block that fell was approximately 33 m<sup>3</sup>, which is the size of a Volkswagen Beetle. Shown below in yellow is the 33 meter section of trail that was covered in freshly broken talus. The rock is blueish in color due to the freshly fractured-unweathered surfaces.

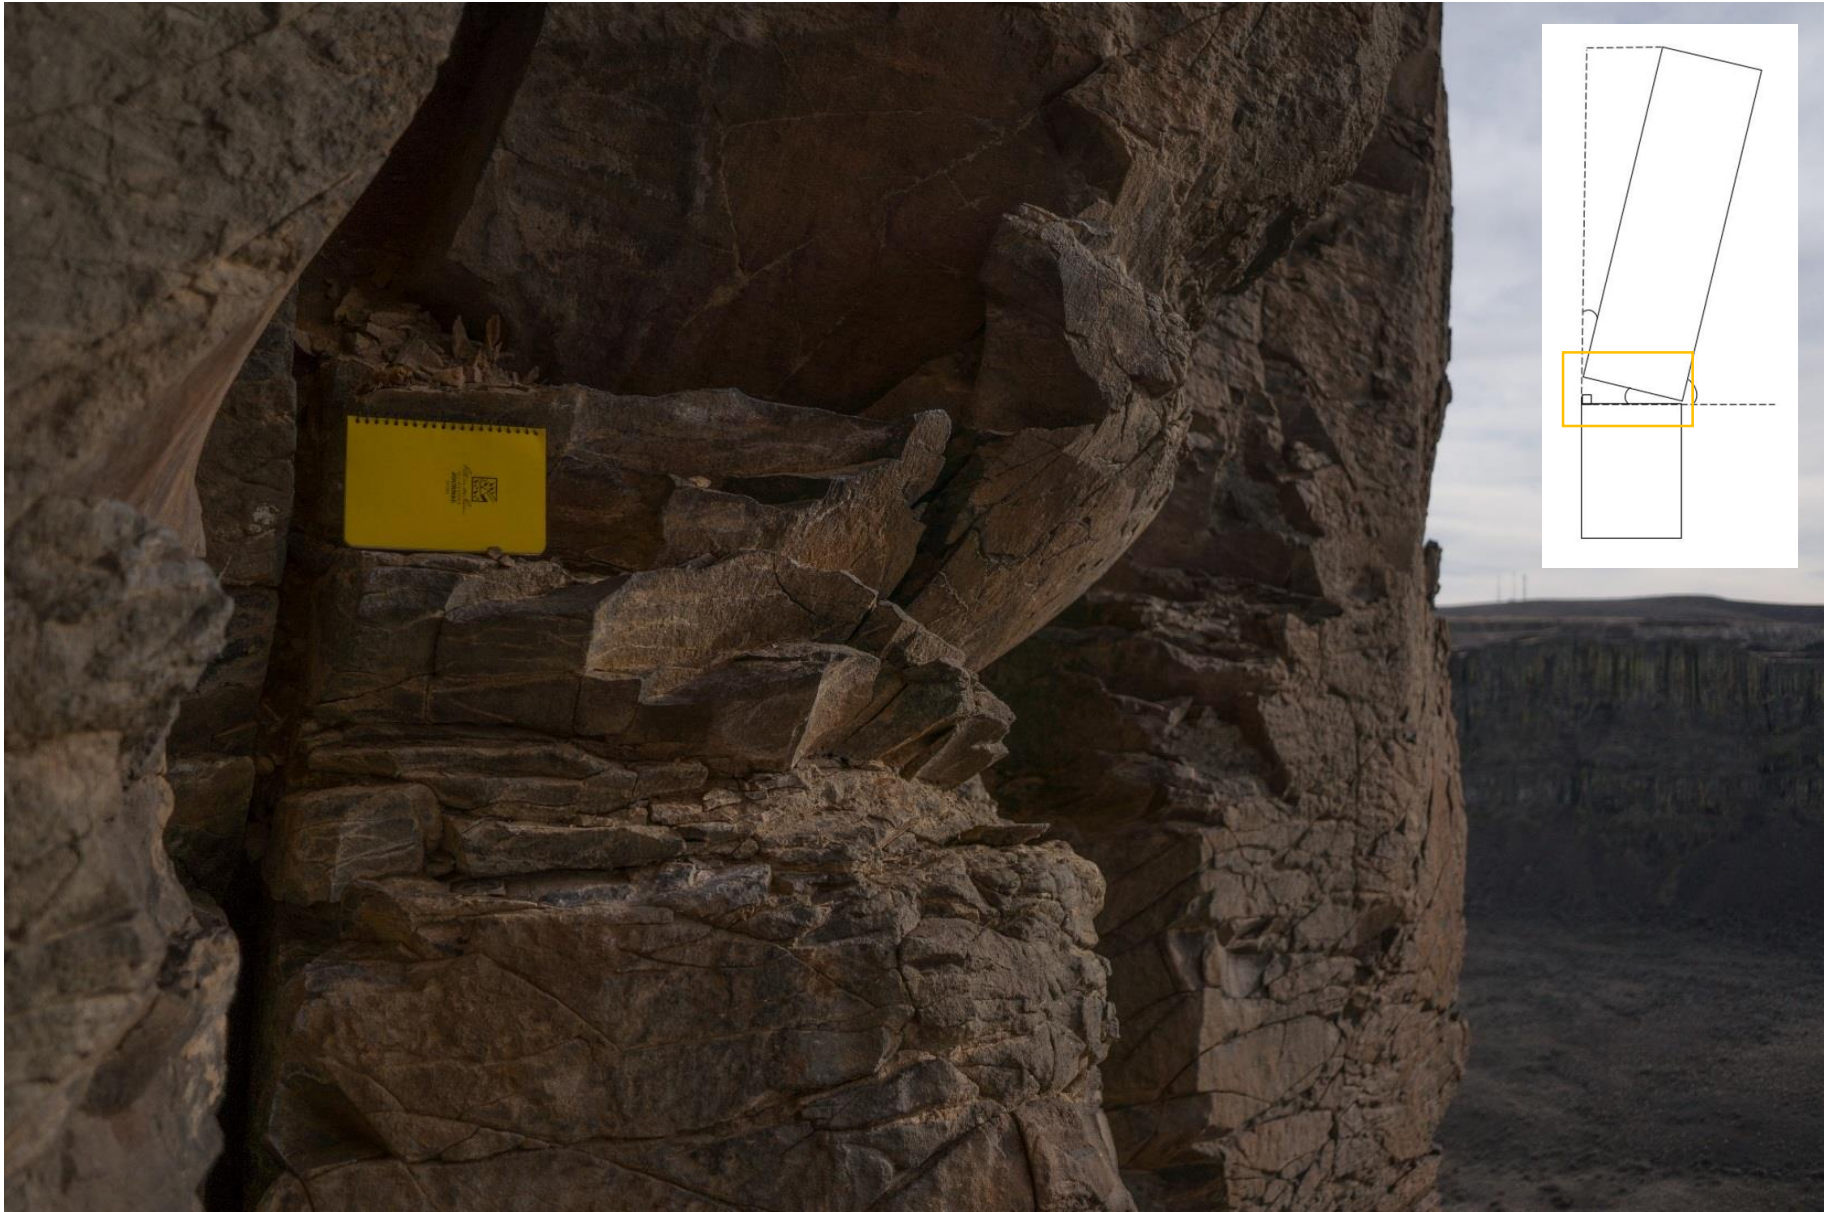
Across the colonnade there were platy zones where lower quality rock was observed. The RQD calculated using the method from Palmstrom (2005) ranged between 10% and 30% for these platy zones, which showed a higher density of sub-horizontal joints specifically. Silty dust covered the fracture surfaces and loose rock could easily be plucked out using my fingers. These rock fragments were easily broken with a rock hammer, indicating that the strength of this rock was lower than that of the intact rock faces. At some platy zones the column width narrows, suggesting some rock has been removed by erosion (Figure 8). The RMR of the weathered zones, within the colonnade, was consistently close to 50. A number of the low RMR zones across the Sunshine Wall and adjacent Kotick Memorial Wall are all within a 5-meter vertical span in elevation. In oblique aerial photographs a prominent linear feature within this elevation band extends across a 140-meter stretch of the Sunshine Wall (Figure 9). This feature coincides with some of these low RMR zones and many of the tops of past-failed columns.

**Figure 8:** Platy Zone. Adjacent to the notebook is the low RMR zone. This particular column has already failed and only the lower 9 meters of the column remain. The remaining section of this column is supported by the neighboring intact column. The yellow notebook shown is 6 inches across, from left to right.

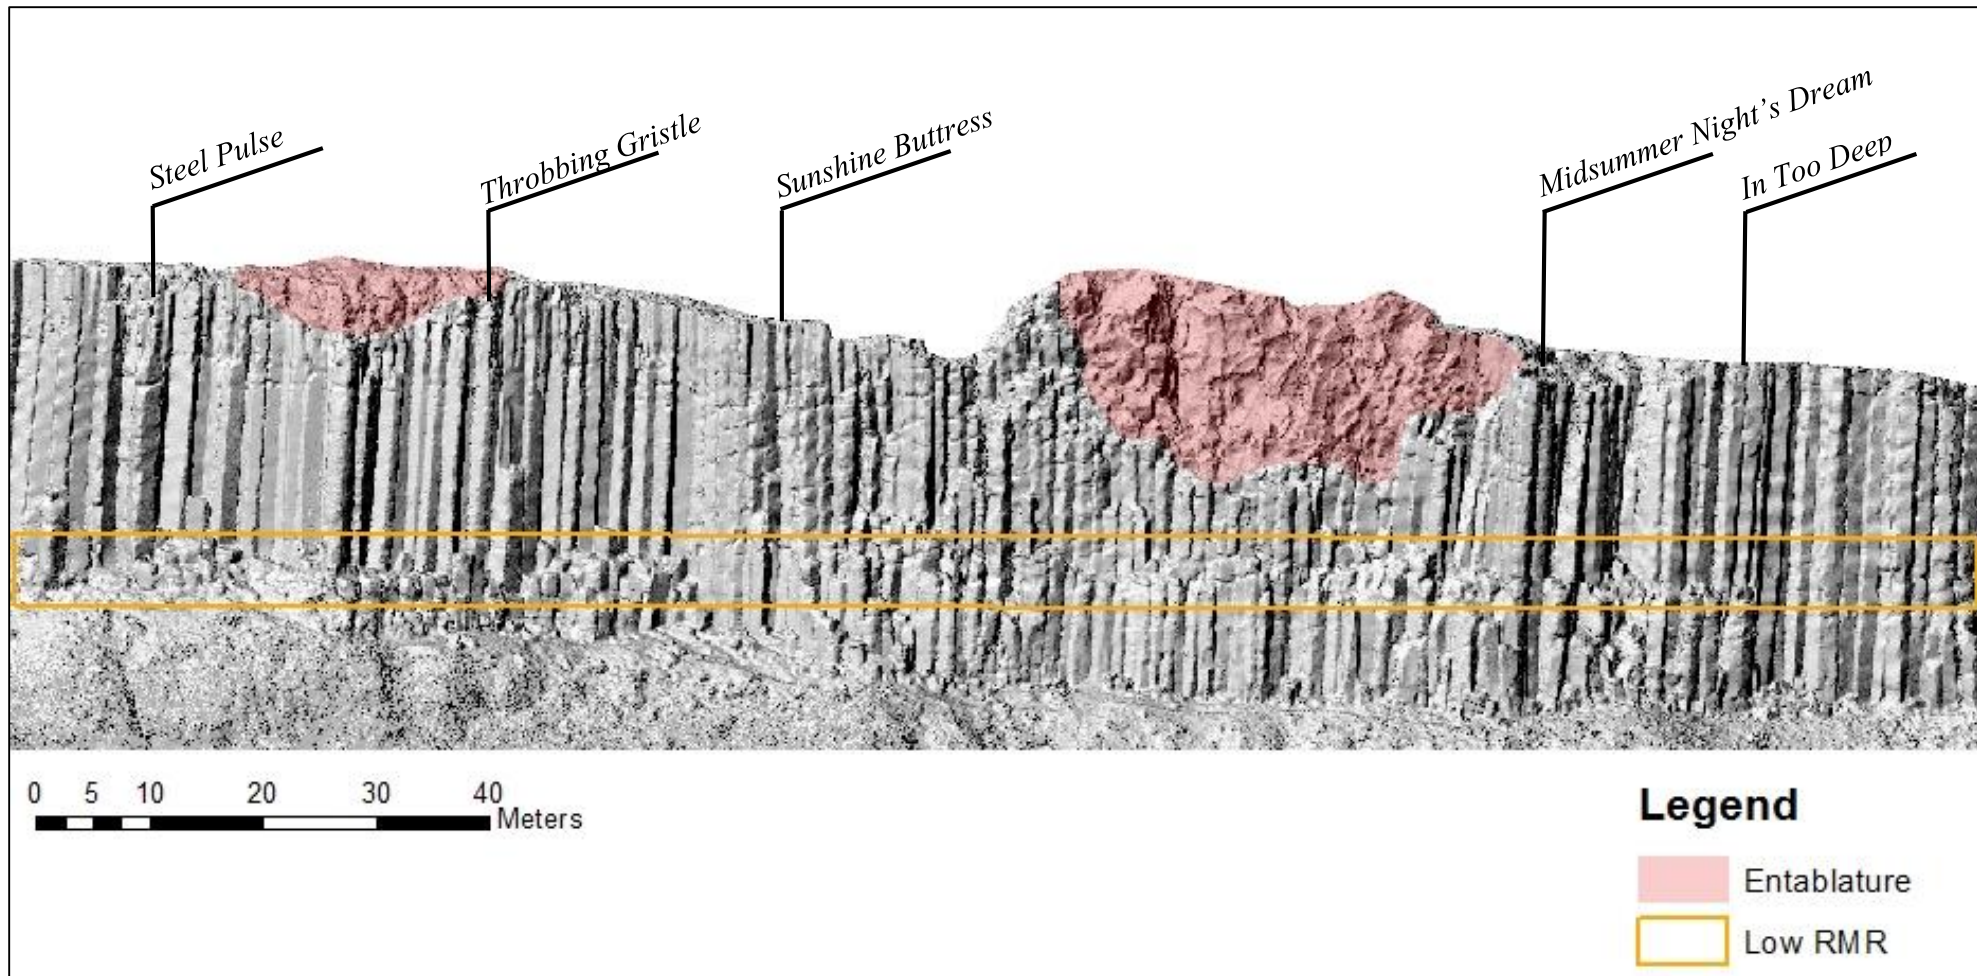
**Figure 9:** Sunshine Wall DSM. Digital surface model showing the linear feature, outlined in yellow, which crosses the colonnade. Also highlighted, in red, are the zones of entablature which show a different geomorphic texture and style of fracturing. Specific climbing routes have also been labeled. The entablature zone highlighted on the right is where the November 2018 rockfall event took place.

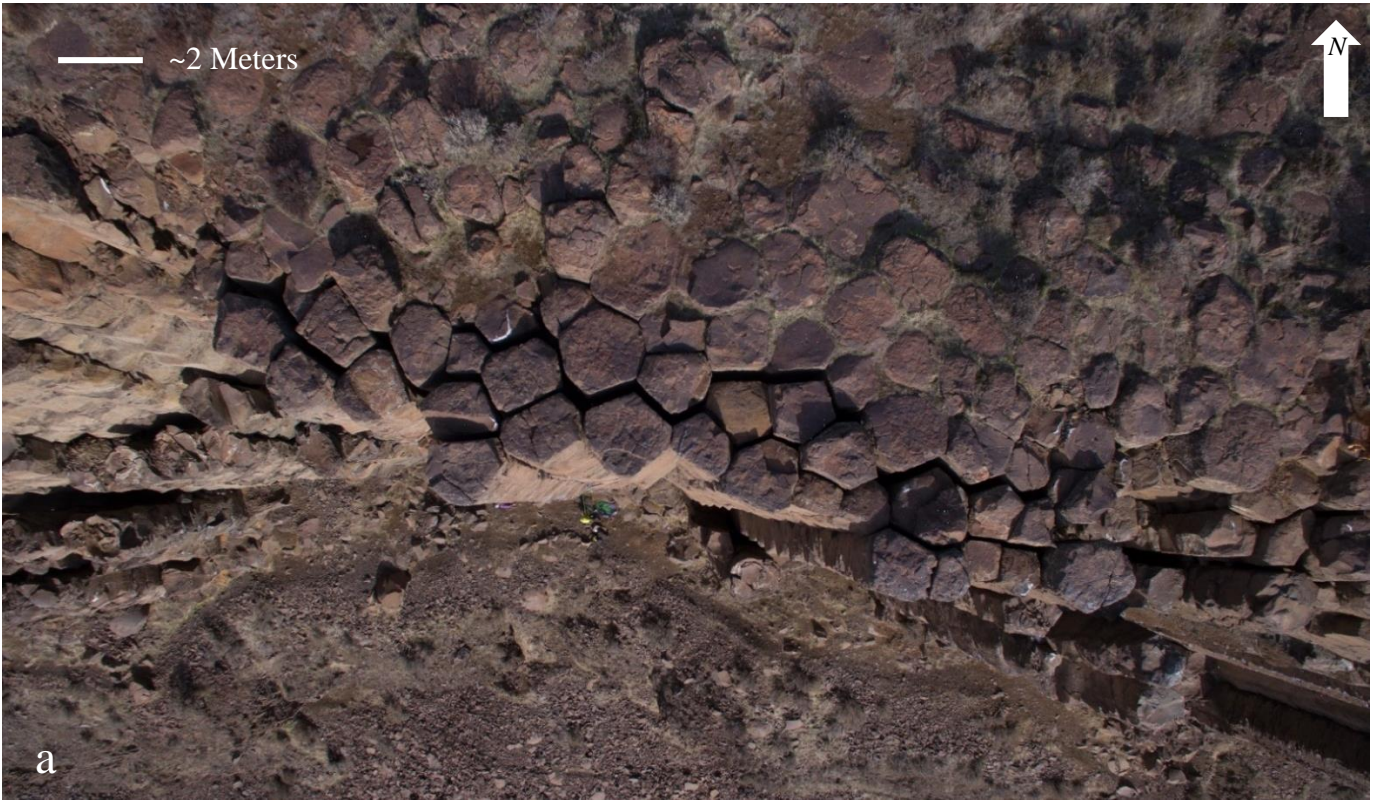
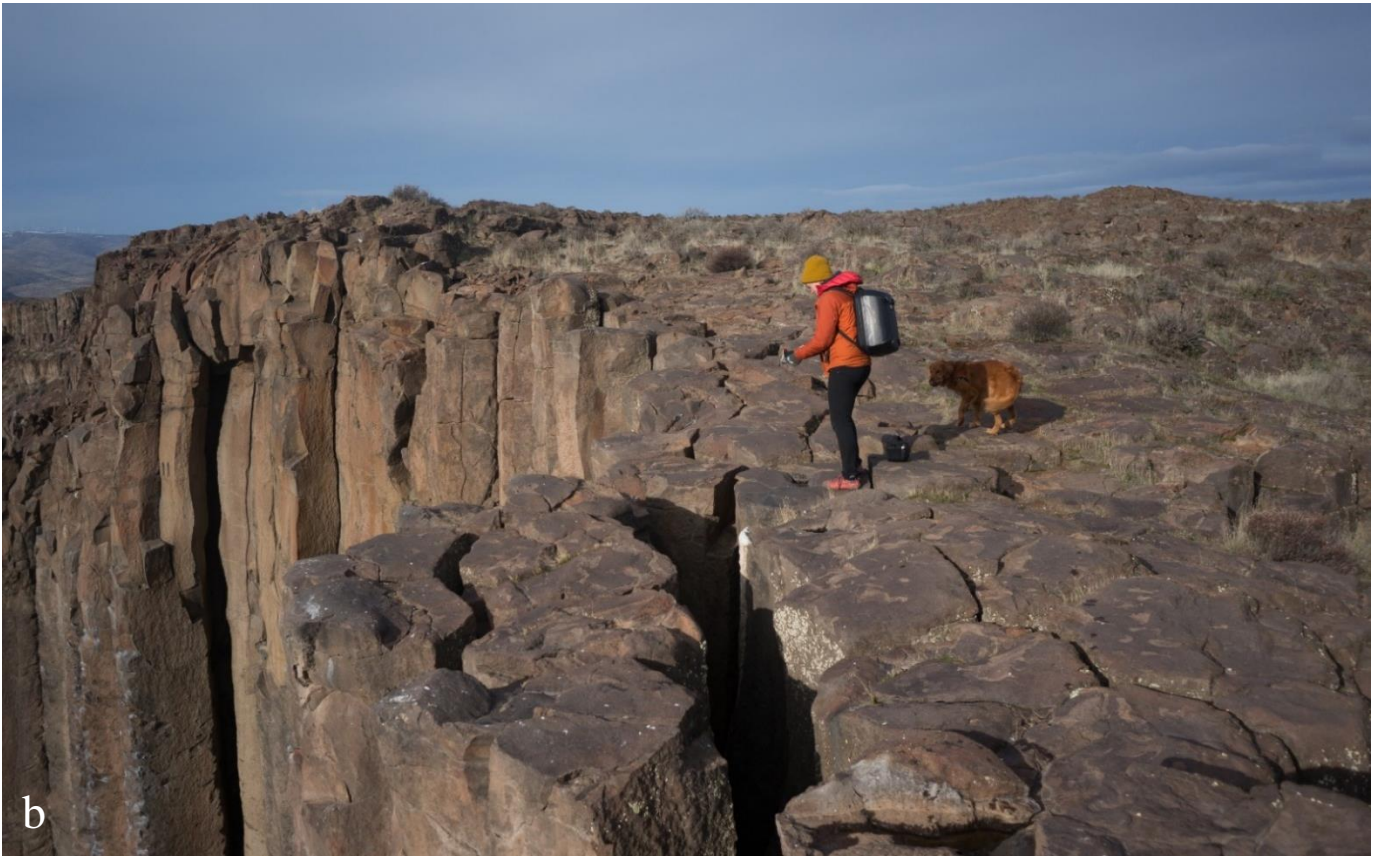
**Figure 13:** Column Separations. (a) Vertical aerial photo of the column tops near “Mr. Boshido” with people on the access trail at the foot of the wall. Note that separations appear larger closer to the face of the wall. This area had some of the smallest column separations. Scale bar is relevant to column tops. (b) Large column separation atop the routes Sunshine Buttrass and Mix it Up. This separation measures approximately 75 cm.

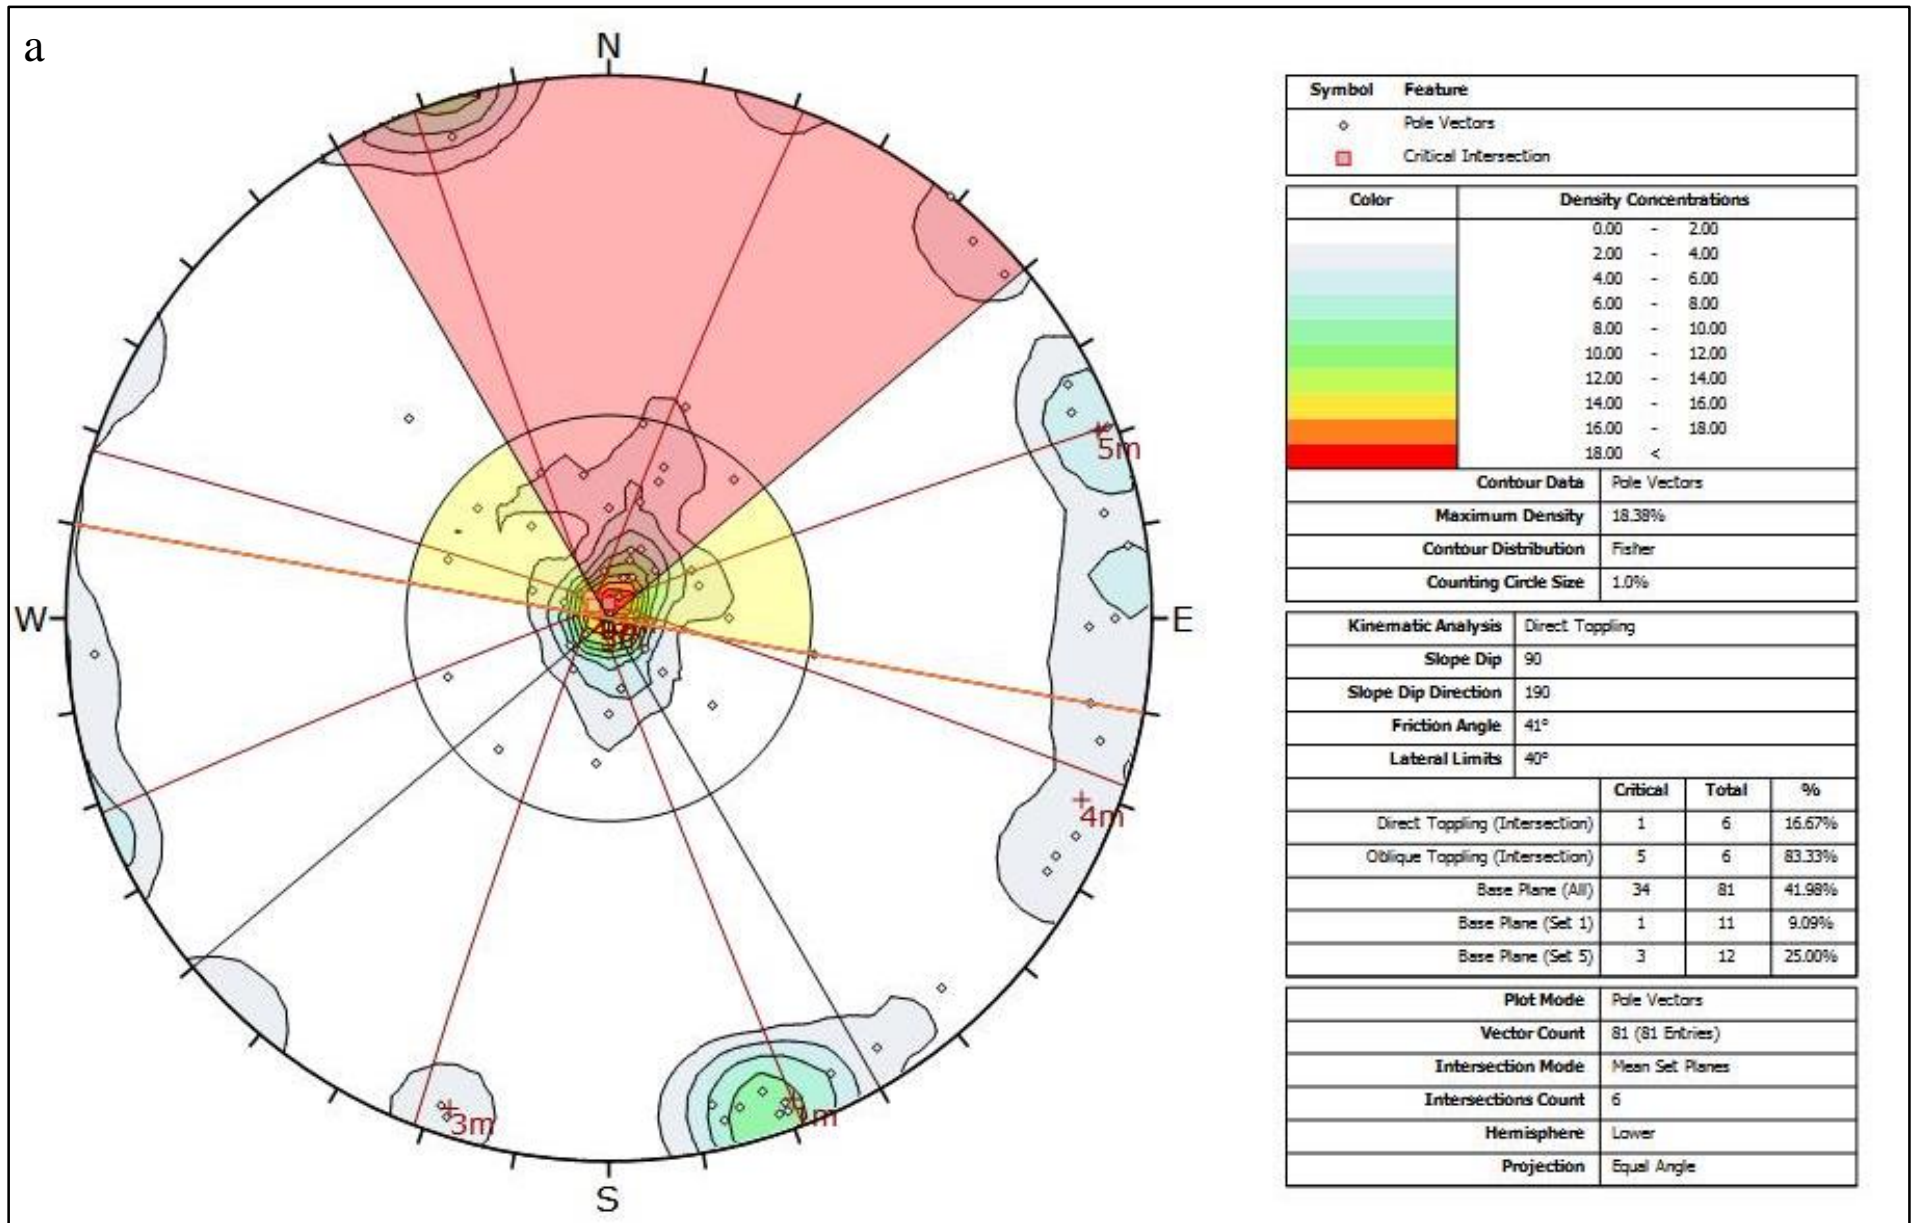
Kinematic analyses using the RocScience Program Dips 7.013 indicated that the slope is most likely to fail in direct topple (Figure 14a). This is due to the high number of vertical joints that form tall rectangular blocks, along with the presence of sub-horizontal joints and low RMR zones which act as release planes.

**Figure 14.** Kinematic Analysis. Red lines represent mean set planes for column faces. Bolder yellow line is the orientation of Sunshine Wall. Combinations of pole vectors and mean set plane intersections in the red and yellow shaded regions indicate that conditions for the respective failure modes are possible. Each mode has its own specific criteria. (a) Direct Topple analysis, showing the presence of release planes dipping to the south and column faces dipping slightly to the north.

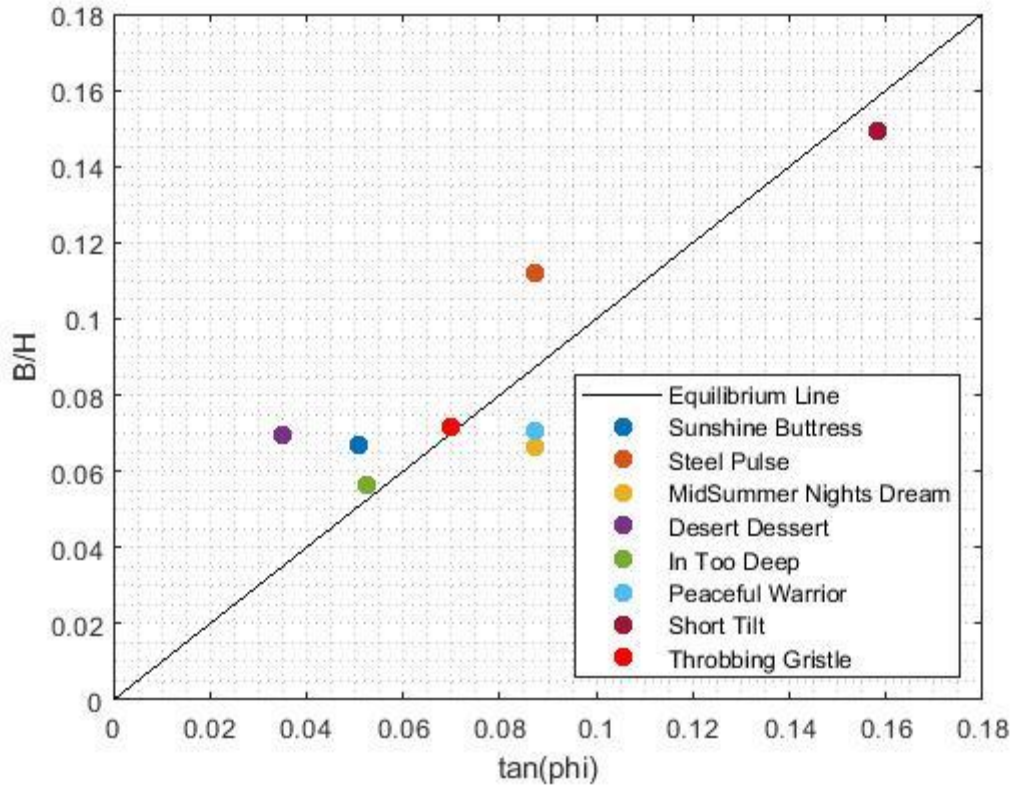
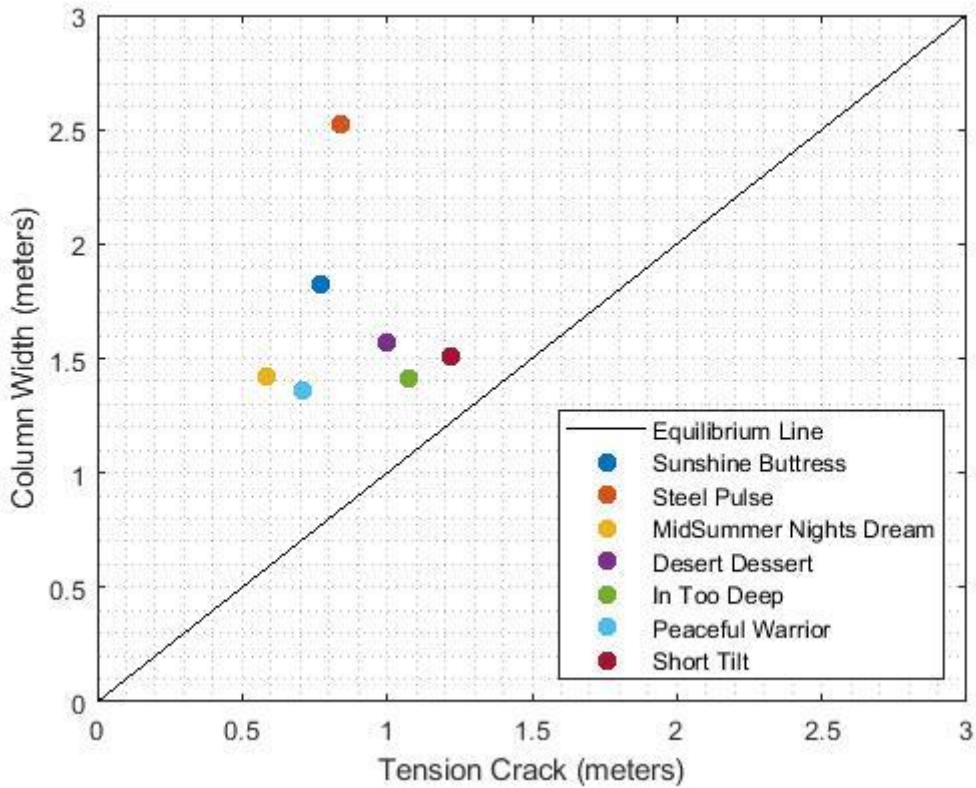
A factor of safety analysis was carried out for a number of columns that appeared to show significant differential separation between the top and base of the colonnade. Although assessments could not be conducted for every single column, individual topple assessments were conducted for the routes known as Sunshine Buttress, Midsummer Night's Dream, In Too Deep, Steel Pulse, Throbbing Gristle, Peaceful Warrior, and Anthropomorphic Chest of Drawers. These routes were chosen because they appeared to be especially at risk with regard to topple failure. This analysis was done to show example calculations and to present an idea of how close these columns may be to failure. A route known as Desert Dessert, which is outside the immediate study area, was included as well because it is well known and the column showed significant differential separation between base and top. Factors of safety were calculated using the traditional comparison presented in Wyllie and Mah (2004), as well as the direct width-separation comparison (Figure 7). Based on results from these two comparisons, the factors of safety for the columns that were inspected range from 0.76 to 3.

A factor of safety plot was created for each comparison (Figure 15). Figure 15a shows the factor of safety in terms of the basal plane angle ( $\tan\Phi$ ) and the base-height ratio, while Figure 15b compares the column width and separation directly. The traditional comparison consistently estimates columns to have a lower factor of safety than that estimated by the direct width-separation comparison. Results based on the traditional comparison indicate that three columns should have already failed.

**Figure 15.** Toppling failure factor-of-safety graphs for specific columns. Points plotting above the equilibrium line have a FS above 1 (considered to be stable). “Throbbing Gristle” is shown in the upper graph only, because the tension crack at the top of the column was not measured during this investigation. Anthropomorphic Chest of Drawers is listed as “Short Tilt”.

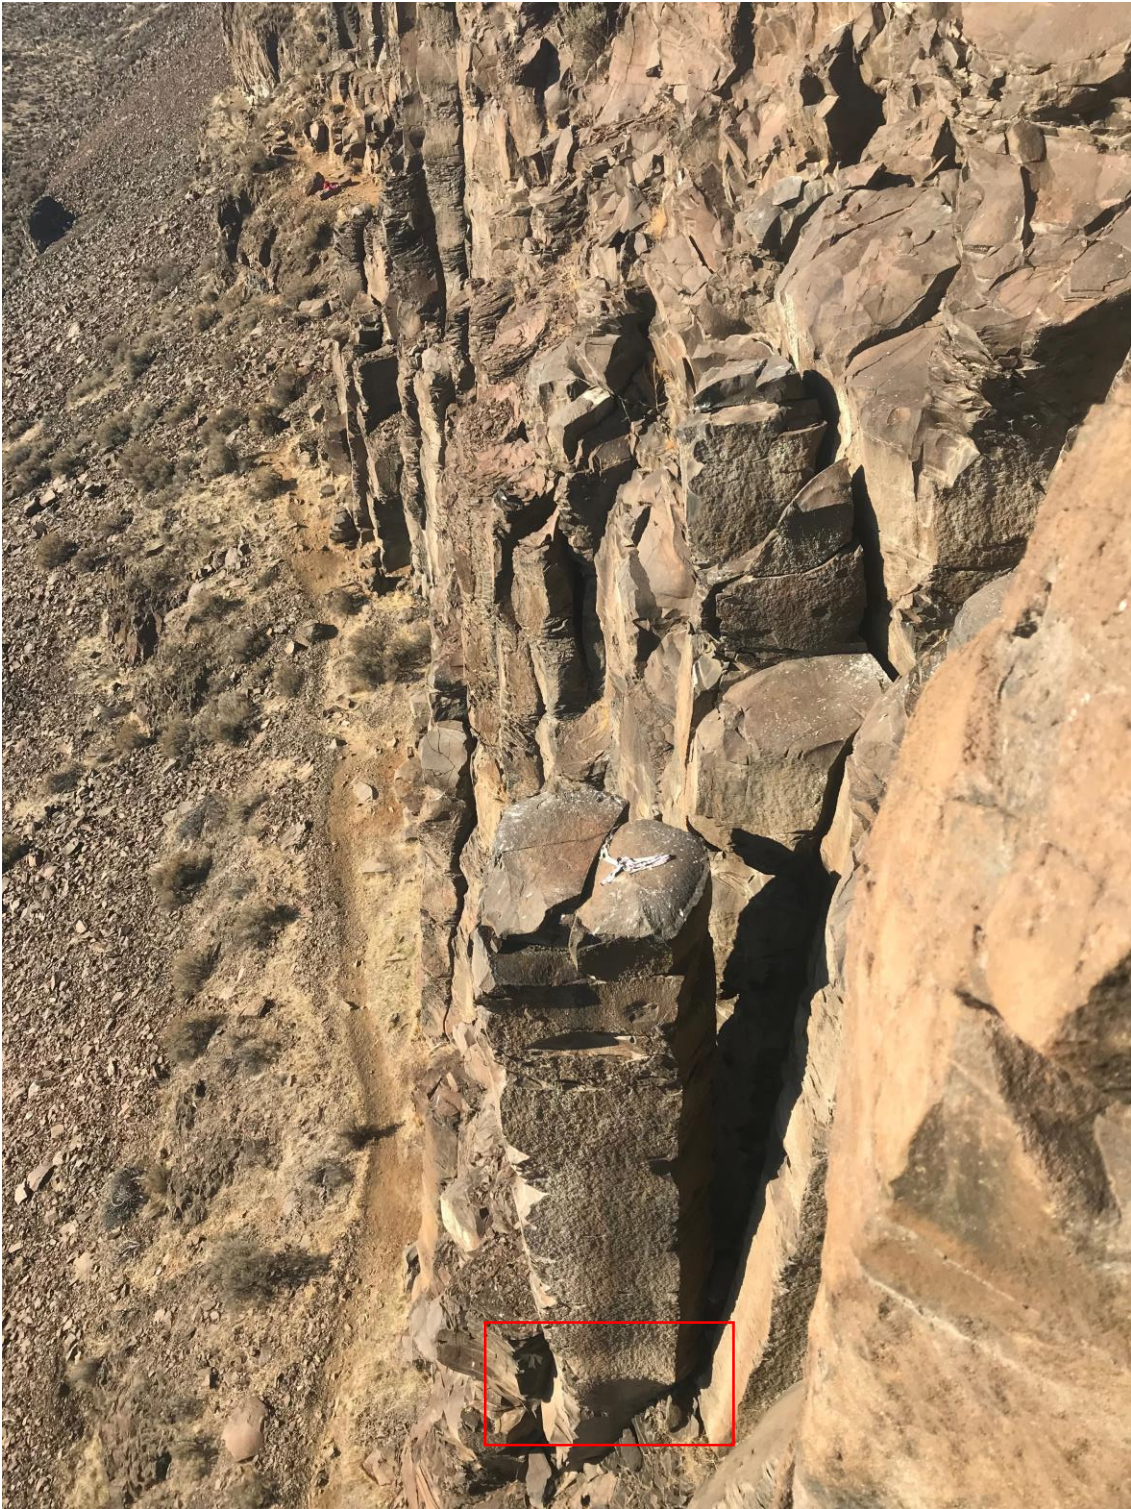
**Figure 17:** Image of Anthropomorphic Chest of Drawers. At the base of the exposed portion of the column (indicated in red), the column appears to curve outward. This “kinked” column does not display typical sub-horizontal joints at this location.

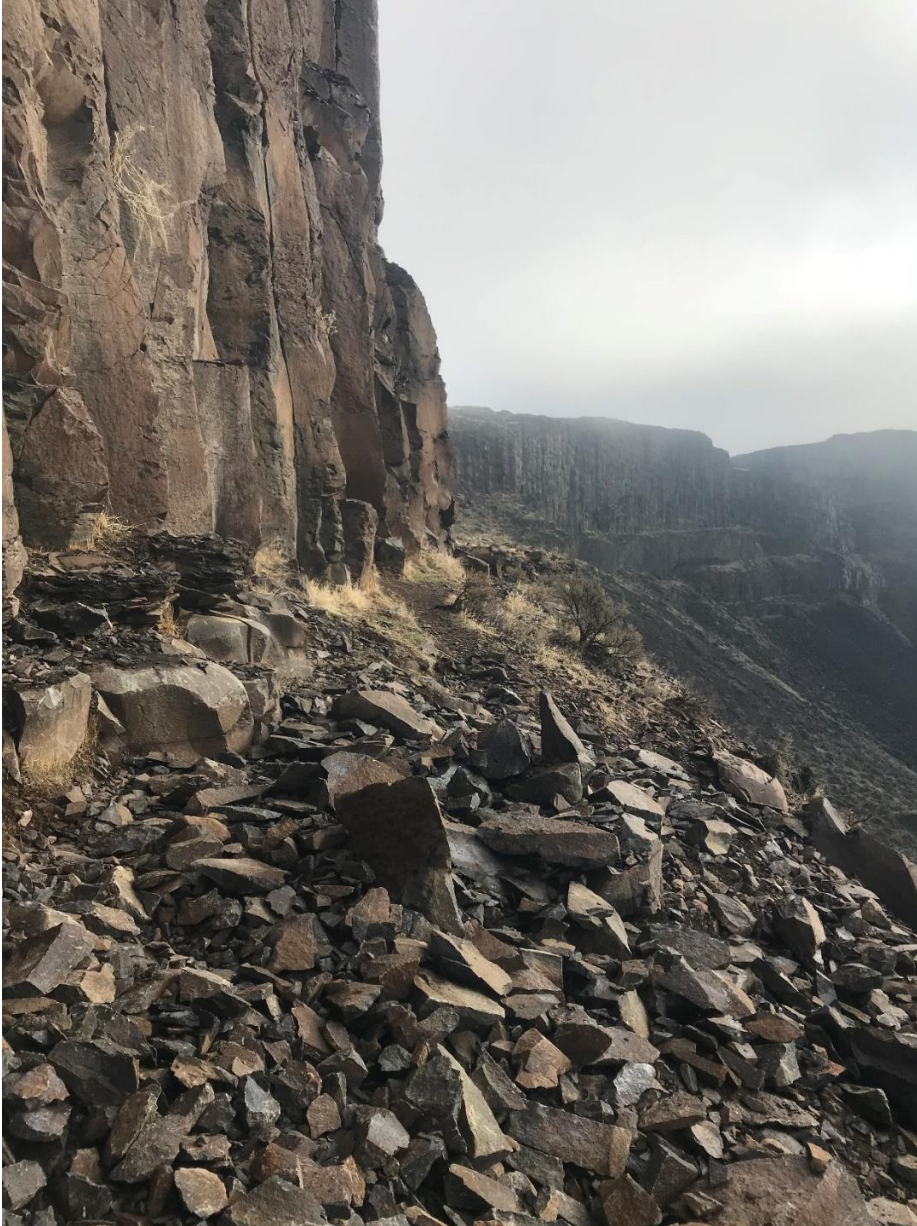
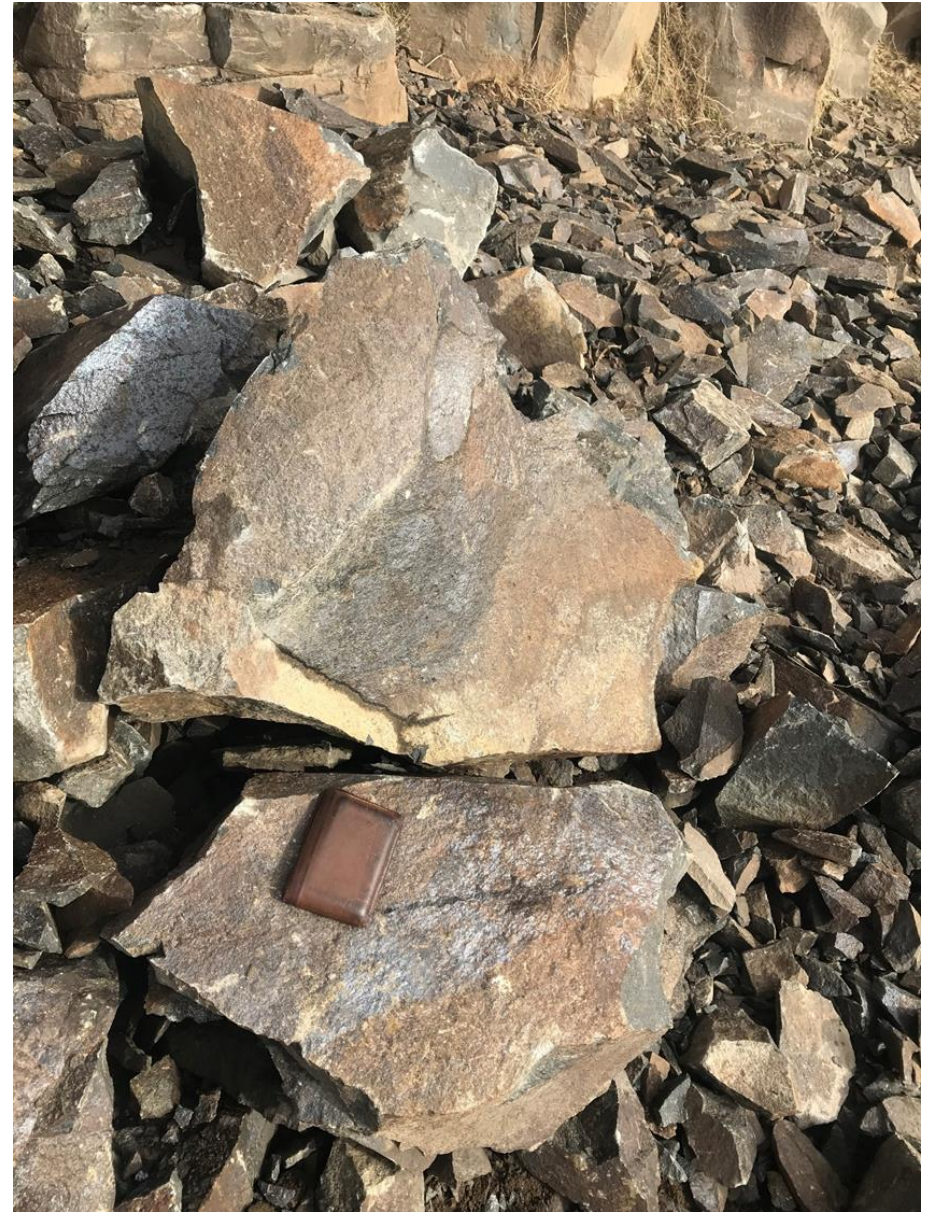
**Appendix A (Images of November 2018 rock fall event).**

These images were taken from the ground within several days of the rockfall event. In the left picture notice the talus in the foreground and the trail in the background. The picture on the right shows the size of blocks that impacted the trail.
