Rockfall Reconnaissance and Stability Assessment: Frenchman Coulee, WA

A report prepared in partial fulfillment of  
the requirements for the degree of  
Master of Science  
Earth and Space Sciences: Applied Geosciences  
University of Washington

March, 2019

MESSAGe Technical Report Number: 071

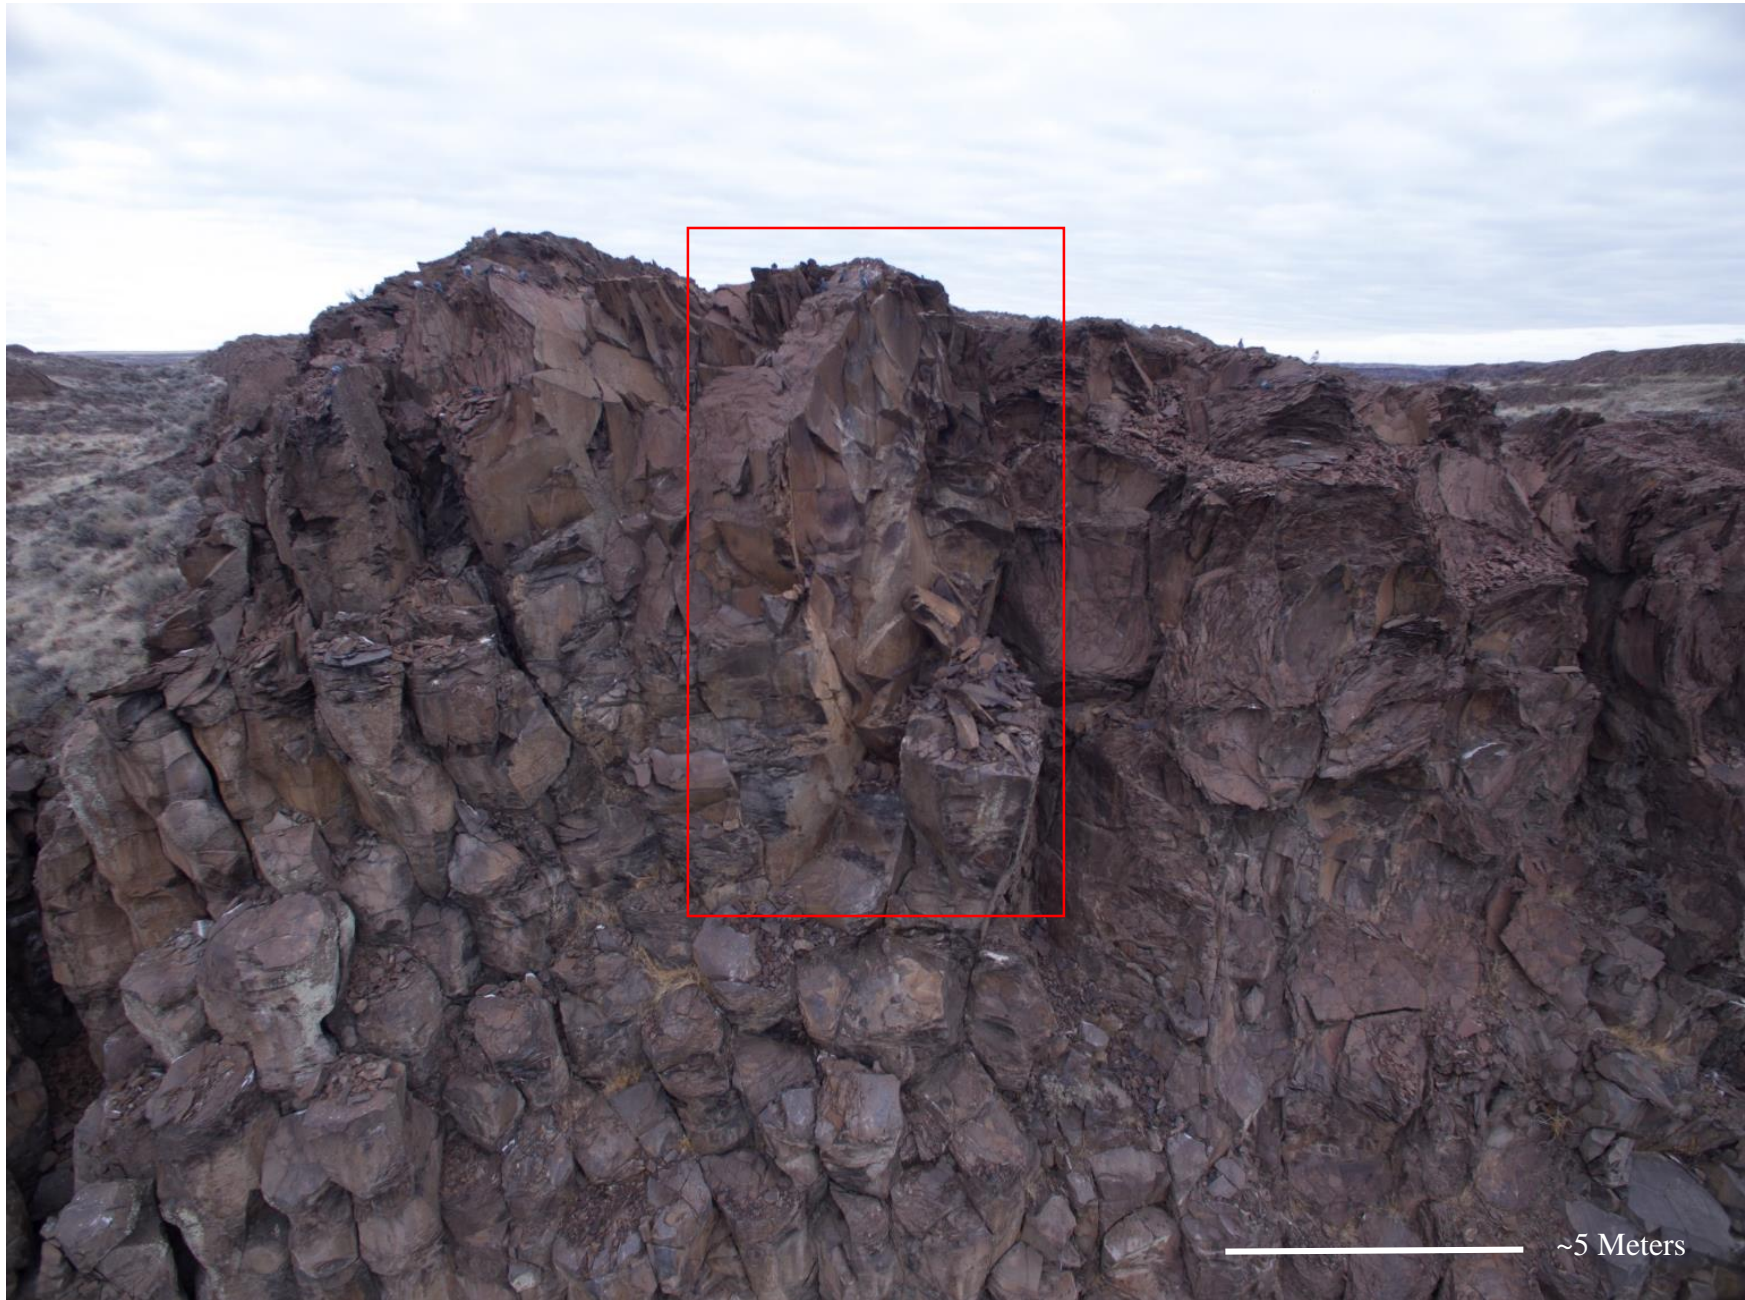
Close up image of detachment zone. The location from which the rock fall originated is outlined in red. Lighter colored surfaces are present showing where fresh fracture surfaces have been exposed. Some loose fractured rock material remains on the cliff face.
