Processing and Analysis of Lidar Derived Point Cloud Models of Low-Rise Large-Volume Steel
Frame Buildings Damaged in Hurricane Michael

A thesis

Master of Science in Civil Engineering

University of Washington

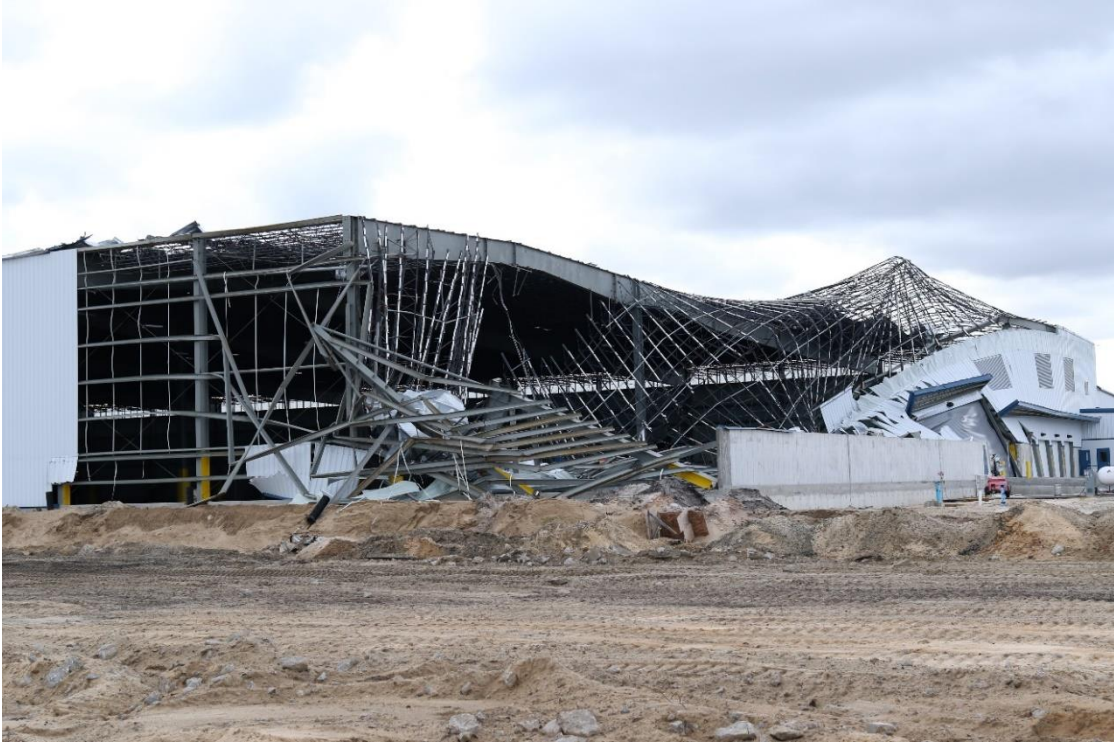
The building suffered a complete collapse of the first bay (between column lines 20 and 21) on the northeastern side and some damages to the second and third bay (between column lines 18 and 20) as is demonstrated in Figure 3.7 and Figure 3.8. The purlins in the first bay show large deflections indicative of buckling and the failure of multiple connections, while the second and third bay mostly demonstrate surface damage to cladding along with comparatively minor deflections of the purlins.

Figure 3.7. A view of the damaged face of Westrock East Terminal.

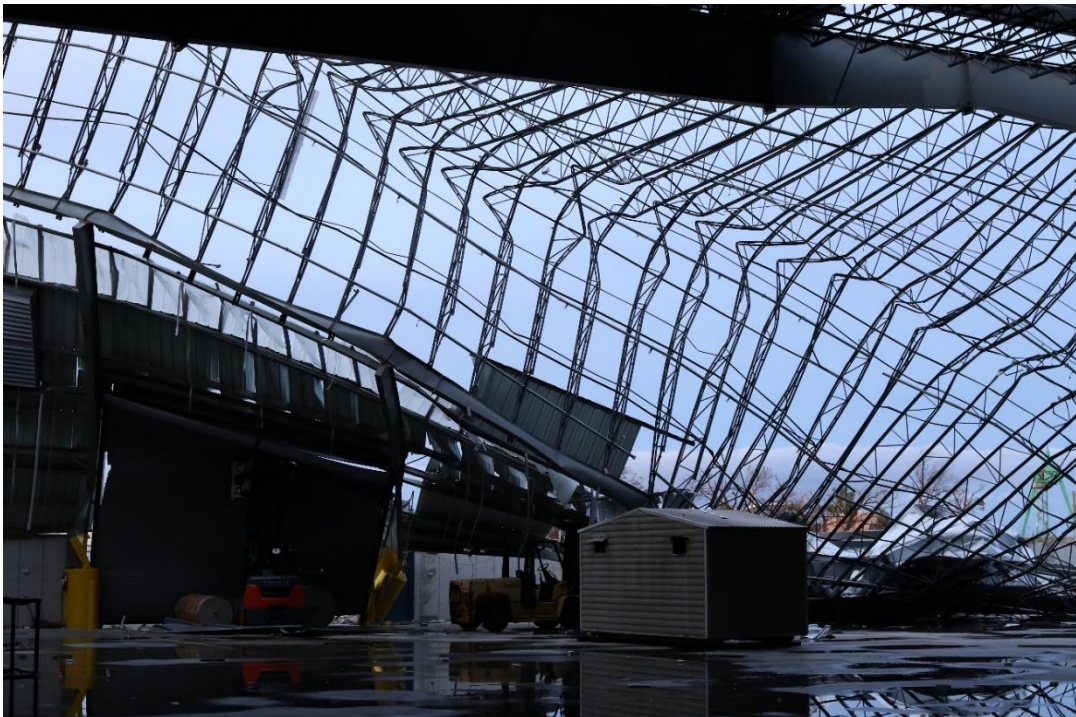
Figure 3.8. A photograph showing the buckled roof trusses in Westrock East Terminal.

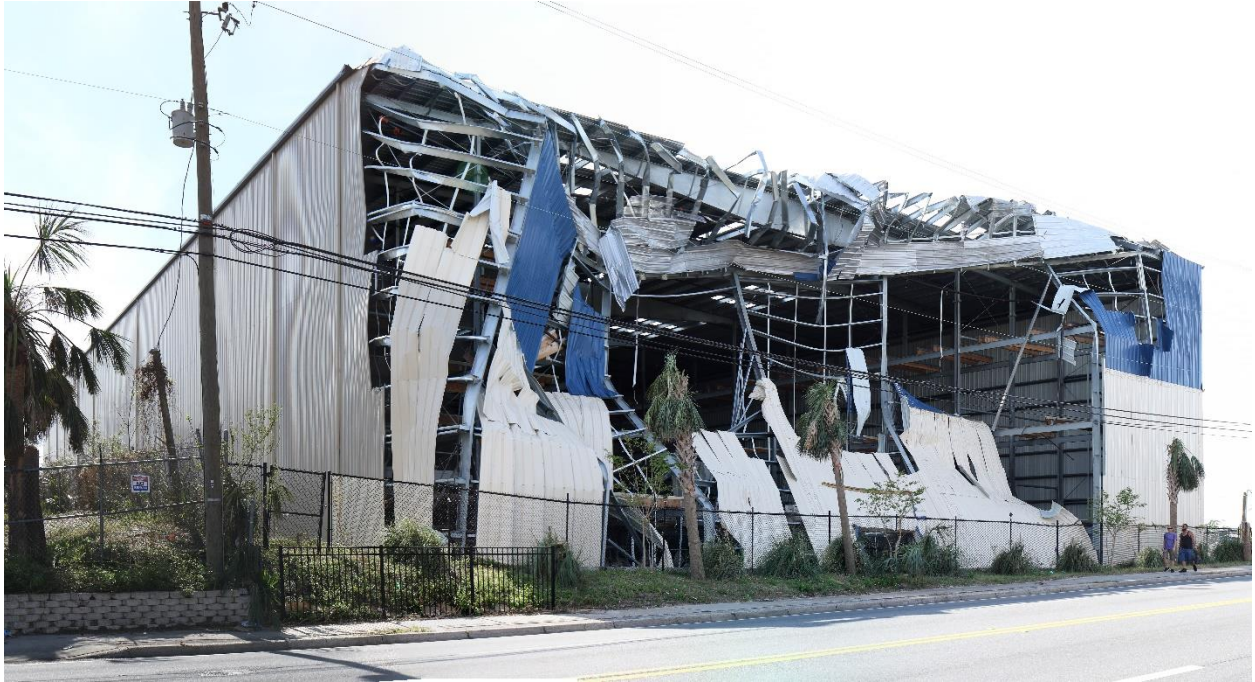
The first bay of Watson Landings Marina from the north (between column lines 1 and 2) collapsed almost completely as can be seen in Figure 3.11, with both the columns along line 1 and the purlins spanning the first bay showing signs of buckling. A closer view of the buckled purlins in the first bay can be seen in Figure 3.12 along with signs of local buckling in the purlins in the second bay. In addition, it is clear that the connections between the first two bays, especially towards the west side (between column lines F and H) suffered some damages, most likely as a result of the buckling in the first bay.

Figure 3.11. A view of the damaged face of Watson Landings Marina.

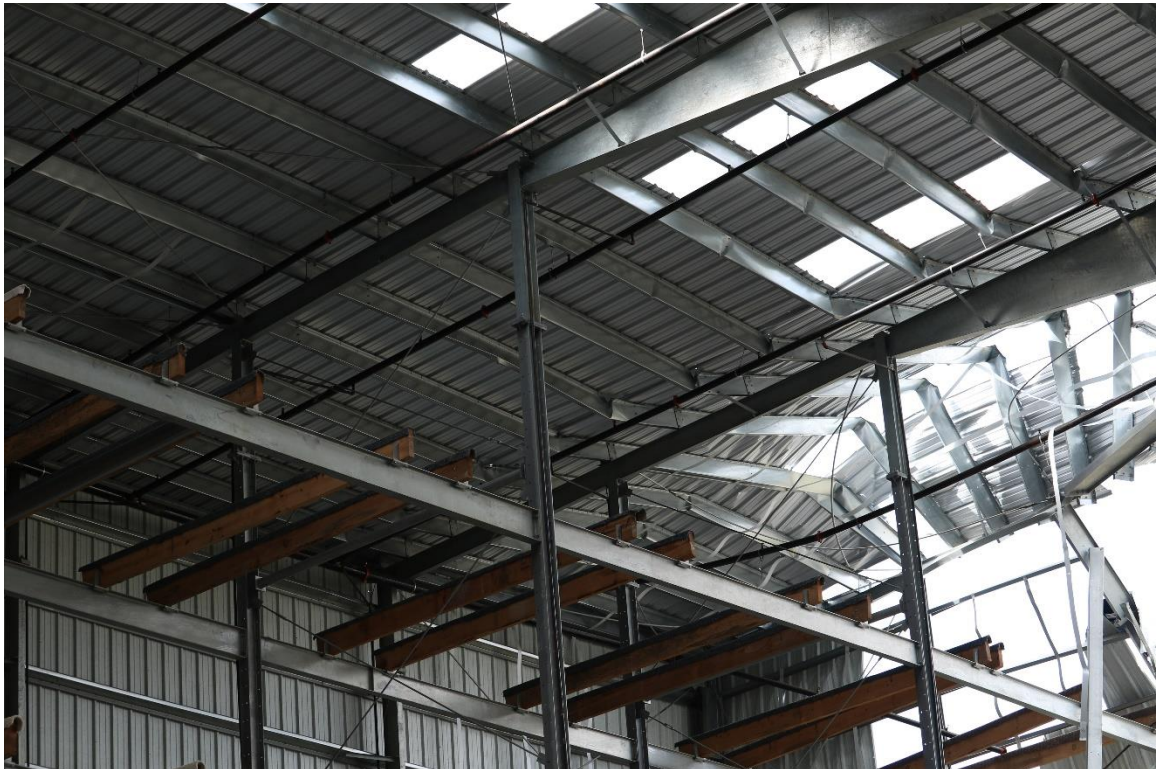
Figure 3.12. A view of the buckled purlins of Watson Landings Marina.

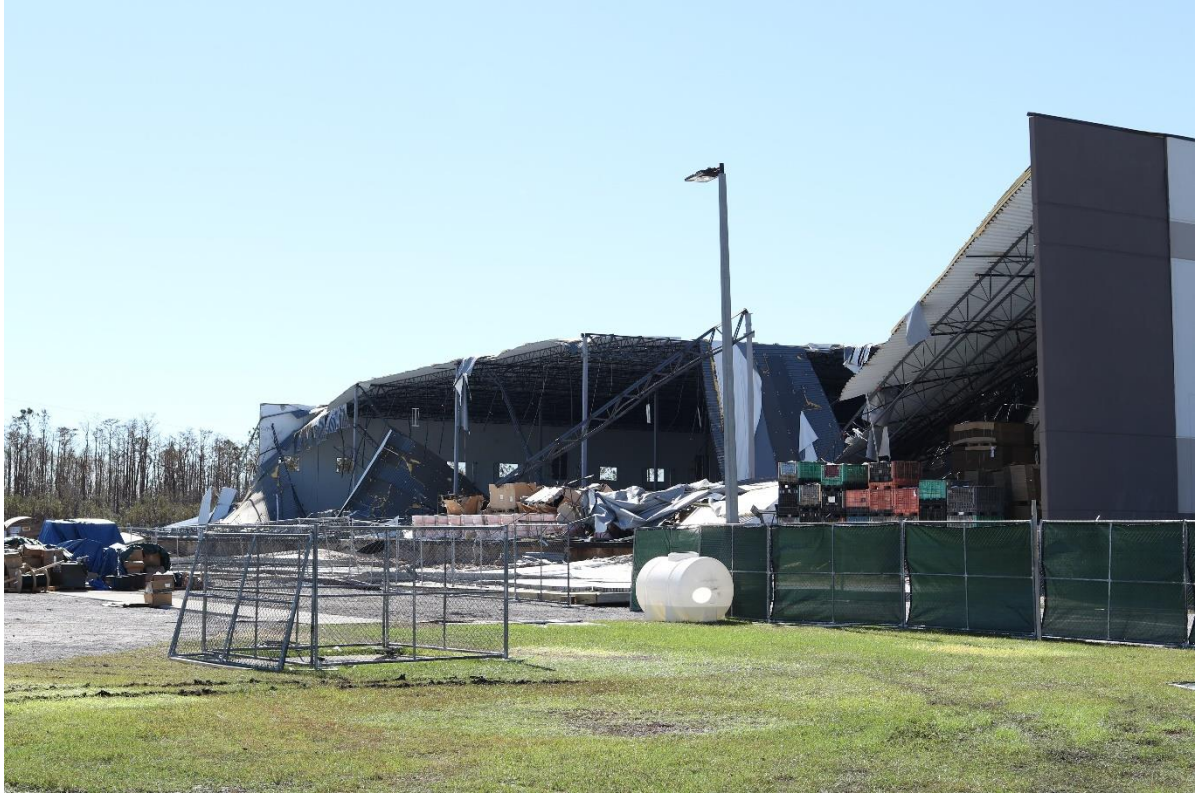
Figure 3.15. The damaged face of the IDC.

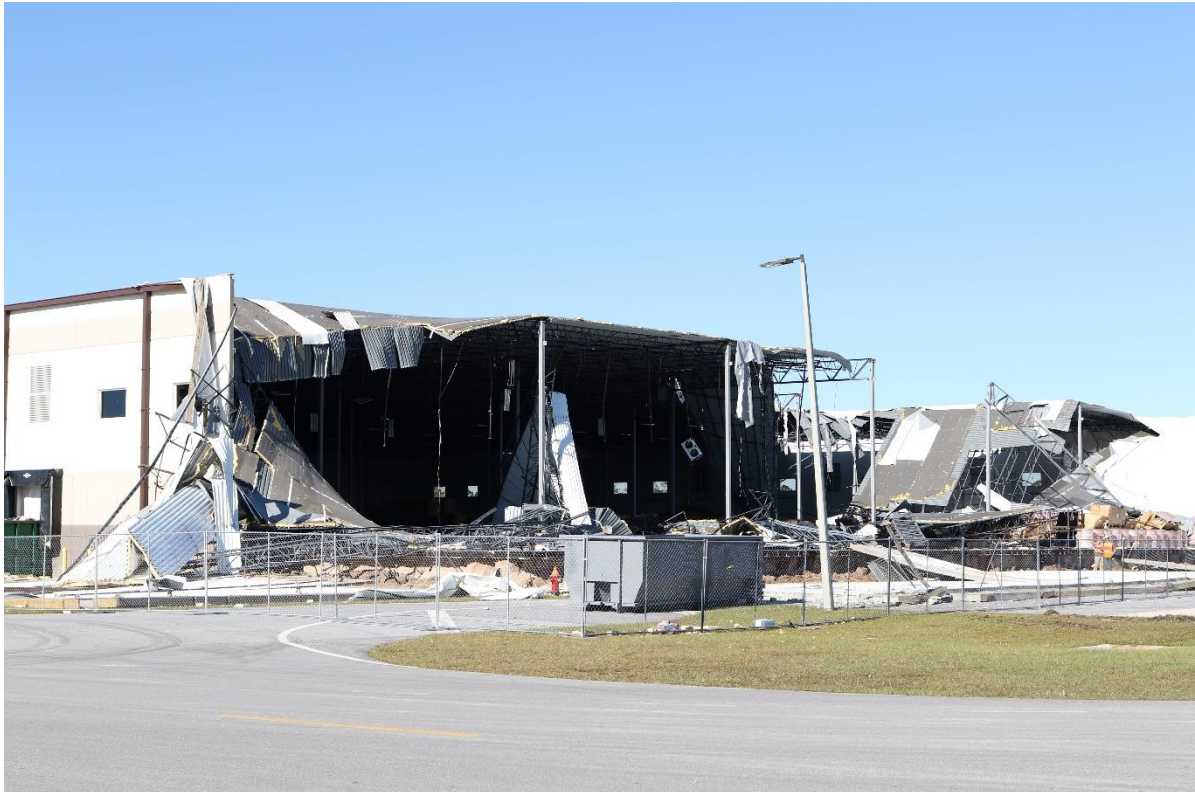
Figure 3.16. The damaged face of the IDC.

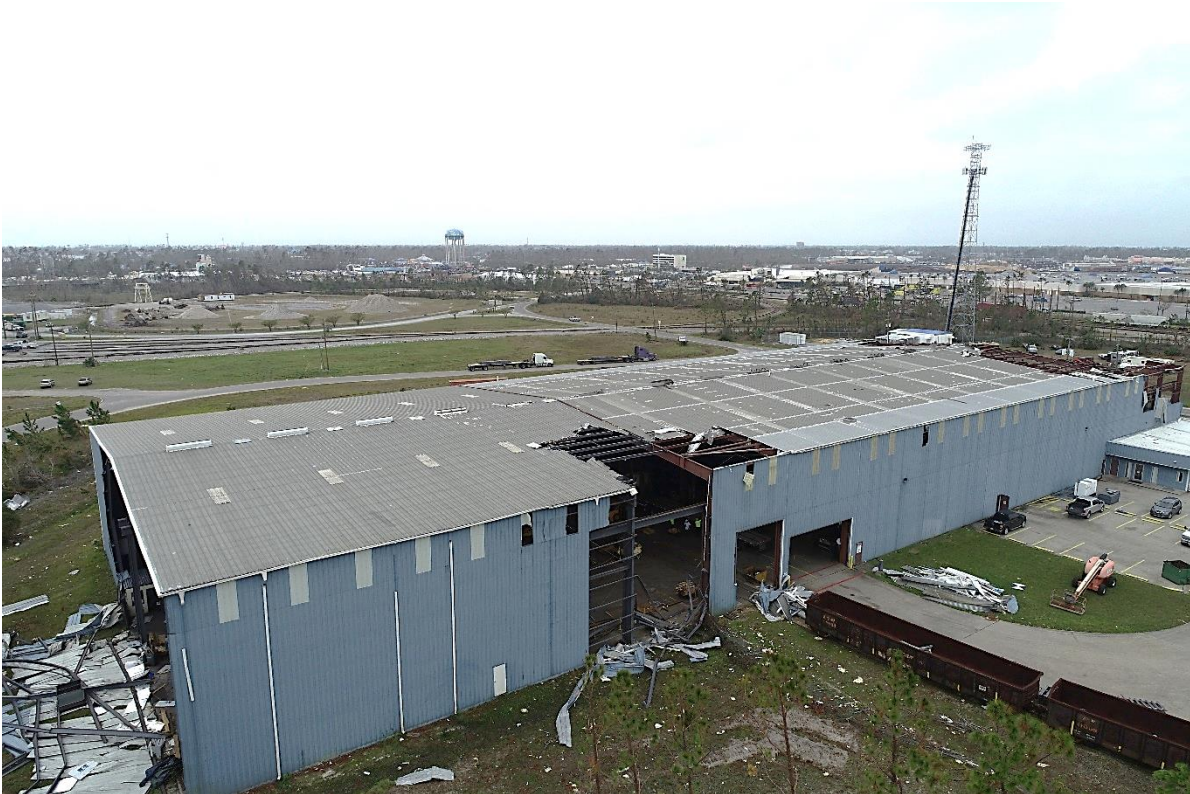
Figure 3.19. Other damage to Cargill Distribution Center.

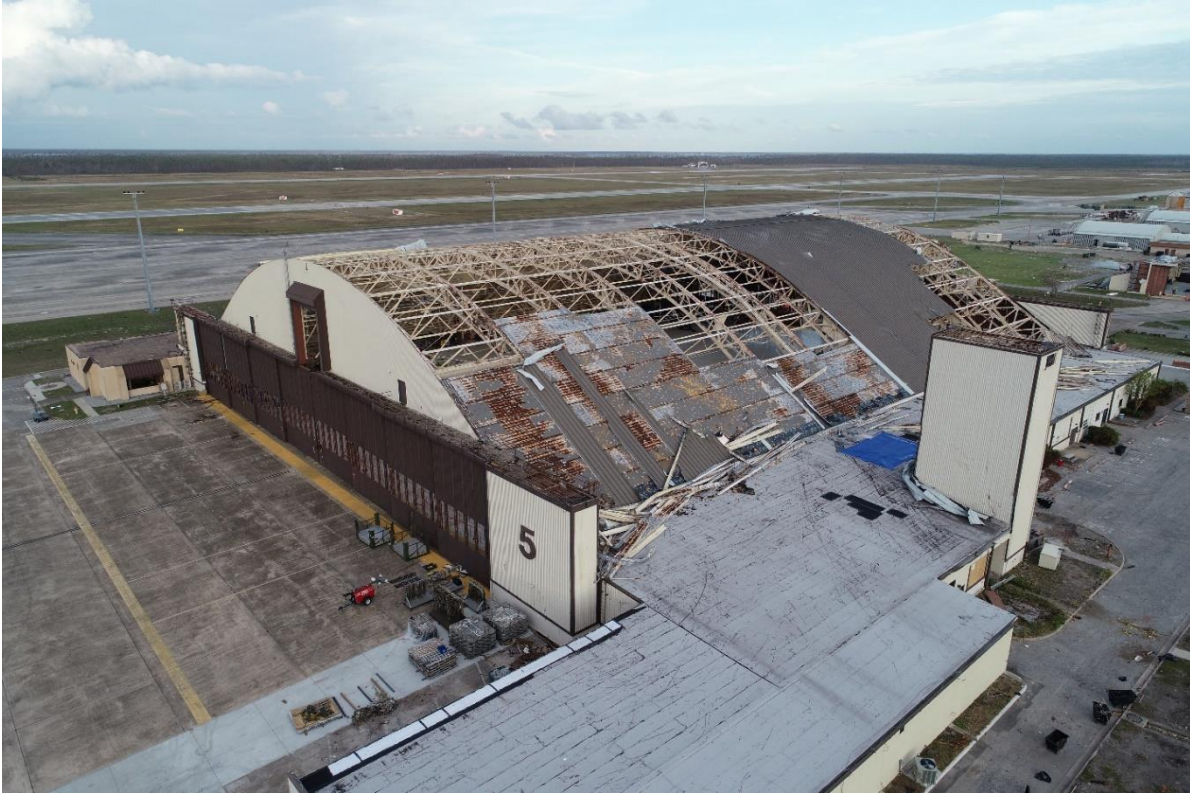
The structural system did not suffer from any obvious damages, but the roofing was torn off in well over half the building as demonstrated in Figure 3.22 and Figure 3.23.

Figure 3.22. Overview of roof damage on the south facing side of Hangar 5.

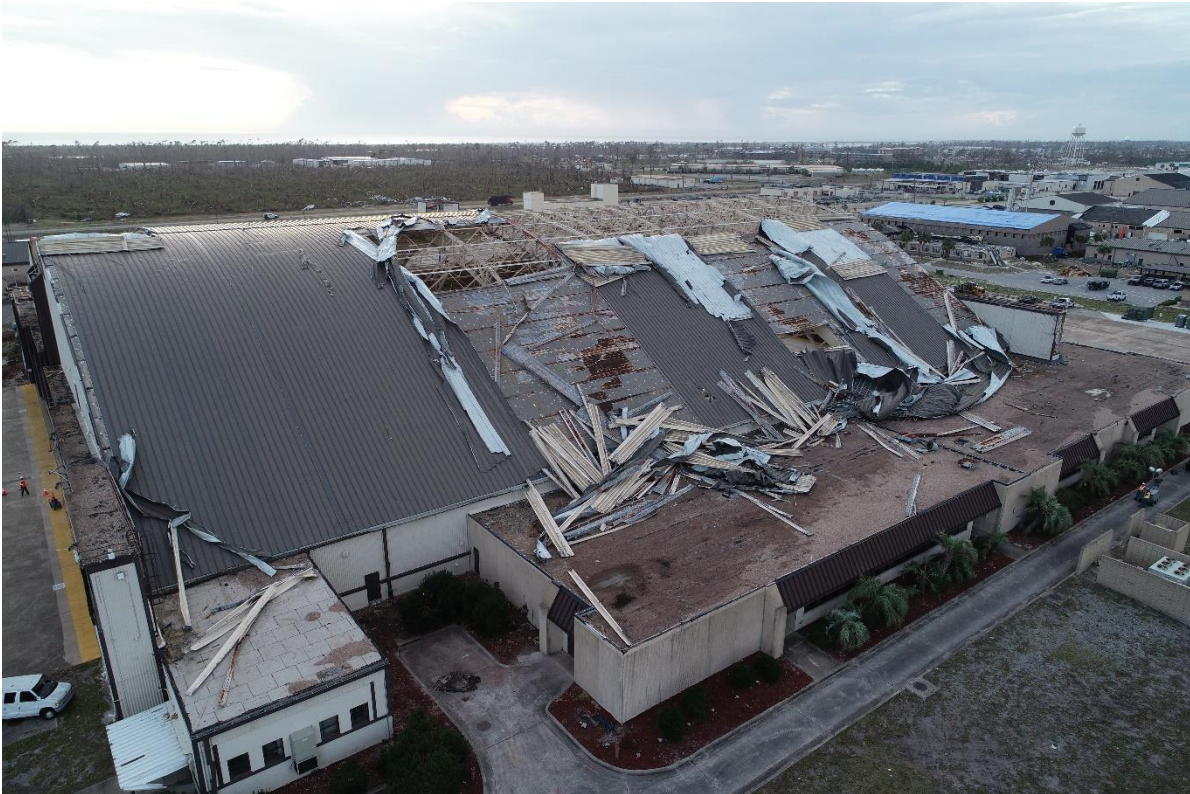
Figure 3.23. Overview of roof damage on the north facing side of Hangar 5.

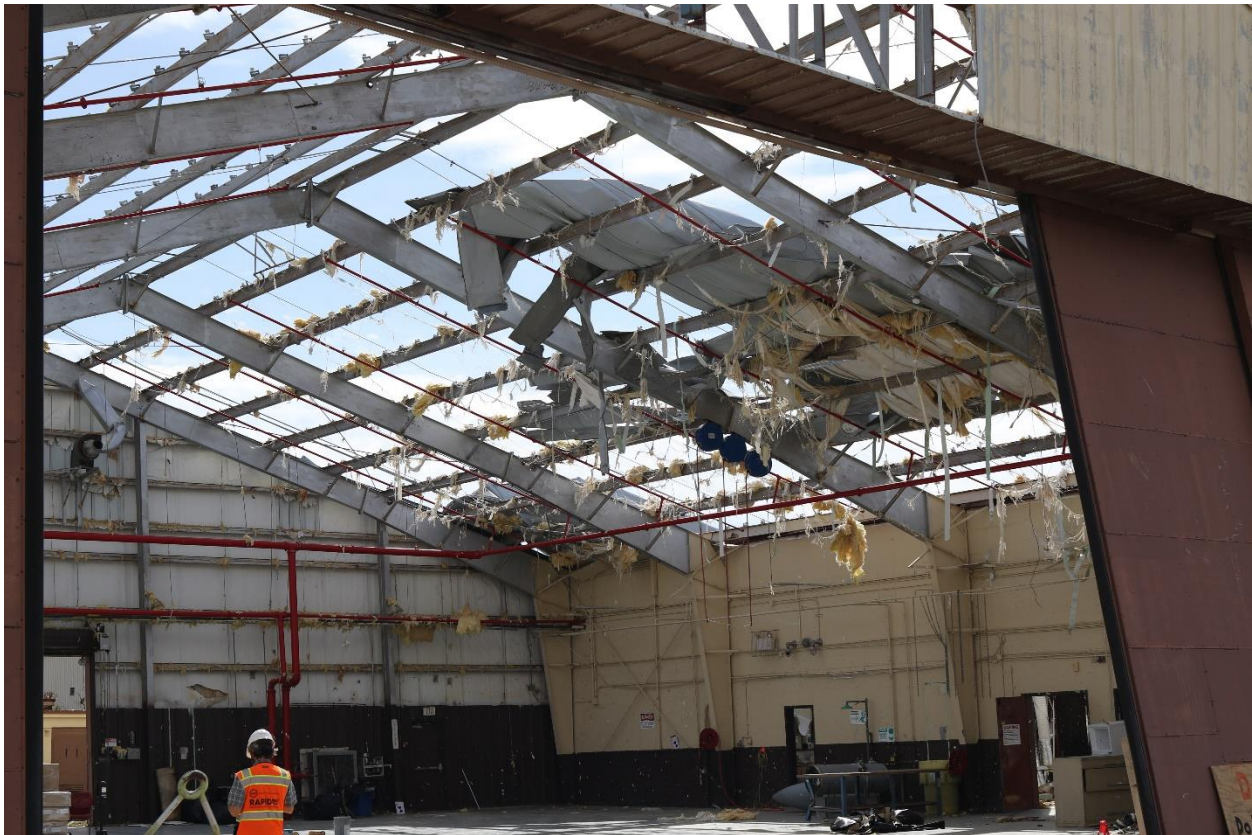
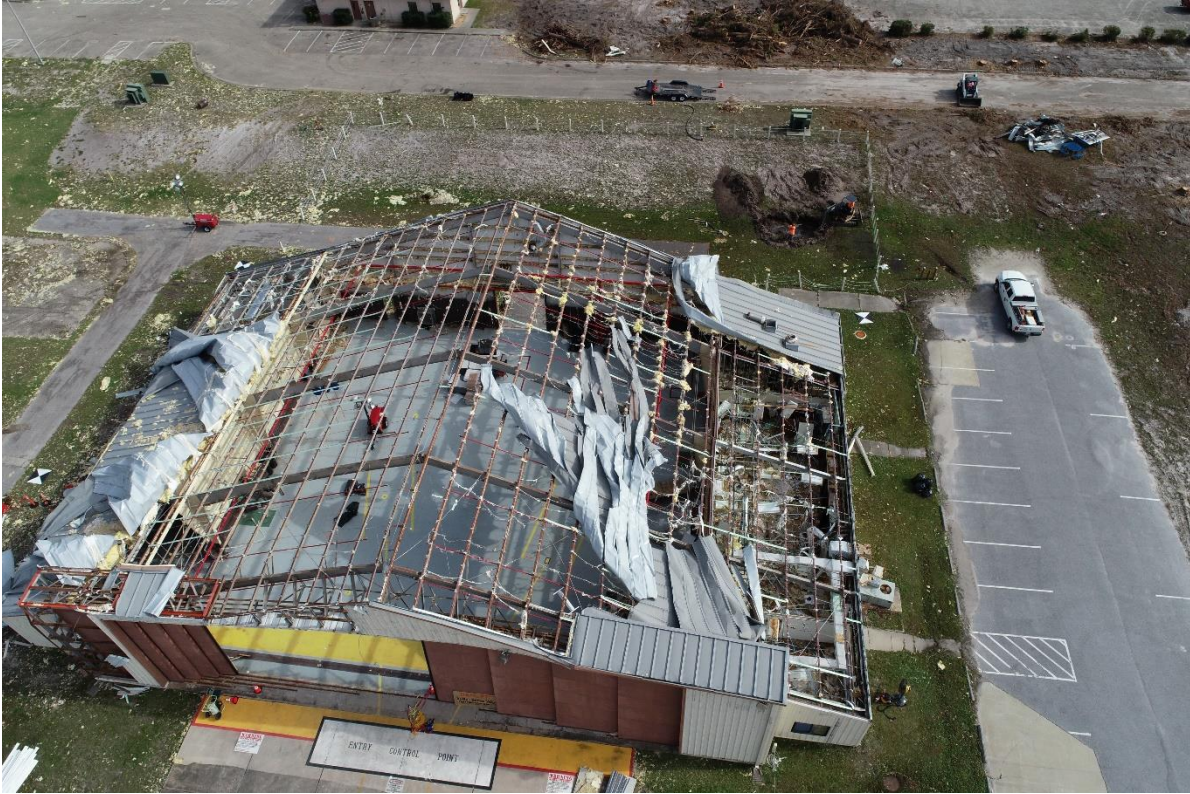
The damage to Building 316 can be described as a total removal of the roof as can be seen in Figure 3.24 and Figure 3.25, but no clear damage to the structural system could be observed.

Figure 3.25. The roof damage to Building 316.

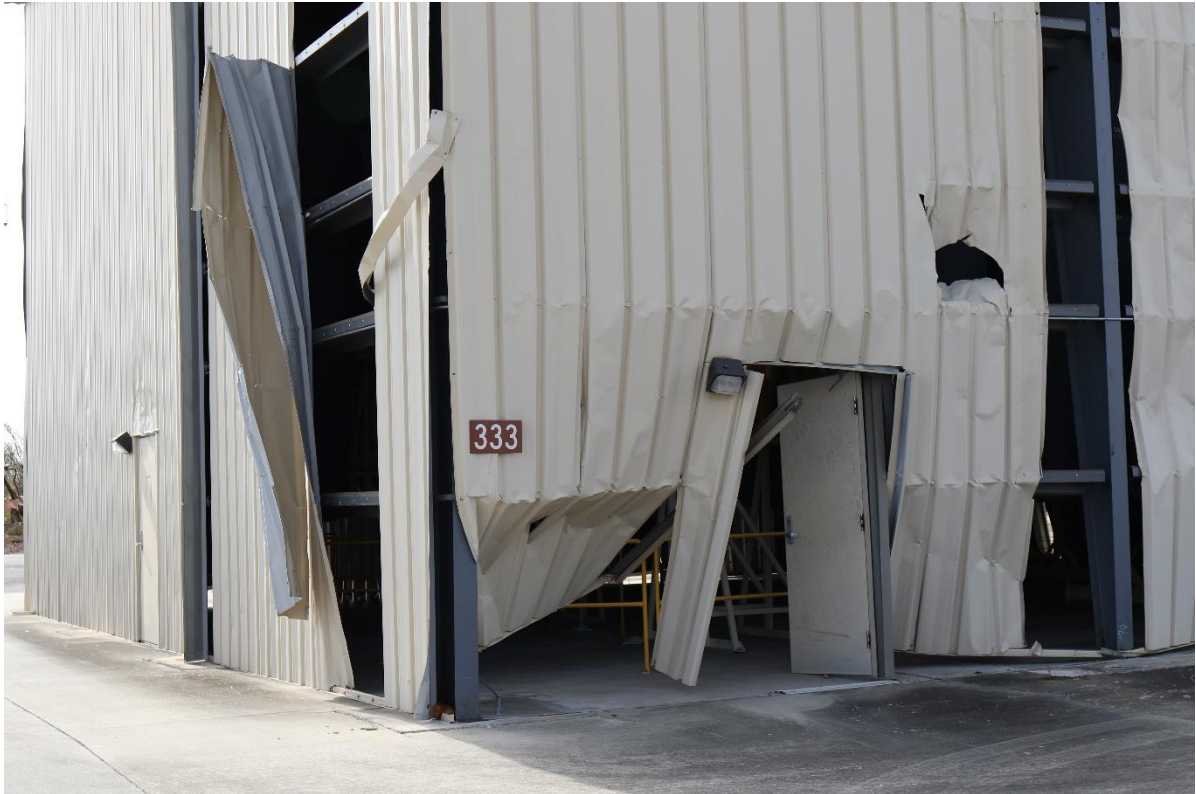
The least amount of damage of all the buildings discussed here was observed in Building 333 at Tyndall Air Force Base, with slight damages to the outside cladding visible in Figure 3.27 and Figure 3.28.

Figure 3.27. Paneling damages to Building 333.

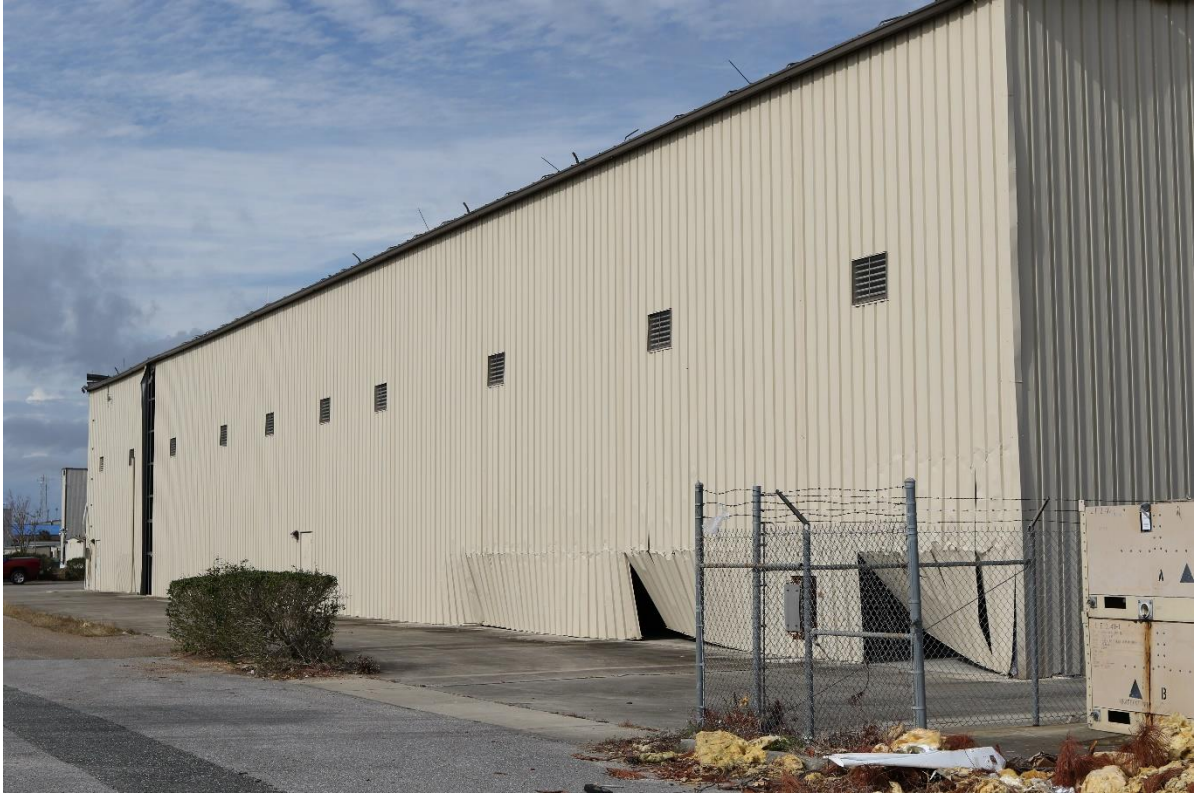
Figure 3.28. More paneling damages to Building 333.

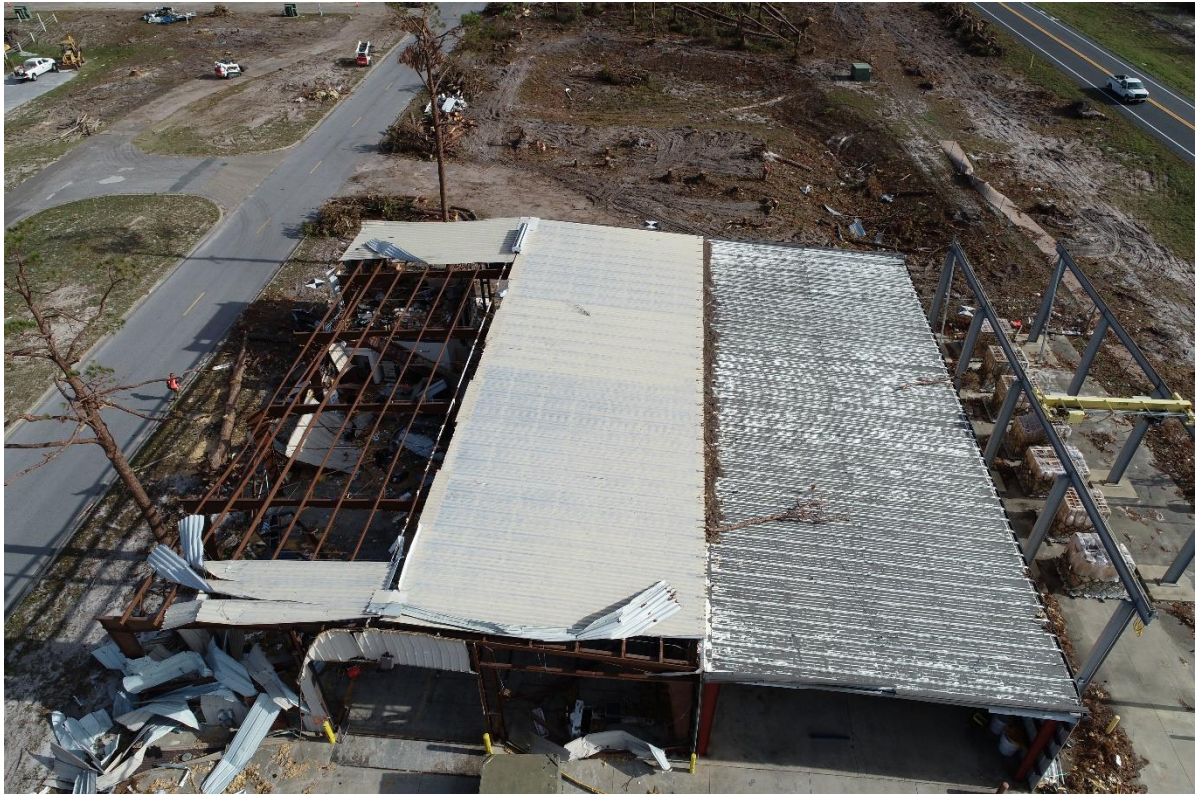
Much like the other buildings scanned at Tyndall Air Force Base, Building 375 suffered mostly from cladding damages to the roof, shown in Figure 3.30, with no clearly visible damages to the structural system.

Figure 3.30. The roof damage to Building 375.

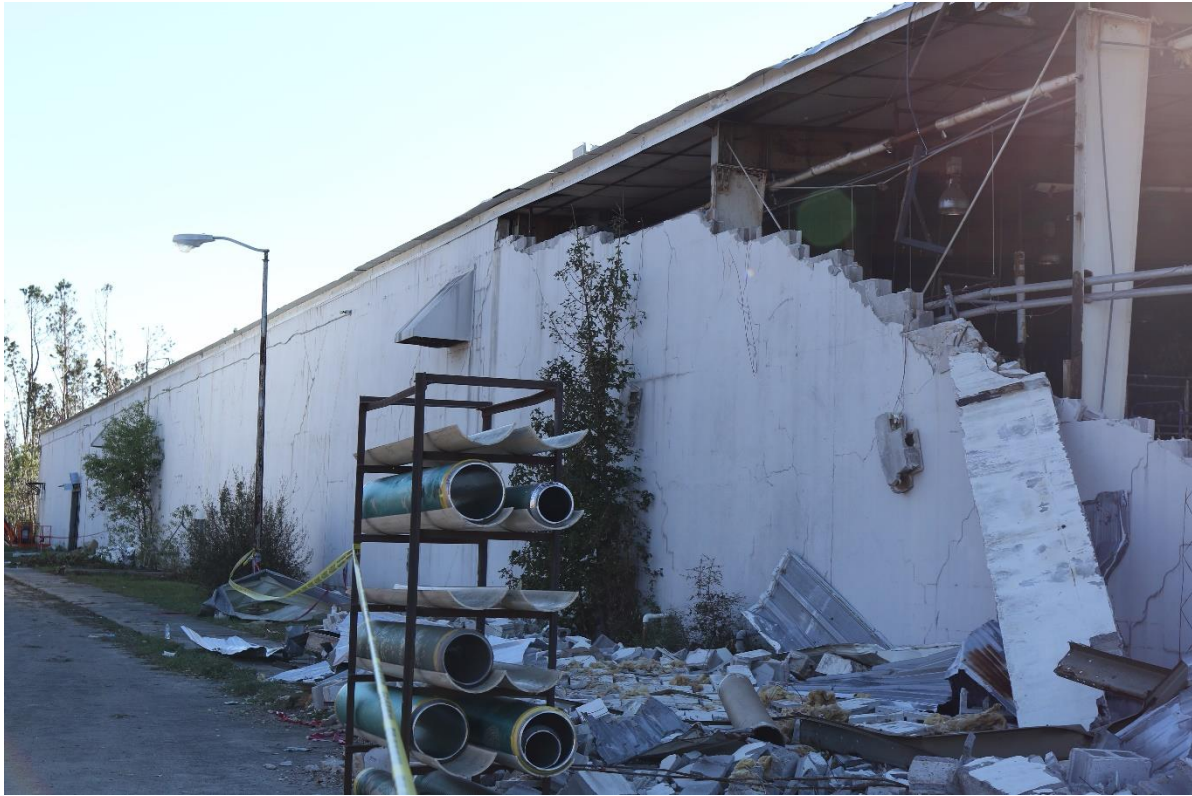
Figure 3.34. View of the damaged wall in Parthenon.

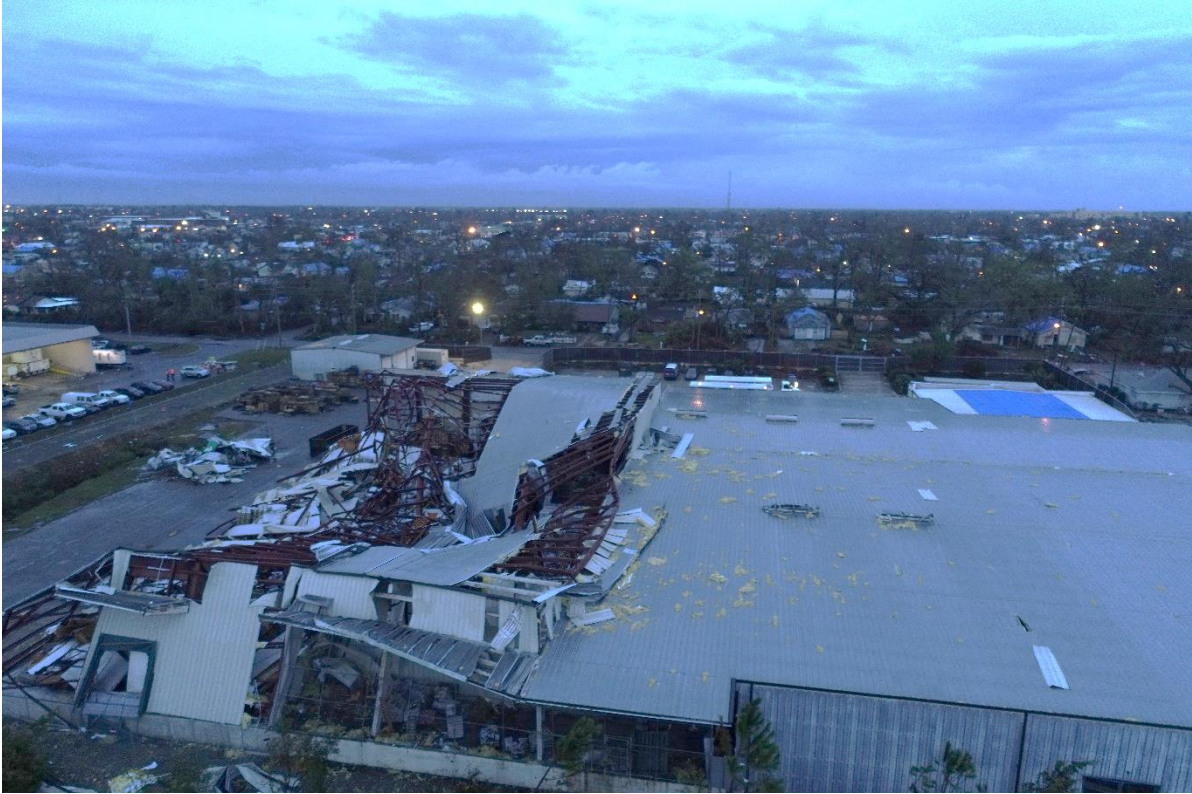
The damage observed included the complete collapse of the roofing system, five bays into the structure from the north side, and large deformations of the side walls supporting the roof over the same distance. Those damages can be seen in Figure 3.35 and a closer view of the buckled purlins between the beams spanning the roof in Figure 3.36.

Figure 3.35. Overview of the damages to Miller Distribution Center.

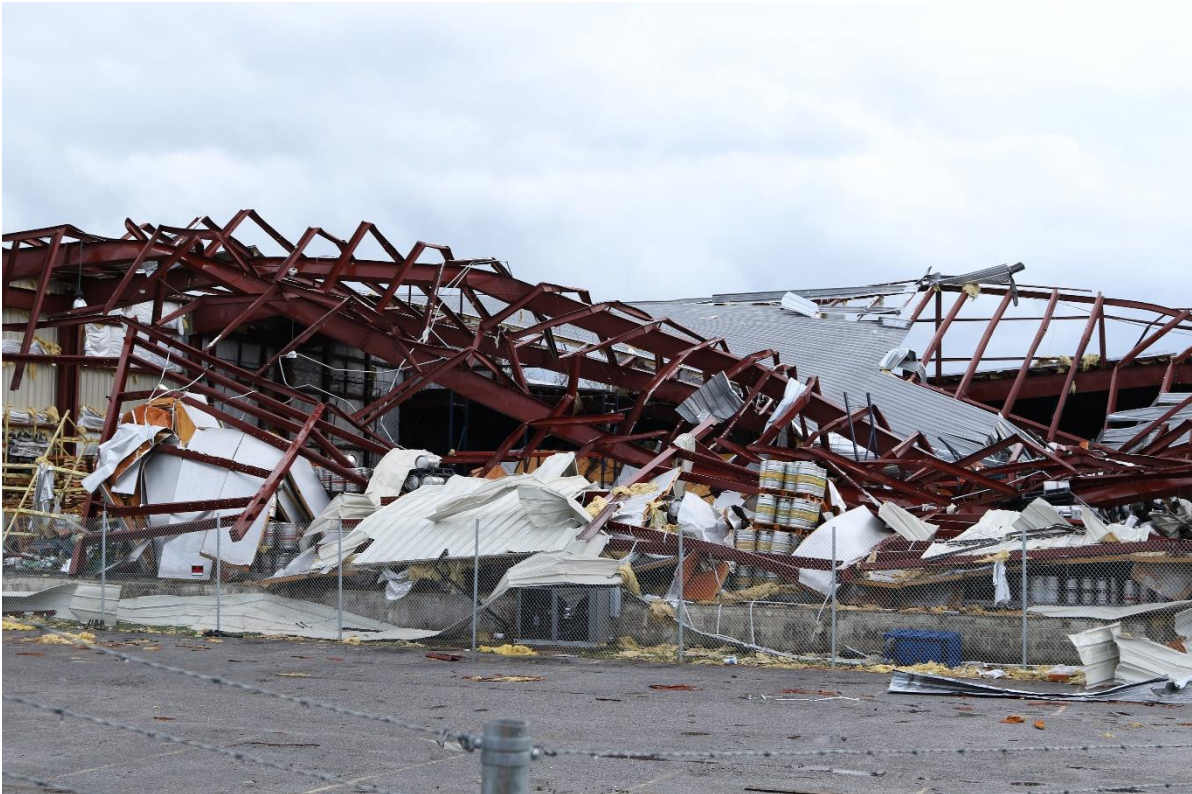
Figure 3.36. Another view of the damages to Miller Distribution Center.

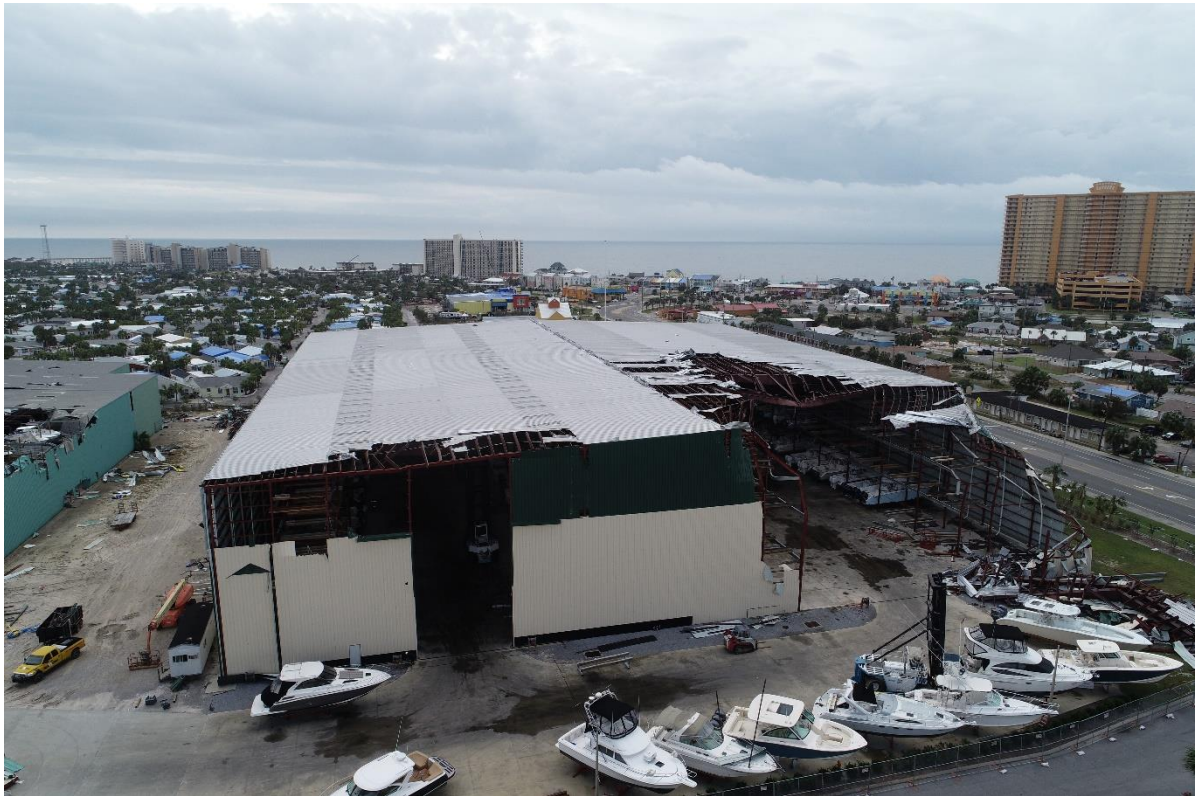
The roofing suffered a complete collapse between the westernmost side and the central row of columns, approximately five bays in from the north along with more minor cladding damages between bays five and nine as demonstrated in Figure 3.37. In addition, there were signs of buckling of roof purlins in the first bay between the easternmost side and the central row of columns which can be seen in Figure 3.39.

Figure 3.39. Pirates Cove Marina seen from the north.

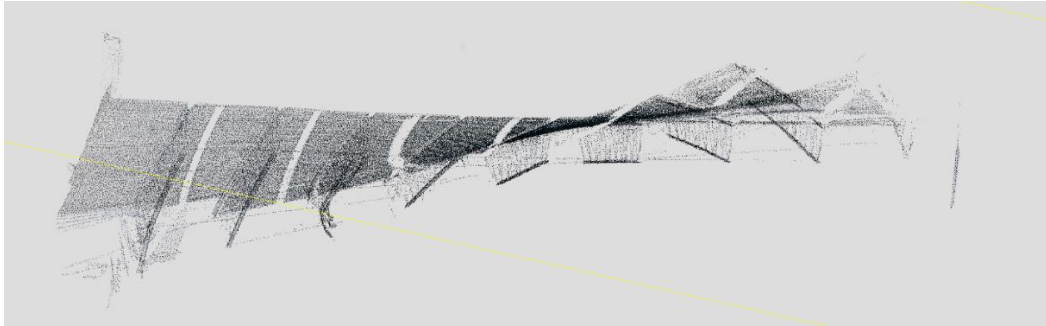
one span which was heavily deformed as can be seen in Figure 5.2, so the distance between the two purlins was measured by fitting a mesh to each of them and measuring the average distance between them.

Figure 5.2. Deformed purlins (Purlin Spacing 2*) in Intermodal Distribution Center
