Effects of Beaver Dam-Break Floods on Downstream Channels in King County, Washington

Cameron Reister

Master of Science
Earth and Space Sciences: Applied Geosciences

MESSAGE Technical Report Number: 066

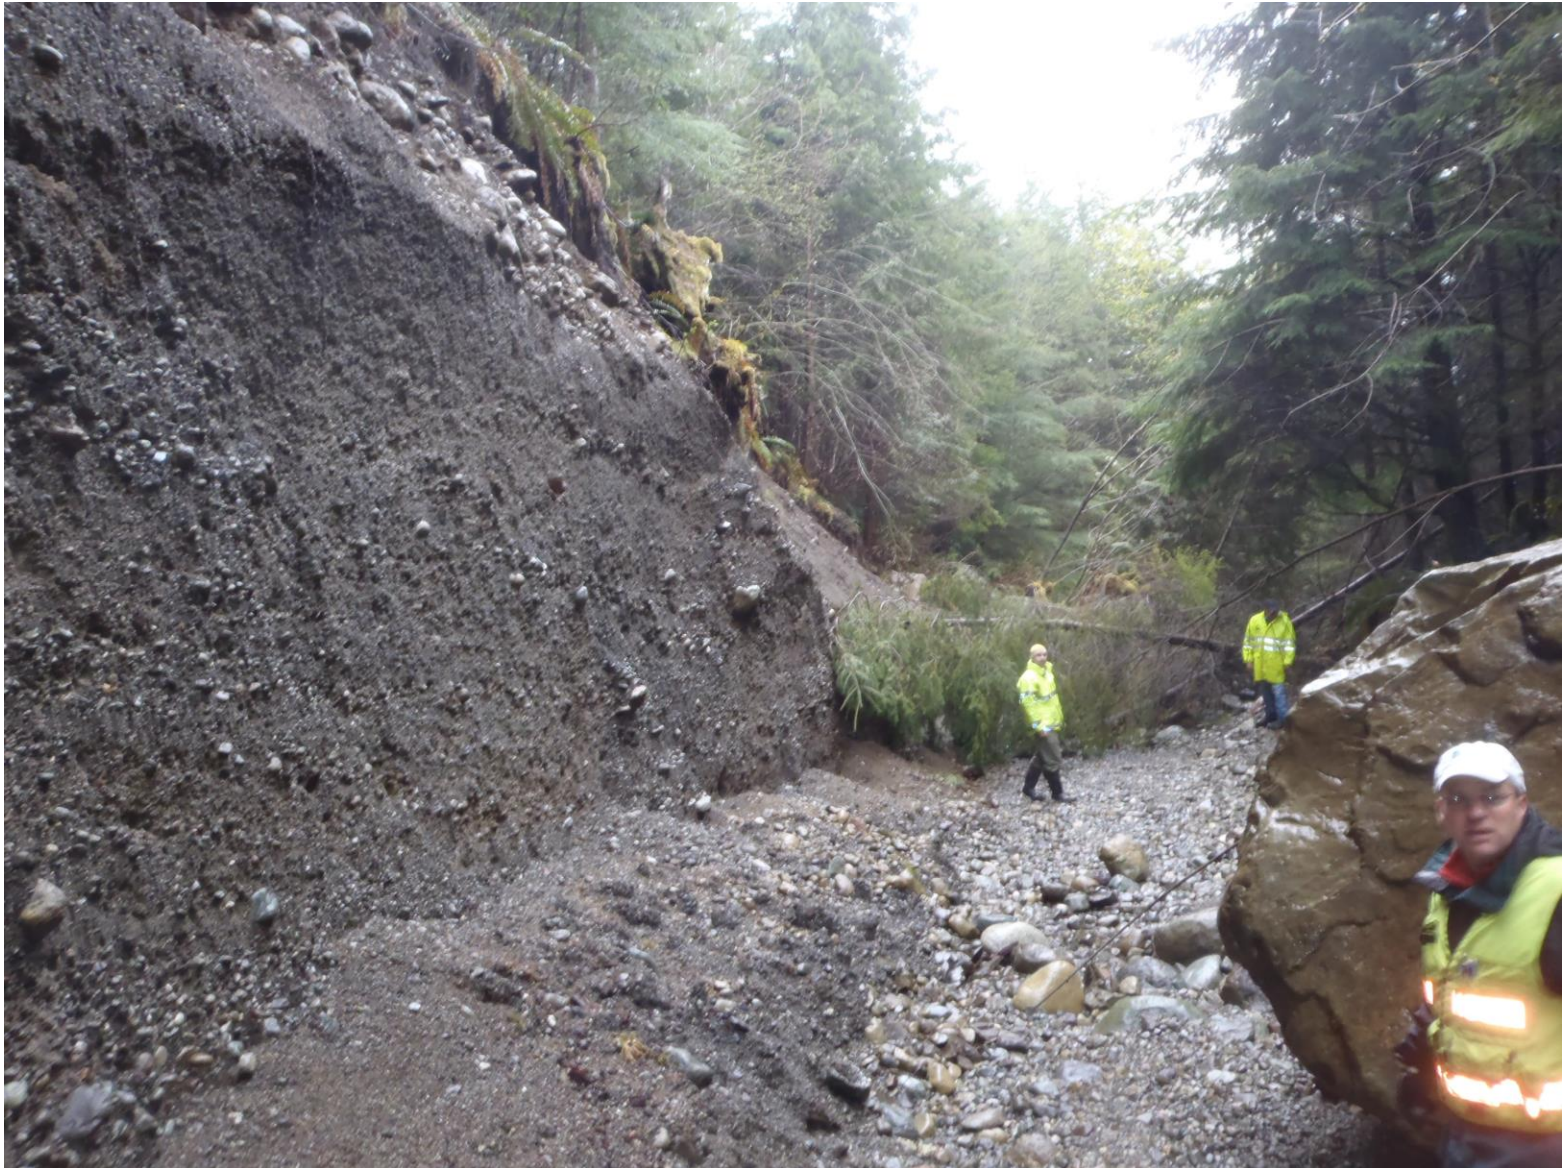
Figure 3a: Channel incision due to a beaver dam failure in Tate Creek in King County in 2011 (Source: John Bethel. Accessed: 2017).

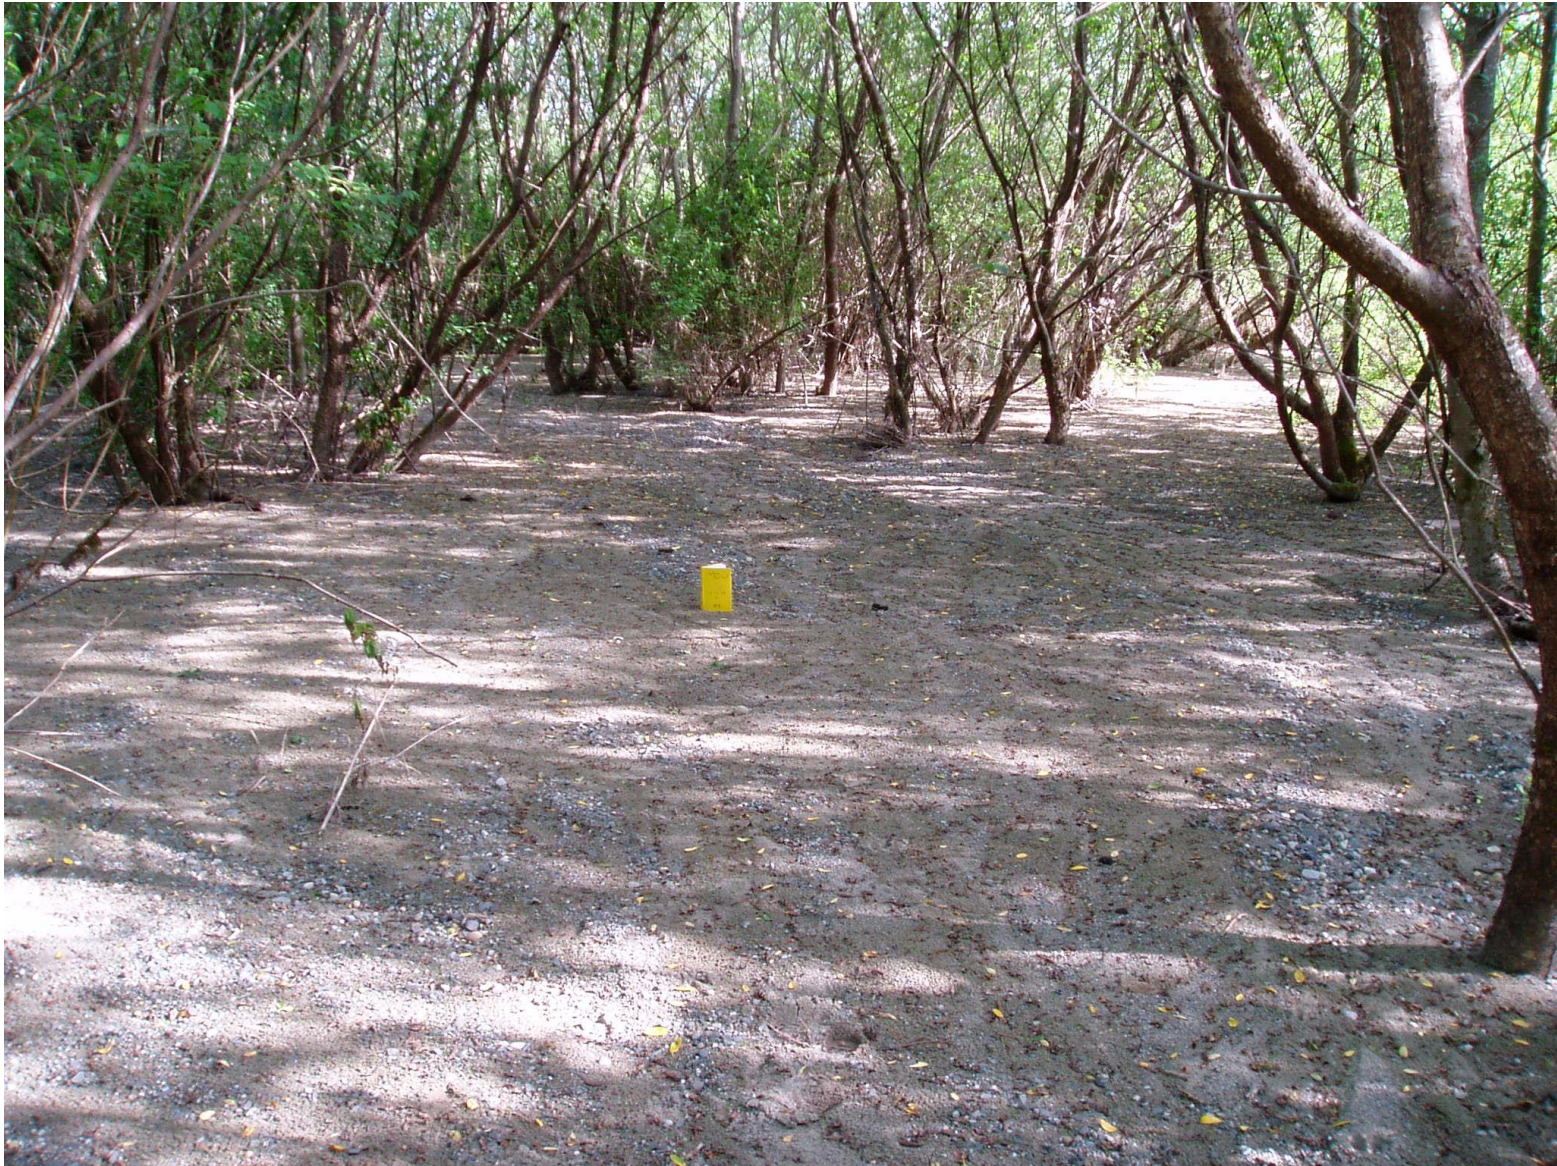
Figure 3b: Fan deposition at the mouth of a stream below the Snoqualmie Valley Trail where a beaver dam failed in King County in 2005. Notebook is 7 inches tall. (Source: John Bethel. Accessed: 2017).

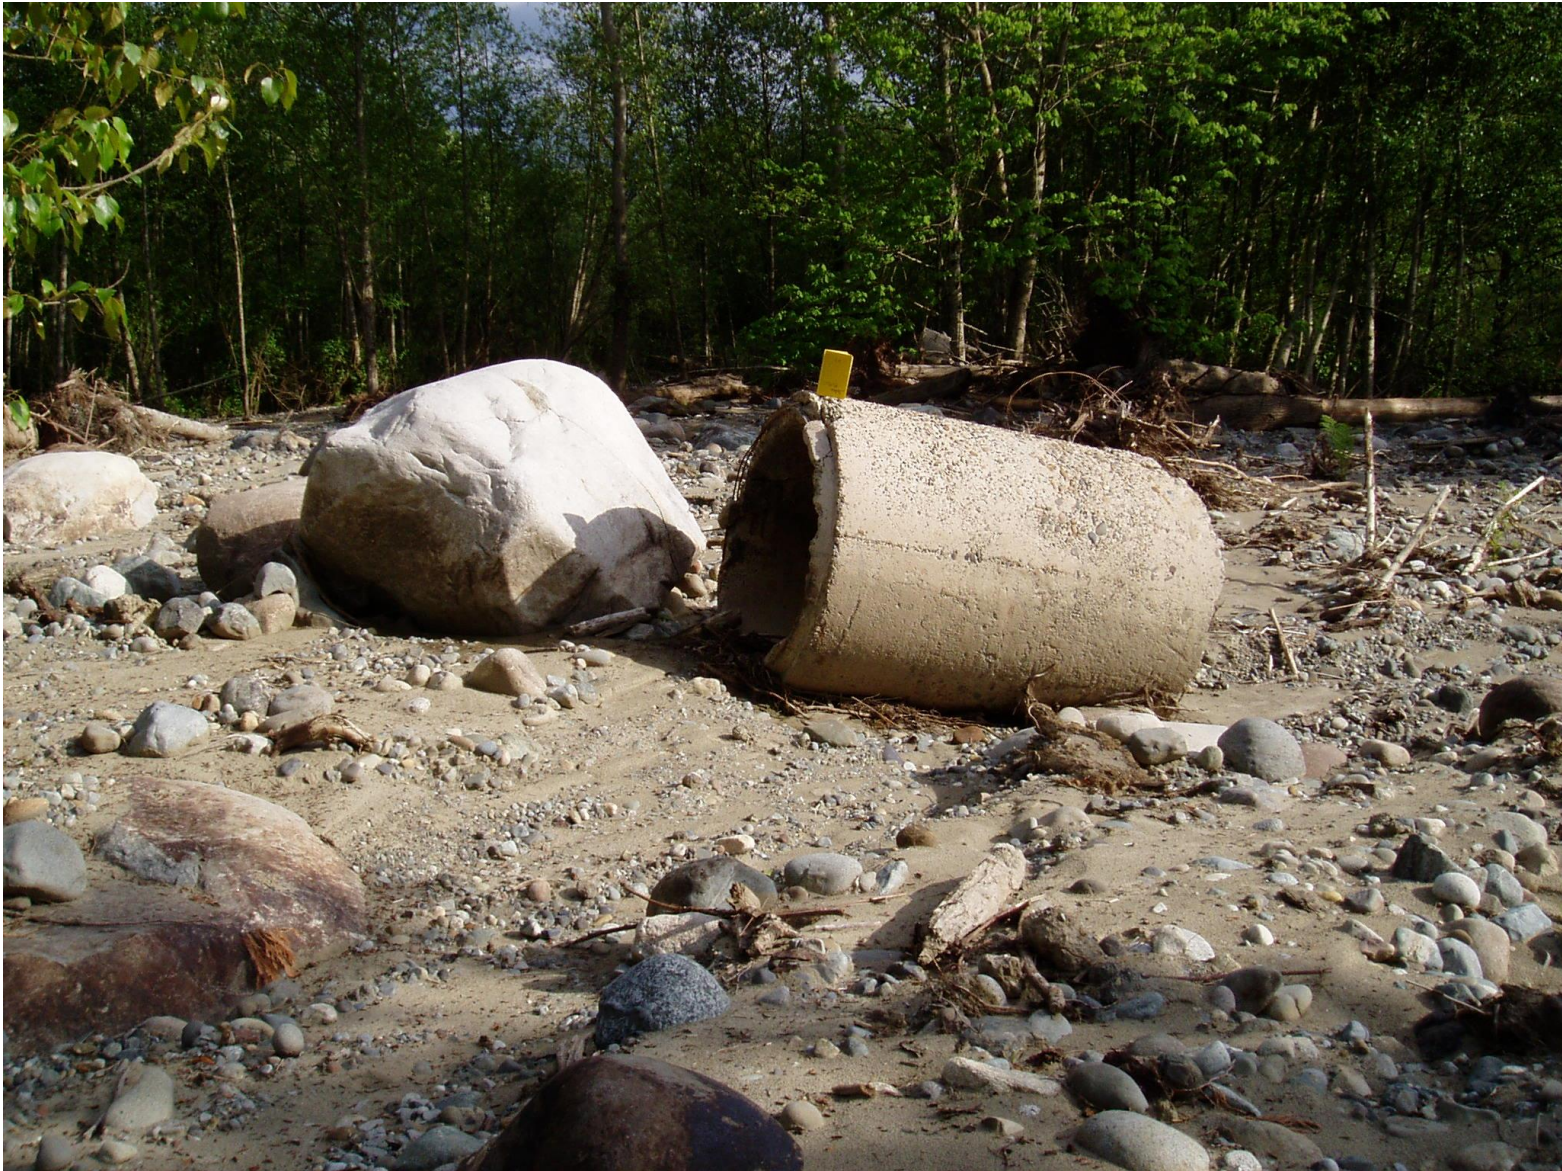
Figure 4a: Image of a concrete culvert that was blown out and transported downstream by the failure of a beaver dam upstream of the Snoqualmie Valley Trail in King County in 2005. Notebook is 7 inches tall. (Source: John Bethel. Accessed: 2017).

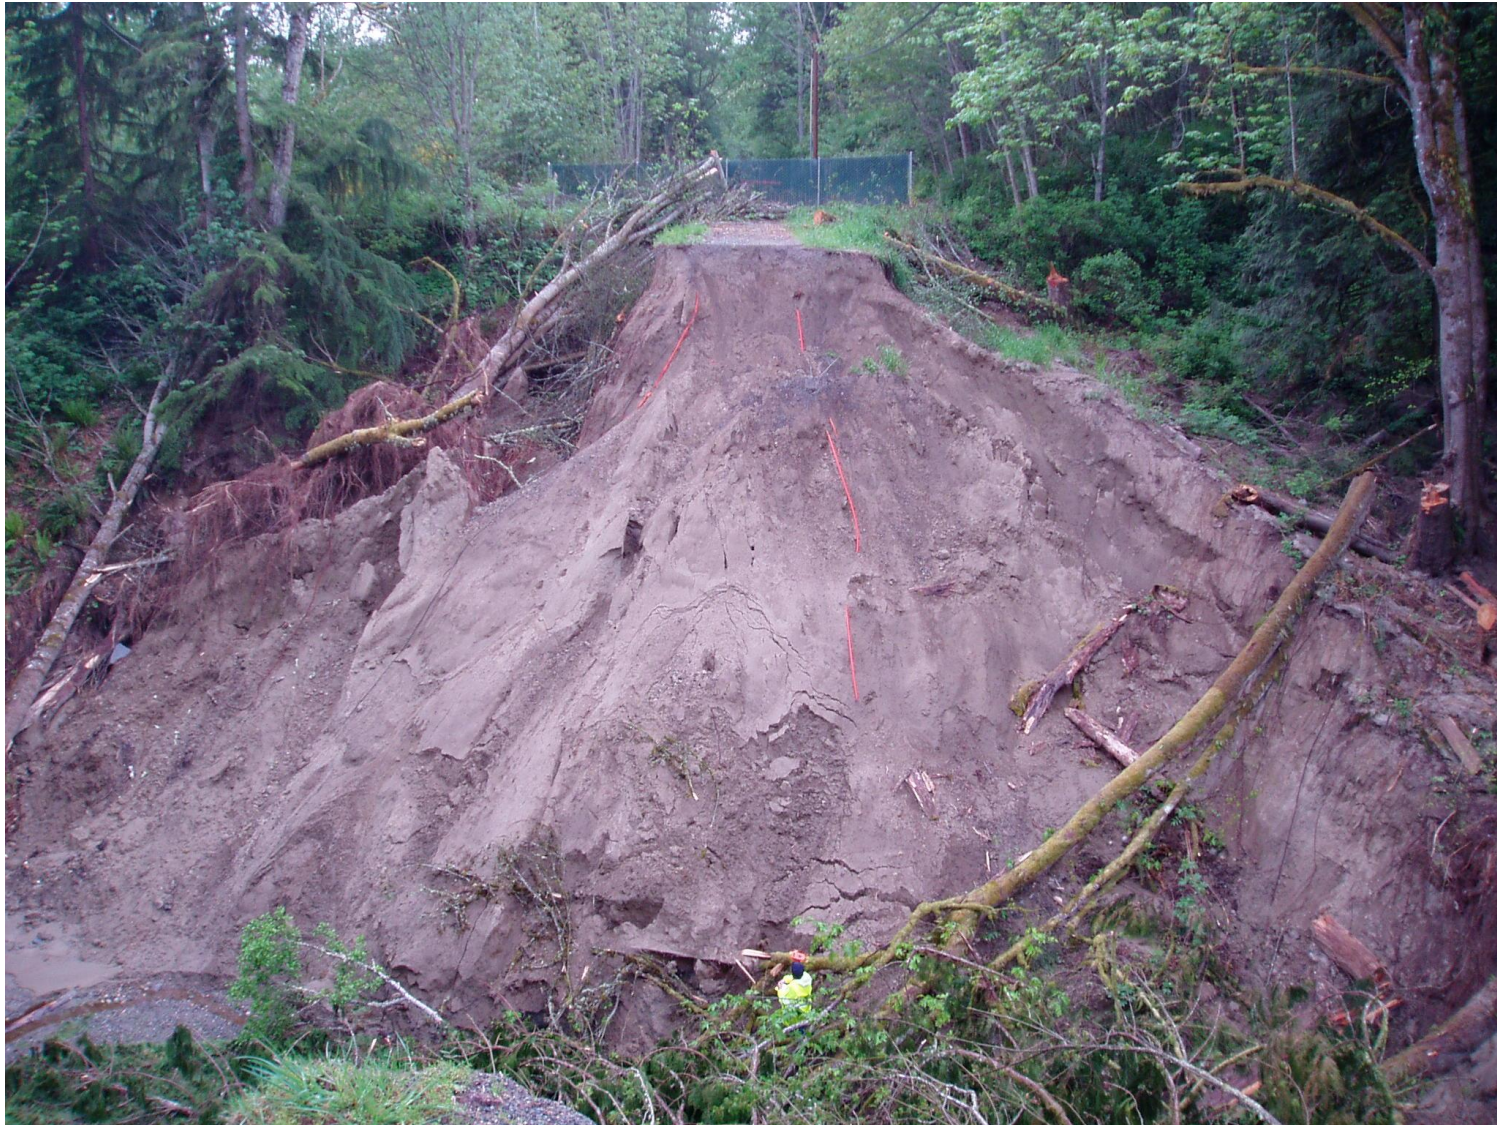
Figure 4b. Image of the damage to the Snoqualmie Valley Trail. Photo is looking across where the trail should connect across the stream in the bottom of the image. A King County employee is in the bottom center of the image wearing high-visibility green jacket. (Source: John Bethel. Accessed: 2017).

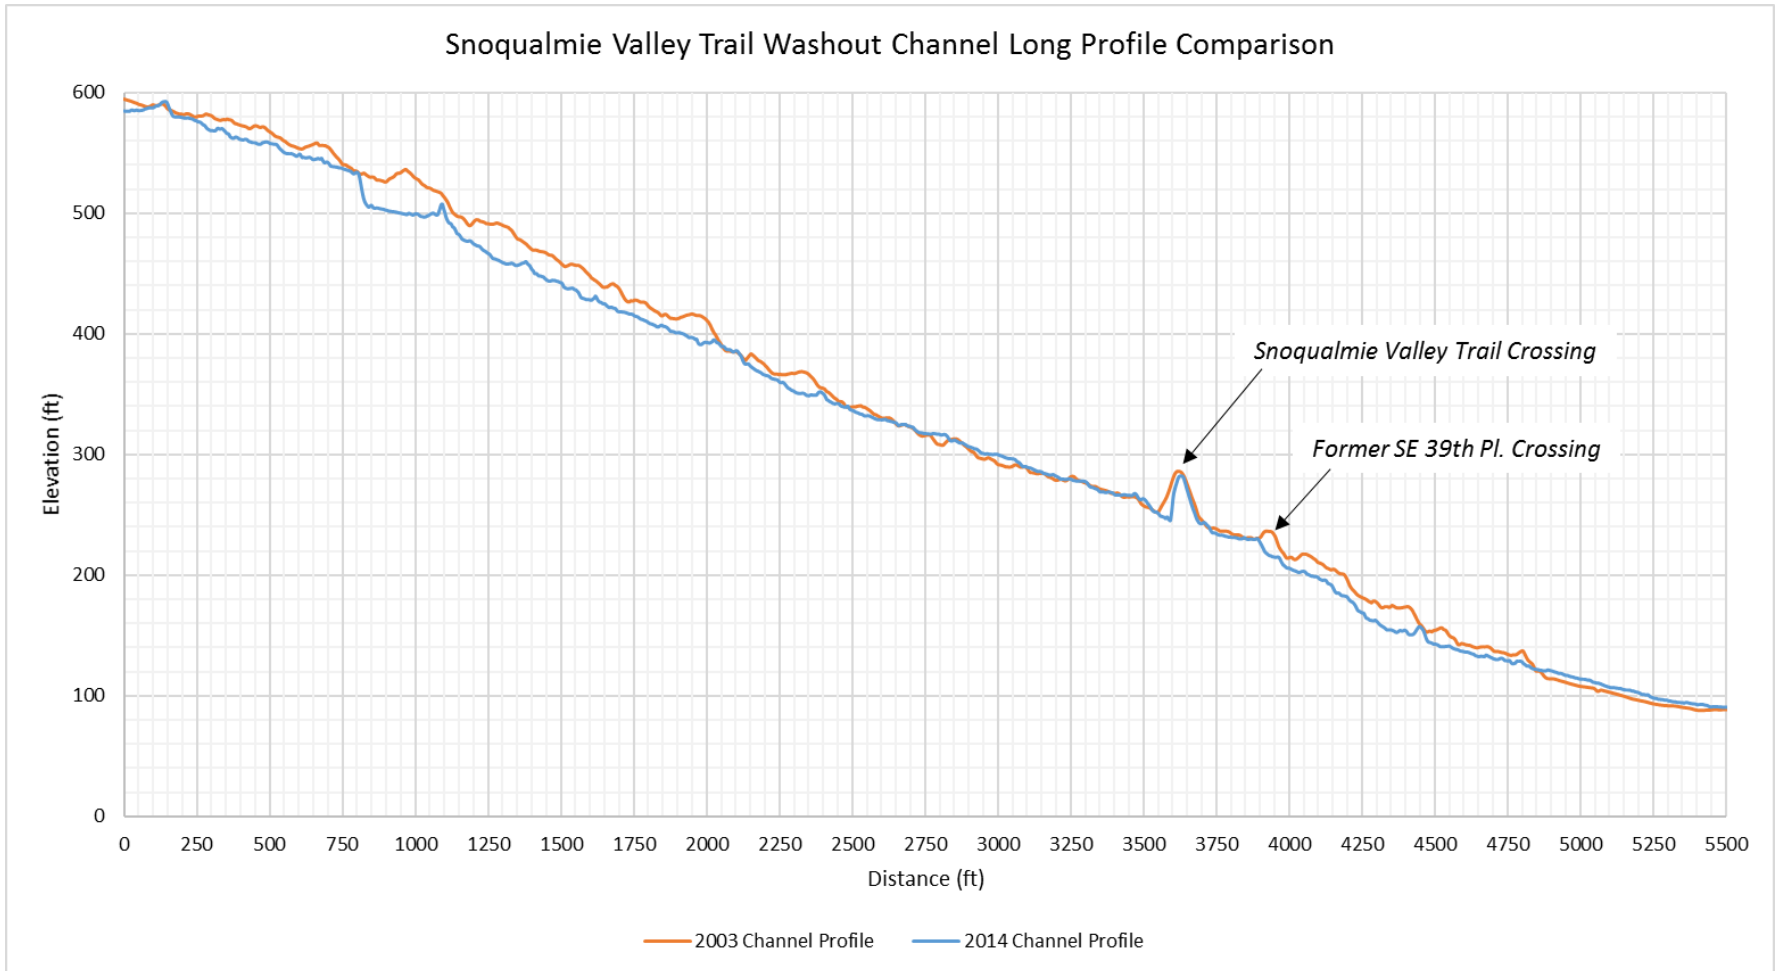
Figure 5a. Long profile channel comparison between 2003 and 2014 for the Snoqualmie Valley Trail Washout.

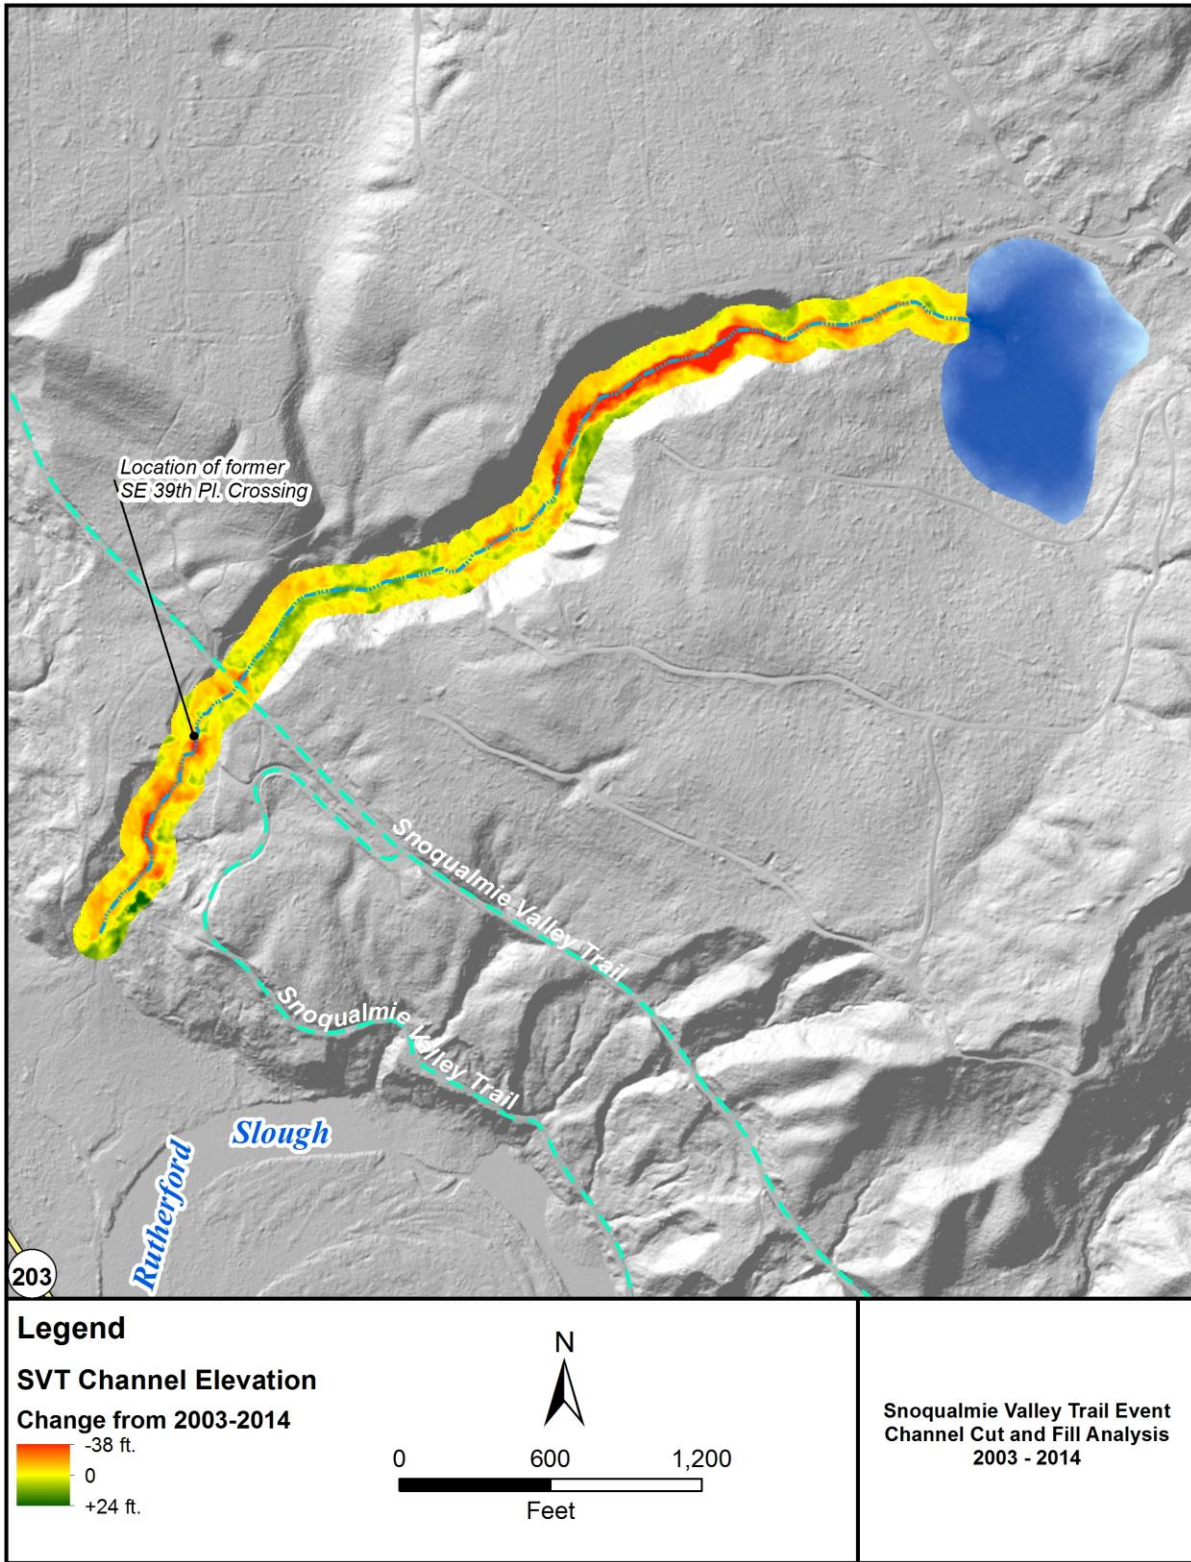
Figure 5b. Cut and fill analysis of the channel that drains the pond (shown in blue) at the site of the Snoqualmie Valley Trail Washout. The channel has degraded in areas of red and aggraded in areas of green between the 2003 LiDAR and 2014 LiDAR. Base map derived from the 2014 LiDAR.

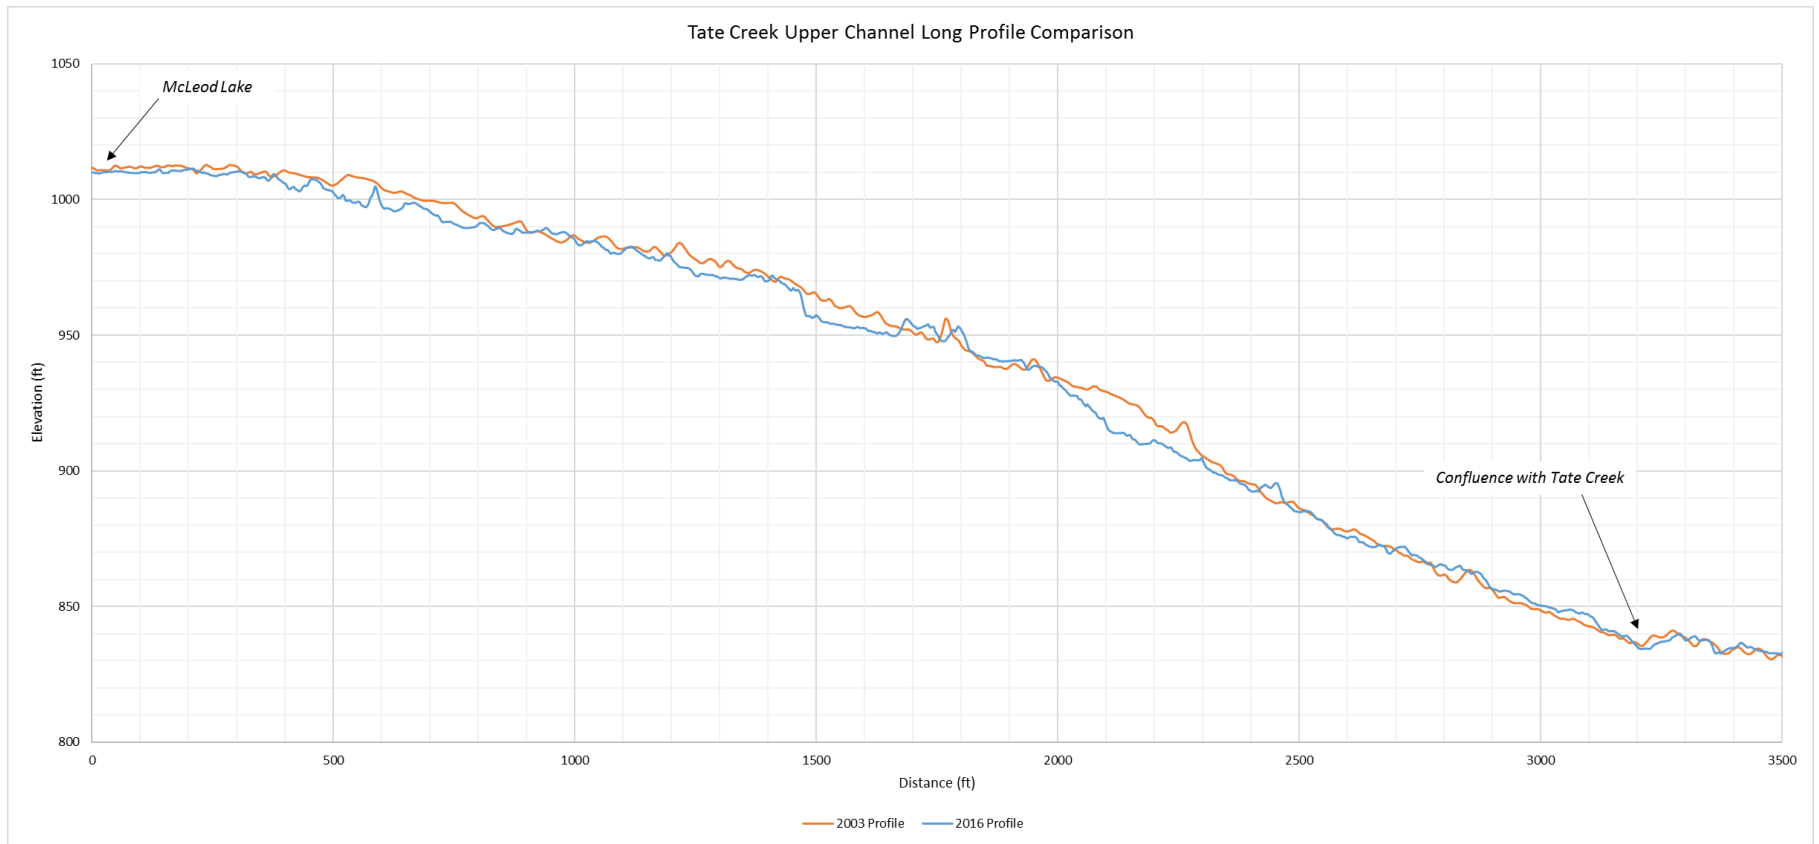
Figure 6a. Long profile channel comparison for the upper 3000 ft. of the Tate Creek failure between 2003 and 2016.

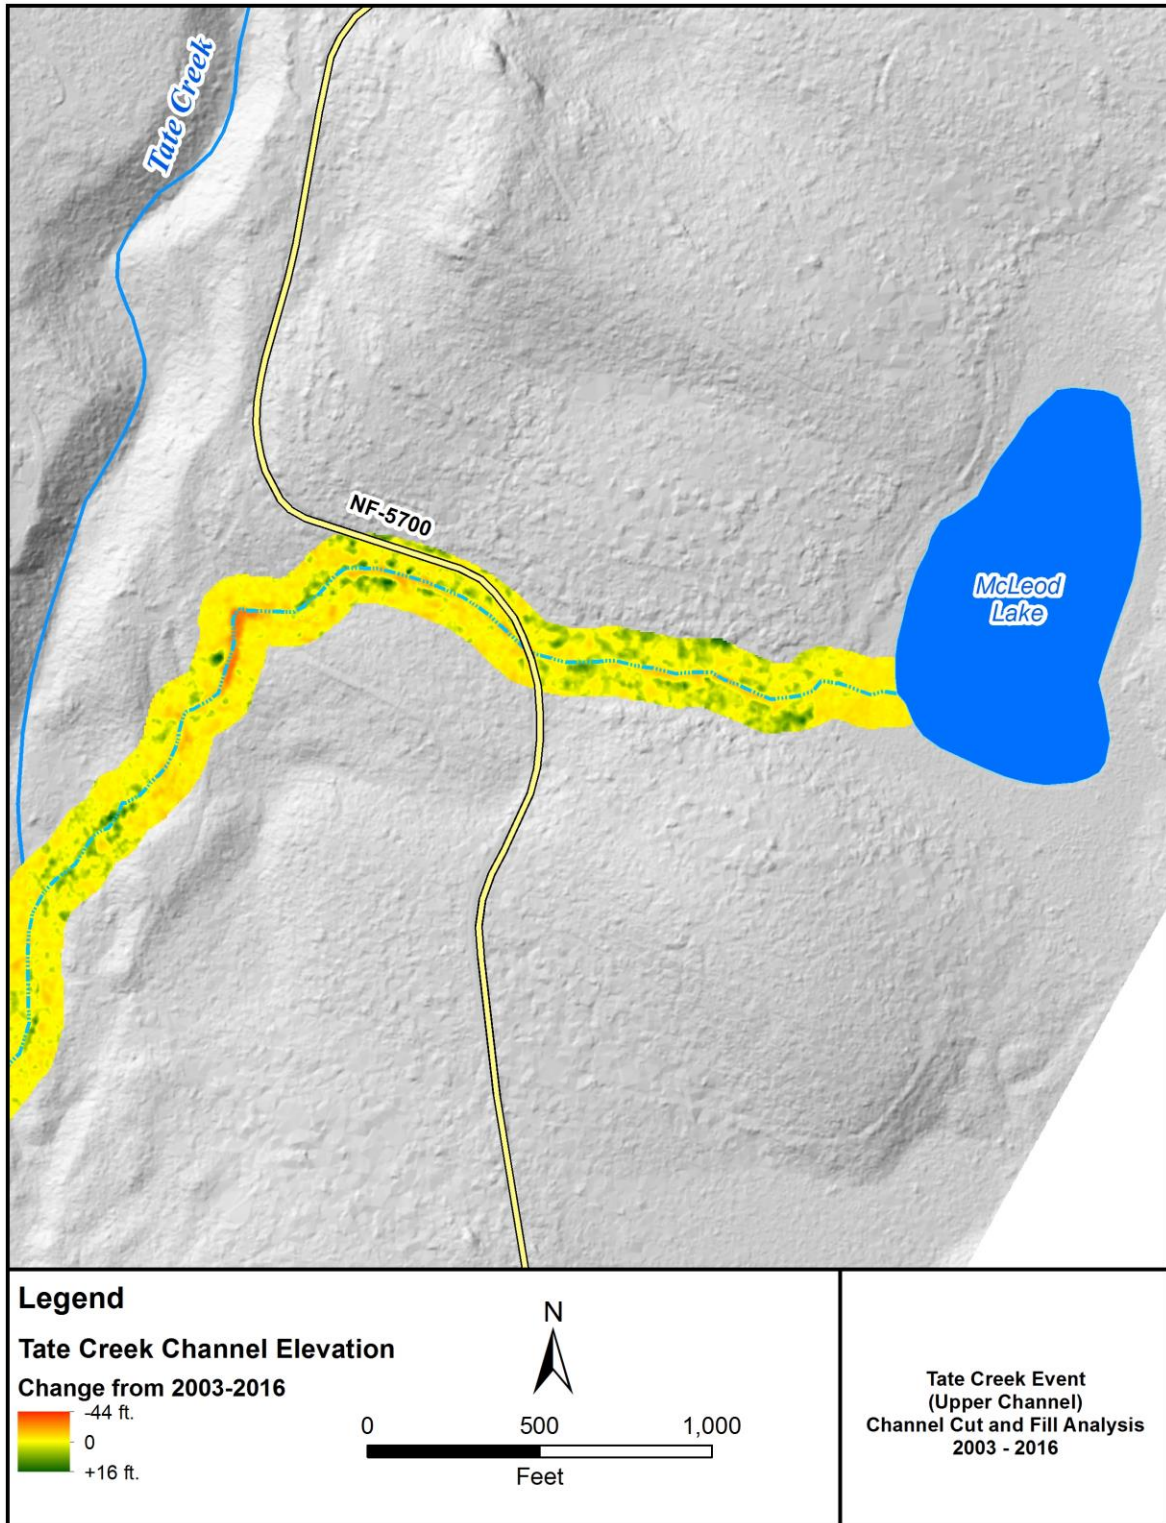
Figure 6b. Cut and fill analysis of the upper channel of the stream that drains McLeod Lake. The channel has degraded in areas of red and aggraded in areas of green between the 2003 LiDAR and 2016 LiDAR. The blue line delineating Tate Creek came from the National Hydrography Database and was not redrawn to match the new LiDAR used in this map. Base map derived from the 2016 LiDAR.

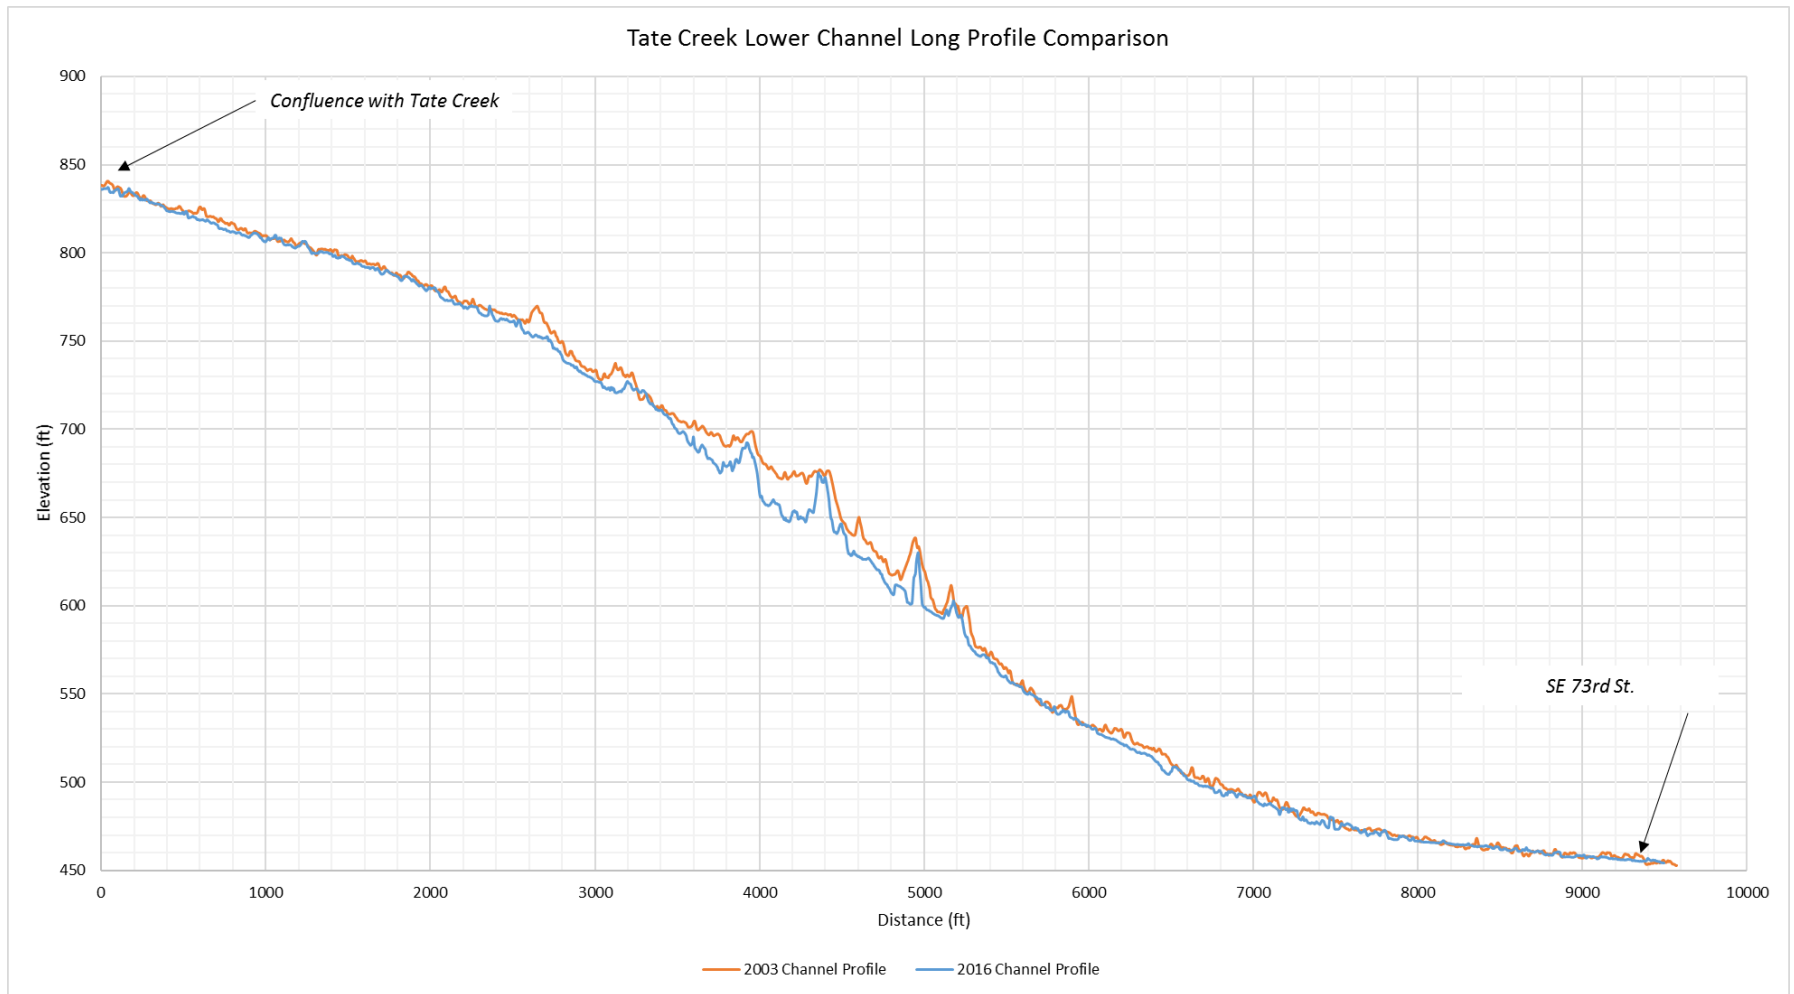
Figure 7a. Long profile channel comparison for the lower channel (downstream of confluence with Tate Creek) for the Tate Creek failure between 2003 and 2016.

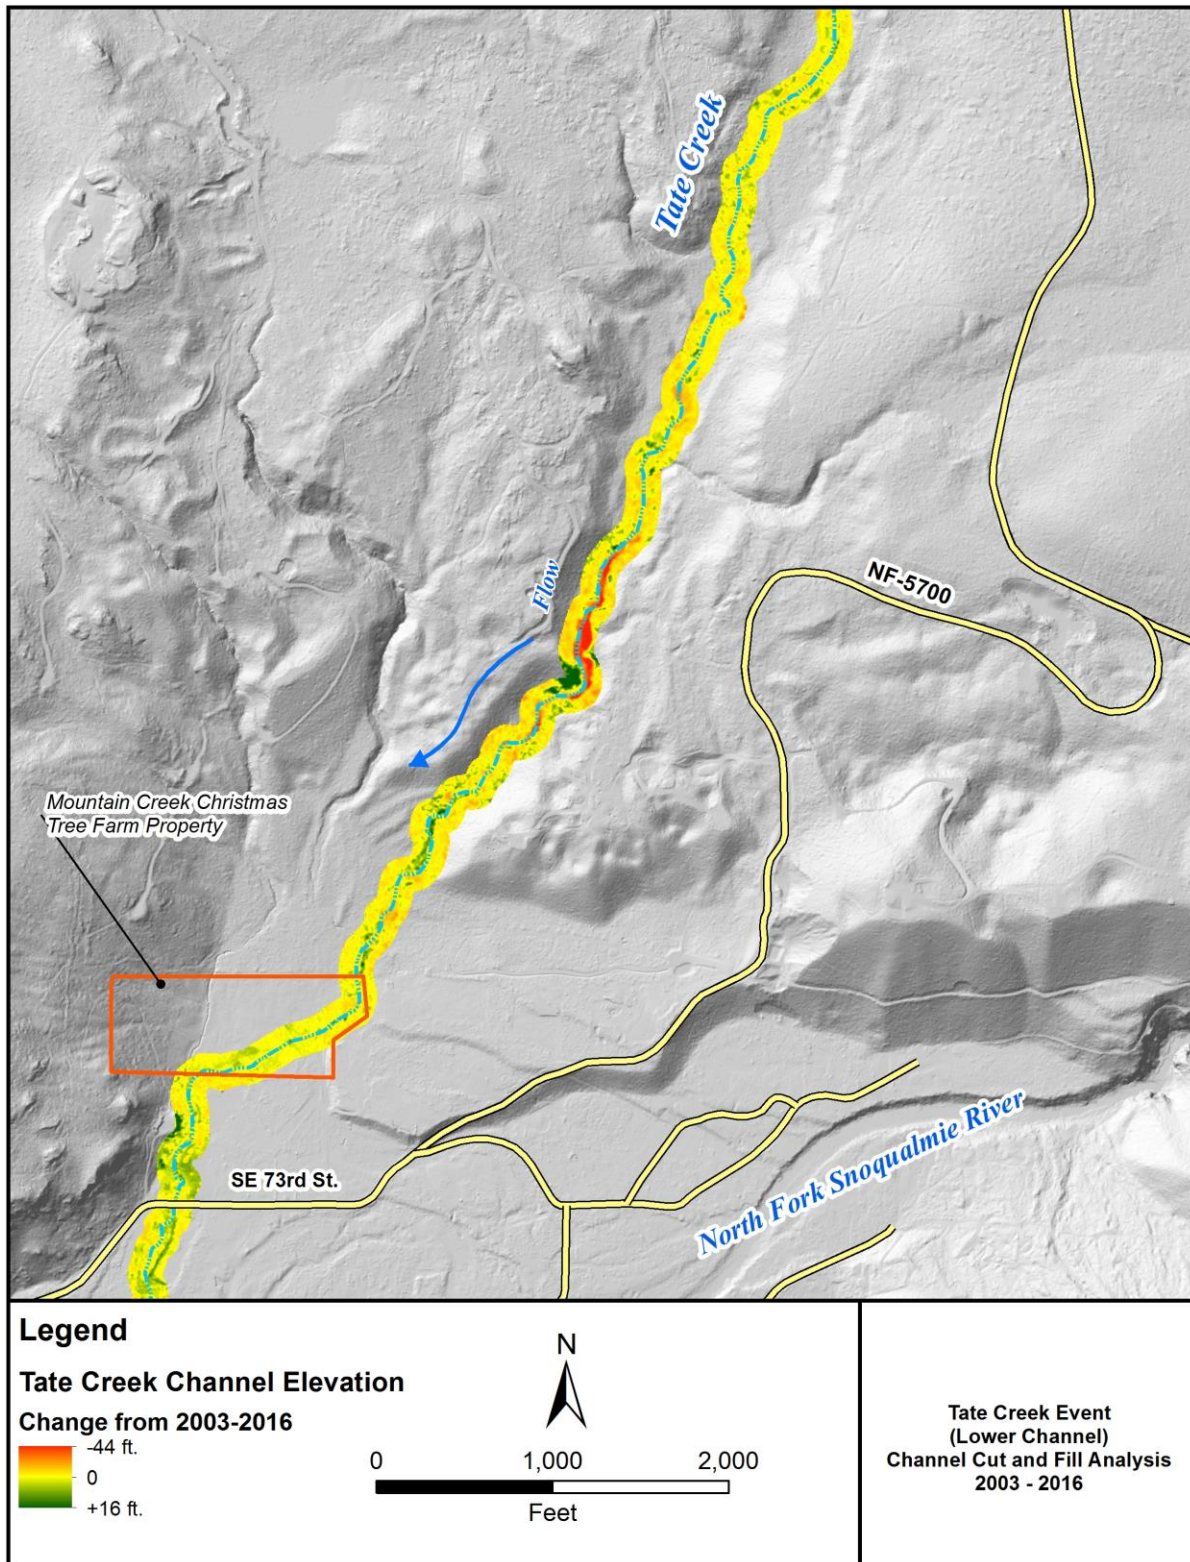
Figure 7b. Cut and fill analysis of the lower channel of the stream that drains McLeod Lake. The channel has degraded in areas of red and aggraded in areas of green between the 2003 LiDAR and 2016 LiDAR. Base map derived from 2016 LiDAR.

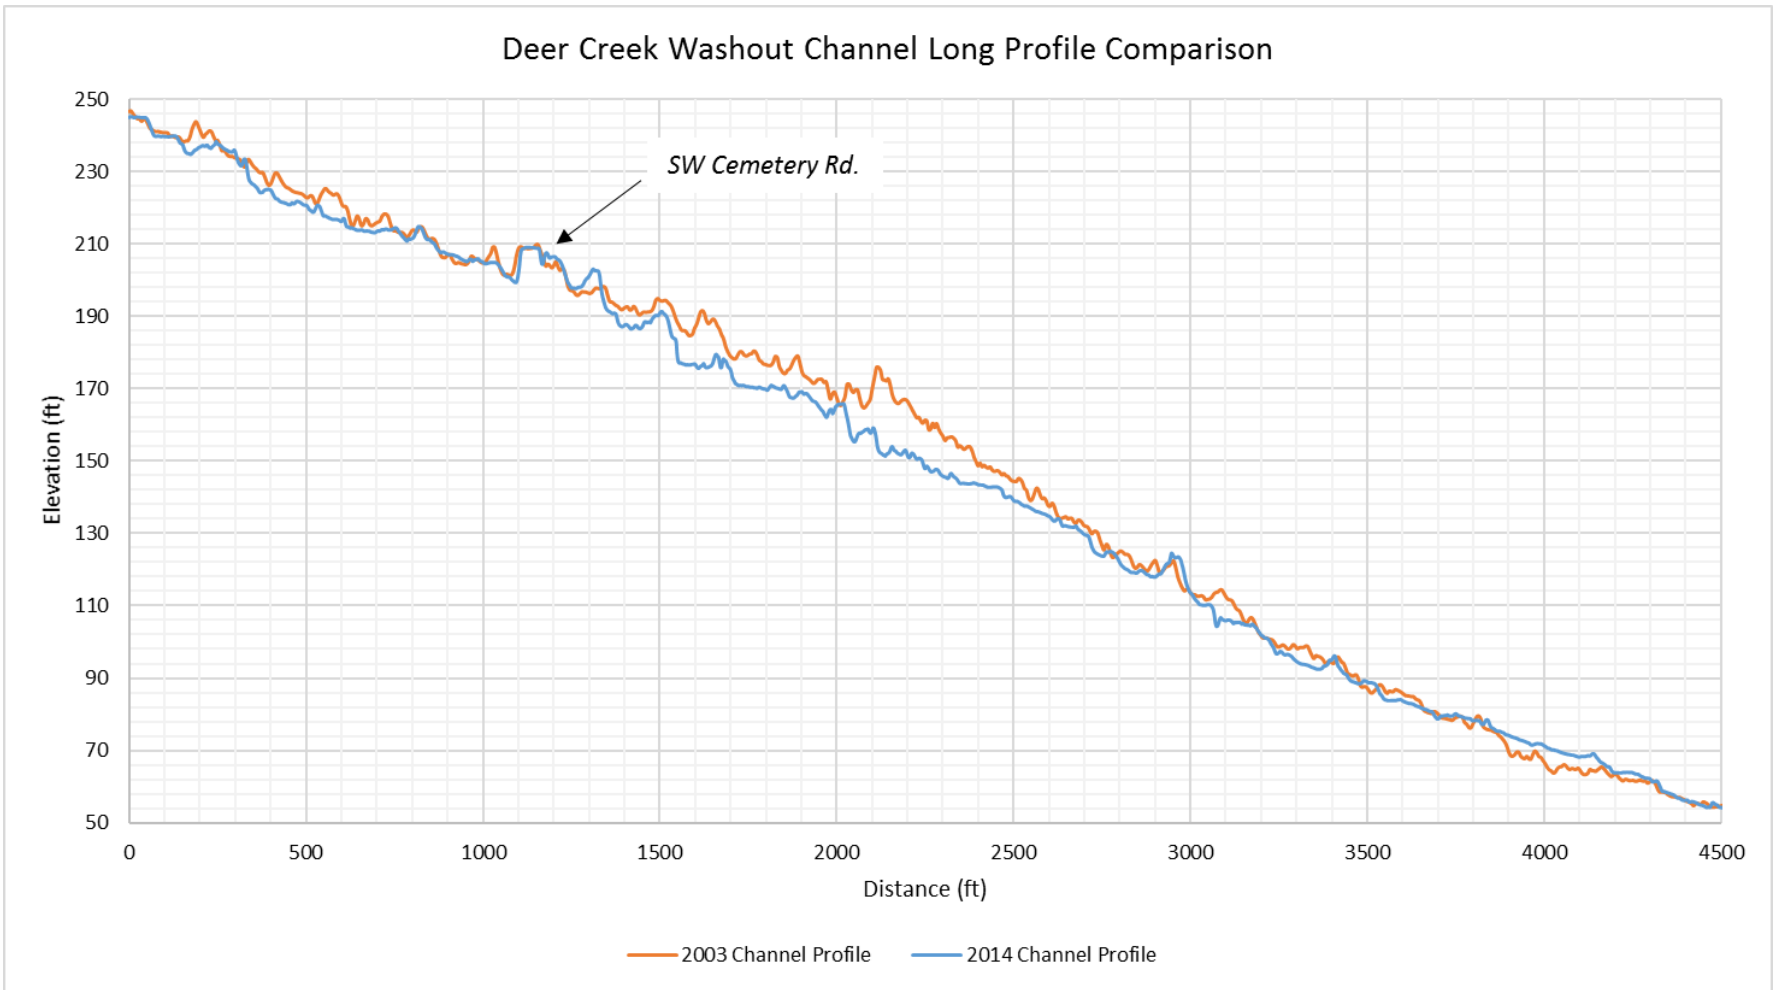
Figure 8a. Long profile channel comparison for the Deer Creek failure between 2003 and 2014.

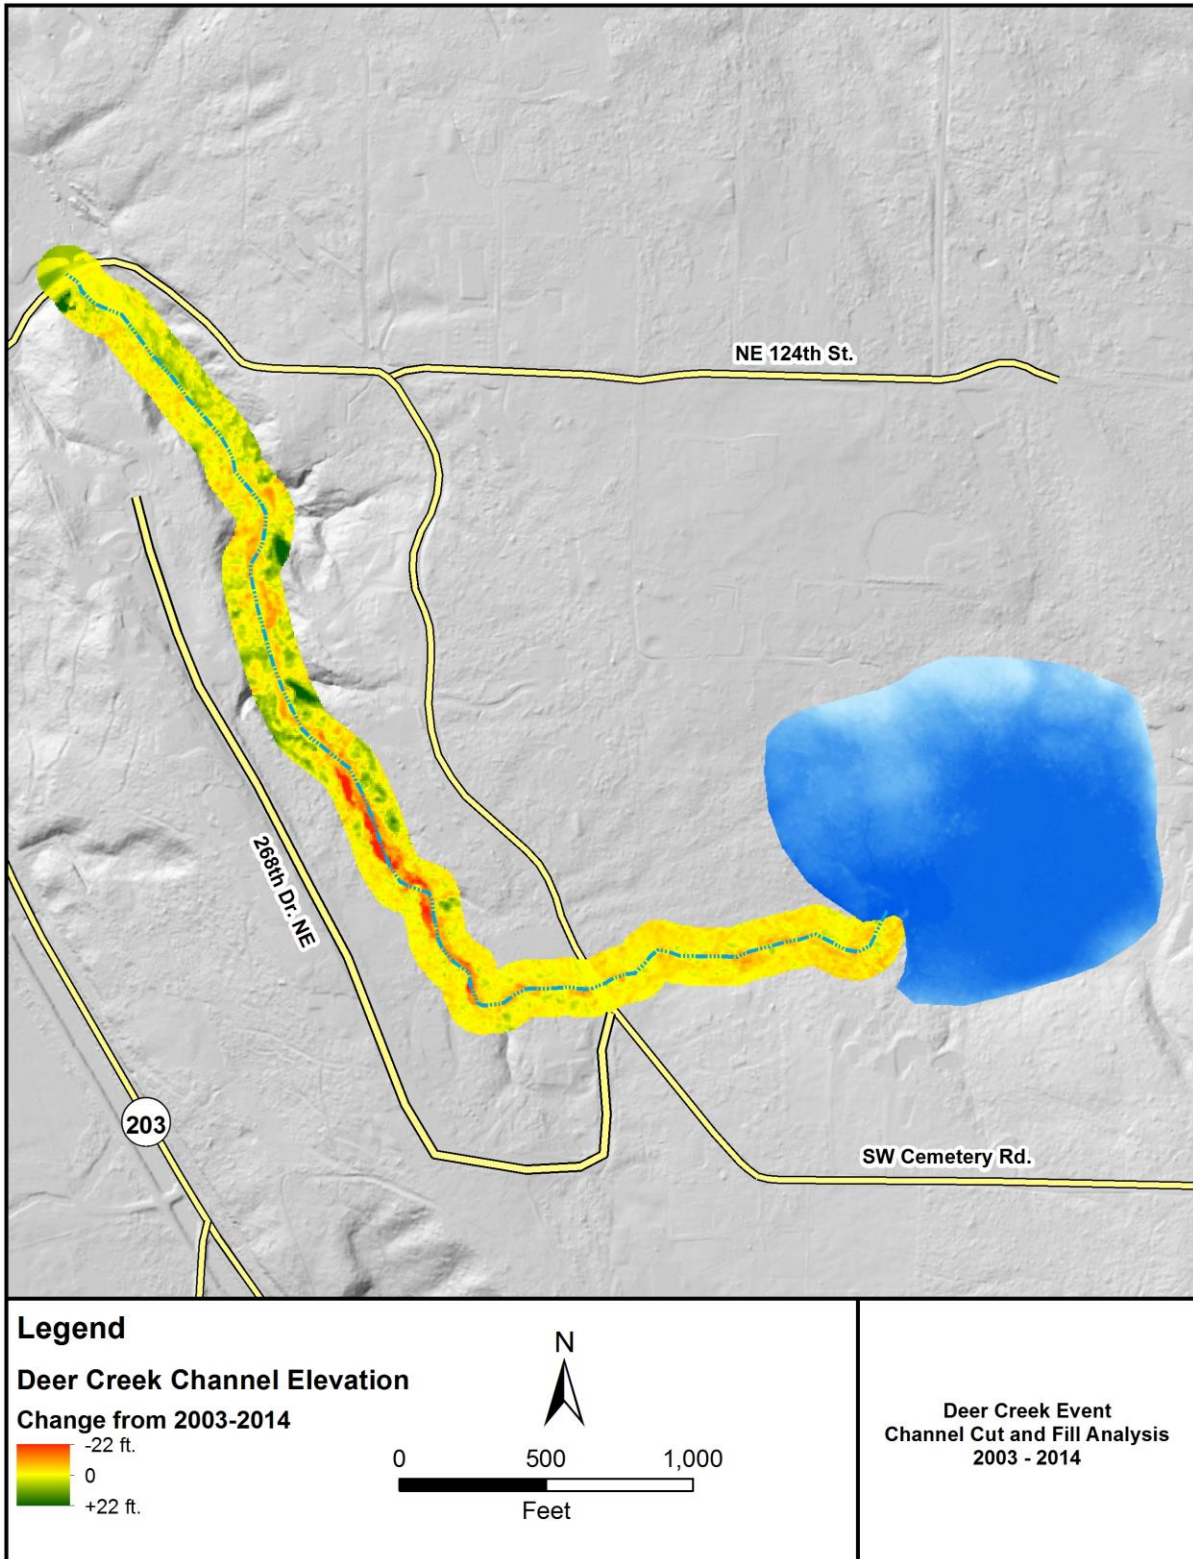
Figure 8b. Cut and fill analysis of Deer Creek which drains an unnamed pond near Novelty, Washington. The channel has degraded in areas of red and aggraded in areas of green between the 2003 LiDAR and 2014 LiDAR. Base map derived from 2014 LiDAR.
