Effects of Beaver Dam-Break Floods on Downstream Channels in King County, Washington

Cameron Reister

Master of Science
Earth and Space Sciences: Applied Geosciences

MESSAGE Technical Report Number: 066

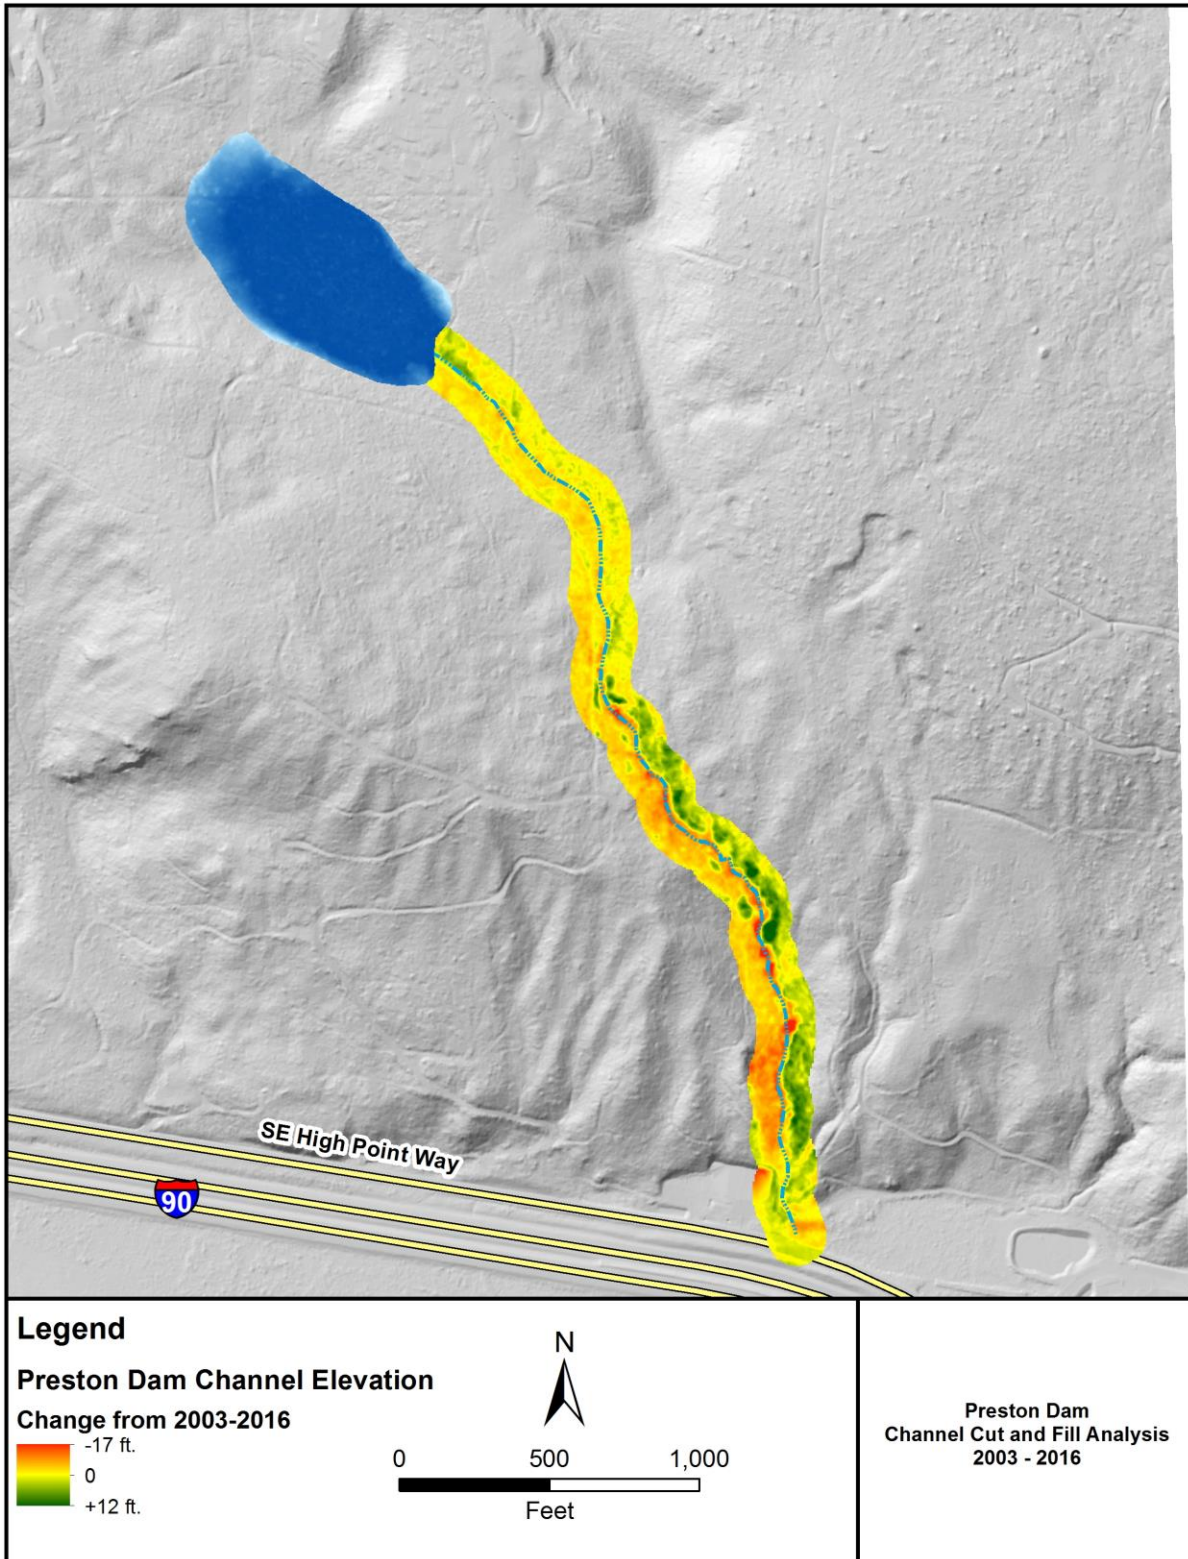
Figure 9b. Cut and fill analysis of the Preston dam which drains an unnamed pond near Preston, Washington. The channel has degraded in areas of red and aggraded in areas of green between the 2003 LiDAR and 2016 LiDAR. Base map derived from 2016 LiDAR.

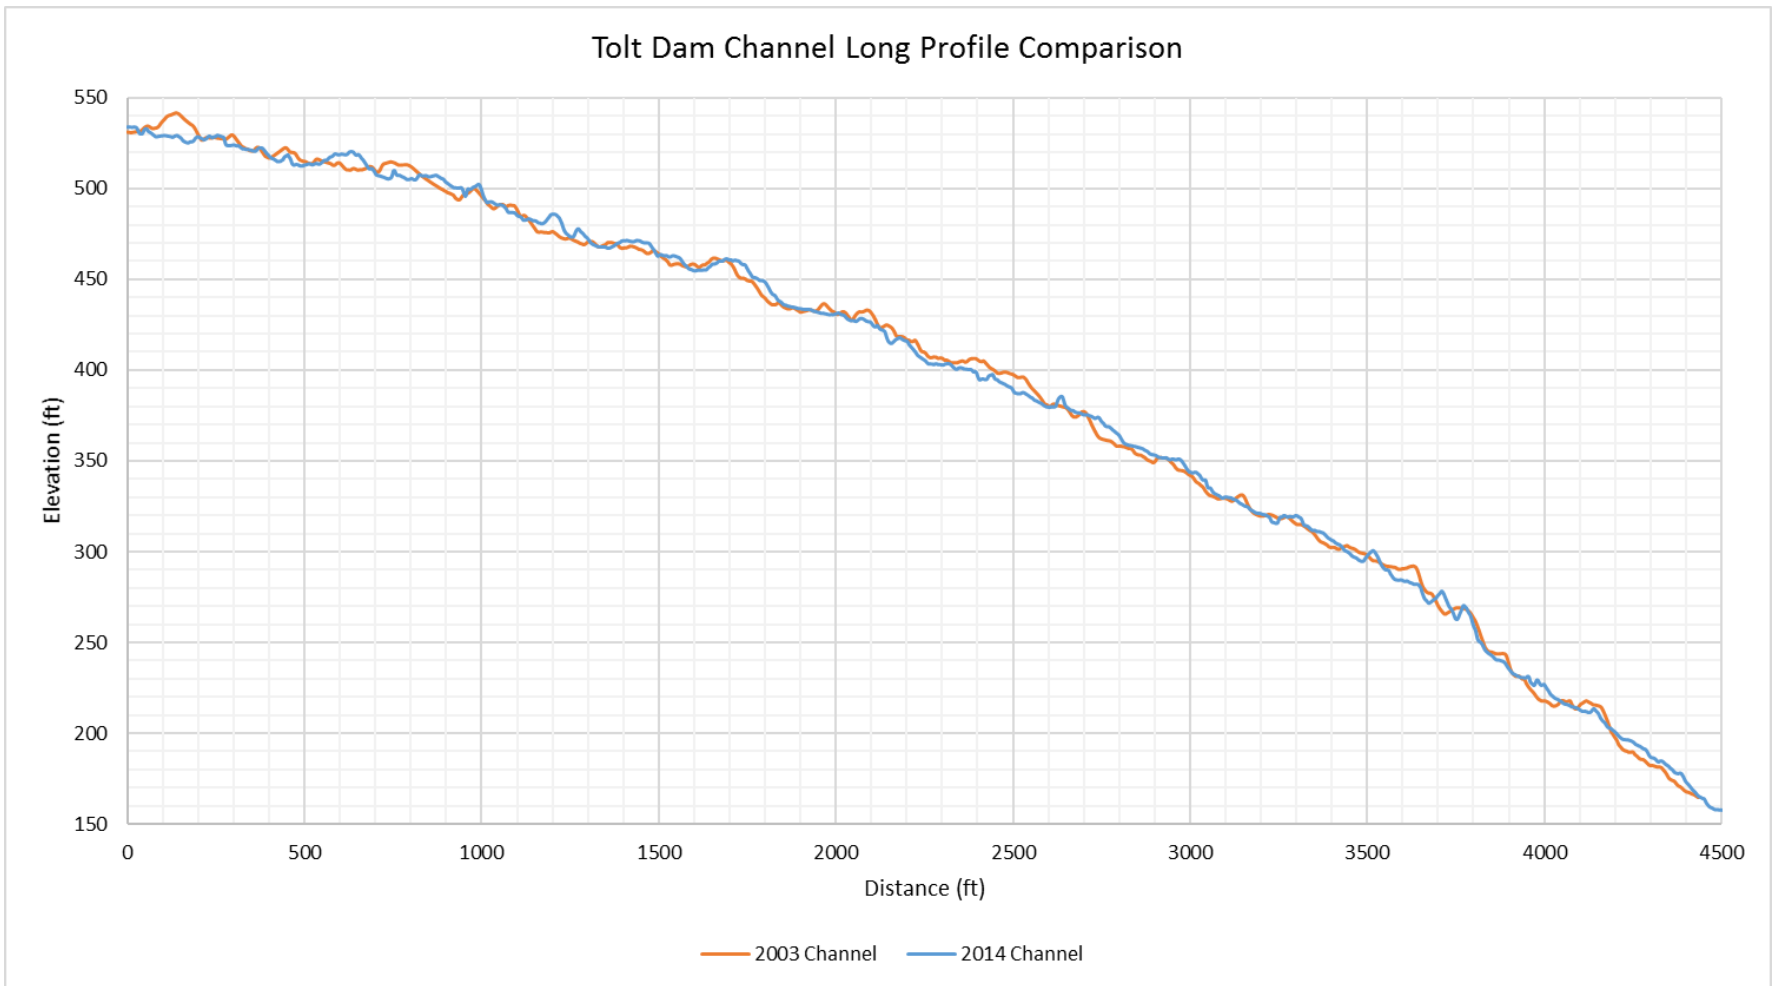
Figure 10a. Long profile channel comparison for the Tolt River dam channel between 2003 LiDAR data and 2014 LiDAR data.

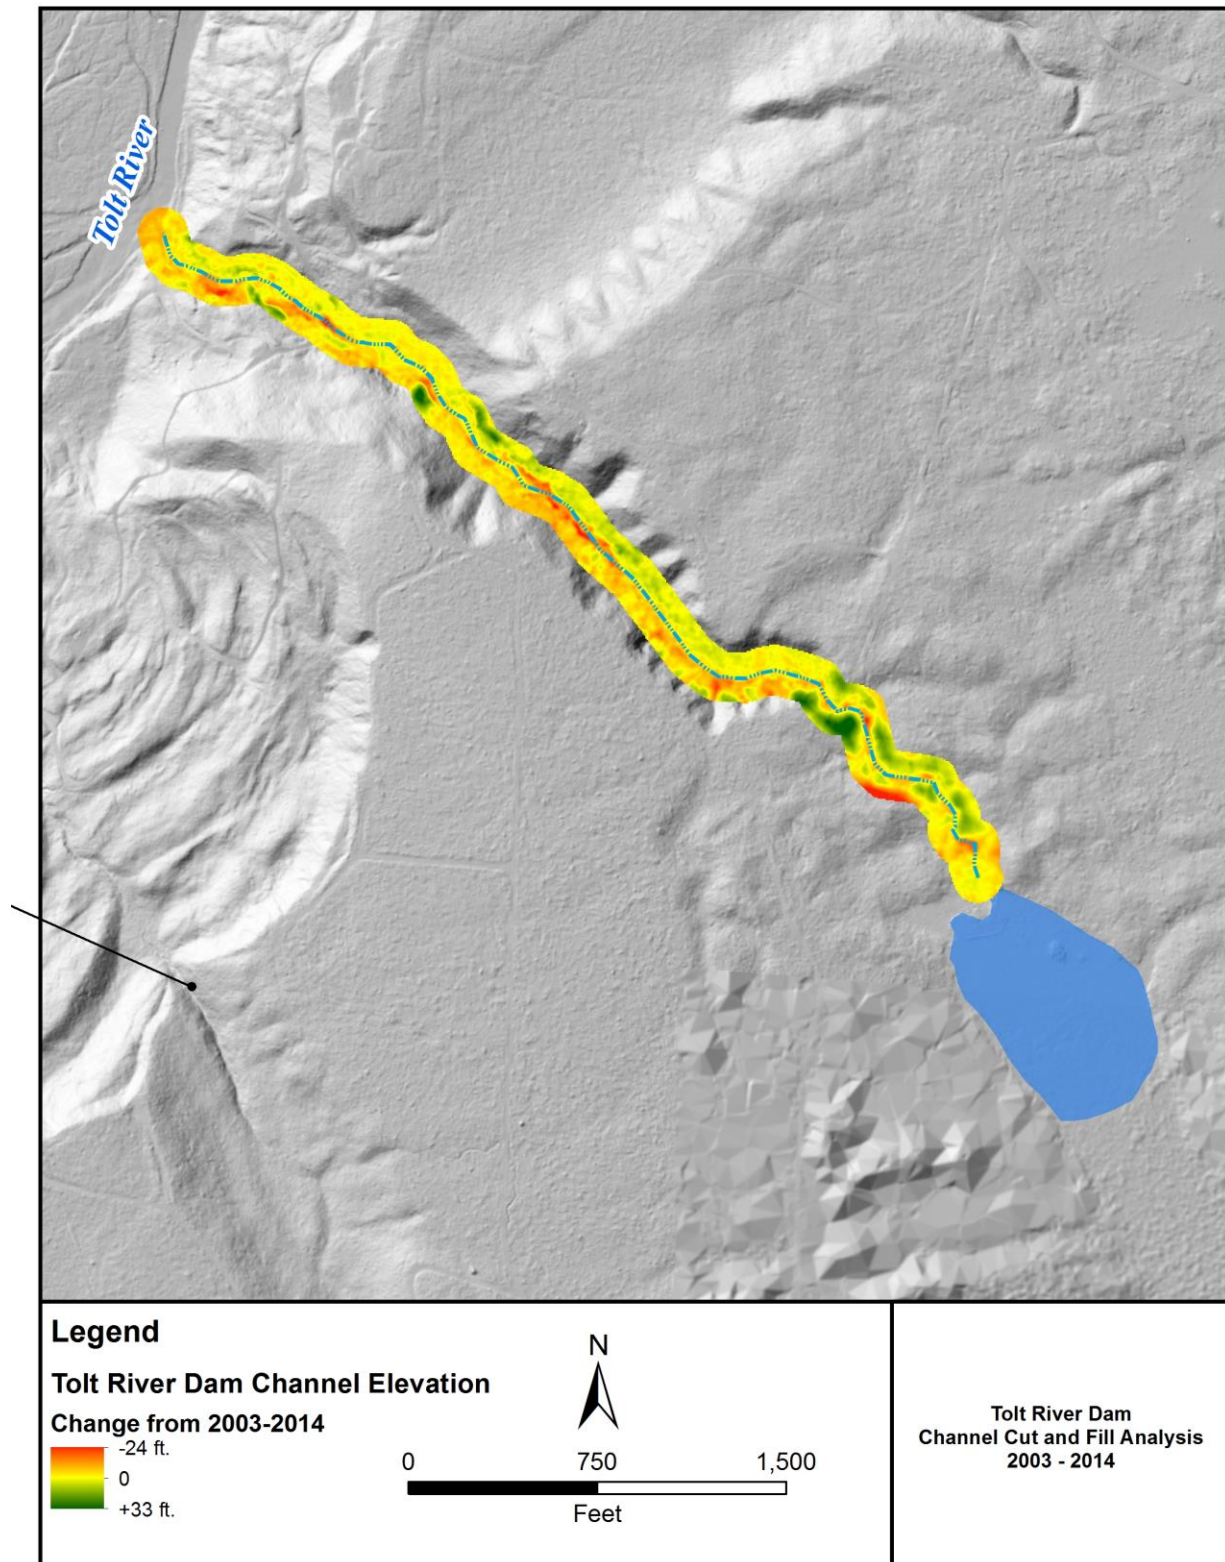
Figure 10b. Cut and fill analysis of the Tolt River dam which drains an unnamed pond east of Carnation, Washington. The channel has degraded in areas of red and aggraded in areas of green between the 2003 LiDAR and 2014 LiDAR. Base map derived from 2014 LiDAR.

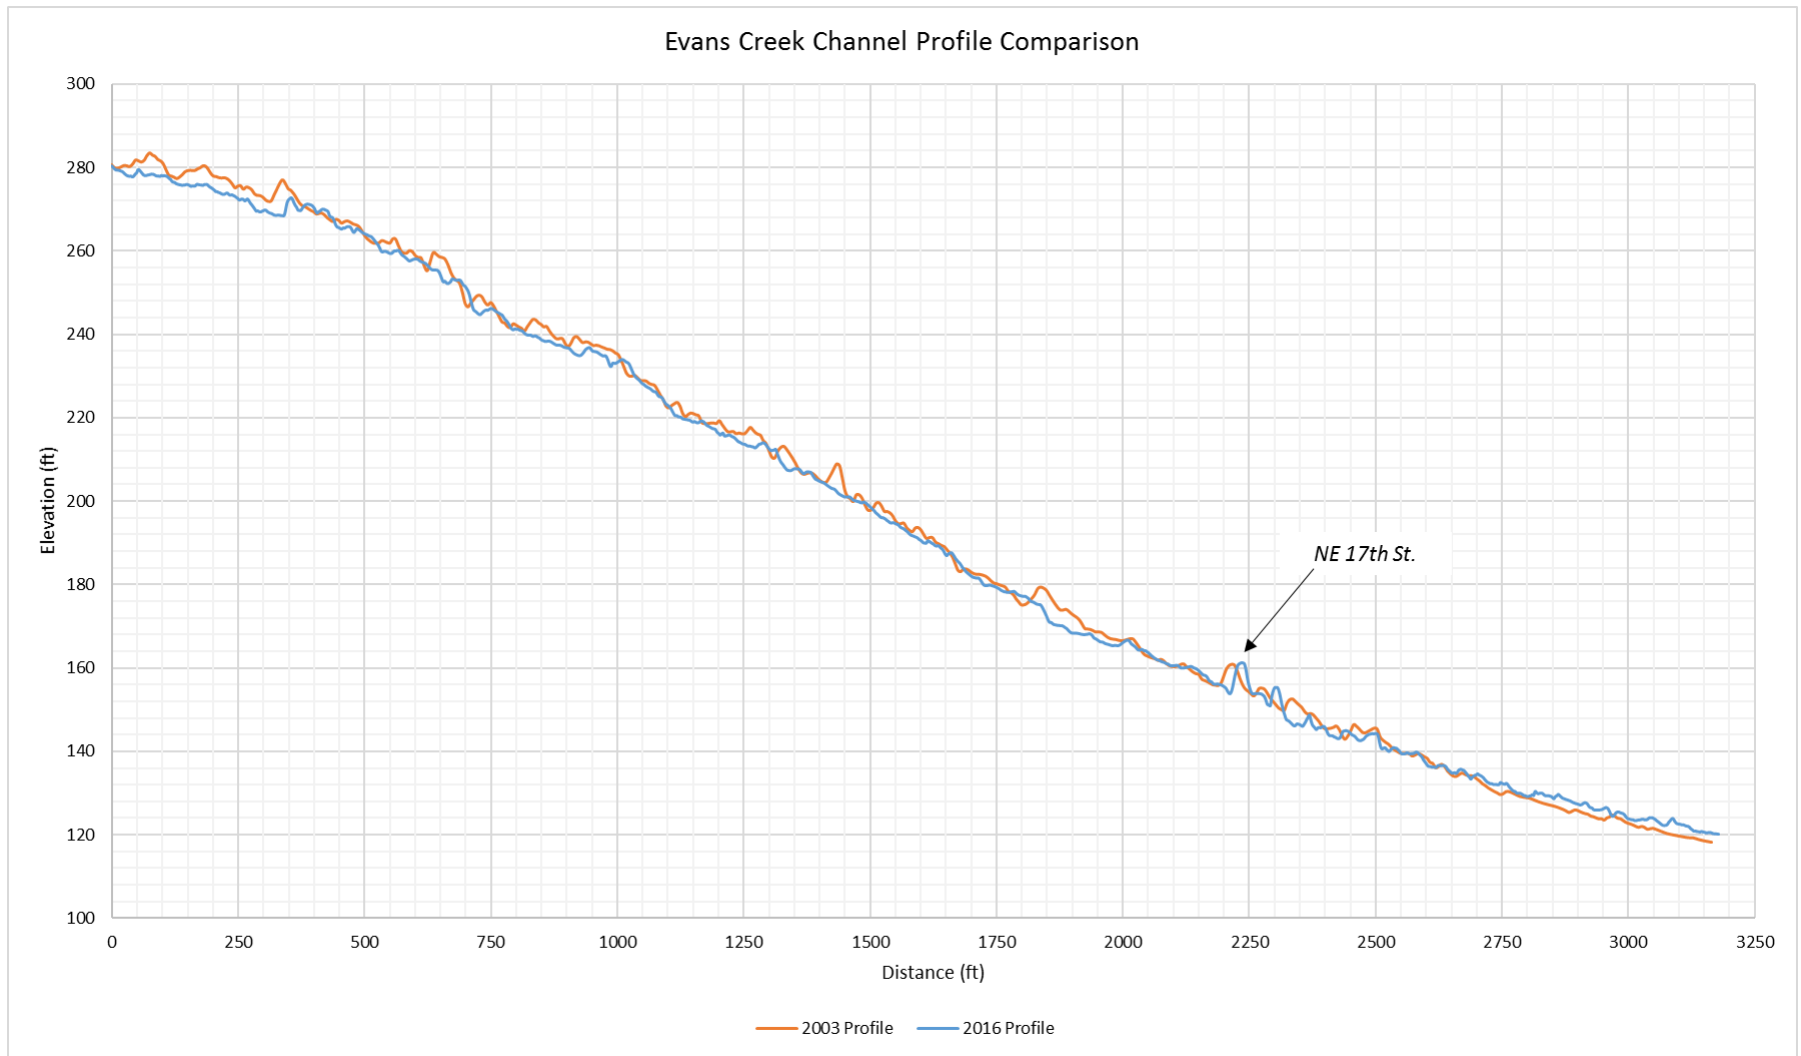
Figure 11a. Long profile channel comparison for the Evans Creek dam channel between 2003 LiDAR data and 2016 LiDAR data.

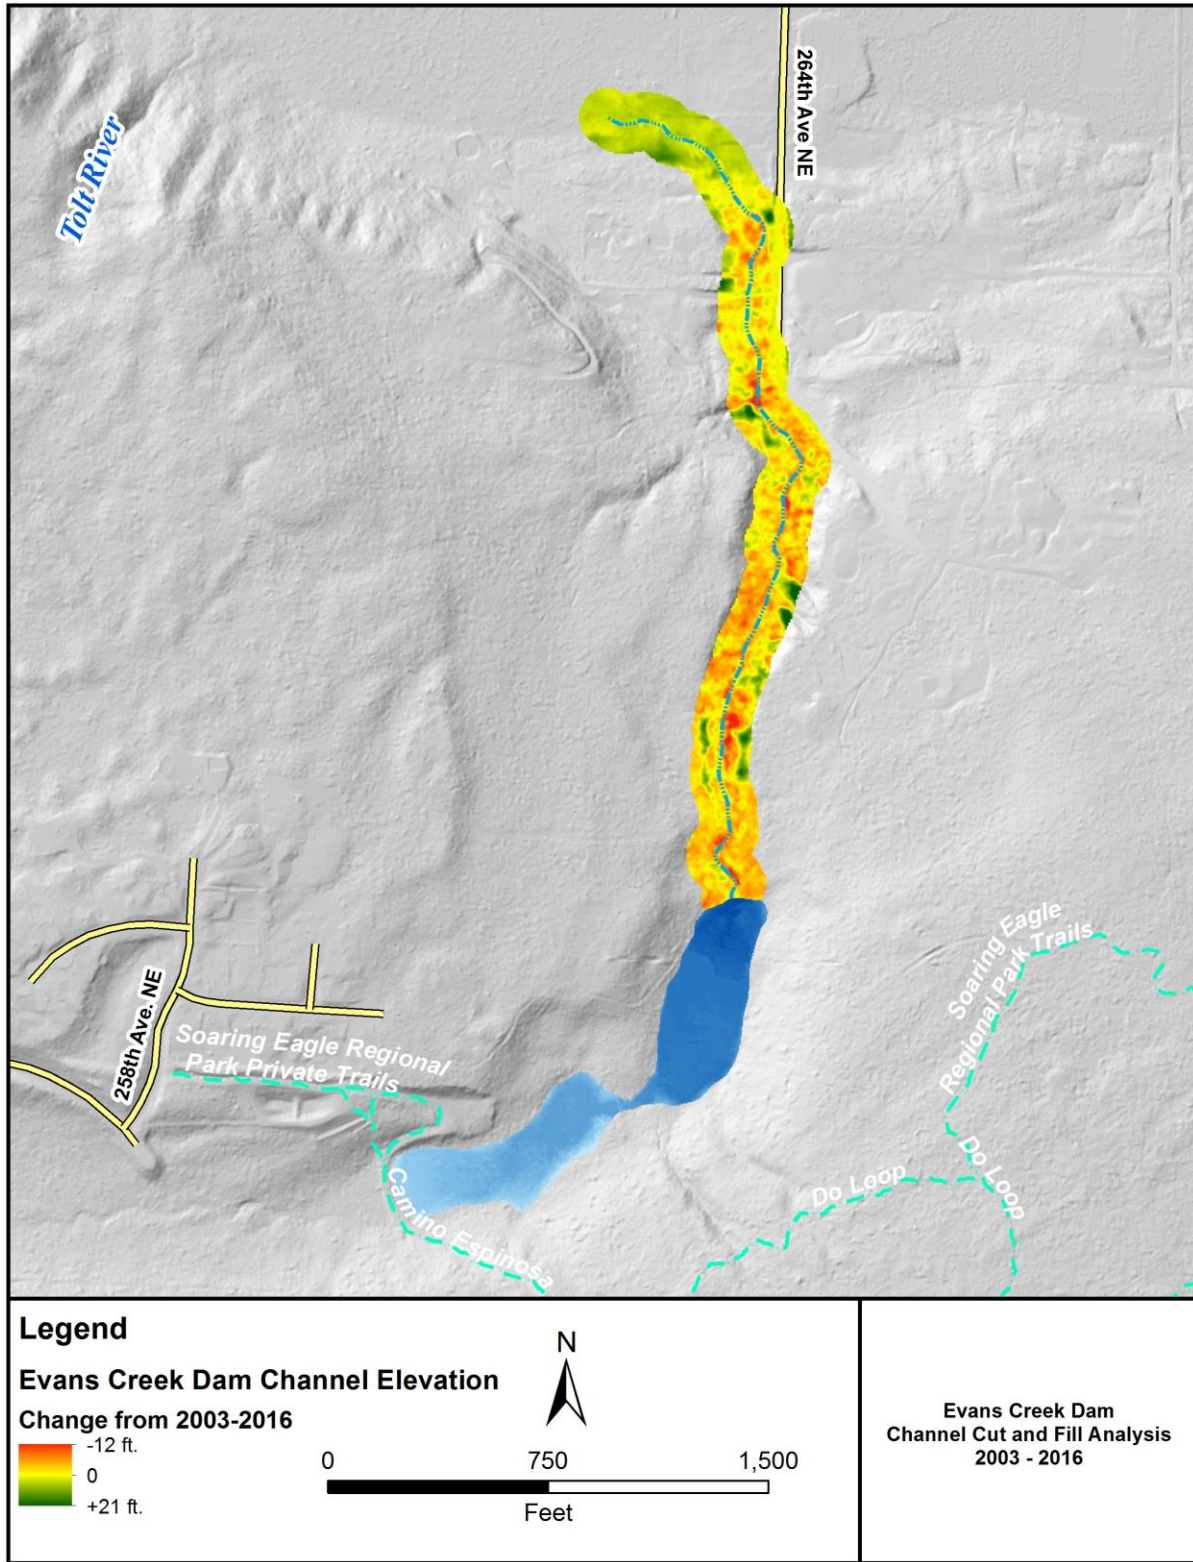
Figure 11b. Cut and fill analysis of the Evans Creek dam which drains an unnamed pond east of Sammamish, Washington. The channel has degraded in areas of red and aggraded in areas of green between the 2003 LiDAR and 2016 LiDAR. Base map derived from 2016 LiDAR.
