**Assessment of Stream Restoration Efforts and Development of  
Effectiveness Monitoring Protocol  
Ohop Creek, Pierce County, Washington**

Master of Science  
Earth and Space Sciences: Applied Geosciences

University of Washington

June 6, 2018

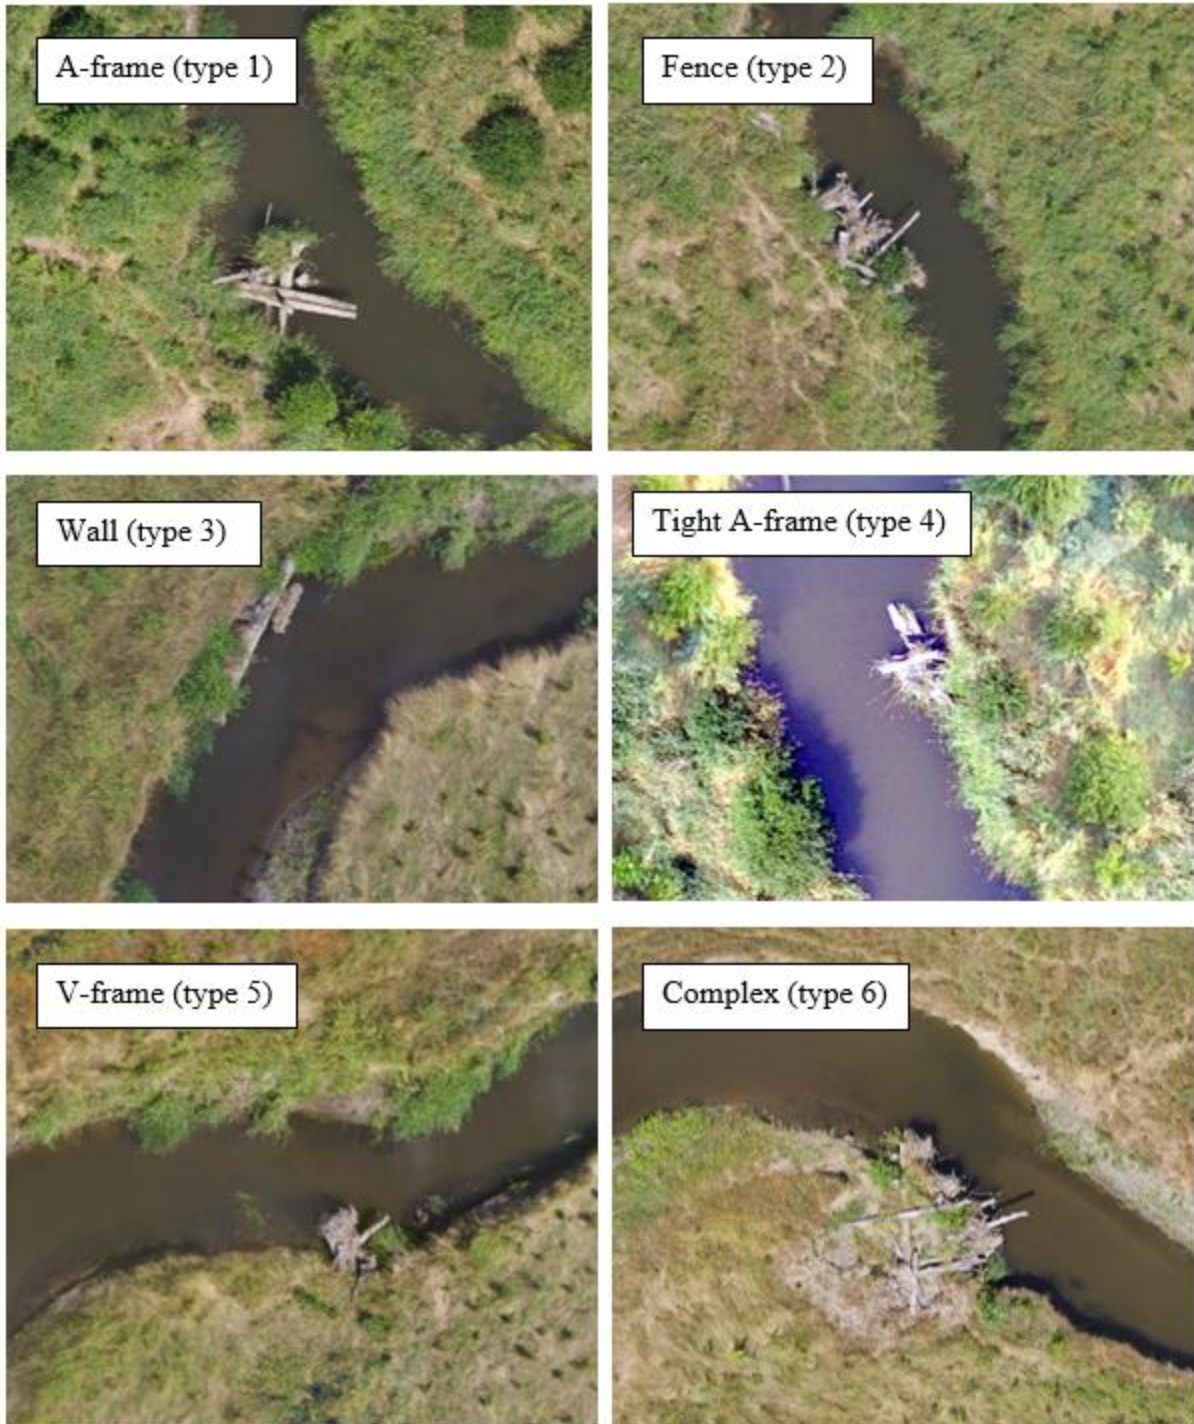
Figure 4. Six different LWM structure types identified in the Project reach. Flow direction for the first four images (types 1-4) is from top to bottom and from right to left for the latter two images (types 5 & 6).

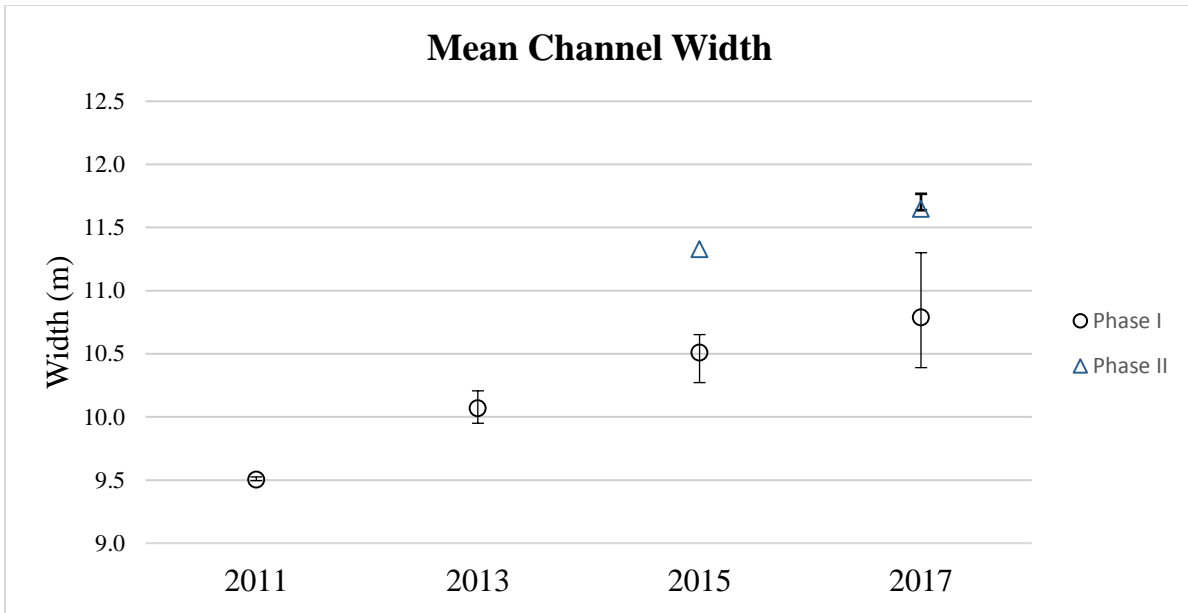
The Phase II reach widened by an average of 0.3 m from 2015-2017. Paired t-Test analysis shows average widening in the Phase II reach to be indistinguishable from no change for this time period ( $p > 0.05$ ). However, widening in areas of the reach where wood structures were located was found to be distinguishable from no change over the 2-year record ( $p < 0.05$ ).

Figure 6. Average channel widening for the Phase I and Phase II reaches. Top and bottom whisker bars indicate the average magnitude of widening associated with transects that intersected LWM structures and those that did not, respectively.

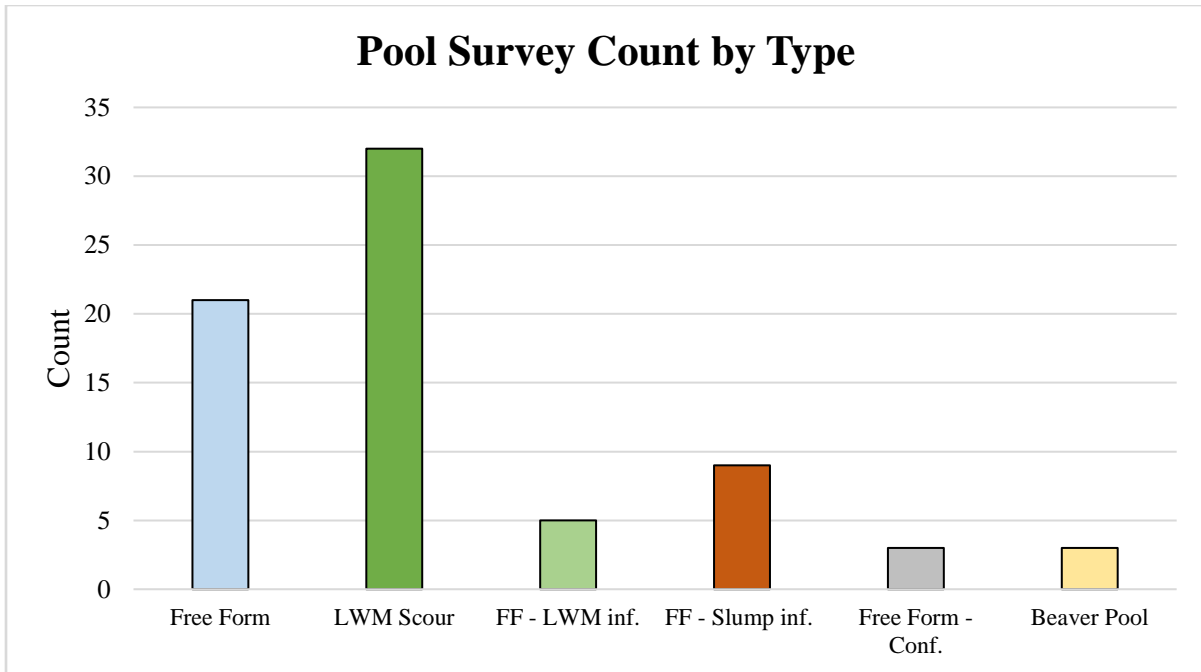
Pools formed from LWM scour constituted 44% of the pools in the Project reach (Figure 10). Free-form pools that were augmented by nearby LWM structures constituted another 7% of all pools surveyed, bringing the total number of pools associated with in-channel wood up to 51%. At the time of the survey, several small beaver dams were observed in the new Phase II channel at locations where the stream approached the southern valley wall. None of the beaver dams remained in February of 2018. Average pool spacing in the Project reach is 2.5 mean channel widths, which is consistent with pool average spacing for forced pool-riffle channels with high wood loading (Montgomery et al., 1995).

Figure 10. Pool survey count by type identified in the Project reach during the summer of 2017. By February of 2018 the beaver pools no longer remained in the Project area.

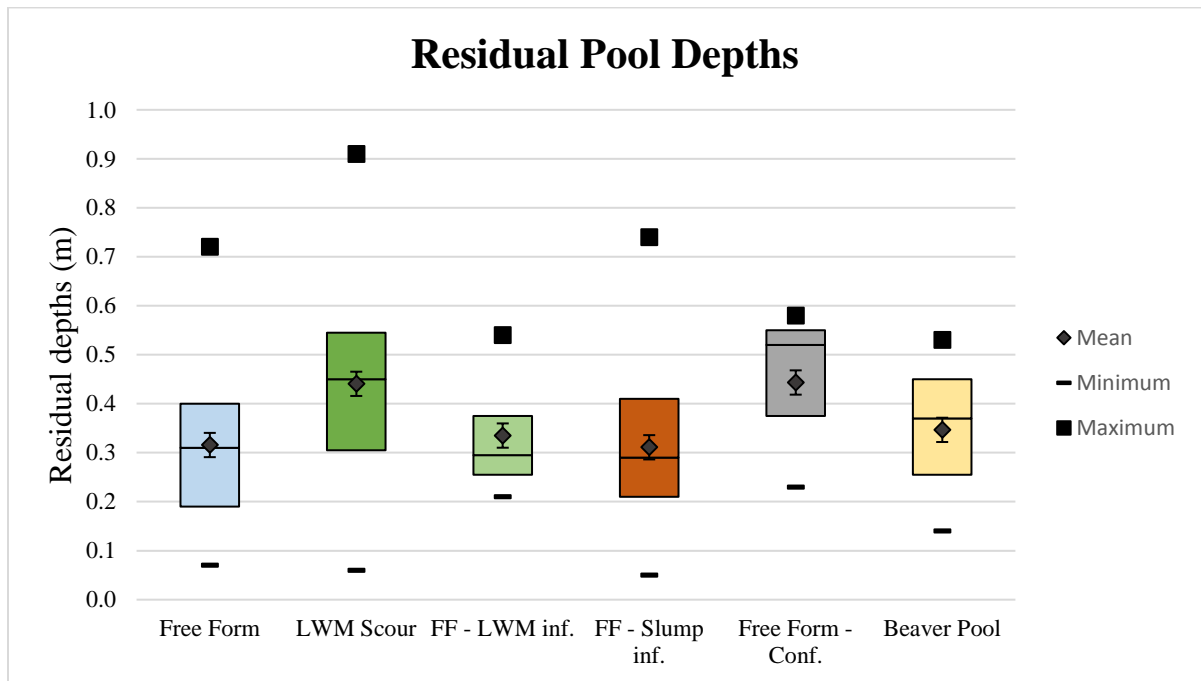
Average residual depth for LWM scour pools was higher (0.44 m, N = 31, SD = 0.17) and showed more variability than most other pool types (Figure 11). The average depths of confluence pools were as high as that of LWM scour pools. Several factors may be contributing to the depth of the confluence pools: (1) accretion of water behind back-channel beaver dams that causes localized downstream incision, or (2) artifacts of the old entrenched channel. Average residual depths for other free-form pool categories were between 0.31-0.34 m.

Figure 11. Residual depths of surveyed pools in the Project reach. Upper and lower boxes show 75% and 25% quartile, respectively, separated by median value. Whisker bars show standard error of the mean.

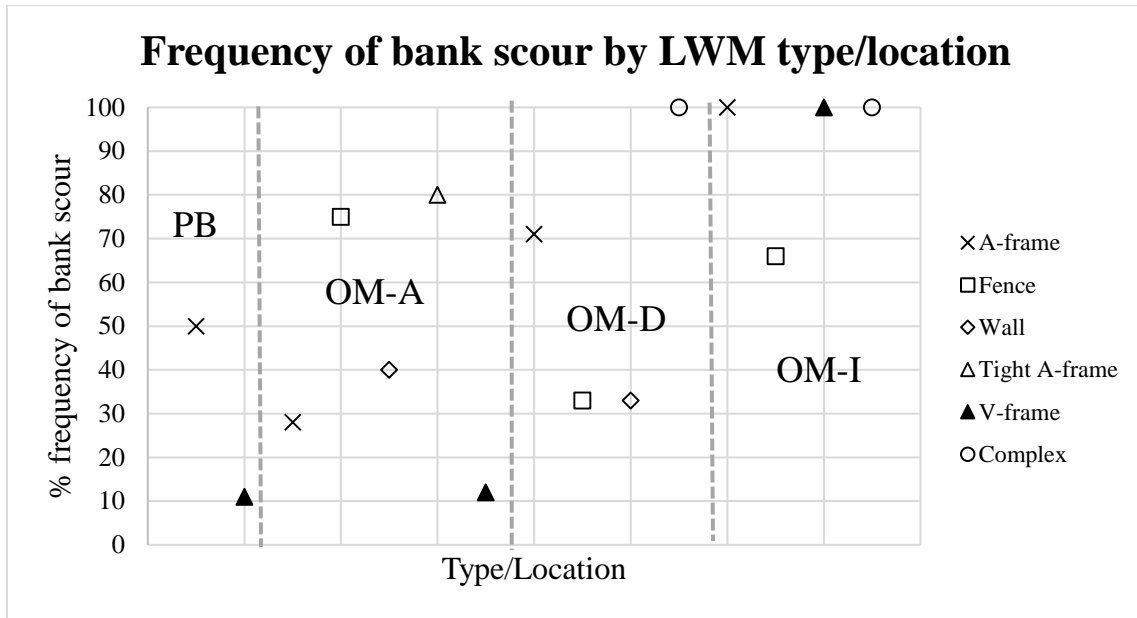
Of the 89 LWM structures identified in this study, 40% were observed to be inducing lateral bank scour (Table 2). Certain combinations of structure type and location in the meander were associated with high frequency and magnitude of bank scour (Figure 12 and 13). The highest occurrence and magnitude of bank scour was attributed to complex structures located at the inflection point between two meanders. Of the three complex structures at this location in the meander, all were contributing to large amounts of bank scour, with an average of 24 m<sup>2</sup> of scour

A-frame and fence structures located at the cut bank apex of meanders in the Phase I reach were associated with high frequency and magnitude of bank scour. In the Phase II reach, both of these structure types were largely positioned at the downstream end of meanders where they tended to cause less bank scour, indicating that the redesign of LWM structures between Phase I and Phase II was at least partly successful in curbing wood-induced bank erosion.

Figure 12. Frequency of bank scour expressed at % of total occurring structures by LWM type and location in the meander. Dashed vertical lines separate locations in the meander. PB = point bars, OM-A = apex of the outside of a meander, OM-D = downstream outside of a meander, OM-I = inflection point between meanders.

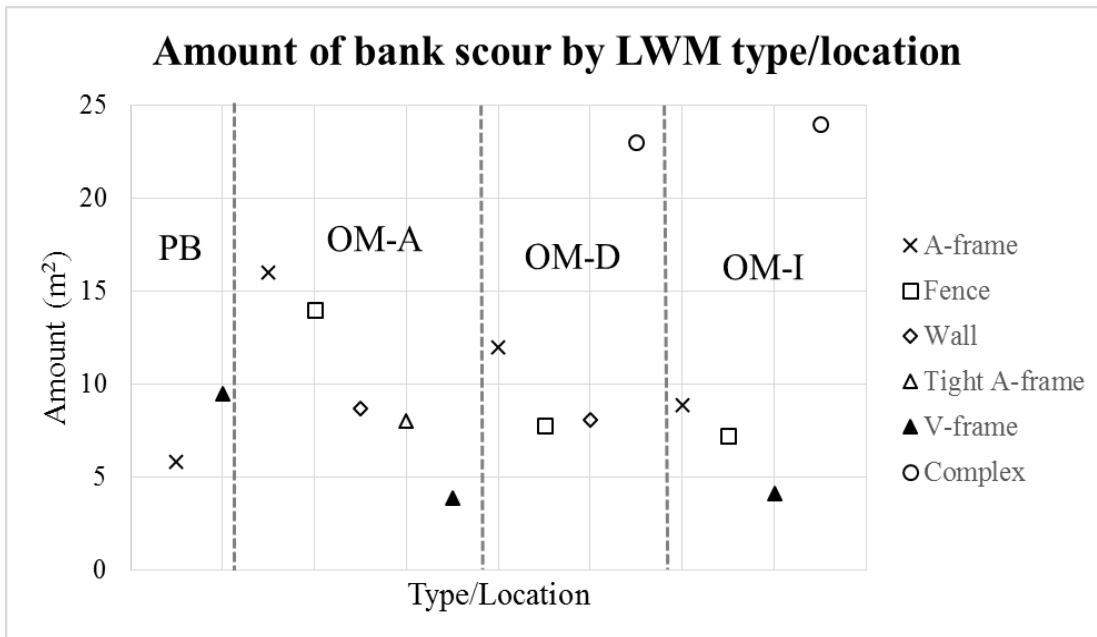
Figure 13. Amount of bank scour by LWM type and location in the meander. Dashed vertical lines separate locations in the meander. PB = point bars, OM-A = apex of the outside of a meander, OM-D = downstream outside of a meander, OM-I = inflection point between meanders.

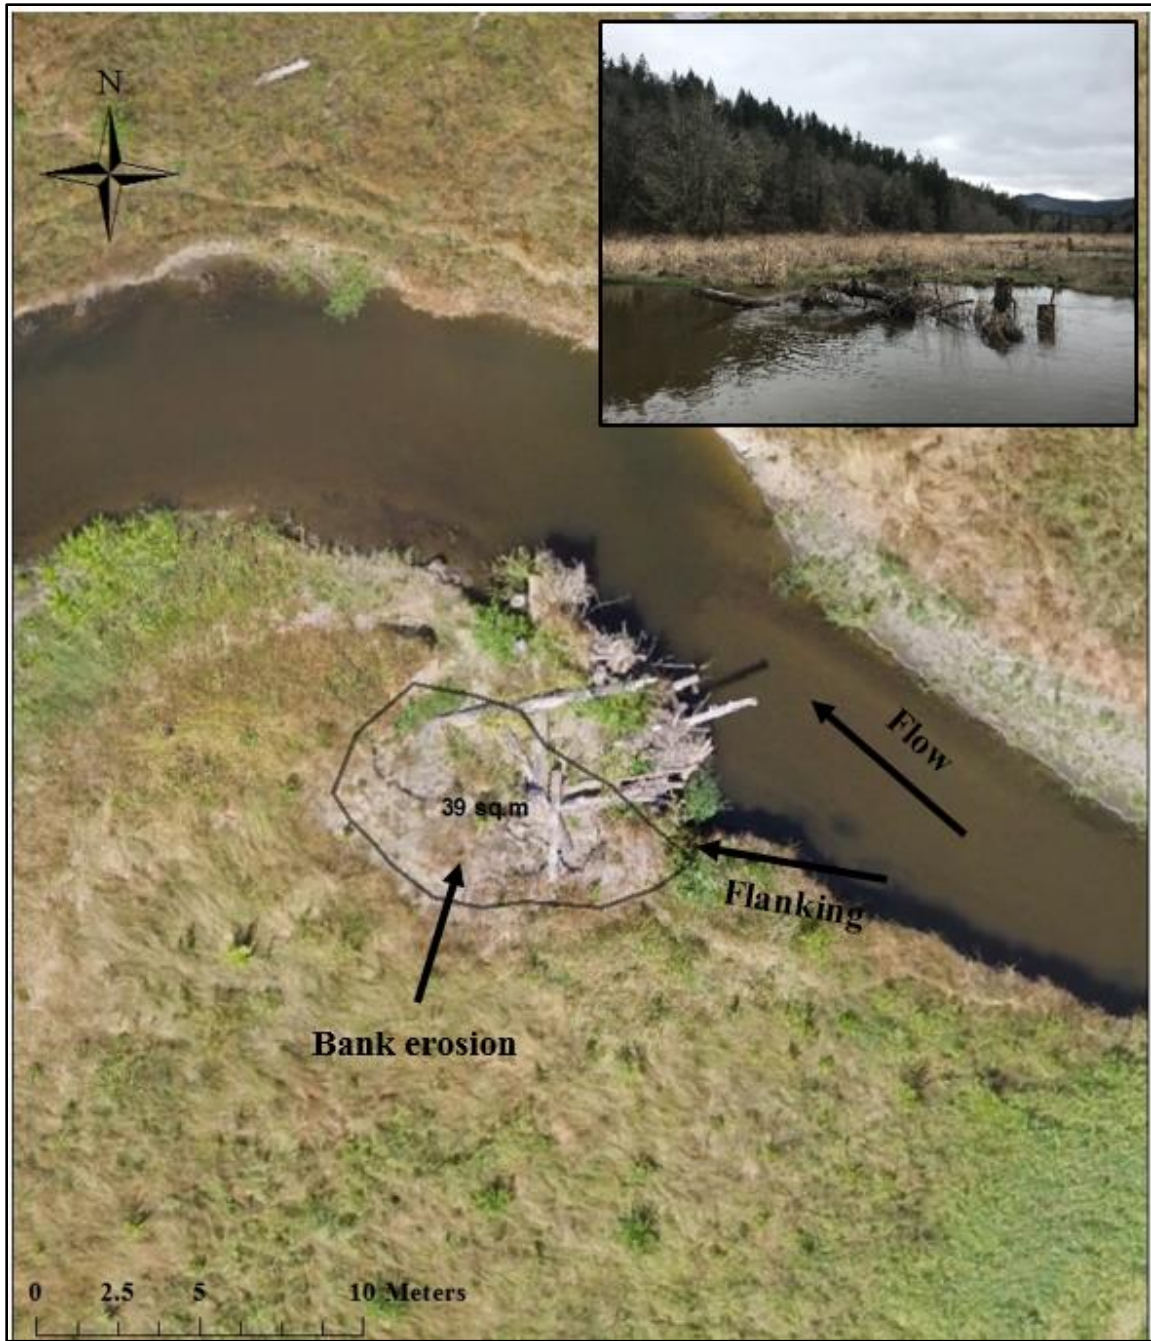
Channel widening was shown to be strongly correlated with lateral bank scour induced by LWM-structures, especially for structures positioned in the downstream reach of a meander. The complex (type 6) structures were shown to initiate the highest frequency and magnitude of bank erosion. During site visits at high-flow conditions, streamflow flanking was observed at all complex structures located at inflection points between meanders (Figure 14). Flanking, where the channel has gone behind the structure and begun to erode the bank from slower, more turbulent currents, suggests that the structure protruded too far into the channel to maintain the bend. Complex structures regularly contain several logs oriented perpendicular to the flow that protruded into the channel more than 4 m, or about one-third of the average channel width. Fence (type 2) LWM structures, which rarely protruded one-third of the channel width, also showed evidence of streamflow flanking when located at inflection points, but to a lesser degree.

Despite areas where large amounts of LWM-induced bank have resulted in streamflow flanking and widening, much of the observed bank scour in the Phase II reach was limited to localized areas of the bank immediately upstream and/or downstream of the wood. Areas where greater amounts of scour and flanking were observed are not inherently problematic and can potentially pose benefit to Project success. Flanking of the LWM structures increases flow complexity by creating new channels and/or backwater alcoves that are beneficial to rearing salmon. Extensive bank scour could decrease the stability and life expectancy of the wood, which could result in rapid channel migration away from the constructed channel. Yet, we would expect this to be a self-limiting process. As the channel moves away from the wood structure, bank erosion would decrease. Because the LWM structures installed in the Project reach were ballasted to prevent them from being removed during high-flow events, it is likely that detached LWM structures would become stream hard points where newly recruited wood would be retained, again serving to increase in-channel habitat and complexity. However, initial channel widening from LWM-induced bank scour does negatively impact the frequency of floodplain inundation, as discussed in Section 5.3 below. Monitoring the LWM structures is a key component of the protocol developed from this study and should be used to inform future restoration in Ohop Valley.

Figure 15. Type 6 (complex) LWM structure in Phase II reach where the channel has gone behind the structure and caused erosion to the bank. Flanking suggests that the structure protrudes too far into the channel to maintain the meander bend. Inset photo was taken on February 3, 2017 at a discharge of  $\sim 9 \text{ m}^3/\text{s}$ .

- Are the LWM structures continuing to provide deep scour pools for aquatic habitat?
- Is streamflow flanking at LWM structures continuing to cause large amounts of erosion to the channel banks and, if so, what implications does this have on bank stability and channel complexity?
- Is the channel continuing to widen and, if so, what implications does this have on frequency of floodplain inundation?
