©Copyright 2017
Alastair M. Croxford

Experimental Characterization of Failure Mechanisms in Carbon Fiber Laminated Joints

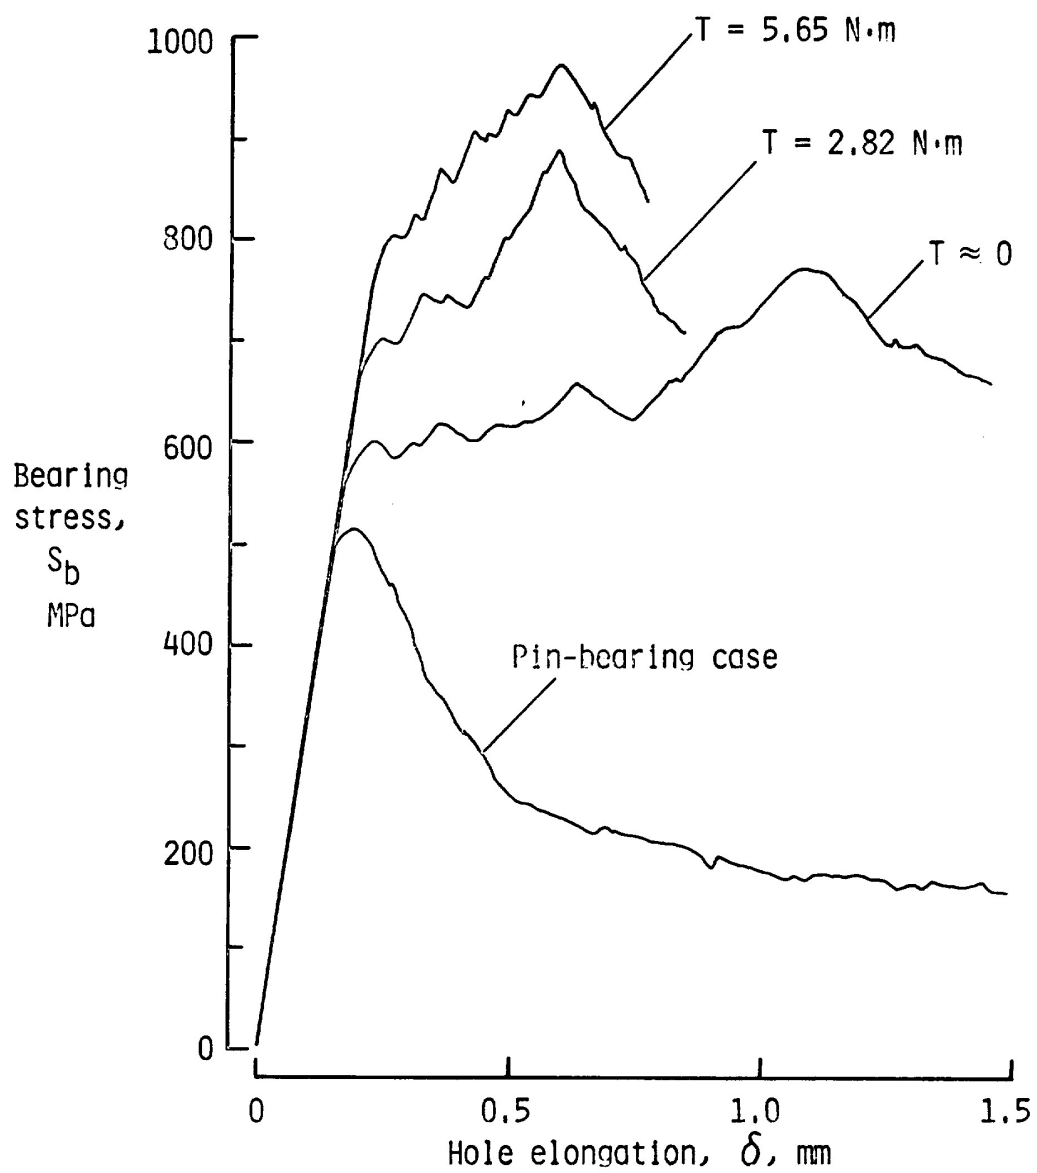
Figure 3.- Static hole elongation for several clampup conditions.

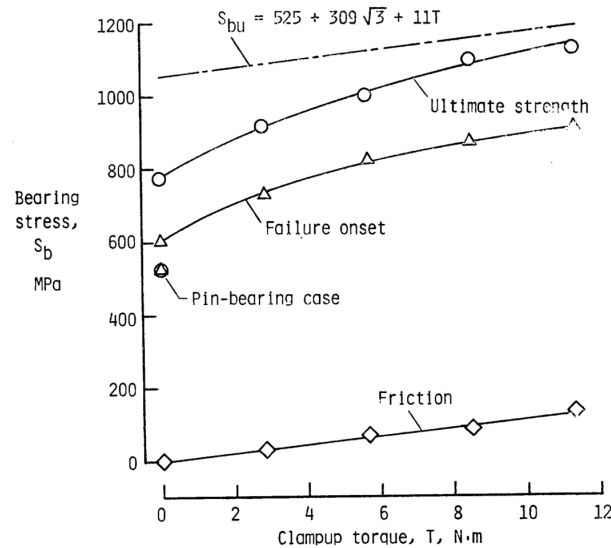
Figure 5.- Static bearing strength for range of clampup torque.

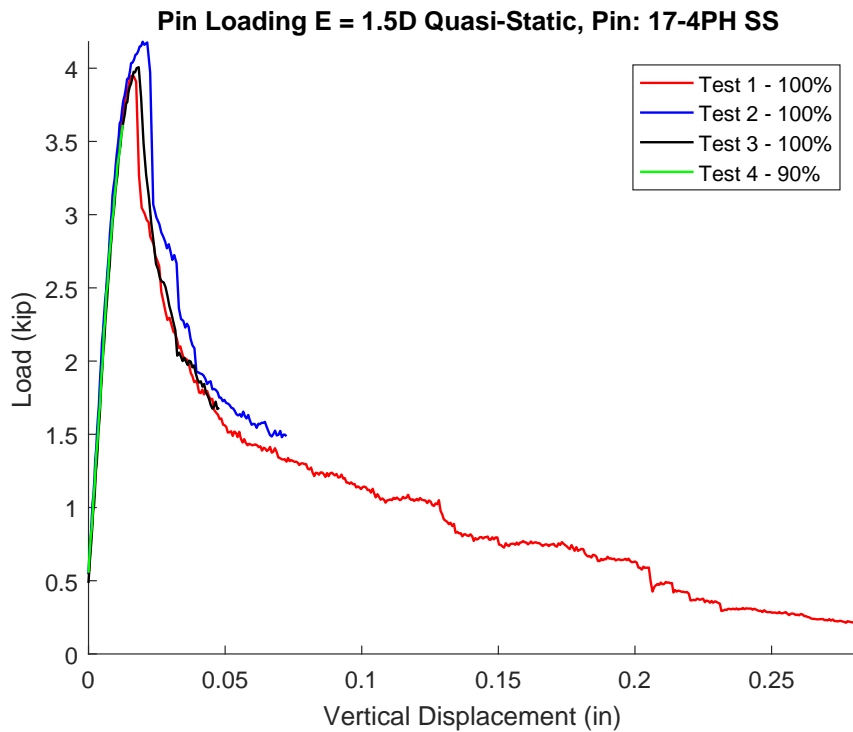
Figure 3.5: Simple Pin Loading, $E = 1.5D$, Pin: 17-4PH Stainless Steel.

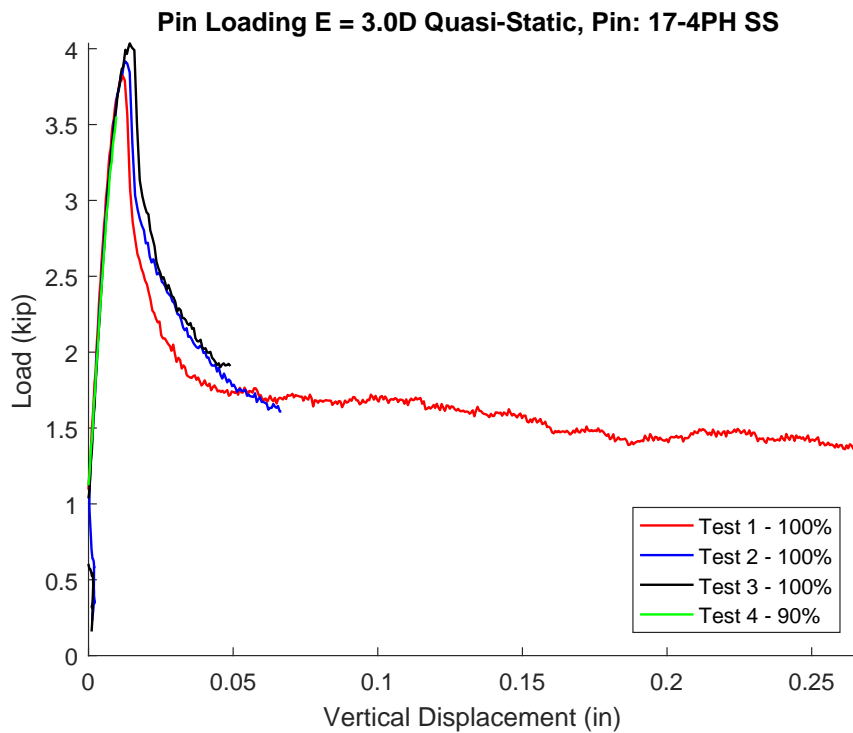
Figure 3.6: Simple Pin Loading, $E = 3.0D$, Pin: 17-4PH Stainless Steel.

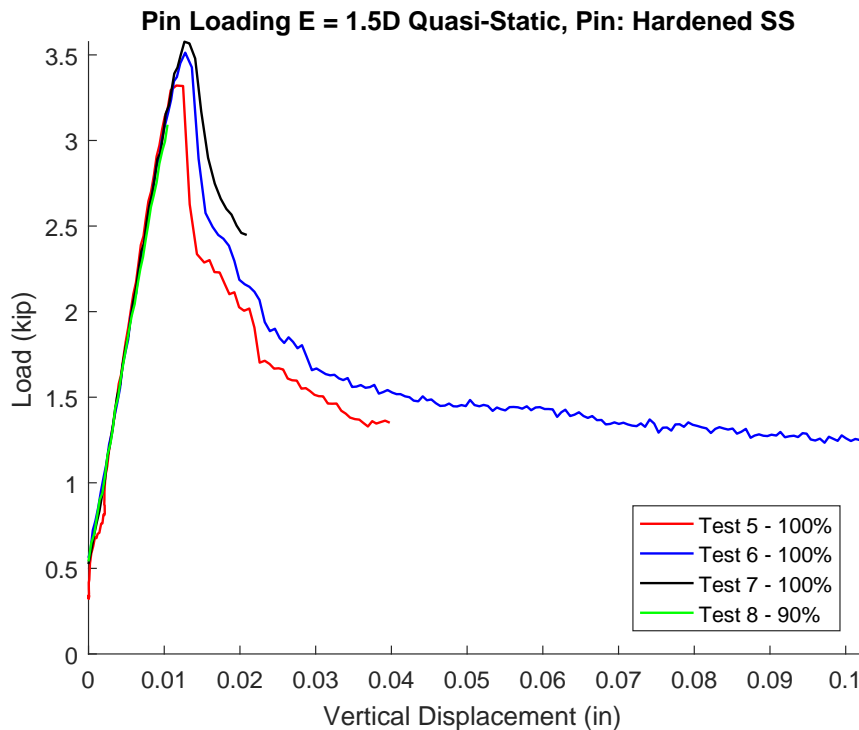
Figure 3.7: Simple Pin Loading, $E = 1.5D$, Pin: Hardened Stainless Steel.

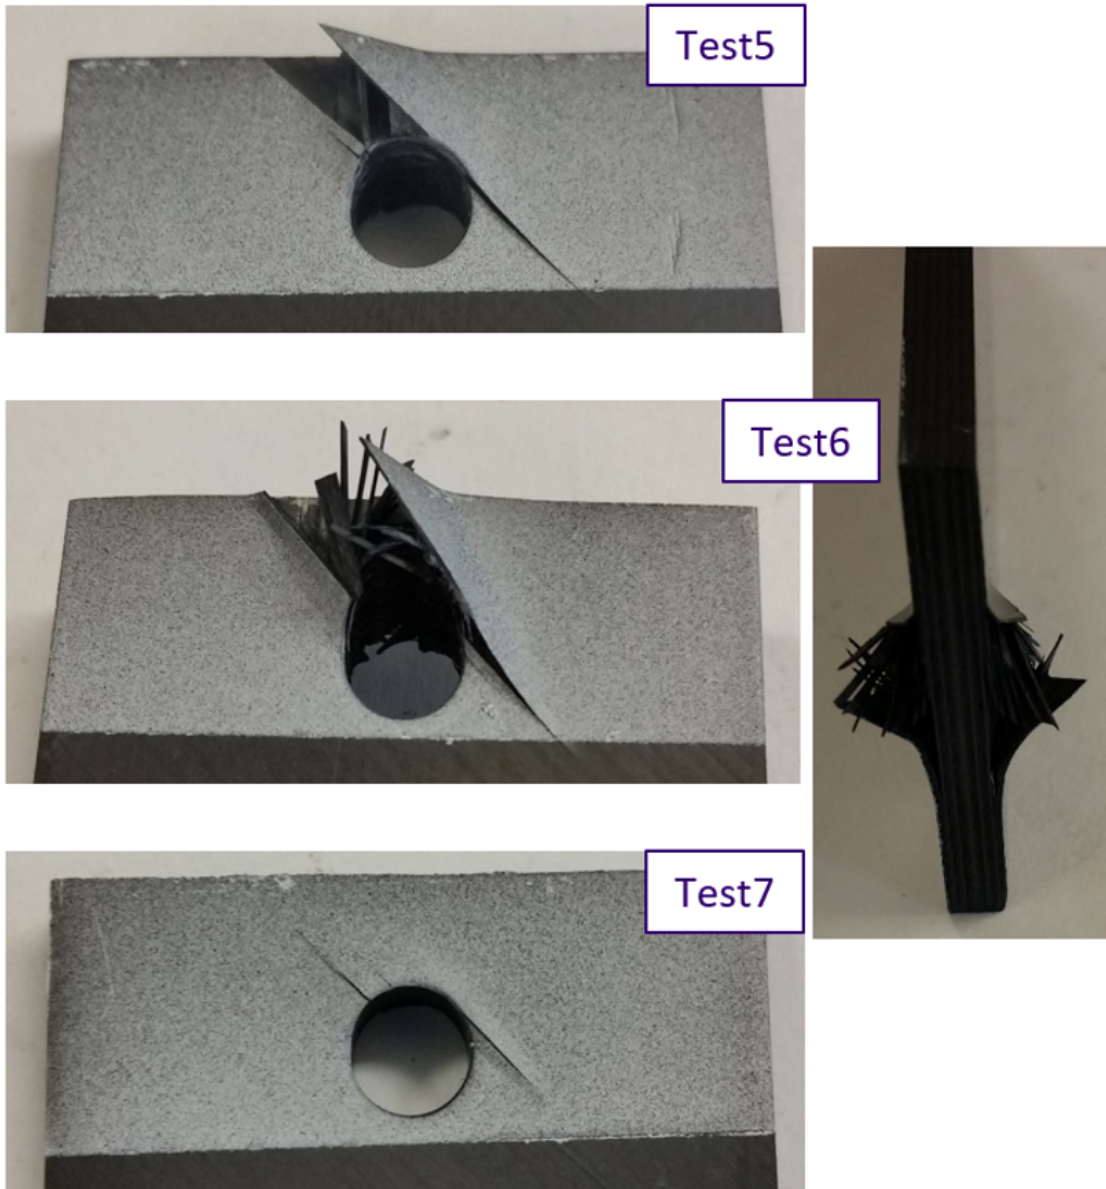
Figure 3.8: Post-test damage for the tests shown in Figure 3.7.

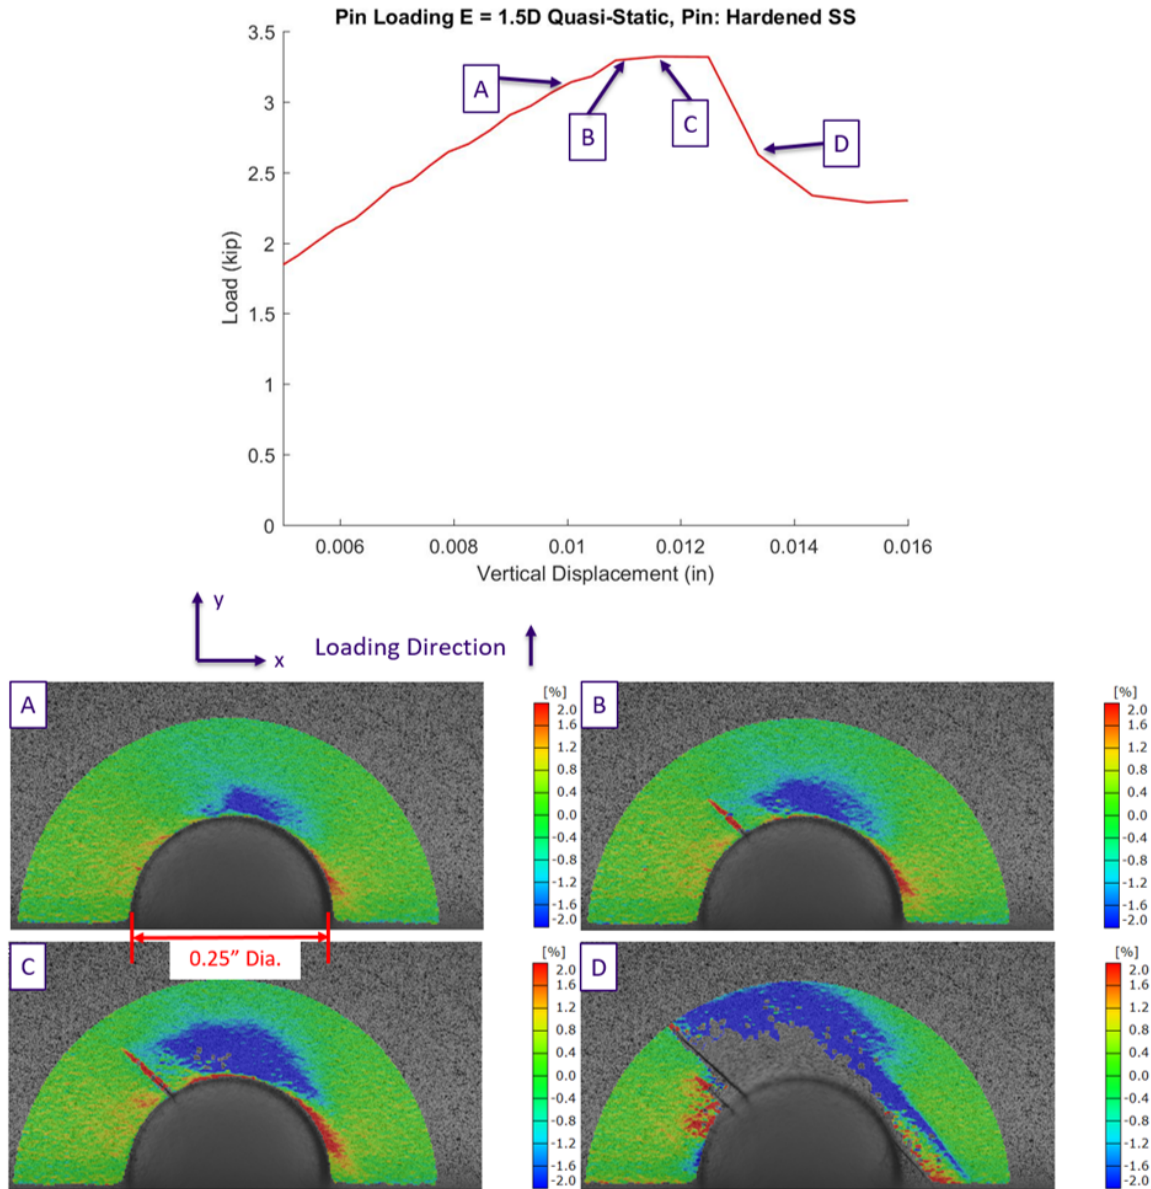
Figure 3.9: ϵ_{YY} DIC Strain Plots for Test 5. Peak region shown.

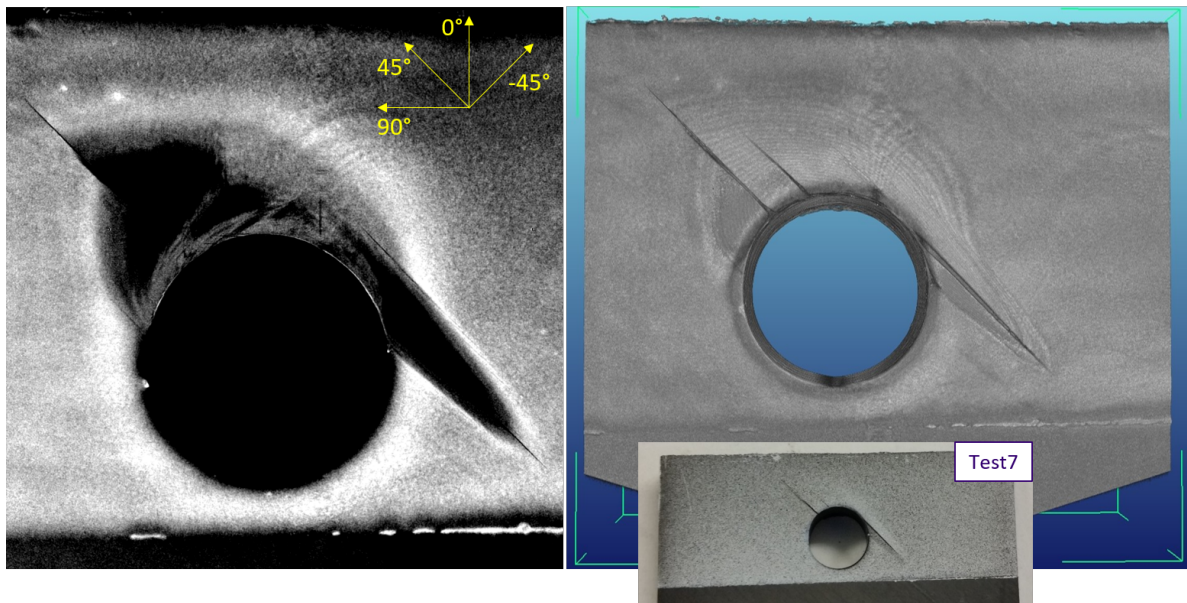
Figure 3.10: CT scan of Test 7. Left: 2D slice of ply 1. Right: 3D rendering of scanned area with overlay of image after testing.

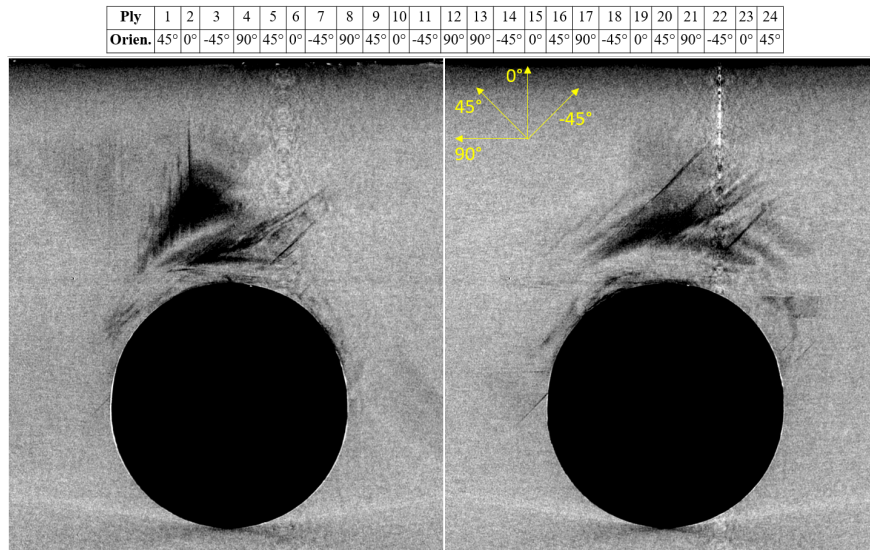
Figure 3.11: CT scan of Test 7. Left: Plies 2 and 3. Matrix cracking in 0 can be seen left of center, towards top. Matrix cracking in -45 can be seen right of center, closer to hole. Right: Ply 3, cracking in -45.

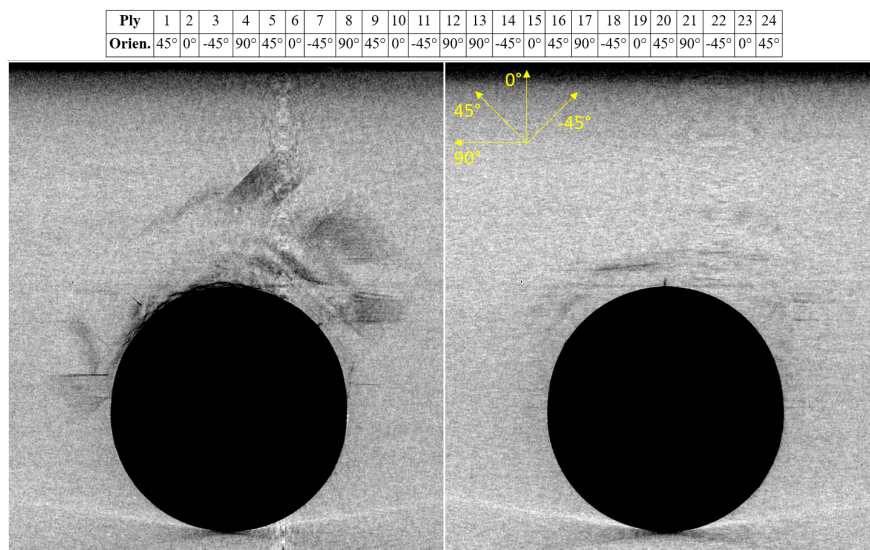
Figure 3.12: CT scan of Test 7. Left: Plies 3 and 4. Fiber cracking in -45, top-left of hole. Matrix cracking in 90, left (very clear) and right. Right: Plies 12 and 13, center of the laminate. Fiber cracking at top-center of hole.

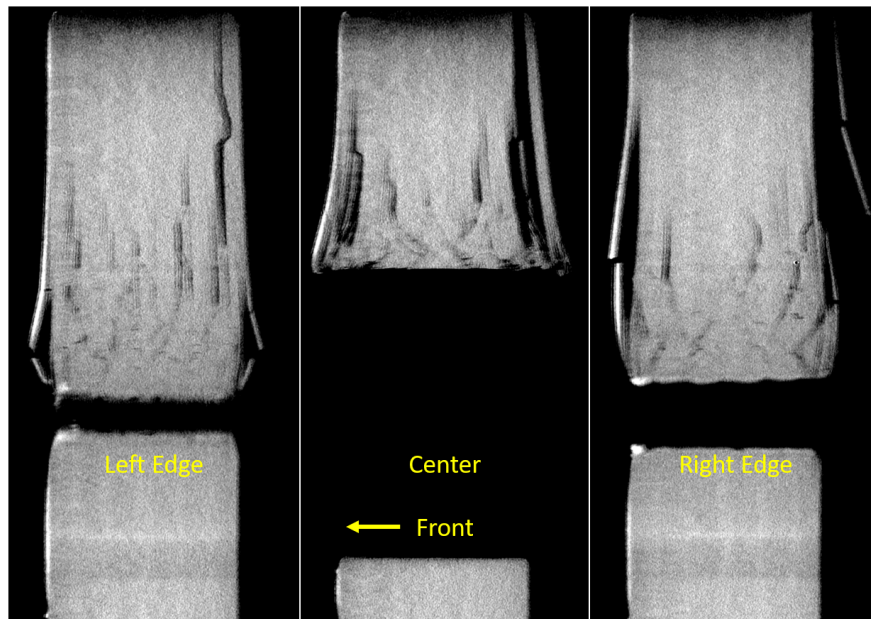
Figure 3.13: CT scan of Test 7. Side slices, loading direction: up. Brooming clearly seen in center image with damage clear in both outer images.

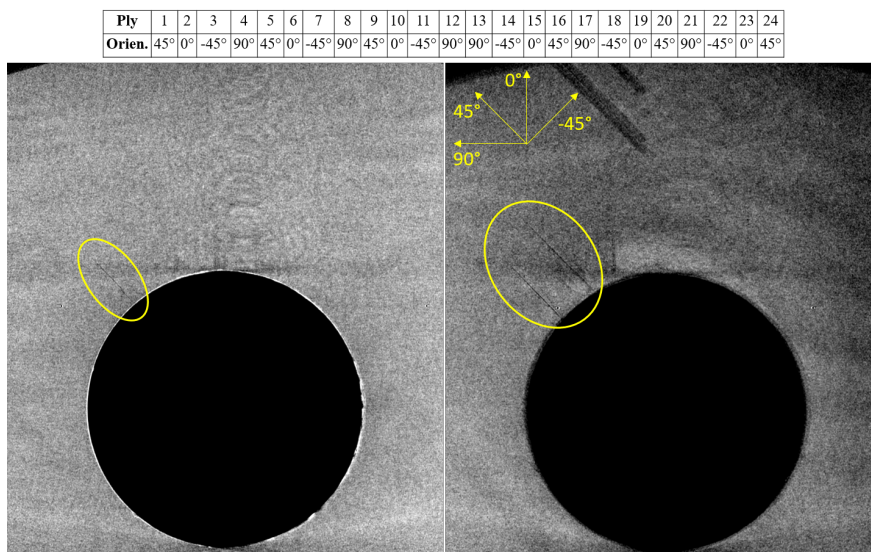
Figure 3.14: CT scan of Test 8. Left: Ply 1 shows minor matrix cracking along fiber direction, perpendicular to hole. Right: Ply 24 also shows minor matrix cracking, perpendicular to hole.

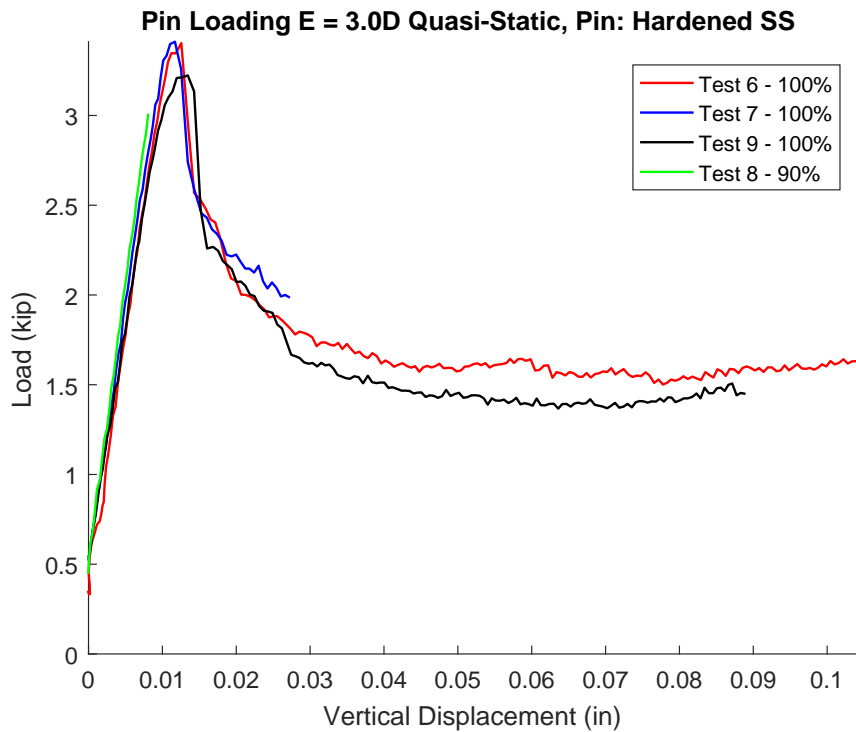
Figure 3.15: Simple Pin Loading, $E = 3.0D$, Pin: Hardened Stainless Steel.

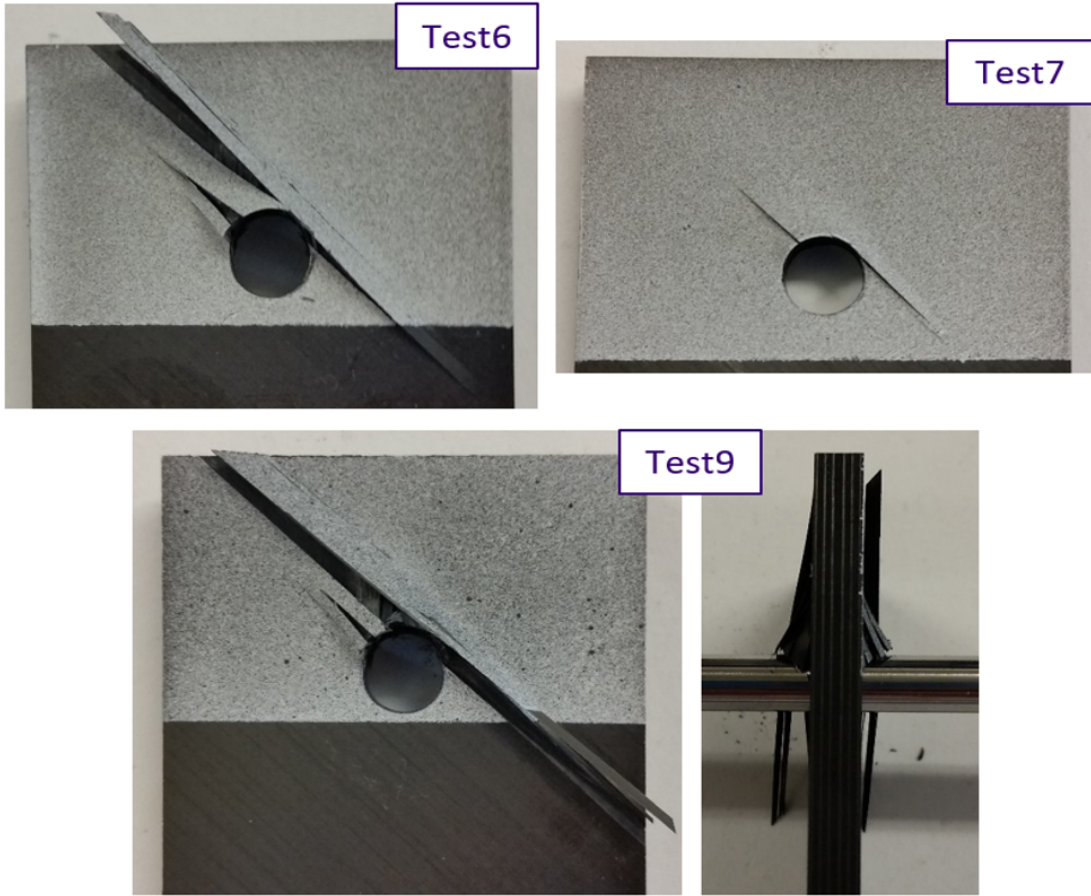
Figure 3.16: Post-test damage for the tests shown in Figure 3.15.

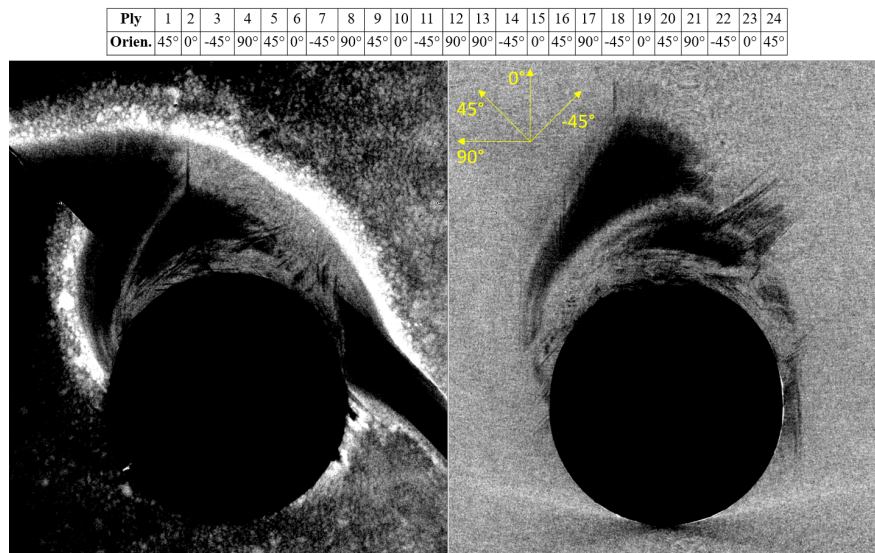
Figure 3.18: CT scan of Test 7. Left: Plies 1 and 2. To the edges, the 45 can be seen failing, while there is matrix cracking in the 0, above the hole, left of center. Right: Plies 2 and 3. Slight matrix cracking in the zero at the top of the image and to the right side of the hole. Matrix cracking in the -45 above the hole, right of center.

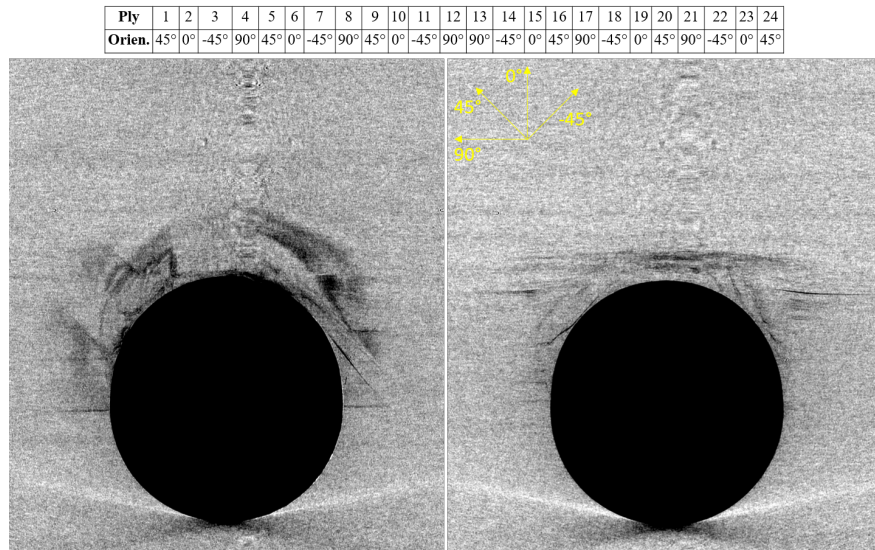
Figure 3.19: CT scan of Test 7. Left: Plies 4 and 5. Matrix cracking in the 90 to the left and right of hole. Matrix cracking in 45 upper left and right of hole, perpendicular to hole and tangent to hole, respectively. Right: Plies 12 and 13. Matrix cracking in 90, likely crushing at top of hole.

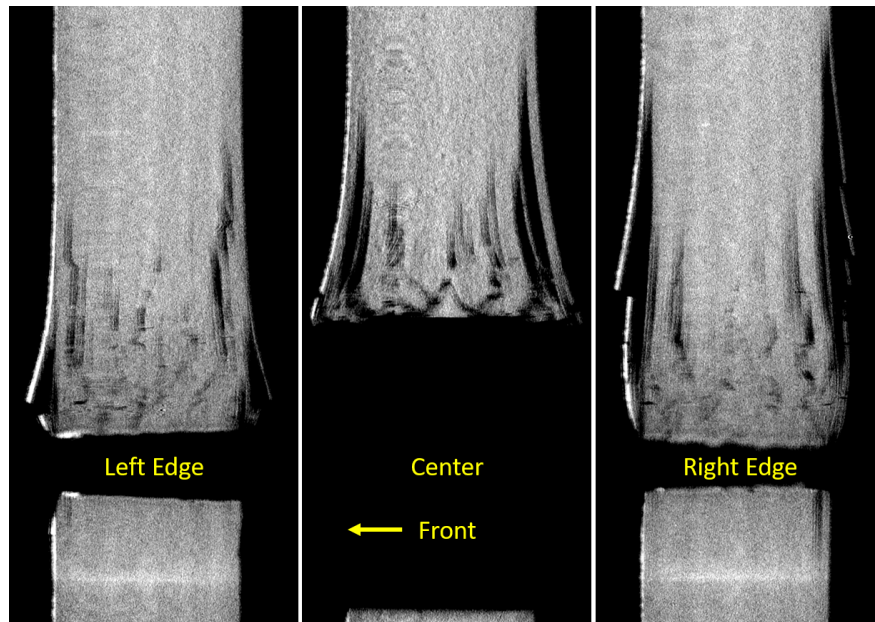
Figure 3.20: CT scan of Test 7. Side slices, loading direction: up. Brooming clearly seen in center image with damage clear in both outer images.

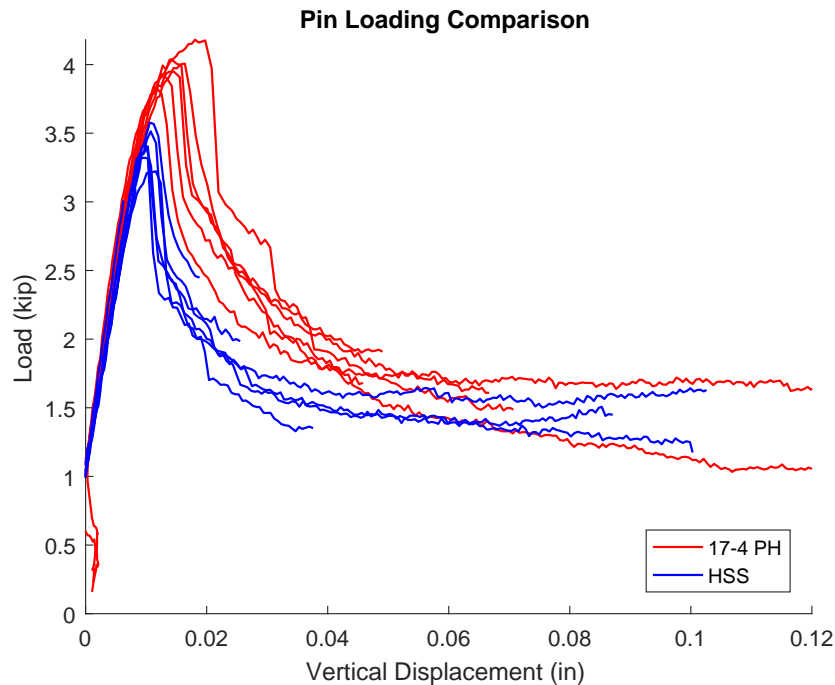
Figure 3.21: Comparison of pin material in Simple Pin Loading.

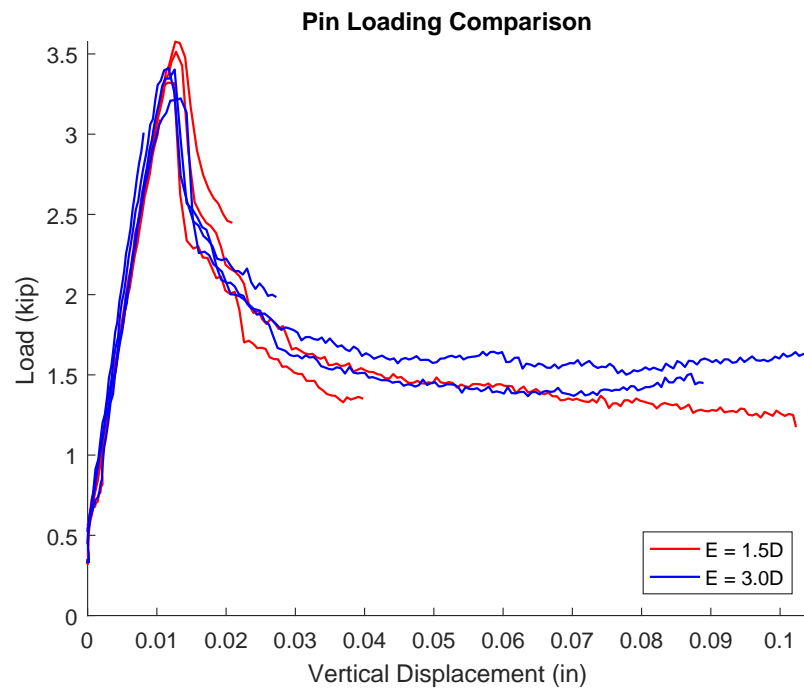
Figure 3.22: Comparison of eccentricity in Simple Pin Loading using Hardened Stainless Steel pins.

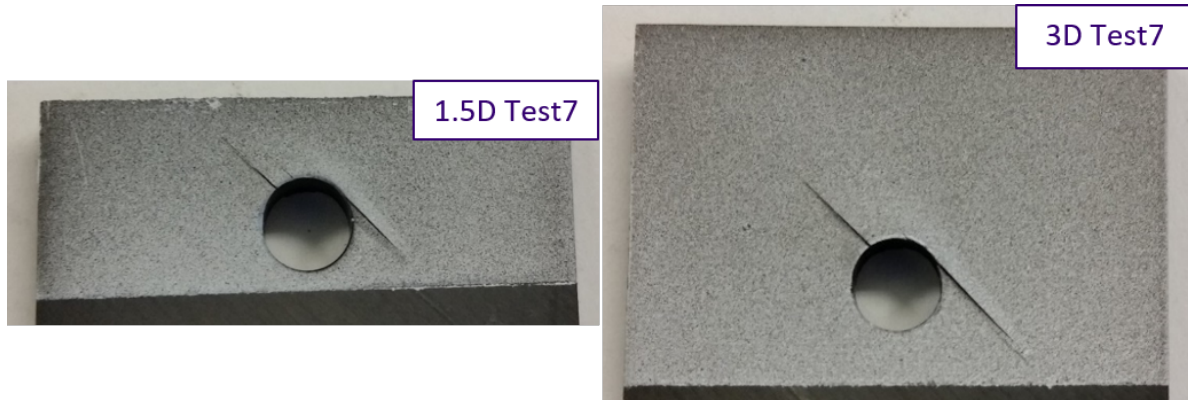
Figure 3.23: Visual comparison of failure mode in Simple Pin Loading specimens.

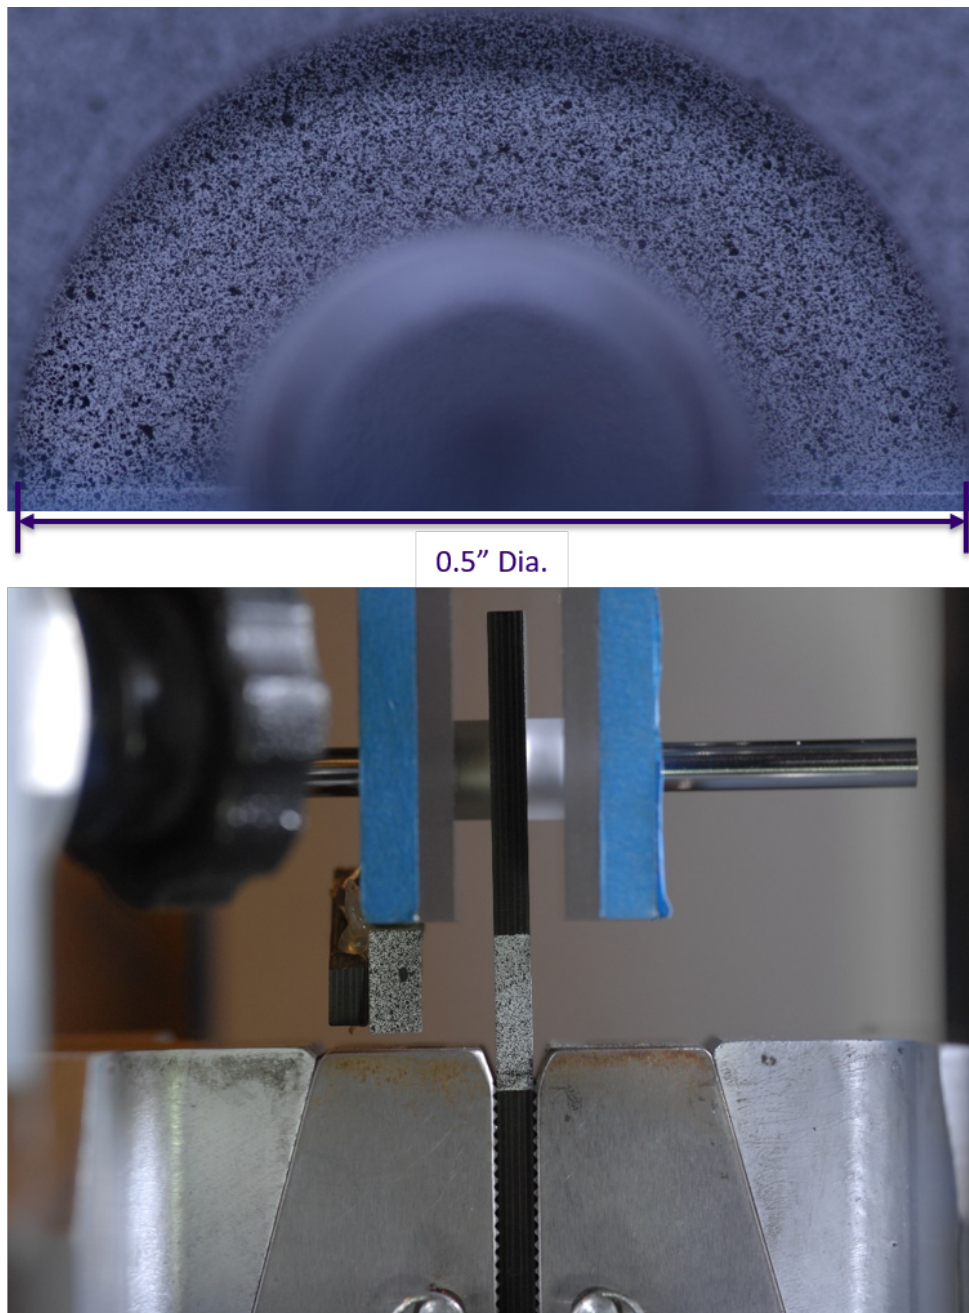
Figure 4.4: Raw images taken from the two cameras seen in Figure 4.3. Top image: Front facing camera. Bottom image: Side facing camera via the mirror reflection.

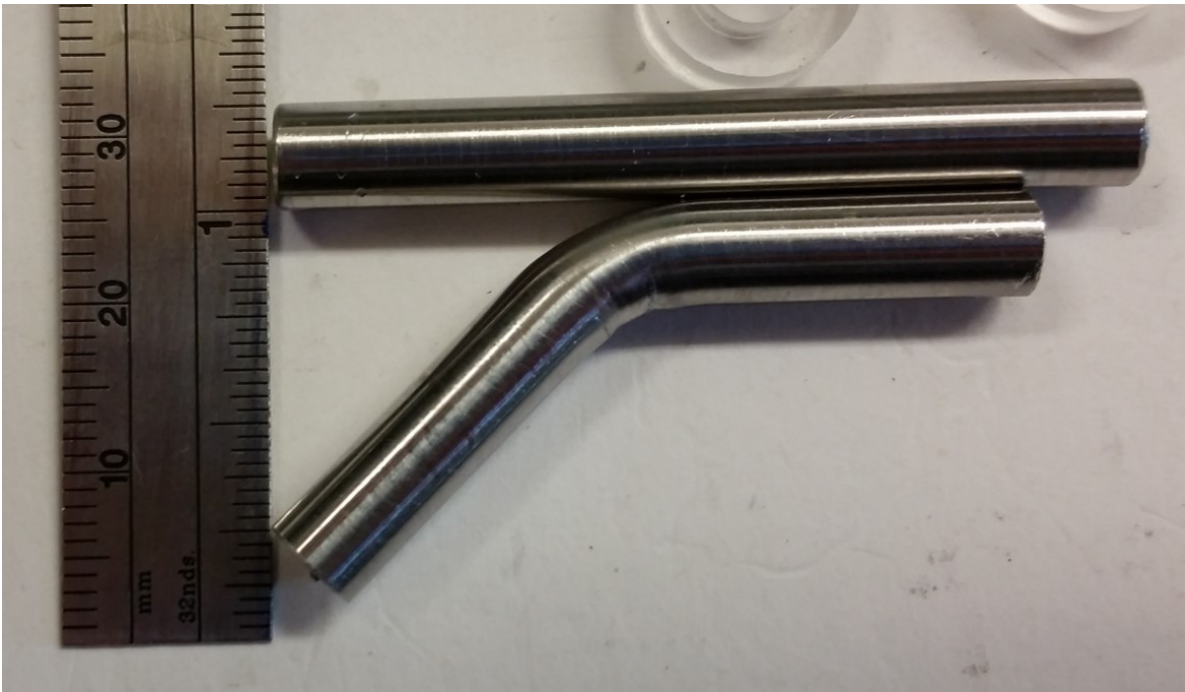
Figure 4.5: Significantly yielded pin shown next to untested pin.

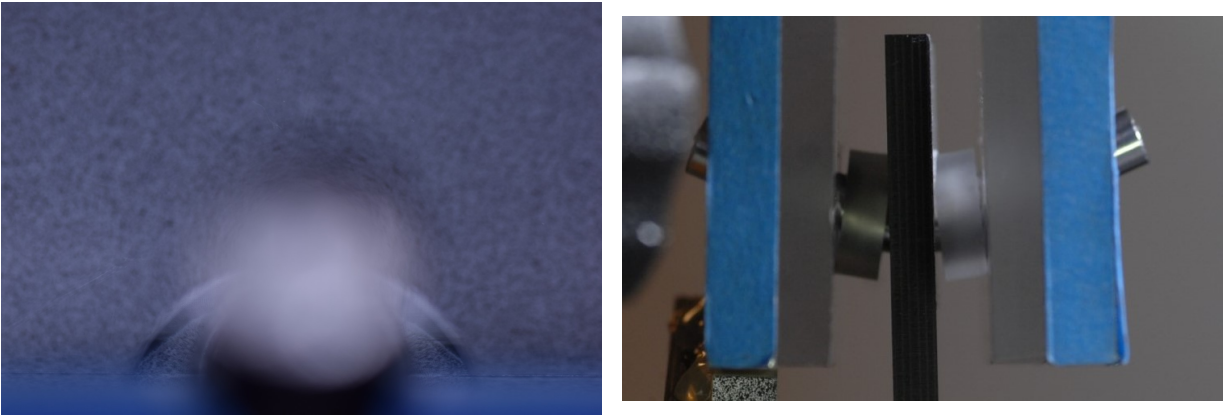
Figure 4.6: Bending of the pin as seen from the forward and side cameras.

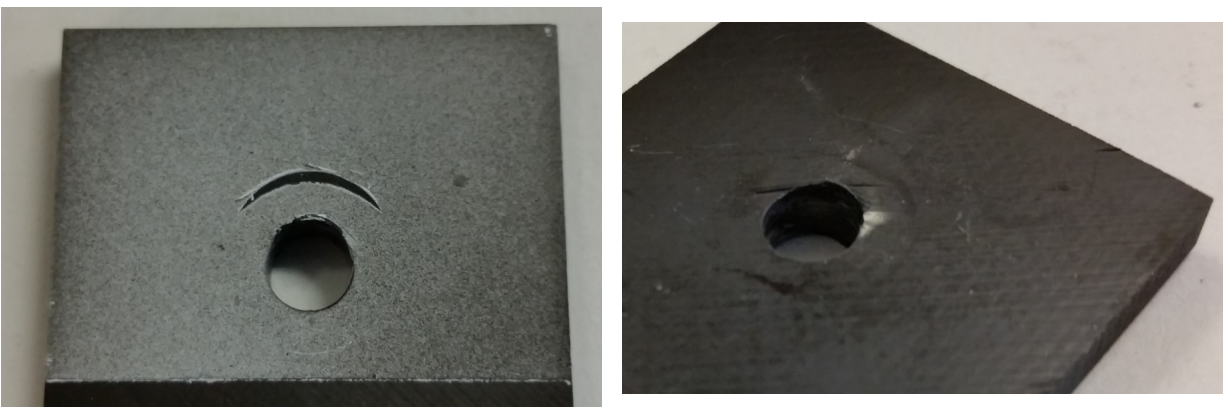
Figure 4.7: Damage incurred on the specimen loaded in the Window test with the 17-4PH SS pin.

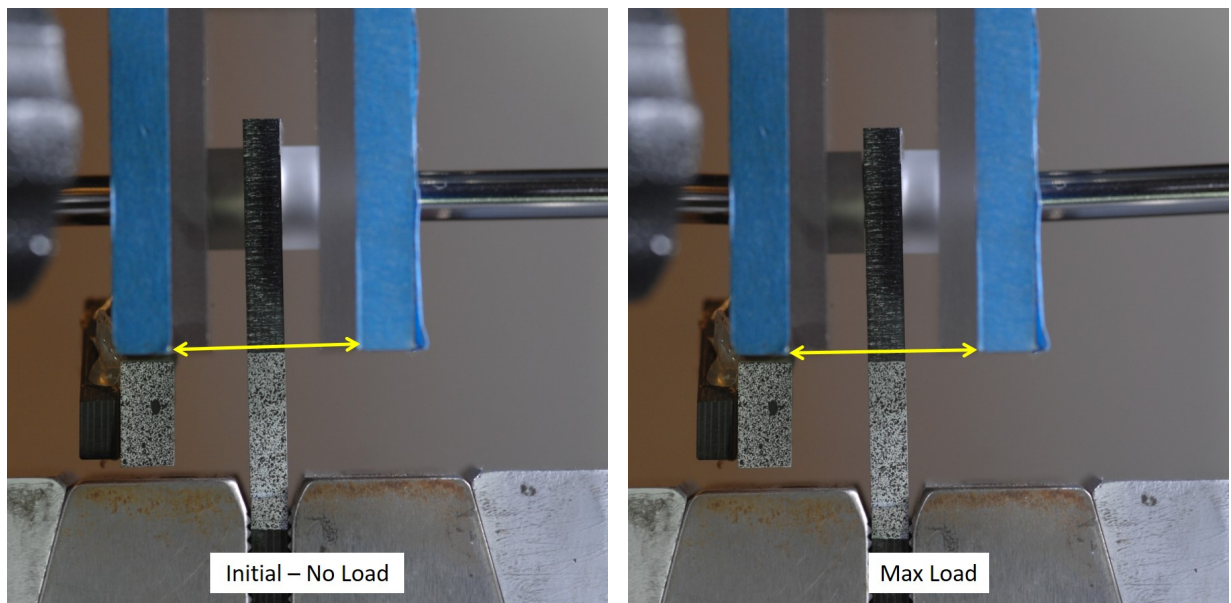
Figure 4.8: Measurement of the deflection of the fixture's outer steel window pieces as shown. An outward displacement at the lower edge of about 0.02 inches.

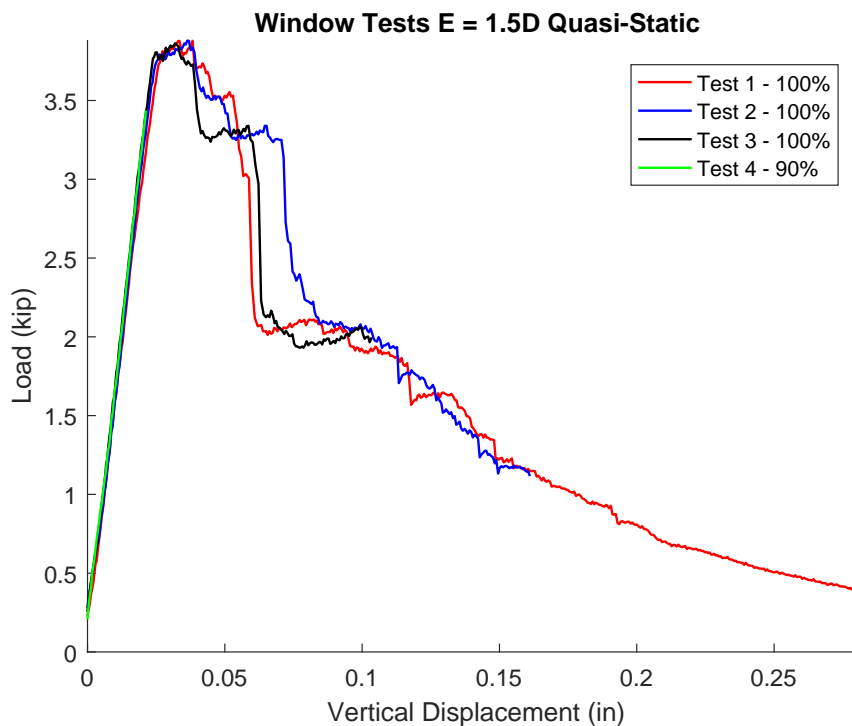
Figure 4.9: Window test, $E = 1.5D$.

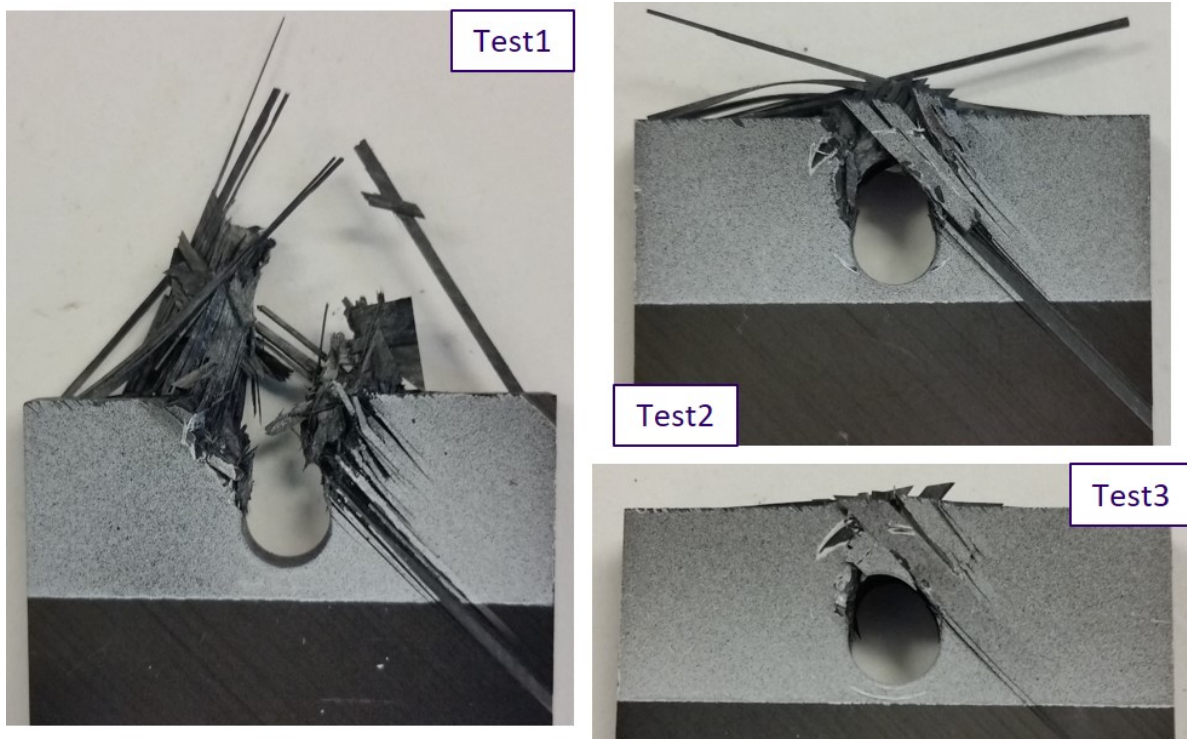
Figure 4.10: Post-test damage for the tests shown in Figure 4.9.

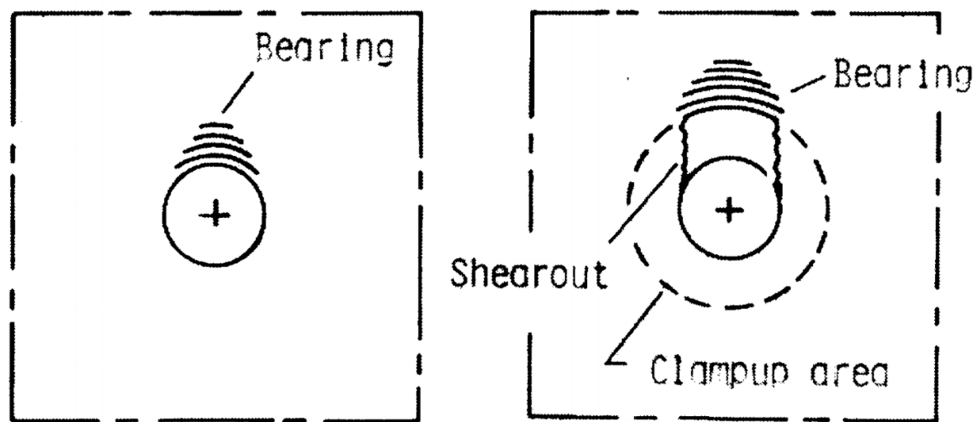
Figure 4.11: Figure 4(a) and (b) from Crews. Left: (a) Bearing failure mode. Right: (b) Combined bearing and shearout failure modes seen in a joint with clamp-up.

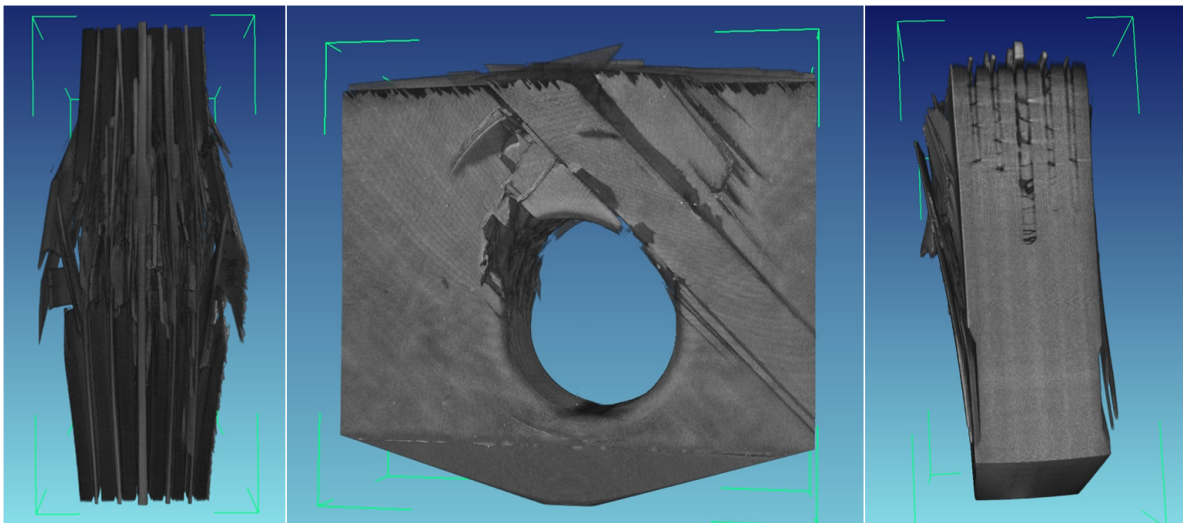
Figure 4.13: CT scan of Test 3. 3D rendering of scanned area. Top, Front, and Side views seen (L to R).

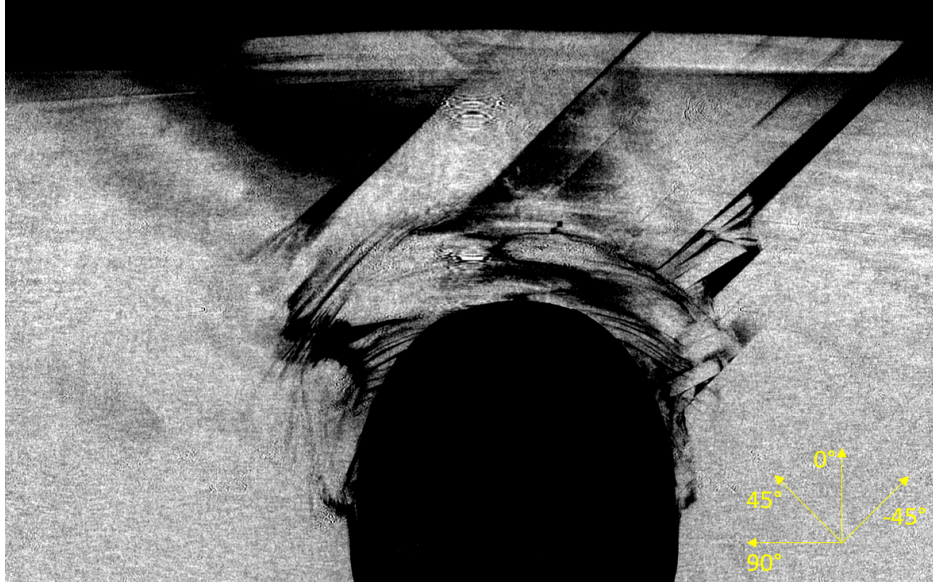
Figure 4.14: CT scan of Test 3, ply 7. Clear signs of shearout failure in -45.

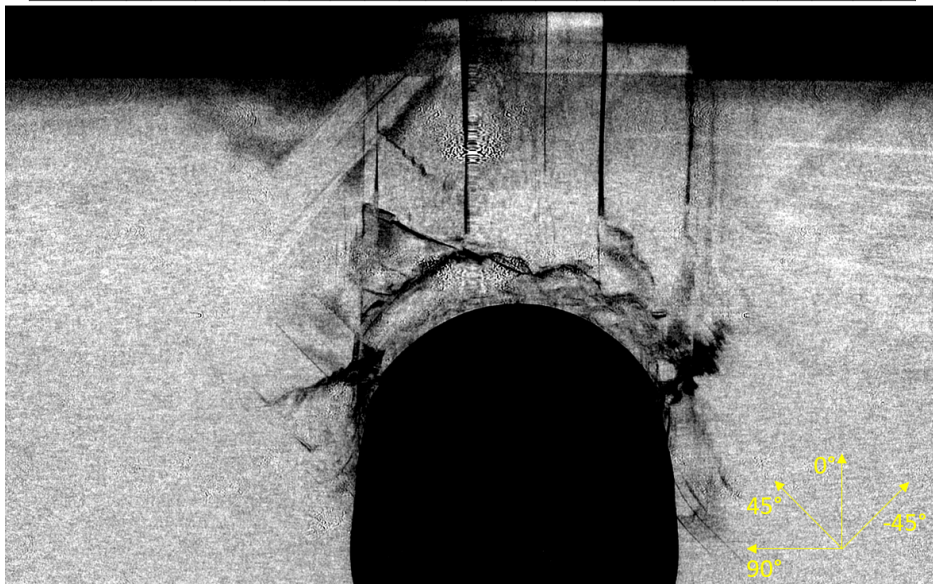
Figure 4.15: CT scan of Test 3, ply 10. Clear signs of shearout failure in 0.

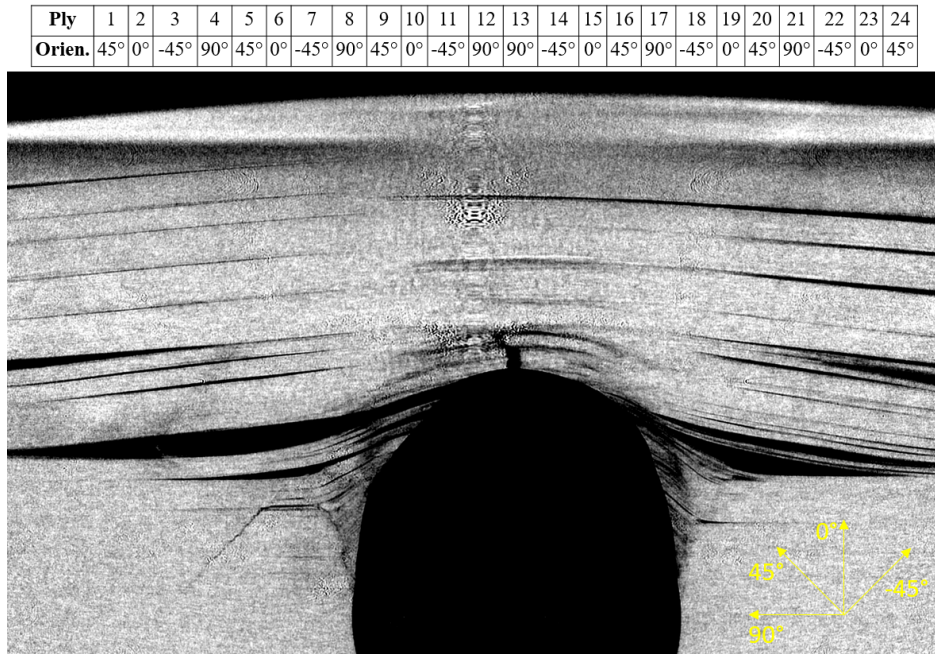
Figure 4.16: CT scan of Test 3, plies 12 and 13, center of the laminate. Clear signs of shearout failure in 90. Matrix and fiber failure.

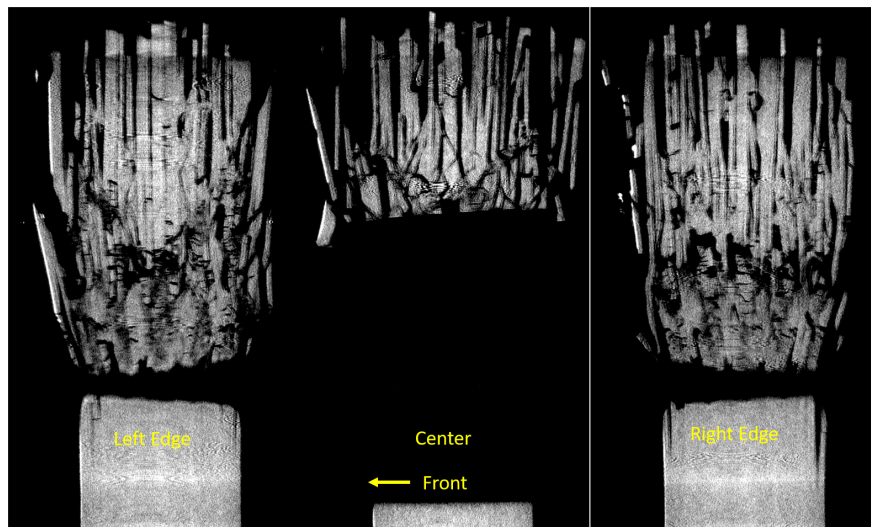
Figure 4.17: CT scan of Test 3. Side slices, loading direction: up. Significant delamination at specimen edge (top). Minimal brooming around hole as expected due to washer constraint.
