©Copyright 2017
Alastair M. Croxford

Experimental Characterization of Failure Mechanisms in Carbon Fiber Laminated Joints

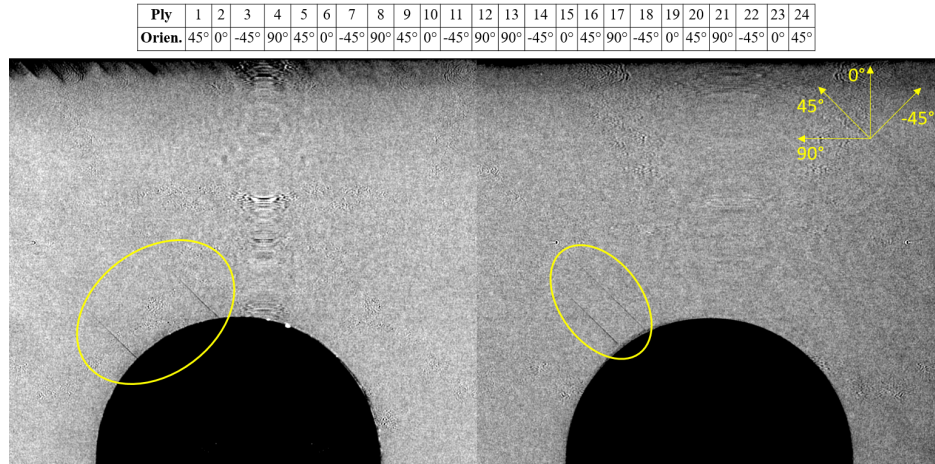
Figure 4.18: CT scan of Test 4, Left: Ply 1. Right: Ply 24. Both plies exhibit minor matrix cracking along fiber direction, perpendicular to hole.

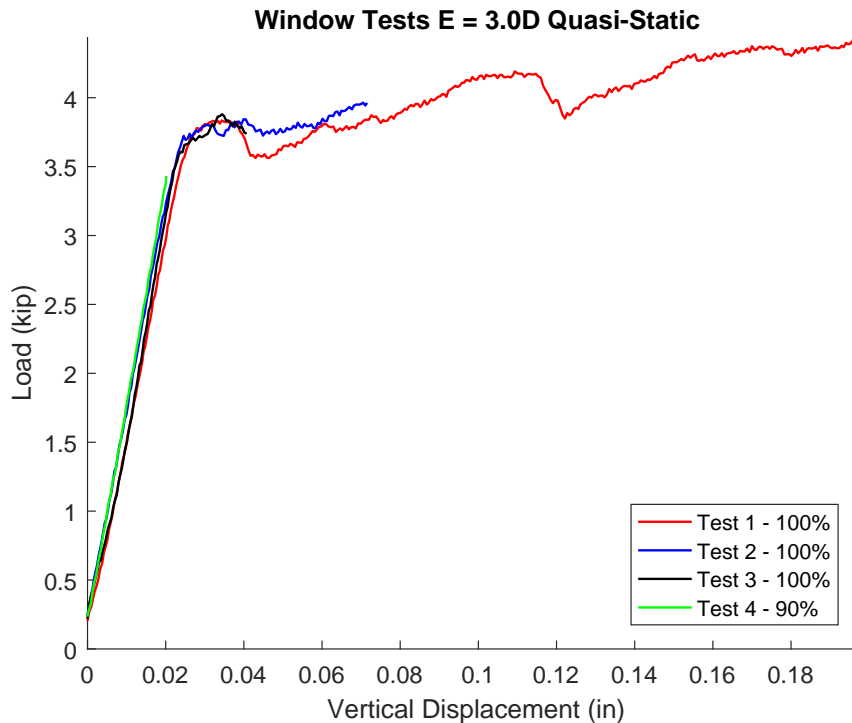
Figure 4.19: Window test, $E = 3.0D$.

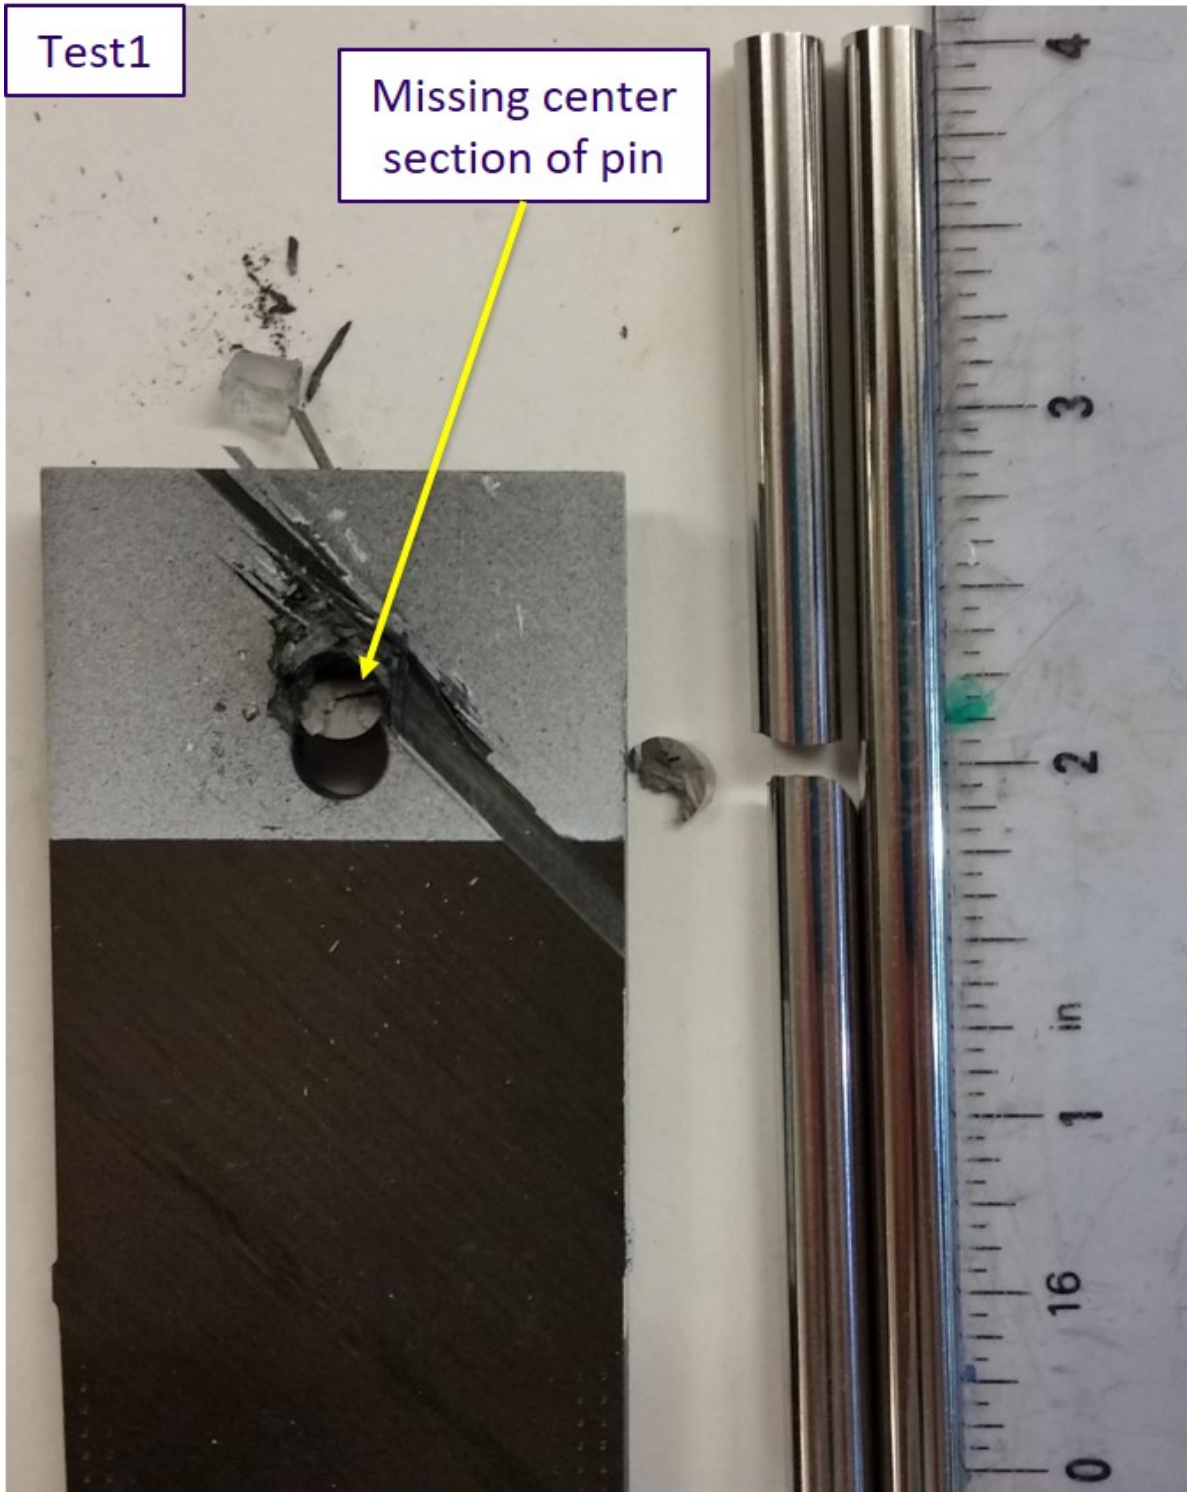
Figure 4.20: Post-test damage for Test 1 shown in Figure 4.19.

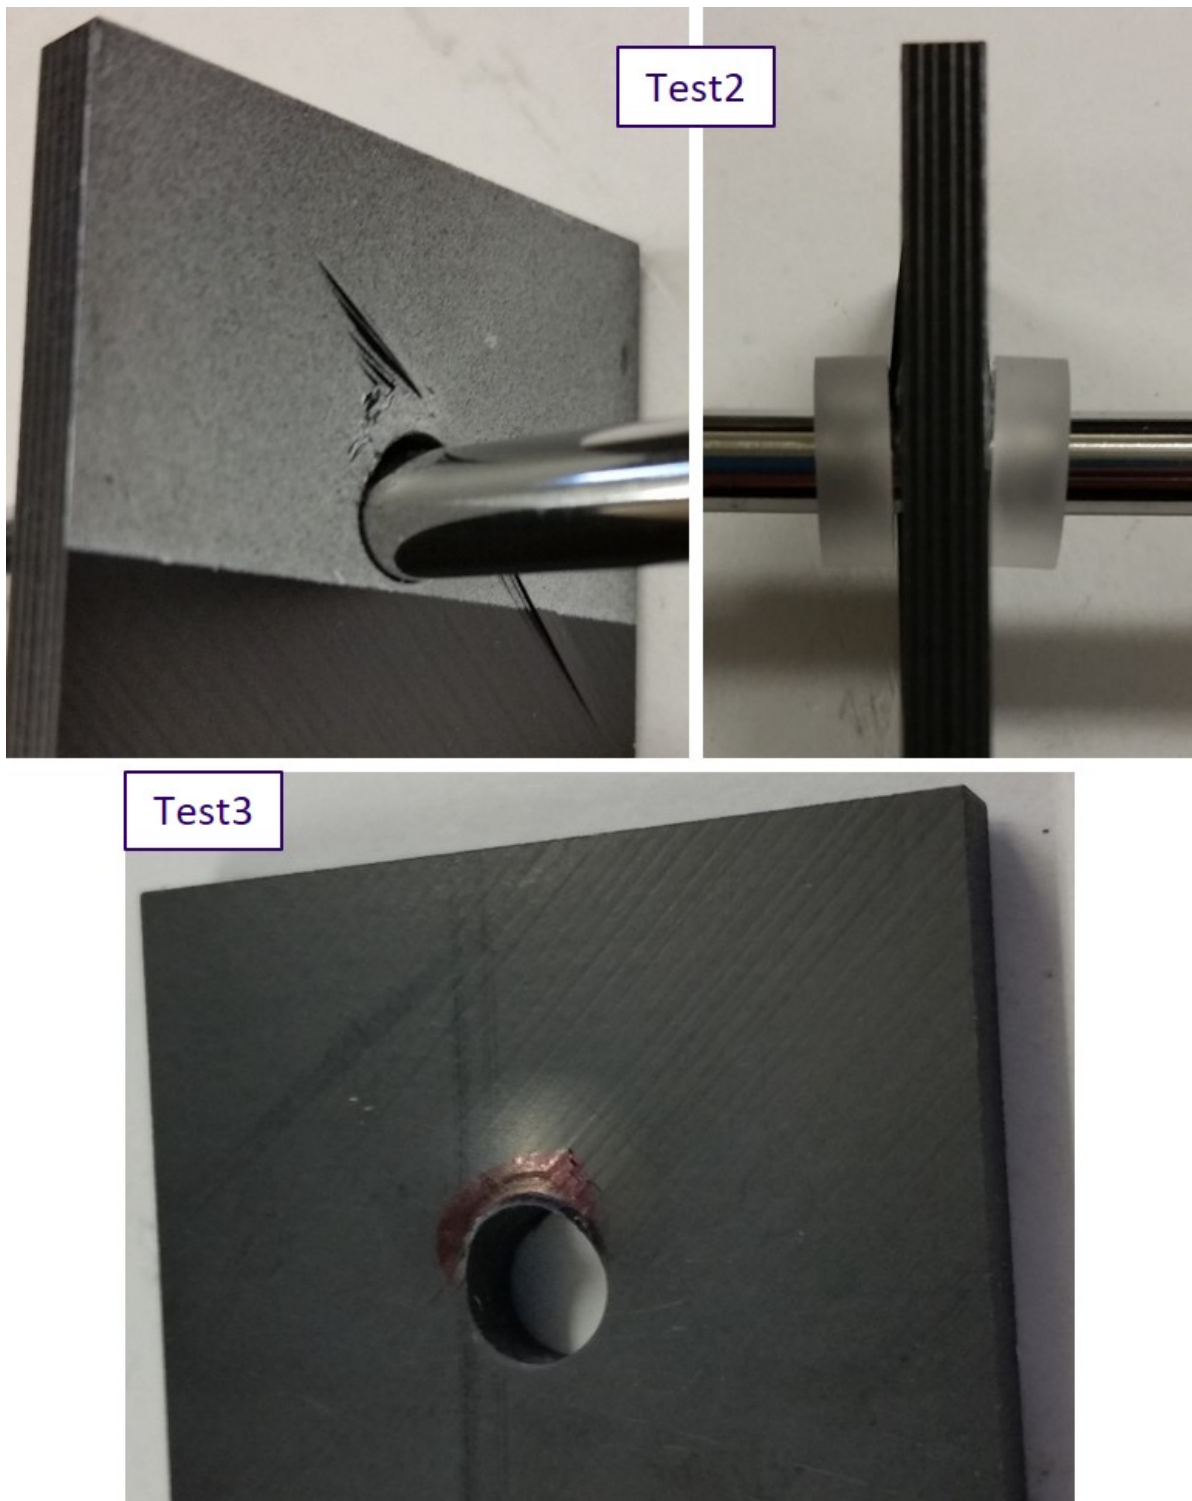
Figure 4.21: Post-test damage for Tests 2 and 3 shown in Figure 4.19.

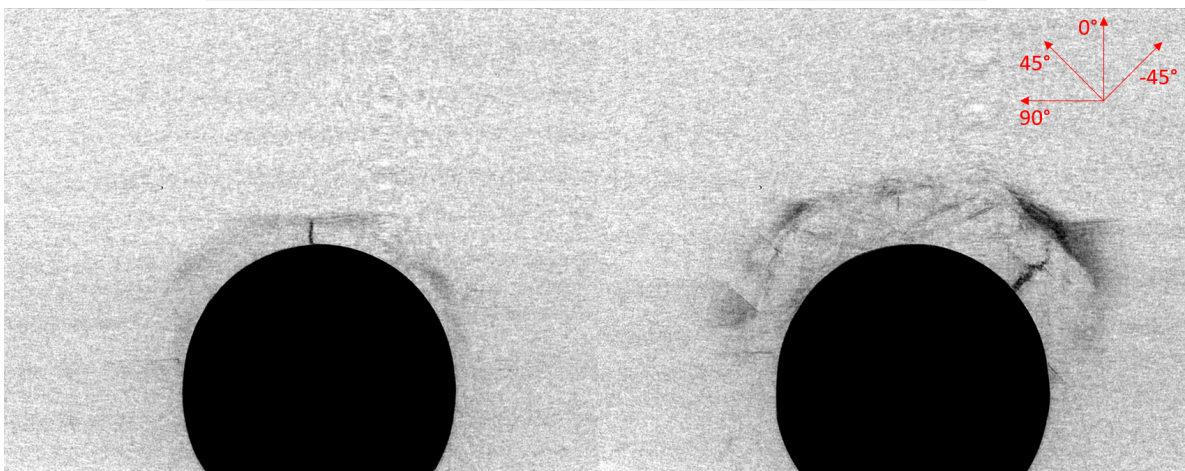
Figure 4.23: CT scan of Test 3. Left: Ply 13. Fiber cracking at the top of the hole. Right: Plies 16 and 17. Fiber cracking in ply 16 (45) to top right of hole. Minor matrix cracking in ply 17 (90) to left of hole.

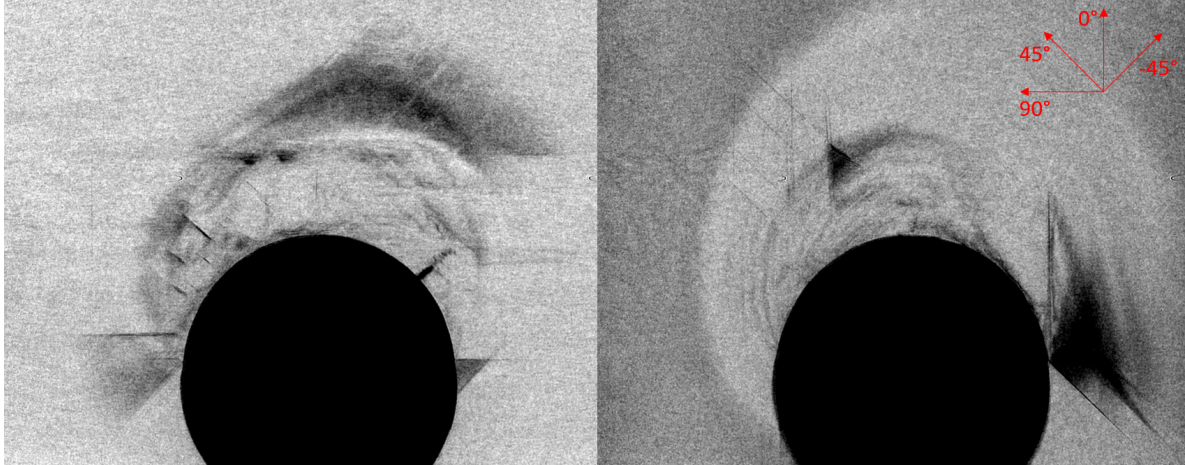
Figure 4.24: CT scan of Test 3. Left: Plies 20 and 21. Matrix cracking to top left and fiber cracking to top right of hole seen in ply 20 (45). Matrix cracking to left in ply 21 (90). Right: Plies 23 and 24. Matrix cracking seen in both plies.

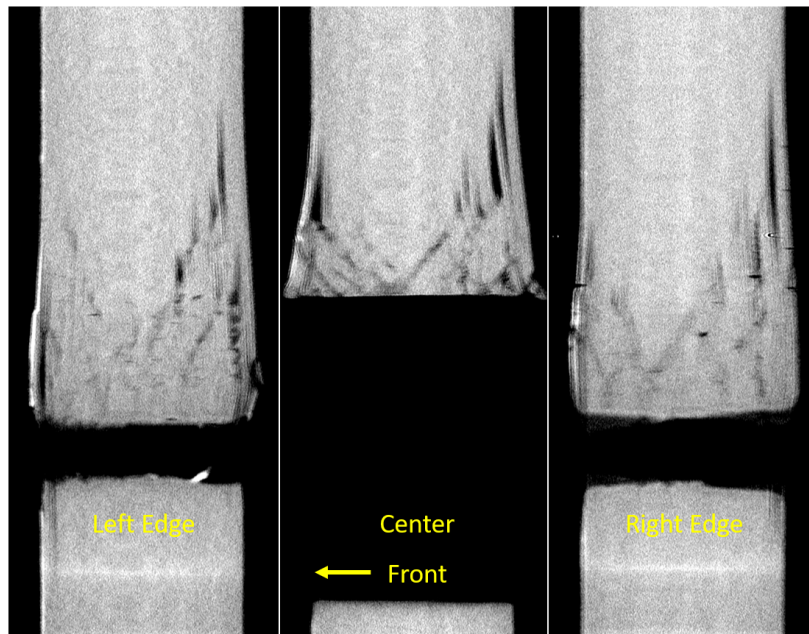
Figure 4.25: CT scan of Test 3. Side slices, loading direction: up. Slight brooming seen in the center of the hole.

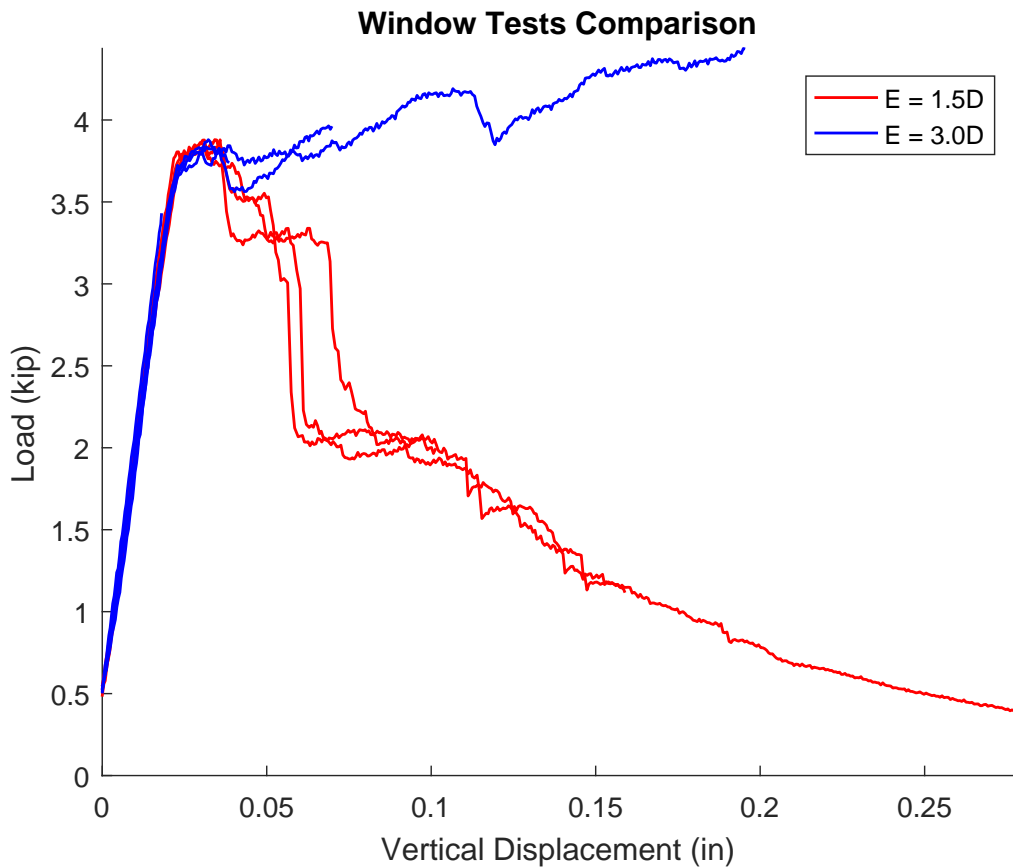
Figure 4.26: Comparison of eccentricity in Window tests. Full extent of data shown.

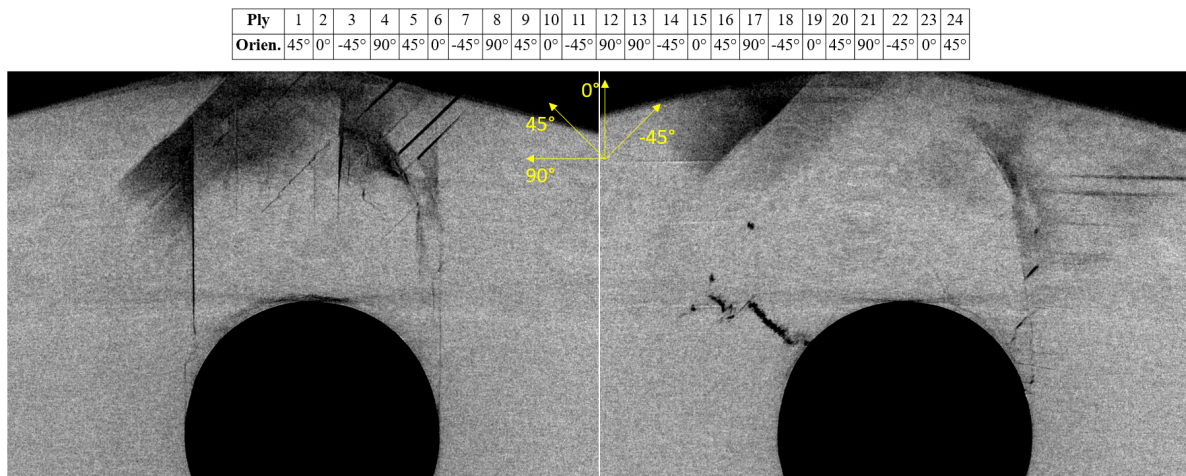
Figure 5.6: CT scan of Test 4. Left: Plies 2 and 3. Matrix cracking. Right: Ply 3. Fiber cracking top left of hole.

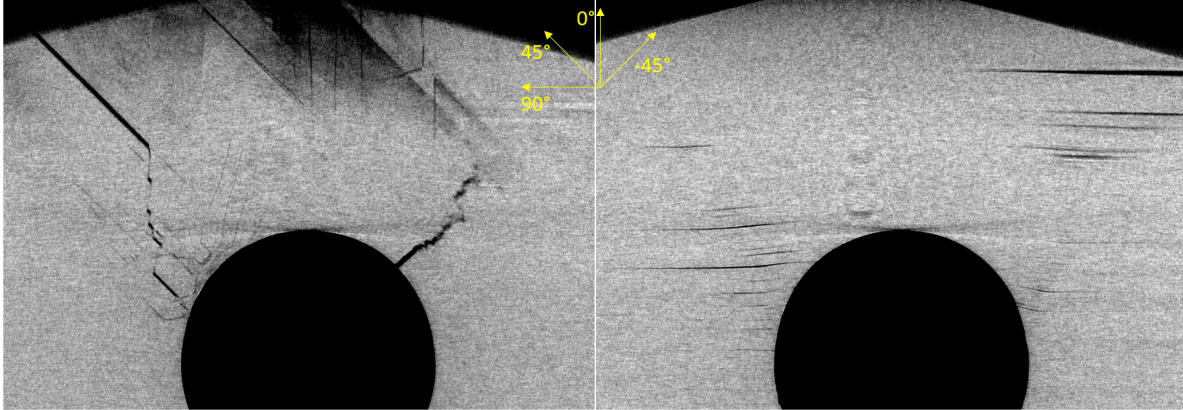
Figure 5.7: CT scan of Test 4. Left: Ply 5. Fiber and matrix cracking. Right: Plies 12 and 13, center of the laminate. Fiber bridging and matrix cracking.

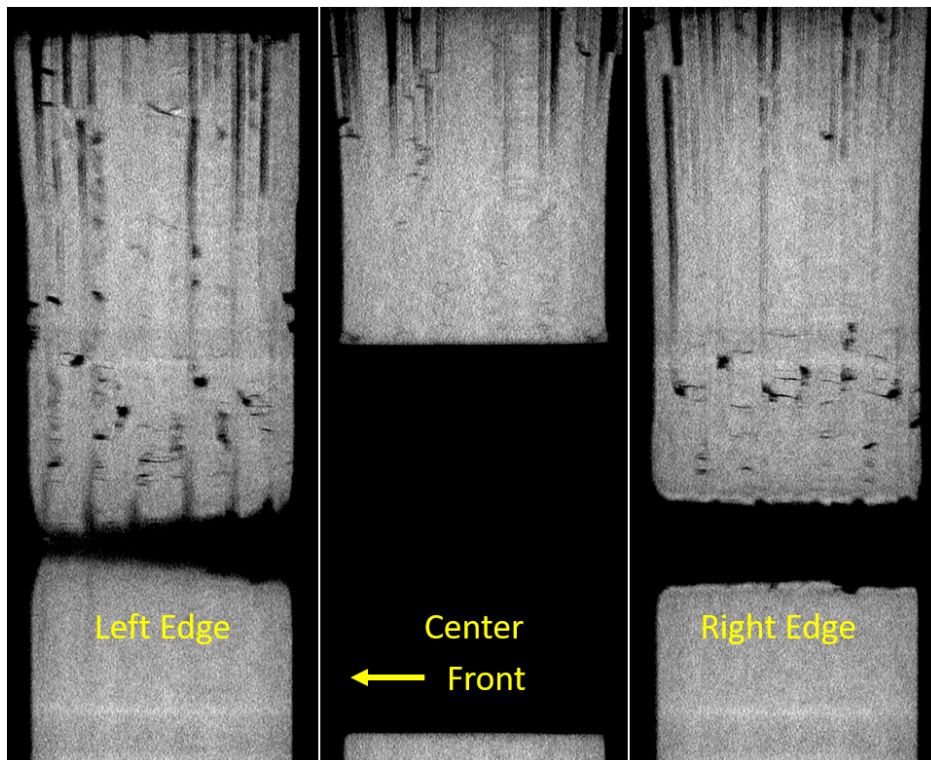
Figure 5.8: CT scan of Test 4. Side slices, loading direction: up. Clear delamination at specimen edge (top).

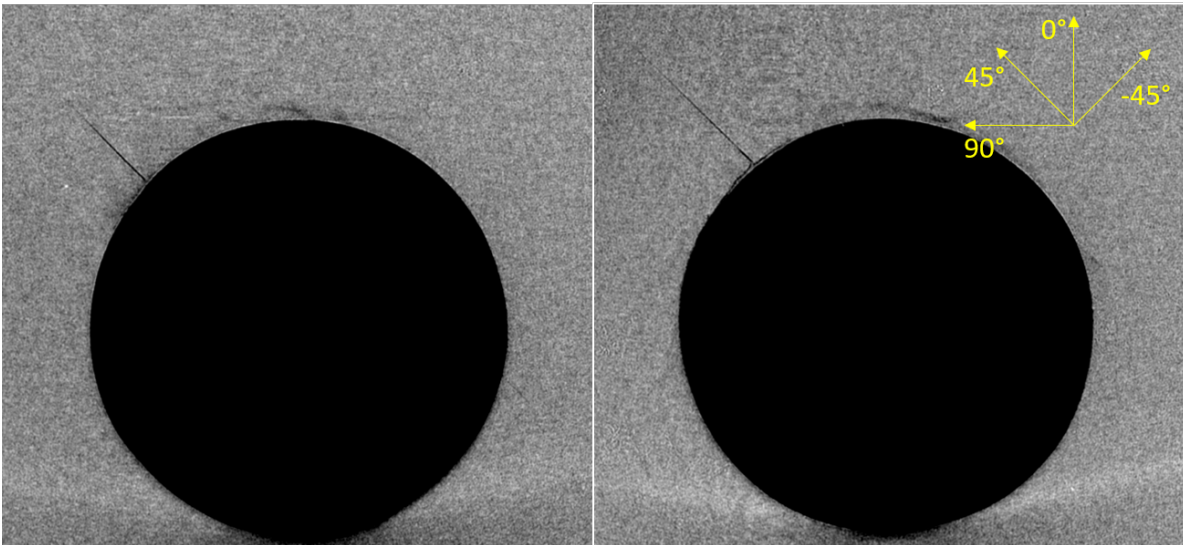
Figure 5.9: CT scan of Test 5. Left: Ply 1. Right: Plies 24. Both plies exhibit matrix cracking along the fiber direction, perpendicular to the hole.

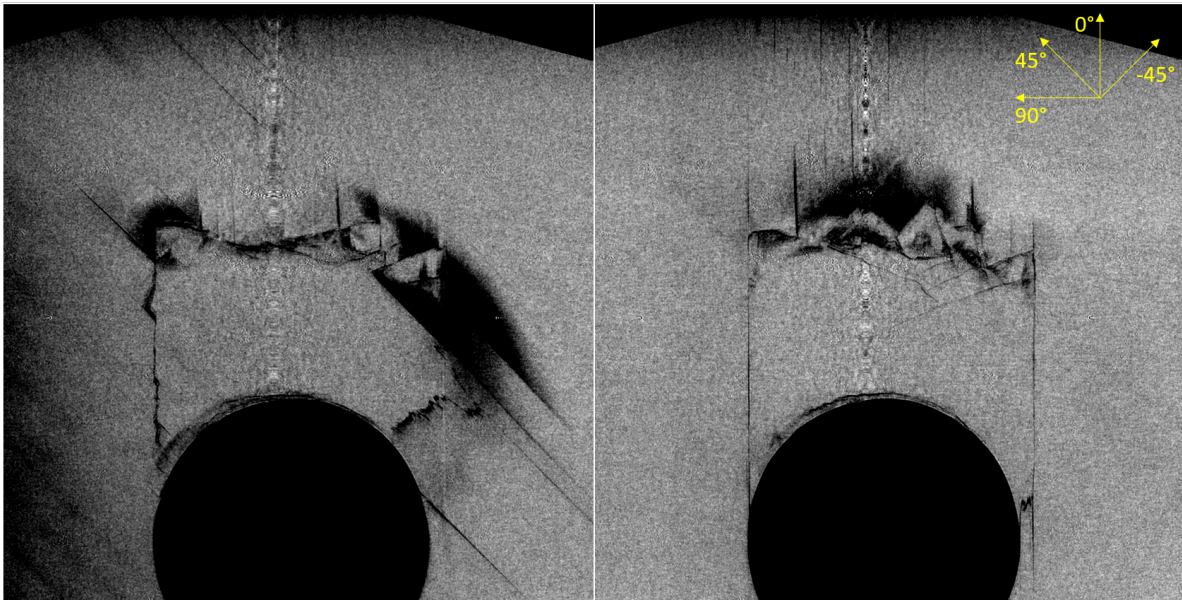
Figure 5.11: CT scan of Test 4. Left: Ply 1. Matrix cracking widespread and fiber cracking to top left and top right of hole. Right: Ply 2. Matrix cracking tangent to hole and fiber crushing above washer footprint.

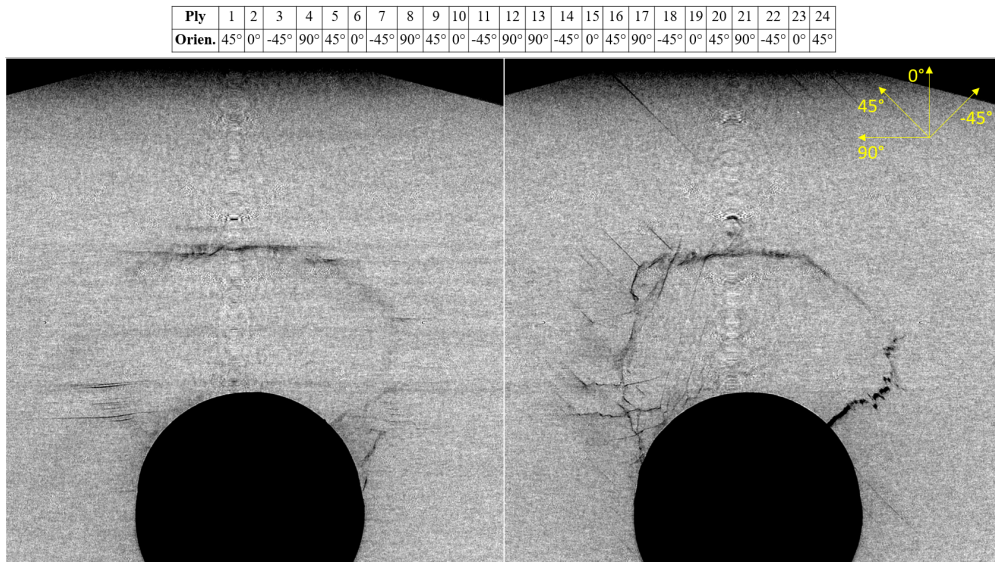
Figure 5.12: CT scan of Test 4. Left: Ply 4. Matrix cracking and fiber bridging (top left). Right: Ply 5. Matrix cracking, fiber crushing above washer footprint, and fiber cracking top right of hole.

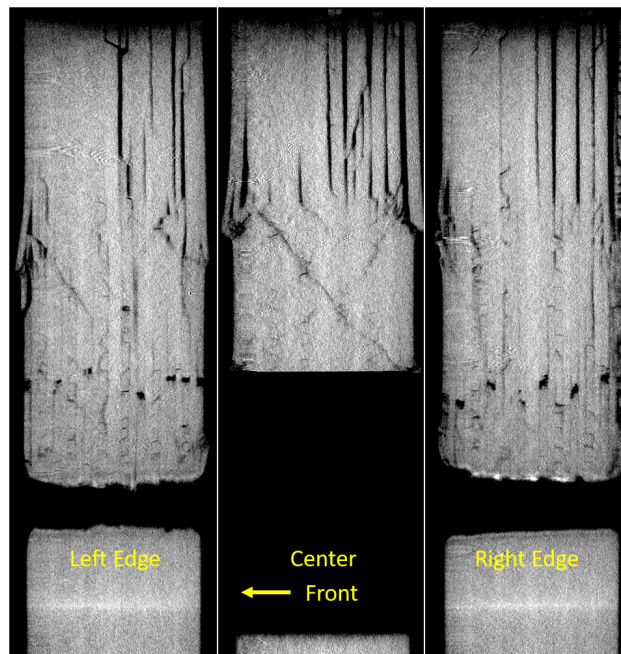
Figure 5.13: CT scan of Test 4. Side slices, loading direction: up. Clear delamination at specimen edge (top).

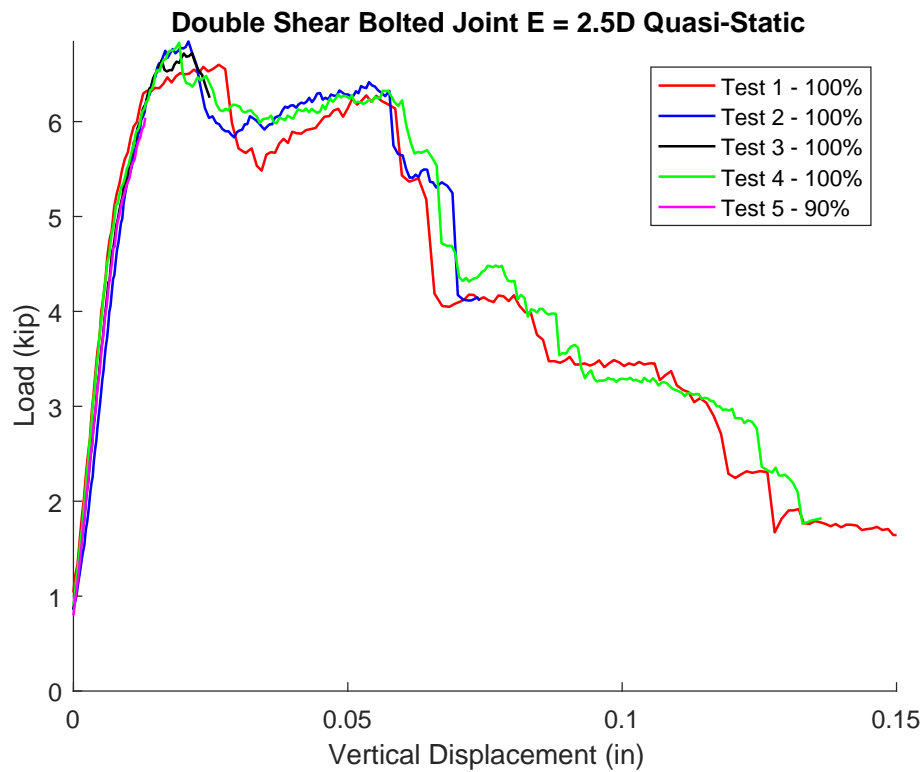
Figure 5.14: Double Shear Bolted Joint, $E = 2.5D$.

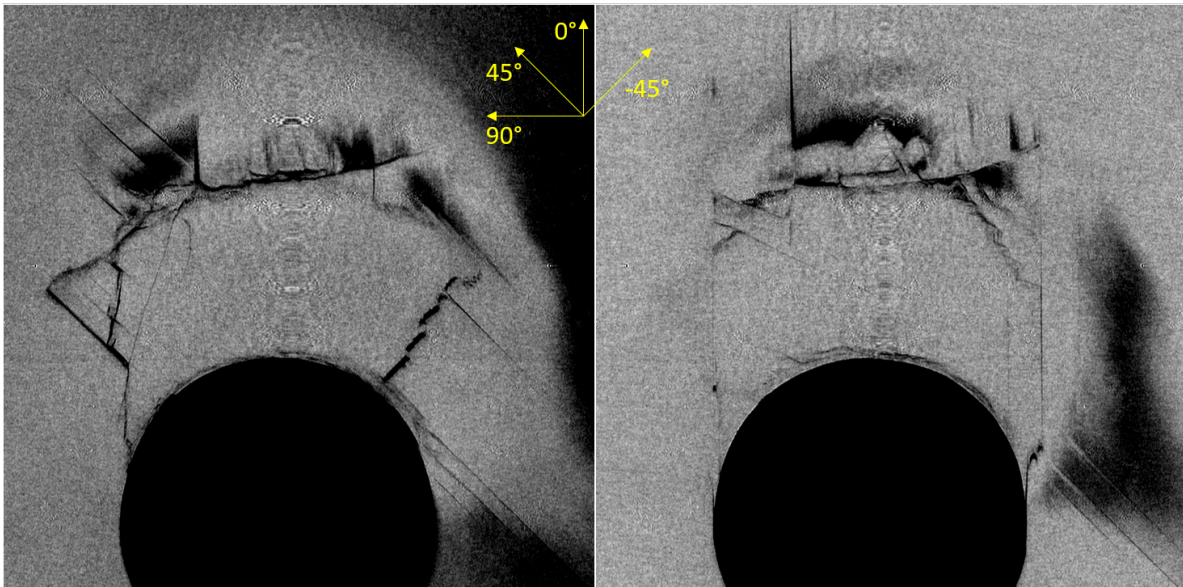
Figure 5.15: CT scan of Test 3. Left: Ply 1. Matrix cracking, fiber crushing above washer footprint, and fiber cracking top right of hole. Right: Ply 2. Matrix cracking tangent to hole and fiber crushing above washer footprint.

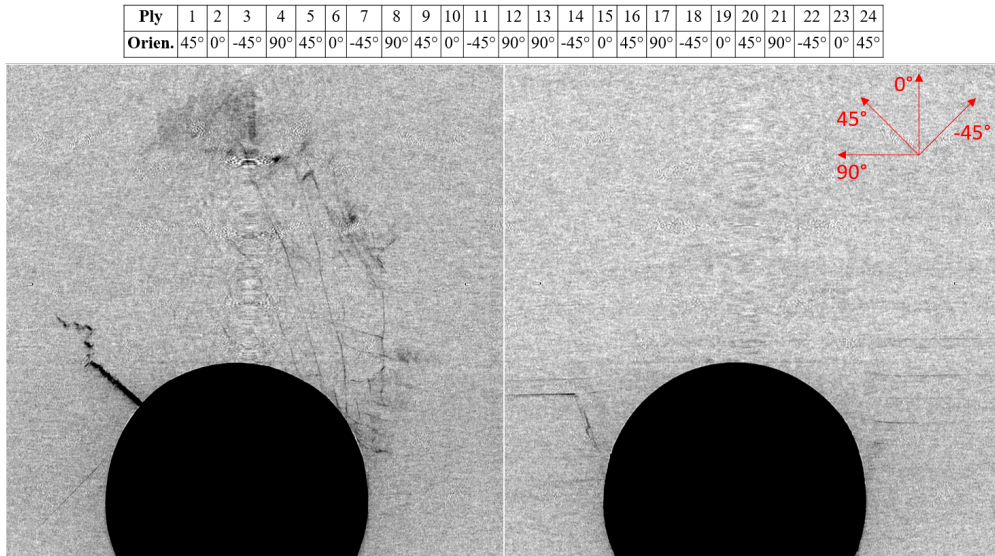
Figure 5.16: CT scan of Test 3. Left: Ply 7. Fiber cracking (top left). Right: Plies 12 and 13, center of laminate. Matrix cracking to left and right of hole.

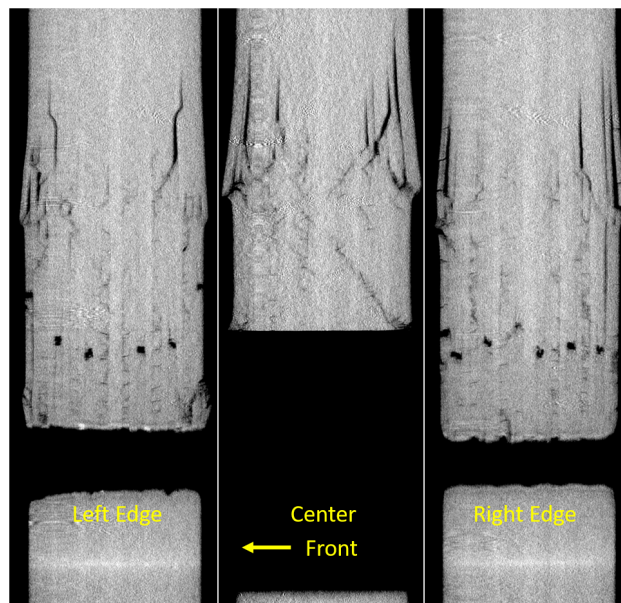
Figure 5.17: CT scan of Test 3. Side slices, loading direction: up. Delamination occurring outside of washer footprint.

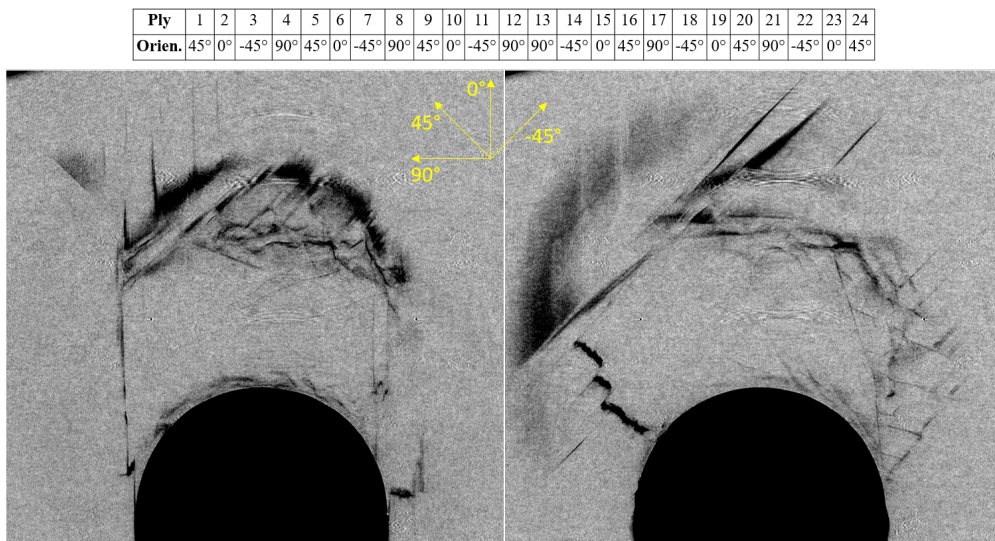
Figure 5.21: CT scan of Test 3. Left: Ply 2. Matrix cracking tangent to hole and fiber crushing above washer footprint. Small amount of fiber cracking to right of hole. Right: Ply 3. Matrix cracking, fiber crushing above washer footprint, fiber cracking to top left of hole.

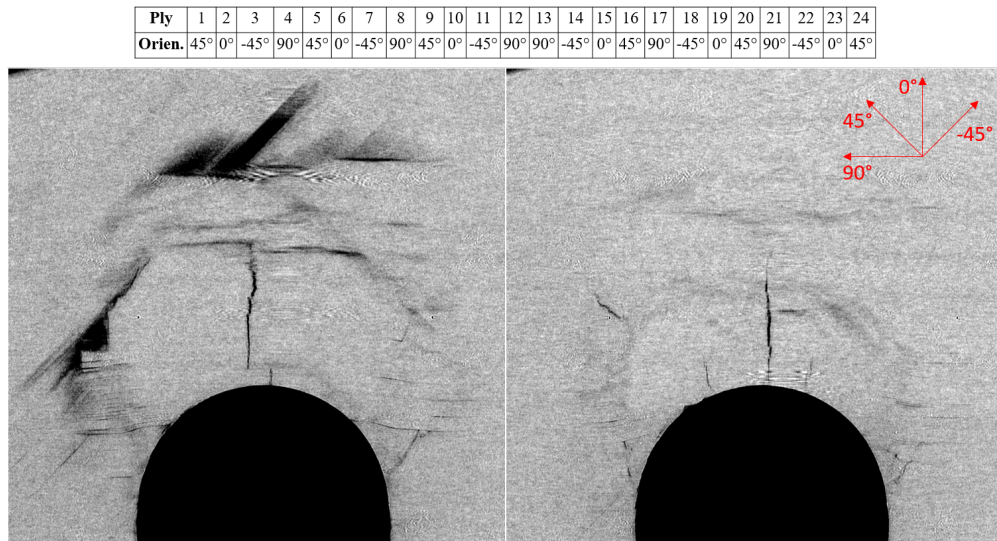
Figure 5.22: CT scan of Test 3. Left: Ply 4. Right: Ply 8. Fiber bridging to left and right of hole, fiber cracking in center for both plies. Features more apparent in ply 4.

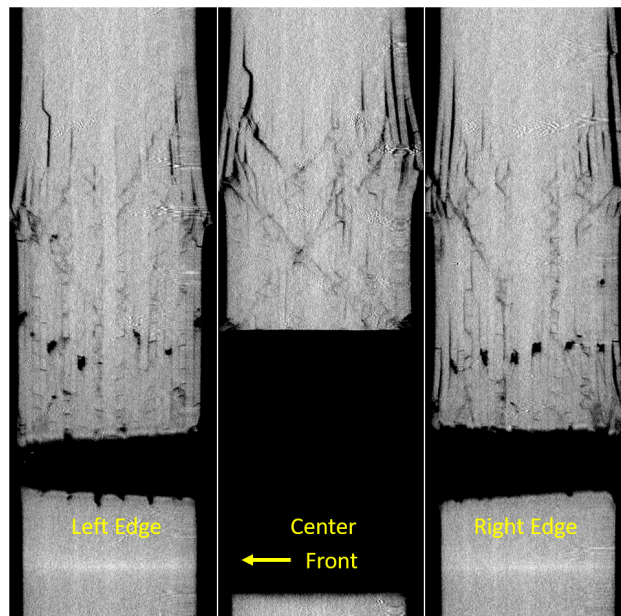
Figure 5.23: CT scan of Test 3. Side slices, loading direction: up. Delamination occurring outside of washer footprint.

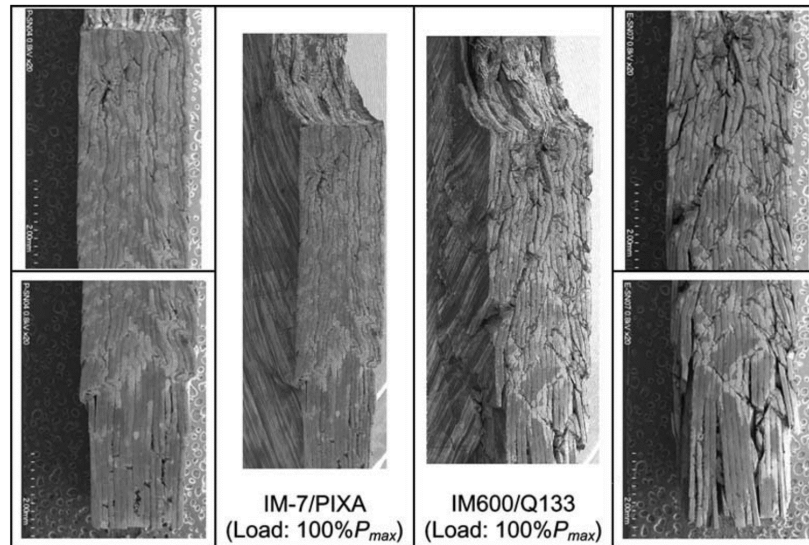
Fig. 10. SEM photographs of through-thickness bearing damage, tested at 100% of maximum load.

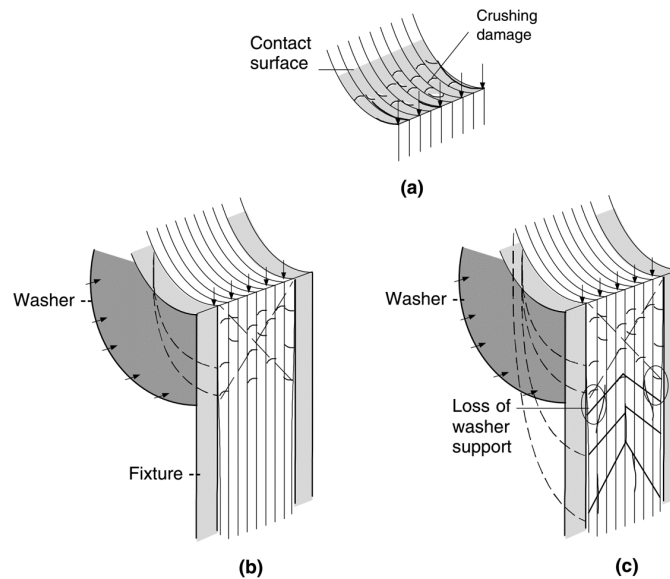
Fig. 11. Schematic descriptions of the bearing failure mechanisms: (a) crushing damage; (b) damage within lateral constraint (inside-washer region); (c) damage without lateral constraint (outside-washer region).

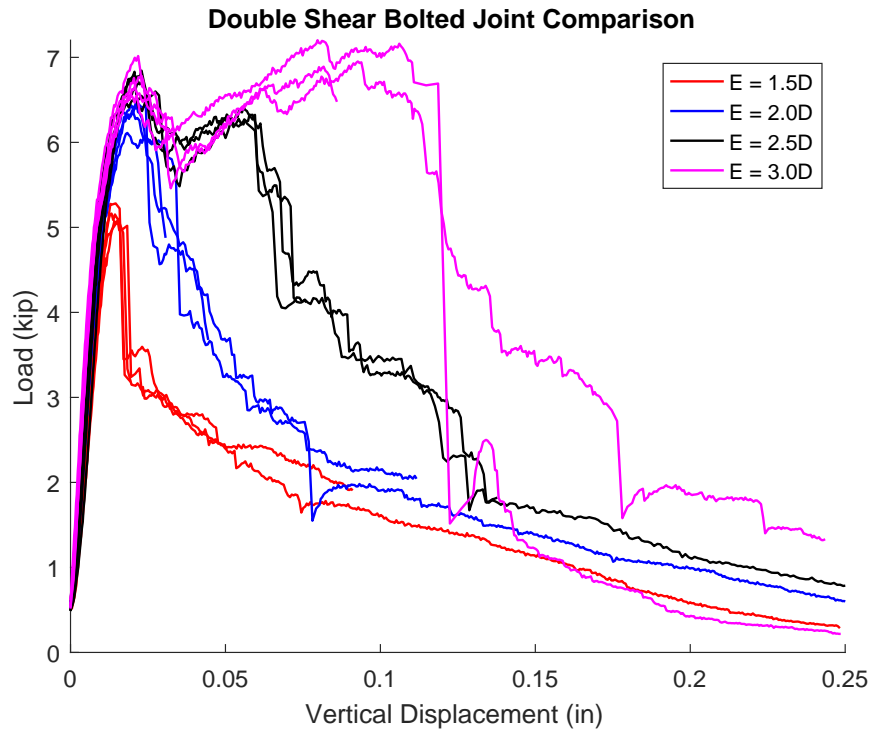
Figure 5.26: Comparison of eccentricity in Double Shear Bolted Joint tests. Full extent of data shown.
