Pedestrian Safety Implications on the Lack of Sidewalks Along Aurora Ave N in Seattle,
Washington

A thesis

Masters in Urban Design & Planning

University of Washington

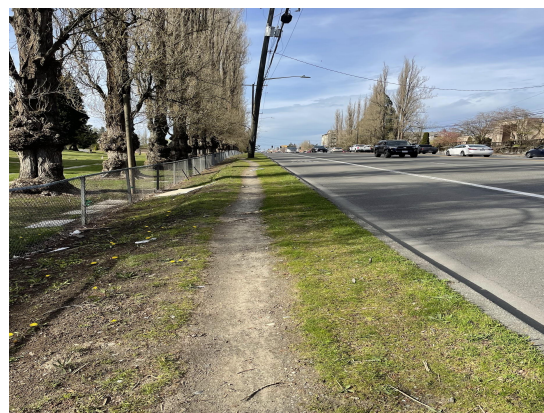
Figure 3.1A Aurora Ave looking north on 115Th showing desired paths

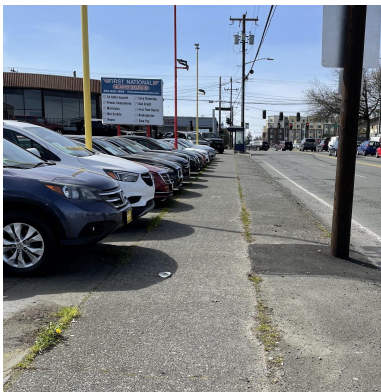
Figure 3.1B 130th showing no clear separation between private and public pedestrian spaces

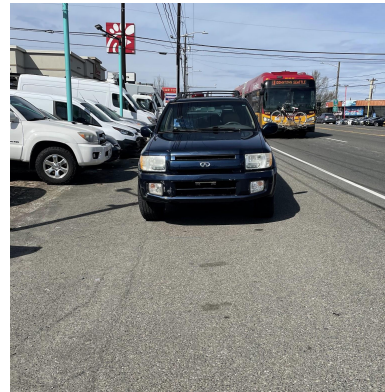
Figure 3.1C Aurora Ave facing 130th, vehicle parked along the available walk space

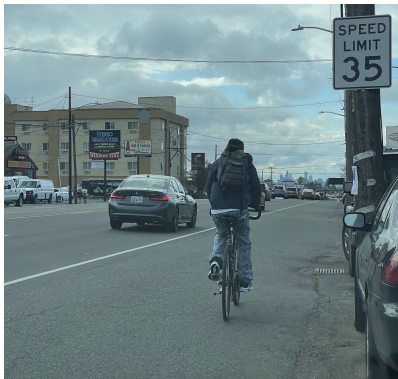
Figure 3.1D Showing Aurora Ave facing south towards 130th with cyclist in walkway

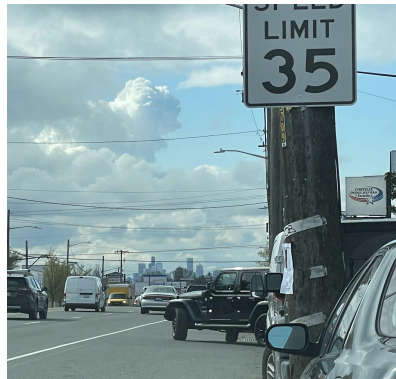
Figure 3.1E Vehicle using the walkway as a turning lane

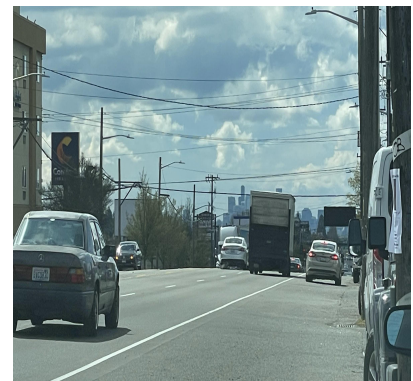
Figure 3.1F Vehicle using the walking as a parking lane

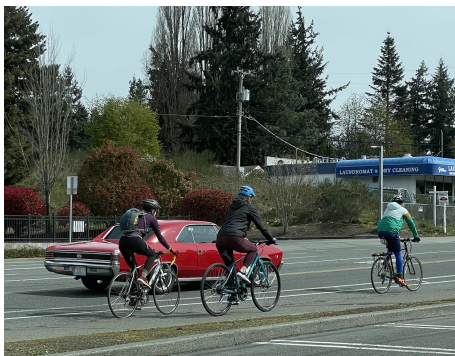
Figure 3.1G Intersection of Aurora Ave & 155th / bike lanes

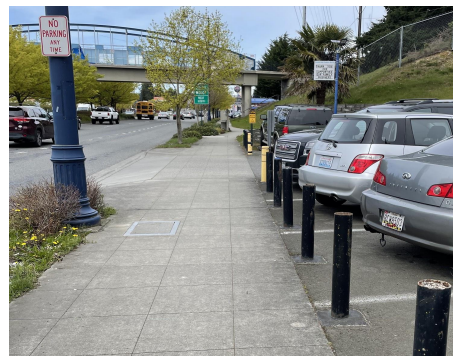
Figure 3.1H Aurora Ave north of 155th / clear separation between private and public walking spaces

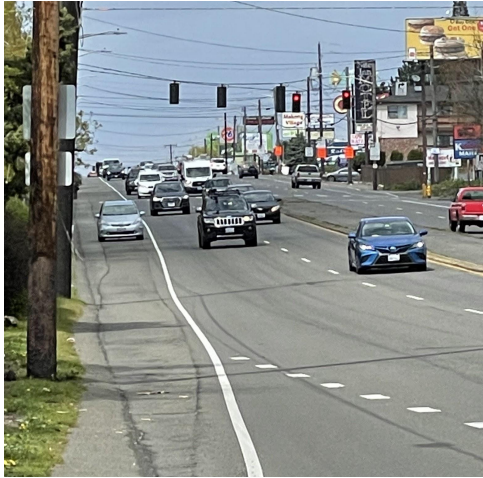
115TH was chosen as a site to observe differences in how pedestrians interacted in a less busy part of Aurora Ave. A cemetery surrounds Aurora Ave on both sides and south of 115TH. North of 115TH only the western side has a cemetery. On the eastern portion of Aurora Ave are apartment complexes and a Home Depot. Safety considerations in this area include the lack of sidewalks on the western side of Aurora Ave. Pedestrians here were seen walking on desired paths parallel to the cemetery. However, north of 115TH pedestrians are forced to walk alongside the traffic. In some cases, having to walk close to traffic as parked vehicles or moving vehicles along the shoulder (only area for pedestrians to walk) created obstructions. Figure 3.2

Figure 3.2 Aurora Ave N looking North on 115th vehicle on walkway

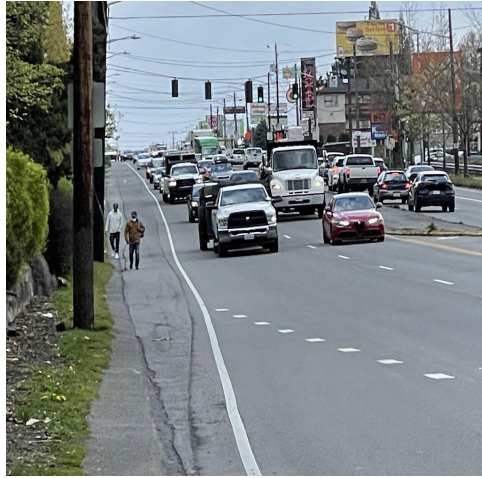
Figure 3.3 Aurora Ave N looking North on 115th showing pedestrian on walkway
