A Failure Analysis Case Study of the Fluid- Structural Interactions on Trashracks

Rock Island Dam, Powerhouse 1: Units B5-B10

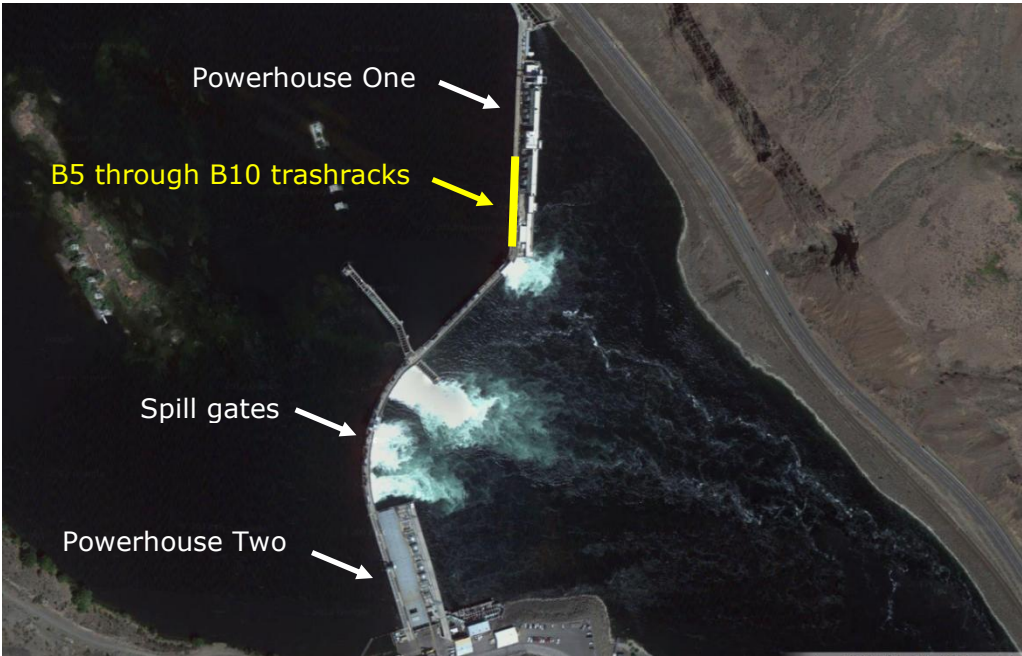
Figure 1: Plan view of Rock Island Dam. The location of the trashracks is identified by the yellow line.

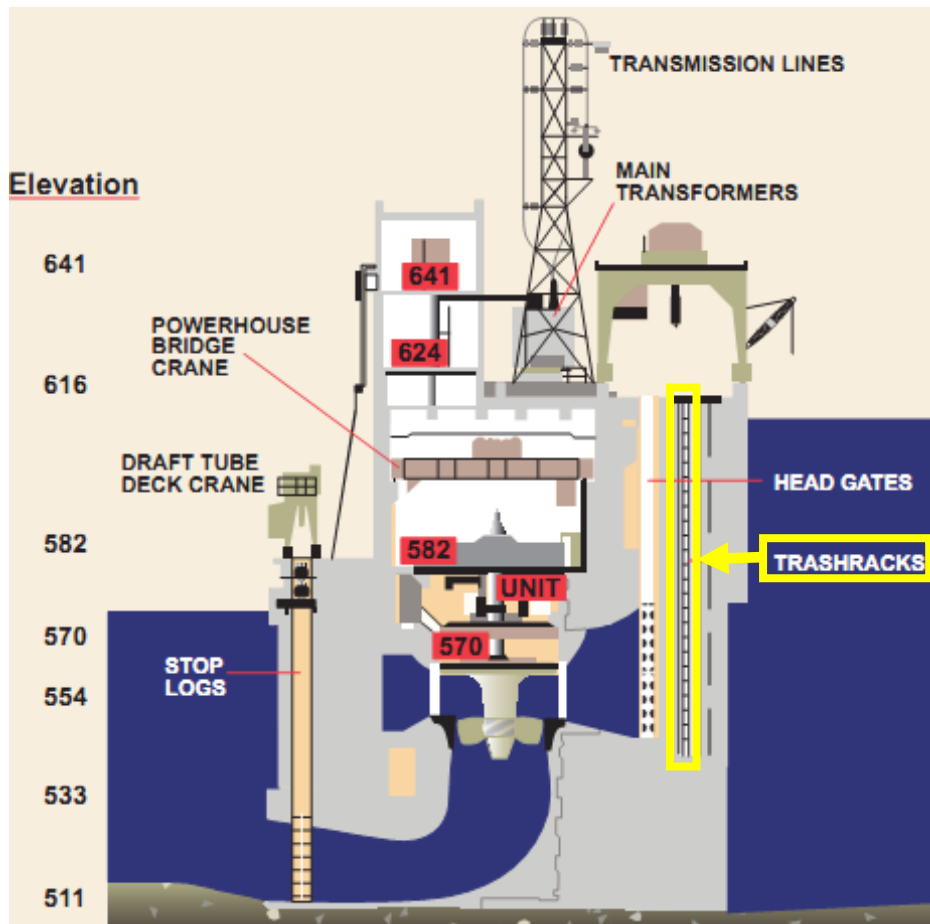
Figure 2: Plan view of Powerhouse One at Rock Island Dam. The trashracks are identified by the yellow box.

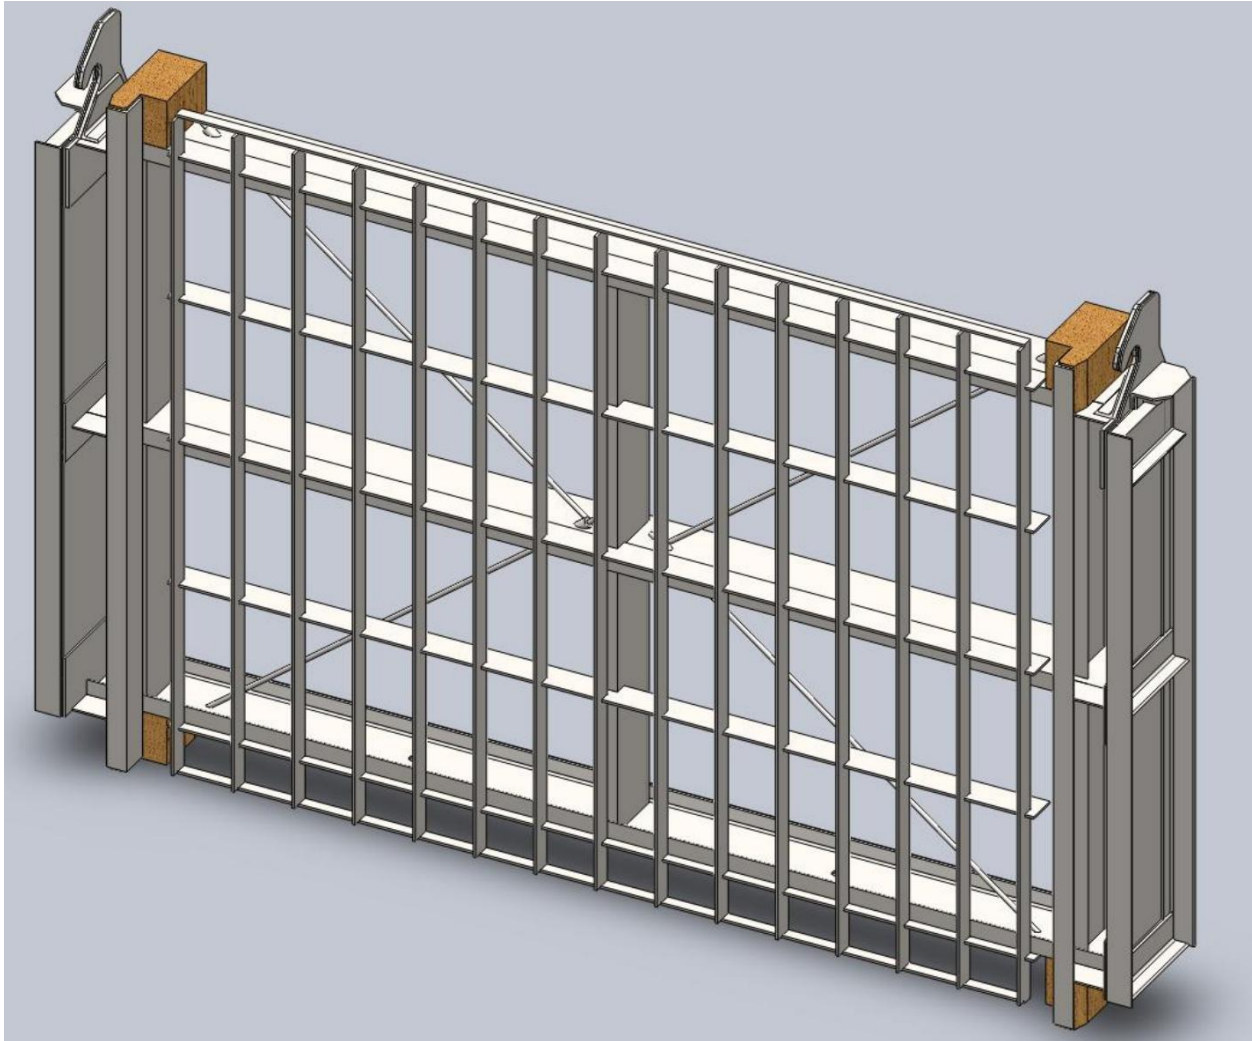
Figure 3: Computer model of the original B5 through B10 trashracks.

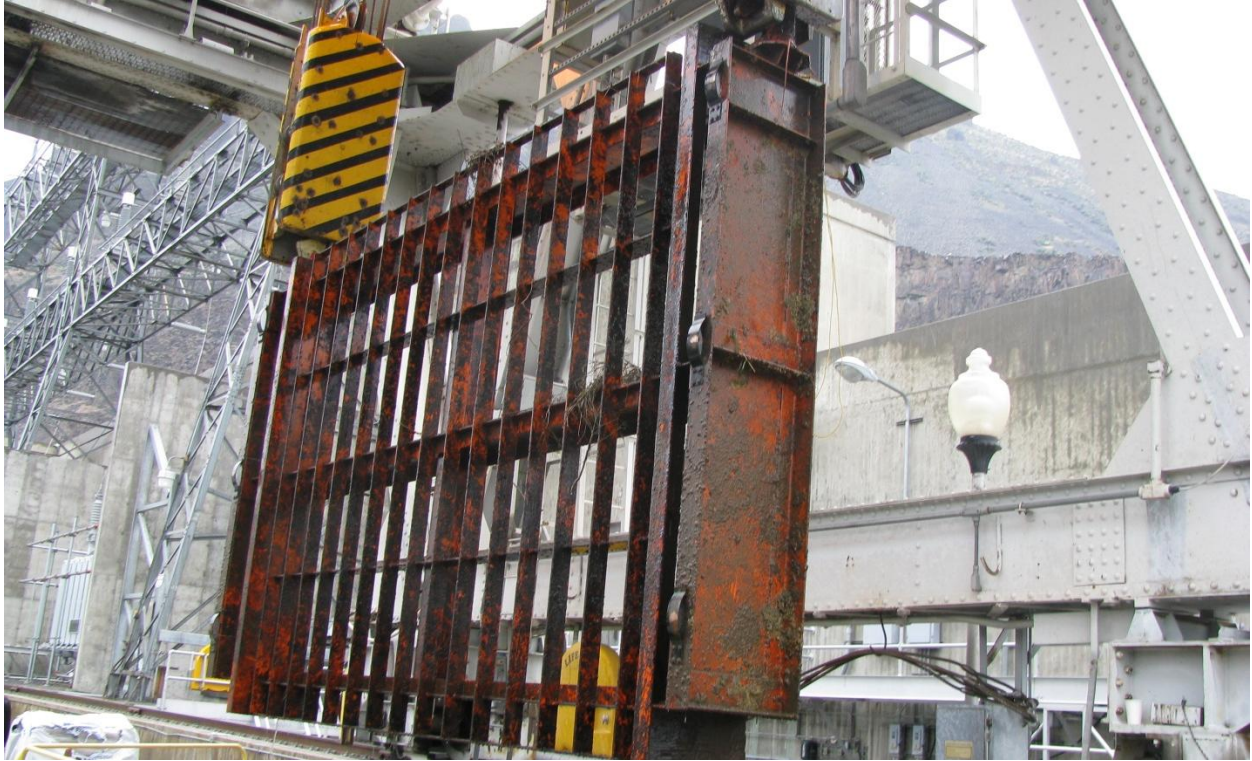
Figure 4: Steel framed trashrack with vertical steel rackbars.

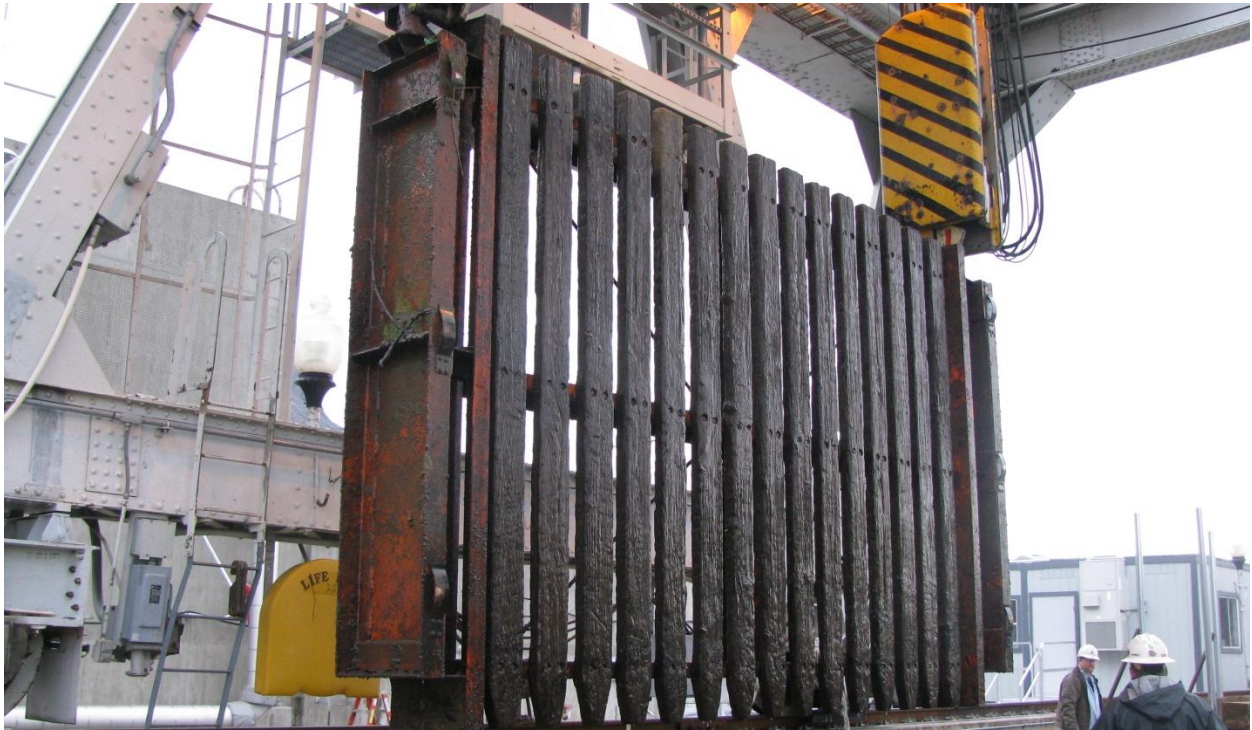
Figure 5: Steel framed trashrack with vertical wood rackbars.

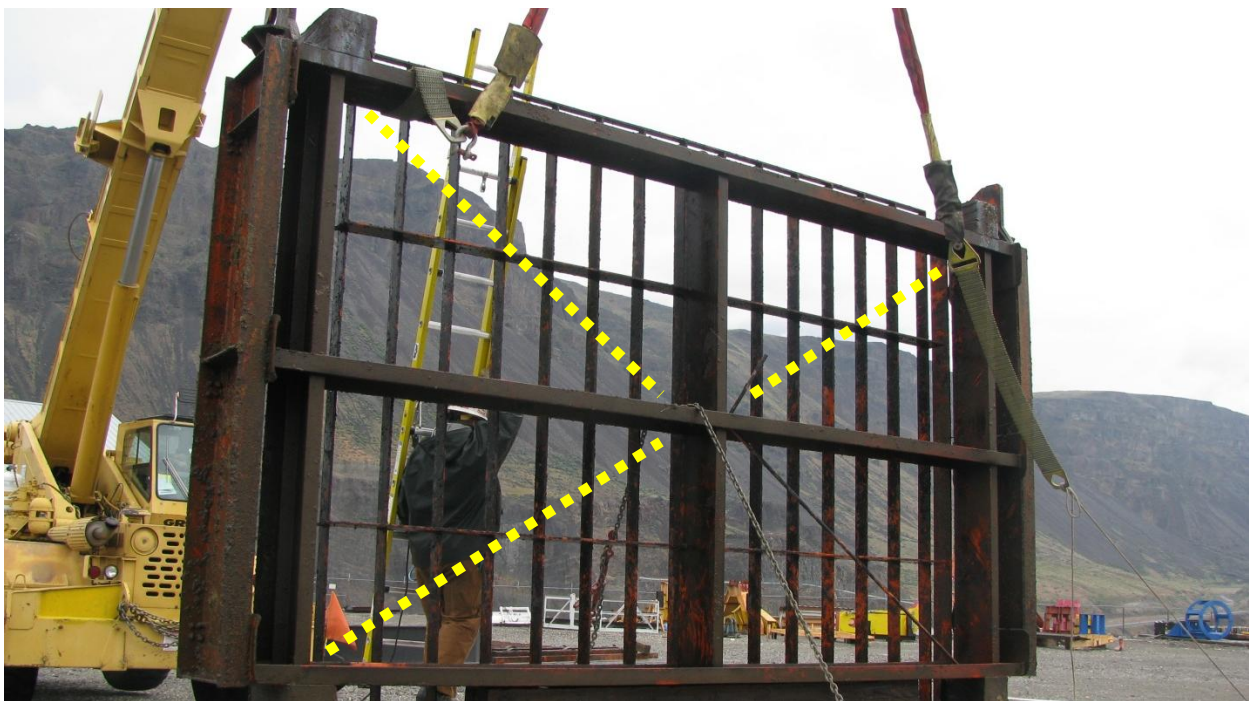
Figure 6: Each trashrack should have four diagonal tie rods to provide stability when moving the 7,000 pound structures. This picture is an example of one rack which is missing three of the tie rods (locations identified in yellow) and the one remaining rod was very loose.

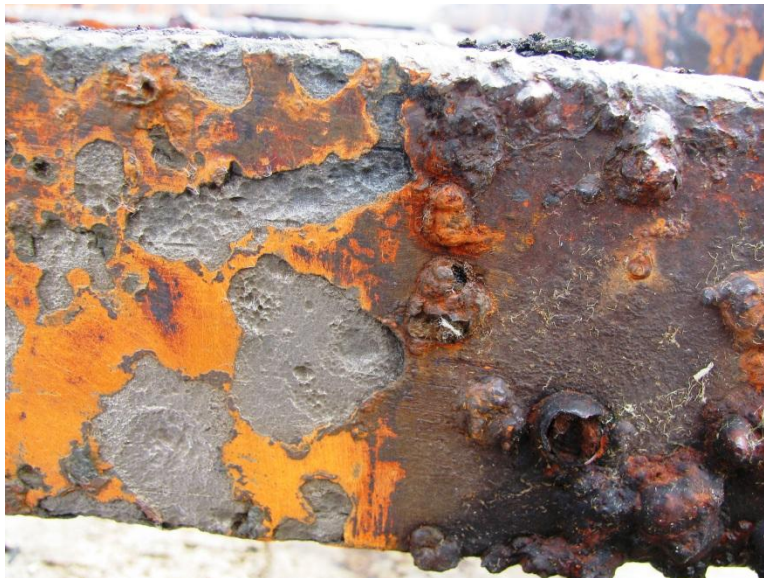
Figure 7: This picture shows a common instance of tubercles as found on the trashracks (right) and the pits which had formed under the tubercles (left).

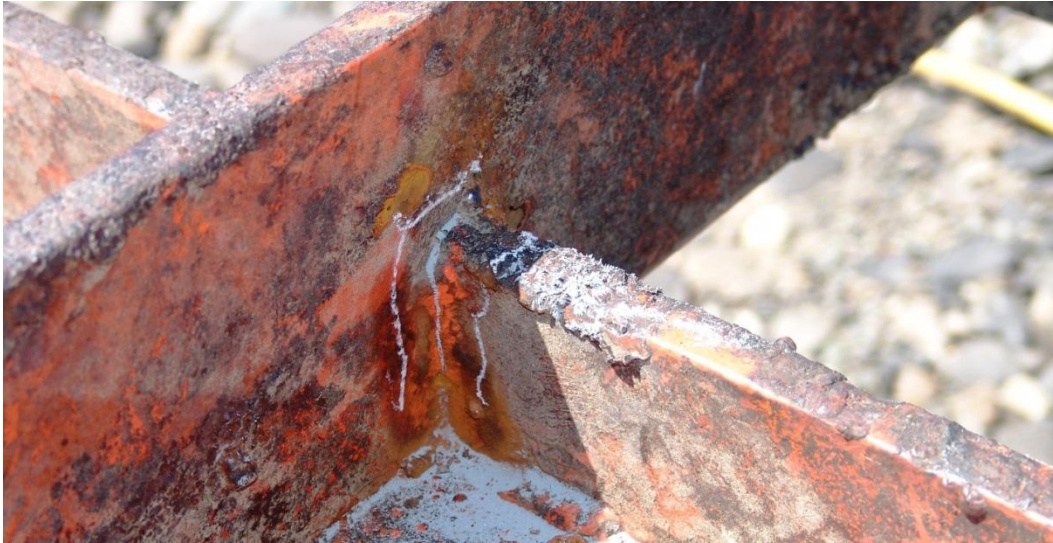
Figure 8: The first round of magnetic particle testing was performed through the paint. The grey powder serves as a strong indication that there is a crack in the weld. This proved to be true after grinding into the weld.

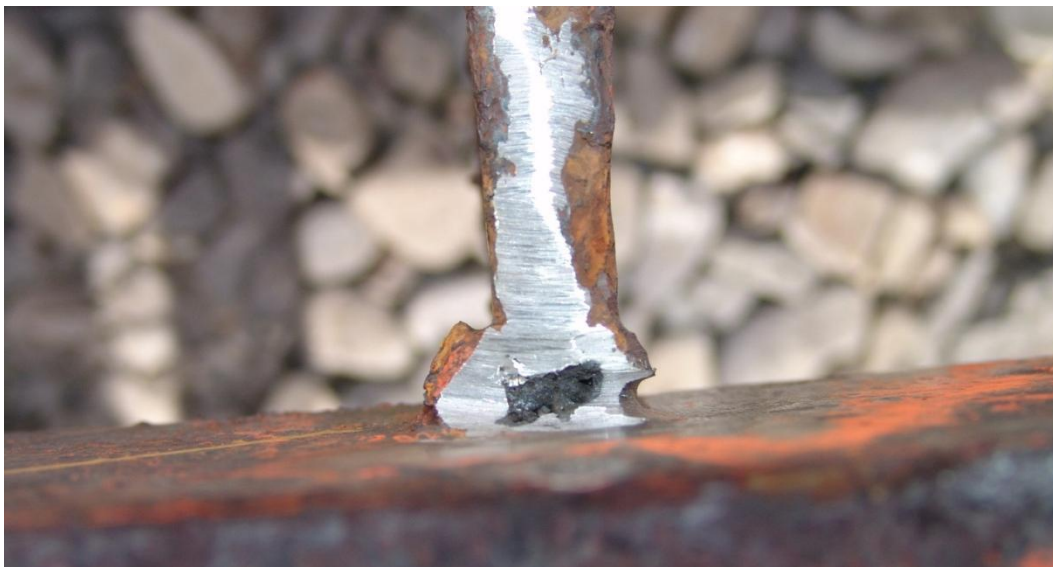
Figure 9: Here is an example of one of the inclusions discovered in the welds. Inclusions are major stress risers in the welds.

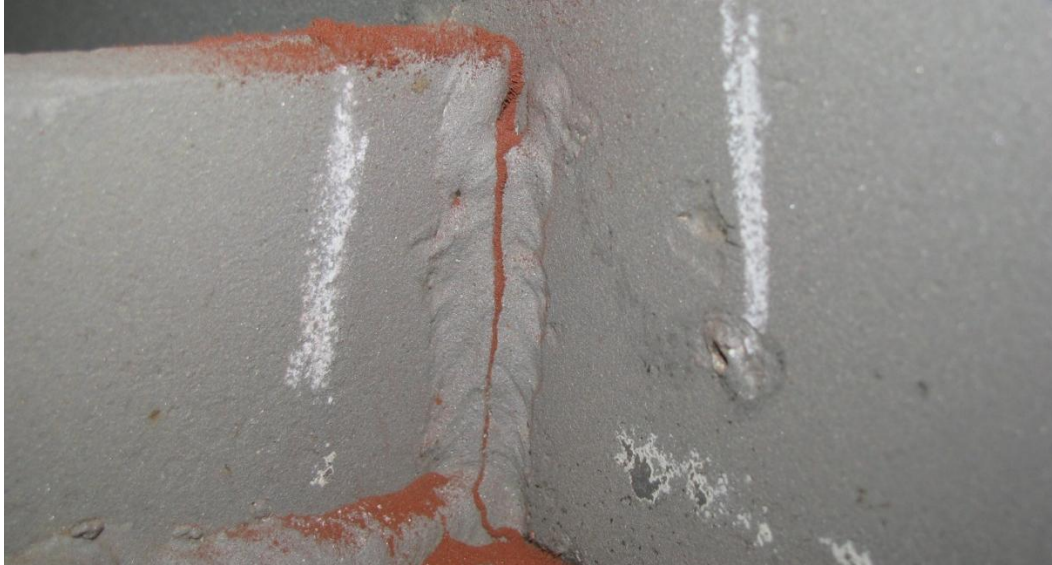
Figure 10: Magnetic particle testing was performed a second time after the trashracks were sandblasted. Red powder was used here to identify the crack.

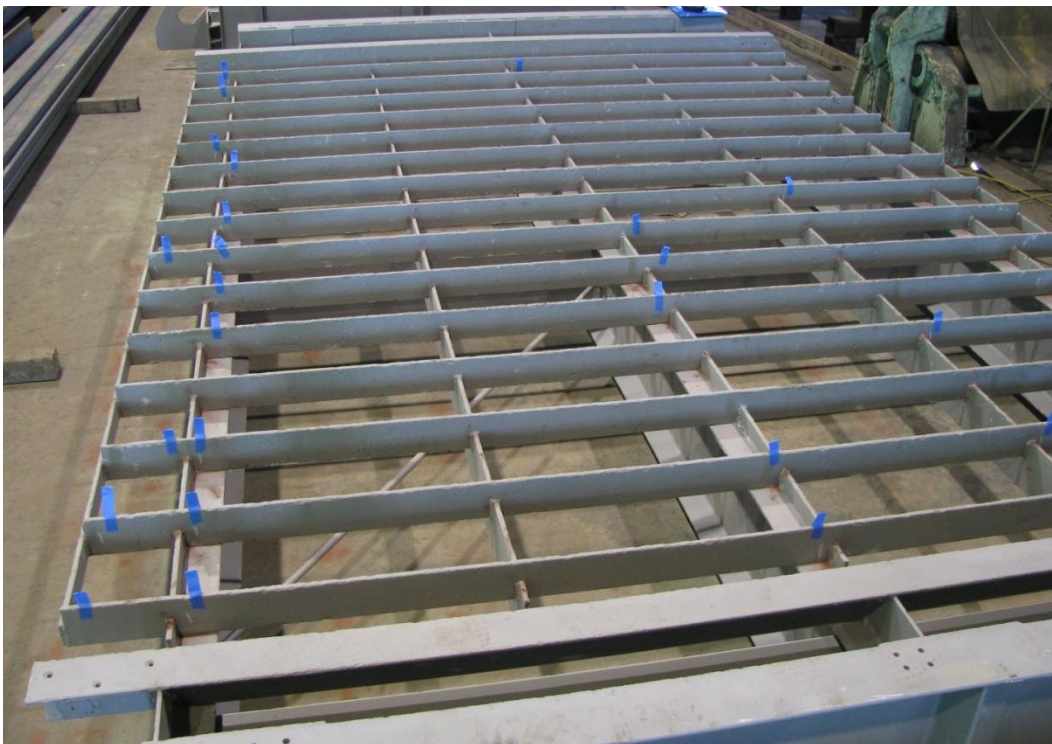
Figure 11: The steel trashracks are grey after sandblasting. This operation removes all the paint which exposes the structure for a thorough investigation and prepares it for painting. The blue tape was used to identify cracks.

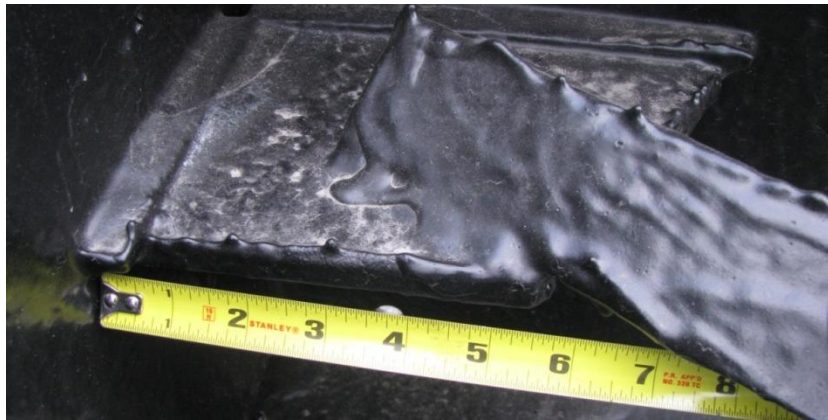
Figure 12: The protective layer of paint was applied unevenly and dripped in many locations. This was likely do to a rushed application process which resulted in uneven layers and was accentuated by the fact that it was applied at an improper ambient temperature.

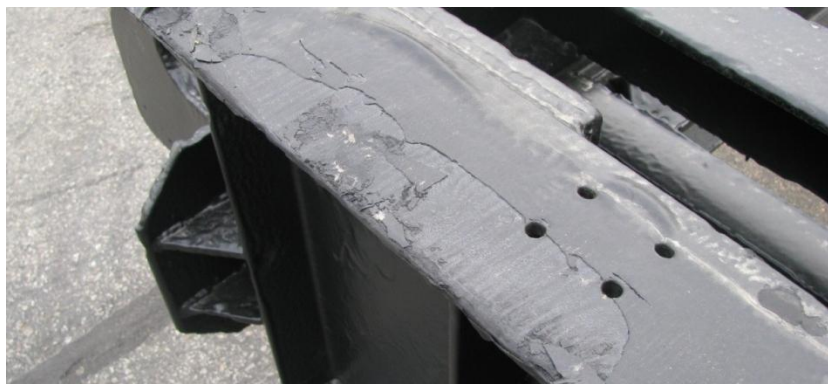
Figure 13: The new paint job was peeling along the guide bars before the trashracks entered the water. This was likely caused by the fabricators stacking the trashracks before the paint was fully cured.

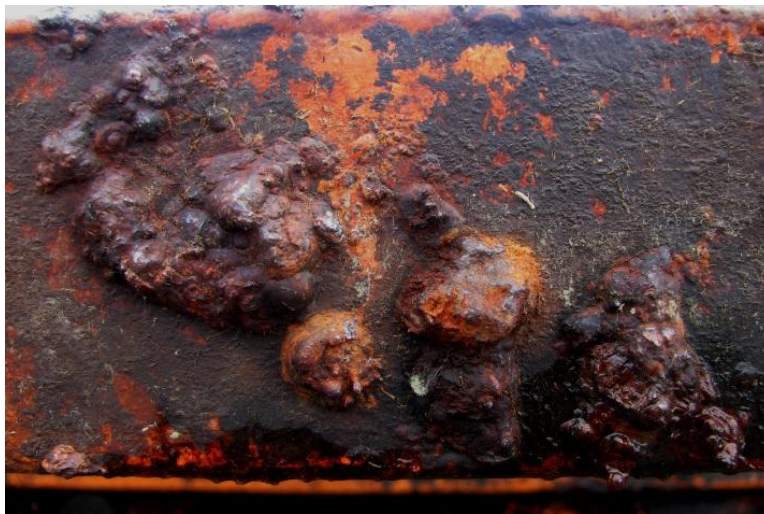
Figure 16: A grouping of individual tubercles.

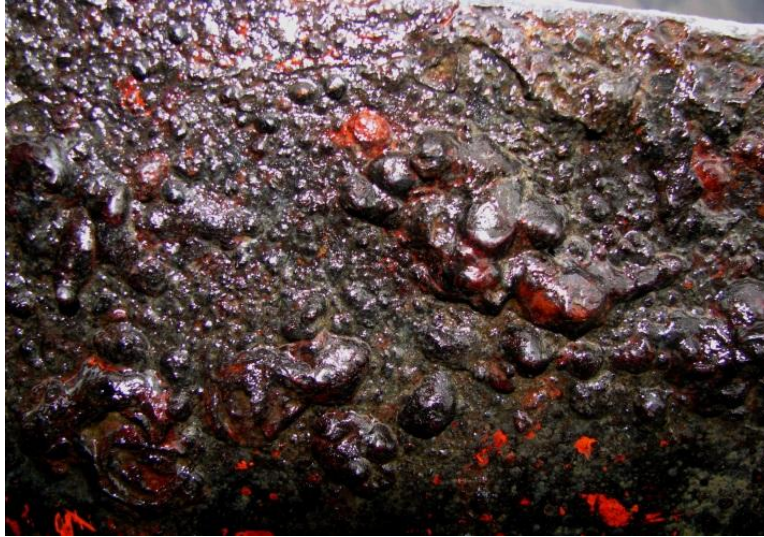
Figure 17: Widespread growth of tubercles.

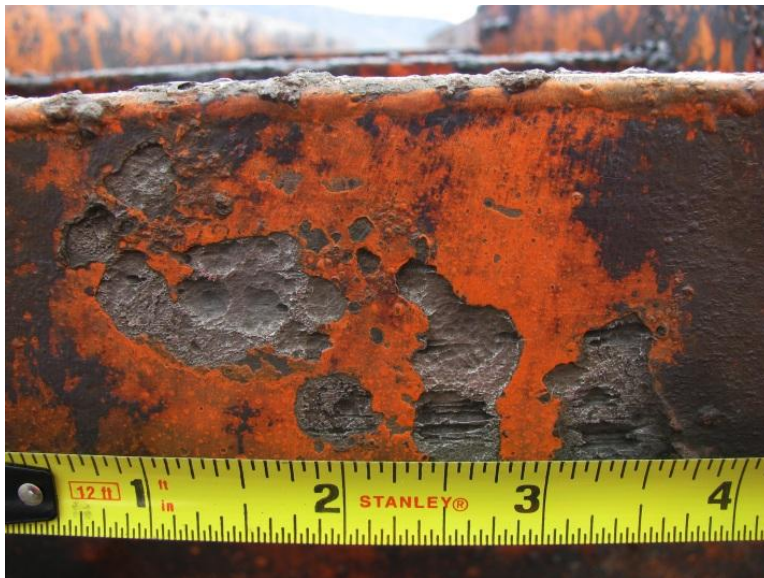
Figure 18: Corrosion damage under a few individual tubercles.

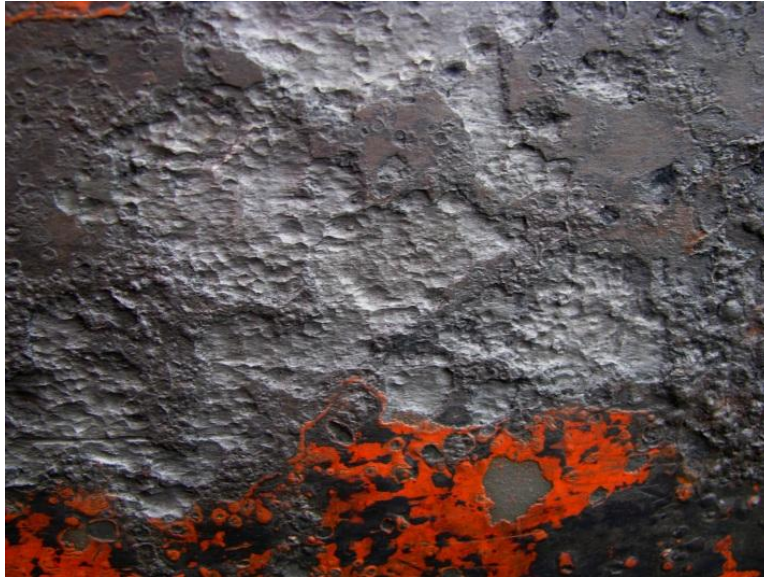
Figure 19: Corrosion damage under a surface covered with tubercles.

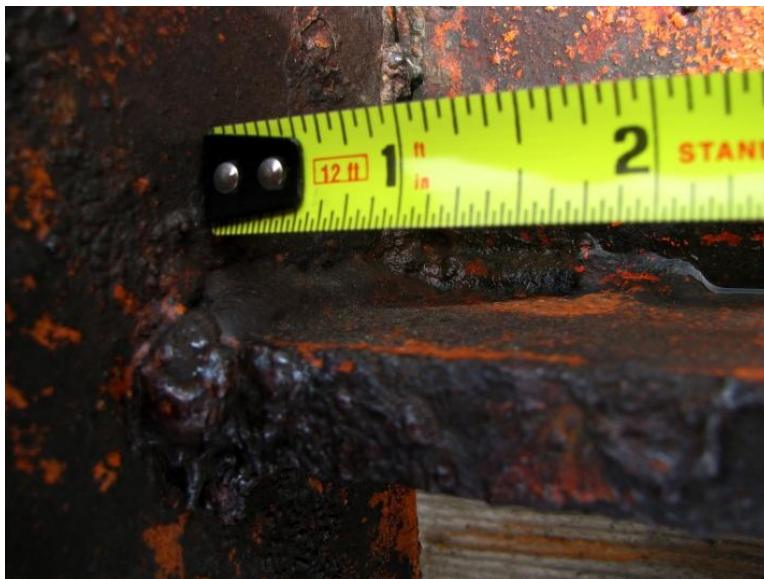
Figure 20: Corrosion deposits along a welded joint.

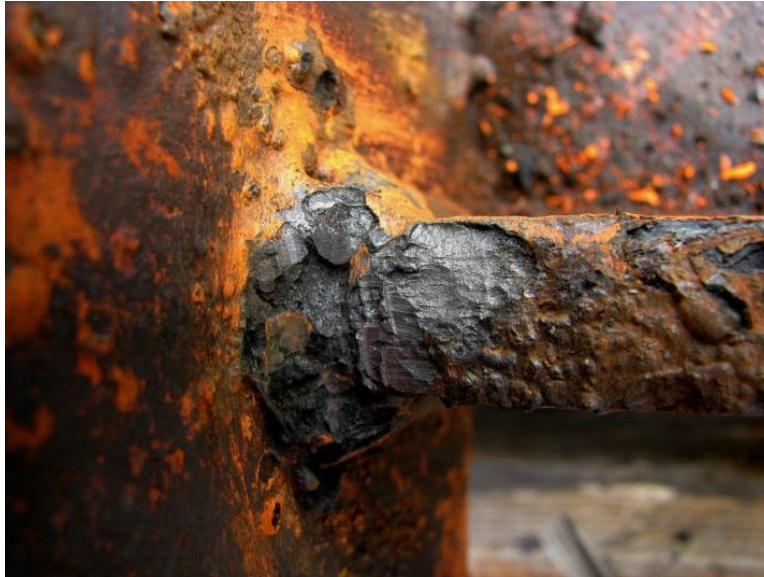
Figure 21: Corrosion damage after the tubercles have been removed from the weld.

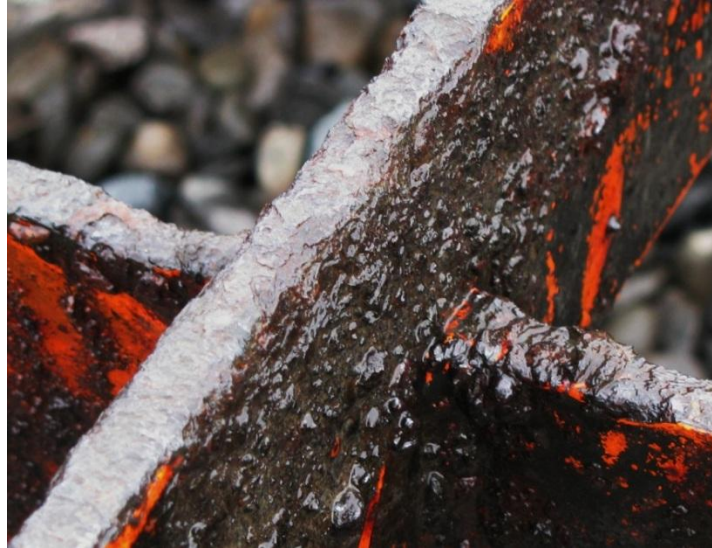
Figure 22: Erosion corrosion damage of leading edge.

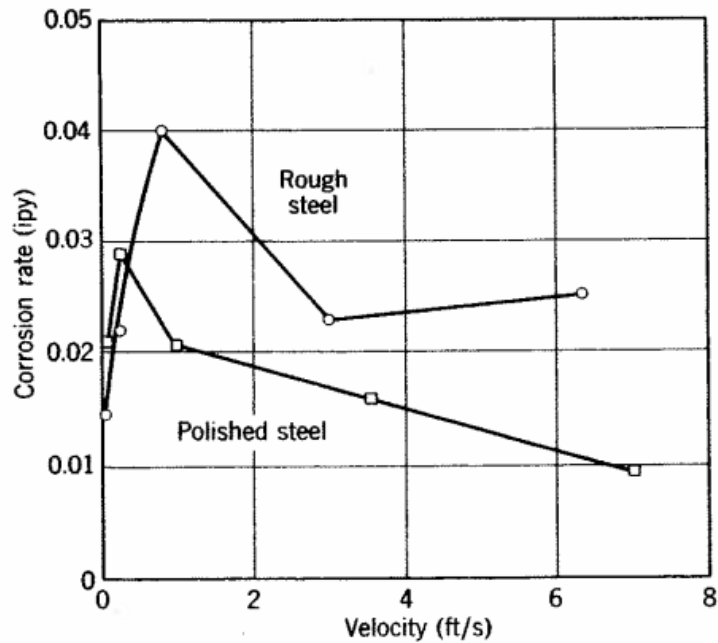
Figure 23: Corrosion rate versus velocity for steel in fresh water.

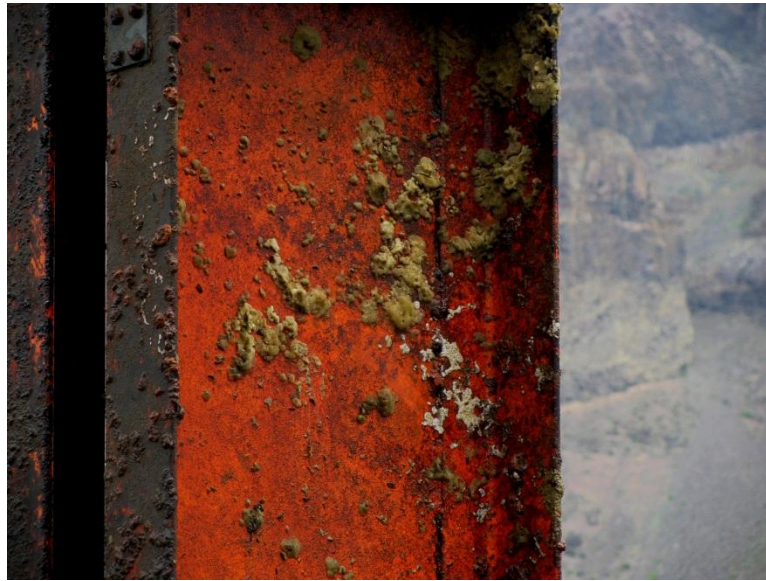
Figure 24: Example of biological growth.

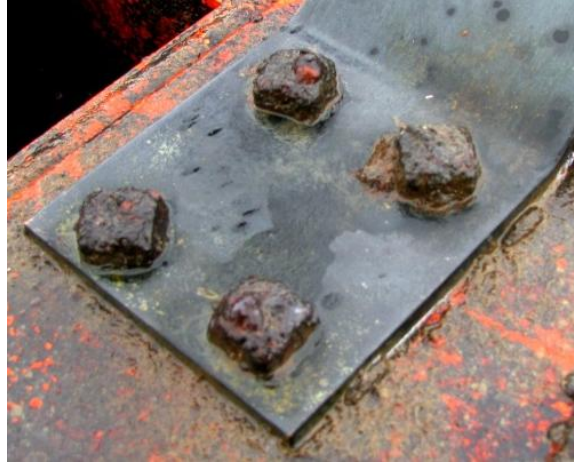
Figure 25: Galvanic corrosion due to coupling of steel bolt to the bronze spring.

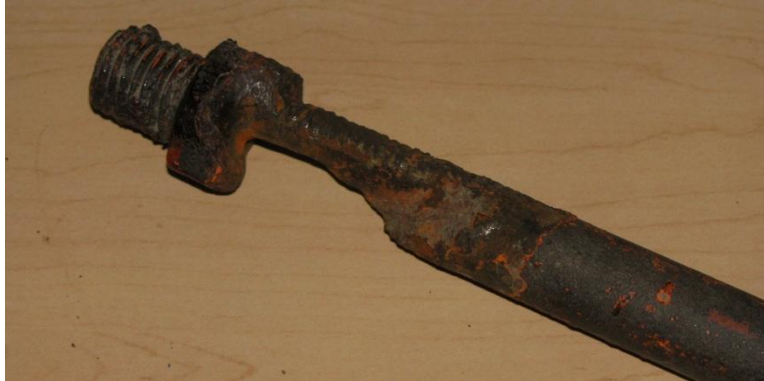
Figure 26: Fretting corrosion evident on the steel tie rod.

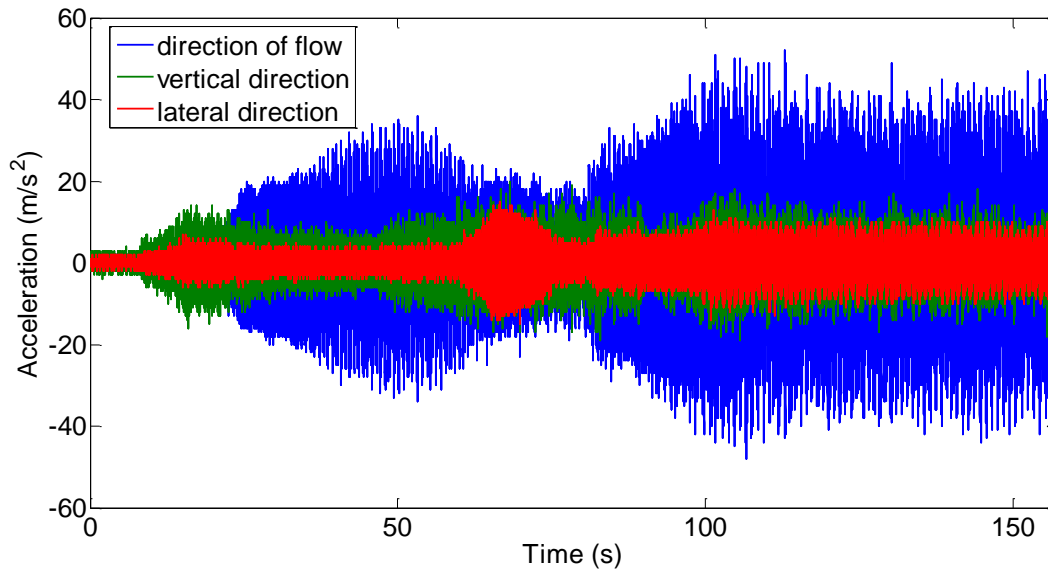
Figure 27: General response of the accelerometer during a sweep in flow rate through the trashrack. Vibrations are plotted in the direction of flow, in the lateral direction, and in the vertical direction.

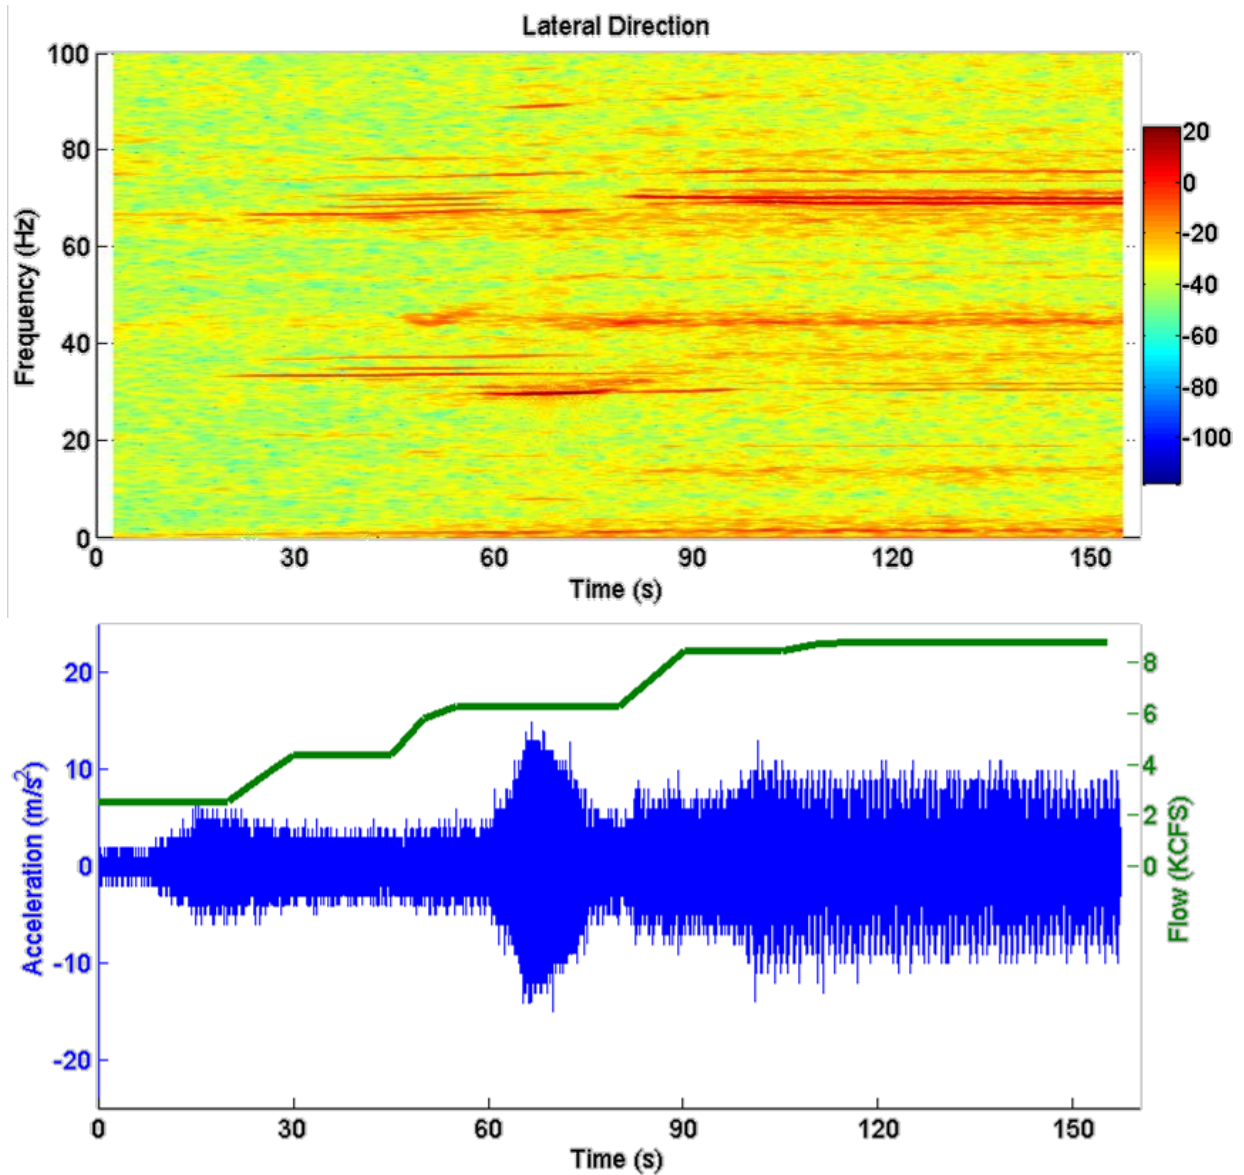
Figure 29: Trashrack vibration response in the lateral direction. The spectrogram plot on the top highlights the dominant frequencies while the bottom plot provides the general response of the accelerometer and the corresponding flow rate. Spectrogram data is presented in decibels and is normalized according to the color bar on the right.

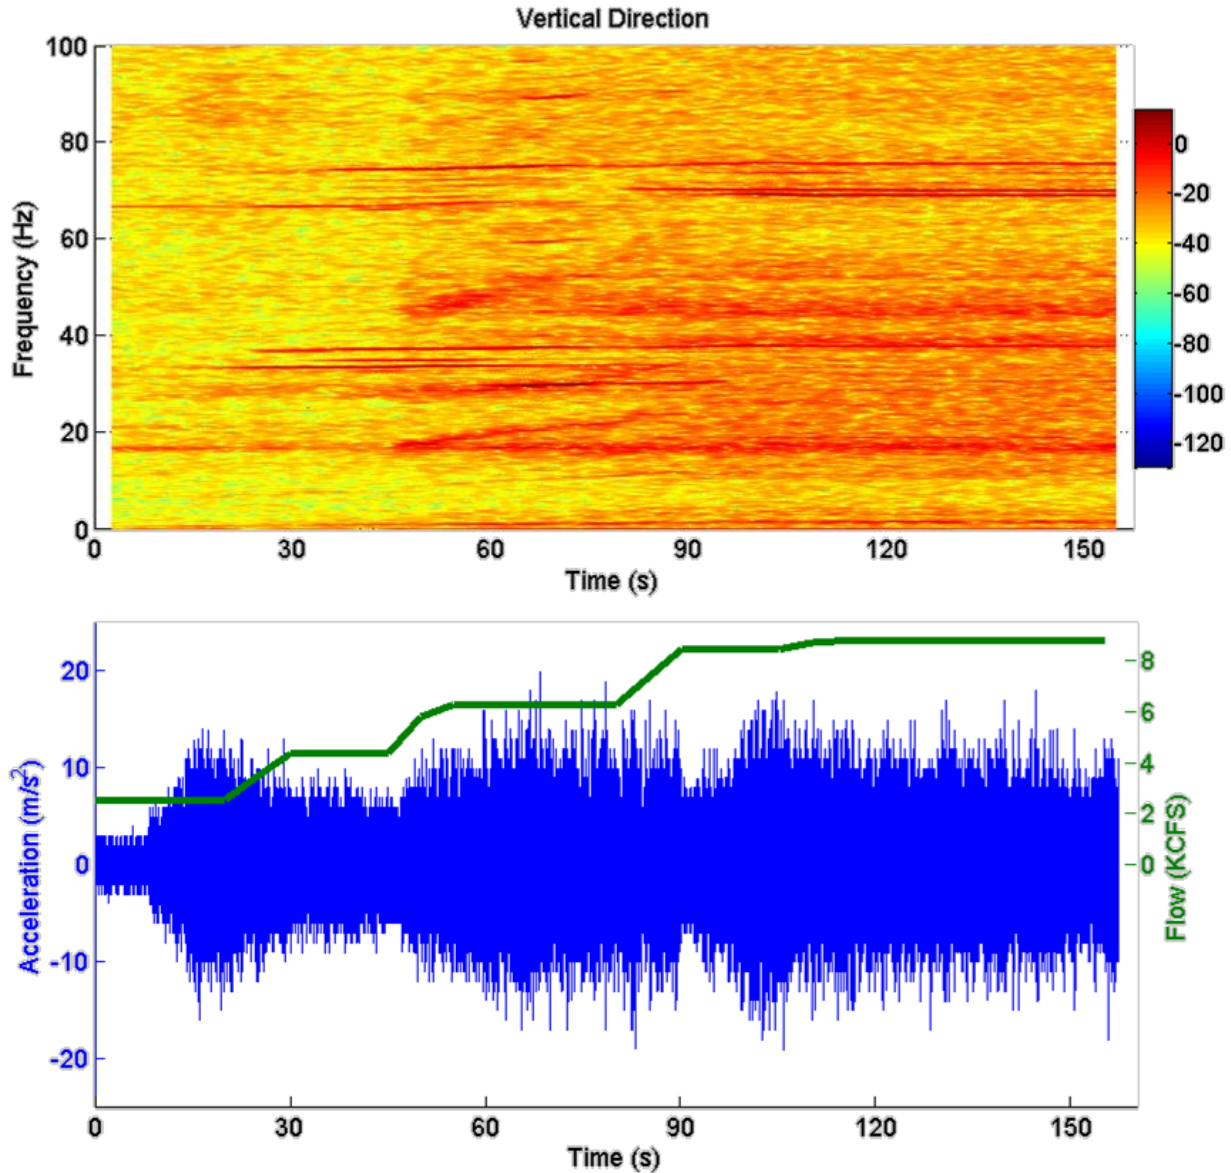
Figure 30: Trashrack vibration response in the vertical direction. The spectrogram plot on the top highlights the dominant frequencies while the bottom plot provides the general response of the accelerometer and the corresponding flow rate. Spectrogram data is presented in decibels and is normalized according to the color bar on the right.

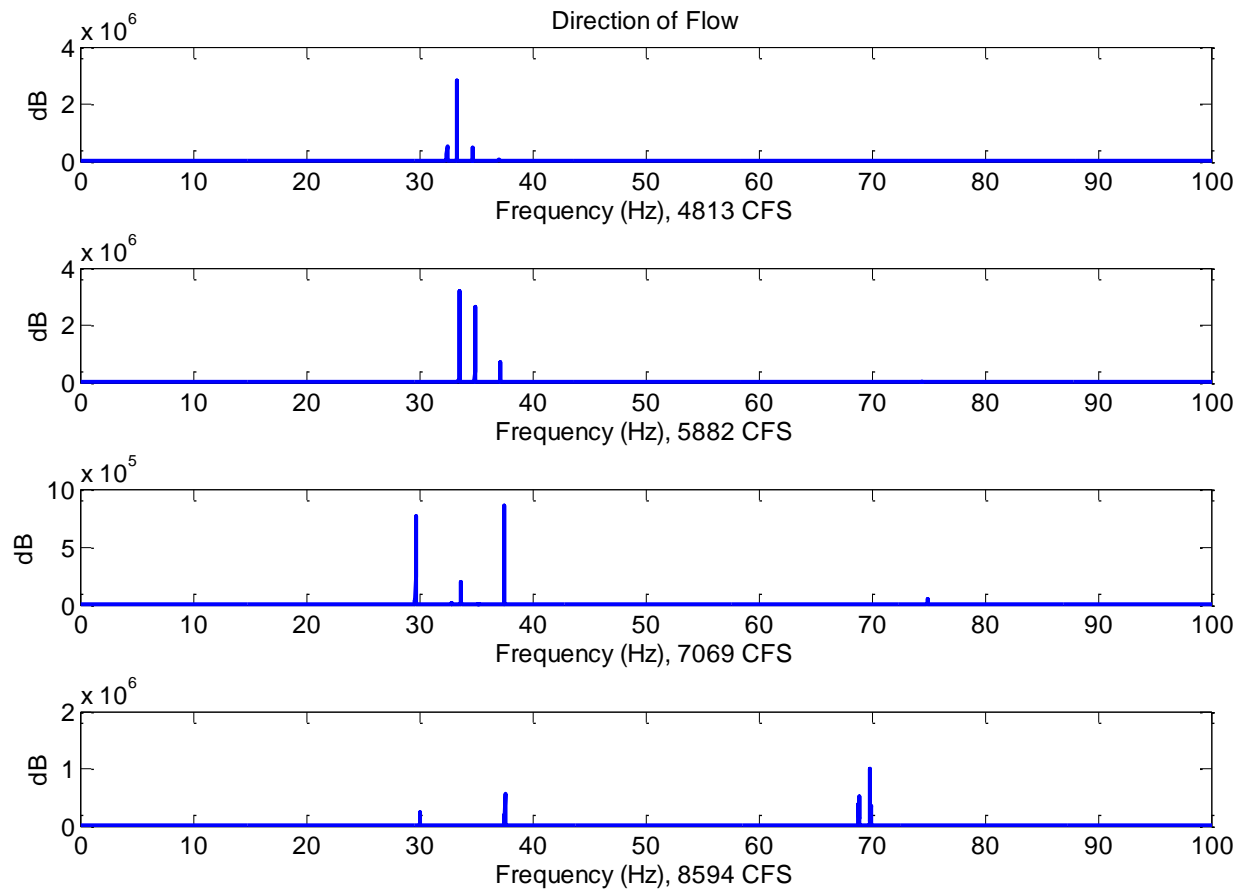
Figure 31: Steady state fast Fourier transform plots at varying flow rates. The power density spectrum for the response data is plotted in units of $(\text{m/s}^2)^2/\text{Hz}$.

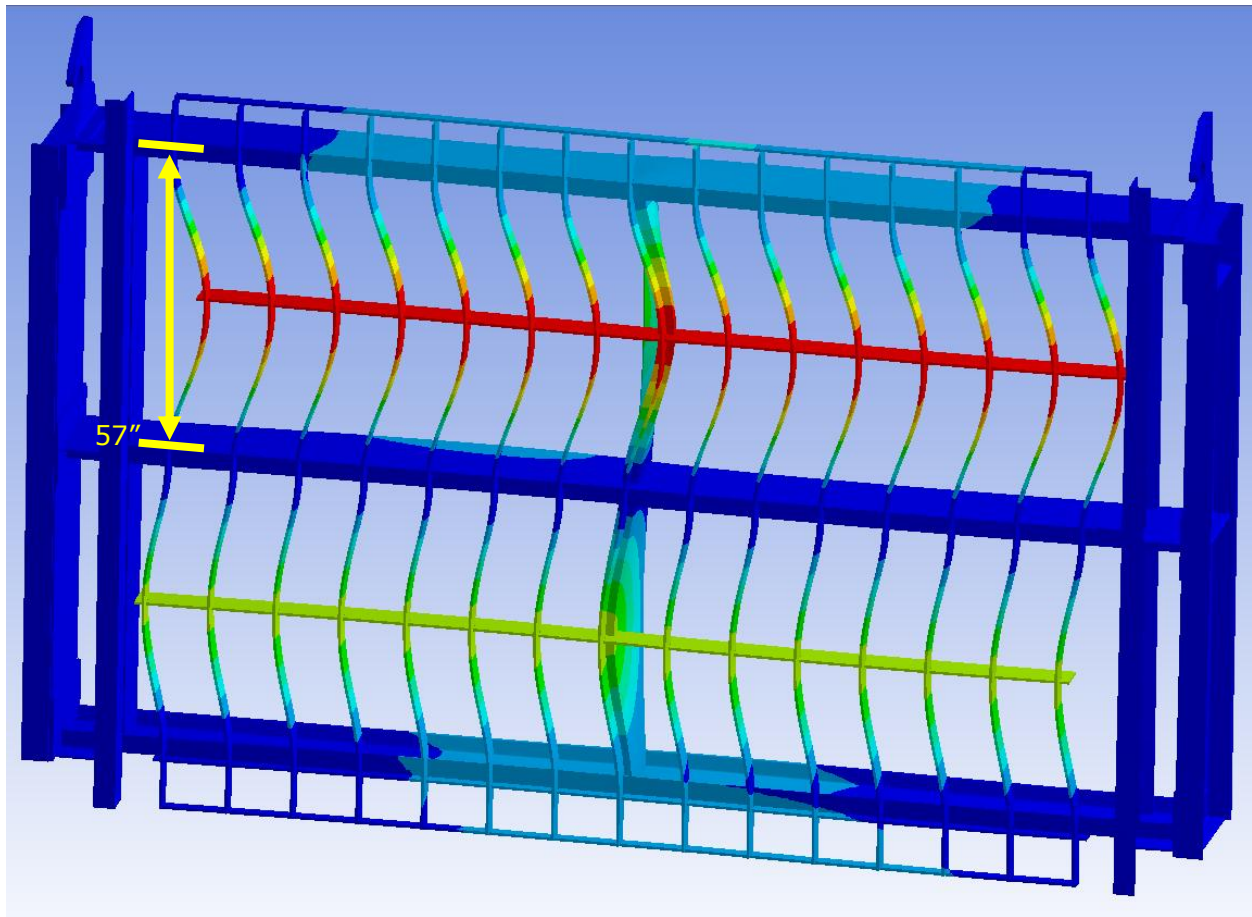
Figure 32: Finite element model vibration mode 5. This is the first resonant frequency of the 57 inch rackbars and occurs at 33.6 Hz.

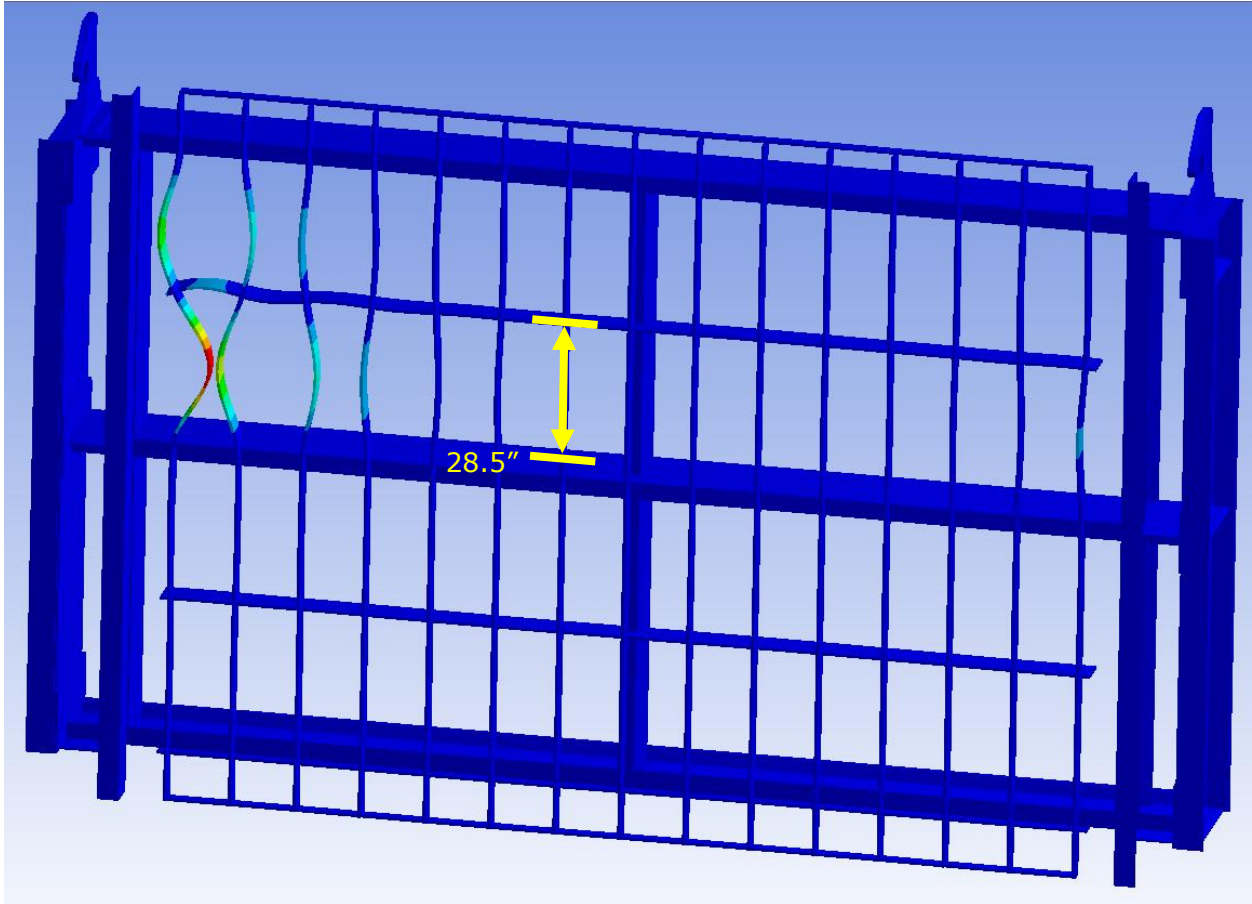
Figure 33: Finite element model vibration mode 13. This is the first resonant frequency of the 28.5 inch rackbars and occurs at 79.7 Hz.

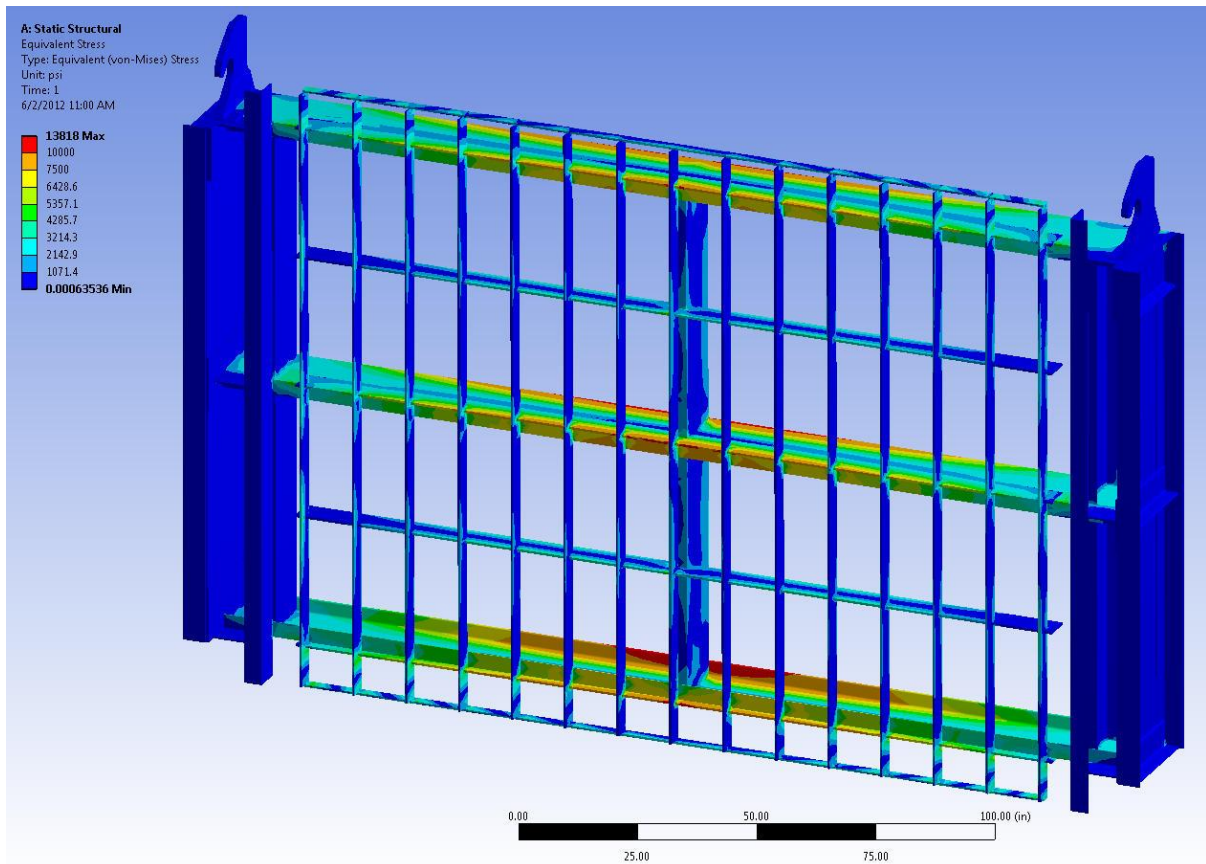
Figure 34: Front view of the trashrack modeled in ANSYS with a differential hydrostatic head of 5 feet. The maximum Von Mises stress is 13.8 ksi.
