A Failure Analysis Case Study of the Fluid- Structural Interactions on Trashracks

Rock Island Dam, Powerhouse 1: Units B5-B10

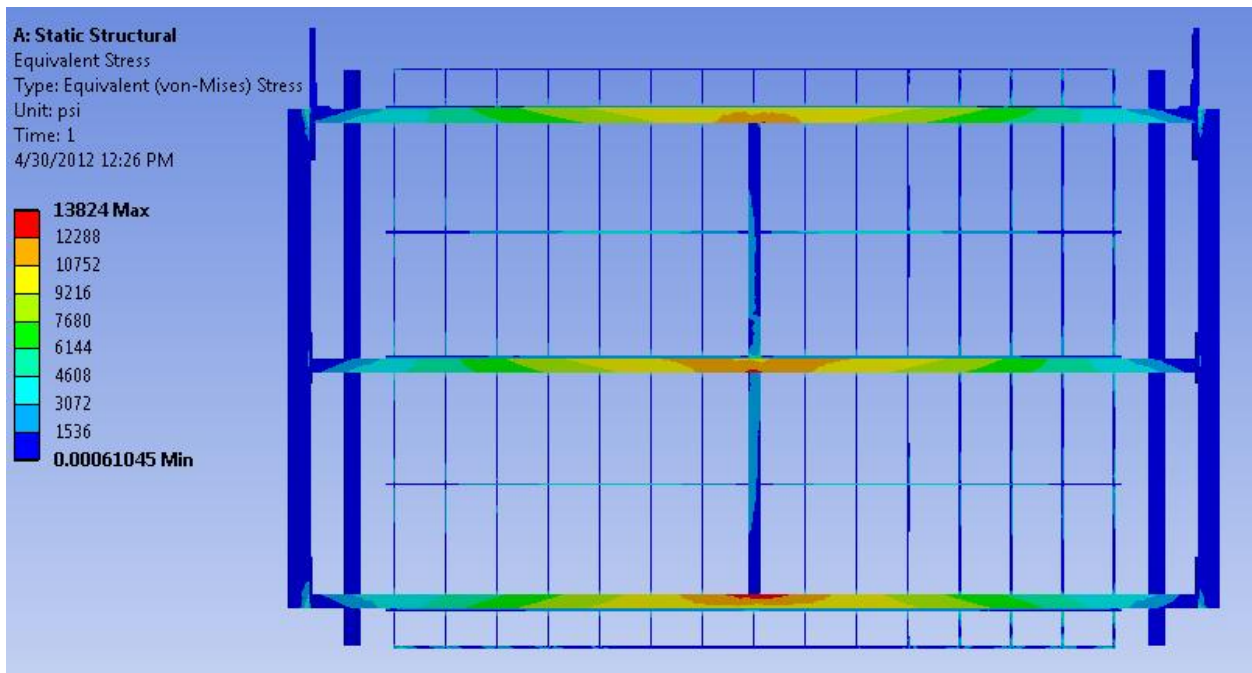
Figure 35: Rear view of the trashrack in ANSYS. The maximum stress (13.8 ksi) occurs at the center of the horizontal structural channels.

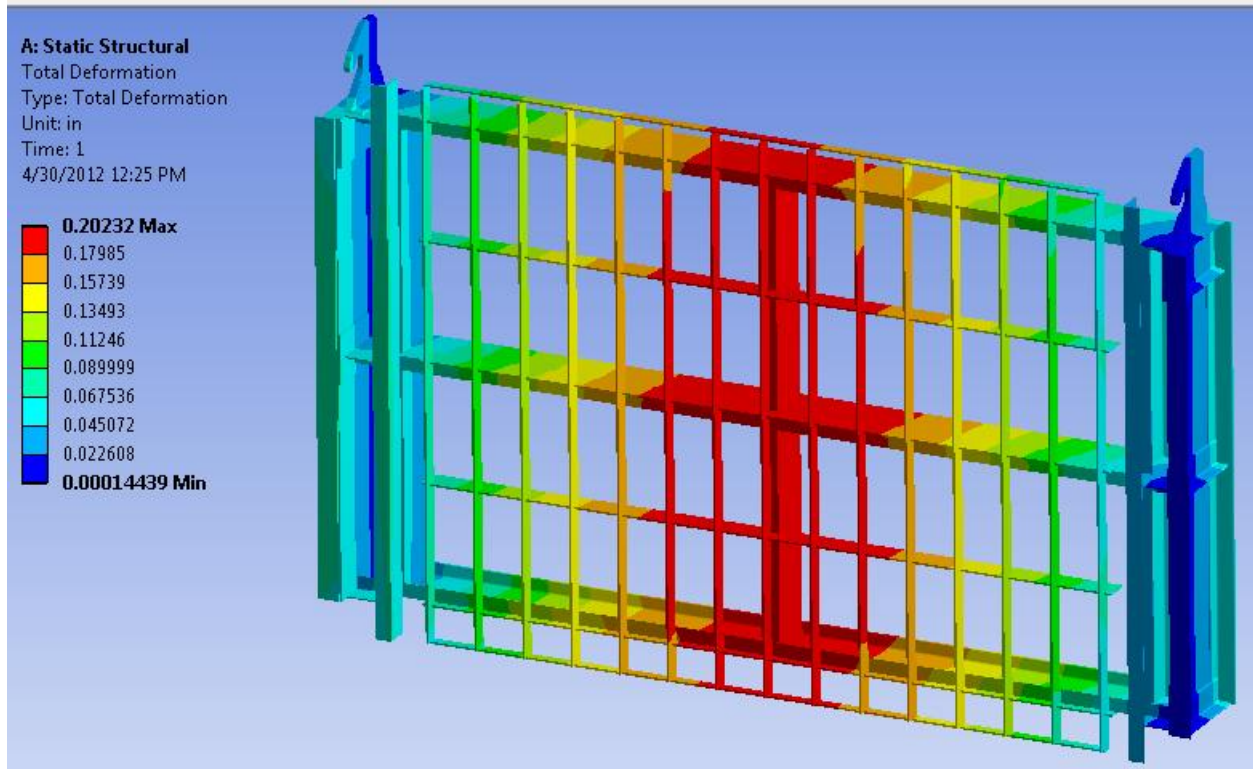
Figure 36: Front view of the trashrack in ANSYS displaying the deformation due to the applied load. The maximum deformation is just over 0.2 inches.

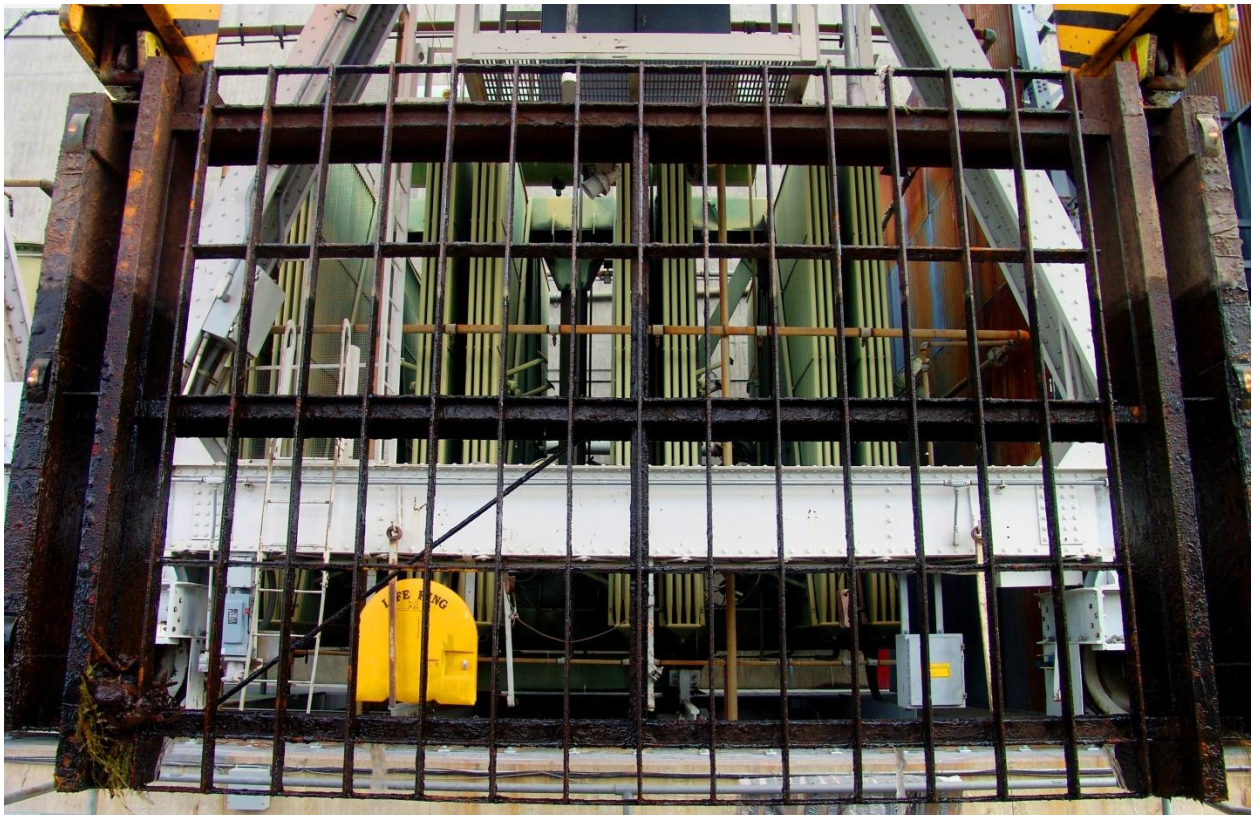
Figure 38: Front view of the original trashrack with steel rackbars while hanging from the gantry crane. Three of the four diagonal tie rods are missing.

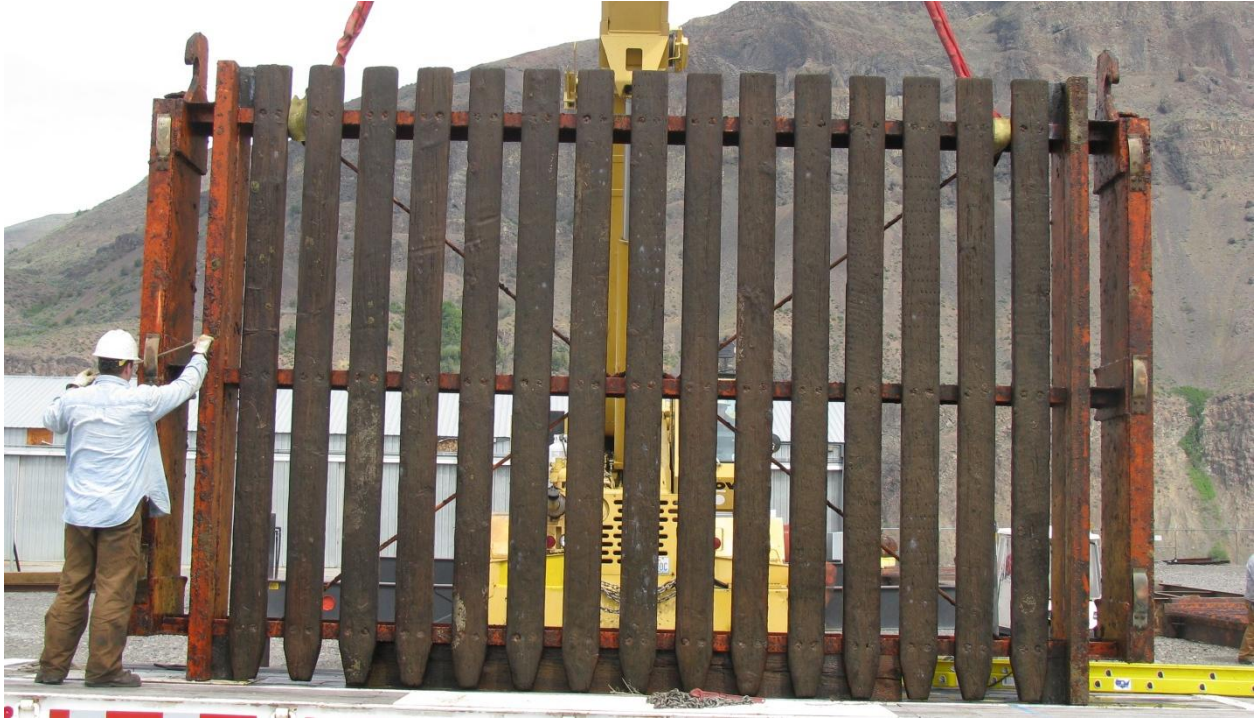
Figure 39: Front view of a original trashrack with wood rackbars. The structural supports and diagonal tie rods are identical for the wood rackbar and steel rackbar trashracks.
