Evaluating North Creek channel conditions after restoration

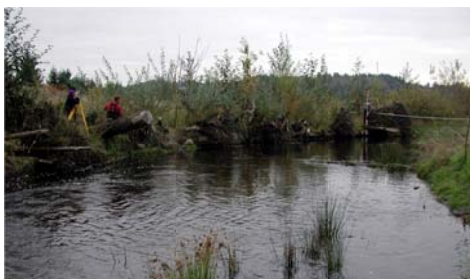
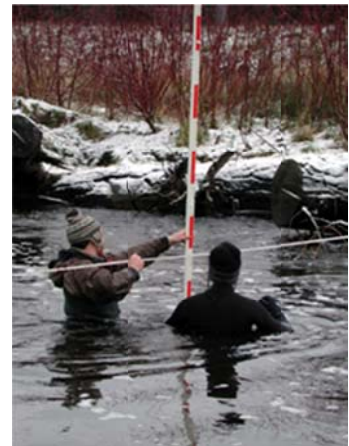
Above pictures: North Creek channel conditions before, during and after restoration, graduate students survey in October 2001, graduate students Jeff Shellberg and Chris Brummer discuss who has to hold the rod in the thalweg.
