Can Dam Removal Restore Threatened Shorelines?

The Elwha Case Study

Marine Sedimentary Processes Research Apprenticeship

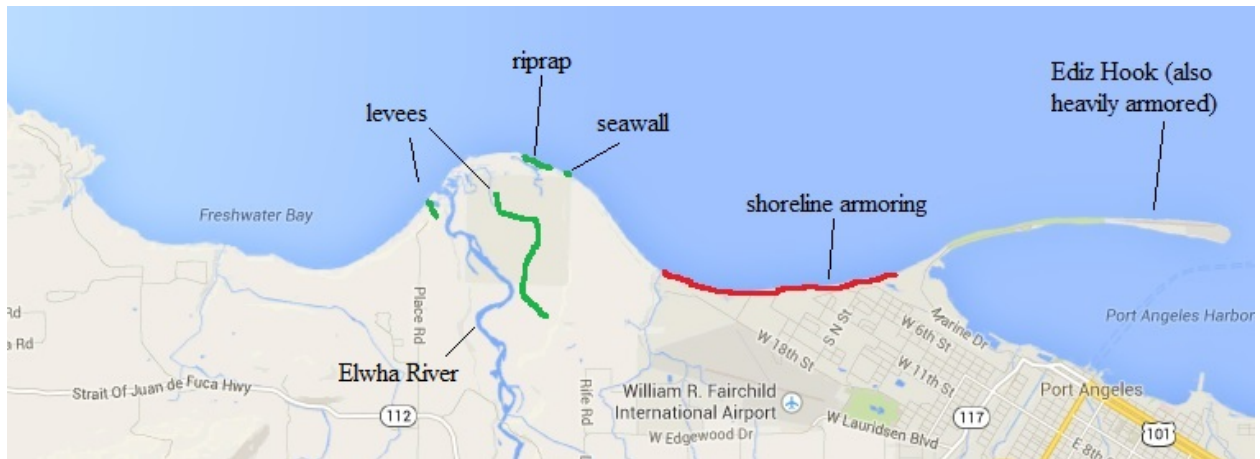
Figure 2. The Elwha River delta and surrounding coastline, extending from Freshwater Bay in the west to Ediz Hook in the east. Man-made modifications to the river channel, floodplain, and coast are also marked. Base map credit: Google Maps

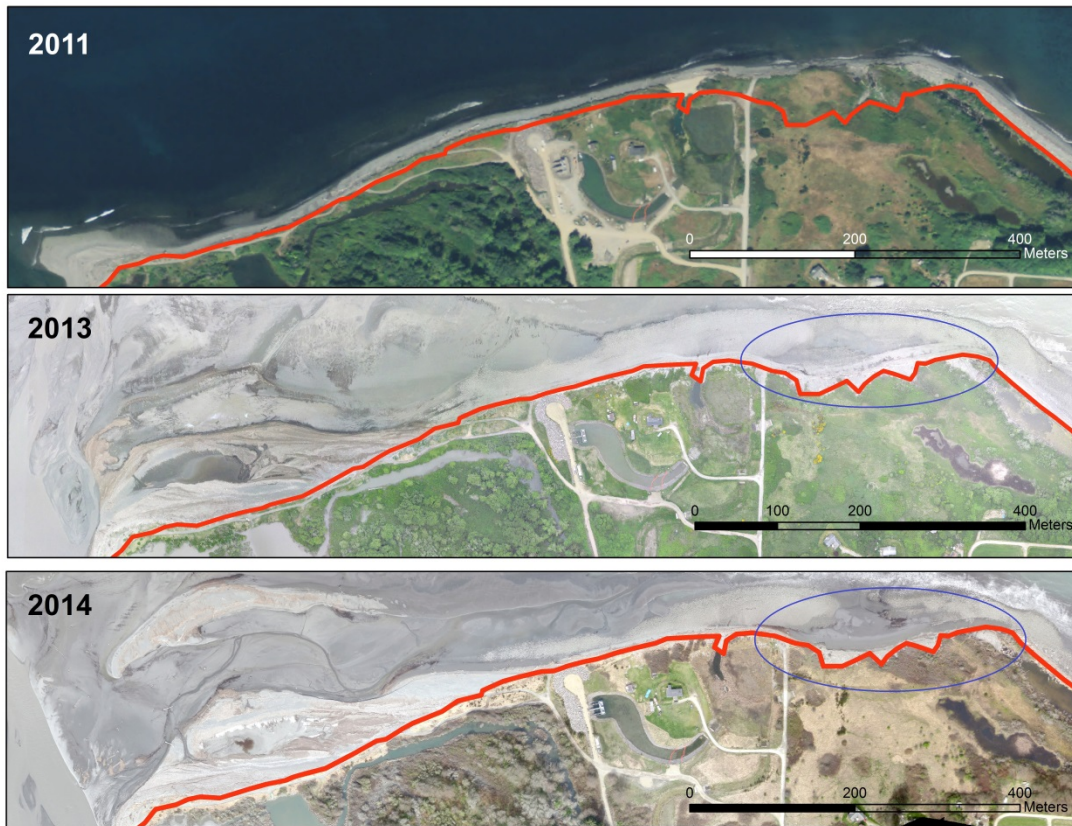
Figure 9. Shoreline evolution east of the river mouth during dam removal. The 2014 vegetation line is marked in red on all three panels. Note the shoreline region circled in blue where sediment resembling the accretion at the river mouth has deposited on top of vegetation between 2013 and 2014. Aerial photograph credits: U.S. Department of Agriculture (2011); Andy Ritchie, National Park Service (2013, 2014)

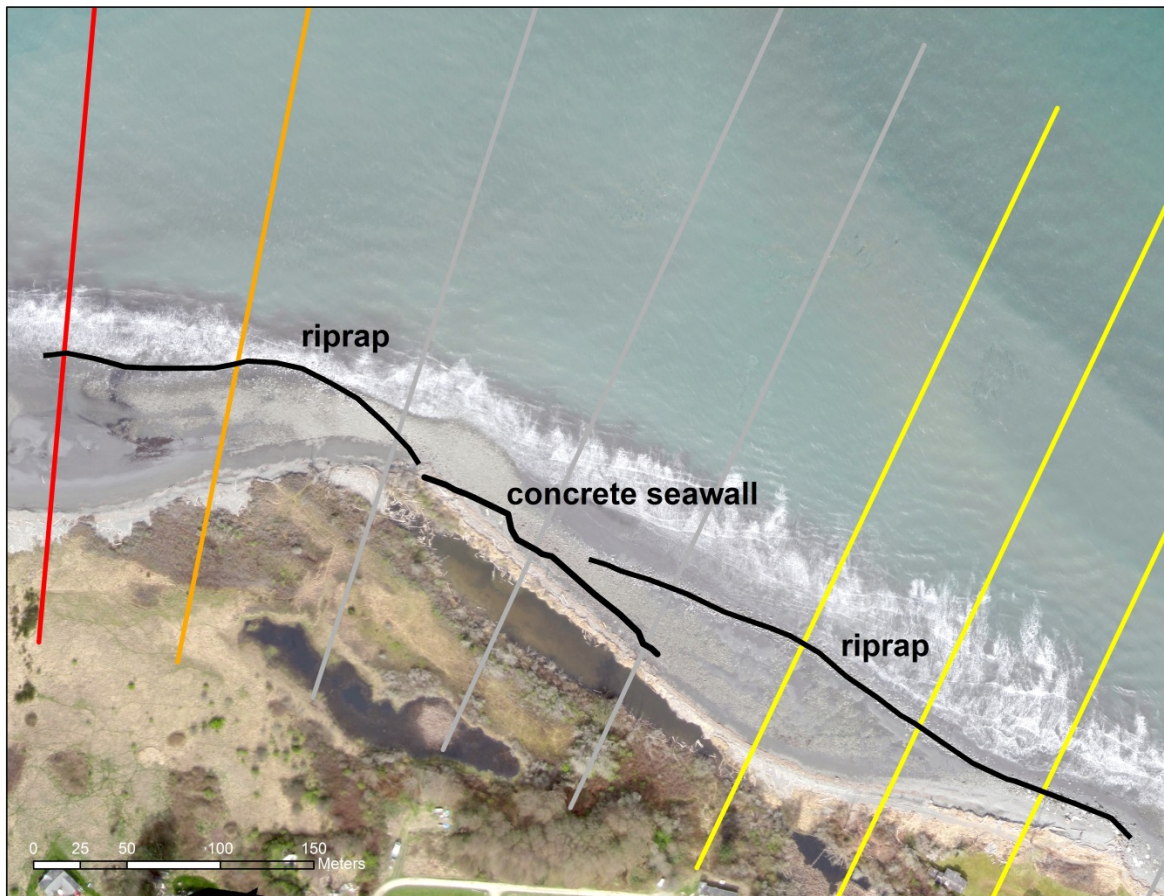
Figure 12. Anthropogenic shoreline armoring overlain with shoreline change transects for 2011-2014. Red transects indicate shoreline with the highest erosion rates (-29 m/yr), with orange representing rates from -16 to -11 m/yr and yellow signifying -6 to -3 m/yr. Gray transects indicate areas without statistically significant change. Aerial photograph credit: Andy Ritchie, National Park Service
