**Rock-slope Activity Index (RAI): a lidar-derived process-based
rock-slope assessment system**

Master of Science in Civil Engineering

University of Washington

2015

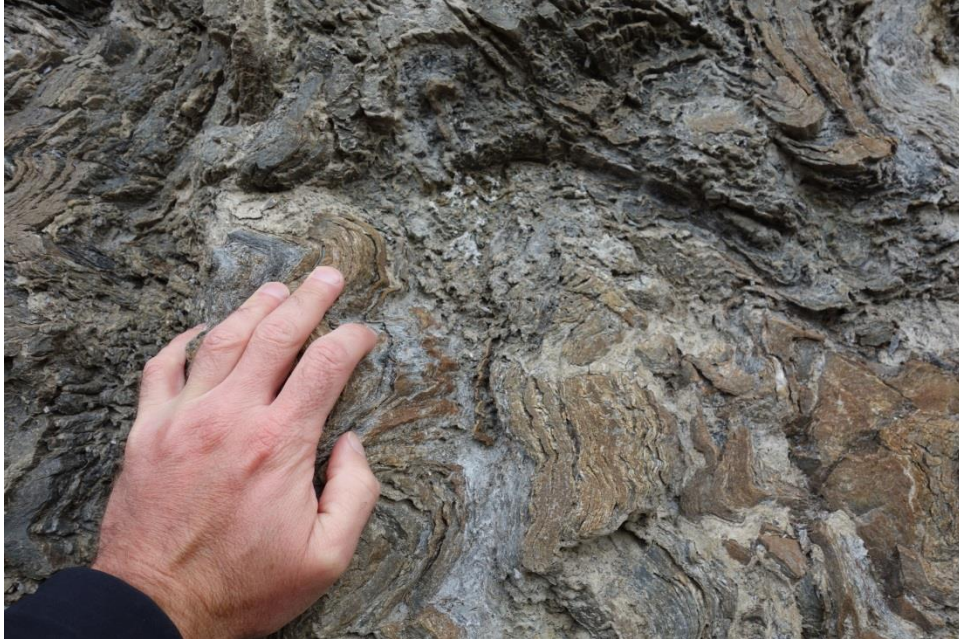
Figure 2.4 Close up of Healy Schist a metamorphic rock containing quartz, schist and mica.

The main type of rock found within the Parks Highway study area is a rock is known as Birch Creek Schist or Healy Schist (Figure 2.4) that Connor (1988) describes as “metamorphic rocks, muscovite-quartz schist, micaceous quartz and lesser amounts of graphitic schist.” Wahrhaftig (1958) notes that Birch Creek schist is inherently weak because of its "ease of separation along planes of foliation, produced by tiny, oriented mica flakes." This rock also includes cross joints, which run near vertical and may locally abut basalt dikes. Figure 2.6 is a geologic map of the area that shows volcanic

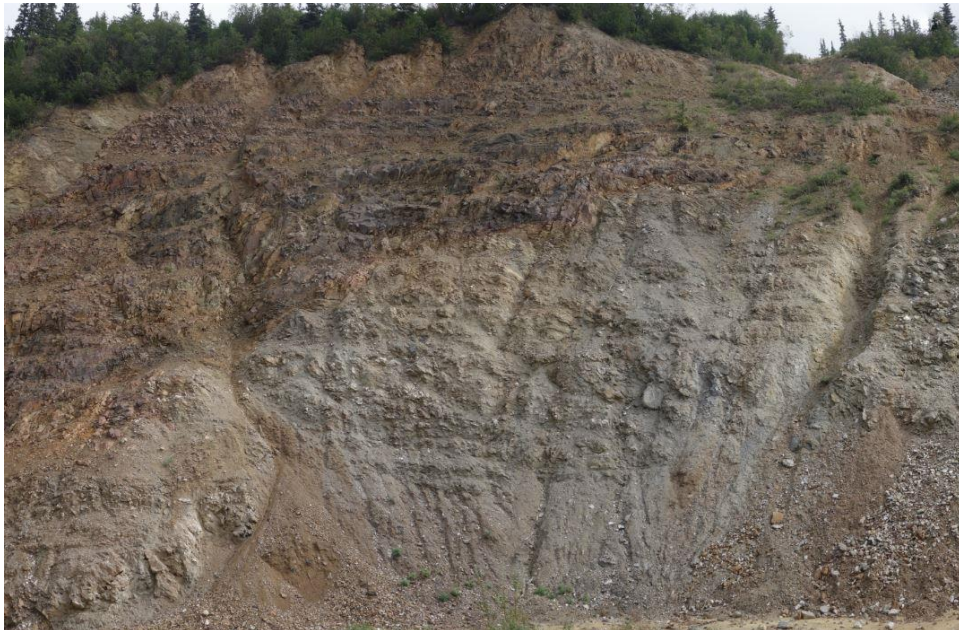
Figure 2.5 Slope at parks highway showing the darker volcanic rock, on top of the lighter Healy schist.

dikes (Tvim, Tvif) within the Healy schist (PzpCp). The volcanic rock can be clearly seen as the darker rock in Figure 2.5, with a lighter Healy schist layer below.

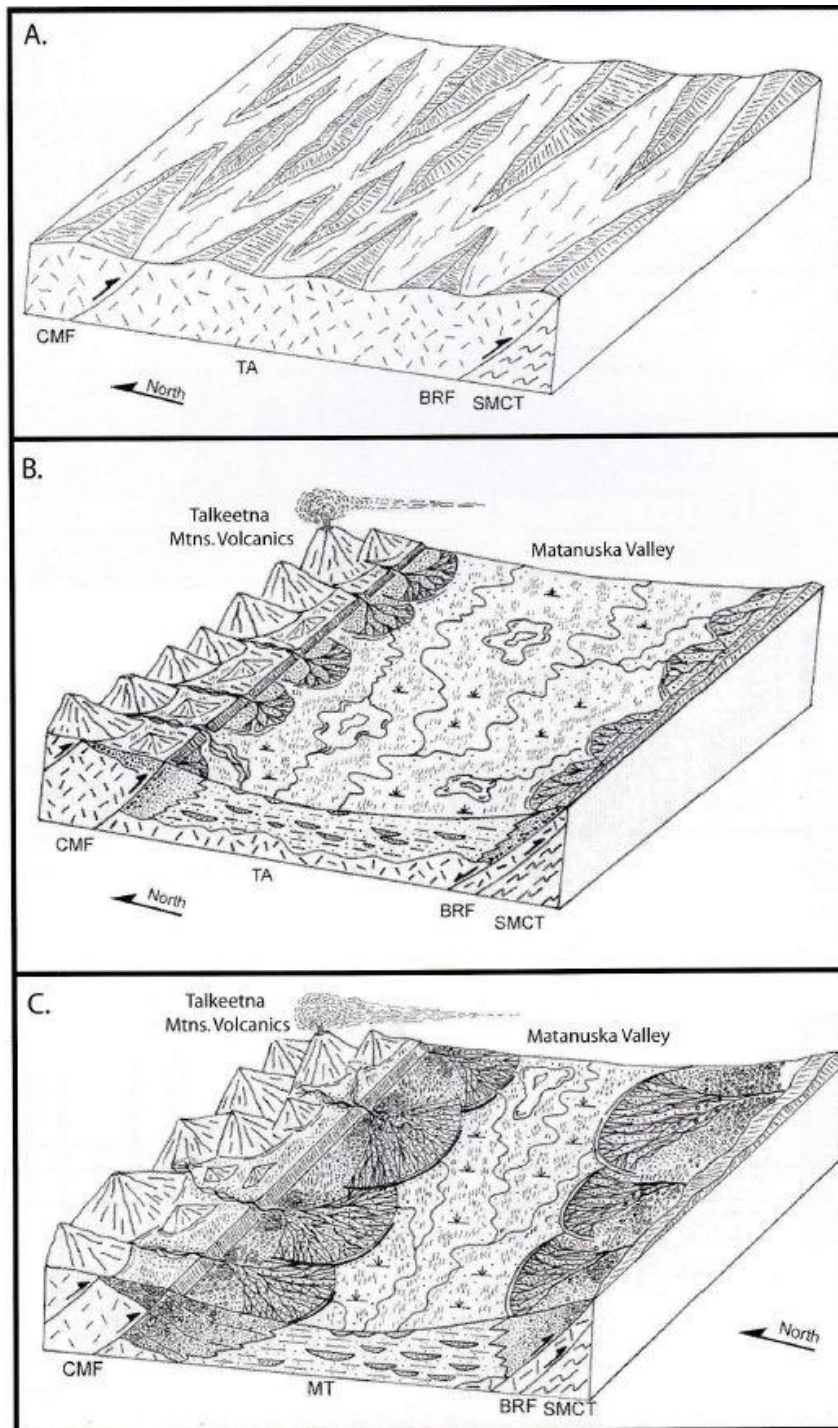
Figure 2.7 The building of the Glenn Highway area. A) Uplift of the Matanuska formation in the Cretaceous-Paleocene from marine strata. B) Talkeetna Mountains form with volcanic activity. Alluvial fans develop at base of mountains. Braided streams within the valley floor. C) Alluvial fans propagate, Castle Mountain fault (CMF) displaces. (Trop 2006)

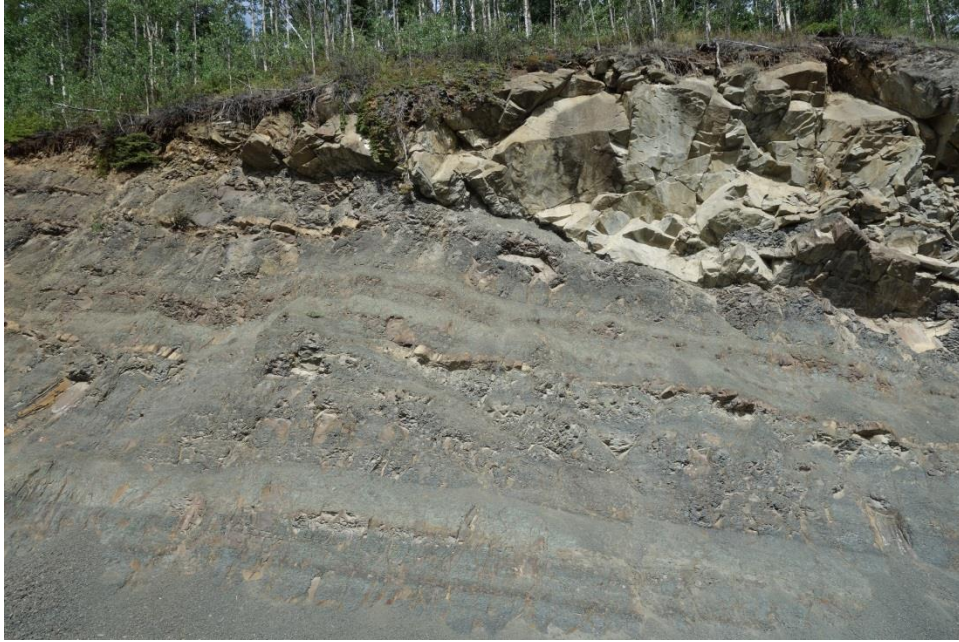
Figure 2.8: Carbonous rock in the Chickaloon Formation below with mafic sill intrusions on top as seen near Milepost 85

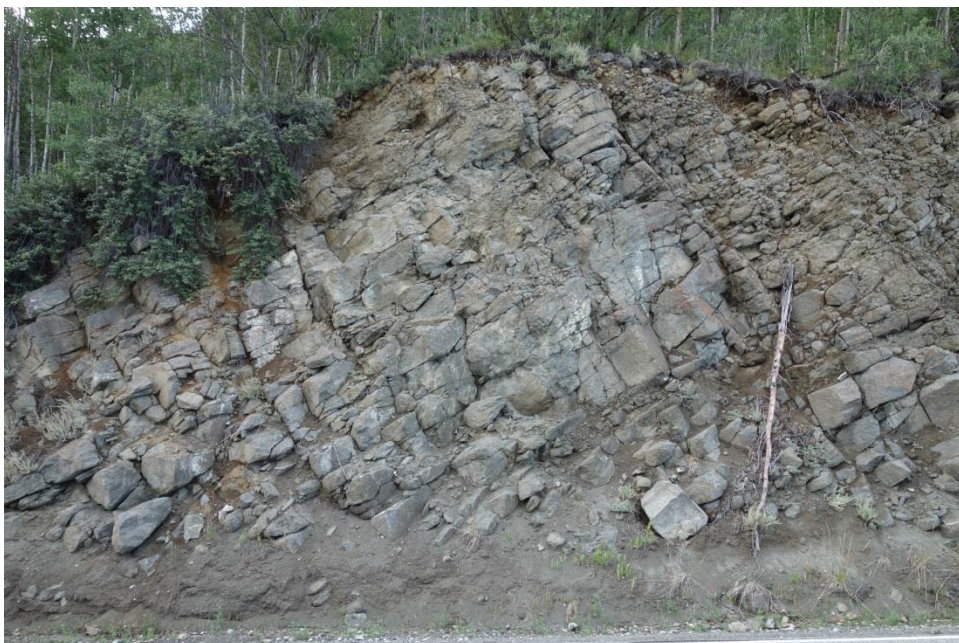
Figure 2.9: Chickaloon formation sandstone in block failure near Milepost 85.5.

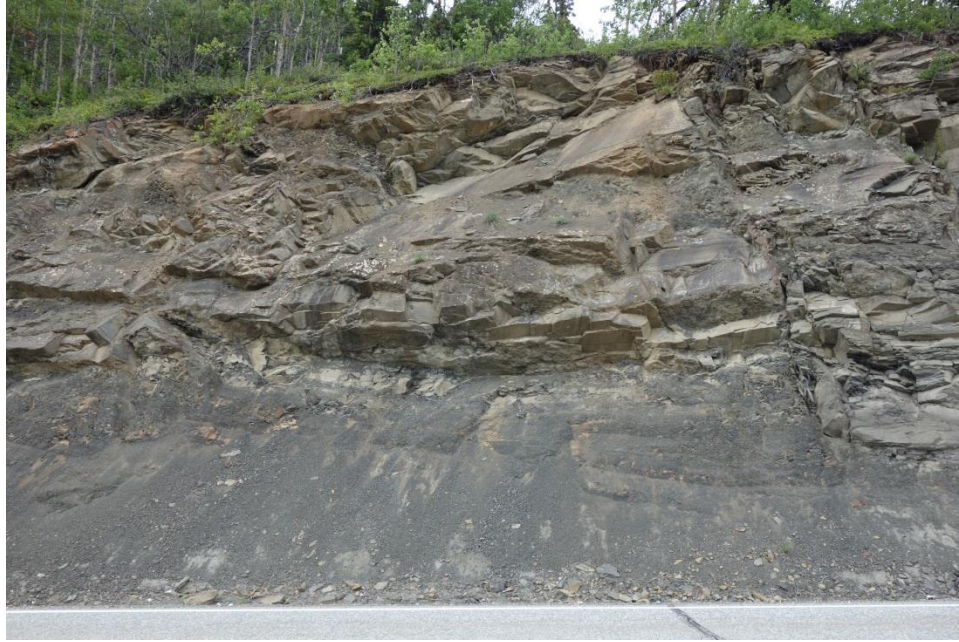
Figure 2.10: Carbonous siltstones overridden by a sill. The siltstones are a weaker material and therefore erode faster than the sill causing overhangs within the sill. To the right a fault can be seen offsetting these strata. These faults can be seen throughout the Chickaloon formation.

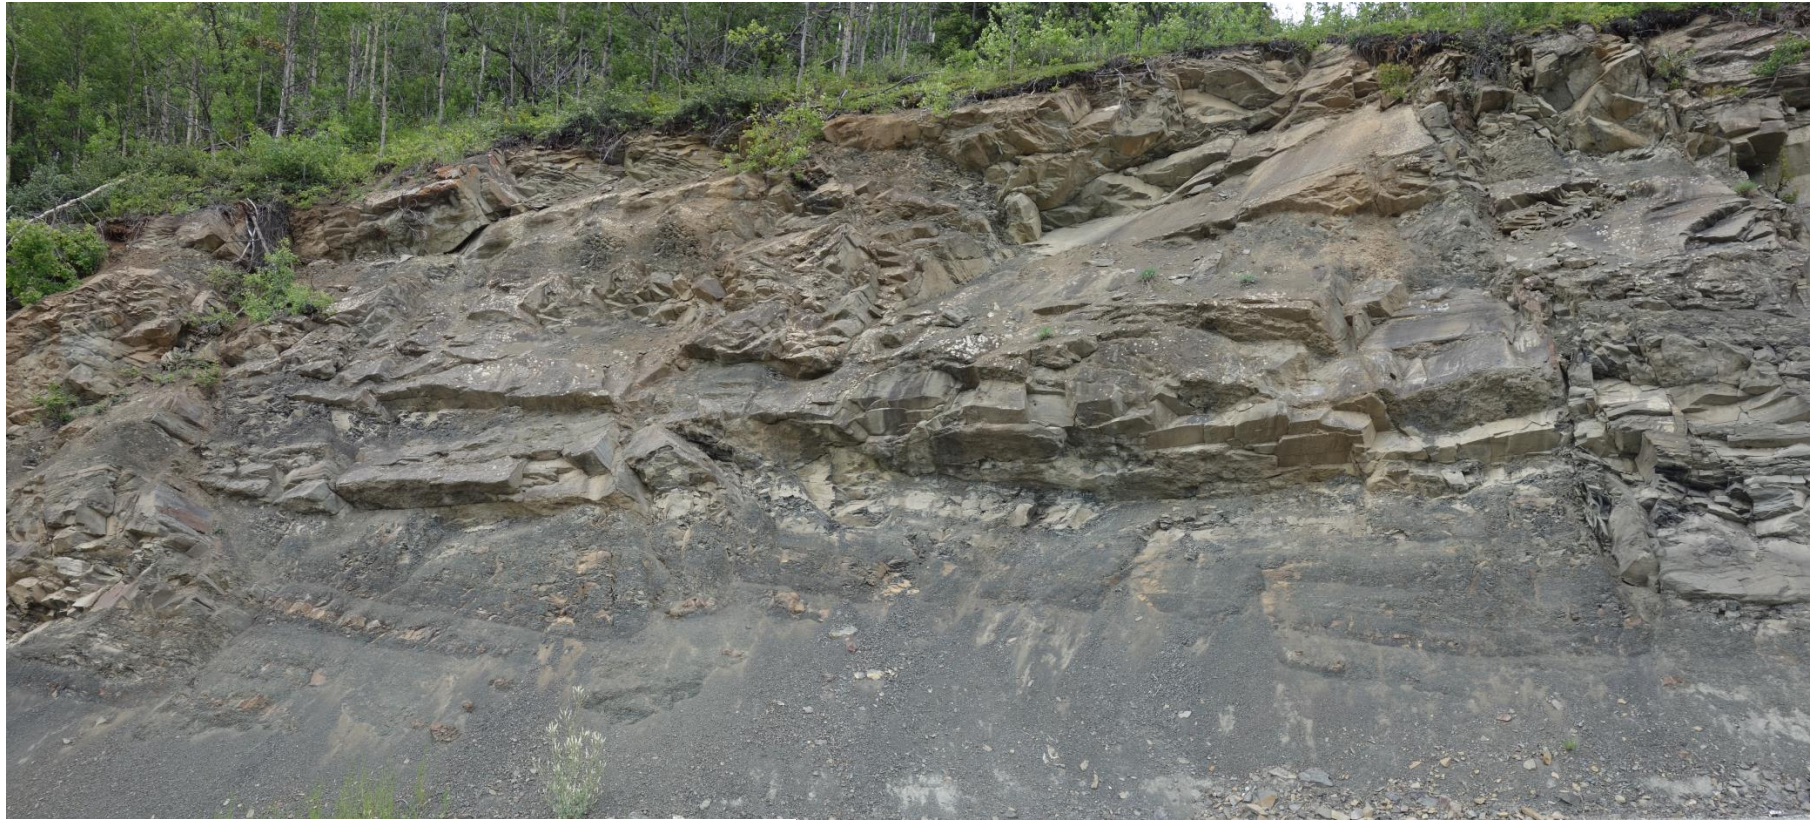
Milepost 87 seen in Figure 2.13 is part of the Chickaloon formation and consists of soft sedimentary rock overridden by hard mafic sills. The contrast between strengths of these units has caused differential erosion forming overhangs within the site. The mafic sills have two major joint sets, one dipping at approximately 50 degrees with a dip direction of 195 degrees and the other dipping at approximately 40 degrees with a dip direction of 5 degrees. The overall slope and direction of the site is approximately 58 degrees slope with a direction of east to west. The stereonet for this site can be seen in Figure 2.14.

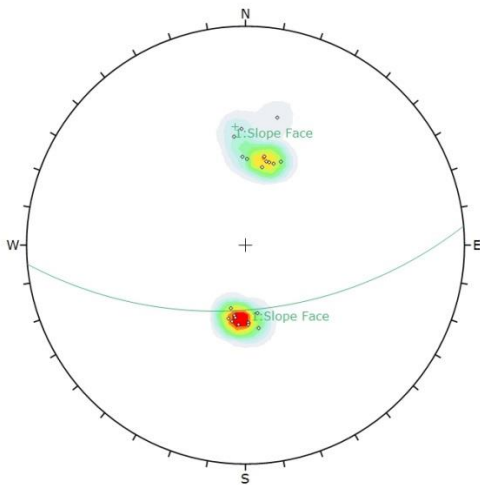
Figure 2.14 (left): Stereonet representing the two joint sets found at milepost 87. The slope face itself runs nearly east west with a slope of 58 degrees. The two joint sets are approximately 50 degrees dip with dip direction of 195 degrees and 40 dip with a dip direction of 5 degrees.

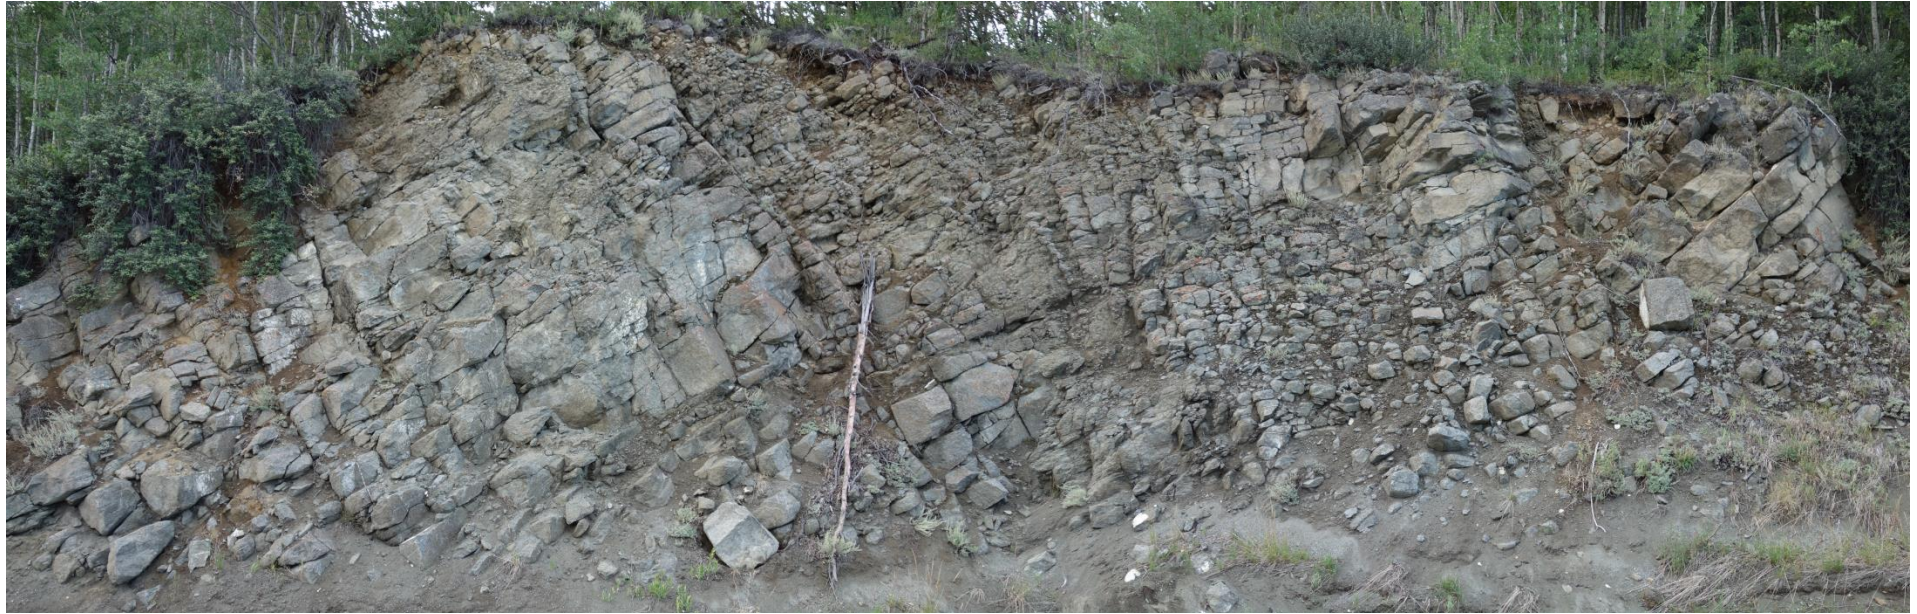
Figure 2.15 (above): Sandstones from Chickaloon formation at Milepost 85.5 along Glenn Highway.

Milepost 85.5 is an outcrop of fine-medium grained grey and tan sandstone of the Chickaloon formation, Figure 2.15. This area has been moderately weathered and three joint sets are visible Figure 2.15. The dip and direction of these sets are approximately: 60 degrees dip, 90 degrees dip direction; 85 degrees dip, 0 degrees dip direction and 30 degrees dip, 200 degrees dip direction. The overall slope and direction of this site is 60 degrees slope with a northeast to southwest direction.

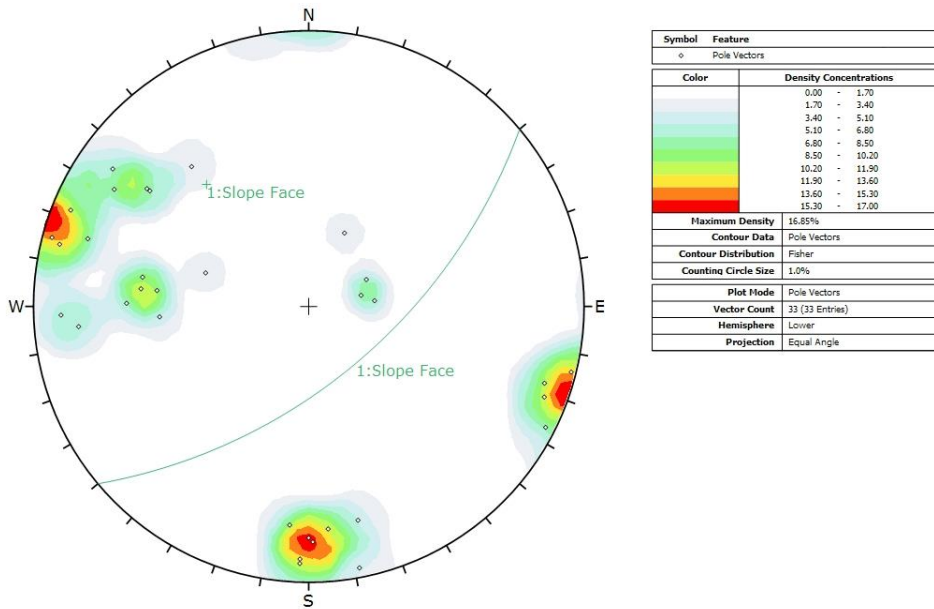
Figure 2.16 (left): Stereonet representing the three joint sets found at milepost 85.5. The slope face itself runs nearly northeast to southwest with a slope of 60 degrees. The three joint sets are approximately 60 degrees dip with dip direction of 90 degrees, 85 degree dip with a dip direction of 0 degrees and 30 dip with a dip direction of 200 degrees.

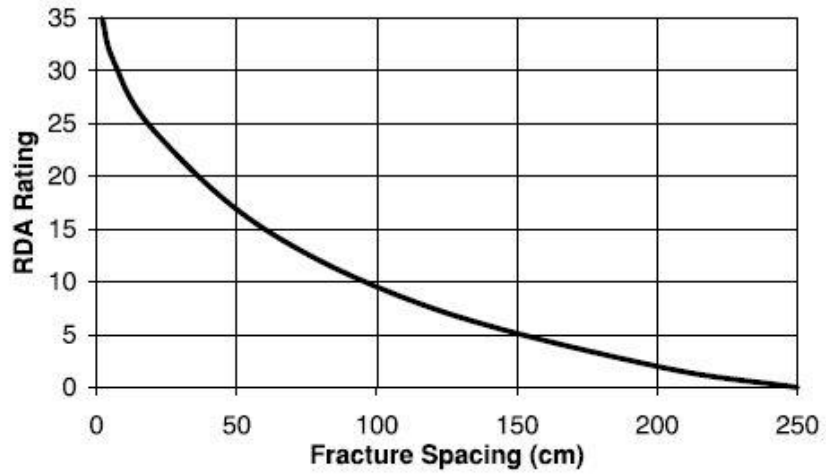
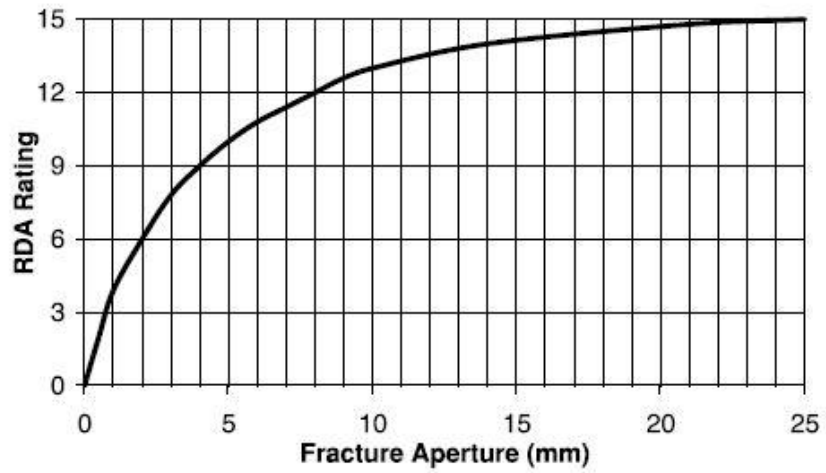
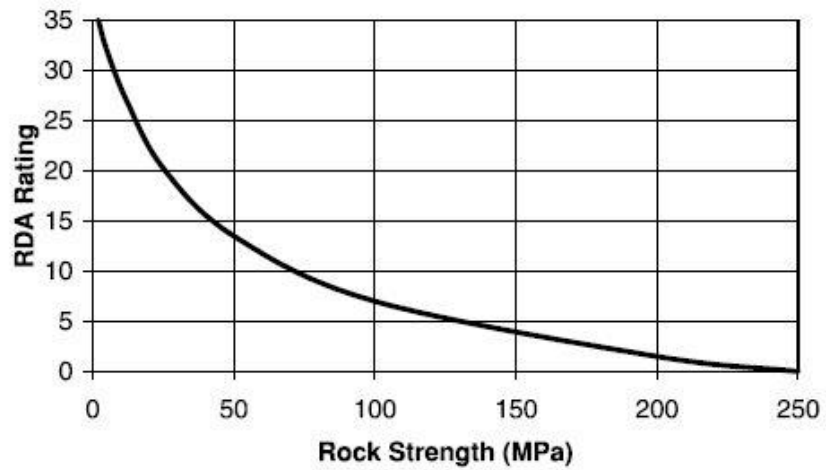
Figure 3.1 RDA Main Factors charts to determine the score of fracture spacing, fracture aperture and rock strength (Nicolson 2004).

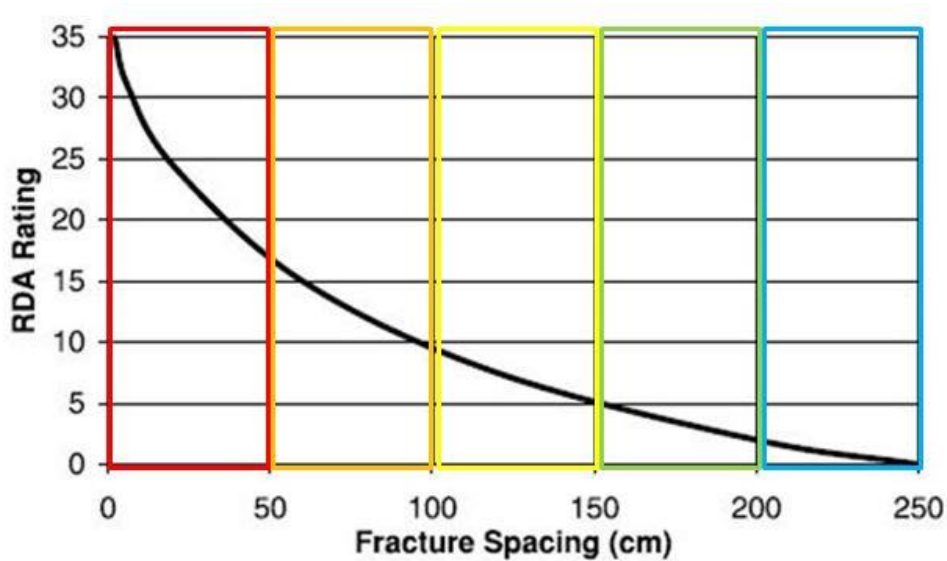
Figure 4.4: Generalization of the fracture spacing as used in the remote application of the RDA. Each color represents a different level. Scores used can be seen in Table 4.6 (Nicholson, 2004).

Fractures spacing was separated into five categories, Figure 4.4, and the mean of each category was used as the score. The spacing was measured using split FX software, Figure 4.5, and then generalized for an area.

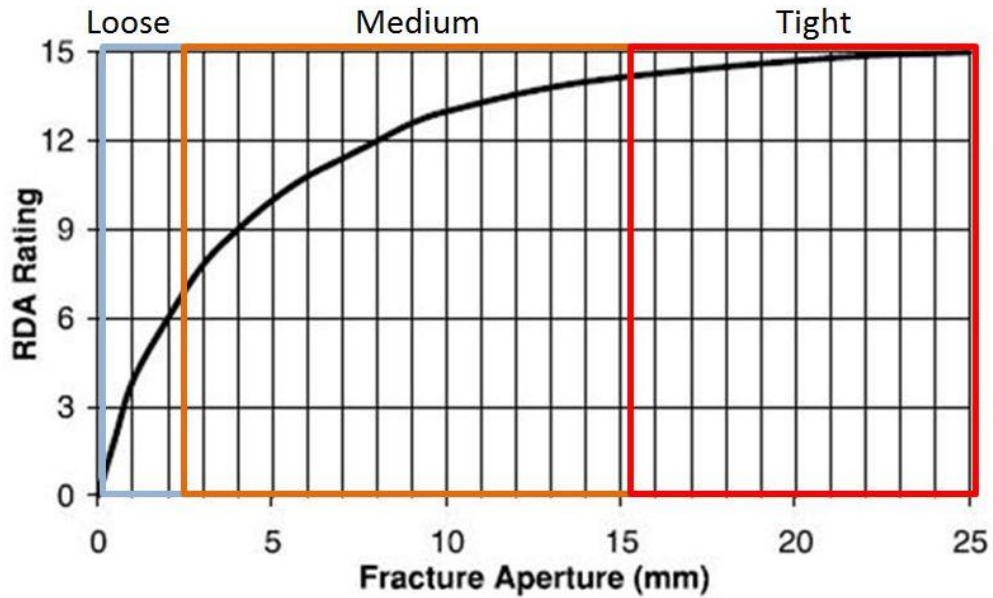
Figure 4.6: Generalization of the fracture aperture. Examples of each level, loose, medium and tight can be seen in Figure 4.7. (Nicholson, 2004)

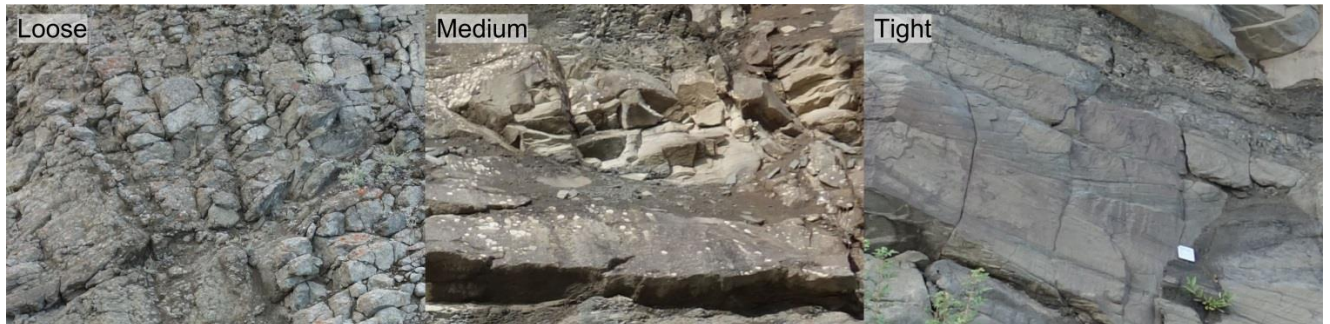
Figure 4.7: Examples of the generalized levels of Fracture Aperture using examples from Glenn Highway and Parks Highway study areas.

These were determined visually as seen in Figure 4.7.

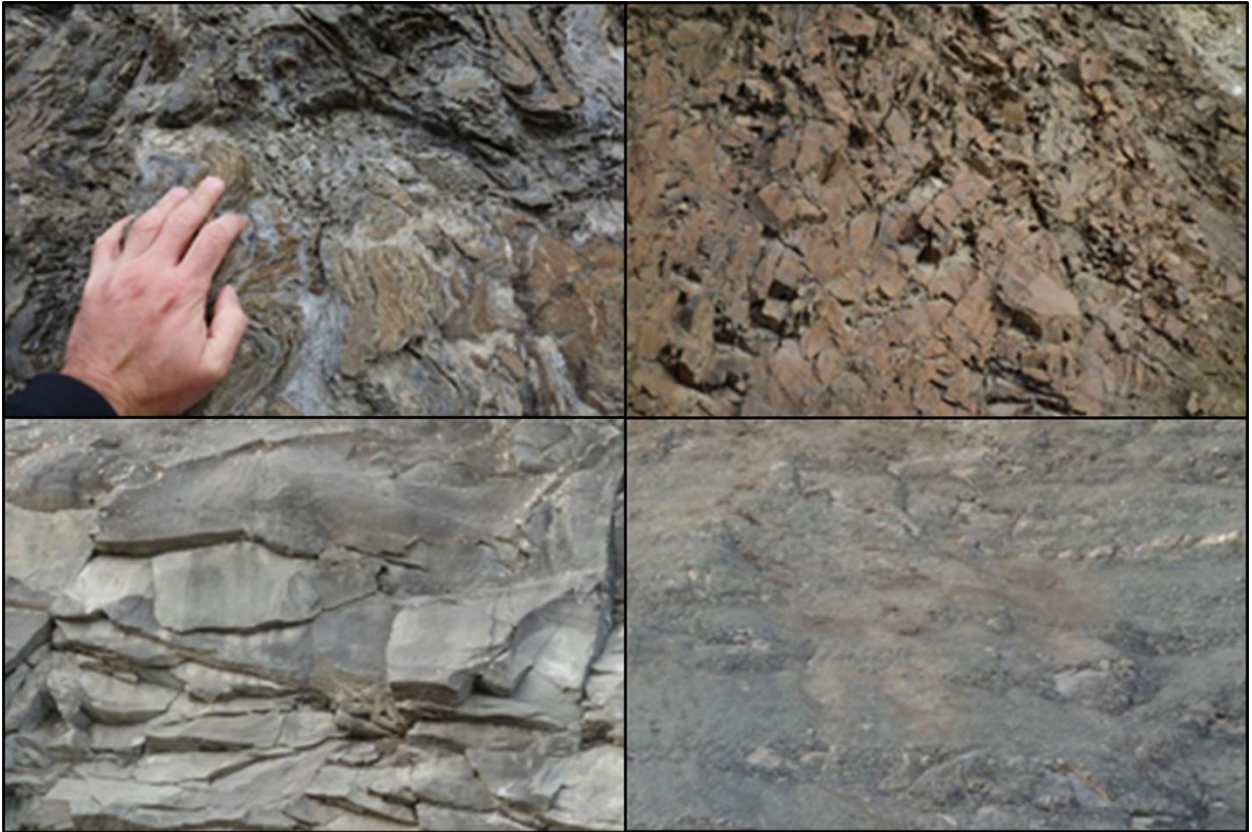
Figure 4.8: Top left, Healy Schist, top right: mafic intrusion along Parks highway, bottom left: sill intrusion along Glenn Highway and bottom right: carbonous rock from the Chickaloon formation.

Rock strength was calculated with the use of Schmidt hammer measurements as described in Appendix B. The sites were then separated according to lithological units as shown in Figure 4.8.

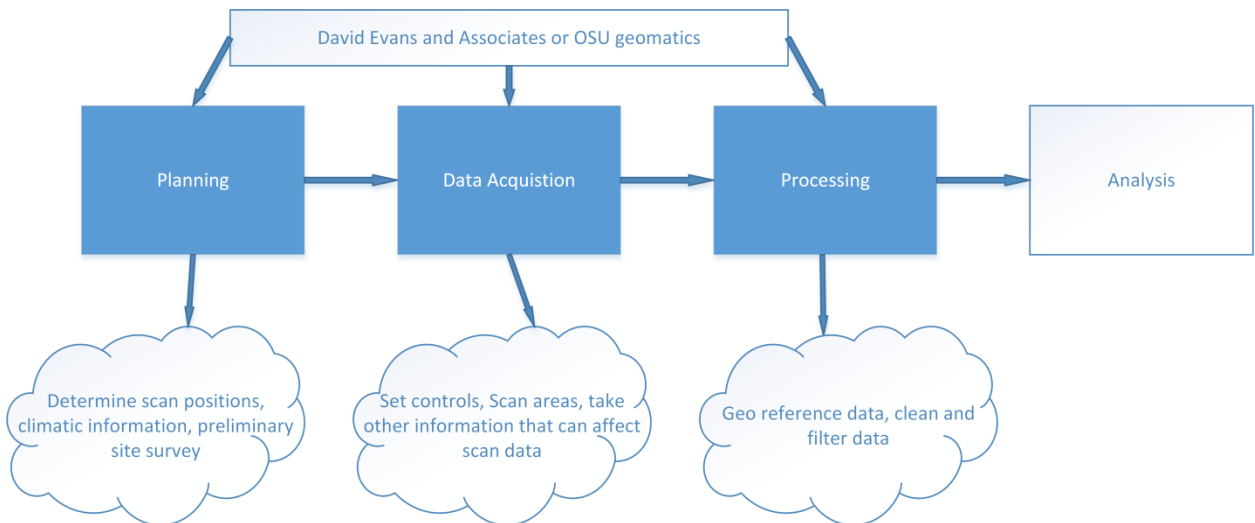
Figure 5.1: Work flow of lidar process. The first three steps were accomplished by David Evans and Associates (2012) and OSU in 2013-14. The analysis was the process that is described later in this report.

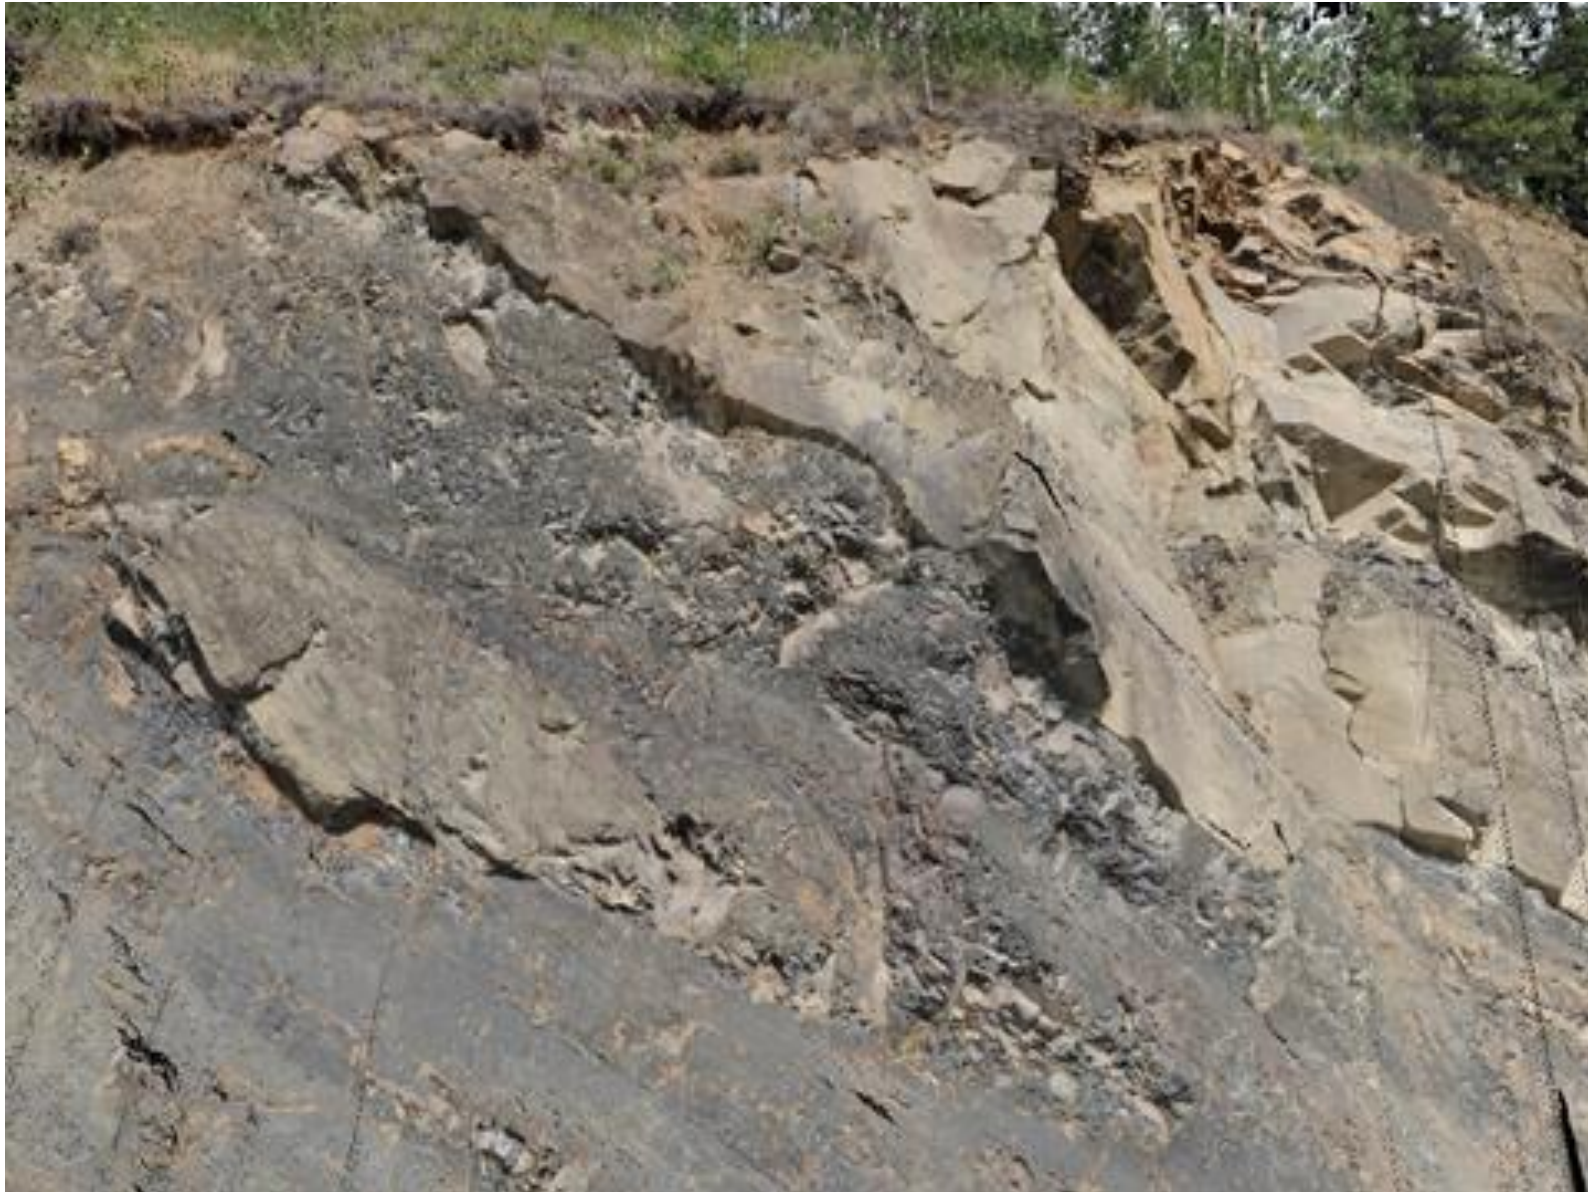
Figure 5.4: Example of 2013 lidar scan from an area along Parks Highway in an area that has highly unstable rocks.

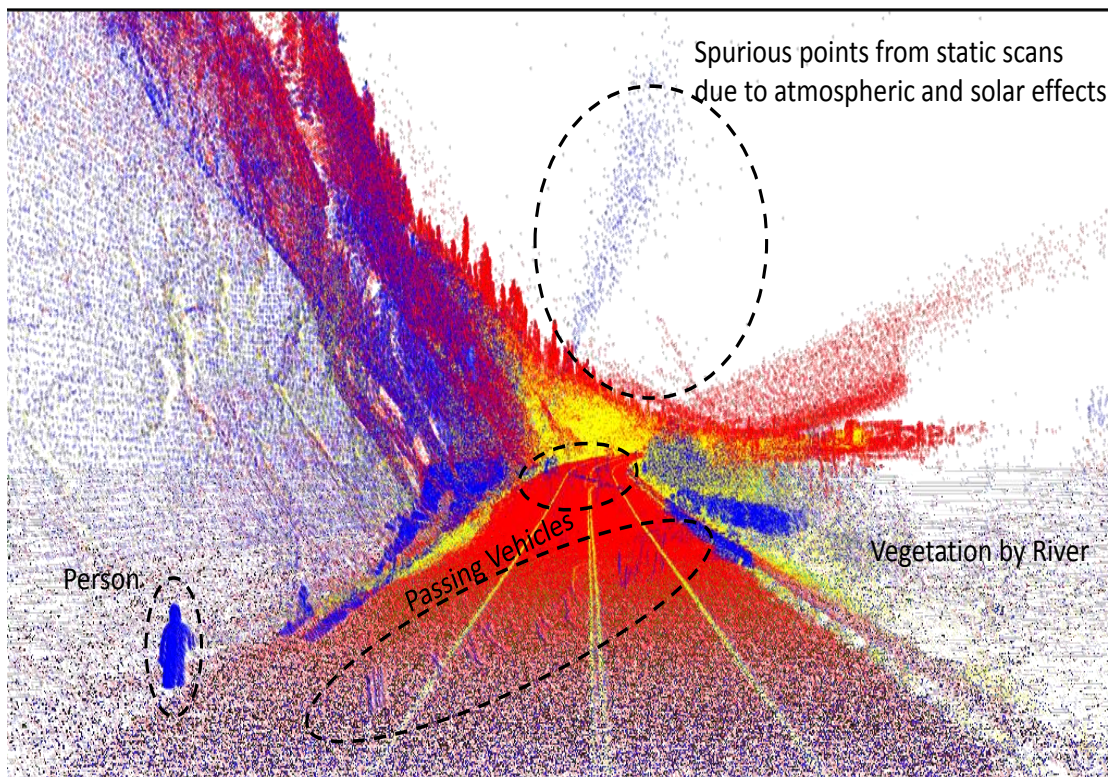
Figure 5.7: Examples of noise that is removed from lidar scans. If this noise is not removed, it can interfere with the analysis of the data.

Once scans are referenced together, data needs to be filtered. Figure 5.7 shows examples of possible noise that needs to be removed from scans. Sources of noise include atmospheric conditions, vehicles, and vegetation. In ground based lidar scans, the removal of vegetation and noise can also cause loss of resolution, so this removal has to be conducted carefully. Ground based filter techniques have been created specifically for this project. (Cunningham, Olsen, Wartman, & Dunham, 2015)

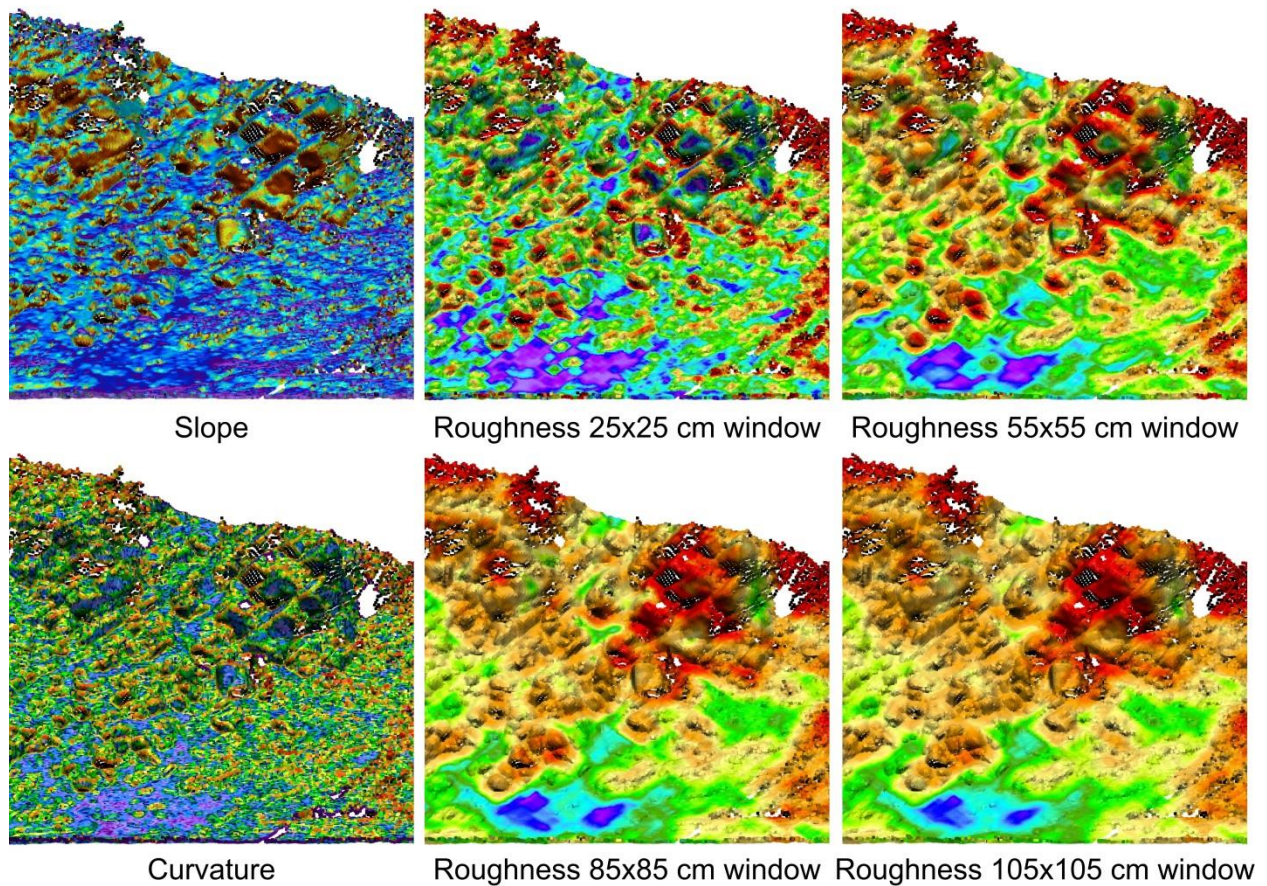
Figure 6.1: Geomorphological indices calculated on 3D point clouds. Each index highlights slightly different aspects of the slope. By combining several indices different erosional processes can be highlighted.

Geomorphological indices, as seen in Figure 6.1, of roughness, slope and curvature are used to distinguish between types of processes and materials found on a rock-slope. Through identification of key classes which affect stability of slopes a hazard rating can be derived. For this analysis, seven classes are used but more or less can be used dependent on the site characteristics. Figures 6.2-6.4 show the different classes. Figure 6.2 shows talus and intact, size classes of 10 cm, 20 cm and 30 cm in Figure 6.3 and the difference in overhang <120 degrees and overhang > 120 degrees in Figure 6.4. Table 6.1 gives a short description of each of class. These classes generalize specific processes and features, identifying areas which would act the same way during failure of a slope not identifying each individual cell belonging to a specific class if such a classification was done by hand.

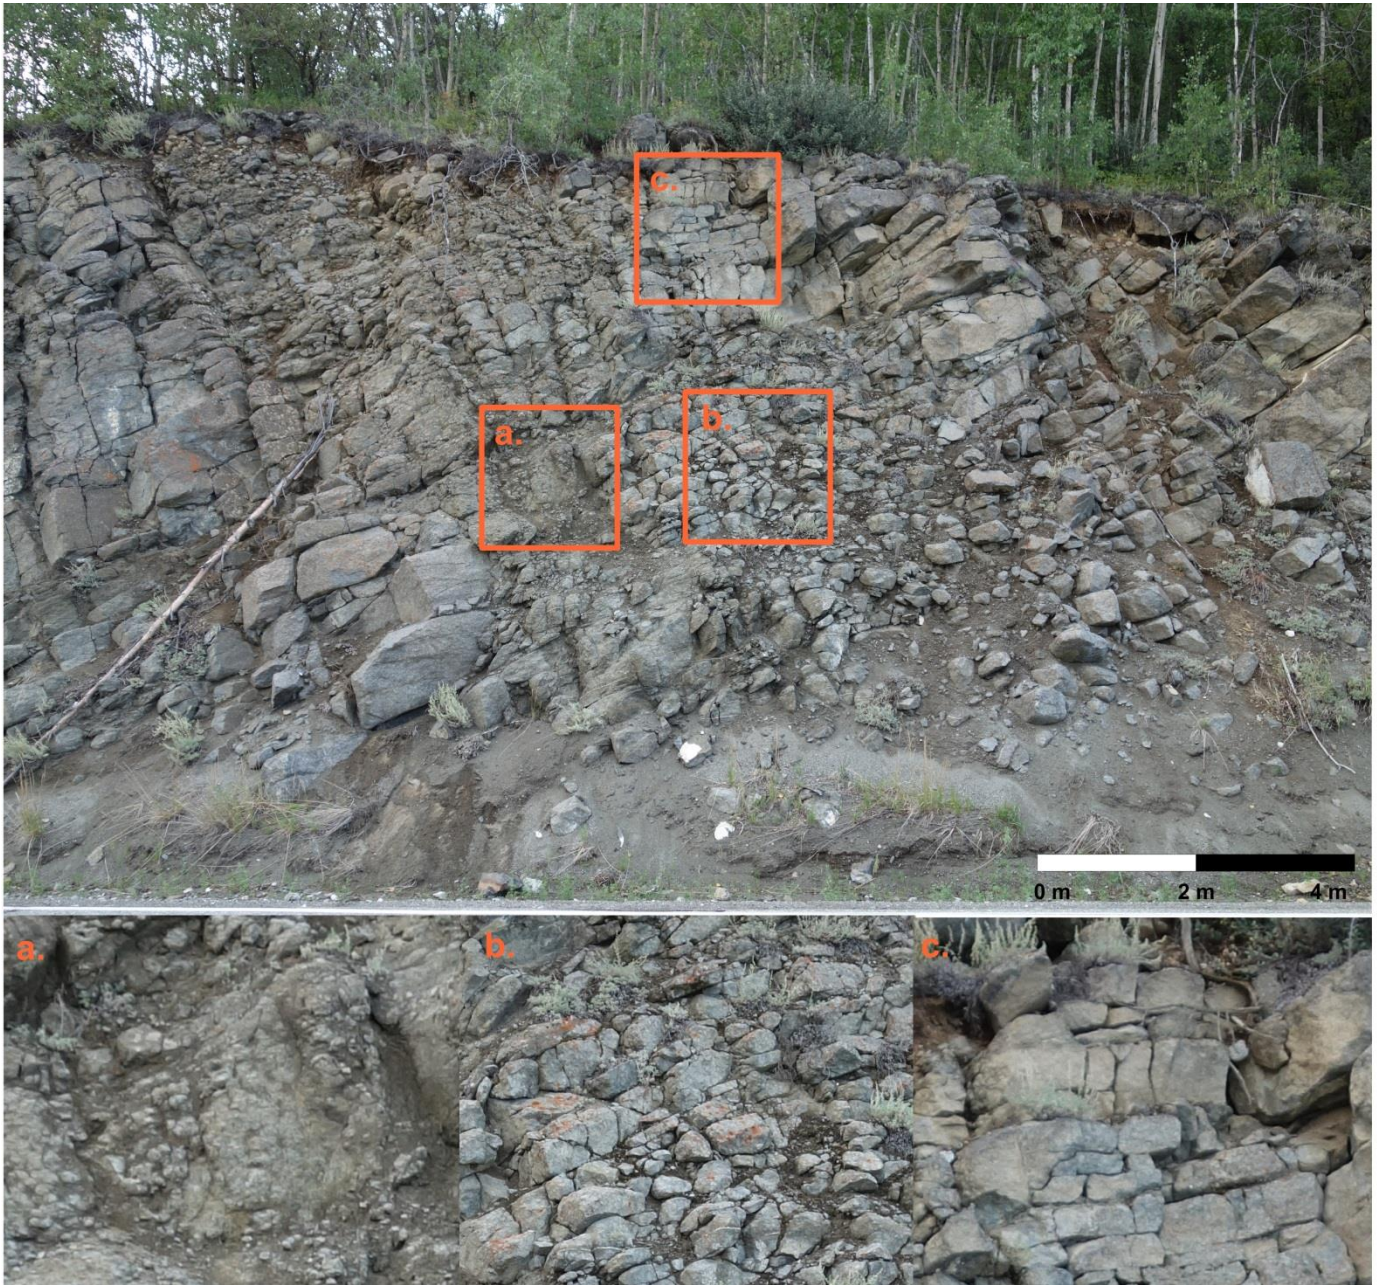
Figure 6.3: Examples of 10 cm, 20 cm and 30 cm active classifications for the RAI at milepost 85

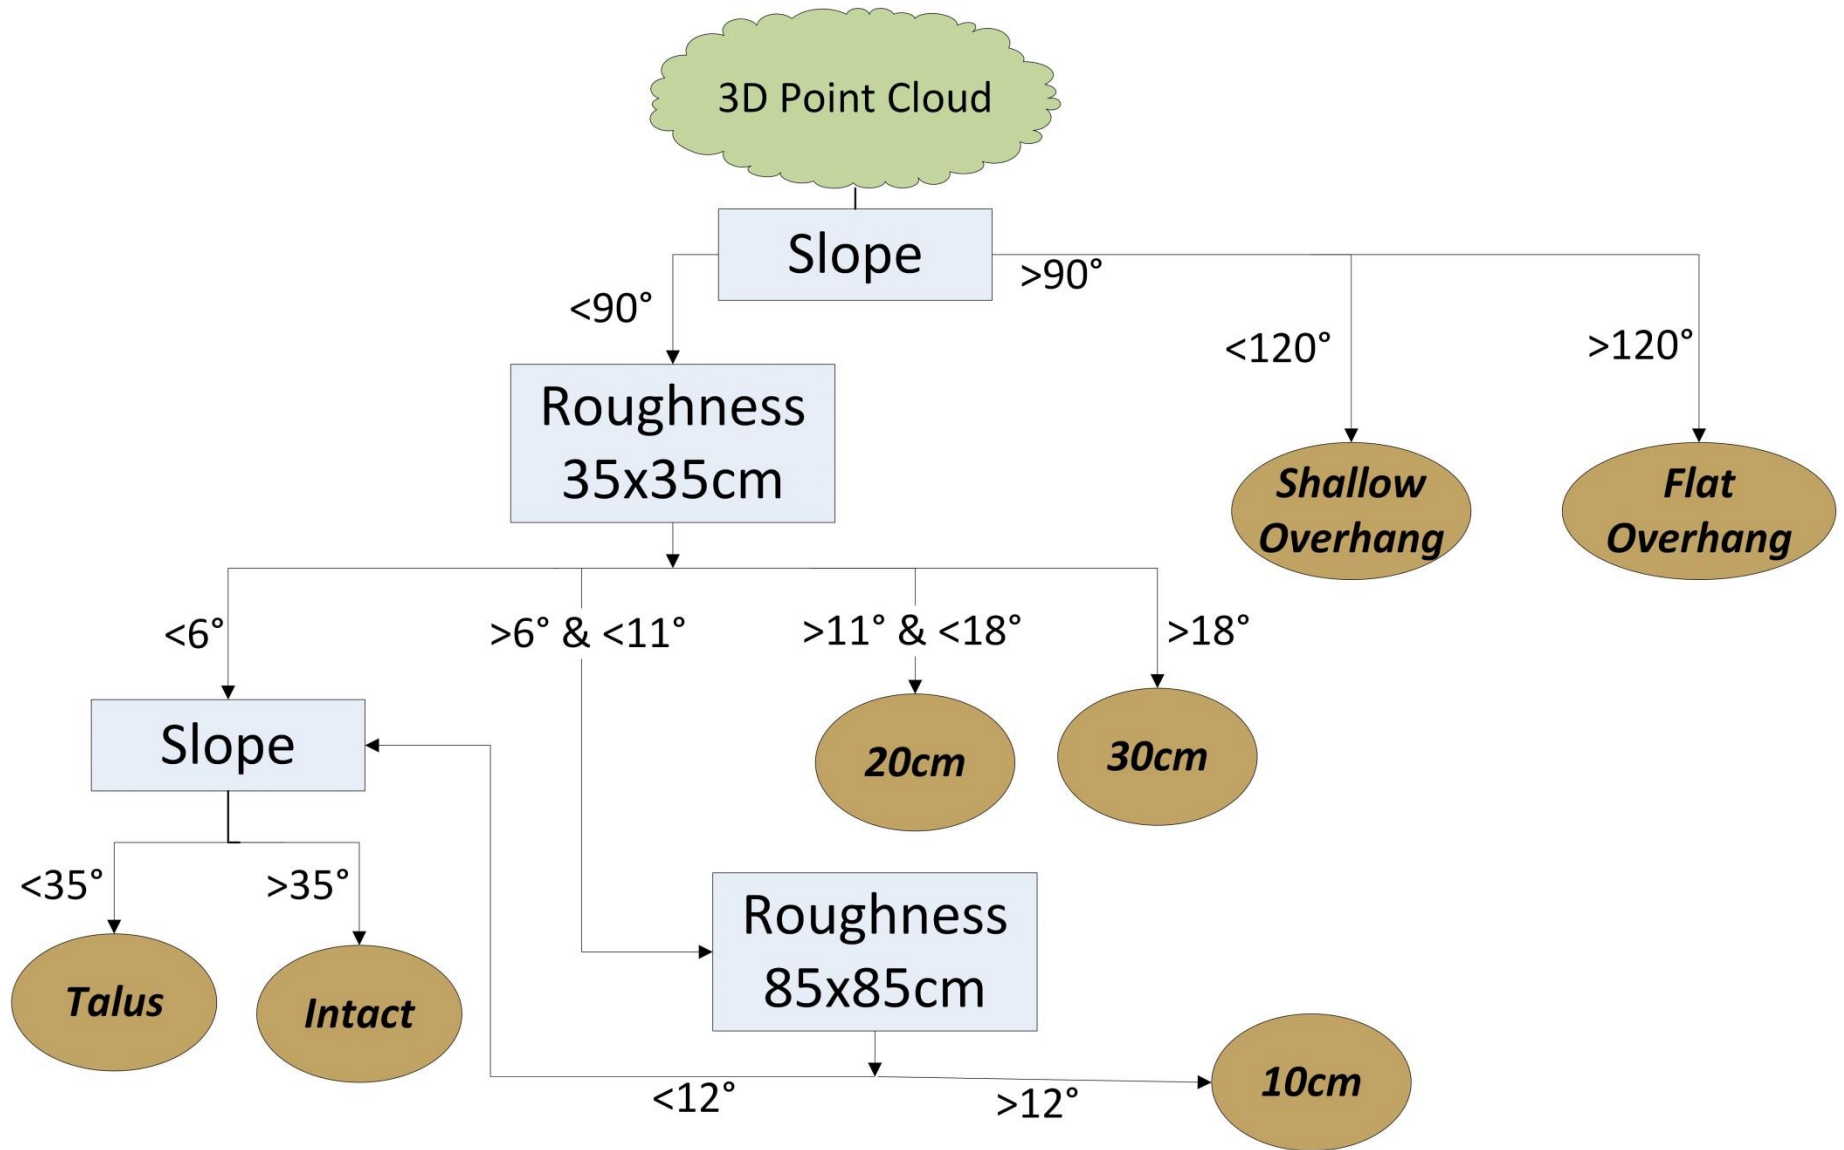
Figure 6.7: Each pixel has values for the roughnesses and slope which are used to determine which use this flow chart to determine classification.
