**Rock-slope Activity Index (RAI): a lidar-derived process-based
rock-slope assessment system**

Master of Science in Civil Engineering

University of Washington

2015

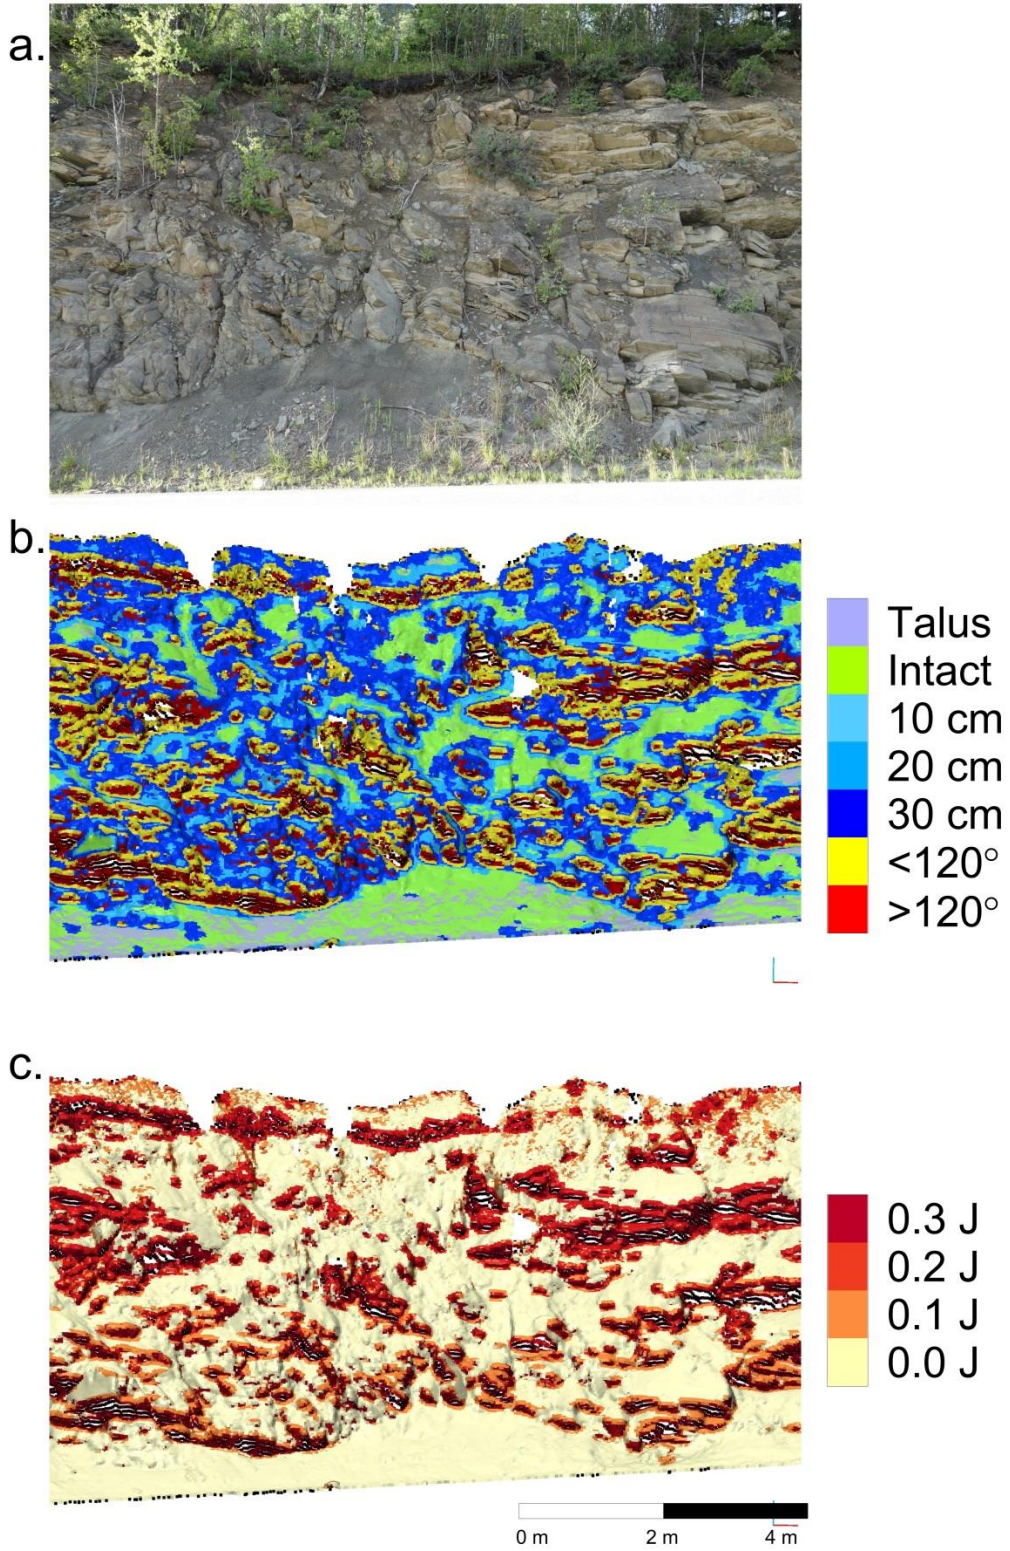
Figure 6.8: Example area of RAI system. a. photo of area, b. RAI classification, and c. RAI hazard rating

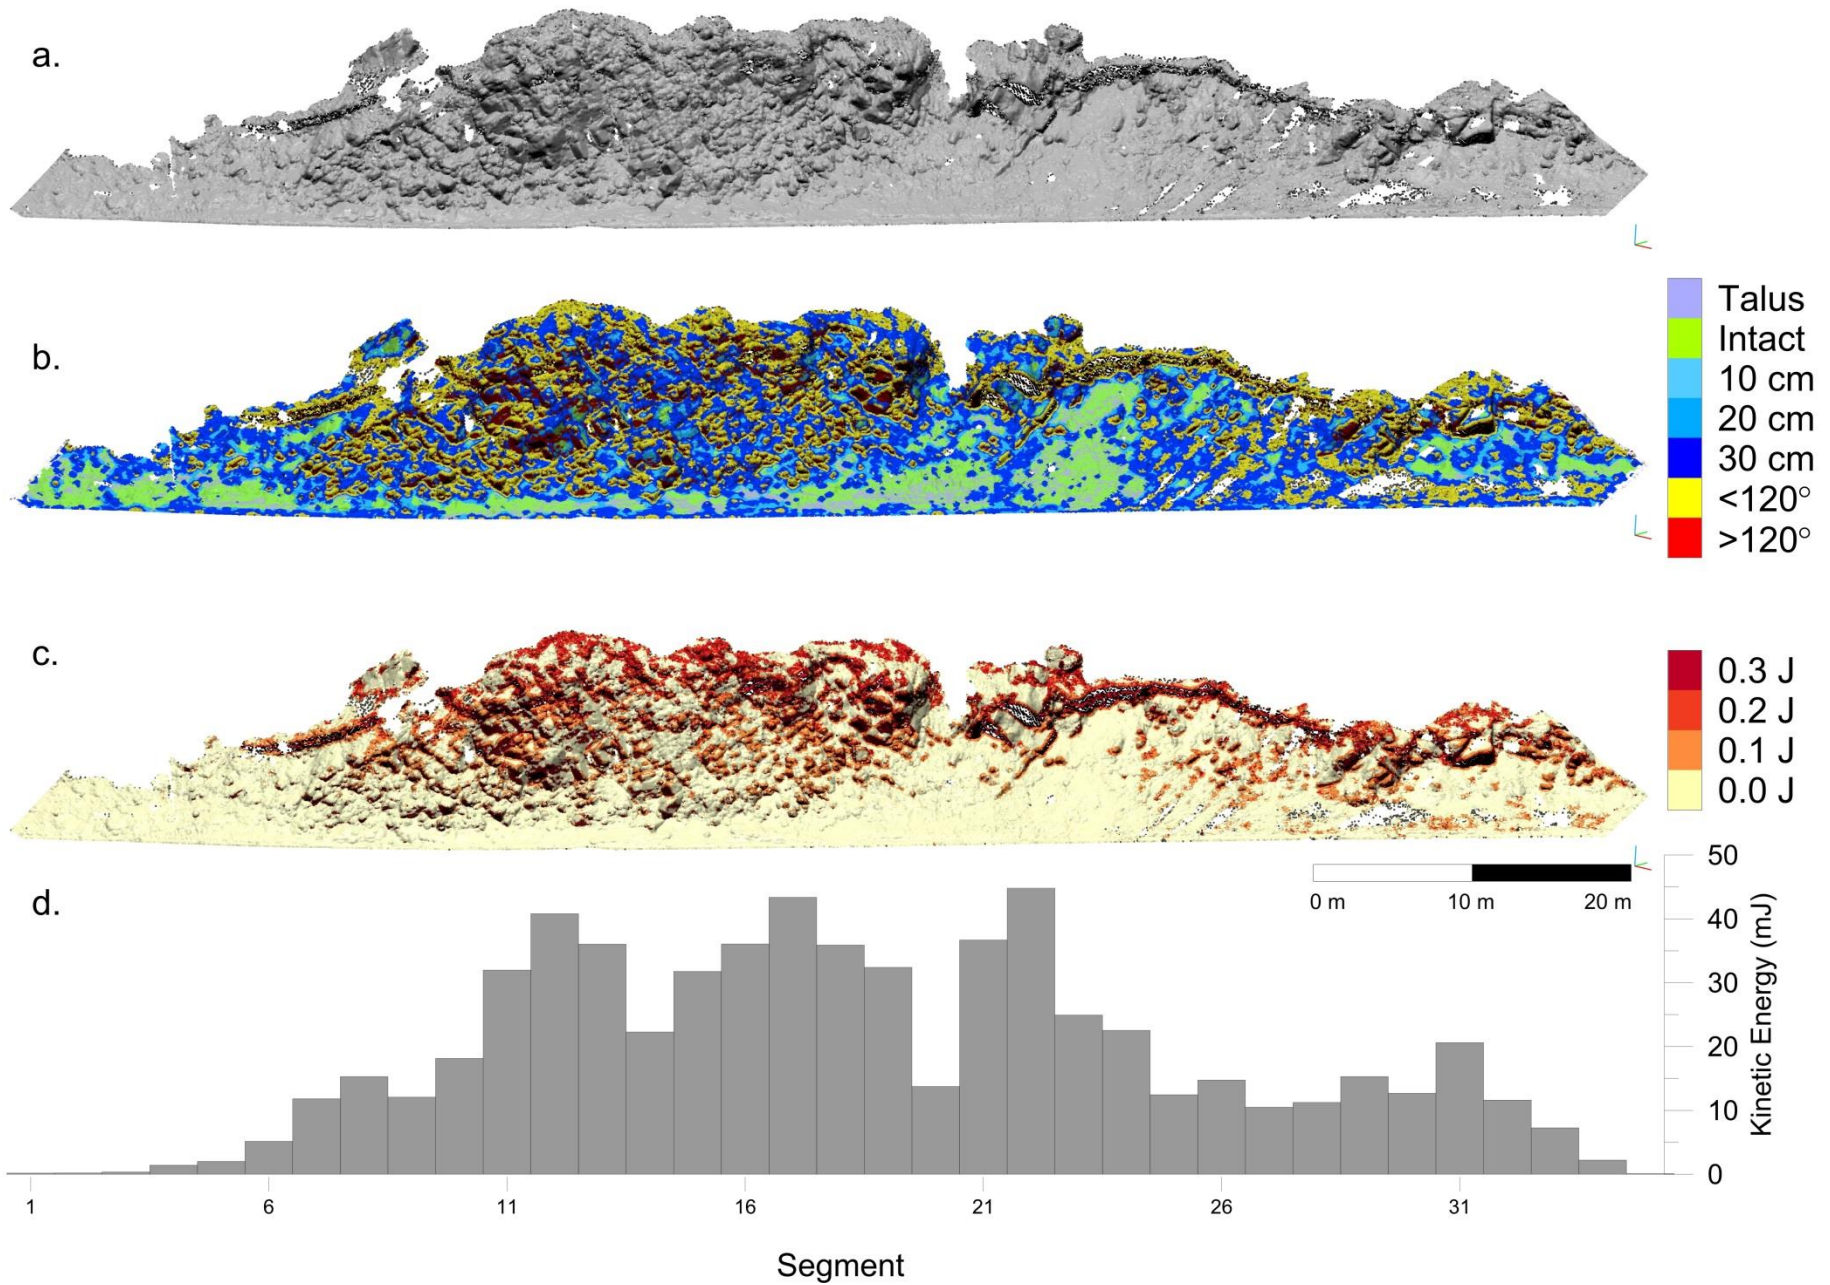
Figure 6.10: MP 85.5 a. lidar scan, b. RAI classification, and c. RAI-KE rating d. 2m RAI-KE totals

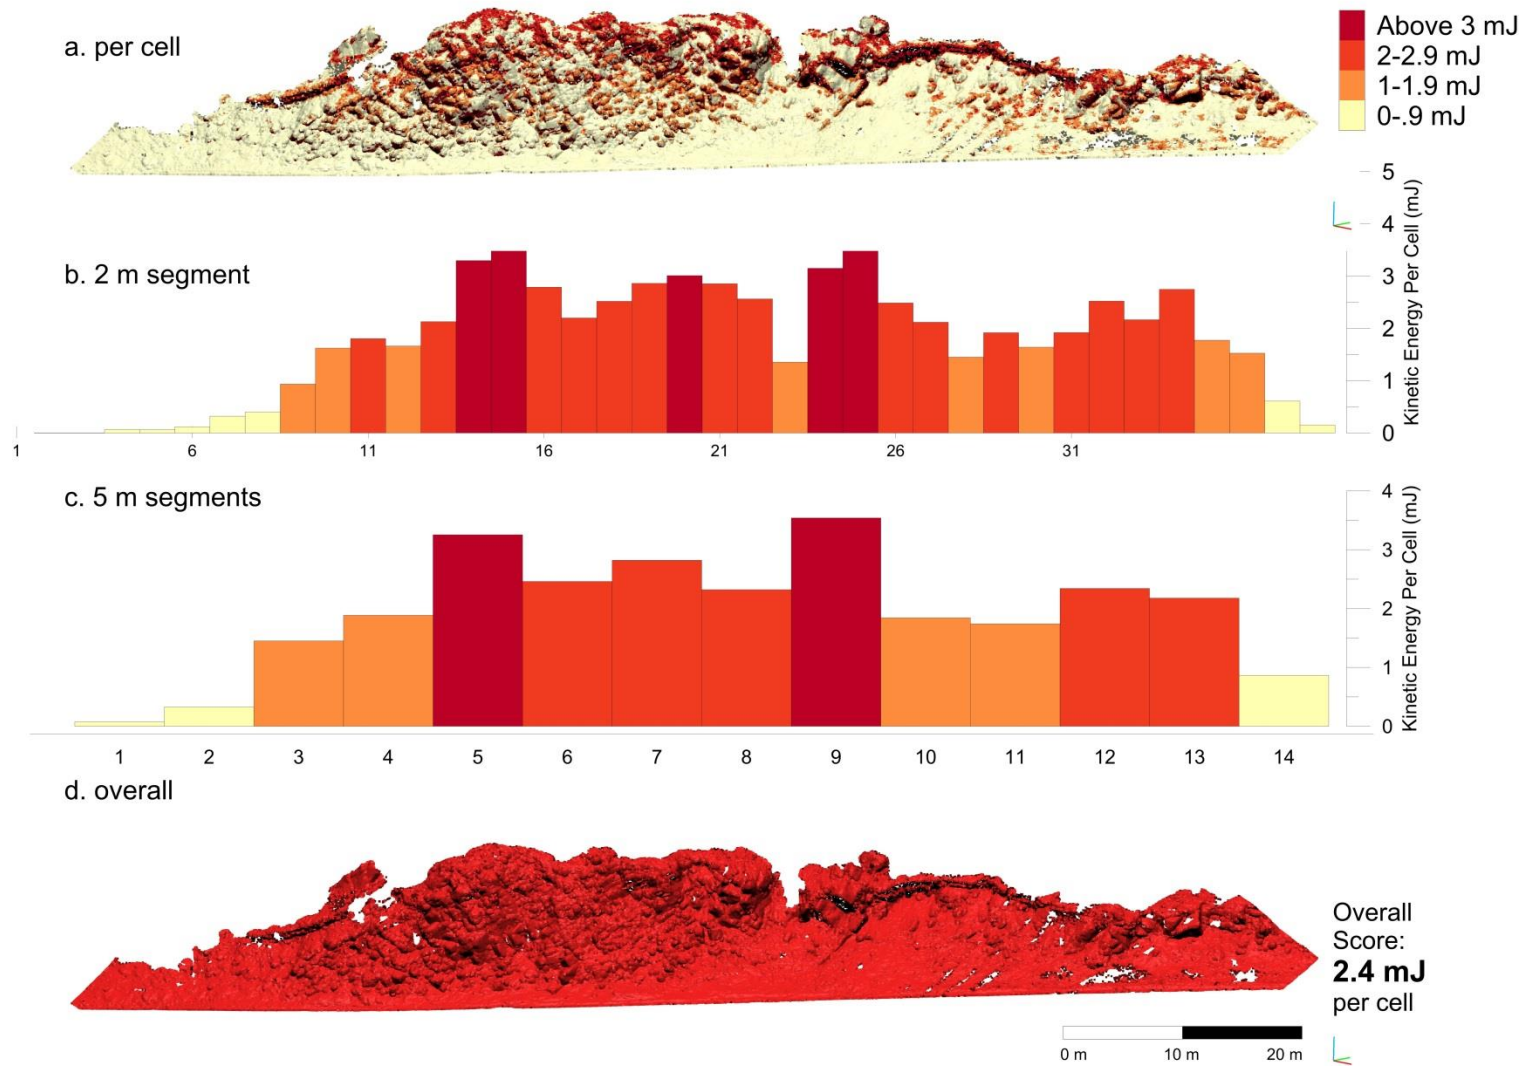
Figure 6.11: Glenn Highway milepost 85.5 shown in four resolutions of RAI a. overall per cell score, b. 2m segments, c. 5 m segments and d. overall site score per cell

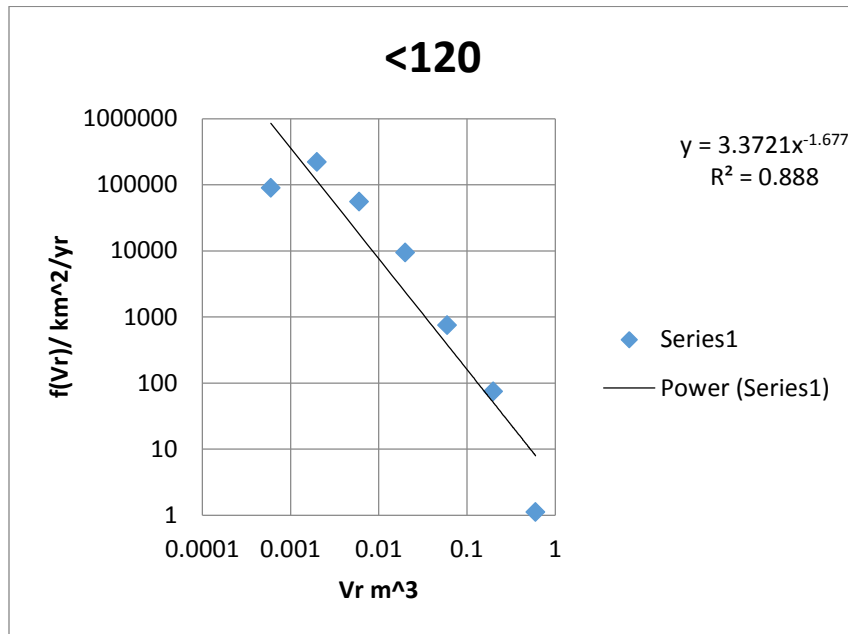
Figure 8.3: Regression of <120 on Glenn Highway MP 87

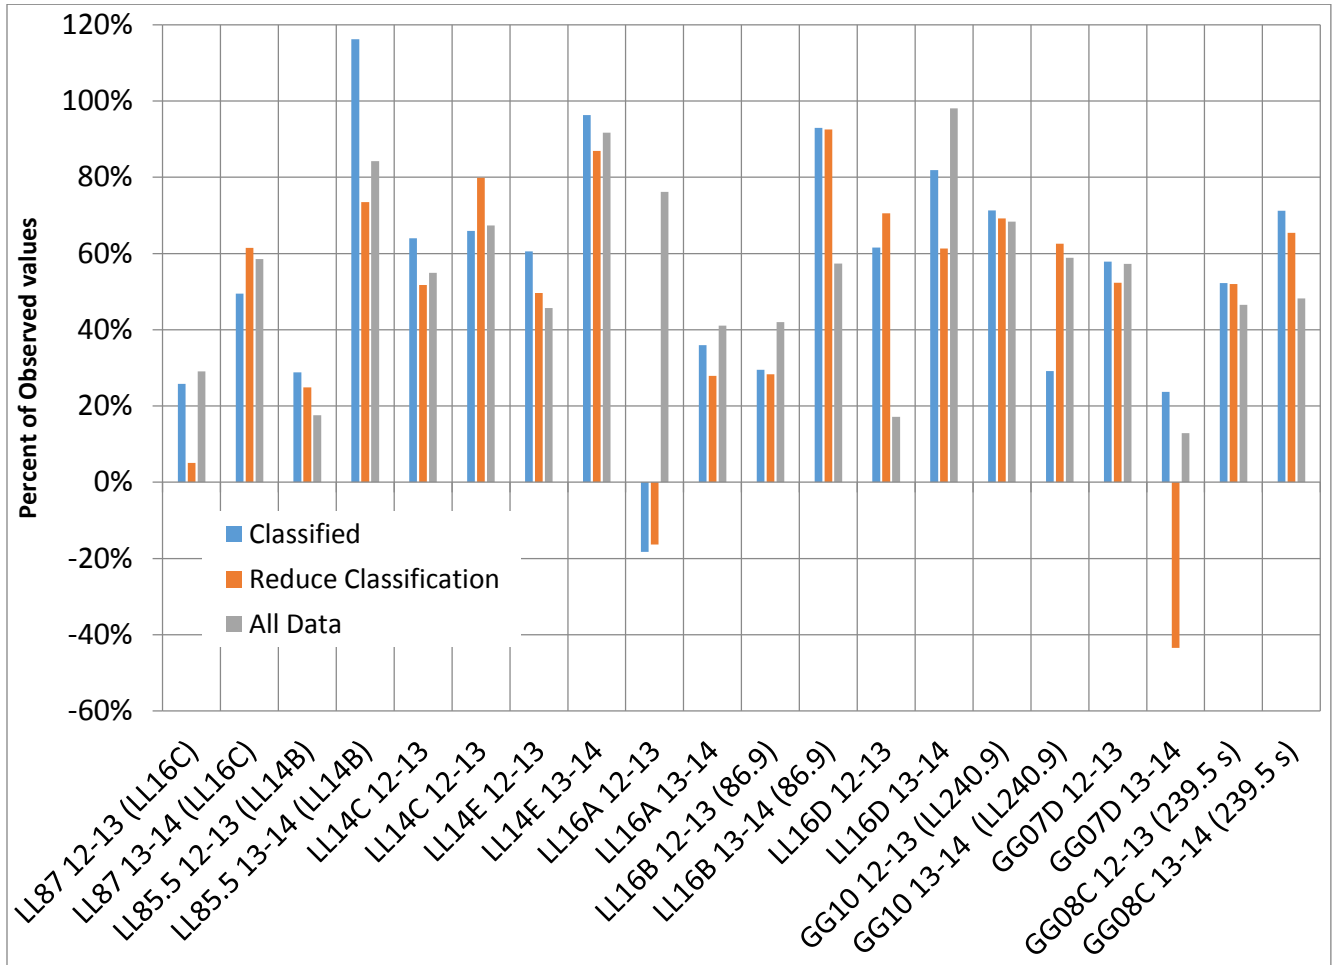
Figure 8.10: Percent of predicted values to observed values assuming that 0% would be equal.

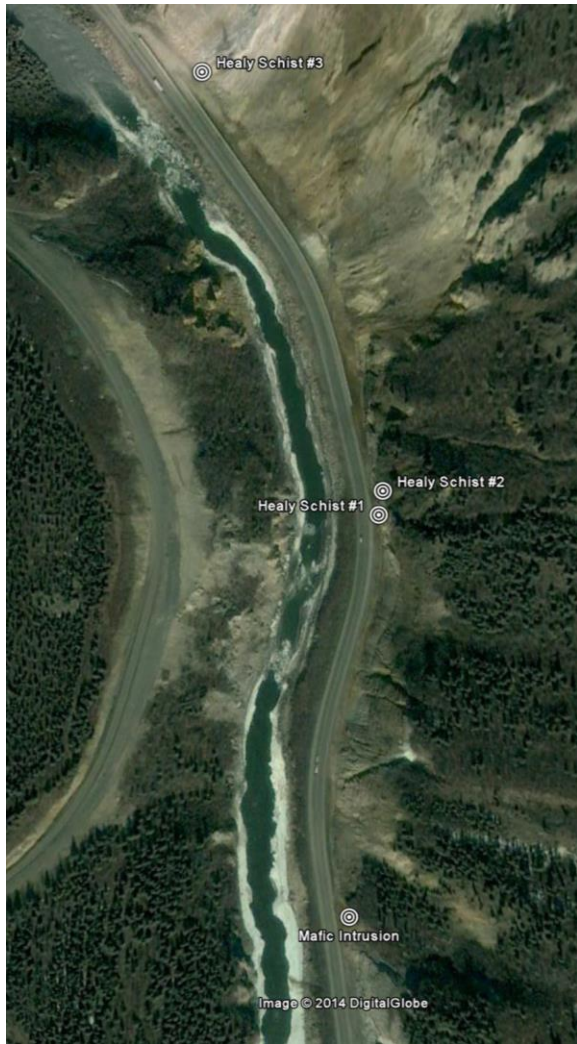
Figure B1: Schmidt hammer sites along Parks Highway

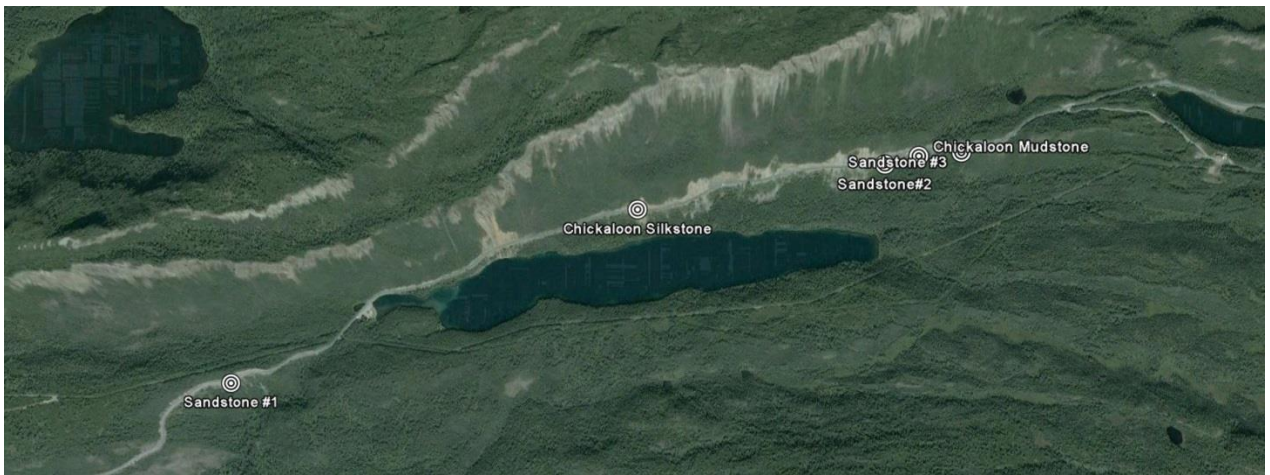
Figure B2: Schmidt hammer sites along Glenn Highway
