Salmon Habitat Restoration Projects:
Success or Learning Opportunity?

**Reach Scale Effectiveness
Monitoring Program**

2005 Progress Report

Preliminary Findings

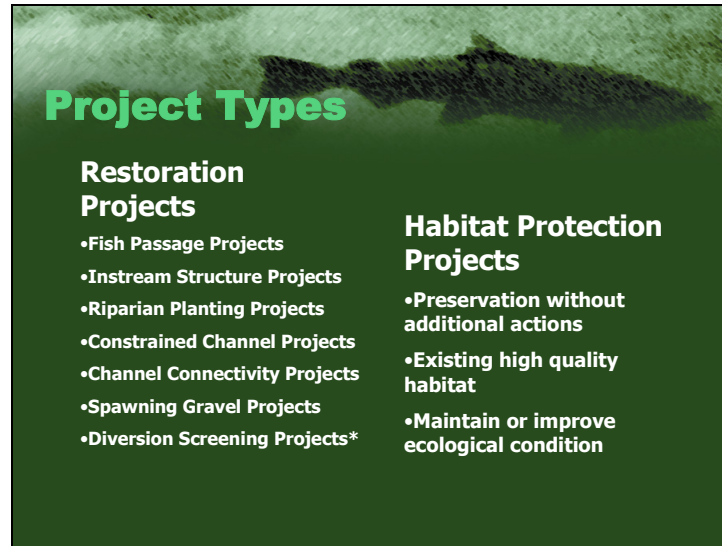
- **Restoration Projects – Monitoring has BACI Design with control and impact reaches; EMAP sample reach; Uses t-test to look for differences before and after implementation (5-10 years)**
- **Habitat Protection Projects – Monitoring focuses on trends in ecological health through time (12 years)**

The Reach Scale Effectiveness Monitoring Program is focused on determining the site specific effectiveness of specific projects funded by the Washington Salmon Recovery Funding Board. These projects broadly fall into two groups – Restoration Projects (where an action takes place on the landscape) and Habitat Protection Projects (where habitat is preserved as is, and the goal is to maintain or improve the condition over time through natural processes). In Restoration Projects, control and impact reaches are generally established and these reaches are sampled before and after the action is implemented to accommodate a Before-After-Control-Impact (or BACI) sample design, and allow for a paired t-test to be used to compare data before and after implementation. Data will be collected after implementation for up to 5 to 10 years depending on project type. For Habitat Protection Projects, ecological health will be tracked through time by measuring in-channel conditions, fish assemblages, aquatic macroinvertebrate communities, riparian vegetation, and upland vegetation over 12 years.

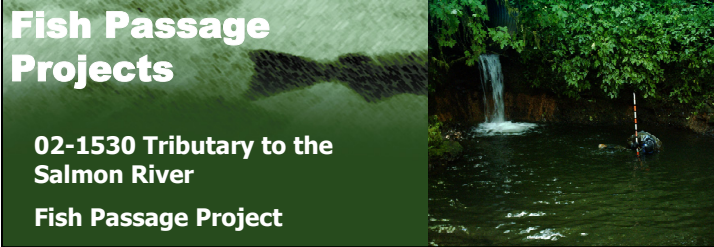
Stream Physical Characteristics				
	CONTROL		IMPACT	
Variable^{1/}	Year 0	Year 1	Year 0	Year 1
Stream Length (m)	N/A	N/A	1,287.48	1,287.48
Reach Length (m)	150	150	120	120
Reach Width (m)	8.00	8.00	2.82	2.82
Fish Data				
Coho Adults (fish/km)	53.3	73.33	0	173.33
Coho Redds (redds/km)	53.3	6.67	0	6.67
Fish Passage				
Passage Design (y/n)	N/A	N/A	N/A	yes

Example of data from a current fish passage project. This data is “pre-project” or before implementation data. As you can see there is some use by juveniles above the barrier (although these are likely rainbow vs. steelhead) and there was a carcass noted above the barrier, although this may have been moved by animals feeding in the area. The culvert is perched above a pool and does not currently allow sufficient passage. The culvert will be replaced this summer and we will go back to monitor both adults and juveniles after the replacement is complete.

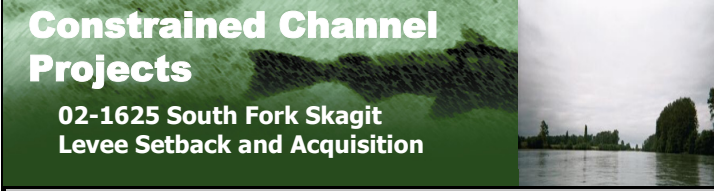
Stream Physical Characteristics				
Variable ^{1/}	CONTROL		IMPACT	
	Year 0	Year 1	Year 0	Year 1
Height of Constraining Structure at Bankfull Width (m)	2.69	2.00	3.05	2.20
Bankfull Width (m)	175.00	183.67	144.26	151.18
Mean Residual Pool Vertical Profile Area (m ² /reach)	215.95	351.66	754.69	792.60
Mean Residual Depth (m ² /100m)	43.19	66.98	143.74	158.52
Reach Length (m)	500.00	500.00	500.00	500.00
Stream Length (m)	N/A	N/A	0.00	762.00
Channel Constraint				
Mean Bankfull Cross-Sectional Area	470.31	367.34	439.73	332.6
Channel Constraint Removed (y/n)	N/A	N/A	no	yes

Example data from a dike removal project on the Skagit River. Mean residual depth at this site is in meters, not in cm. The bankfull cross sectional areas in the control and impact reaches are currently similar. The dike has been removed and subsequent monitoring will show the effects of that action.

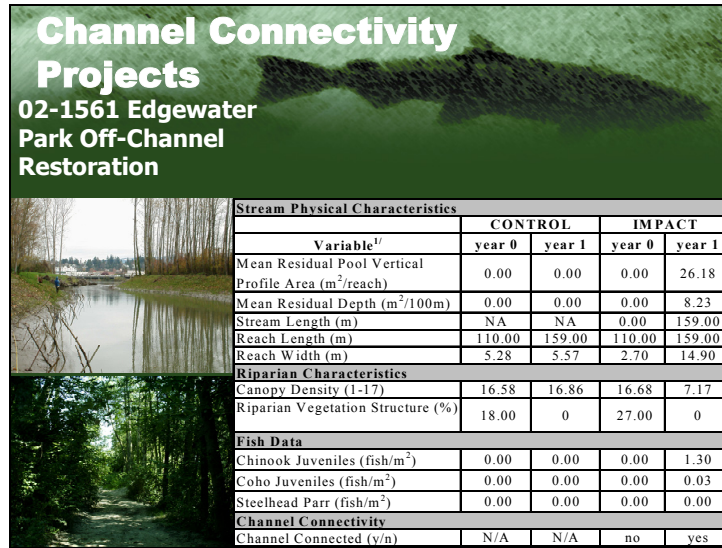
Example data from a reconnection project also on the Skagit River. Very similar conditions currently between control and impact reaches. Both are off-channel habitat. Subsequent monitoring will show the effects of the reconnection which will occur this summer.

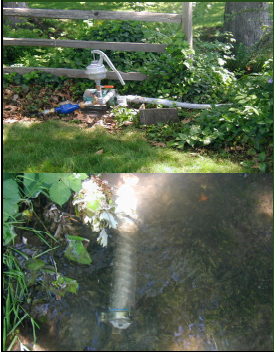
**02-1543 Walla Walla
Fish Screening Project**

Screen Design (%)	100
--------------------------	------------

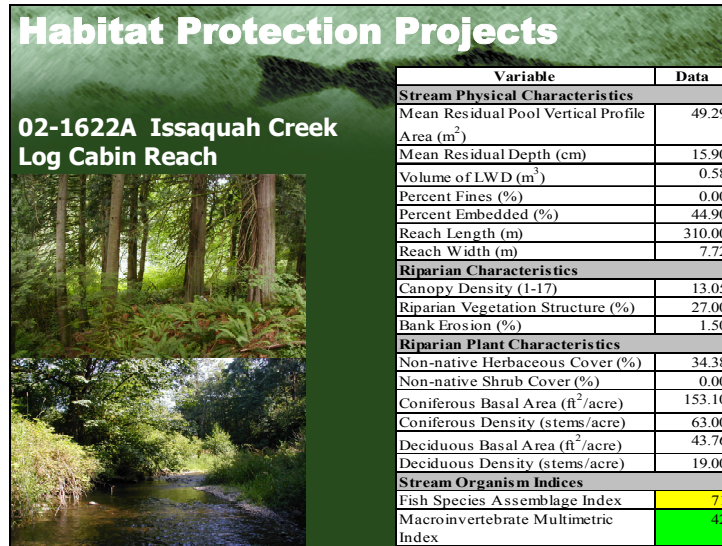
Here is some example data from a habitat protection site in Western Washington. As mentioned previously, there are not controls for these sites, so we will have to look at subsequent data sets to establish the ecological trend for each site. The bottom two cells show the index scores and the color coded rating associated with them. As you can see the fish index rating is fair, and the invertebrate rating is good.
