A Phase I and Phase II Environmental Site Assessment of Langus Riverfront Park,
Everett, Washington

Joshua Hilderbrand

University of Washington

December 2016

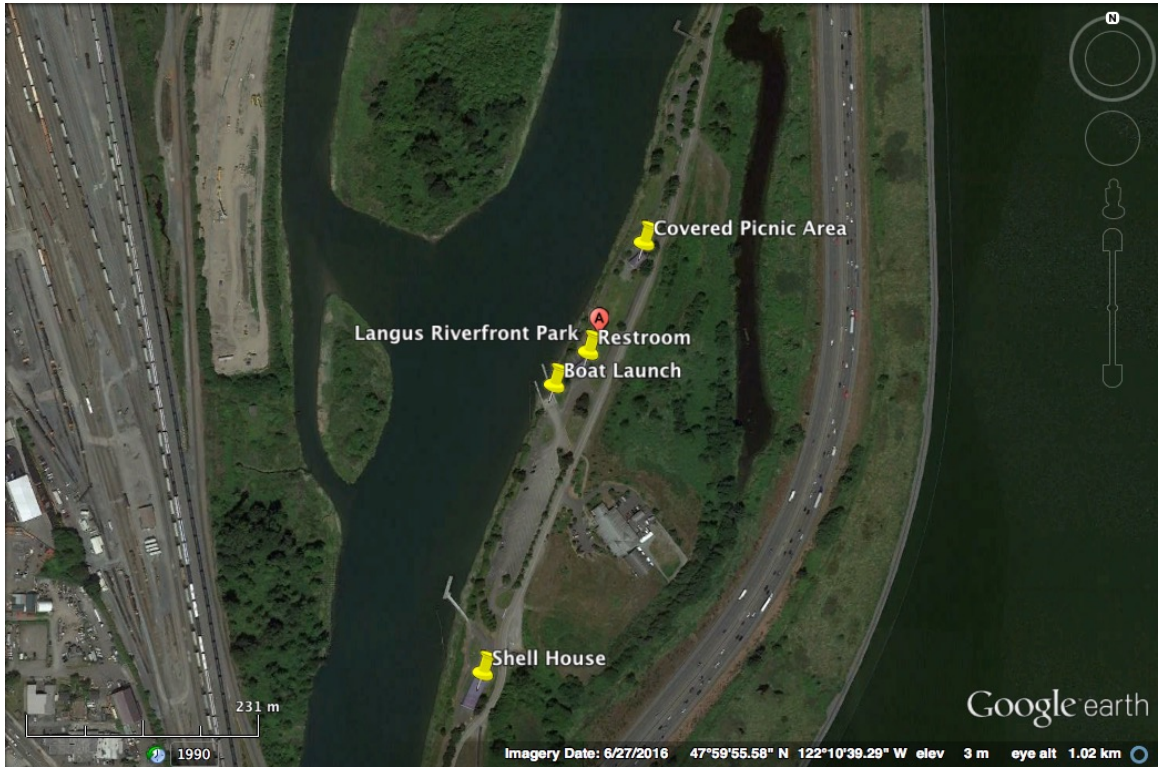
Figure 2: Google Earth image showing the extent of Langus Riverfront Park, with buildings labeled.

Langus Riverfront Park is located along the east bank of the Snohomish River in Everett, Washington (Figure 1). The park has a shell house (boat storage), boat launch, restrooms, and a sheltered picnic area (Figure 2;Everettwa.gov, 2016). The park is attached to a 3-mile paved trail that encompasses 96 square acres (Everettwa.gov, 2016). This location was chosen for this project because it is located one mile southwest of the Everett smelter site and is well within the distance the smelter plume could have travelled. For comparison, the Tacoma smelter plume covered 1,000 square miles (Department of Ecology, 2016).

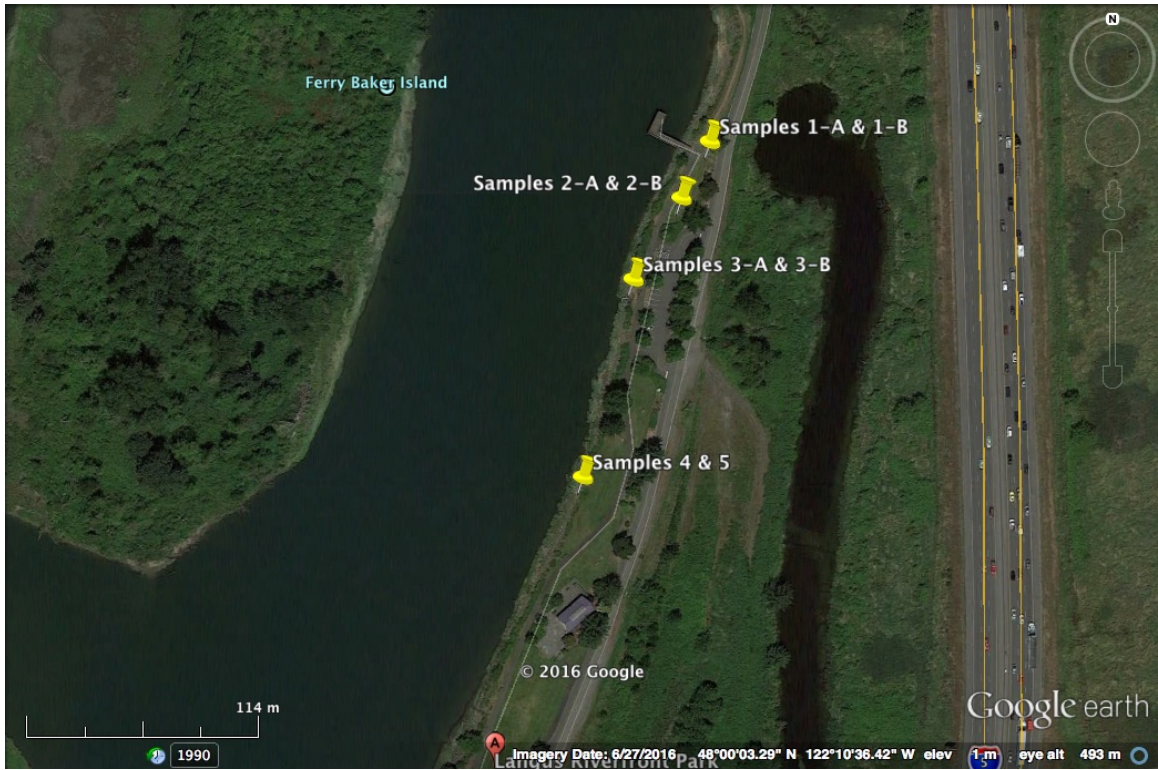
Figure 5: Enlarged aerial photo, showing sample locations 1-5 (Google Earth).

Samples 1-A and 1-B were taken on the north side of the park using a hand auger. The hand auger was driven 18 inches into the soil. 1-A was taken from 0-9 inches in depth and 1-B was taken from 9-18 inches. Both 1-A and 1-B consisted of fine grain sands.

Samples 2-A and 2-B were taken roughly 20 yards south of samples 1-A/B using the same method. These two samples consisted of the same fine grain sand as samples 1-A and 1-B.

Sample 3-A and 3-B were taken along the riverbank using a small shovel near a white two-inch PVC discharge pipe southwest of the first two samples locations. Sample 3-A was taken from a horizon six feet below the parking lot grade. Sample 3-B was taken from the horizon below 3-A at seven feet below parking lot grade. Both 3-A and 3-B consisted of fine to medium grain sand.

Sample 4 was taken from the edge of the river north of the bathrooms using a small hand shovel. The sample consisted of high organic content with high plasticity silts (OH).

Sample 5-A was taken from a soil layer below the grass using a sample container at the same location as sample 4. The sample was mostly organics with some fines (PT).

All sample locations are shown in Figures 4, 5, and 6.

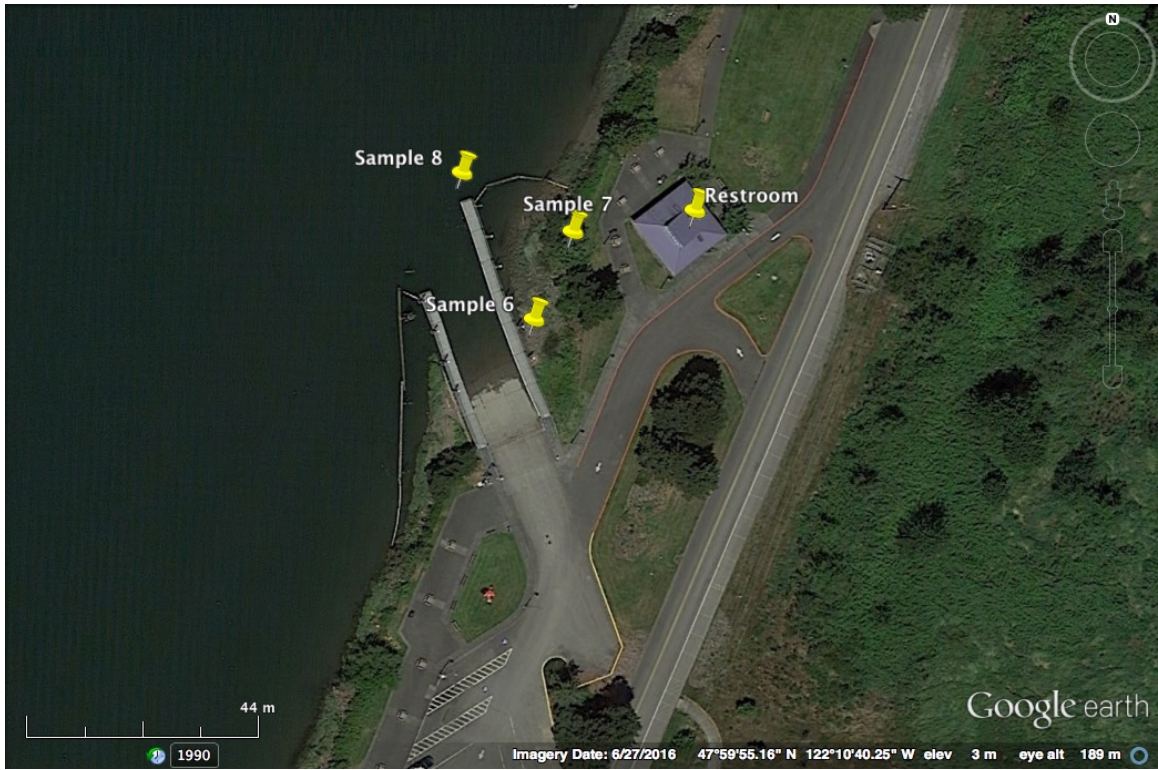
Figure 6: Enlarged aerial photo, showing sample locations 6-8 (Google Earth).

Sample 6 was taken from a muddy bank next to the boat launch using a small hand shovel. The sample contained high organic content with high plasticity silts (OH).

Sample 7 was taken below the sod next to the southern side of the restroom facility using a small hand shovel. The sample contained inorganic silts and fine grain sands (ML).

Sample 8 was taken from the end of the northern dock at the boat launch.

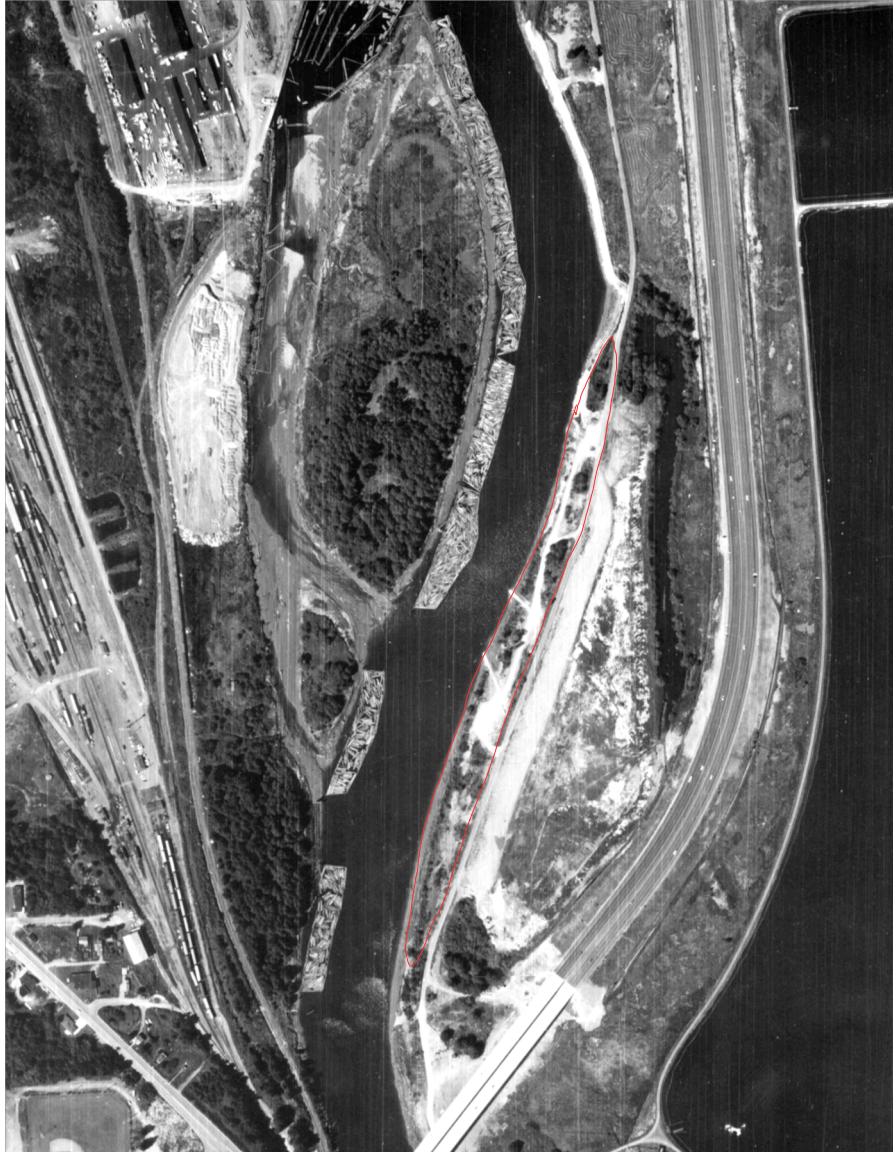
Figure 8: Aerial photograph of the park location taken in 1970.

A survey map drawn in 1887 (figure 9) along with an aerial photograph taken in 1958 (figure 10), the aerial photograph taken in 1970 (figure 8), a Google Earth image from 1990 (figure 11A), and a current Google Earth image (figure 11B) all show that the shape of the river or riverbanks has not largely changed during the past century.

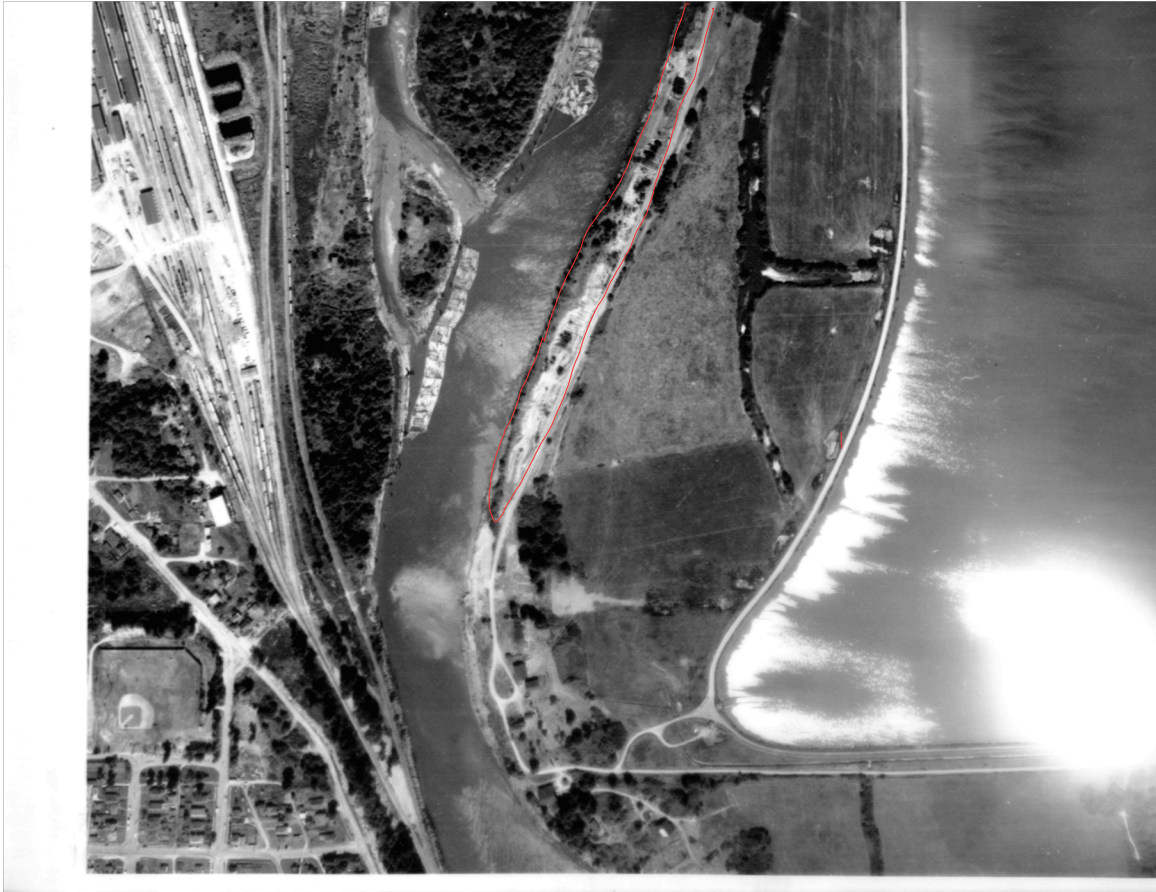
Figure 10: Aerial photograph of the park location taken in 1958 Courtesy of the University of Washington Library.

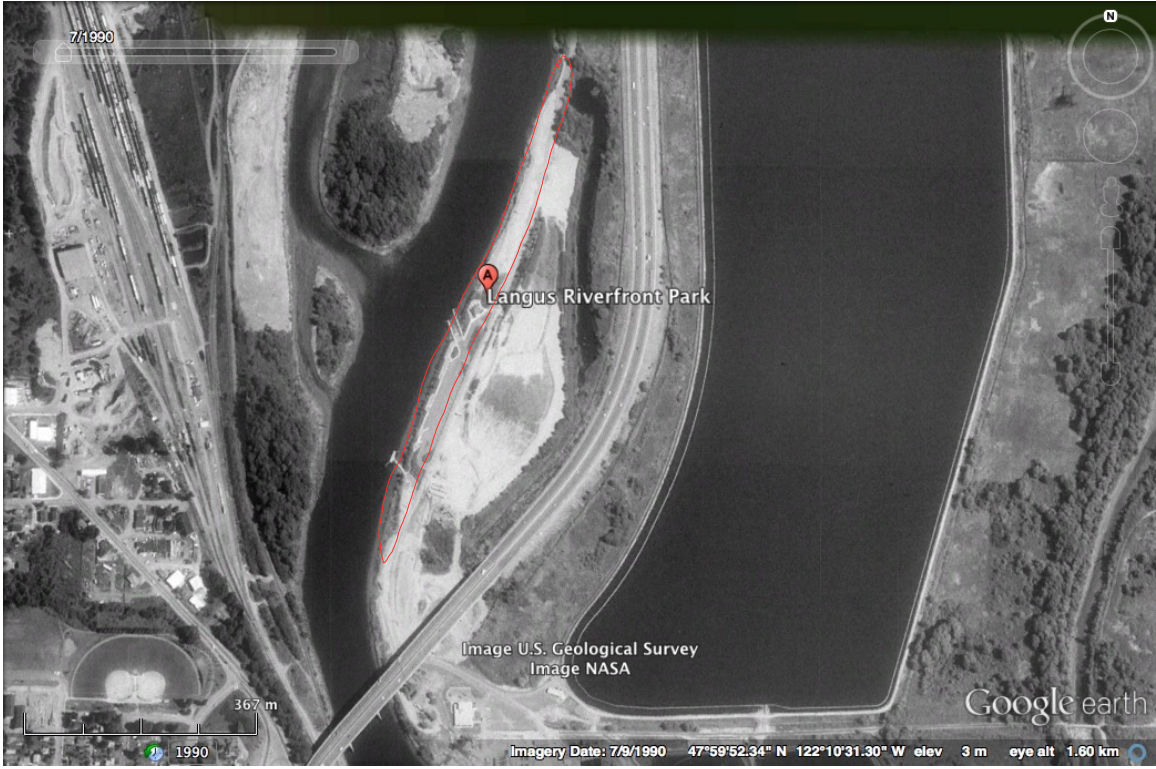
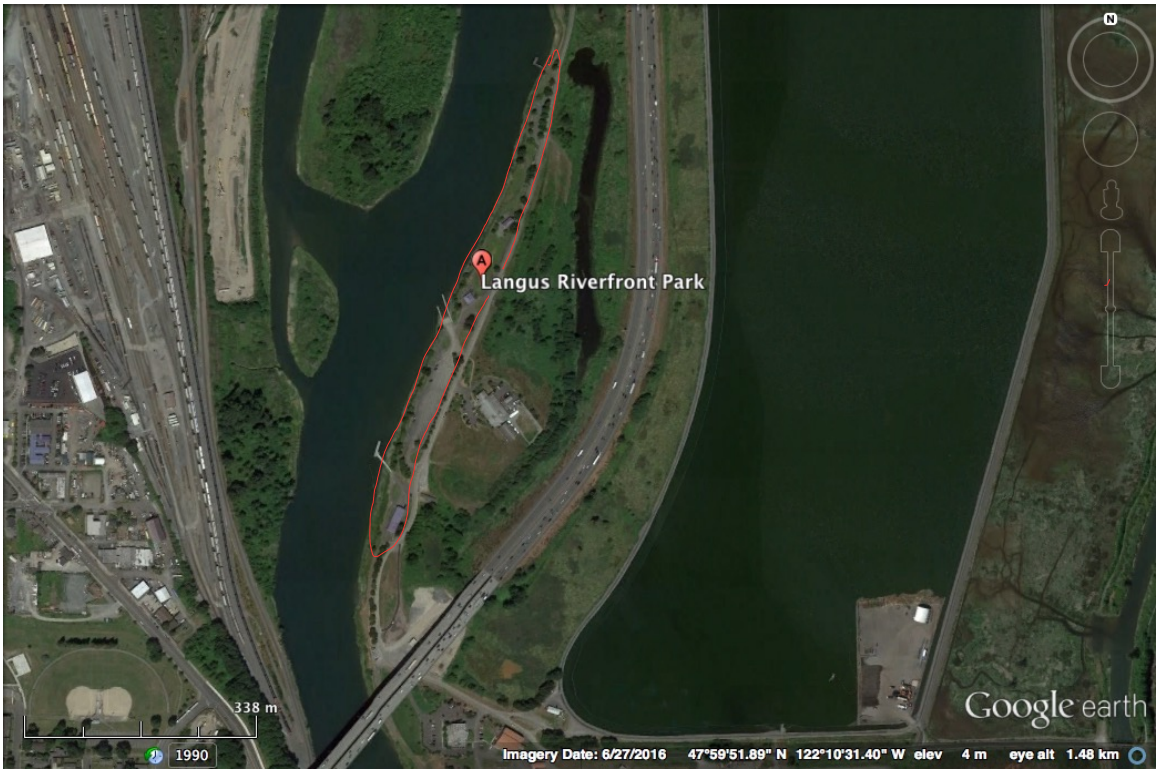
Figure 11. A: Google Earth image of the park location from 1990.
B: Google Earth image of the park location in 2016.
