**Seismic Evaluation of Bolted Connections in  
Non-Seismic Concentrically Braced Frames**

A thesis

Master of Science in Civil Engineering

University of Washington

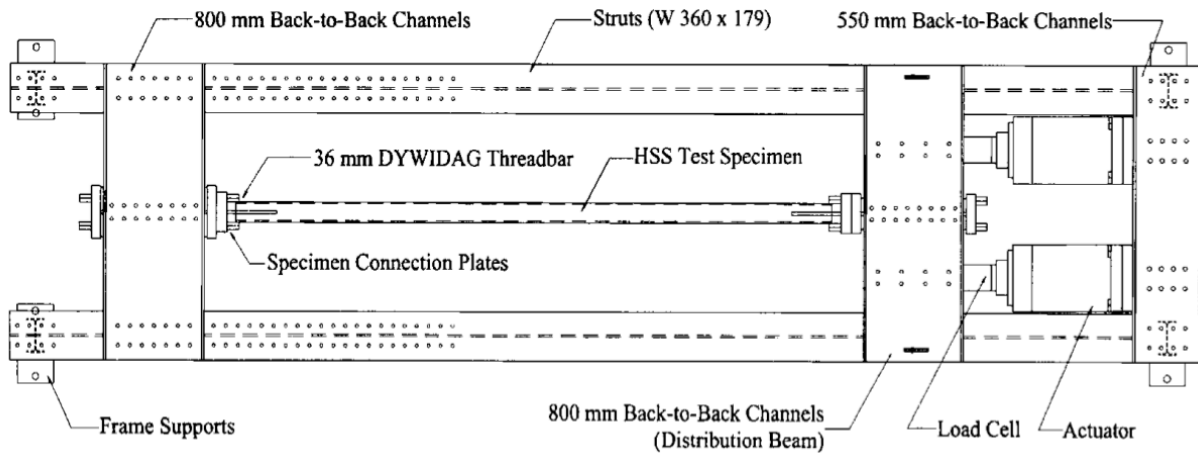
Figure 2.2 - Test Frame Assembly (Shaback and Brown, 2003)

For this experimental study, nine full-scale HSS shape brace specimens with typical end connections were tested under axial cyclic loading until failure in the test setup shown in Figure 2.2. One disadvantage of SCBFs is early HSS brace fracture due to low-cycle fatigue, which can impact the lateral stiffness and energy dissipation capabilities of the SCBF (Shaback and Brown, 2003). This research found that the effective slenderness ratio and the width to thickness ratio were parameters that highly influenced the fracture life of HSS braces. Previous research (Tang and Goel, 1987) found that more slender specimens experience less severe buckling. To illustrate

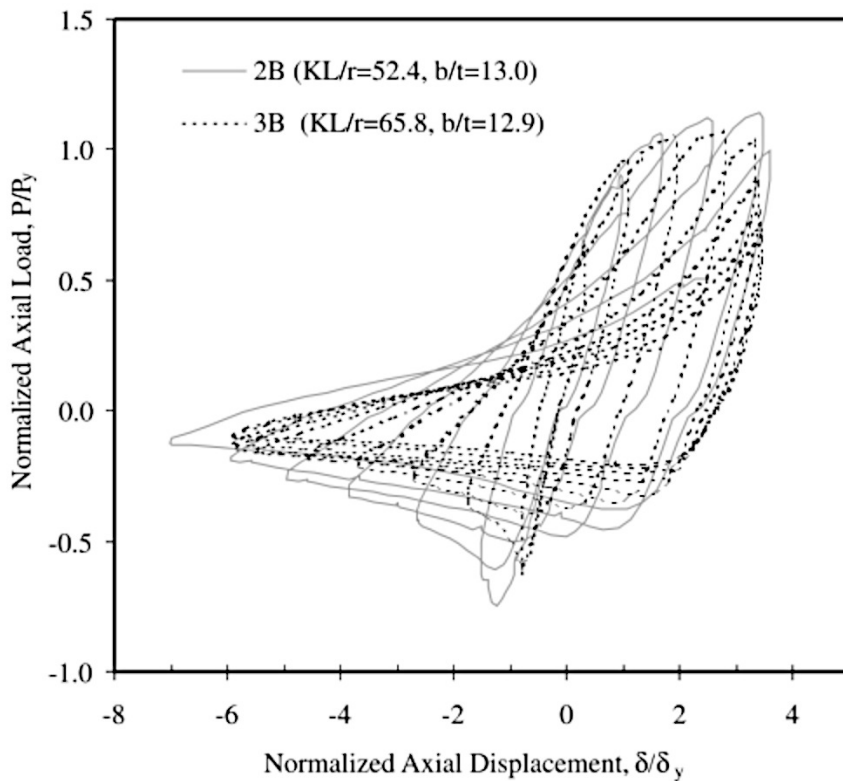
Figure 2.3 - Normalized Hysteretic Curve Comparison (Shaback and Brown, 2003)

the effect of the slenderness ratio on brace hysteretic performance, two specimens with almost identical width to thickness ratios and different slenderness values were compared within Shaback and Brown (2003). The normalized force versus normalized displacement response is presented in Figure 2.3.

Specimen 2B was stockier than 3B. Their hysteretic response shows that 2B exhibits better behavior in compression with fuller loops than 3B. It can be seen that as the effective slenderness ratio decreases, the stiffness degradation decreases, and energy dissipation per cycle increases (Shaback and Brown, 2003). The researchers found that the effective slenderness ratio had the most impact on a brace's hysteretic response. They also found that while the width to thickness ratio had minimal effect on the hysteretic response, it was influential on the brace fracture life. As the width to thickness ratio decreased, the specimens successfully completed more load cycles and reached greater maximum displacements than those with higher width to thickness ratios (Shaback and Brown, 2003).

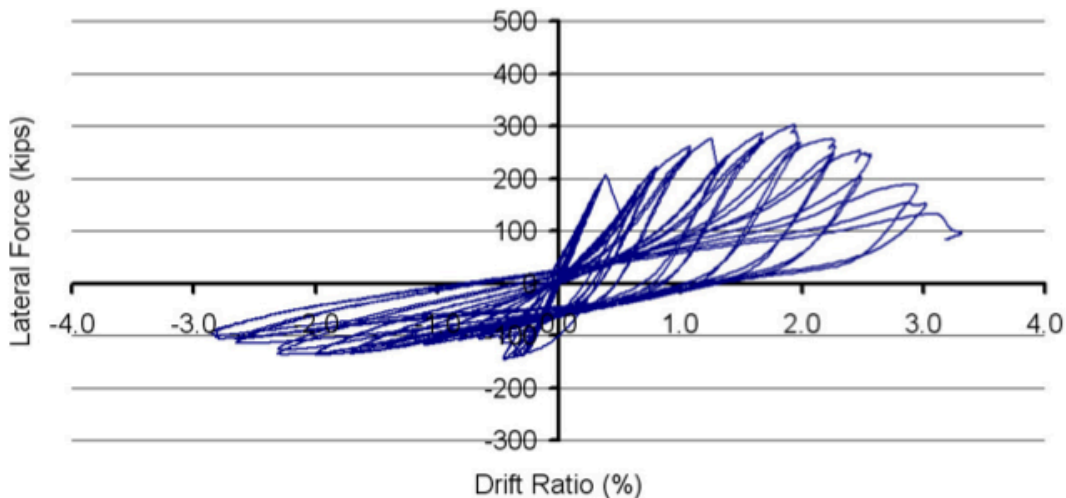
Figure 2.6 - Specimen HSS-16 Force vs. Drift Response (Kotulka, 2007)

The force versus drift response for specimen HSS-16 is shown in Figure 2.6. This specimen reached the highest drift range of any of the UW test specimens at 5.89%. On the other hand, it reached a much lower total force capacity than the other test specimens at 447 kip (78 kip less than HSS-05) and it had an undesirable failure mode of net section fracture in the brace to gusset plate extension plate. Figure 2.7 shows the plate cracking prior to full fracture. The smaller compressive capacity of the frame was due to the fact that the connection buckled before the brace capacity was developed (connection was weaker than brace) (Kotulka, 2007).

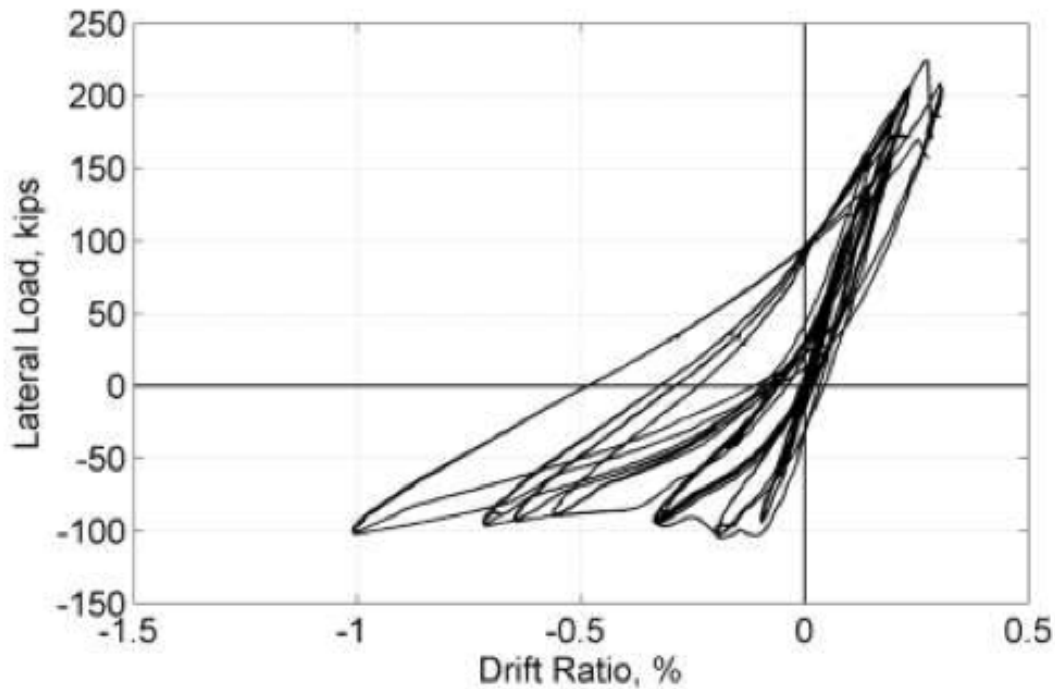
**Figure 2.9 - Specimen HSS-19 Force vs. Drift Response (Powell, 2010)**

The force versus drift response of the frame is shown in Figure 2.9. This frame reached a low total drift range of 1.32% and had a total force range in the frame of 326.2 kip. The failure mode of the test specimen was fracture of the splice plate connecting the WT's to the brace. While designed to improve upon the performance of HSS-16, this frame reached a significantly lower drift level, resisted a smaller force range by 121 kip, and also had an undesirable failure mode. There was minimal yielding in the framing elements and gusset plates throughout the test, failing to accomplish one of the testing goals of utilizing total ductility of the system components (Powell, 2010). All inelastic deformation was located in the splice plates, which led to plate fracture, shown in Figure 2.10.

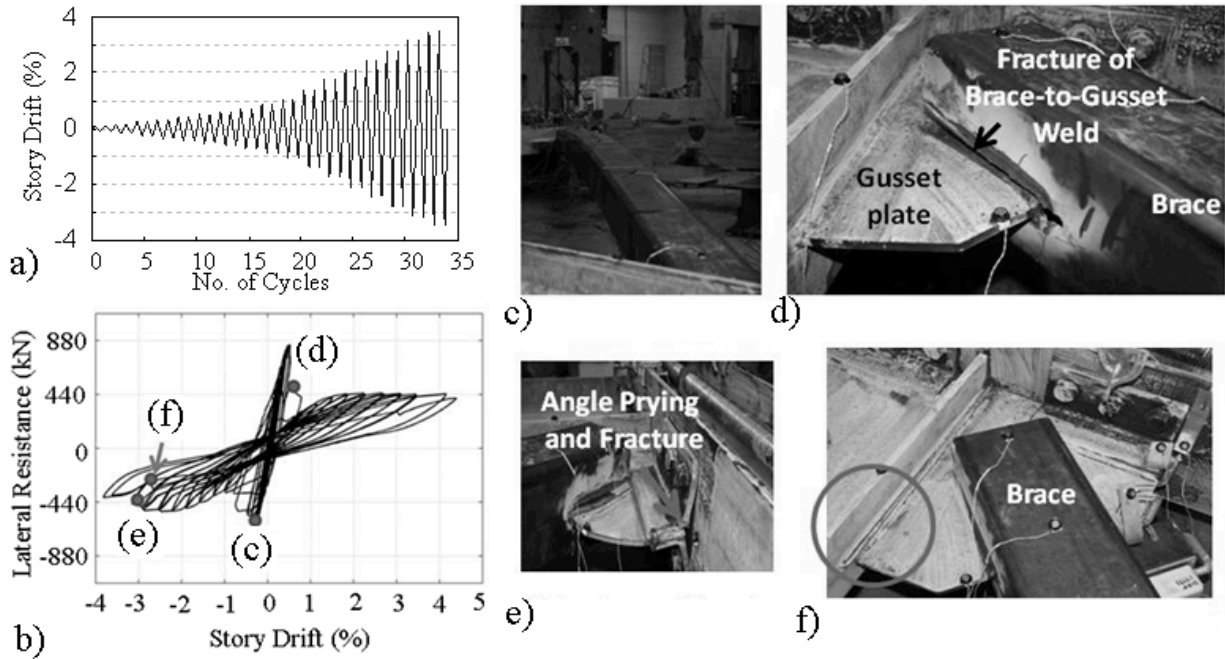
with the gusset plates (Hsiao et al., 2011). The bolted angle connections underwent large deformations, which led to angle fracture at +3.1% story drift. Weld fracture was also seen in the gusset plate to beam welds. For this NCBF, the strength of the connection controlled the system performance. The test exhibited an extremely brittle, unpredictable, and undesirable failure mode of weld fracture. Although the system was classified as “failed” early on, NCBF 32 retained some residual lateral resistance and drift capacity until the test was stopped.

a. Load Protocol, b. Force vs. Drift Response, c. Brace Local Deformation at Plastic Hinge, d. Connection Fracture, e. Fracture of Gusset Plate Connecting Angle, f. Weld Tearing in Opposing Gusset Plate.

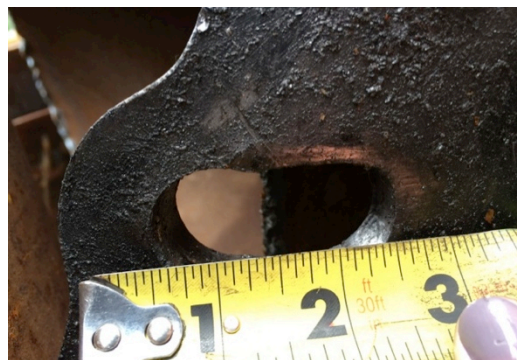
b. Bolt Bearing Deformation from NHSS-B3

Figure 2.15 - Bolt Bearing Deformation

The left side of the equation is related to bolt tearout, discussed below. The right side of the equation is related to bolt bearing. The specified minimum tensile strength of the connecting material is multiplied by the area shown in Figure 2.15 (bolt diameter multiplied by the material thickness).

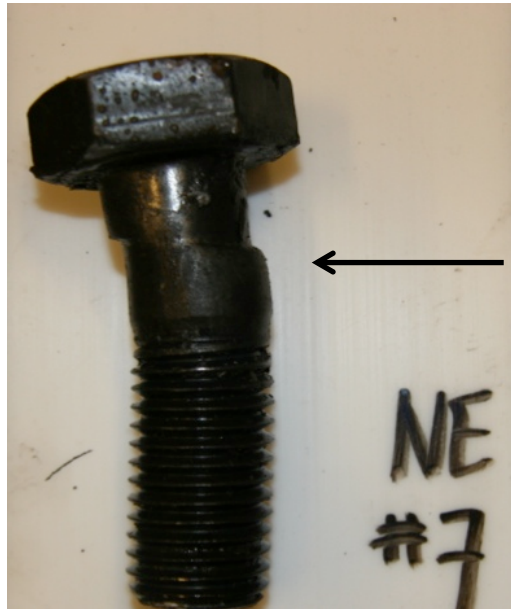
Shear Plane

b. Bolt Deformation from NHSS-B3

Figure 2.16 shows an illustration of a bolt in single shear undergoing bolt shear deformation, and a photo of bolt deformation from NHSS-B3 after the completed test. In the latter, there is a clear shear plane that developed in the bolt, but did not cause a bolt shear failure. All bolted specimens describes in this thesis were loaded in single shear. For bolts, the location of the shear plane is important to a bolt's shear strength. The shear strength of the bolts can either be calculated when the threads are excluded (resulting in a higher shear strength per bolt), or when the threads are included (resulting in a lower shear strength per bolt). Eventually, with increased force, this deformation can result in a bolt shear failure, discussed below.

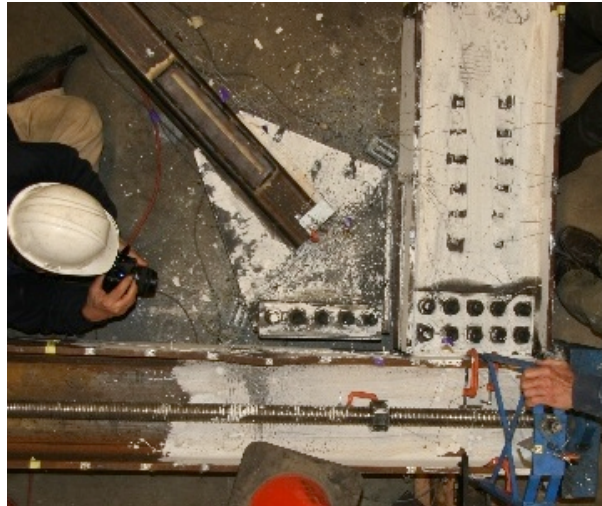
**c. Severe Yielding, Y3**

**Figure 5.3 - Typical Yield Progression on Gusset Plate (from Specimen SHSS-B2)**

Strain gauge measurements (described in Chapter 6) and whitewash yield patterns (described in Chapter 3) are used for measuring and observing yielding in the UW braced frame system experiments. To compare damage levels and to expand upon the notation in Table 5.2, samples of yield progression in the gusset plates and framing elements are shown through photos in Figure 5.3 and Figure 5.4, respectively.

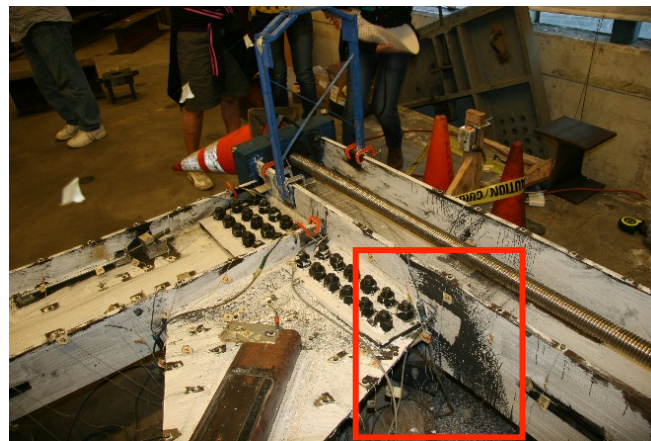
**c. Severe Yielding, Y3**

**Figure 5.4 - Typical Yield Progression in Columns (from Specimen SHSS-B1)**

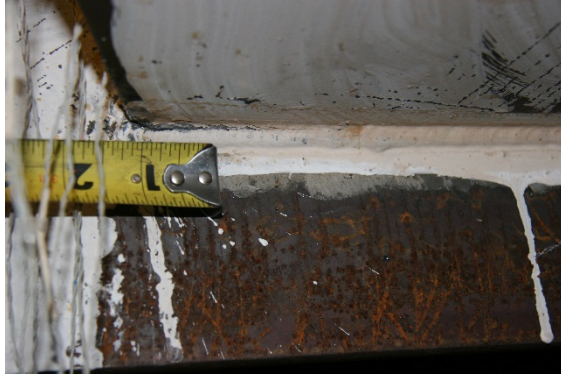
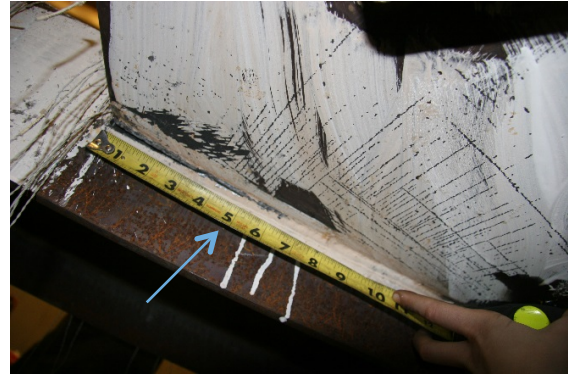
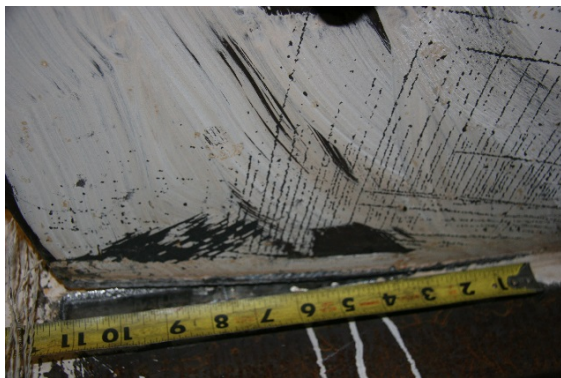
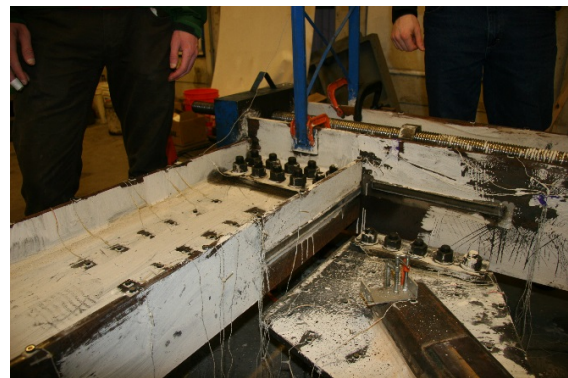
a. Initial Weld Tearing, WB1

b. Moderate Weld Tearing , WB2

c. Severe Weld Tearing, WB3

b. Weld Fracture, WBF

Figure 5.7 - Progression of Weld Fracture (from Specimen SHSS-B2)

Weld tearing was prominent in all specimens, but the extent of the tearing varied. With stable crack growth, weld tearing is tolerable and can accommodate increased drift levels without strength degradation. Weld fracture implies the weld has torn along its entire length and no longer joins the two welded parts. The resistance to unstable weld fracture is related to the CVN toughness of the weld metal. The E71T-11 weld metal used for the specimens is not demand critical weld material and has limited resistance to fracture.

Progression of weld tearing is defined by the performance states from Table 5.2. The photo series in Figure 5.7 shows the development of weld tearing at the beam to gusset plate connection (WB), but weld tearing at the gusset plate to column shear tab (WC) also occurred and followed a similar progression through performance states. Initial weld cracking (WB1), shown in Figure 5.7a, is designated when the crack was visible and had propagated less than 5% of the total weld length. Once it grown to between 5% and 25% it was considered moderate weld cracking (WB2), as seen in Figure 5.7b. Cracks longer than 50% of the total connection length were considered severe weld cracking (WB3), shown in Figure 5.7c. Figure 5.7d shows the connection after the beam to gusset plate weld fractured (WBF).

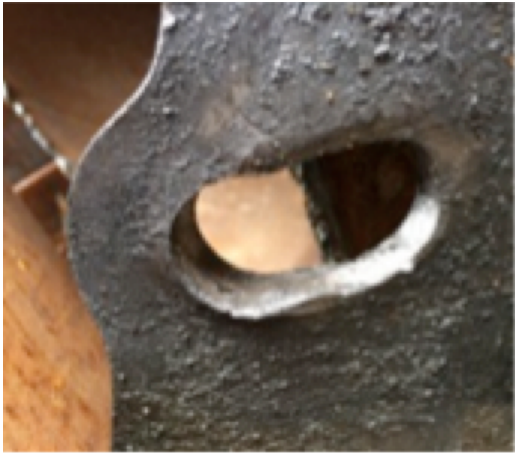
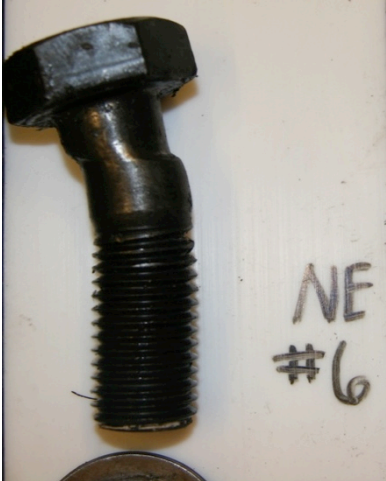
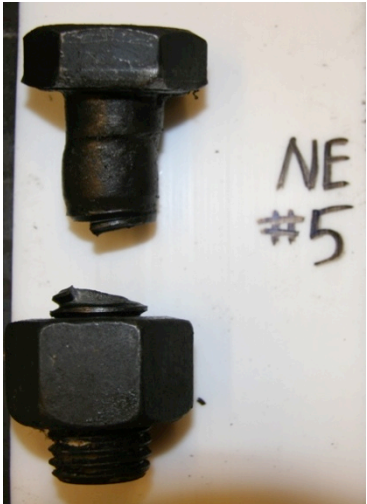
a. Bolt Hole Elongation, BoE (shown in GP)

b. Bolt Deformation, BD

c. Bolt Fracture, BoF

Figure 5.8 - Bolt Performance State (from Specimen NHSS-B3)

Bolted connection yield mechanisms and failure modes were described in Chapter 2. Bolt hole elongation (BoE) and to a much lesser extent, bolt shear deformation can add drift capacity to the system. However, bolt fracture (BoF) is a clear, undesirable failure mode that should be avoided. The bolt performance states presented in Table 5.2 are illustrated in Figure 5.8. Additionally, at the end of each subsection of Section 5.3, diagrams for each bolted connection of the frame illustrate the bolt damage in the bolts, the beam web and/or gusset plate, and the shear tabs. Bolt fracture is dictated with an “X”, elongation/deformation between 1/16 in. and 1/4 in. is hatched with diagonal lines, and bolt elongation/deformation greater than 1/4 in. is fully shaded. For

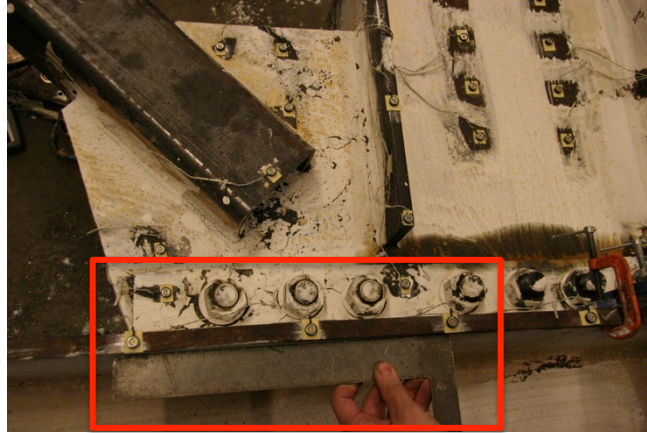
**Figure 5.13 - NE Corner Local Flange Buckling (B1) at -1.0% Drift**

As the cycles continued, the NE corner sustained more yielding and damage than the SW corner. In the NE corner at +0.4% drift, local buckling (B1) of the west flange of the east column at the south end of the gusset plate to shear tab connection occurred, as shown in Figure 5.13. At this same drift level and location in the SW corner (west column, east flange), there was also local buckling of the column flange (B1). After reaching -0.7% drift, the brace had buckled upwards OOP at the midspan 6.1 in. (B2).

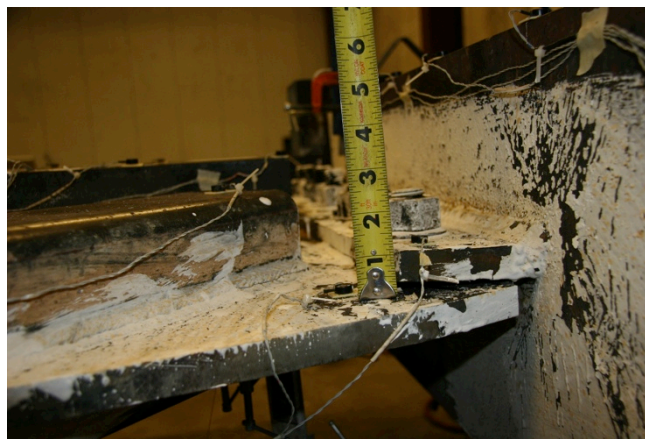
**Figure 5.16 - Gap Between Shear Plate and Gusset Plate in NE Corner**

At +0.5% drift there was a 1/8 in. vertical gap between the gusset plate and shear tab in the SW corner of NE connection, shown in Figure 5.16. This gap indicated that the shear tab was bent upward, sustained inelastic deformation, and did not straighten back out in tension. The gap was only located at the free end of the shear tab, since bolt clamping forces held the plates together at other locations. At +0.7% drift, yield lines (Y1) began to form in the SW gusset plate that ran 45° in each direction from the end walls of the brace.

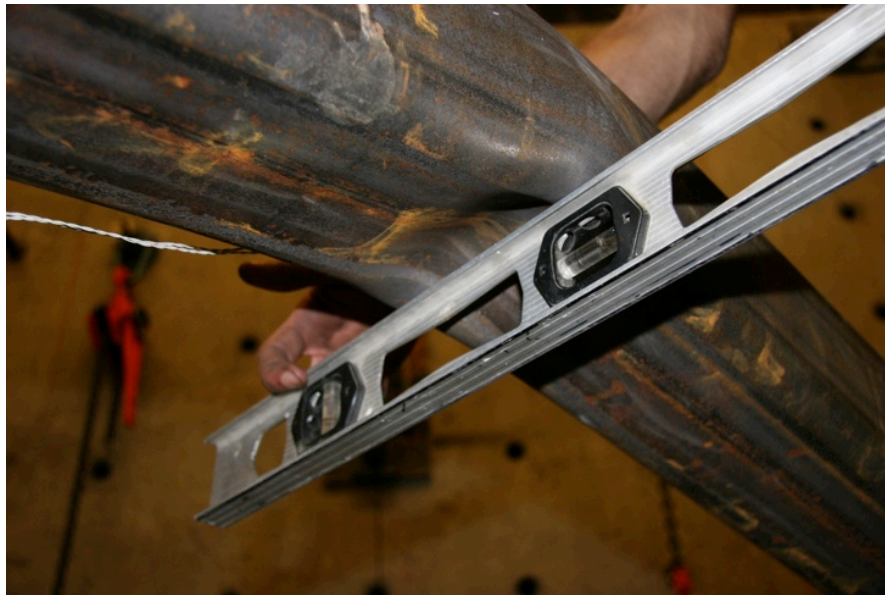
**Figure 5.18 - Brace Local Deformation (B3-Cupping) at Midspan at -2.7% Drift**

At -2.7% drift, the severity of the hinge at midspan of the brace increased (B3-cupping) with the bottom wall cupping inward as shown in Figure 5.18. A 1 in. weld crack on the underside of the SW beam to gusset plate developed (WB1). In the SW corner, a 3 in. long weld crack also developed in the CJP weld (WC1) joining the shear plate to column beginning at the north end of the connection and propagated south. In compression at -2.9%, the weld crack in the NE beam to gusset plate connection had grown to 4.25 in. on top and 6.5 in. on the bottom fillet weld (WB2).

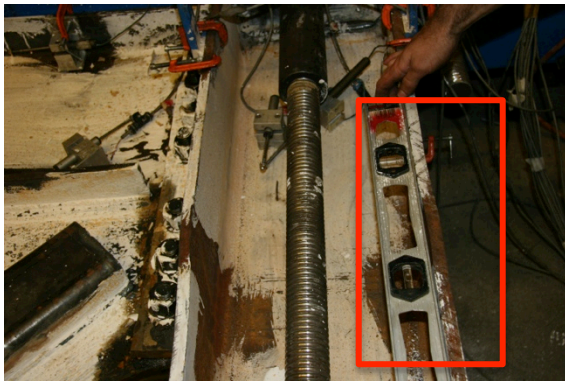
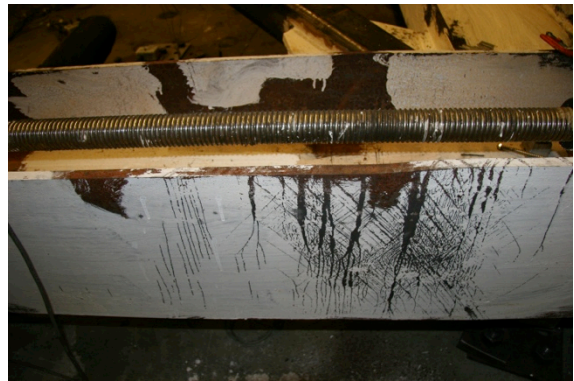
**a. Local Buckling (B1) on West Flange**

**b. Severe Yielding (Y3) on West Flange**

**Figure 5.20 - Damage in West Column in SW Corner at -2.8% Drift**

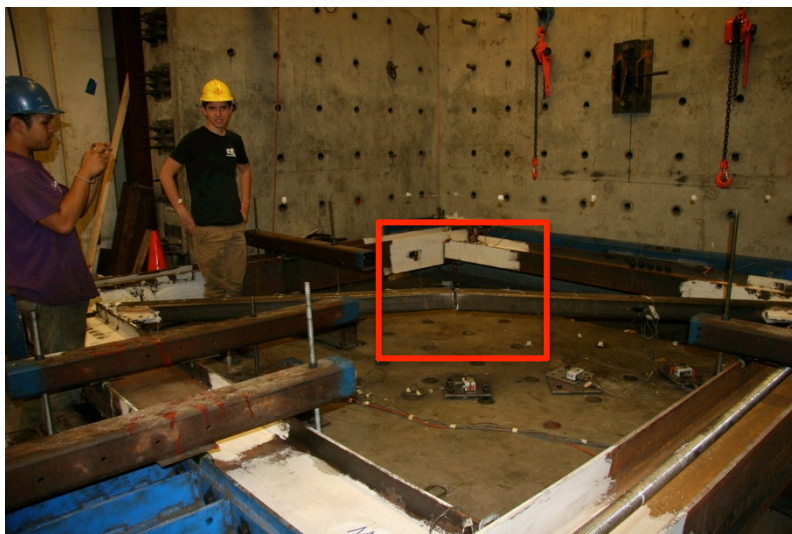
**Figure 5.21 - Brace Fracture (BF) at +2.2% Drift**

The bottom corners of the brace began to tear at midspan at +1.9% drift (shown in Figure 5.19), while framing element rotations increased in both corners. The west column in the SW corner sustained significant yielding over the full depth of the column (Y3) and the west flange of the west column in the SW corner locally buckled (B1) at -2.8% drift, both shown in Figure 5.20. Additionally, the CJP weld crack in the SW corner grew to 5 in. in length but only 3 in. cracked fully through the thickness (WC1). At this compression drift level, there was severe increased local buckling of the brace (B3-cupping) at midspan. At +2.2% drift, the brace fractured (BF), shown in Figure 5.21.

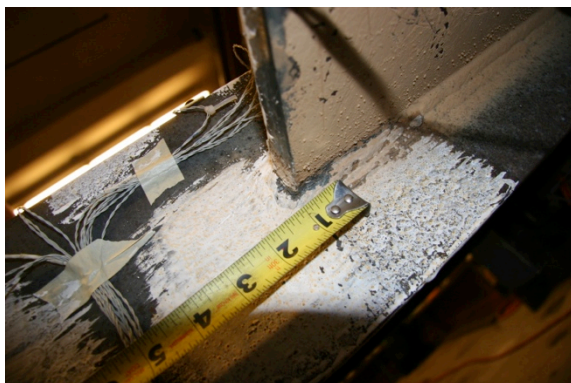
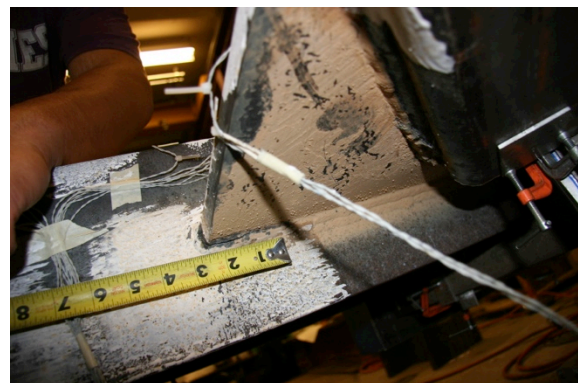
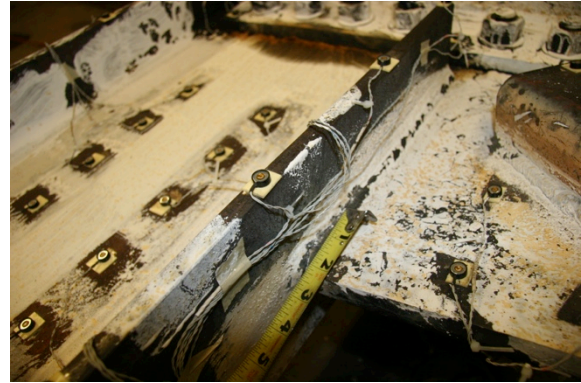
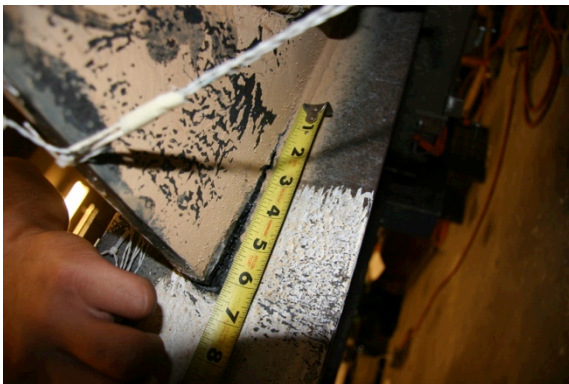
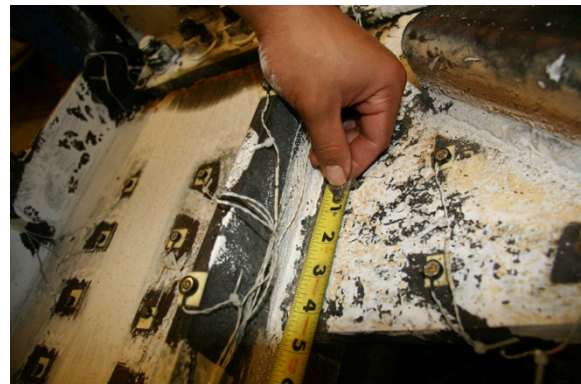
a. 3/4 in. weld crack (WB1) at -1.5% drift

b. 2.125 in. weld crack at -1.9% drift

d. 2.25 in. weld crack (top) at -2.7% drift

e. 6.5 in. weld crack (bottom) at -2.9% drift

f. 4.25 in. weld crack (top) at -2.9% drift

**Figure 5.22 - Progression of Weld Cracking in NE Beam to Gusset Plate Connection**

At the NE beam to gusset plate connection, weld crack initiation was observed at -1.5% drift and increased with increased story drift (see Figure 5.22). At the completion of the -2.7% drift compressive cycle, the weld crack was 5.125 in. long on the bottom (Figure 5.22c) and 2.25 in. long on the top (Figure 5.22d). The weld crack was 6.5 in. long on the bottom (Figure 5.22e) and 4.25 in. (Figure 5.22f) on the top at brace fracture. The weld crack did not fracture despite the use of welds with low CVN toughness.

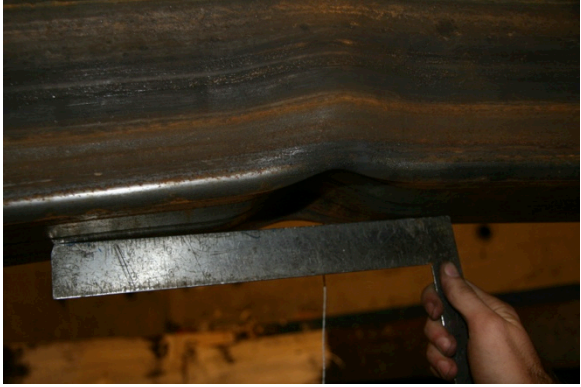
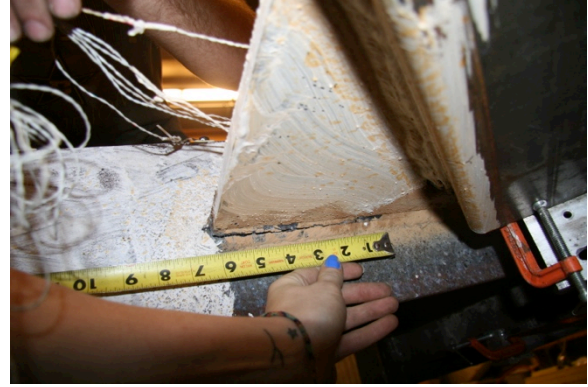
**c. Brace Hinge (B2-Hinge)**

**d. 6 in. Weld Crack (WB2) at Beam to Gusset Plate**

**Figure 5.31 - Increased Damage in the NE Corner at -1.1% Drift**

The damage sustained at -1.1% drift is shown in Figure 5.31. There was local buckling (B1) at the NE corner on the west column flange of the east column (Figure 5.31b) and increased yielding (Y2) in the same location (Figure 5.31a). During this same cycle there was visible yielding in the north flange of the north beam on both the inside and outside adjacent to the load beam. At the brace plastic hinge there was visible local deformation in the walls (B2-cupping), shown in Figure 5.31c. In the NE corner, a 6 in. weld crack (WB2) appeared suddenly in the beam to gusset plate connection through the top and bottom of the fillet welds as seen in Figure 5.31d.

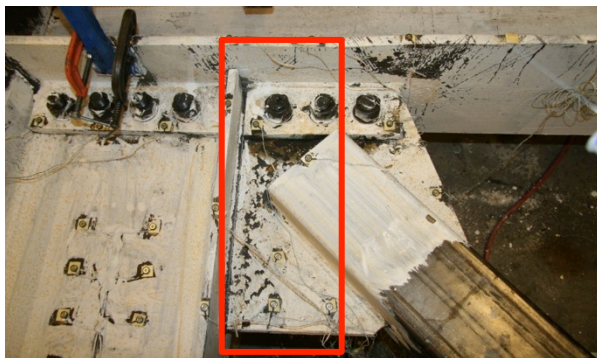
**a. Complete Fracture of Beam to Gusset Plate Weld**

When the brace was in tension at +0.7% drift, there was slight residual local deformation in the brace hinge at midspan, but no increase in lengths of weld tearing. At the next compressive cycle at the same drift level, the hinge at brace midspan increased in severity, (B2-cupping). At -1.1% drift, the weld tear in the NE corner had grown to 12 in. long on top and 11.125 in. long on the bottom. The NE gusset plate dislocated upward OOP out of the weld seat by 1/4 in. During the following tensile cycle at a higher drift level, complete fracture of the beam to gusset plate weld in the NE connection occurred (Figure 5.32a). While investigating the weld fracture during the pause in the load cycle, initial tearing was observed on the bottom of the brace at midspan in the corners (Figure 5.32b). The tension cycle was continued, and simultaneous fracture of the 3 bolts connecting the column to gusset plate shear tab in the NE corner occurred (Figure 5.32c). The test did not reach the full tensile cycle. This full failure progression is shown in Figure 5.32.

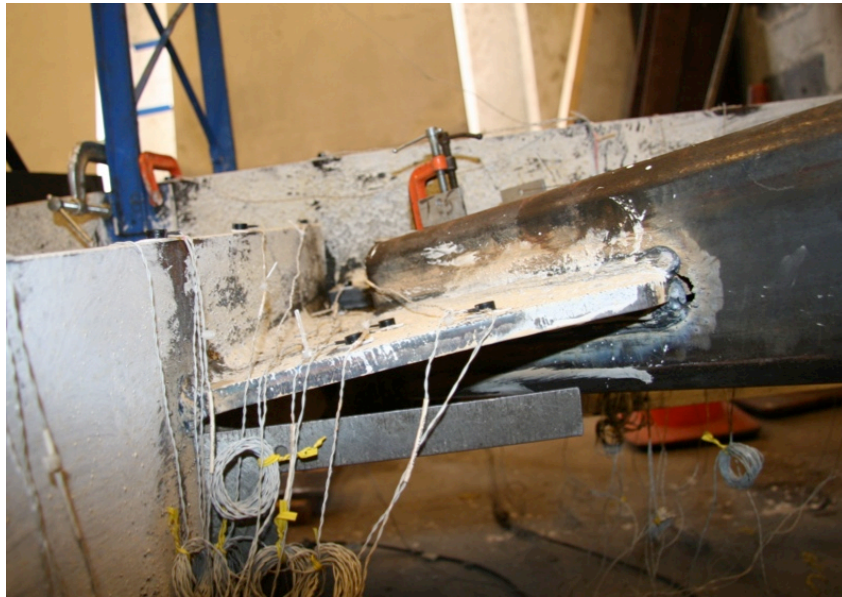
**Figure 5.43 - Gusset Plate Rotation at -1.3% Drift**

At the next compressive cycle at -0.94% drift, yield lines (Y1) also formed on the north flange of the north beam about 8 in. east of the load beam. The brace continued to buckle upwards OOP and at -0.68% drift, the brace midspan had displaced 5.7 in. (B2). At -1.3% drift, there was increased yielding (Y1) at the base of the west column on the west flange. Also at this drift level, a 1 in. long weld crack (WB1) initiated in the NE corner at the west end of the gusset plate to beam weld on the bottom of the plate, shown in Figure 5.53a. The OOP rotation of the gusset plate in the NE corner is shown in Figure 5.43. Tensile yield lines were observed on the

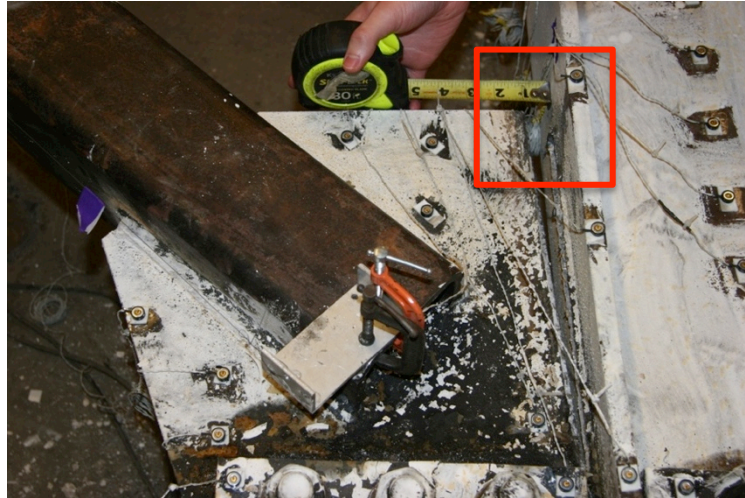
**Figure 5.45 - 1 in. Gap Between NE Gusset Plate and Beam at +0.88% Drift**

The test was paused during the +0.88% drift cycle when the beam to gusset plate weld in the NE corner fractured, as seen in Figure 5.53d. Once the tensile drift peaked at +0.88%, there was a residual 2 in. vertical OOP displacement of the brace. The fully fractured weld crack in the NE corner opened a gap of 1 in. at the far west side, seen in Figure 5.45. On the underside of the NE gusset plate three bulges formed east of the bolt heads caused by bolt hole elongation, shown in Figure 5.46. On the south ends of the brace to gusset plate splice, small weld cracks initiated. At -1.6% drift, the brace had increased in vertical OOP displacement to 11.2 in. (B2). At -1.8% drift, the SW beam to gusset plate connection now had a 5 in. long weld crack on the bottom and 2.5 in. long weld crack on the top, shown in Figure 5.54c.

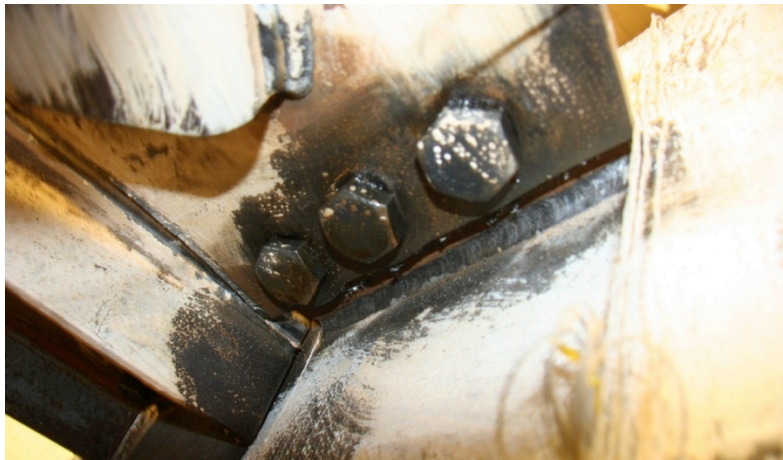
**Figure 5.46 - Bolt Hole Elongation in the Gusset Plate in the NE Corner**

There was significant elongation of bolt holes (BoE) from bearing stresses, most notable in the NE gusset plate. Those three holes elongated to a final oval diameter of between 2.125 in. (closest to the beam), which is double the original diameter, and 1.625 in. (southernmost), which is 9/16 in. larger than the original diameter. With these elongations, it is clear that bolt hole elongation contributed a large portion of the maximum story drift. The edges of the NE gusset

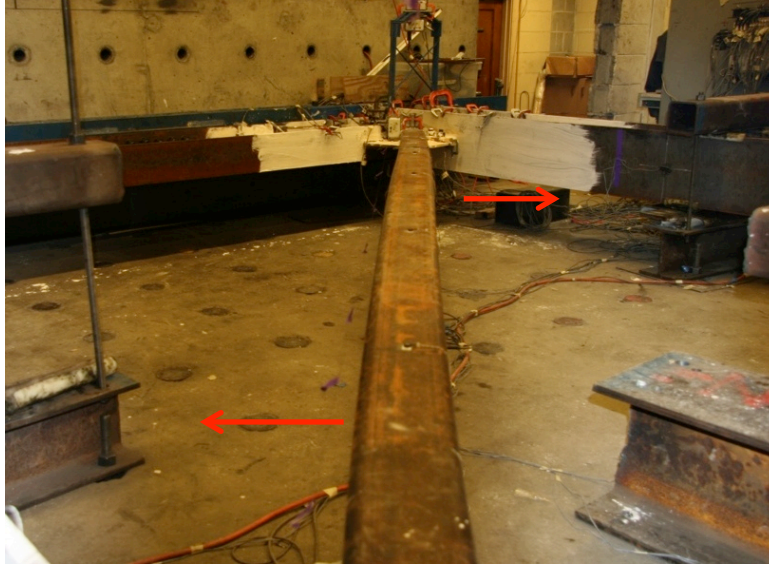
**Figure 5.47 - Brace "S" Shape at +1.0% Drift**

In the following cycles, the SW beam to gusset plate weld continued to deteriorate, and at -2.1% drift it had cracked 8.5 in. on top and 11 in. on the bottom (WB3), as shown in Figure 5.54d, and the east flange of the west column continued to rotate. By the second cycle at +1.0% drift, the bottom weld crack fractured and the crack length was 14 in. on top. In these larger compression drift cycles, the brace began to buckle in-plane to the NW due to the eccentricity from the connection weld fractures. When stretched in tension, the brace developed into an “S” shape, shown in Figure 5.47. The photo shows that in the SW corner the brace was displaced towards the west, and in the NE corner the brace was displaced towards the east.

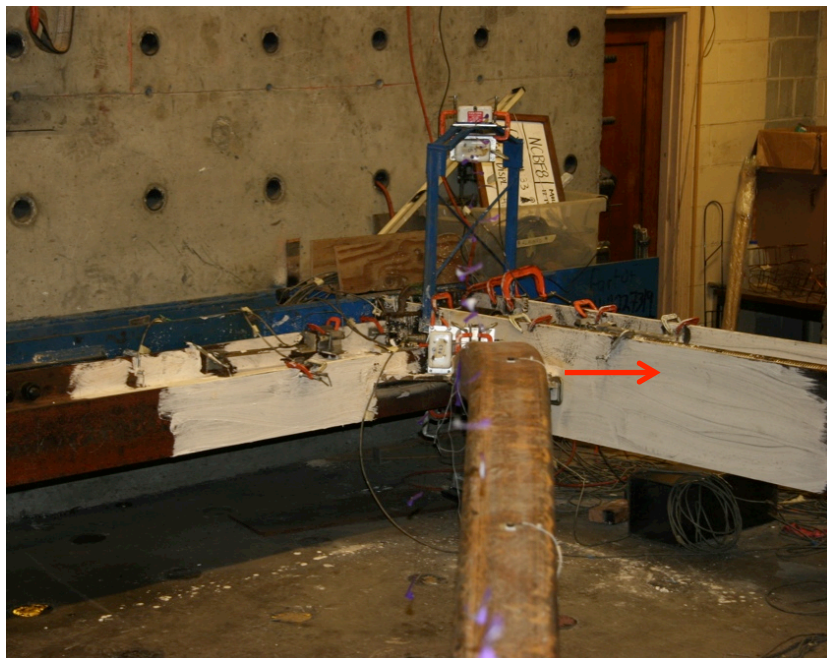
**Figure 5.49 - In-plane Brace Buckling at -3.1% Drift**

By -3.1% drift, the brace in-plane buckling increased at its midspan from the first observation (shown in Figure 5.49), likely due to the flexibility and eccentricity caused by the beam to gusset plate weld fracture. The brace appeared to be developing slight local deformations in the brace

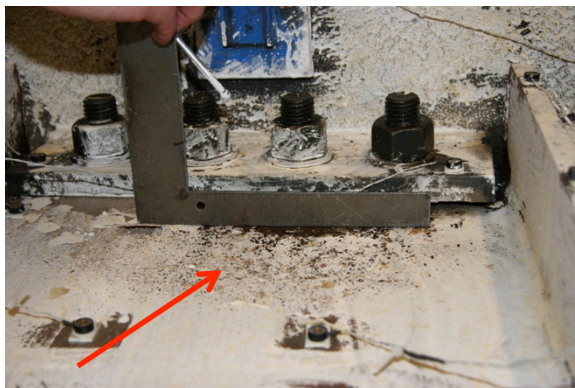
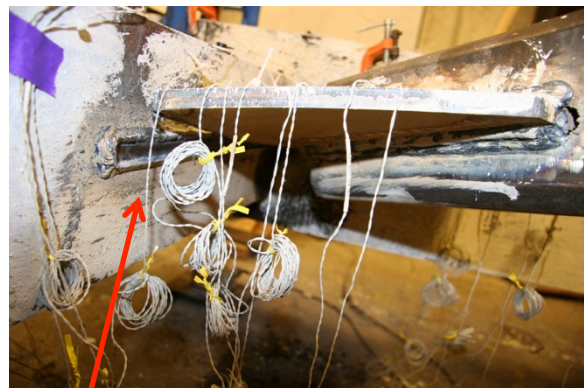
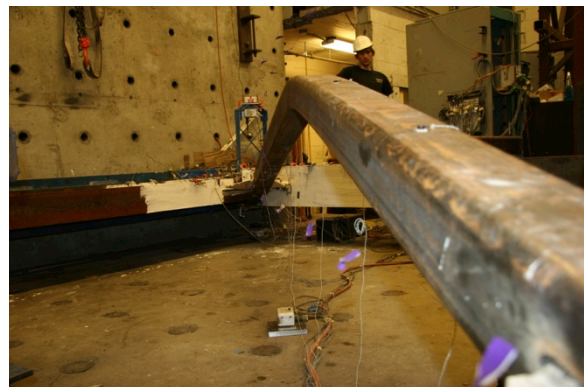
**a. Local Buckling of Beam Web NE Corner**

**b. OOP Rotation of North Gusset Plate**

**d. Brace Hinge at Midspan**

**Figure 5.52 - Final Test Photos at -3.7% Drift**

At -3.7% drift, slight beam web local buckling (B1) in NE beam to column connection occurred, as shown in Figure 5.52a. This behavior was seen because of the eccentricities induced by weld fractures in the gusset connections. The free edge of the gusset plate at the beam to gusset plate connection had displaced out of the weld seat significantly as shown in Figure 5.52b and Figure 5.53e. The elongation of the bolt holes and deformation in the bolts in the gusset plate to column shear tab was so severe the bolts were pointing diagonally – towards the west; and in viewing from below, the edge of the bolt hole was visible from around the bolt head, as shown in Figure 5.52c. The brace continued to develop deformation at the plastic hinge at midspan, with a total vertical displacement of 17.8 in (Figure 5.52d). The actuator reached its full stroke capacity and the test was stopped at +2.6% drift. There was one bolt fracture in the NE gusset plate to column shear tab connection (the northernmost bolt). The test was stopped after this bolt fracture – a photo summary of the last compression cycle is below in Figure 5.52.

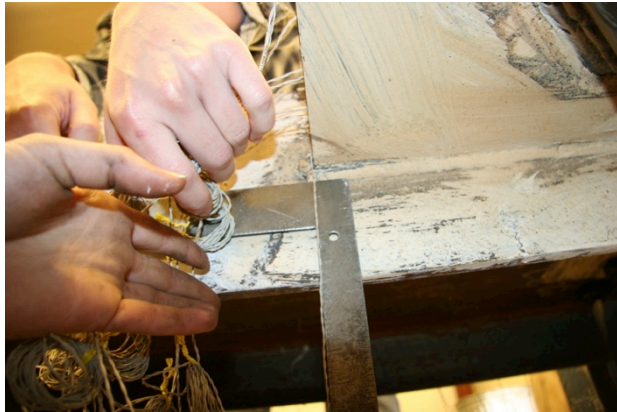
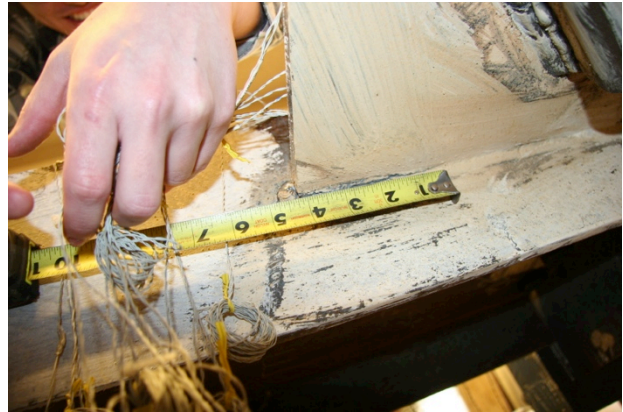
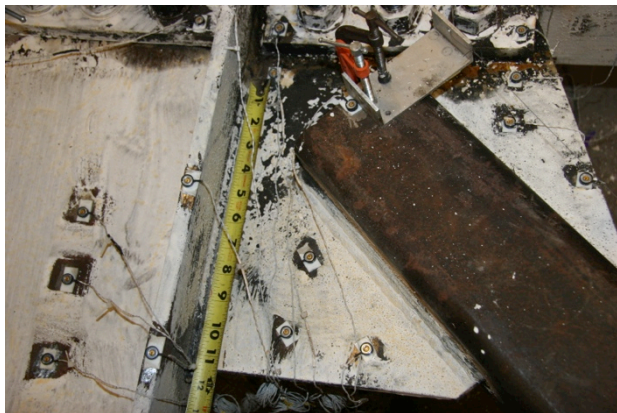
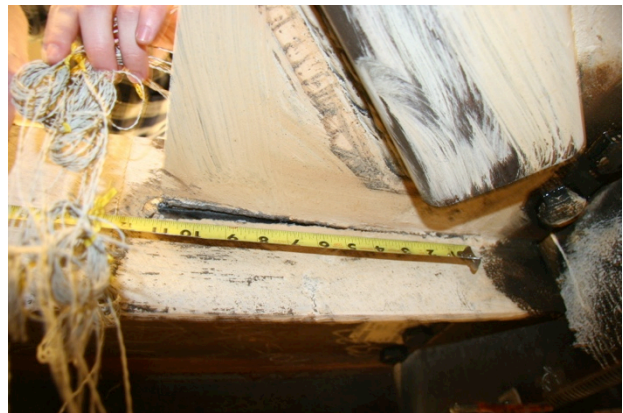
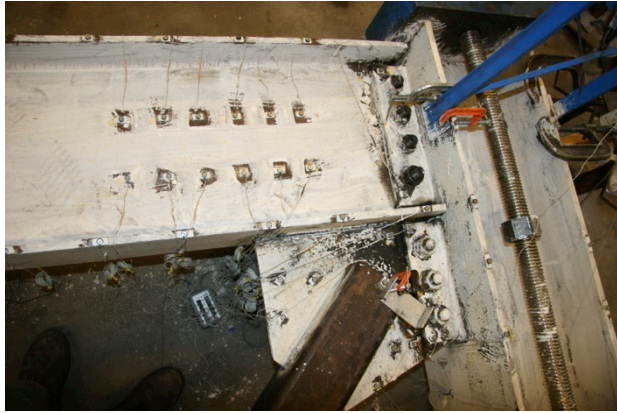
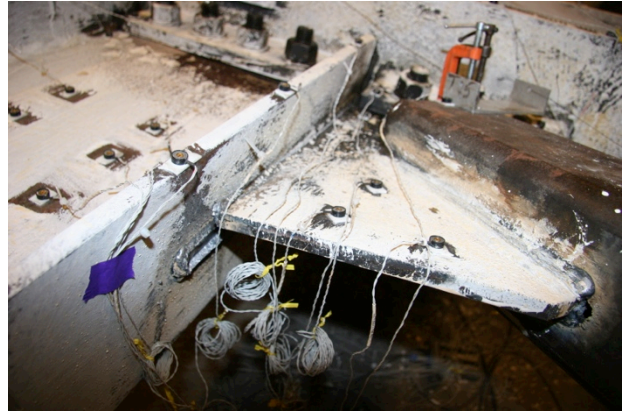
**a. 1 in. long weld crack at -1.3% drift**

**b. 4.125 in. (bottom) & 0.75 in. (top) weld crack at -1.3% drift**

**c. 11.25 in. (bottom) & 11.25 in. (top) weld crack at -1.6% drift**

**d. Weld fracture at +0.88% drift**

**e. Post weld fracture at -3.7% drift**

**Figure 5.53 - Progression of NE Beam to Gusset Plate Weld Fracture**

By the second compressive cycle at the above drift, the crack in the NE beam to gusset plate weld had propagated to 3/4 in. and 4.125 in. long (WB2) on the top and bottom, respectively, as shown in Figure 5.53b. In the SW corner, the beam to gusset plate weld crack (WB1) had propagated to 2.75 in. long on the bottom, as seen in Figure 5.54a. After this compression cycle, there was increased yielding in the NW beam to column shear tab at the southern end. Moving to the tension cycle, at +0.70% drift there was significant yielding in the NE gusset plate and about 40% of the whitewash had flaked off.

During the compressive cycle at -1.6% drift, the NE weld tearing propagated to 11.25 in. (WB3) through both welds and the gusset plate had dislocated OOP at the west end by 1/2 in., as seen in Figure 5.53c. The SW corner beam to gusset plate weld tearing had propagated to 4 in. and 1 in. long on the top and bottom fillet weld (WB2), respectively, shown in Figure 5.54b. In this corner, the east flange of the west column had rotated over the entire depth of the SW

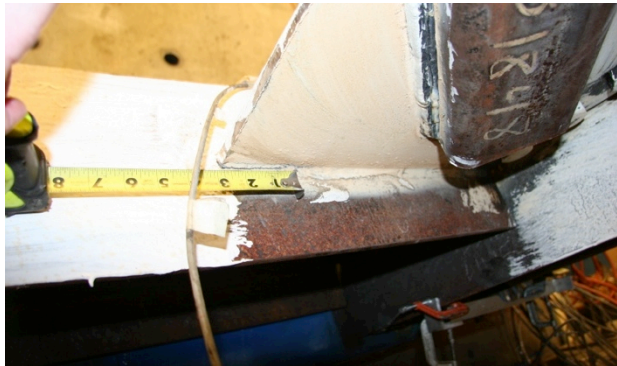
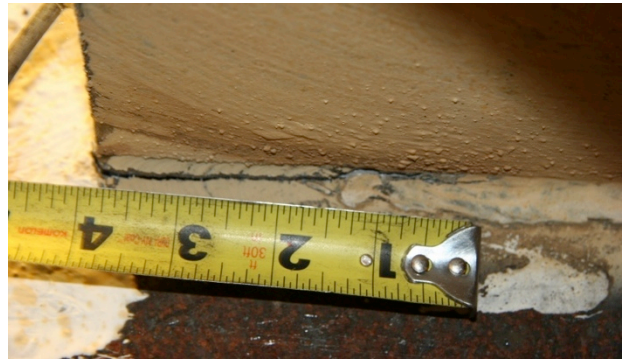
**a. 2.75 in. long weld crack at -1.3% drift**

**b. 4 in. (bottom) & 1 in. (top) weld crack at -1.6% drift**

Figure 5.54 - Progression of SW Beam to Gusset Plate Weld Fracture

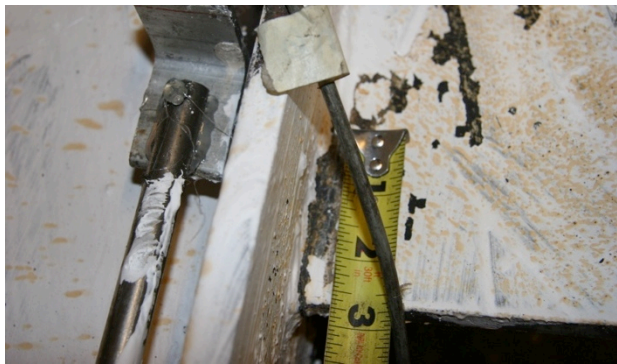
**c. 5 in. (bottom) & 2.5 in. (top) weld crack at -1.8% drift**

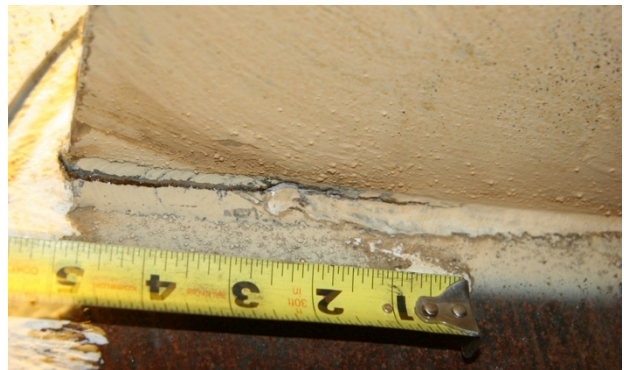
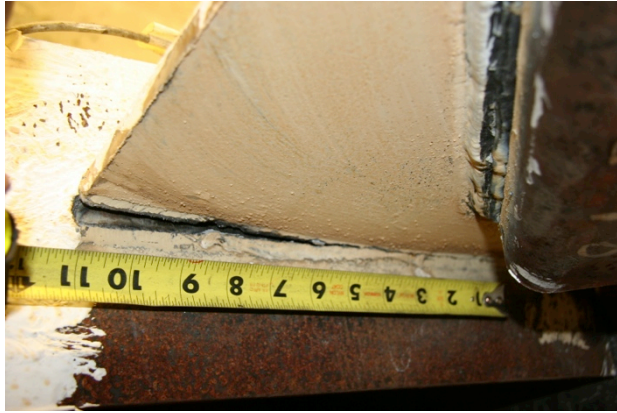
d. 11 in. (bottom) & 8.5 in. (top) weld crack at -2.1% drift (first cycle)

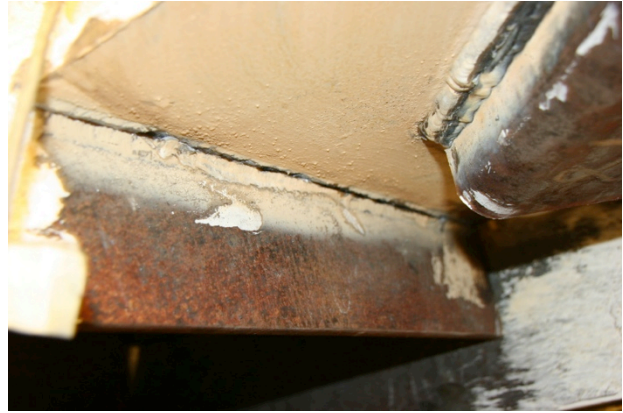
e. Weld fracture at -2.1% drift (second cycle)

At the second compressive cycle at -2.1% drift, the SW beam to gusset plate weld fractured, as shown in Figure 5.54e and the gusset plates were attached to the columns by 3 bolts at each gusset. After this event, the specimen lost significant lateral resistance, but the test was still continued. At -2.1%, a gap of 1/8 in. between the load beam and the north beam flange at the east end was first observed. The NE bolt holes continued to elongate at increasing drift levels. Bolt hole elongation (BoE) was first seen at in the SW corner at -2.4% drift.

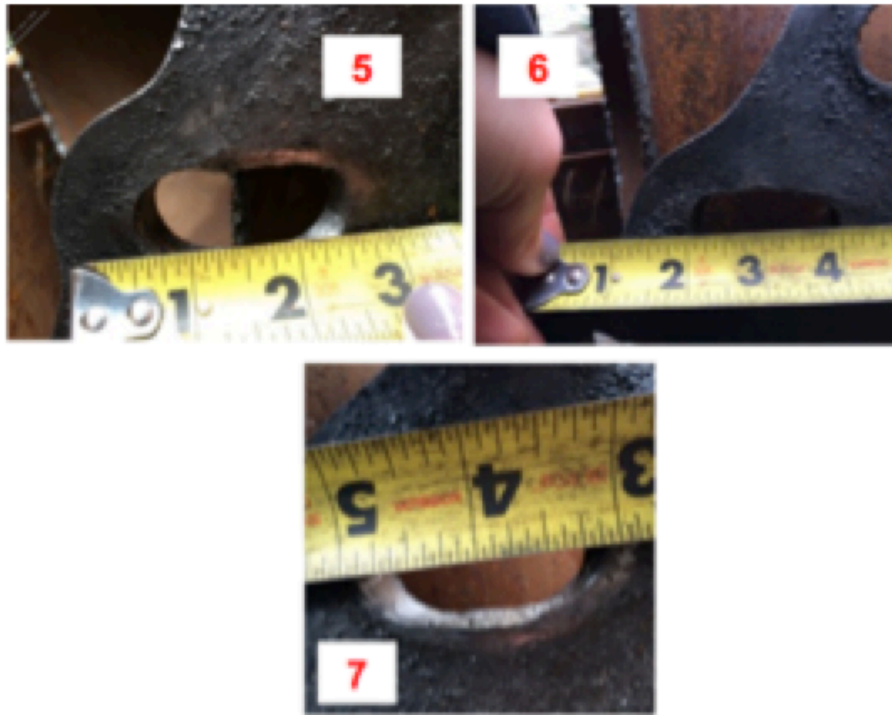
Figure 5.57 - Bolt Hole Elongation in NE Gusset Plate

Post-fracture cycles were completed as part of the full test cycles. Typically, to conduct post-fracture cycles, the testing had to be stopped and a portion of the brace cut out to prevent binding. The beam to gusset plate weld fracture in both corners was the cause of the loss in resistance, but the gusset plates remained connected to the columns. Because of this connectivity, the test did not have to be stopped prior to post-fracture cycles. At the conclusion of the test, the frame was disassembled and the bolts and bolt holes were studied. The diagrammatic sketches below in Figure 5.55 through Figure 5.60 document the bolt damage found with key photos included. Additionally there are photographs of all bolts and connecting plates in the Appendix. A few bolts in the gusset plates withstood significant deformation (BD) from bearing stresses and looked close to shear failures, as seen in Figure 5.57 and Figure 5.58.

plate and NE beam web were deformed significantly from bolt bearing. Photos of these elongated bolt holes are shown in Figure 5.57. Bolt #5, located closest to the beam in the gusset plate connection, fractured during the final tension cycle, seen in Figure 5.58, making bolt shear failure the controlling failure mode over individual bolt tearout.
