**Seismic Evaluation of Bolted Connections in  
Non-Seismic Concentrically Braced Frames**

A thesis

Master of Science in Civil Engineering

University of Washington

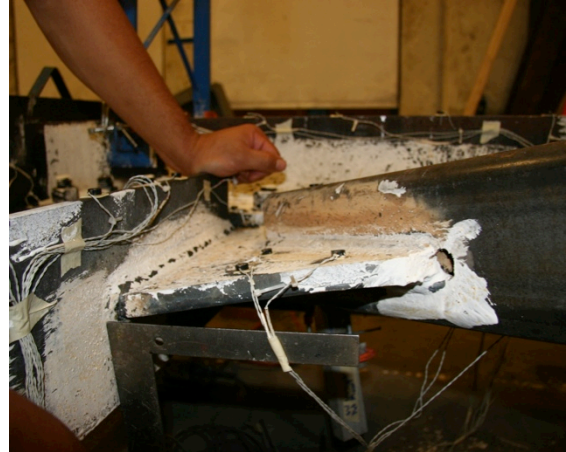
**a. NHSS-B1 (Photo at -2.3%)**

**Figure 6.10 - Gusset Plate OOP Displacement along Gusset Plate Length**

Additionally, the OOP displacement of the gusset plate was plotted along the length of the gusset plate connection at each LED marker, shown in Figure 6.10. The marker on the beam is at the “0 in.” length along the gusset plate. These displacements are compared with photos from the specimen to provide assurance the calculations were reasonable and are also shown in Figure 6.10. From Figure 6.10, it can be seen the photos have a generally good correlation with what the data reflects. NHSS-B1 had somewhat smaller gusset plate rotations and displacements as shown in Figure 6.9 and Figure 6.10. Additionally, between markers “0” and “1” there is a line with the same slope as between “1” and “2” when the gusset plate to beam weld had not fractured. NHSS-B3 has a kink in these lines at -3.7% drift, after the weld had fractured and was moving OOP disconnected from the beam.

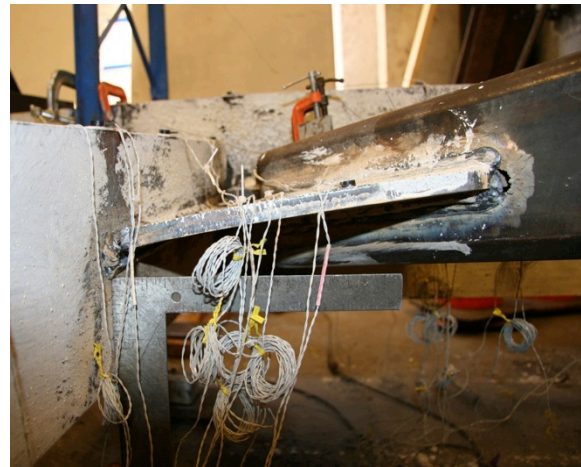
**b. NHSS-B3 (Photo at -1.6%)**

Figure 6.9 shows that NHSS-B3 had the highest gusset plate OOP rotation. However, the beam-gusset interface welds fractured fairly early in the experiment. The fracture allowed a large portion of the gusset plate to rotate because it was no longer fixed to the beam. Further, these markers have some inherent inaccuracy because the gusset plate became disconnected from the beam flange at larger drift levels.

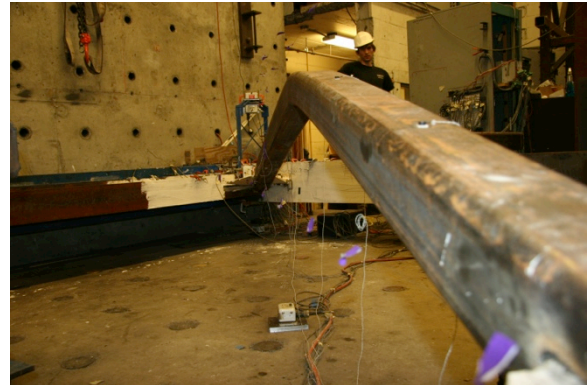
a. NHSS-B1 [photo at max OOP displacement]

Figure 6.17 - Brace Out-of-Plane Buckled Shape for Each Specimen

The brace buckled shape was plotted using Optotrak markers on the top wall of the brace along its length. Figure 6.17 presents the brace buckled shape as it reached each brace performance state (described in Chapter 5), compared to a photo of brace buckling from the test. For reference, the “0” end is the NE corner, and the brace length is the SW corner. The Optotrak camera volumes were unable to capture the full brace length and for these instances, the brace behavior was mirrored from the recorded data and marked in a lighter grey line with no markers.

The maximum OOP displacement of each specimen achieved is listed in Table 6.12. Visual observations match the plots well. It was postulated that since the NCBF specimens had no rotation clearance provided on the gusset plate, that the brace ends might have some restraint causing the brace buckled shape to resemble a “bell” shape rather than a sine curve. It can be seen from the plots in Figure 6.17 that this behavior did not occur. The lack of rotational clearance for the NCBF specimens did not prohibit a curve resembling an ideal pinned end condition to occur. For all specimens, during early cycles when the brace was in stage B1, the brace took on a more gradual curved shape over the entire brace length. As local strain concentrations increased at the plastic hinge region, the brace OOP shape became more triangular, meeting close to a point at brace midspan. For NHSS-B2, the only non-seismically compact brace, this triangular shape occurred at a lower OOP displacement by about 50% (at 8 in.) than the other specimens. At this severe pointed shape, the plastic hinge region displayed cupping and bulging of the brace walls. The severity of this local deformation varied based on the braced frame failure mode. Specimens NHSS-B1, and NHSS-B2 saw tearing at the bottom corners of the brace, which led to brace fracture for NHSS-B1. NHSS-B3 saw local deformation at the brace hinge of slight cupping and bulging, but not close to the extent of the other specimens.

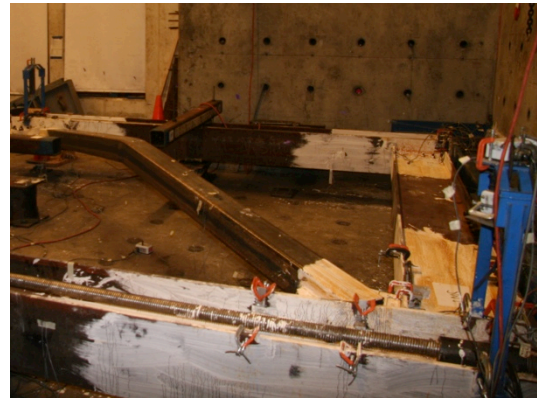
b. NHSS-B2 [photo at max OOP displacement]
