**Pedestrian Safety in Peru: The role of visible signalization, transit stops and other features of the
built environment**

A dissertation
submitted in partial fulfillment of the
requirements for the degree of

University of Washington

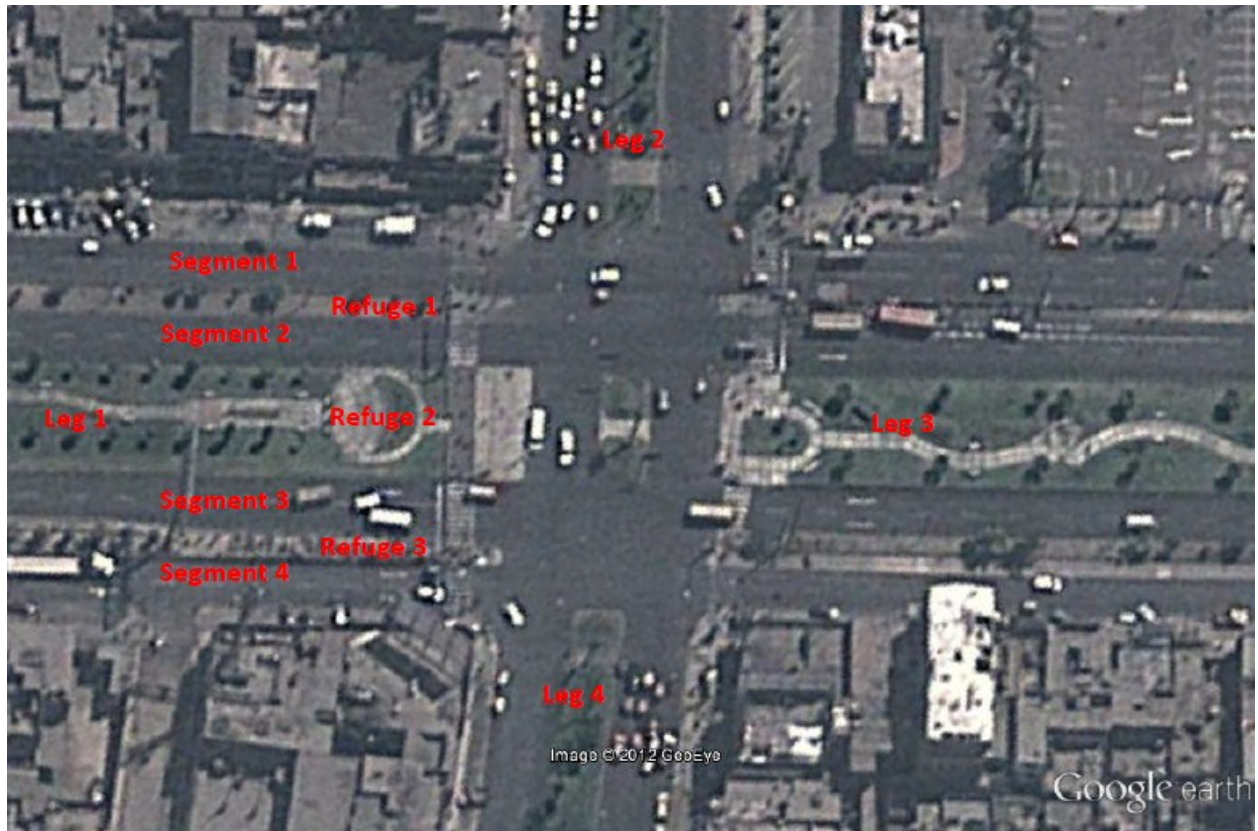
FIGURES AND TABLES**Figure 1.** Road geometry of an intersection. Image attribution: © 2012 Google and © 2012 GeoEye.

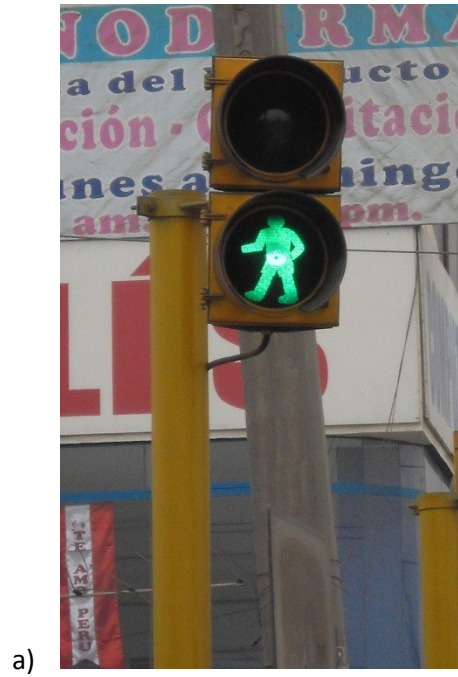
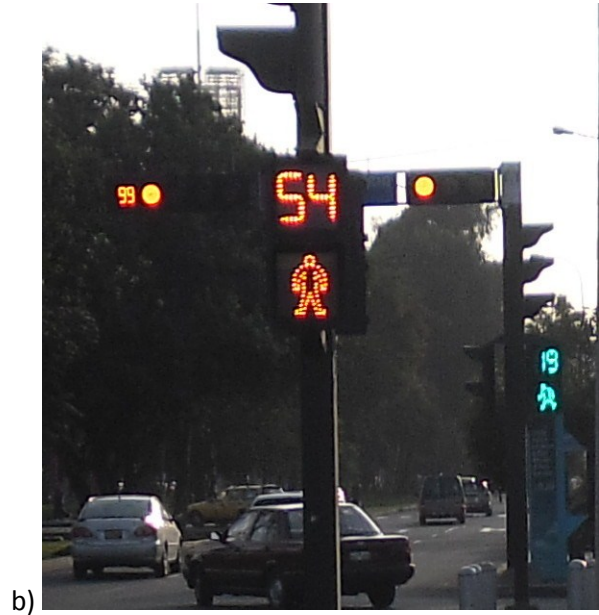
Figure 3. Two types of pedestrian signals found in Lima: a) signal with alternating green- and red-lit with a non-moving figure; b) signal with a regressive countdown and a moving figure.

signalization. At sites with a pedestrian signal, a longer “green” crossing duration was significantly associated with case status (OR 1.19, 95% CI 1.15-1.23). Most cases and (94%) and controls (73%) met MUTCD standards for the recommended allowed green crossing rate of 3.5 feet per second.

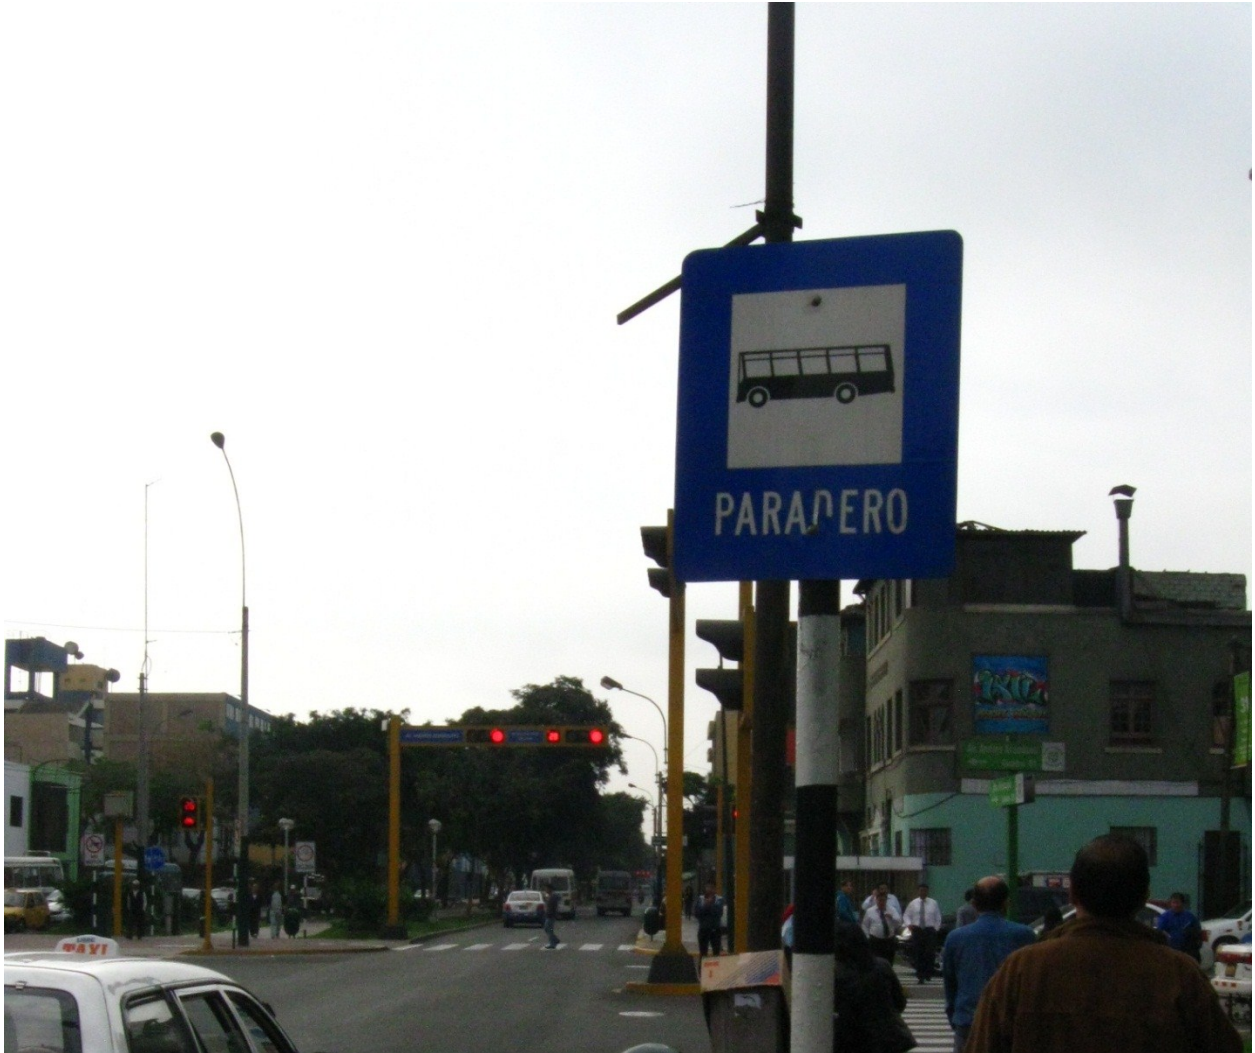
Figure 4. Sign indicating an authorized bus stop.

There are also some limitations to the bus stop characteristics we examined. For unauthorized bus stops, if signs authorizing bus stops were absent and we observed buses boarding or alighting passengers then we coded the site as having an unauthorized site. It is possible that such authorized activity was not occurring at the time of the incident or was a regular occurrence at the site, thus the findings could be spurious if the site does not regularly have unauthorized stops. Because such stops are

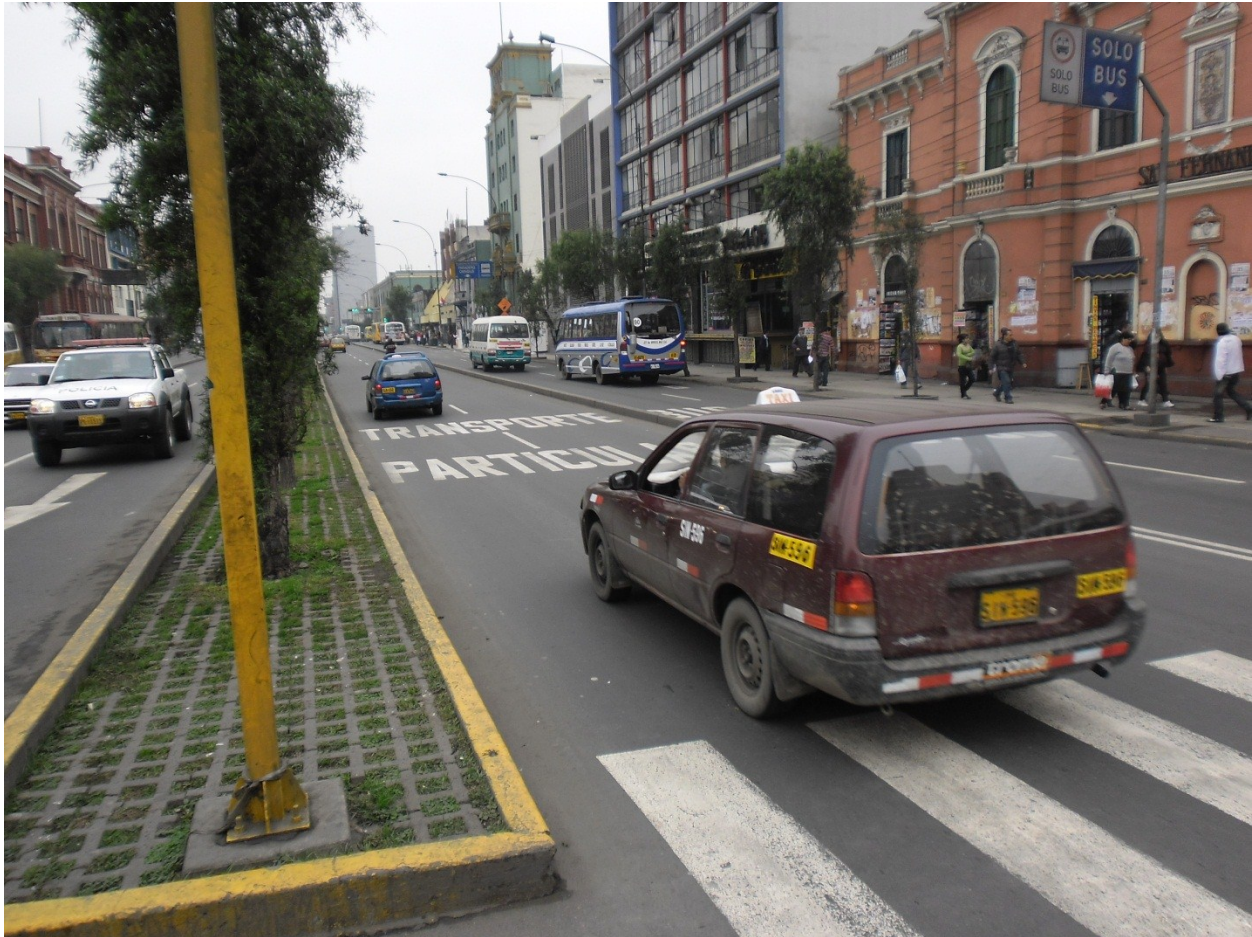
Figure 5. Curb-side or exterior type bus lanes (far right lanes) with private/mixed vehicle traffic in the median lanes.

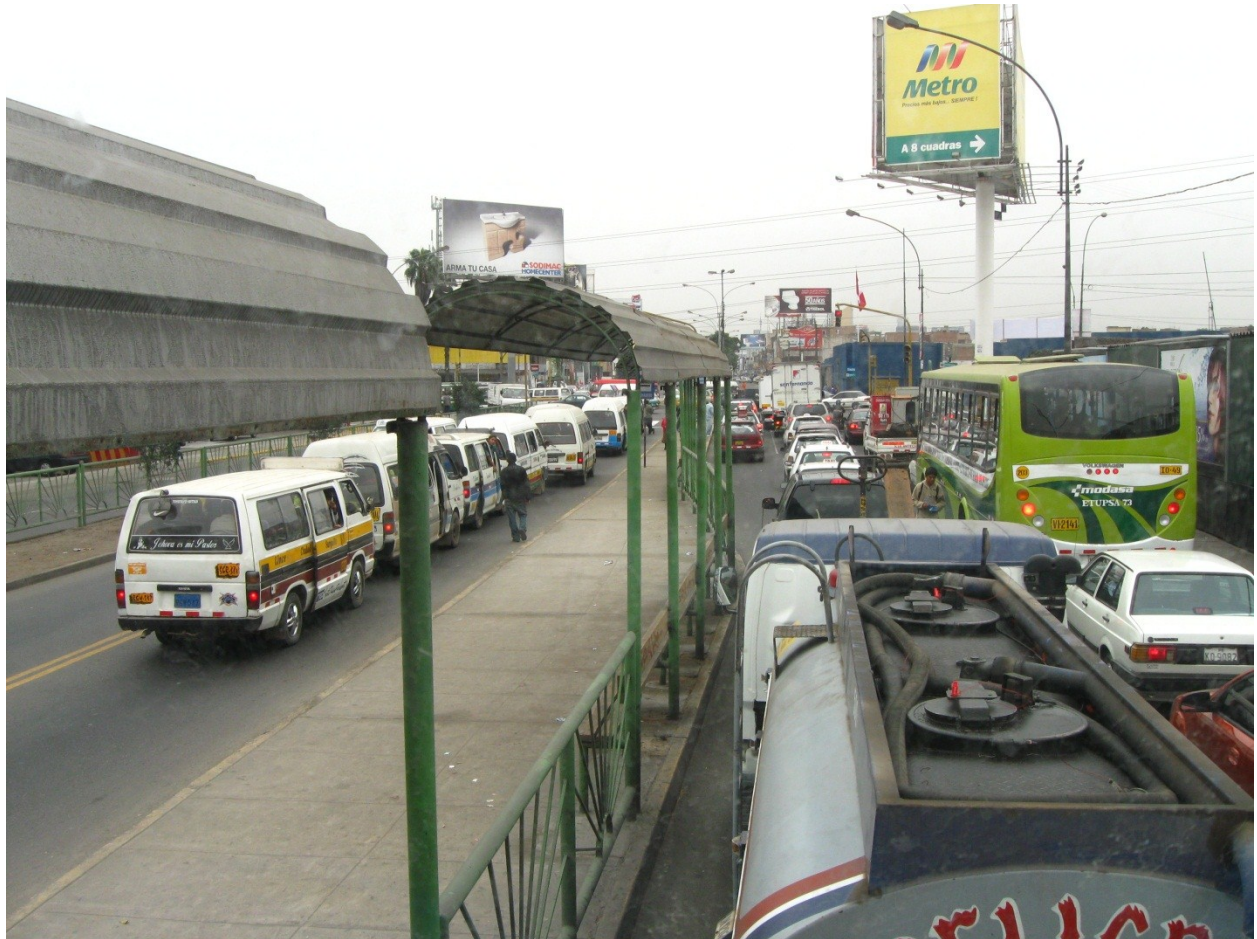
Figure 6. Median or interior bus-dedicated lanes (left lanes) with private/mixed traffic lanes on the exterior/curb-side (right two lanes).

Bus-dedicated lanes are meant to enhance traffic flow and lessen non-transit vehicle conflicts with public transit.³ The effect of transit-dedicated lanes on pedestrian safety is unknown though they improve motor vehicle flow.^{28, 30-32} In this study, this feature could not be examined fully due to a small number of sites with any transit-dedicated lanes. Bus lanes may have offered some benefit to pedestrians at intersections, but were associated with PMVCs at mid-block sites. The latter finding could be due to unsafe crossing conditions at mid-block sites where bus lanes were present. The crossing distance is much larger when bus lanes are present, and pedestrians may be more exposed to vehicle traffic, especially if there is no traffic control in place. It should also be noted that there appeared to be an association between bus stops at intersections without any bus lanes and the occurrence of PMVCs. These findings provide a mixed picture for the role of bus lanes and pedestrian safety that suggest more detailed research of these structures is needed to understand how to improve their safety.

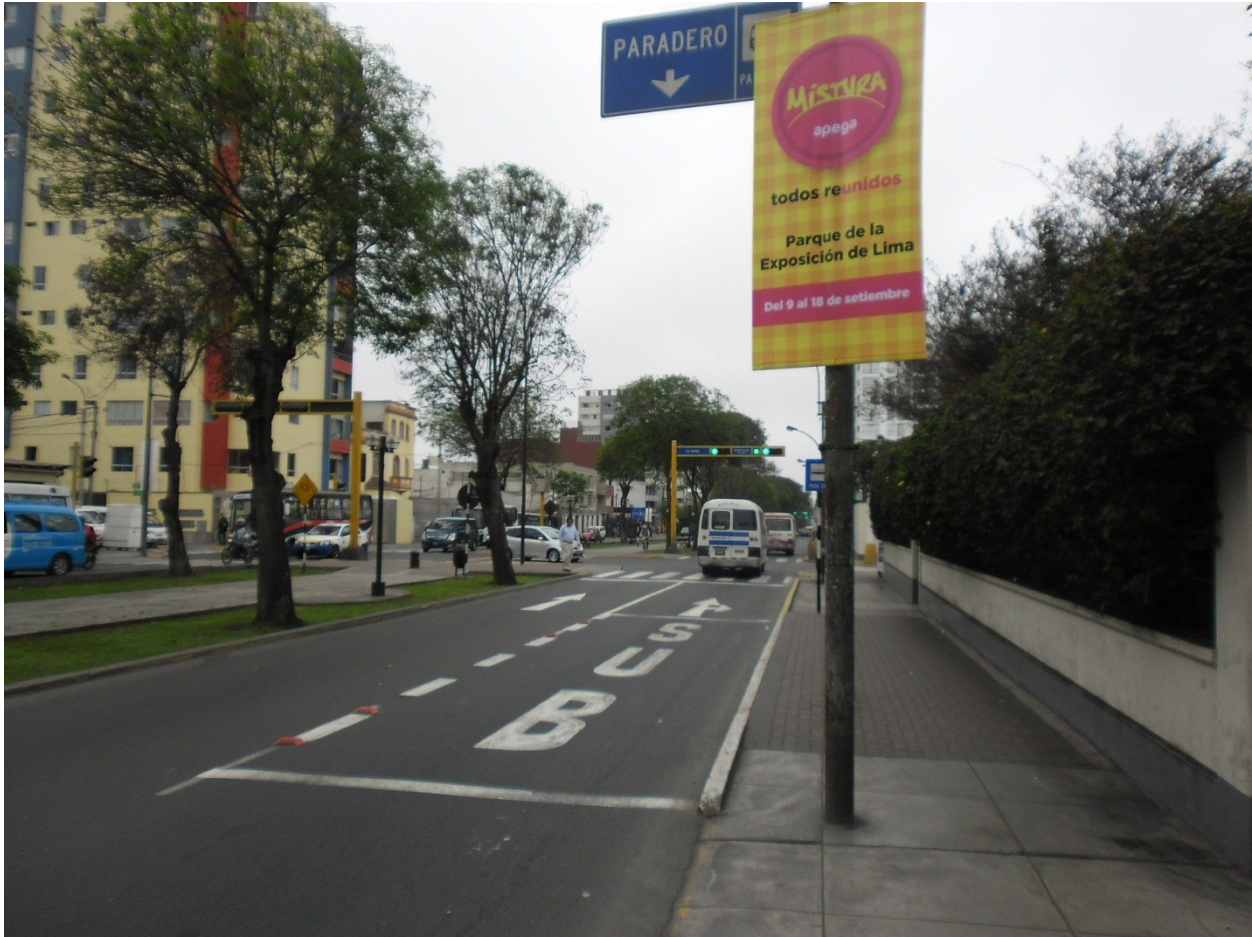
Figure 7. A bus stop with a painted area designating where buses are authorized to alight and board passengers.

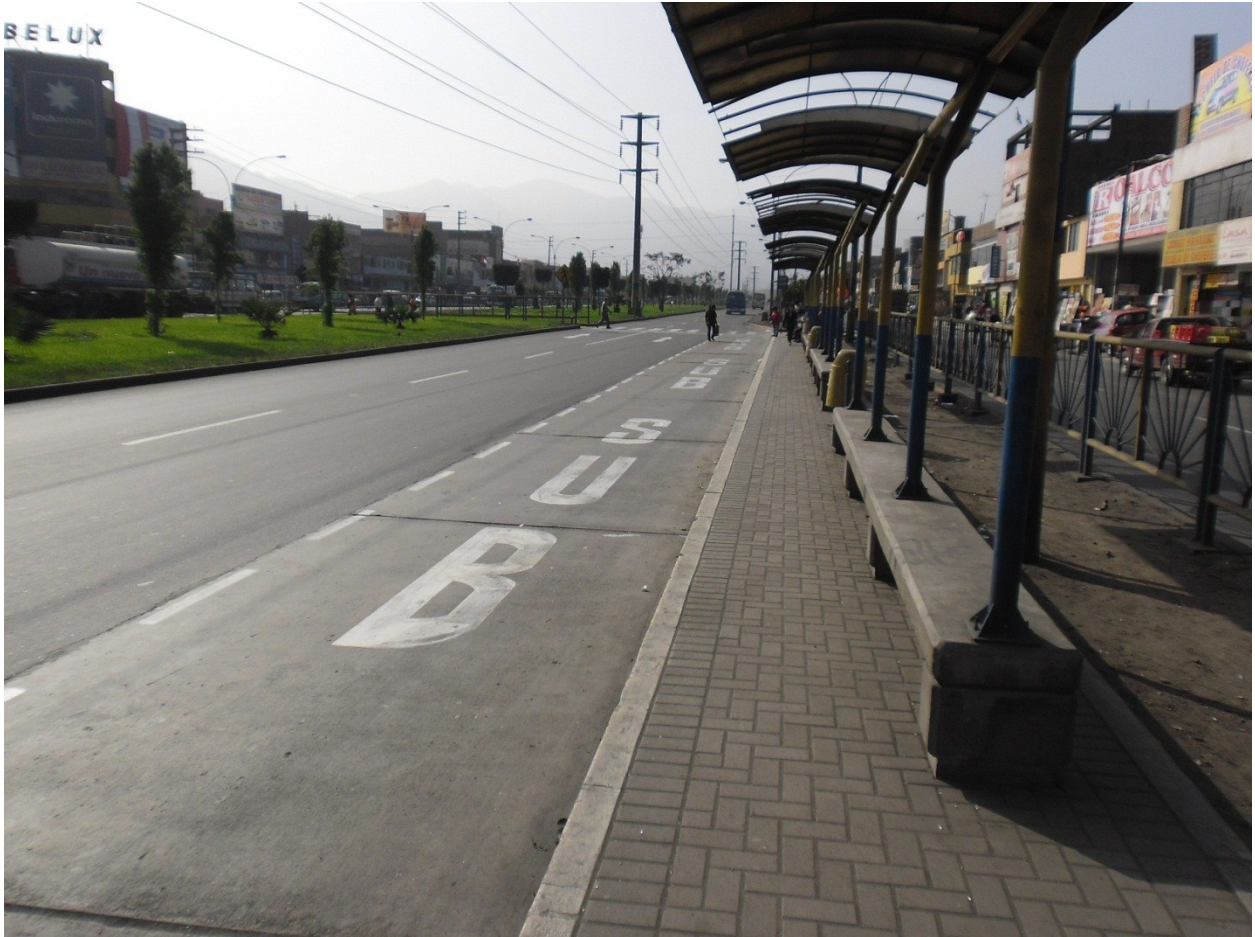
Figure 8. A bus stop with a bus bay or pullout area allowing buses to exit moving traffic to board and alight passengers.

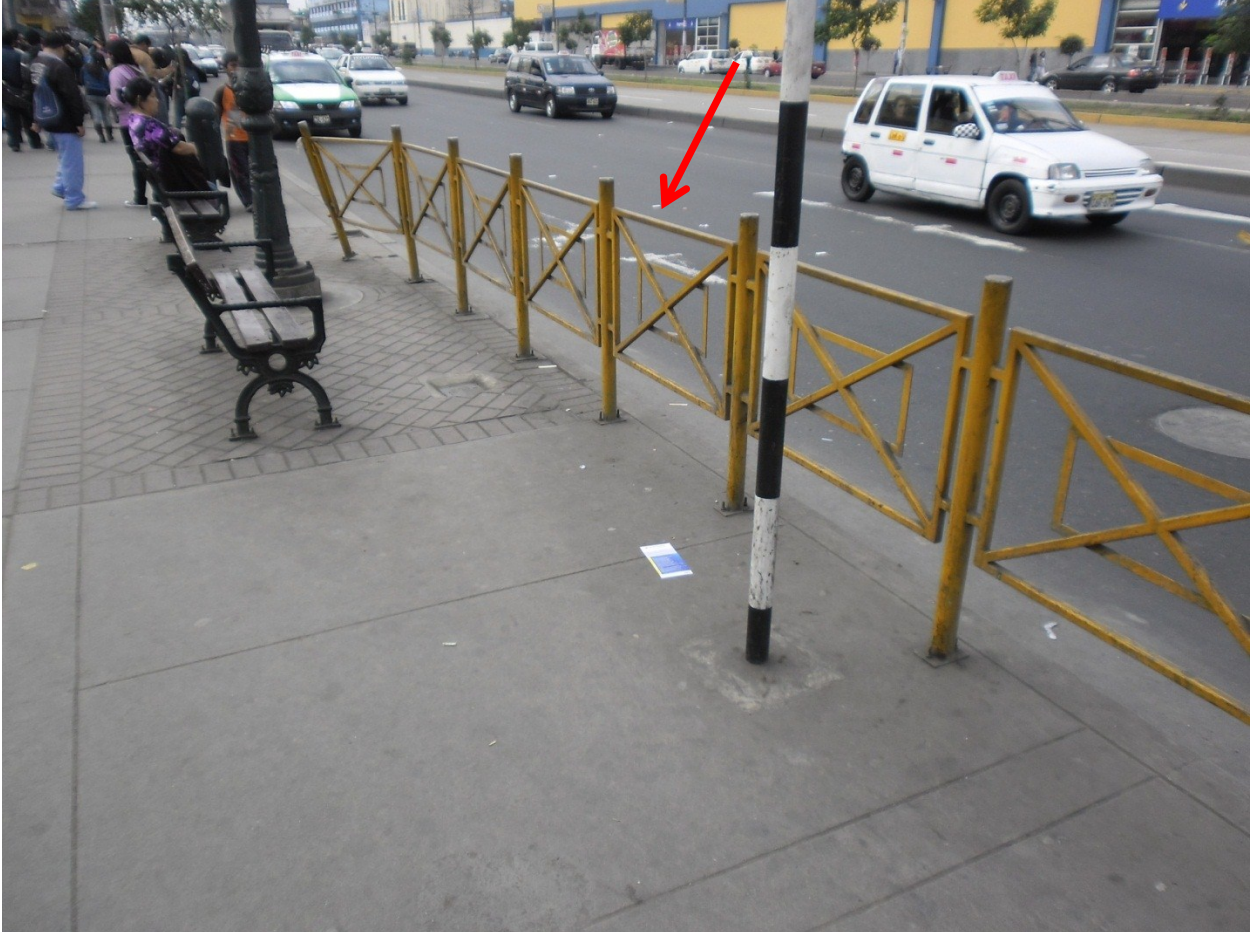
FIGURES AND TABLES**Figure 9.** Example of a pedestrian barricade.

Pedestrian barricades were also a potential beneficial feature for pedestrians. The structures that we considered barricades to direct and block pedestrian traffic serve several purposes on the roadways. Some of the barricades we observed functioned to discourage pedestrian crossing in unsafe areas, or directed pedestrian traffic to a specific crossing area. There were many types of barricades but most

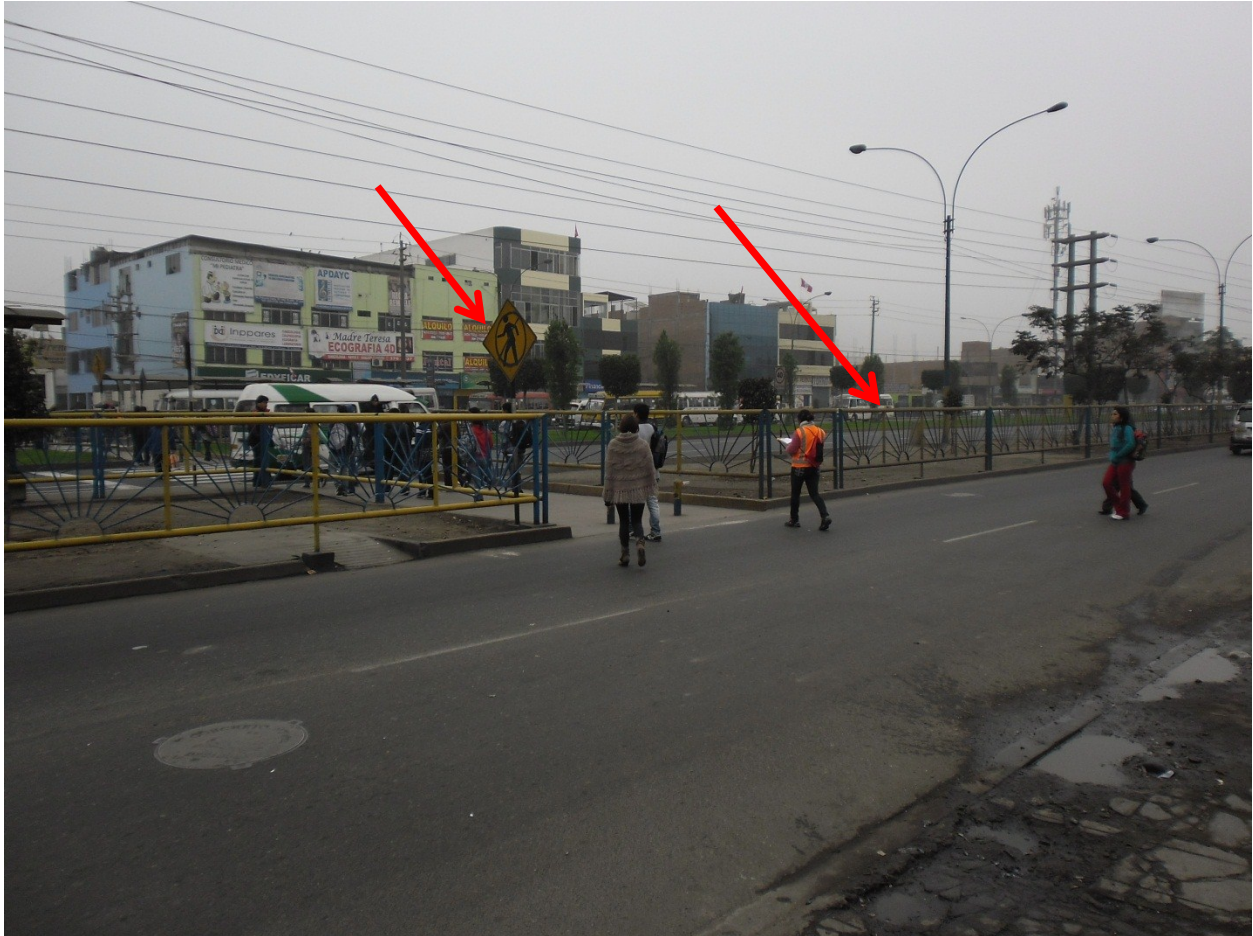
Figure 10. Mid-block crossing with pedestrian barricades and a (modified) pedestrian crossing sign.

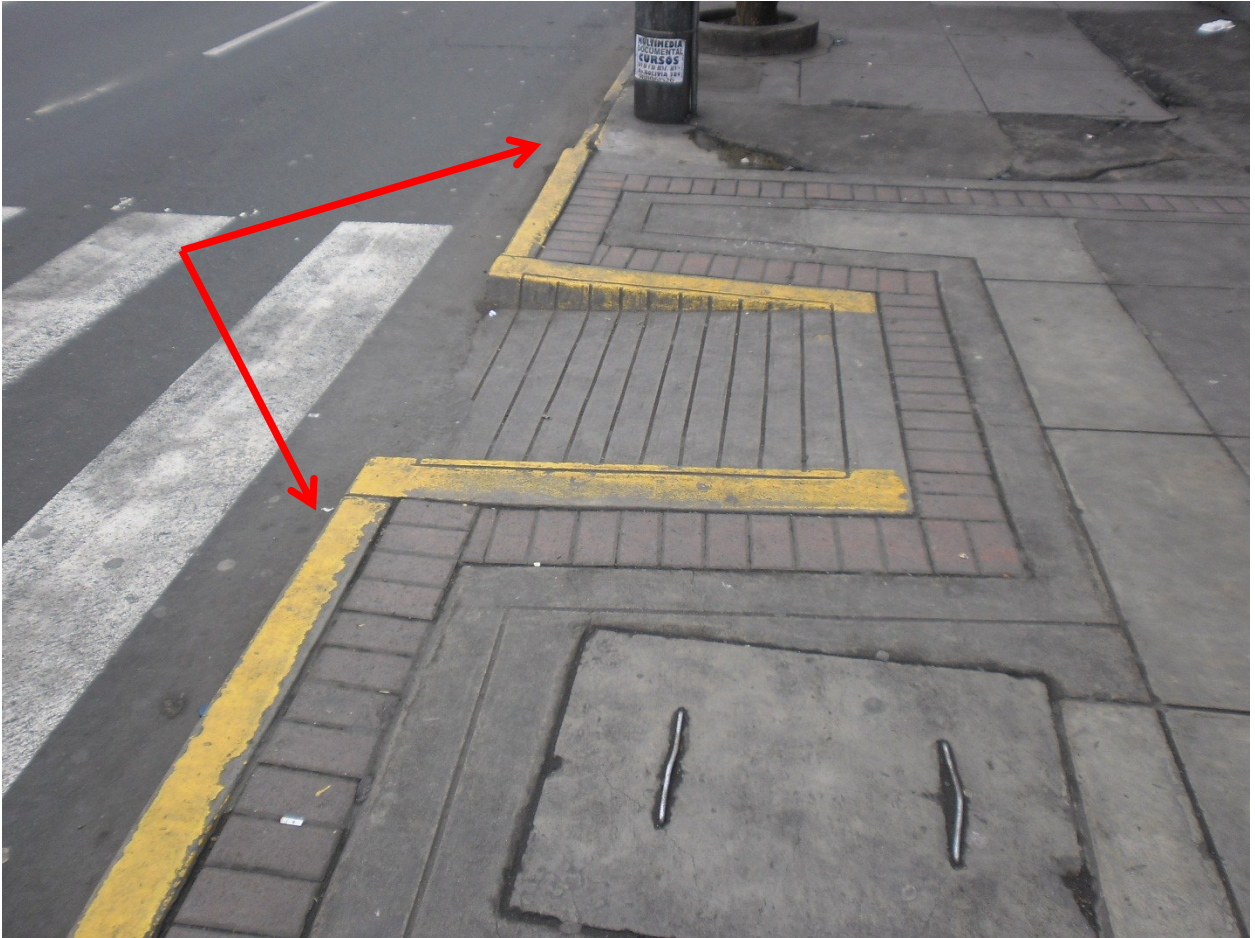
Figure 11. Typical hard-edged curb.

In this exploratory analysis of the walking environment for pedestrians in Lima, we found several features of the built environment may have a beneficial effect on pedestrian safety. The presence of hard-edged curbs was associated with a lower likelihood of a PMVC, as were pedestrian barricades. Hard-edged curbs are not consistently present in Lima. On some roads, especially more residential-type roads, there is not a curb separating the pedestrian walking area from the roadway; rather, the transition may be gently sloped or angled or it is a dirt or concrete area. These transitions allow vehicles to park in these areas and which may then block the paths of pedestrians and force them walk in the roadway to get around the parked vehicle. A high, hard-edged curb may help reduce this type of behavior by drivers and can keep them in the roadway were they belong.³¹

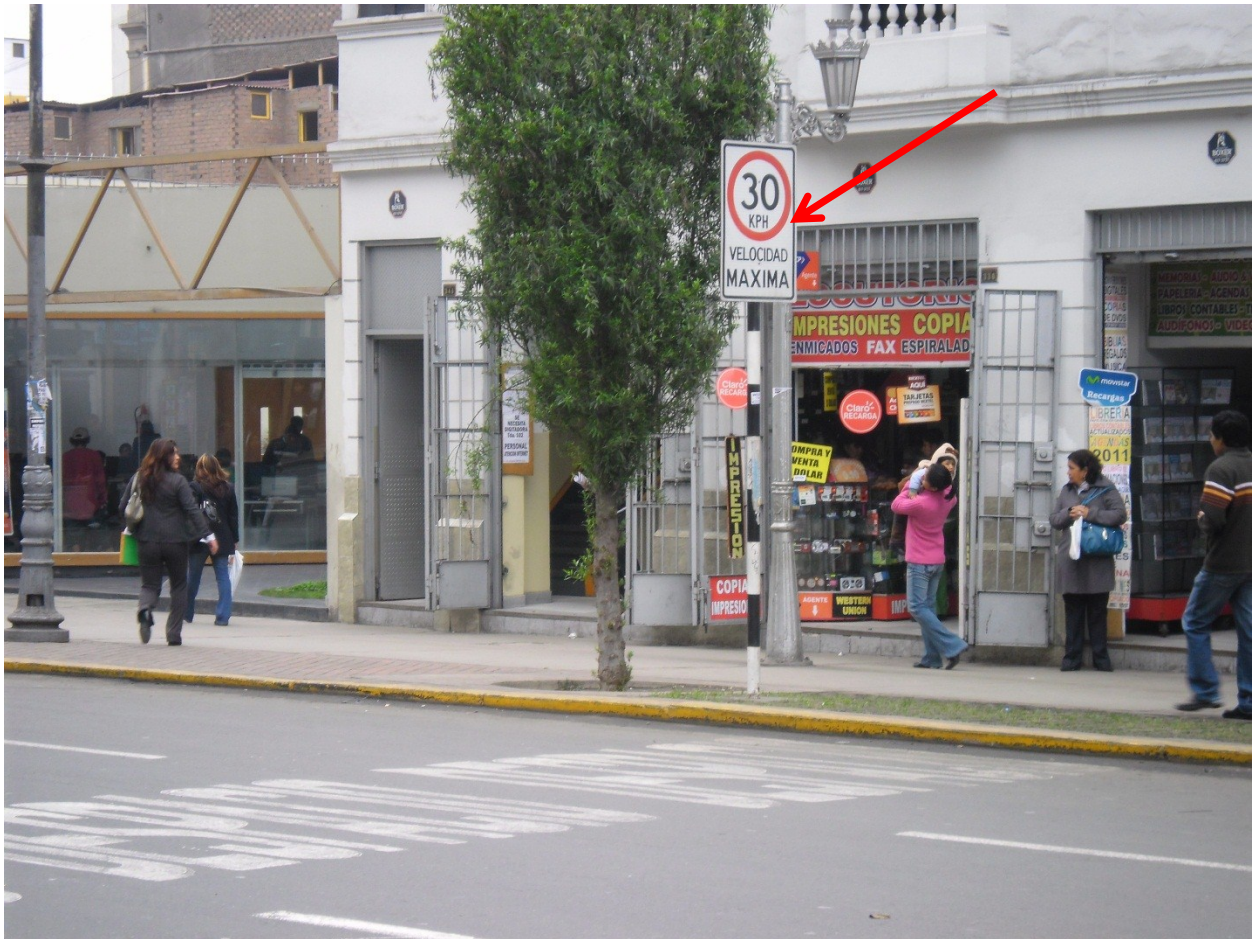
Figure 12. Typical speed limit sign.

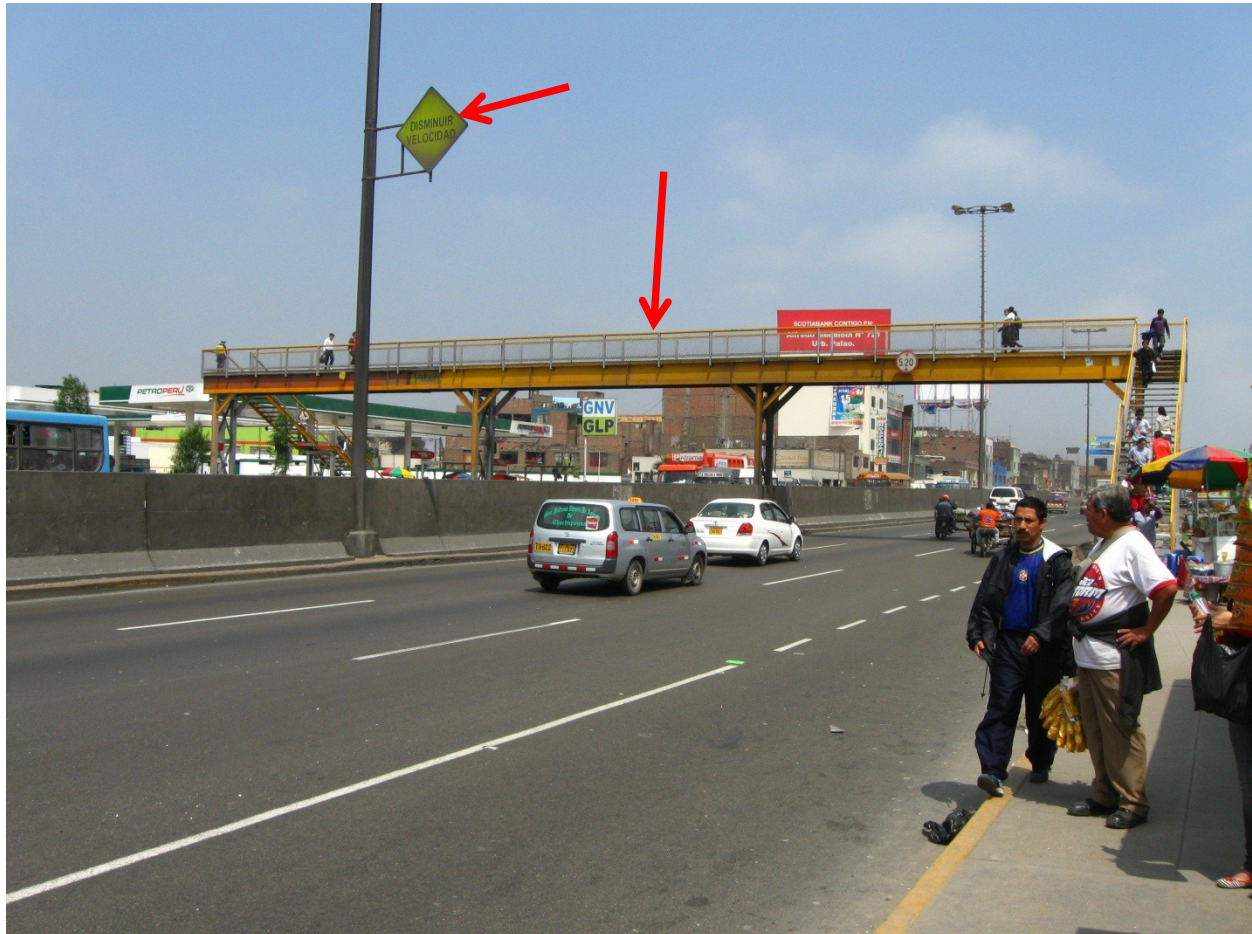
Figure 13. Example of a pedestrian bridge over the Panamerican Highway and a “Slow Down” (Disminuir Velocidad) sign.

the Pan-American Highway that runs through the North-South corridor of Lima. At other sites, speed bumps have been placed near crossing areas to slow down vehicle traffic. Pedestrian crossing signals have been added at some intersections. We previously evaluated the relationship between pedestrian crossing signals and PMVCs and found that, paradoxically, pedestrian signals may be associated with PMVCs.[Ch1] Anecdotally, pedestrians in Lima often ignore such measures, possibly reducing their effectiveness.²

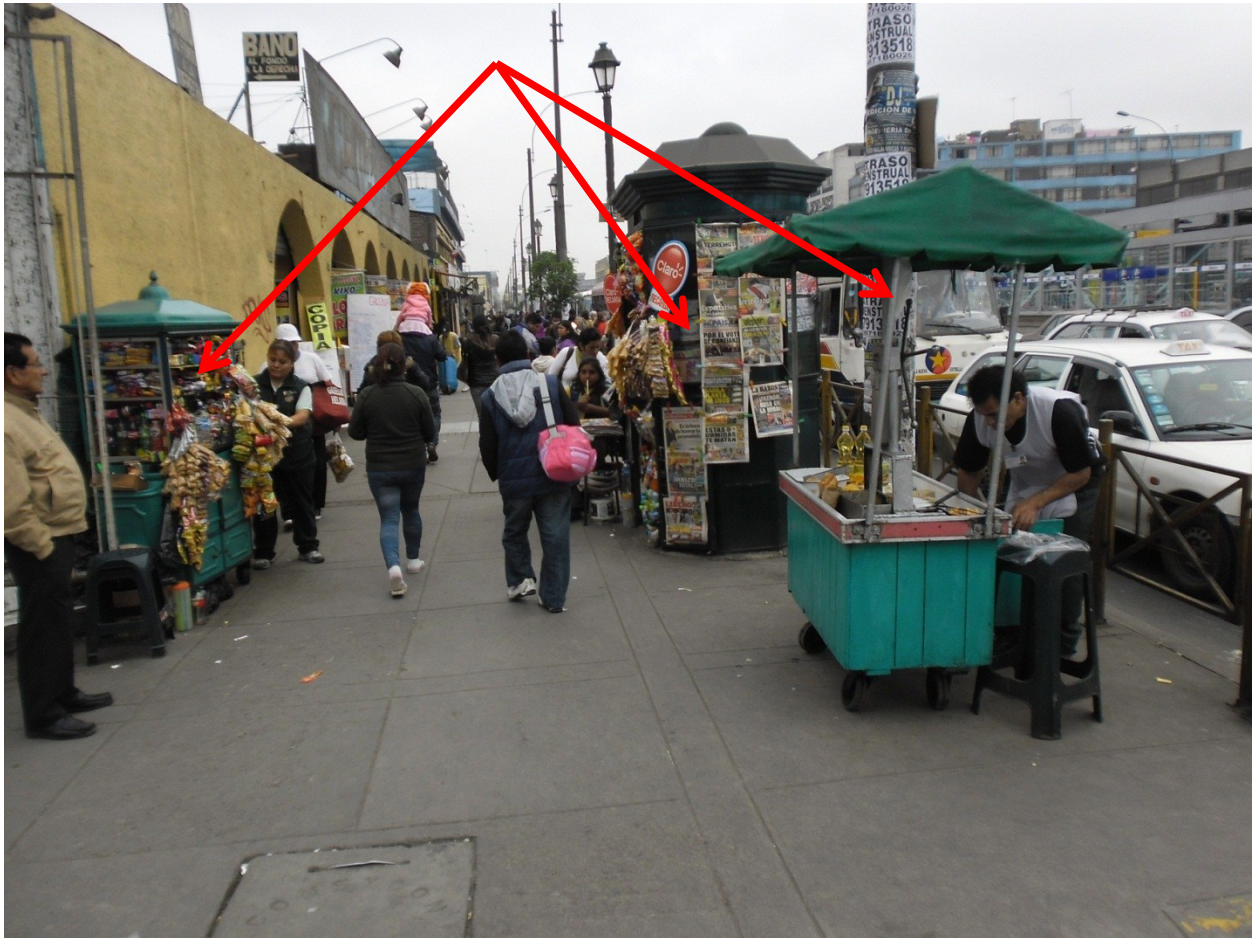
Figure 14. Example of street vendors near an intersection.

There are several potential dangers that street vendors may present to pedestrian safety. We observed that vendors tended to place themselves at or near street corners at intersections. This placement seemed to cause problems such as blocking or reducing entry into the walking path area from the roadway, reducing the waiting area to cross the roadway resulting in pedestrians spilling onto the roadway, and limiting the ability of drivers to spot pedestrians who may dash out into the roadway to cross. These situations may be further complicated if the vendors have several customers being served or waiting to be served. One would also expect street vendors to potentially draw foot traffic to an intersection, which might increase pedestrian exposure. Our study approach allowed us to separately control for pedestrian volume and thus to incorporate information about exposure as well as risk.³³ While banning all street vendors is one possible solution in principle, this would likely impose serious economic hardship on those that rely on this as their livelihood and would probably not be met with enthusiasm. Another option could be prohibiting selling within the pedestrian corridor (street corners, near a crosswalk

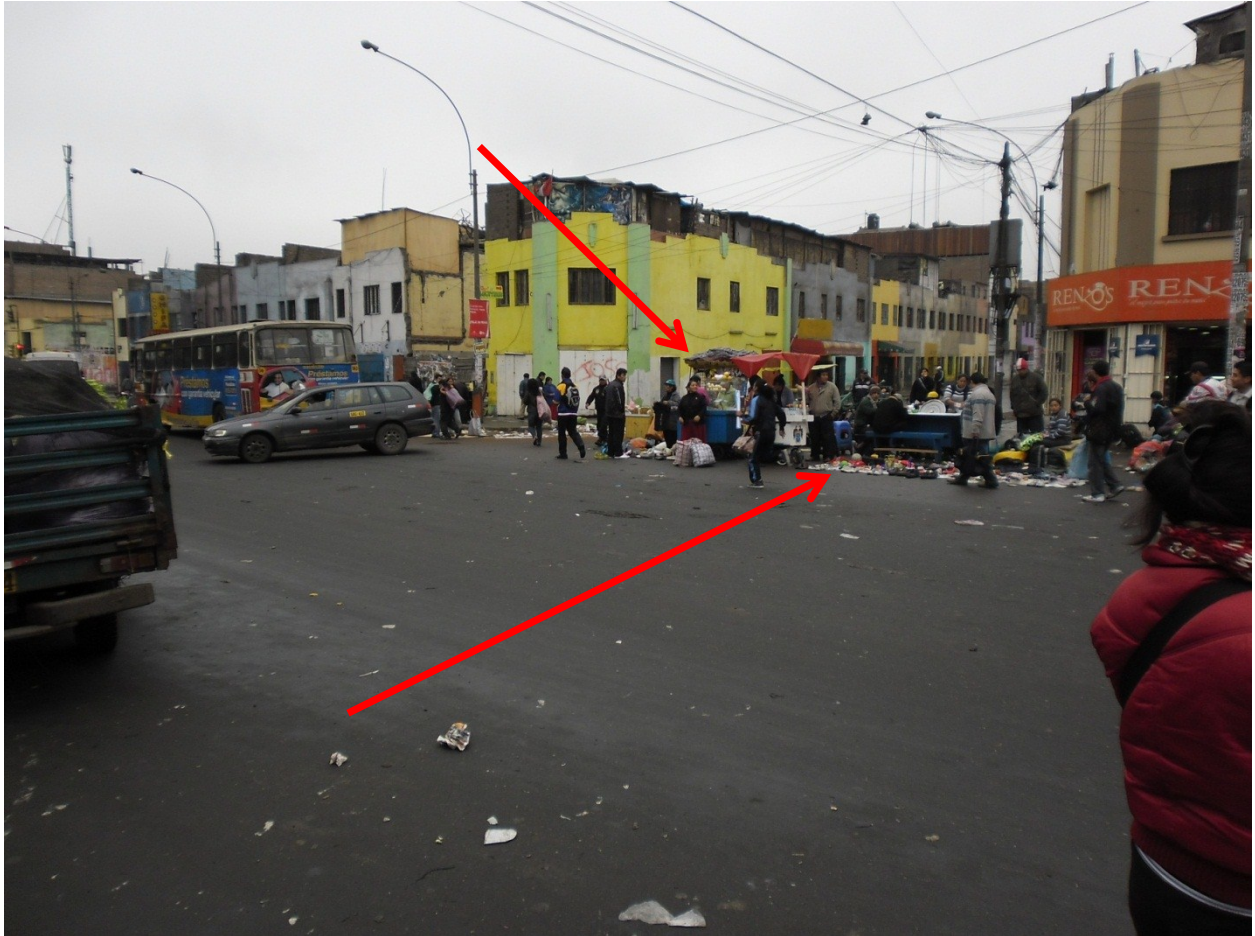
Figure 15. Street vendors blocking access to the sidewalk on one side of the road.
