RECAPTURING A CULTURAL LANDSCAPE:
THE PAST AND FUTURE CHARACTER OF THE
HALLER GARDENS

DORIS J. McMAHON

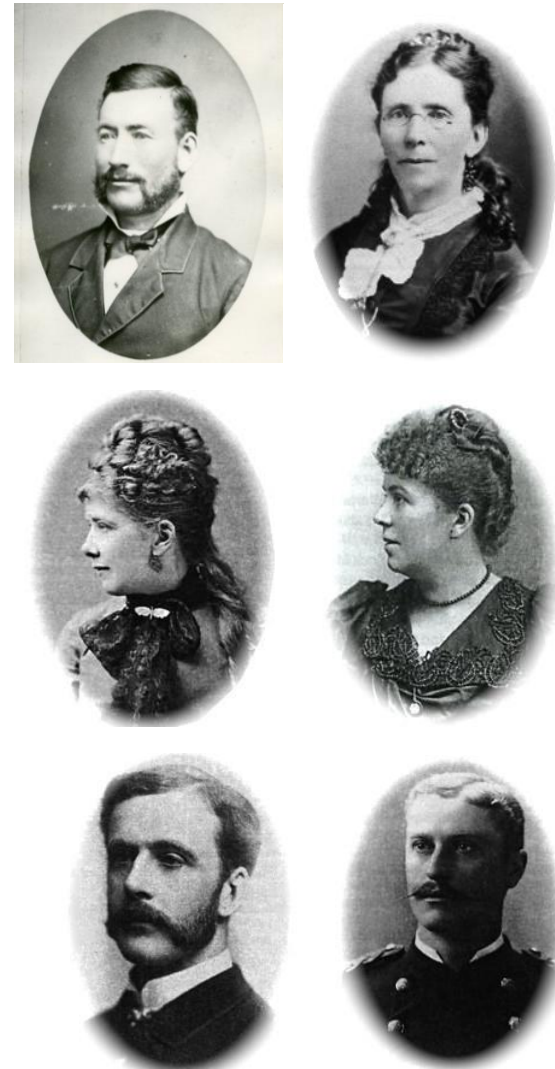
Figure 2.2.-2.7. Top left to right: Major Granville O. Haller, Henrietta M. Haller, Alice Mai, Charlotte, George, and Theodore.

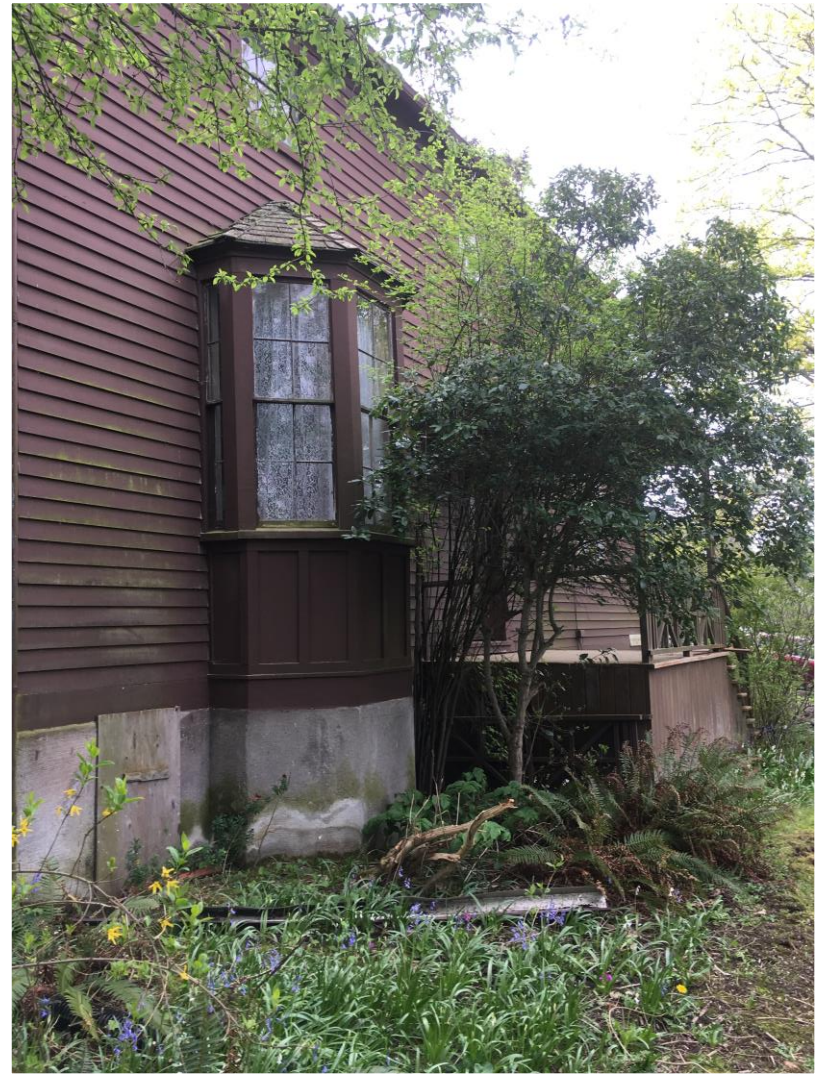
Figure 2.11. View of North Bay Window and Front Porch. December 2015.

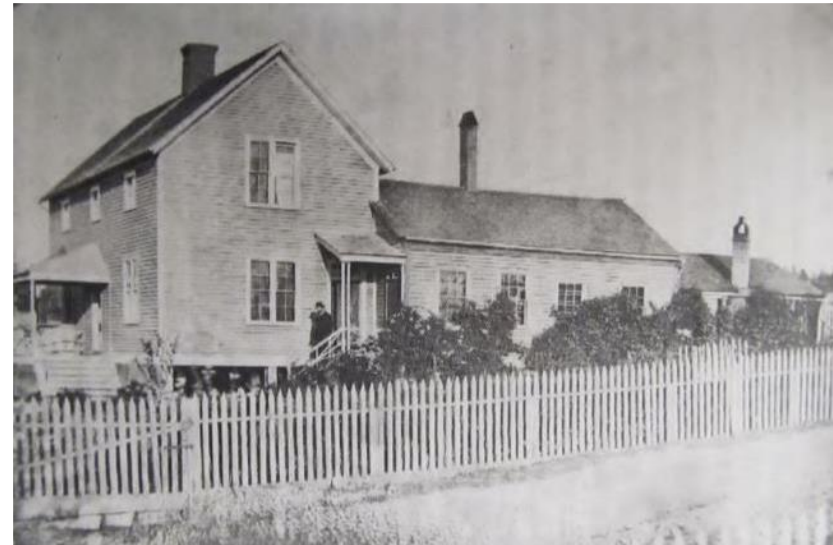
Figure 2.13. Presumably Colonel Haller at the steps on the northwest entry way. It is not known if the plants and boundary fence existed before the Haller tenure. 1870. Island County Historical Society.

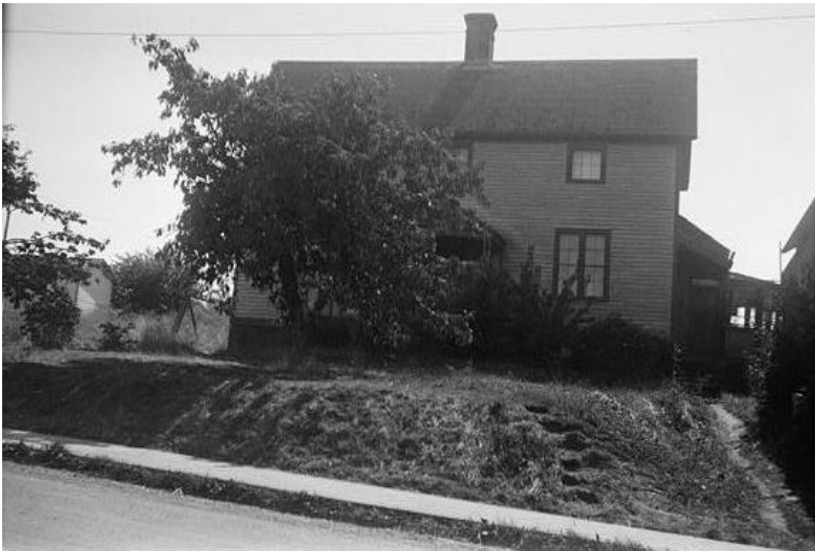
Figure 2.21. In this north view of the Haller property, the front yard sloped down to the boardwalk on Front Street. On the photo right, a dirt path leading to the side entrance, the conservatory is visible in the rear, and a cinema stands on the right picture edge. The yard included some grass, a tree and ornamentals around the foundation. June 22, 1948. Historic American Building Survey. HABS WASH. 15. COUP. 6—1

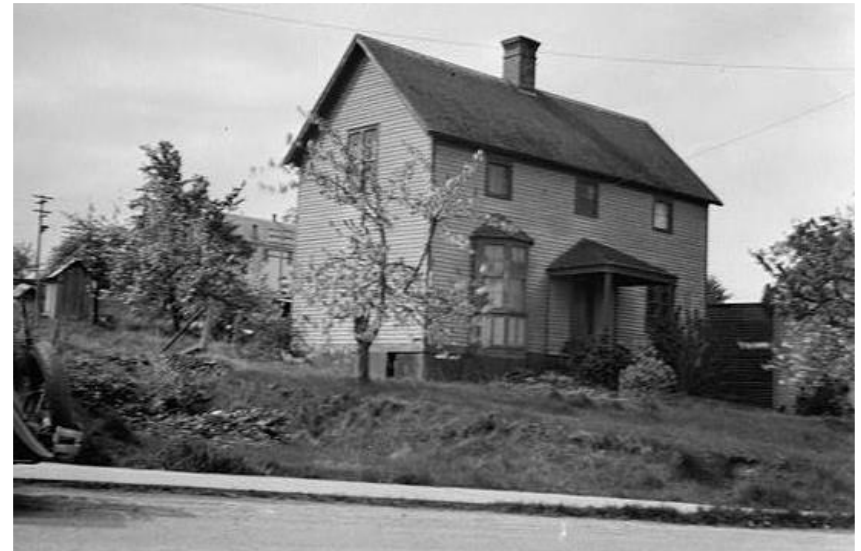
Figure 2.22. Northeast view of the Haller property. On the photo left debris from a demolished structure to the east structure labeled D.G. on 1914 map. The front and side yards included grass and trees. Outbuildings are visible in the rear yard and the cinema is also visible on the photo right. The bay window and the front porch offered prominent views to Penn Cove. June 22, 1948. Historic American Building Survey. HABS WASH. COUP. 6—2

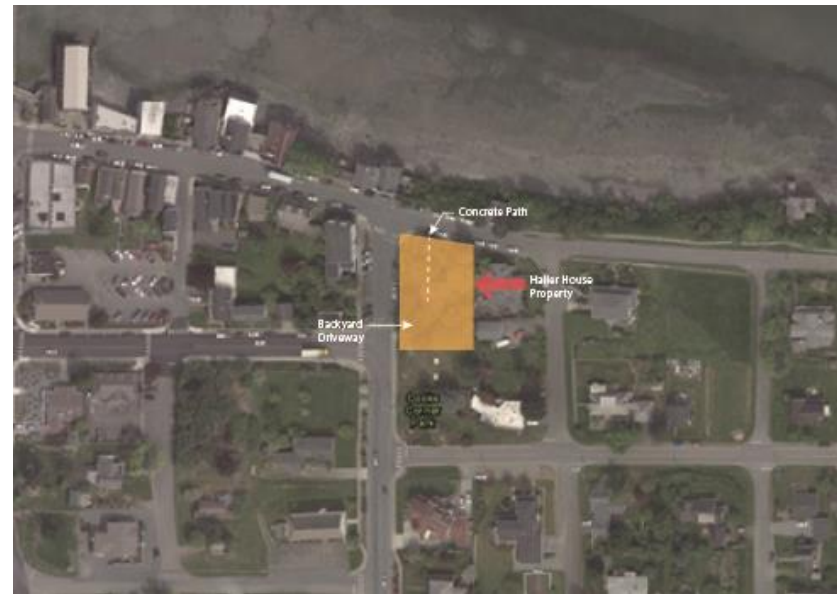
Figure 2.28. Haller House Property Vicinity Map. Accessed January 2016. Google Image

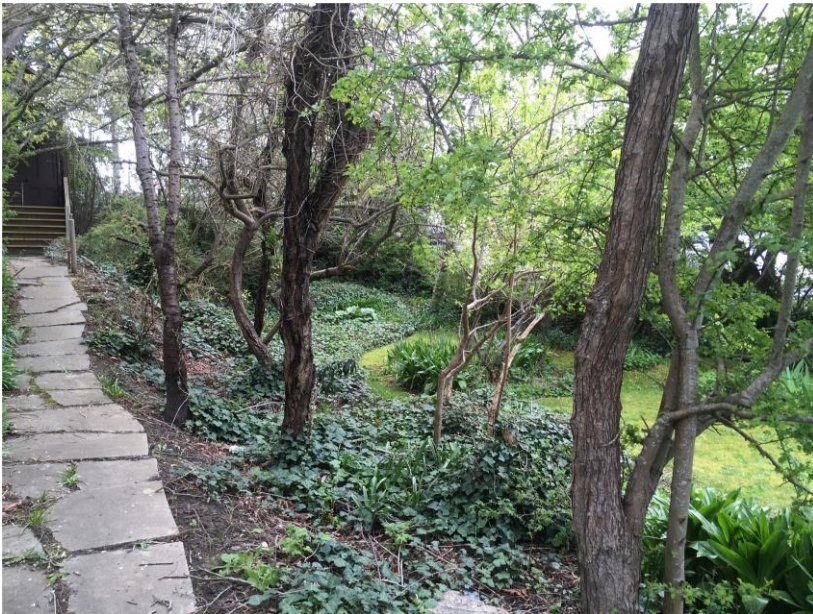
Figure 2.29. Photograph left is view of the path to front door and picture right is the ravine.

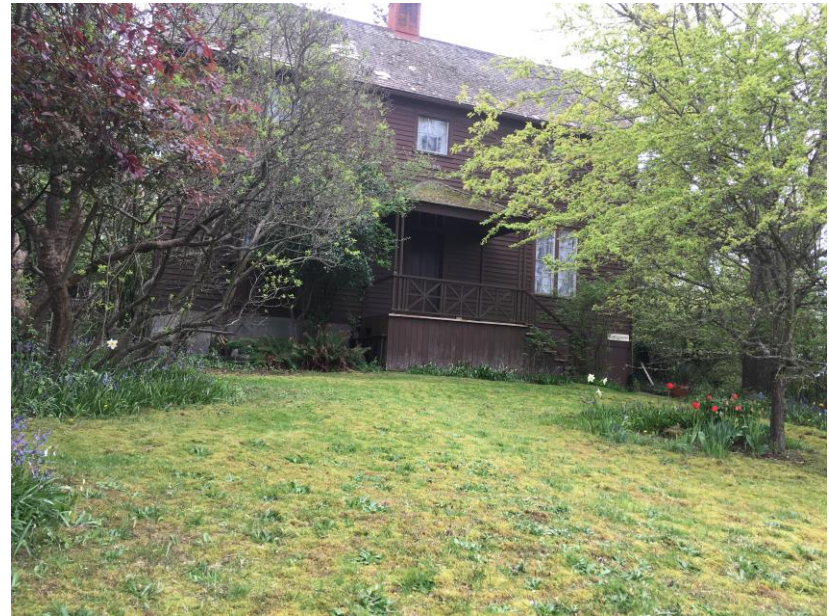
Figure 2.34. North view of the Haller House. Open area in front yard is planted with grass, Hawthorn, Big leaf Maple, notable ilac, roses, and Honeysuckle. Sword ferns, Forsythia, and Oceanspray, are planted in the flower beds along the foundation. March 2016.

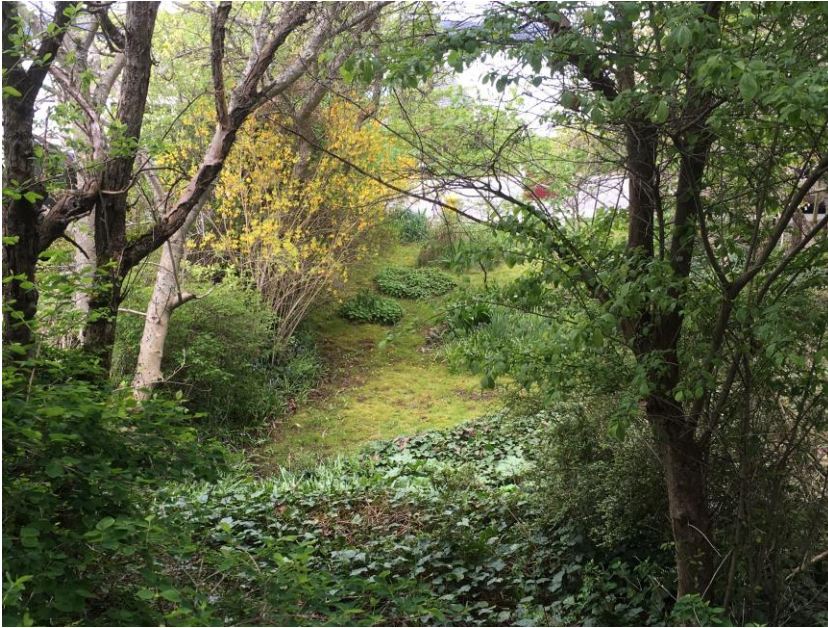
Figure 2.35. This location at the northwest corner of the property was once the site of the mercantile store and cinema. A ravine remains at this location. The area includes Spurge laurel and an abundance of invasives. December 2015.

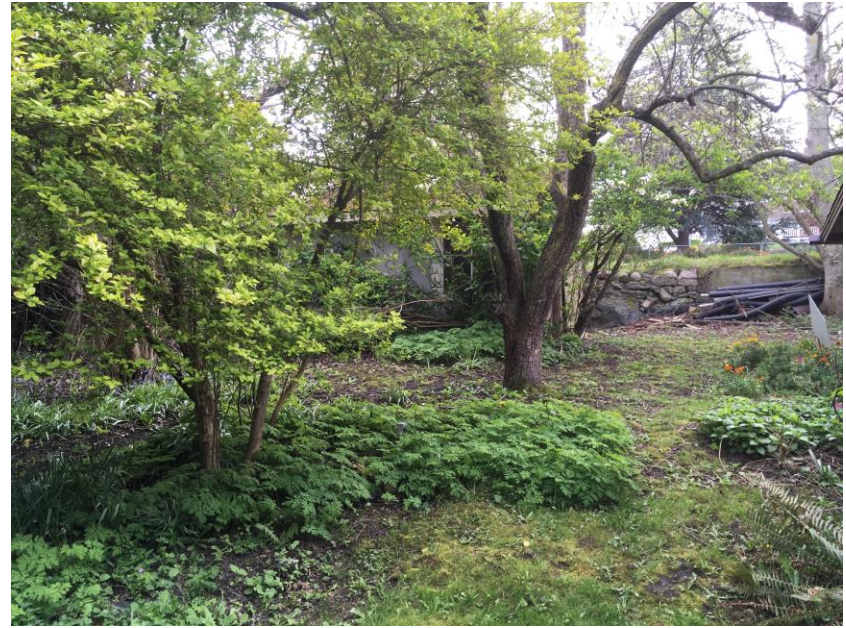
Figure 2.38. Southeast view of the neglected backyard. The garage and shed are deteriorating and will be removed. March 2016.

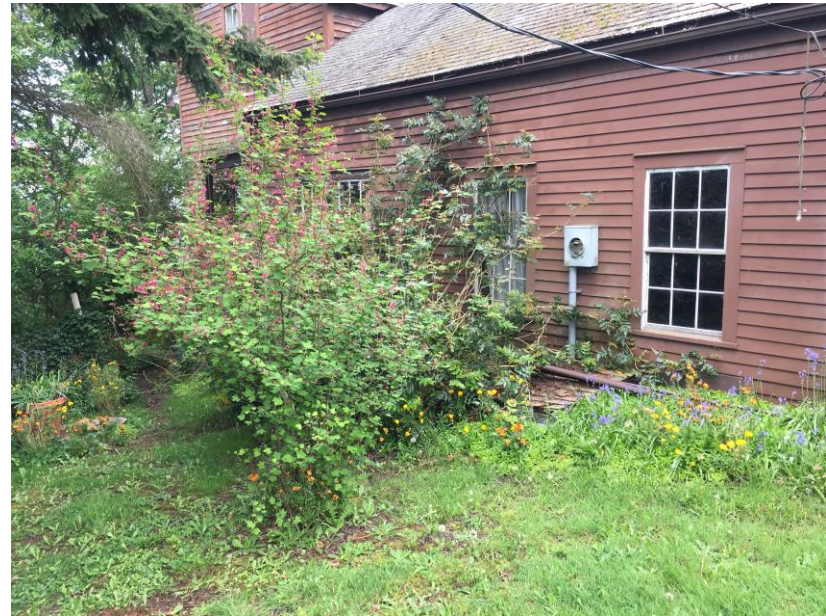
Figure 2.39. West side view of the overgrown side yard. Early photographs show a conservatory was once located on the west wall. March 2016.

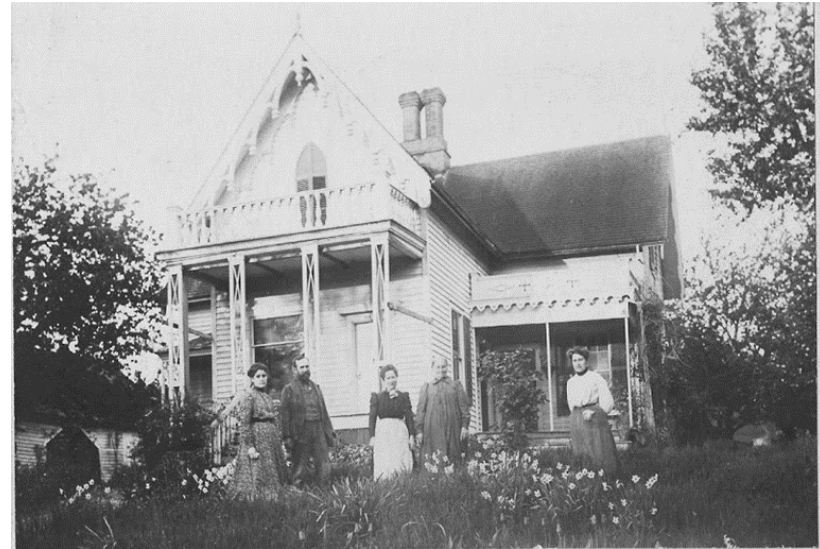
Figure 3.5. Members of the Bigelow family in the blossoming ornamental garden, 1905. Accessed February 12, 2016. Picasa Bigelow House Historic Photos. <https://picasaweb.google.com/103680888674821862427/BigelowHouseHistoricPhotos>

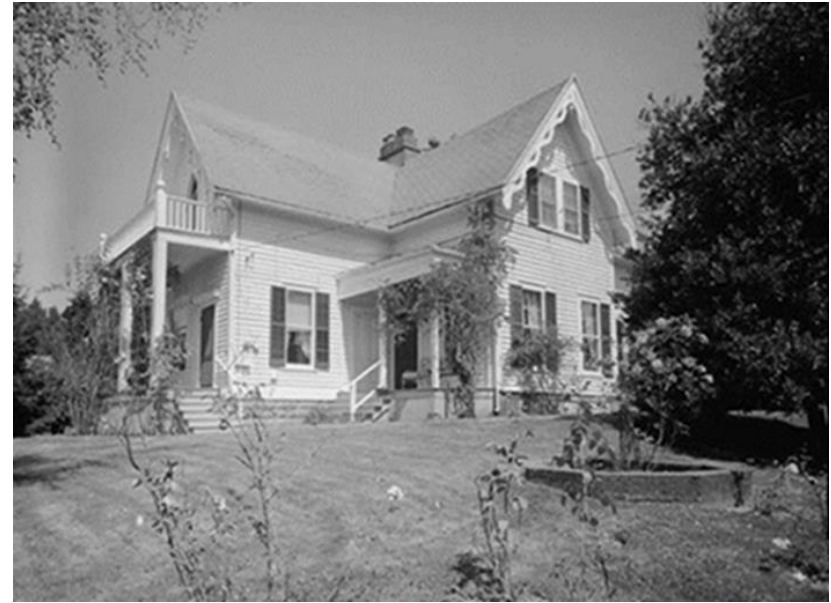
Figure 3.11. A later photograph shows many of the plants in existence today. The expanse of ornamental plants visible in earlier photographs were replaced with a lawn. Accessed February 12, 2016. Picasa Bigelow House Historic Photos.

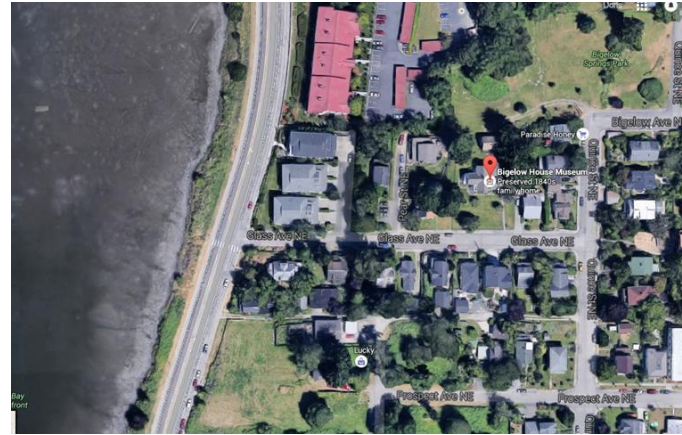
Figure 3.12. Bigelow House Museum Site Plan. Budd Inlet on left. Accessed February 10, 2016. Google Image.

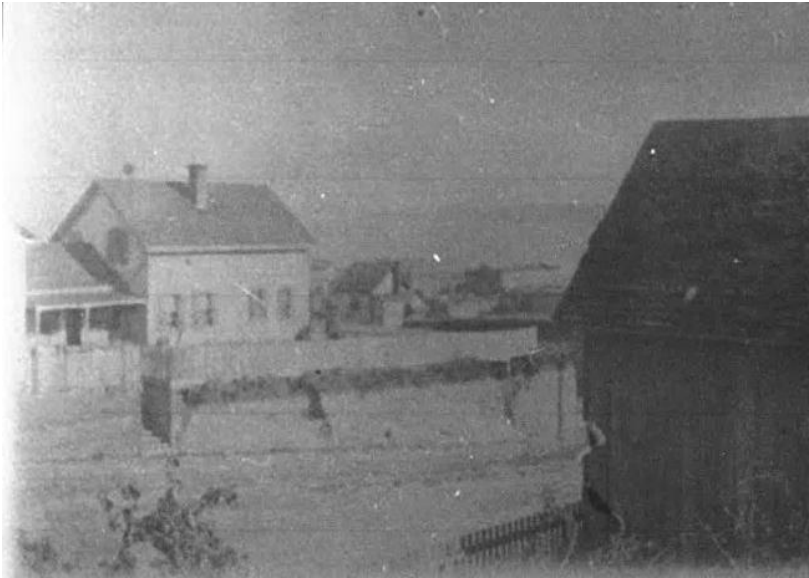
Figure 4.7. A view of the Rothschild House looking out towards downtown. A picket fence borders the south property along Taylor Street. n.d. Accessed February 5, 2016. Jefferson County Historical Society <http://www.jchswa.org/>

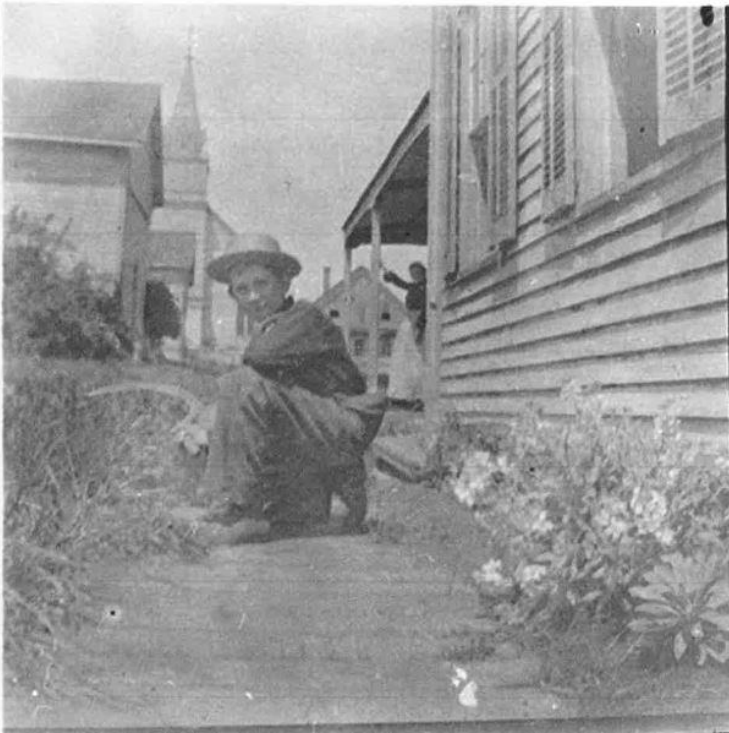
Figure 4.12. Eugene Rothschild cutting grass with a scythe at the family home. Ornamental flowers were planted around the foundation, circa 1900. Accessed February 5, 2016. Jefferson County Historical Society <http://www.jchswa.org/>

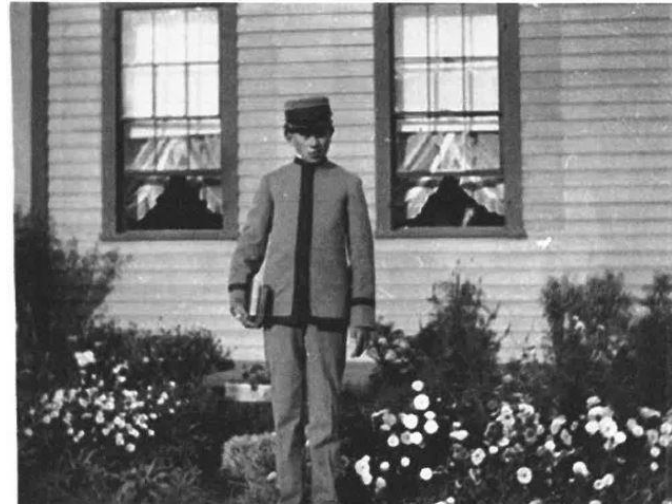
Figure 4.13. Eugene Rothschild, the youngest child, standing on the south side of the Rothschild House. Assorted ornamentals were grown around the foundation, n.d. Accessed February 5, 2016. Jefferson County Historical Society <http://www.jchswa.org/>.

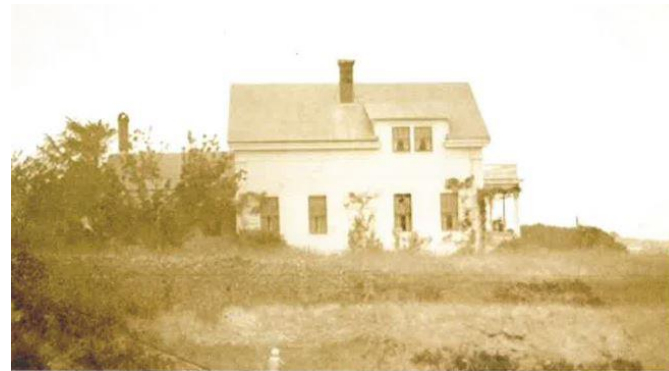
Figure 4.14. Rothschild House, n.d. south view showing dormer windows and overgrown yard. Accessed February 5, 2016. Jefferson County Historical Society <http://www.jchswa.org/>

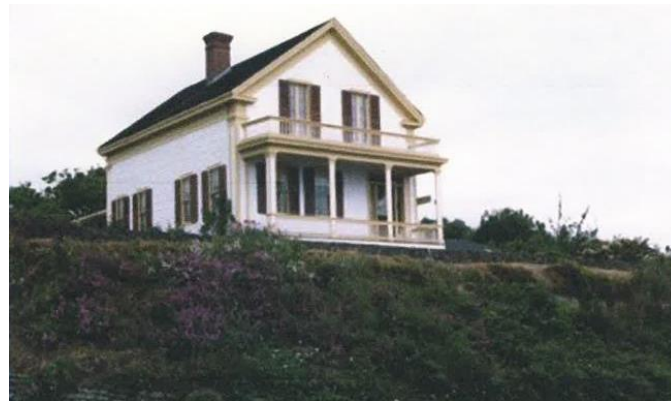
Figure 4.17. Rehabilitated Rothschild House Museum landscape. Ground cover, cover a retaining wall. Accessed February 5, 2016. Jefferson County Historical Society <http://www.jchswa.org/>.

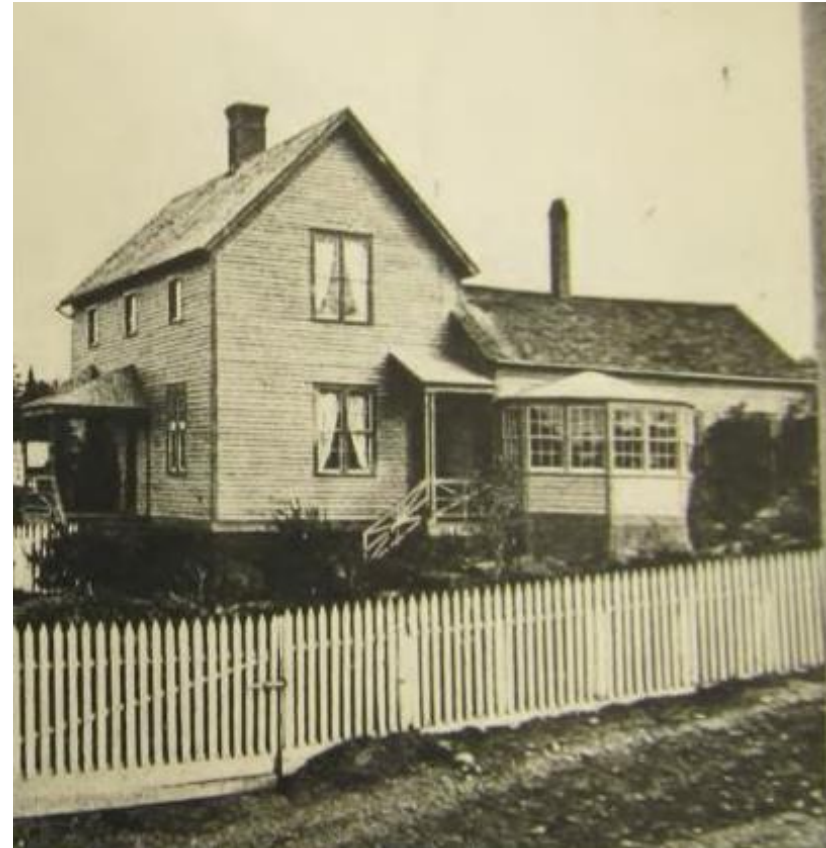
Figure 5.4. The conservatory overlooking a garden with assorted plants the side yard and around the house foundation. 1900. Island County Historical Society image.
