Recovery Reimagined: Regenerative Intervention in the Upper Stillaguamish River Valley

A thesis
submitted in partial fulfillment of the
requirements for the degree of

Master of Architecture

University of Washington

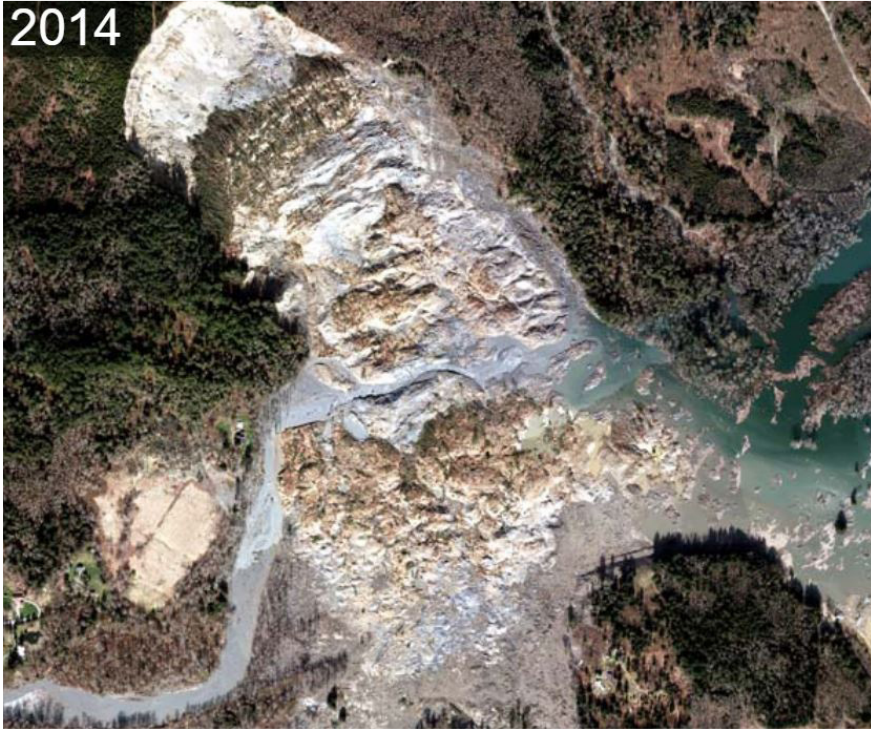
Figure 17: Aerial photo showing 2014 slide

While there have been slides throughout the valley, one area has garnered significant attention due to its history of slides and the effects they have had on human life. Just east of Oso, a river bend called Hazel has experienced six landslides since 1951. The soft soil of the hillside is carved away by the river below until a slide event occurs, typically prompted by a loosening of the soil either by heavy rainfall or human intervention such as logging.² Despite the hazards, a neighborhood was established in this river bend in the 1950's and by 2014 more than 30 homes were built. All of these home were destroyed on March 22, 2014 when “Slide Hill” gave way and spread 10 million cubic yards of soil, killing 43 people.³

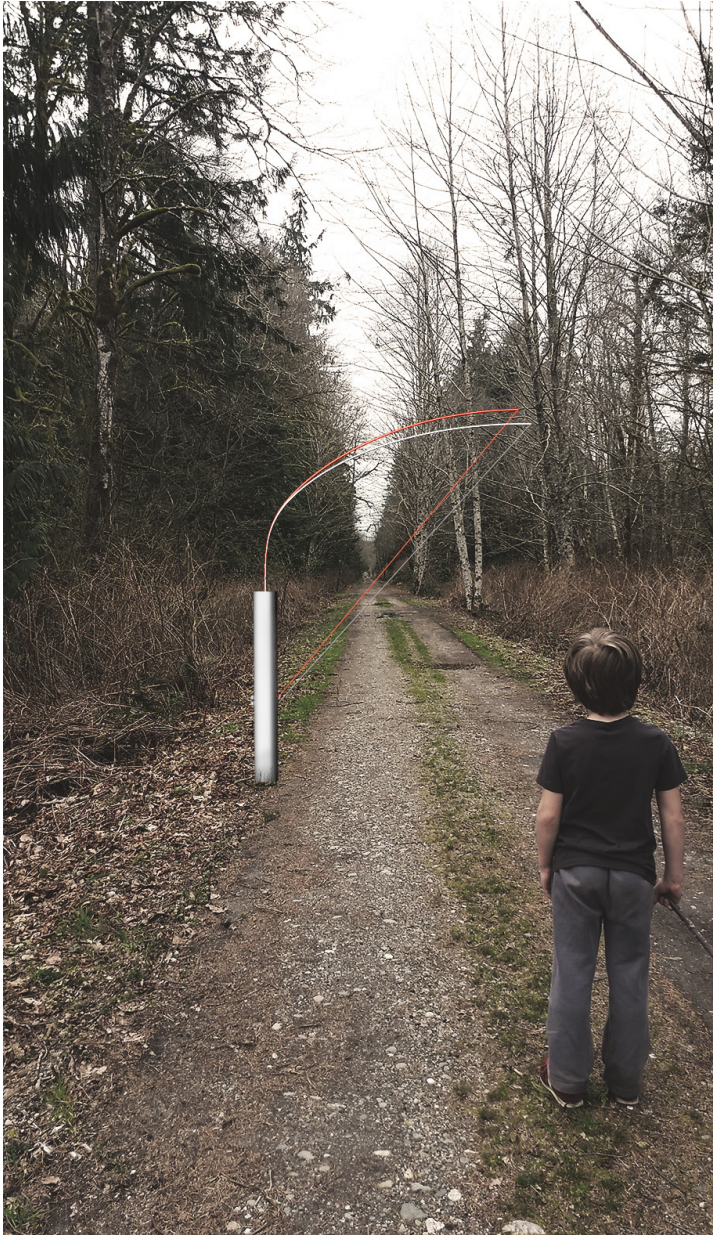
Figure 40: Marker along the trail, signaling an approaching river

is movable. It is moved when the riverbank edges closer or farther from the starting point datum, which is established on the date of installation. The markers indicate where the river is in relation to their specific points along the trail and record the shifting of the riverbank over time. A visitor will most likely observe these shifts on a long time scale, as they typically occur quite slowly. However, shifts can occur quickly, as in the case of a landslide or when portions of riverbank fall away due to erosion or weathering.

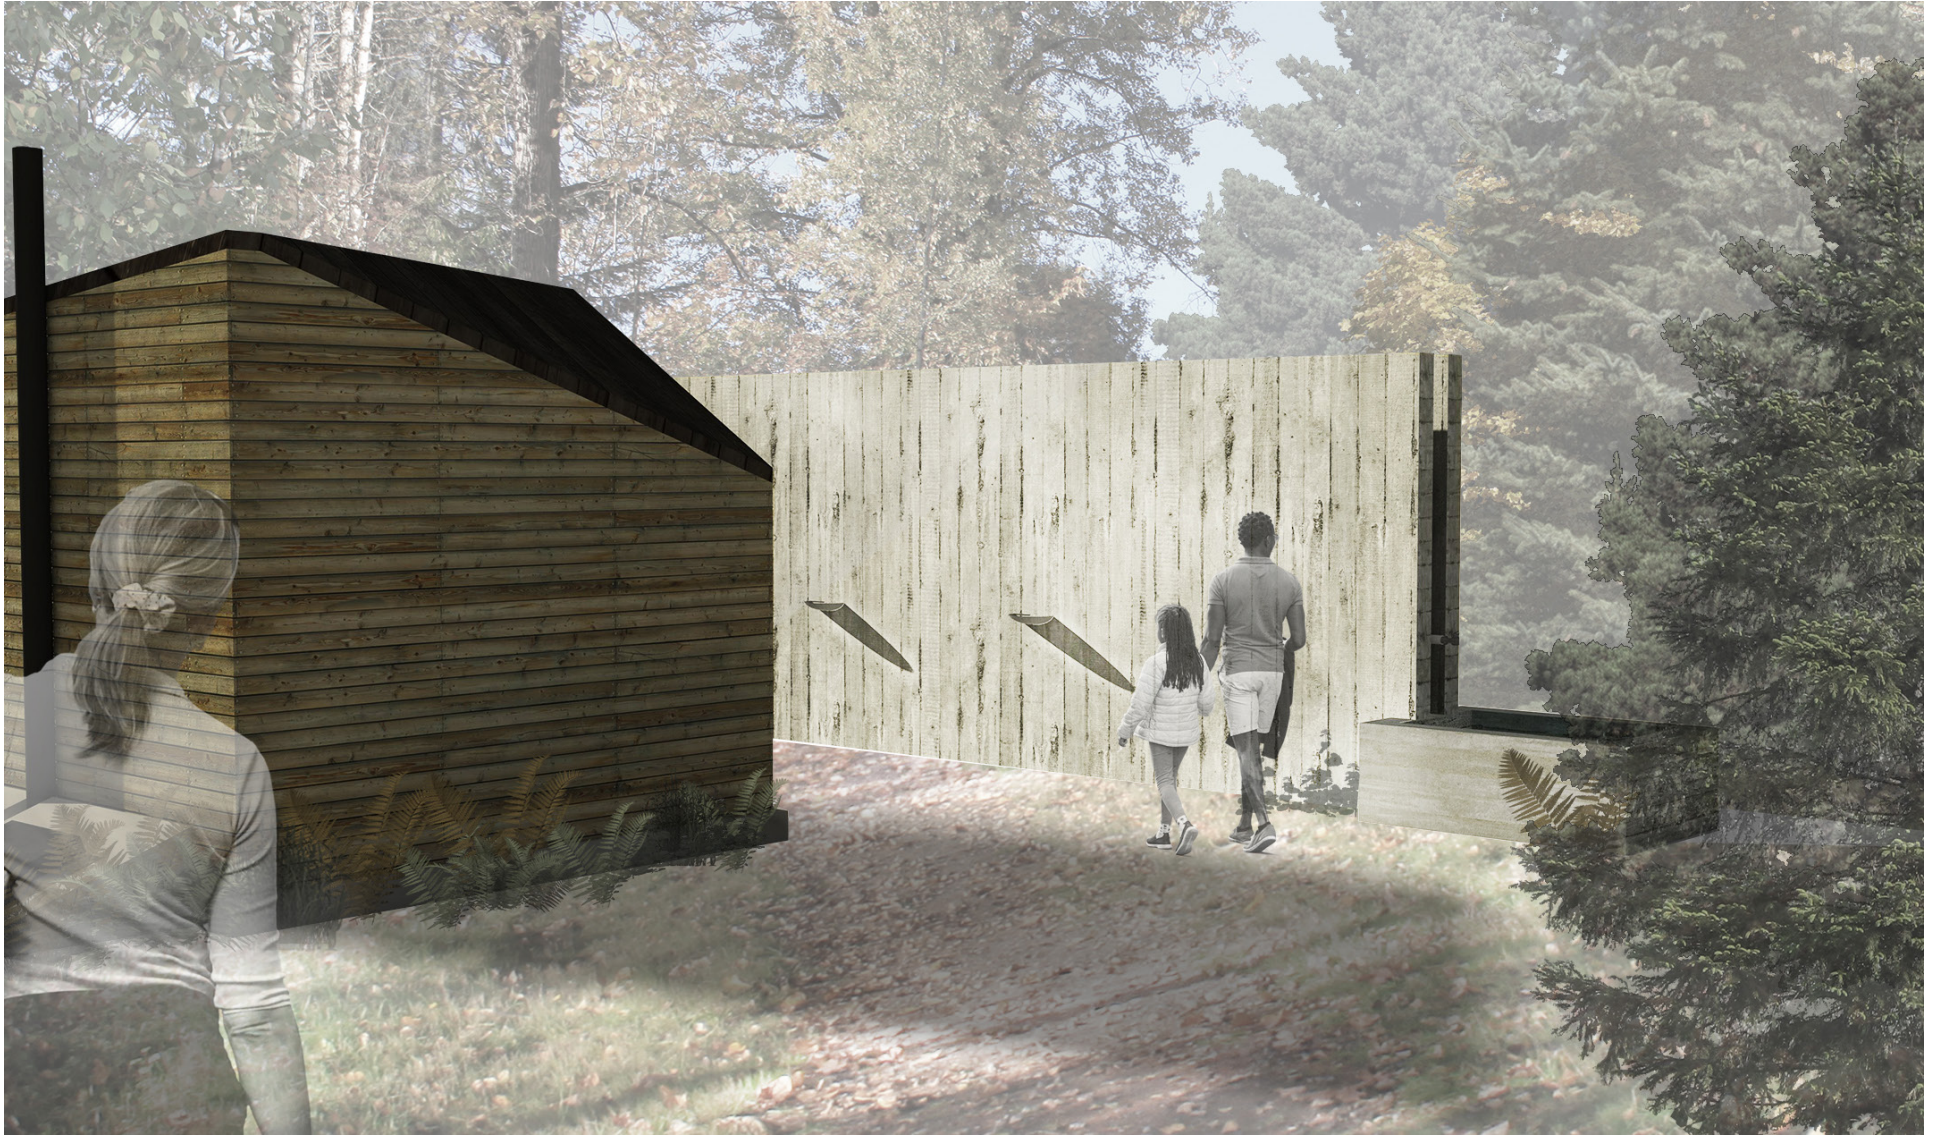
Figure 47: *Darrington Approach*

between town and trail is made distinct in order to highlight the transition from built realm to natural realm. The experience of moving from the confines of a car, to the space between two built forms, to the space between trees is important for cultivating a better understanding of nature.

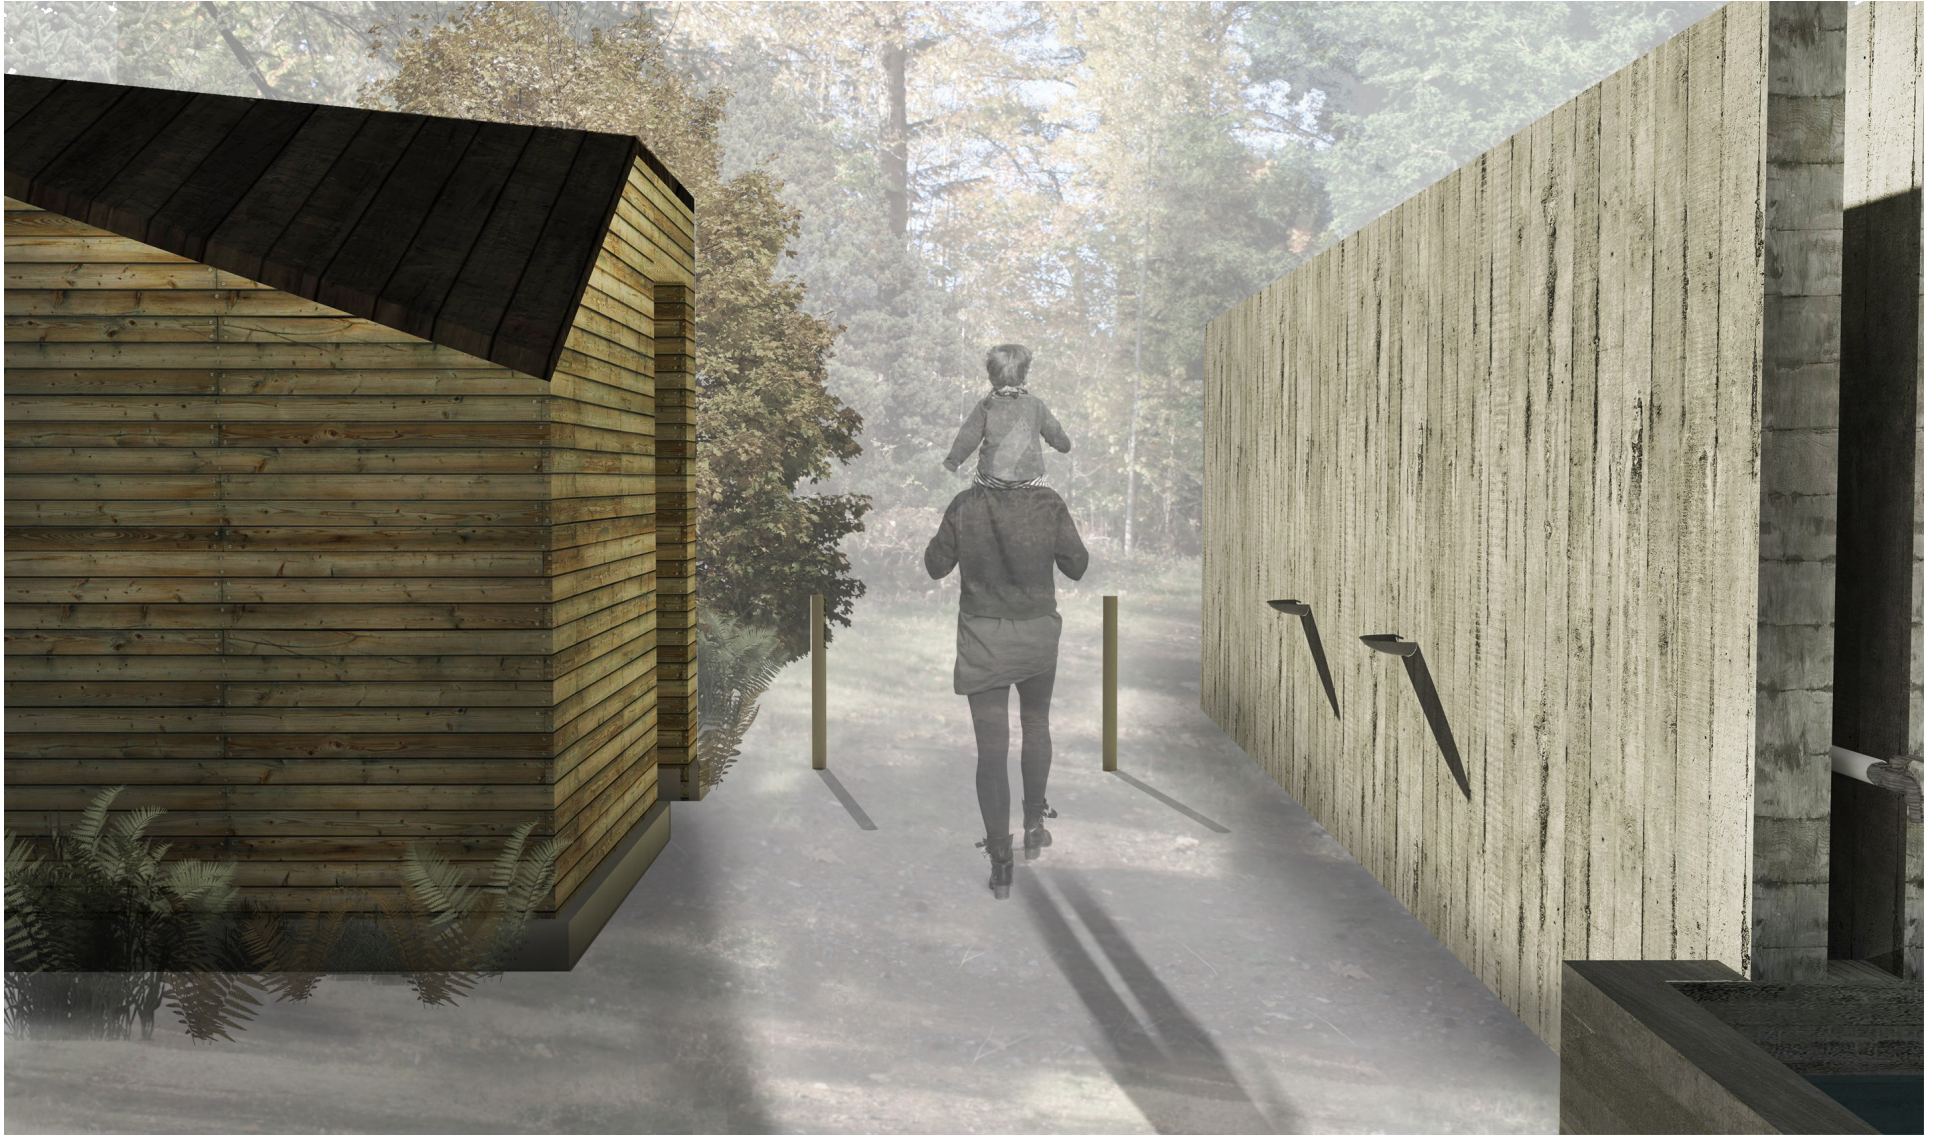
Figure 48: *Darrington Needs*

The Needs segment is geared toward the physical requirements of visitors and their animals, most likely dogs and horses. A water trough for animals and fountains for people are tied into the municipal water system. A simple hut with a composting toilet is a standard feature at trailheads and serves practical needs in preparation for a hike or ride.

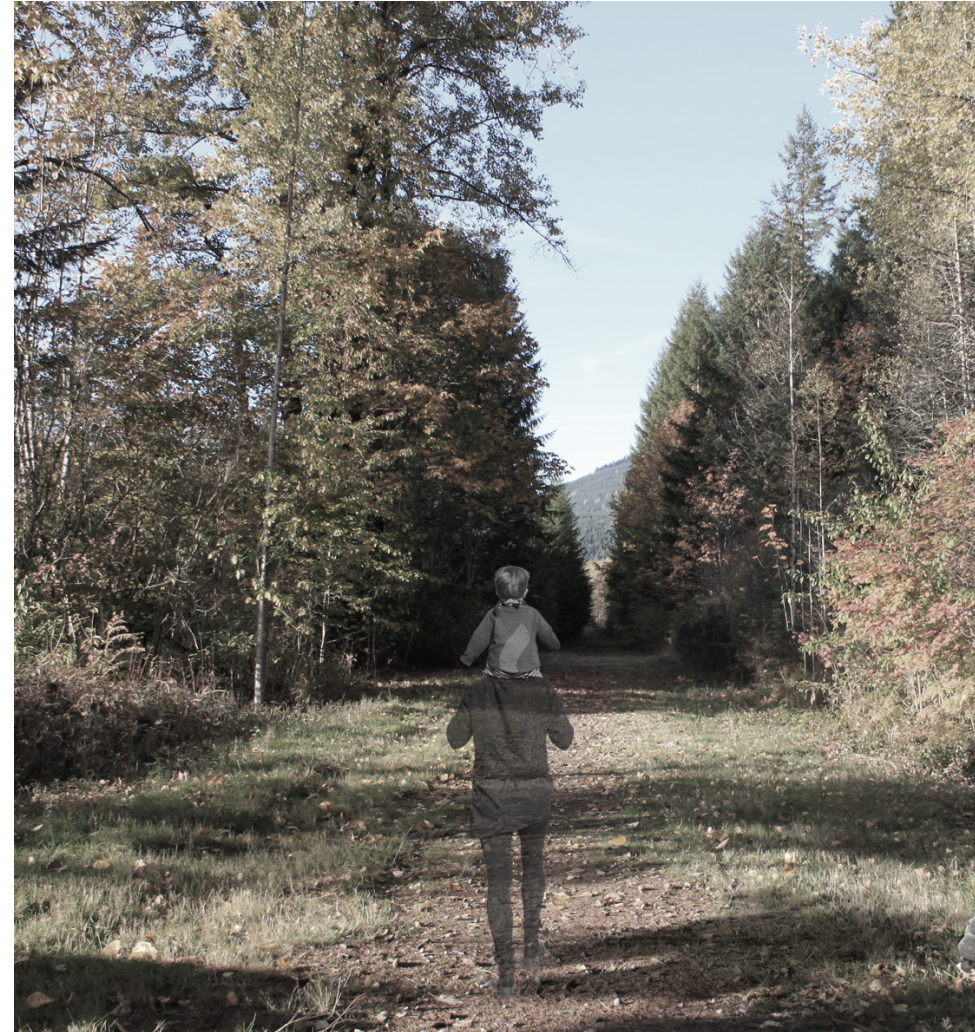
Figure 49: Darrington Reflection

The habitat portion of the regenerative approach for this site emanates from the trailhead along the trail. Bat houses are positioned at one mile increments in order to support the existing struggling bat population. Their presence is crucial for maintaining a healthy ecological cycle involving insects, soils, and plant growth. The visibility of the houses along the trail calls attention to the area's status as a priority habitat for the species, continuing the story of the place that began at the Darrington trailhead.

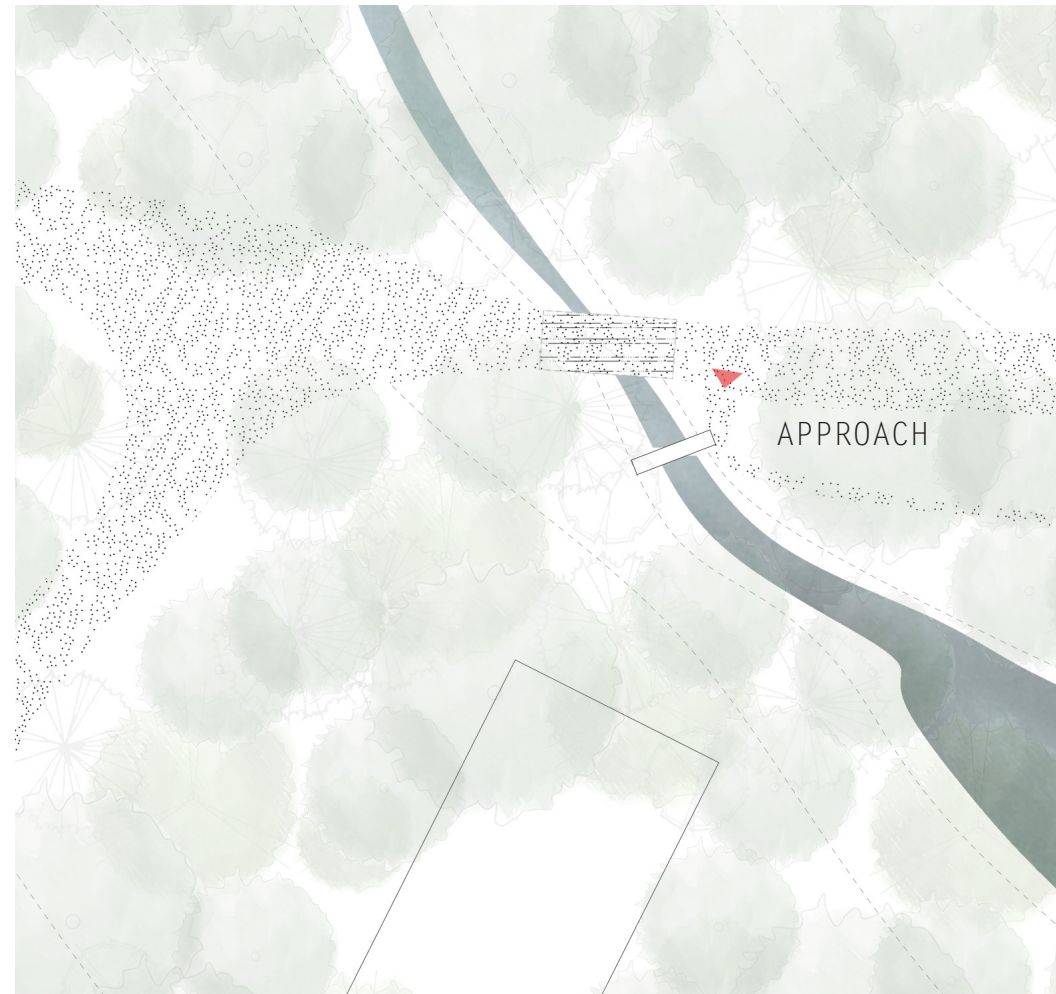
Figure 52: Fortson site organization

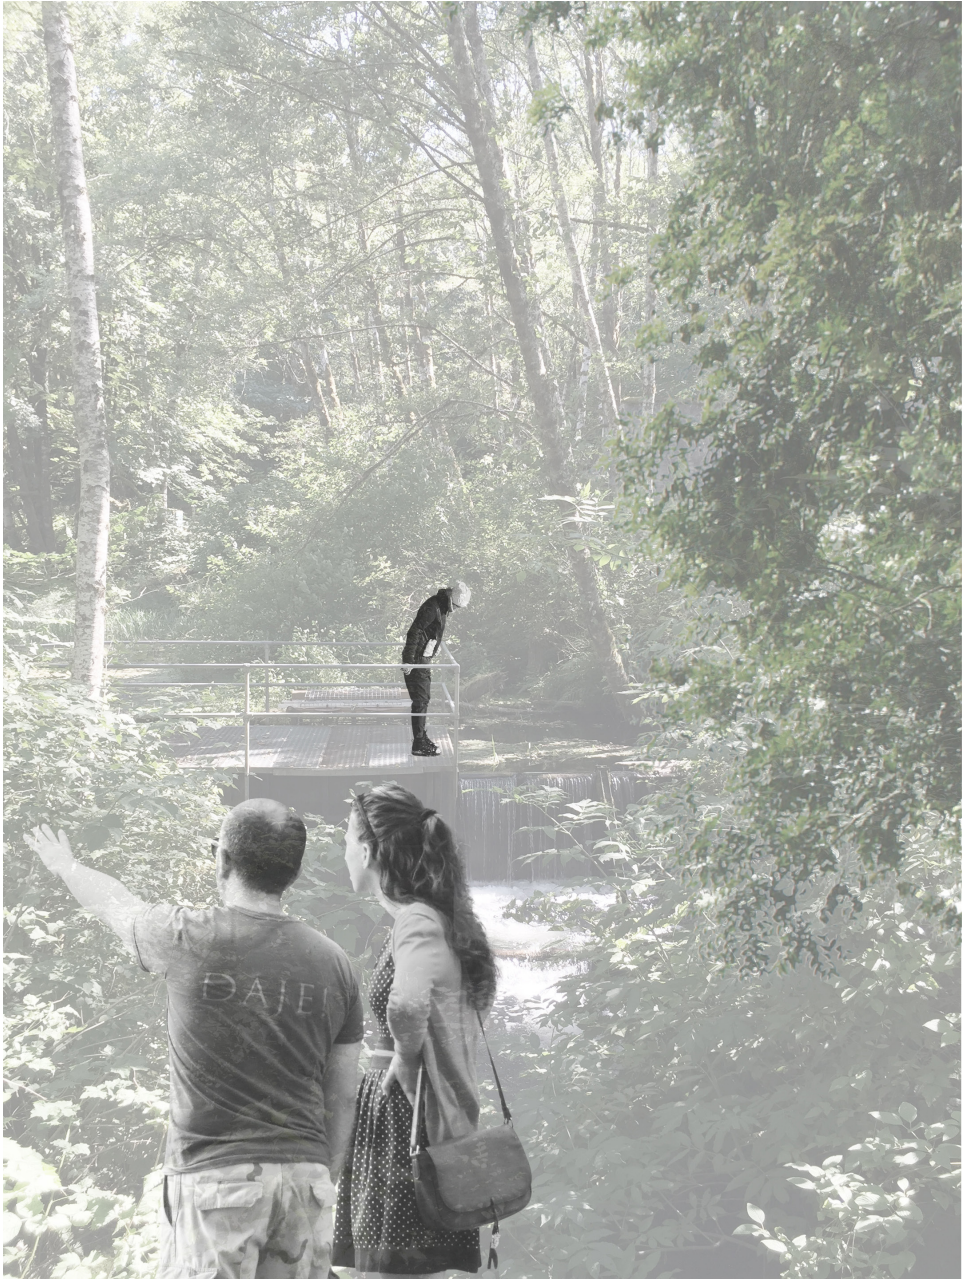
Figure 53: Fortson Approach at fish ladder

salmon. The Approach to the intervention is from the west at the fish ladder, which spawning salmon climb in order to reach the pond. The visitor follows a narrow trail through the trees a short distance where the hut emerges at the edge of the pond. This Needs portion parallels the salmon's own need of the pond for spawning. Whether passing through the hut or under its canopy, the visitor follows the path onward toward a wooden walkway jutting out over the water's edge. From the walkway, there is a view of a glacial mountain peak and the visitor is closest to the water. This is the moment of Reflection and while salmon die and return to the ecosystem within the pond, the visitor continues along the path, which returns them to main trail.

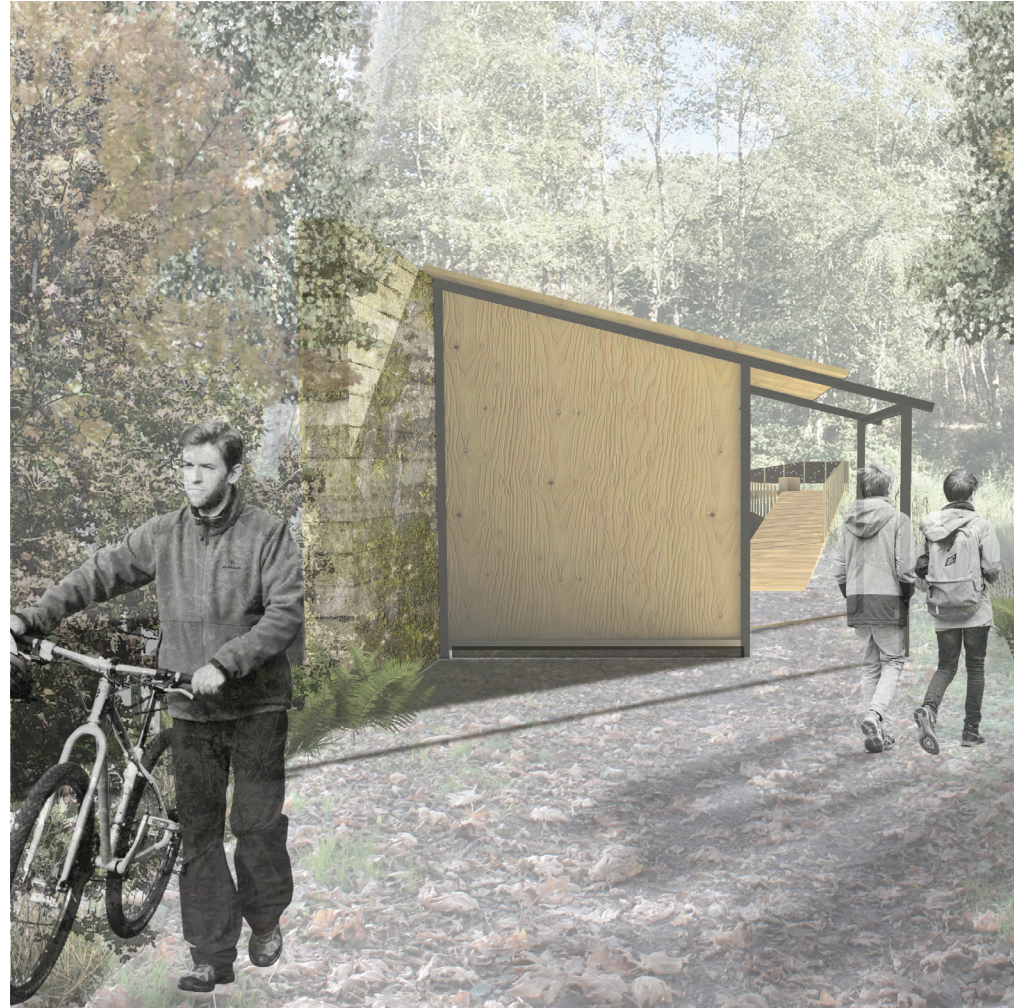
Figure 54: Fortson Needs

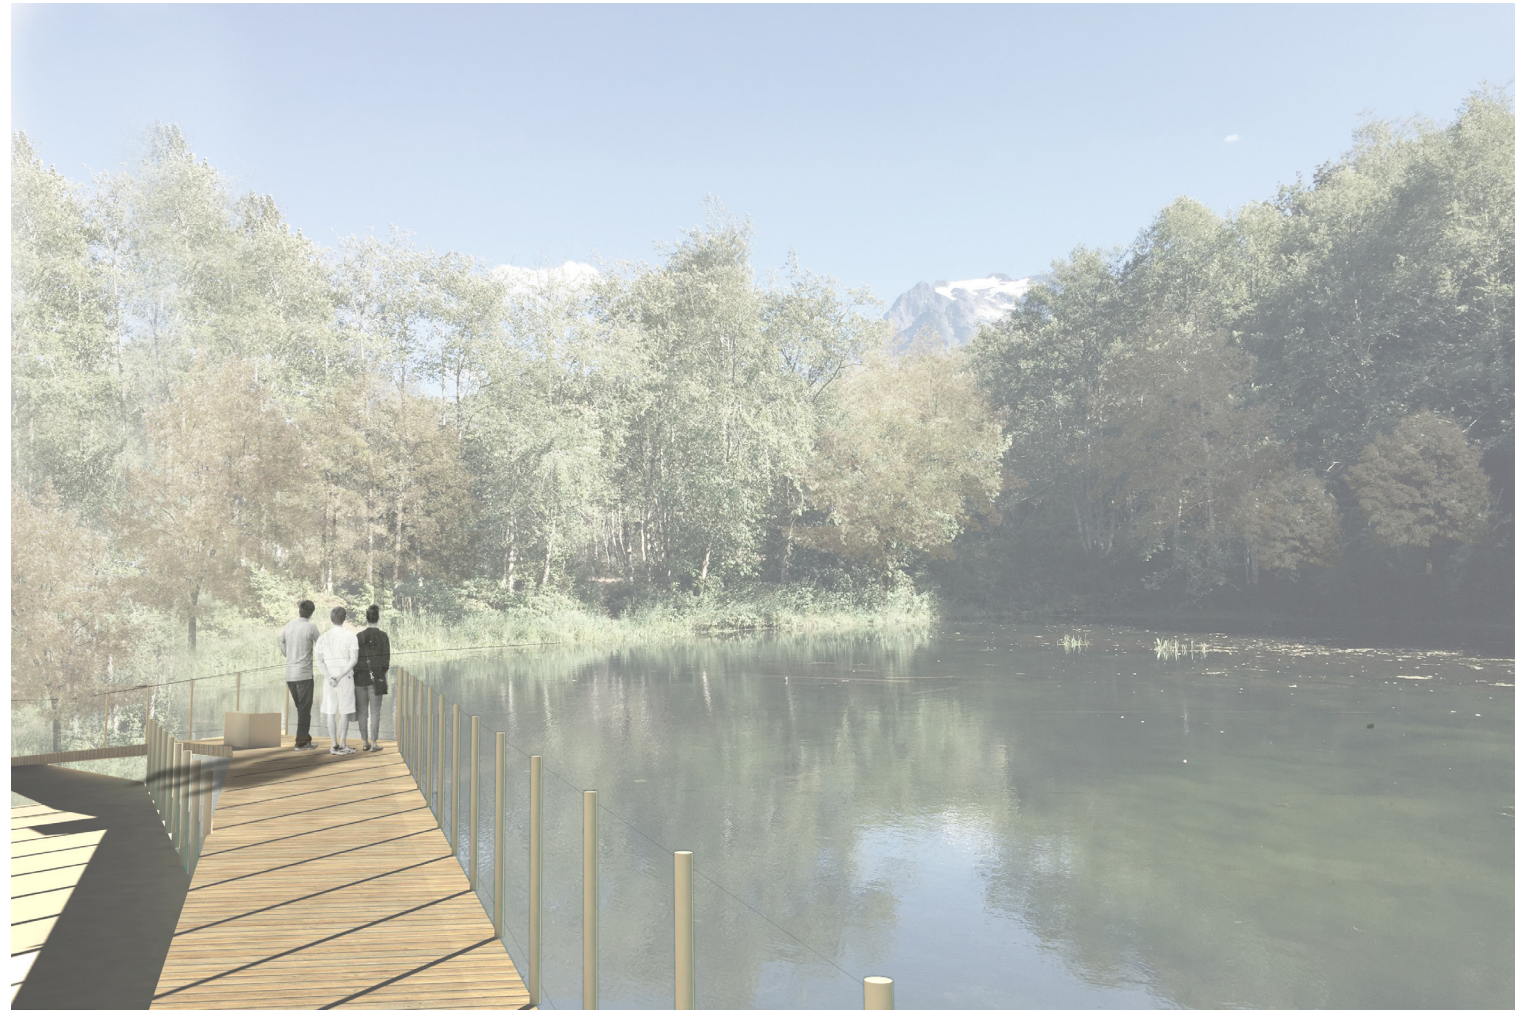
Figure 55: Fortson Reflection at mill pond

Again, the regenerative priority is enforcing the notion of place and the revealing of nature. Through subtle direction along the path, aspects of the landscape are exposed to the visitor. The natural elements of water and wildlife are made visible and accessible. The story of this landscape as a salmon habitat is revealed and in doing so, visitors are made more aware of the processes around them.

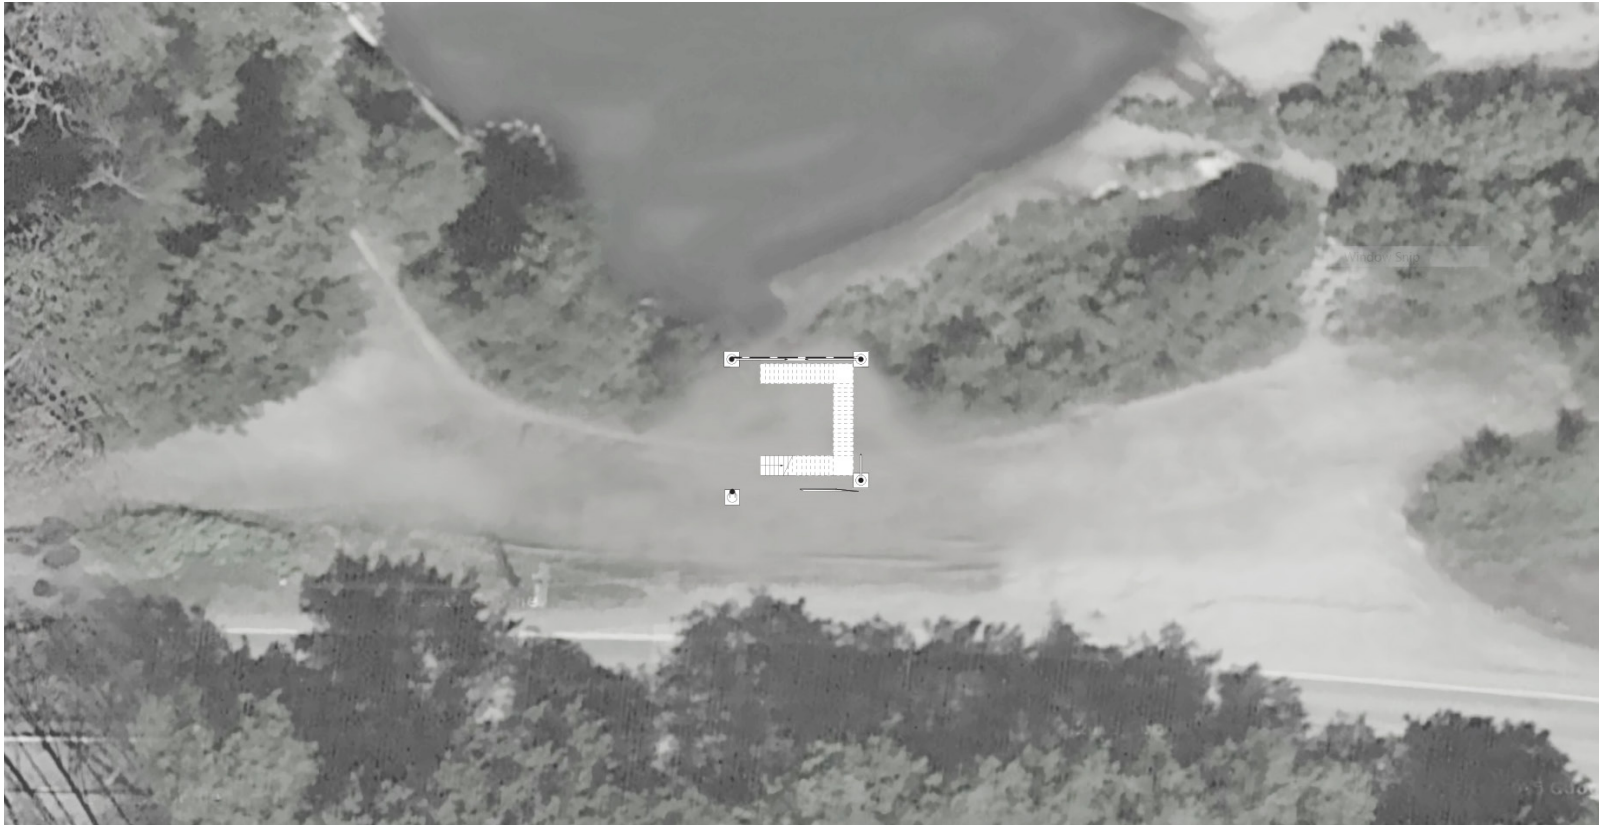
Figure 59: Ground plan within context [portion one]

The first portion is the ground plane which provides access to the tower stairs. The tower faces are open in the direction of the trail to the east and west. Enough height is given between the ground and the structural supports in order to allow a person on horseback to pass underneath the tower. The ground plane of the tower is treated as a continuation of the trail and draws attention to the relationship between the three intersecting channels - river, trail, and highway. It is seen as a place of everyday encounter, experience, and views.

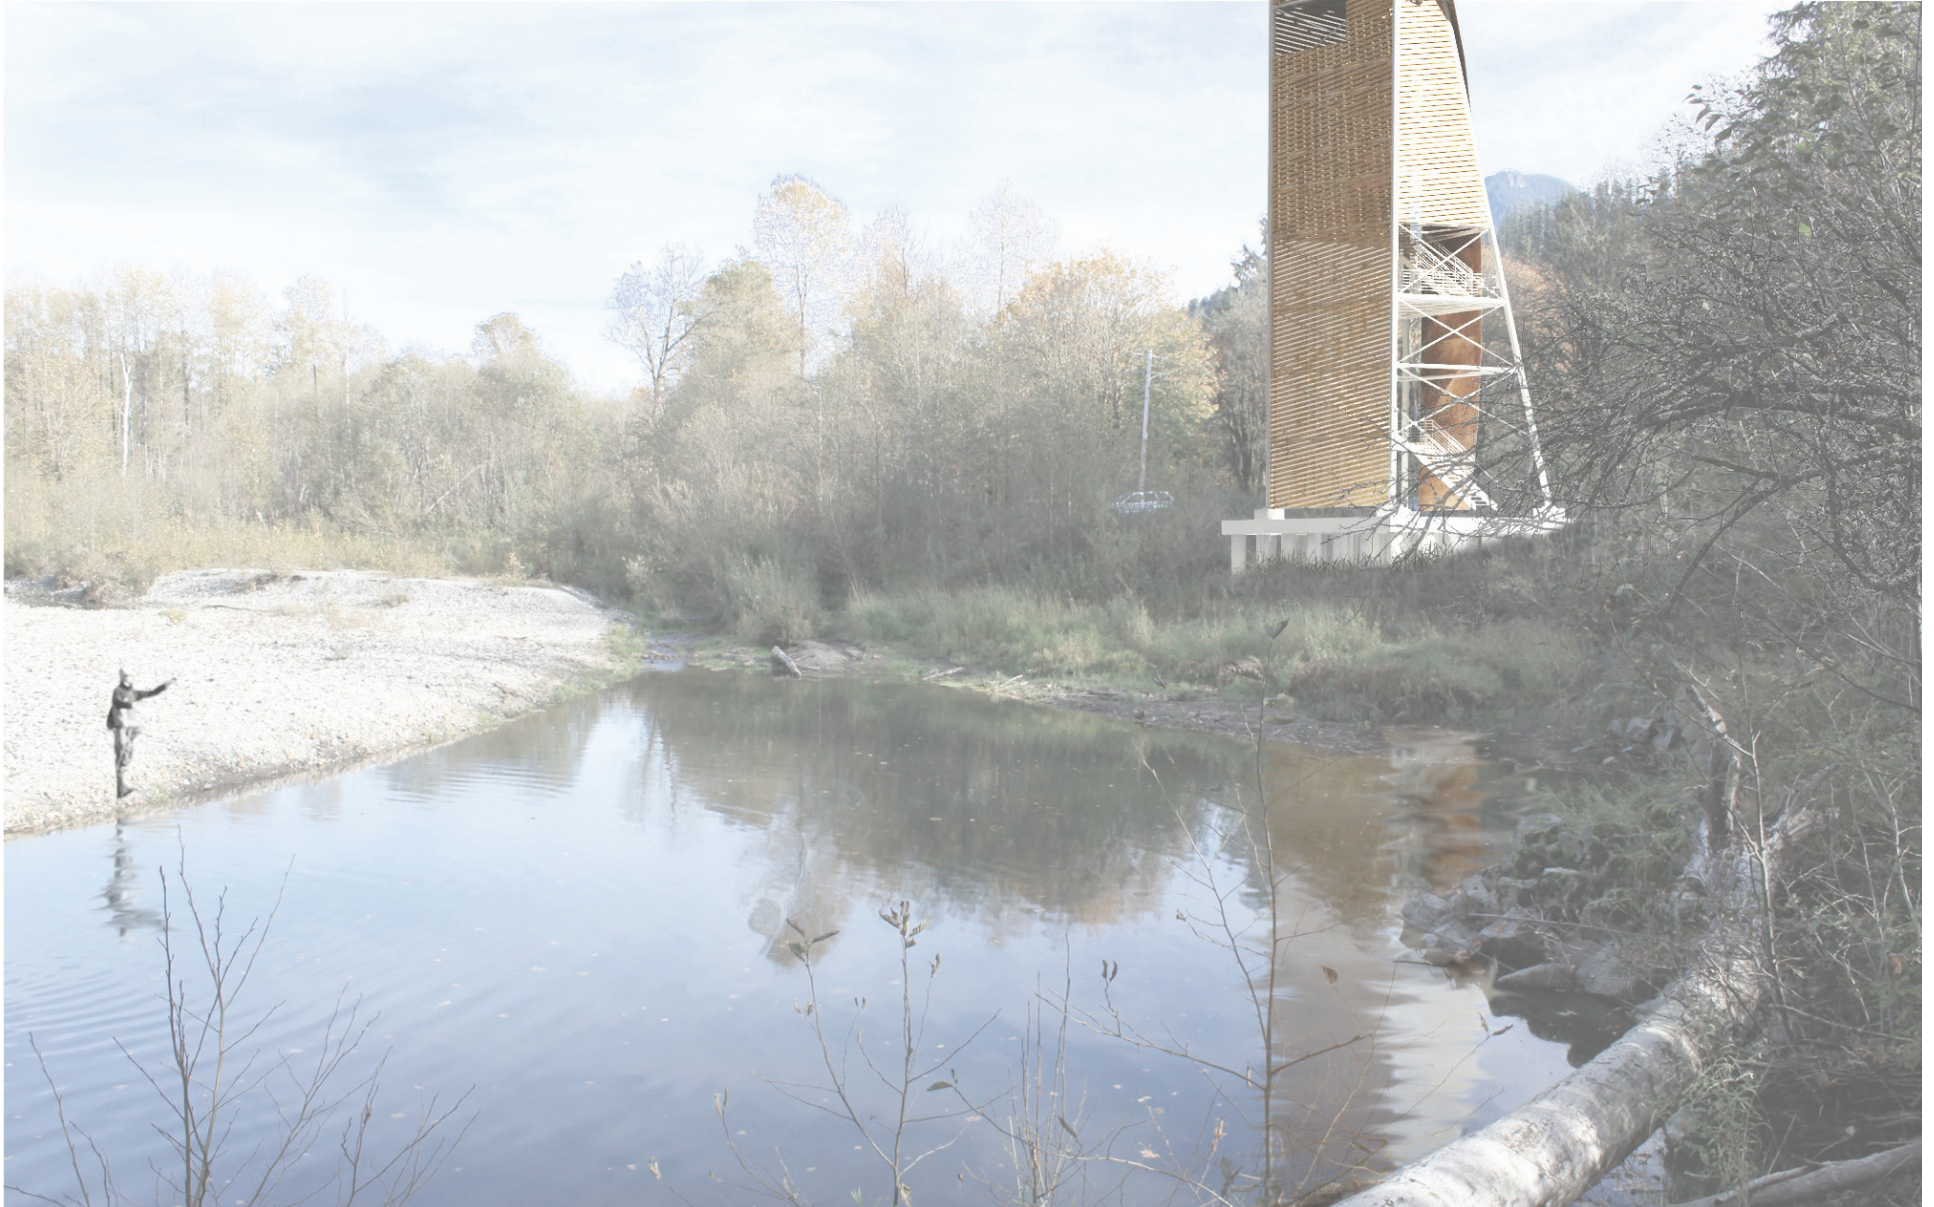
Figure 60: View of tower from ground plane

method of revealing nature. Due to the shifting nature of the river and the height of the tower, a sturdy system of friction piles is engineered for the foundation. In a regenerative effort, these piles act to support the tower as well as stabilize the fine soil in which they sit, slowing but not completely stopping the natural erosion of the riverbank.

The materials chosen for the cladding of the tower are specified for several reasons. First, both the wood slats and the Corten steel have the potential to weather, wear, and show their age. This thesis acknowledges that such a riverfront structure is at the mercy of the elements. Showing that vulnerability in the non-structural building components is an act of transparency and shows awareness of the natural processes. In contrast to the cladding materials, the steel structural pieces are designed to remain sturdy and strong until the river has completely inundated the area and access to the tower is cut off. The integrity of the tower structure in steel is to remain intact until the tower can no longer be reached. At that moment, the need for the tower to continue standing is lost and it can surrender to the natural forces of the river.

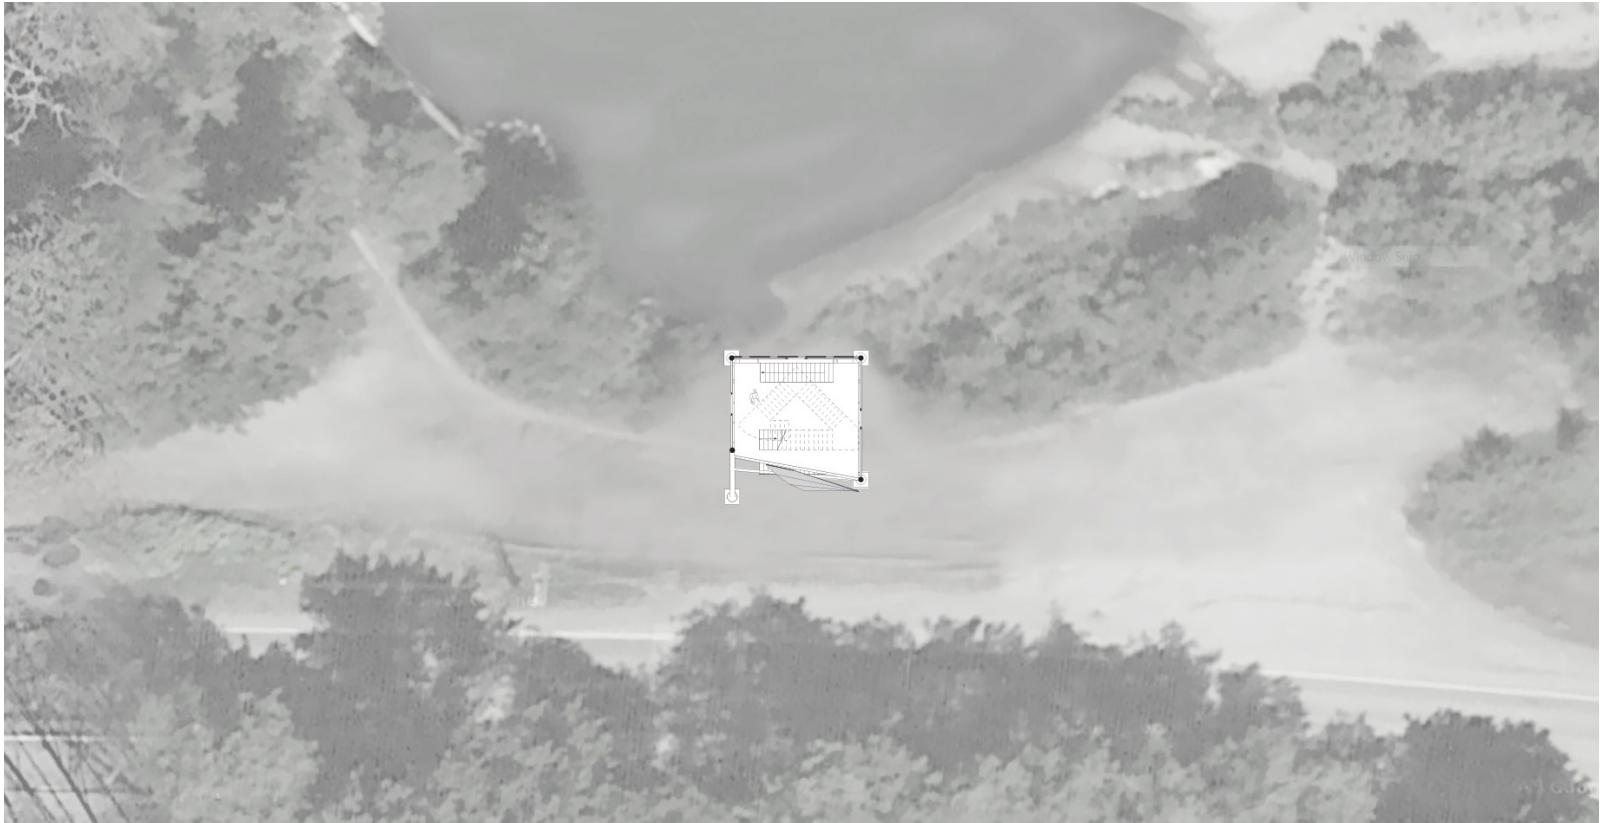
Figure 61: First platform

The second portion occurs within the tower as one climbs the stairs and arrives at the first large landing platform. While climbing and while on the platform, the viewer is directed to look down from this slight elevation onto where they have just come from. The faces open up to the east and west to allow for this.

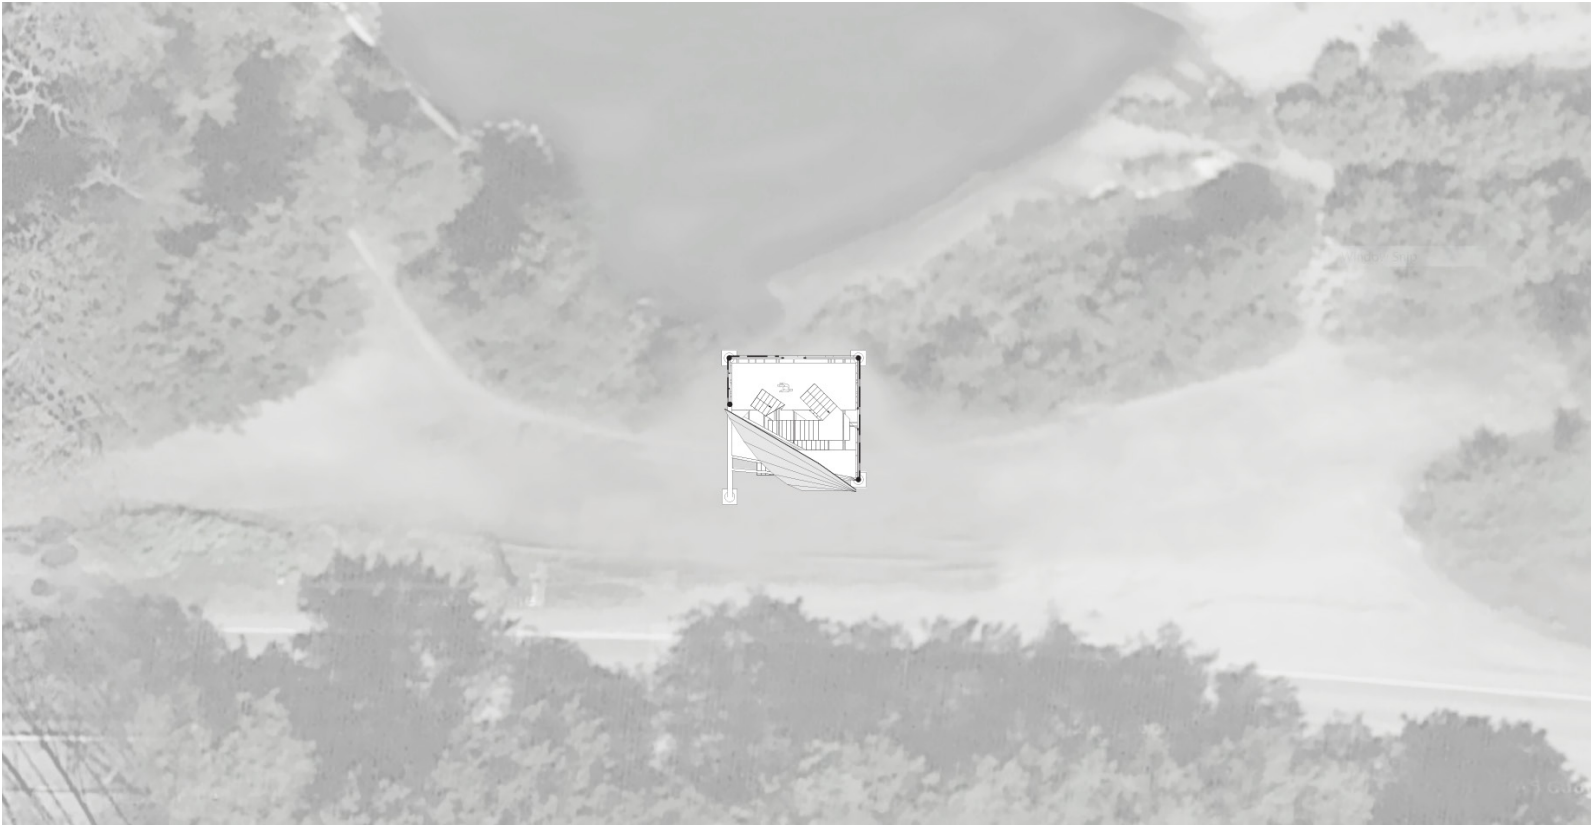
Figure 62: Second platform

Portion three is focused on an upward movement and view. The faces are closed to views outside of the tower and the gaze is drawn upwards towards the twisting stairs and the platform above.

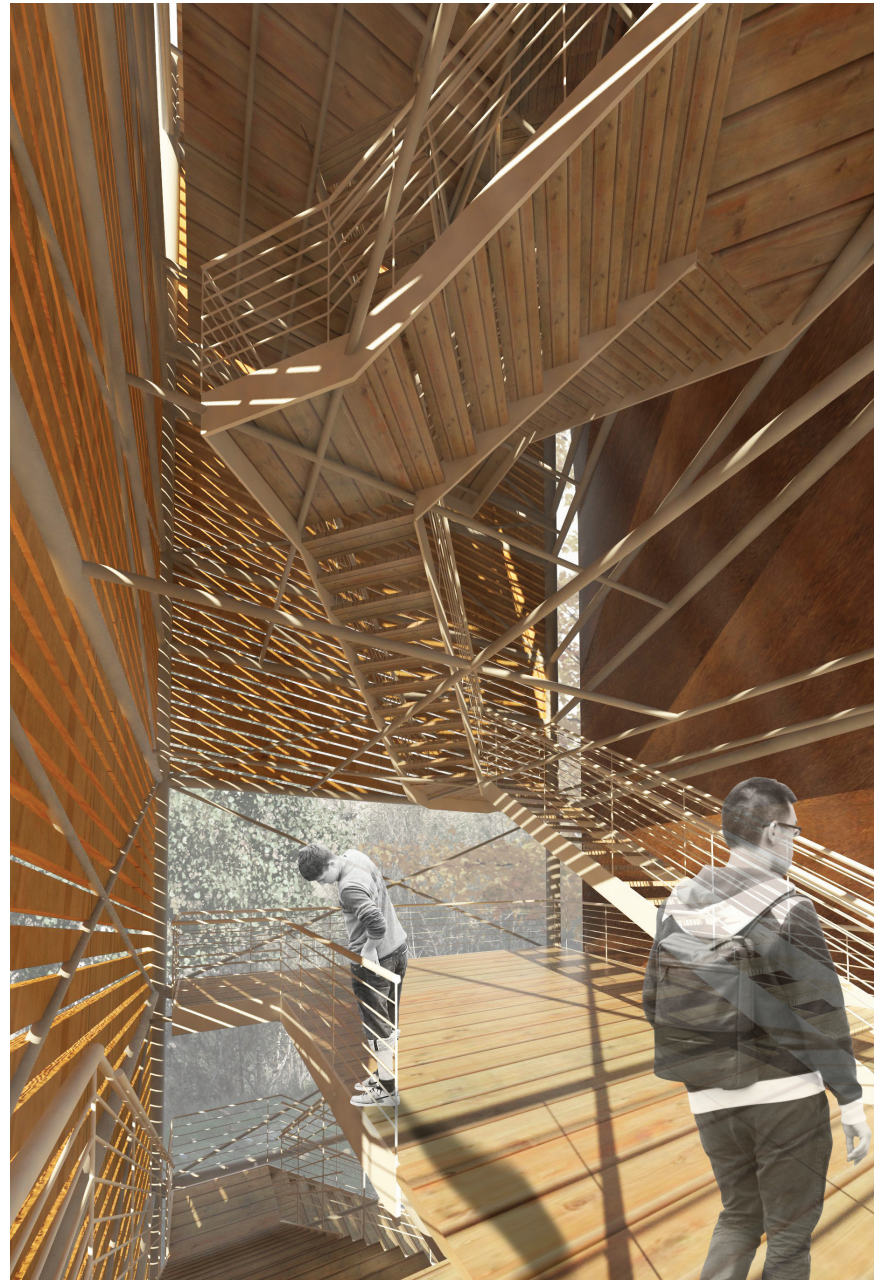
Figure 63: View up from first platform

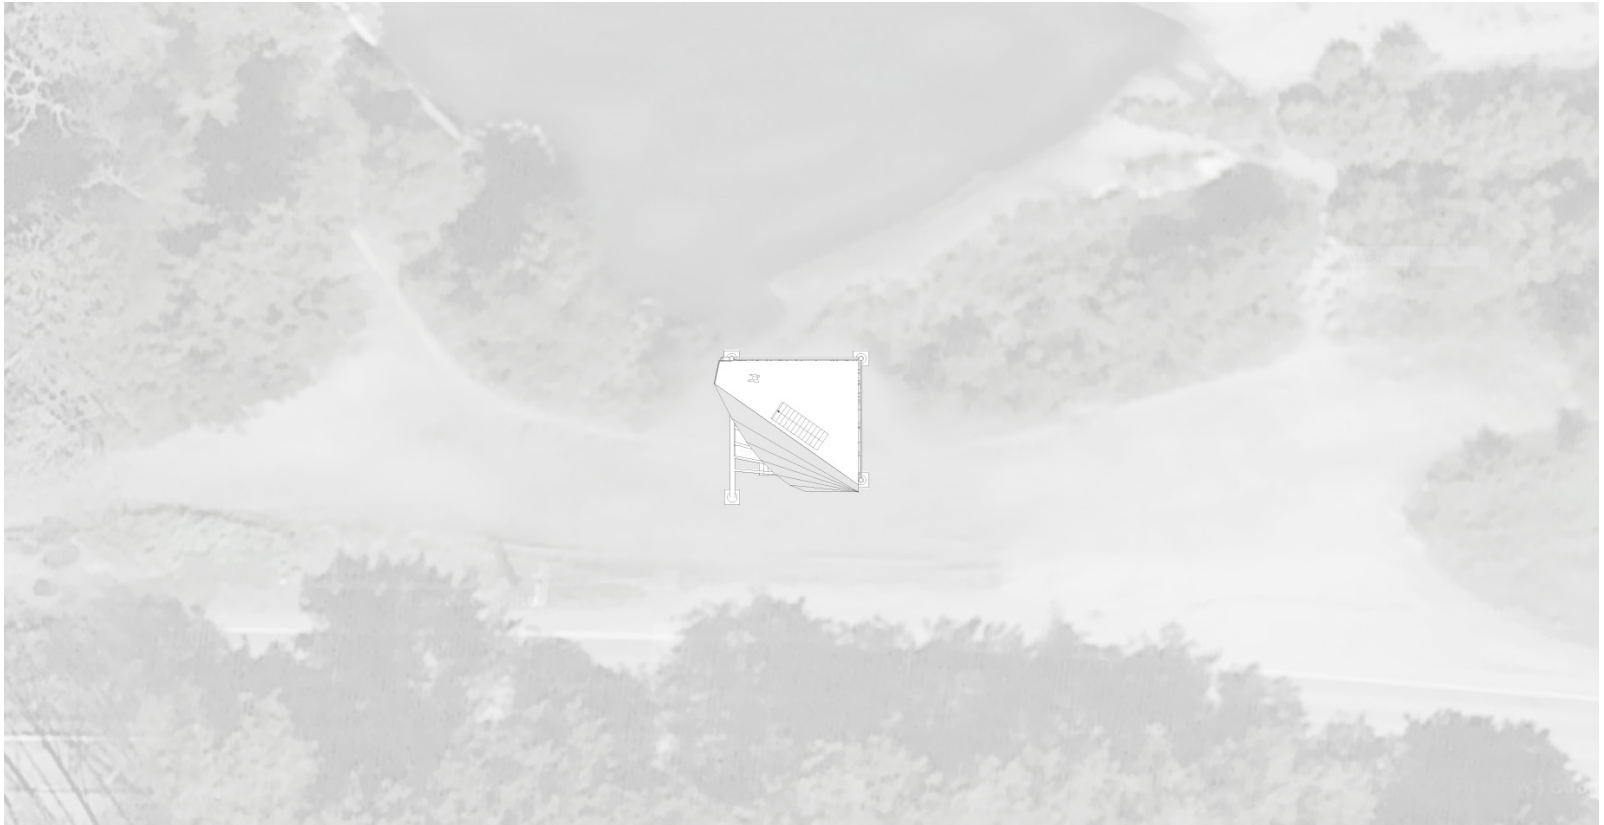
Figure 64: Third and uppermost platform

The south side cladding is asymmetrical and shifts as the tower rises in order to act as a wayfinding device within the tower. This side is clad in Corten steel, as opposed to wood, so that it may stand out from the other three sides and clearly indicate its direction in order to orient the visitor. The material continues to fold and unfold as it forms the roof pavilion over the top platform.
