Calling the Cedar River's Bluff: A study of bed elevation changes and  
characterizing bluff grain size distributions in the Cedar River upstream  
of a depositional zone in the City of Renton, Washington

A report prepared in partial fulfillment  
of the requirements for the degree of  
Master of Science  
Earth and Space Sciences:  
Applied Geosciences University of Washington

MESSAGE Technical Report Number: 073

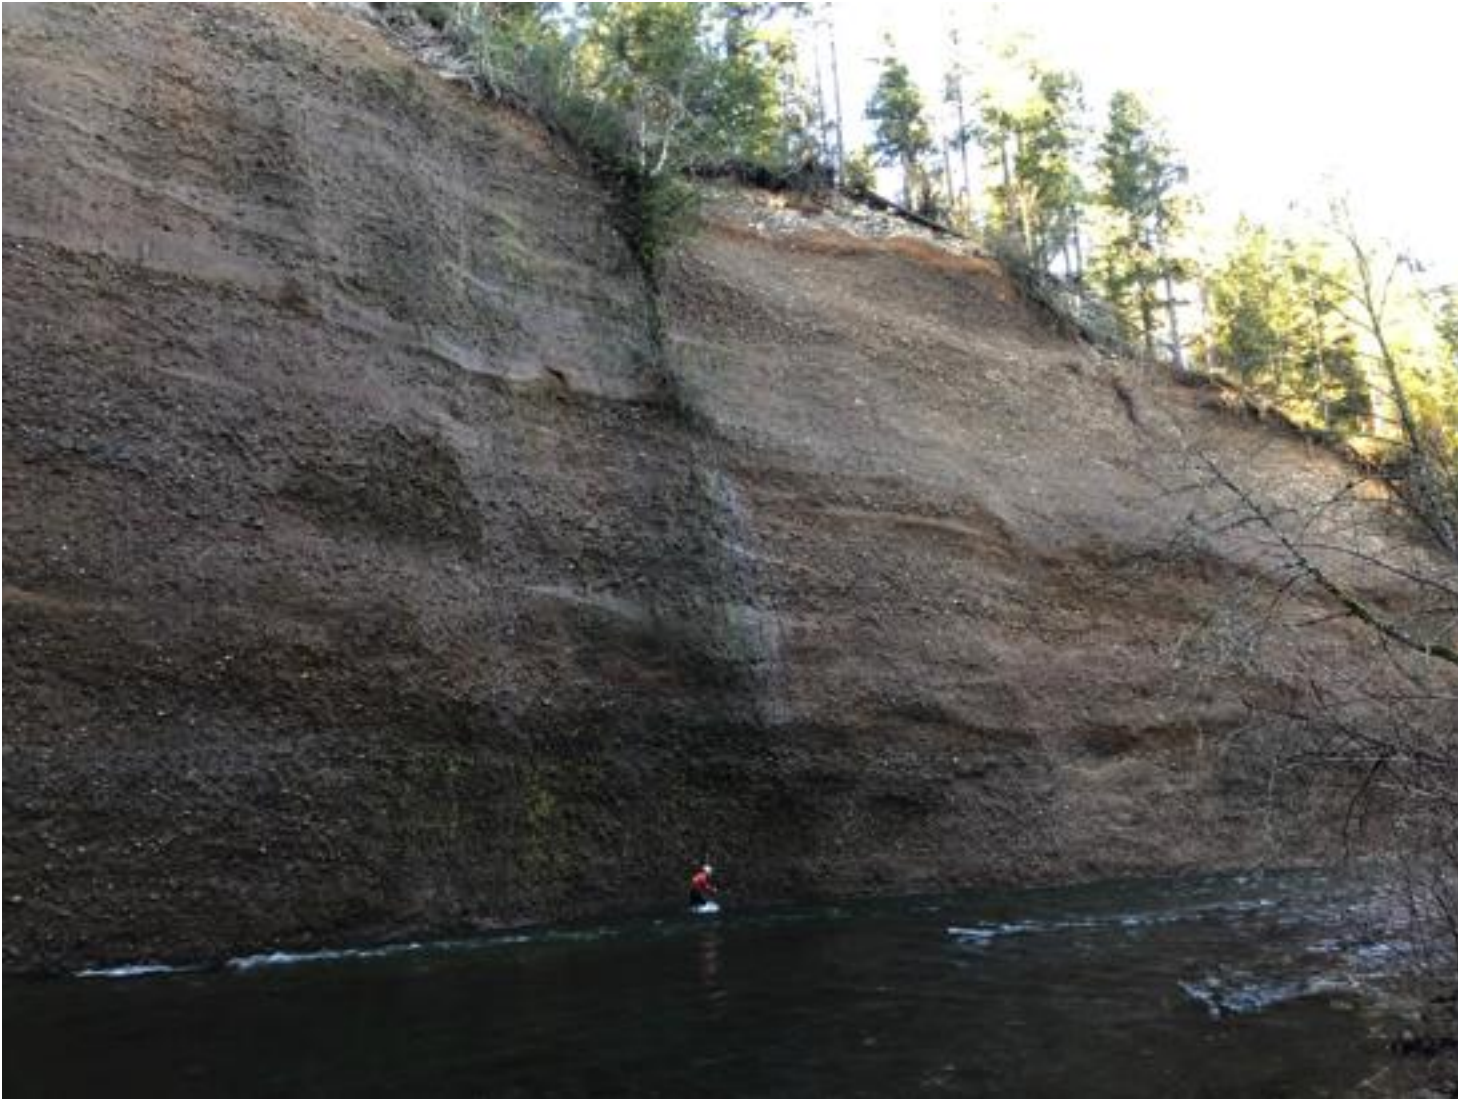
Figure 3. Eroding bluff of interest at rkm 33.4 characterized for cumulative grainsize distributions using image analysis. Maximum bluff height is 33.4 m. Photo is taken from the right bank. River is flowing from left to right.

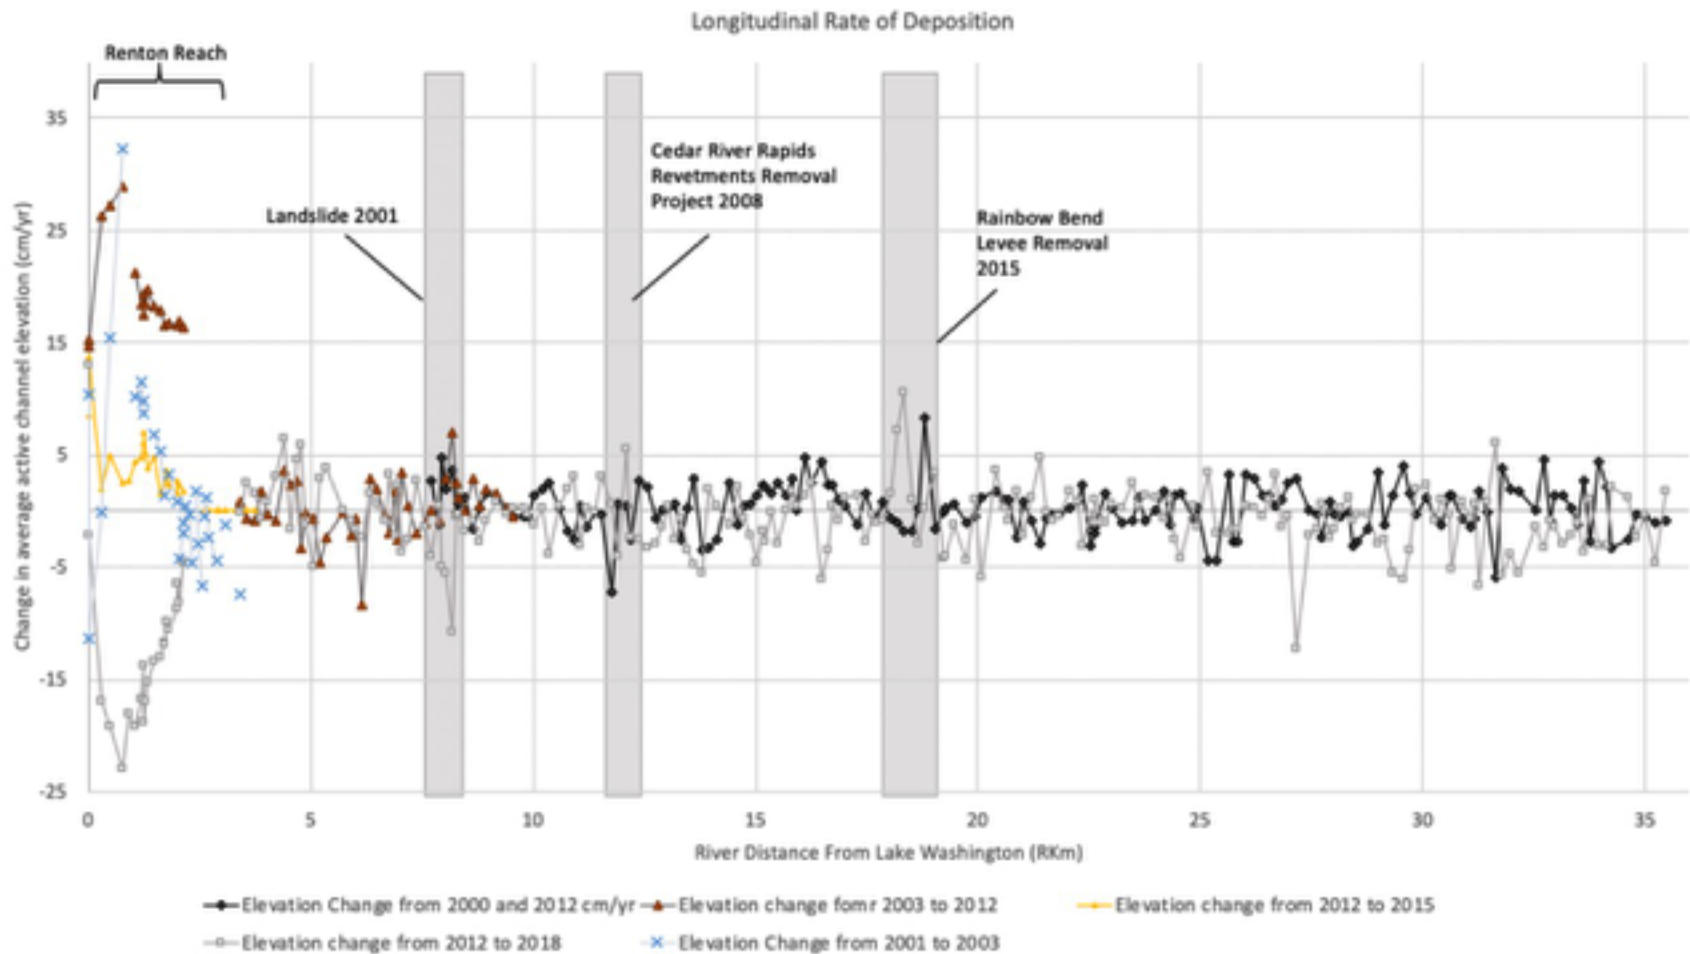
Figure 8. Rates of deposition for each cross section between 2000 and 2003 to 2012 (black line and orange triangles) and 2012 to 2018 (Gray line) along the Cedar River up to river kilometer 35.2. Landslide and Levee Setback projects sub reached are highlighted.

The earlier survey period between 2000 to 2012 has an average depositional rate of 0.00 m/yr with a standard error ( $\pm$ ) of 0.00 m/yr (number of cross sections (n) =196) for the entire study area from rkm 3.3 to 35.2. The later survey period between 2012 to 2018 has an average incisional rate of  $-0.01 \pm 0.02$  m/yr (n=196) (Table 3). The two-tailed t-test for both survey periods show no significant net change in bed elevation (Table 3). Changes in bed elevation of the cross sections oscillate spatially along the study reach with no significant trend or pattern in incision or deposition (Fig. 8).
