QUANTIFYING THE IMPACT OF ROCKFALL ON THE MOBILITY OF CRITICAL TRANSPORTATION CORRIDORS

FINAL PROJECT REPORT

Sponsorship
Pactrans and Oregon DOT

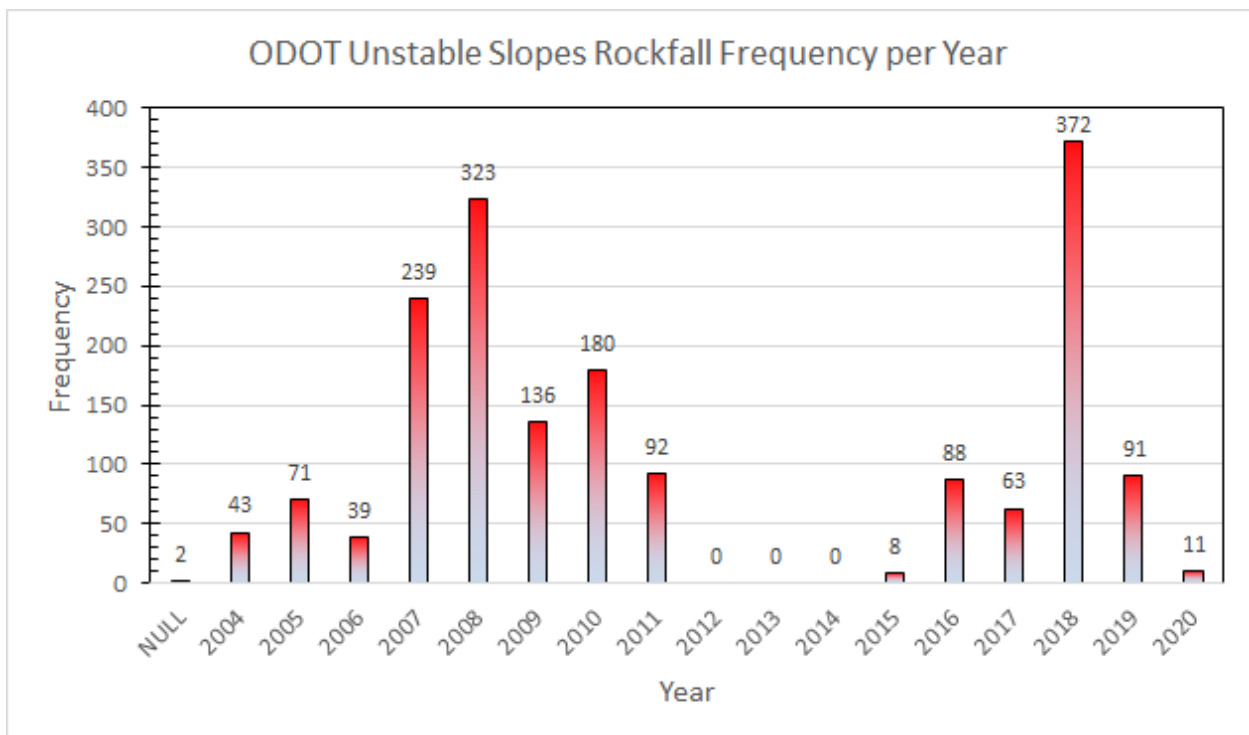
Figure 2.2 Rockfalls per year observed in Oregon from the ODOT Unstable Slopes database.

Oregon DOT manages a database of unstable slopes (landslides and rockfalls) that affect highways across the state (figure 2.1). This database contains detailed information related to the cost of repair of those sites to help in prioritizing mitigation. The database does not track the volumes of materials dislodged in a rockfall event but tracks volumes of materials hauled away or brought to the site for repairs. A basic design is completed for each slope to estimate the materials required to mitigate it. The database also contains ancillary traffic information such as average annual daily traffic (AADT) and accidents. A valuable component of this database is that it tracks rockfalls over time (figure 2.2), which shows the variability in recorded rockfalls

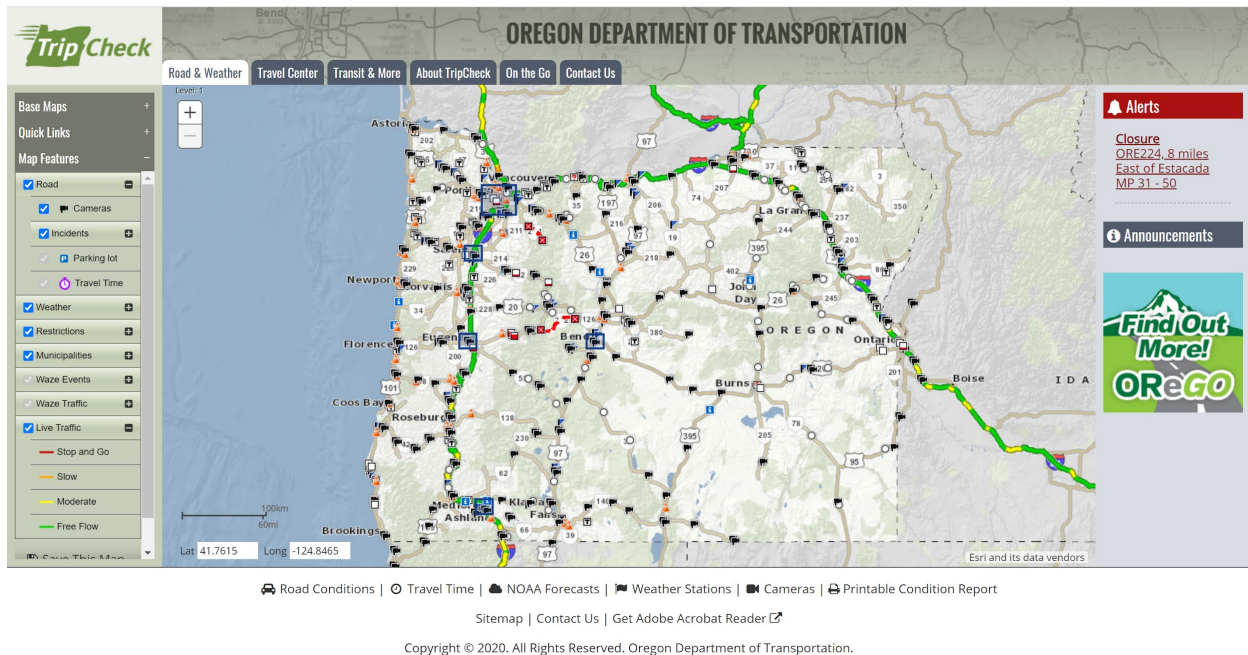
Figure 2.4 ODOT TripCheck database.

ODOT TripCheck (figure 2.3) provides incident reports that result in highway closures shown to the public in real time on its webGIS (figure 2.4). A detailed log identifying the hazard, precise location, and the resulting closure time is maintained in this database. However, it does not track volumes of failed materials or details about the rockfalls. The events in this database vary in severity and often result from a few rocks rolling onto the roadway from known

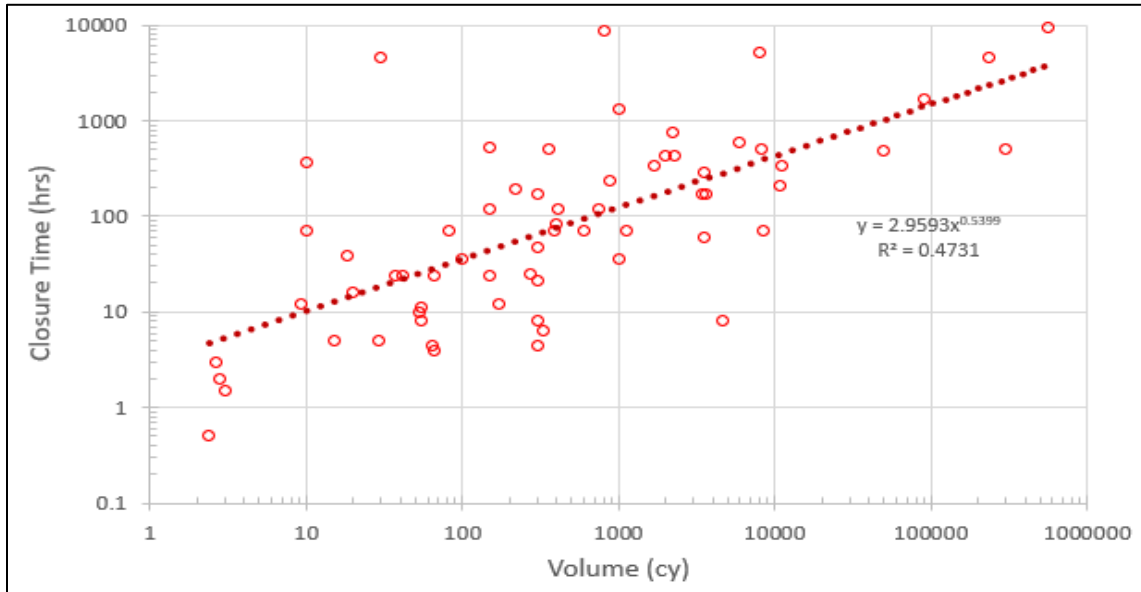
Figure 2.20 Estimated rockfall volumes versus associated closure times catalogued in the RIM database. An associated power-law regression line is shown.

on the spatial collocation of rockfalls and adjacent right-of-way, it was evident that larger rockfall events resulted in longer closure times—in some cases, those closure times were in the order of days to weeks. A power-law regression is presented for application by transportation planners.

Figure 2.23 shows the impacts of event size on closure duration from the information solely provided in the AKDOT Event Tracker. No distinguishable trend was observed, likely a result of the data being recorded in generalized categories rather than actual volumes and durations, as shown in figure 2.20 in the RIM database.

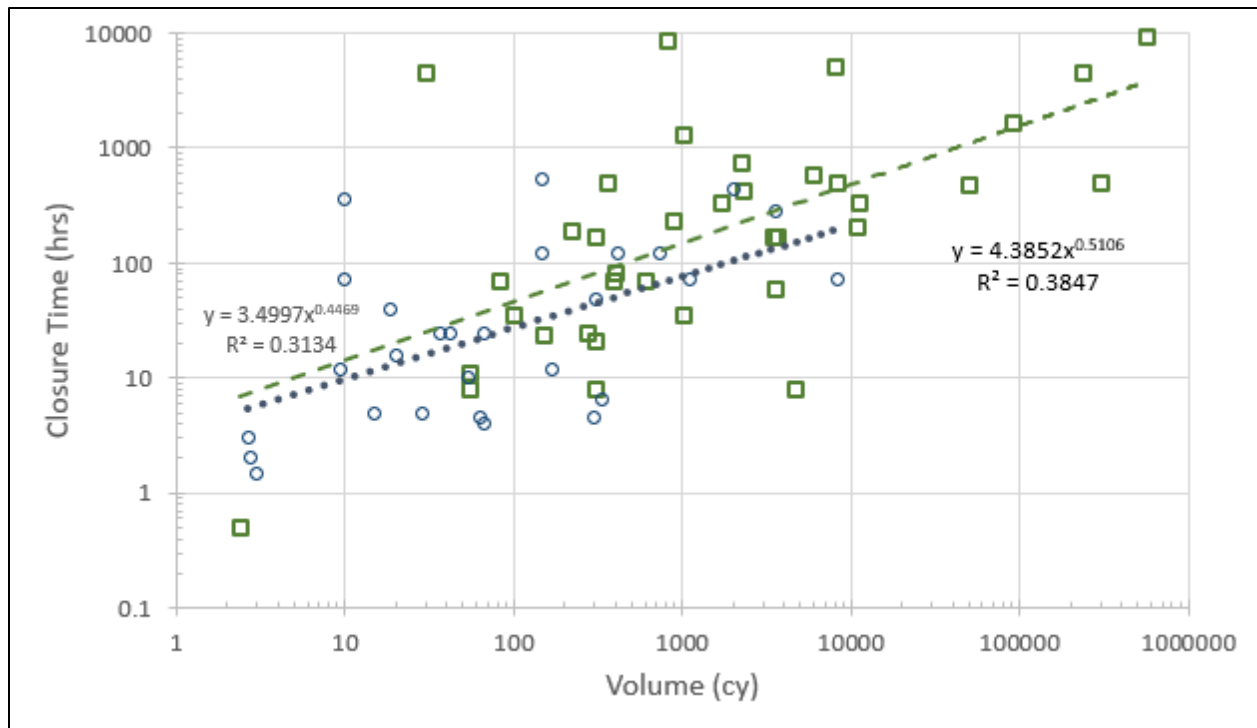
Figure 2.21 Estimated rockfall volumes versus associated closure times catalogued in the RIM database distinguished by reported rockfall volumes (green squares) and estimated rockfall volumes (blue circles). An associated power-law regression line for each is shown.

Figure 2.21 shows closure times regressed to both estimated and reported rockfall volumes to identify whether there was significant bias in estimating the volumes from the photographs. Both relationships demonstrated trends similar to those previously described—larger rockfall volumes tended to result in longer closure times. The trends were similar, demonstrating that the procedure for estimating rockfall volumes was relatively consistent with data from reports. This supports the concept that images and estimates from news reports may be used to supplement the data in the RIM database when the information has not been recorded. A power-law regression is presented for both relationships for comparison.

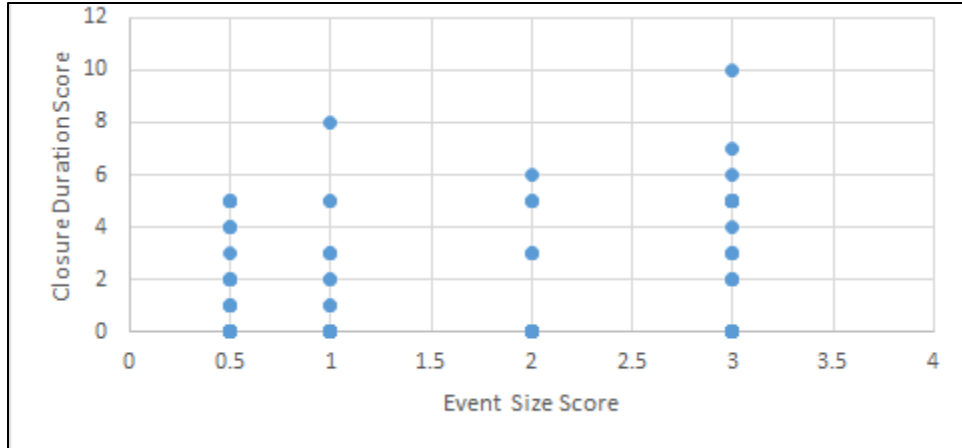
Figure 2.23 AKDOT Geo Event Tracker event size score vs. closure duration score. See Table 2 for definitions of the codes.

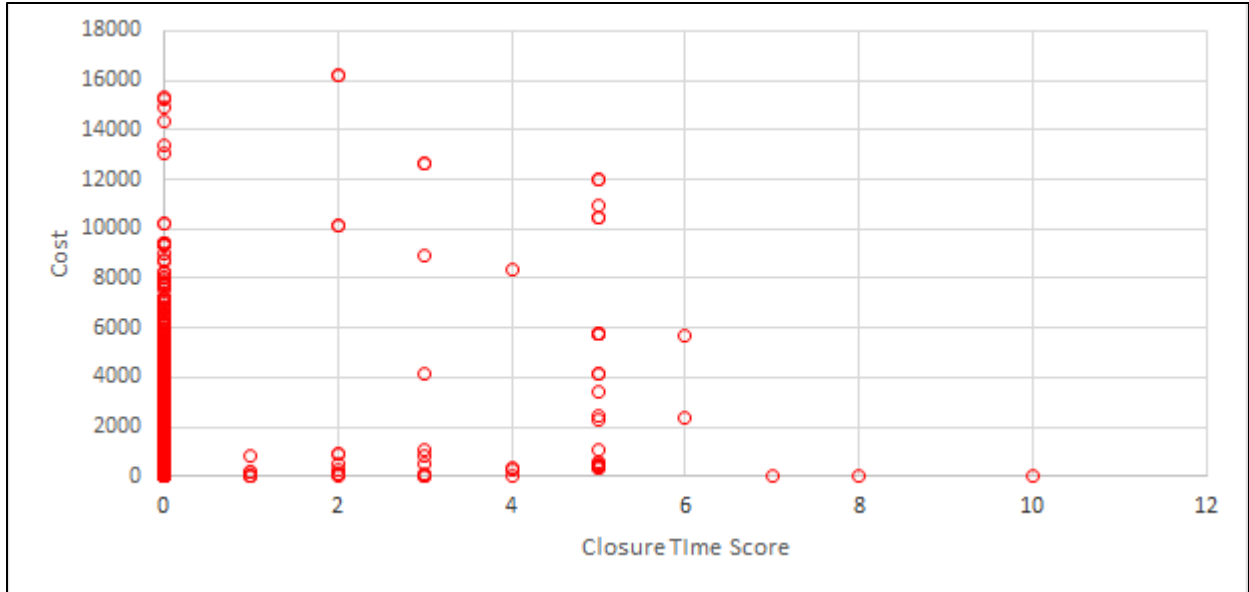
Figure 2.26. Closure times and costs from the AKDOT Geo Event Rockslide and Landslide database.

Rockfall event closure time scores were compared to repair costs from the AKDOT database (figure 2.26). The data showed significant scatter, likely owing to rockfall events not directly creating road closures but to AKDOT taking preventative mitigation measures to ensure that future rockfall events would not affect closures or driver safety. For large estimated closure time scores with small repair costs, it was hypothesized that either (1) data gaps existed or (2) large rockfall events resulted in significant closure times but costs were relatively small for the debris removal. The costs presented did not include lost time, commerce, or rerouting expenses that would likely have been very significant with the associated closure times. These data also suggested that smaller events likely dominated costs, as these events occurred notably more frequently than large events.

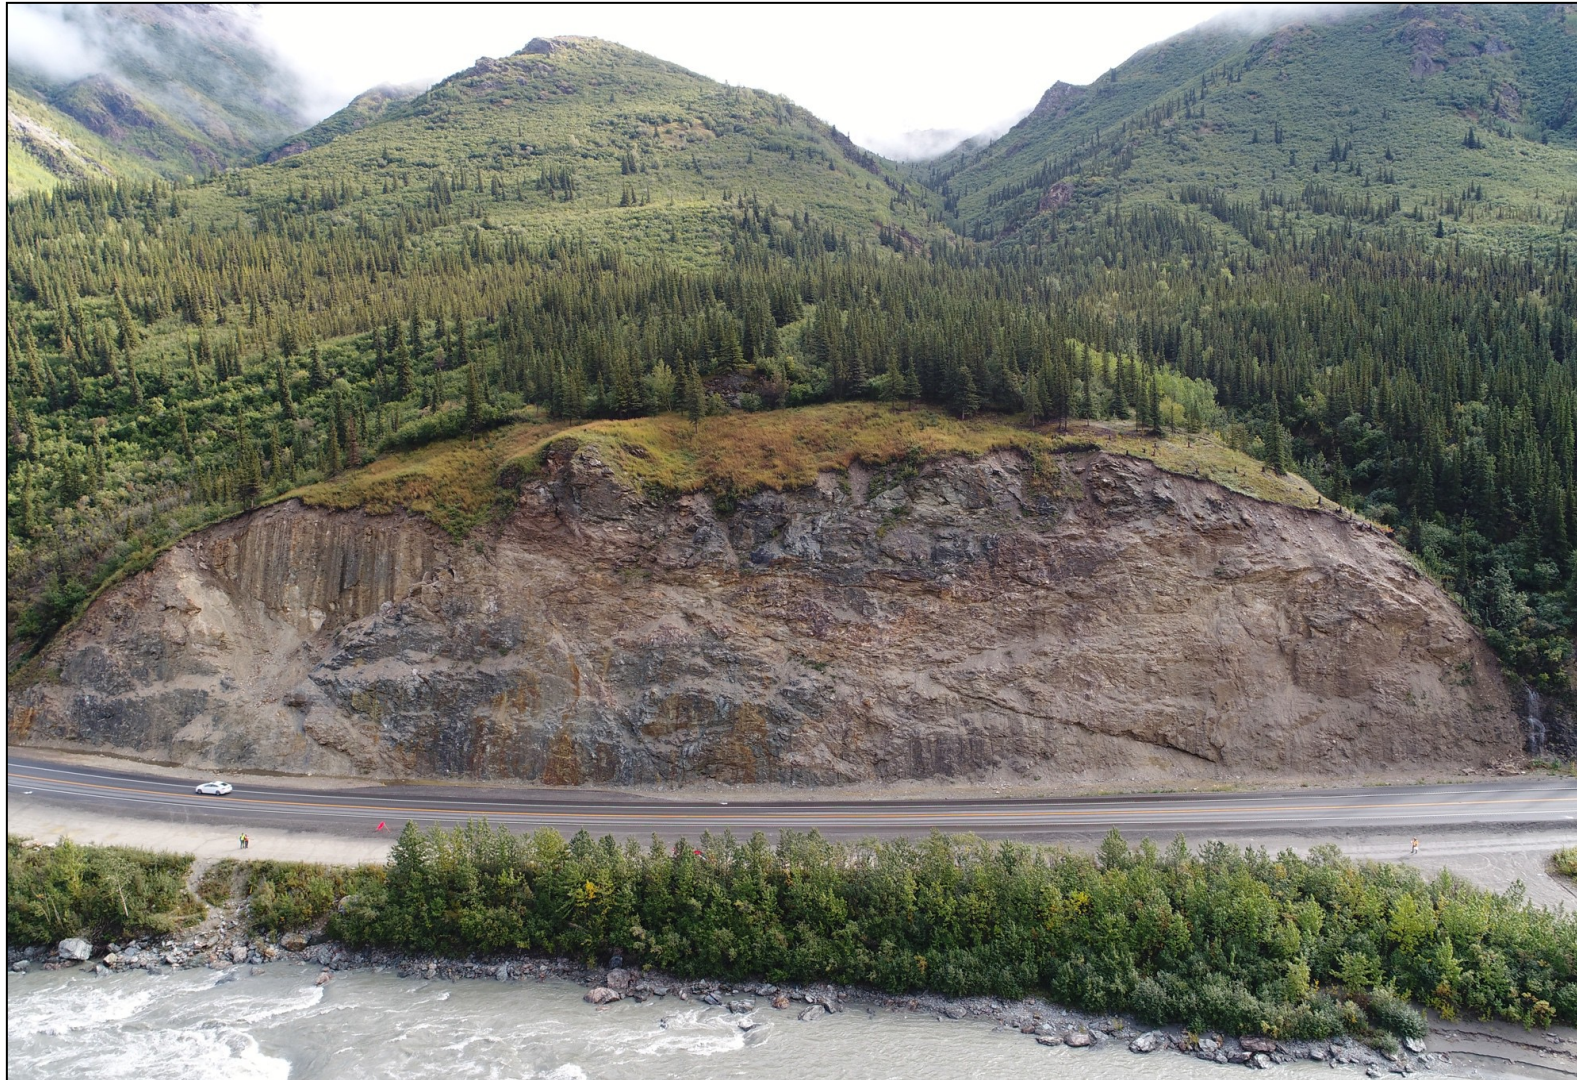
Figure 4.4 Oblique photograph taken in August 2018 of the study slope at MP 241 on the George Parks Highway near Glitter Gulch, Alaska. The image was captured with a DJI Phantom 4 drone flown by Jake Dafne. Sugar Loaf Mountain is in the distance, and the Nenana River is in the foreground.

The study slope presented as a competent, near-vertical mass of rock protruding from the hillside, necessitating a strong bend in the highway that leads to a slight blind corner for the northbound traveling traffic (figure 4.4). An arcuate feature with significant drainage to the south and a lower, talus slope to the north, this portion of the eastern flank of Mount Healy was amputated by the Nenana River. The rock had an unconfined compressive strength (UCS) of weak to very weak ($<25\text{mPa}$) where schist dominated, and of strong to extremely strong ($>25\text{mPa}$) where quartzite veining dominated. Micaceous talus clung to the slope above ledges, and oxidization stained approximately 75 percent of the face. The schistosity was parallel/sub-parallel to the slope, and there were a few, widely spaced, intersecting joint sets with very high persistence.

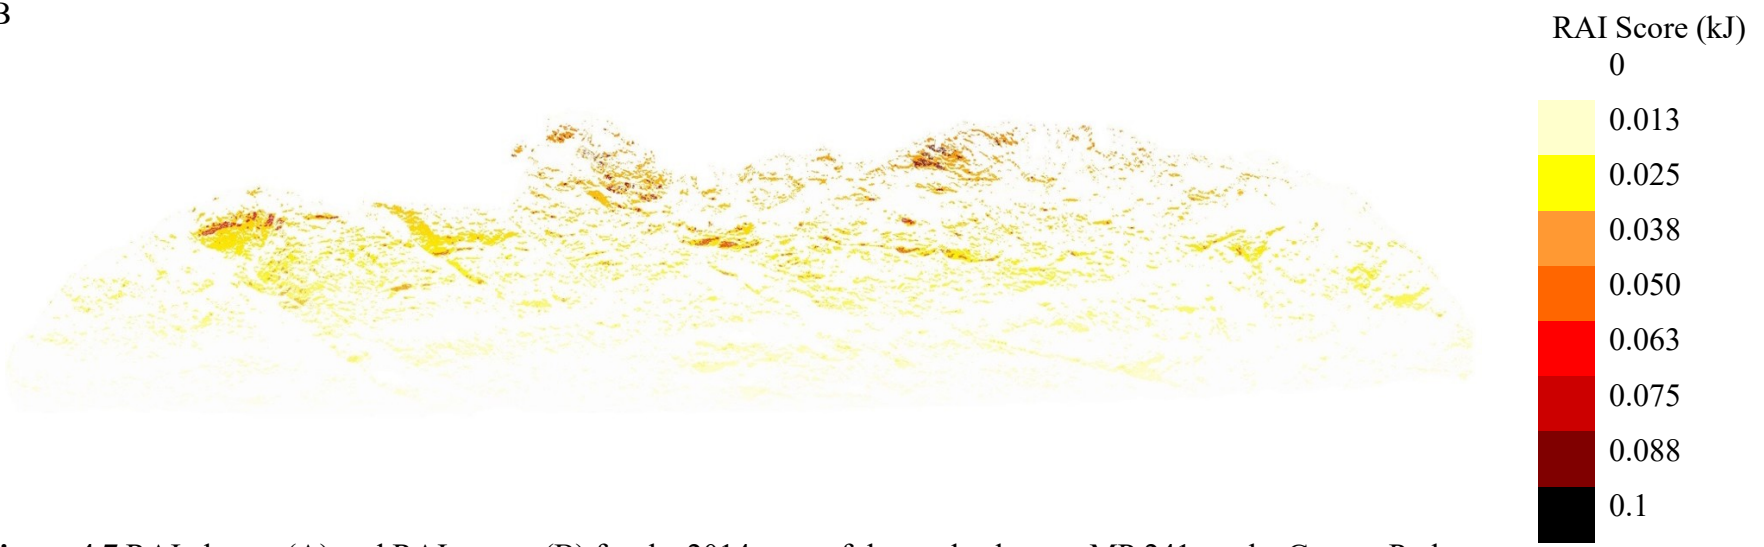
Figure 4.7 RAI classes (A) and RAI scores (B) for the 2014 scan of the study slope at MP 241 on the George Parks Highway near Glitter Gulch, Alaska.

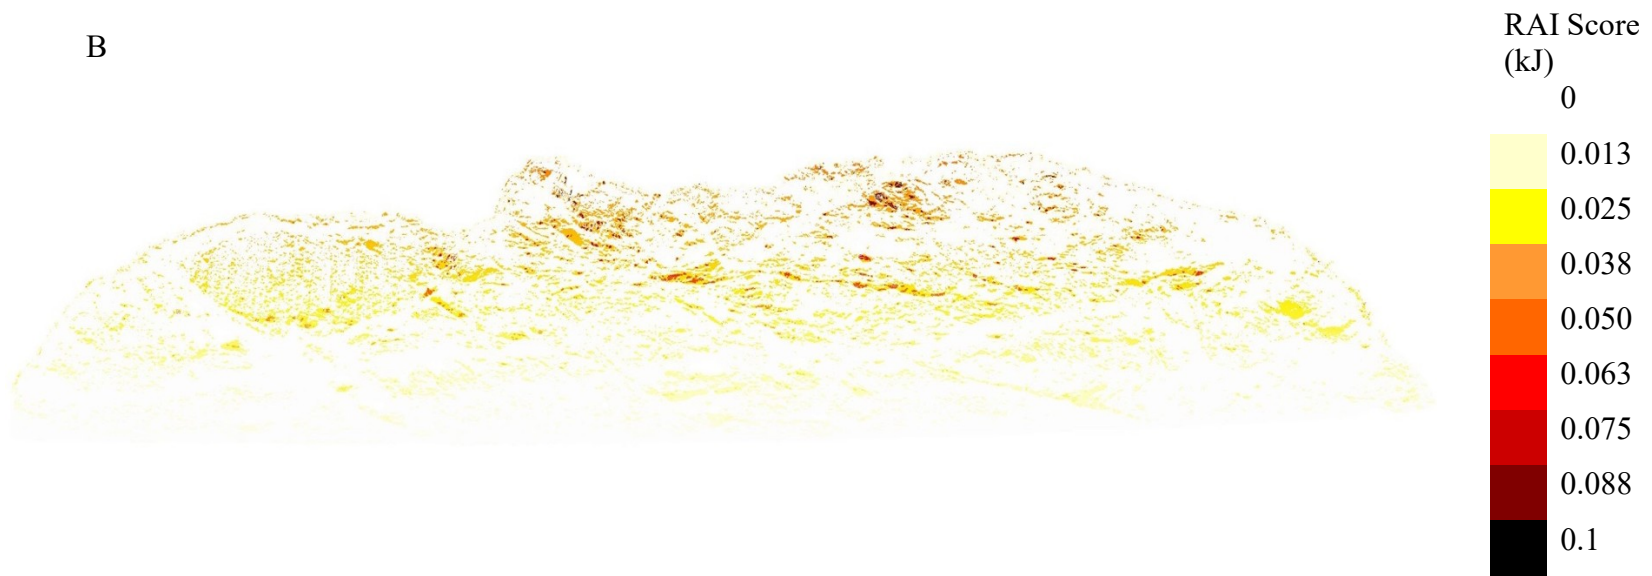
Figure 4.10 RAI classes (A) and RAI scores (B) for the 2018 scan of the study slope at MP 241 on the George Parks Highway near Glitter Gulch, Alaska.

Morphology identification patterns continued to follow those of 2013, while there did not appear to be a significant change in morphology classification (figure 4.10: A). The only notable changes in the morphology map were the sizes of data holes; some increased while others decreased. Also, the amount of rock classified as talus, downslope of the large wedge removed in 2016, increased while intact rock decreased.
