Evaluation and Retrofit of Non-Capacity Designed Braced Frames

A thesis

Master of Science in Civil Engineering

University of Washington

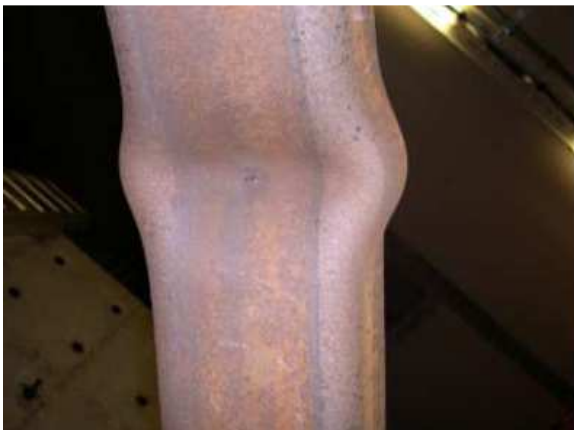
Figure 2.6 HSS18 Brace Cupping (Powell 2010)

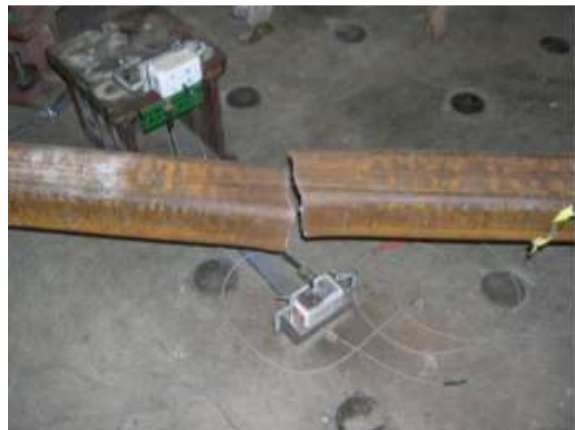
Figure 2.7 HSS18 Brace Fracture (Powell 2010)

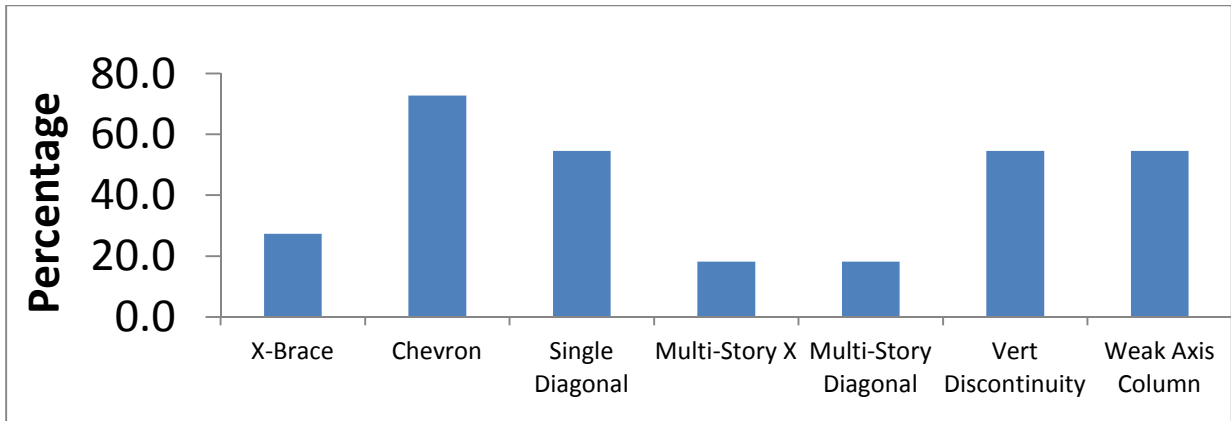
Figure 2.20 Brace Configurations in Surveyed Buildings

The infrastructure review also revealed several trends in design, displayed in Figure 2.20 and Figure 2.21. It is important to note that many buildings used multiple types of braces and bracing configurations, so the total percentages shown add to more than 100%. By far the most common type of brace was square HSS, which were found in over 70% of buildings. Wide flange sections were the next most common, and some pipe and angle braces were also observed. The most common brace configuration was chevrons, which were present in 70% of buildings. All of the buildings using chevrons were less than five stories tall. Single diagonal braces, as shown in Figure 1.1, were present in half of the analyzed buildings. This was the predominant system in taller buildings. X-bracing was less common, though it was also more popular in taller structures. An example of X-bracing can be found on the first story of the frame in Figure 2.22. About half of the buildings had some type of vertical discontinuity. Typically, these were areas where braced frames were not stacked vertically, but were diagonally adjacent, as shown in Figure 2.22. These types of configurations raise additional concerns about their ability to transfer seismic forces to adjacent bays.

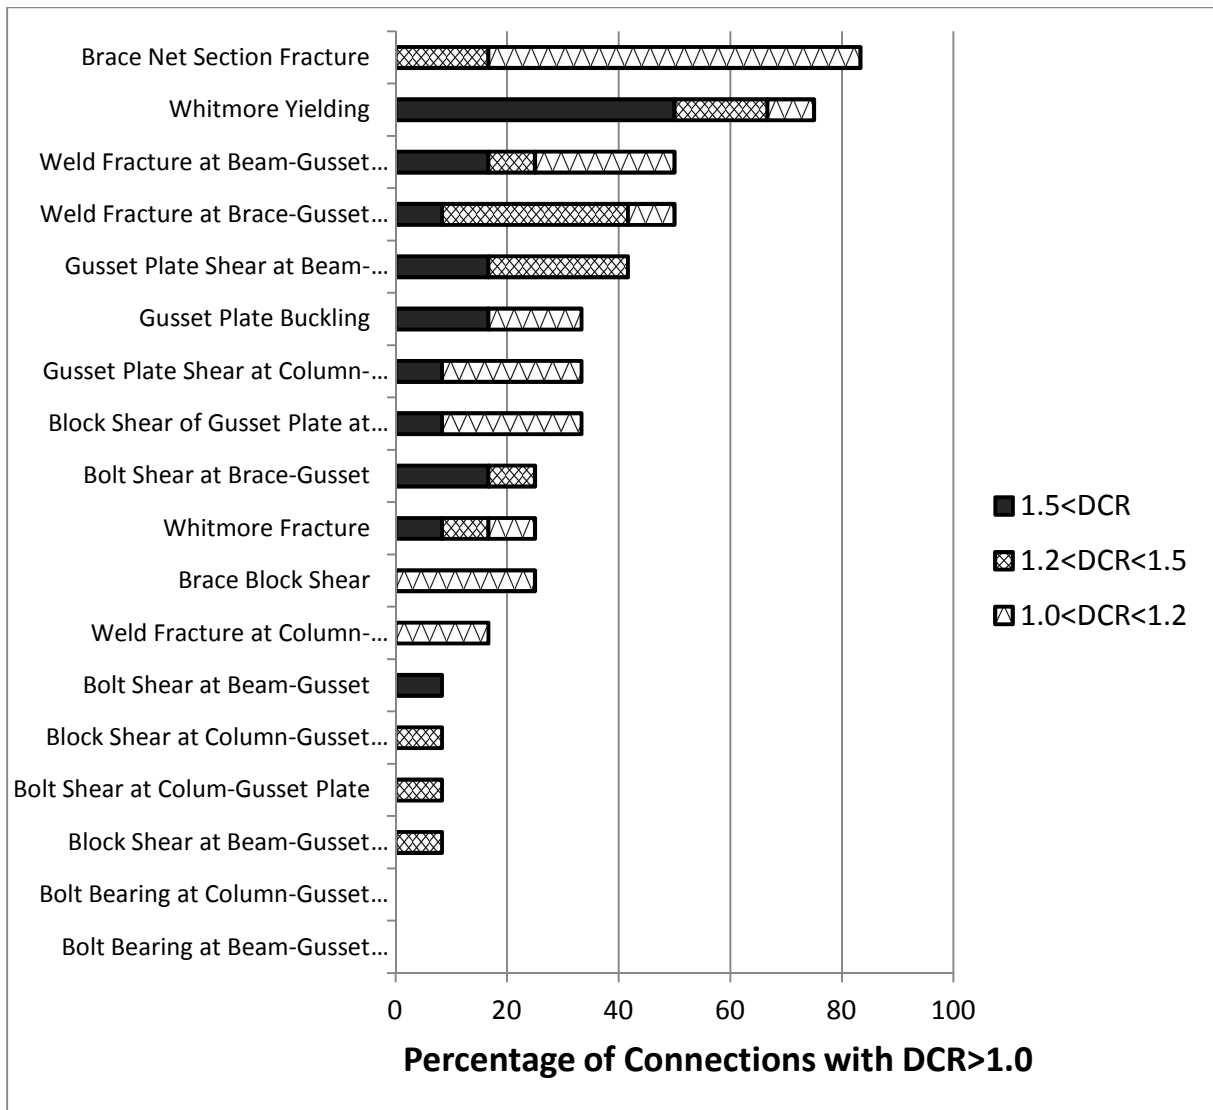
Figure 2.30 Connection Limit States - by DCR

Figure 2.30 summarizes the observed deficiencies in the connections analyzed. It shows the percentages of analyzed connections with a DCR greater than 1 for each failure mode. The results are shaded to indicate the severity of the deficiency in each case. Figure 2.31 summarizes the same information as Figure 2.30, in that it shows the number of frames failing each design check. However, the shading in Figure 2.31 indicates where the limit state falls within the failure hierarchy for each connection. If a limit state is indicated as "primary", then it had the highest DCR of all limit states for that connection, and is thus likely to control the strength of the system. In some cases, a limit state that is often deficient may typically be only slightly deficient, meaning that it is unlikely to be the cause of a connection failure. Figure 2.32 shows limit states for the framing members using the same convention as Figure 2.30. The complete list of DCRs for the connections can be found in Appendix A.

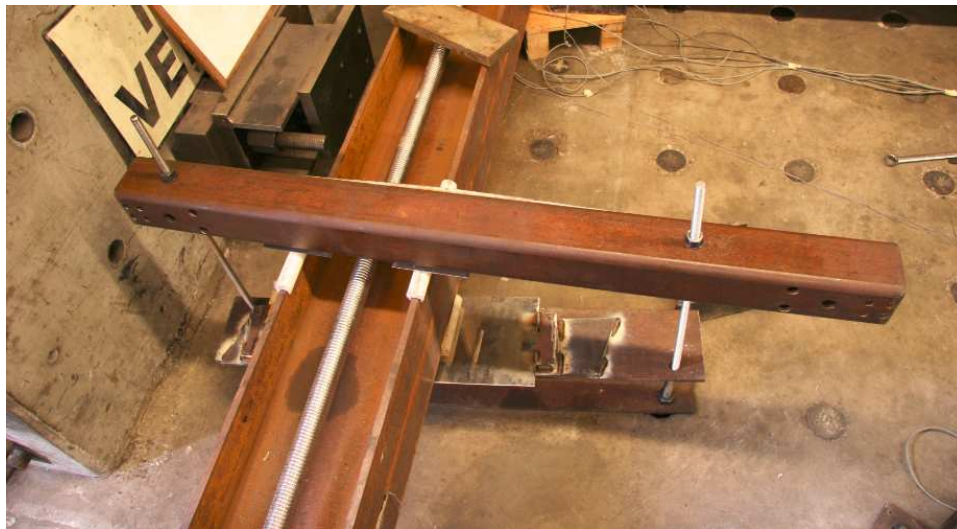
Figure 4.5 East Column Out-of-Plane Restraint

In order to prevent out-of-plane moment of the beams and columns, sliding out-of-plane restraints were placed at four locations on the specimen, as seen in Figure 4.3. The configuration of these restraints was changed slightly from the original experimental setup. A schematic of a typical restraint is shown in Figure 4.4, and an image of one is shown in Figure 4.5. The locations of the restraints remained the same, but all top restraints were changed to HSS5x5x3/8 sections, and some of the rod spacings were adjusted to improve accessibility.

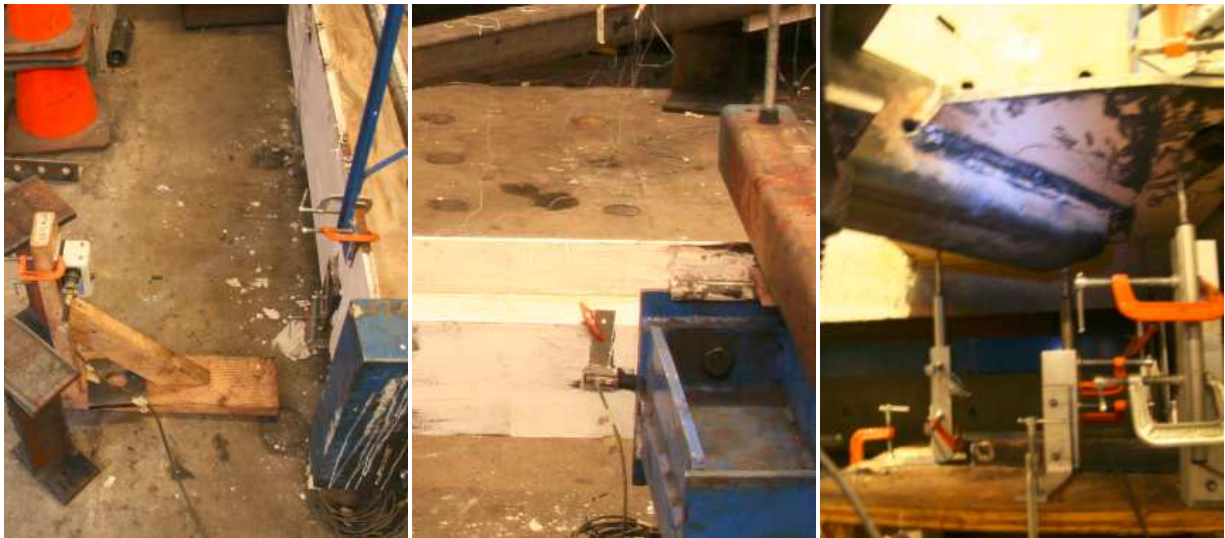
Figure 4.7 Potentiometers (a) Unimeasure P510 (b) BEI Duncan 9600 (c) BEI Duncan 600

Three types of potentiometers were used to measure specimen absolute and relative displacements. For displacements larger than 3 inches, UniMeasure model P510 string potentiometers were used. These were necessary for measuring absolute displacements of the North half of the frame, because lateral displacements of the frame typically reach  $\pm 5$  inches during testing. BEI Duncan linear conductive potentiometers were used for displacements smaller than 3 inches, with the 9600 Series models used for displacements between 1 and 3 inches, and the 600 Series models used for displacements smaller than 1 inch. Examples of the three potentiometer types are shown in Figure 4.7.

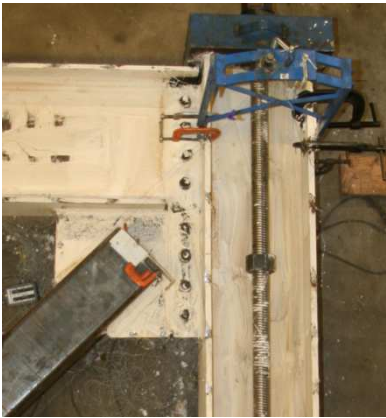
Figure 5.2 Gusset Plate Y2  
NCBF1-R5

50% of the area contains yield lines, then the element enters performance state Y3 - severe yielding. This performance state is often also characterized by large, contiguous areas of flaked whitewash. Figures 5.1-5.3 show the yielding performance states for the gusset plate. Figures 5.4-5.6 show the yielding performance states for the shear tab. Finally, Figures 5.7-5.8 show the yielding performance states in the column flange.

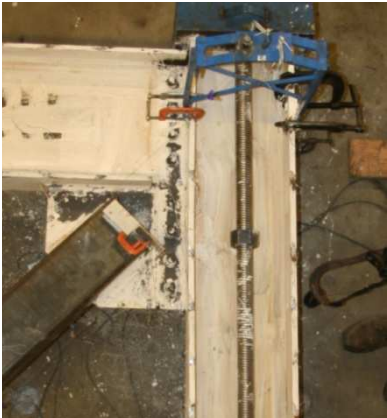
Figure 5.3 Gusset Plate Y3  
NCBF1-R5

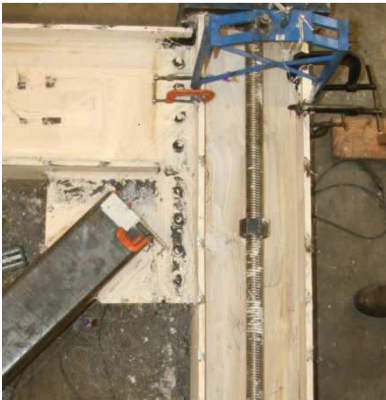
Figure 5.5 Shear Tab Y2  
NCBF1-R5

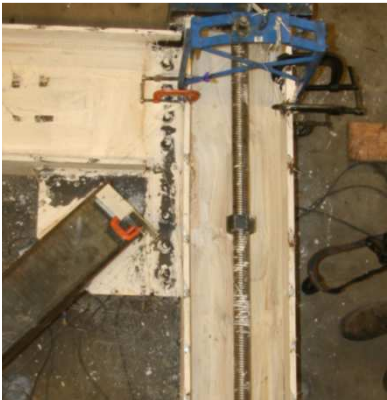
Figure 5.6 Shear Tab Y3  
NCBF1-R5

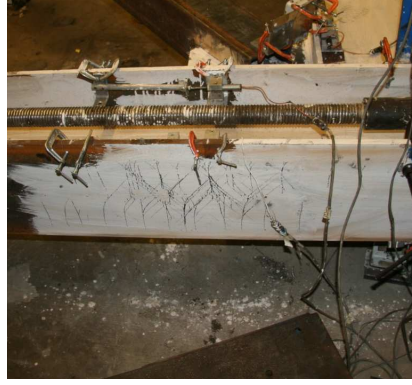
Figure 5.8 Column Flange Y2  
NCBF1-R5

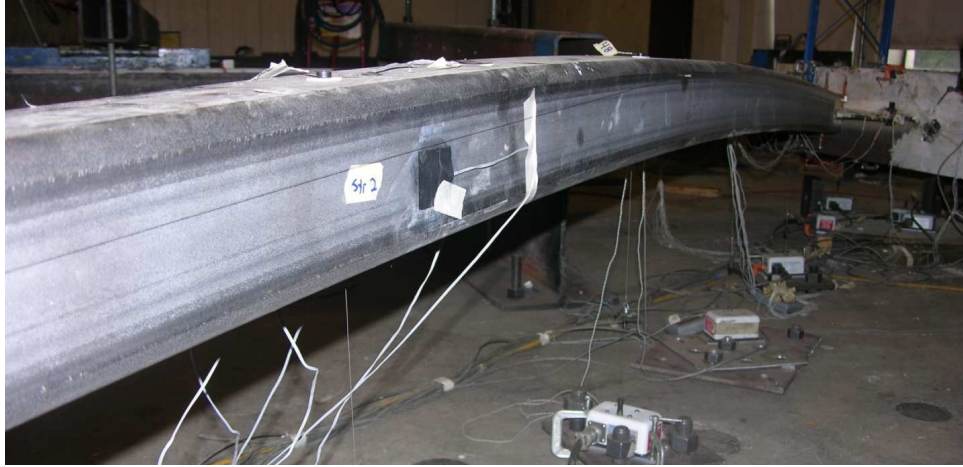
Figure 5.9 Initial Brace Global Buckling - B1 NCBF1-R2

Global buckling of the brace is divided into 3 categories. Initial brace buckling, B1, includes behavior from when the brace begins to lose axial load resistance in compression until the mid-span deflection reaches the depth of the brace, as shown in Figure 5.9. Moderate brace buckling, B2, describes brace mid-span deflections between one and two times the brace depth, as shown in Figure 5.10. Severe brace buckling, B3, describes all brace deflections greater than two times the brace depth, as shown in Figure 5.11.

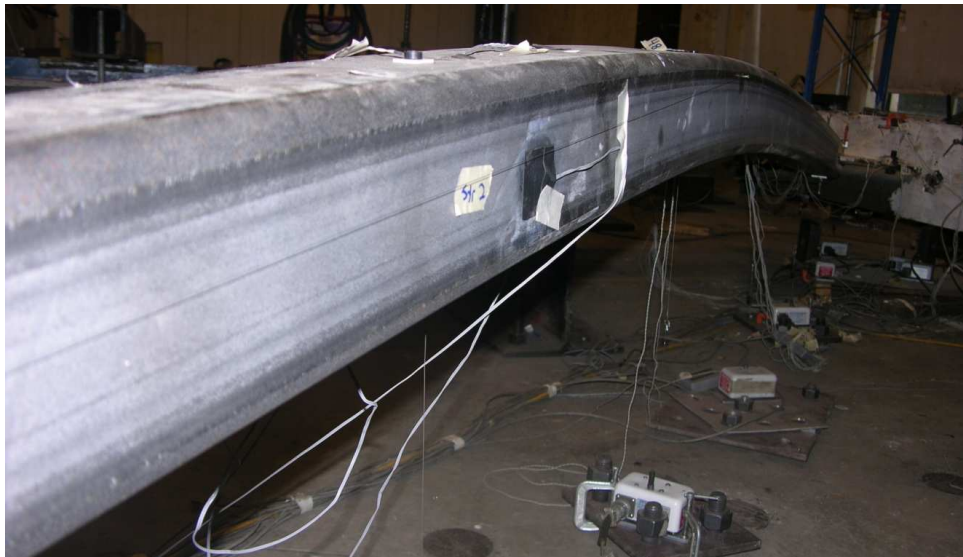
Figure 5.10 Moderate Brace Global Buckling - B2 NCBF1-R2

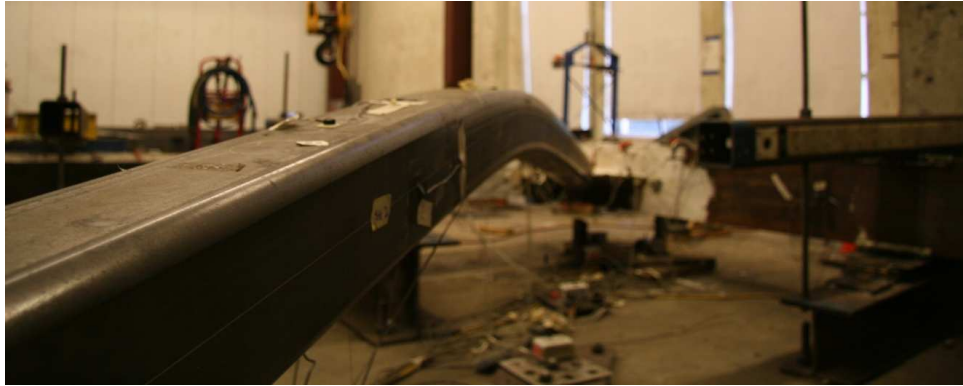
Figure 5.11 Severe Brace Global Buckling - B3 NCBF1-R2

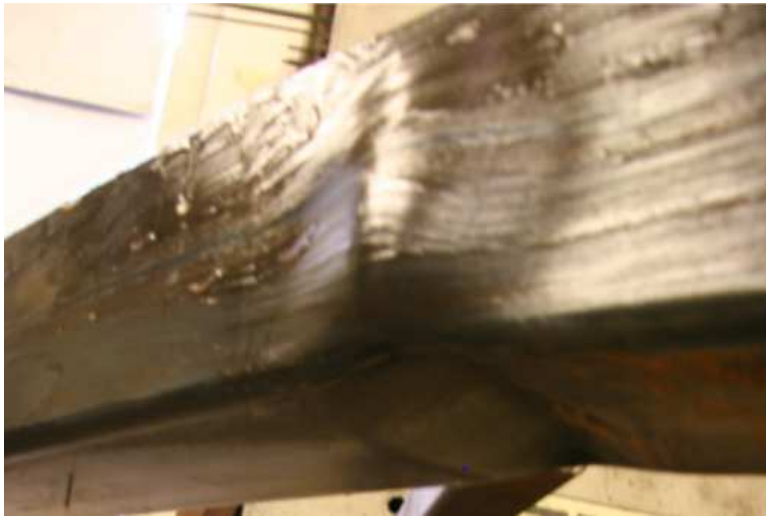
Figure 5.12 Brace Cupping - BC NCBF1

If the out-of-plane displacement of the brace becomes large enough, a plastic hinge will form. Ultimately, the brace will sustain localized damage to the brace flanges with increased local buckling. This is described as brace cupping, BC, as shown in Figure 5.12. In some cases, if the width-to-thickness ratio for the brace is large, brace cupping may occur before severe brace buckling.

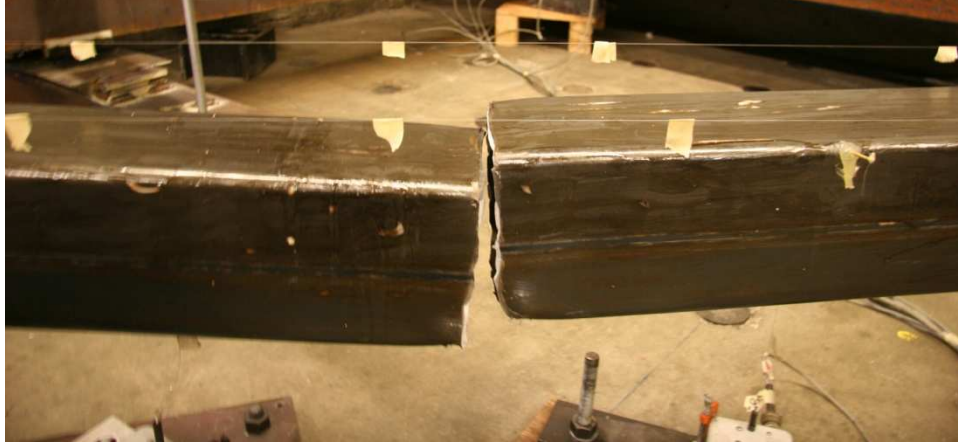
Figure 5.13 Brace Fracture - BF NCBF1

Performance state BF is reached if the tears in the brace result in complete fracture of the brace cross section. This is the desired ultimate limit state for braced frames. Figure 5.13 shows a brace that has reached the brace fracture performance state.

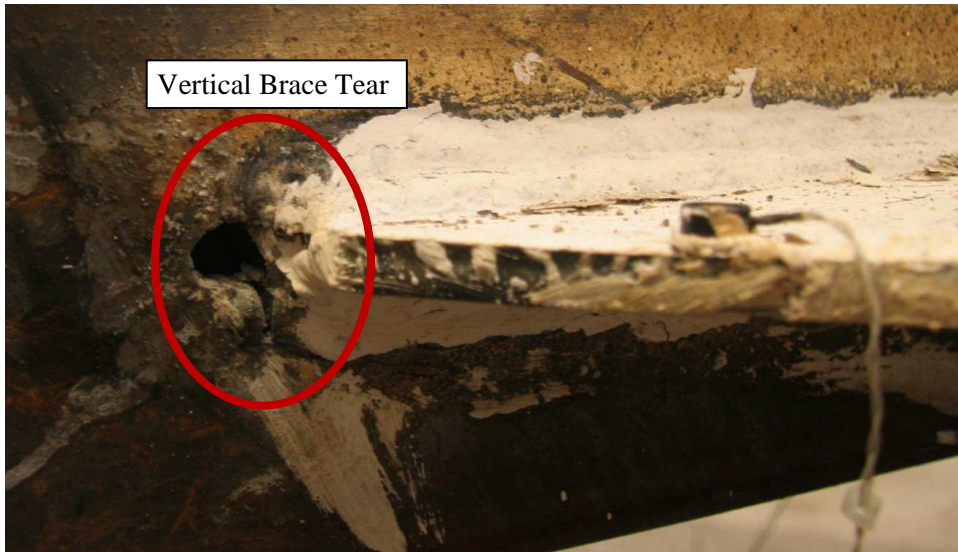
Figure 5.14 Brace Net Section Tearing - BNS NCBF1-R5

In some cases, braces may crack at the net section, where the brace is slotted at the edge of the gusset plate. This damage does not fit predictably into the damage progression of B1-B3, so it is given a separate designation - BNS. Figure 5.14 shows a brace whose net section has reached this performance state, and Figure 5.15 shows an illustration of the brace net section.

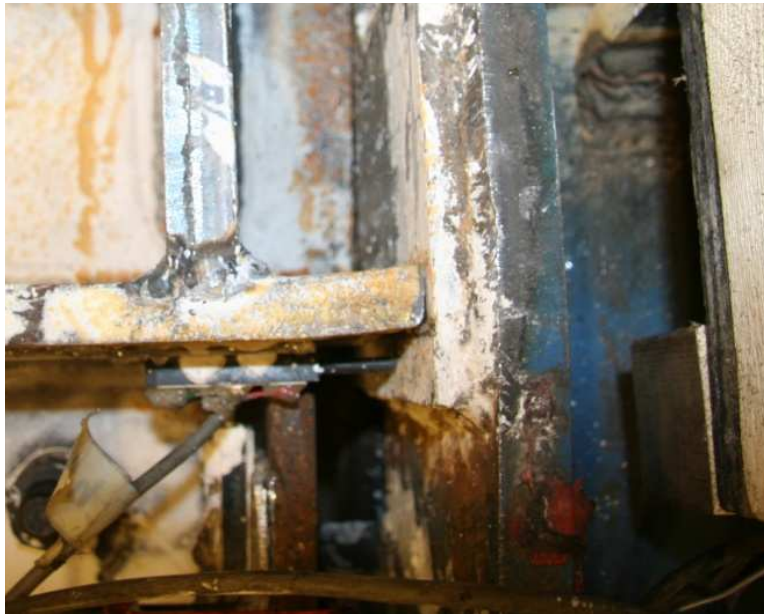
Figure 5.16 Column Flange Buckling - LB NCBF1-R3

When a component, such as a web or flange deforms locally out of its plane, it is designated as local buckling, LB, as shown in Figure 5.16 for a column flange. Local buckling pertains only to the performance of the beams and columns in these specimens.

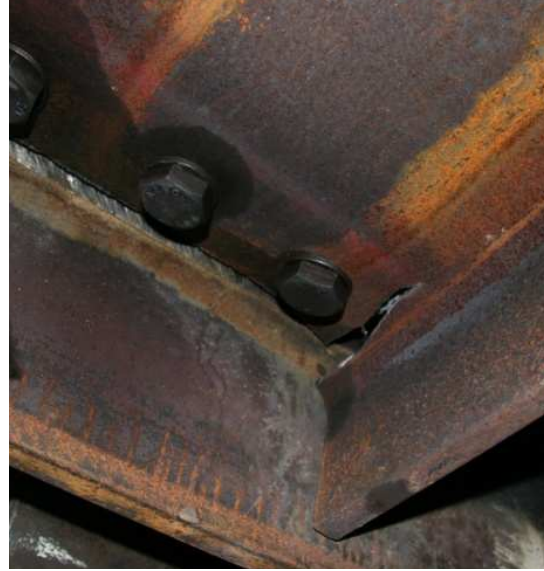
Figure 5.18 Beam Web MT NCBF1-R5

The metal tearing performance state pertains to all frame components except the brace. It includes damage up to, but not including complete fracture of the component. Figure 5.17 shows tearing of a shear tab, and Figure 5.18 shows tearing of a beam web.

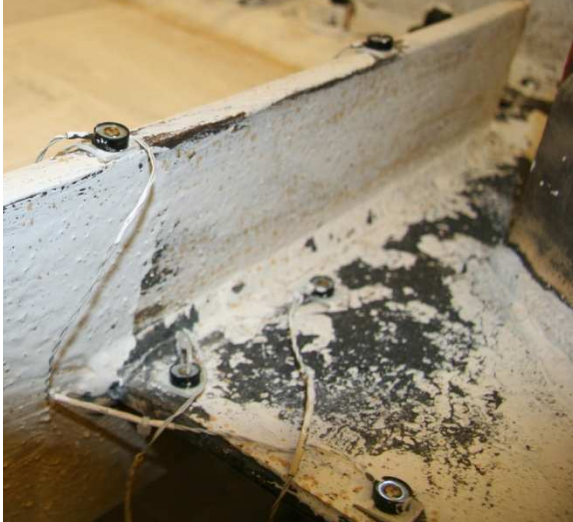
Figure 5.19 Initial Weld Tearing - W1 NCBF1-R5

Weld damage is described by four performance states, which indicate progressively larger degrees of weld tearing. Initial weld tearing, W1, describes welds that are torn along less than 10% of their length. Figure 5.19 shows a weld exhibiting this performance state. Moderate weld tearing, W2, includes welds that are torn along 10-30% of their length. Figure 5.20 demonstrates this performance state. Severe weld tearing, W3, describes welds torn over greater than 30% of their length, as shown in Figure 5.21. In some cases, a single weld has multiple separate tears along its length. The weld performance state is determined by the total length of weld cracking, not the length of a single crack. Weld fracture occurs when a weld has torn through its thickness along its entire length and is referred to by the performance state WF. Figure 5.22 shows a typical weld fracture.

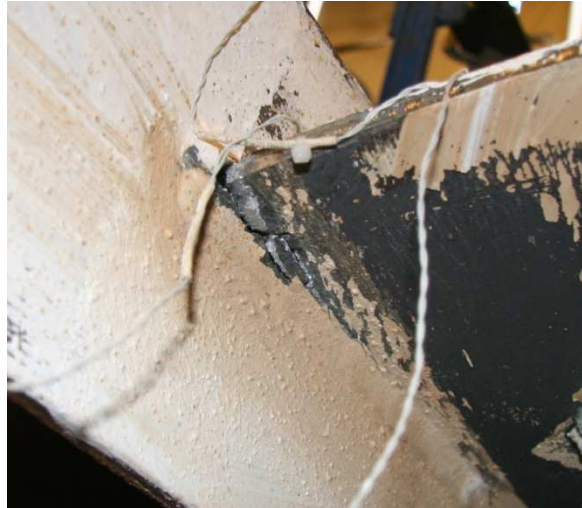
Figure 5.20 Moderate Weld Tearing - W2 NCBF1-R5

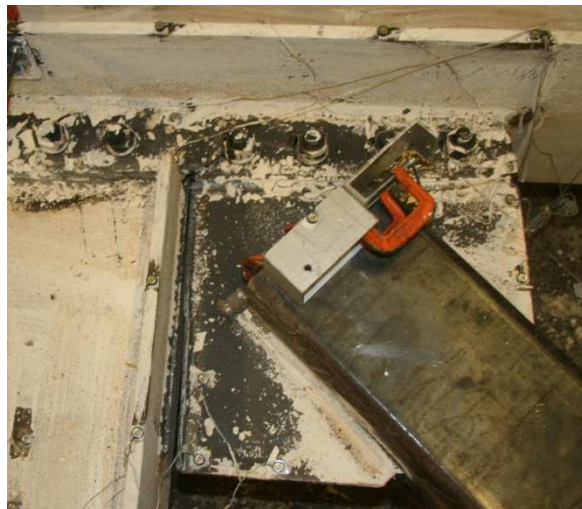
Figure 5.22 Weld Fracture - WF NCBF1-R5

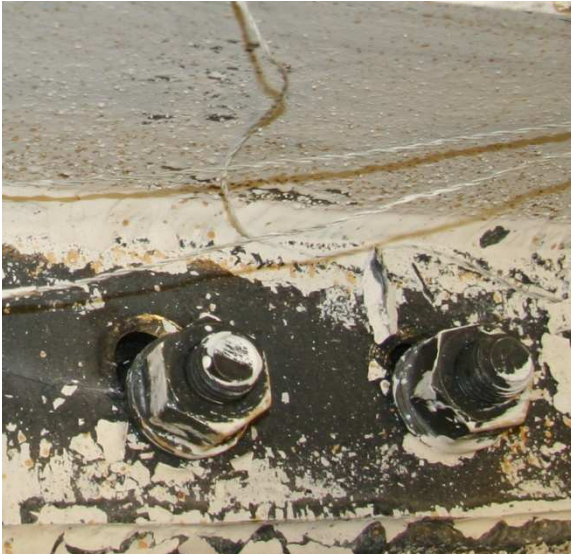
Figure 5.23 Bolt Hole Elongation - BTE  
NCBF1-R5

Bolt hole elongation, BTE, refers to visibly discernible deformation of the base metal around the bolt, which results in an elongated, oblong hole. Figure 5.23 shows a typical elongated bolt hole.

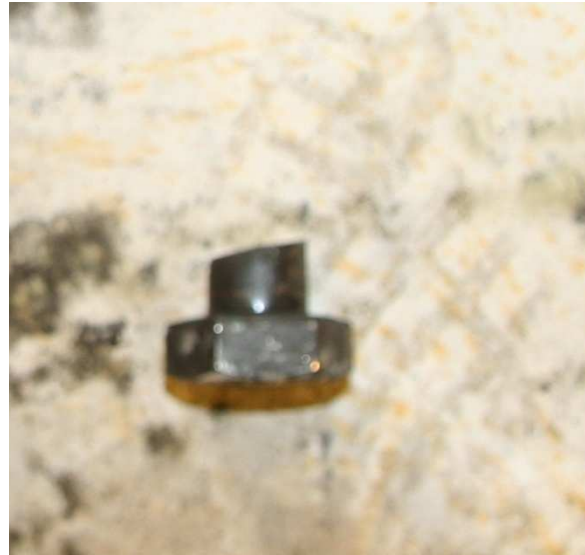
Figure 5.24 Bolt Fracture - BTF NCBF1-R5

Bolt fracture, BTF, refers to the complete shear fracture of the bolt. Figure 5.24 shows a typical fractured bolt.

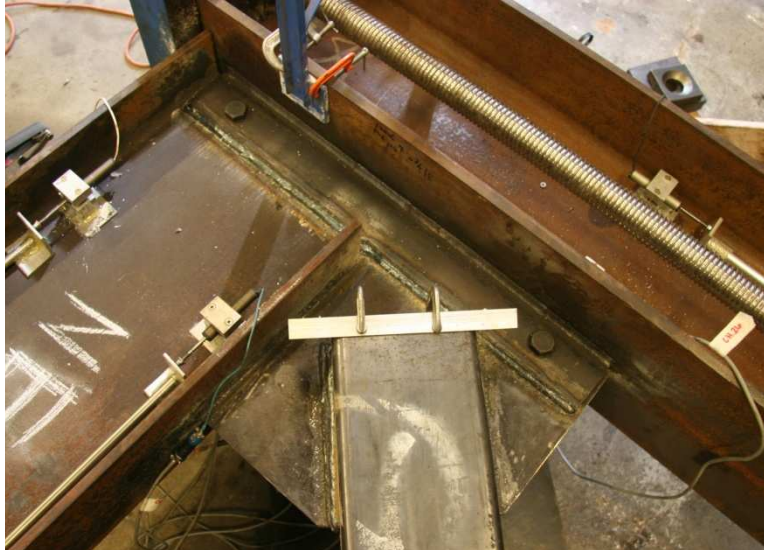
Figure 5.32 NCBF Undamaged North Connection

Specimen NCBF1 was designed to represent a common connection configuration and the typical deficiencies it exhibited in the infrastructure review, as described in Chapter 3. The connection is a shared shear tab, which is welded to both the gusset plate and the beam, as shown in Figure 5.31. Figure 5.32 shows the undamaged connection and Figure 5.33 shows the frame configuration. Welds for NCBF1 used an E70-T7 electrode, which does not meet notch-toughness requirements for demand-critical welds. This practice was common during the period of construction of the reference structures. Two of the welds on the specimen unintentionally used an E71-T8 electrode, which does meet the requirements for demand critical welds.

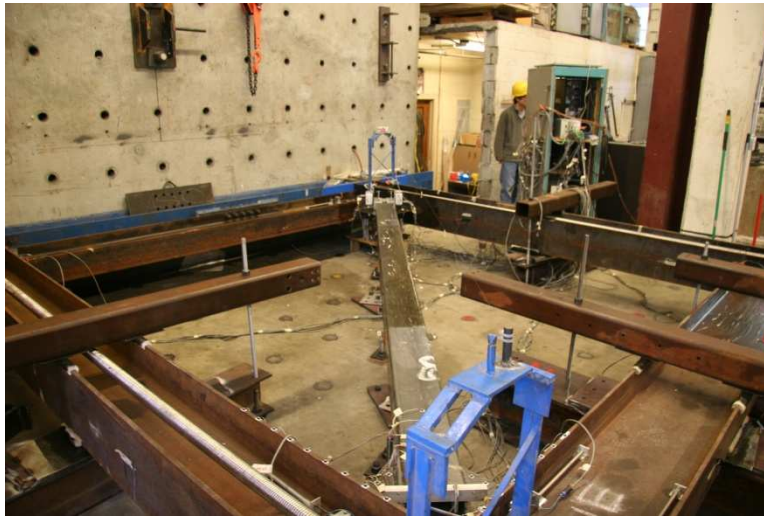
Figure 5.33 NCBF1 Frame Overview

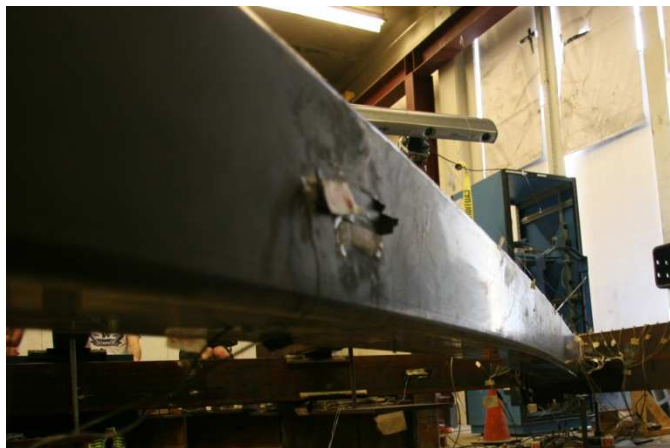
Figure 5.35 Initial Visible Brace Buckling - B1

At the compressive peak of cycle 12 (-0.12% drift), initial global buckling of the brace, performance state B1, was observed, as shown in Figure 5.35. This corresponded to the point of maximum compressive resistance for the frame, as shown in Figure 5.34. As a result of the brace buckling, the gusset plates began to bend upward at both connections. Both gusset plates were bending away slightly from the shear tab, creating a small gap, as shown in Figure 5.36. This gap continued to open for subsequent cycles.

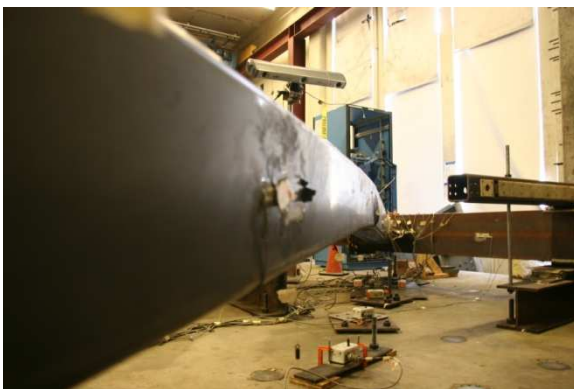
Figure 5.37 Brace Buckled Shape at Cupping

At the compressive peak of cycle 16 (-0.50% drift), local deformations of the brace walls appeared 1 foot North of the brace mid-span. The brace behavior was classified as performance state BC, as shown in Figure 5.37 and Figure 5.38. The cupping of the brace corresponded with a substantial drop in compressive resistance for the frame, as shown in Figure 5.34. The bending of the gusset plates away from the shear tabs increased at the occurrence of brace cupping, as shown in Figure 5.39. As expected, the severe local slenderness of the brace resulted in rapid degradation of compressive strength and severe local buckling.

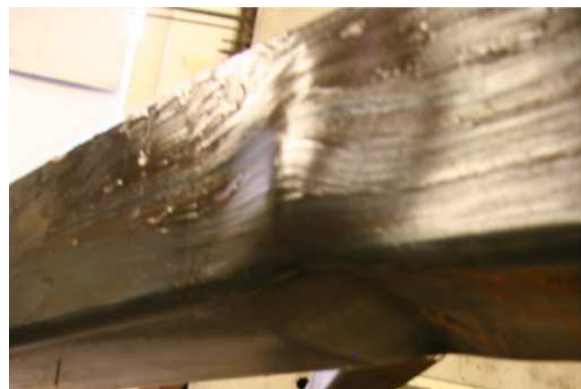
Figure 5.38 Brace Cupping - BC

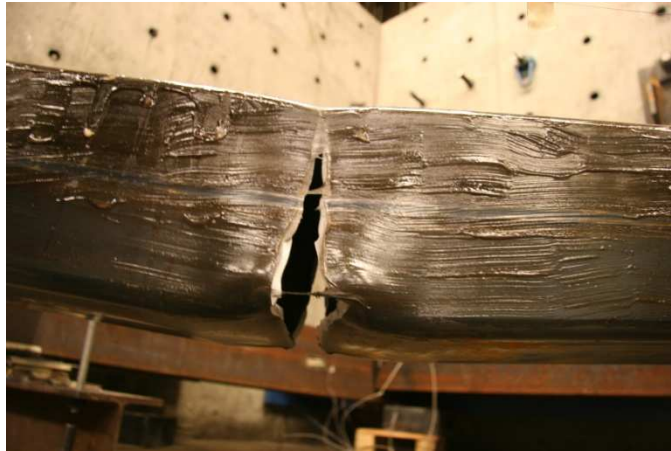
Figure 5.41 Mid-Cycle Brace Tearing

Prior to reaching the tensile peak of cycle 20, brace tearing initiated at the bottom corners of the brace and propagated up the side walls of the brace, as shown in Figure 5.41. This tearing caused the brace to deflect downward to attain equilibrium. This caused downward bending of the connections, shown for the

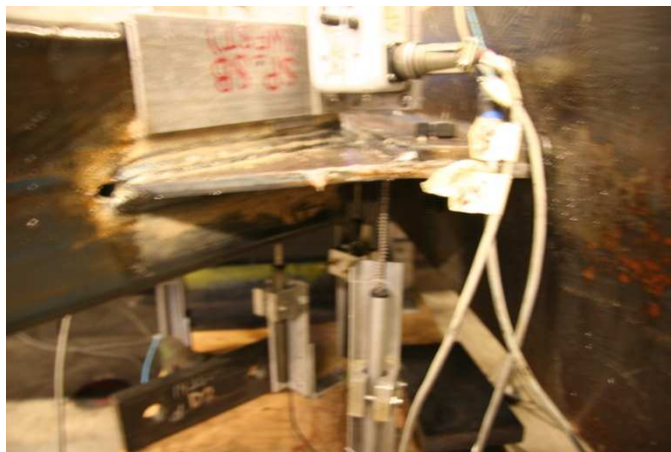
Figure 5.42 Downward Bending of South Gusset Plate

South connection in Figure 5.42. Brace fracture occurred prior to reaching the tension peak, as shown in Figure 5.43.

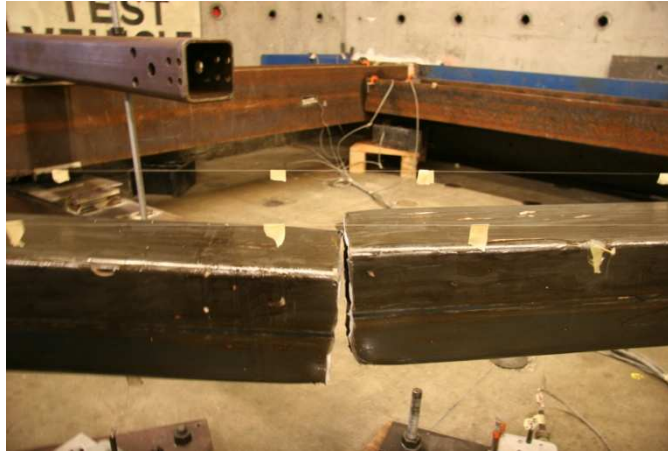
Figure 5.43 Brace Fracture

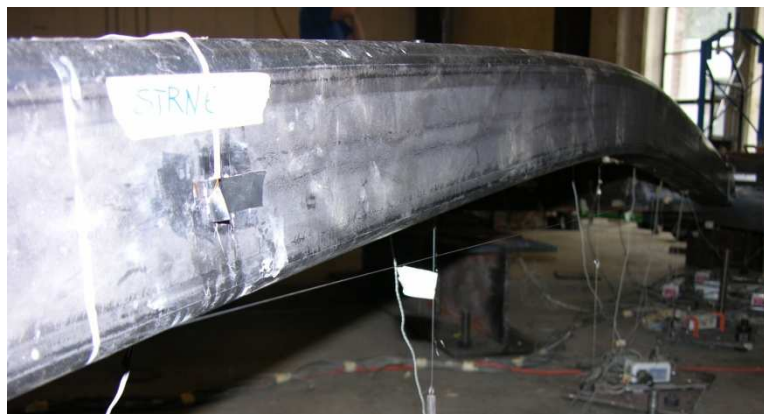
Figure 5.51 Brace Buckling - B2

Upward bending of the gusset plates was significant, and bending of the gusset plates away from the shear tabs was observed in both connections. This bending is shown for the North gusset plate in Figure 5.50. The mid-span deflection of the brace also increased sufficiently to categorize it as performance state B2, as shown in Figure 5.51. Unlike NCBF, NCBF1-R1 did not suffer a substantial loss of lateral load resistance as brace buckling progressed, as shown in Figure 5.46.

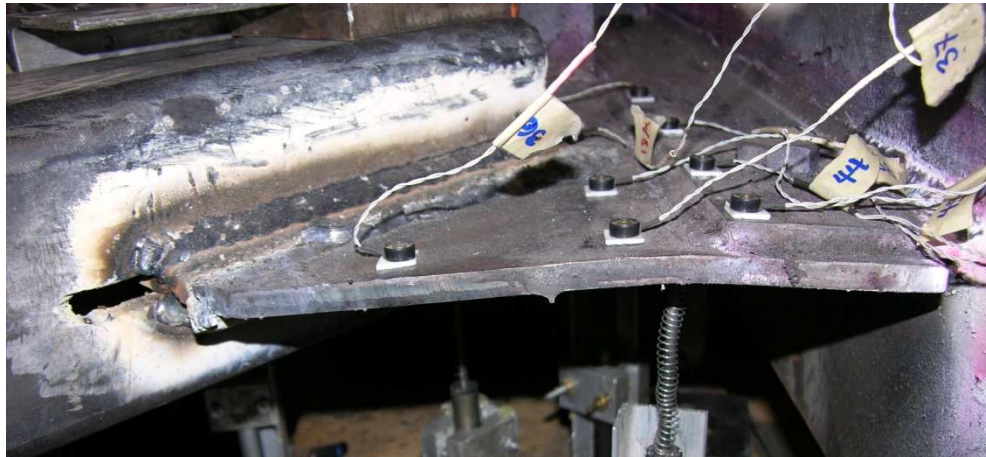
Figure 5.52 Downward Hinging of South Gusset Plate

At the tensile peak of cycle 17, the second cycle at this drift level (0.40% drift), the shear tabs retained some of their upward bending from the compressive cycle, forcing the gusset plate to hinge downward at the edge of the shear tab. This bending is shown for the South gusset plate in Figure 5.52. Also at this drift level, the slope of the load-drift envelope in tension began to decrease, as shown in Figure 5.46. This was likely a result of yielding at the brace or connections, which was not directly observable.

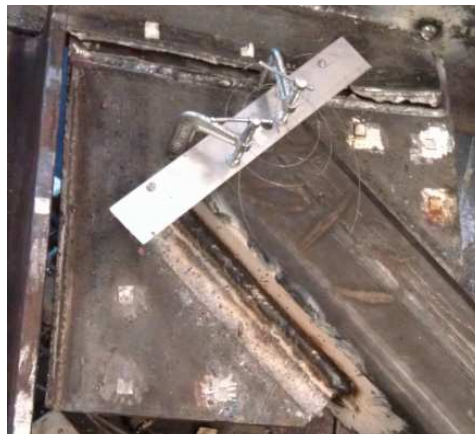
Figure 5.55 Fracture of North Gusset-to-Beam and Gusset-to-Shear Tab Welds

Prior to reaching the tensile peak of cycle 22, the North gusset-to-beam and North gusset-to-shear tab welds both fractured completely. This fracture disconnected the brace and gusset plate from the frame, effectively ending the test, as shown in Figure 5.55. These fractures corresponded to a 60% loss of lateral load capacity, as shown in Figure 5.46.

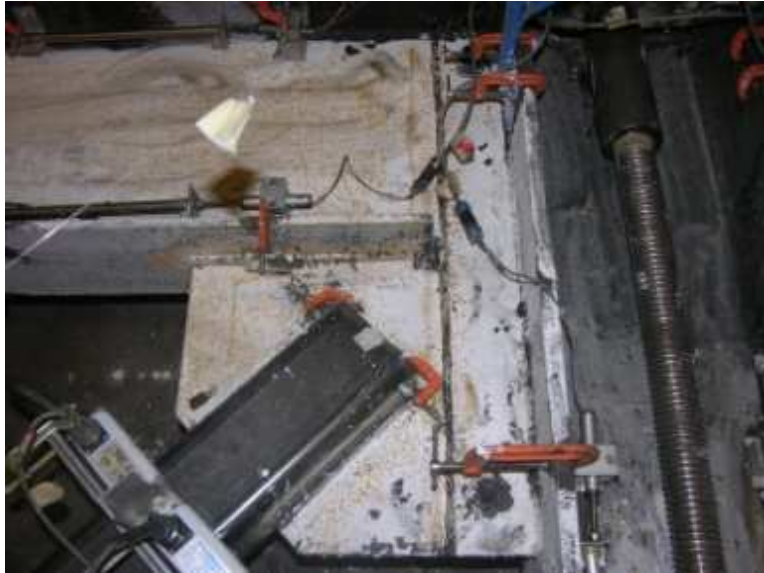
Figure 5.57 North NCBF1-R2 Undamaged Connection

Figure 5.56 shows the schematic for the retrofit, and Figure 5.57 shows an image of the undamaged connection. NCBF1-R2 reused the columns from NCBF1-R1. No significant damage occurred in the columns during NCBF1-R1, so they were deemed acceptable for reuse. The existing plates were removed, and the columns were rotated so the new plates could be attached to a clean face of the column. New beams were used for NCBF1-R2.

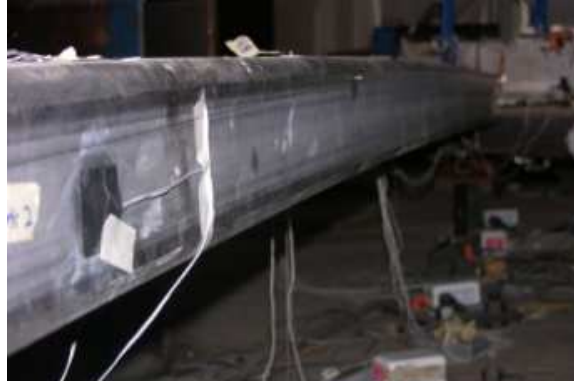
Figure 5.59 Initial Brace Buckling - B1

At the compressive peak of cycle 7 ( -0.16% drift), upward out-of-plane buckling of the brace was visible, classified as performance state B1. This initial buckling is shown in Figure 5.59. At the initiation of brace buckling, the compressive behavior of the system changed substantially, as shown in Figure 5.58.

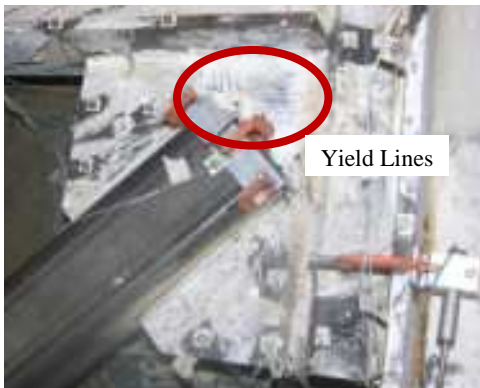
Figure 5.60 North Gusset Plate - Y1

At the tensile peak of cycle 9 (+0.24% drift), initial yielding was observed in the North gusset plate and North shear tab. This yielding, classified as performance state Y1, is shown in Figure 5.60 and Figure 5.61. Additionally, both gusset plates bent upward to accommodate the out-of-plane buckling of the brace. The bending of the North and South gusset plates can be seen in Figure 5.62 and Figure 5.63, respectively.

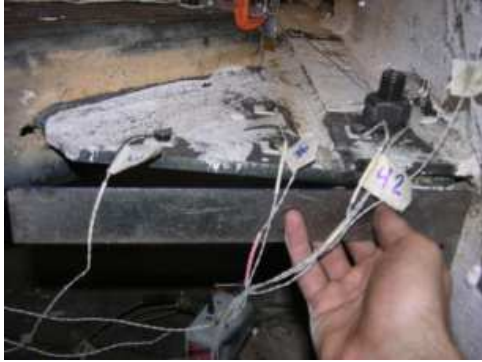
Figure 5.62 North Gusset Plate Bending

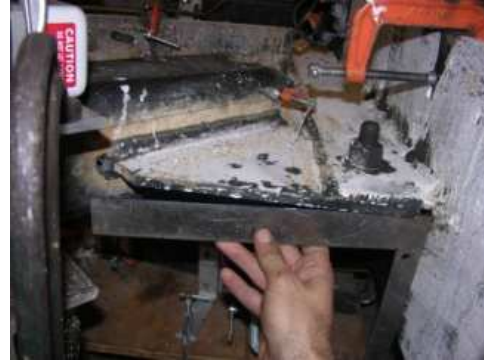
Figure 5.63 South Gusset Plate Bending

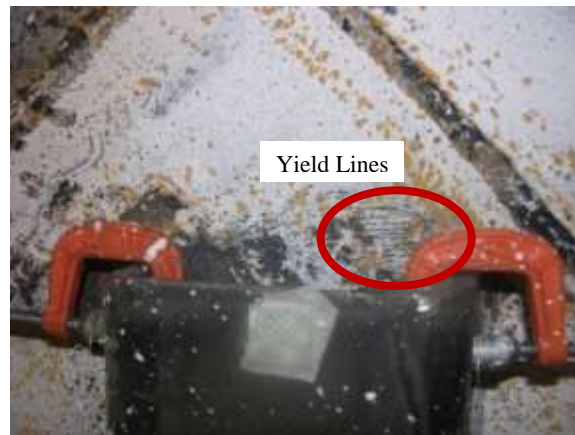
Figure 5.64 South Gusset Plate - Y1

At the compressive peak of cycle 9 (-0.24% drift), the South gusset plate formed initial yield lines at the end of the brace, entering performance state Y1. This is shown in Figure 5.64.

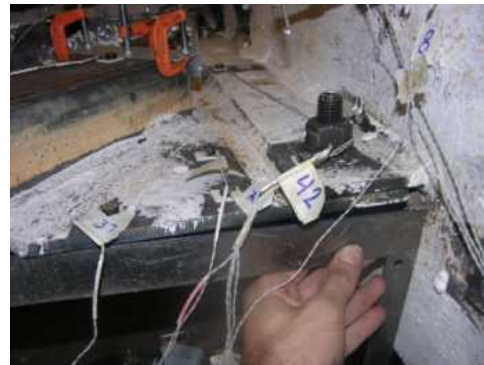
Figure 5.66 North Gusset Plate Downward Bending

At the tensile peak of cycle 11 (+0.29% drift), initial yielding was observed in the South shear tab, indicating performance state Y1. This yielding is shown in Figure 5.65. Also, the straightening of the brace caused retained some upward rotation, and the gusset plate bent at the edge of the shear tab, as shown for the North connection in Figure 5.66. downward bending of the gusset plates relative to the shear tabs. The shear tabs

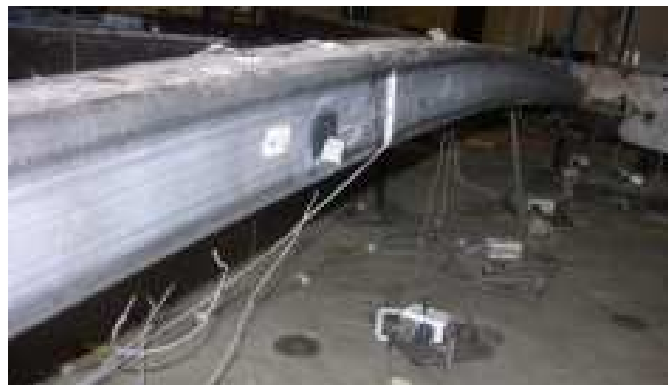
Figure 5.67 Brace Buckling - B2

At the compressive peak of cycle 15 (-0.48% drift) the brace transitioned to performance state B2, as shown in Figure 5.67. The compressive resistance of the frame at this drift was comparable to the resistance at performance state B1, as shown in Figure 5.58. This is demonstrative of the post-buckling strength retention of compact sections.

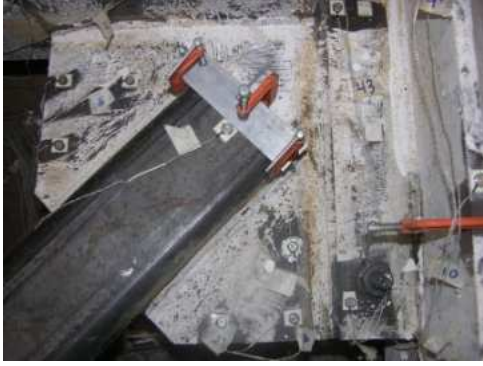
Figure 5.68 North Gusset Plate and North Shear  
Tab - Y2

At the tensile peak of cycle 17 (+0.68% drift), the North gusset plate, North shear tab, and South gusset plate all transitioned to performance state Y2. The North and South connections are shown in Figure 5.68 and Figure 5.69, respectively. The slope of the load-drift behavior of the frame in tension decreased substantially at this point, as shown in Figure 5.58. This is indicative of yielding, which was extensive in the South gusset plate. Yielding may also have occurred in the brace at this point, but it was not directly observable.

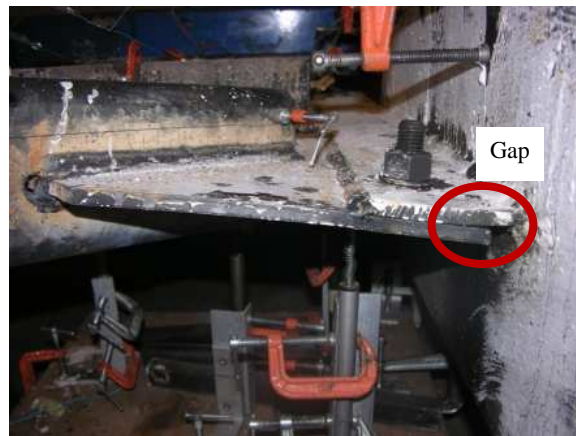
Figure 5.70 Bending of South Gusset Plate from Shear Tab

At the compressive peak of cycle 19 (-0.82% drift), the gusset plates began bending away from the shear tabs as a result of the upward buckling of the brace. The small gap between the two plates in the South connection is shown in Figure 5.70.

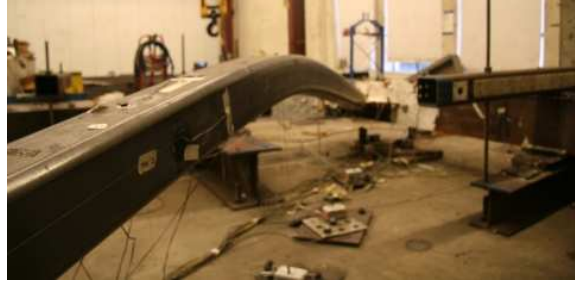
Figure 5.71 Brace Buckling - B3

At the compressive peak of cycle 21 (-1.33% drift), the brace transitioned to performance state B3, as shown in Figure 5.71. The frame continued to maintain lateral load resistance in compression, as shown in Figure 5.58.

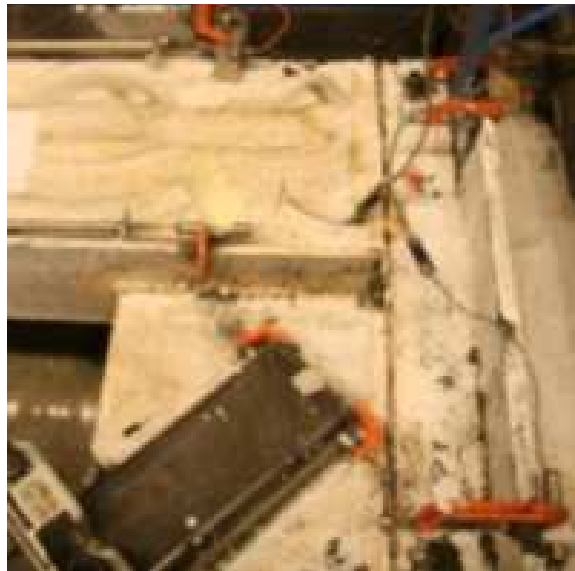
Figure 5.72 South Shear Tab - Y2

At the tensile peak of cycle 22, the second cycle at this displacement level (+1.24% drift), the South shear tab yielding increased, transitioning to performance state Y2, as shown in Figure 5.72.

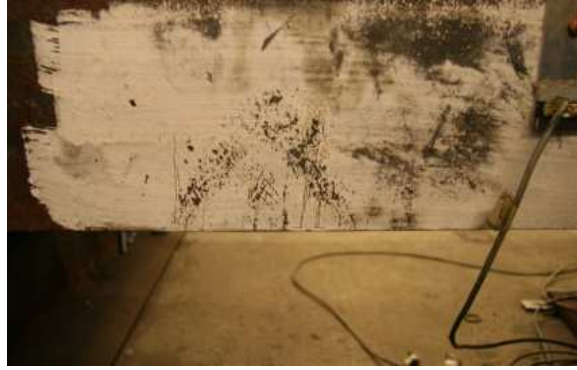
Figure 5.73 North Flange of North Beam - Y1

At the tensile peak of cycle 23 (+1.41% drift), initial yielding was observed in the North flange of the North beam, 12 inches East of the end of the load beam. This was classified as performance state Y1, as shown in Figure 5.73.

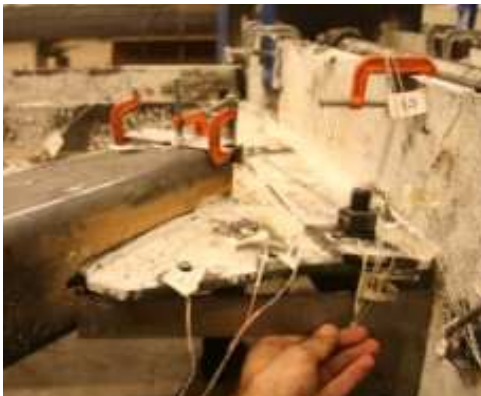
Figure 5.74 Bending of North Gusset Plate

Also at the tensile peak of cycle 23, a substantial increase in the downward bending of the North gusset plate at the shear tab was observed. Residual upward bending of the shear tab increased from previous cycles, forcing a hinge to form in the gusset plate at the edge of the shear tab, as shown in Figure 5.74. Yielding also increased in the North shear tab, which moved to performance state Y3, as shown in Figure 5.75.

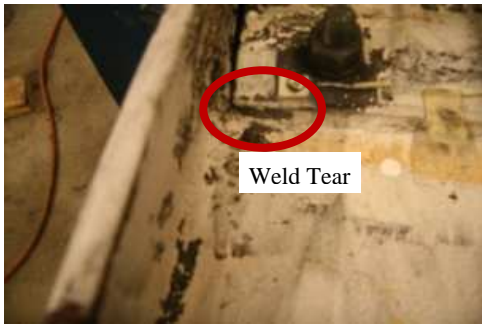
Figure 5.76 W1 in North Beam-to-Shear Tab Weld

At the compressive peak of cycle 23 (-1.92% drift), initial weld damage was observed. A 1 inch weld tear initiated at the North end of the North beam-to shear tab weld. This tear was classified as performance state W1 and is shown in Figure 5.76. A 1/4 inch long hairline crack developed at the West end of the North gusset-to-bea weld. This was also categorized as performance state W1, and it is shown in Figure 5.77. It is surprising that tearing initiated first in this weld, as the DCR for the beam-to-gusset weld was significantly higher than for the shear tab weld.

It is somewhat surprising that the shear tab weld failed first in NCBF1-R2, as the DCR for the gusset plate-to-beam weld was significantly larger. Other limit states with DCRs greater than 1, including net section fracture and gusset plate and brace block shear, did not occur, indicating that high DCRs for these limit states may not be as large of a concern. The gusset plates yielded extensively, as expected given the high DCR for Whitmore yielding. However, this yielding does not appear to have adversely affected the system performance, although it is possible that high strain concentrations caused initiation of weld tearing.

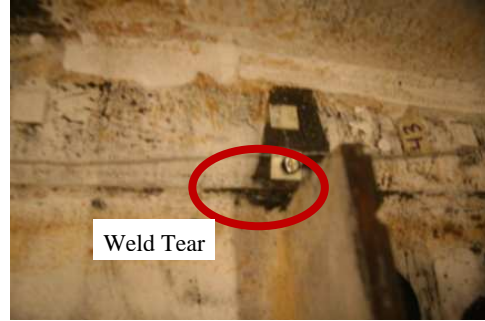
Figure 5.80 New Tear in North Beam-to-Shear Tab  
Weld

At the tensile peak of cycle 24, the second cycle at this displacement level (1.31% drift), a large crack appeared in the middle of the North gusset-to-shear tab weld. This crack was 4 inches in length, immediately putting the North gusset-to-shear tab weld in performance state W3. This crack is pictured in Figure 5.79. A second weld crack developed at the South end of the North beam-to-shear tab weld. This crack was 1.5 inches in length, bringing the North beam-to-shear tab weld into performance state W2, as shown in Figure 5.80. Also, new weld tear was also observed in the South connection. A 1 inch tear developed at the South end of the South beam-to-shear tab weld, classified as W1 and shown in Figure 5.81.

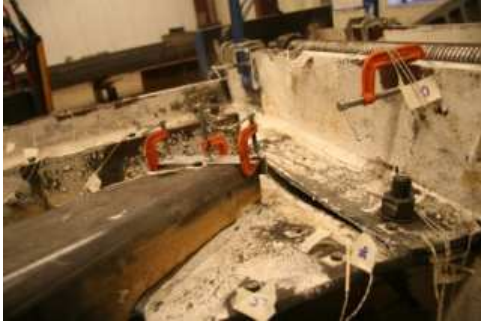
Figure 5.82 Fracture of North Gusset-to-Shear Tab Weld

At the compressive peak of cycle 24 (-1.63% drift), complete fracture of the North gusset-to-shear tab weld occurred, as shown in Figure 5.82. As a result of this fracture, the North shear tab curled downward significantly along the length of the North beam-to-shear tab weld, shown in Figure 5.83. This fracture did not substantially affect the lateral load capacity of the system in compression, as shown in Figure 5.58.

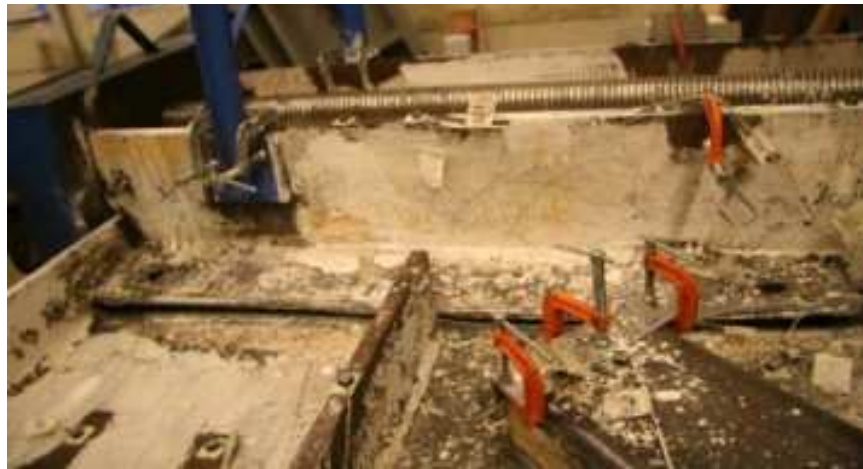
Figure 5.84 Complete Fracture of the North Shear Tab Weld

Prior to reaching the tensile peak of cycle 25, the North beam-to-shear tab weld fractured completely, ending the test. The fracture of the North beam-to-shear tab weld is shown in Figure 5.84. The weld fracture also caused the fracture of both erection bolts in the NE shear tab. The North beam was pulled downward by the brace, causing the North flange of the beam to bear against the North shear tab, as shown in Figure 5.85. The point of fracture on the load-drift history is shown in Figure 5.58.

This connection failed by a different, and less desirable series of weld fractures than NCBF1-R1. These connections were almost identical to one another, which highlights the level of uncertainty associated with the performance of deficient and non-notch tough welds. Brace end rotation appeared to put substantial demands on the connection, as was the case with NCBF1-R1. Improving the brace performance and drift range came at the cost of a less desirable failure mode.
