Evaluation and Retrofit of Non-Capacity Designed Braced Frames

A thesis

Master of Science in Civil Engineering

University of Washington

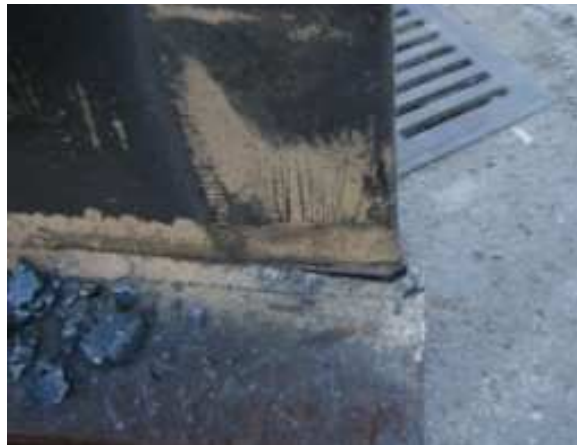
Figure 5.86 W1 in North Gusset-to-Beam Weld (After Disassembly)

A 2 inch weld crack also formed at the East end of the North gusset-to-beam weld, classified as performance state W1. The crack is shown after frame disassembly in Figure 5.86. Both the north and South gusset plate had slightly increased yielding, moving both plates to performance state Y3. The gusset plates are shown in Figure 5.87 and Figure 5.88.

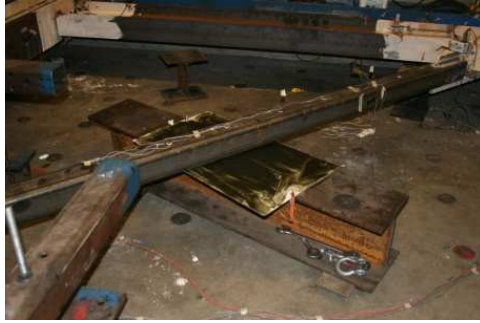
Figure 5.91 NCBF1-R3 Brace Support

During early cycles of the test, it was discovered that the brace was buckling out-of-plane downward. Limited clearance between the frame and the floor would not permit completion of the test, so a support with a friction reducing interface was placed under the mid-span of the brace, as shown in Figure 5.91. The specimen had sustained negligible damage at that point, so the test was restarted with the support in place.

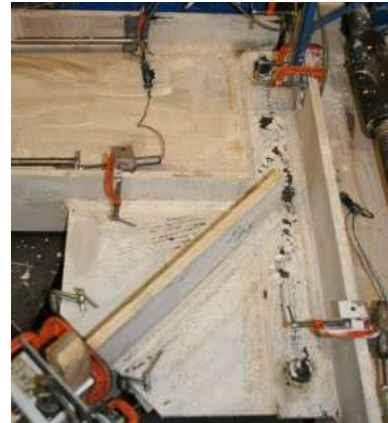
Figure 5.97 South Shear Tab - Y2

At the tensile peak of cycle 15 (+0.22% drift), the North shear tab entered performance state Y1 with emergence of yield lines around the end of the knife plate, shown in Figure 5.96. The south shear tab yielded along most of its length, transitioning to performance state Y2, as shown in Figure 5.97.

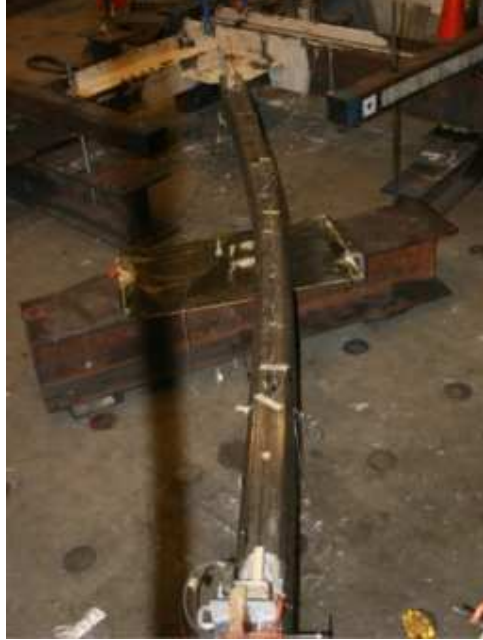
Figure 5.98 Brace In-Plane Buckling - B1

At the compressive peak of cycle 17 (-0.40% drift), the brace buckled suddenly in-plane to the South, entering performance state B1 and causing a significant drop in compressive resistance, as shown in Figure 5.92. This sudden buckling likely occurred due to the restraint at the brace midspan, which may have restricted in-plane movement via friction until the resistance was suddenly overcome as slip occurred. The brace buckled shape is shown in Figure 5.98. As a result of the buckling, both knife plates yielded substantially in the clear region between the brace and the gusset plate on the South side. Yielding in the North and South plates, shown in Figure 5.99 and Figure 5.100, was characterized as performance state Y2. The brace buckling also resulted in a substantial loss of compressive lateral load resistance, as shown in Figure 5.92.

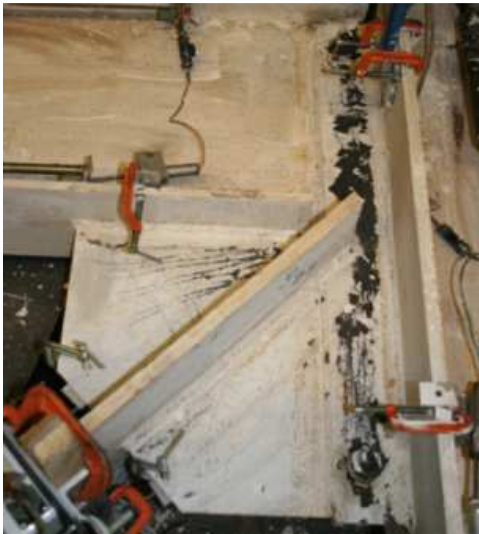
Figure 5.101 South Shear Tab - Y3 and South Gusset Plate - Y2

At the tensile peak of cycle 19 (+0.38% drift), the South shear tab was yielded over the majority of its area, indicating performance state Y3. The South gusset plate also had increased yielding, transitioning to performance state Y2. Yielding in the South connection is shown in Figure 5.101. The North gusset plate also had increased yielding, categorized as performance state Y2, as shown in Figure 5.102. At this point, the slope of the load-drift behavior of the frame in tension decreased substantially, indicating extensive

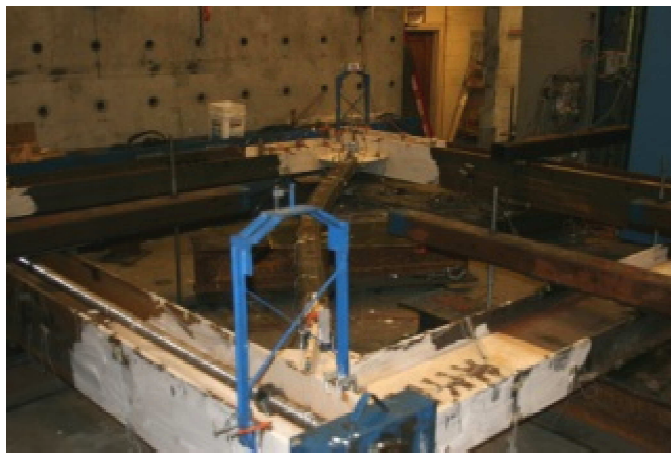
Figure 5.104 Brace Buckling - B2

At the compressive peak of cycle 19 (-0.82% drift), brace in-plane buckling increased to performance state B2, as shown in Figure 5.104. After the initial sudden buckling, the compressive resistance of the system remained relatively stable as displacement increased, as shown in Figure 5.92. This is consistent with the behavior of the compact brace sections used in NCBF1-R1 and NCBF1-R2. As a result of the increased buckling, both knife plates transitioned to performance state Y3, with yielding over almost the entire region between the gusset plate and the brace. Yielding of the North and South knife plates is shown in Figure 5.105 and Figure 5.106. Although the knife plates were designed to carry the full tensile capacity of the brace without yielding, the rotational demands due to brace buckling still caused extensive yielding.

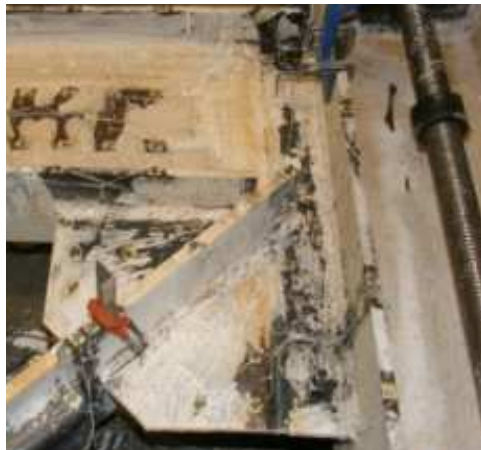
Figure 5.107 North Gusset Plate and Shear Tab - Y3

At the tensile peak of cycle 21 (+0.63% drift), yielding in the North connection increased substantially. The gusset plate and shear tab transitioned to performance state Y3, as shown in Figure 5.107. This increased yielding corresponded to the peak tensile load resisted by the frame. After this point, the extensive connection damage caused a gradual weakening of the system in tension.

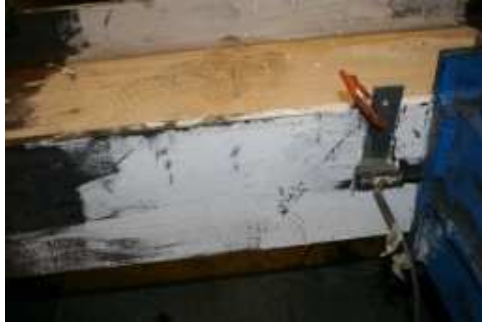
Figure 5.108 North Flange, North Beam - Y1

Additionally, initial yielding was observed in the North beam at the end of the load beam. This yielding, classified as performance state Y1, is shown in Figure 5.108.

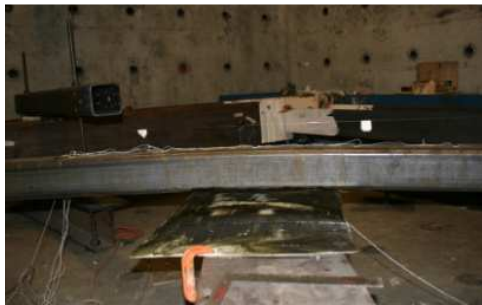
Figure 5.109 Brace Upward Out-of-Plane Buckling

At the compressive peak of cycle 21 (-1.27% drift), the brace began to buckle upward out-of-plane, in addition to the in-plane buckling. At this cycle, the in-plane deformation was four times as large as the out-of plane deformation at the midspan. The upward buckling of the brace is shown in Figure 5.109. As a result of this upward buckling, upward bending was observed in both gusset plates. Bending of the North and South gusset plates is shown in Figure 5.110 and Figure 5.111.

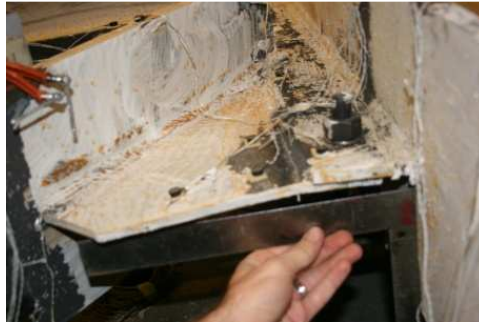
Figure 5.112 North Gusset Plate Downward Bending at Shear Tab

At the tensile peak of cycle 22, the second cycle at this displacement level (+0.72% drift), both gusset plates hinged downward slightly at the edge of the shear tab. The shear tabs retained some upward out-of-plane rotation from the brace out-of-plane buckling, and the gusset plate folded downward to accommodate the straightening of the brace. The bending of the North gusset plate is shown in Figure 5.112.

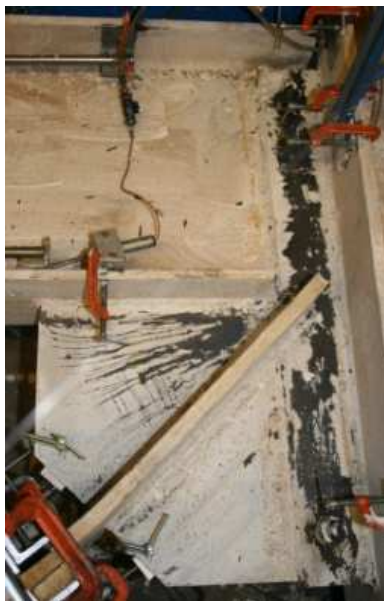
Figure 5.113 South Gusset Plate - Y3

At the tensile peak of cycle 23 (+0.78% drift), yielding in the South gusset plate increased to performance state Y3, as shown in Figure 5.113. Additionally, the South shear tab was almost completely yielded at this drift level. Also, two weld cracks were observed. 3 inch long weld cracks formed in both gusset-beam welds on the underside at the face of the column. These cracks, classified as performance state W2, are shown in Figure 5.114 and Figure 5.115 for the North and South connections, respectively. Damage of this type was not observed in the first three specimens, so it may have resulted from the knife plate retrofit.

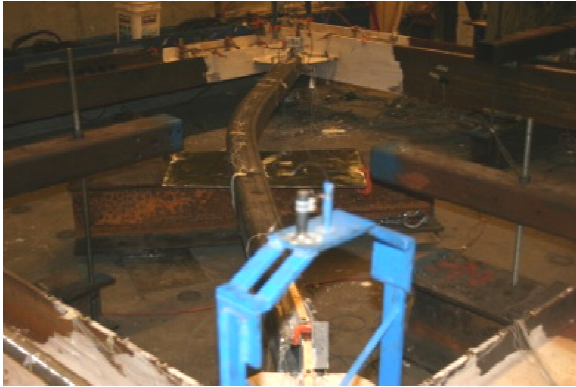
Figure 5.116 Brace In-Plane Buckling - B3

At the compressive peak of cycle 23 (-1.84% drift), the combined in-plane and out-of-plane deformations classified the brace in performance state B3. The in-plane and out-of-plane deformations were roughly equal at this cycle. Figure 5.116 shows the in-plane buckling, and Figure 5.117 shows the out-of-plane buckling.

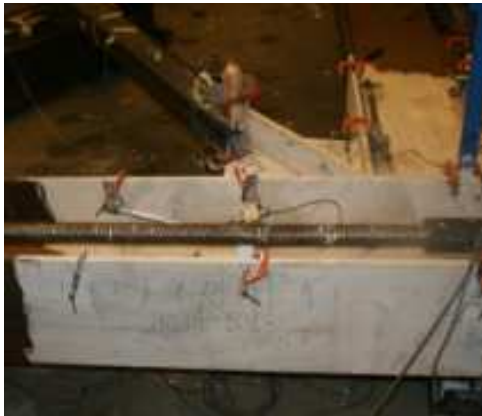
Figure 5.118 Scattered Yielding in East Column -  
Y1

Also at the compressive peak of cycle 23, additional frame damage was observed at several locations. The East flange of the East column at the North connection entered performance state Y1, as shown in Figure 5.118. The West Column, West Flange at the south connection also entered performance state Y1, shown in Figure 5.119. Upward bending of the web of the North beam was observed at the North shear tab, as shown in Figure 5.120. The North erection bolt fastening the beam web to the shear tab effectively clamped the two components, causing the beam web to curl upward in conjunction with the downward bending of the shear tab, which is shown in Figure 5.121.

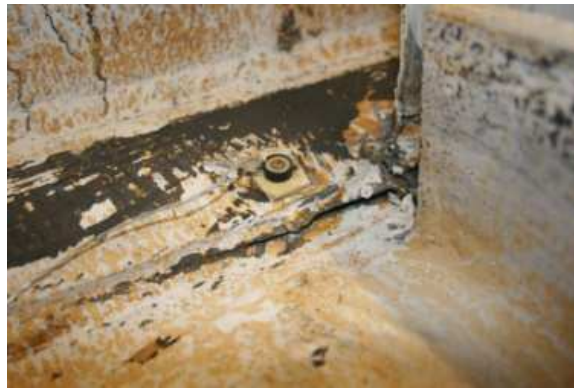
Figure 5.122 North Beam-to-Shear Tab Weld - W2 and North Shear Tab - MT

At the tensile peak of cycle 25, (+1.02% drift), a crack formed in the North beam-to-shear tab weld at the end of the knife plate. The crack was 4" in length, classified as performance state W2. At the end of the knife plate, the weld crack propagated West 1/8" into the shear tab. This damage is shown in Figure 5.122. This supports the concept that damage may concentrate around the end of the knife plate.

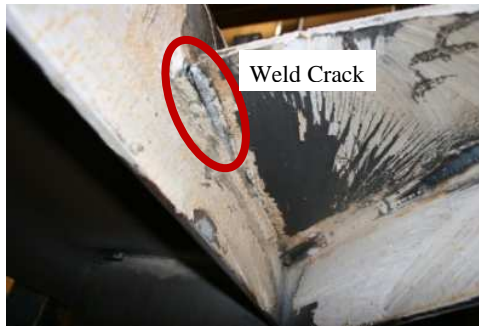
Figure 5.123 W3 in North Gusset-to-Beam Weld

At the compressive peak of cycle 25 (-2.05% drift), a 6 inch weld crack formed at the West end of the North gusset-to-beam weld. This crack, classified as performance state W3, is shown in Figure 5.123. This crack was unusual in that it covered a large portion of the weld length immediately after initiation, whereas previous specimens initially had more gradual crack growth. Also, yielding increased in the West Flange of the West column at the South connection. The new yielding, classified as W2, is shown in Figure 5.124.

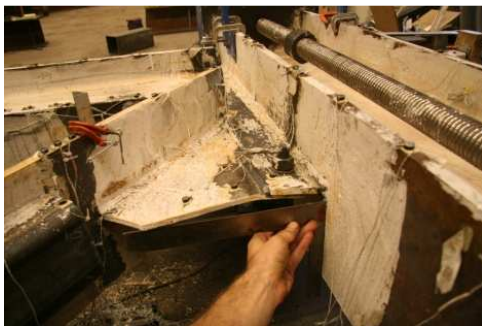
Figure 5.125 Upward Bending of N Beam Web

At the tensile peak of cycle 26, the second cycle at this displacement level (+1.02% drift), the North gusset plate began to exhibit torsional deformation. The plate was twisting about the axis of the brace. Figure 5.125 and Figure 5.126 show the bending of the South and West edges of the gusset plate, respectively. This deformation was due to the combined in-plane and out of plane buckling of the brace, which caused it to twist slightly as it deformed.

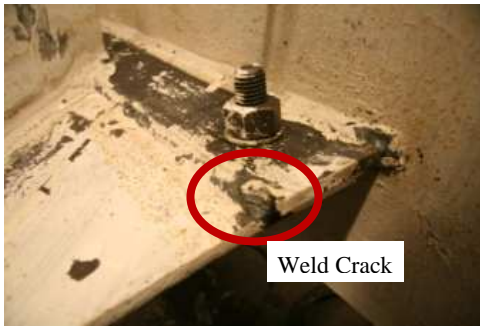
Figure 5.127 W-SGS - W1

Also at the tensile peak of cycle 26, two weld cracks were observed in the South connection. A 1 inch tear in the North gusset-to-shear tab weld at the North end, classified as performance state W1, is shown in

Figure 5.127. A 1 inch tear in the South beam-to-shear tab weld at the end of the knife plate, classified as performance state W1, is shown in Figure 5.128.

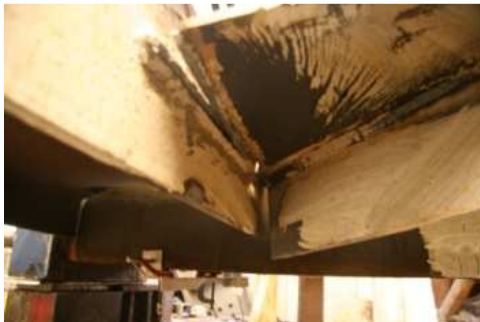
Figure 5.129 Increased Tearing in North Gusset-to-Beam Weld

At the compressive peak of cycle 26 (-1.76% drift), tearing in the North gusset-to-beam weld increased to the point where only 1/2 an inch of intact weld remained. This is shown in Figure 5.129. A new weld tear also initiated in the South gusset-to-beam weld at the East end. The 1 inch tear, which did not change the performance state of the weld, is shown in Figure 5.130.

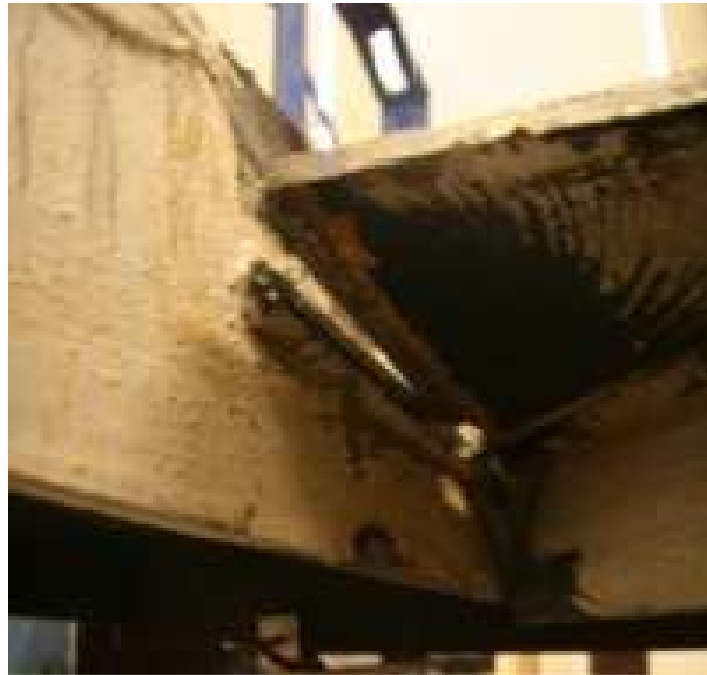
Figure 5.131 Fracture of North Gusset-to-Beam Weld

At the tensile peak of cycle 27 (0.92% drift), the North gusset-to-beam weld fractured completely, as shown in Figure 5.131. As a result of this fracture, tearing in the North beam-to-shear tab weld increased substantially, transitioning to performance state W3, as shown in Figure 5.132. In conjunction with this tear, the North shear tab bent downward more severely in the beam region, shown in Figure 5.133. The weld fracture caused a substantial loss of tensile resistance in the frame, shown in Figure 5.92.

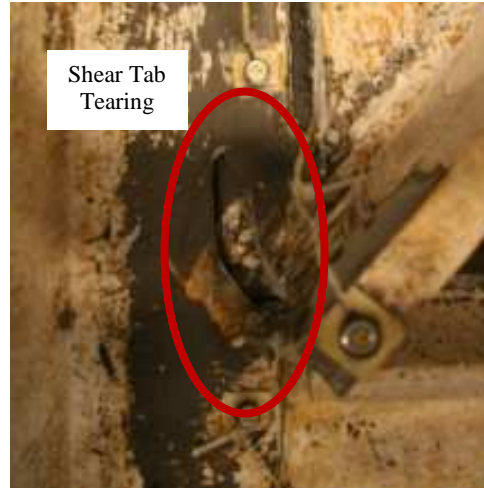
Figure 5.135 Increased MT of North Shear Tab

A large weld tear also formed in the North gusset-to-shear tab weld, starting at the end of the knife plate and propagating South. This tear was also classified as W3, as shown in Figure 5.134. The metal tearing in the North shear tab at the end of the knife plate also intensified significantly. The tear propagated South 2 inches and was 1/2 an inch wide, as shown in Figure 5.135. No new damage was observed in the South connection.

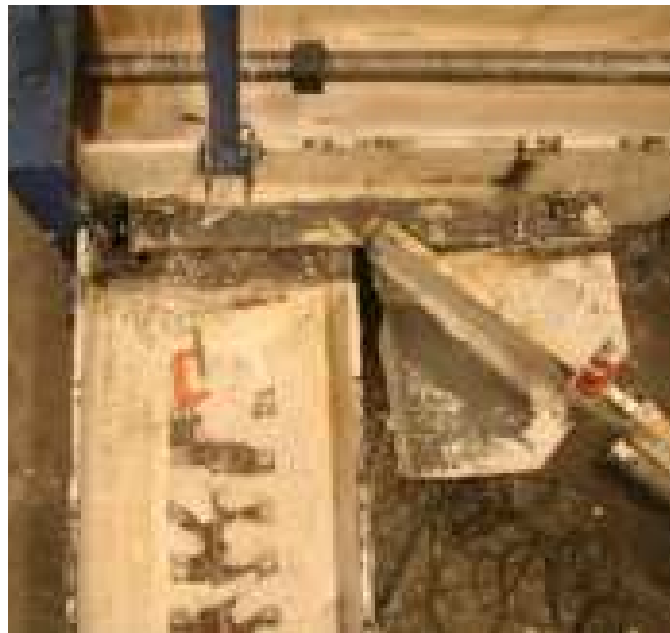
Figure 5.136 Fracture of North Beam-to-Shear Tab Weld

Prior to reaching the compressive peak of cycle 27, complete fracture of the North beam-to-shear tab weld occurred, ending the test, as shown in Figure 5.136.

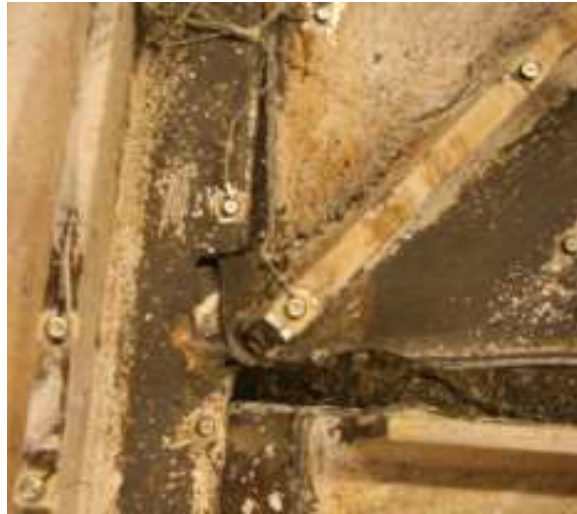
Figure 5.137 North shear tab - MT

As a result of this fracture, the tearing of the North shear tab propagated and joined with the tear in the North gusset-to-shear tab weld, as shown in Figure 5.137. A small portion of the North gusset-to-shear

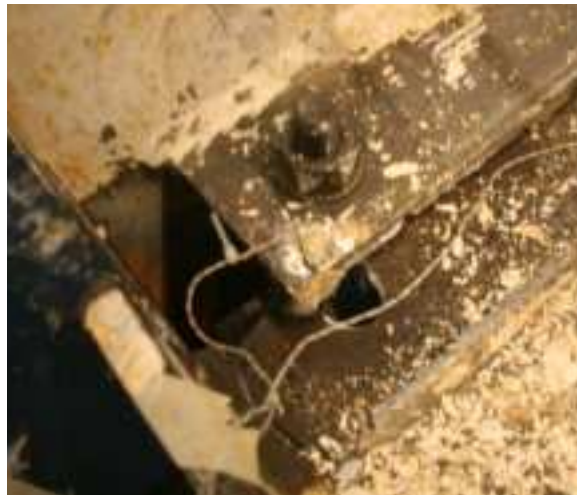
Figure 5.138 Erection Bolt Pullout from North Beam Web

tab weld at the South end was intact. The North erection bolt in the North connection had a pullout failure in the beam web as a result of the weld fracture. This is shown in Figure 5.138.

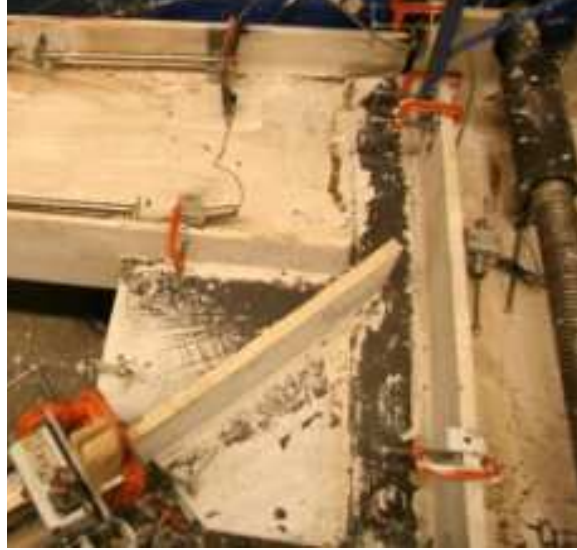
Figure 5.139 Final Damage to South Connection

The South connection did not sustain a significant increase in damage during this cycle. The final state of the South connection is shown in Figure 5.139.

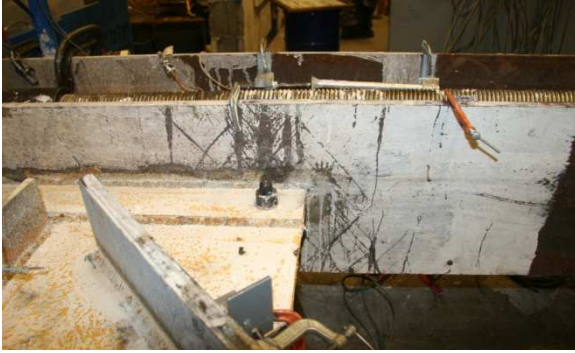
Figure 5.143 Existing Damage to West Column  
Flange

NCBF1-R4 reused the columns from NCBF1-R3 because they had sustained minimal damage in the previous test. The columns were flipped so that the welds from the previous test were on the outside faces of the columns. The West column had moderate yielding at the South connection in the West flange and the web, shown in Figure 5.143 and Figure 5.144, respectively. The East column had initial yielding at the North connection on the East flange, shown in Figure 5.145.

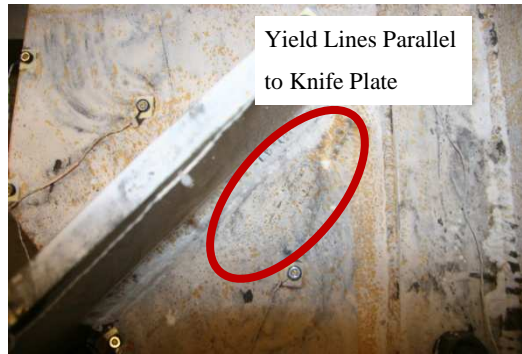
Figure 5.146 Y1- Initial Yielding in North Gusset Plate

At the tensile peak of cycle 7 (+0.17% drift), initial yield lines appeared in the North gusset plate parallel to the knife plate, resulting in performance state Y1 for the gusset plate. These lines are shown in Figure 5.146.

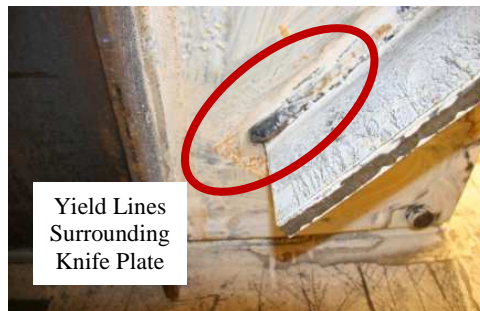
Figure 5.148 South Gusset Plate - Y1 (Underside)

At the tensile peak of cycle 9 (+0.21% drift). Performance state Y1 was observed in the North shear tab and the South gusset plate, shown in Figure 5.147 and Figure 5.148, respectively.

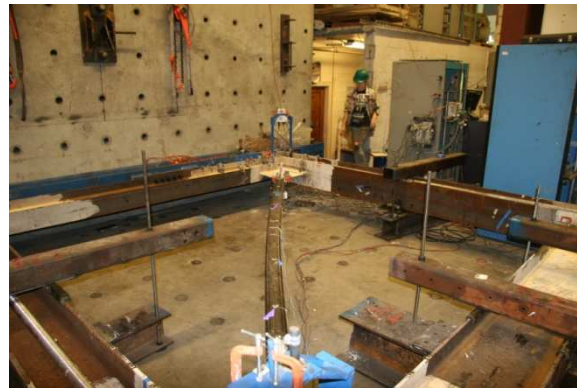
Figure 5.149 In-Plane Buckling of Brace - B1

At the compressive peak of cycle 11 (-0.32% drift), the brace behavior progressed to performance state B1 with the first visible in-plane buckling toward the South, shown in Figure 5.149. The brace buckling corresponded to a peak in compressive frame resistance, as shown in Figure 5.142. Concurrent with this buckling, performance state Y1 was observed on the South side of both the North and South knife plates, as shown in Figure 5.150 and Figure 5.151, respectively. No yielding was observed on the opposite faces of the plates.

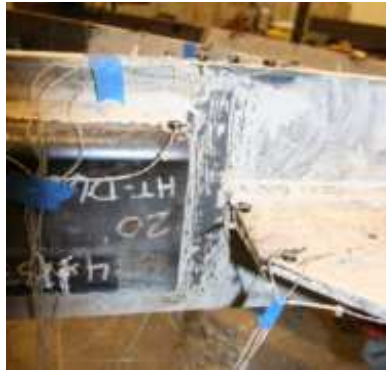
Figure 5.152 North Knife Plate, South Side - Y3

At the compressive peak of cycle 13 (-0.43% drift), the North knife plate transitioned from performance state Y1 to Y3 due to a substantial increase in yielding, shown in Figure 5.152. The South knife plate remained in performance state Y1. Also, downward bending of both gusset plates was observed. This

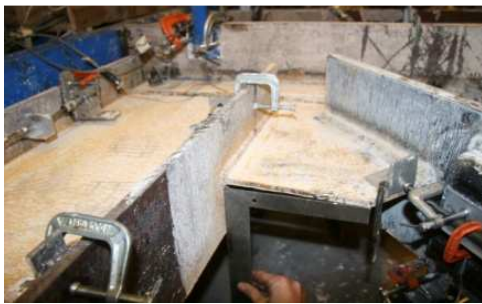
bending resulted from mild downward out-of-plane deflection of the brace. The bending of the South gusset is shown in Figure 5.153, and the bending of the North gusset is shown in Figure 5.154.

Figure 5.153 Downward Bending of S Gusset Plate      Figure 5.154 Downward Bending of N Gusset Plate

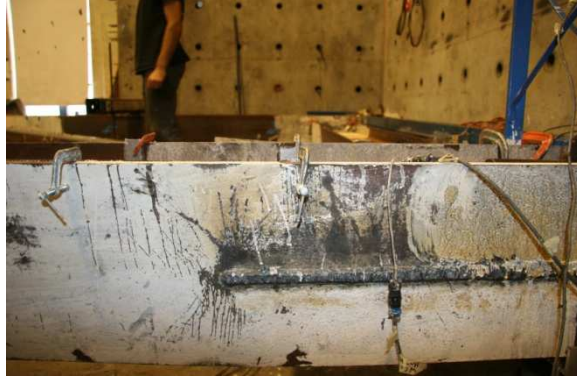
Figure 5.155 West Column, West Flange - Y1

At the tensile peak of cycle 15 (+0.39% drift), new yielding was observed in the West flange of the West Column at the South connection, shown in Figure 5.155. At this point, slope of the load-drift behavior in tension decreased substantially, indicating that yielding was occurring, as shown in Figure 5.142. Some of this was likely due to yielding in the connections, which increased substantially in subsequent cycles. The brace yielding may also have contributed, but it was not directly observable.

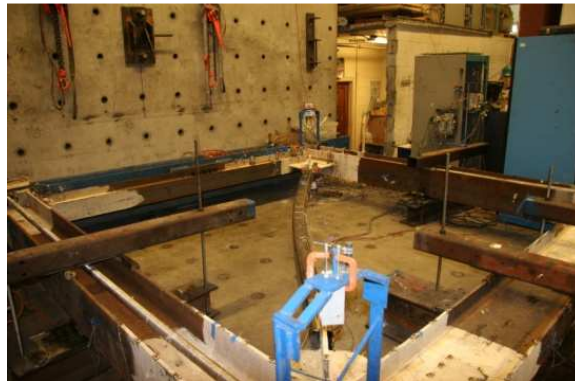
Figure 5.156 Brace In-Plane Buckling - B2

At the compressive peak of cycle 15 (-0.52% drift), the brace entered performance state B2. Buckling continued to be primarily in-plane to the South, as shown in Figure 5.156. As a result of the increased buckling, the South knife plate entered performance state Y2, shown in Figure 5.157. The increase in buckling corresponded with a slight decrease in compressive lateral load capacity, though much less than NCBF1, as shown in Figure 5.142. As with previous specimens, the compact brace maintained a large portion of its compressive strength as buckling progressed.

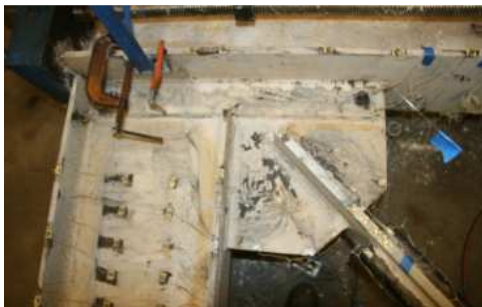
Figure 5.158 North Gusset Plate - Y2

At the tensile peak of cycle 17 (+0.52% drift), both gusset plates transitioned into performance state Y2. Yielding was more widespread in the North gusset, shown in Figure 5.158, than in the South gusset plate, shown in Figure 5.159.

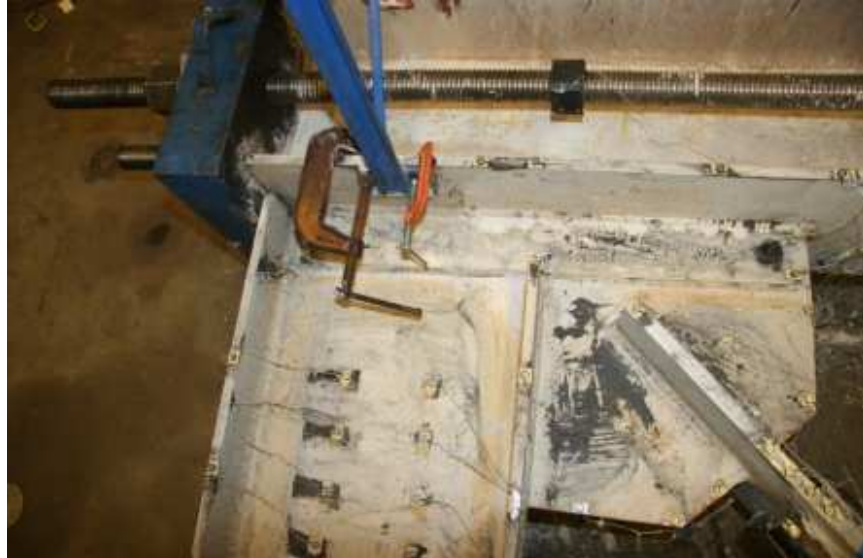
Figure 5.160 North Gusset Plate Y3 and North Shear Tab Y2

At the tensile peak of cycle 19 (+0.65 drift), there was a significant increase in damage in the North connection. The North gusset plate entered performance state Y3, with a large portion of the plate completely clear of whitewash. The North shear tab entered performance Y2 at the same time. This yielding is shown in Figure 5.160. The extensive yielding in the connections was indicative of the high DCRs for gusset plate Whitmore yielding and block shear.

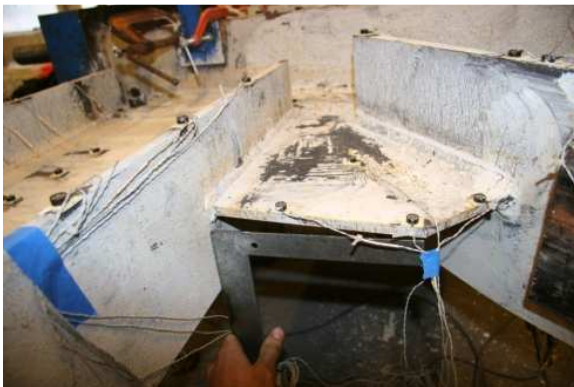
Figure 5.161 North Gusset Plate Bending

At the compressive peak of cycle 19 (-0.92%), drift increased downward bending of both gusset plates was observed. This bending resulted from a slight increase in downward out-of-plane buckling of the brace, which was at this point 2 inches at the brace mid-span. The North and South gusset plates are shown in Figure 5.161 and Figure 5.162, respectively.

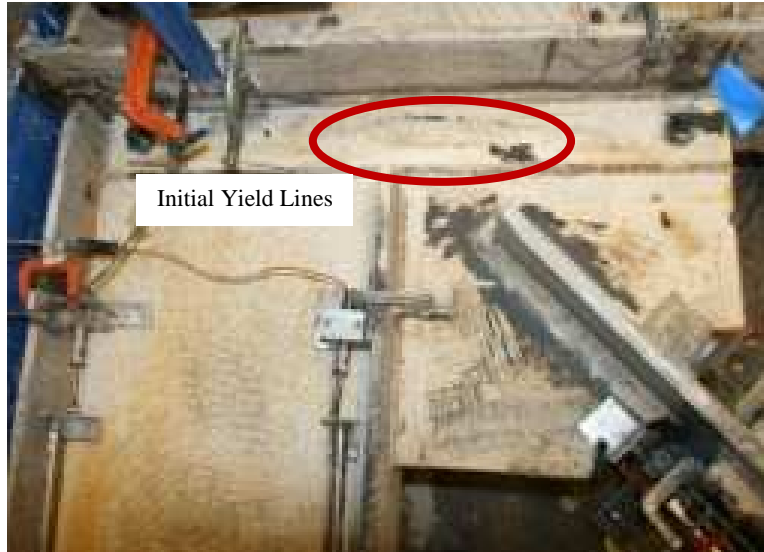
Figure 5.163 South Shear Tab - Y1

At the tensile leak of cycle 20, the second cycle at this displacement level (+0.63% drift), the South shear tab entered performance state Y1, as shown in Figure 5.163.

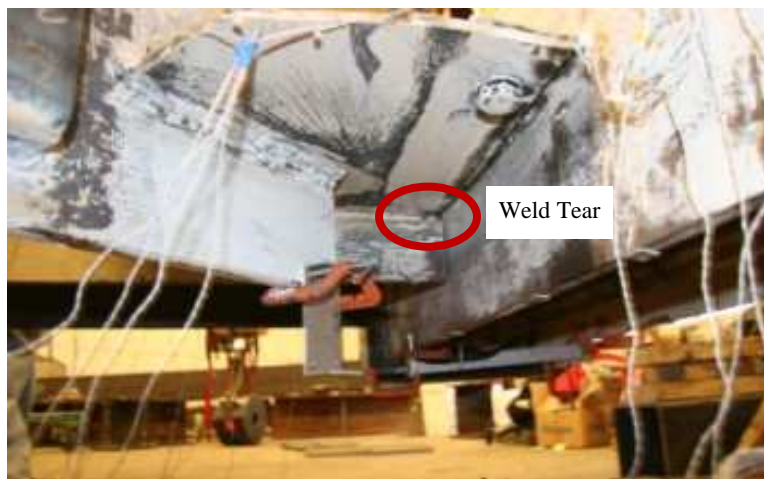
Figure 5.164 W1 in North Gusset-to-Beam Weld

At the tensile peak of cycle 21 (+0.91% drift), a weld crack was observed in the underside of the North gusset-to-beam weld at the east end. The tear was 1 inch in length, categorized as performance state W1, as shown in Figure 5.164. This tear was similar to tears observed in NCBF1-R3, indicating that tearing at this location may result from the knife plate retrofit geometry.

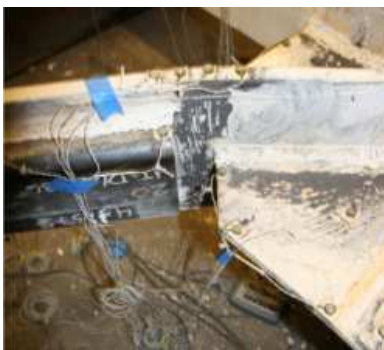
Figure 5.166 North Knife Plate - Y3

knife plates. Yielding in the North knife plate is shown in Figure 5.166. Yielding in the south knife plate, which progressed to performance state Y3, is shown in Figure 5.167. Additionally, the in-plane rotations of the North and South knife plates are shown in Figure 5.168 and Figure 5.169, respectively. As mentioned for NCBF1-R3, the knife plates yielded extensively due to the rotational demands from in-plane buckling, despite being designed to resist the full tensile capacity of the brace.

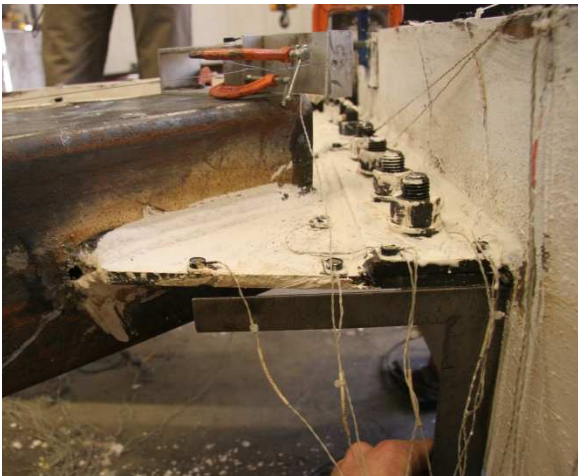
Figure 5.176 Upward Bending of N Gusset

At the compressive peak of cycle 11 (-0.20% drift), initial upward bending of both gusset plates was observed. This upward bending resulted from the out-of-plane bending of the brace, which had a mid-span deflection of 0.5" in this cycle. The deflection of the brace was not yet visible. Figure 5.176 shows the upward bending of the South edge of the North Gusset Plate. Additionally, initial yield lines were observed parallel to the beam flange in both gusset plates, shown for the North plate in Figure 5.177.

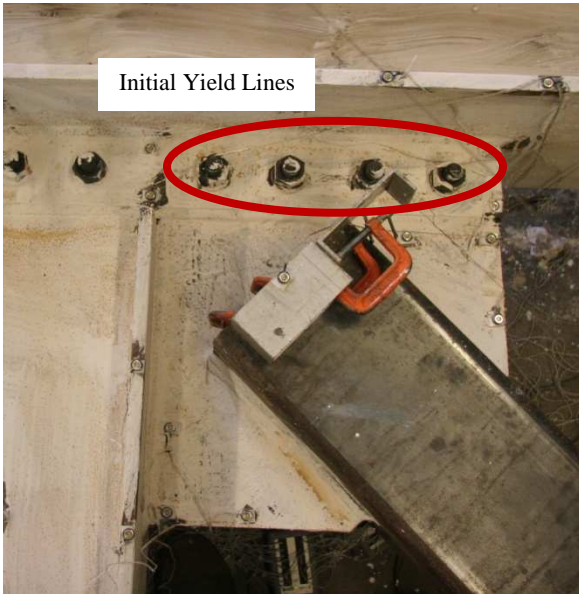
Figure 5.181 Yielding in North Shear Tab

At the tensile peak of cycle 13 (+0.25% drift), Y1 was observed in the South shear tab near the north flange of the beam. This yielding is shown in Figure 5.180. Yielding increased in the North shear tab, with yield lines between the four Southernmost bolts. This yielding is shown in Figure 5.181.

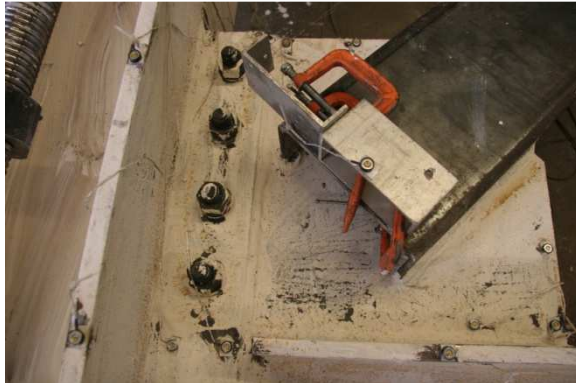
Figure 5.182 Yielding in North Gusset - Y2

At the tensile peak of cycle 15 (+0.29% drift), both gusset plates progressed to performance state Y2, as shown in Figure 5.182 and Figure 5.183. At this point, the slope of the load-drift frame behavior in tension decreased substantially, indicating yielding in the frame, as shown in Figure 5.174. This is consistent with the observation of substantial yielding in the gusset plates, which were expected to have a lower tensile capacity than the brace.

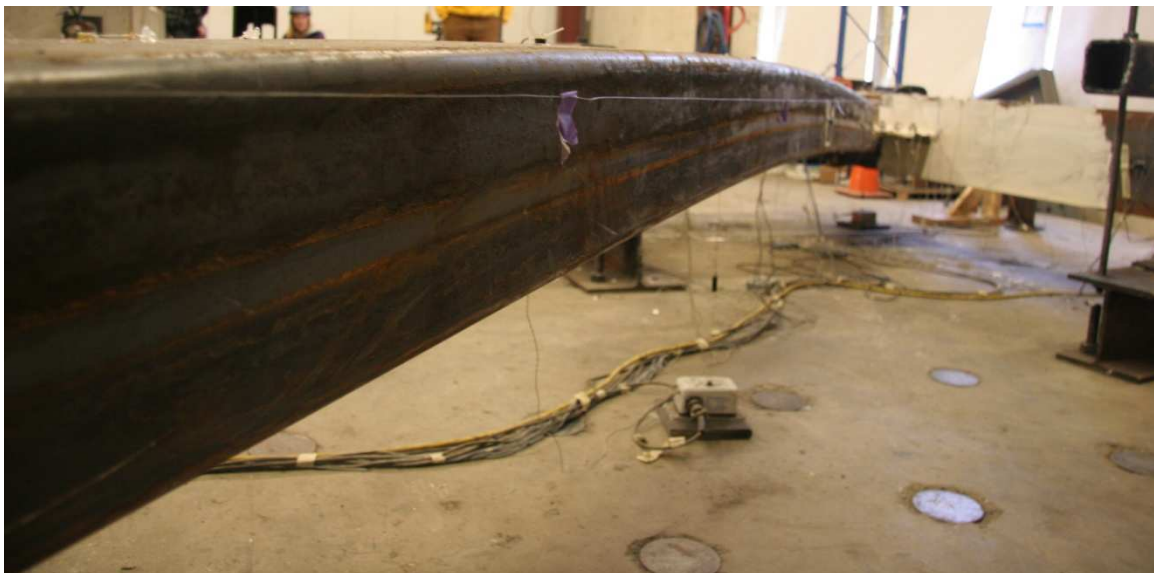
Figure 5.184 Initial Visible Brace Buckling - B1

At the compressive peak of cycle 15 (-0.31% drift), out-of-plane buckling of the brace became visible. The brace mid-span deflection was 1.7 inches, as shown in Figure 5.184. This point also corresponded to the peak compressive lateral load resistance of the frame, as shown in Figure 5.174. The compressive resistance reached was almost identical to that for NCBF1.

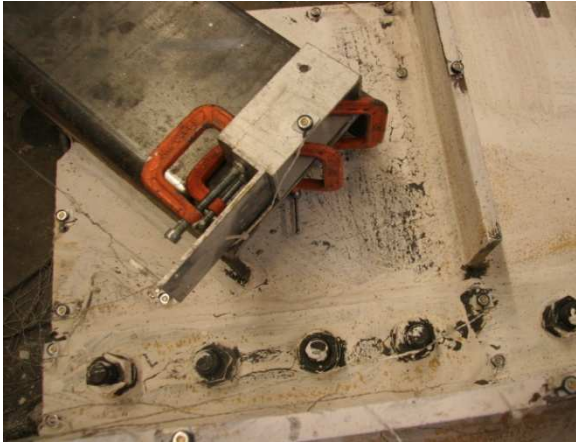
Figure 5.185 North Shear Tab - Y2

Yielding in both shear tabs increased at the tensile peak of cycle 17 (+0.39% drift). Figure 5.185 shows yielding in the North shear tab, and Figure 5.186 shows yielding in the South shear tab, which progressed to performance state Y2.

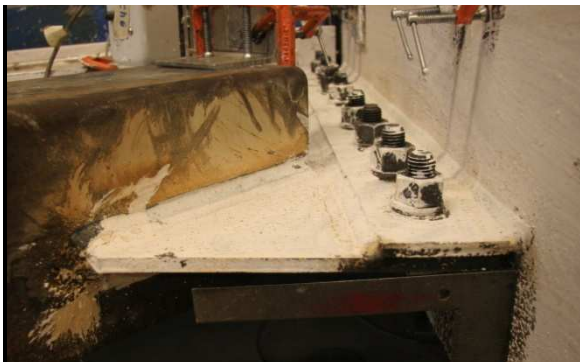
Figure 5.187 Upward Bending of South Gusset Plate

At the compressive peak of cycle 17 (-0.48% drift), increased upward bending of the gusset plates and shear tabs was observed. The South edge of the North shear tab was bent upward relative to the column, and the South edge of the North gusset was hinged upward slightly at the edge of the shear tab. Similar behavior was observed at the South connection, shown in Figure 5.187. Slight upward bending of the beam side of the gusset plates was also observed. At the tensile peak of cycle 18, the second cycle at this displacement level (+0.39% drift), downward hinging of the gusset plates was observed at the shear tabs. The shear tabs retained some residual upward bending, causing the gusset plates to hinge downward as the brace straightened. The hinging of the South gusset is shown in Figure 5.188.

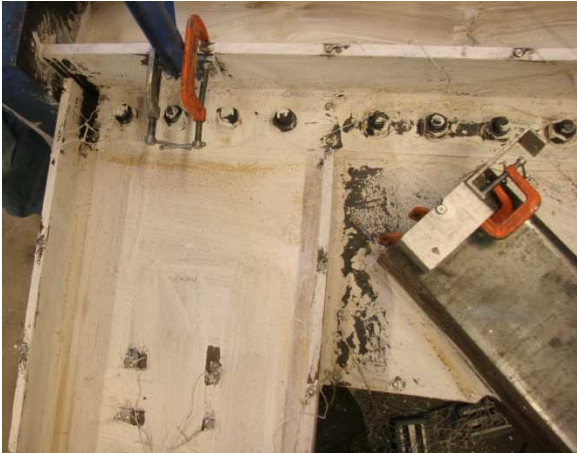
Figure 5.189 Yielding in North Connection

At the tensile peak of cycle 19 (+0.51% drift), increased yielding was observed in both connections, but none of the components progressed to more severe performances states. Yielding in the North and South connections is shown in Figure 5.189 and Figure 5.190, respectively.

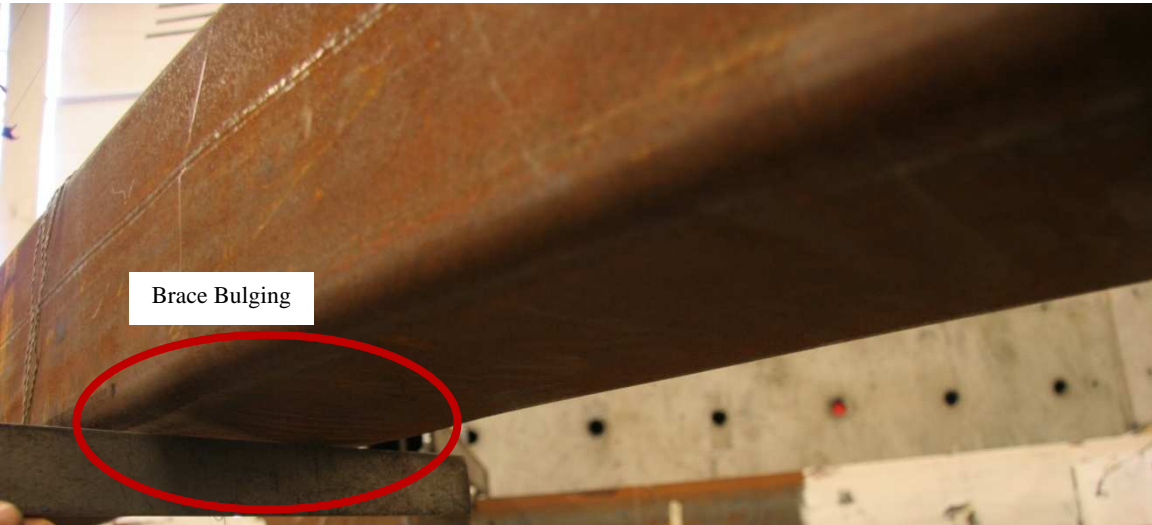
Figure 5.191 Bulge 3.5" SW of Brace Center

At the compressive peak of cycle 19 (-0.69% drift), outward bulging of the bottom flange of the brace was observed at 3 locations: 3.5 inches SW, 5 inches NE, and 13 inches NE of the brace mid-point. Figure 5.191 shows the largest bulge, 3.5 inches SW of center. This outward bulging is typical of concrete filled braces, as described in Chapter 2.

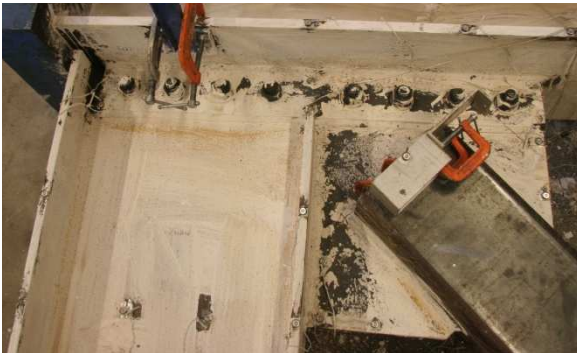
Figure 5.192 North Gusset Plate - Y3 and North Shear Tab - Y2

At the tensile peak of cycle 21 (+0.73% drift), yielding increased significantly in both connections. The North shear tab transitioned to performance state Y2, and the South shear tab and North gusset plate transitioned to performance state Y3. The shear tab yielding at both connections was concentrated in the region along the line of bolts. Figure 5.192 and Figure 5.193 show the yielding in the North and South connections, respectively. Brace net section cracking appeared in all four brace slots. The most severe cracking was on the brace South wall at the North connection, where a 1/8 inch wide, 1/4 inch long crack appeared. Figure 5.194 and Figure 5.195 show net section cracking on the brace South wall at the South and North connections, respectively.

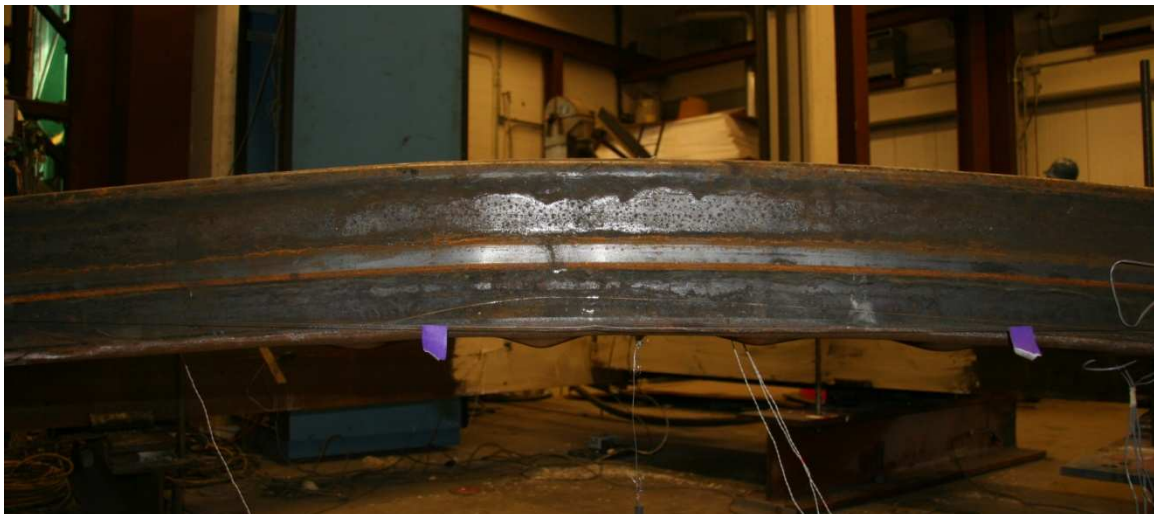
Figure 5.196 Bulging of Brace Bottom Flange

Two new bulges emerged on the bottom flange of the brace at the compressive peak of cycle 21 (-1.07% drift). They were located 12 inches SW and 21 inches NE of the brace center. Additionally, the side walls

of the brace were cupped inward slightly at the locations of each of the bottom flange bulges. The side wall deformations were less than 25% of the bottom flange deformations. The brace mid-span deflection reached 7.9 inches moving the brace into moderate buckling, B2. Figure 5.196 shows the bottom flange bulges, Figure 5.197 shows the side wall cupping, and Figure 5.198 shows global brace buckling. As the buckling of the brace progressed, the compressive resistance of the frame decreased slowly, as shown in Figure 5.174. This indicates higher post-buckling strength than NCBF1, as expected for the concrete fill. The brace did retain less compressive capacity than the compact braces on a percentage basis, but it achieved higher maximum load.

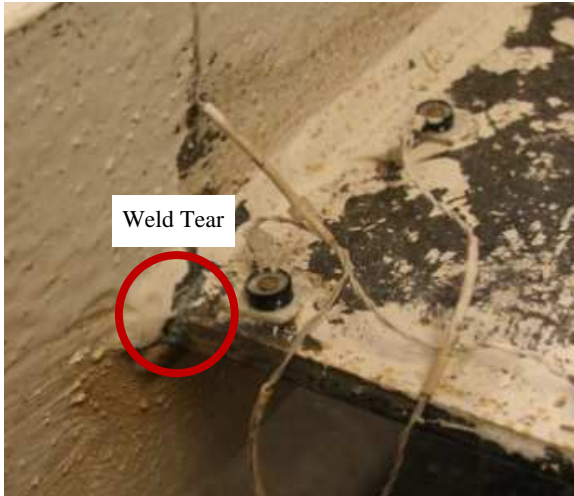
Figure 5.199 W1 in North Gusset-to-Beam  
Weld

Also at the compressive peak of cycle 21, a weld crack initiated at the West end of the North gusset-to-beam weld that was  $\frac{3}{8}$  of an inch in length, categorized as W1. Figure 5.199 shows the weld crack, which grew to 1 inch in length at the compressive peak of cycle 22, the second cycle at this displacement level (-1.12% drift). The crack was caused by rotational demands from the gusset plate, shown for the South Gusset plate in Figure 5.200. Yielding throughout both gusset plates and shear tabs increased at the tensile peak of cycle 21 (+1.03% drift). The North shear tab and South gusset plate progressed to performance state Y3. Figure 5.201 and Figure 5.202 show the yielding in the North and South connections, respectively.

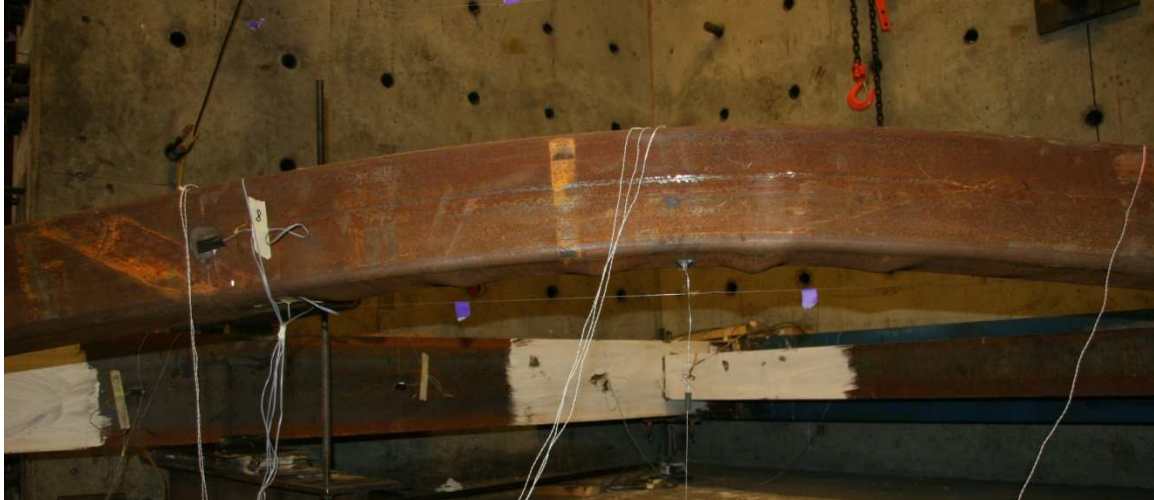
Figure 5.203 Bulges in Brace Bottom Flange

At the compressive peak of cycle 23 (-1.55% drift), a sixth bulge appeared in the bottom flange of the brace, 19 inches Southwest of the brace center. At this point, the heights of the six bulges, from Northernmost to Southernmost were: 3/8 in, 7/16 in, 9/16 in, 7/8 in, 5/8 in, 3/16 in, shown in Figure 5.203. Figure 5.204 shows the corresponding inward cupping of the North wall of the brace.

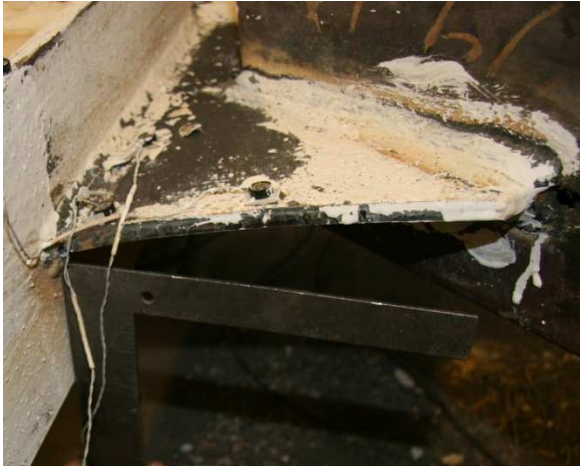
Figure 5.206 North Gusset Plate Bending

5.205. At the location of the weld crack, the gusset plate was curled downward substantially, as shown in Figure 5.206. New frame damage was observed in the West column, South end, West flange, where vertical yield lines were scattered along the depth of the South connection. This is shown in Figure 5.207.

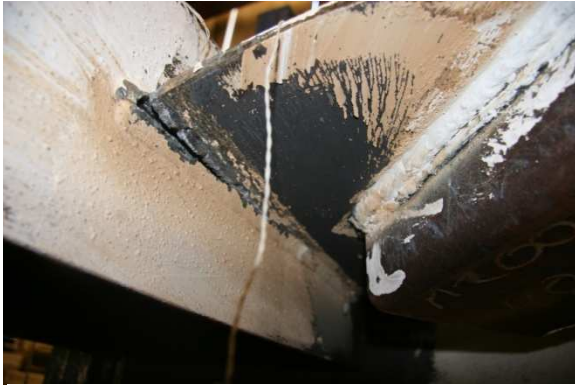
Figure 5.208 North Gusset-to-Beam Weld - W3

At the compressive peak of cycle 24, the second cycle at this displacement level (-1.57% drift), the weld crack in the North gusset-to-beam weld increased to 6.5 inches in length, entering performance state W3. The end of the North gusset-to-beam weld was dislocated vertically out of the weld seat at the west end. This is shown in Figure 5.208. A new hairline weld crack appeared in the South gusset-to-beam weld at the East end. It was less than 1/2 an inch in length. This is shown in Figure 5.209.

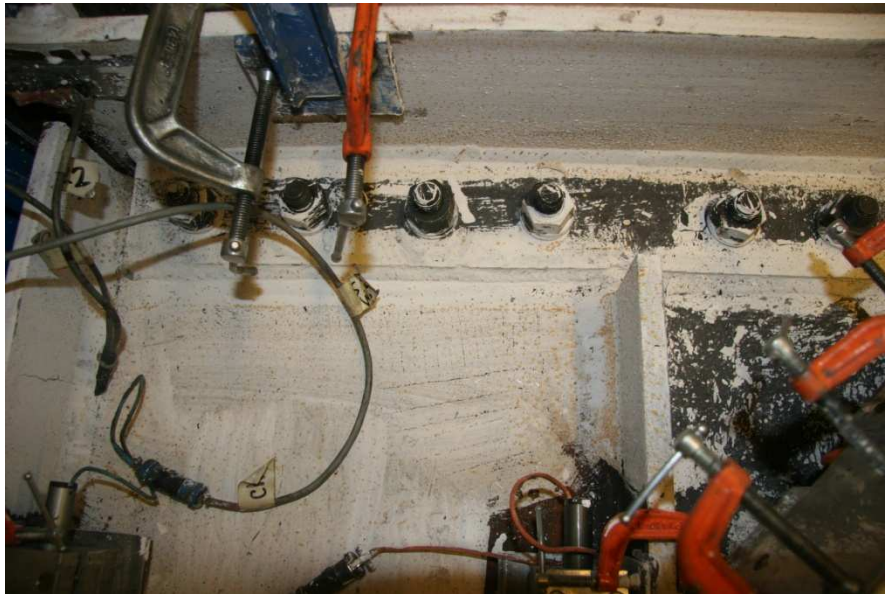
Figure 5.210 North Beam Web at South Connection - Y1

At the tensile peak of cycle 25 (+1.18% drift), diagonal yield lines appeared near the South shear tab in the South beam web, shown in Figure 5.210. Yielding in the connections increased slightly.

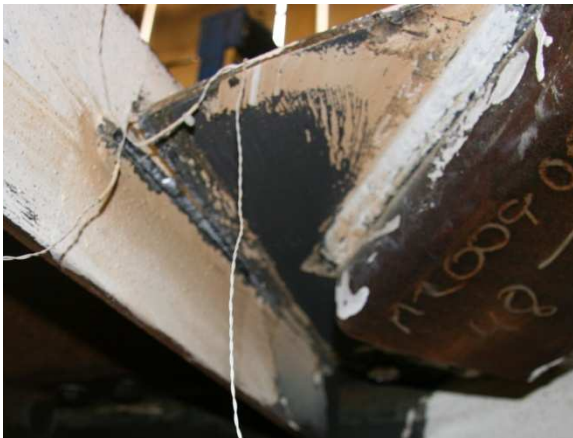
Figure 5.211 WF in North Gusset-to-Beam  
Weld

While loading to the compressive peak of cycle 25 (-1.77% drift), the North gusset-to-beam weld fractured completely. The test was paused momentarily, before loading continued to the peak displacement. The weld fracture is shown in Figure 5.211. This fracture corresponded to a substantial loss of tensile lateral load resistance in subsequent cycles, as shown in Figure 5.174. The fracture of this weld

is unsurprising, as it had a high DCR and fractured in previous tests with substantial out-of-plane brace buckling.

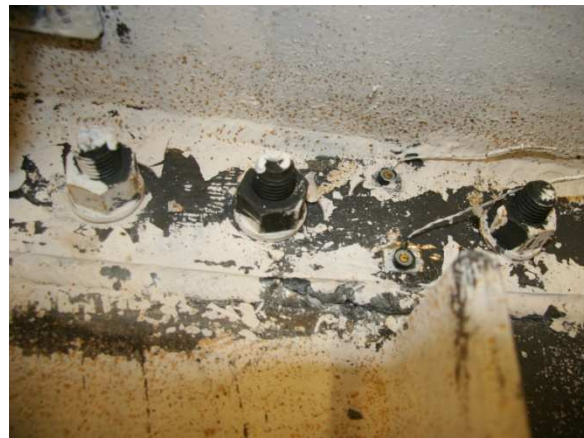
Figure 5.212 Weld Crack W-NBS - W2

A new weld crack formed, propagating out of the termination of the North gusset-to-beam fracture. The crack, in W-NBT, was 2 inches in length, putting the weld immediately into performance state W2. This crack is shown in Figure 5.212. Both gusset plates were bent in a slight S-shape along their edge due to the hinging of the gusset at the edge of the shear tab. Figure 5.213 shows the deflected shape of the North edge of the South gusset. Yielding in the West flange of the West column at the South end increased, transitioning to performance state Y2. This is shown in Figure 5.214. Brace cupping also formed at the largest of the bulges in the brace, 3 inches SW of the brace midpoint. Figure 5.215 and Figure 5.216 show the brace cupping and brace deflected shape, respectively. The local deformations of the brace center are not characteristic of the typical cupped shape for an HSS, in which the bottom flange of the brace deforms inward. However, the implications of the large local deformations are the same here as they are for the typical case, so the same terminology is used.
