Evaluation and Retrofit of Non-Capacity Designed Braced Frames

A thesis

Master of Science in Civil Engineering

University of Washington

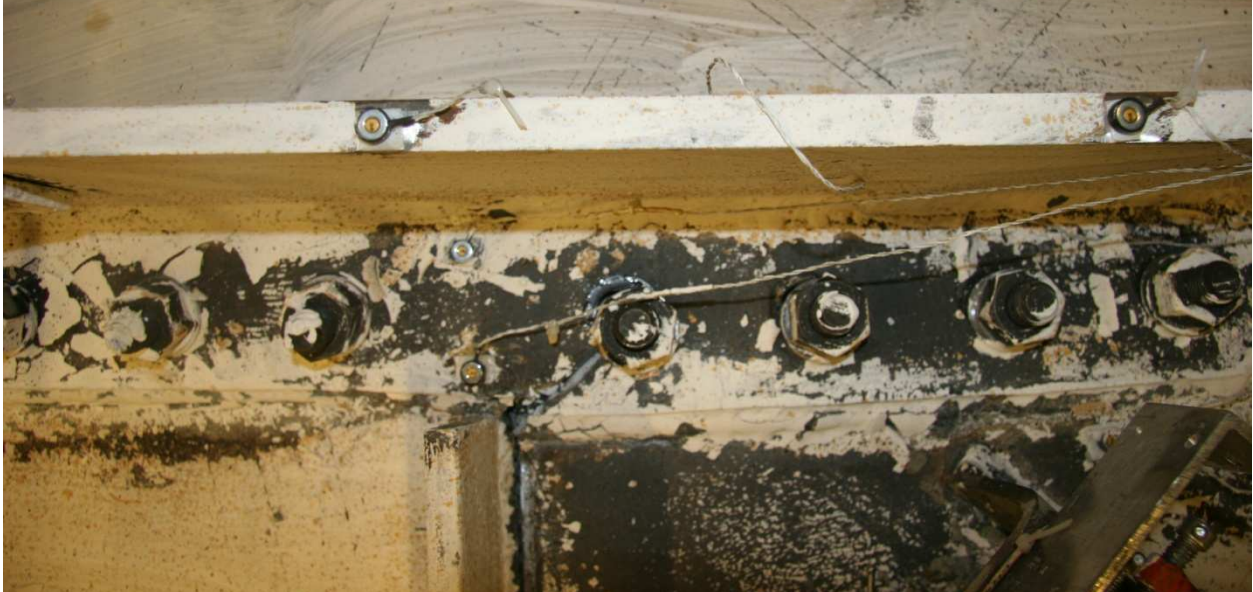
Figure 5.217 North Shear Tab - MT,BTE

At the tensile peak of cycle 26, the second cycle at this displacement level (+1.18% drift), a tear developed in North shear tab, propagating from the fractured North gusset-to-beam weld diagonally into the Northernmost bolt hole in the gusset plate. Additionally, bolt hole elongation was visible in the two Northern bolts of connecting the gusset plate to the shear tab. The bolt hole elongation and metal tearing, performance states BTE and MT, are shown in Figure 5.217.

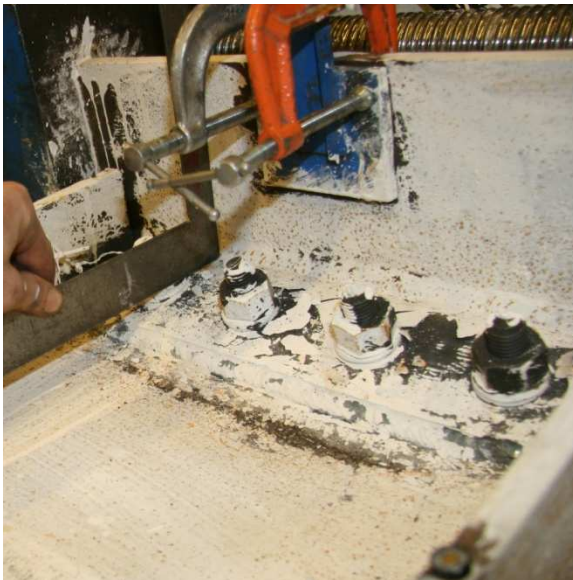
Figure 5.218 Bending of North Shear Tab

The portion of the North shear tab connected to the beam was bent downward substantially along the depth of the beam. The North beam web was bent upward significantly at the shear tab due to the clamping effect of the bolts. This local deformation caused yielding in the web, characterized as performance state Y2. Figure 5.218 shows the downward bending of the North shear tab and the yielding of the North beam web. Figure 5.219 shows the upward bending of the beam web on the underside.

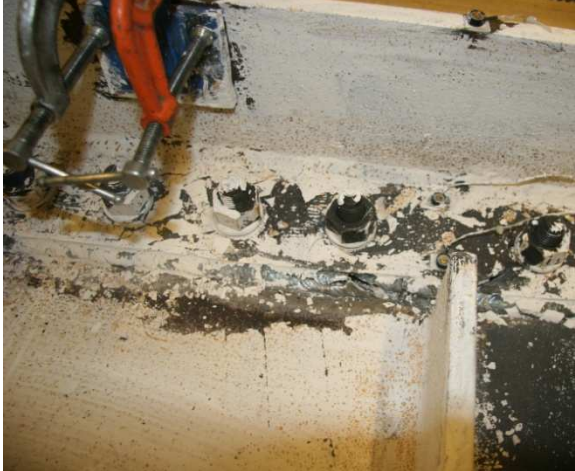
Figure 5.220 W3 in North Beam-to-Shear Tab  
Weld

At the compressive peak of cycle 26 (-1.80% drift), the crack in North beam-to-shear tab weld grew to 4.5 inches in length, becoming a severe weld crack, performance state W3. Figure 5.220 shows the crack.

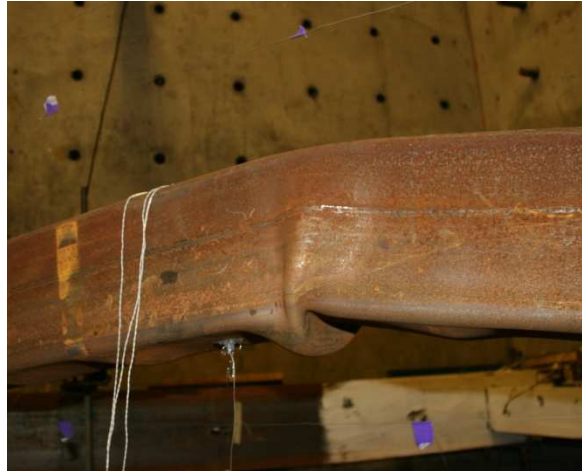
Figure 5.221 Increased Brace Cupping

Additionally, the hinge at the brace center intensified slightly, shown in Figure 5.221.

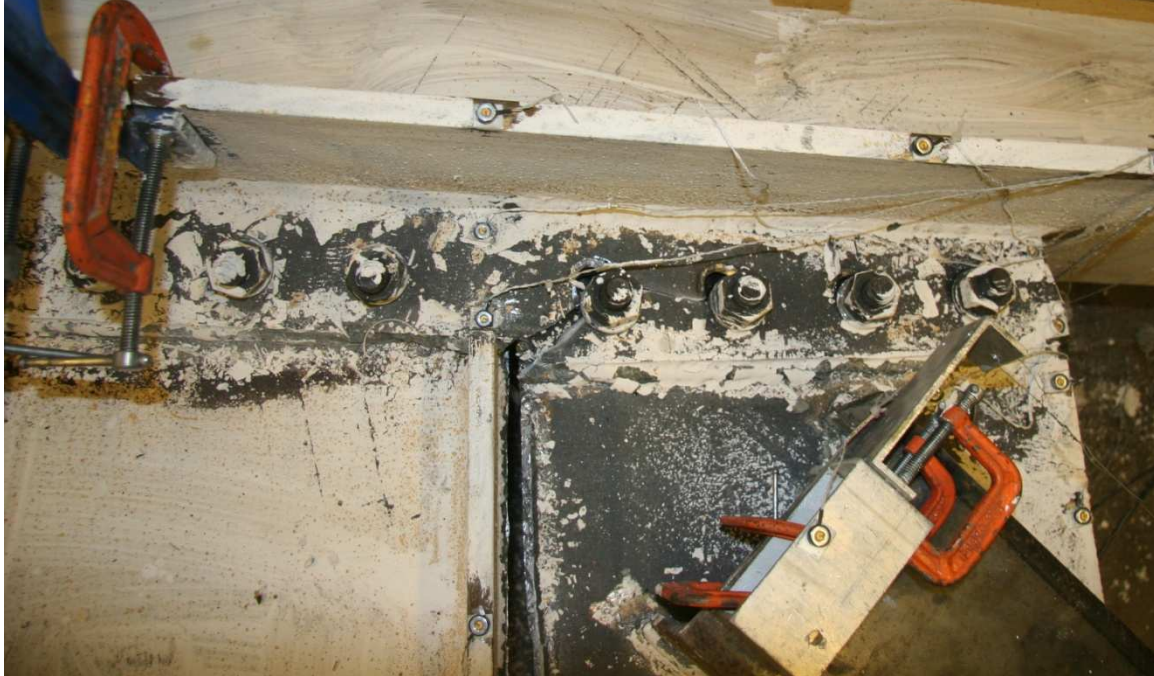
Figure 5.223 North Shear Tab - BE,MT

At the tensile peak of cycle 27 (+1.35% drift), tearing was observed on the bottom corners of the brace at the hinge location. Exposed, crushed concrete was visible through the two diagonal tears. Figure 5.222 shows the tearing. The tear in the North shear tab propagated South to the next bolt hole in the gusset plate. Bolt hole elongation was now visible in the second to Southernmost bolt in the shear tab. Figure 5.223 shows the damage to the shear tab. The increased damage in the brace and connection corresponded to a gradual loss of lateral load resistance in both compression and tension, as shown in Figure 5.174.

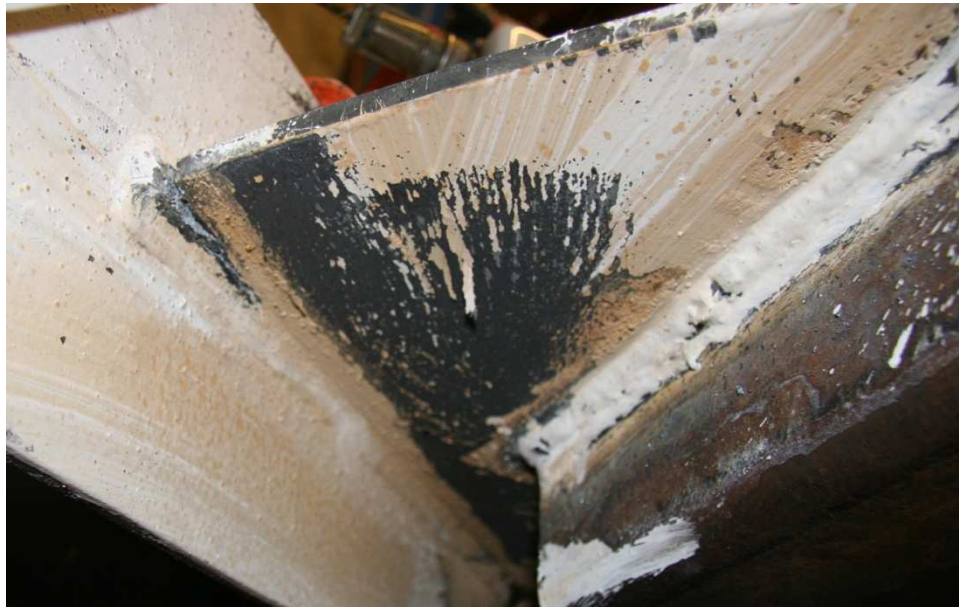
Figure 5.224 W2 in South Gusset-to-Beam Weld

At the compressive peak of cycle 27 (-2.13% drift), the weld tear in the South gusset-to-beam weld increased to 2 inches in length, entering performance state W2. The weld tear is shown in Figure 5.224.

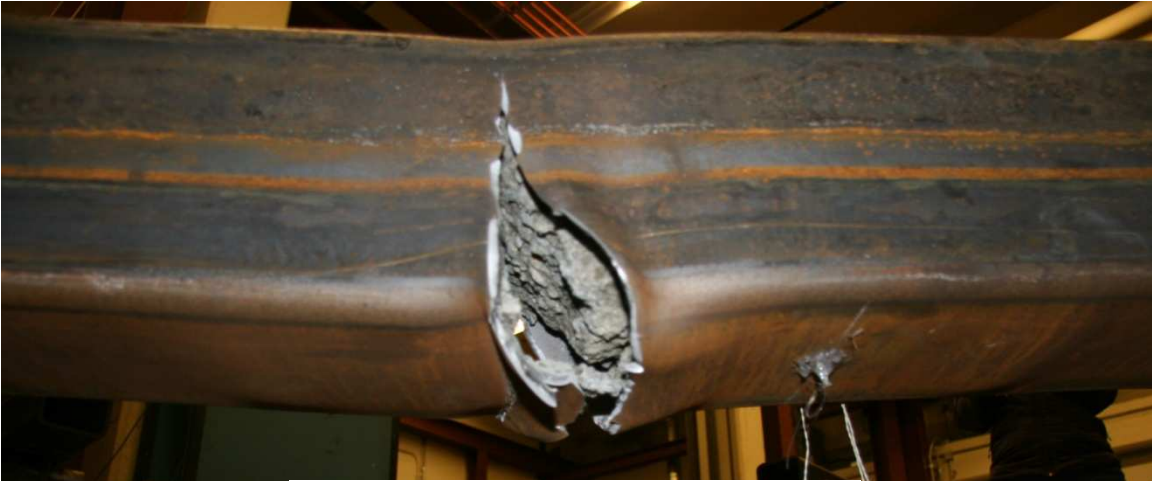
Figure 5.225 Tearing of Brace

At the tensile peak of cycle 28, the second cycle at this displacement level (+1.35% drift), the bottom flange of the brace tore completely, as did the majority of both the North and South wall of the brace.

Figure 5.225 shows the damage at the hinge location. The tearing of the brace caused the brace to deflect downward, due to the movement of the neutral axis. As a result, the South gusset plate underwent a significant increase in bending on both edges. Figure 5.226 and Figure 5.227 show the bending of the plate. Yielding appeared in the West column, South end, in the East flange and web, as shown in Figure 5.228 and Figure 5.229, respectively.

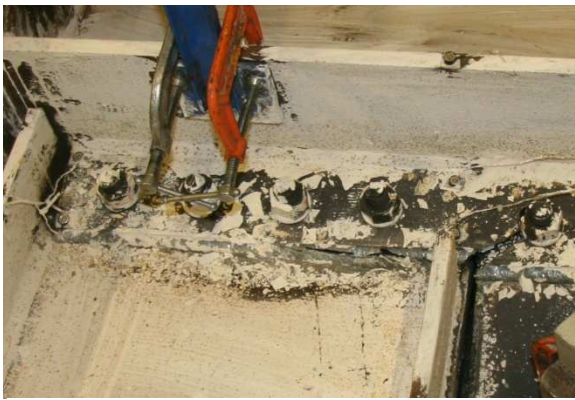
Figure 5.230 Tearing of North Beam-to-Shear  
Tab Weld

At the compressive peak of cycle 28 (-2.18% drift), the brace buckled upward, despite the downward deflection at the tension peak. The weld tears in the North beam-to-shear tab and South gusset-to-beam welds both increased slightly in length, but did not enter new performance states, as shown in Figure 5.230 and Figure 5.231, respectively.

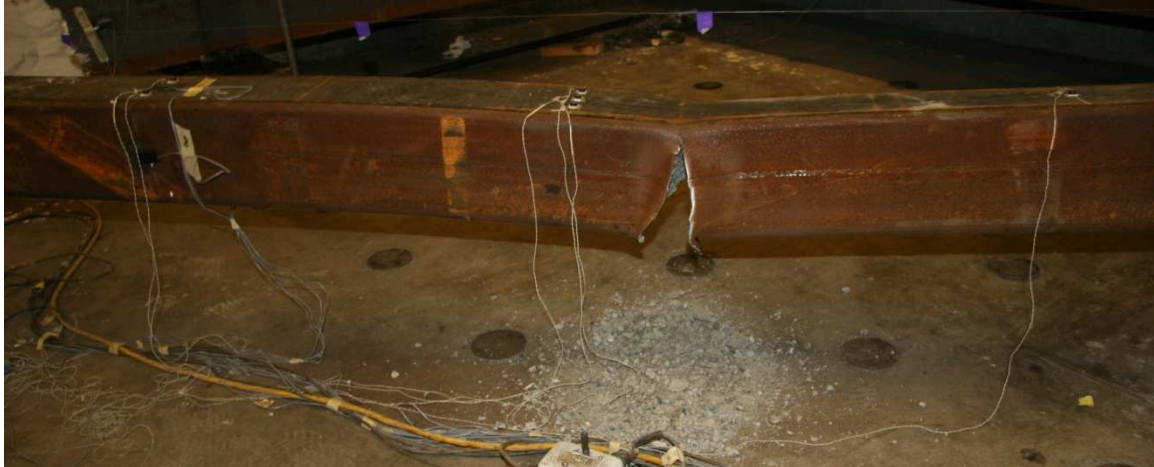
Figure 5.232 Tearing of Brace

At the tensile peak of cycle 29 (+1.59% drift), the brace tearing increased, propagating to the top of both side walls. This is shown in Figure 5.232. The brace downward deflection increased slightly, shown in Figure 5.233.

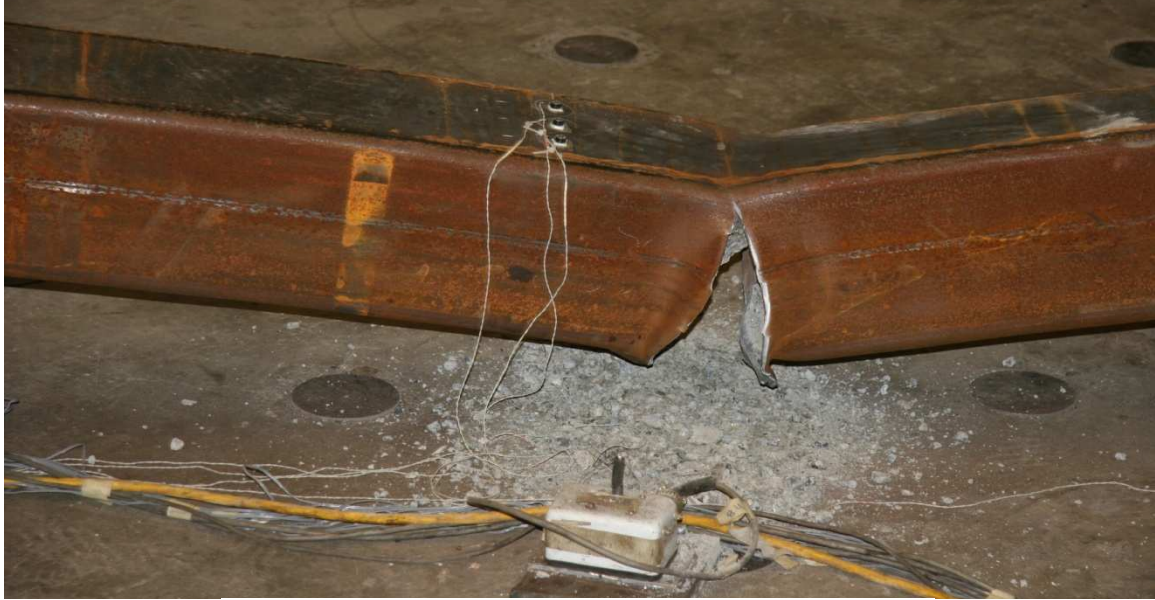
Figure 5.234 Maximum Downward Brace Deflection

The test was paused before reaching the compressive peak of cycle 29 because the brace buckled downward toward the floor. Figure 5.234 shows the brace when the cycle was stopped. Because loading in compression was no longer possible, the specimen was loaded in the tensile direction until brace fracture occurred at +2.09% drift. The fractured brace is shown in Figure 5.235. The only other notable damage increase was the propagation of the tear in the North shear tab, which continued to halfway between the two center bolts of the gusset plate, as shown in Figure 5.236.

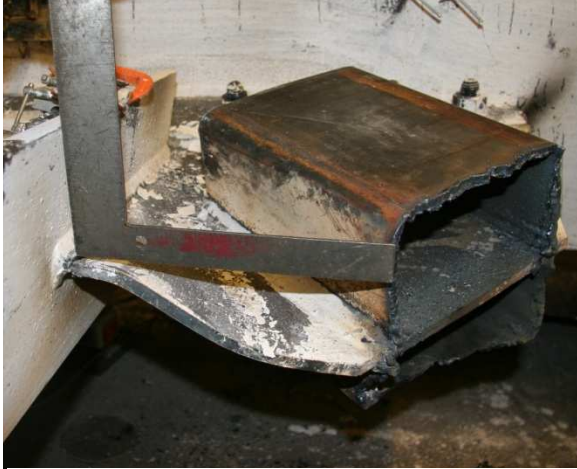
Figure 5.238 Buckling of South Gusset Plate

No notable increases in damage occurred until the maximum displacement levels from the main test cycles were reached. At 5.15% total drift range, new significant new damage became visible. At positive drift, the South gusset plate and North flange of the South beam buckled downward. Figure 5.238 shows the gusset plate, and Figure 5.239 shows the beam. At negative drift, a W1 weld crack formed in the South beam-to-shear tab weld at the North end, shown in Figure 5.240. Additionally, a new weld crack formed at the North end of the North beam-to-shear tab weld, shown in Figure 5.241. The tear in the South gusset-to-beam weld also extended to 4.5 inches in length, moving to performance state W3. This is shown in Figure 5.242.

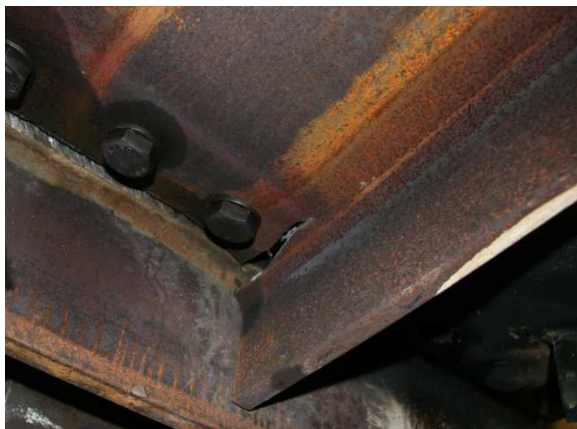
Figure 5.243 Tear in North Beam Web - MT

At the tensile peak of the 5.64% total drift range cycle, metal tearing was observed in both beams at the shear tabs. The North beam had a 3 inch tear along the Southernmost bolt, shown in Figure 5.243, and the South beam had a 3 inch tear along the Northernmost bolt, shown in Figure 5.244. Weld cracking in the North beam-to-shear tab weld also increased slightly.

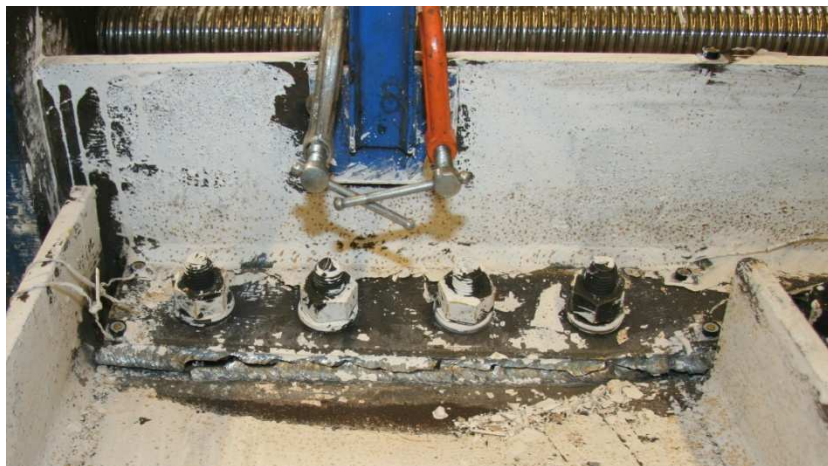
Figure 5.247 Fracture of North Beam-to-Shear Tab Weld

At the tensile peak of 6.27% total drift range, the North beam-to-shear tab weld completely fractured, leaving only the bolts connecting the beam to the column. This is shown in Figure 5.247. Over subsequent cycles, no major changes in damage occurred. Slight increases in framing member yielding and weld tearing were observed. The test was concluded after a cycle at 6.85% total drift.

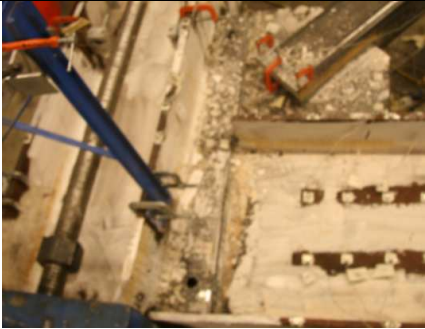
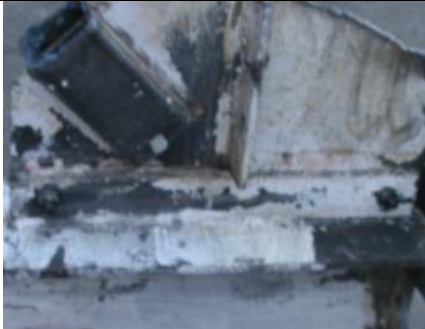
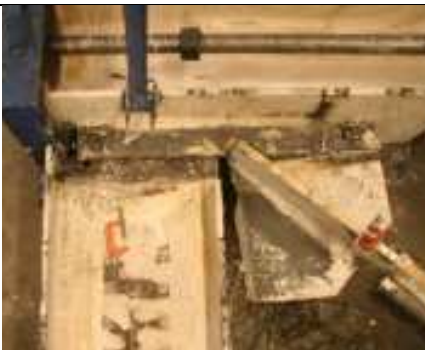
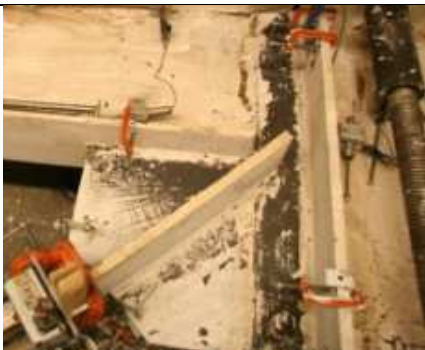
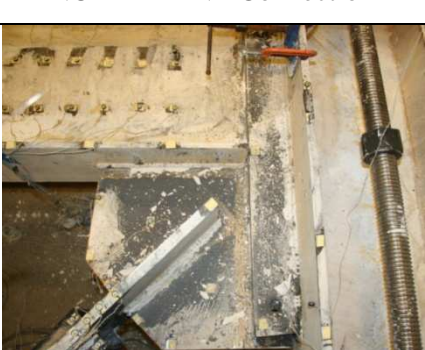
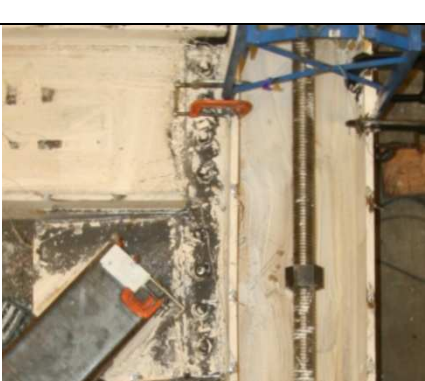
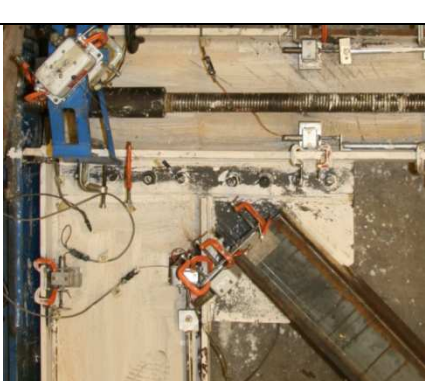
Figure 6.23 NCBF Connection Yielding

The gusset plates used in NCBF1 and its retrofits had substantial deficiencies relative to the brace strength, as summarized in Table 6.2. As a result of these deficiencies, yielding and deformation in the gusset plate was typically extensive, as shown in Figure 6.23. Although yielding of the gusset plate was substantial, it did not appear to have a significant adverse impact on the performance of the specimens tested. Yielding of the gusset plate is a ductile limit state, and can actually contribute to the overall ductility of the system by providing an additional yielding mechanism. However, a more severe deficiency in gusset plate strength could lead to a gusset plate failure, so the gusset plate strength is still

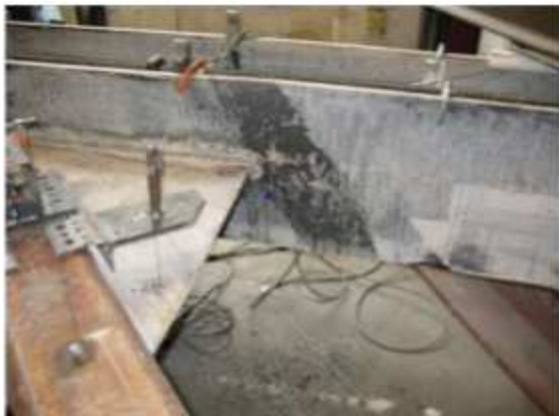
Figure 6.27 Column Flange Yielding (Powell 2010)

The location of large deformations will typically also be the location of the most substantial damage. SCBF tests conducted at the University of Washington have demonstrated that SCBF connections can experience relatively comparable amounts of yielding in the gusset plate and the framing members (Powell 2010). Figure 6.27 and Figure 6.28 show yielding in the column and gusset plate, respectively, in an SCBF connection.

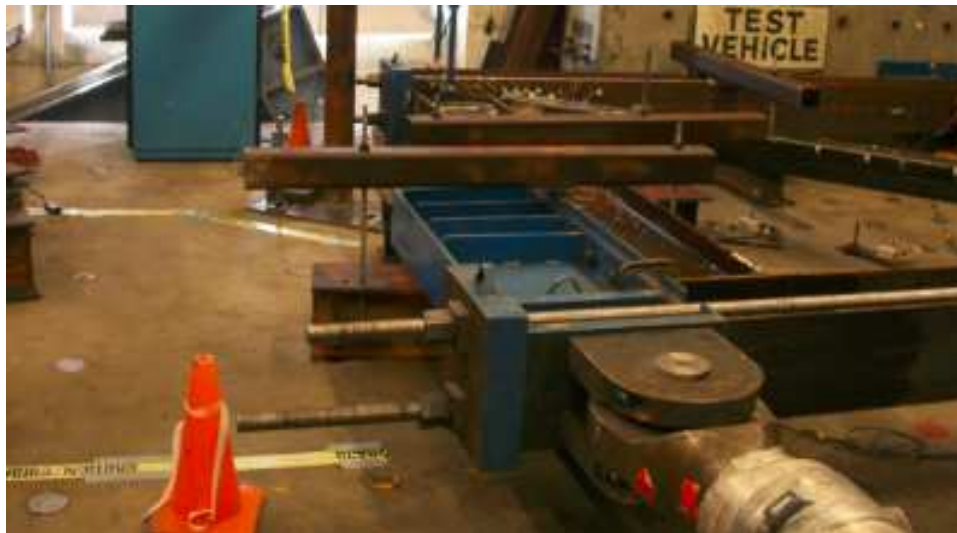
Figure C.3: Load Beam

The eccentricity between the line of action of the actuator force and the center of the beam depth causes a moment to develop in the load beam. This moment results in a compressive force at the leading edge of the load beam where it contacts the flange of the North beam of the specimen. This compressive force causes local buckling of the web and beam of the specimen. Because this damage is a result of the loading conditions and not reflective of performance of a real system, a web double plate is provided for the beam to reduce the severity of this damage.

The positioning of the load beam is intended to be reflective of loading conditions in a structure, where lateral load typically enters the frame through a shear connection between the floor slab and the beam. Providing a full-length shear connection would increase the stiffness of the beam by an unacceptable margin, so load is instead applied over only 40% of the length.

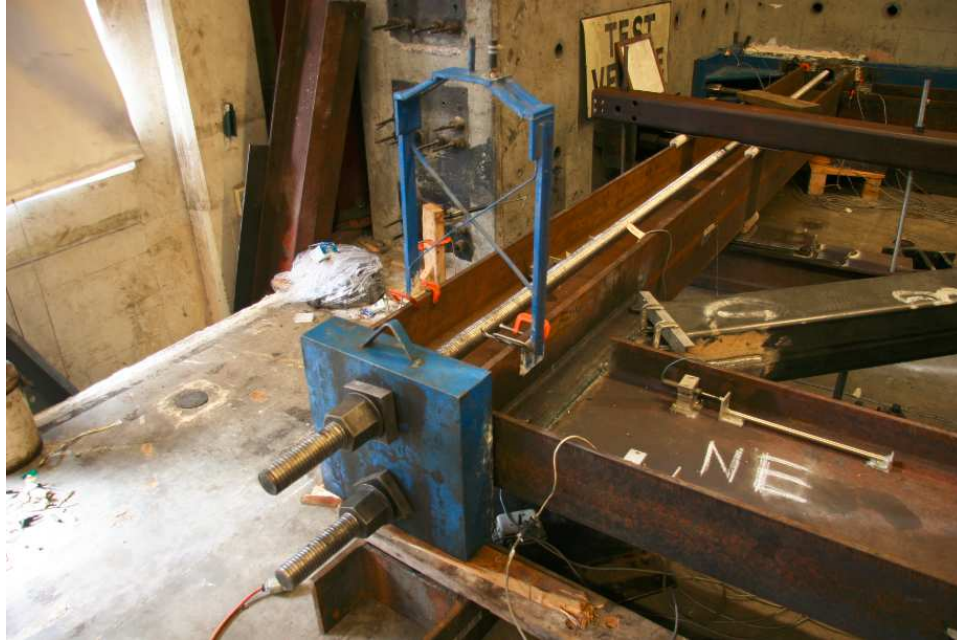
Figure C.4: East Column Cap Plate and Axial Load Rods

Axial load was applied to each of the columns to simulate gravity loads from the structure. Two 1 3/4 inch diameter Williams rods were tensioned in each column, with one on each side of the web. Each rod was tensioned to 225 kips, providing an axial load of 450 kips to each column. The axial load was applied using a short-stroke hydraulic ram. 4 inch thick cap plates provided a bearing surface for the nuts on the rods to transfer the axial load to the column. At the column bases, the rods pass through HSS4x4x1/2 tubes welded to the channel reaction assembly. The ends of the rods were fastened with Williams spherical hex nuts and dish plates. The interface surface between the nuts and plates was cated with machine grease. This system allowed the rods to rotate freely at the ends, preventing bending moments from developing when lateral drift was applied to the frame.

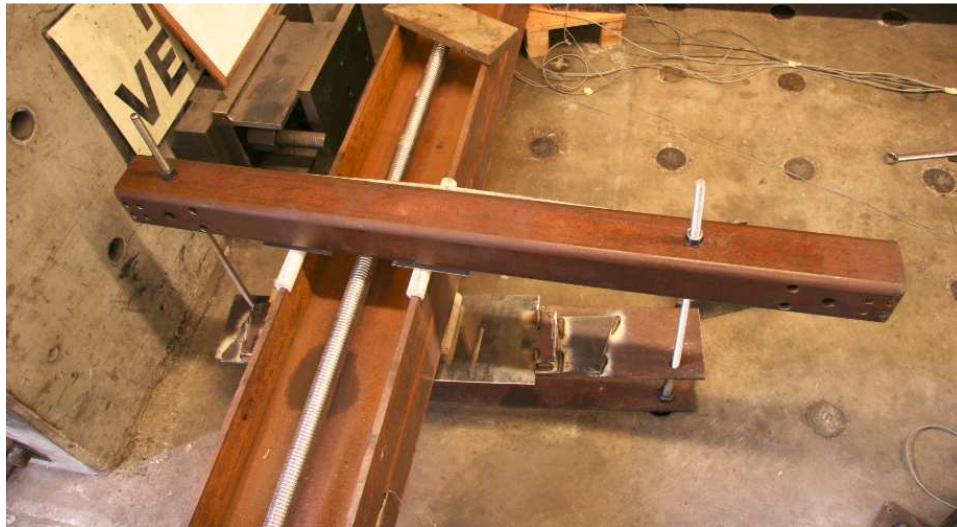
Figure C.6: Out-of-Plane Restraint for East Column

restraints used, and figure 4.3.6.5 shows a schematic of the out of plane restraints. Two restraints were applied on the North beam of the specimen along its length. These simulate the restraint that would be imposed by the floor slab in a structure. One restraint was applied to each column at mid-height. These simulate the fixity of columns coming from beams in both orthogonal directions, as well as continuity with columns in floors above and below. The layout of the testing area did not permit the restraint of the corners of the frame, so the columns are braced at mid-height as an approximation. The North Beam was braced at 2 points along its length, simulating the lateral restraint provided by a floor slab in a typical structure. The South Beam was effectively restrained by the bolts fastening it to the reaction assembly.

The base of the OOPs were wide flange sections, which were tensioned to the strong floor with 1 inch diameter threaded rods. The top of the restraints were HSS5x5x3/8. Which were tensioned with  $\frac{3}{4}$ " threaded rods to the wide flange restraints. Sliding interface was created by affixing slotted nylon rods to the flanges of the beams and columns, which slid on greased stainless steel plates attached to the restraints. This created a low-friction interface, minimizing restraint to in-plane movement.
