**Impact of Connection Type on Performance of
Non-Seismic Concentrically Braced Frames**

Master of Science in Civil Engineering

University of Washington

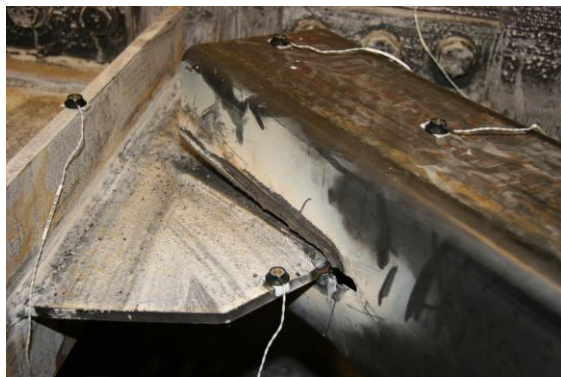
(2) Brace Splice Weld Fracture

1. Brace begins to buckle out-of-plane
2. Brace splice weld fractures.
3. Bolted angles connecting gusset plate and column fracture.

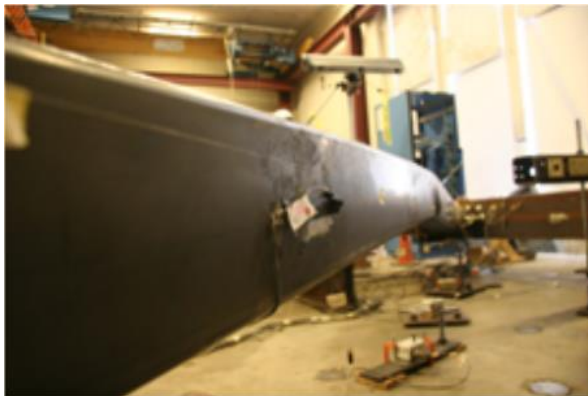
(2) Brace Hinging

1. Brace begins to buckle out-of-plane.
2. Brace begins hinging at mid-span.
3. Brace fractures.

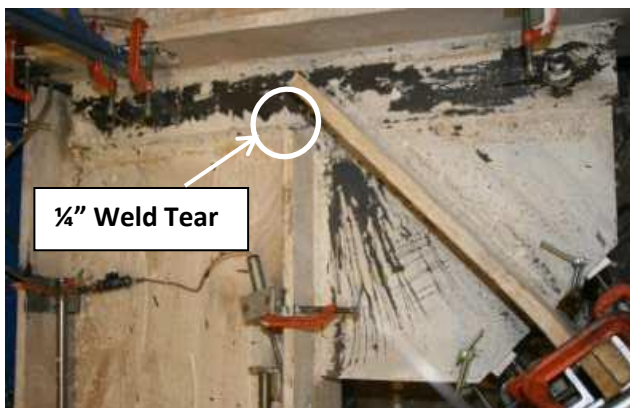
(3) Weld Crack Initiation

1. Brace buckles in-plane.
2. Initial weld (<1/4") tearing in shear plate weld at end of knife plate.
3. Moderate weld tearing (4") in shear plate weld at end of knife plate.
4. Initial weld tearing (6") in beam-to-gusset plate
5. **Beam-to-gusset plate weld fracture.**
6. **Shear plate weld fracture**

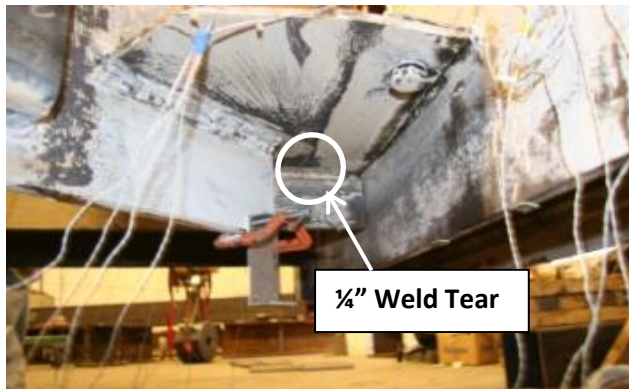
(2) Initial Weld Tearing

1. Brace begins to buckle in-plane.
2. Initial weld tearing at intersection of shear plate and gusset plate welds.
3. Shear plate weld fractures.

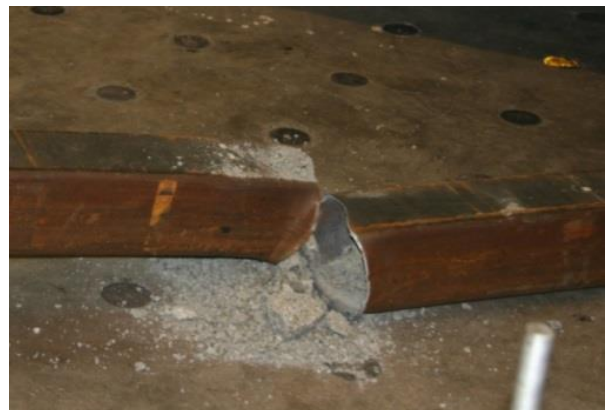
(6) Brace Fracture

1. Brace begins to buckle out-of-plane.
2. Initial weld tearing at edge of beam-to-gusset plate weld.
3. **Beam-to-gusset plate weld fractures.** Brace begins to hinge near mid-span.
4. Metal tearing in shear plate.
5. Brace tearing.
6. **Brace fracture.**

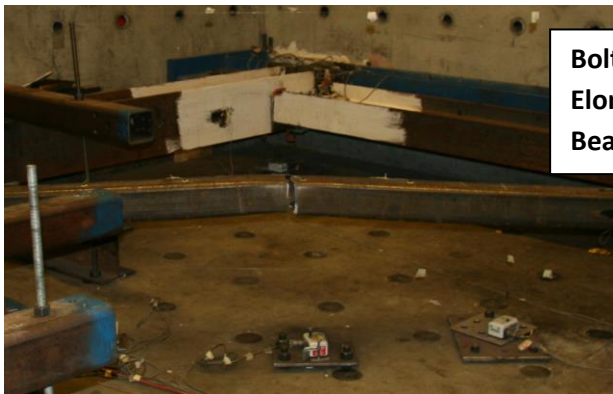
(5) Brace Fracture

1. Brace begins to buckle out-of-plane.
2. Initial weld tearing at edge of beam-to-gusset plate weld.
3. Brace begins to hinge at mid-span.
4. Brace begins tearing at hinge location.
5. **Brace fractures.**

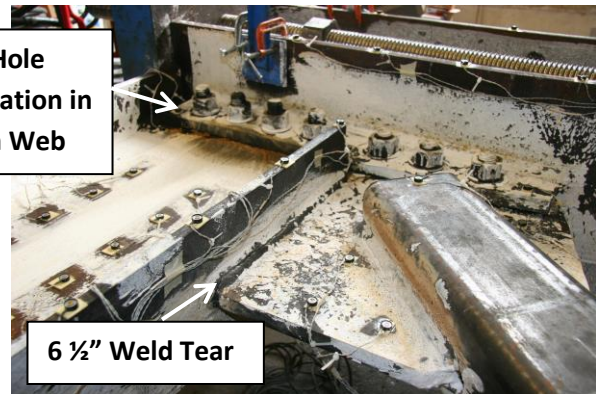
(5) NE Connection Damage at End of Test

Bolt Hole Elongation in Beam Web

6 1/2" Weld Tear

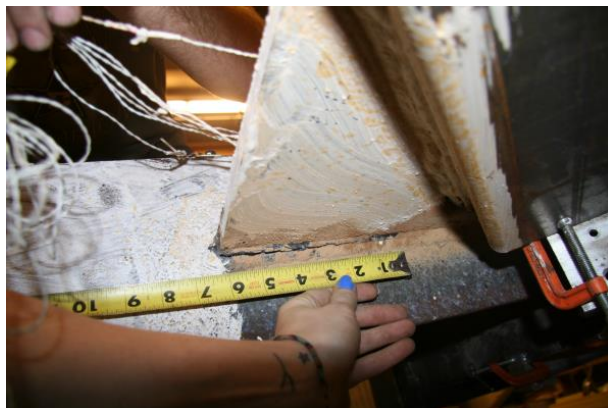
(2) Initial Weld Tear in Beam-to-Gusset Plate Weld

1. Brace begins to buckle out-of-plane.
2. Initial weld tearing at edge of beam-to-gusset plate weld.
3. **Beam-to-gusset plate weld fractures.**
4. **Bolt rupture in gusset plate-to-shear plate.**

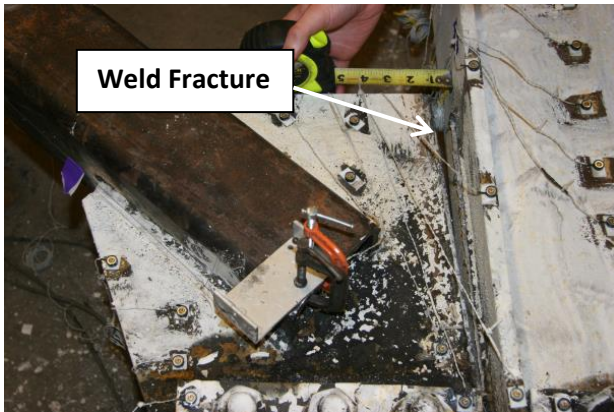
(2) Beam-to-Gusset Plate Weld Fracture

1. Brace begins to buckle out-of-plane
2. Initial weld tearing at edge of beam-to-gusset plate weld.
3. **Beam-to-gusset plate weld fractures**
4. Brace begins hinging at mid-span
5. **Bolt ruptures in gusset plate-to-shear plate.**

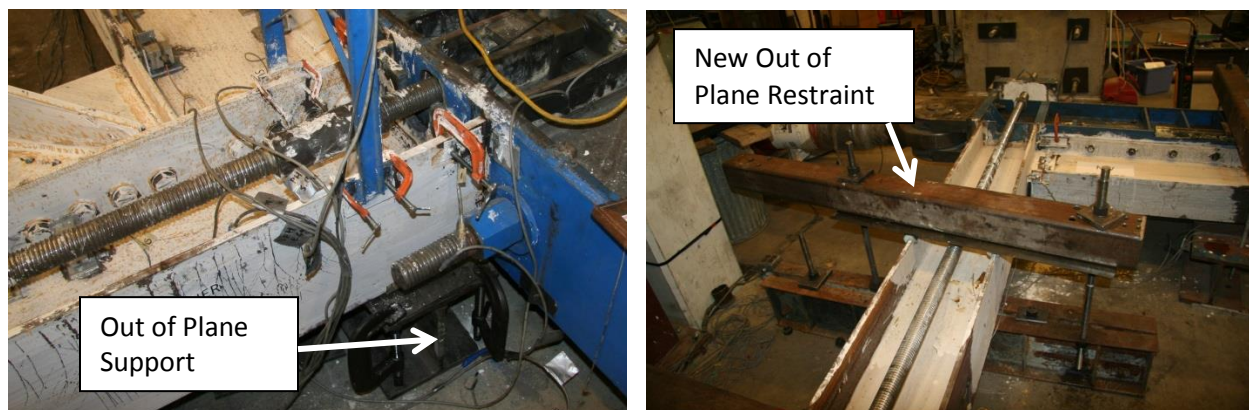
Figure 4-3: New Out-of-Plane Supports

During the testing of Specimen NCBF4-R2 two additional temporary out-of-plane restraints were installed on either end of the west column to realign the frame and correct actuator out-of-plane movement. The out-of-plane restraint on the north side of the west column had the same detail as the existing out-of-plane restraints (Powell 2009). The out-of-plane support on the south end of the west column prevented the out-of-plane displacement of the column towards the strong floor. The two temporary out-of-plane supports are shown in Figure 4-3.

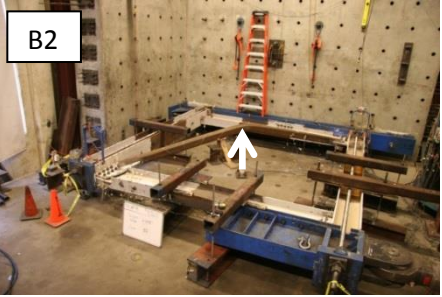
B1	Initial Global Buckling	Brace mid-span deflection is visible but less than two times the brace depth.
	B2	Moderate Global Buckling	Brace mid-span deflection exceeds two times the brace depth.

The brace out-of-plane deformation was measured using the Optotrak data (as described in 4.5.3). This measurement was used to distinguish between the B1 and B2 performance states.

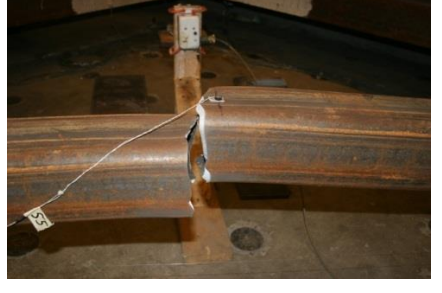
B4-BF	Brace Fracture	Brace fractures through entire section.

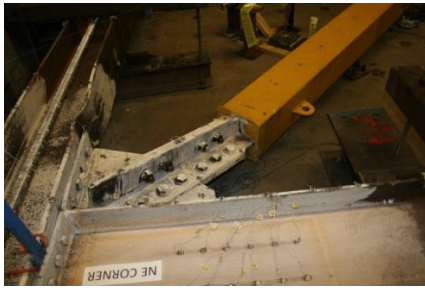
B4-BH	Out-of-plane hinging	Unstable plastic hinge develops at the edge of BRB casing.

Inelastic deformation of the core plate was measured using the relative displacement of the steel core plate and the edge of the BRB casing at each brace end. Since different levels of elongation were recorded for compression and tension cycles, the performance state thresholds were compared with the average elongation from successive tension and compression cycles.

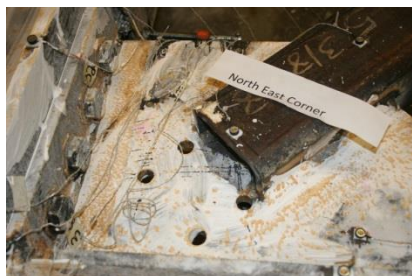
Y1	Initial Yielding	First visible yield lines observed on connection element.

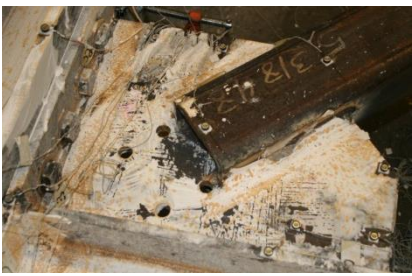
Y2	Moderate Yielding	Whitewash is flaked off on >20% and <50% of planer area of connection element.

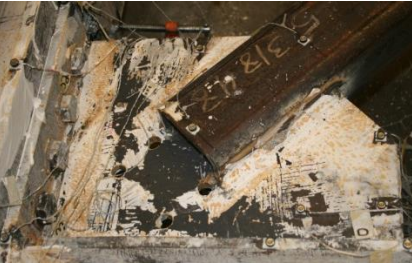
Y3	Severe Yielding	Whitewash is flaked off on >50% of planer area of connection element.

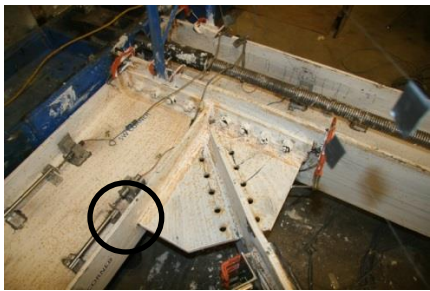
W1	Initial Weld Tearing	First visible weld cracks are observed.

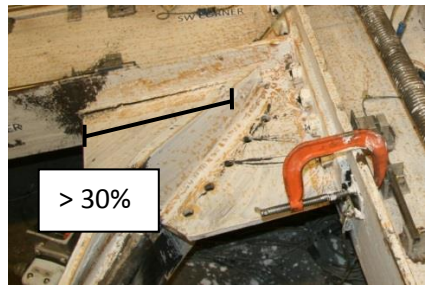
W3	Severe Weld Tearing	Weld tear exceeds 30% of weld length.

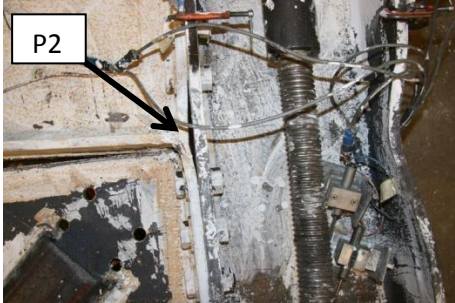
P1	Initial Prying	End plate and column begin separating at location between bolts
	P2	Moderate Prying	Separation exceeds half the end plate thickness.
	P3	Severe Prying	Separation exceeds the end plate thickness.

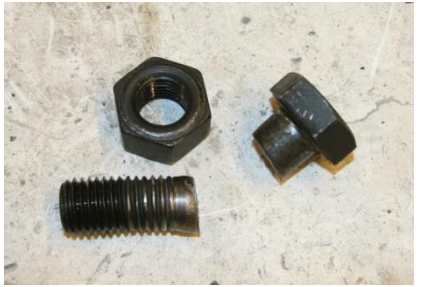
Bo4-BF	Bolt Fracture	Complete fracture of bolt occurs.

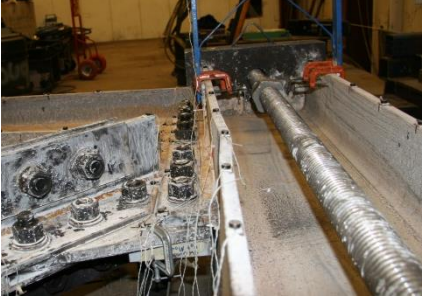
LB1	Initial Local Buckling	OOP local deformation observed in flange and/or web.

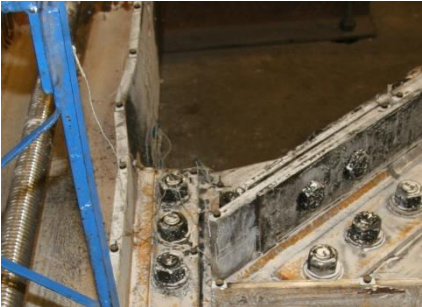
LB2	Moderate Local Buckling	OOP local deformation exceeds element thickness.

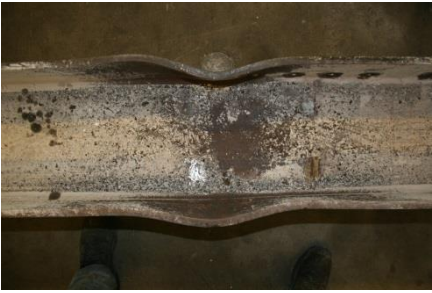
LB3	Severe Local Buckling	OOP local deformation exceeds two times the element thickness.

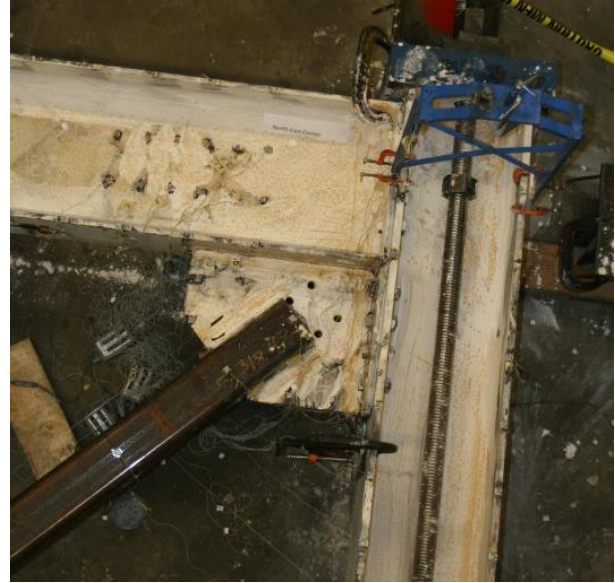
b. NE Connection

Figure 5-4: Specimen NCBF4-R1 Photos Prior to Testing

Specimen NCBF4-R1, as shown in Figure 5-3 and Figure 5-4, was designed to be a retrofit of a frame using quadruple angle bracing and bolted end plate connection at the gusset-beam-column connection and is discussed in detail in Section 3.2. The objective of the test was to determine the deformation capacity of a frame with bolted end plate connection representative of the bolted end plate connections identified in the infrastructure review (Section 2.3.1) and to provide a comparison point to other specimens tested by Sloat (2014) and Johnson (2014).

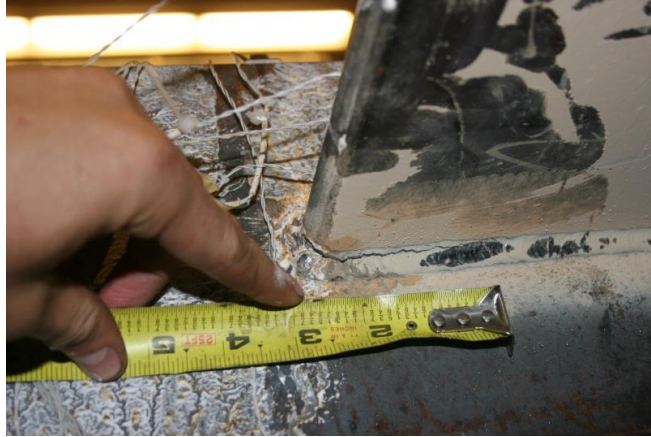
Figure 5-8: Initial Weld Cracking in NE Beam-to-Gusset Plate Weld (PS W1, 1.1 %)

Each successive compression peak after initial buckling of the brace resulted in increasing out-of-plane deformation of the brace. The out-of-plane deformation of the brace resulted in out-of-plane rotation of the gusset plates. At 1.1% drift range, the out-of-plane rotation of the gusset plate caused cracking in the NE beam-gusset plate weld (PS W1, Figure 5-8), and the gusset plates had sustained a moderate level of yielding (PS Y2, Figure 5-9). The weld crack opened to a length of 2-3/4" (16% of the weld length) and was only contained within the bottom fillet weld. Yielding in the gusset plates was spread across the Whitmore section with concentrated yielding occurring between the two existing gusset plate holes.

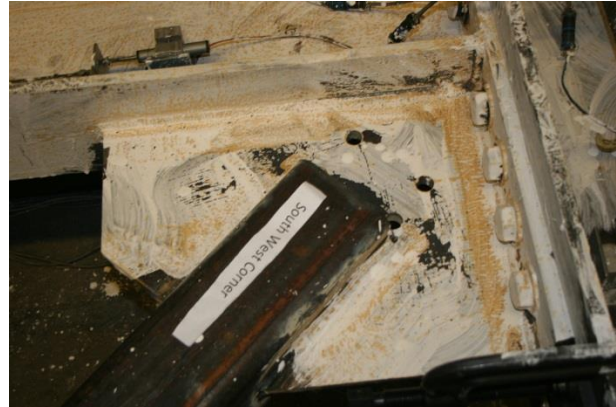
b. SW Corner Gusset Plate Yielding

Figure 5-9: Moderate Yielding in Gusset Plates (PS Y2, 1.1%)

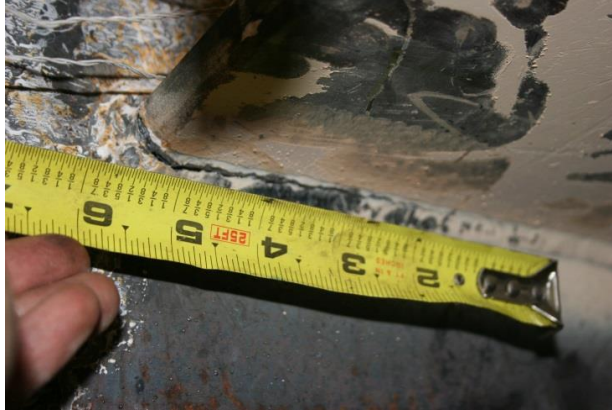
Figure 5-10: Severe Weld Tearing in NE Beam-to-Gusset Plate Weld (PS W3, 1.6%)

By a drift range of 1.6%, the tear in the NE beam-to-gusset plate bottom fillet weld increased to a length of 5 ½" (31%) (PS-W3, Figure 5-10). While loading to the second tension peak at a 1.6% drift range, the weld crack propagated 3" into the top fillet (Figure 5-11); the first time that weld damage had propagated during a tension cycle. Initial frame damage was also observed at a drift range of 1.6%. Initial frame damage included initial yielding along the inside flange of the N beam (PS Y1-IF, Figure 5-12a), initial yielding in the plastic hinge region in the east column (PS Y1-PH, Figure 5-12b), and initial yielding in both end plates (PS Y1, Figure 5-13). Yield lines in the end plate originated from the bolt holes on the interior edge of the gusset plates and were likely in response to prying action induced by the gusset plate.

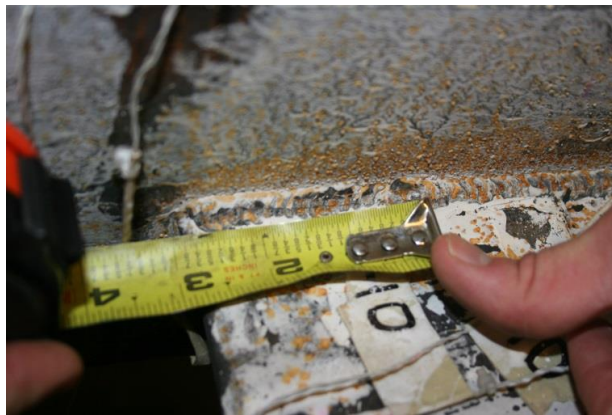
Figure 5-11: Weld Damage in NE Beam-to-Gusset Plate Upper Fillet Weld (1.6%)

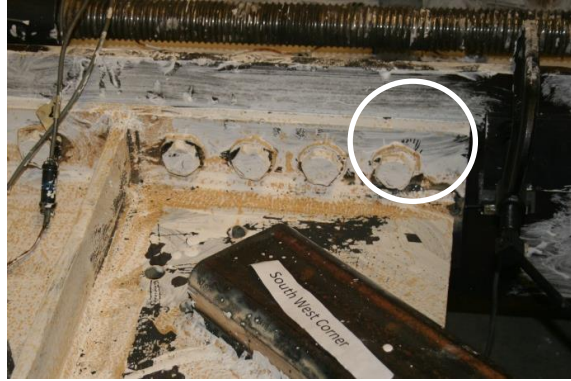
Figure 5-13: Initial Yielding in SW End Plate (PS Y1, 1.6%)

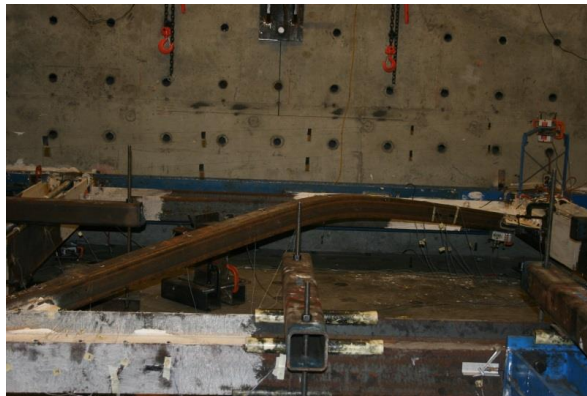
Figure 5-14: Moderate Brace Global Buckling (PS B2, 2.3%)

At a drift range of 2.3%, the brace out-of-plane deformation exceeded twice the brace depth (PS-B2, Figure 5-14). The weld cracking along the NE beam-to-gusset plate weld had propagated to 6 ¼" on the top and 7 ¾" on the bottom. A new tear also was observed in SW beam to GP weld. The weld tear was 2" on the top and 5 ½" on the bottom (PS W3, Figure 5-15). The NE beam-to-gusset plate weld tear continued to propagate in every successive tension and compressive cycles. Weld tear lengths throughout the test are documented in Table 5-11 near the end of this section.

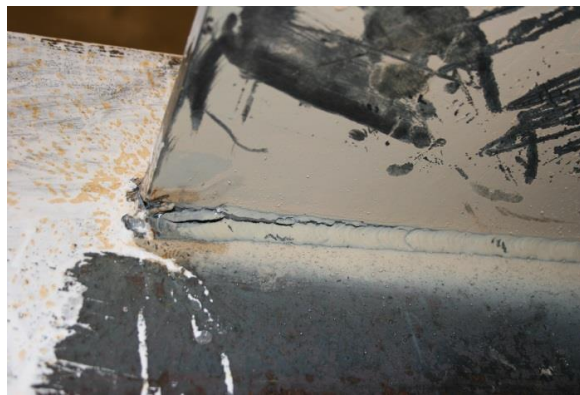
Figure 5-15: Severe Weld Tear in SW Beam-to-Gusset Plate Weld (PS W3, 2.3%)

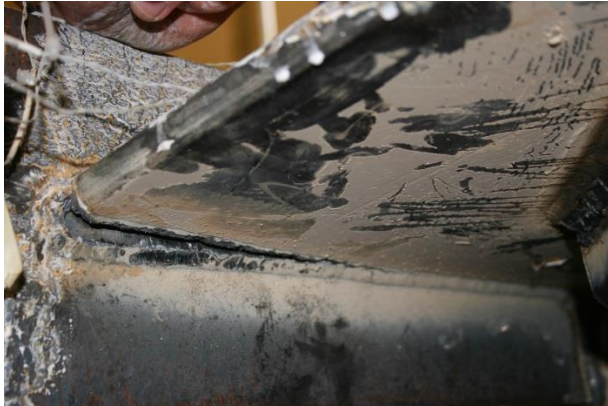
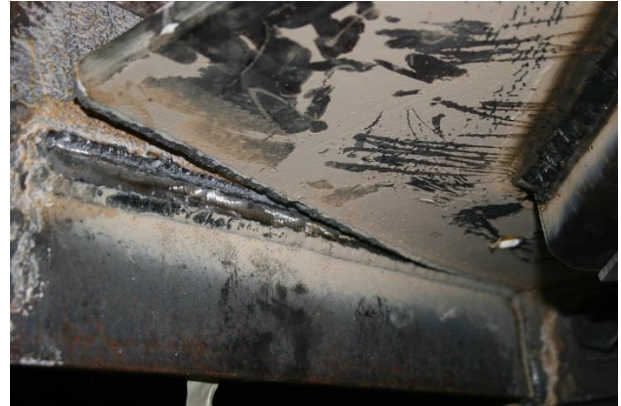
a. NE Beam-to-Gusset Plate Weld Tear at 2.4%

b. NE Beam-to-Gusset Plate Weld Tear at 2.9%

Figure 5-16: Out-of-Plane Displacement of NE Gusset Plate as a Result of Severe Weld Tearing

By a drift range of 2.9%, the NE beam-to-gusset plate weld tear was well over 50% of the weld length and the weld could no longer resist the out-of-plane deformation of the brace. The gusset plate began rotating about the end plate-to-gusset plate weld (Figure 5-16). Despite this severe out-of-plane deformation and the full brace compressive load, the beam-to-gusset plate weld remained intact for a few more cycles due to the additional ductility provided by prying action of the end plate. The prying action of the end plate had first become evident at a drift range of 2.4% but did not reach PS P2 until the cycle at 2.9% drift range (Figure 5-17). There was no prying action observed in the SW beam-to-gusset plate weld during the test.

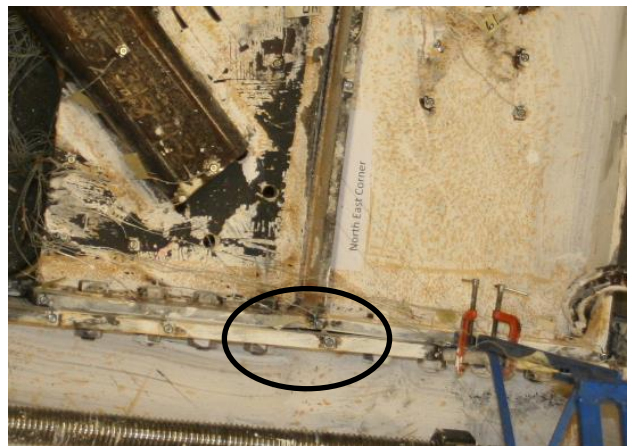
Figure 5-17: Prying Action of NE End Plate (PS P2, 2.9%)

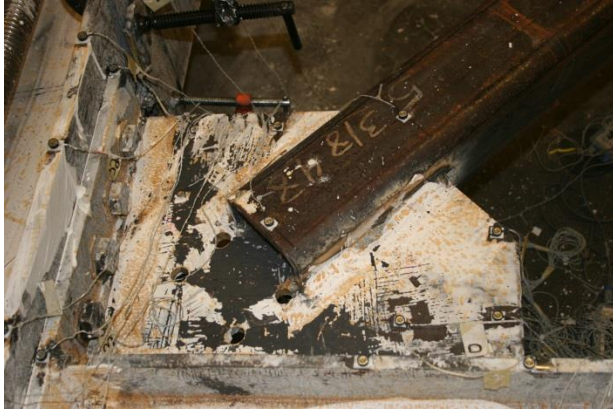
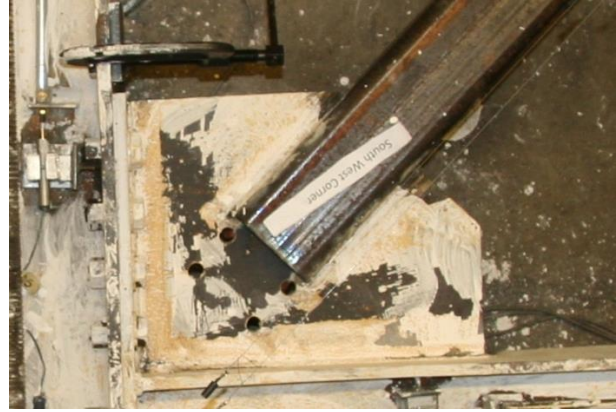
a. NE Gusset Plate

b. SW Gusset Plate

Figure 5-18: Severe Gusset Plate Yielding (PS Y3, 2.9%)

Both gusset plates had also reached a severe yielding state at a drift range of 2.9% (PS Y3, Figure 5-18). Up until this point, yielding in the gusset plates during tensile loading occurred primarily along the Whitmore width while yielding in the compression cycles occurred primarily within an elliptical clearance as defined by Roeder et. all (2011).

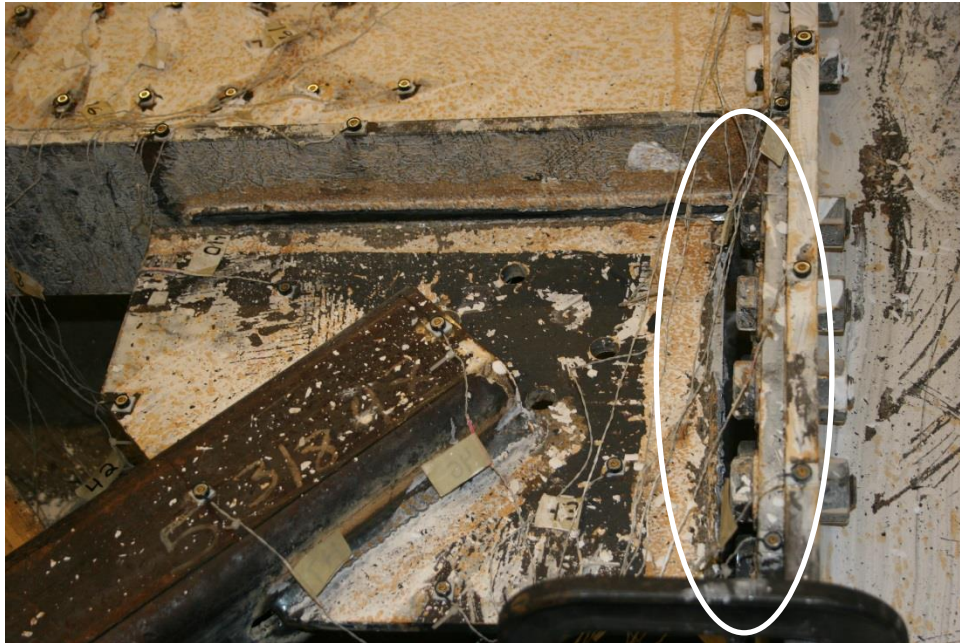
Figure 5-19: NE Gusset Plate-to-End Plate Weld Fracture (PS W4-WF, 2.9%)

In the loading up to the tension peak of the 2nd cycle at 2.9% drift range, the NE beam-to-gusset plate weld tore the remaining length followed promptly by the fracture of the NE gusset plate-to-column weld (PS W4-WF, Figure 5-19). The fracture resulted in a large loss of lateral load capacity and marked the end of the test. Moderate yielding in the east column web (PS Y2-W, Figure 5-20a) and moderate yielding in the west column plastic hinge location (PS Y2-PH, Figure 5-20b) was also observed during this drift cycle.

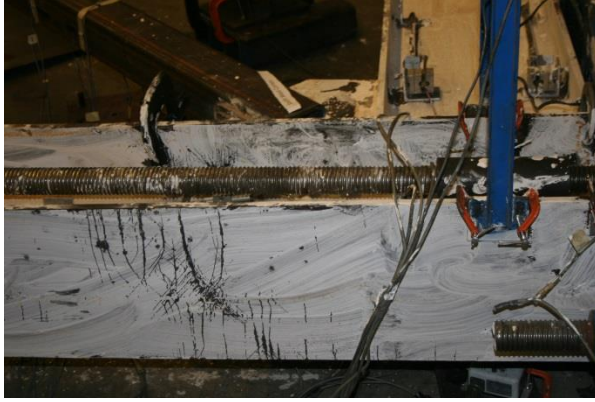
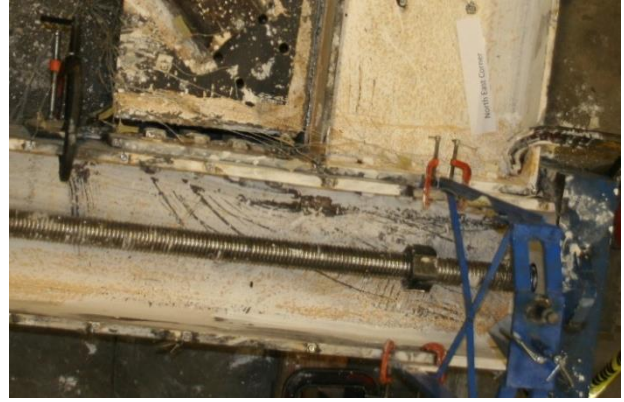
a. SW Corner Outside Column Flange (Y2-PH)

b. NE Corner Column Web (Y2-W)

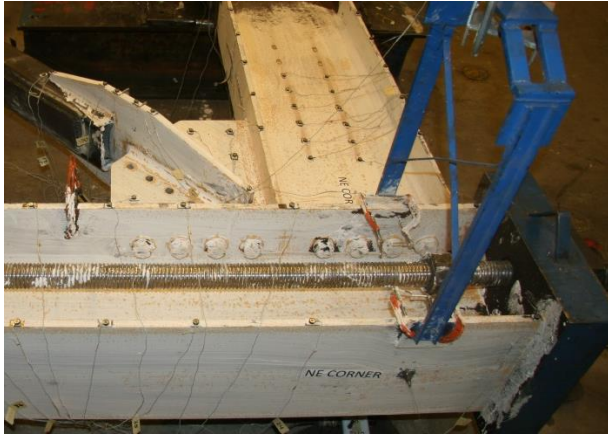
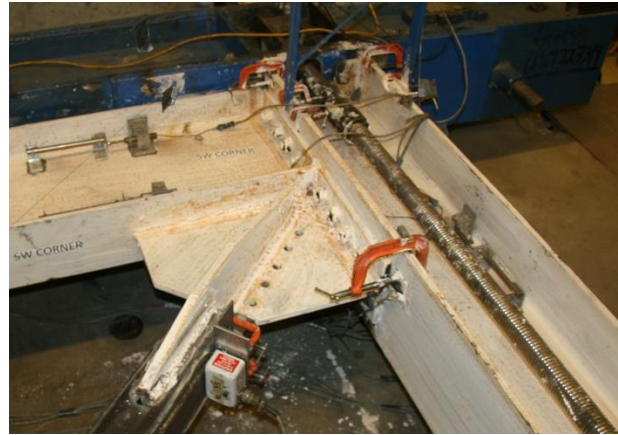
Figure 5-22: Specimen NCBF4-R2 Photos Prior to Testing

a. NE Connections

b. SW Connection

Specimen NCBF4-R2 was designed to simulate a retrofit of the scaled connection detail developed in Section 3.2. The connection detail for Specimen NCBF4-R2 is shown in Figure 5-21 and the connection before testing is shown in Figure 5-22. The connection was nominally identical to Specimen NCBF4-R1 (which was also designed as a retrofit of the same system) except that Specimen NCBF4-R2 utilized an in-plane buckling brace. The in-plane buckling brace was used to minimize the out-of-plane deformation demands placed on the gusset plate welds. To accommodate in-plane buckling, a knife plate was used to connect a HSS 6x4x3/8 brace that met the AISC requirements for a moderately ductile HSS brace to the existing gusset plate (note the holes in the gusset plate were there to simulate connection of the as-existing quad-angle brace). The design of Specimen NCBF4-R2 is discussed in more detail in Section 3.3.

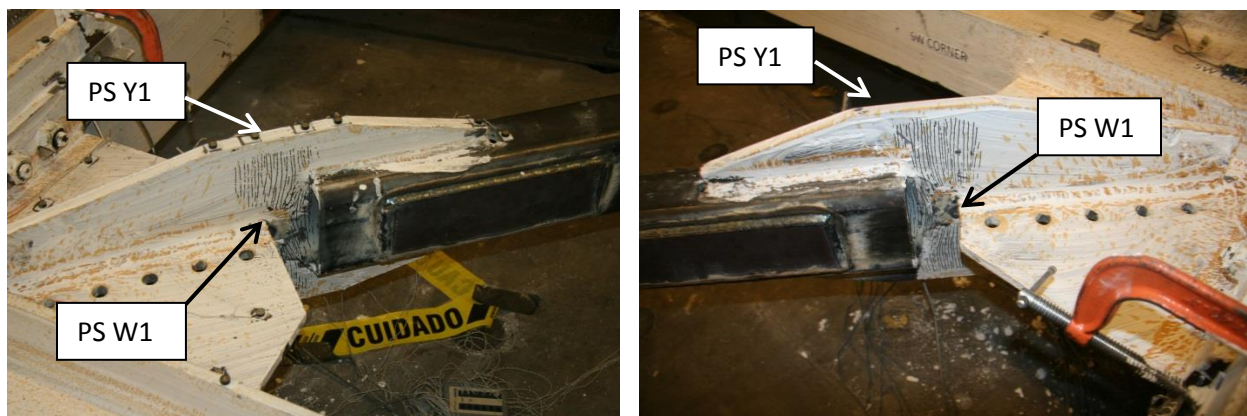
Figure 5-25: Initial Damage in Knife Plates and Splice Welds (0.6%)

a. NE Corner Knife Plate

b. SW Corner Knife Plate

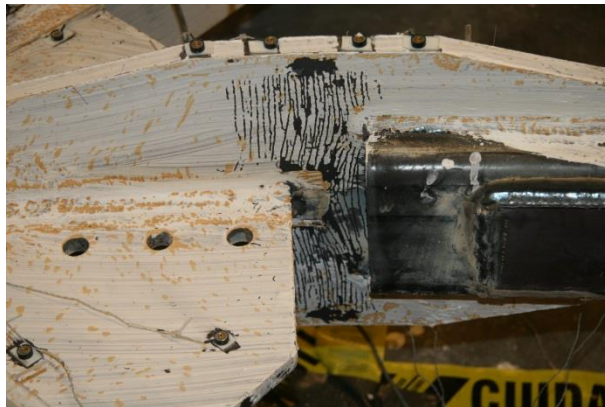
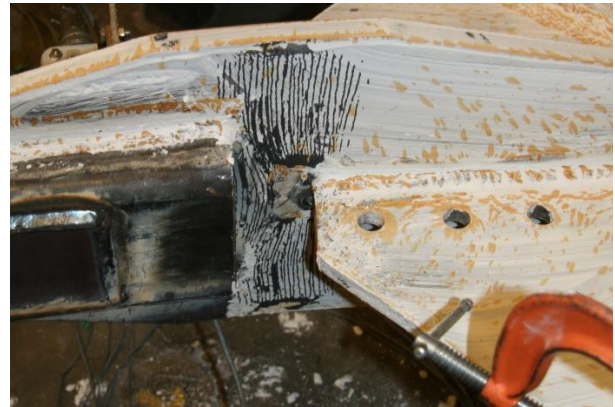
Figure 5-26: Moderate Yielding in the Knife Plates (PS Y2, 1.1%)

By a drift range of 1.1%, the knife plates had reached a moderate yield state (PS Y2, Figure 5-26) with concentrated yielding at the top and bottom of the knife plate. By a drift range of 2.1% the brace in-plane displacement had exceeded the brace depth by a factor of two, the threshold for moderate brace buckling (PS B2, Figure 5-27).

a. NE Knife Plate

b. SW Knife Plate

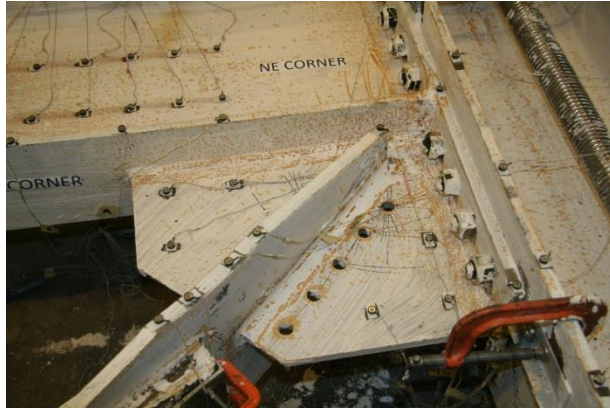
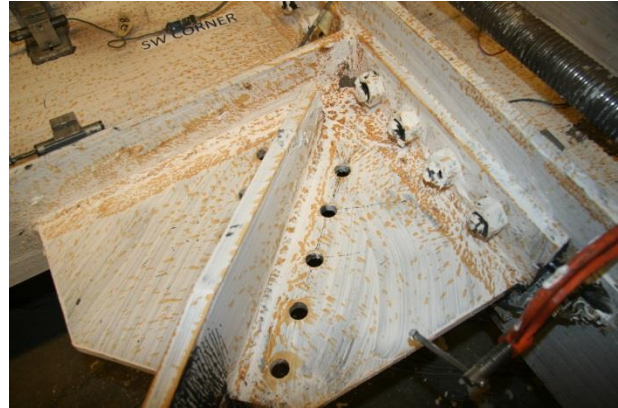
Figure 5-28: Initial Yielding in the Gusset Plates (PS Y1, 2.1%)

At a drift range of 2.1% initial yielding in the gusset plates (PS Y1, Figure 5-28) and initial yielding of the NE corner framing members was observed. Yield lines in the gusset plates extended between the existing gusset plate holes and radiated outwards towards the gusset plate welds. Yielding in the N beam was observed along the top of the inner flange (PS Y1-IF, Figure 5-29a) while yielding in the east column was observed in the plastic hinge location near the end of the end plate (PS Y1-PH Figure 5-29b).

a. NE Gusset Plate

b. SW Gusset Plate

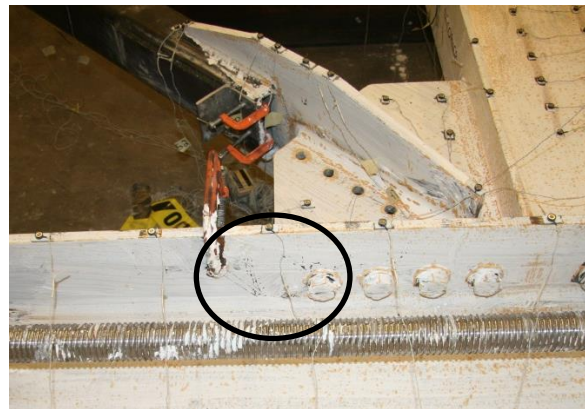
Figure 5-29: Initial Yielding in NE Corner Framing Members (2.1%)

b. E Column Inner Flange (PS Y1-PH)

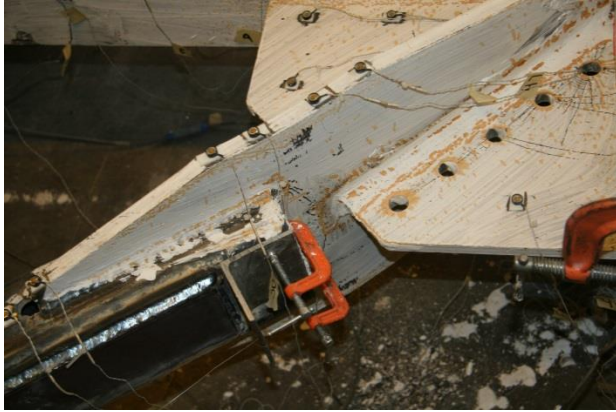
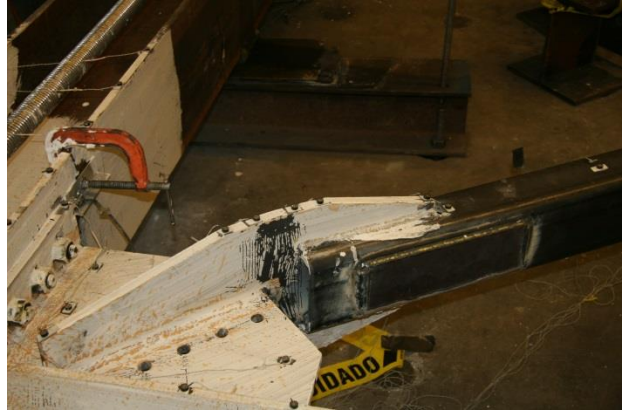
Figure 5-30: Severe Yielding in the NE Knife Plate (PS Y3, 2.8%)

By a drift range of 2.8%, the knife plates had completely yielded along the compression side and had new yield lines on the tension side signifying severe yielding in the knife plates (PS Y3, Figure 5-30). Weld tearing occurred at the edge of both beams to gusset plate welds (PS W1, Figure 5-31). Some local yielding in the beam flange extended diagonally from the edge of the beam-to-gusset plate weld (PS Y1-IF, Figure 5-31). The weld cracks and yielding in the beam flange at the edge of the connection were most likely induced from the opening and closing of the beam-column joint. Initial yielding on the outside flange of the west column was also observed at a drift range of 2.8% (PS Y1-OF, Figure 5-32).

a. Tension Side of Knife Plate

b. Compression Side of Knife Plate

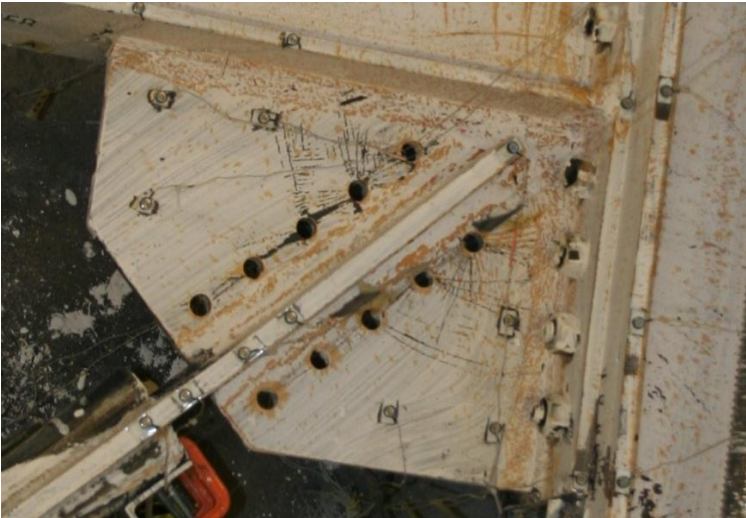
Figure 5-34: Moderate Yielding in NE Gusset Plate (PS Y2, 3.6%)

At a drift range of 3.6%, the NE gusset plate reached a moderate yielding state (PS Y2, Figure 5-34). Yield lines extended from the edge of the gusset plate through all of the bolt holes and around the end of the knife plate. The yield lines were in the same pattern as the rupture lines assumed for calculation of the gusset plate block shear strength. Additional yield lines that were not part of the block shear rupture pattern extended from the bolt holes out to gusset plate welds. A similar yielding pattern also was developing in the SW gusset plate but the performance state did not progress to PS Y2 until a drift range of 3.9%.

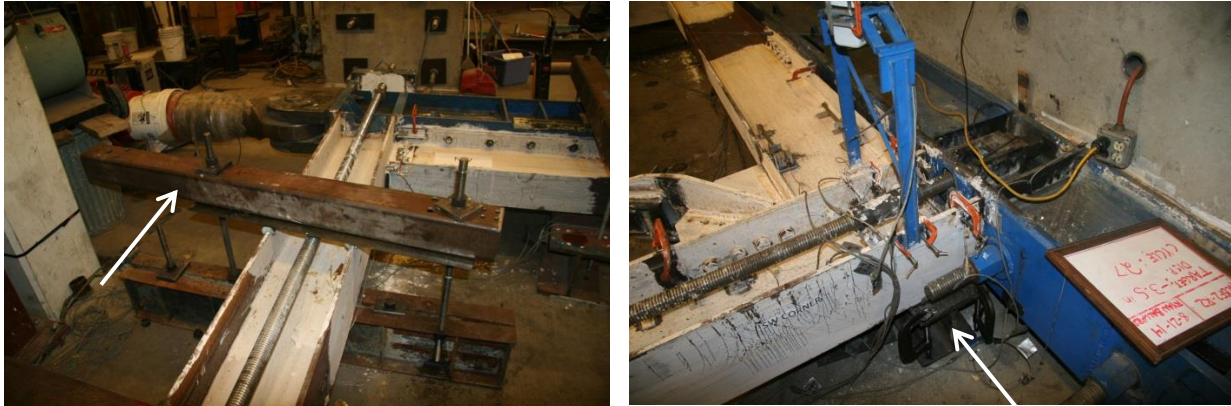
Figure 5-38: New Out-of-Plane Restraints

The S end of the column displaced over an inch down as a result of the column rigid body rotation. On the other end of the column the actuator clevis became pinched (Figure 5-37). To protect the actuator, the load was returned to zero and the test was put on hold until a solution could be implemented. An additional out-of-plane restraint was installed on the N end of the west column as shown in Figure 5-38 (see Section 4.3 for details on out-of-plane restraints). The new out-of-plane restraint was used to ratchet down the N end of the column and rigidly rotate the S end of the column back most of the way back to its original position. At this point another out-of-plane support was positioned beneath the S end of the column to prevent the column from rigidly rotating out-of-plane again. The post tension rods were re-tensioned to initial values to limit future uplift. The test was resumed the following day.

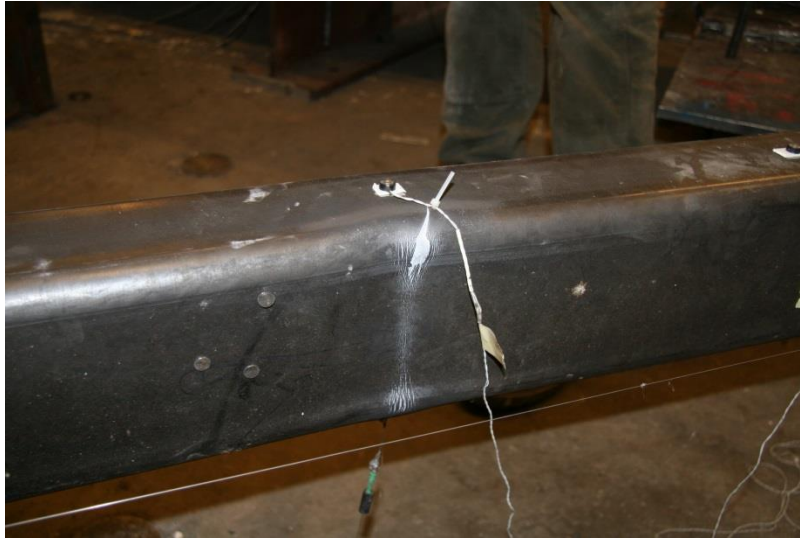
Figure 5-40: Brace Tearing (PS B4-BT, 3.9%)

The gusset plate to end plate weld fractured completely during to the next tension peak. Simultaneously, additional yielding was observed in the framing members. Final damage of the SW connection is shown in Figure 5-41 while final damage of the NE connection is shown in Figure 5-42. Although weld fracture along the SW beam-to-gusset plate weld was the ultimate failure mode of the specimen it is worth noting that the brace was also close to failure. In fact, the brace had begun tearing prior to fracture of the gusset plate to end plate weld. A picture of the torn brace is shown in Figure 5-40.

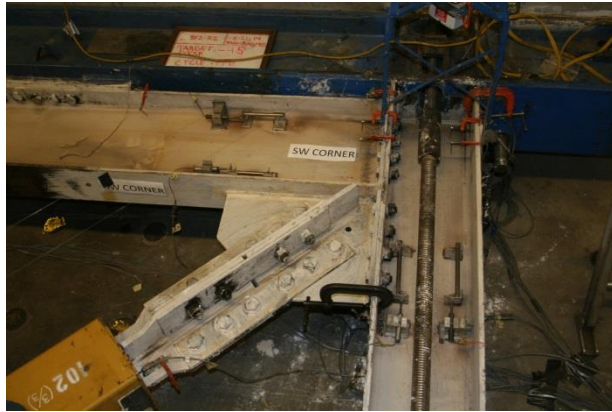
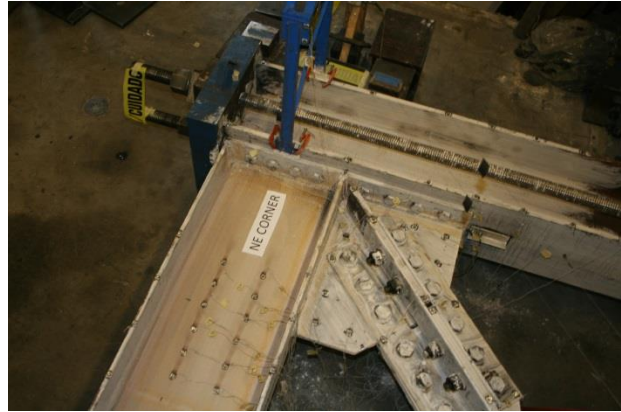
Figure 5-44: Specimen NCBF4-R3 Photos Prior to Testing

The BRB was connected to the gusset plate using ten splice plates bolted on either side of each leg of a cruciform section. Two rib plates were welded to the gusset plate to create a matching cruciform shape. Twenty 1" A490 bolts in each corner transferred the load between the BRB and the gusset plate. The bolts were slip critical and prevented dynamic slip of the BRB during the test. The existing NCBF gusset plate of the connection was assumed to be left in place, and all welds were non-notch tough. A 3/8" plate was welded to the beam web to prevent local instabilities in the beam web; this follows the recommendation of Palmer et. all (2011).

a. SW Corner

b. NE corner

Specimen NCBF4-R3 was a retrofit design using BRBs for the NCBF with bolted end plate connections as described in Section 3.2 and as shown in Figure 5-43 and Figure 5-44. The objective of the test was to test another brace option that could limit the deformation demands on the gusset plate welds. Aspects of the connection geometry were scaled up from the two previous end plate connections (Specimens NCBF4-R1 and NCBF4-R2) to accommodate a BRB with a length of 142". The BRB was not collared; the extension plate was exposed. A bolted connection was used (BRB details in Appendix E).

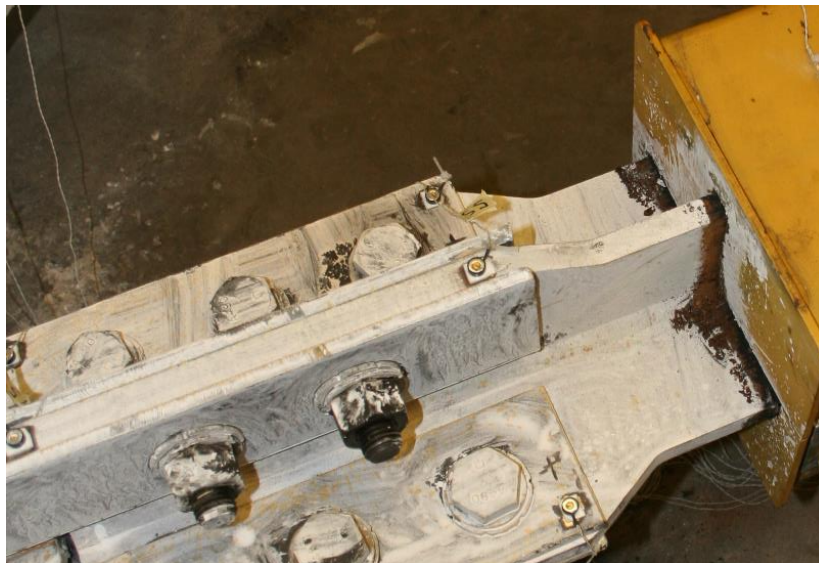
Figure 5-48: BRB Core Plate Moderate Yielding (PS B2, 2.0%)

By a drift range of 2.0%, the BRB had reached a state of moderate yielding (PS B2), as determined by the brace elongation measurements and the yield lines on the exposed portion of the core plate. Figure 5-48 shows the movement of the BRB, which is the gap between the edge of the whitewash and the edge of the BRB casing at the NE corner.

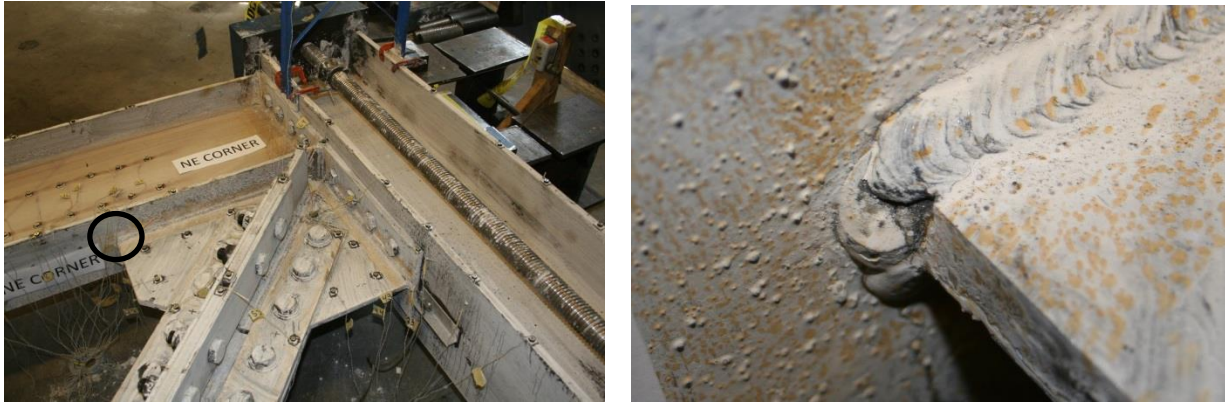
Figure 5-49: Initial Weld Cracking in the NE Beam-to-Gusset Plate Weld (PS W1, 2.5%)

Initial weld cracking in the NE beam-to-gusset plate weld was observed at a drift range of 2.5% (PS W1, Figure 5-49). The weld crack was measured to be $\frac{1}{4}$ ".

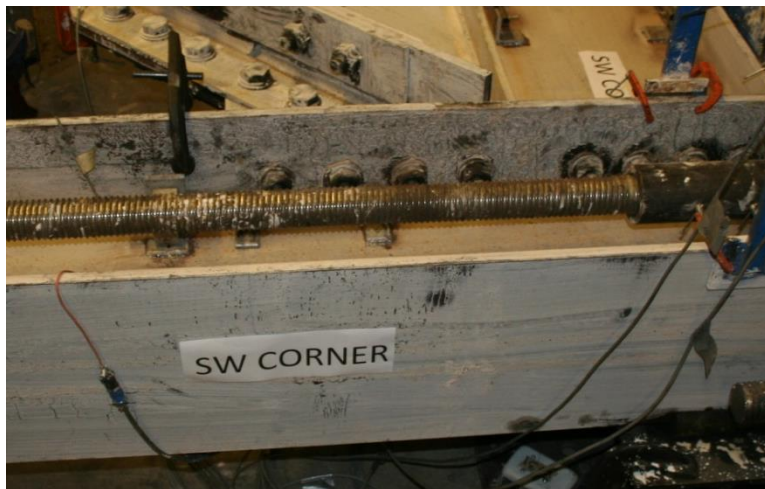
Figure 5-52: Initial Yielding in the West Column Outer Flange (PS Y1-OF, 3.0%)

The frame also sustained additional yielding at a drift range of 3.0%, including local buckling in the east column at the plastic hinge location (PS LB1, Figure 5-51) and initial yielding of the west column outer flange (PS Y1-OF, Figure 5-52).

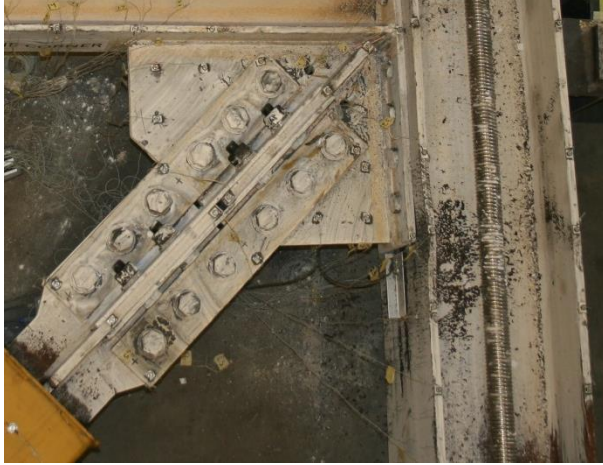
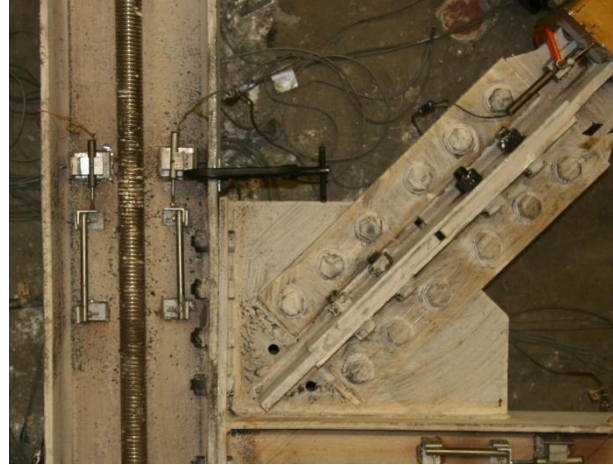
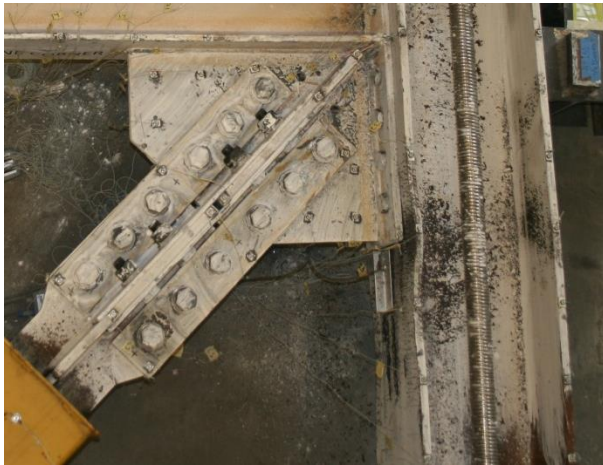
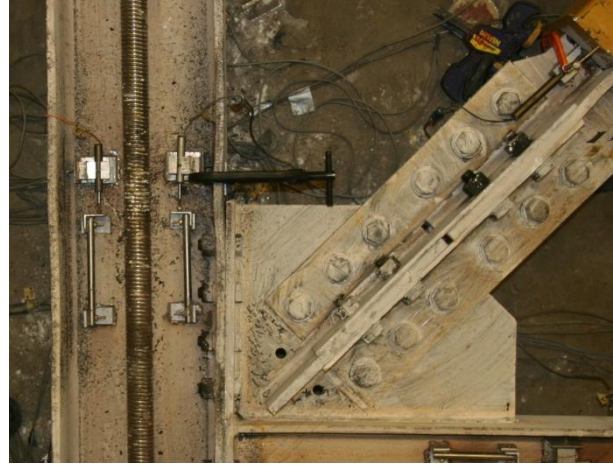
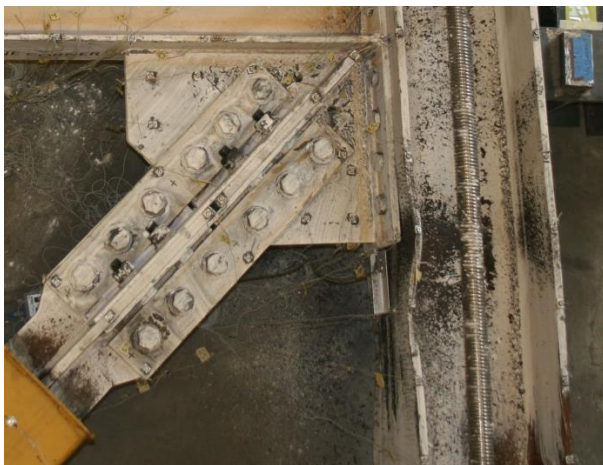
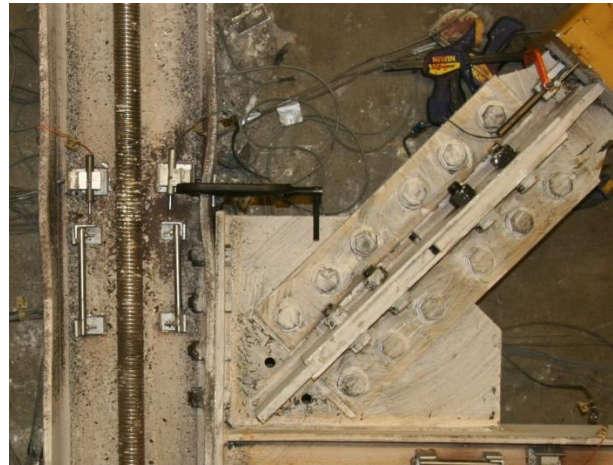
Figure 5-55: Damage in the Columns at Increasing Drift Range

Yielding and buckling occurred in the east column while the brace was in tension and the west column while the brace was in compression. Yielding in the endplates, beams, and gusset plates was minimal. The yielding progression in the columns from 3.6% to 4.5% drift range is documented in Figure 5-55. Once the 4.5% drift range was achieved, both columns had developed full plastic hinges.

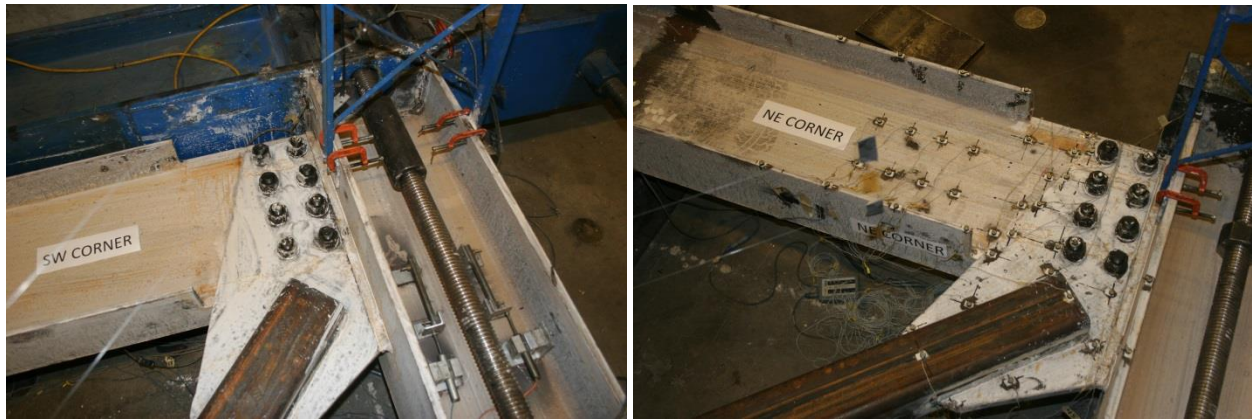
The gusset plate was 7/8" thick, the brace had limited clearance, and the bolt group was composed of eight A325-X bolts. Both flanges of the beam were coped to allow for construction and to limit the moment capacity of the beam in relation to the bolt group. The brace-to-gusset plate splice weld was detailed as a ductile weld (E71-T8) to reduce the potential for brace slice weld fracture mechanism which was studied in Specimen NCBF0 (Section 2.4.4).

a. SW corner

b. NE corner

Specimen NCBF5, shown in Figure 5-58 and Figure 5-59, was designed to represent a subset of connections analyzed during the infrastructure review that had shared gusset plates, i.e. connections utilizing a single plate as the gusset plate and a bolted shear-tab beam-to-column connection. As shown, the gusset plate is connected to the column with a CJP weld and connected to the beam with a bolt group.

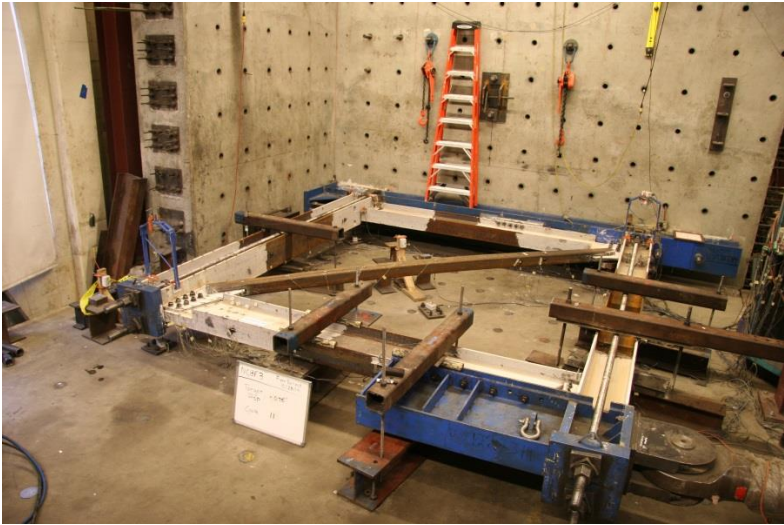
Figure 5-61: Initial Brace Global Buckling (PS B1, 0.4%)

The response of Specimen NCBF5 was essentially elastic up to a drift range of 0.4%, after which the brace began to visibly buckle out-of-plane (PS B1, Figure 5-61). This drift coincided with the peak compressive strength of the frame. To accommodate the out-of-plane movement of the brace, the gusset plate rotated out-of-plane.
