**Impact of Connection Type on Performance of
Non-Seismic Concentrically Braced Frames**

Master of Science in Civil Engineering

University of Washington

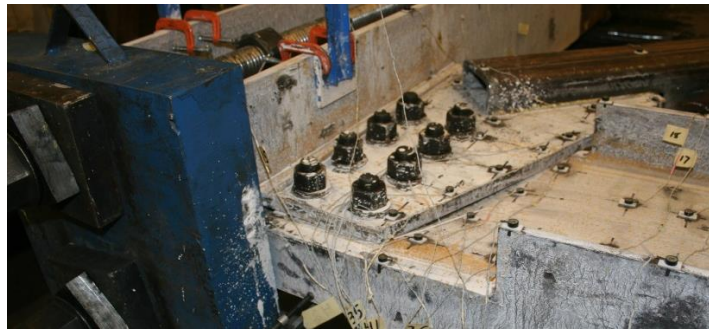
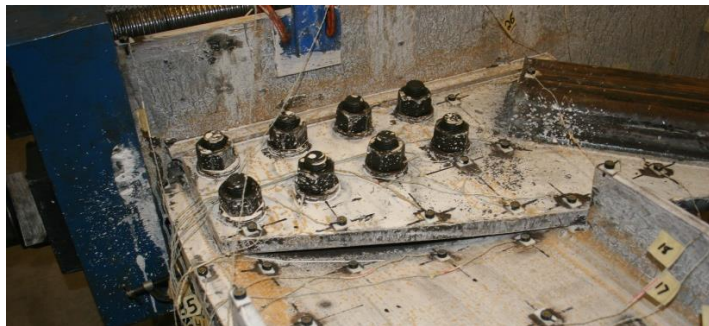
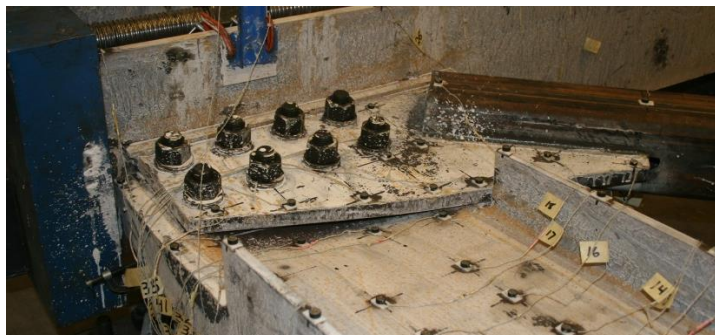
Figure 5-64: Local Buckling Progression in N Beam Web

At a drift range of 1.9%, the gusset plate separated from the middle of the NE beam web as a result of web buckling. In the next cycle the tension portion of the drift range dropped from 0.5% to 0.4% as the web collapsed. The beam flanges began to buckle, and the associate local deformations induced moderate yielding on both the inner (PS Y2-IF) and outer flange (PS Y2-OF) of the N beam. The progression of damage in the beam web is shown in Figure 5-64 below.

a. Initial Web Local Buckling (PS LB1, 1.9%)

b. Moderate local buckling (PS LB2, 2.3%)

c. Severe Local Buckling (PS LB3, 2.2%)

Local buckling of the beam web occurred because all of the force from the actuator had to go through an undersized beam web. The issue was exacerbated further by coped flanges of the beam. The local instability in the beam web became a global instability and the N beam bent about its weak axis. The N end of the E column deflected towards the strong floor and visibly twisted about its axis. The global instabilities can be seen in Figure 5-65 and Figure 5-66.

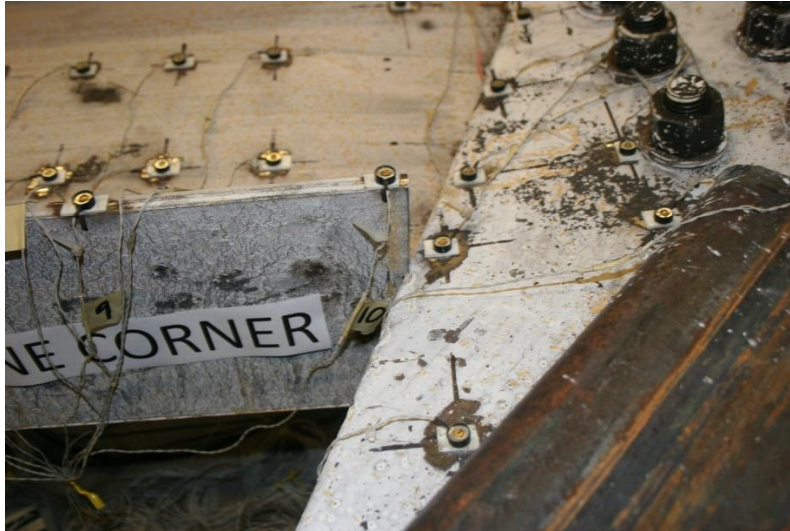
Figure 5-67: Contact Between Inner Beam Flange and Edge of Gusset Plate (2.7%)

The frame sustained additional drift in tension through contact of the inner beam flange and the gusset plate. The contact of these two elements (shown in Figure 5-67) transferred some of the axial load, reducing the demand on the beam web.

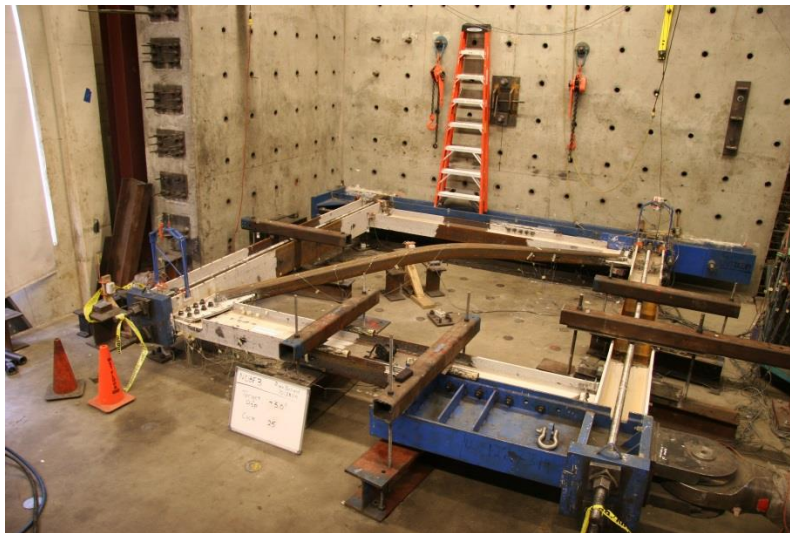
Figure 5-68: Moderate Brace Global Buckling (PS B2, 2.7%)

Although the tension cycles were accompanied by instabilities and had a limited drift capacity, the performance of the frame in compression remained stable. At a drift range of 2.7%, the brace had surpassed the threshold for PS B2 (Figure 5-68), and weld cracks were present in both gusset plate-to-column CJP welds (PS W1, Figure 5-69). The maximum length of the weld crack was 10% (PS W2) of the weld length. Weld damage at the end of the test is shown in Figure 5-78.

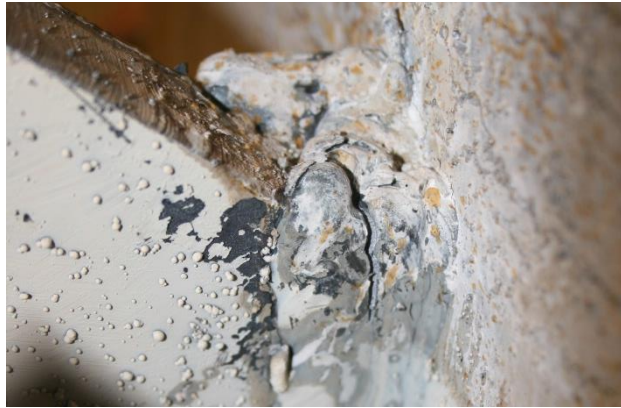
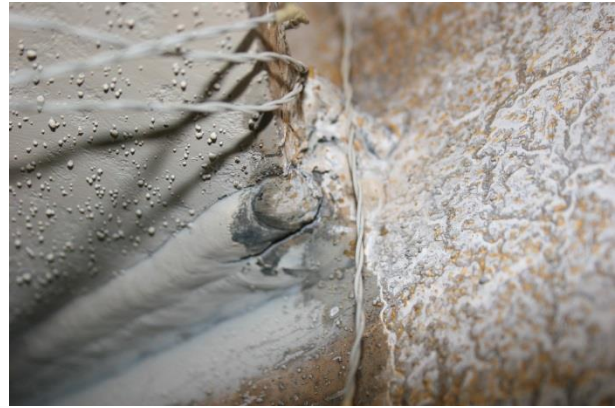
Figure 5-69: Initial Weld Cracking in Column CJP Welds (PS W1, 2.7%)

a. SW Gusset Plate - N End of Weld

b. NE Gusset Plate – S End of Weld

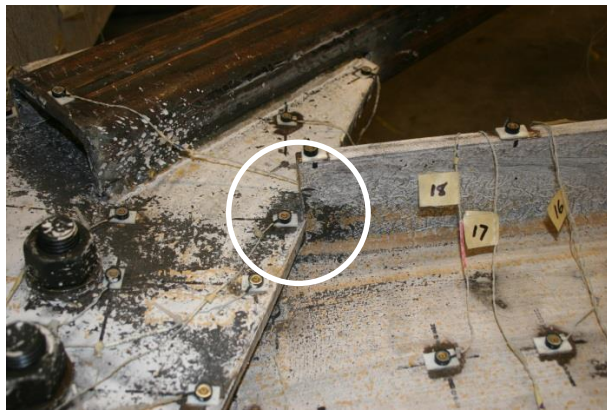
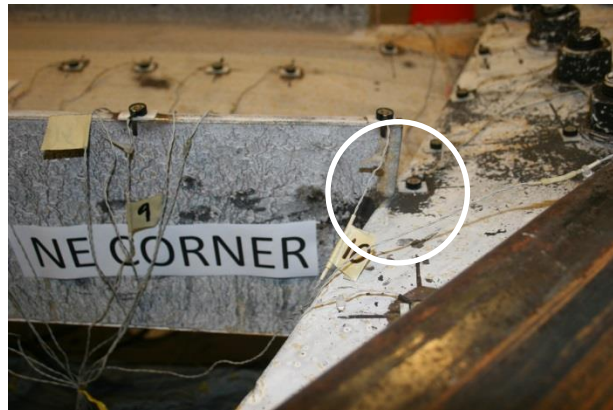
Figure 5-70: Local Yielding from Beam-to-Gusset Plate Contact (3.7%)

The buckling of the NE beam web had stabilized and at drift range of 3.7% the contact of the lower flange and gusset plate resulted in local yielding in both the beam flange and the gusset plate (Figure 5-70).

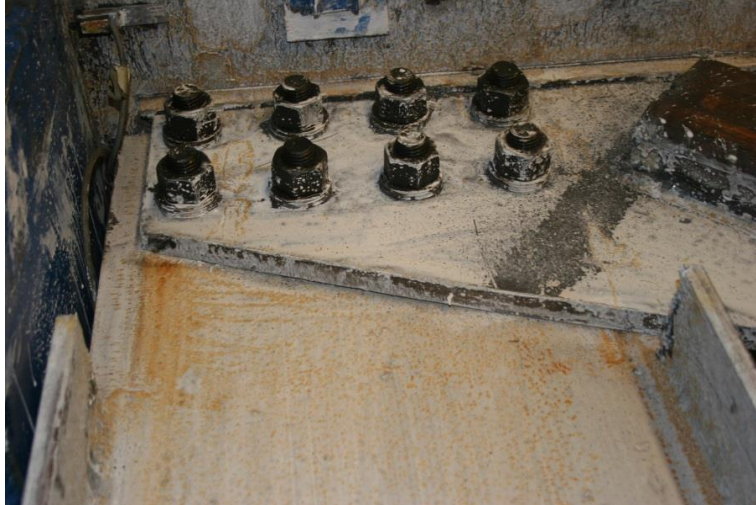
Figure 5-71: Local Web Buckling in SW Corner (PS LB1, 3.7%)

Additional damage to the frame at a drift range of 3.7% included buckling of the SW beam web (PS LB1, Figure 5-71), initial yielding in the outer flange of the west column (PS Y1-OF, Figure 5-72), and hinging in the brace (PS B3-BH, Figure 5-73). The lower amount of web buckling in the SW beam web resulted from the restraint of the column in the SW corner by the reaction beam. Although the west column flange was observed to have additional yielding in the remaining compression cycles it would not reach a higher performance state. The N end of the E column did not acquire any damage during the test.

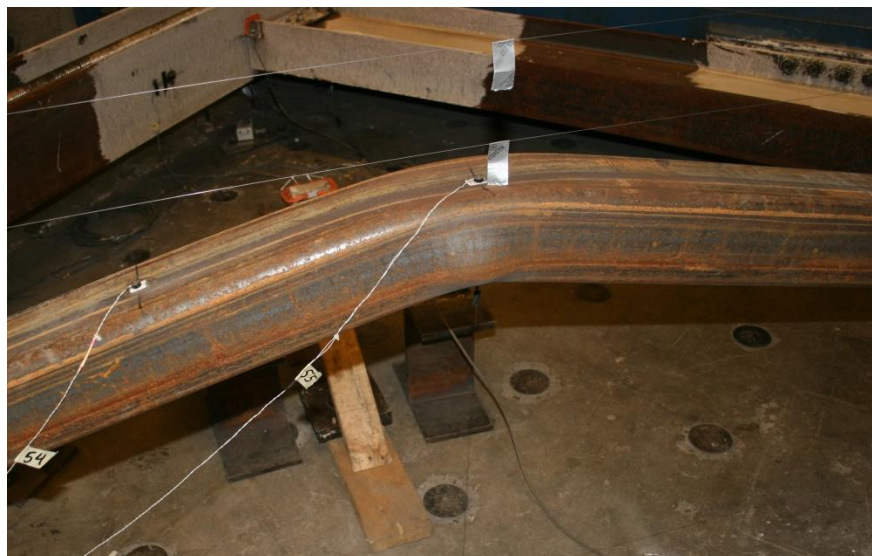
Figure 5-74: Brace Hinging Prior to Fracture (5.0%)

At a drift range of 5.0%, local cupping at the brace mid-span became more pronounced. Figure 5-74 shows the brace hinging in the compression cycle prior to brace fracture; in the figure the brace out-of-plane deformation had exceeded 17". Prior to reaching the subsequent tension peak, the bottom half of the brace tore. With continued loading, the brace fractured completely. Final drift range was 5.0%.

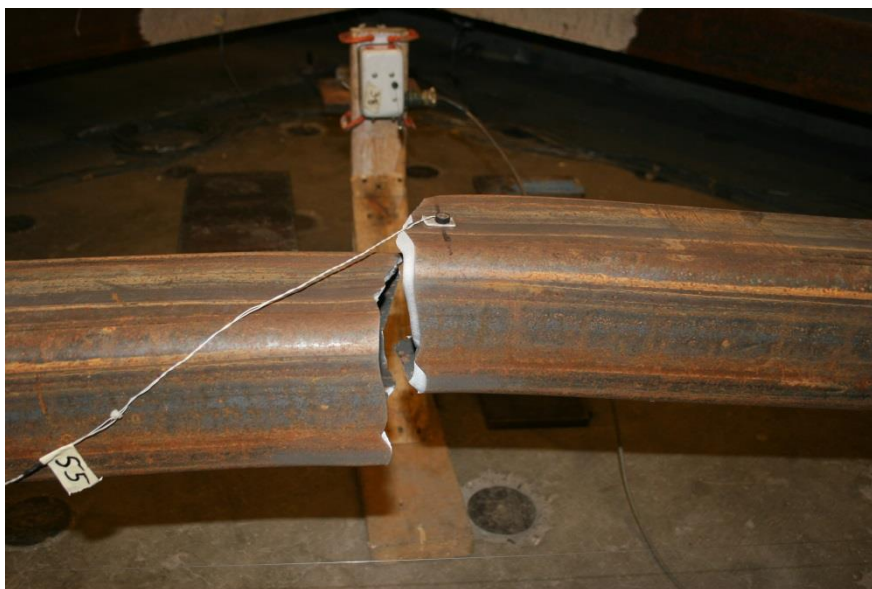
Figure 5-75: Brace Fracture (PS B4-BF, 5.0%)

An image of the fractured brace is shown in Figure 5-75. Damage to the connection immediately after brace fracture is shown in Figure 5-76 and Figure 5-77.

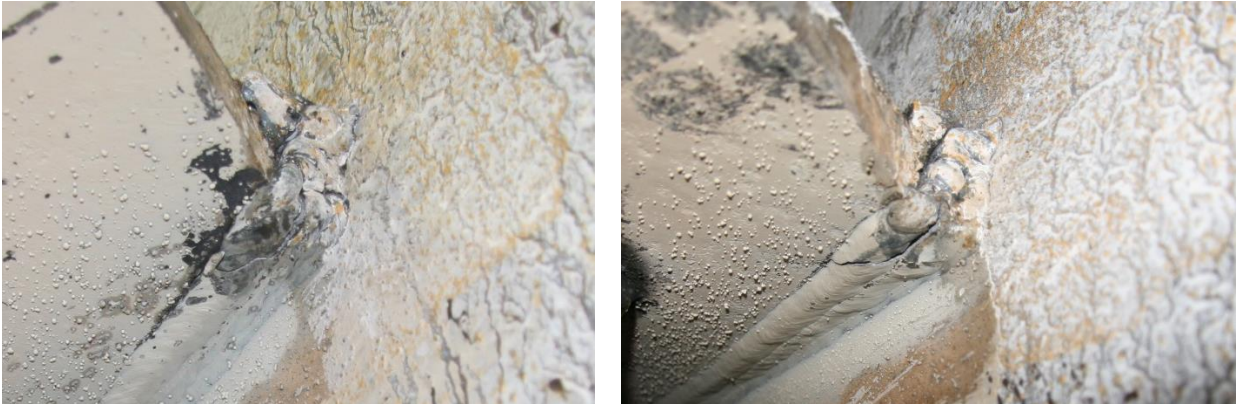
Figure 5-78: Weld Damage at End of Test (5.0%)

Figure 5-78 shows the final column to gusset plate weld damage. Both welds had a similar cracking pattern and had the same overall length of 1 ¼" (6% weld tear length). Figure 5-79 and Figure 5-80 show the damage in both beam webs at the end of the test. Values of bolt-hole deformation are recorded in Table 5-18. In general the deformation at the bolt holes were less than ¼".

a. SW Gusset Plate - N End of Weld

b. NE Gusset Plate – S End of Weld

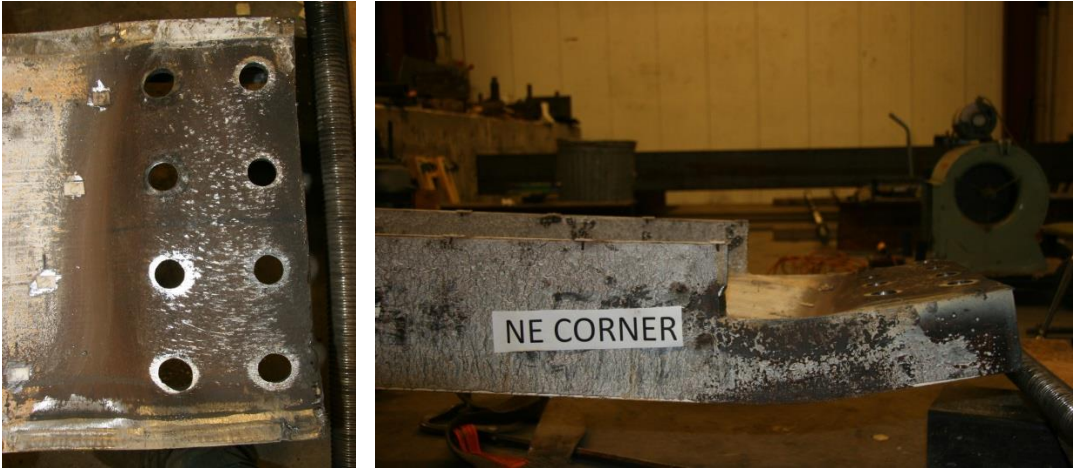
Figure 5-79: Damage to the NE Beam Web at End of Test (5.0%)

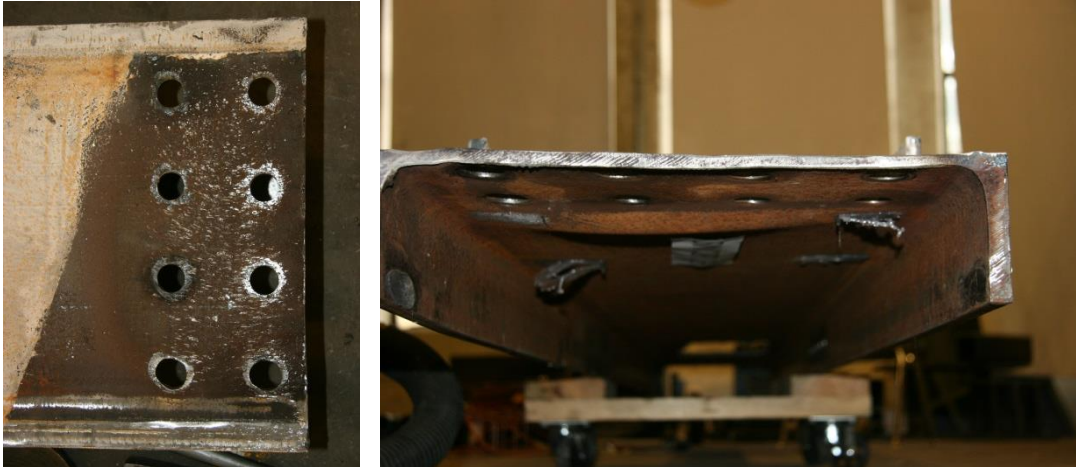
Figure 5-80: Damage to the SW Beam Web at End of Test

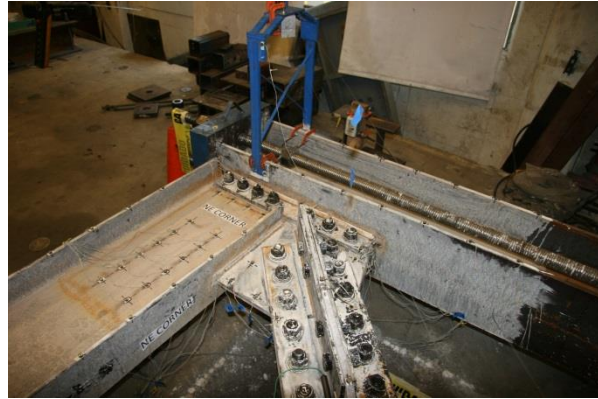
b. NE Connection

Figure 5-82: Specimen NCBF2-R1 Undamaged Connections

Specimen NCBF2-R1 was designed as a BRB retrofit of a specimen tested by Johnson (2014) and is shown in Figure 5-81 and Figure 5-82. The BRB was selected as a retrofit option for deficient non-compact braces seen in the infrastructure review. Aspects of the connection geometry were scaled up from the original connection detail (Specimen NCBF2) to accommodate a BRB with a length of 142". The BRB was not collared; the extension plate was exposed. A bolted connection was used (BRB details in Appendix E).

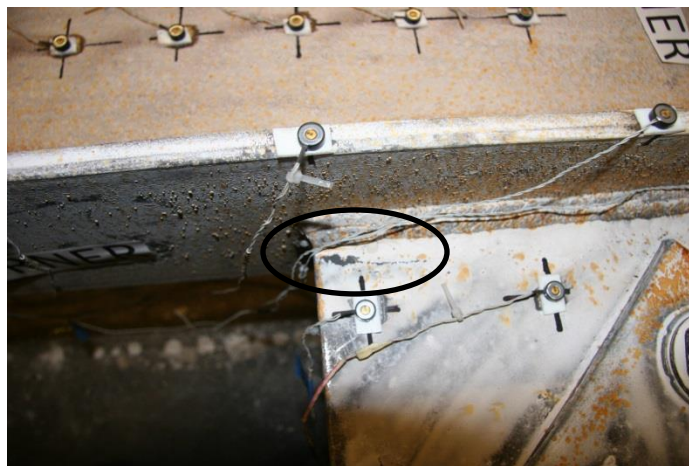
Figure 5-84: Initial Yielding in the NE Gusset Plate (PS Y1, 1.0%)

Initial yielding in the NE gusset plate (PS Y1, Figure 5-84) and initial yielding in the plastic hinge location of the east column (PS Y1-PH, Figure 5-85) also occurred at a drift range of 1.0%. Yield lines in the NE gusset plate were observed at the edge of the beam-to-gusset plate connection signifying that a large moment was being transferred at the beam-to-gusset plate interface. Yield lines in the column extended diagonally from the edge of the shear plate to the edges of the column flange.

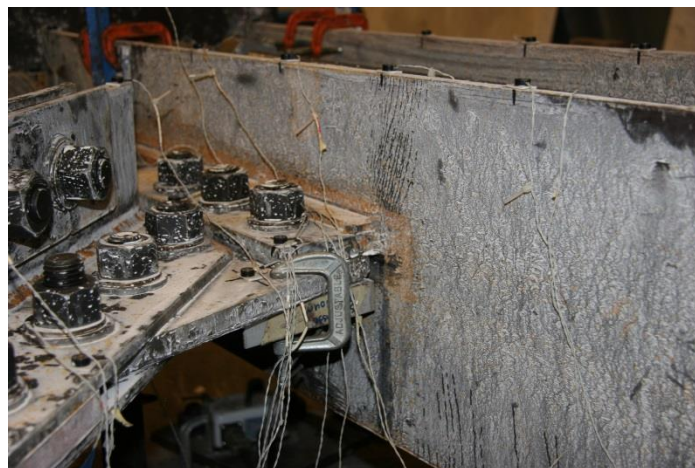
Figure 5-85: Initial Yielding in the E Column (PS Y1-PH, 1.0%)

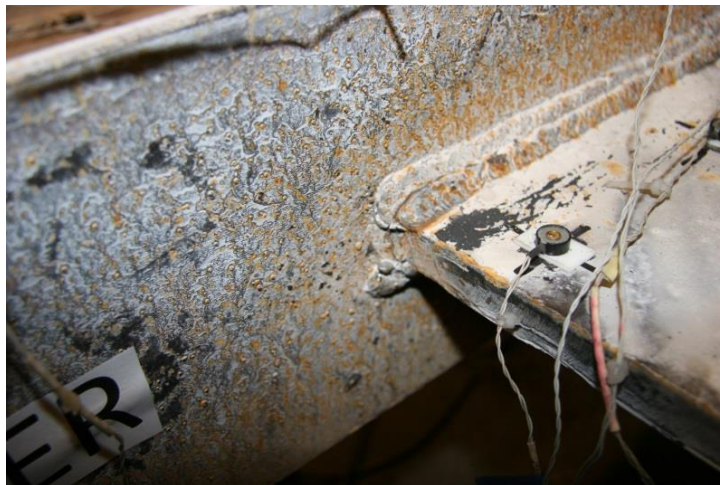
Figure 5-89: Weld Cracking in NE Beam-to-Gusset Plate Weld (3.4%-27%)

Initial weld cracks in both beam-to-gusset plate connections were also observed at a drift range of 3.4% (PS W1, Figure 5-89). The NE beam-to-gusset plate weld cracks would propagate at higher drift ranges, but did exceed 10% of the weld length (PS W2). At the end of the test, the NE beam-gusset plate weld crack had grown to only 1" long. The SW beam-to-gusset plate weld crack did not propagate throughout the remainder of the test.

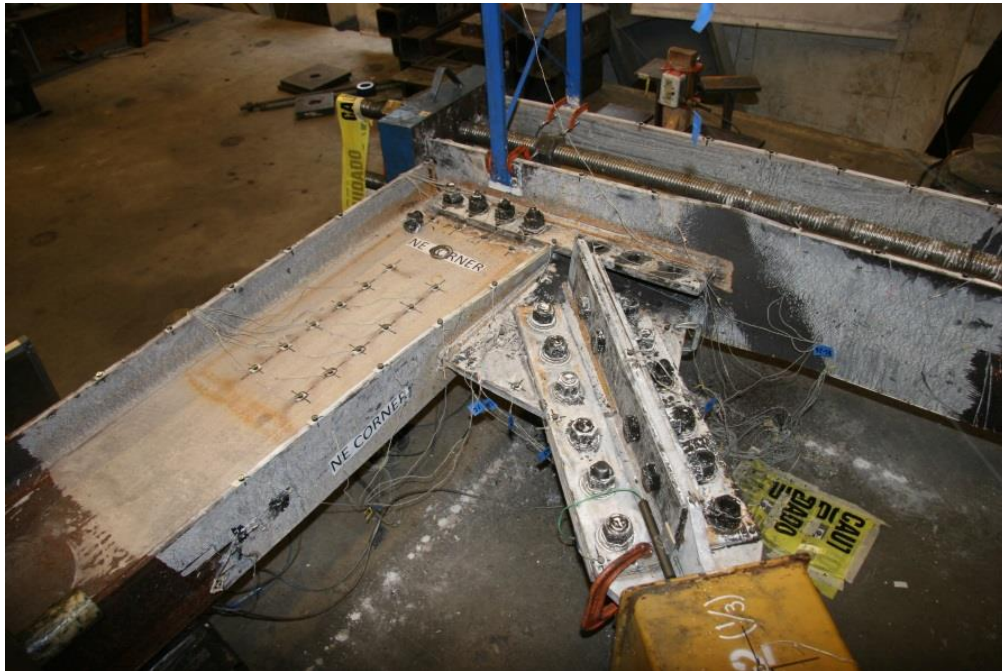
Figure 5-92: Bolt Fracture of NE Gusset Plate-to-Shear Plate Bolts (5.2%)

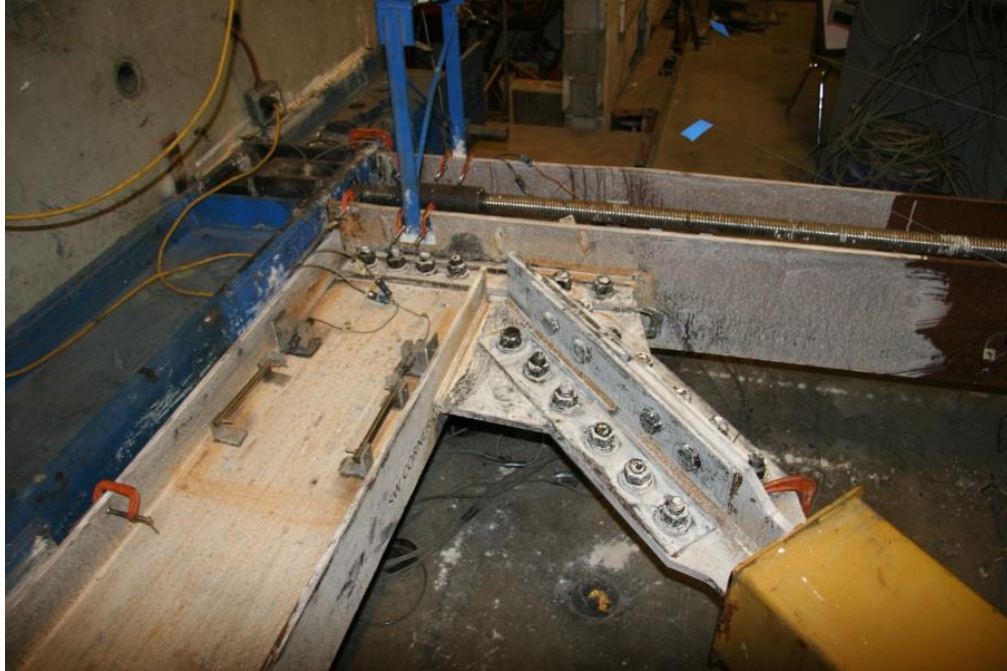
Figure 5-93: Damage in SW Corner End of Test (5.2%)

Just prior to reaching a drift range of 5.2%, the three bolts connecting the gusset plate to the shear plate fractured (PS Bo4-BF) and the exposed portion of the BRB core plate began to hinge (PS B4-BH). With increased drift, the hinging became more severe, the beam flange began twisting out-of-plane, and the elongation of the bolt holes in the NE connection increased. At this point the NE connection was considered to be unstable, the actuator load had dropped significantly, and the test was terminated. Damage in the NE and SW corners at the end of the test is shown in Figure 5-92 and Figure 5-93. No post fracture cycles for the test were run.

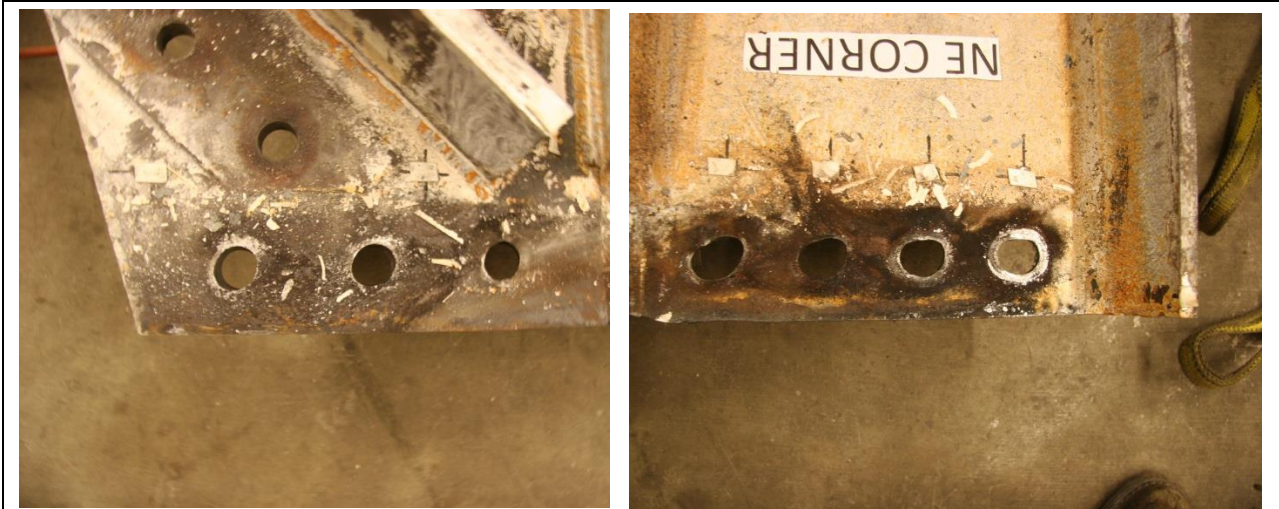
Figure 5-94: Bolt Hole Elongation and Bolt Damage in NE Connection

Bolt hole elongation values and bolt damage in the continuous shear plate connections at the end of the test are documented in Figure 5-94 and Figure 5-95. As noted above the high values of bolt hole elongation in the NE connection (bolts 4 and 5) were most likely amplified upon reloading after bolt fracture in the gusset plate (all of the BRB force went through the bolts in the beam web after fracture and placed demands in excess of the bolt bearing capacity). In general the bolts appeared to have deformed a little over a $\frac{1}{4}$ " through a combination of bolt hole elongation and bolt shear deformation. Up to another $\frac{1}{16}$ " of deformation at the bolt hole may have been provided by rotation of the bolts themselves.

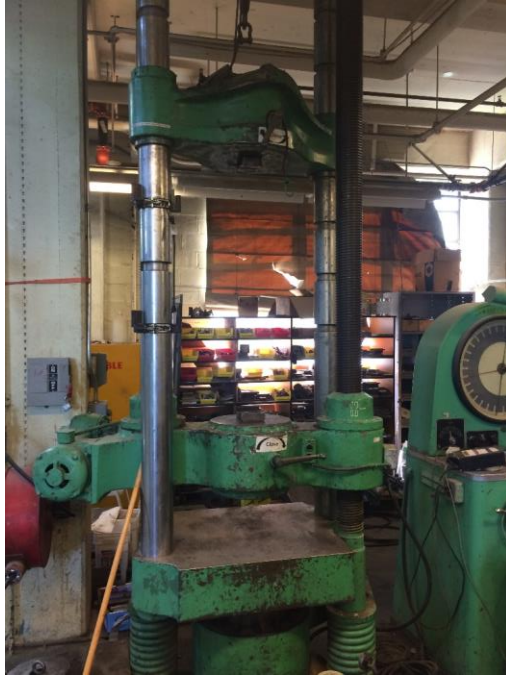
Figure C-3: 300 Kip Baldwin testing Machine

The steel coupons were tested using 300-kip capacity Baldwin testing machine as shown in Figure C-3. The machine held the coupons at the grip sections of the coupons. An extensometer was attached to each specimen in order to measure the elongation to the gauge length simultaneously with the load. A string potentiometer was used to measure the crosshead separation of the testing machine. The load on the specimen was recorded at all times during the tests using a load cell attached to the actuator.

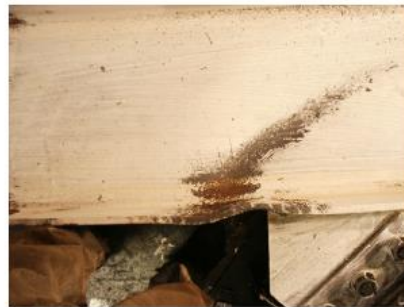
a) Extensive Local Beam Yielding of BRB05

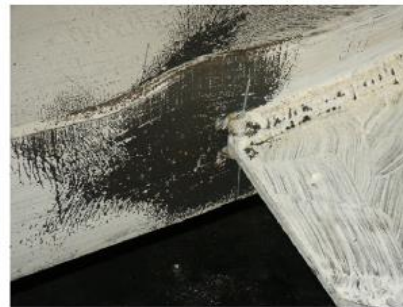
b) Beam Flange Fracture Noted with BRB01

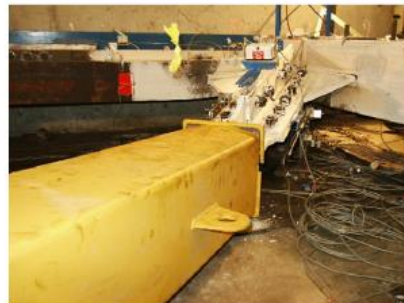
c) OOP Deformation Noted with All Specimens

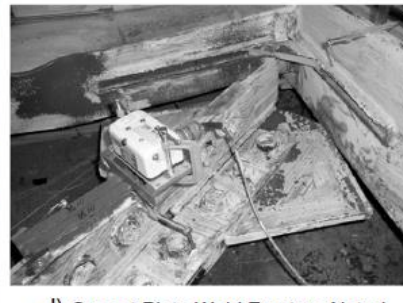
d) Gusset Plate Weld Fracture Noted with BRB06
