New Methods for Seismic Performance Evaluation and Retrofit of Nonductile Concentrically Braced Frames

A dissertation
submitted in partial fulfillment of the
requirements for the degree of

University of Washington

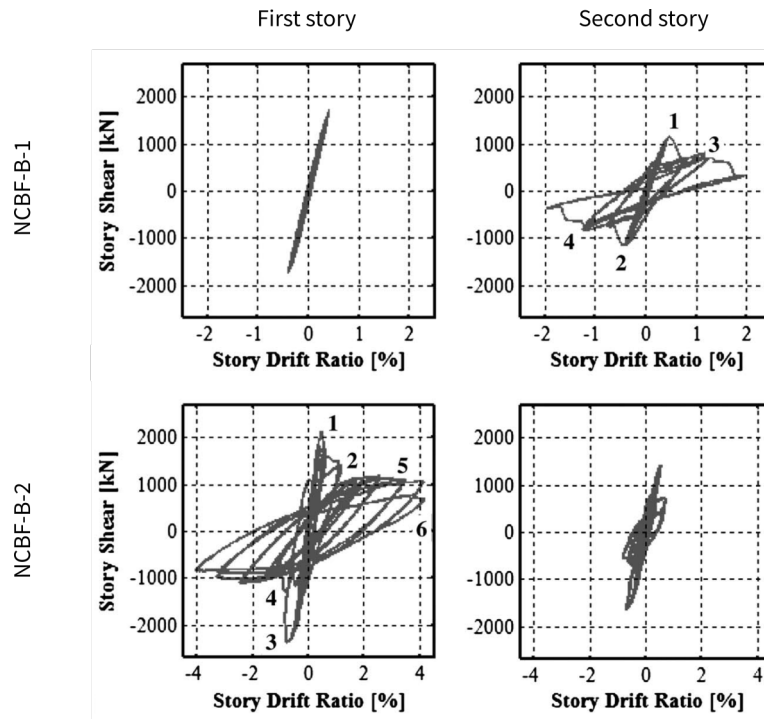
Figure 2.25: Hysteretic response of each story of NCBF-B specimens (Simpson and Mahin 2018)

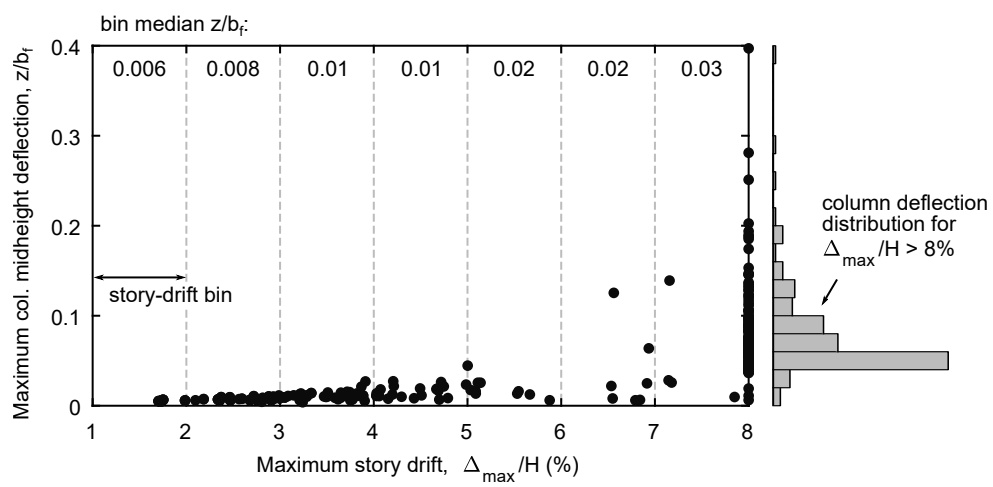
Figure 7.17: Relationship between column midheight deflection and story drift
