# Unbonded Pre-tensioned Bridge Columns with Rocking Detail

A thesis

Master of Science in Civil Engineering

University of Washington

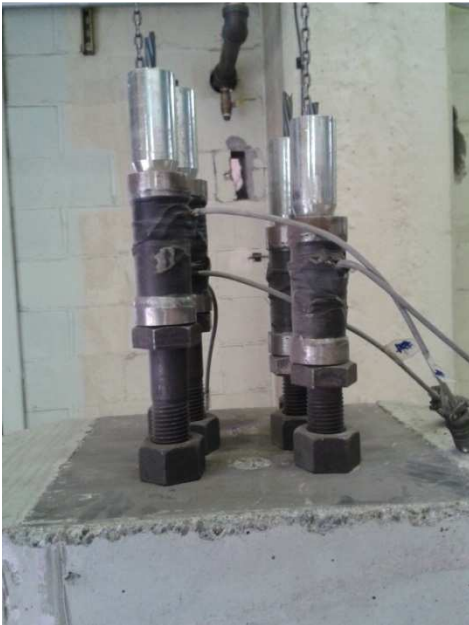
**Figure 2.5** Photograph (Left) and schematic (Right) views of the system to detect and prevent the strands from slipping.

To anchor the strands during the tests, each strand was fitted with a prestressing chuck at each end. Each strand had a load cell at its top end, in between the chuck and the column face (Figure 2.5). Using 7/8" diameter ASTM A490 bolts and a plate with welded nuts of complimentary size (STD Plate), each end of the strand was stressed to four kips by turning the bolts against the resisting chucks (Figure 2.4). During the tests, the load cell would detect any slip in the strand, while the chuck would guarantee continued anchorage. Load cells were only placed at the top of the column, because the bond length was shorter at the top end. Any slip that would occur in the footing portion of the column would occur in the actuator end, and the load cell would detect it.

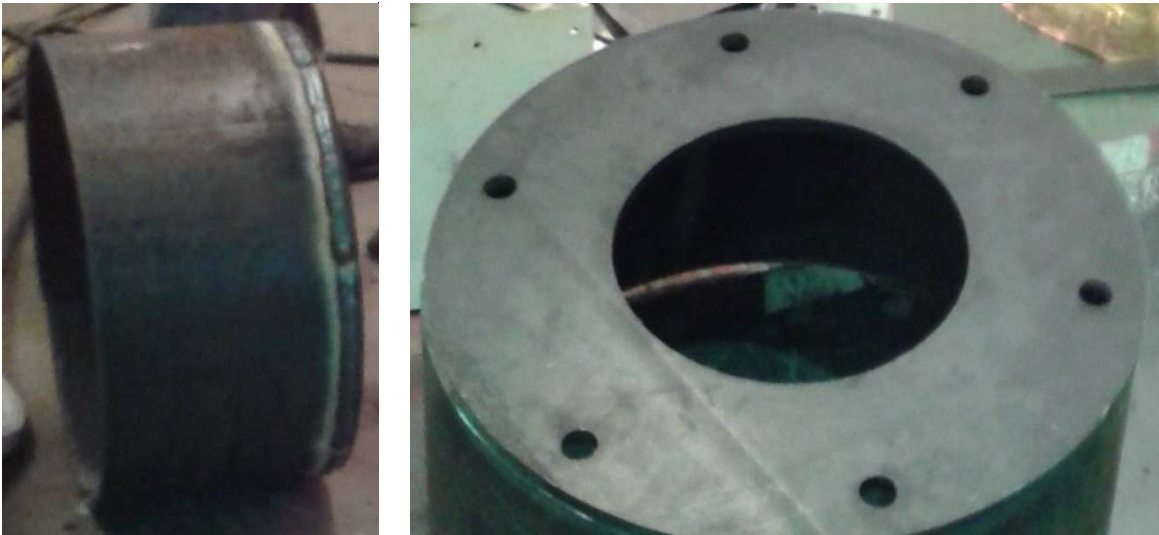
**Figure 2.6** Steel shoe. On left is an elevation view of the shoe while on right is a bottom view of the shoe.

The column had a special connection (“steel shoe”) at the location of the column-footing interface to encourage rocking and to minimize damage. The rocking connection consisted of a shoe annular plate, a shoe wall, discontinuous welded bars, and through bars.

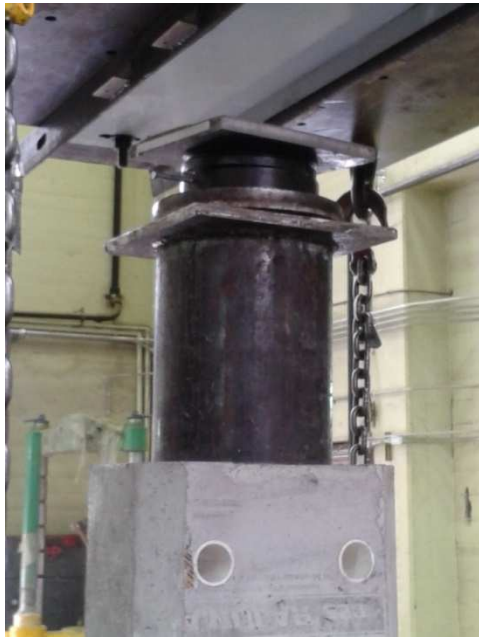
**Figure 3.2** Actual (Left) and Schematic (Right) views for the system that transfers load from the Baldwin to the specimen while safely covering prestressing load cells and chucks.

A system was needed to keep the column aligned in the correct vertical plane as it underwent cyclic loading. The system consisted of a steel encasing tube, spherical bearing head, greased PTFE plate and stainless steel channel, arranged in accordance with Figure 3.2. This steel encasing tube was necessary because space was required above the column for the chucks that anchored the prestressing strands and the load cells that detected potential slip. The steel tube had an inside diameter of 12" and wall thickness of 0.5". The square steel plate welded atop the tube had length of 16" and thickness of 7/8". Above the steel plate was a spherical bearing on which rested a greased PTFE pad. When the column rotated during the test, the PTFE plate slid against a stainless steel channel fixed to the head of the Baldwin and the spherical bearing adjusted for the relative rotation.

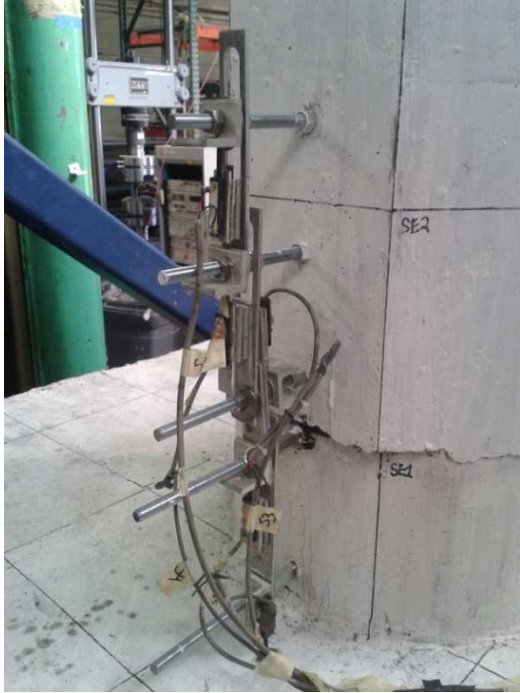
**Figure 3.6** Photograph (Left) and schematic (Right) views of the curvature rod system used on the north face.

The system consisted of a series of linear potentiometers attached to metal plates. These metal plates, in turn, were connected to a set of threaded rods that protruded from the column. The threaded rods were located on both the north and south face at 2.5", 9", 12", 18" and 24.5" above the column-to-footing interface. The lowest linear potentiometer measured the change in height between the footing and the lowest threaded rod.

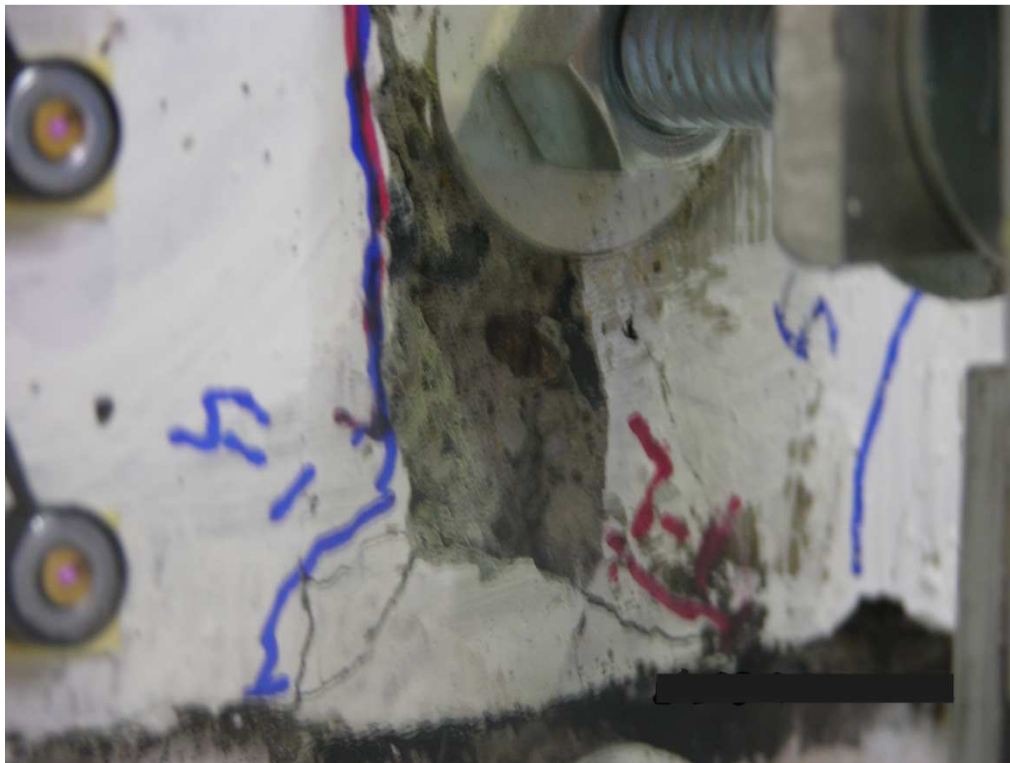
**Figure 4.5** South view of PreT-SF-ROCK after cycle 8-4 showing spalling damage above the steel shoe.

The higher tensile strength of HyFRC prevented this architectural spalling from occurring in PreT-SF-ROCK-HyFRC.

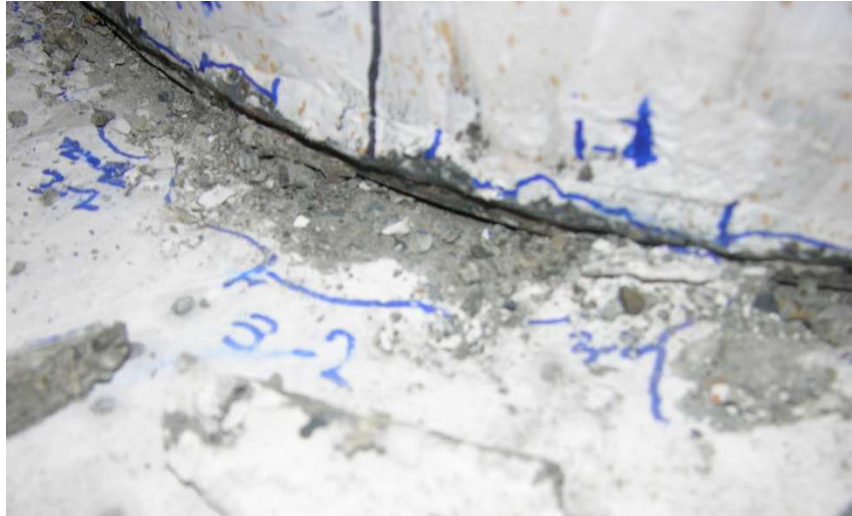
**Figure 4.6** South view of PreT-SF-ROCK showing the fillet spalling of the footing induced by the rocking action of the steel shoe.

(2011), in which no footing spalling occurred either. The footings were capacity-designed, forcing all damage to occur in the columns.

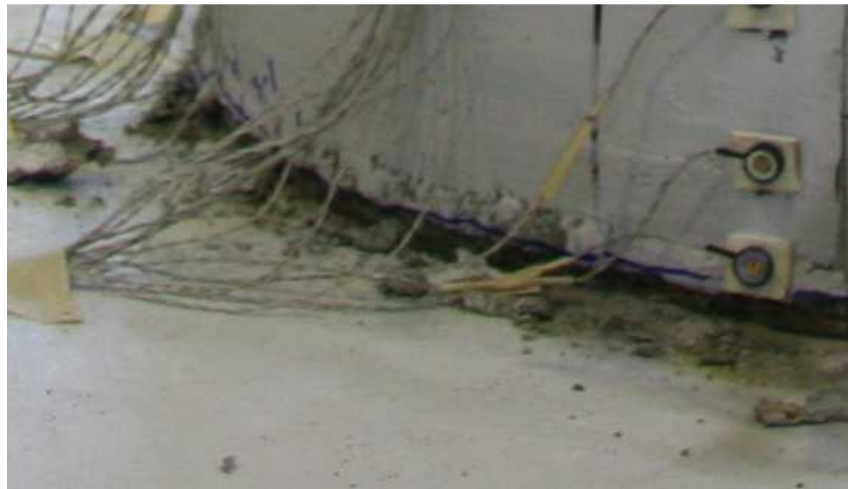
**Figure 4.7** South view of PreT-SF-ROCK-HyFRC showing the fillet spalling of the footing induced by the rocking action of the steel shoe.

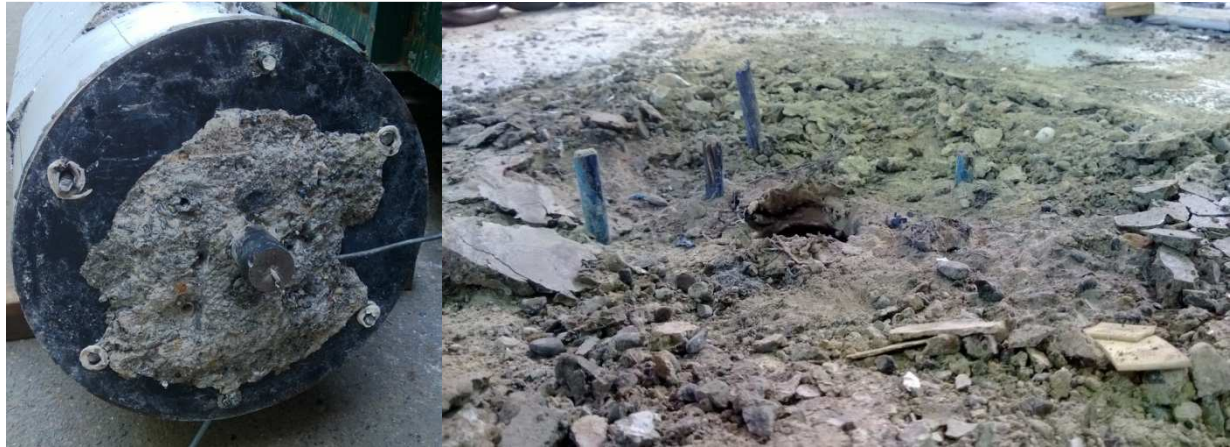
**Figure 4.8** Jagged portion of HyFRC that seeped through steel-wire mesh (Left). Column-footing interface after top portion of column was removed (Right).

perfectly rigid or impermeable. As a result, a small amount of HyFRC seeped underneath the bottom of the steel shoe, forming a jagged surface. During the test, this portion of HyFRC was crushed between the base of the steel shoe above and the conventional concrete beneath it. After both tests were complete, researchers detached the column from the footing in specimen PreT-SF-ROCK-HyFRC for closer observation of the column-footing interface (Figure 4.8).

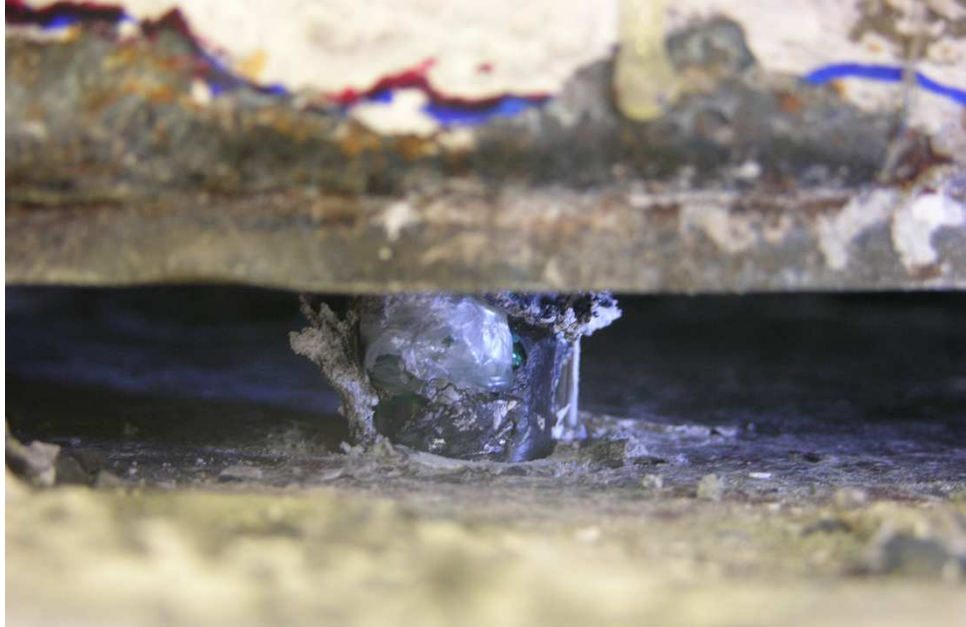
**Figure 4.9** Exposed north bar of PreT-SF-ROCK.

In earlier tests (Finnsson et al. 2013, Davis et al. 2011 and Haraldsson et al. 2011), the base of the column was not confined externally by a steel shoe. As the cover spalled, the bars lost lateral support and consequently buckled. Conversely, no bars ever buckled in the footing due to the large quantity of concrete that provided significant lateral support. Thus, the steel shoe appears to offer an effective means of lateral support that consequently prevented bar buckling.

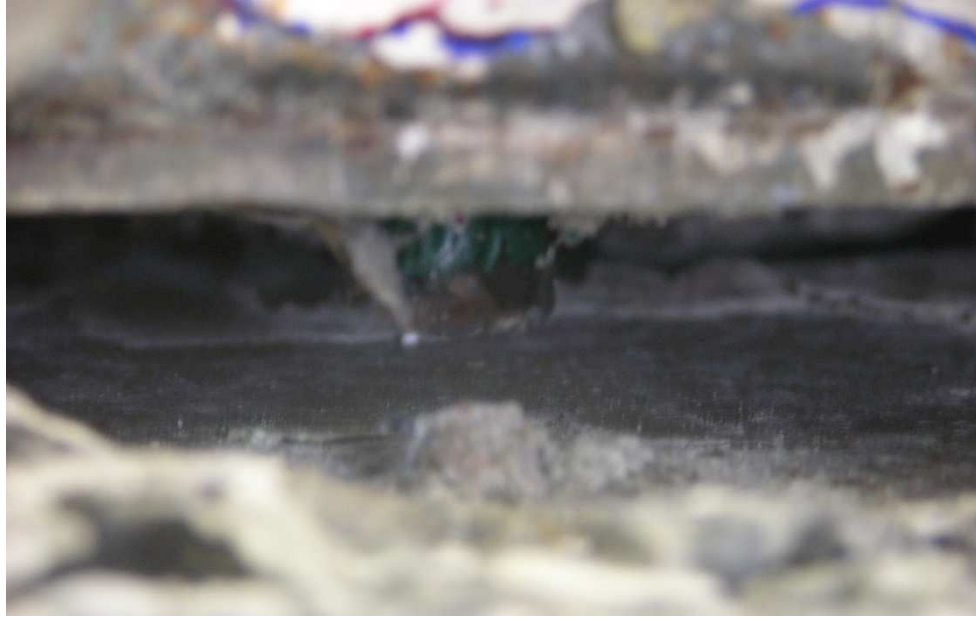
**Figure 4.11**      **Fractured north bar of PreT-SF-ROCK.**

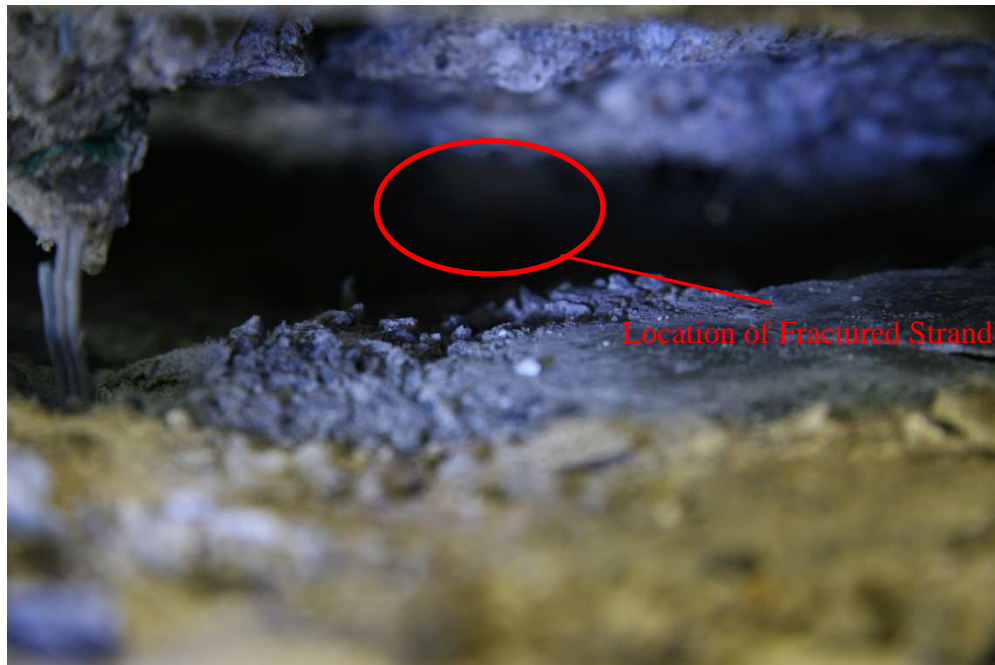
**Figure 4.12**      **Northwest view of PreT-SF-ROCK-HyFRC showing location of missing strand (fractured).**

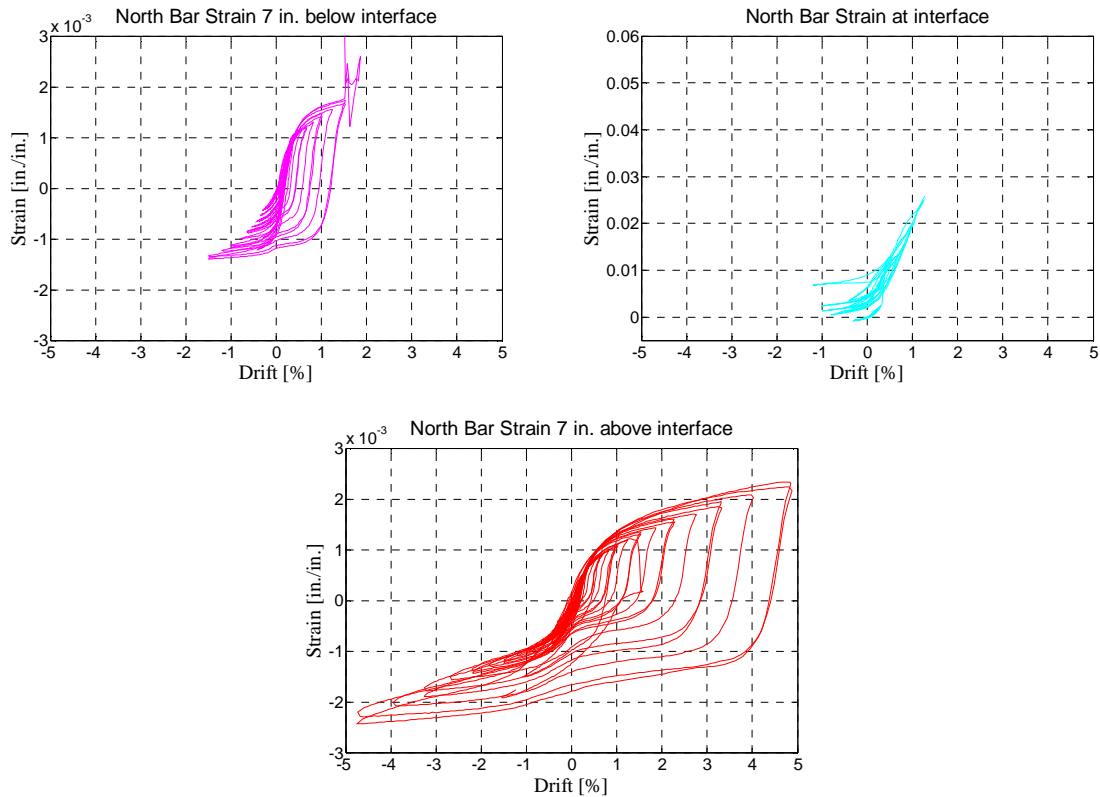
**Figure 5.28 Strain vs. drift in North No 4 Bar, PreT-SF-ROCK.**

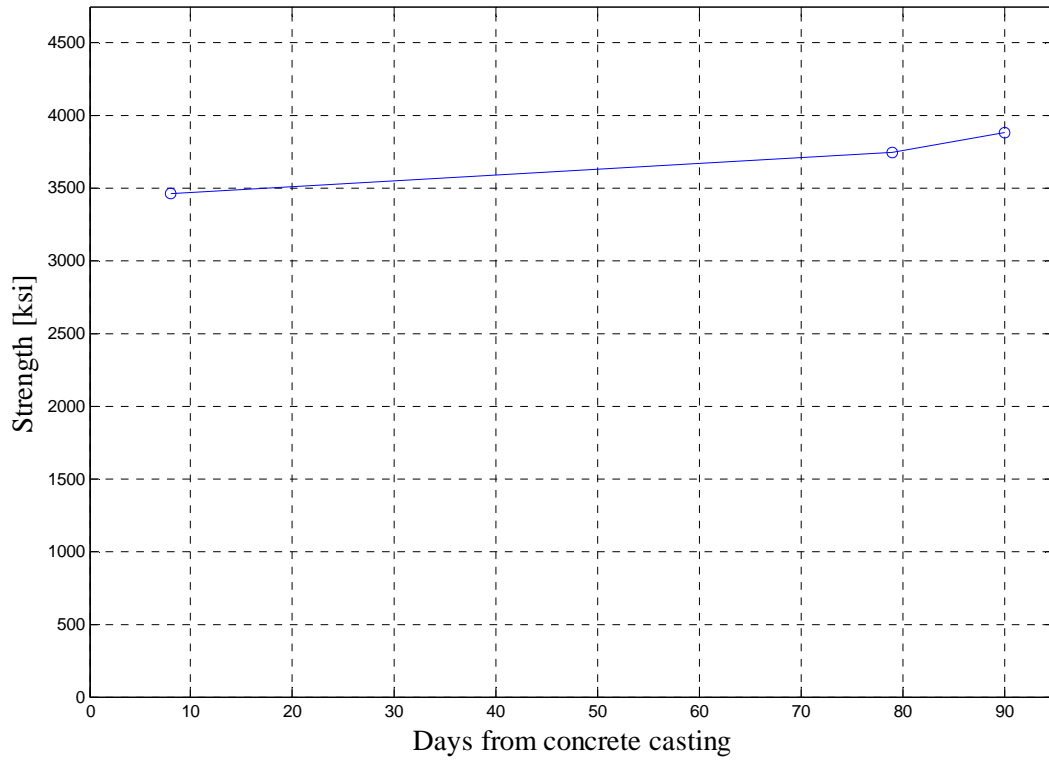
**Figure A.2 E-MOD history for the column conventional concrete.**

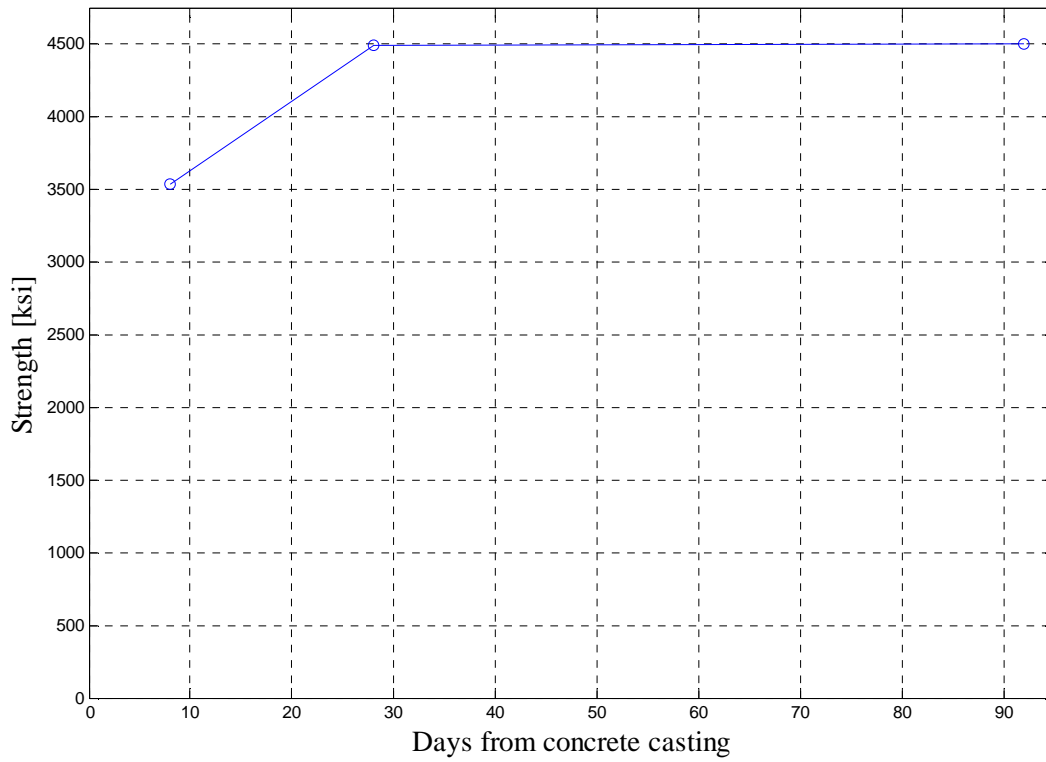
**Figure A.4 E-MOD history for the HyFRC.**

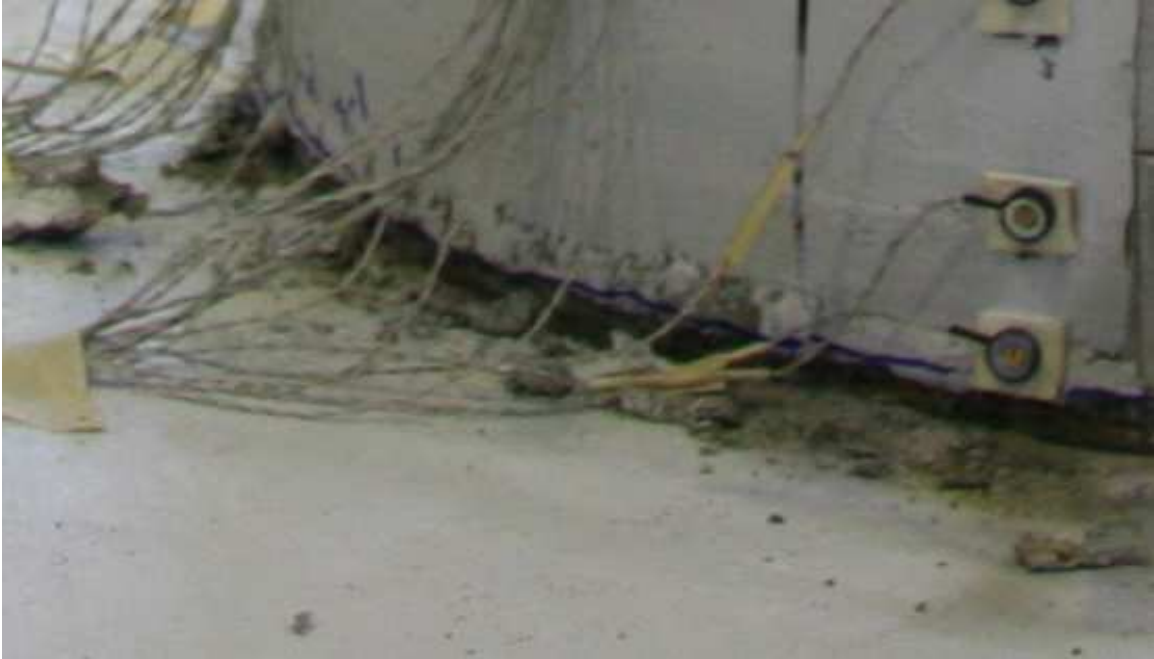
**Figure C.2 Footing fillet-spalling.**

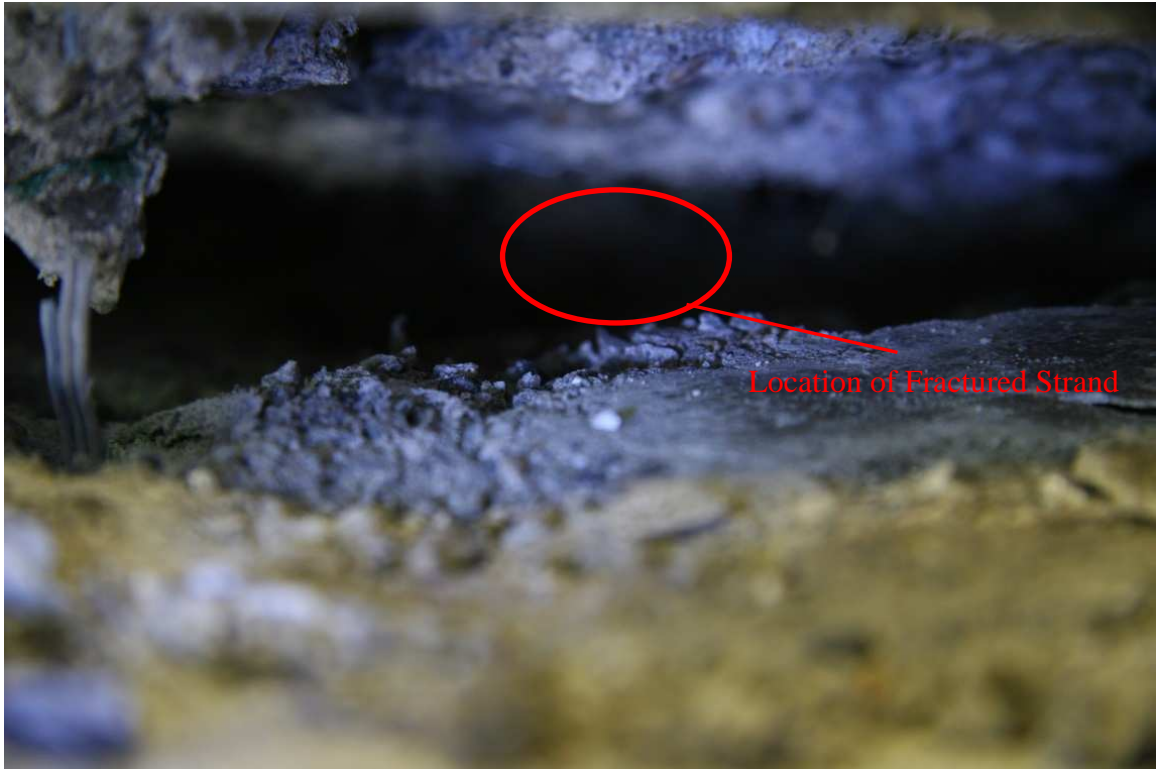
**Figure C.4** Fractured Strand, cycle 9-2.

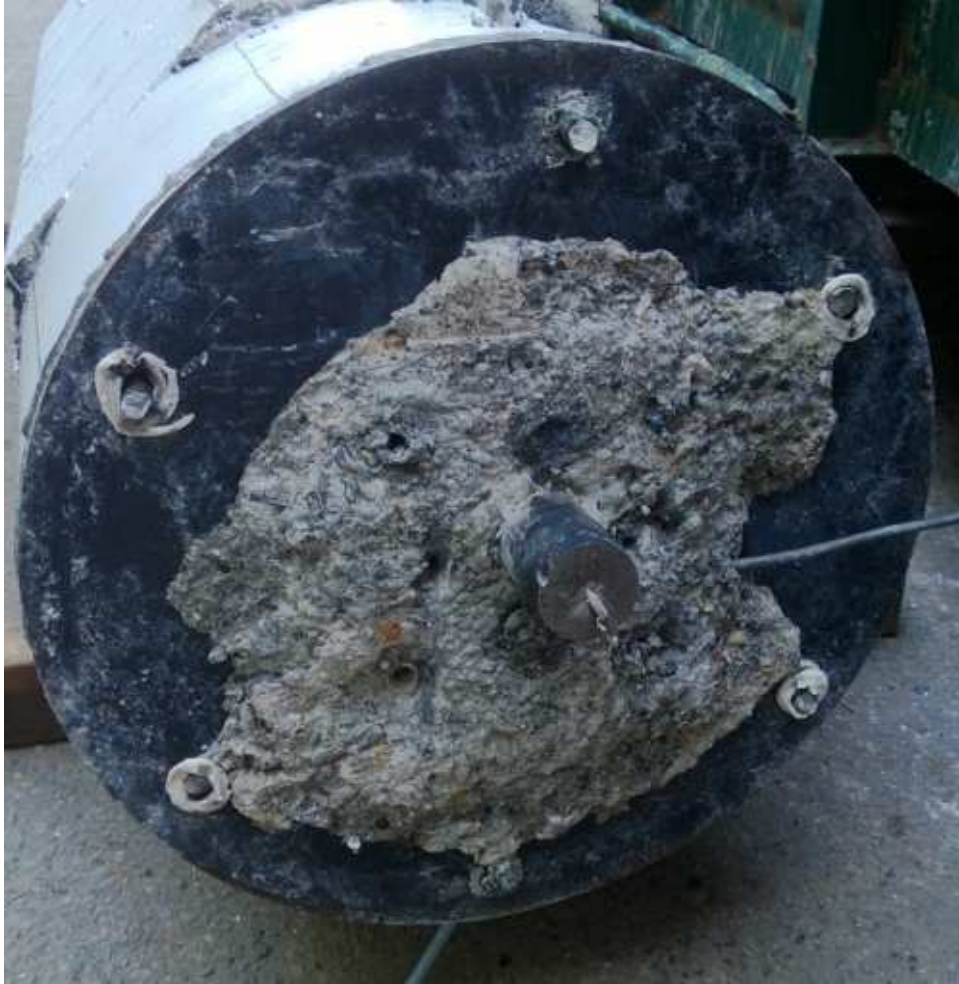
**Figure C.6** Bottom of shoe after testing.

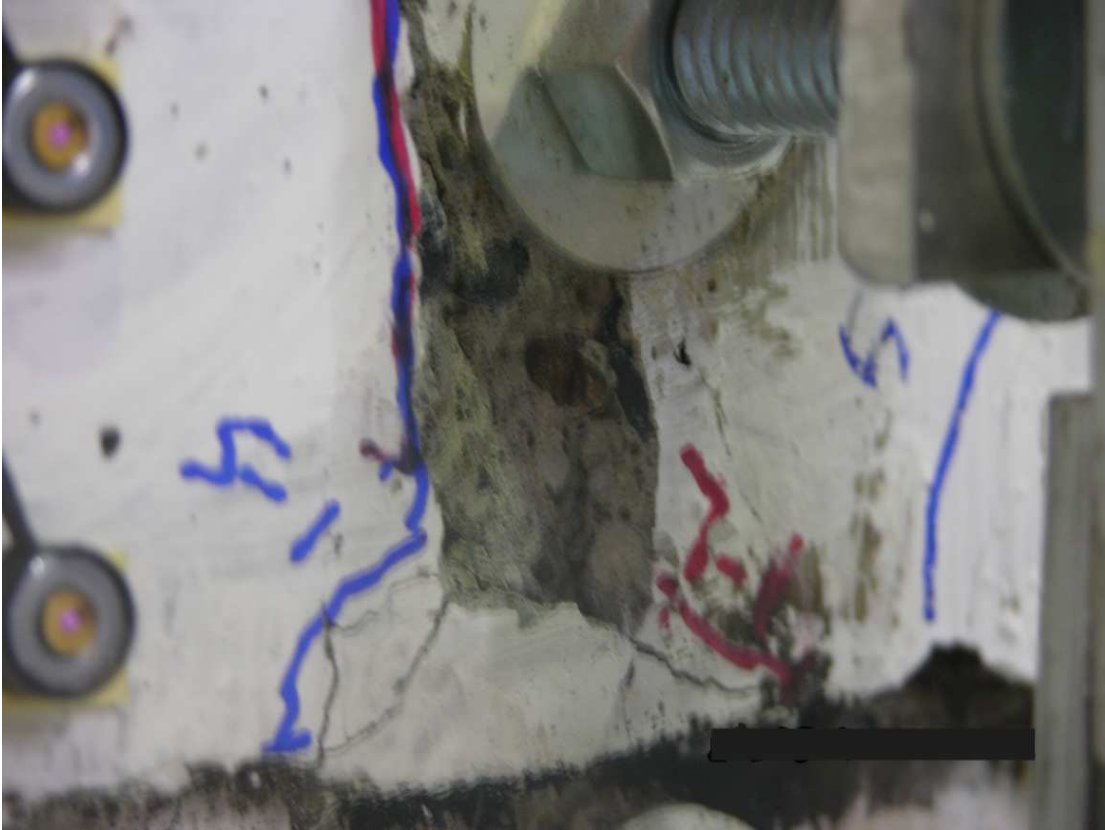
**Figure C.9** Cosmetic spalling at top of shoe.

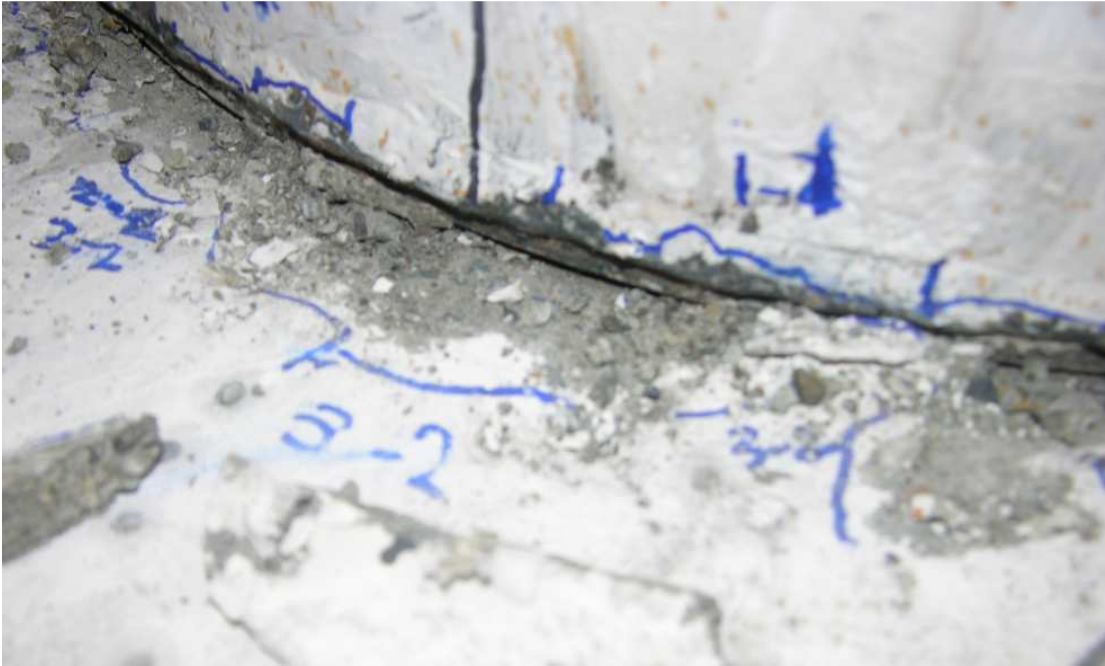
**Figure C.10** Footing fillet-spalling.

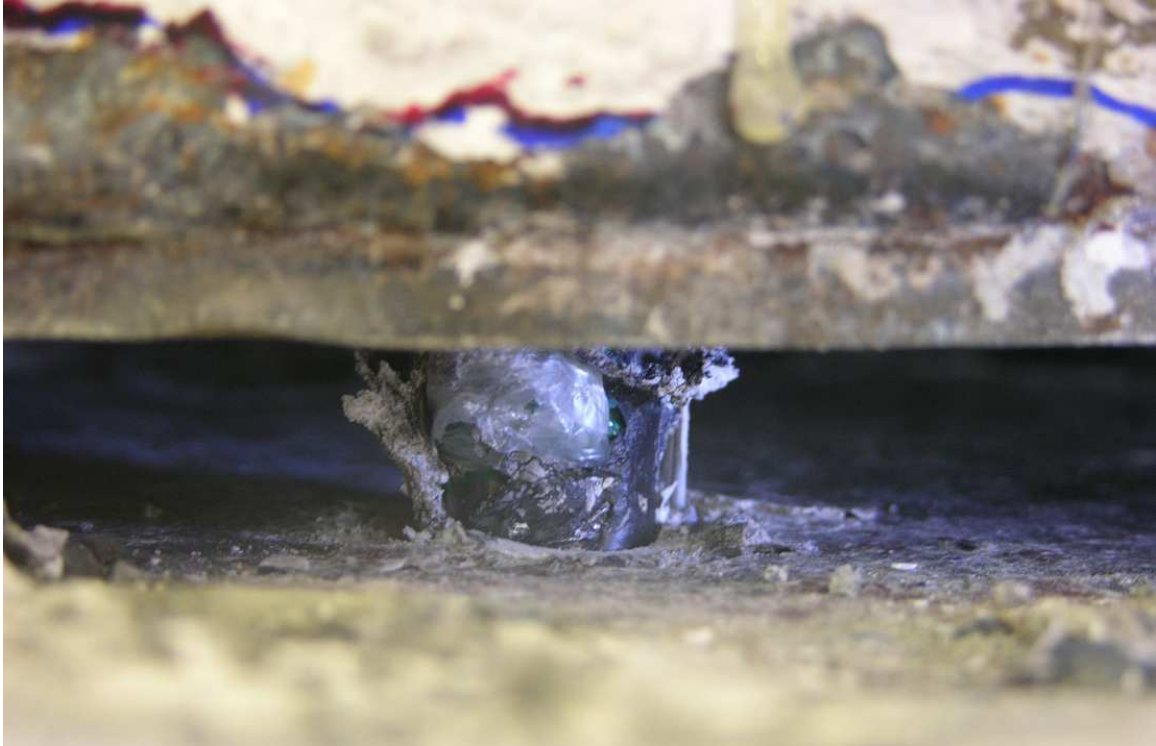
**Figure C.11 Exposure of rebar.**

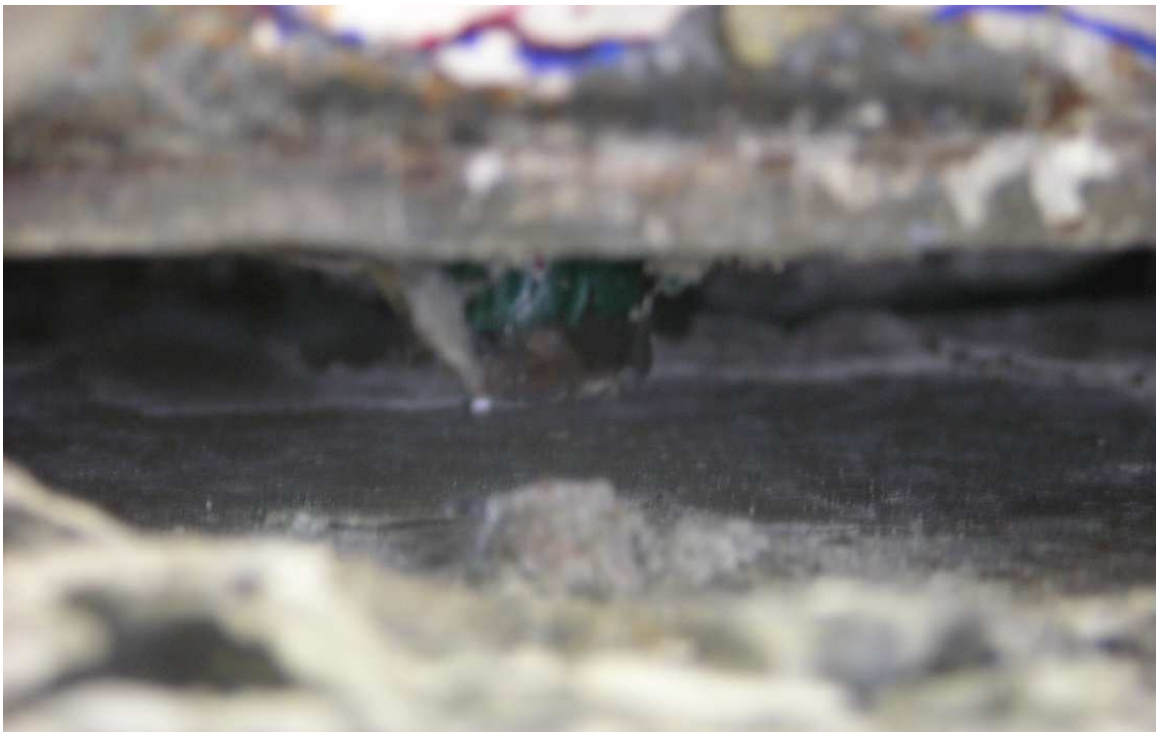
**Figure C.12 Fracture of rebar.**
