A RC Slab to CFT Column Connection for Improved Seismic Behavior of Multi-  
Story Buildings

A thesis

Master of Science in Civil Engineering

University of Washington

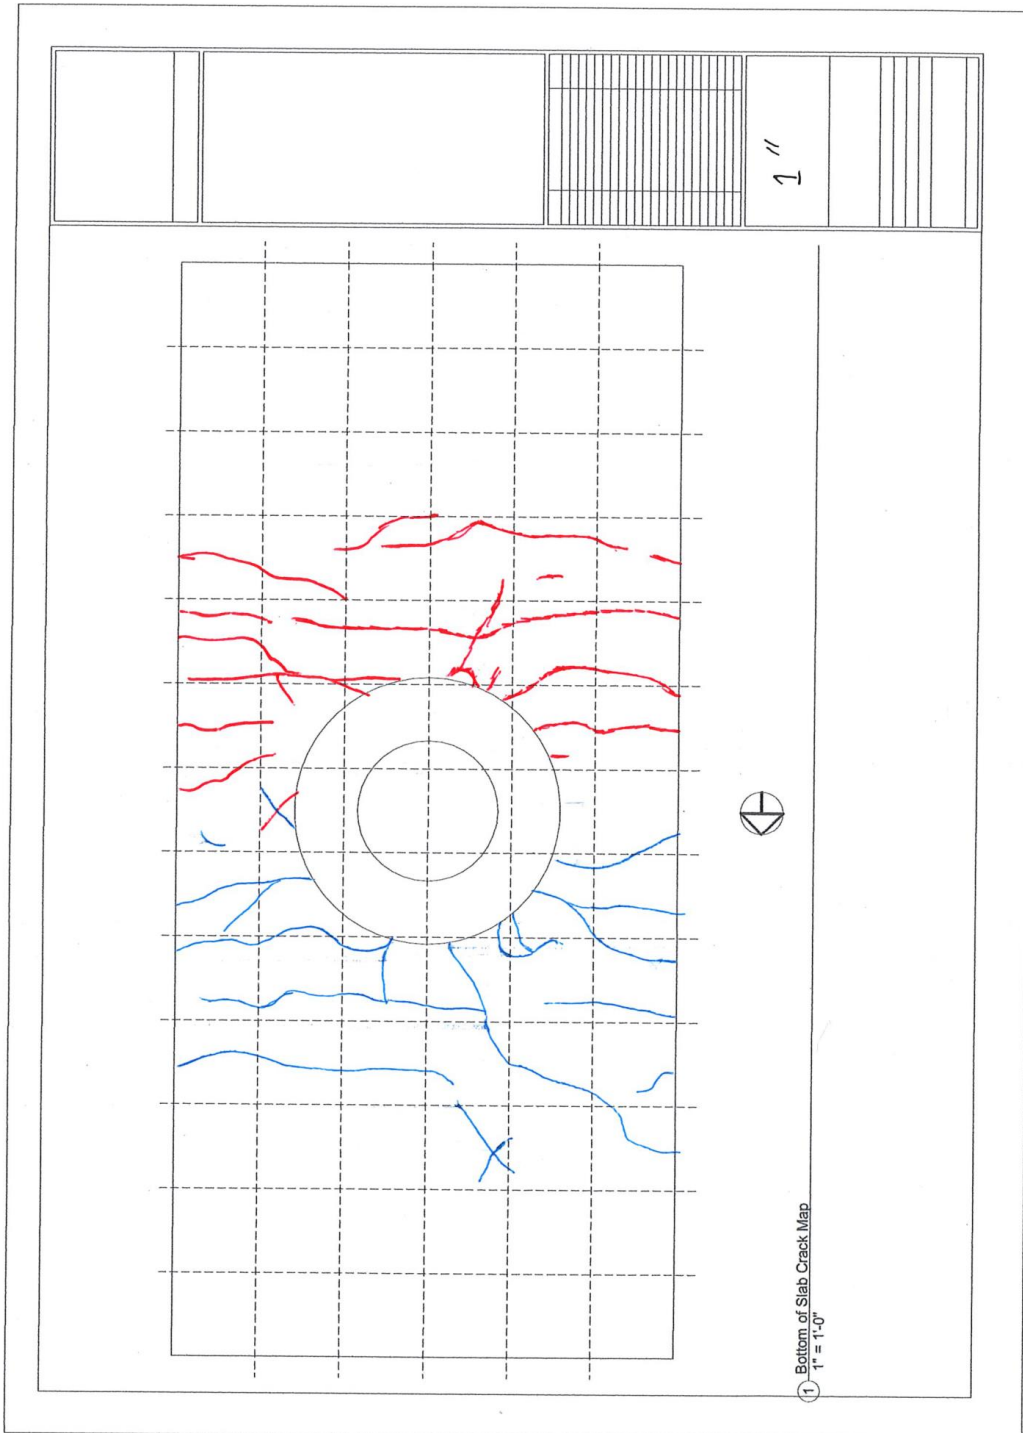
**Figure 67: Bottom of Slab Crack Map– 0.63/-0.64% Drift (PTB\_9\_2\_0)**

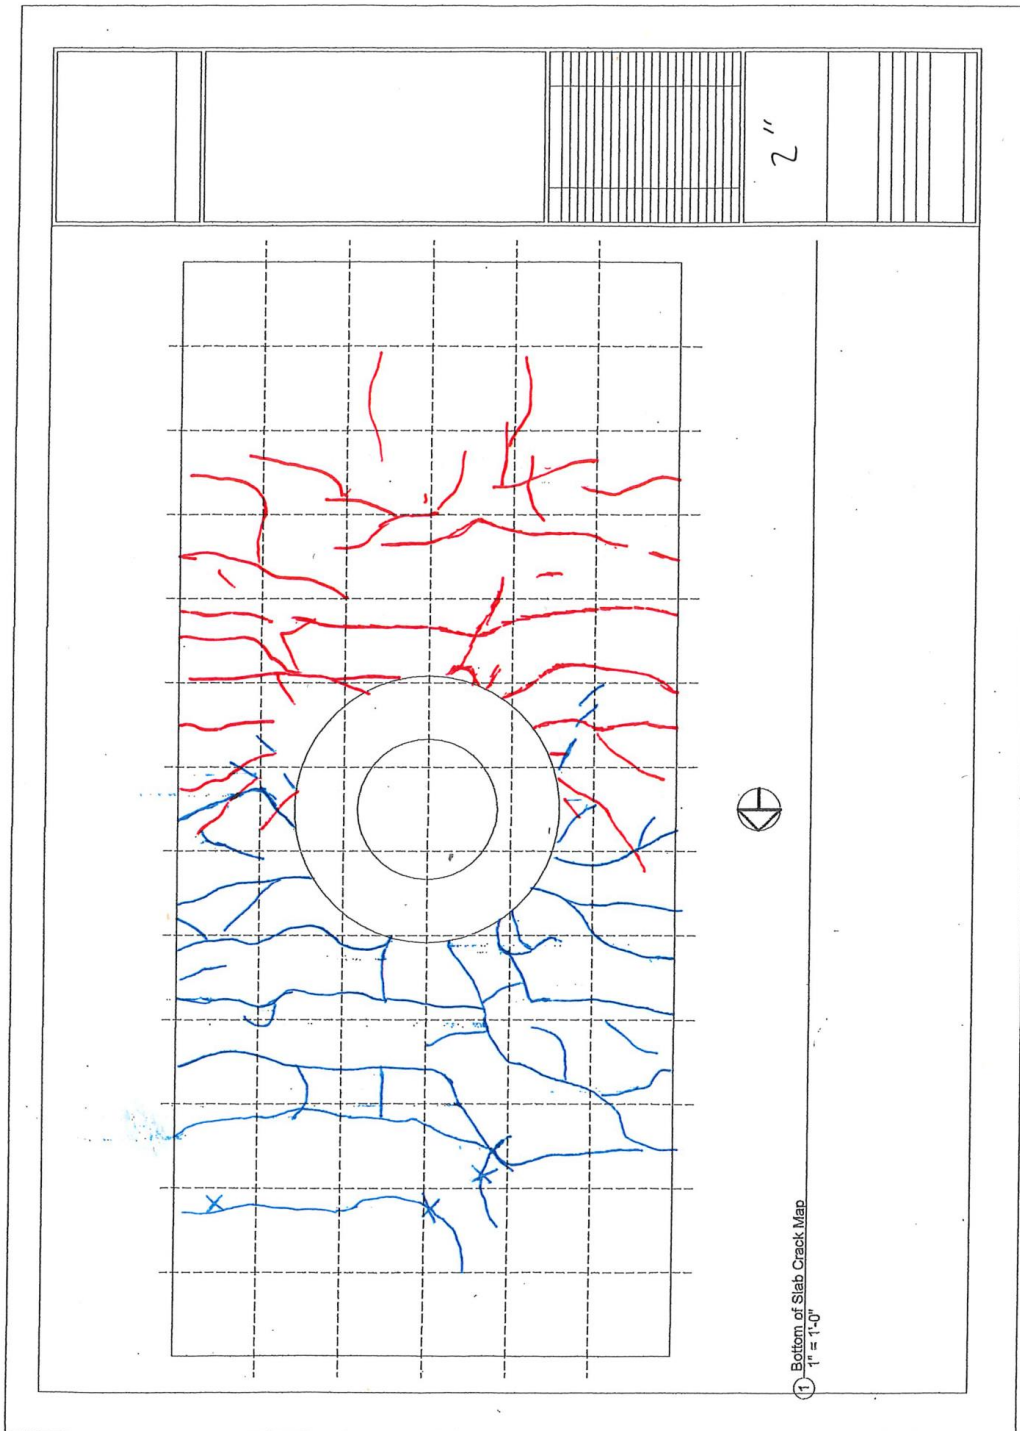
**Figure 69: Bottom of Slab Crack Map– 1.3/-1.3% Drift (PTB\_9\_2\_0)**
