Inelastic Behavior of Direct RC Column to CFST Pile Connections

A thesis

Master of Science in Civil Engineering

University of Washington

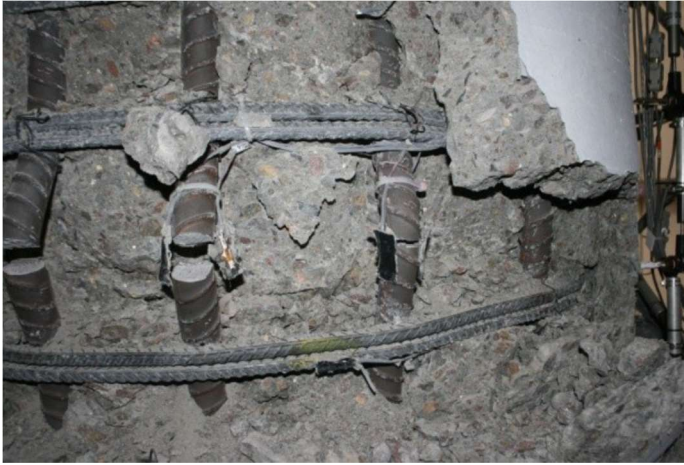
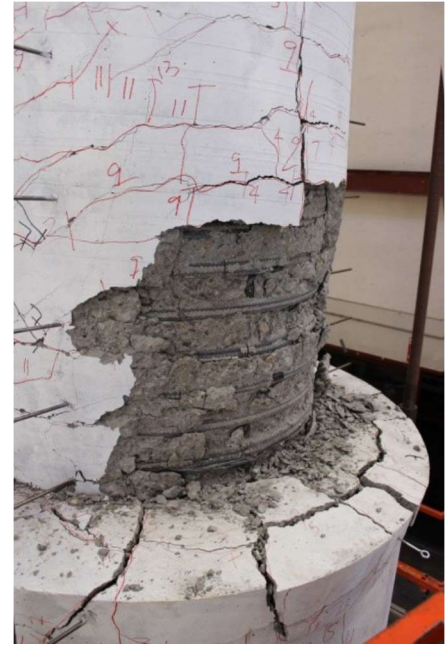
Figure 2.7. Liu (2012) Buckling and Fracture of Longitudinal Bars: a) Specimen 1 and b) Specimen 2

Both tests were stopped after bar fracture occurred in the longitudinal reinforcement, shown in Figure 2.7. This occurred at cycle 14, (10.4 in. to -13.95 in.) for Specimen 1 and cycle 18 (21.54 in. to 22.46 in.) for Specimen 2.

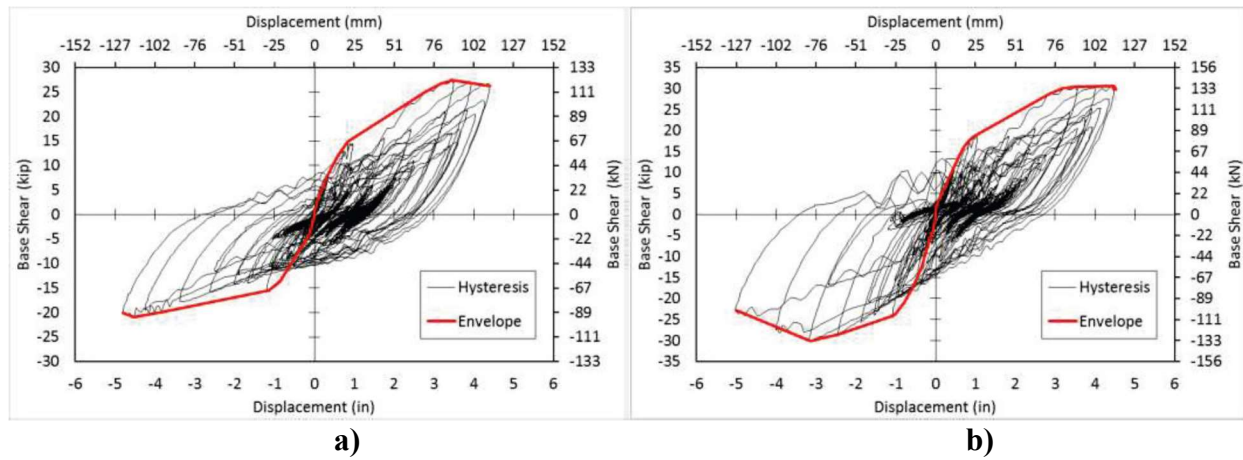
Figure 2.14. Mehraein (2016) Force-Displacement Curve a) BPSA CIP and b) BPSA PC

displacement curve and the BPSA PC force-displacement curve are shown in Figure 2.14. The final state of the connection is shown in Figure 2.15.

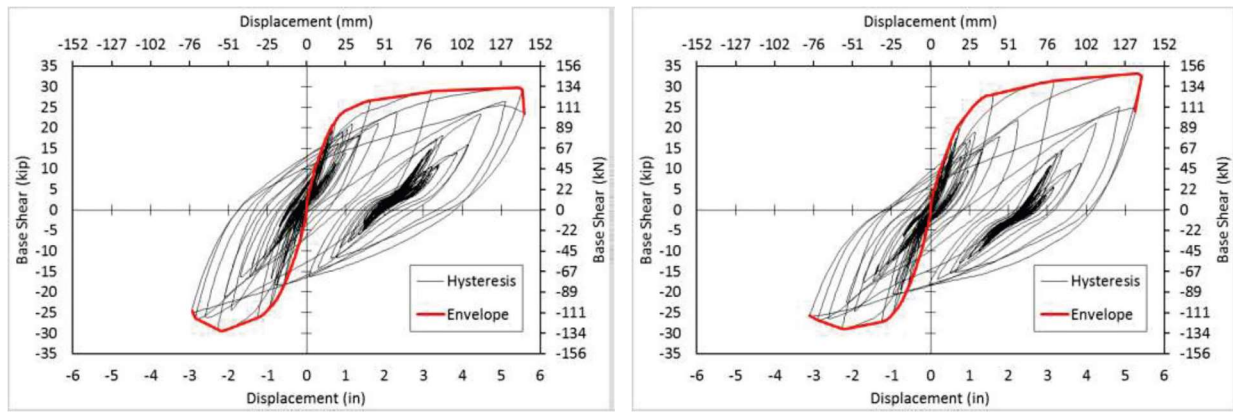
Figure 2.16. Mehraein (2016) Force-Displacement Curve a) BRSA CIP and b) BRSA PC

did not grow with the remaining runs. The BRSA CIP and the BRSA PC force-displacement curves are shown in Figure 2.16. The final state of the connection is shown in Figure 2.17.

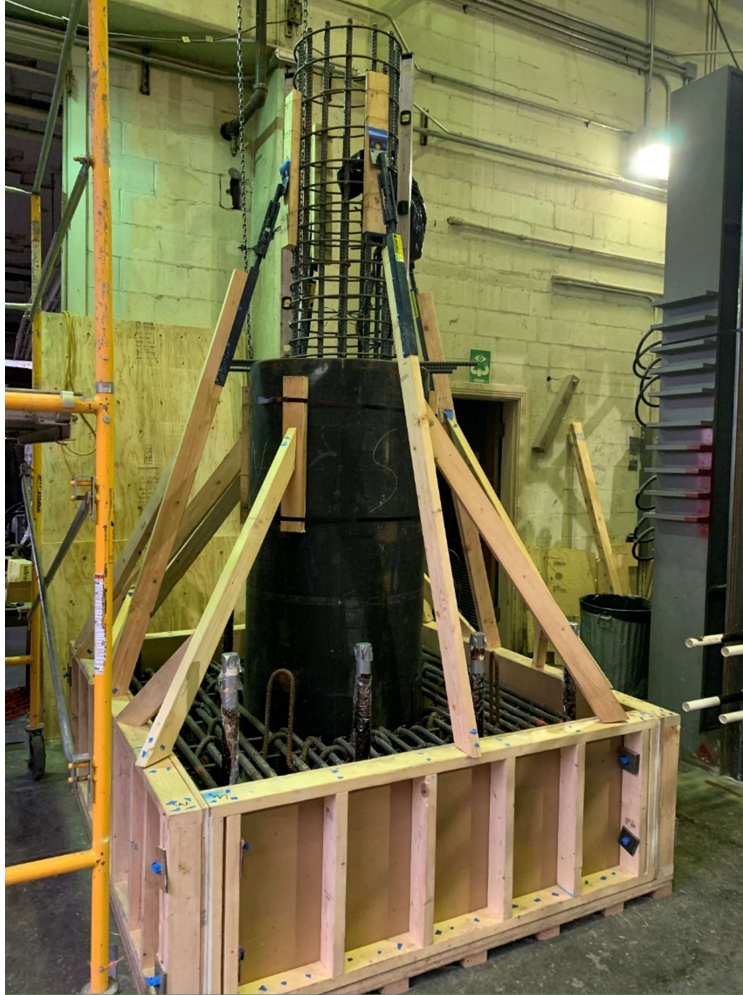
Figure 3.3. Specimen 30-21 Reinforcement

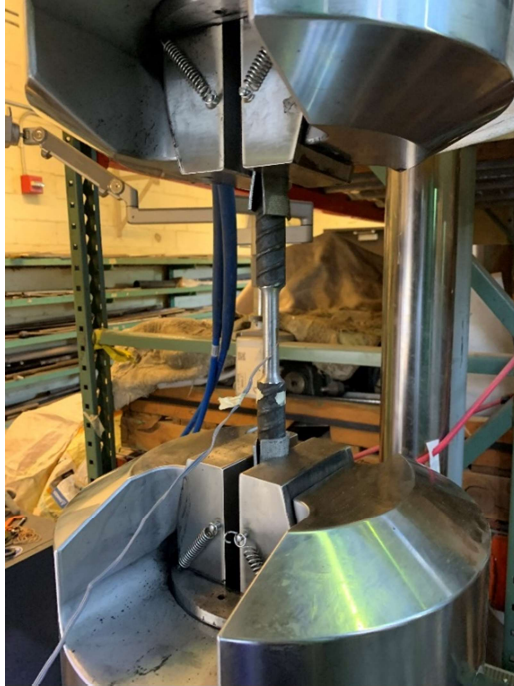
Figure 3.6. Reinforcement Tensile Test Setup

The reinforcement was expected to yield from the lateral loading during the test. To determine the actual stress-strain relation of the reinforcement, steel from the longitudinal column reinforcement was tested in tension to ASTM 370 standards. The test setup is shown in Figure 3.6. The stress-strain relationship of the reinforcement was characterized using the stress and strain at the Yield, Ultimate, and Fracture points, which are shown in Table 3.4 below.

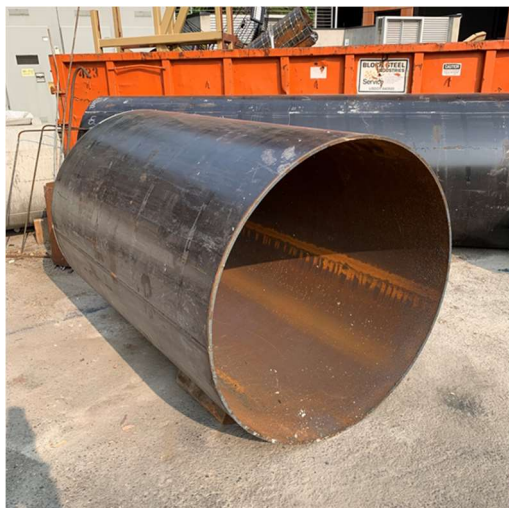
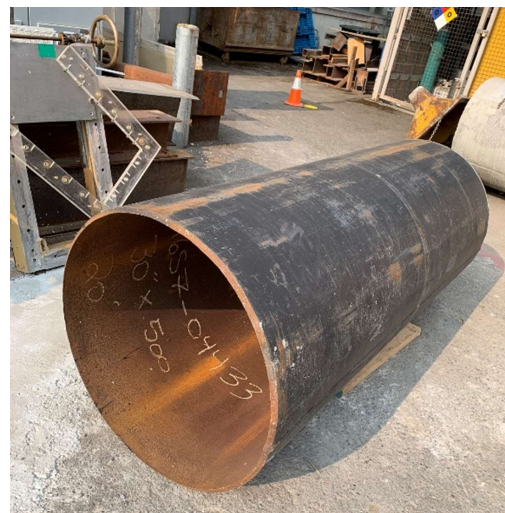
Figure 3.7. a) 48 in. and b) 30 in. Diameter Steel Tubes Cut to Size

The straight seam welded steel tubes are API 5L X52 for the 30 in. diameter tube, a 52 ksi yield strength, and API 5LB X42 for the 48 in. diameter tube, a 42 ksi yield strength. Tubes were purchased from Richards Pipe & Steel, Inc. in Pacific, Washington.

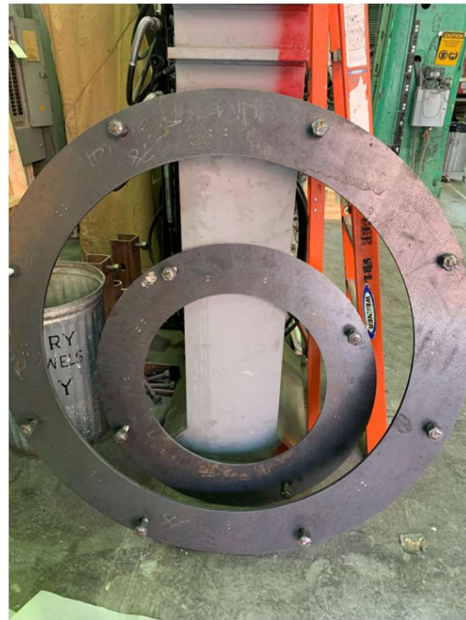
Figure 3.8. Annular Rings for Specimens 30-21 and 48-21

The rings were purchased from and manufactured by Bloch Steel in Seattle, Washington. They are A572 Gr. 50 steel. The rings were fillet welded to the tubes using a 5/64 in. diameter Coreshield 8 E70 welding electrode. All structural welding was performed by a certified welder.

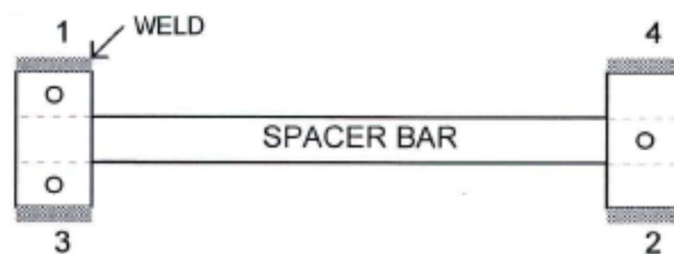
Figure 3.14. Welding Sequence for the Mounting Blocks (Geokon, 2010)

To attach the Model 4000 VWGs to the pile, first, the mounting blocks were attached with spacer bars and tack welded to the tube, as shown in Figure 3.14, however for these tests the VWG was oriented vertically, not horizontally. Second, the Model 4000 vibrating wire strain gauges were inserted into the mounting blocks. The bottom end of the gauge was first slid through the top mounting block. The end of the strain gauge which had a V-groove in it was inserted into the mounting block that only had one set screw, and the screw was tightened hard. Third, the coil and thermistor housing were then attached to the center of the gauge, secured with a hose clamp. Fourth, the bottom end of the gauge, after making sure all readings were in the usable range of the strain gauge, was screwed into the other mounting block. Finally, the mounting blocks were tapped with the handle of a screwdriver to remove any installation strains and stabilize the reading.

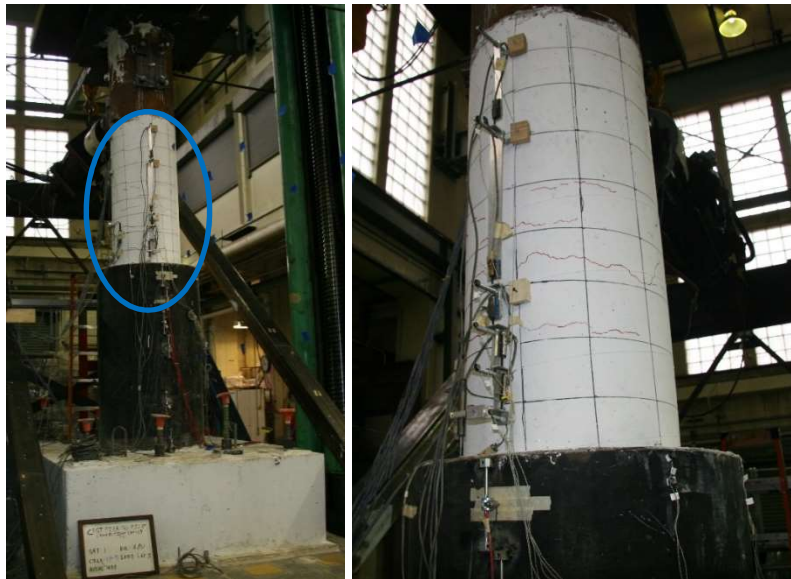
Figure 4.10. Specimen 30-21 Horizontal Cracks on North Column Face

Small horizontal cracks, less than 0.5 mm in width, formed along the height of the column during this cycle, primarily on the northern and southern faces of the column, as shown in Figure 4.10.

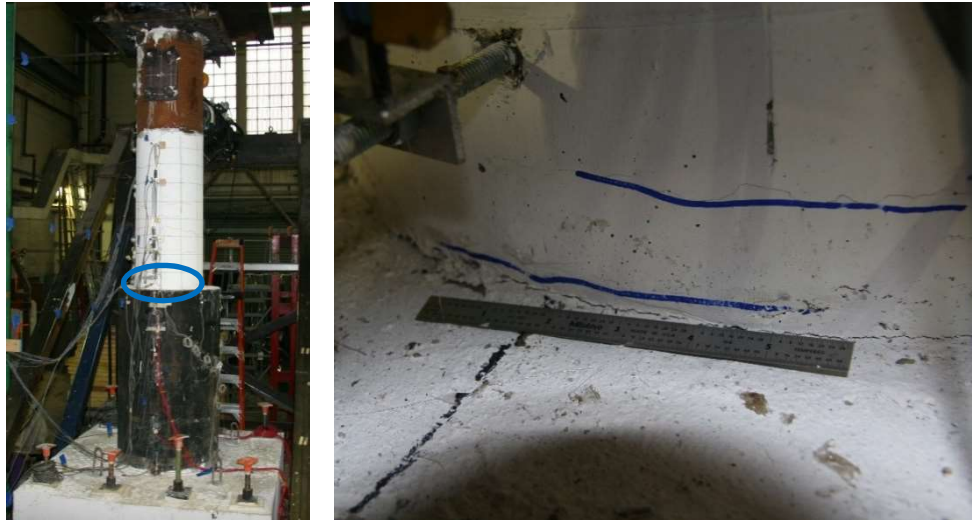
Figure 4.13. Specimen 30-21 Interface Cracks on Southern Face at 0.9% Drift

Horizontal cracks formed along the height of the column on both the north and south sides. The cracks, at the interface of the column and the top of the pile, ranged in width from 0.3mm to 0.5mm, shown in Figure 4.13.

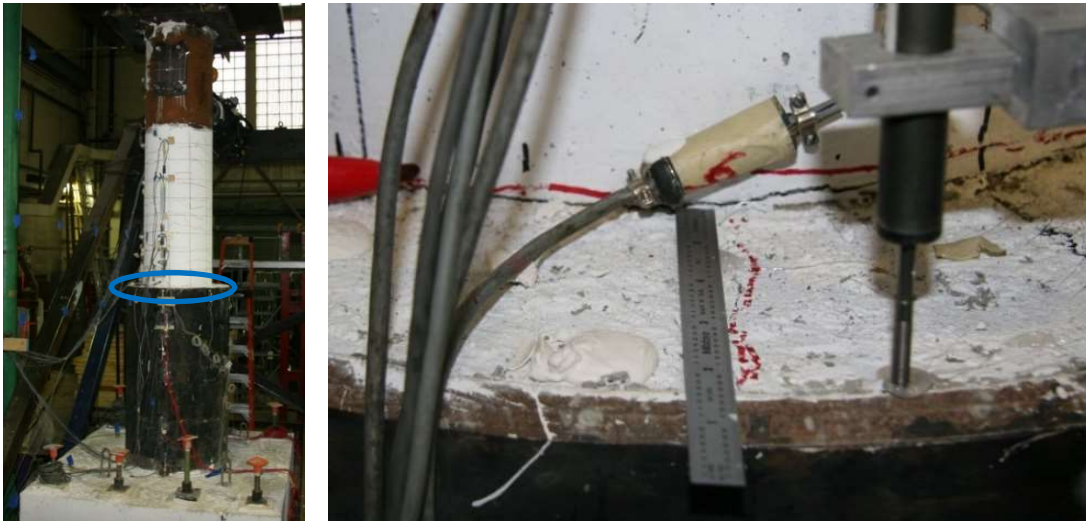
Figure 4.15. Specimen 30-21 Radial Cracks on North Face of Column

Radial cracks formed at three different locations on the top of the pile, going from the perimeter of the pile to the column, shown in Figure 4.15.

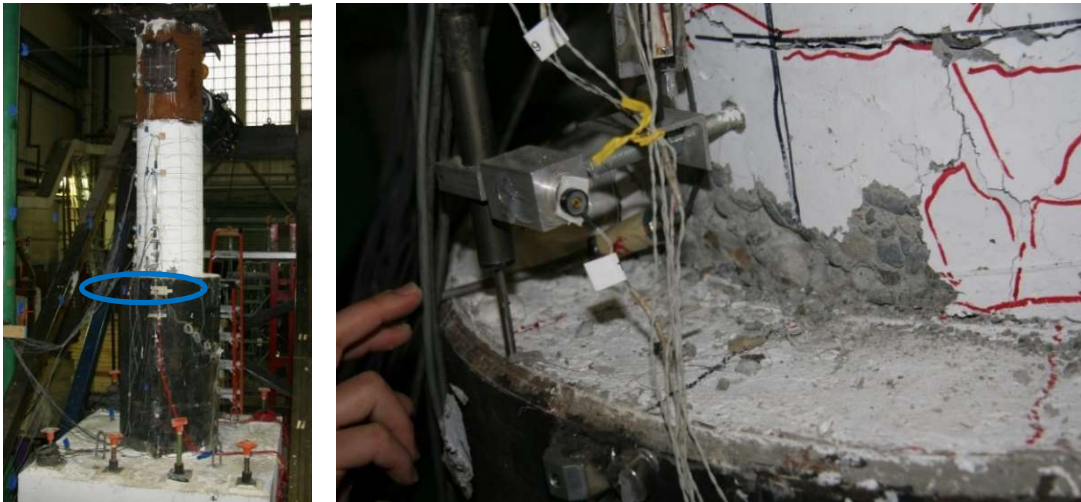
Figure 4.18. Specimen 30-21 Initial Spalled Region on North Face at 2.2% Drift

Spalling occurred at the bottom 2.5 in. of the column, but no reinforcing bars were exposed. The horizontal cracks increased to a maximum width of 2 mm, shown in Figure 4.18, with the largest cracks being at the interface of the column and the top of the pile, with the largest crack width being 1.75 mm.

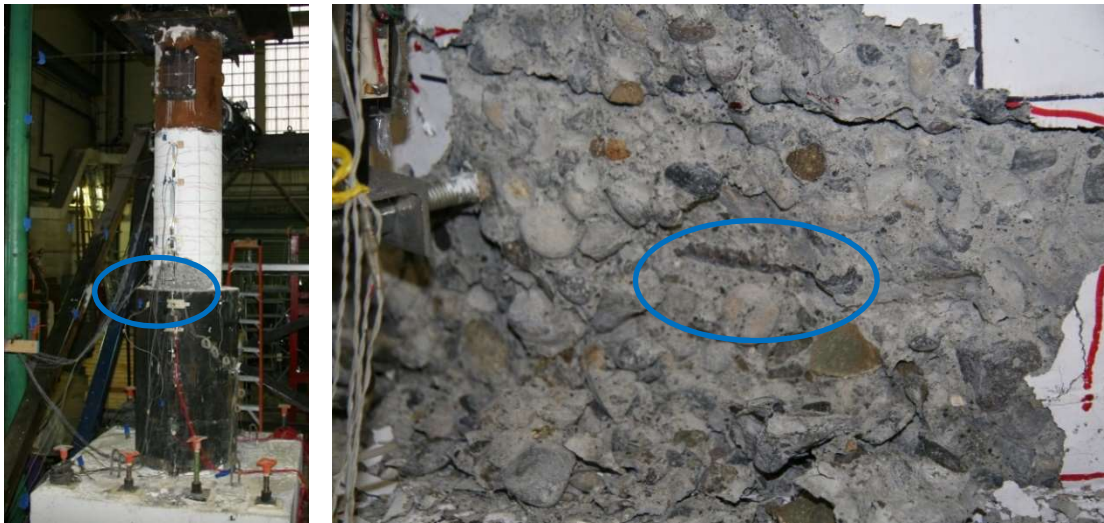
Figure 4.21. Specimen 30-21 Spalled Region on Northern Column Face at 3.7% Drift

The crack widths at the column base continued to increase to a maximum width of 3 mm. The spalling increased to the point where transverse reinforcement, #3 hoops located approximately 3 in. from the base of the column, was exposed on the second cycle, shown in Figure 4.21.

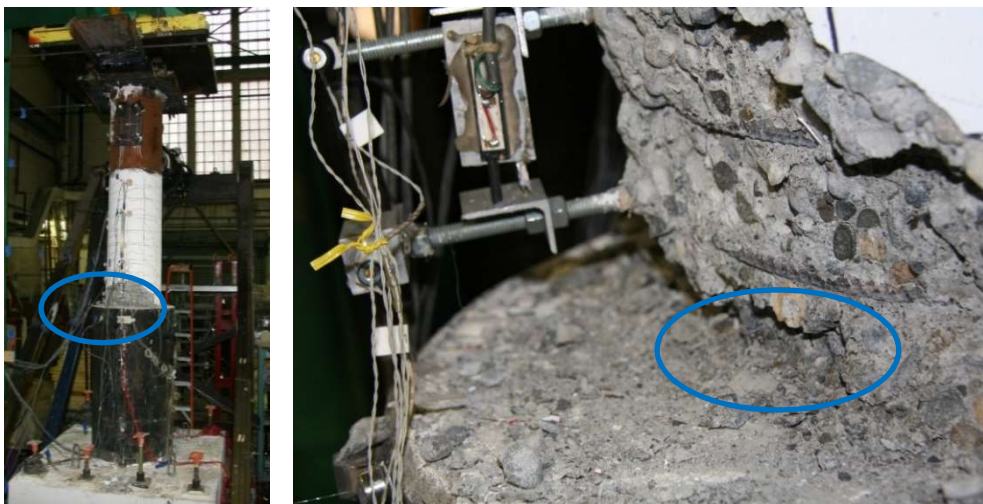
Figure 4.24. Specimen 30-21 Exposed Longitudinal Reinforcement on South Face

The spalled region increased to $0.50D_{COL}$ (10 in.) above the base of the column and multiple transverse reinforcement bars and the first longitudinal reinforcement were exposed on the northern face of the column, shown in Figure 4.24. There was a 3 mm wide crack at the interface of the column and the top of the pile.

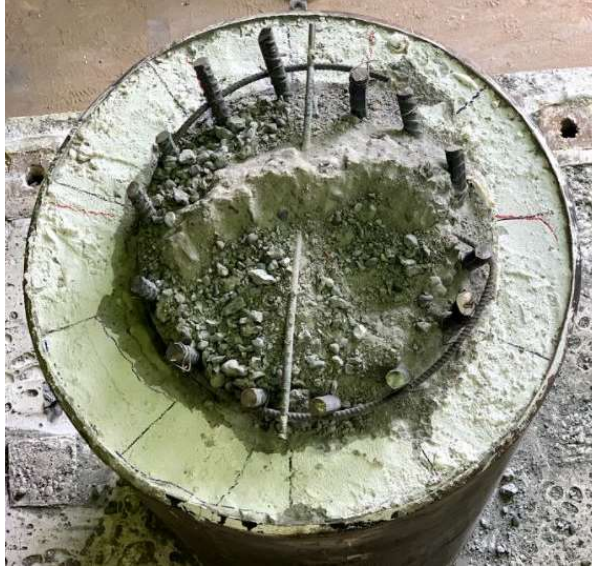
Figure 4.31. Top of Specimen 30-21 Pile with Column Removed

Throughout all load cycles, the pile and transfer block showed no visible damage. There was no buckling or yielding of the pile. The largest measured tube strain was 0.0006 in/in, which occurred at 52 in. below the top of the tube, during the 3.7% drift cycles. There was no noticeable slip between the pile concrete in comparison to the edge of the steel tube at any point of the test. No cracks formed anywhere on the transfer block. After the test was finished, the column was removed from the top of the pile. As shown in Figure 4.31, except for the radial cracks and minor concrete damage around the base of the column, the top of the pile concrete appears to be largely undamaged.

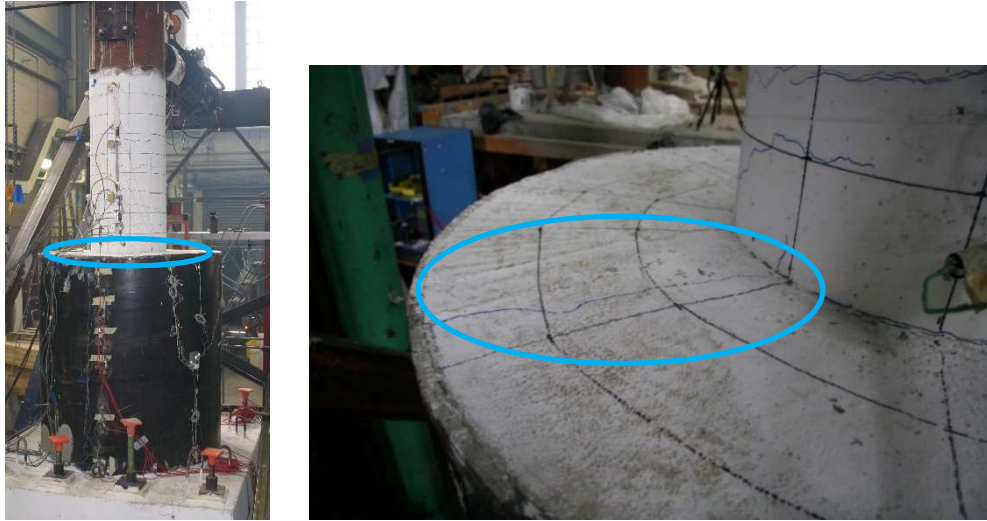
Figure 4.39. Specimen 48-21 Radial Cracks on Top of Pile Concrete at 0.8% Drift

The already formed horizontal cracks continued to propagate circumferentially. The maximum width measured was 0.7 mm. New horizontal cracks formed 40 in. above the column base. Radial cracks were also measured at this displacement on the top of the pile shown in Figure 4.39. The radial cracks had a maximum width of 0.8 mm. From this point on additional radial cracks did not form and the already formed radial cracks did not expand in width.

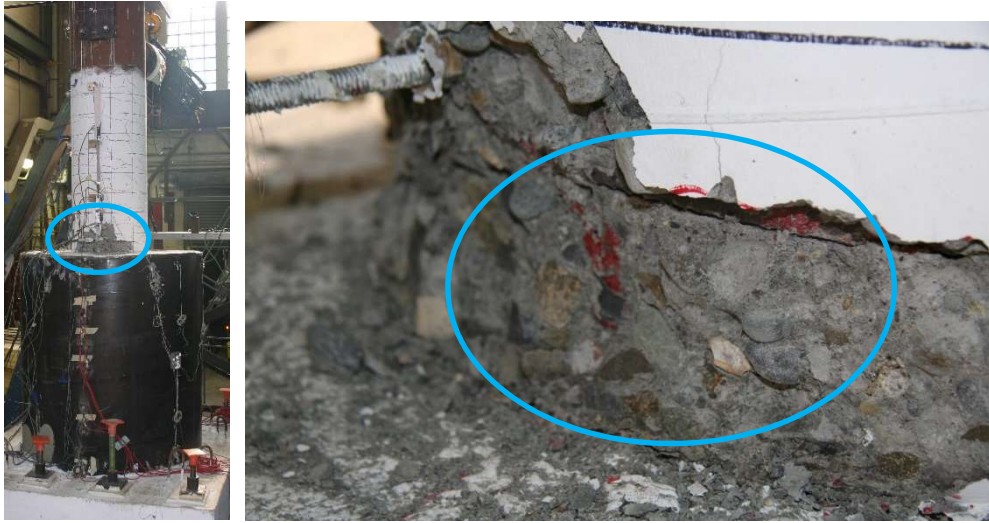
Figure 4.51. Specimen 48-21 Exposed Transverse and Longitudinal Reinforcement at 4.1% Drift

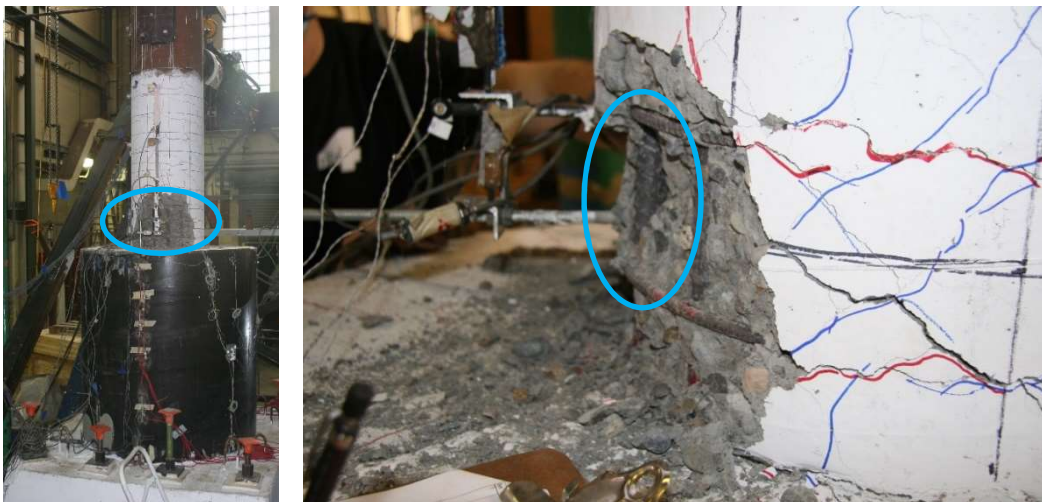
Figure 4.54. Specimen 48-21 Buckled Longitudinal Reinforcement at 5.8% Drift

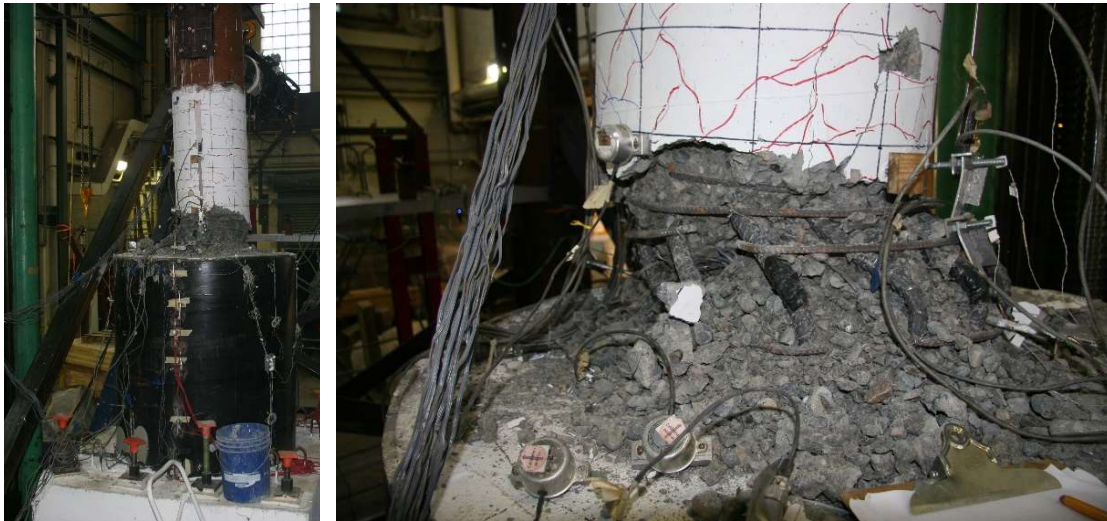
Figure 4.57. Final State of Specimen 48-21 after 9.7% drift

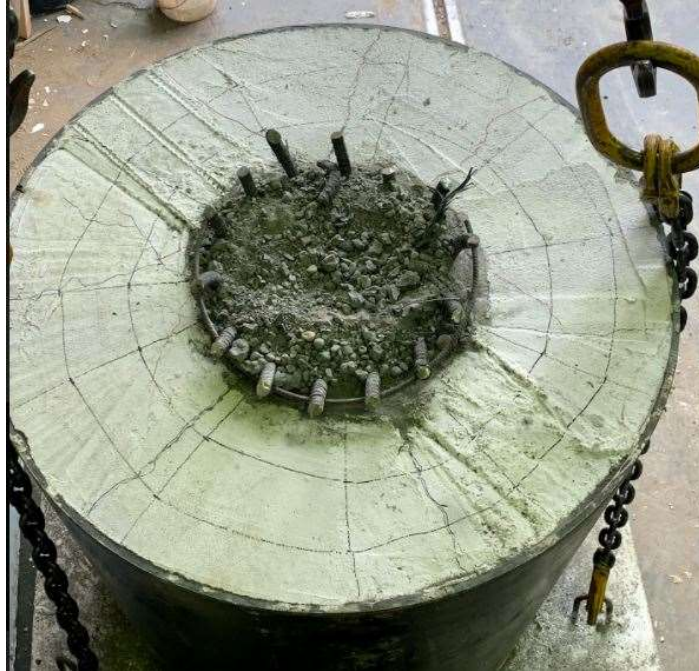
Figure 4.58. Top of Specimen 48-21 Pile with Column Removed

Throughout all load cycles, the pile and transfer block showed no visible damage. There was no buckling or yielding of the pile, with the largest measured strain being 0.00017 in/in, which occurred at 52 in. below the top of the tube, during the 4.1% drift cycles. No cracks formed anywhere on the transfer block. A 3 in. section of the transfer block did break off when moving the specimen onto the testing rig and was not related to the actual testing of the specimen. There was no noticeable slip between the pile concrete in comparison to the edge of the tube at any point of the test. As shown in Figure 4.58, except for the radial cracks, the top of the pile concrete appears largely undamaged.

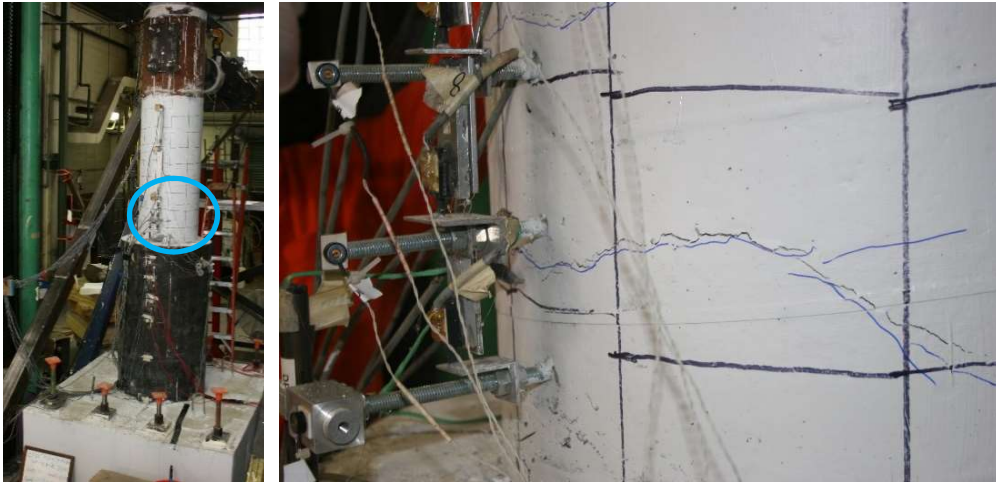
Figure 4.73. Specimen 30-21-R Column Northern Face crack at 1.75% Drift

The measured cracks widened noticeably to a maximum width of 1.0 mm. The largest cracks were located on the northern and southern faces, both 6 in. from the base of the column, as shown in Figure 4.73. During the zero-force displacements at this cycle, the southern cracks were

not visible at all, but the northern cracks 6 in. from the base of the column were visible and had a width of 0.4 mm.

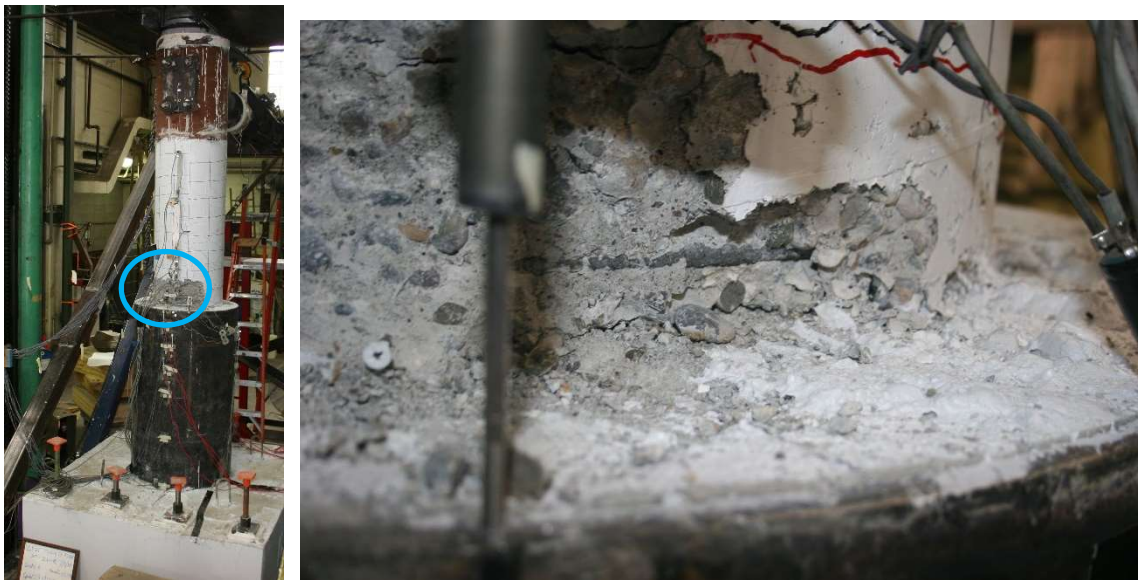
Figure 4.79. Specimen 30-21-R Exposed Transverse Reinforcement at 4.0% Drift

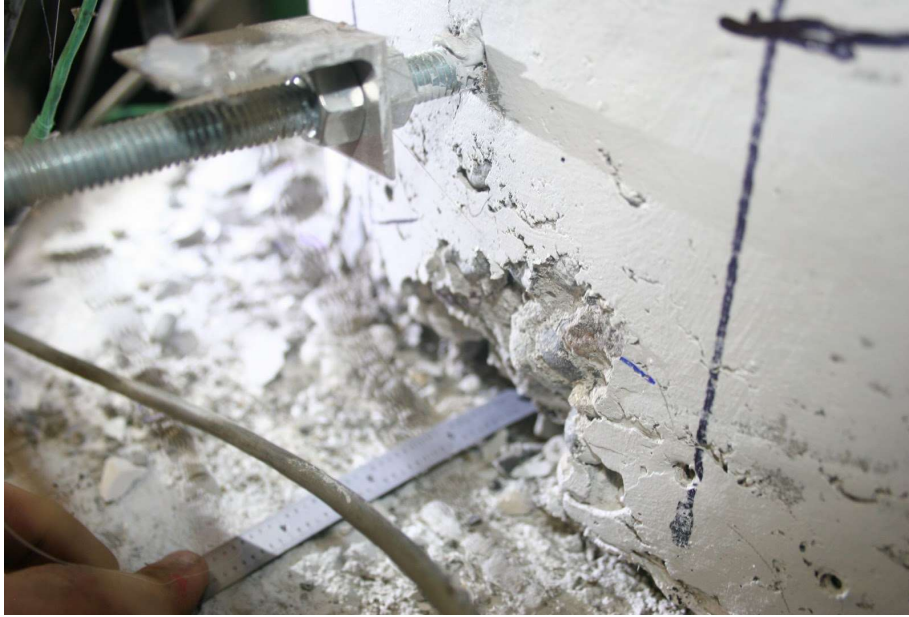
Figure 4.80. Specimen 30-21-R 2 in. Deep Crack at Northern Base of Column at 4.0% Drift

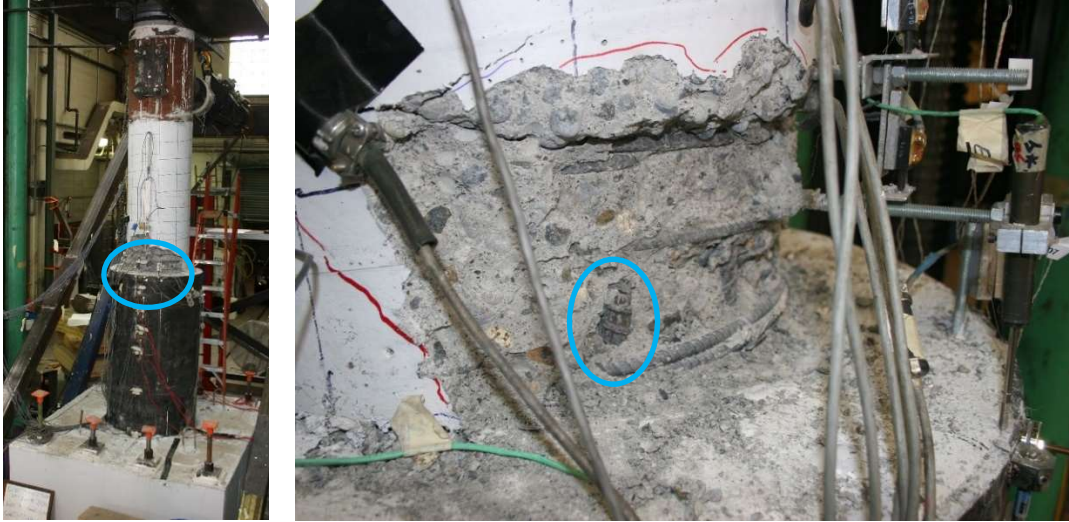
Figure 4.83. Specimen 30-21-R Exposed Northern Longitudinal Reinforcement at 5.5% Drift

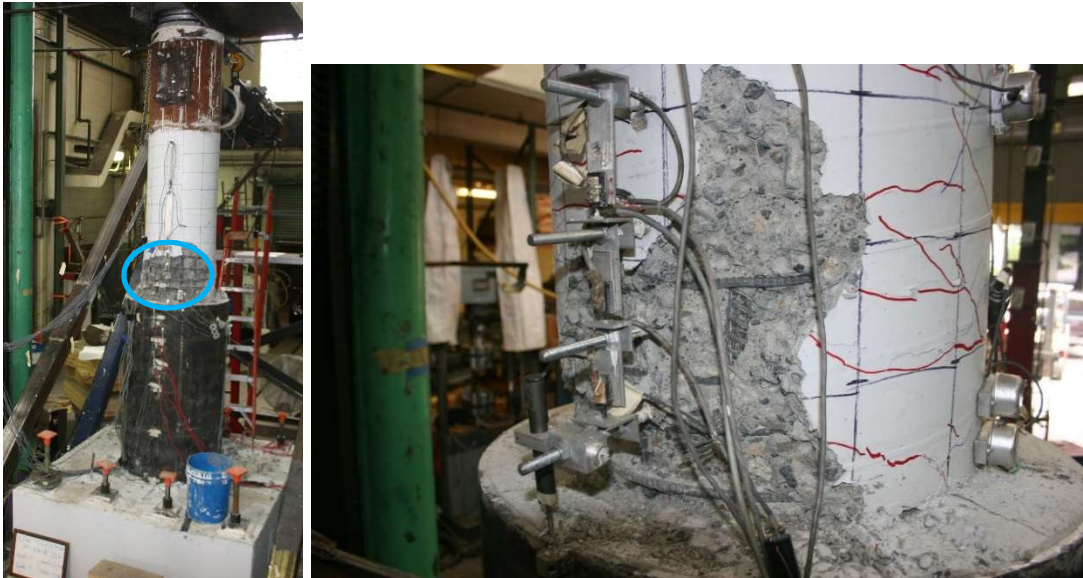
Figure 4.85. Specimen 30-21-R South Face Buckled Longitudinal Reinforcement Bars at 8.9% Drift

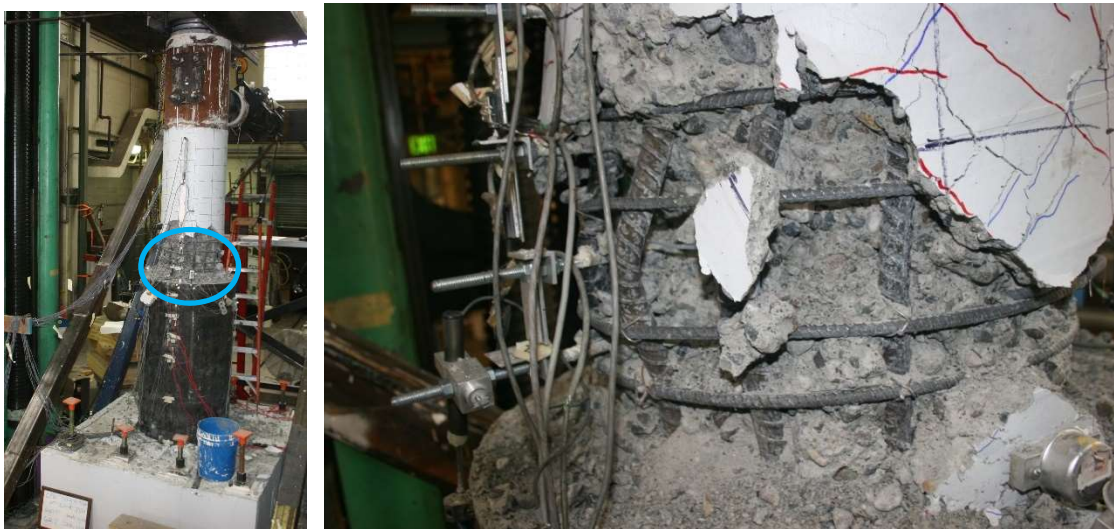
Figure 4.89. Specimen 30-21-R Base of Column at 9.3% Drift

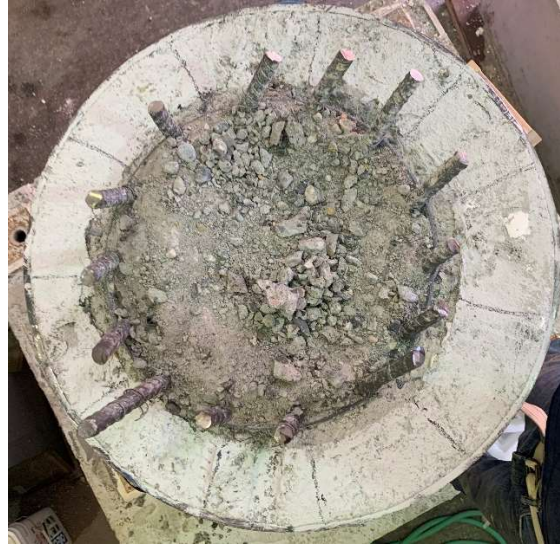
Figure 4.91. Top of Specimen 30-21-R Pile with Column Removed

Throughout all load cycles, the pile and transfer block showed no visible damage. The largest measured strain in the pile was 0.008 in/in, which occurred 52 in. below the top of the tube, during the 4.0% drift cycles. No cracks formed anywhere on the transfer block. There was no noticeable slip between the pile concrete in comparison to the edge of the tube at any point of the test. The Duncan potentiometer measuring the slip had a maximum uplift of 0.003 in. As shown in Figure 4.91, the top of the pile concrete appears largely undamaged. Unlike Specimens 30-21 and 48-21, no radial cracks formed on the top of the pile concrete.

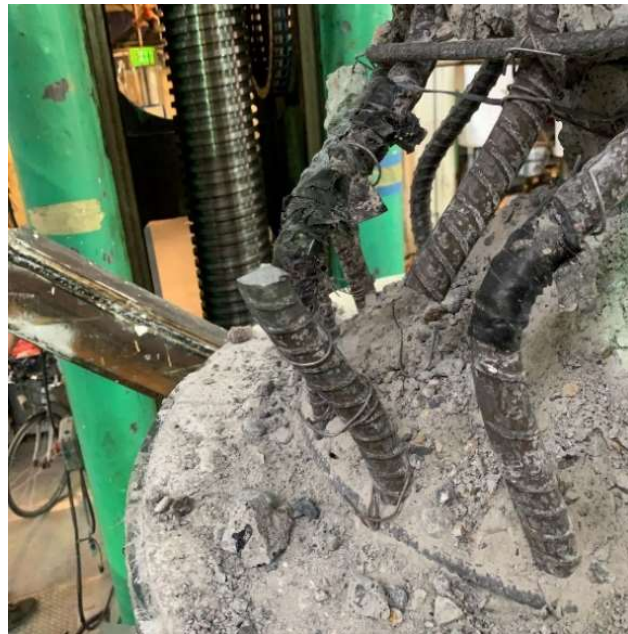
Figure 4.92. Specimen 30-21-R Fractured Longitudinal Reinforcement

The day after the test, when working on removing the specimen from the testing rig, it was noticed that the most extreme southern longitudinal reinforcing bar had fractured overnight. No applied loads had occurred between now and the end of testing, but the fracture was caused by the weight of the column resting overnight. The fractured bar is shown in Figure 4.92.

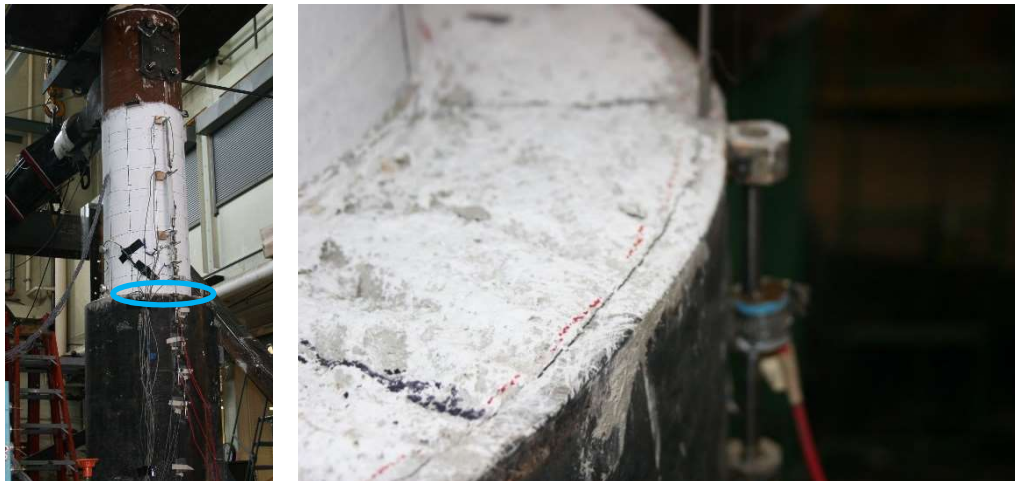
Figure 4.98. Specimen 30-21-LD Cracks at Edge of the Pile at 0.7% Drift

Horizontal cracks on the northern and southern faces formed roughly every $0.25D_{COL}$ (5 in.) going up the height of the column, with the maximum width of the cracks being 0.5 mm, which occurred $0.25D_{COL}$ (5 in.) from the base on both the North and South sides. Cracks also formed around the perimeter of the tube, which can be shown in Figure 4.98.

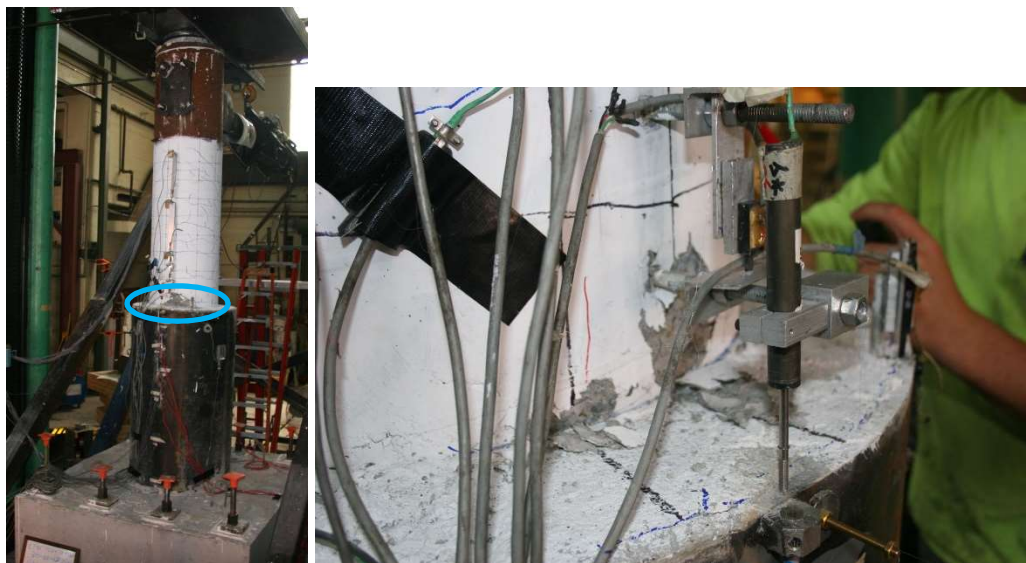
Figure 4.101. Specimen 30-21-LD 1st Spalled Region on Northern Column Face at 2.4% Drift

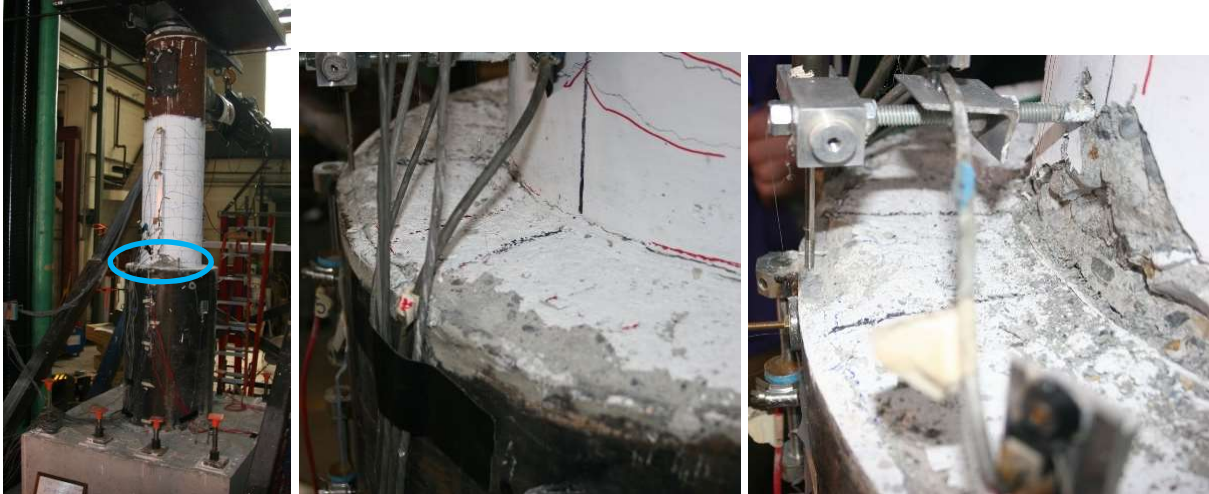
Figure 4.104. Specimen 30-21-LD a) Concrete Damage at the Edge of the Pile and b) Concrete Damage Near Base of the Column at 2.4% Drift

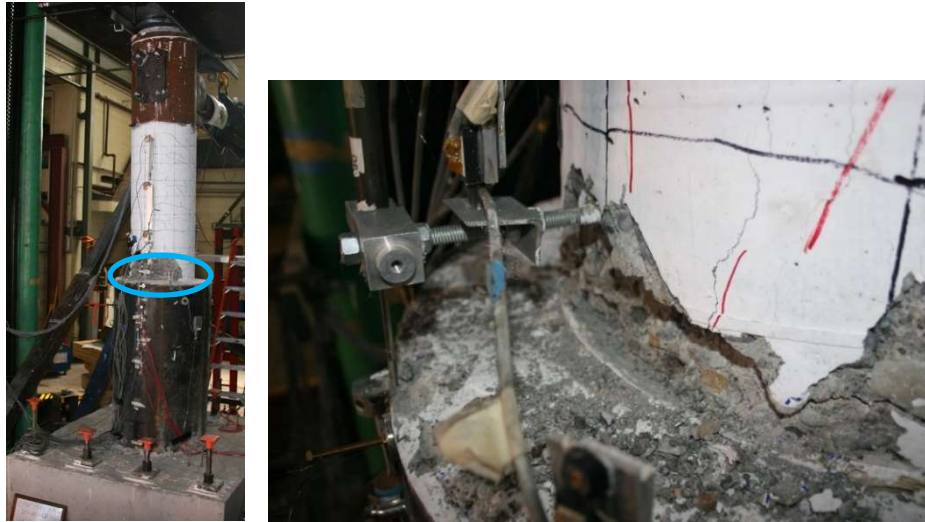
Figure 4.106. Specimen 30-21-LD Northern Column Face Spalled Region at 3.8% Drift

The cracks widened to a maximum width of 2.5 mm. The largest cracks were located on the northern and southern faces, both $0.3D_{COL}$ (6 in.) from the base of the column. The main observation during this cycle was the spalled region on the northern side increased greatly in area,

as shown in Figure 4.106. Also, a small spalled area formed on the base of the southern face of the column.

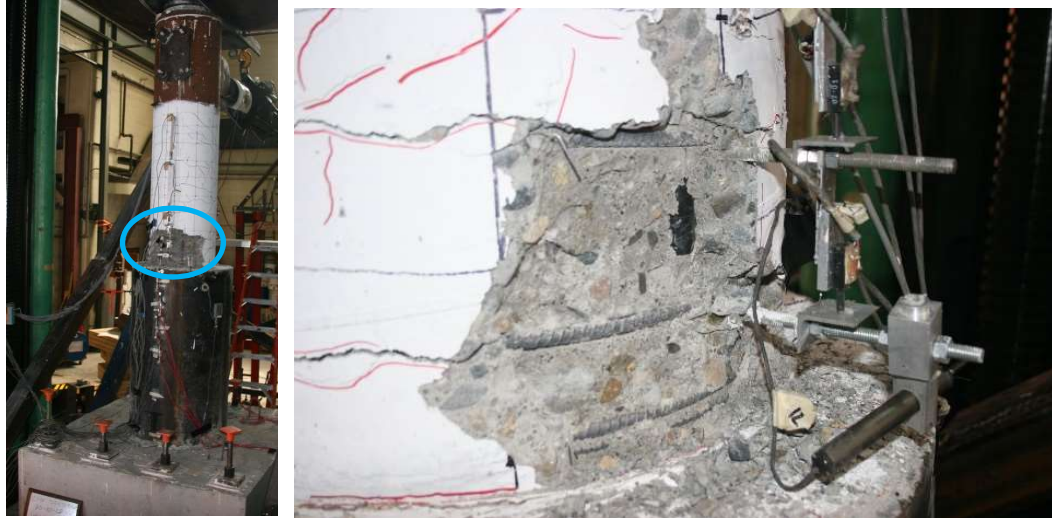
Figure 4.109. Specimen 30-21-LD Exposed Longitudinal Reinforcement at 5.5% Drift

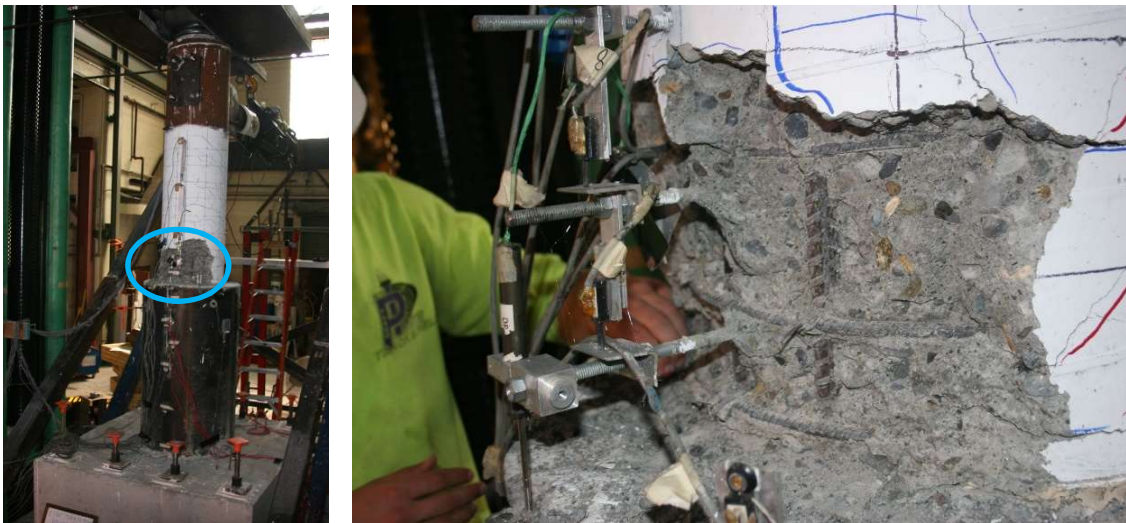
Figure 4.111. Specimen 30-21-LD Increased Spalled Region at 5.5% Drift

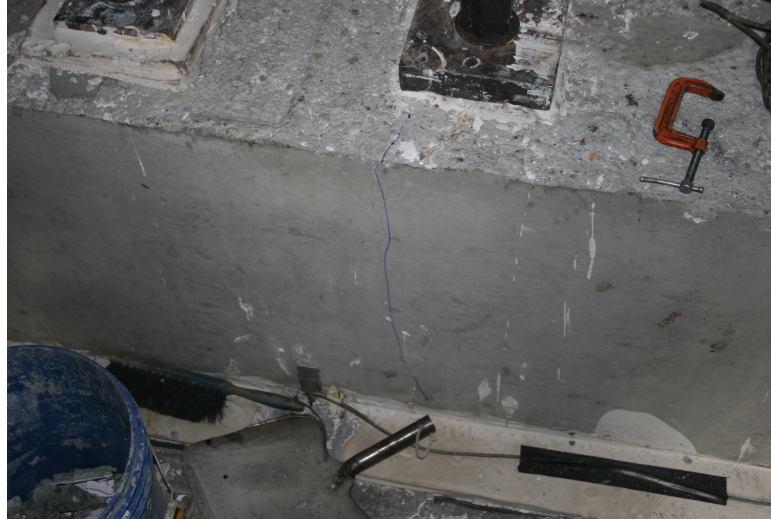
Figure 4.113. Specimen 30-21-LD Crack on Southern Side of Transfer Block

During the fourth cycle, a crack on the southern side of the transfer block was noticed extending the entire height of the transfer block, shown in Figure 4.113. There was no noticeable change in the instrumentation or results before, during, or after this was noticed.

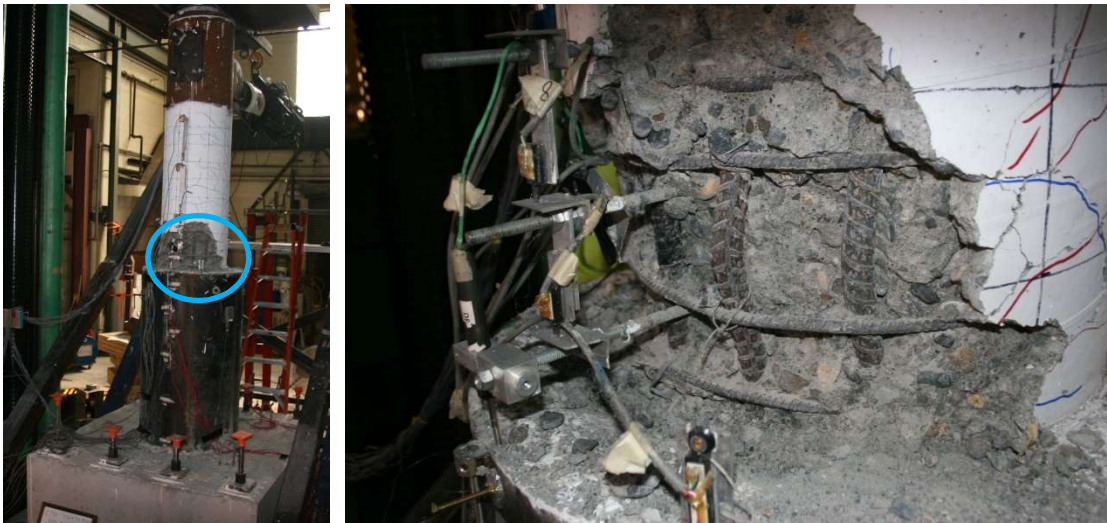
Figure 4.117. Specimen 30-21-LD Northern Face of Column after 10 cycles at 5.5% drift

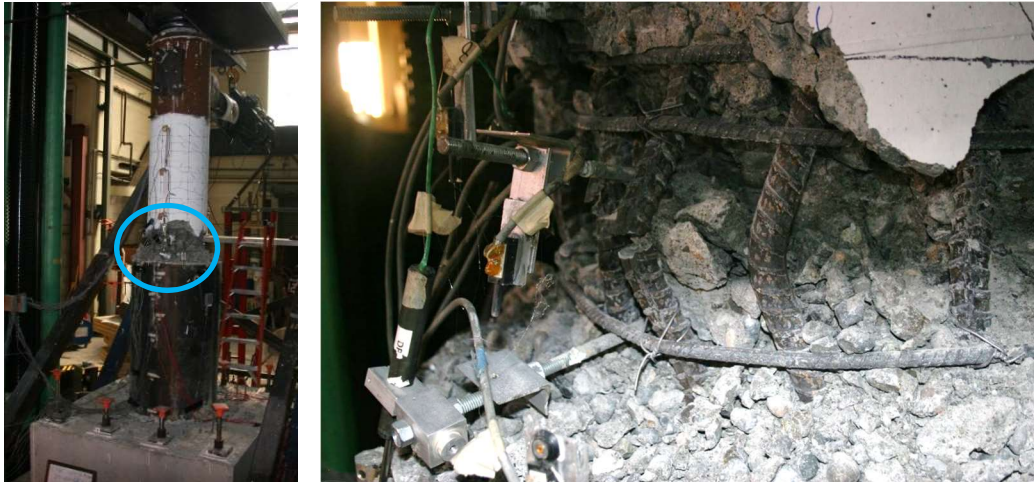
Figure 4.120. Specimen 30-21-LD Final State of Column after 9.9% Drift

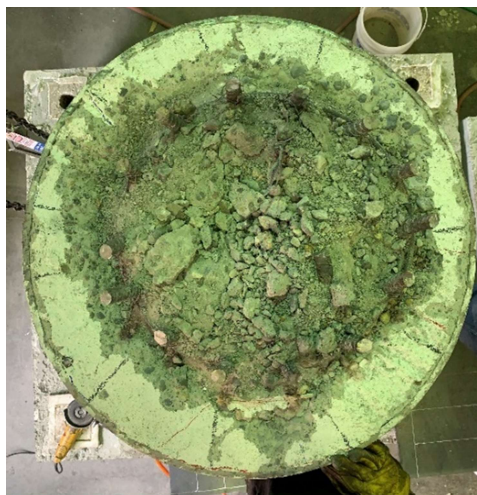
Figure 4.121. Top of Specimen 30-21-LD Pile with Column Removed

Throughout all load cycles, the pile showed no visible damage. There was no buckling or yielding of the pile, with the largest measured strain being 0.00017 in./in., which occurred 52 in. below the top of the tube, during the 5.5% drift cycles. There was no noticeable slip between the pile concrete in comparison to the edge of the tube at any point of the test. The measured slip on the outside of the tube had a maximum reading of 0.05 in. for the whole test. As shown in Figure 4.121, the top of the pile concrete appears heavily damaged on the edges and around the base of the column.
