Inelastic Behavior of Direct RC Column to CFST Pile Connections

A thesis

Master of Science in Civil Engineering

University of Washington

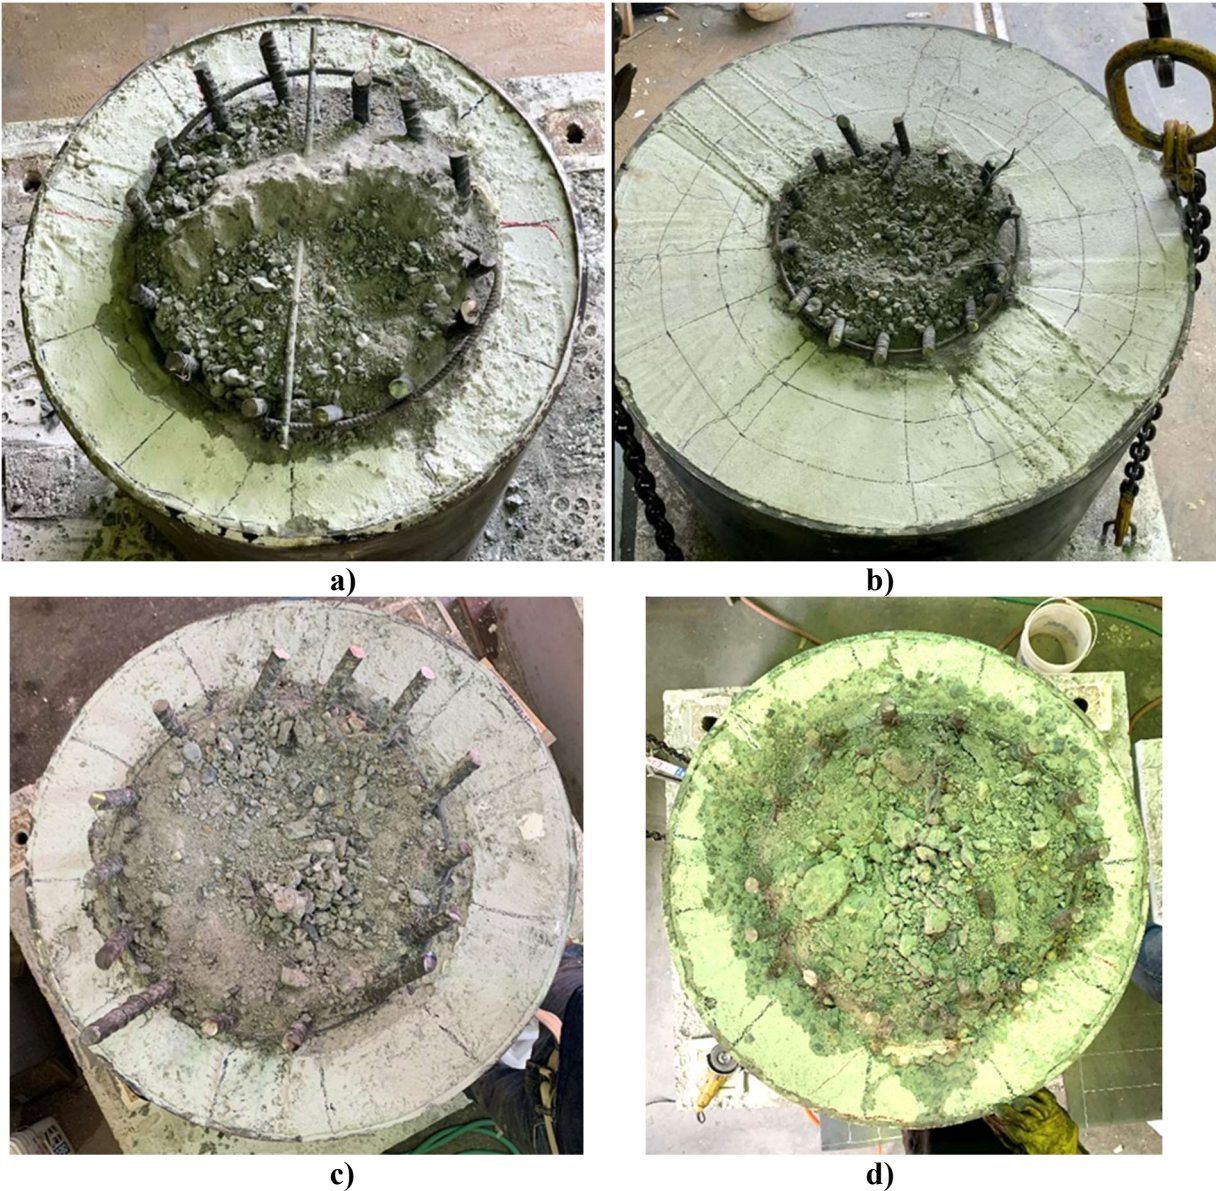
Figure 5.31. Specimens with Columns Removed: a) 30-21, b) 48-21, c) 30-21-R and d) 30-21-LD

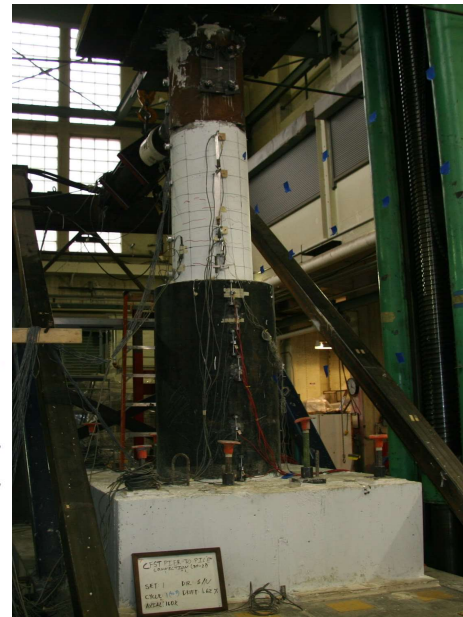
Fig. 4. As-Built Specimen
