No Worker Left in the Dust:

A case study on the highly-contrasted and variable levels of silica safety

A thesis

Master of Science in Construction Management

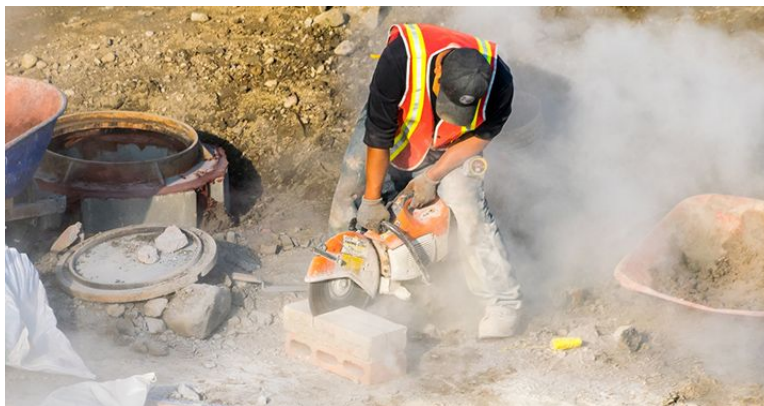
Figure 1: Heavy Silica Exposure (Benton, 2017).

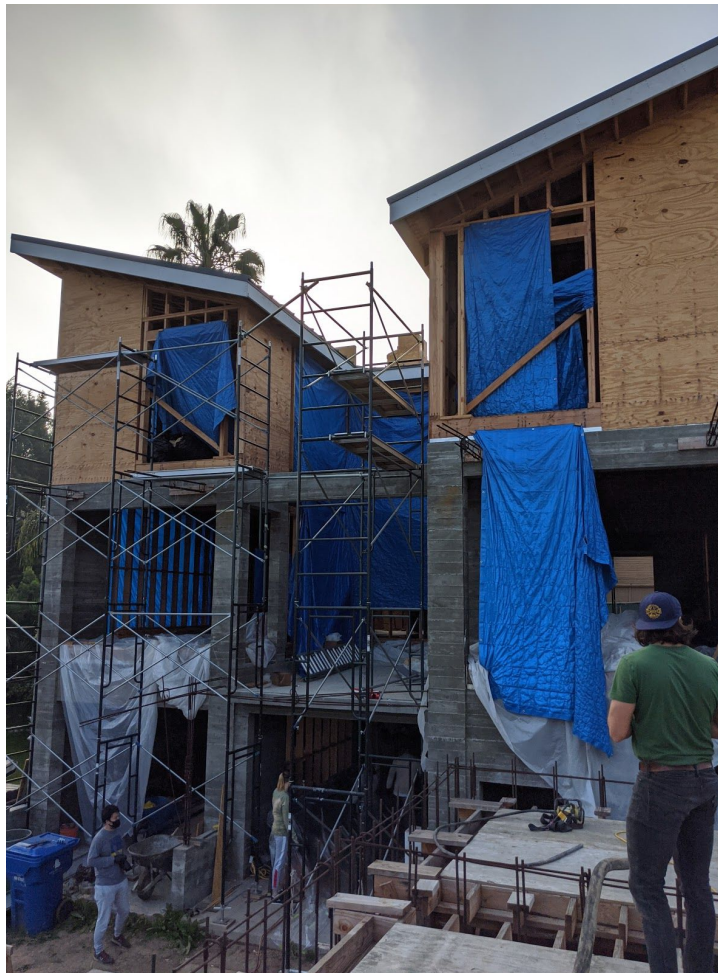
The Waterloo House is a single-family construction project being built in one of the fastest up-and-coming and trendiest neighborhoods in Los Angeles. The architecture, materials, and constructability methods are incredibly unique, utilizing 2x6 concrete formwork techniques to build pour-in-place concrete walls for the first two floors and the basement of the house. When complete, the house should be an architectural marvel, with it's own stormwater collection system and tanker (made entirely of concrete) and efficiently designed landscape to allow for a completely self-sustaining urban farm in the heart of one of the largest cities in the U.S.

Figure 6: Concrete Walls in Los Angeles

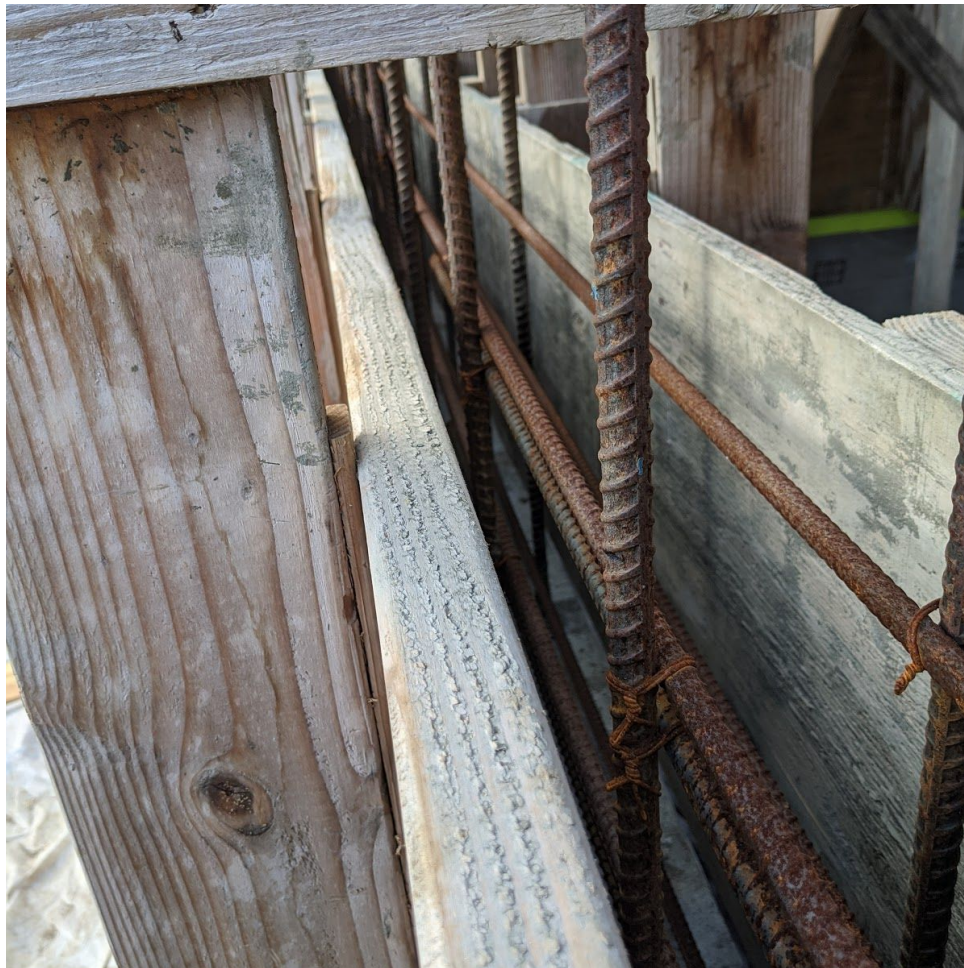
Figure 7: Reused Concrete Form Boards, Scraped

When the form boards would break loose of the pressure from the expanded concrete, they would fall to the ground at the same time. The faces of these form boards still contained a large amount of dried concrete, which would blow up in a dust cloud when the board dropped. None of the workers would wear a respirator during this activity (except one who wore a reusable APF 10 mask).

After every vertical concrete pour, the crew would strip the 2x6's being used for the forms, clean them, and use them for the next set of forms. This removal process was not unique to this job, as formboards are typically reused to decrease waste. The boards would be tapped off gently with a hammer (in order to not disturb the finished wall product) or pried off gently with a crowbar.

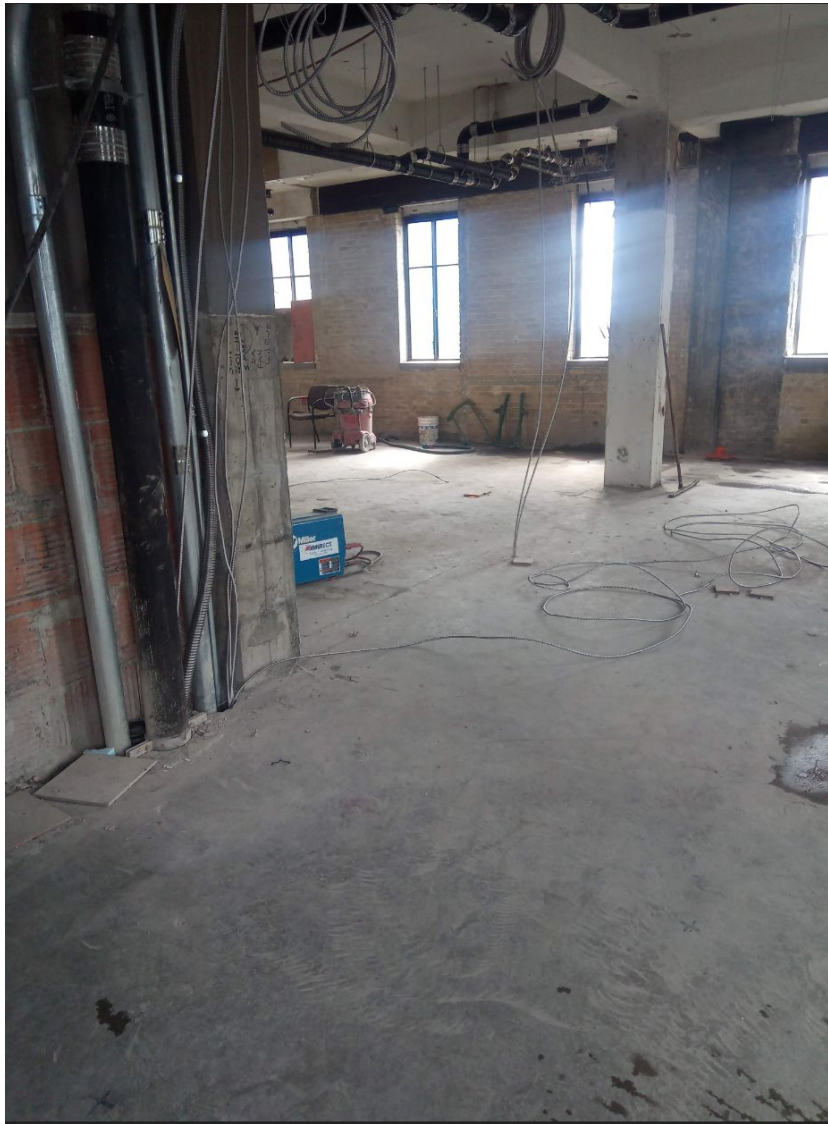
Figure 8: Visible Dust

The first observation that needs to be made about this project is that for the first eight months there was visible dust on every floor being worked on at any time. Again, the building was 90 years old, had a lot of settled dust, and the demolition process was extensive and very dust-producing. Figure 8 below shows what the average floor looked like on a day-to-day basis, even when no activity was happening.

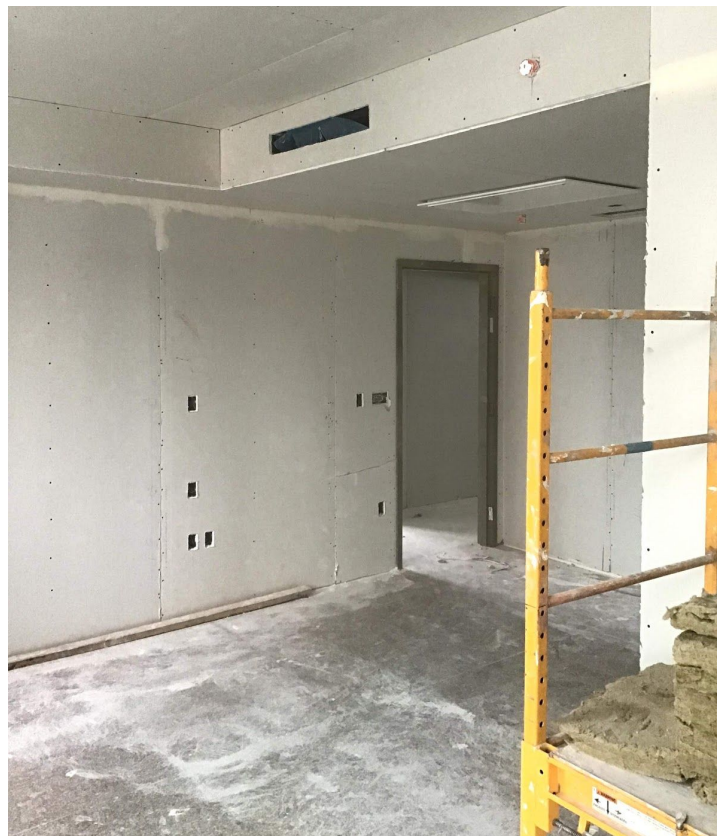
Figure 9: Drywall (Silica) Dust

One worker was observed sweeping up a room following drywall installation. The room was similar to the one shown in Figure 9 below, with silica-containing drywall dust collected all over the floor.

The worker was a general laborer, was employed directly by the general contractor, and was not using any of the dust-suppressing compounds supplied by his employer. He was also not using the medical mask supplied to him. When asked why he wasn't using any of the engineering controls or PPE required to complete the task, the worker replied that those items (the sweeping compound and masks) were in the basement, and he didn't want to take the elevator down to retrieve them. When asked if he understood the dangers of sweeping dust in an enclosed space without the proper specified protections, the worker replied that he "knew and didn't care."

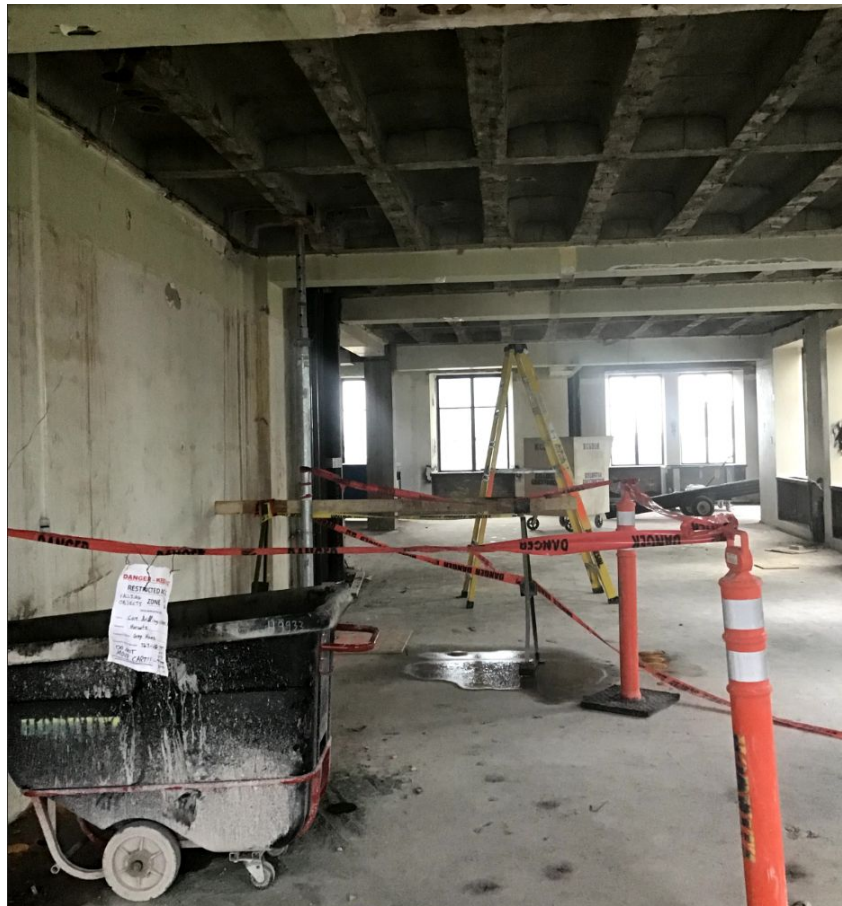
Figure 10: Water suppression used during core drilling.

During renovations of buildings with concrete floor slabs, oftentimes new layouts call for wiring, plumbing, and staircases to come up through holes that don't exist. The holes then have to be cut. This involves core drilling for opening up small holes or sawcutting for larger openings. This building's new plans called for both, and both were performed to satisfy OSHA's standards, using water integrated delivery systems and APF 10 respirators. Figure 10 below shows the setup below the floor being core drilled, where a trolley was placed to collect the water that came through from the engineering controls. The image shows a slurry buildup on the side of the trolley.

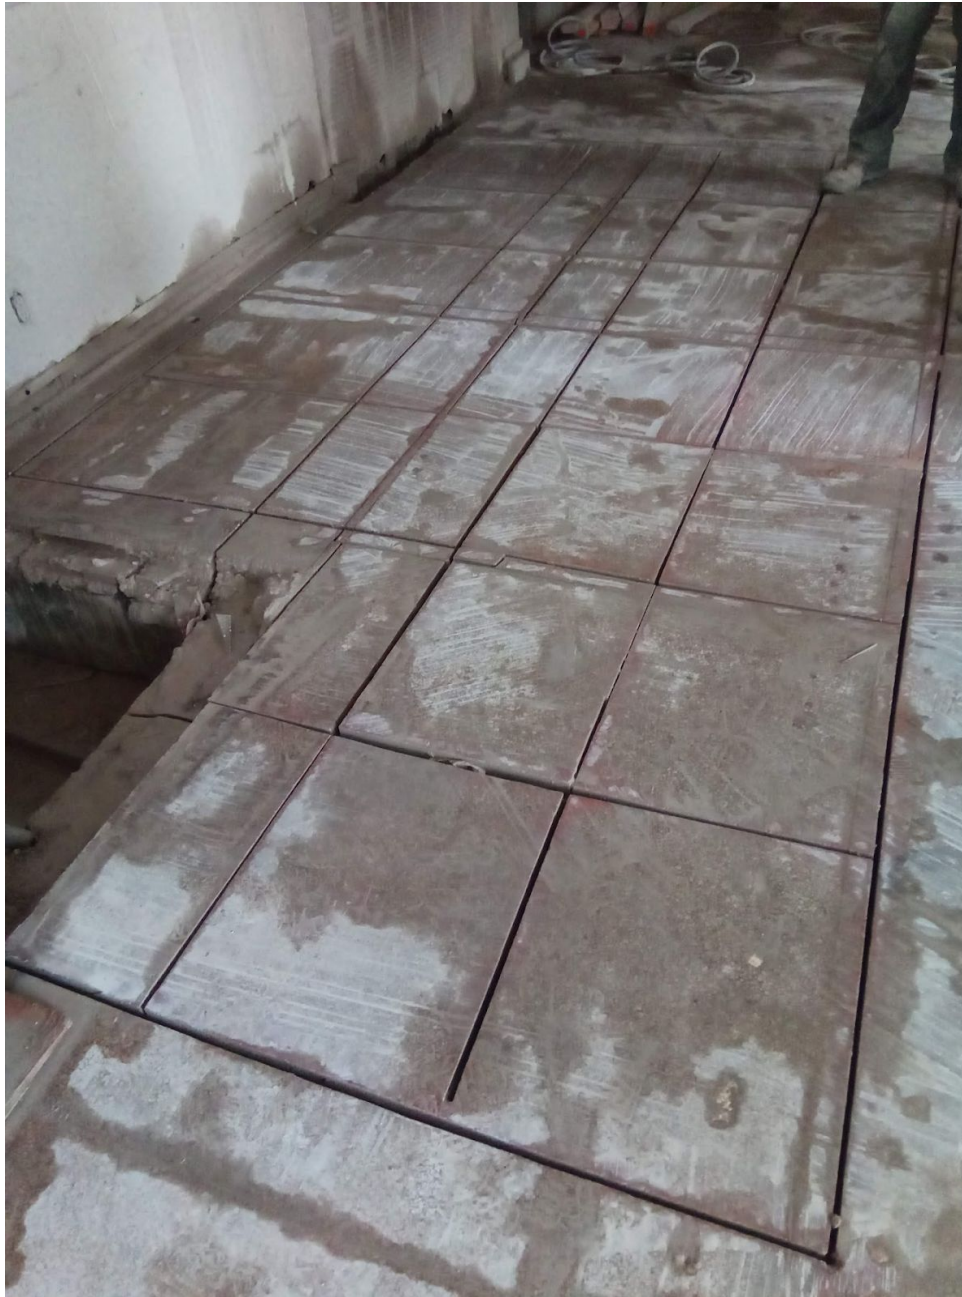
Figure 11: Remnants of water used while sawcutting

Figure 11 below shows the sawcutting process being used. Supports were set to hold the slab from below, and the floor was cut into square chunks and lifted up and out of the building. The Image shows slurry across the separate slab squares, from an adequate integrated water delivery system use.

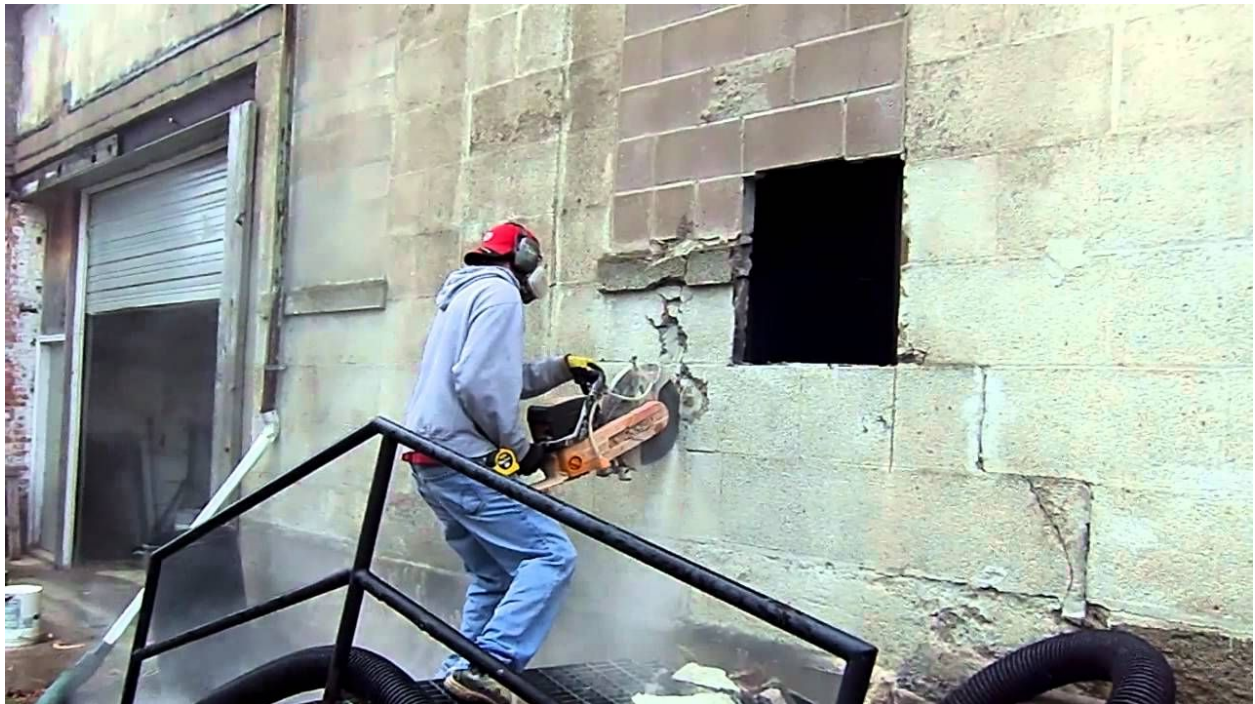
Figure 12: Demolition saw being used to demolish a concrete/CMU wall (Televideo, 2011).

Following the excavation process. A section of the cinderblock wall needed to be cut through to access the crawlspace. Figure 12 shows the process of cutting a similar wall to the one in the case study. First, the outline needs to be cut through with a demolition saw, and OSHA requires a hose attachment with a water delivery system to be used on the saw, unlike the one shown in Figure 12.

Demolishing a cinderblock wall was not an everyday occurrence for the general contractor's work, so he wouldn't need to use the saw more than once or twice a year. He decided to rent the saw from a local tool supply for a few hours, as opposed to spending thousands of dollars on a new tool. The rental tool came with an attachment for a hose, and the contractor was able to use the household hose to equip the saw, making a respirator nonessential for the task.

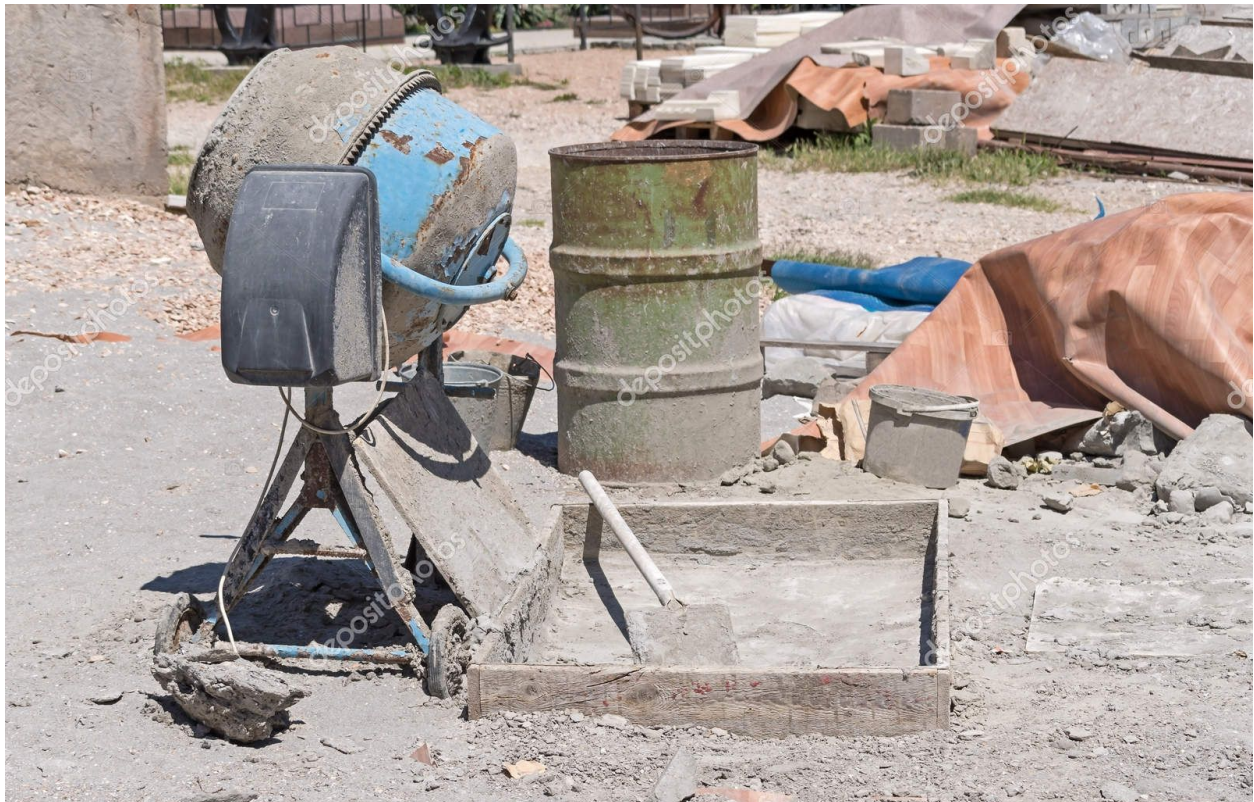
Figure 14: Concrete Mixer, used on smaller jobs with custom mixes (Vega240, 2019)

to mix bagged concrete outside the jobsite building. One employee would be stationed outside, using a parked trailer mixer similar to the one shown below in Figure 14.

To mix the powder, the worker would drop the tightly packed bag on a sharp spike, and rotate it so that it would rip open further, and then drop the powder into the mixing drum. This created a large plume of dust that would rise into the air. Often, whoever chose to be the mixer would have their entire face and upper body covered in the pre-mixed dust. Depending on the surface area to be covered by concrete that particular day, the worker would be working at the mixer constantly for six to ten hours a day. Most of the workers that were mixing on any given day wore an APF 10 single-use mask, some wore no mask at all and just tried to hold their breath when ripping the bags open.

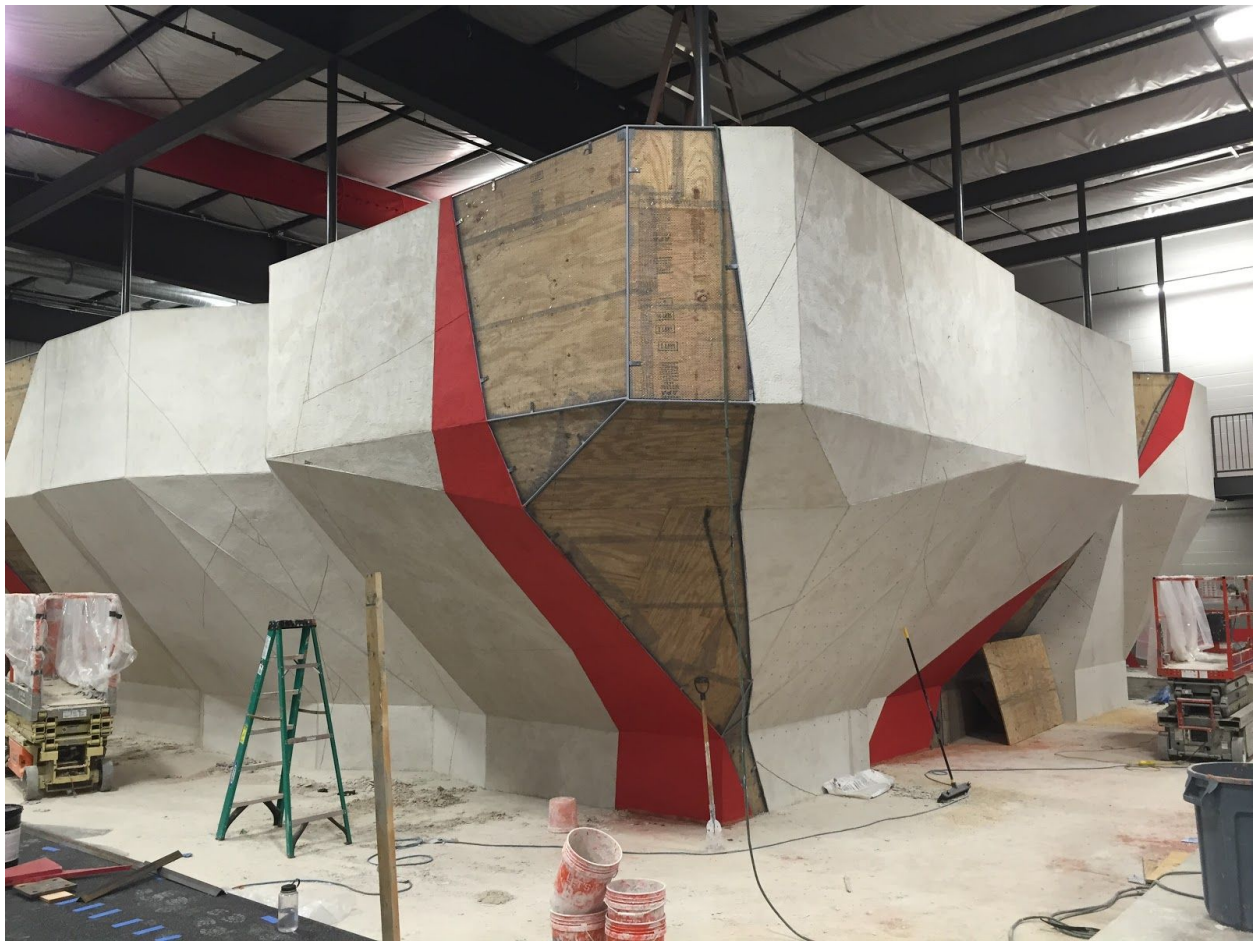
Figure 15: Almost finished climbing wall, with visible slurry, cuts, and sweeping compound being used.

Surface grinding was used as a technique to smooth and create aesthetic edges in the concrete. Once the mix was applied to the lathe and then dried overnight, the crew would return the next day to fix any imperfections and to carve the granite-inspired crack lines as shown in Figure 15 below. This grinding was either done with a diamond-bladed skill saw or angle grinder. No form of integrated water delivery system was used, and no form of shroud collection system was equipped with the tools. None of the workers wore respirators when performing this task.
