**MEASURING, MANAGING, AND REDUCING
PAVEMENT MACROTEXTURE AND
ROUGHNESS TO IMPROVE CYCLISTS' SAFETY AND
RIDE QUALITY**

FINAL PROJECT REPORT

Prescott Dylan Benner and Erdem Coleri, Ph.D.

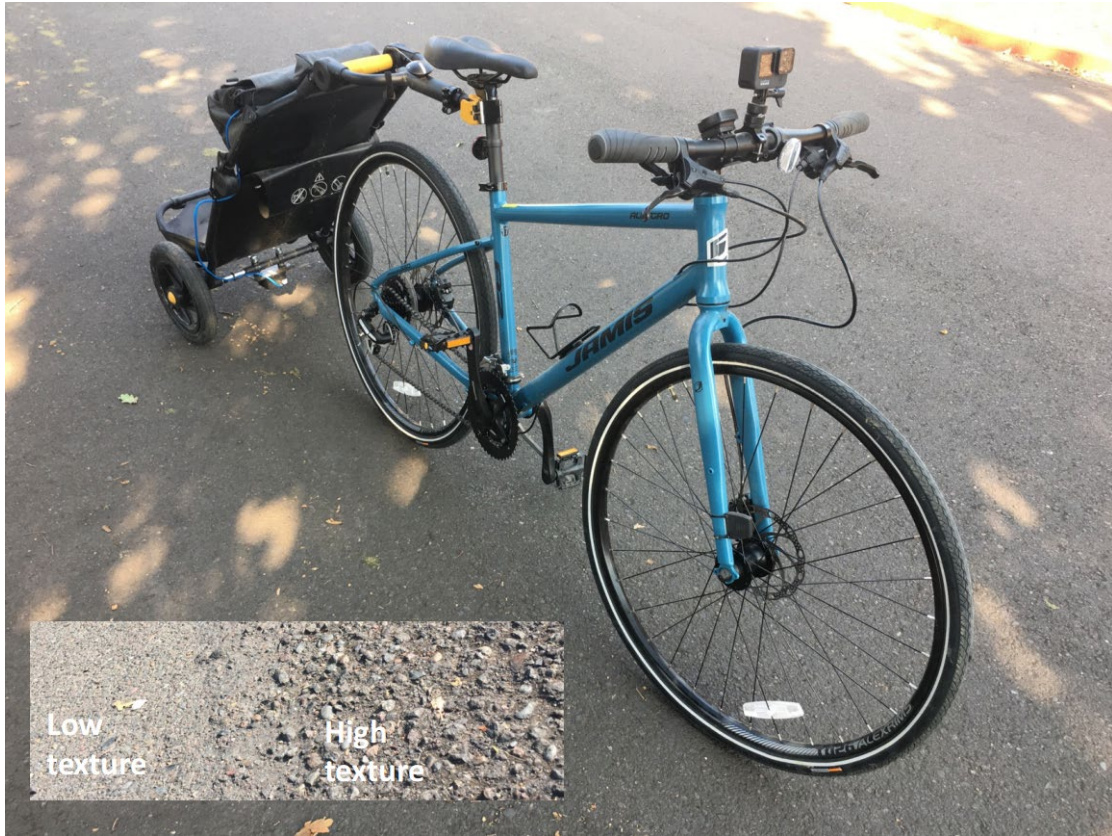
Figure 2-2. Developed bike system with all components with a high and low texture comparison.

Figure 2-1 shows the components of the developed system, and Figure 2-2 shows the developed bike system with all components. An ADXL 335 accelerometer was secured directly to the axle of a bike trailer so that the movement of the wheels would directly translate to the accelerometer. The trailer had the necessary capacity to carry the electronics and data acquisition system (DAQ) as the bike was ridden. The accelerometer produced an analog voltage output that was converted to a digital signal by the DAQ and then saved to a laptop in the electronics package. All of the accelerometer data for each section of pavement was saved to a single data file. In order to analyze this file, the accelerometer data corresponding to a specific bike rider had to be isolated. The system was designed to be versatile by utilizing three independent records that could be correlated to accelerometer data.

The first installed component was a video camera that recorded the pavement surface during the entire ride. This video could be reviewed to compare visible surface defects and distresses with accelerometer data. The bike rider could also issue voice commands to the camera, which could be used to automatically highlight and isolate segments of the accelerometer data. The camera recordings were synchronized with the collected accelerometer data.

The second component of the system was a Global Position System (GPS) device that recorded the bike position, synchronized with collected accelerometer data. This system could be overlaid by a satellite image to identify a specific section of a bike path and the corresponding accelerometer data.

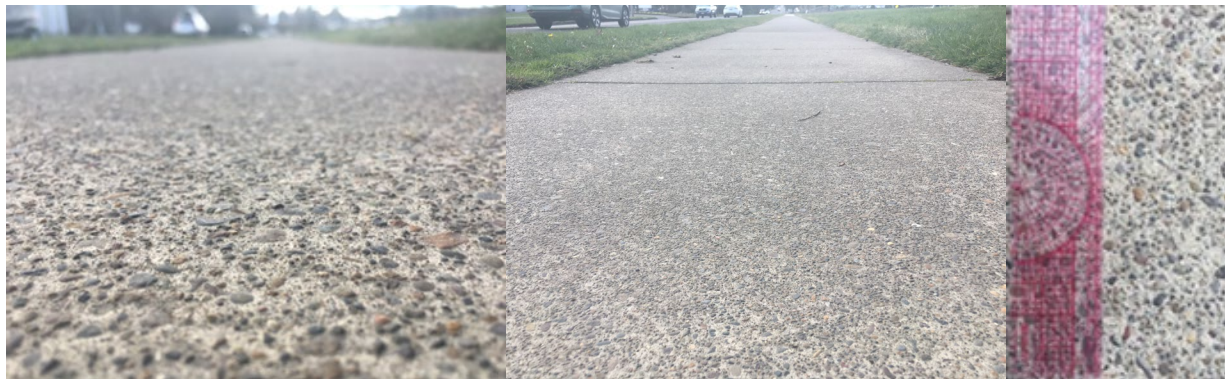
Section A was a concrete sidewalk with a smooth surface texture and no distress patterns outside of the expansion joints every 4-ft. Rating: Good

The photos of the six test sections with different surface textures are shown in Figure 2-3. The two photos show the extent and texture of each section from different height levels. The third photo (on the far right) shows an orthogonal view of a 6-in. roller to illustrate the relative scale of the surface texture.

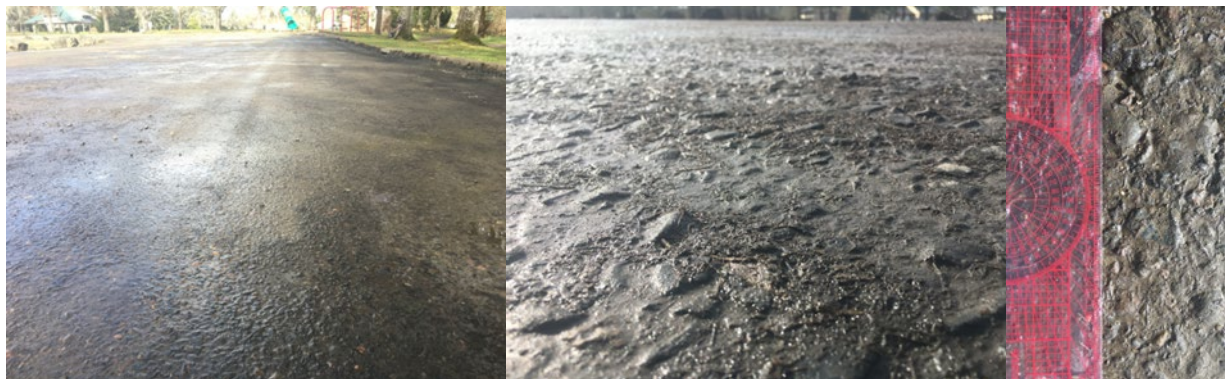
Section B was a highly compacted gravel parking lot with a relatively high (rough) surface texture . Rating: Poor

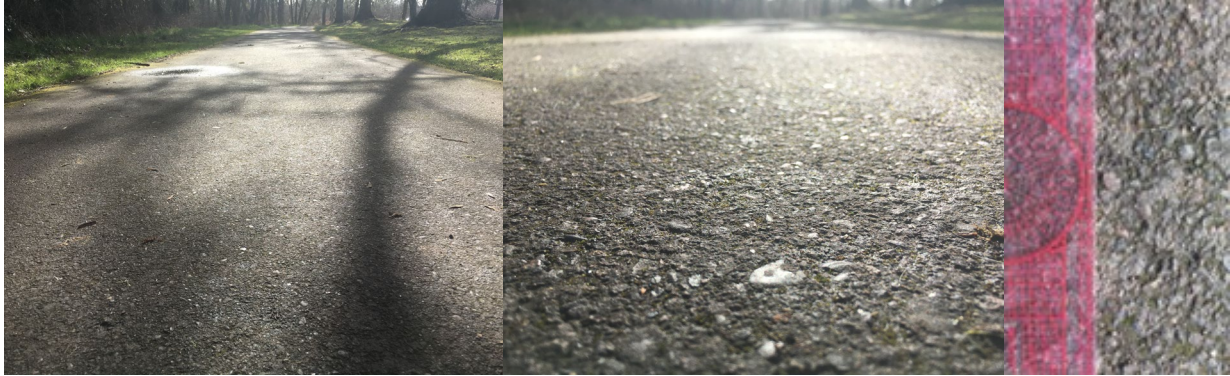
Section C was a smooth asphalt bike path with some bumps caused by adjacent tree roots but no visible distress patterns. Rating: Good

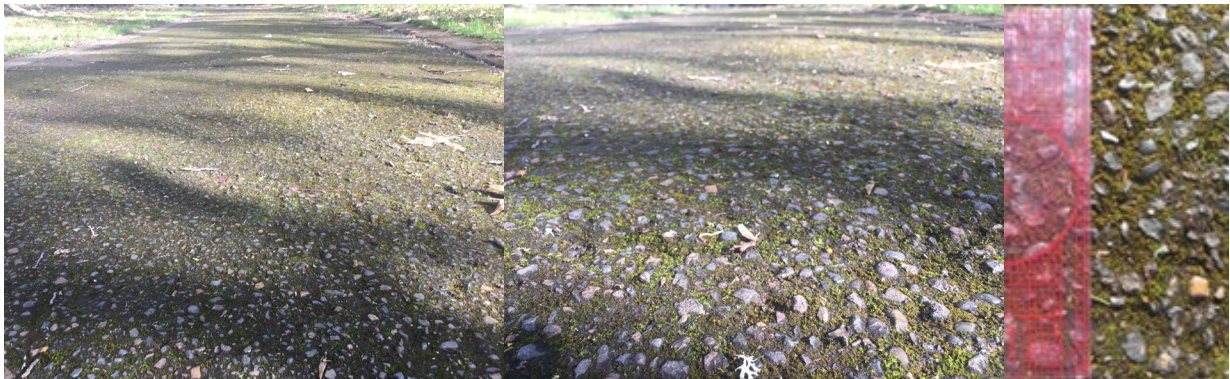
Section D was an asphalt bike path with a rough surface texture and occasional distress patterns. Rating: Fair

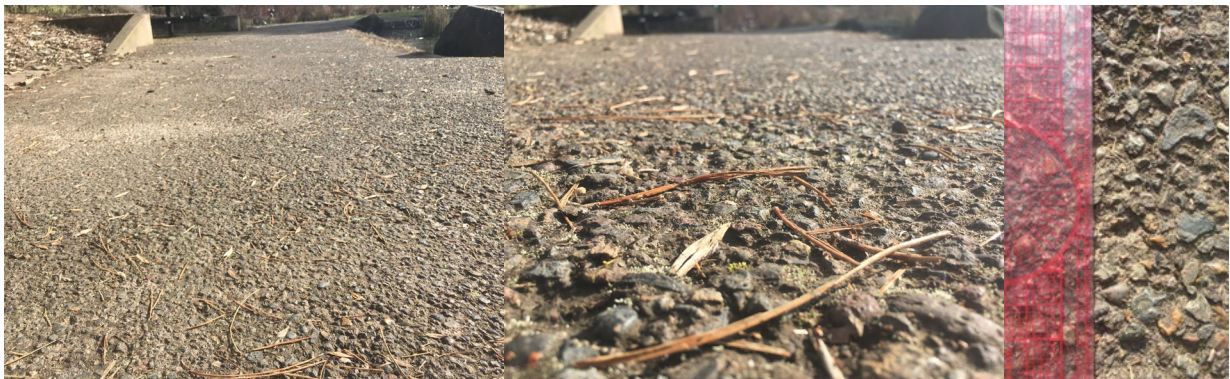
Section E was an asphalt bike path with a rough surface texture, and moderate bumps caused by adjacent tree roots. Rating: Fair

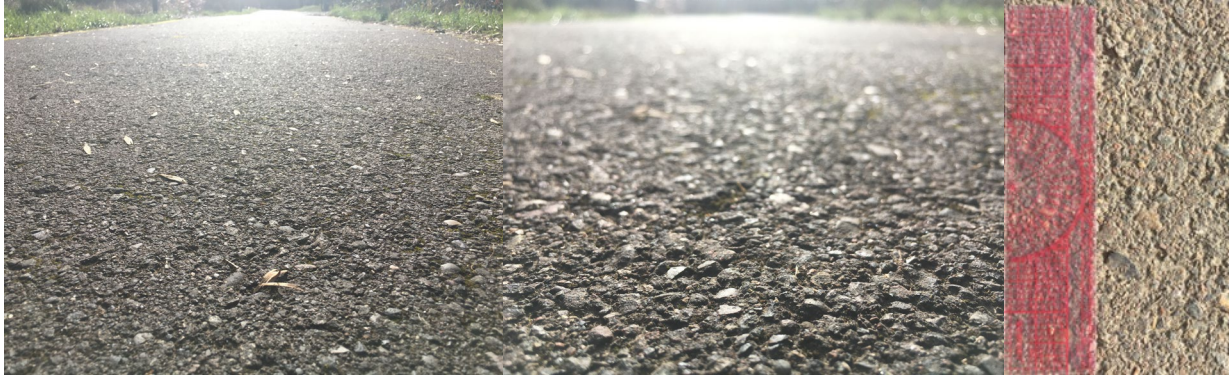
Section F was a smooth asphalt bike path with no bumps or distress patterns. Rating: Very Good

Figure 2-3. Evaluated test sections with different surface textures and rating levels.

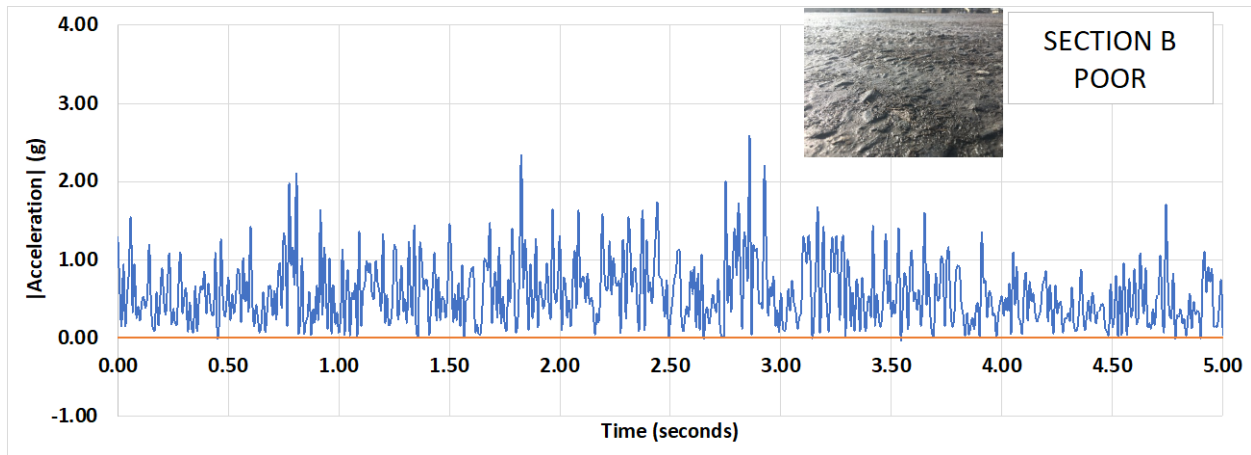
Figure 3-1. Example acceleration data from two sections with best and worst surface textures – Absolute value of normalized acceleration.

Once the raw data from the DAQ had been converted to units of gravitational force (Gs), they could be analyzed and correlated to the perceptions of ride quality. The first analysis method assessed the maximum value of vertical acceleration recorded over each section. This value was extracted from the data by subtracting the mean acceleration and taking the absolute value. This defined all acceleration values as positive acceleration starting from zero. Figure 3-1 shows the calculated acceleration parameter for the first rider for the roughest (Section B) and smoothest (Section F) test sections. The figure shows that there were significant differences in measured acceleration and its variation across the two test sections. The sections with the highest surface textures had the greatest normalized acceleration starting from zero acceleration. The accelerometer data were also assessed by using the standard deviation and coefficient of variation. The means of these values were assessed across all six participants for each section.

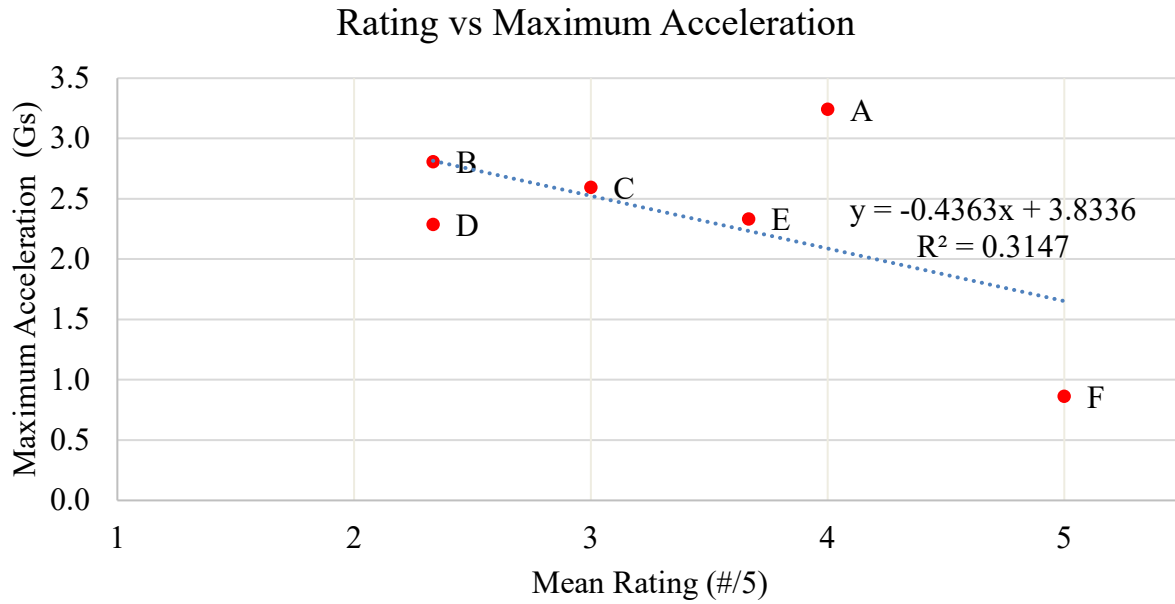
Figure 3-2. Maximum vertical acceleration of the bike correlated with the mean value of the participants' perceptions of ride quality.

Figure 3-2 shows that for the average results for Section A, the strength of the linear correlation between the system output and the mean perception of ride quality obtained from the rider survey was reduced. This was a result of the periodic spikes in the data for Section A, which resulted from the joints in the concrete sidewalk. The raw normalized absolute value of the acceleration data for Section A is given in Figure 3-5. Those jumps on the joints did not appear to negatively affect the perceptions of ride quality for the riders, whereas their quality perceptions

were highly affected by surface texture and roughness. For this reason, maximum acceleration is not recommended as an effective parameter for evaluating ride quality and surface properties.

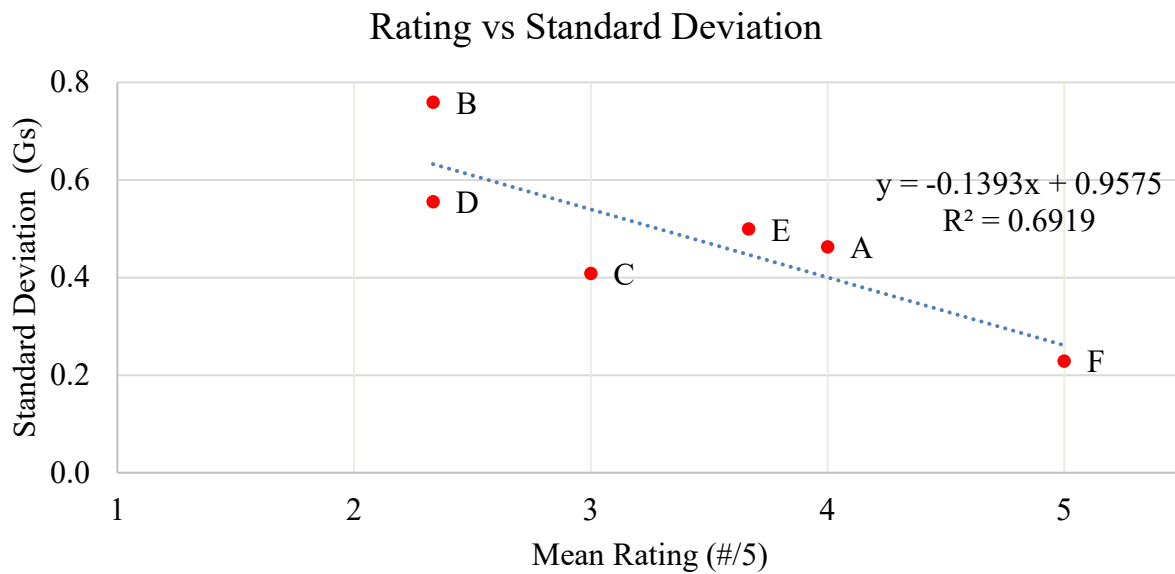
Figure 3-3. Standard deviation of acceleration correlated with the mean value of the participants' perceptions of ride quality.

These results suggested that the standard deviation and coefficient of variation of acceleration provide a more holistic assessment of ride quality. Figures 3-3 and 3-4 show that those two parameters were linearly correlated with the average perception of ride quality values. The coefficient of determination value for the coefficient of variation parameter (Figure 3-4) was higher than the coefficient of determination value for the standard deviation parameter (Figure 3-3). For this reason, this study recommends use of the coefficient of variation parameter for surface and ride quality evaluations. Note that it was not possible to achieve a very high coefficient of variation value (around 90 percent) because there was also some level of variability between the responses of the riders. Some gave a rating of 2 for one section, whereas others gave a rating of 4 for the same section. This may have been a result of deviance in the exact ride line on the pavement section. The high variability among the riders of each test section suggests that some of the riders may have hit rougher spots, which may have resulted in lower ratings. The variation may also have been a result of differences in perceptions among different riders.

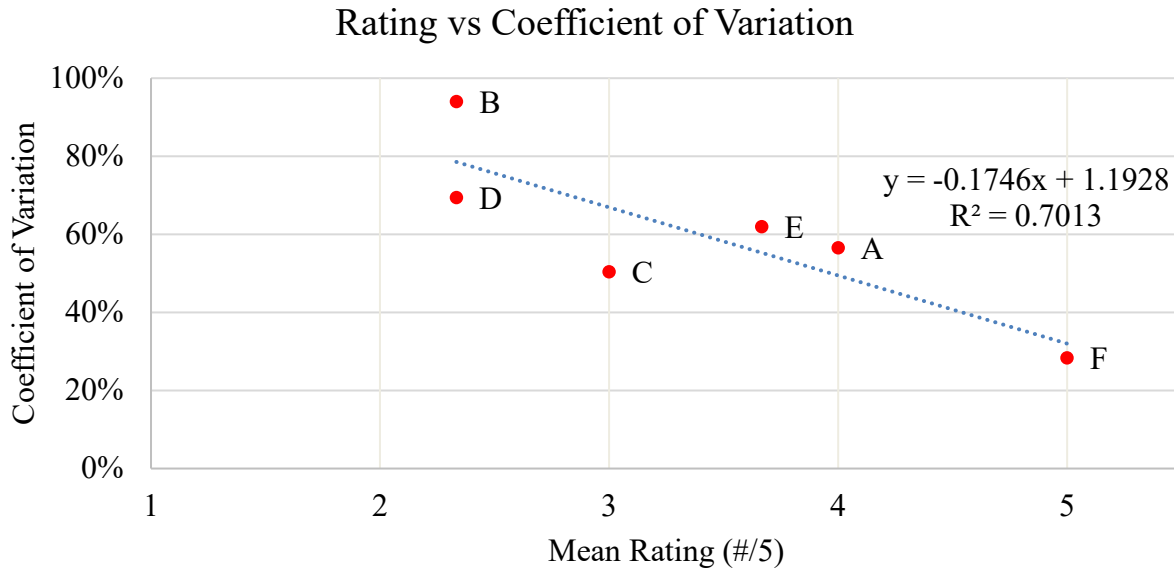
Figure 3-4. Coefficient of variation of acceleration correlated with the mean value of the participants’ perceptions of ride quality.

$$\text{COV parameter} = -0.1746 * \text{Rating} + 1.1928 \quad \text{Eq 1}$$

$$\text{For Rating}=3, \text{COV parameter threshold} = -0.1746 * 3 + 1.1928 = 0.67 \text{ (67\%)}$$

On the basis of this calculation, after 5-second data collection and data processing, if the coefficient of variation (COV) parameter from the system is higher than 67 percent (a worse than fair rating), then the surface of the bike path needs to be improved by maintenance. This number can be called a “maintenance trigger” parameter for bike path condition assessment and management.

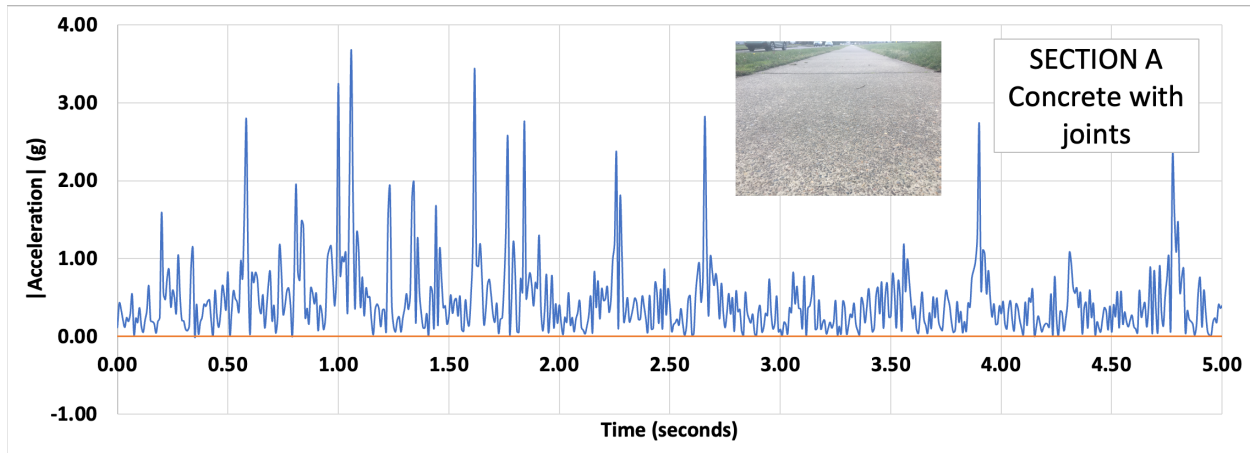
Figure 3-5. Acceleration data from Section A (concrete sidewalk with joints) – Absolute value of normalized acceleration.

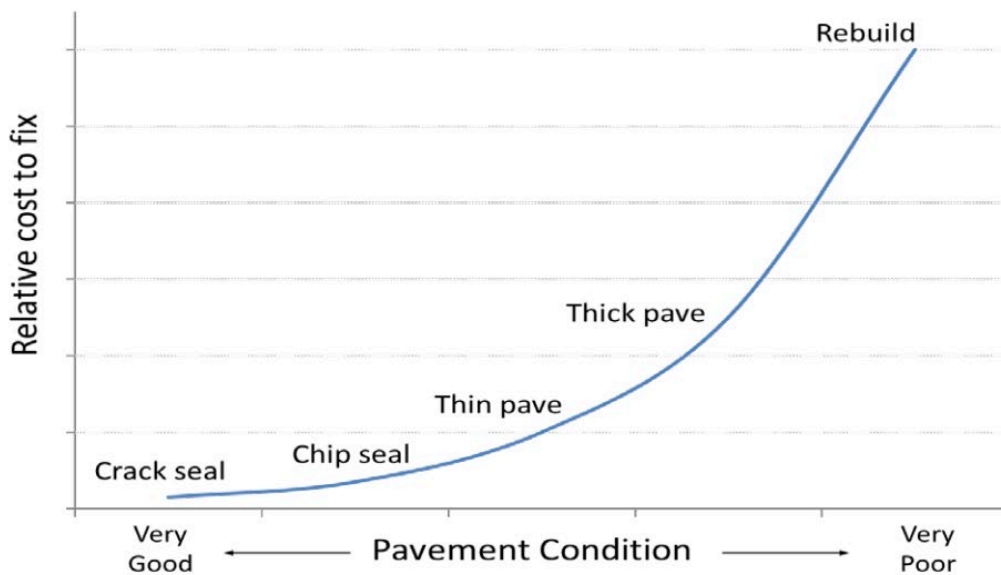
Figure 4-1. Pavement condition versus required maintenance and rehabilitation strategies with cost (Coplantz, 2022)

Depending on funding availability, a bike path can be maintained either by replacing the entire asphalt/concrete material (a thick pave or rebuild) or by laying a thin preservation surface on the pavement (a thin pave, chip seal, crack seal, fog seal). Those options vary in cost and should be selected carefully to maintain the path with minimum cost to achieve longer pavement life (see Figure 4-1).
