# **Green Lake Alum Treatment – Dose for a Decade**

**By  
Rob Zisette, Herrera Environmental Consultants**

**For  
Water Center Seminars 2008**

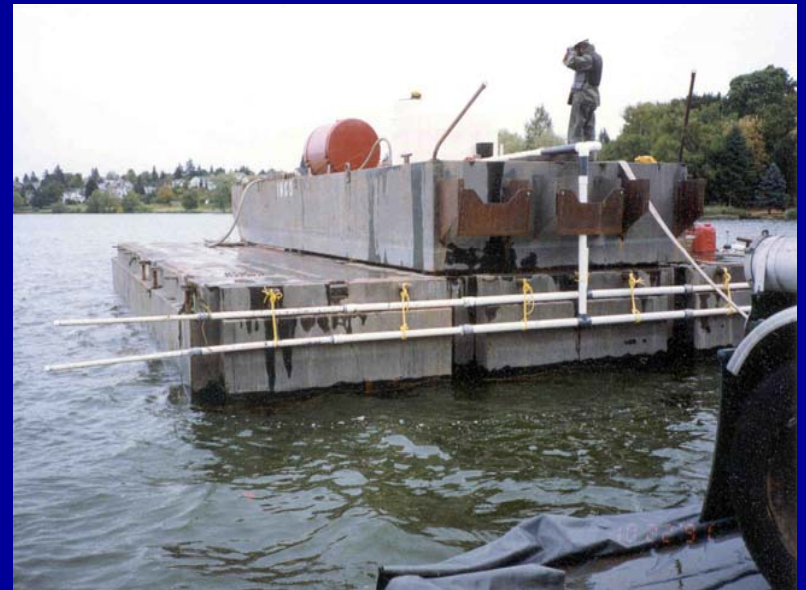
# 1991 Alum Treatment

- Applied liquid alum and sodium aluminate buffer in 2:1 ratio
- Calculated dose by alkalinity method to maintain pH above 6.0
- Recommended dose of 13.7 mg Al/L
- Applied 8.6 mg Al/L dose

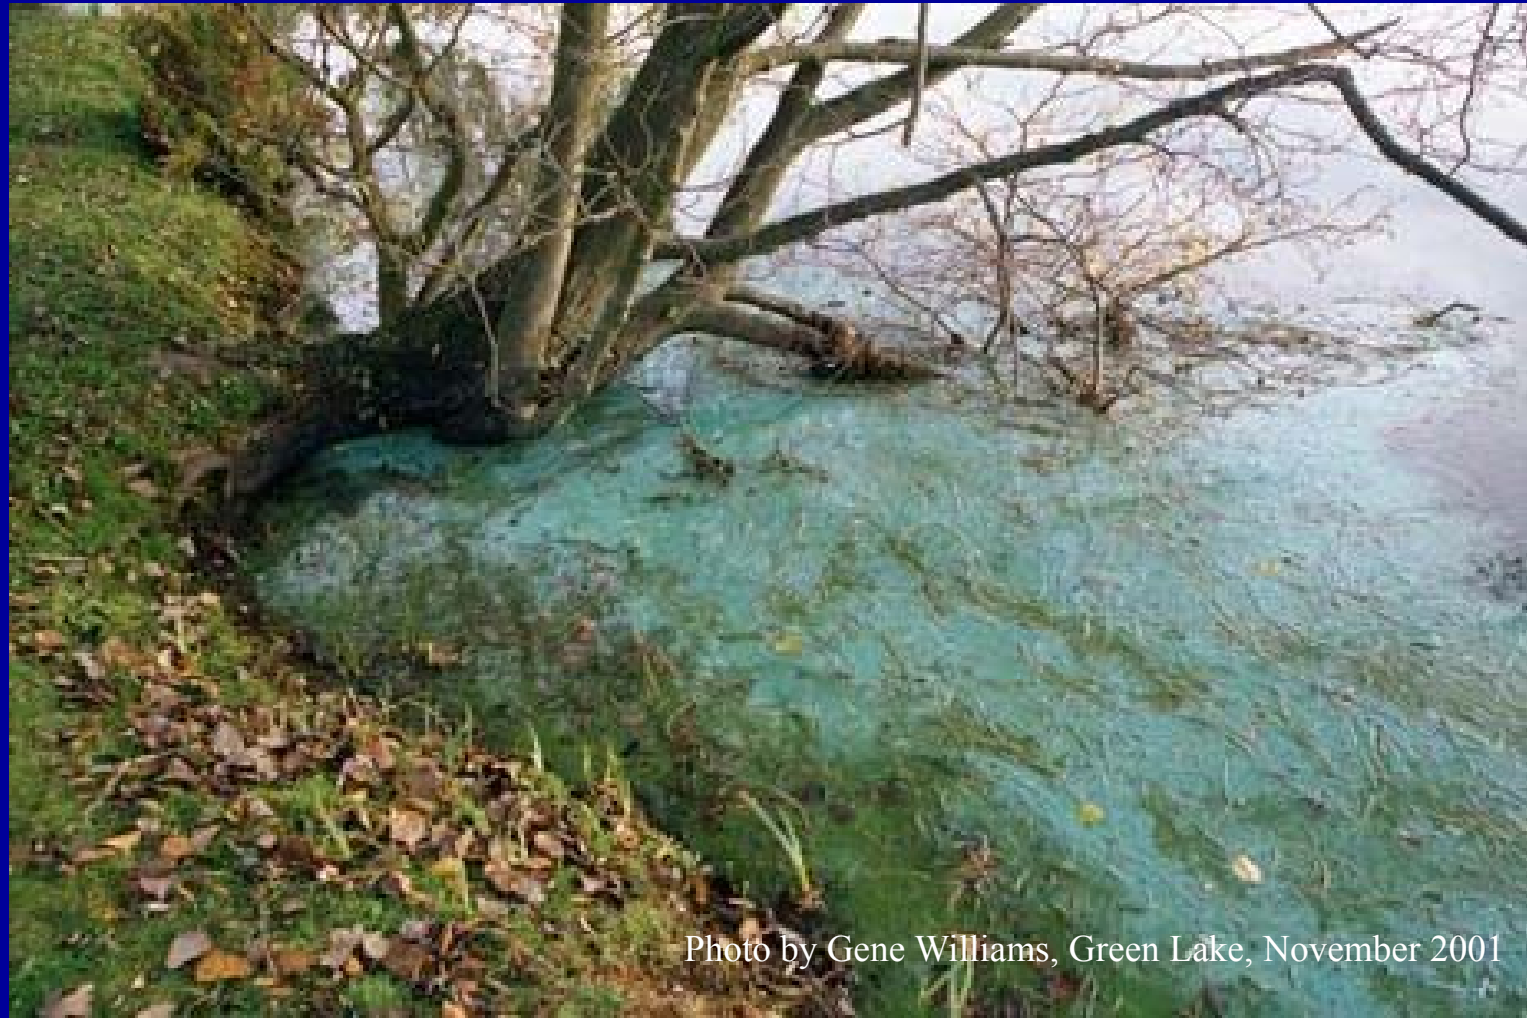
# Milfoil Die-off Fueled Cyanobacteria Blooms

Photo by Gene Williams, Green Lake, November 2001

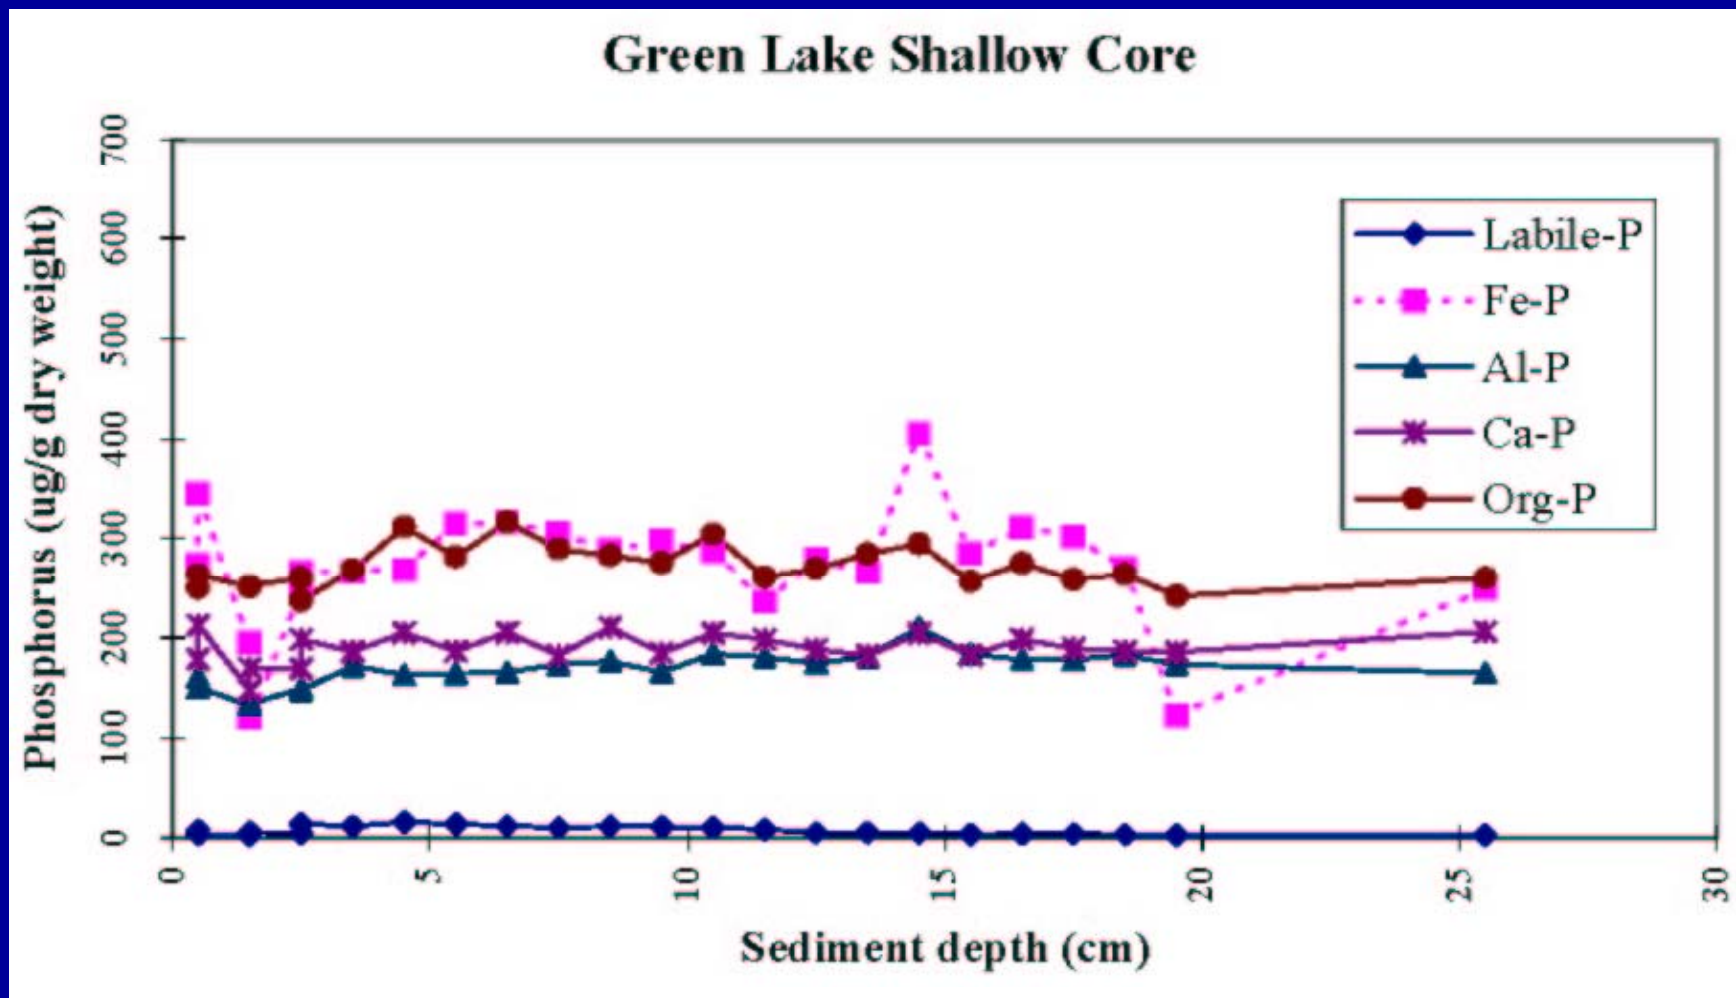
## Sediment Phosphorus Profile at Station A

Collected in 1998 for alum-treated lake study by Emil Rydin

- Bind mobile phosphorus in sediment  
(mean Fe bound + labile P = 370  $\mu\text{g/g}$ )
- 20 cm sediment depth
- 10 % binding efficiency
- Estimate 18 mg Al/L for sediment phosphorus
- Add 6 mg Al/L for water column phosphorus
- Use 2:1 alum to sodium aluminate by volume

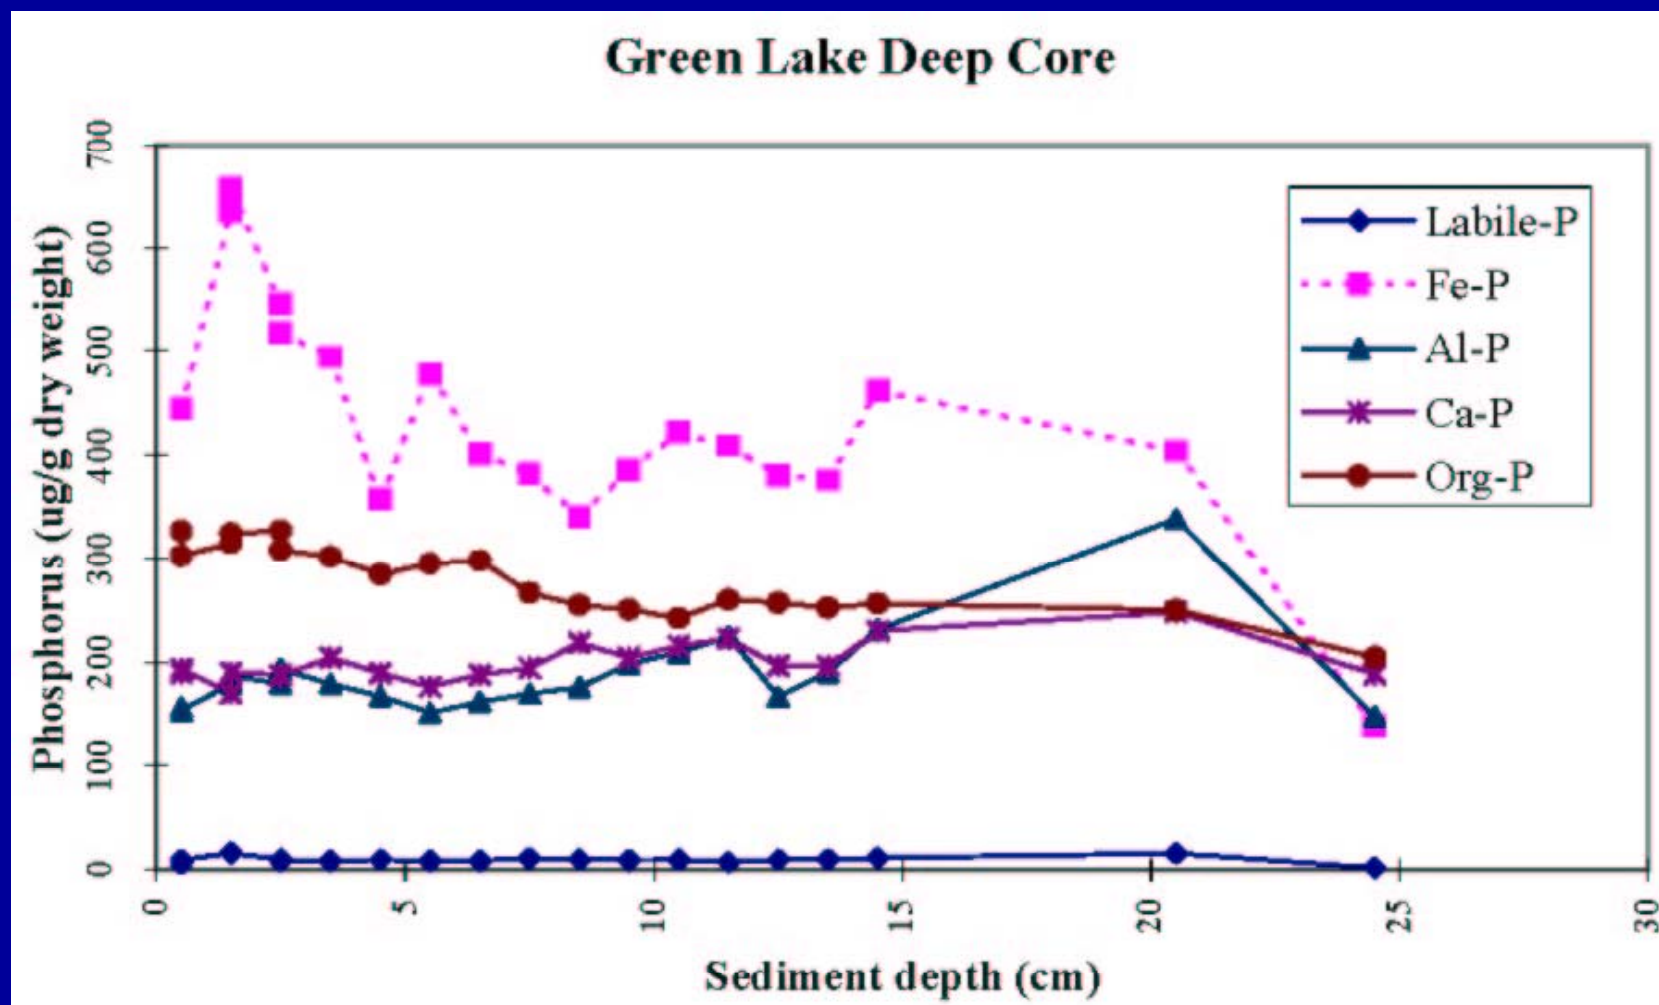
# Sediment Phosphorus Profile at Index Station

Collected in 1998 for alum-treated lake study by Emil Rydin

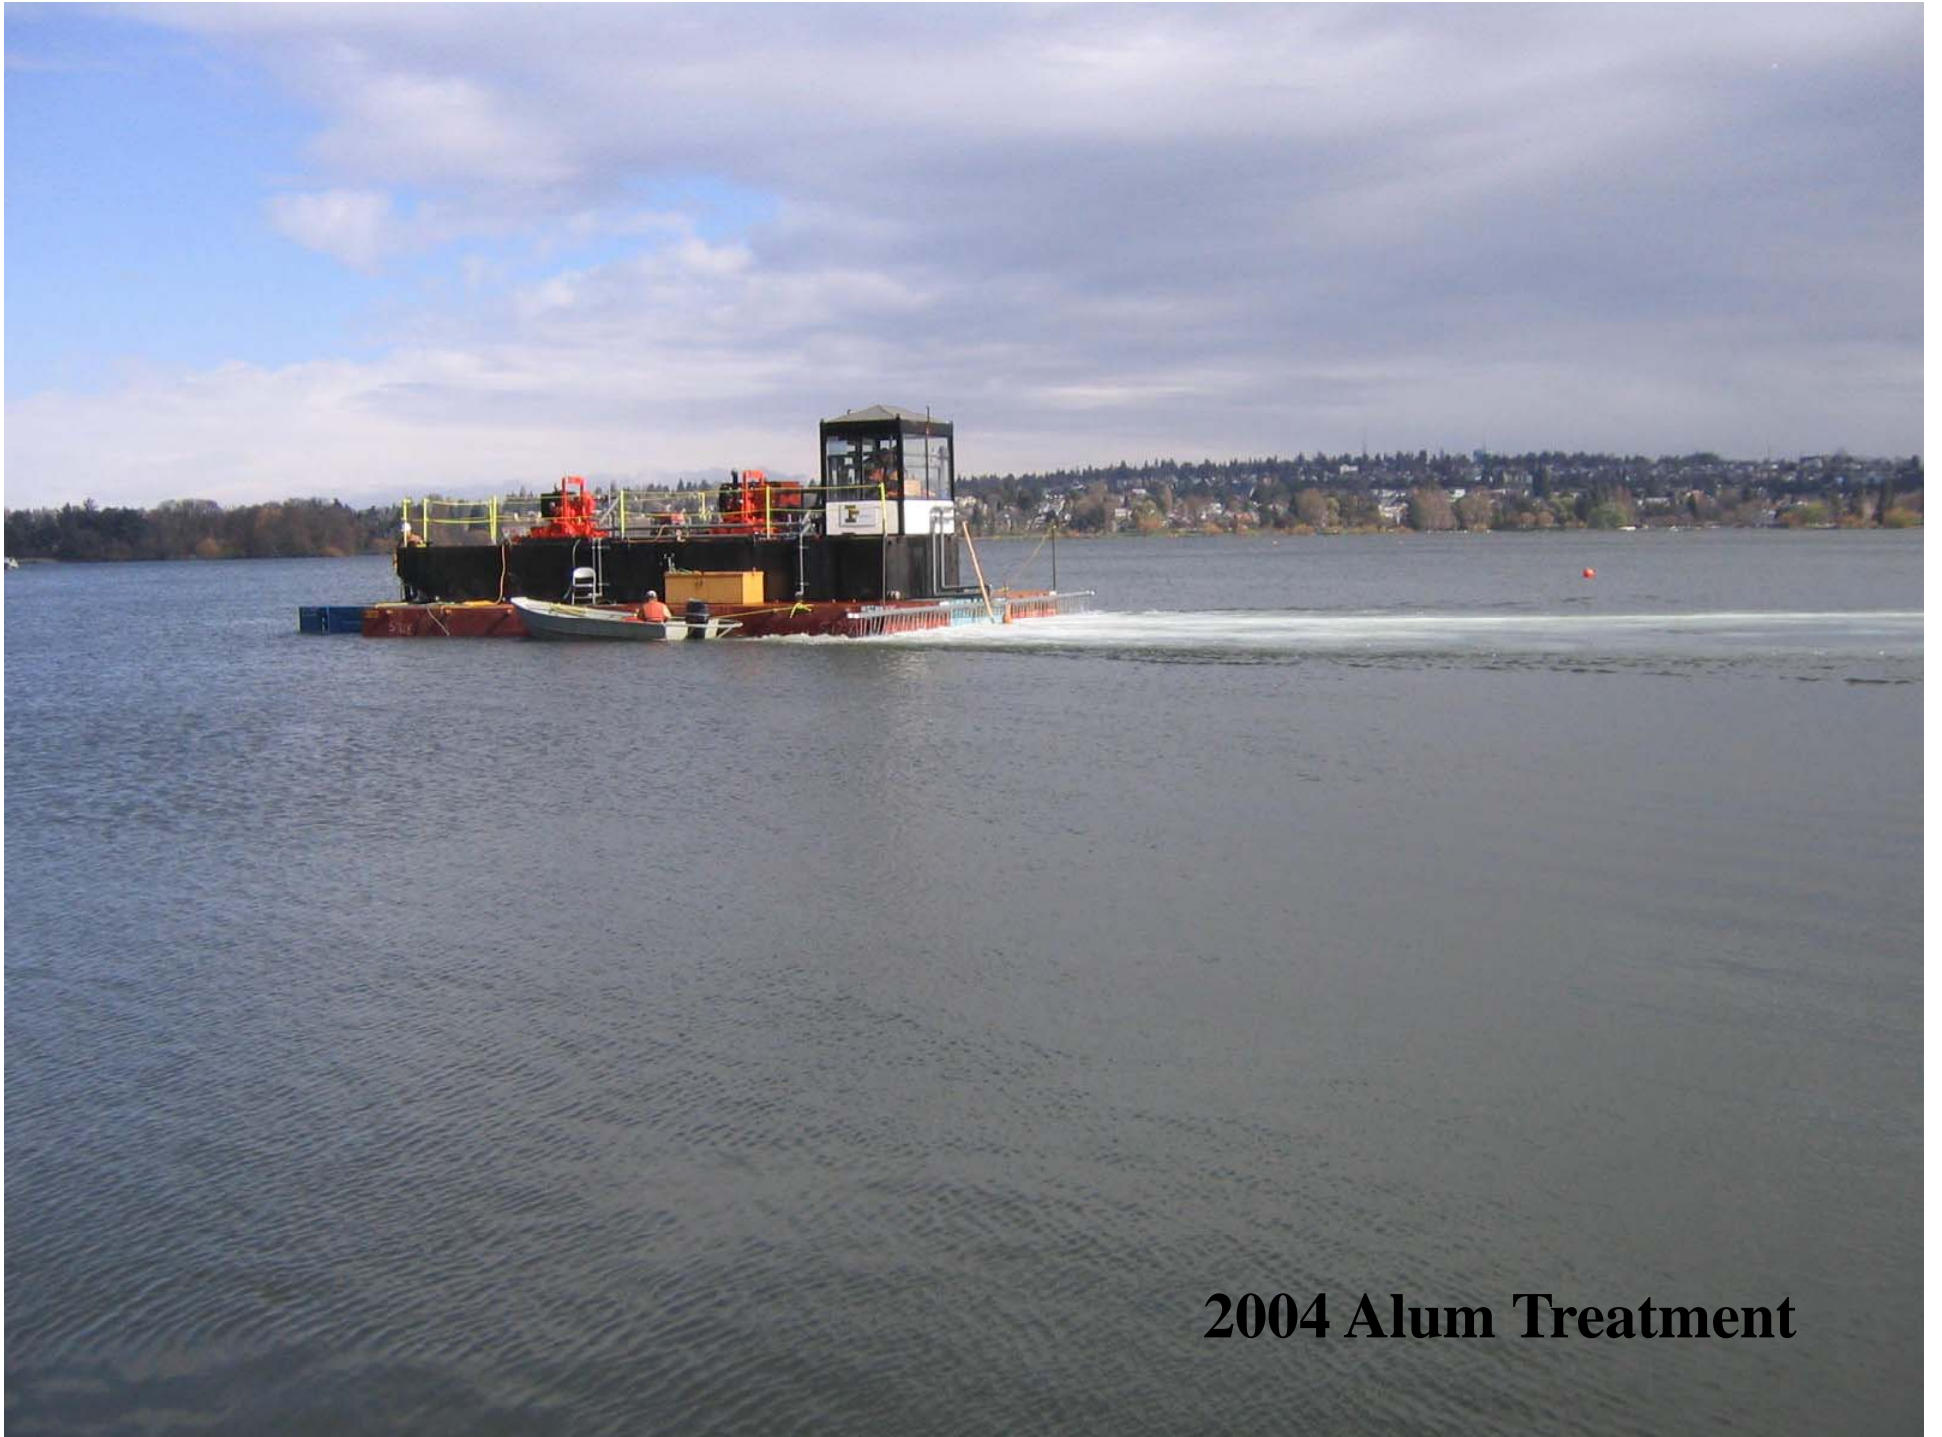
**2004 Alum Treatment**

- Apply in January – March 2004 (no plants)
- Apply 632 tons (234,000 gallons) alum and 373 tons (117,300 gallons) sodium aluminate
- Adjust rate with depth using sonar and GPS for 24 mg Al/L dose throughout lake (>5 ft depth)
- Estimate up to 21 days for treatment (actual 15)
- Estimate total cost of \$ 1.5 million (actual ~1)

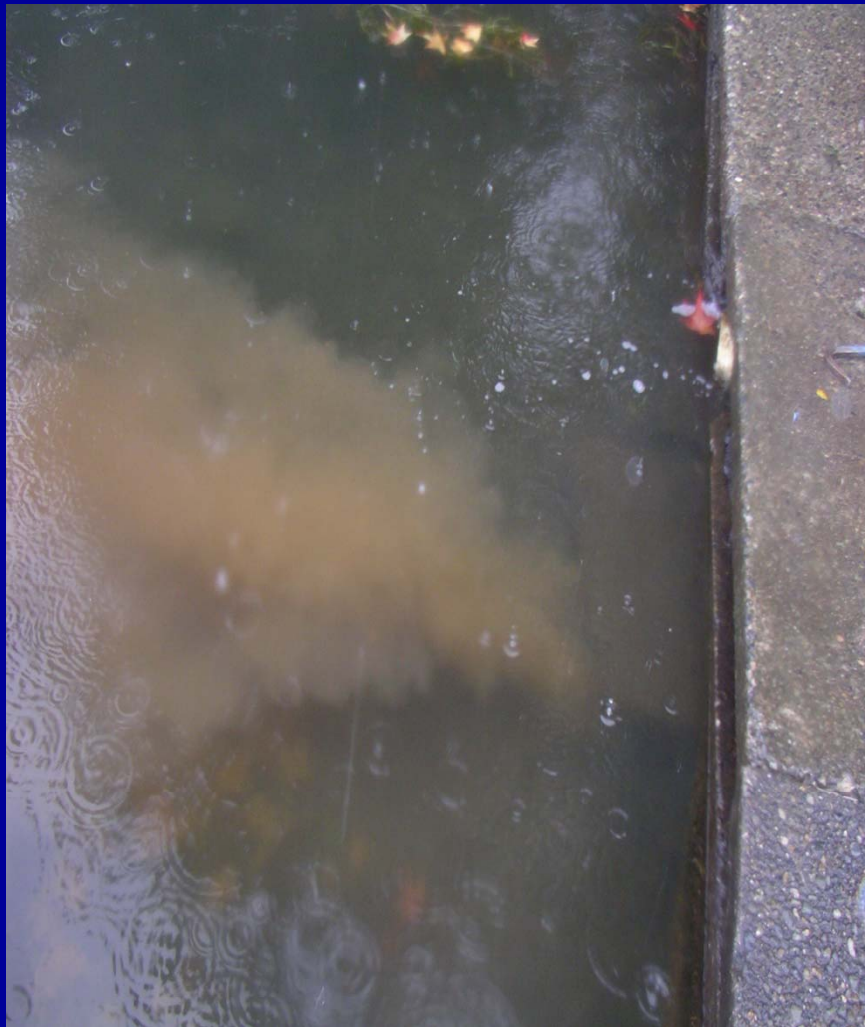
South Outfall

- 6 grab samples per station
- 4 storm events (Nov. – Dec. 2004)
- Measure:
  - Discharge rate
  - Total suspended solids (TSS)
  - Total phosphorus (TP)
  - Total dissolved phosphorus (TDP)
  - Fecal coliform bacteria
- Also measure wood chip pile inflow/outflow in January 2005 storm
- Perform genetic fingerprinting of 60 E. coli isolates from collected samples.

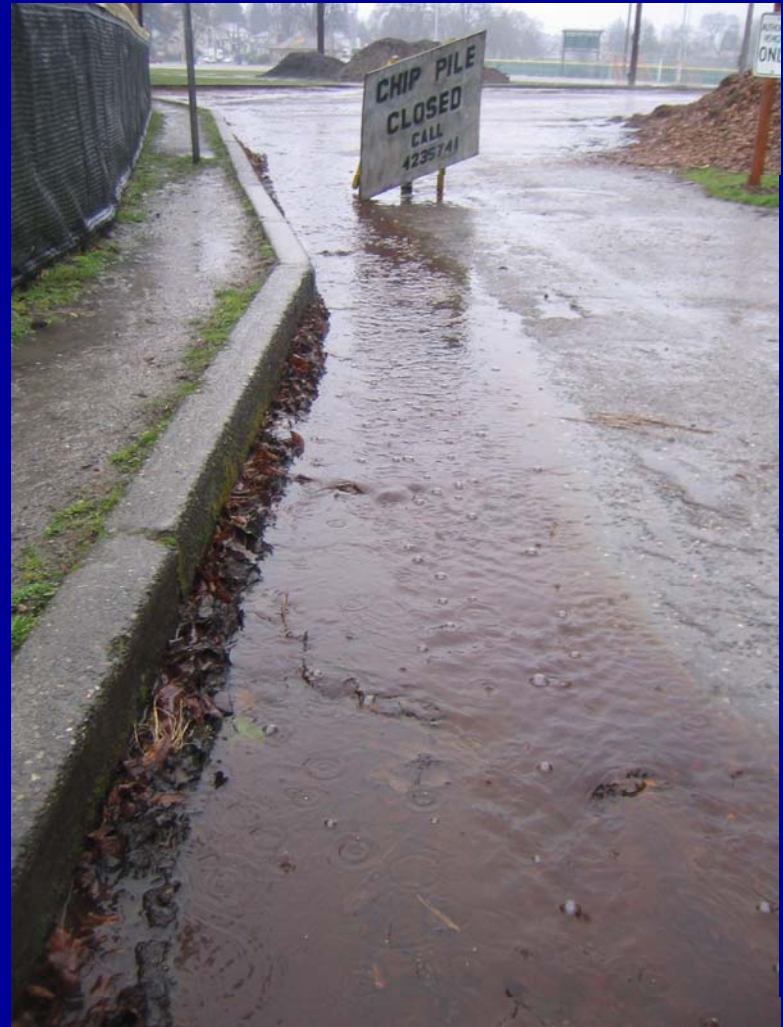
Park Runoff

- Very high TP at Woodland Park outfalls (1,615 and 874  $\mu\text{g/L}$  at south and north) compared to Densmore outfall (142  $\mu\text{g/L}$ ) and lake goal ( $<25$   $\mu\text{g/L}$ ).
- Woodland Park outfall TP increased 66% and Densmore outfall TP decreased 24% since 1995.
- High proportion of TP is dissolved (45%) due to wood chip pile.
- No TSS or TP removal by dirt field sediment vault .
- Wood chip pile increased TP from 1,066 to 21,100  $\mu\text{g/L}$  in forest runoff.

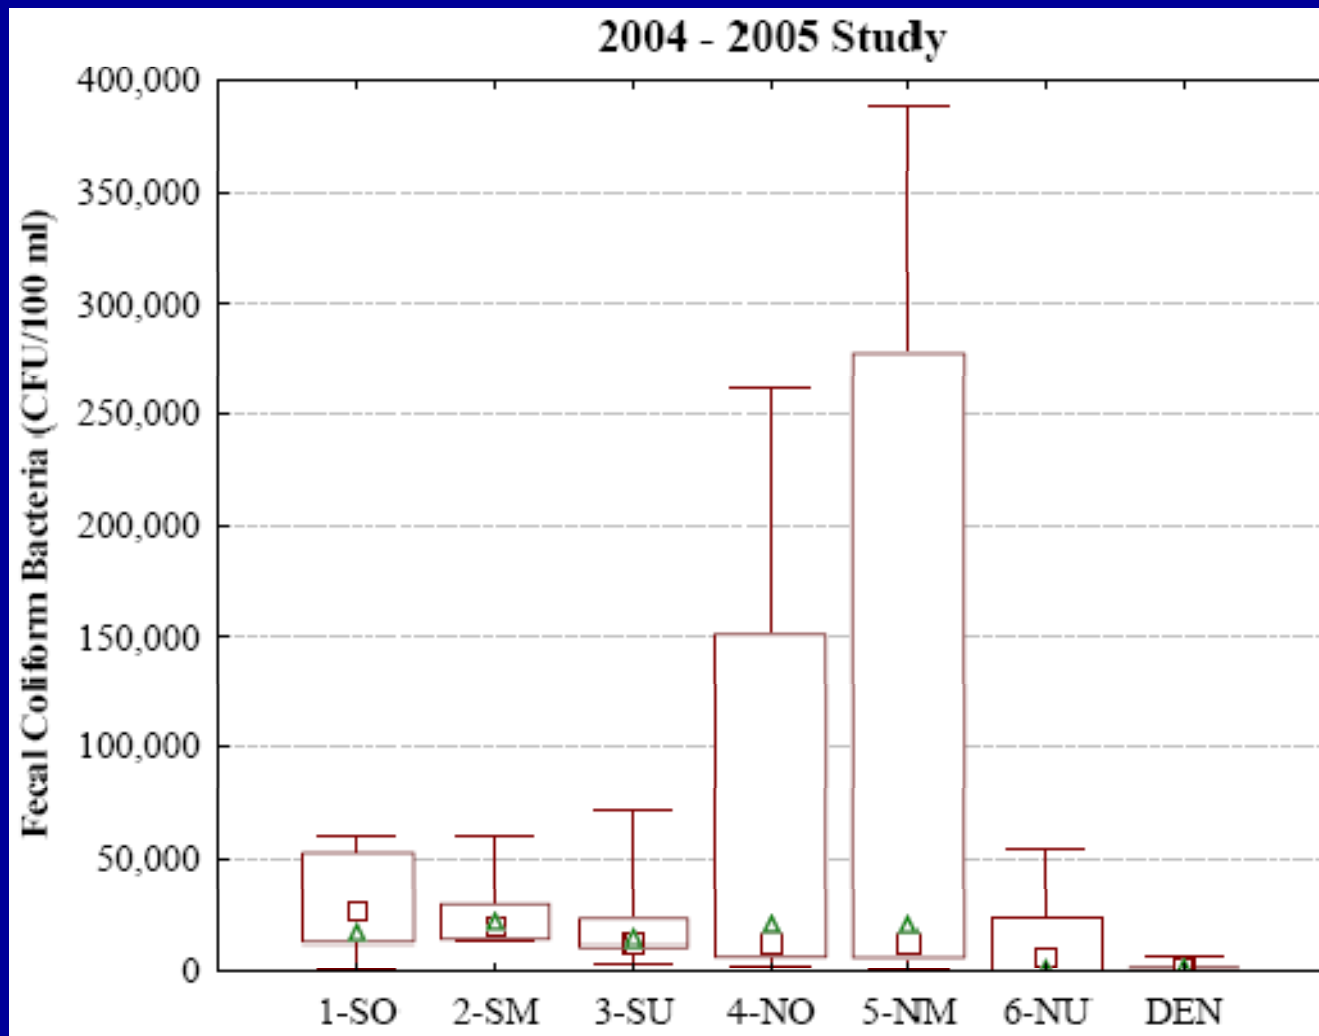
# Stormwater Fecal Coliform Bacteria Concentrations

- Very high fecals at South Outfall (>16,000) and North Outfall (>20,000) compared to Densmore (>1,600) and standard (<50).
- Wood chip pile is the major source of fecal coliform bacteria (>60,000), but >90 % were *Klebsiella*.
- Most common sources include birds, rodents, and dogs, but no humans observed.

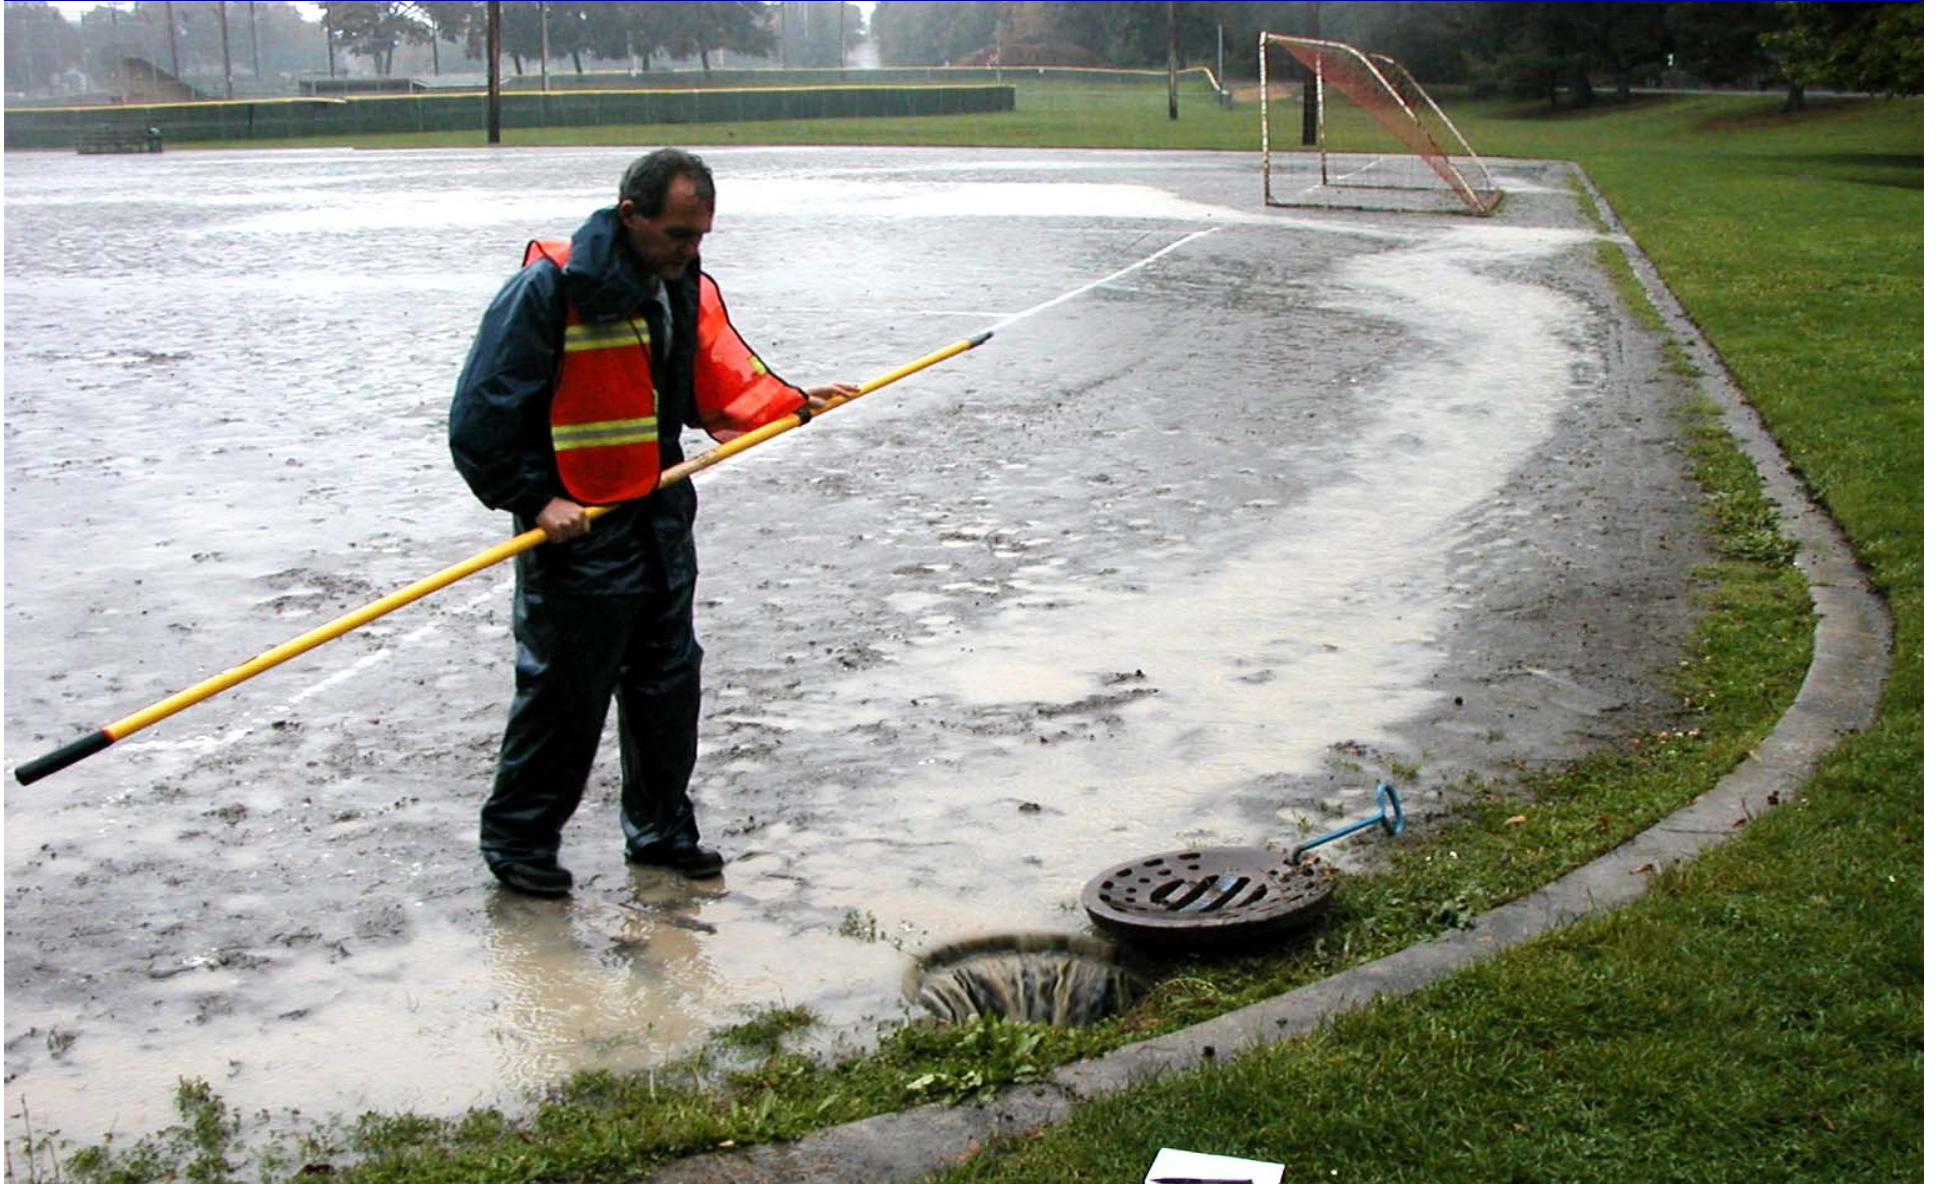
# Convert Dirt Soccer Fields to Synthetic Turf

Removed  
Convert to sport turf and clean vault  
Regrade with pervious pavement  
Street sweep  
No phosphate fertilizer; apply BMPs  
Apply BMPs  
Curb road and clean catch basins  
Plug catch basin and infiltrate runoff
