Port Gamble S'Klallam Tribe Coastal Analysis:
Shoreline Change and Extreme Water Levels

A report prepared in partial fulfillment of
the requirements for the degree of

Master of Science
Earth and Space Sciences: Applied Geosciences

MESSAGe Technical Report Number: 087

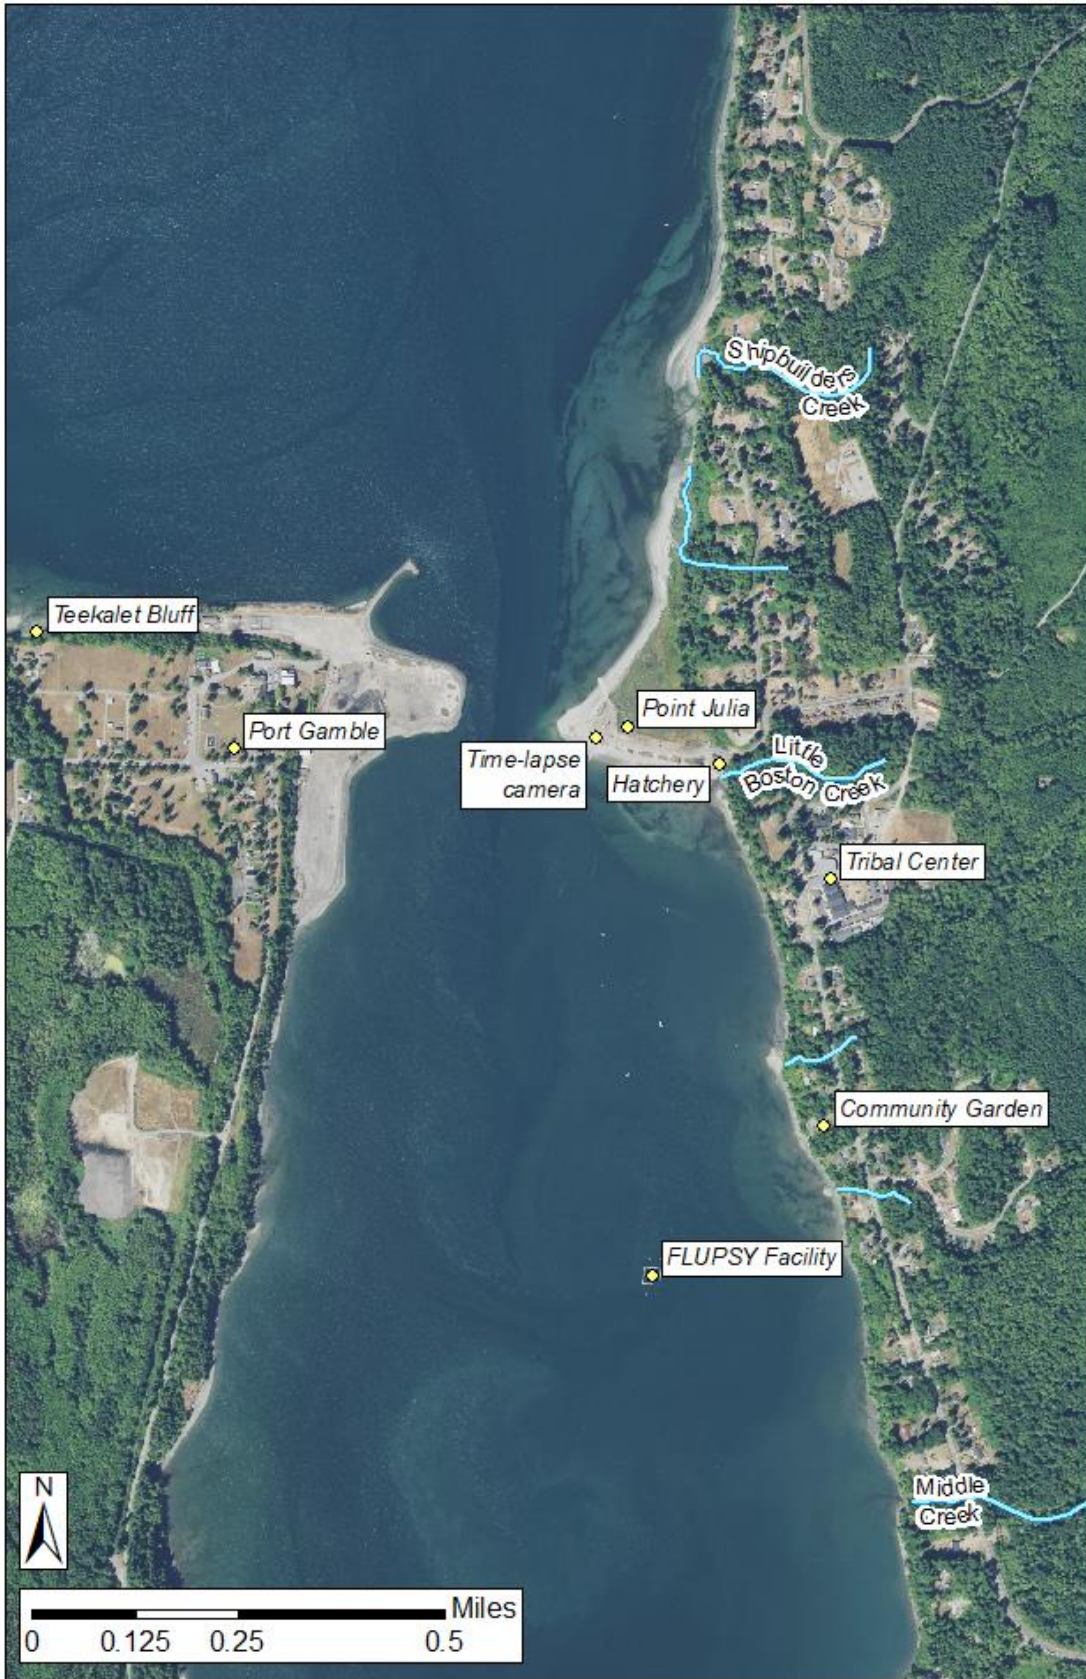
Figure 2. Site map of the PGST coast. The PGST coastline is primarily bluff-backed beaches with a cusped foreland (Point Julia). Six main streams drain the uplands forming fan deltas along the coast. Base maps from 2017 USDA NAIP satellite imagery and Washington State Geospatial Data Archive.

year period at McChord Air Force Base and Bremerton National Airport (Fain Environmental, 2016). Based on that record they modelled waves for a peak windspeed of 76 mph with a southerly fetch. They found the maximum significant wave heights to be about 4.2 ft with a breaking wave height of approximately 6.3 ft at the FLUPSY facility (Figure 2).

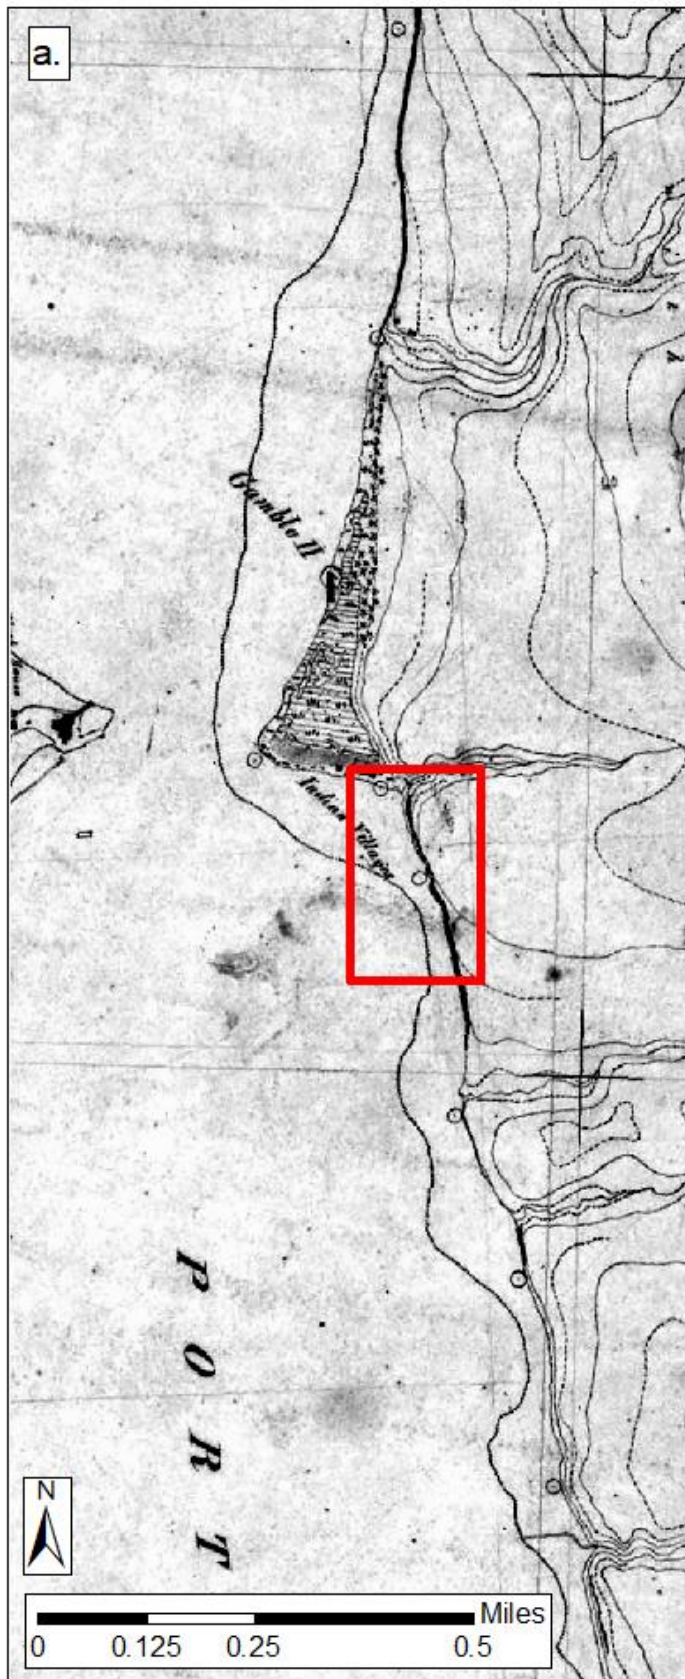
Figure 4. a) T-sheet of PGST coastline as mapped in 1856 (T-585). Four sections of bluff were mapped along the PGST coastline. Bluffs are shown as thick black lines along the coast. This T-sheet was mapped using a plane-board system. Red outline shows extent of Figure 4b. b) Bluff crest of bluff near the Tribal Center as digitized by the Puget Sound River History Project (2003).

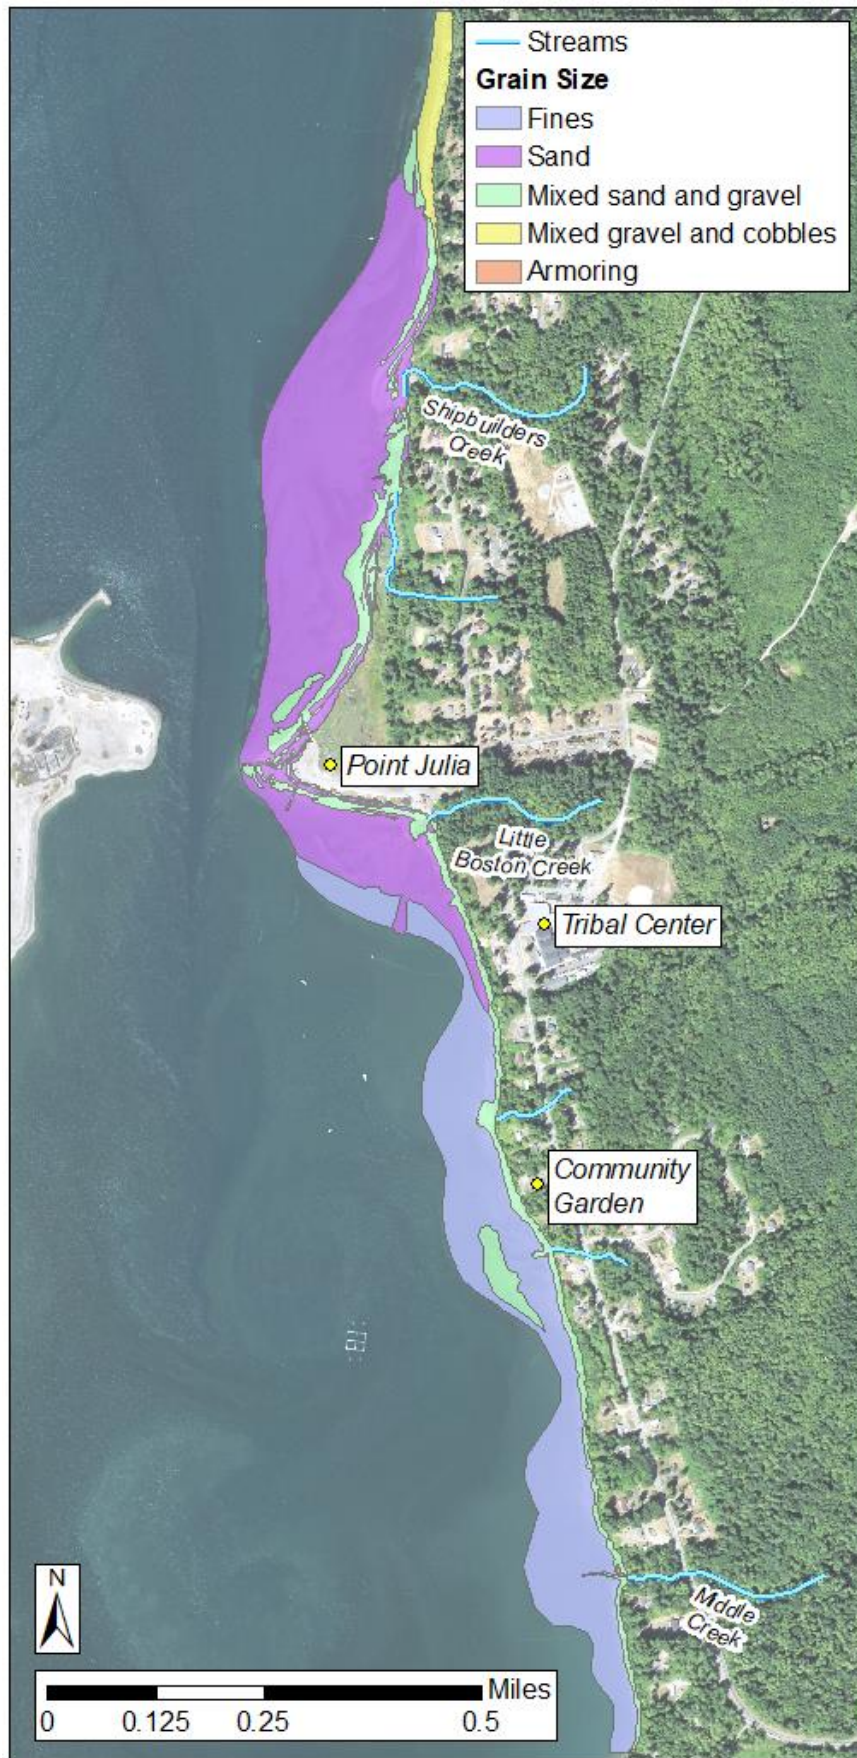
Figure 7. PGST beach grain size map. The beaches along PGST coast vary from fines (fine sand, silt, and clay) to mixed sand and gravel, up to boulders. Base map aerial imagery from 2017 USDA NAIP and 2019 PGST orthomosaic.

To establish baseline conditions of the beach, I mapped beach sediment grain size (Figure 7). I classified grain sizes visually and using field techniques. I mapped grain size in the field using a high resolution (~0.79 in) orthomosaic image from drone photography as the base map (Figure 8). I used Agisoft PhotoScan 1.2.6 to create the orthomosaic from 2,514 photos captured with a DJI Phantom 3 drone FC300X camera flown at 100-165 ft above the beach surface (Appendix A). To increase the spatial accuracy of the orthomosaic, I used 13 ground control points (GCP) captured using a Trimble Geo7x GNSS receiver.

PGST beaches are generally divided into fines (fine sand, silt, and clay) south of Point Julia, sands (fine to coarse) around Point Julia and north to Shipbuilders Creek, and gravel/cobbles north of Shipbuilders Creek (Figure 7). It should be noted that grain size map shows the *predominant* grain size on the beach face. Much of PGST beaches have mixed grain sizes and grain size may vary with seasons and storms. Table 9 has a more detailed description of mapped grain sizes.

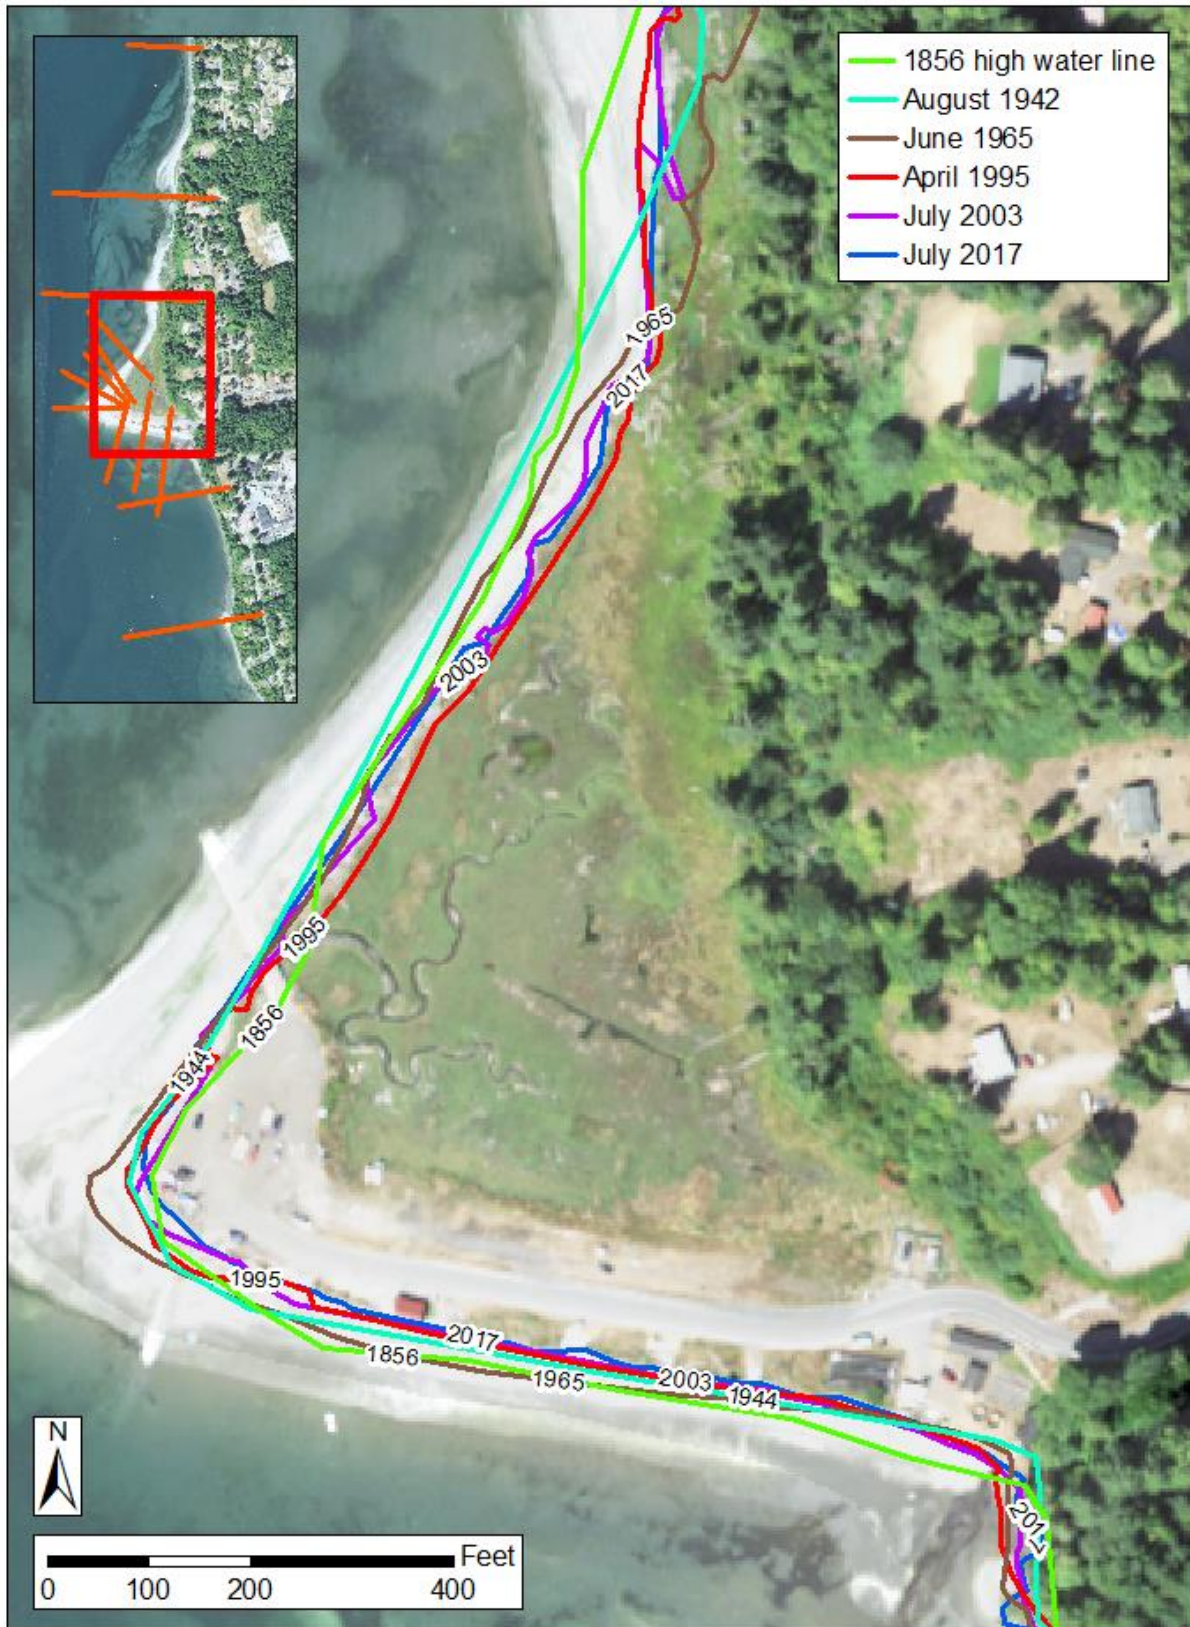
Figure 9. Shoreline change map of Point Julia. These data show a potential pattern of sea level rise with slight landward movement of the shoreline on the south side of Point Julia. I mapped shoreline from 1856 T-sheet high water line and vegetation lines from aerial imagery available at the University of Washington Libraries. Base map aerial imagery from 2017 USDA NAIP.

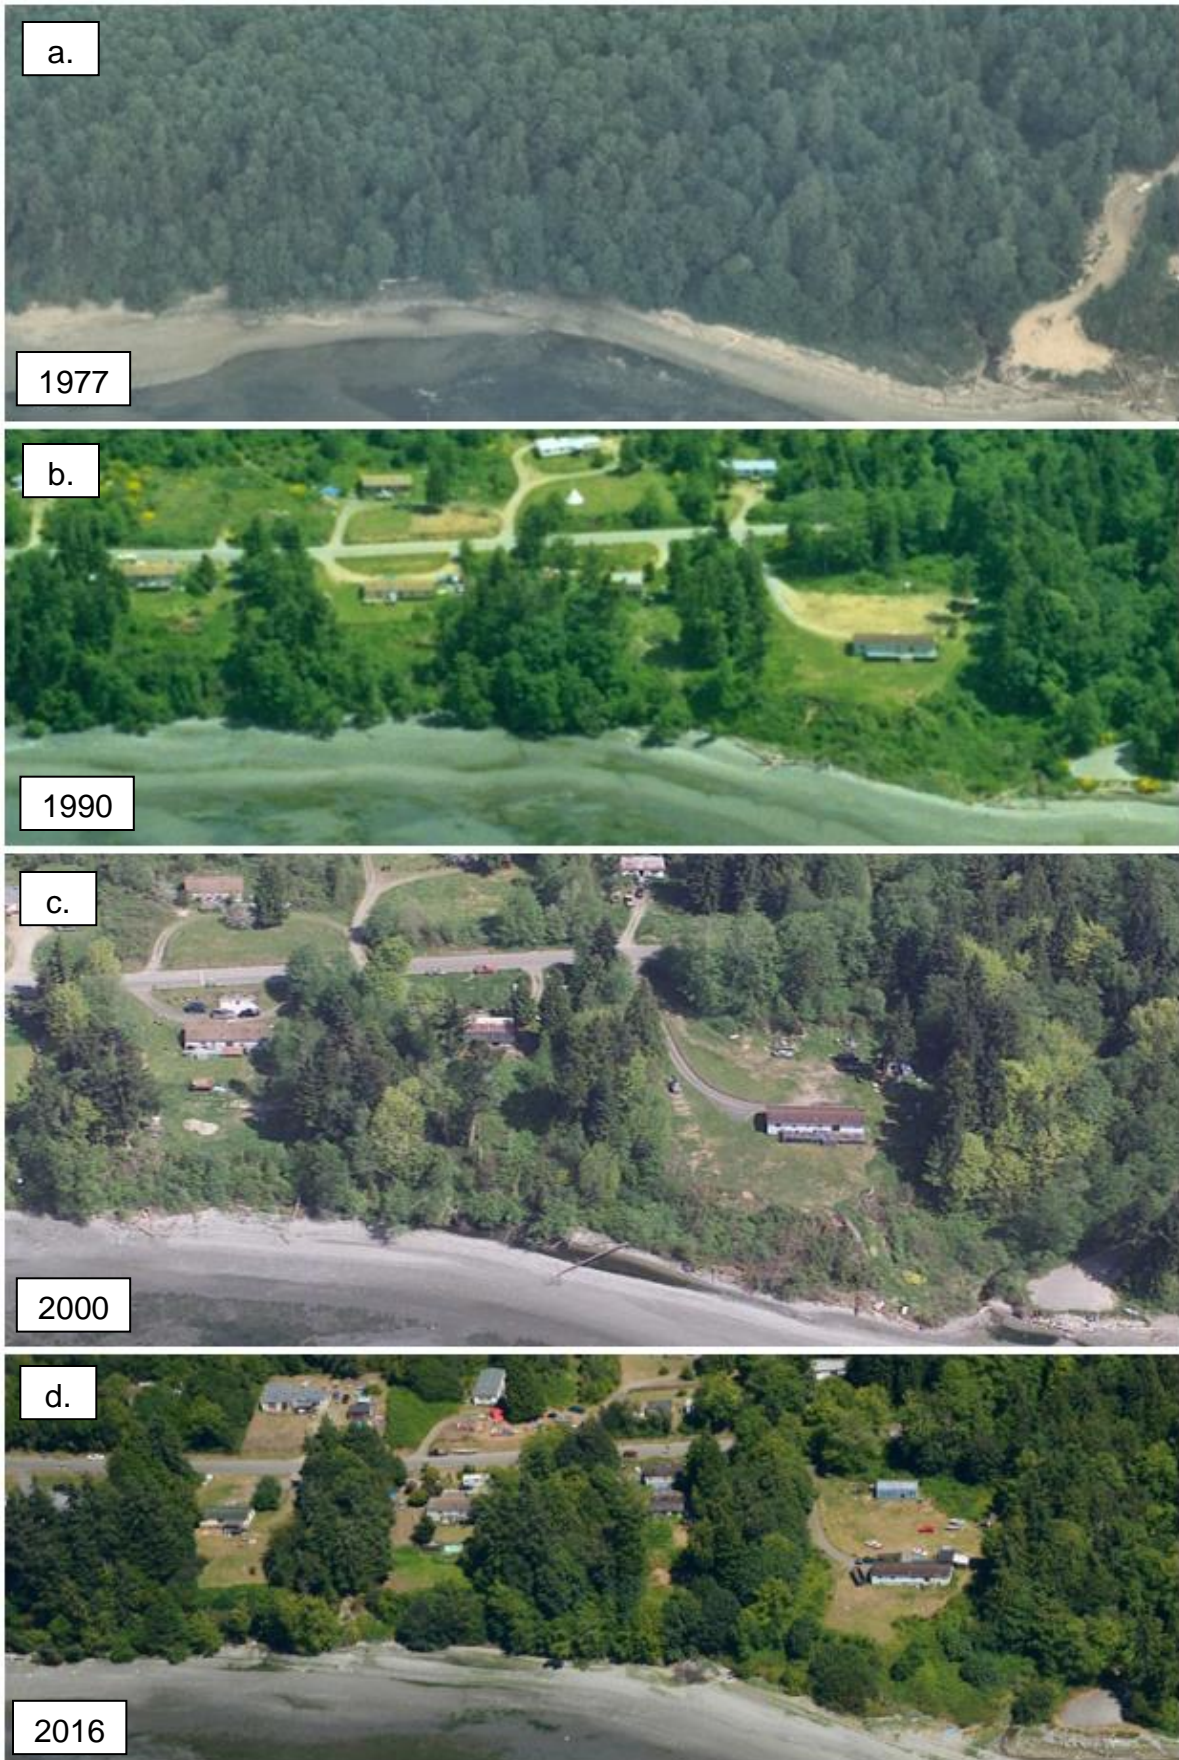
Figure 14. Tree removal along the PGST coastline since 1977. a) 1977 photo with abundant trees. b) 1990 photo with loss of trees since 1977. c) 2000 photo. d) 2016 photo. View to the east with Shipbuilders Creek outlet in the bottom right corner of the images. Photos from WA Department of Ecology.

Oblique photographs showed signs of bluff instability along the PGST coast (Figure 11). Bluff failures often seem to be associated with tree removal along the bluffs (Figures 12, 13), and tree removal on bluffs appears to have been common, especially between 1977 and 1990 (Figure 14).

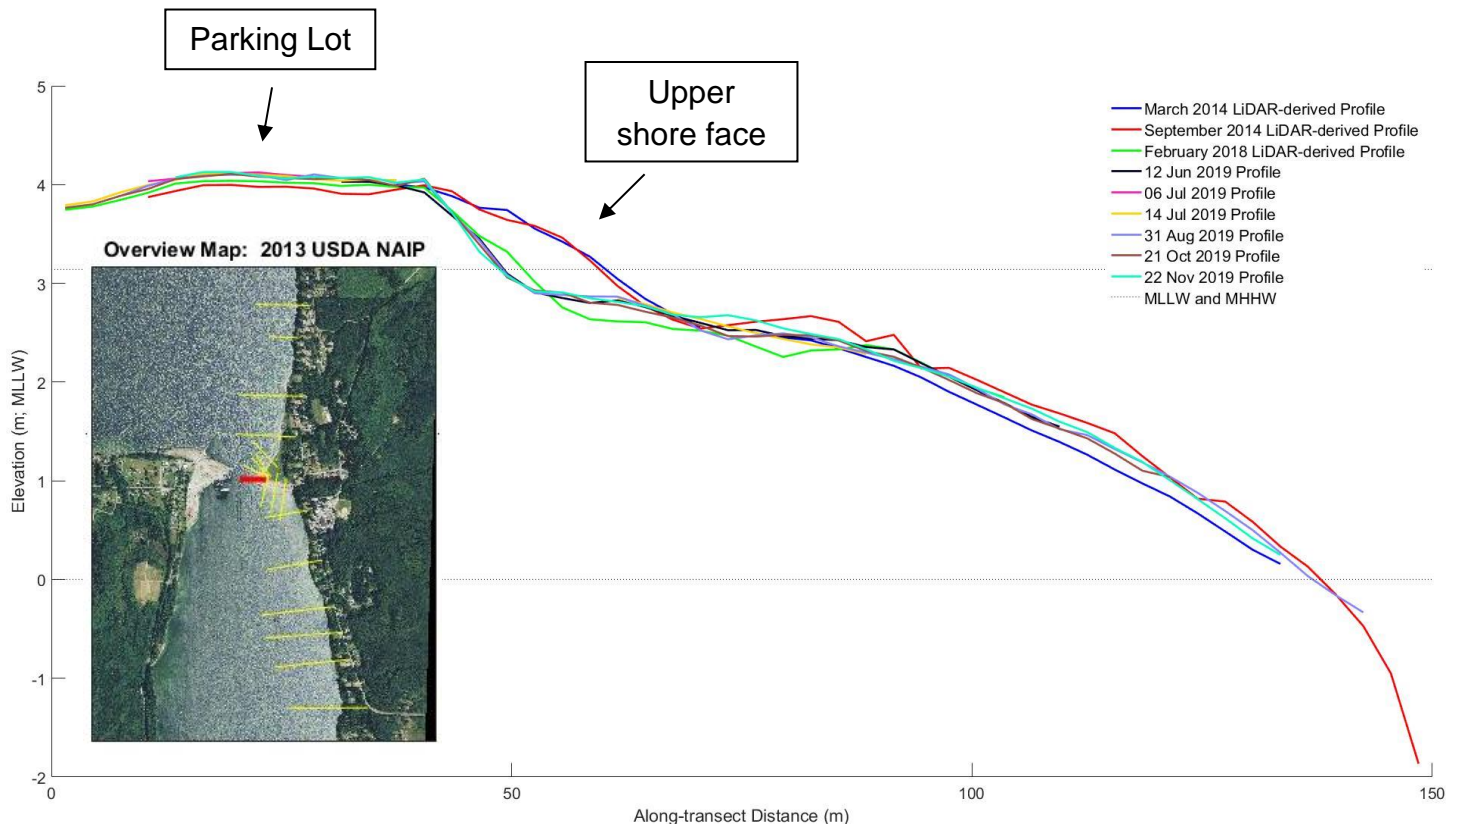
Figure 17. Shoreline profile of focus transect 10 on the tip of Point Julia. This profile showed the most significant change of all our beach profiles. The upper shoreface shows distinct changes between 2014 and 2018. We derived profiles from LiDAR data and GNSS surveying.

Our GNSS survey data coupled with LiDAR suggest little in the way of seasonal shoreline dynamics, Most short-term shoreline change observed during our study is generally associated with creek mouths to the north of Point Julia (Figure 10). The LiDAR in particular does not appear to have adequate resolution to detect small changes on the bluff face, and possible changes in the intertidal zone are rarely larger than the uncertainty. Overall, the shoreline appears to be relatively stable over the last 5 years (Appendix B). However, the shoreline profile on the tip of Point Julia shows measurable scallop of about 1 m in the upper intertidal zone between 2014 and 2018 (Figure 17).

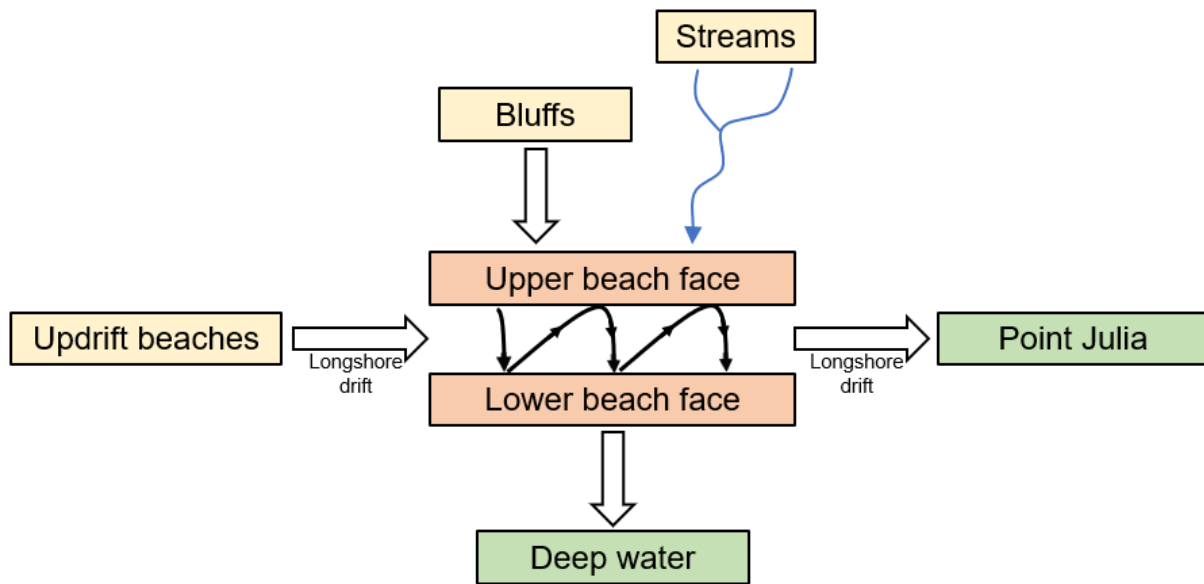
Figure 21. Conceptual model of sediment budget for the PGST beaches. This simple box model shows sediment inputs, areas of sediment transport/storage, and sediment deposition/sinks. Model modified from Shipman et al. (2014).

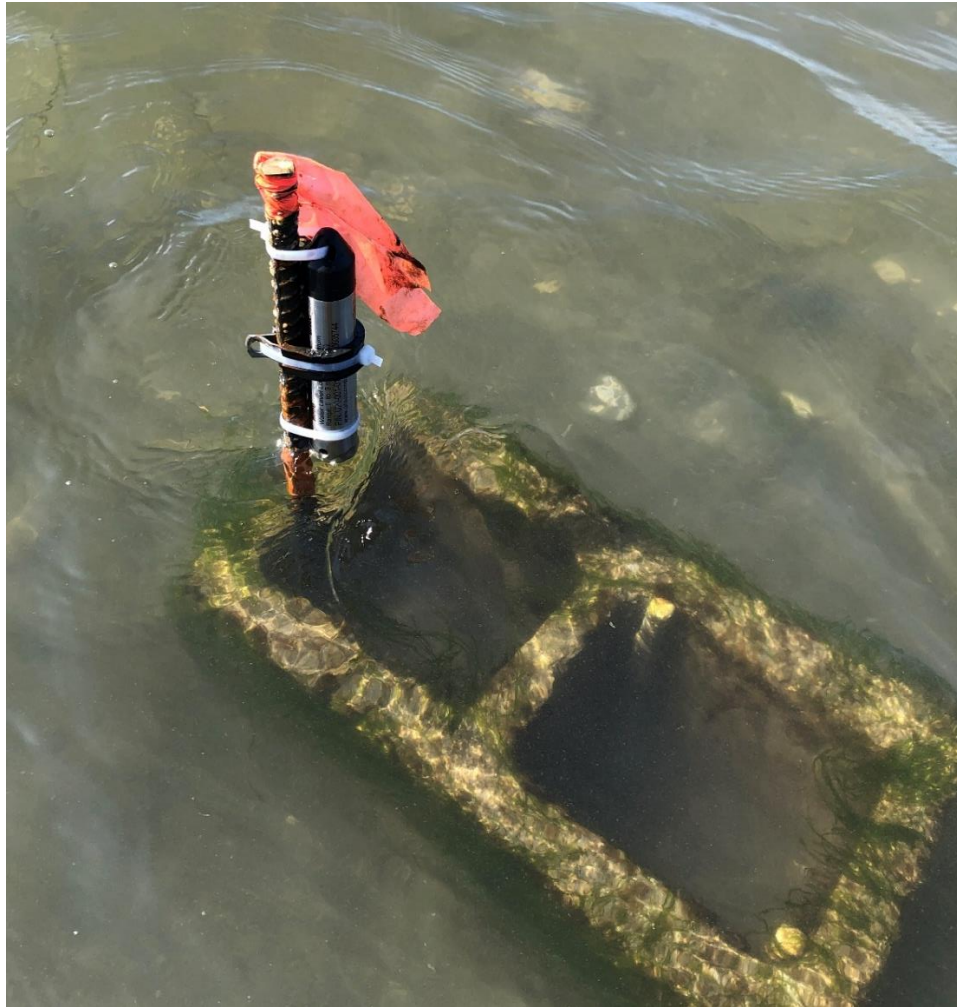
Figure 24. One of the Onset water loggers deployed on the tidal platform of the PGST beaches. I used the water loggers to calculate water levels along PGST beaches to compare to permanent tide gauges at Seattle and Port Townsend.

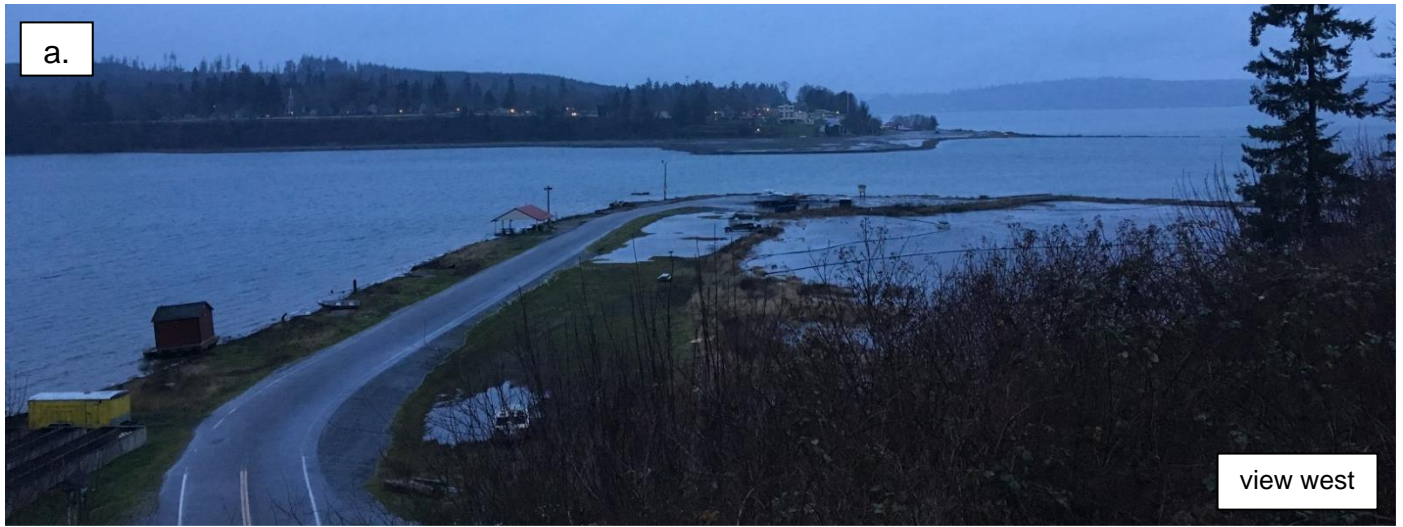
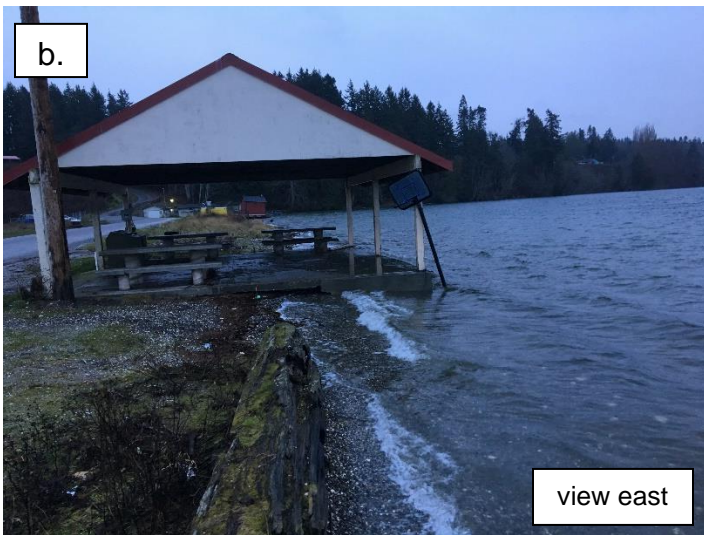
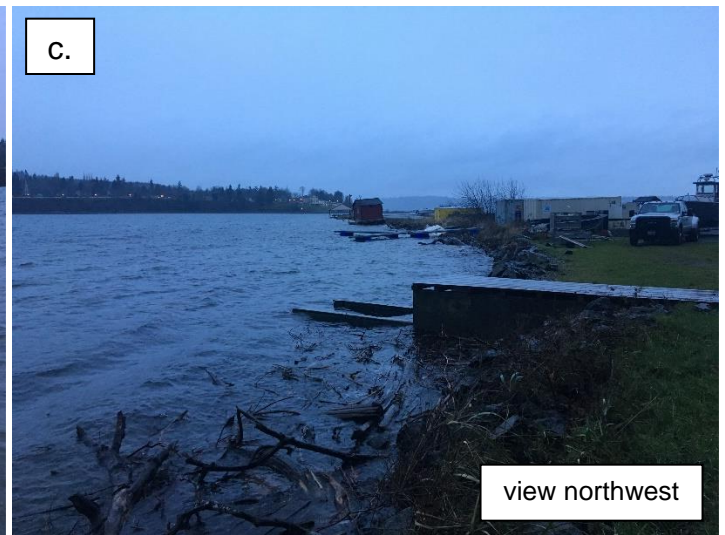
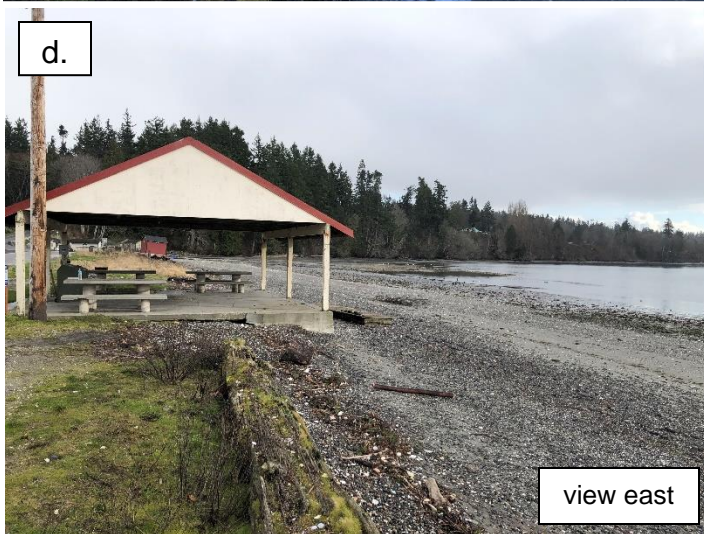
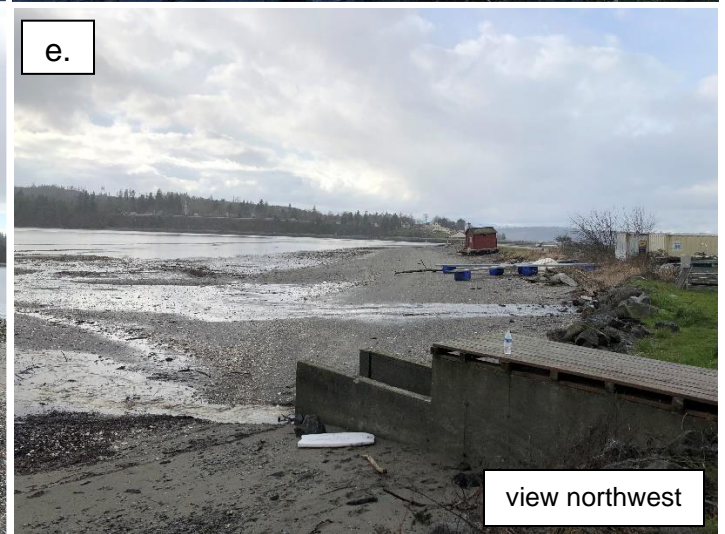
Figure 25. a) Photo overlooking Point Julia during a “king” tide event on December 26, 2018. b) Photo looking east toward the pavilion on Point Julia during the “king” tide event. c) Photo view west near the hatchery on Point Julia during the “king” tide event. d) Photo looking east toward the pavilion on Point Julia on February 17, 2020. Water level was about 5 ft above MLLW at the time of the photo (~2:45pm). e) Photo view west near the hatchery on Point Julia on February 17, 2020. Water level was about 5 ft above MLLW at the time of the photo (~2:45pm). I used this photo set to get an idea for water levels at Point Julia during extreme tide events. “King” tide photos taken by Sam Phillips ~8:00am on December 26, 2018.

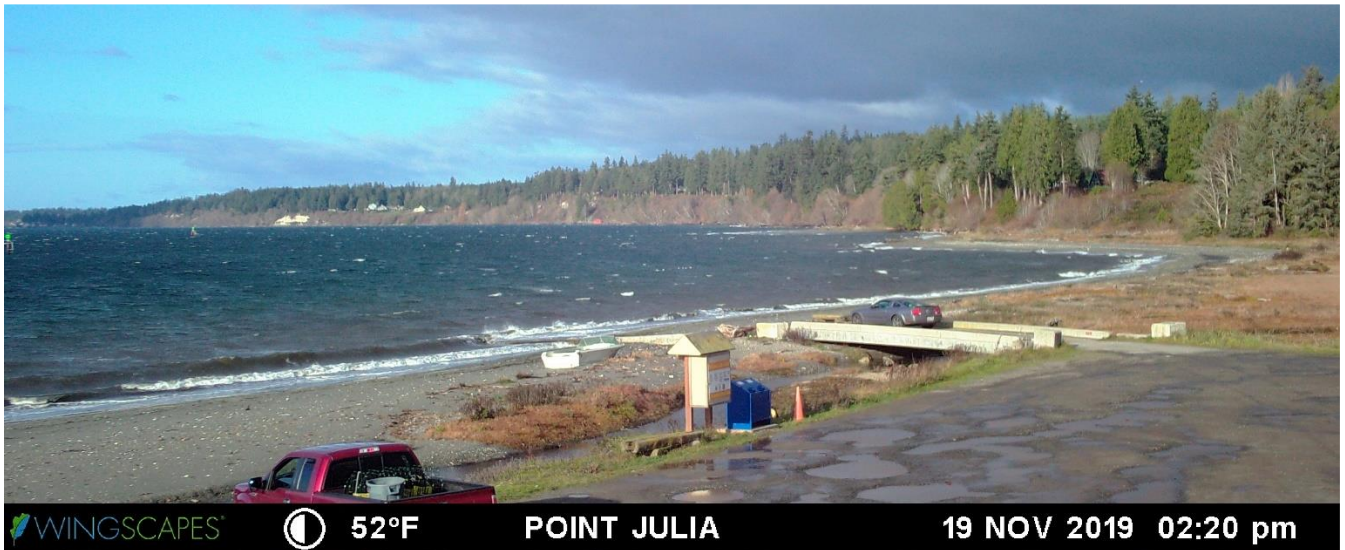
Figure 28. Waves breaking on Point Julia during a slightly breezy period (gusts up to 6 mph at Port Townsend, WA) on November 19, 2019. View north from time-lapse camera.

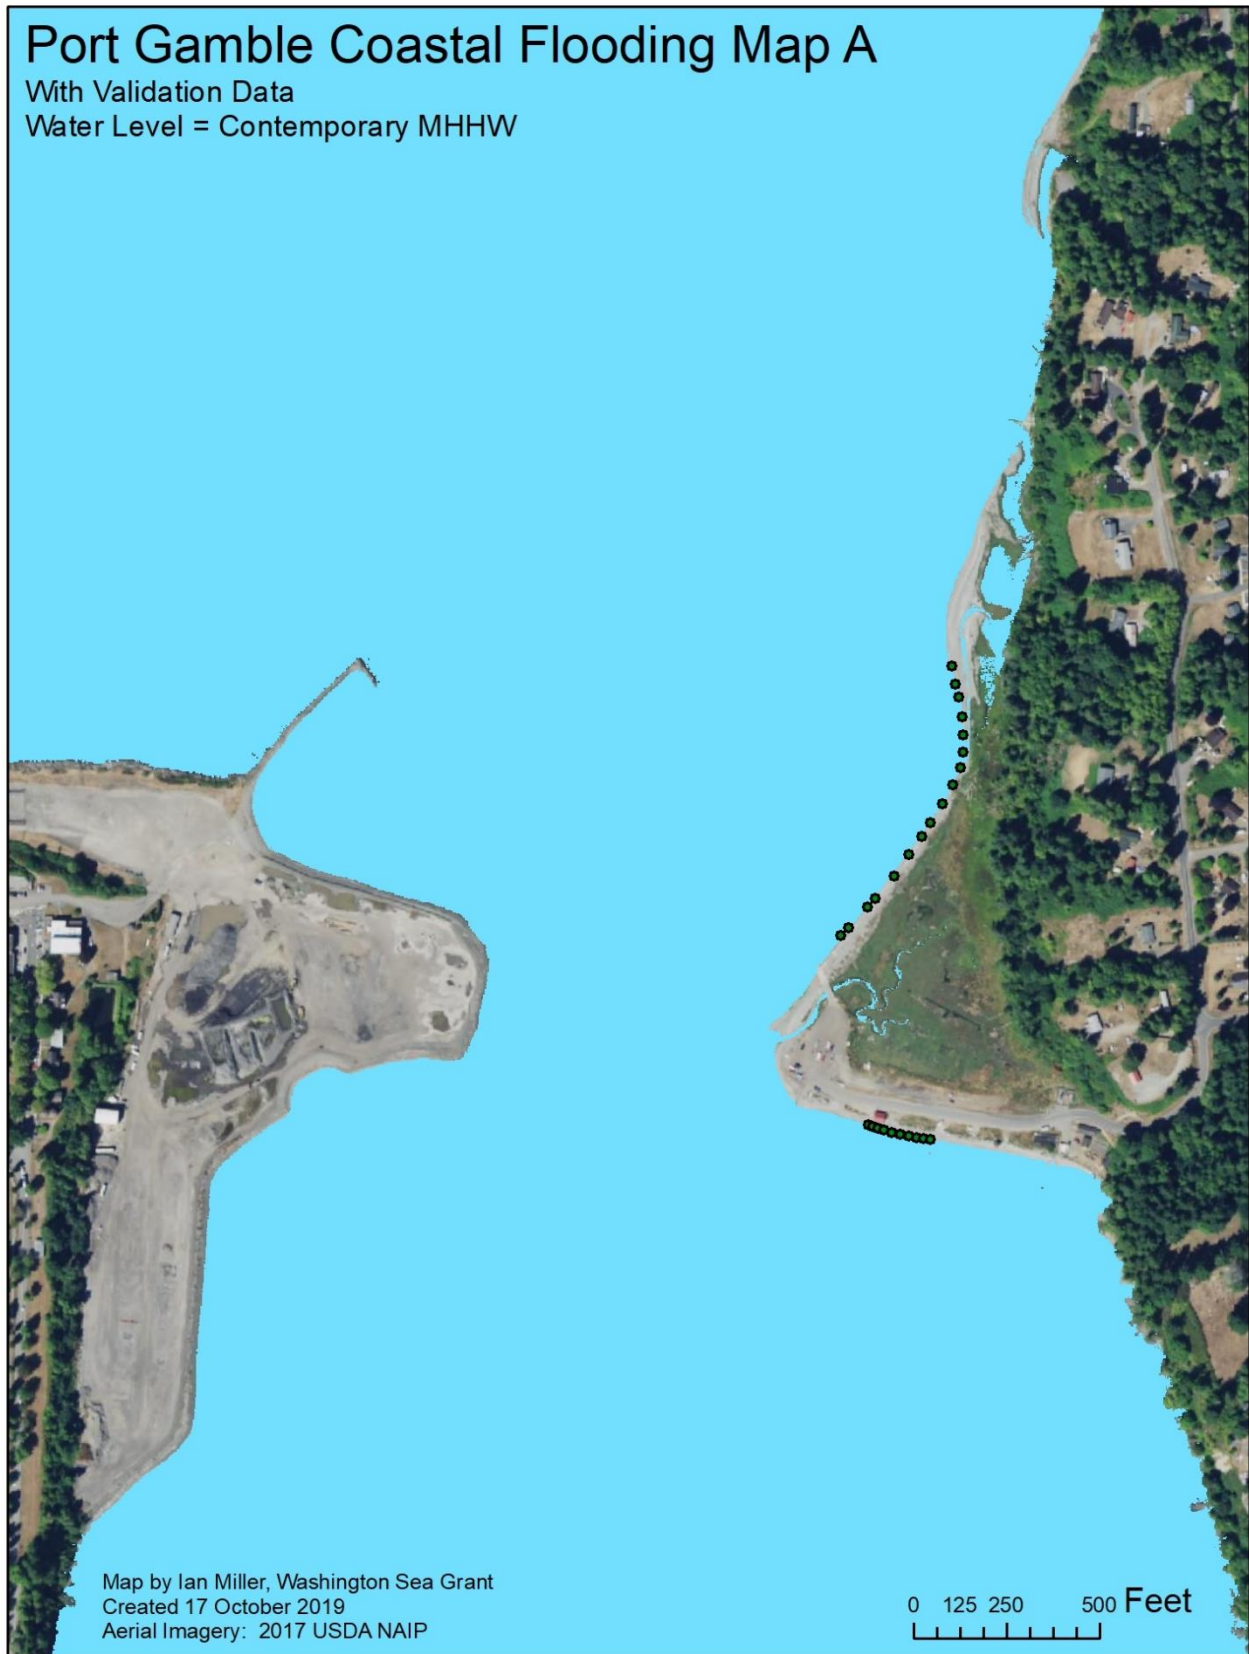
Figure C1. Inundation map showing current flooding extent of Point Julia at current Mean Higher High Water (8.446 ft NAVD 88). Points along Point Julia show the wrack line as surveyed by Sam Phillips in Fall 2019.

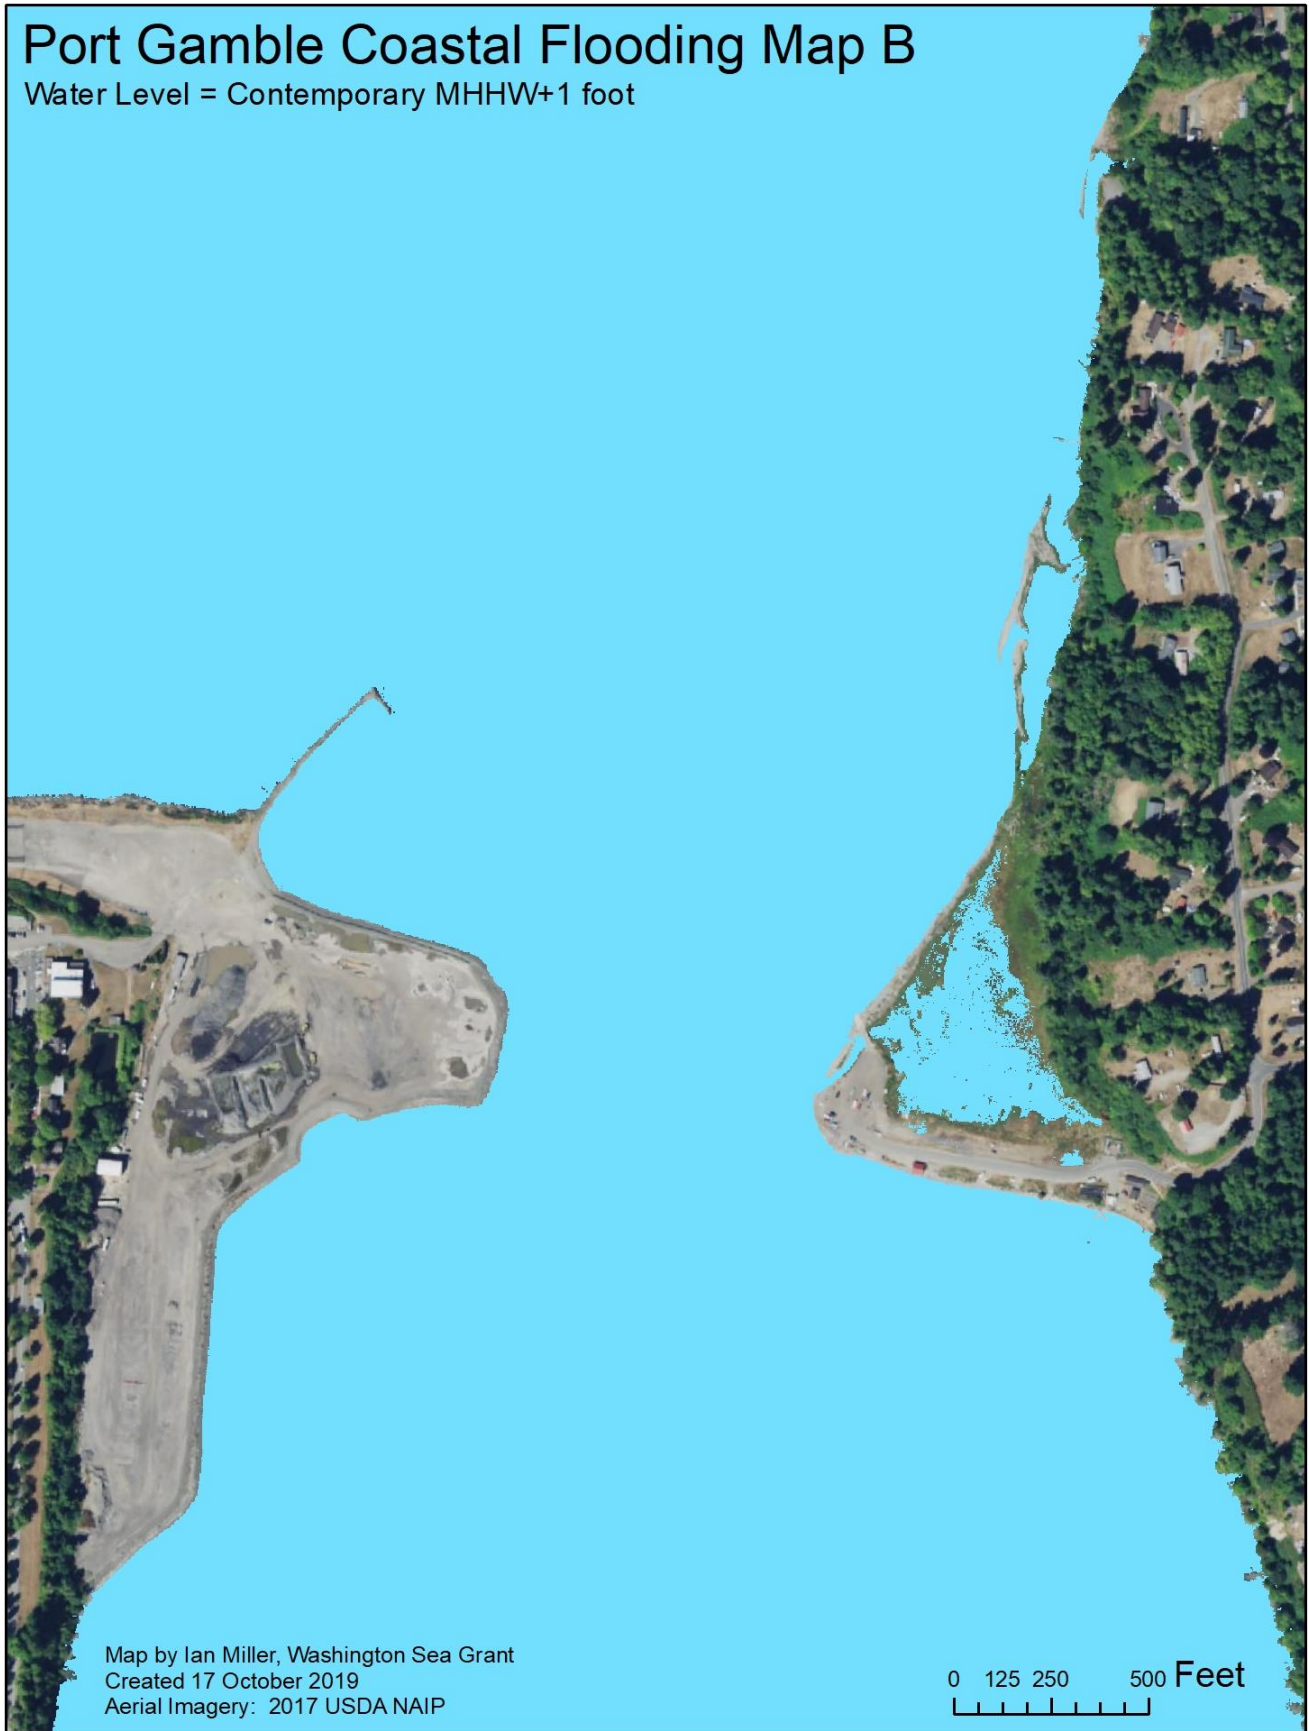
Figure C2. Inundation map showing estimated flooding extent of Point Julia at current MHHW plus 1 foot.

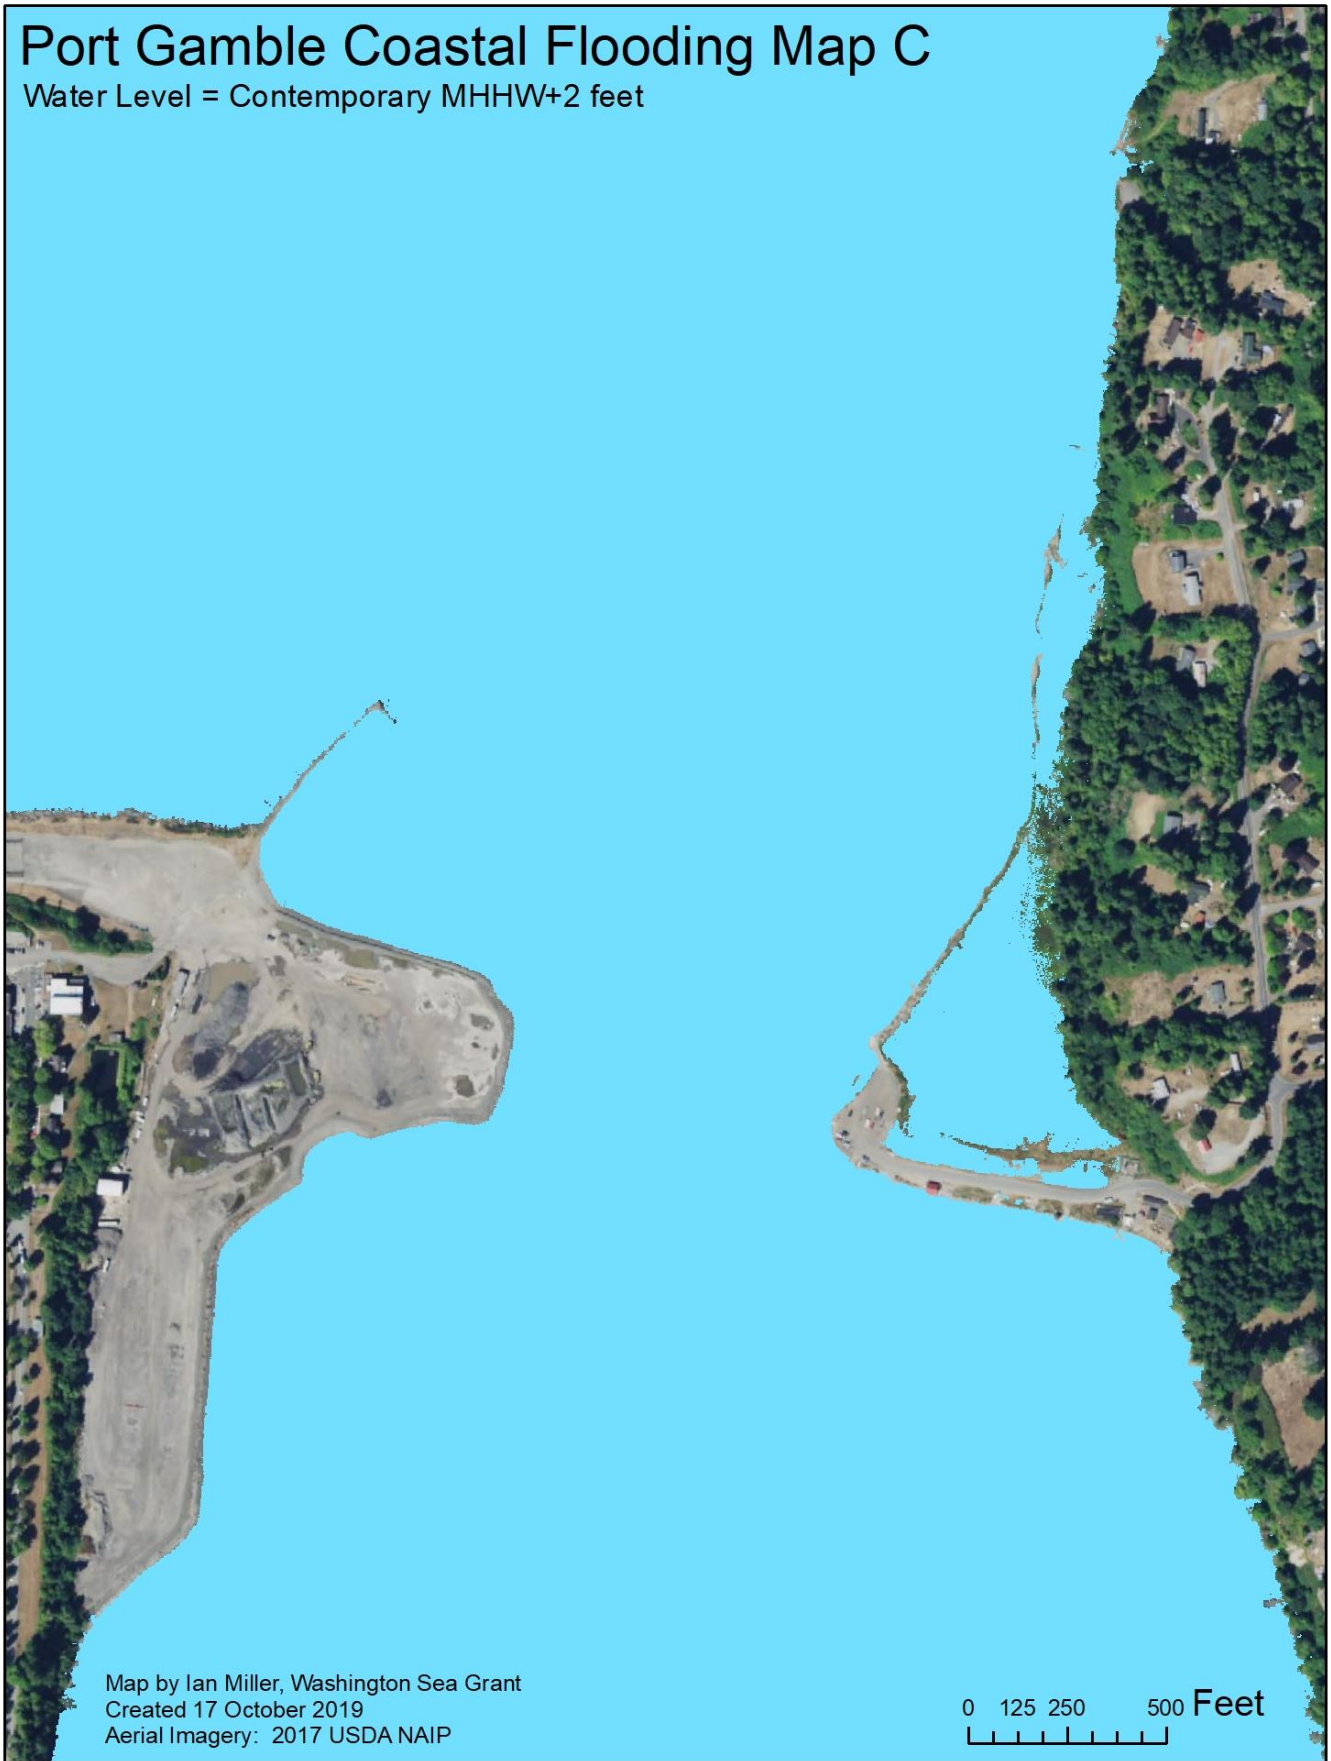
Figure C3. Inundation map showing estimated flooding extent of Point Julia at current MHHW plus 2 feet.
