Port Gamble S'Klallam Tribe Coastal Analysis:
Shoreline Change and Extreme Water Levels

A report prepared in partial fulfillment of
the requirements for the degree of

Master of Science
Earth and Space Sciences: Applied Geosciences

MESSAGe Technical Report Number: 087

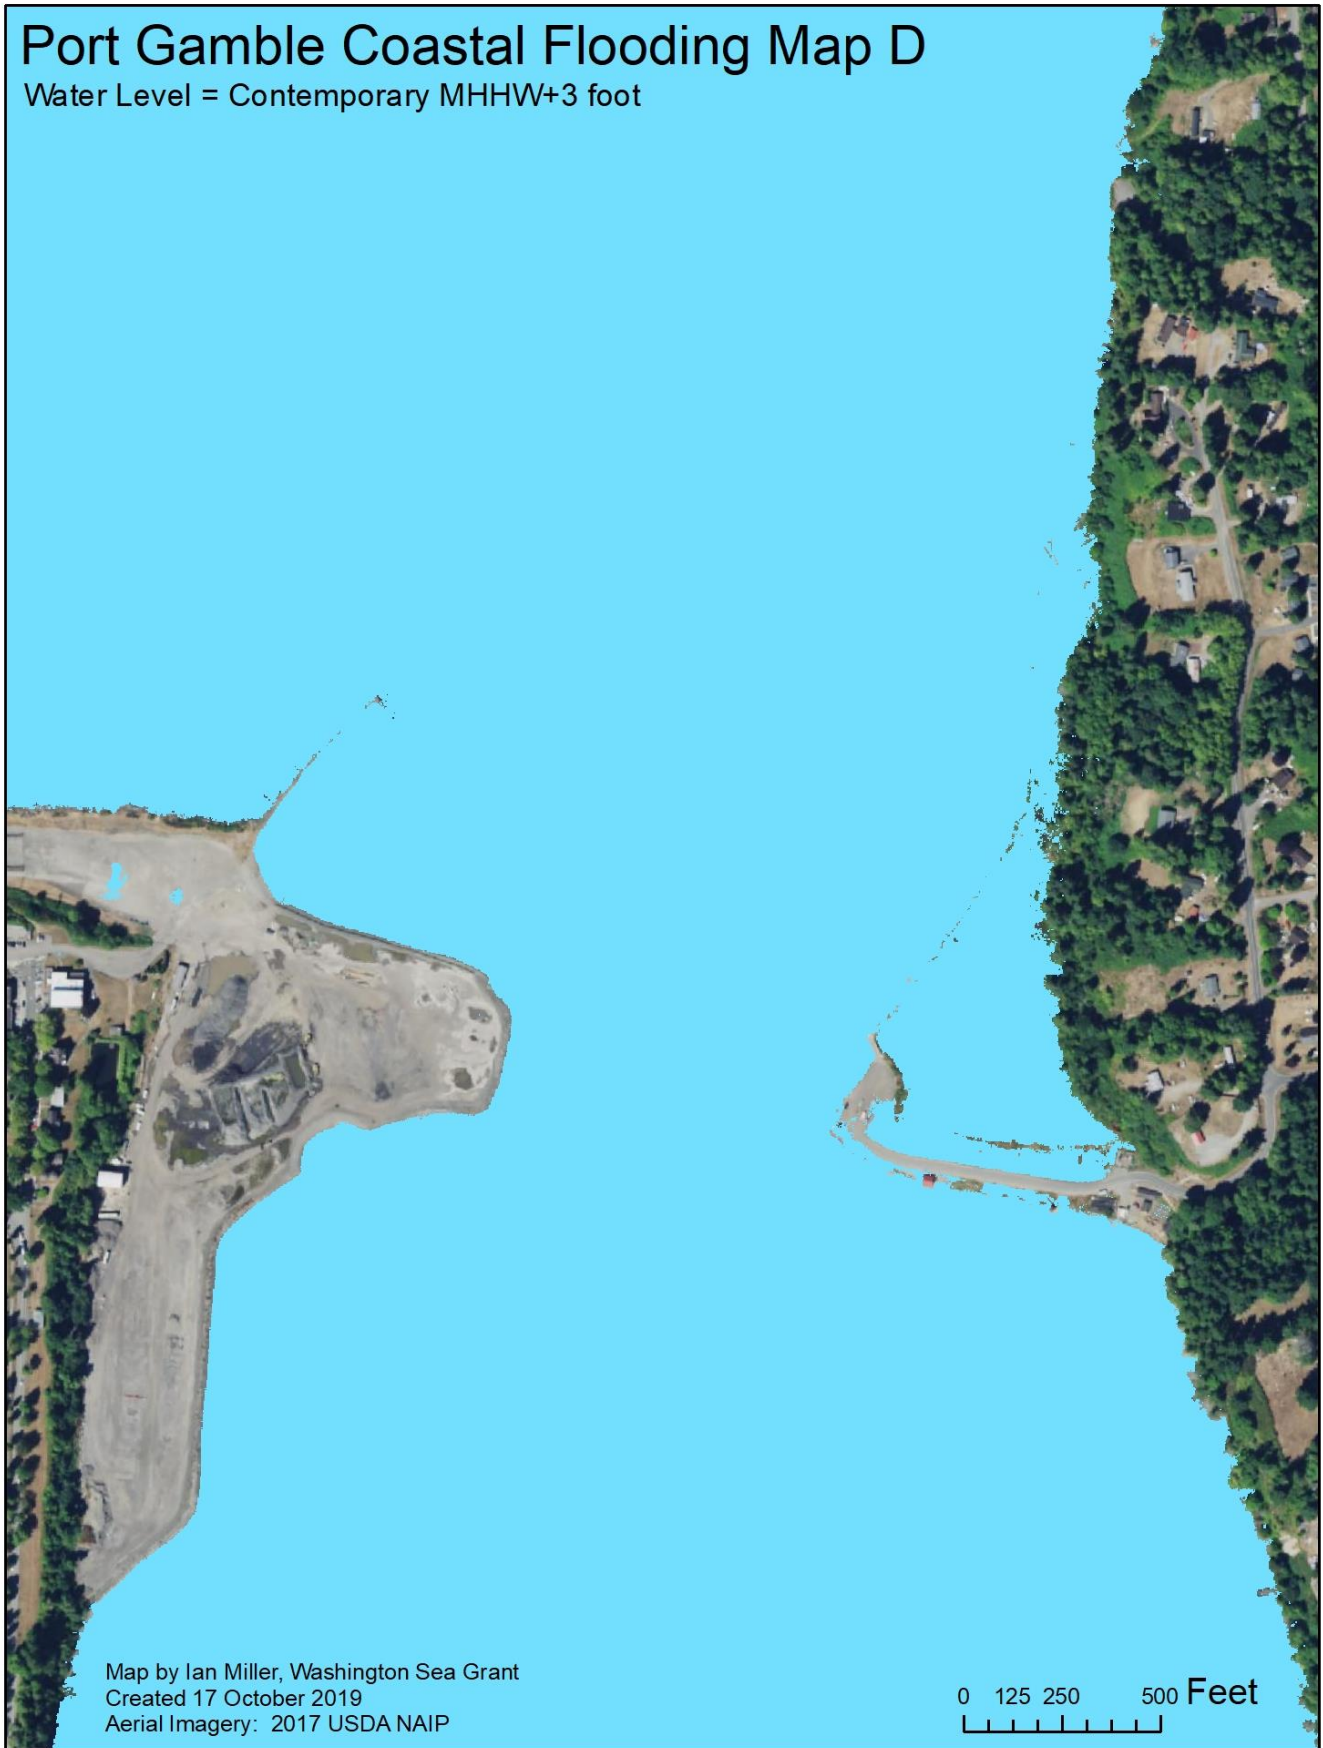
Figure C4. Inundation map showing estimated flooding extent of Point Julia at current MHHW plus 3 feet.

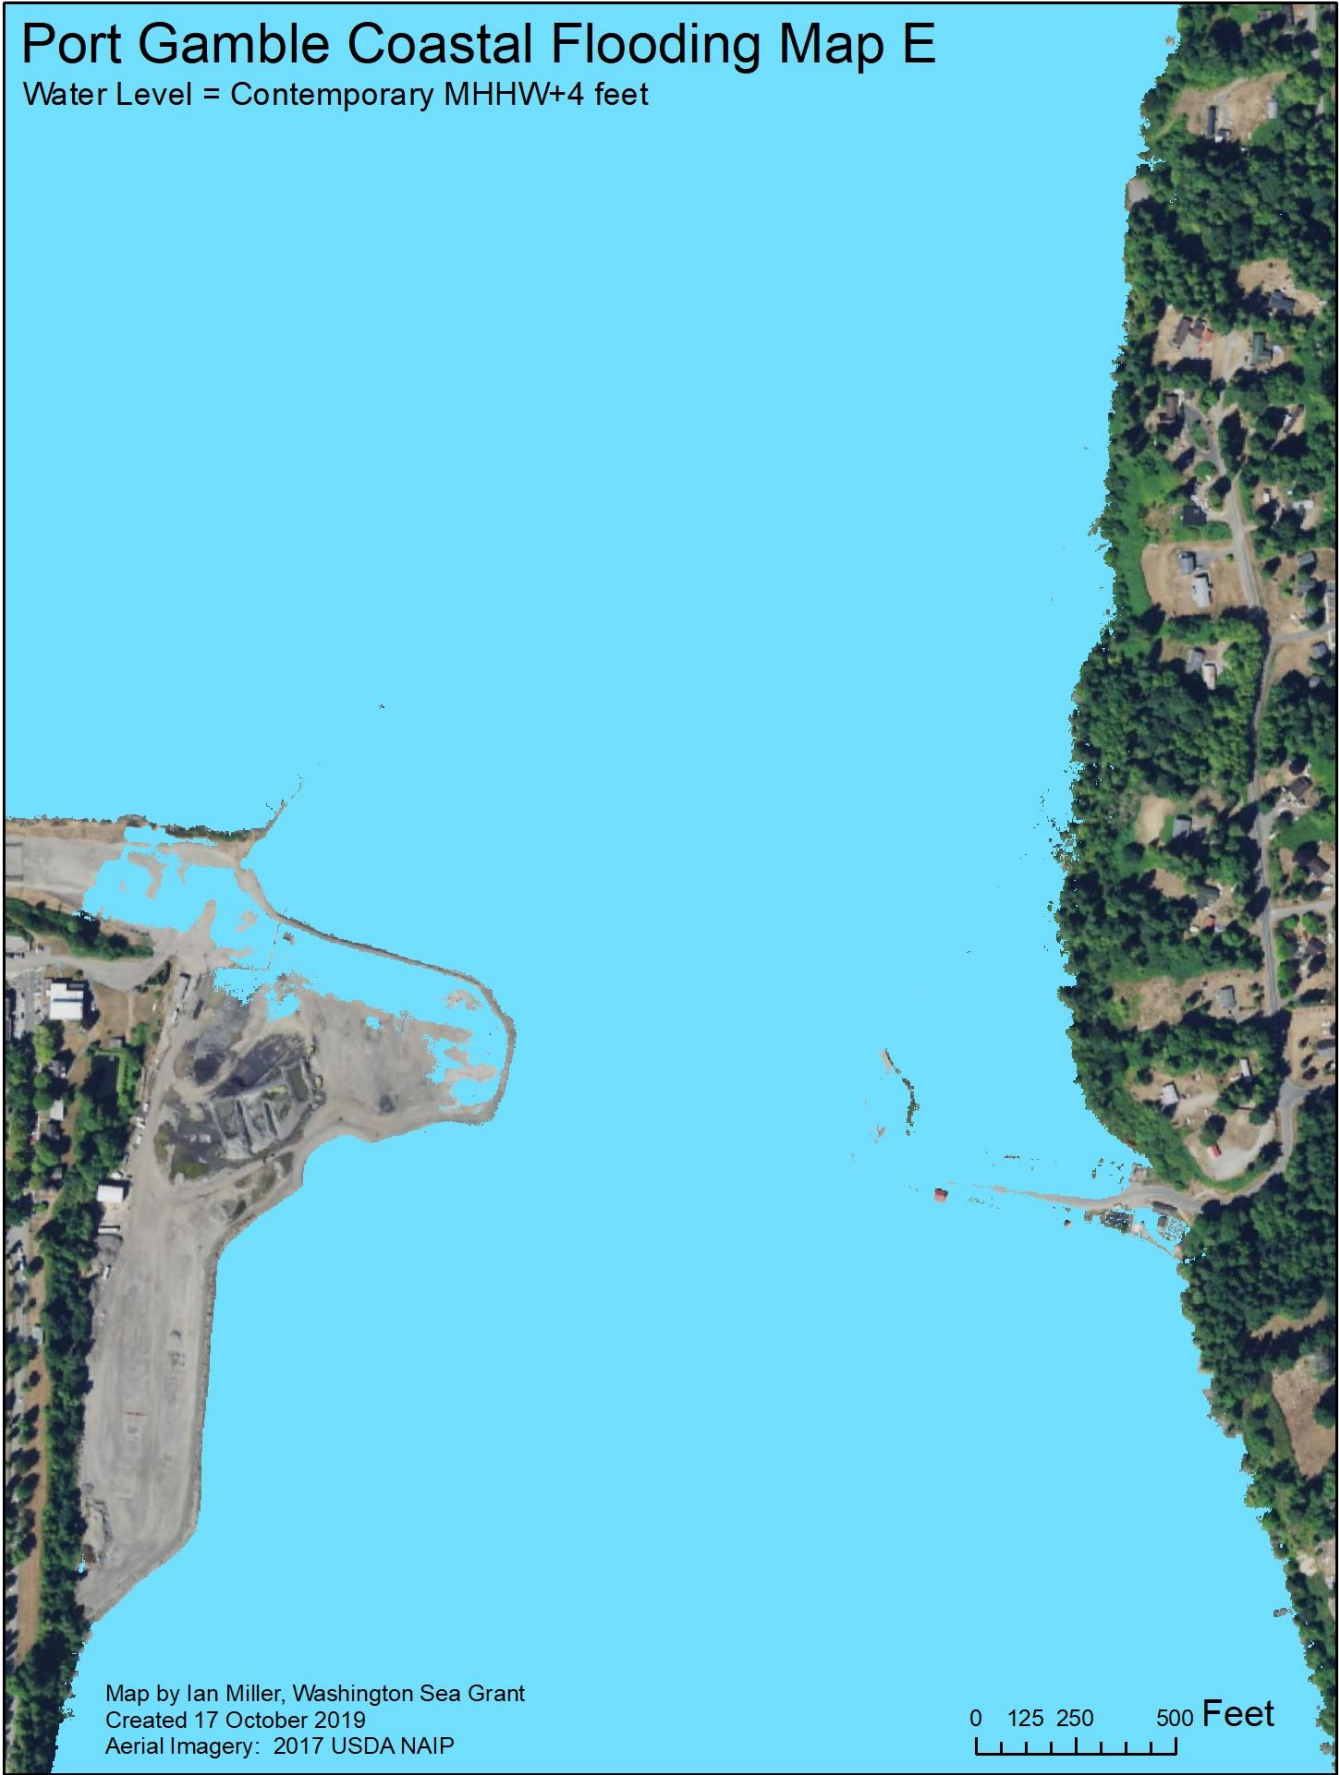
Figure C5. Inundation map showing estimated flooding extent of Point Julia at current MHHW plus 4 feet.

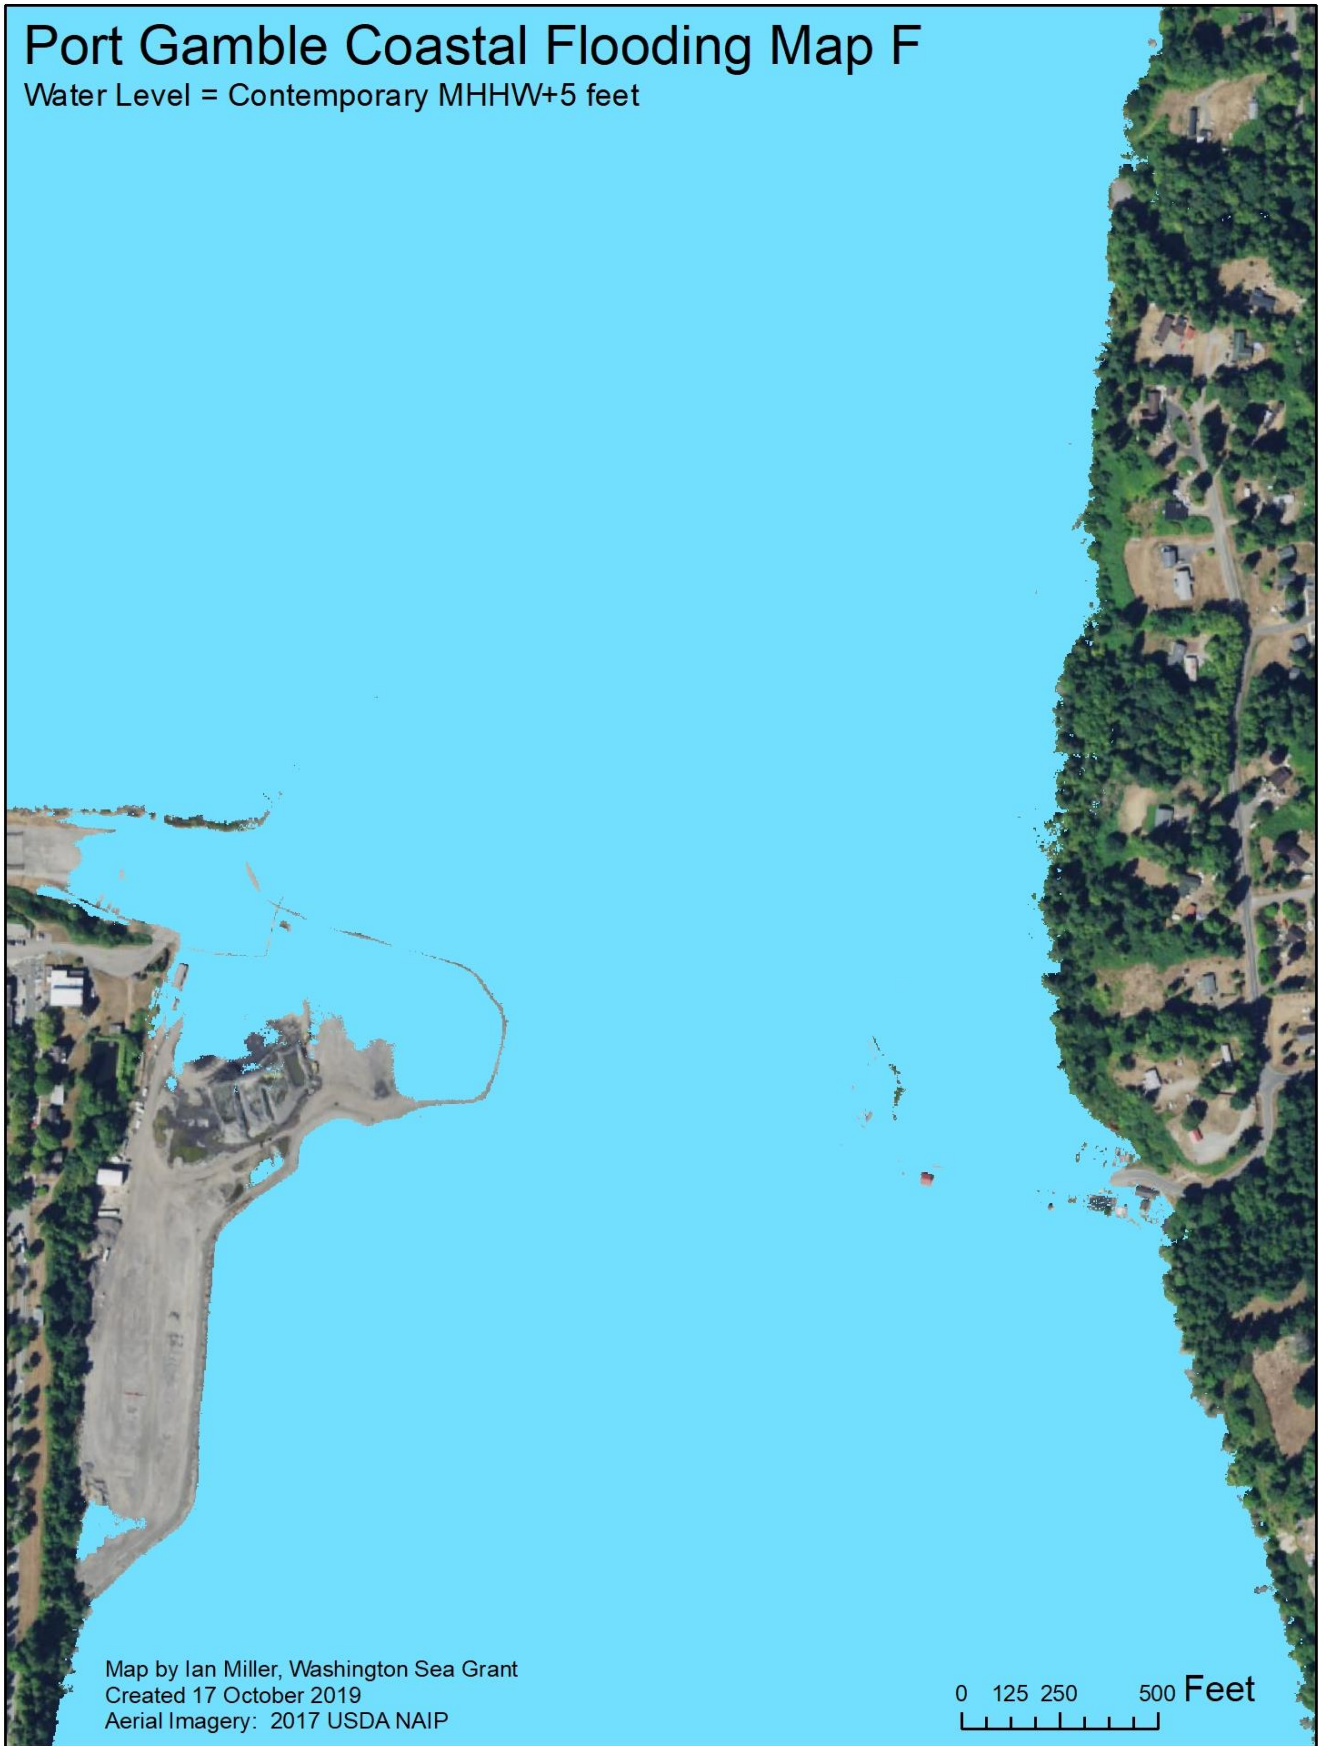
Figure C6. Inundation map showing estimated flooding extent of Point Julia at current MHHW plus 5 feet.

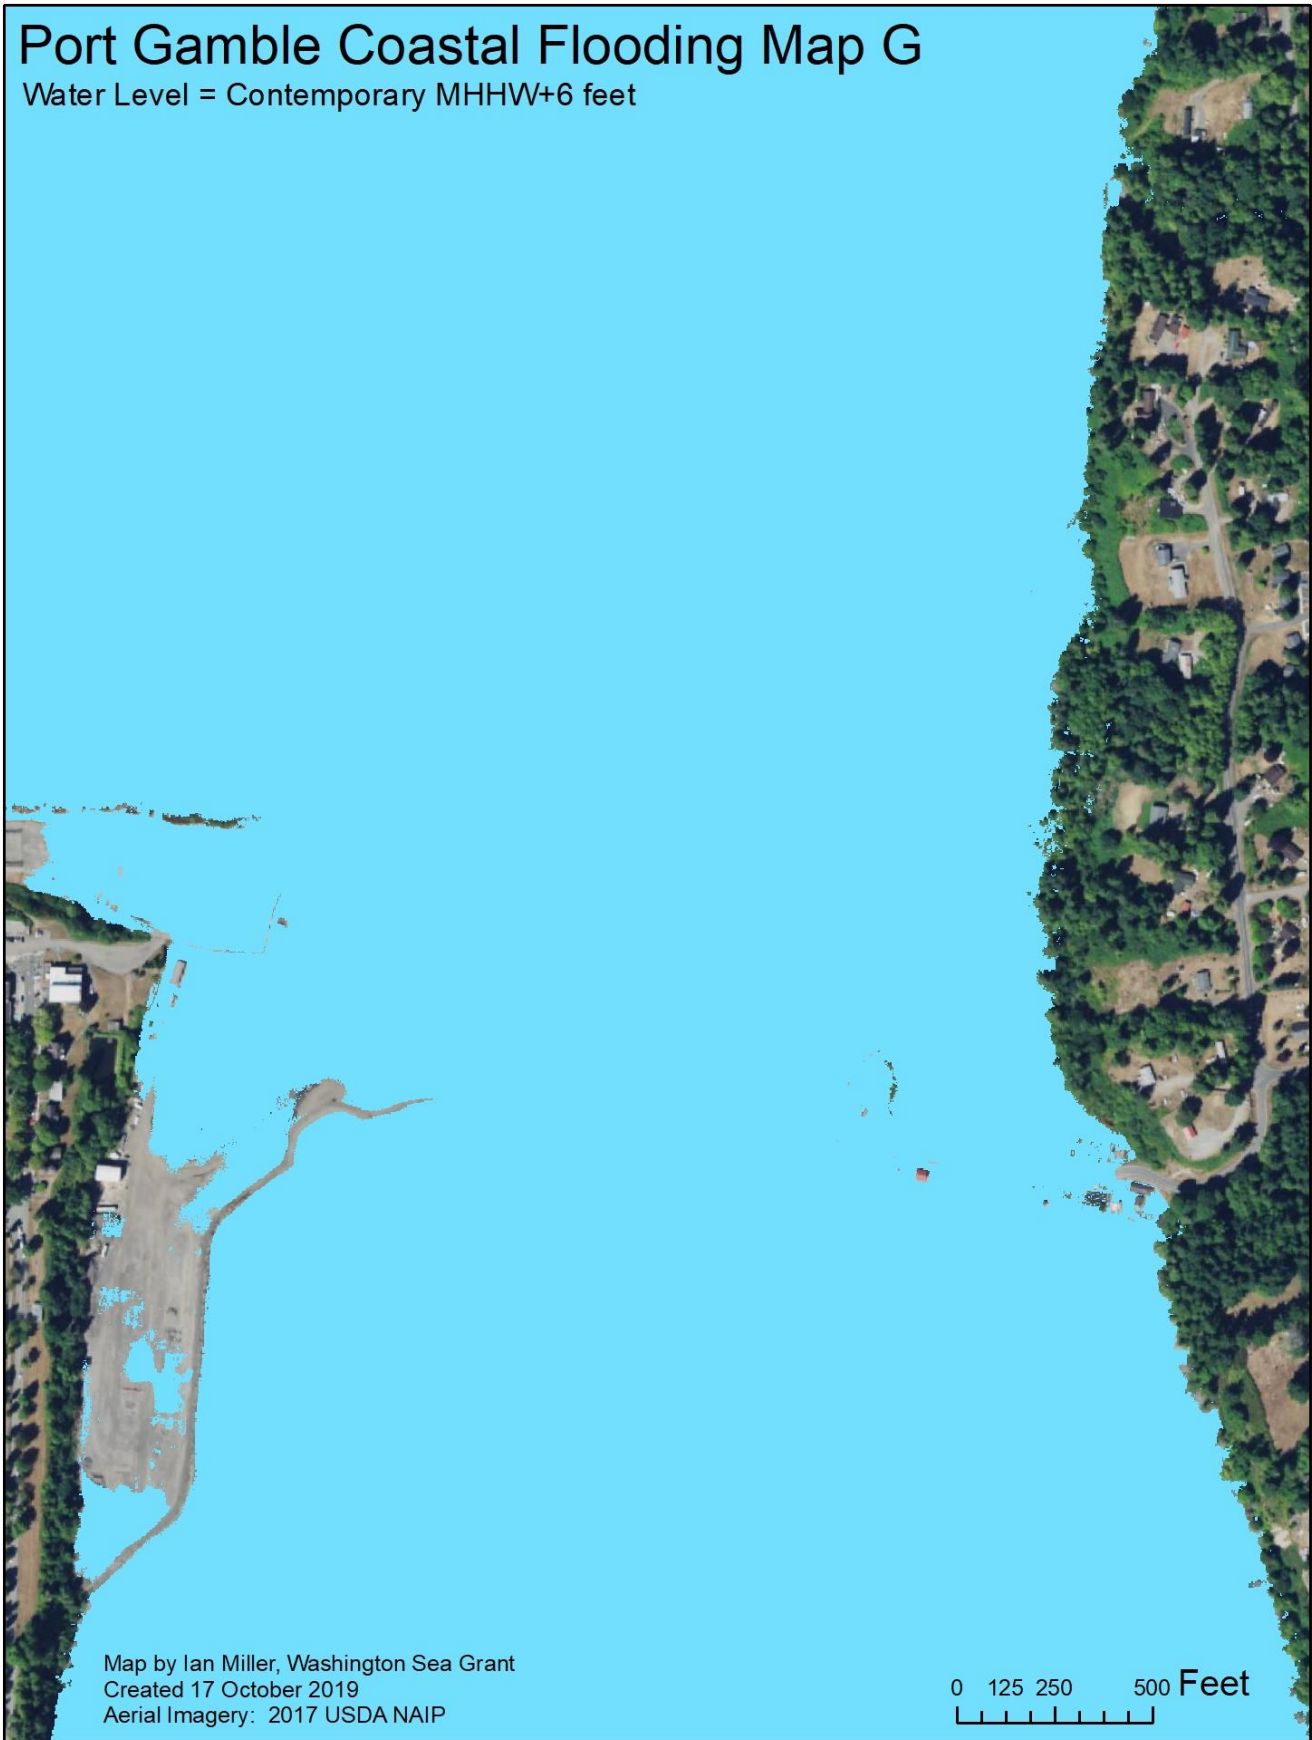
Figure C7. Inundation map showing estimated flooding extent of Point Julia at current MHHW plus 6 feet.

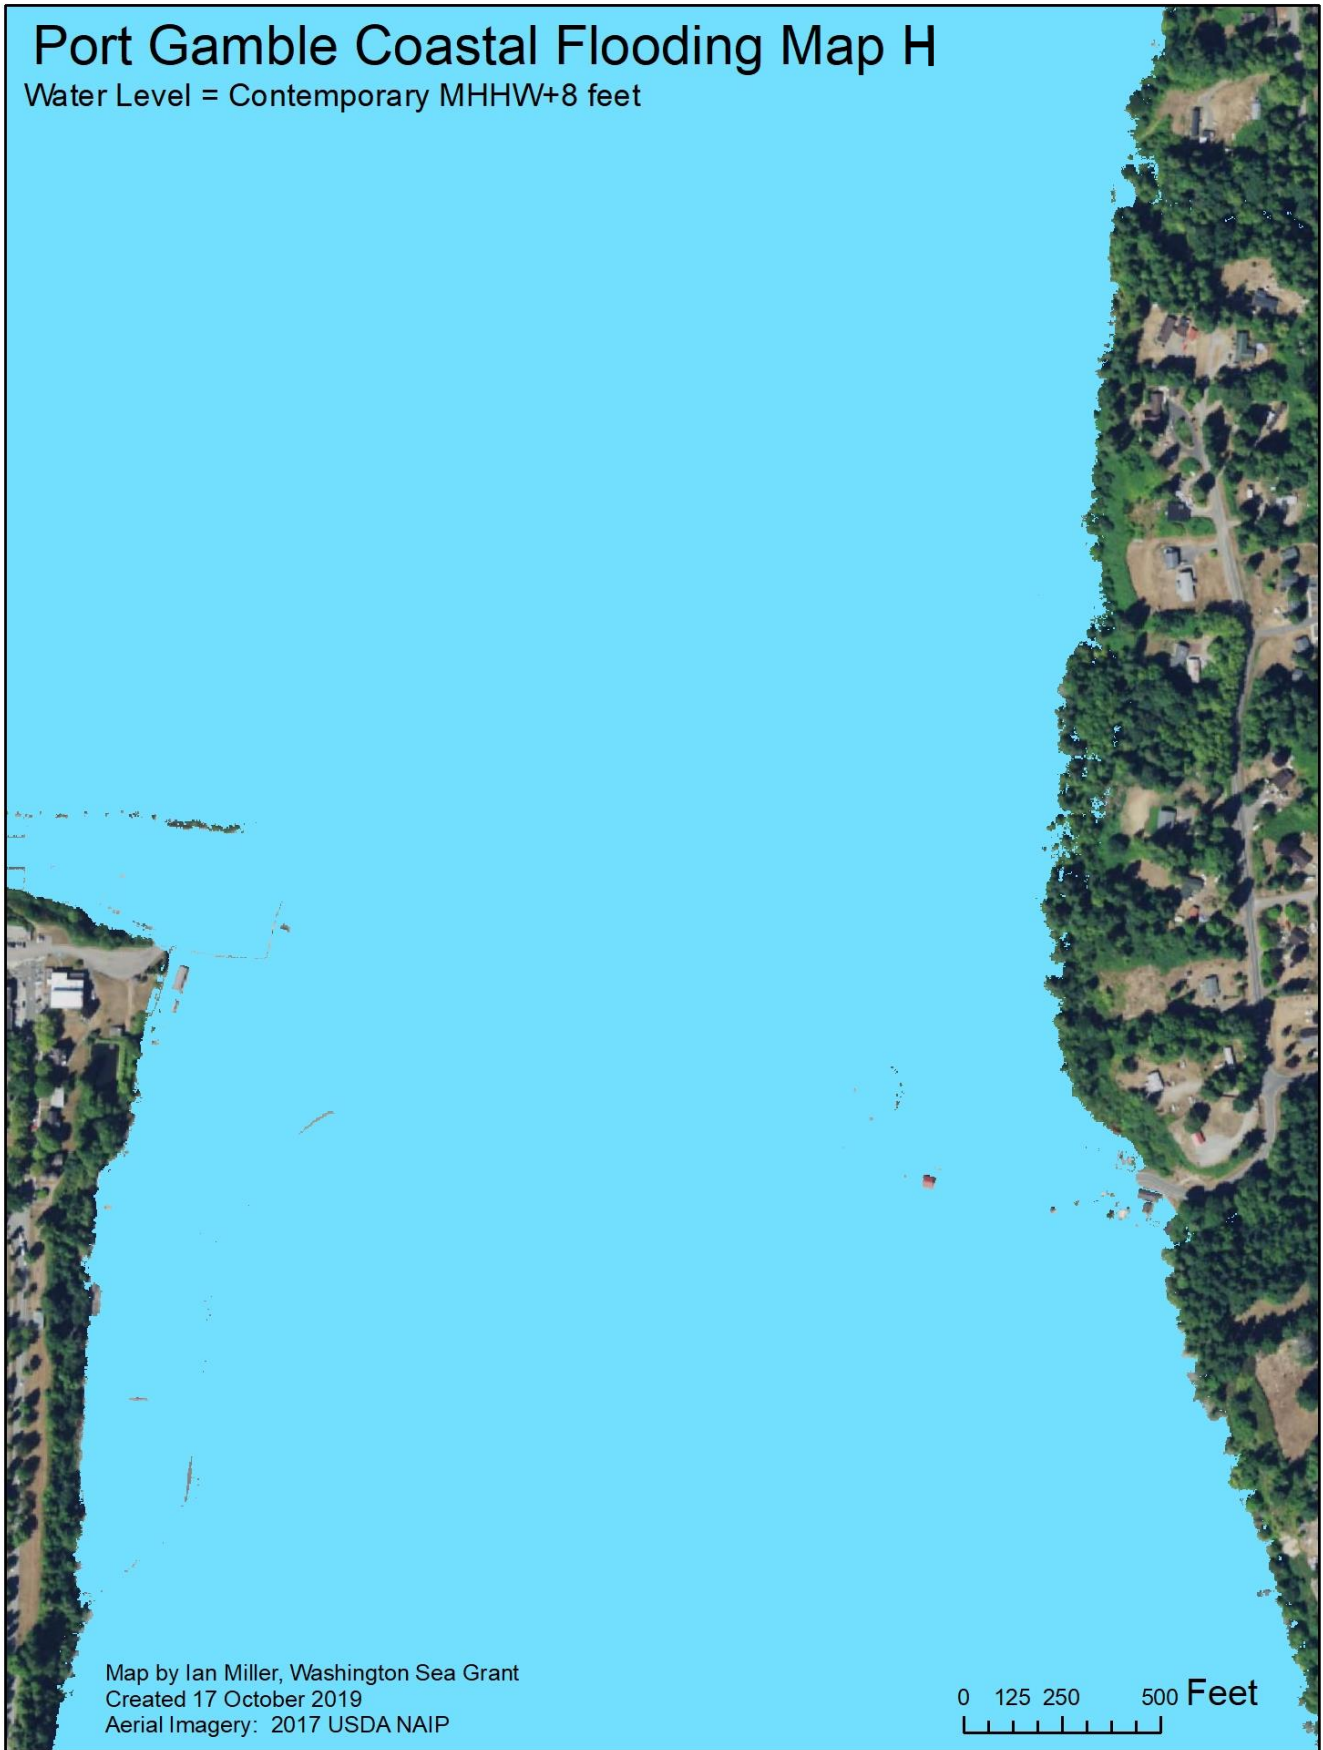
Figure C8. Inundation map showing estimated flooding extent of Point Julia at current MHHW plus 8 feet.

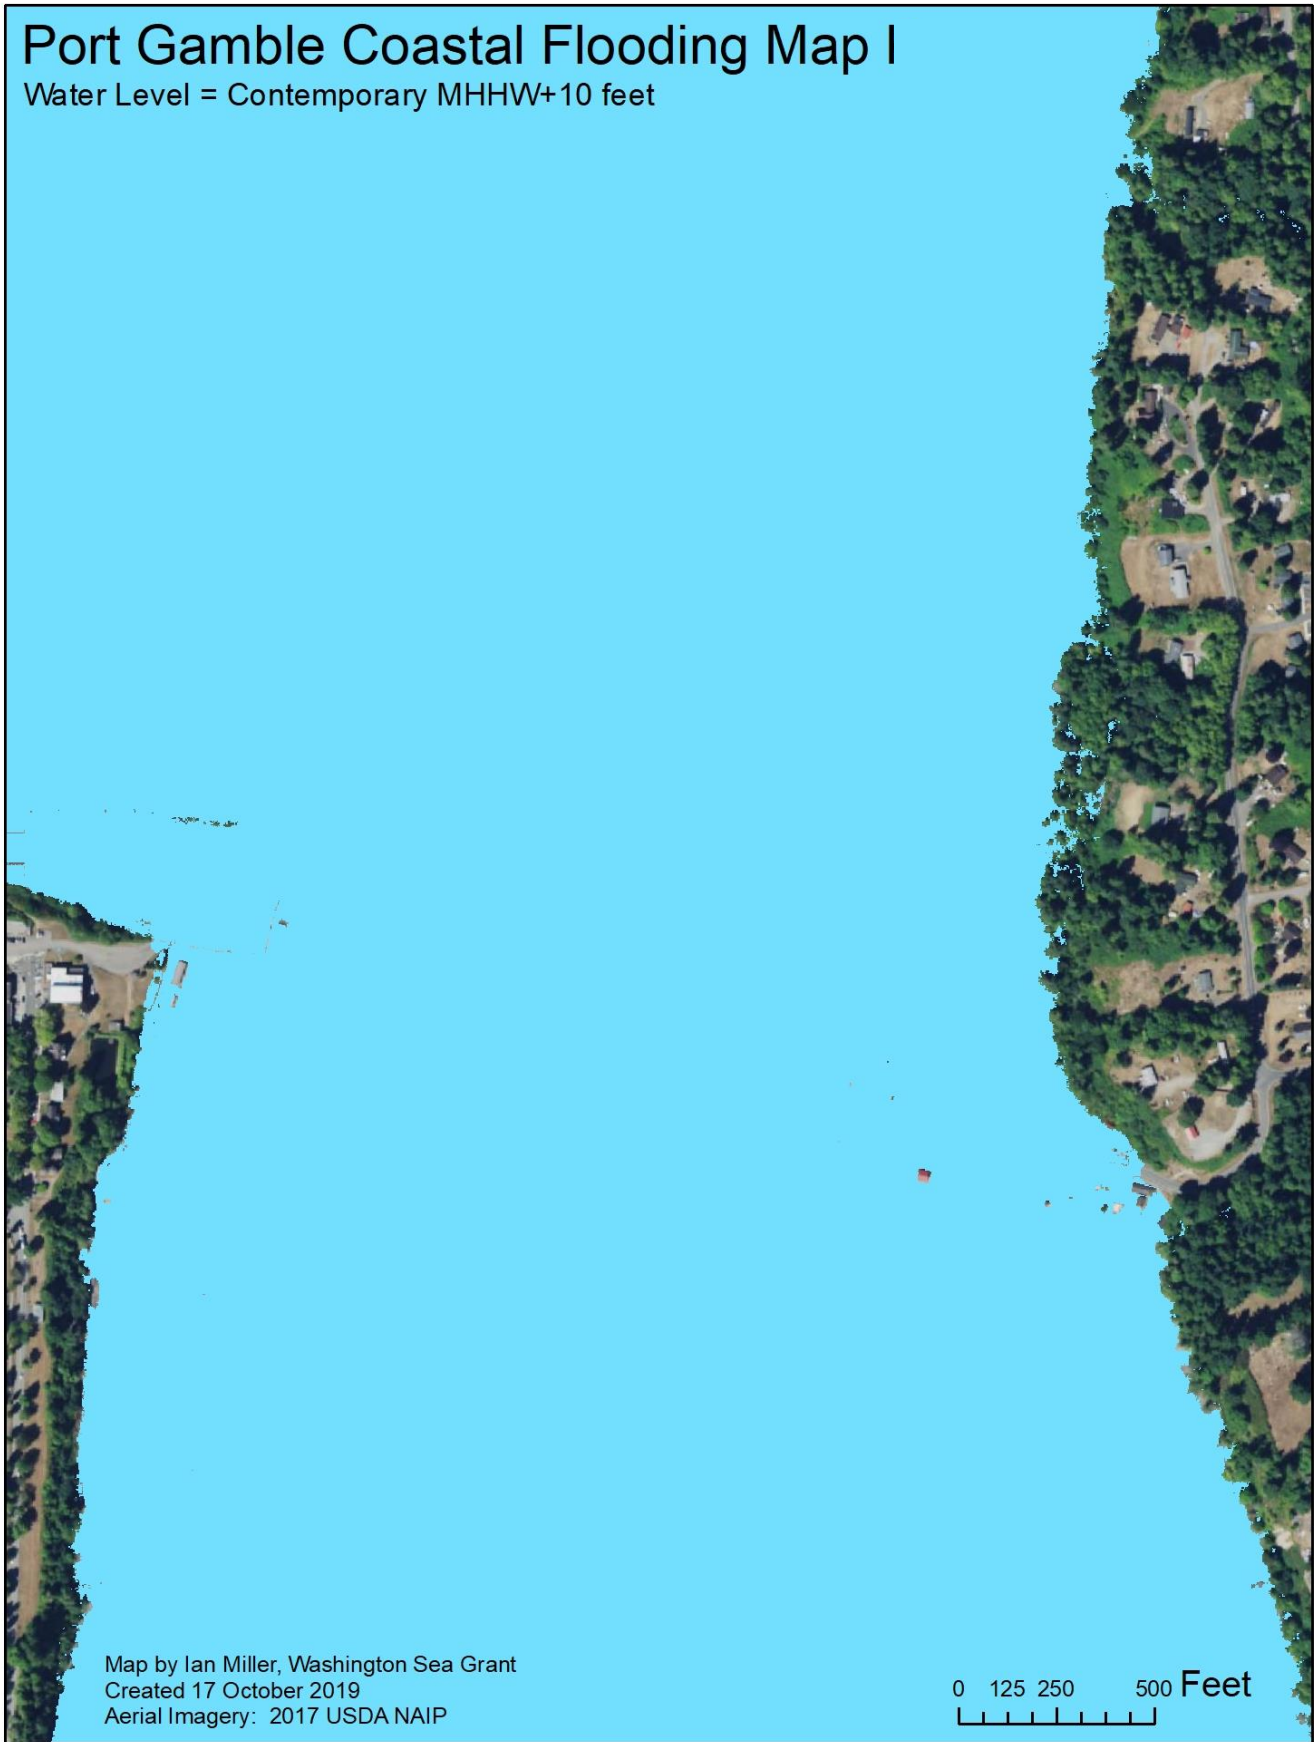
Figure C9. Inundation map showing estimated flooding extent of Point Julia at current MHHW plus 10 feet.
