BRIDGE STRUCTURAL INSPECTIONS USING BRIDGE INFORMATION MODELING (BrIM) AND UNMANNED AERIAL VEHICLES (UAVs)

Yelda Turkan, Ph.D., Assistant Professor
Yiye Xu, Graduate Research Assistant
School of Civil and Construction Engineering
Oregon State University, Corvallis, OR 97331

Pacific Northwest Transportation Consortium

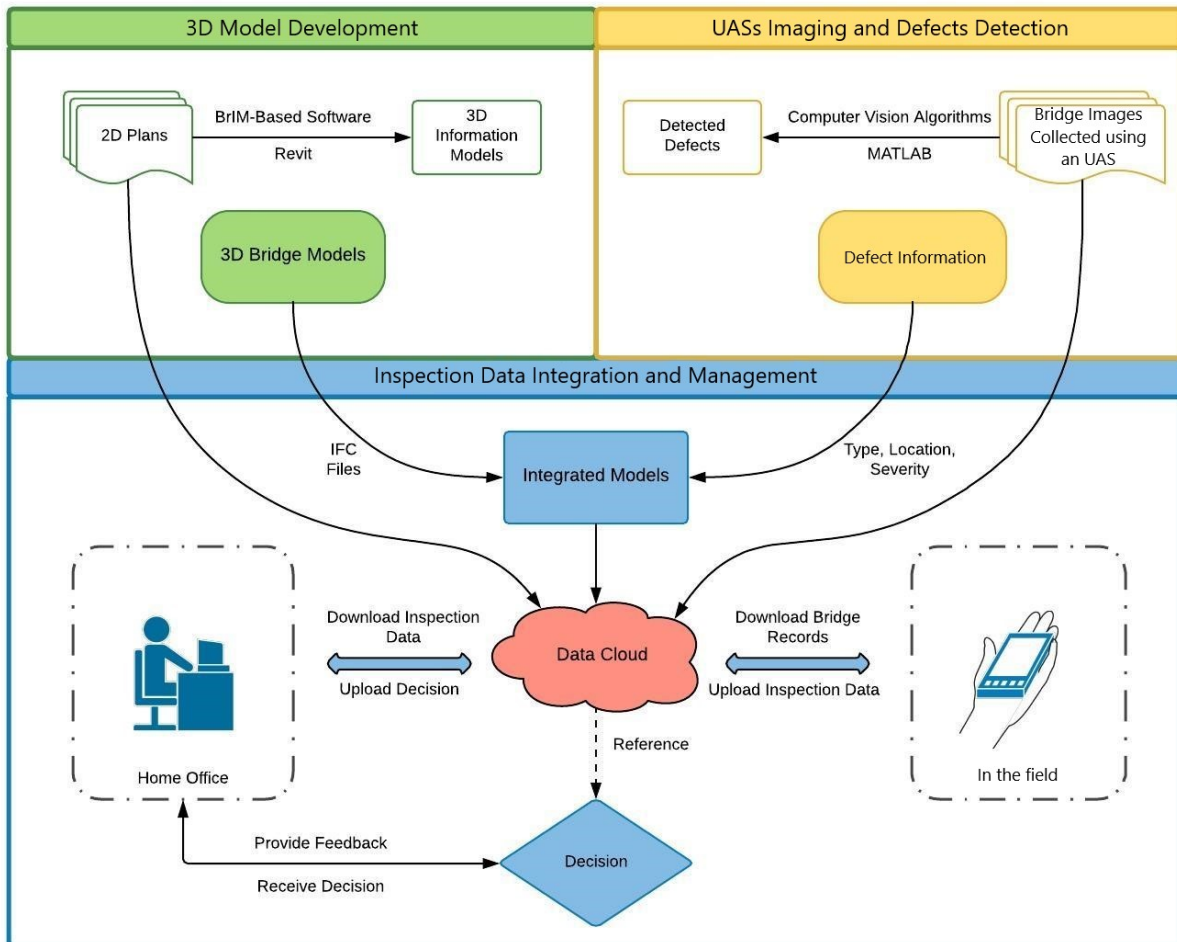
Figure 3.1 Proposed Bridge inspection and management framework

The main objective of this study was to develop a novel, systematic approach that implemented UAS and BrIM technologies to improve the efficiency of current bridge inspection and management practices. Figure 3.1 provides an overview of the proposed framework, which has three main phases: 1) development of 3D bridge as-built models; 2) UAS data collection and application of computer vision algorithms to the UAS images to detect any defects; 3) integration of image processing results into the 3D model, and uploading of the integrated information models to the data cloud for future inspections and data management.

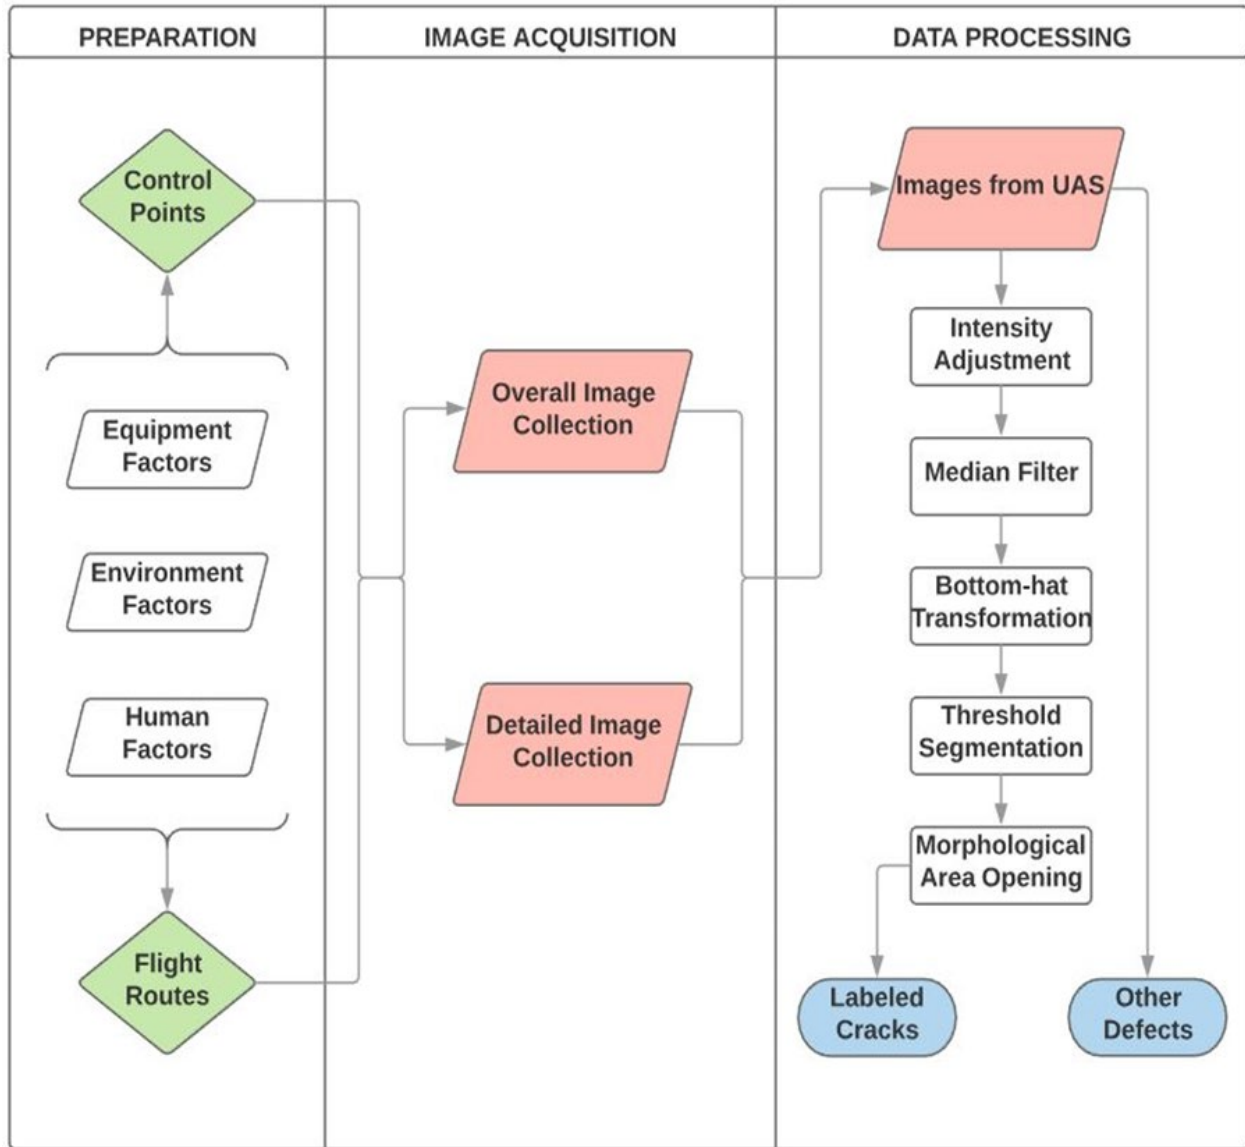
Figure 3.2 Overview of UAS imaging and processing phase

This phase was divided into three stages, which are schematically shown in figure 3.2.

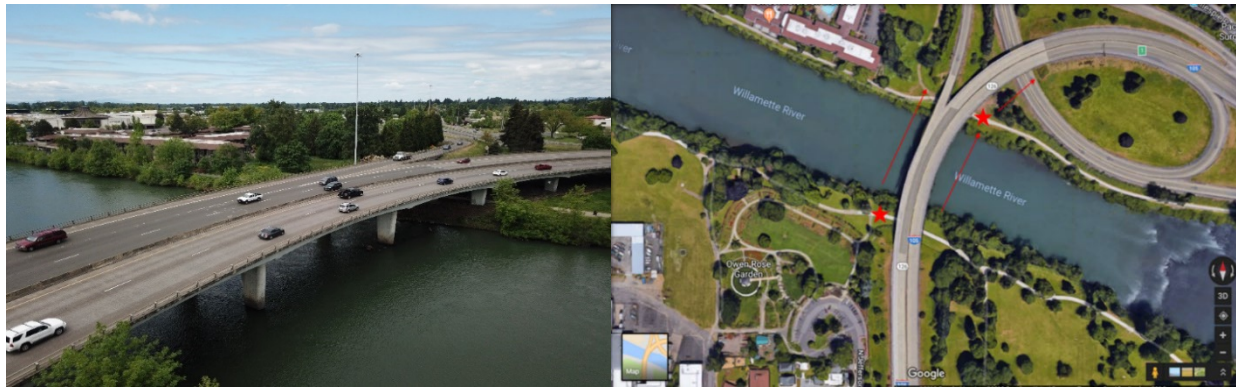
Figure 4.1 (a) The study site, Eugene, OR; (b) Plan for control points and flight routes

The UAS was operated on December 1 and 7, 2017, because of good weather conditions, without strong winds for the flight. Figure 4.1(b) presents the control points and the flight routes that were determined before the data collection. Both the control points and the flight routes were determined by taking the equipment-, environment-, and human-based factors into account, which were detailed in the framework development section. The battery capacity of the UAS was

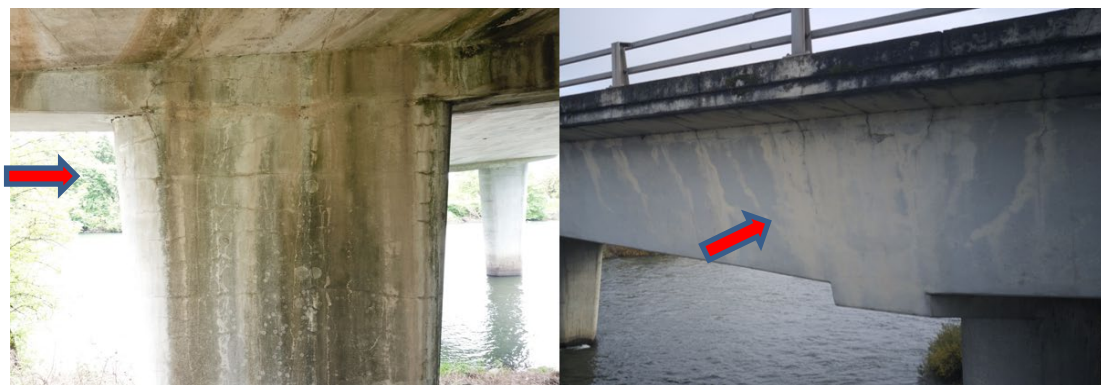
Figure 5.1 (a) Hairline shrinkage cracks on a column; (b) Hairline flexure cracks with efflorescence on the sides of boxes

During overall image collection, 74 high-resolution images of the bridge were collected. The bridge elements containing defects were identified from the overall images visually, and more detailed images, a total of 260, containing defects such as cracking, efflorescence, spalling, and joint leakage were collected in the next step. Figures 5.1 through 5.3 present some of the defects identified from the detailed images. The total flight time per data collection was approximately 40 minutes, which was significantly less than the amount of time typically needed (several days) to collect data with the traditional inspection methods detailed in the introduction.

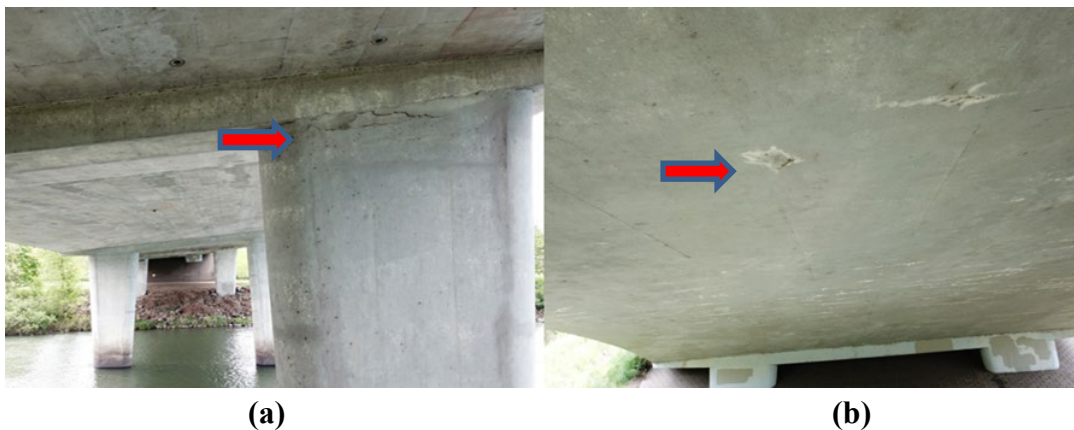
Figure 5.2 (a) Sacking is falling off of a column; (b) Spalling at the bottom of the girder box

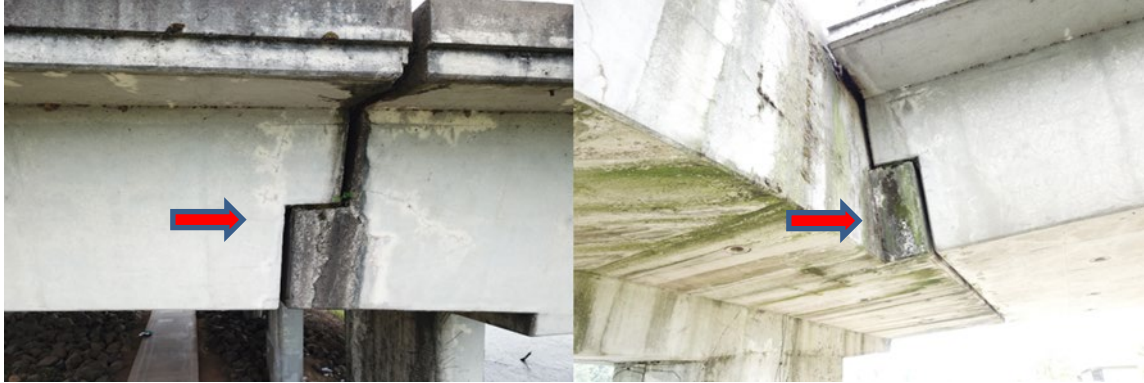
Figure 5.3 A failed joint seal leaking water

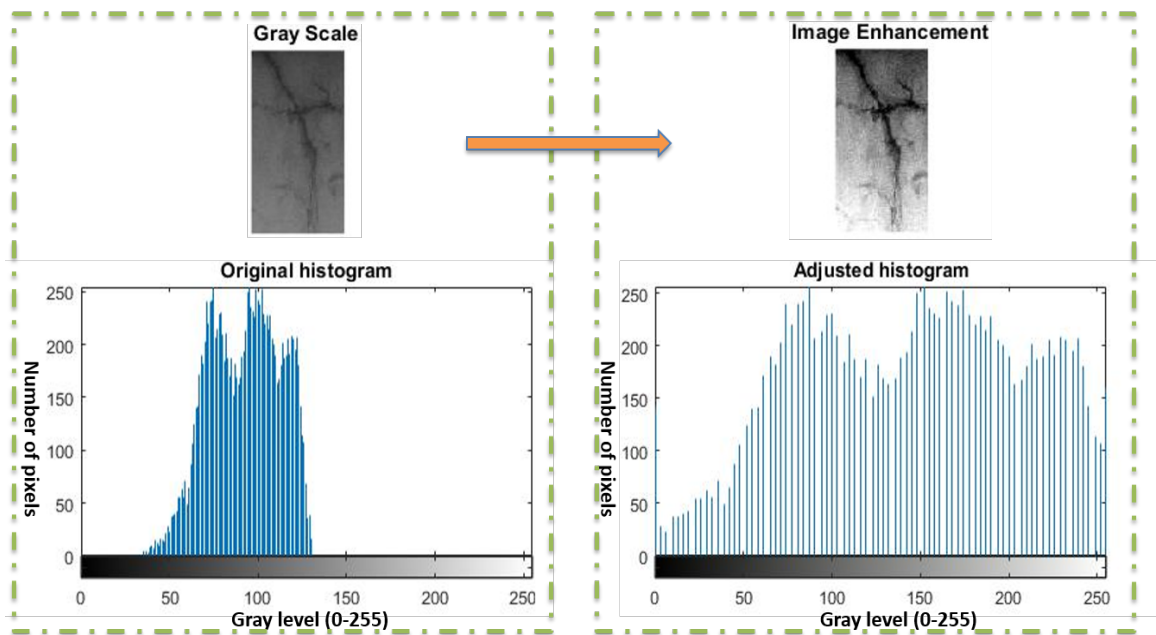
Figure 5.4 The original and adjusted histograms of a sample image

First, all RGB color format images were converted into grayscale images for further processing. The gray scale values were stretched to fill the entire gray-level range (0-255) by applying a mean filter to the high-resolution images. Figure 5.4 shows both the original and adjusted image histograms of a sample image. The grayscale adjustment resulted in a higher contrast, i.e., larger differences of pixel intensity, between the background and the cracks, making the cracks darker and the background brighter. However, the crack edges on the concrete surface were complex and could contain holes or material deficiencies. Contrast enhancement also highlighted these small deficiencies around the cracks. Therefore, the mean filter smoothed the gray values of the pixels, which discarded the unnecessary details of material deficiencies without affecting the shape and detail of the cracks. Through image enhancement and filtering, the contrast between the crack and background became more evident. As shown in figure 5.5, a 3D representation of the sample image after preprocessing, the gray levels of the crack were significantly lower than those of normal regions; therefore, a bottom hat transformation was performed to extract these dark regions of interest. However, some dark regions that were not cracks were classified in the same group as cracks at the end of the previous step. Therefore, threshold segmentation was applied to separate the cracks from those dark regions. However, at

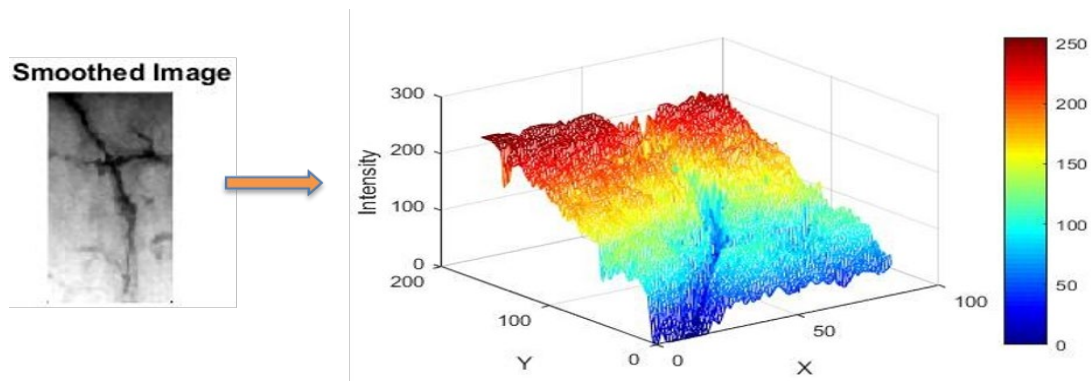
Figure 5.5 3D representation of the sample gray level image

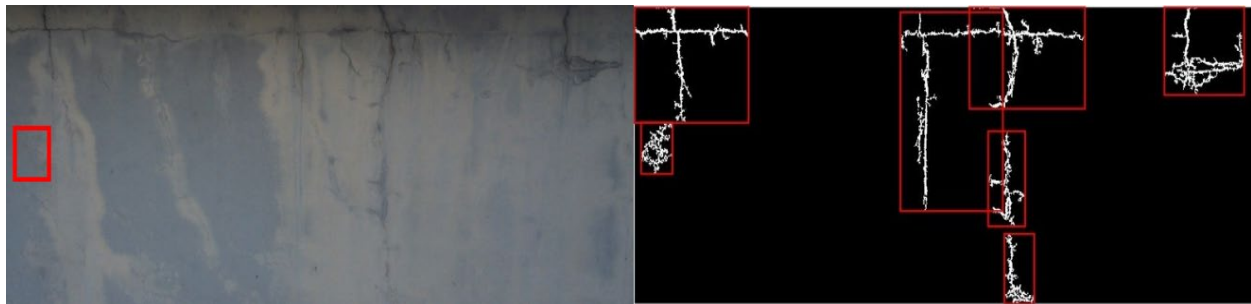
Figure 5.7 Crack detection results: (a) Original UAS image; (b) Detected and labeled cracks on the UAS image

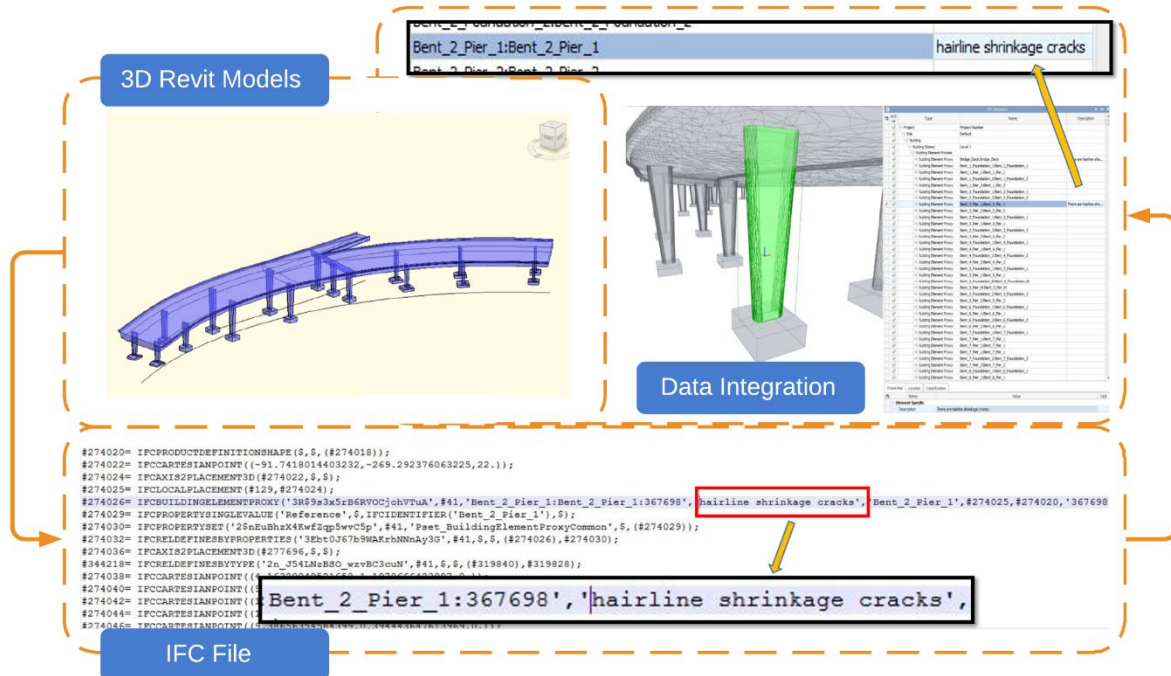
Figure 5.8 Procedure for integrating bridge inspection data

The IFC file could be opened in Notepad++, and the identified defect information in the previous step could be assigned to individual bridge elements by modifying the IFC text file. This was done by updating the line that corresponded to a specific bridge element with a string containing defect information for this particular element. This information could then be found in

the description field for the corresponding element when the IFC file was imported into the BIM vision software.

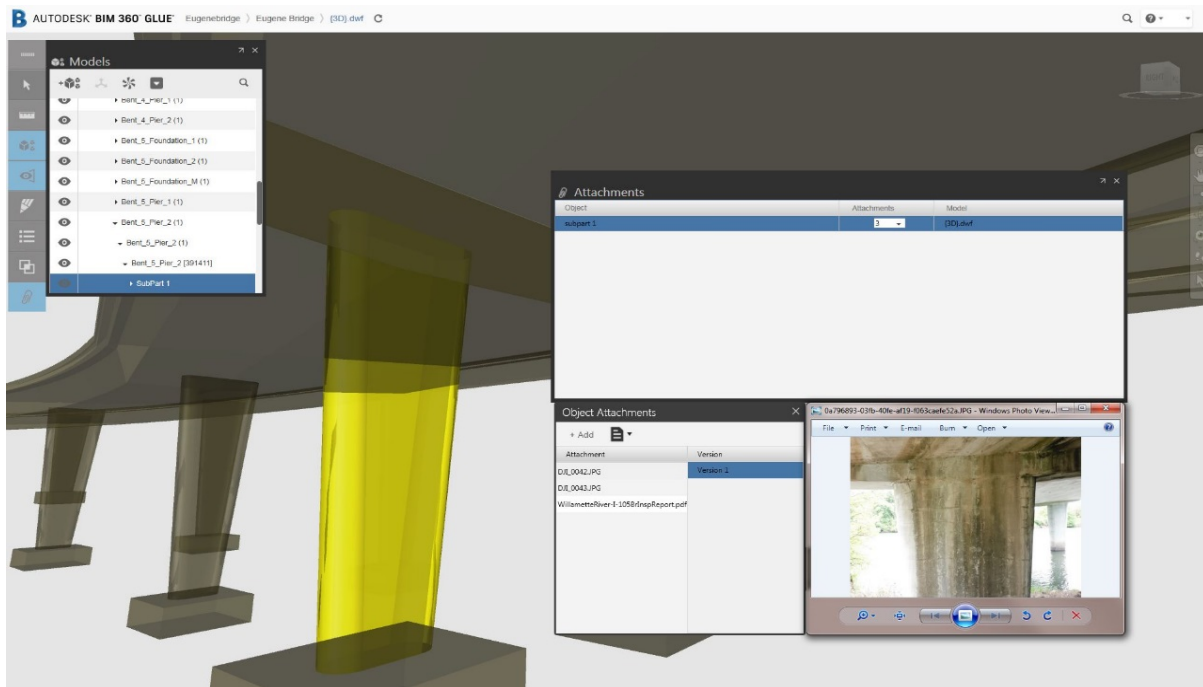
Figure 5.9 Bridge information management using Autodesk BIM 360 Glue

For data management, BIM 360 Glue was used to store the integrated model containing the defect information along with original UAS images and the historical inspection data (figure 5.9). With this program, different colors could be used to represent different severity levels based on the severity of the defect of a specific element, as in traditional inspection reports (figure 5.9). BIM 360 Glue would also enable access to the model along with the bridge inspection information that could be accessed and updated using mobile devices. This would enable effective and real-time communication between on-site personnel, e.g., inspectors and engineers, and decision makers in the office regarding inspection data.

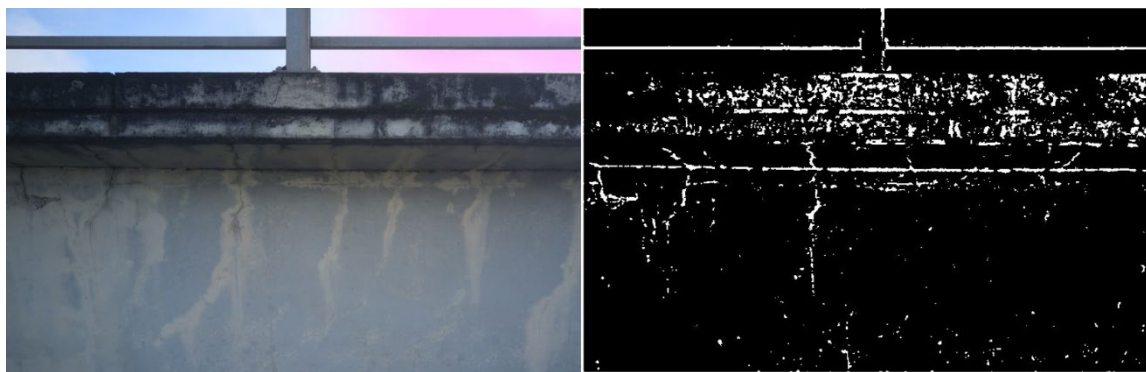
Figure 6.1 (a) Original image; (b) Corresponding binary image

Although cracks could be automatically detected by coding for loops in MATLAB, obvious edges of bridges and other objects (e.g., rivers) in overall images would affect the crack detection results adversely. The image processing algorithms used in this study analyzed the gray level of each pixel. However, edges are usually larger and more obvious than cracks. Therefore, it would be difficult to detect cracks without also detecting edges using the image processing method proposed in this study. For this reason, the detailed images had better crack detection results than overall images (detailed images did not contain as many edges and covered smaller areas around a defect/crack). This is why only detailed images were used for crack detection, and the precision and recall values were calculated by using the results obtained processing those detailed images. Figure 6.2 shows an example of crack detection results obtained by processing an overall image. In addition to the real cracks, the algorithm also identified the river, as well as the edges and railings of the bridge as cracks.

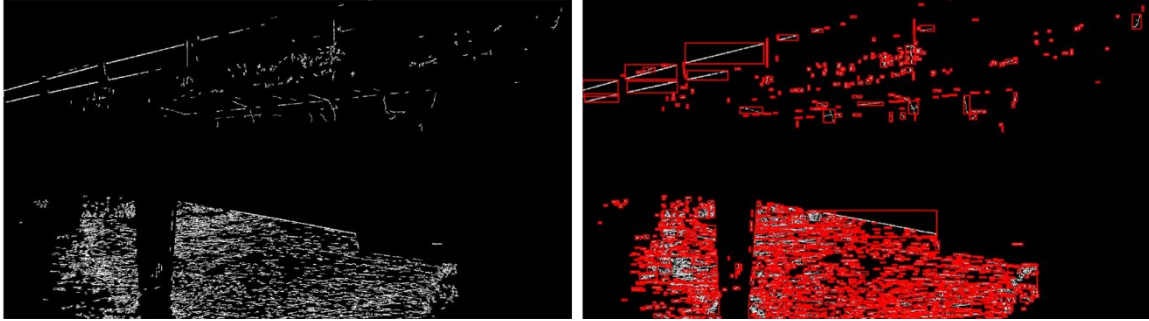
Figure 6.2 An example of a (a) binary image and (b) labeled cracks on the binary image
