# **EVALUATE H2RI WICKING FABRIC FOR PAVEMENT APPLICATION – YEAR 2 FINAL PROJECT REPORT**

by  
**Xiong Zhang**, Ph.D., P.E., Associate Professor  
Department of Civil and Environmental Engineering  
University of Alaska Fairbanks

<b>1. Report No.</b> 2013-S-UAF-0026	<b>2. Government Accession No.</b> 01497959	<b>3. Recipient's Catalog No.</b>	
<b>4. Title and Subtitle</b> Evaluate H2RI Wicking Fabric for Pavement Applications		<b>5. Report Date</b> 10/31/2015	
		<b>6. Performing Organization Code</b> INE/PacTrans 15.12	
Xiong Zhang, and Billy Connor		<b>8. Performing Organization Report No.</b> INE/PacTrans 15.12	
<b>9. Performing Organization Name and Address</b> PacTrans Pacific Northwest Transportation Consortium University Transportation Center for Region 10 University of Washington More Hall 112 Seattle, WA 98195-2700 Alaska University Transportation Center P.O. Box 755900 Fairbanks, AK 99775-5900		<b>10. Work Unit No. (TRAIS)</b>	
		<b>11. Contract or Grant No.</b> G00008085	
<b>12. Sponsoring Organization Name and Address</b> United States of America Department of Transportation Research and Innovative Technology Administration Alaska Department of Transportation & Public

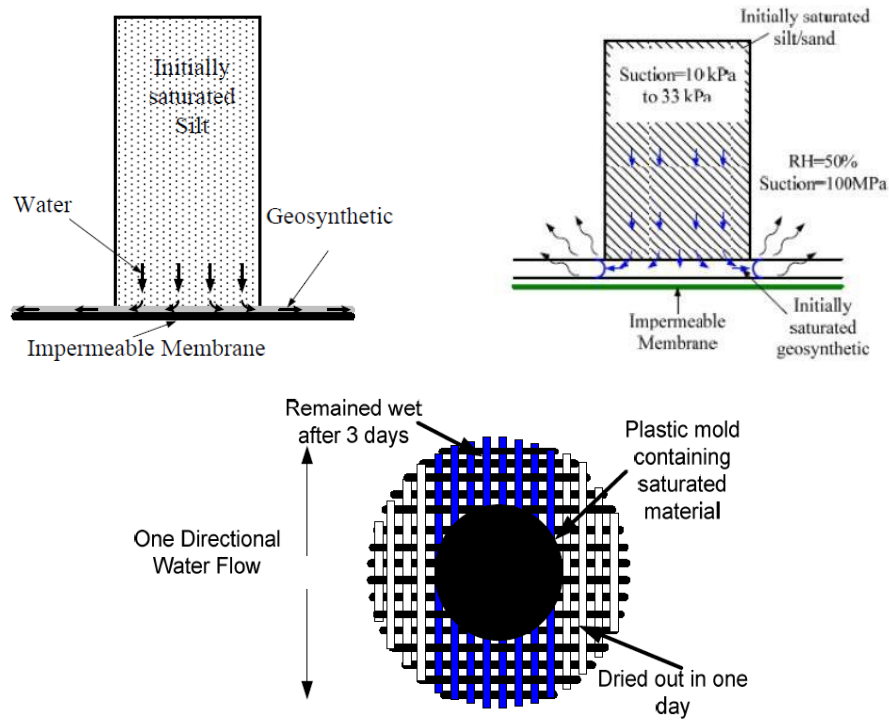
**Figure 2.11 Schematic Plots of Rainfall Infiltration Test**

Researches at University of Alaska Fairbanks (Zhang and Presler, 2012) also conducted a series of tests, including drainage test, capillary rise test, rainfall infiltration test and frost heave test, to evaluate the effectiveness of this geotextile in controlling frost heave issue. For the drainage test, similar results were found that vertical wicking height was 12 inches, which was slightly different from TENCATE's results. The variation might come from several sources such as temperature, relative humidity, testing geotextile width. As for rainfall infiltration test, the test apparatus is shown in Figure 2.11. Four different types of geotextiles were adopted in the rainfall infiltration test, including a wicking fabric, a high performance (HP) reinforcement geosynthetic, a geotextile water filter, and a drainage composite. The tested soil was first saturated and compacted within a plastic mold. Then the mold was put upside down on a layer of geotextile with an impermeable membrane beneath it. The water was allowed to flow for 3 days. Test results indicated that conventional geosynthetics ceased to transport water within 1 day. This phenomenon could be explained the relatively low geosynthetics' air entry values. Due to larger pore geosynthetic pore size, air could easily block the voids under small suction value. Air bubbles were considered similar as soil solids, which were impermeable for water to flow. However, the atmospheric suction value could be as large as 140 MPa and the geosynthetics could be dried very fast under room temperature and relative humidity. Therefore, within limited time period, the geosynthetics ceased to transport water and the tested soils would have larger final water content. In contrast, the geotextile with wicking fabric had large surface area and large air entry value, which enabled the geotextile to wick water out of the soil under higher

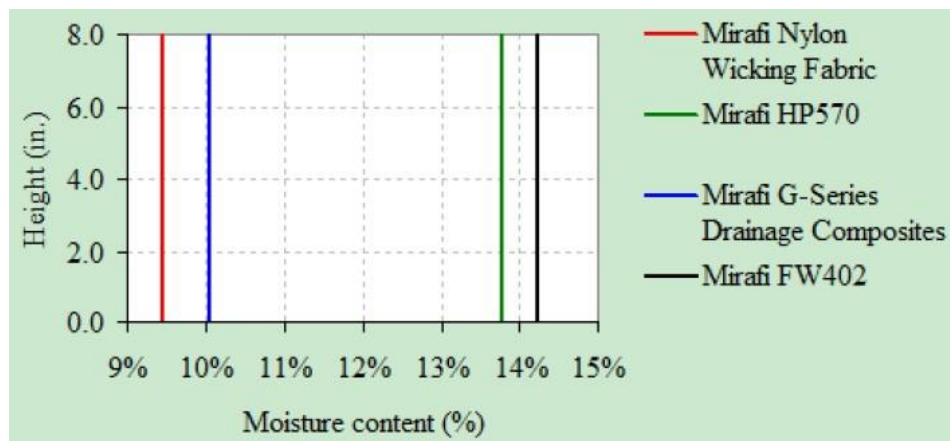
**Figure 2.12 Rainfall Infiltration Test Results**

suction value and resulted in a lower final water content, as shown in Figure 2.12. Test results of the four different types of geotextile further confirm the fact that the geotextile has advantages to wick water out of soil under unsaturated conditions.

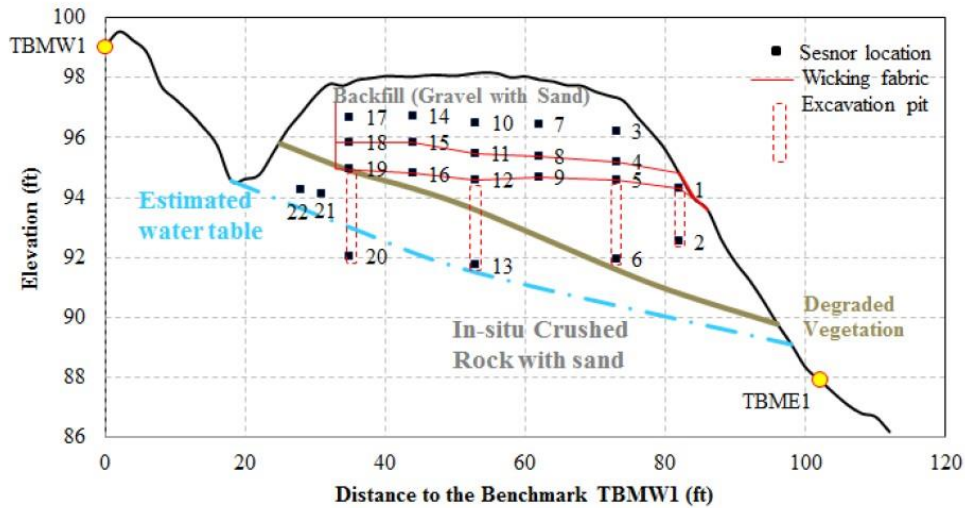
**Figure 2.13 Schematic Plot of Test Section**

Zhang (Zhang et al., 2014) reported successful application for the innovative geotextile to prevent frost boils in Alaska pavements. This project located at a section of Dalton Highway, named as “Beaver Slide”, which was unpaved and suffered significant heavy truck traffic. Frost heave and thaw weakening caused extensive damages to the pavement structures. Previous rehabilitation with geocomposite has been proved unsuccessful. In total 22 TDR sensors were used to monitor the temperature and water content change of a 60 ft. long road section the most soft spot, as shown in Figure 2.13. Sieve analysis results indicated that some soils had fine content larger than 6%, which considered as Frost Susceptible (FS) soils. Two layers of innovative geotextile were installed 45 cm apart with the bottom geotextile. Besides temperature and water content sensors inside the test section, other useful data such as air temperature and relative humidity was also recorded for over 2 years.

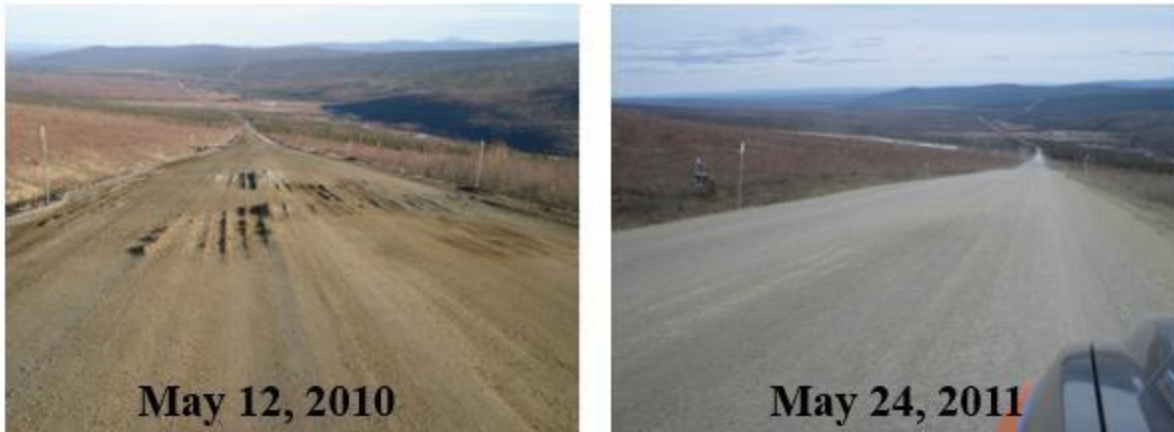
**Figure 2.15 Test Section Comparison**

In a summary, over 2 years of monitoring shows good overall performance for the testing section. Field observation showed a clear road surface difference for sections with and without geotextile, as shown in Figure 2.15. No soft spot was observed during early springs and soil at shoulder was damp, which indicated that water flowed along the direction of the geotextile wicking fabric. The geotextile successfully eliminated the frost and thaw weakening to a depth of 3.5 ft. This could be considered as the effective depth or functional range of the geotextile wickability. Even though soil 4.5 ft. beneath the surface and lower showed the existence of excess water, it was beyond the frost heave and thaw weakening affecting depth and had limited effect on roadway performance.

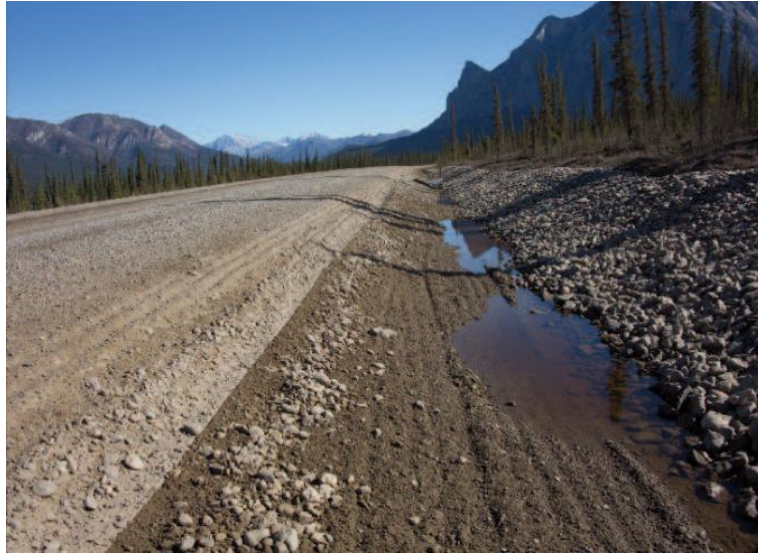
**Figure 2.16 Preliminary Field Observation at Coldfoot, AK**

Similar frost heave problems also occurred at harsh environment that located at about 30 miles north of Coldfoot, AK. The road experienced extreme cold temperature and the adjacent ice-rich soil made the frost heave problem even worse. A 12 mile test section (6 mile with geotextile and 6 mile without) was constructed in 2012, which aimed at mitigating the frost heave issue and preventing ice lens formation. 12 inches of aggregate over the geotextile was completed by one lane first. Then the other lane was constructed using the same structure with a minimum of 1.5 ft. geotextile overlap. Test results also showed successful application for geotextile to break water from rising up to the subgrade via capillary action. Since this project was newly operated, close monitoring is required to further evaluate the overall roadway performance for the long-term.

However, as shown in Figure 2.15, preliminary observation already proved the geotextile effectiveness served as a capillary break to wick water out of the pavement structure.

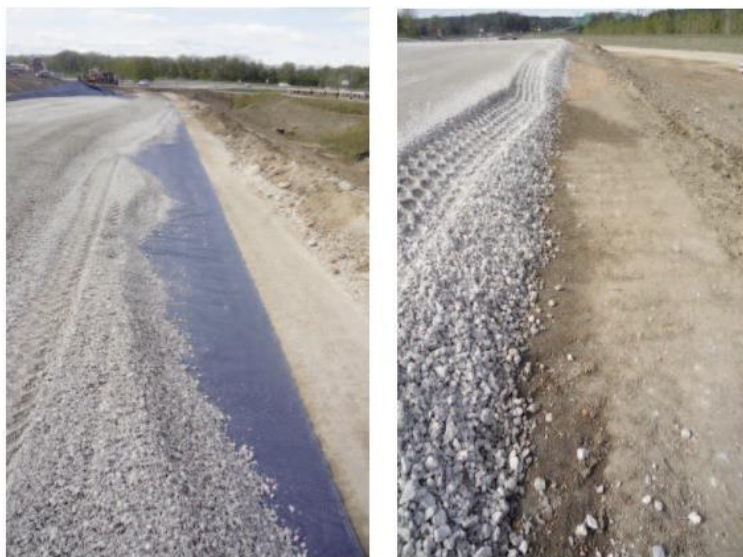
**Figure 2.17 Field Observation at St. Louis County, MO**

A new bridge was being constructed over the Missouri River. The objective of using the geotextile was to remove water from underneath the pavement section. The original design was to construct a pavement section with 4 inches of base aggregate, 4 inches of drainable aggregate and a prepared subgrade. It was expected that the geotextile could reduce the aggregate base material by 2 inches, and also be able to wick water from under the pavement. Observation was shown in Figure 2.16 and the results proved that the geotextile successfully wicked the water out of the aggregate.

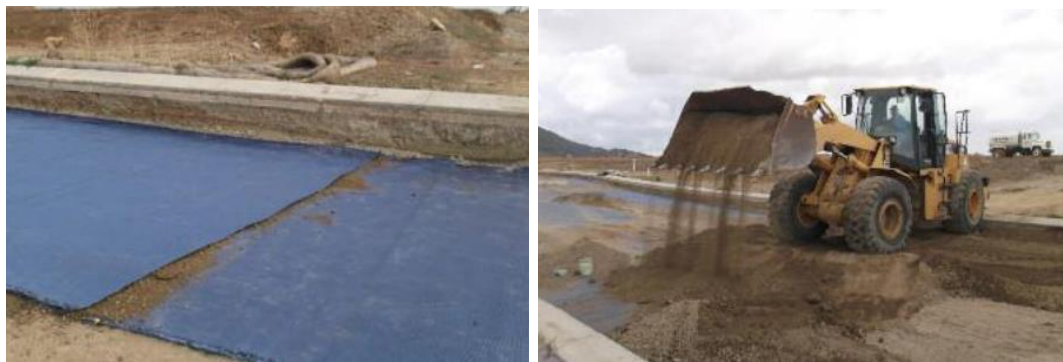
**Figure 2.19 Field Construction at Corona, CA**

In Corona, CA, a large section of roadway was experiencing an excessive amount of natural water run-off, which made the roadway section become saturated and ultimately fail. The geotextile with wicking fabric was provided to help drain away the excess water while providing enhanced stabilization. A 6-inch layer of base material was placed on top of the geotextile. Then, a layer of geogrid was placed on top followed by another 6-inch of base material. A 4-inch layer of AC was the final element of design to complete the road section. Observation indicated that the geotextile provided superior tensile strength at low strain for subgrade support, separated the natural subgrade soils from the aggregate base, wicked excess water, and provided lateral confinement for base section.

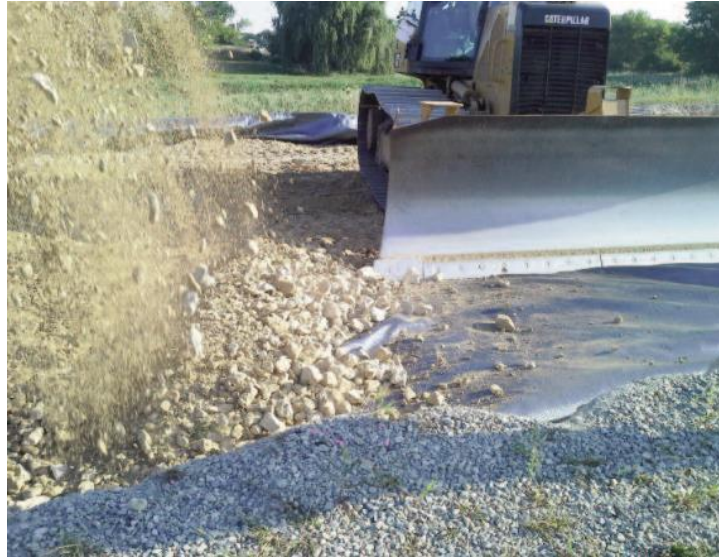
**Figure 2.20 Field Construction at Jefferson County, WI**

Another application occurred at Jefferson County, WI, and the geotextile was used to solve differential settlement problem. The primary challenge was the presence of wet and saturated silt and peat deposits to depths exceeding 30 feet below the existing pavement. Simply removing the deposits is not an economically feasible solution. The geotextile was directly placed on the exposed subgrade, followed by a 15-inch lift of crushed stone, a single layer of geogrid, and a 15-inch lift of crushed stone, as shown in Figure 2.19. Jefferson County Highway Department reported that subgrade undercutting was minimized to 30 inches, compared to a potential 5-8 feet undercut (or more) for the soil conditions present. In addition to the cost savings there was also a substantial time savings in the project construction schedule.

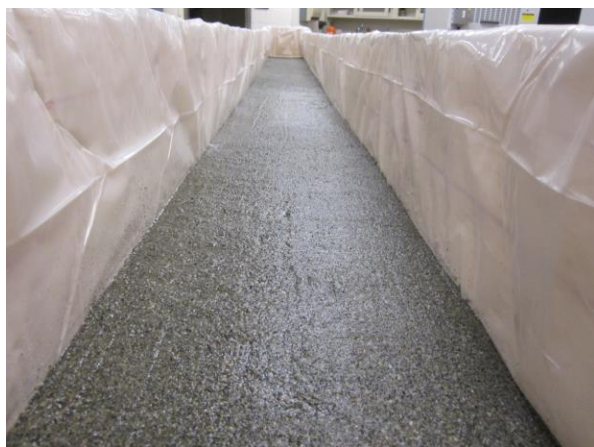
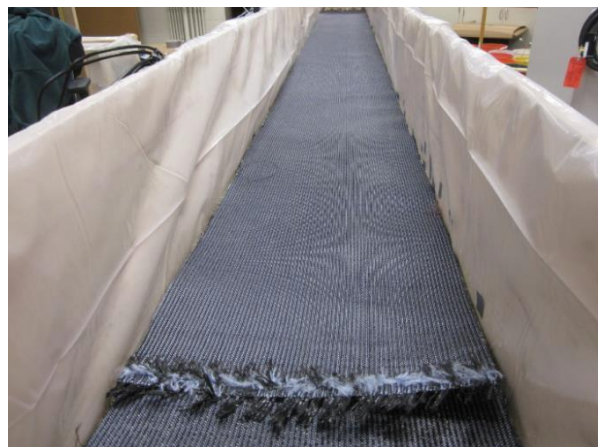
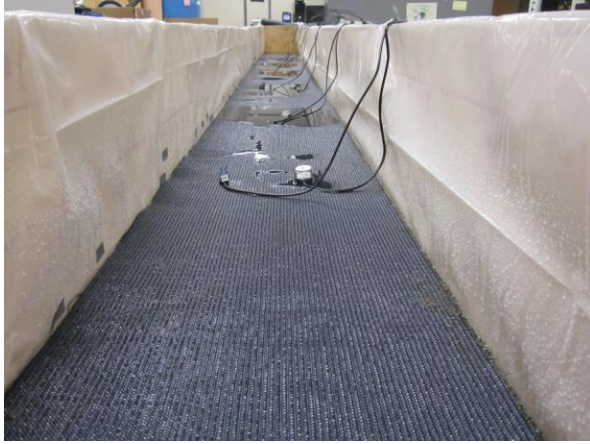
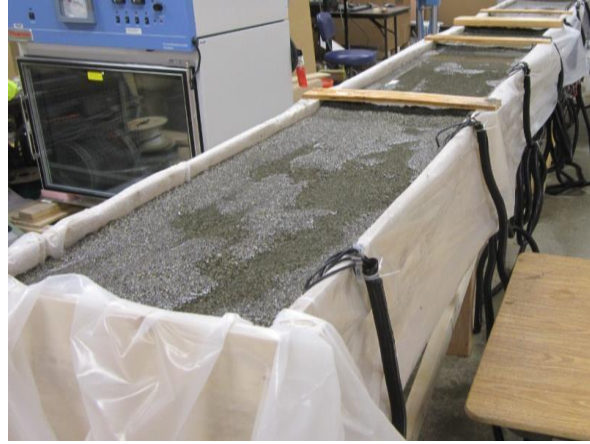
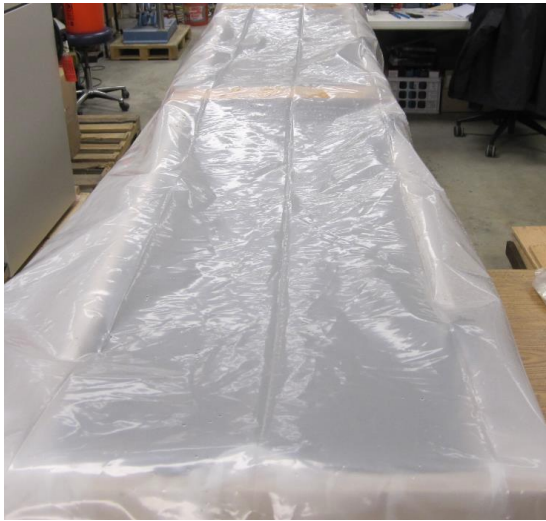
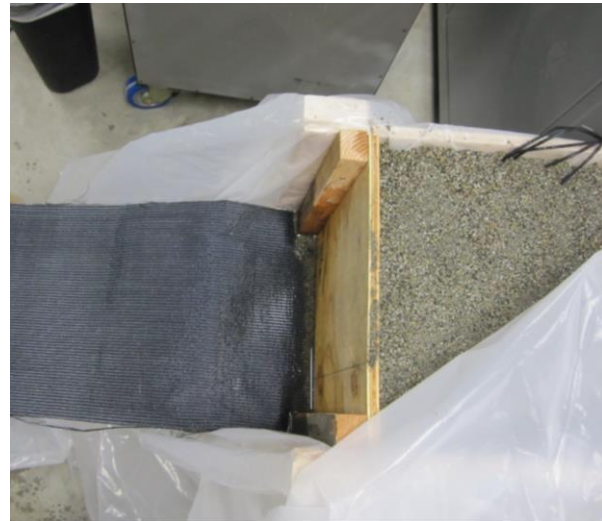
**Figure 3.2 Testing Flume Construction**

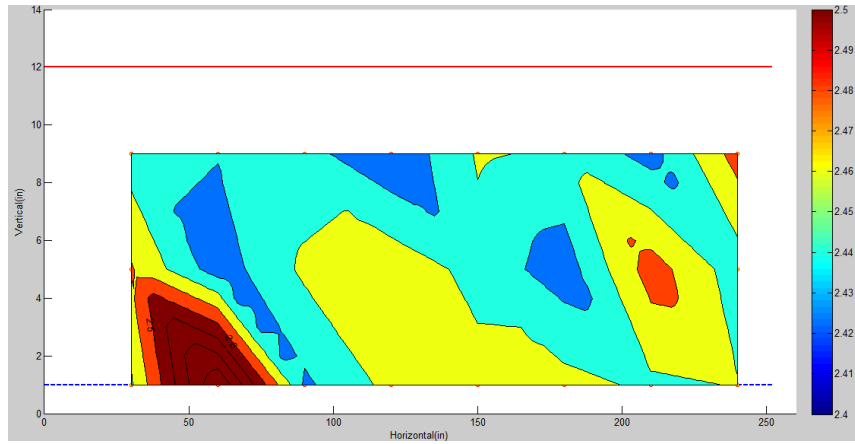
**Figure 4.5 Moisture Contour for Rewicking Test (Silt)**

Rewicking test for silt started at 2 pm on March 12, 2014. The moisture content contours are plotted at starting point, 2 hours, 1 day, 10 days and 1 month, as shown in Figure 4.5. Compared with wicking test, the water flow rate for rewicking test was much smaller. After 1 day, the shape of the moisture contour did not change too much. Two major reasons would cause such phenomenon: 1) the permeability of silt itself is much smaller than that of sand; 2) the wicking paths within the fabric might be detained by the fine particles and thus significantly reduced the water flow rate. After 1 month, the moisture contents near the three major cracks further decreased and the amount of accumulated excess water was much smaller than previous.

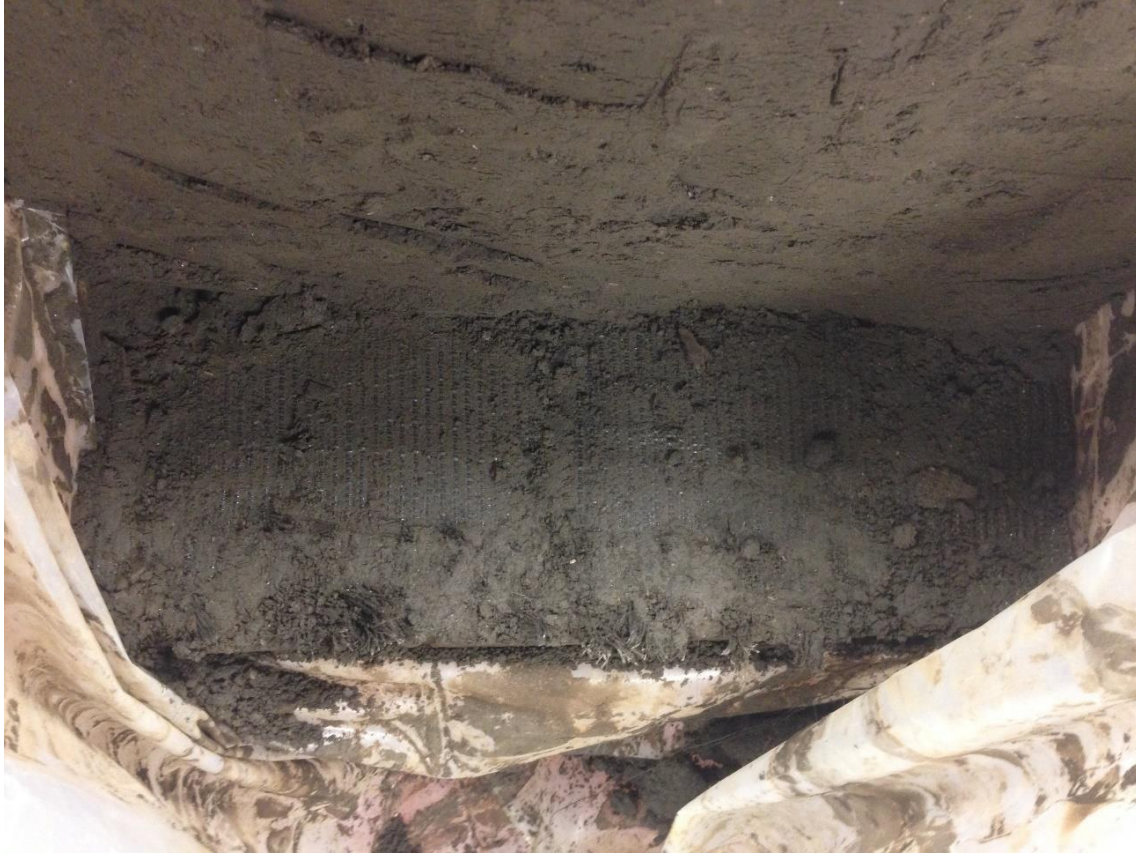
**Figure 4.6 Photo of organic silt and blinding of the fabric at the bottom.**

It is clear that the organic silt has low permeability. The water added the inlet end of the flume stabilized at about 8 inches and remained essentially at that height. This clearly indicates that the silt is impermeable and that the wicking fabric had failed to transfer water. Photo-micrographs were taken of a bundle of fibers at a magnification of 1500x. Figure 4.6 shows that the fibers were blinded by the small clay particles contained in the silt which rendered the fabric ineffective.
