**Effects of Powder Reuse on The Mechanical Properties of Electron Beam Additively
Manufactured Ti-6Al-4V**

A thesis submitted in partial fulfillment of the requirements for the degree of

Master of Science

University of Washington

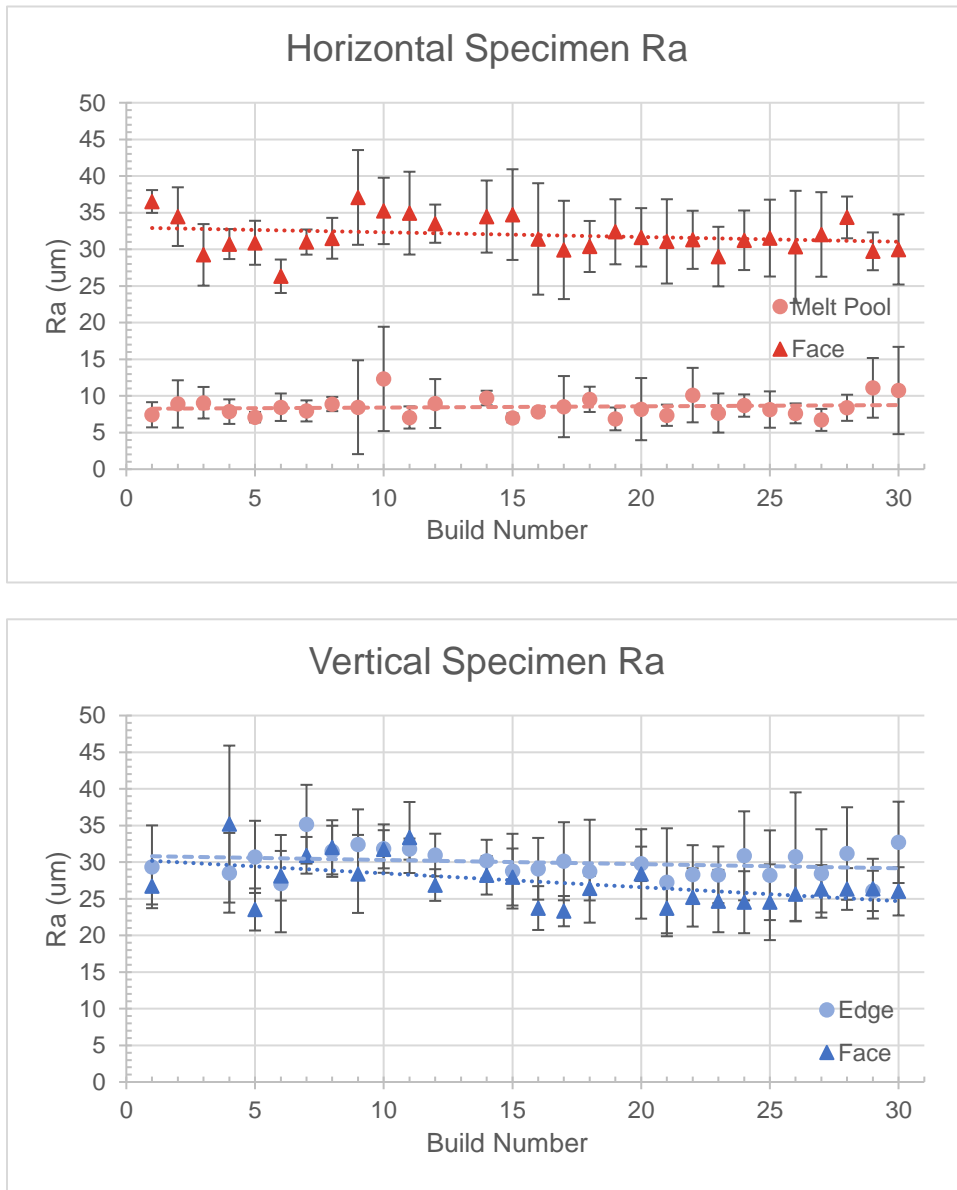
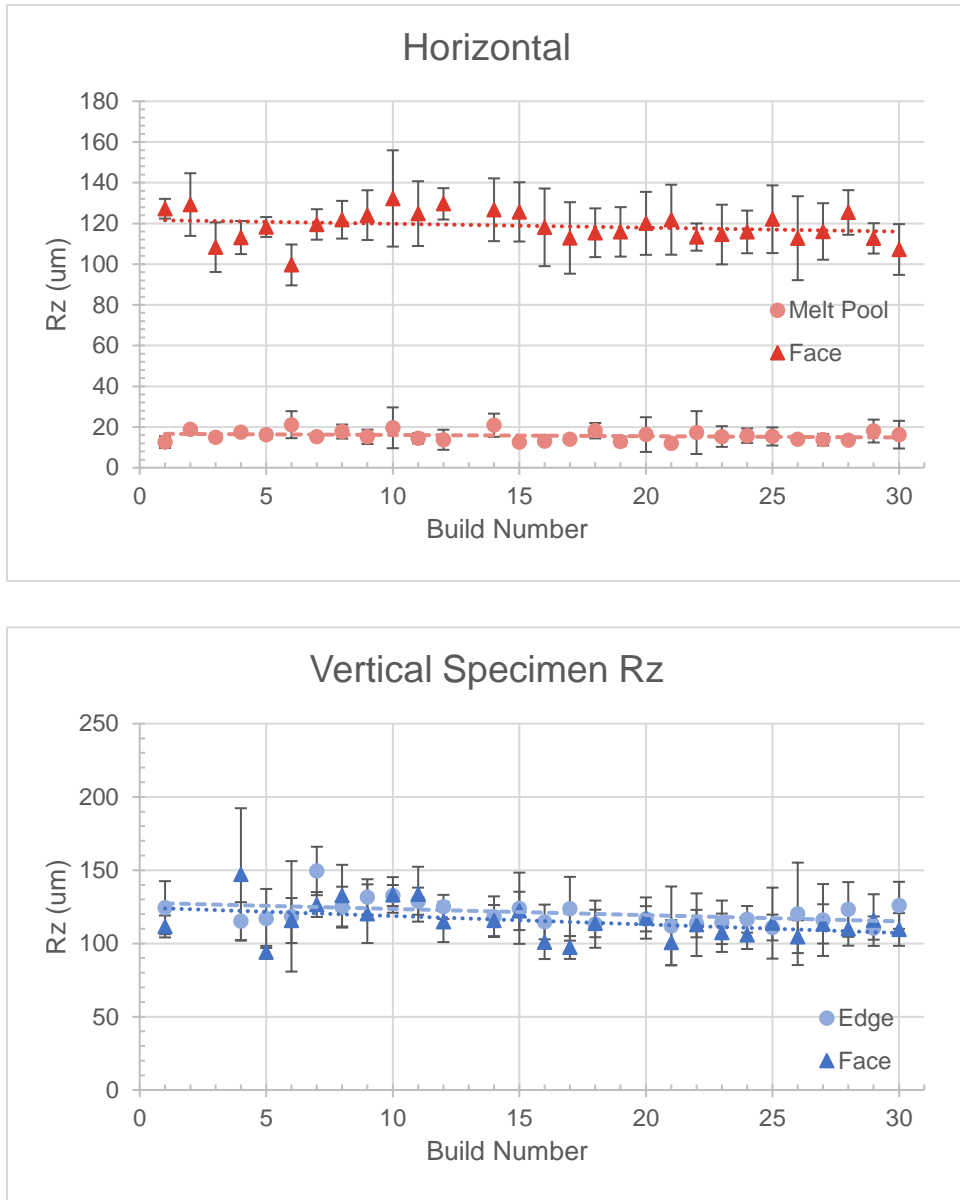
Figure 7 –

lower than the horizontal specimen's faces. Furthermore, any vertical surface (horizontal specimen faces, vertical specimen edge and faces) have similar Ra values, ranging from 23-37 μm . Rz values follow the same trends; the melt pool has a significantly lower value than the vertically oriented surfaces, 12-21 μm and 94-149 μm respectively.

Figure 7: Ra and Rz from a multi-line analysis.

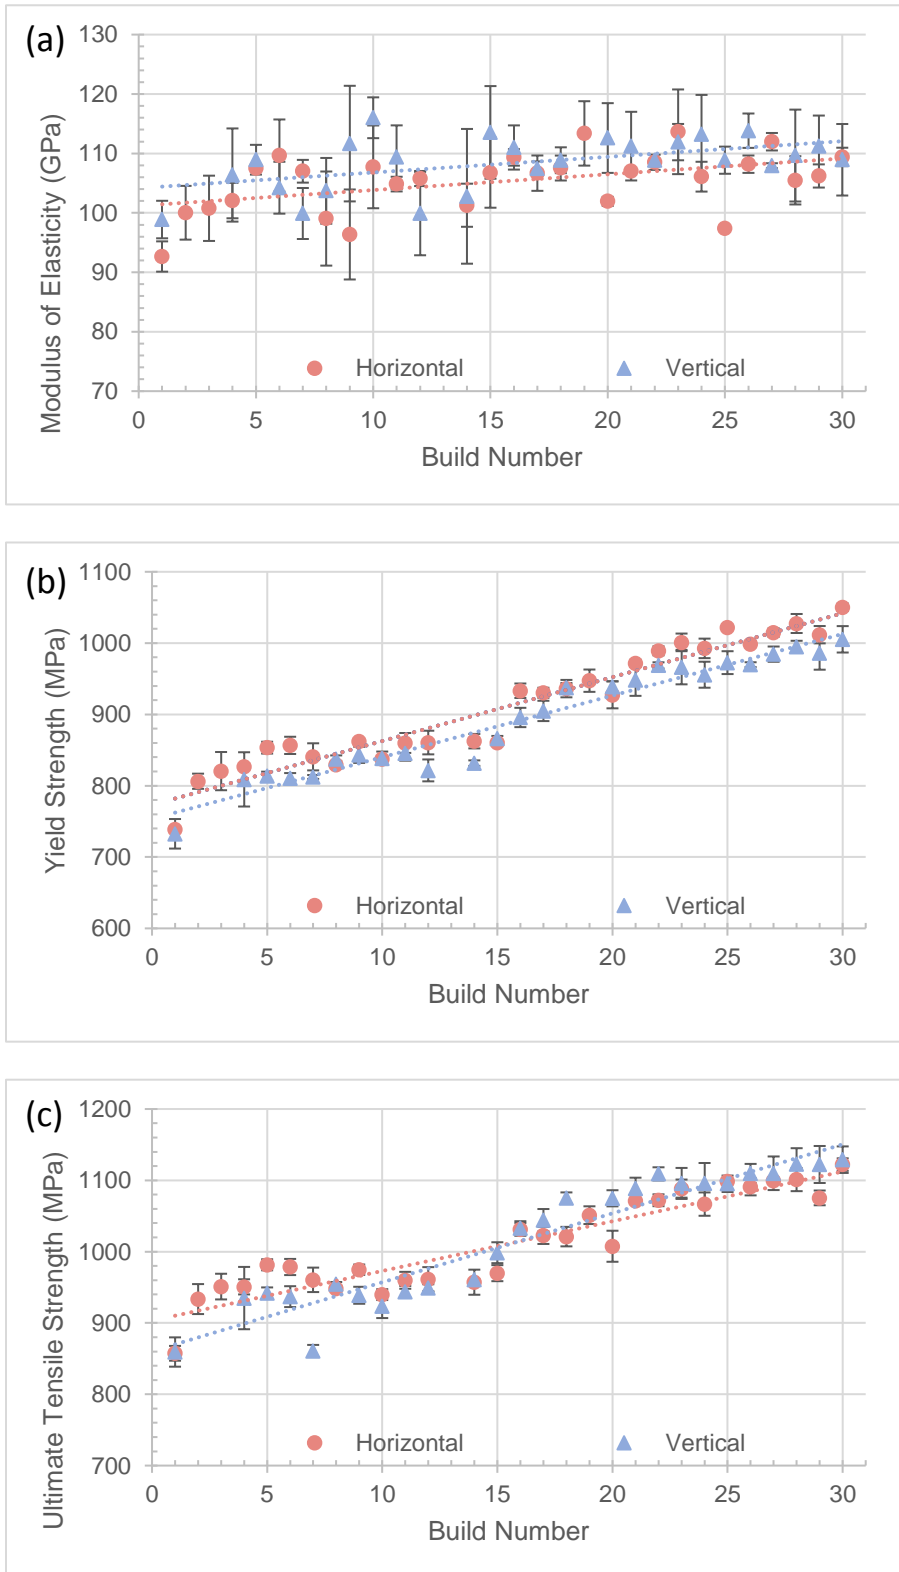
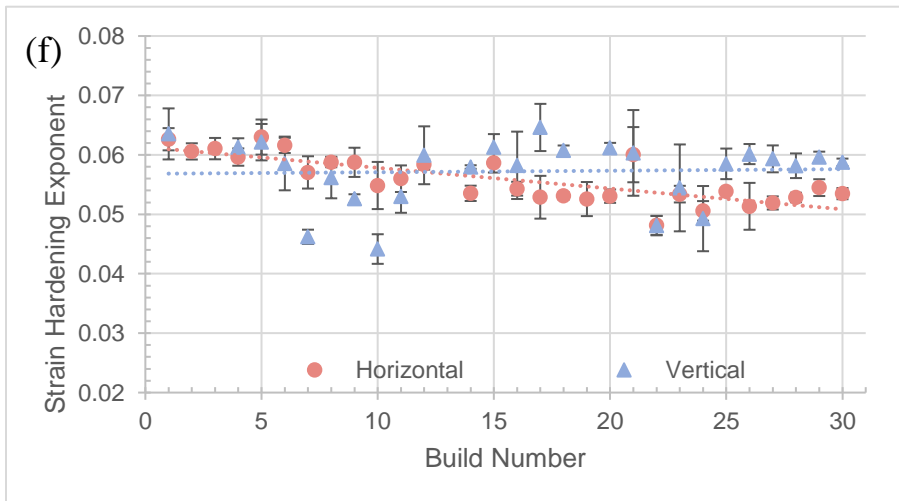
Figure 10 –

To quantitatively assess these trends, the modulus of elasticity, yield strength, ultimate tensile strength, % elongation, strain hardening exponent, and strength coefficient were calculated for each tensile specimen. These results were averaged according to specimen build direction (vertical or horizontal). The mechanical properties were determined through the build history and are plotted against the build number in Figure 10.

Figure 10: Plots of the modulus of elasticity (a), yield strength (b), ultimate tensile strength (c), % elongation (d), strength coefficient (e), and strain hardening exponent (f) versus build number.

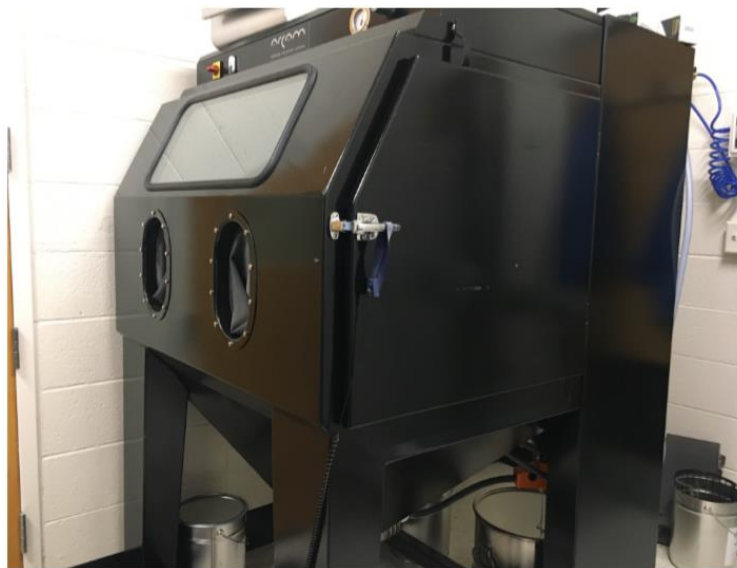
Arcam Powder Recovery System.

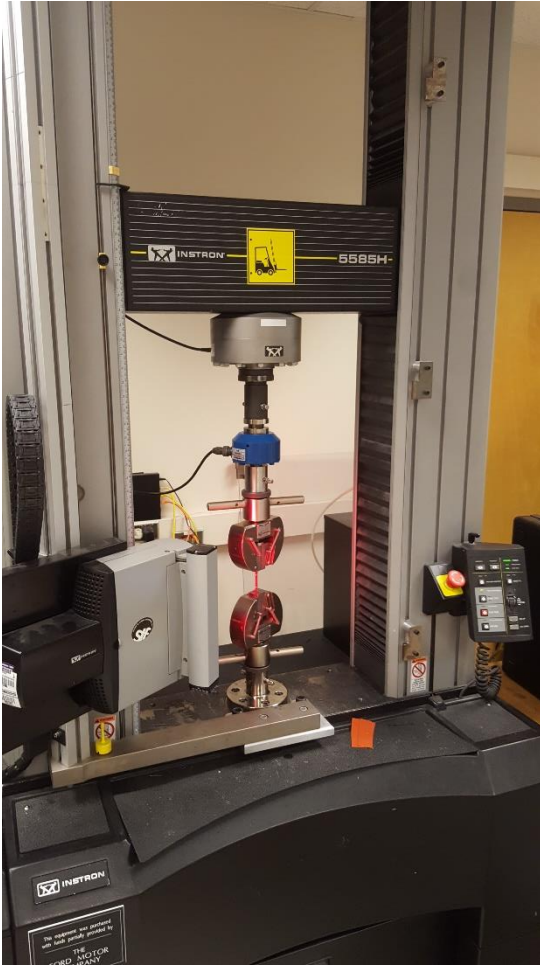
Instron load frame equipped with 50 kN load cell, 30 kN wedge grips, and an optical extensometer.

The tensile tests were performed using an Instron 5585H load frame, equipped with a 50 kN load cell (Appendix C). A 250 kN load cell was used for b21-b24 due to damage to the 50 kN load cell. A displacement rate of 1.27 mm/min was used for these tests, which corresponds to a strain rate of approximately 0.0006 s^{-1} . The load and displacement data from the tensile tests were used to generate true stress-true strain curves for each specimen evaluated. The yield strength (0.2% offset), ultimate tensile strength (UTS), modulus of elasticity, % elongation (% EL), strain hardening exponent, and strength coefficient were extracted from the true stress-true strain curves. After testing, the fracture surfaces were removed for fractography.

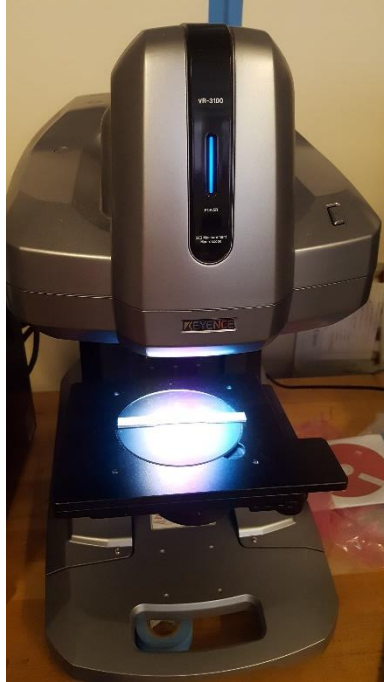
Keyence VR-3100. Non-contact 3D imager used for profilometry.

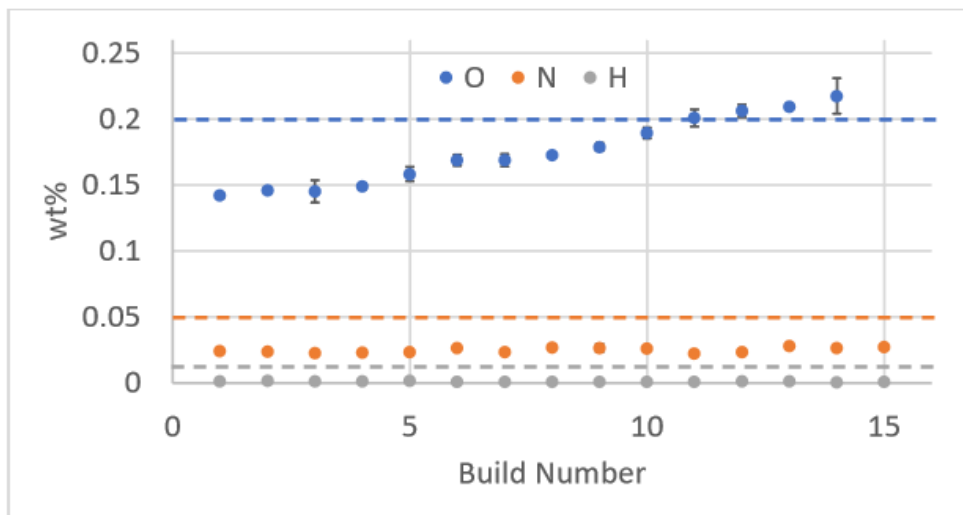
O, N and H content obtained by Sean Ghods using inert gas fusion courtesy of Boeing Everett.

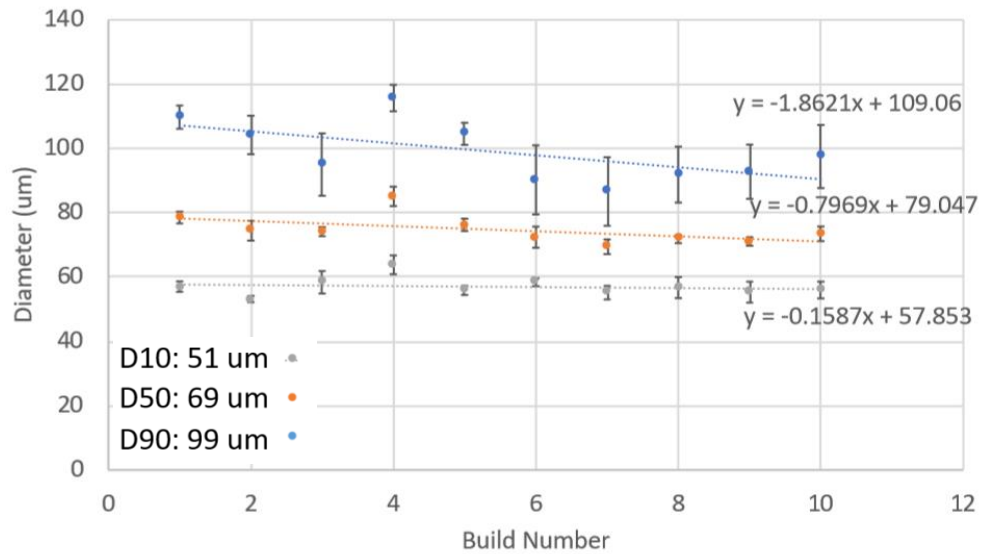
D10, D50, D90 particle size diameters against build number, including the values at build 10. Obtained by Sean Ghods using light scattering techniques.

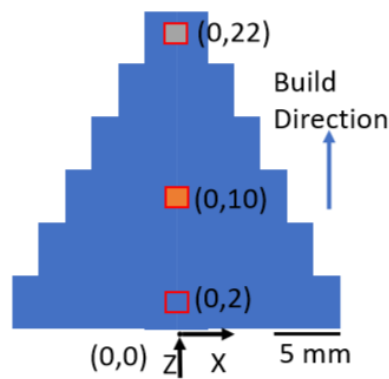
Diagram indicating locations of microstructural evaluation on a cylindrical pyramid.
