Further Investigation of a New RC Slab-Column Connection for Improved Seismic Performance of Multi-Story Buildings

A dissertation

Master of Science in Civil Engineering

University of Washington

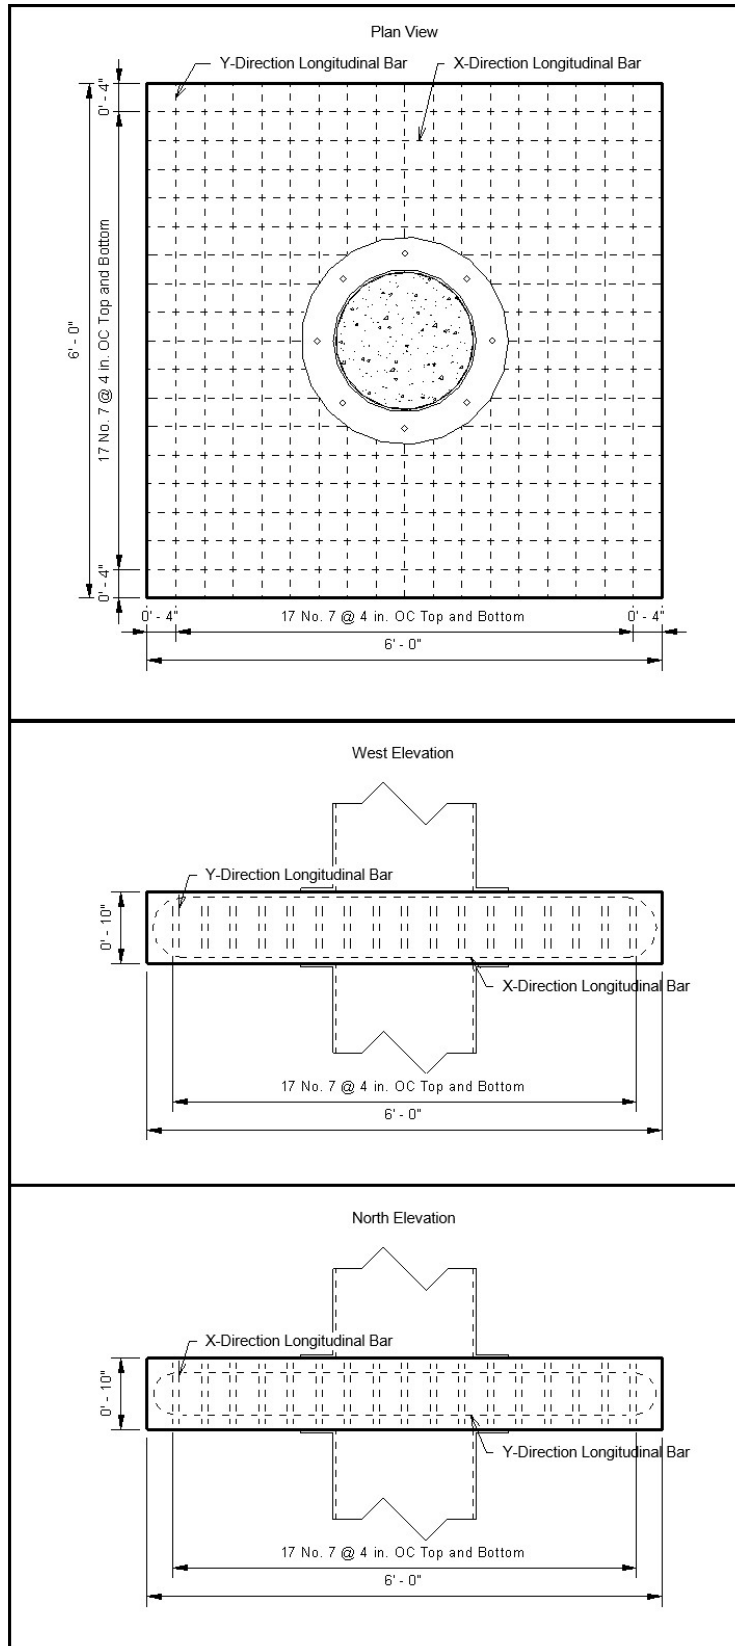
Figure 3.6. Slab Longitudinal Reinforcement Layout for Punching Specimens

punching tests in Chapter 2 that the KCI 2012 had the most accurate prediction. The KCI punching capacity and the flexural strength of the slab are both dependent upon the flexural reinforcement ratio. The slabs predicted flexural capacity was determined using a yield line model. The flexural reinforcement ratio was then modified until the predicted KCI punching capacity was greater than the predicted flexural capacity indicating a punching failure. This resulted in flexural reinforcement ratio of 1.79%. Figure 3.6 provides the layout of the flexural reinforcement.

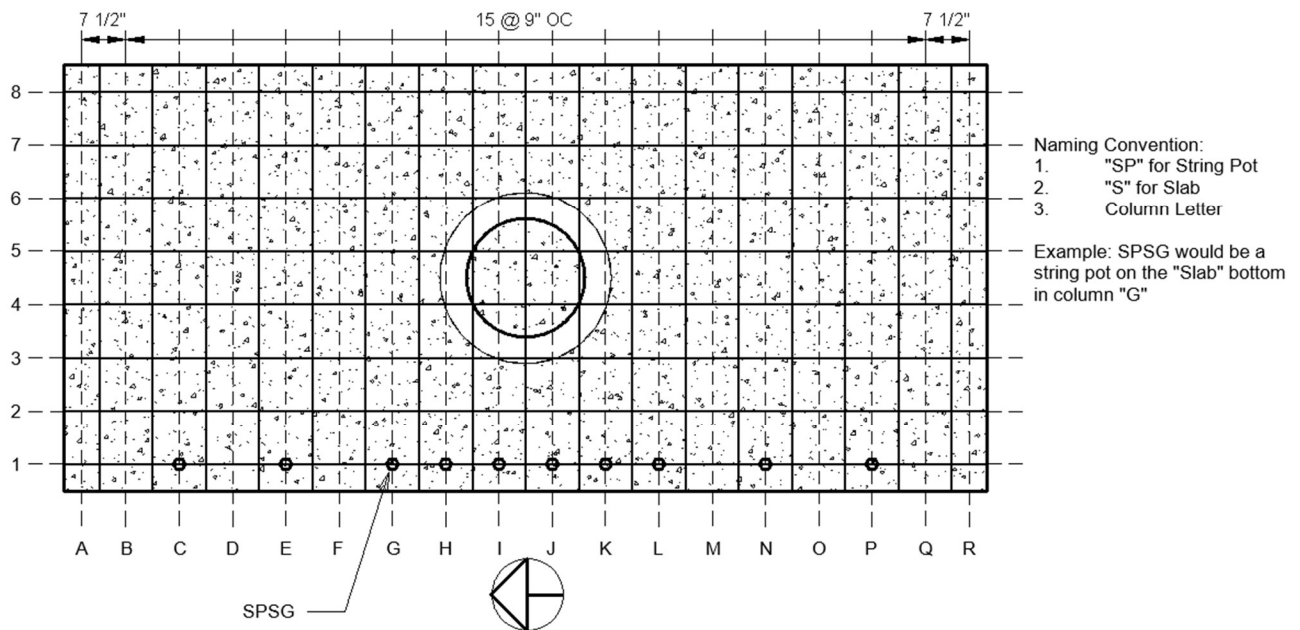
Figure 3.16. Combined-Loading String Pot Layout

To understand the slab displacements vertical string potentiometers were attached to the bottom side of the slab in the locations given in Figure 3.17. As the slab vertically displaces during testing the array of string potentiometers plots the displacement. The majority of the slab damage and deformations were expected to occur around the joint which is why there is a higher density of string pots at that location. The string potentiometers were connected by piano wire to threaded rods that were screwed into slab inserts.

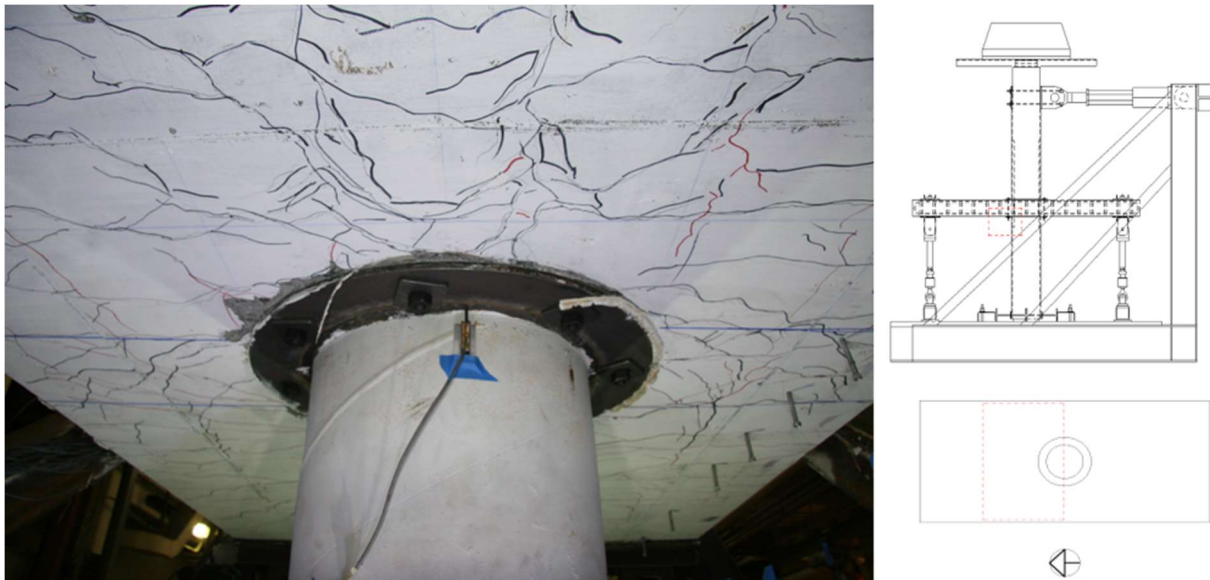
Figure 4.3. Example of Spalling

Figure 4.3 shows an example of initial spalling within the critical section from PTB_4.5_1_0_6. The figure includes a graphic to the right of the photo that indicates photo location.

Spalling results from large monotonic compression strains (typically compressive strains between -0.005 and -0.008) or cyclic loading from tension to compression where cracking due to tension loading can reduce the compressive strain corresponding to spalling. The longitudinal reinforcement in one direction is placed at the same depth and therefore after cracking, which can result in cracking at this plane and results in the cover delaminating from the concrete below the reinforcement. Spalling initiate in the slab-column joint region, as refined by ACI critical section.

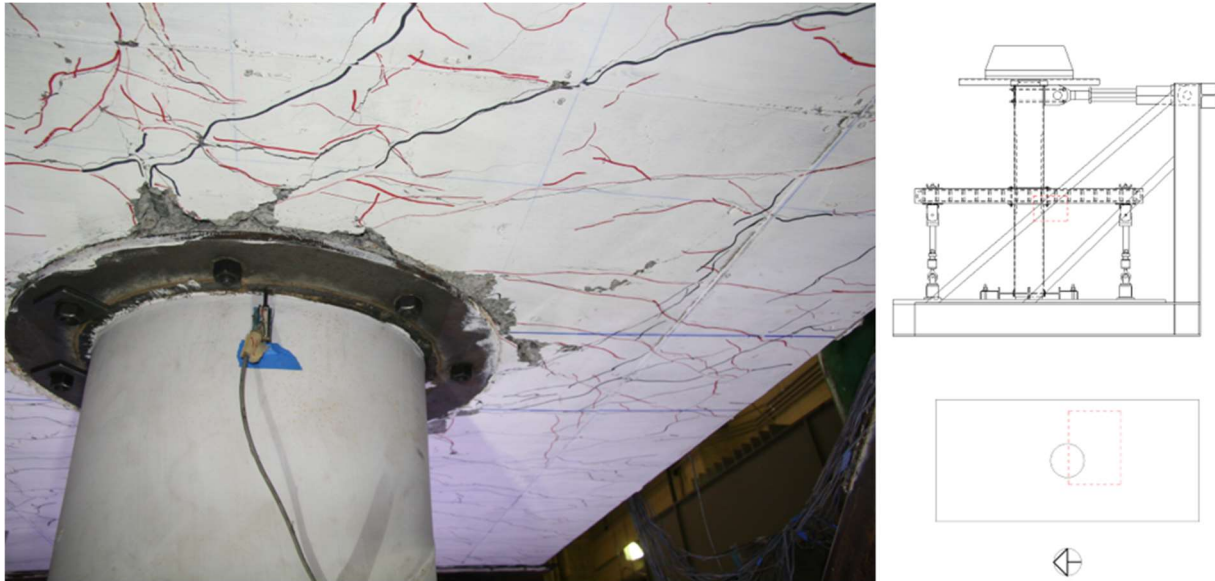
Figure 4.4. Example of Core Concrete Crushing

Crushing is defined as the complete loss of concrete cover revealing concrete core damage (beyond the cover). An example of concrete crushing is shown in Figure 4.4.

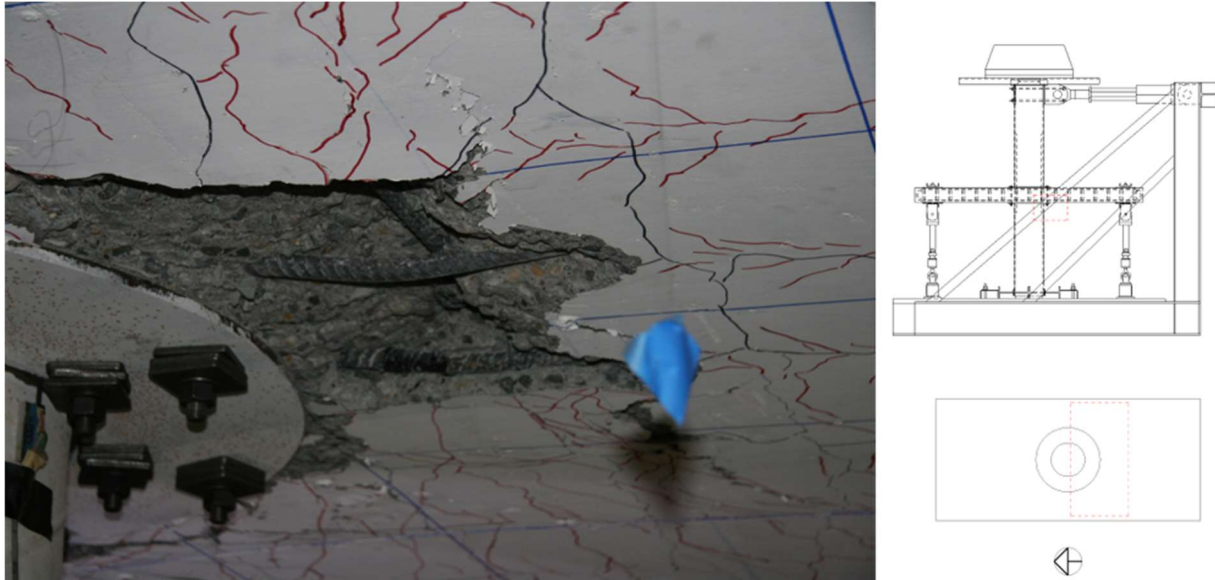
Figure 4.5. Example of Bar Buckling

Bar buckling typically follows crushing of the concrete and depends on the length of the spalled region along the bar length. Bar buckling depends on the unsupported length and tangent stiffness of the bar, which reduces locally with yielding. Crushing of the concrete reduces the compressive strength of the core concrete, and transfers the force to the flexural reinforcement. With the reduced modulus and increased unsupported length and compressive force, buckling of the bar is expected. Figure 4.5 provides an example of bar buckling. Since the reinforcement is not always visible during testing, the observation of bar buckling will only refer to damage that is visible during testing.

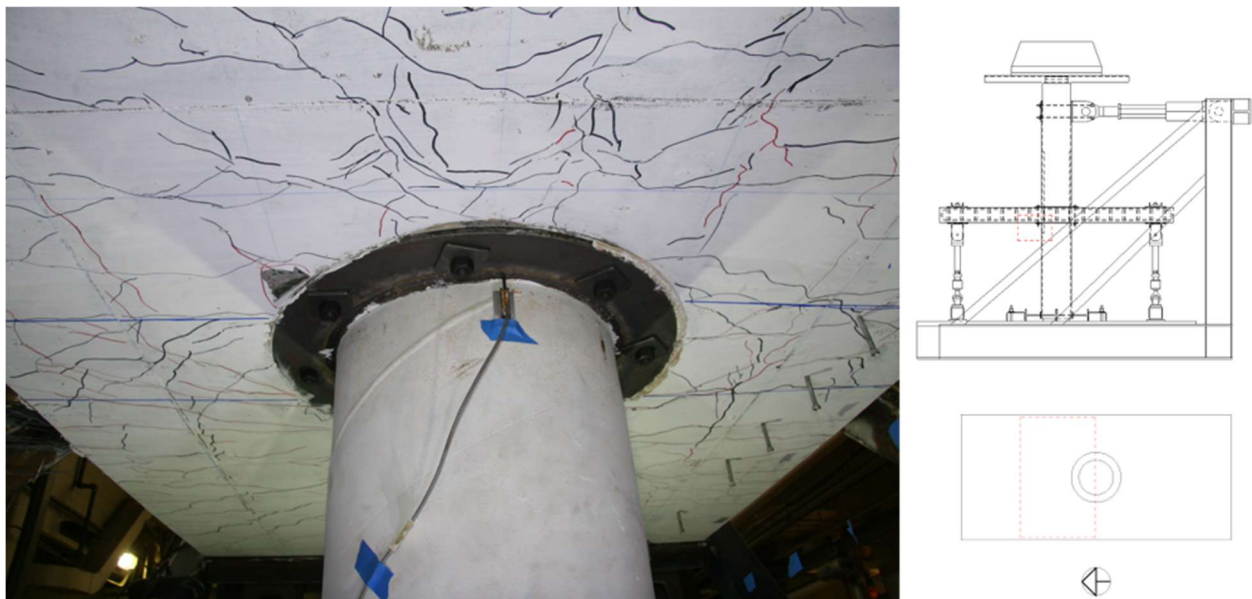
Figure 4.16. Spalling on North Side of Bottom Face – 3.48% Drift (PTB_4.5_1_0_6)

During 5.0-2 large cracks were measured on the top face of the slab near the connection. The cracking around the ring edge gave way to spalling seen in Figure 4.16. The spalling occurred on the northeast edge of the ring and extended roughly 2.5 in. from the edge. A crack width of 4.5 mm was measured on the south edge of the ring flange during the north peak displacement and 4.5 mm on the north edge during in the reverse direction. A few more strain gauges recorded yielding around the ring flange or along the reinforcement within the column width. The lateral load began to plateau at this load step.

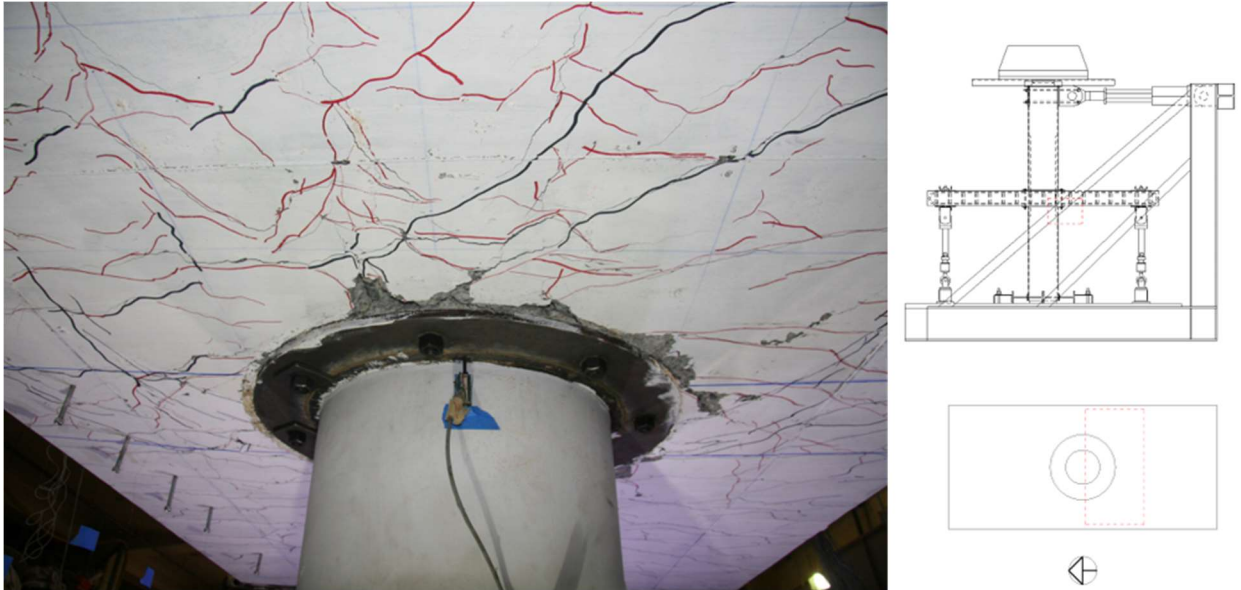
Figure 4.21. Crushing on South Side of Bottom Face – 4.91% Drift (PTB_4.5_1_0_6)

During 7.0-2 (+4.79/-4.89 drift) spalling increased and was measured extending approximately 4 in. away from the edge of the ring flange. The spalling is still mostly focused on the north and south edges of the connection. At this drift level crushing occurred on the north and south edges of the ring. It extended approximately 2 in. out from the ring on the north edge of the connection and approximately 2.5-3 in. on the south edge of the connection. The crushing on the south side is shown in Figure 4.21. The initiation of crushing begins the degradation of strength of the specimen. Yielding of the flexural reinforcement continues to extend further across the slab. The top and bottom reinforcement both indicate yielding of three bars. The yielded strain gauge of the third bar was located to the south of the ring flange edge and could indicate a high deformation demand at this location due to formation of a flexural hinge.

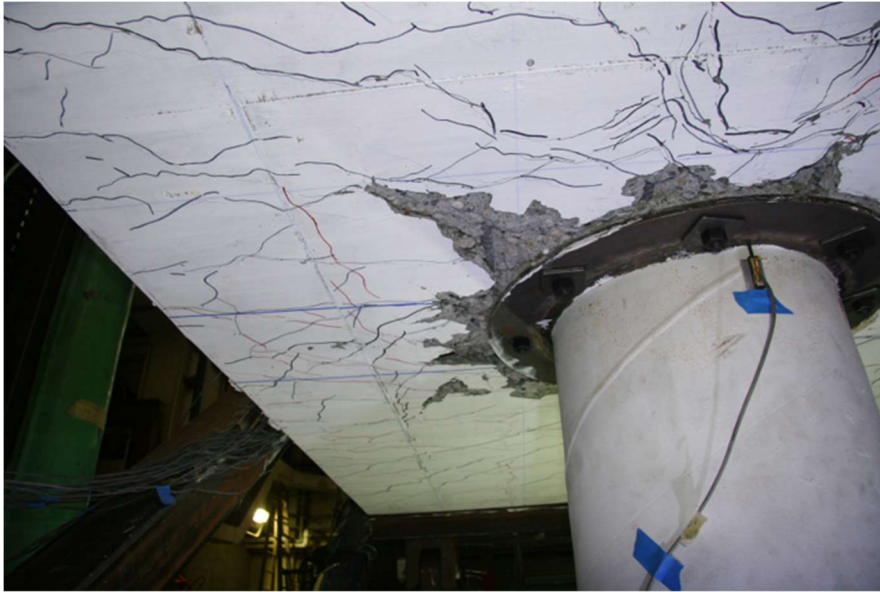
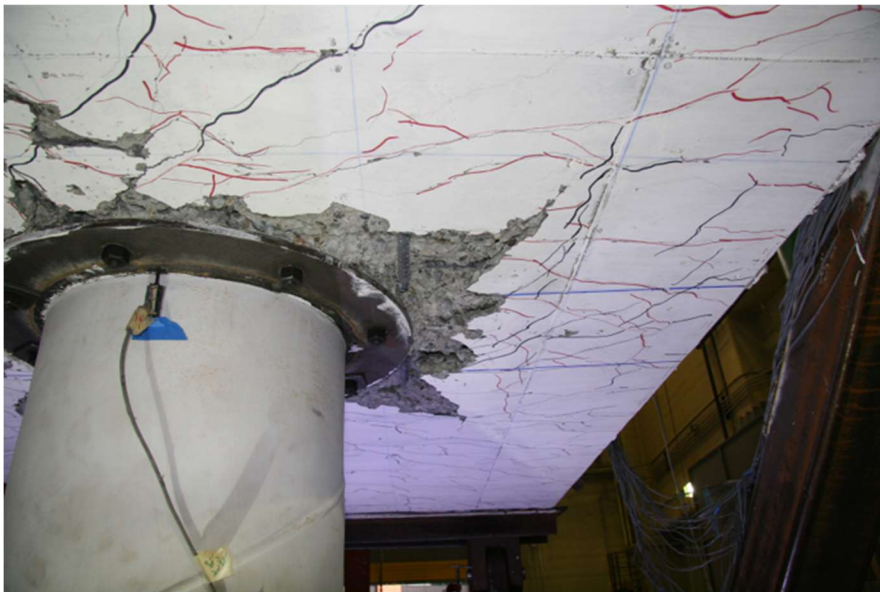
8.0-2 (+5.45/-5.44 drift) resulted in a significant increase in the amount of crushing in the slab. Multiple reinforcing bars were exposed. The resulting damage due to crushing is shown in Figures 4.22 and 4.23. The extent of crushing was concentrated on the east side of the connection, with small increases in the amount of crushing developed to the north and south of the connection. The top face of the slab shows no signs of crushing, but the concrete around the connection has spalled. The third bar of the top flexural reinforcement did not record yielding during this drift level. There was a significant loss in lateral force resistance during 8.0-2 as a result of the damage to the slab.

Figure 4.22. Crushing on North Side of Bottom Face – 5.63% Drift (PTB_4.5_1_0_6)

Figure 4.23. Crushing on South Side of Bottom Face – 5.63% Drift (PTB_4.5_1_0_6)

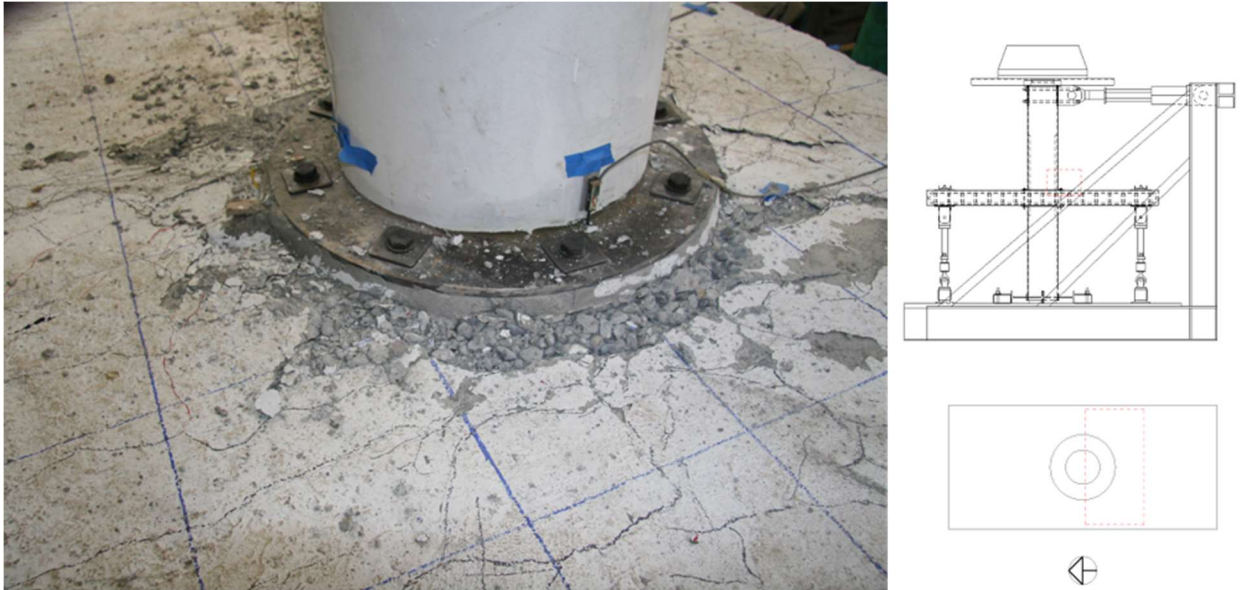
Figure 4.26. Damage on South Side of Top Face – 6.35% Drift (PTB_4.5_1_0_6)

Since 9.0-2 was run without interruption, the photos of the resulting damage were not taken until after the test. The column was returned to a displacement of zero and measures were taken to secure the specimen before inspection of the damage. Damage to the top face of the slab is provided by Figure 4.26. Extensive crushing near the base of the ring flange was found. The crushing extended 3-4 in. from the north and south edge of the ring flange. Large cracks to the east and west of the connection indicate larger areas of spalling/delamination of the concrete that were not visible. The cracks extend approximately 1 ft. in both directions.

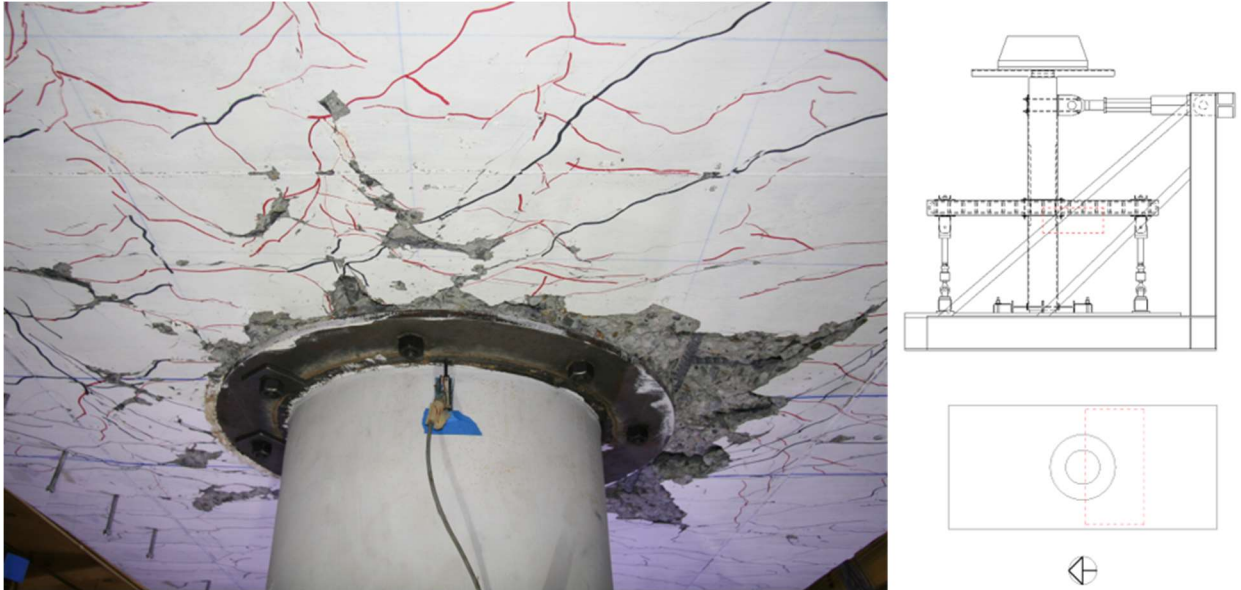
Figure 4.29. Damage on South Side of Bottom Face – 6.35% Drift (PTB_4.5_1_0_6)

On the bottom face of the slab, the crushing and spalling damage increased as shown in Figures 4.27 to 4.29. Looking at the North side of the slab, there is spalling to the West of the connection that appears to be in a direction radial to the column. The South side of the slab shows increased spalling South of the ring flange, but the majority of the crushing is concentrated to the East of the connection. One bar just within the confinement zone of the ring flange shows complete debonding from the interior concrete. While it is difficult to determine from the shape of the bar at a displacement of zero, it likely would have buckled at the target displacement since the concrete could no longer confine the bar.

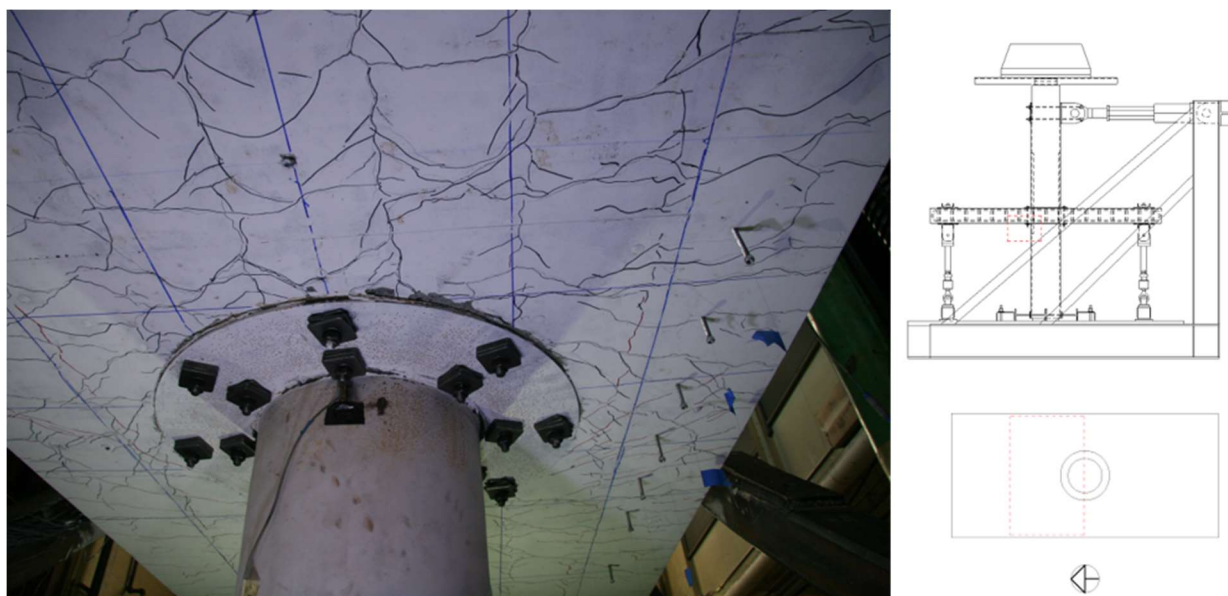
Figure 4.39. Spalling on North Side of Bottom Face– 3.54% Drift (PTB_9_2_0_6)

5.0-2 (+3.53/-3.39 drift) showed insignificant difference in the crack pattern from the previous drift level. The majority of the crack development was on the top slab to the east and west of the column. The maximum crack widths at the north peak displacement were measured at 1.5 mm on both the top and bottom face of the slab. During the south peak displacement the maximum measured crack widths are 2.0 mm on both the top and bottom face of the slab. Initial spalling occurred at the north and south edges of the ring flange. Figure 4.39 shows the minimal spalling

that measures approximately an inch in distance from the ring flange. The yielding of the flexural reinforcement began to spread further across the width of the specimen as shown in Figures 4.40 and 4.41. The bottom reinforcement shows yielding of the bar just outside the ring flange. Some of the strain gauges within the ring flange did not show yielding, showing that confinement of the ring reduced the strain they experienced.

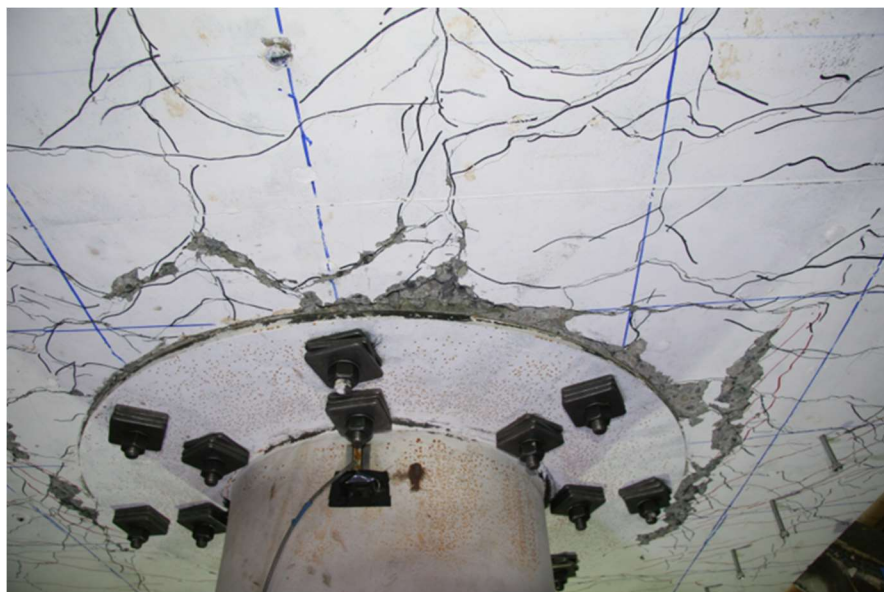
Figure 4.44. Spalling on North Side of Bottom Face– 5.00% Drift (PTB_9_2_0_6)

During 7.0-2 (+4.89/-4.84 drift) PTB_9_2_0_6 showed significant increase in spalling on the top and bottom faces of the slab. Spalling occurring on the top face was primarily around the north and south edges of the ring. Spalling on the bottom face is shown in Figure 4.44. In addition to the spalling at the north and south edges of the ring, spalling occurred along the flexural reinforcement west of the ring flange. During 7.0-2 crushing was noticed on the bottom face of the slab shown in Figures 4.45 and 4.46. The extent of crushing measured approximately 2 in. from the north edge of the ring. The crushing on the south side occurred at roughly 1 ft from the ring edge and had a length of about 3 in.. The flexural reinforcement strain summary did not change for the top bars. The bottom bars changed slightly.

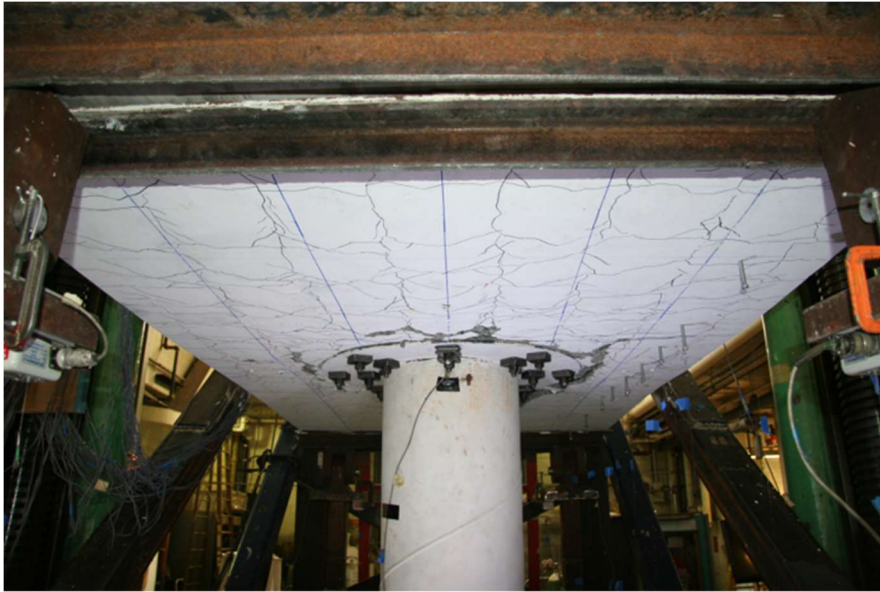
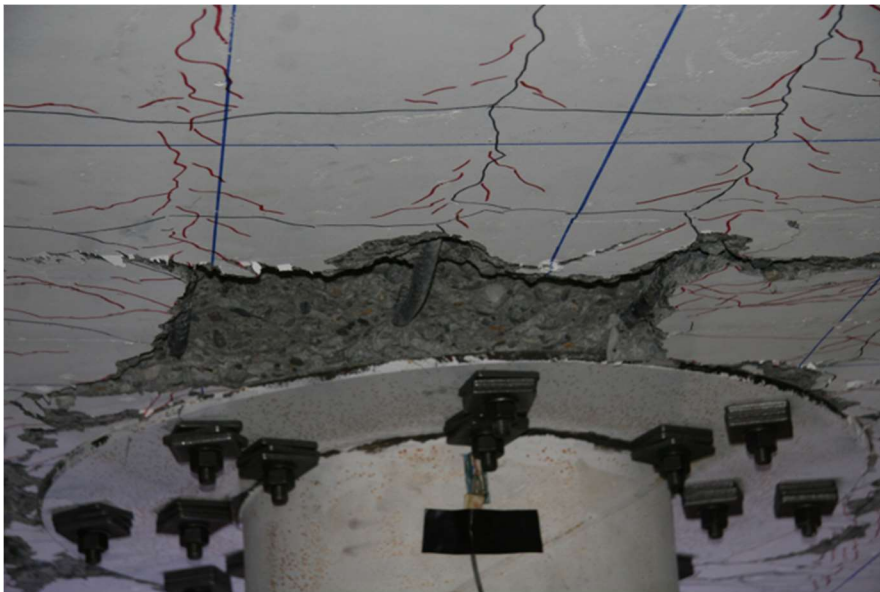
8.0-2 (+5.61/-5.46 drift) was paused at the north peak. The strength loss was high enough that for safety precautions the specimen was not inspected in the same manner as the other drift levels. The cycle was completed without further interruption. Figures 4.47 and 4.48 show the concrete damage increased significantly. The spalled regions expanded in the north and south. Much of the spalled region showed significant crushing of the concrete near the north and south edge of the ring. The two reinforcing bars passing through the column buckled and can be seen on the south side of the specimen. In addition a crack on the west face of the slab similar to PTB_4.5_1_0_6 formed as shown in Figure 4.49. The strain status of the reinforcement can be seen in Figures 4.50 and 4.51. The bottom bars show yielding of the outermost bar. Based on the location of the strain gauges not being in line with the north and south edge of the ring flange, they may yield at a higher drift than if the outermost bar had four gauge locations. The strength loss was large enough to satisfy the end of testing criteria.

Figure 4.47. Damage on North Side of Bottom Face– 5.61% Drift (PTB_9_2_0_6)

Figure 4.48. Bar Buckling on South Side of Bottom Face– 5.61% Drift (PTB_9_2_0_6)

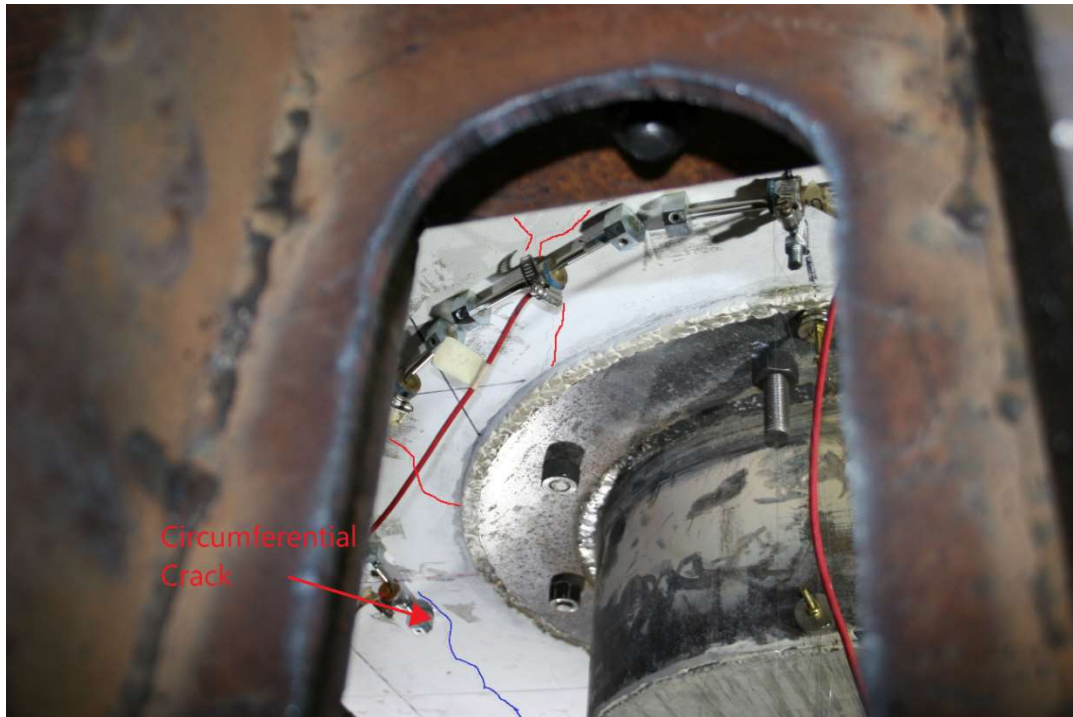
Figure 6.2. Cracking on Bottom Face of Northeast Slab – 500 kips (PTB_4.5_1_0_P)

Cracking developed significantly during the load step 5 (400-500 kips) which can be seen in Figure 6.2. The circumferential crack formed around the perimeter of the ring flange is outlined in blue. Cracks emanating from the ring flange aligned with the flexural reinforcement. Cracks began to appear on the north face of the specimen that were mostly vertical and appeared to originate from the bottom face of the slab. The cracks are highlighted in Figure 6.3. At 500 kips the flexural reinforcement indicated yielding as shown in Figure 6.4.

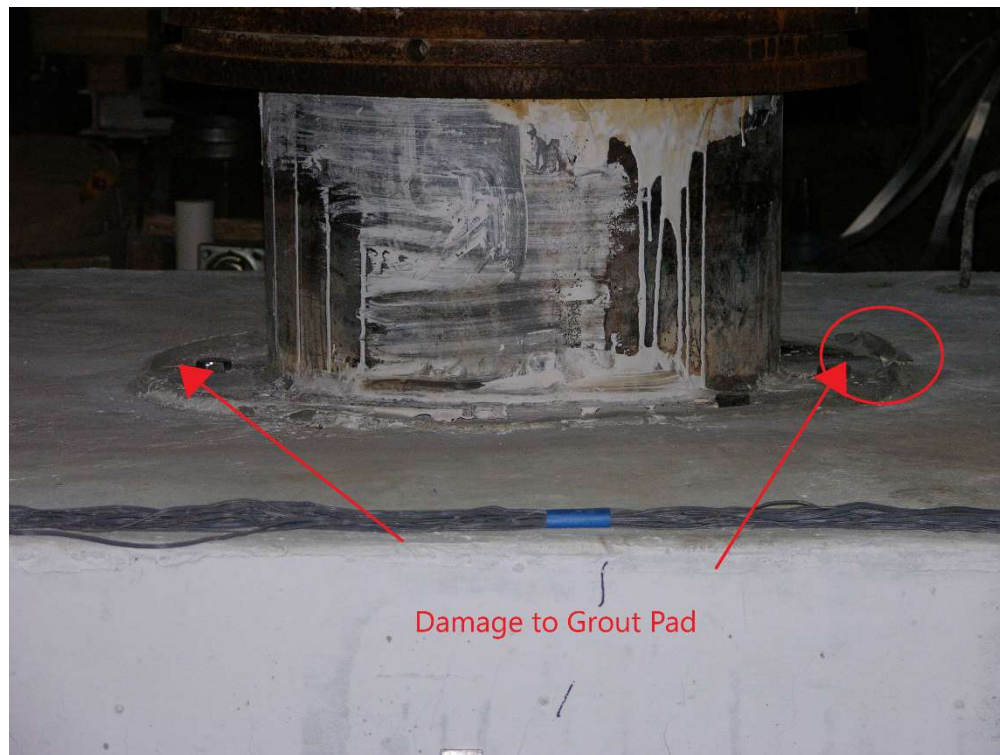
Figure 6.6. Crushing of Grout Pad North Side of Slab – 470 kips (PTB_4.5_1_0_P)

During load step 8 (500-400), the rate of resistance loss decreased in comparison with that of load step 7. The resistance loss plateaued around 470 kips. During the plateau the grout pad underwent significant damage as the ring flange was pressed into the slab shown in Figure 6.6. The circumferential crack width grew significantly during this load step. Cracks between the inner

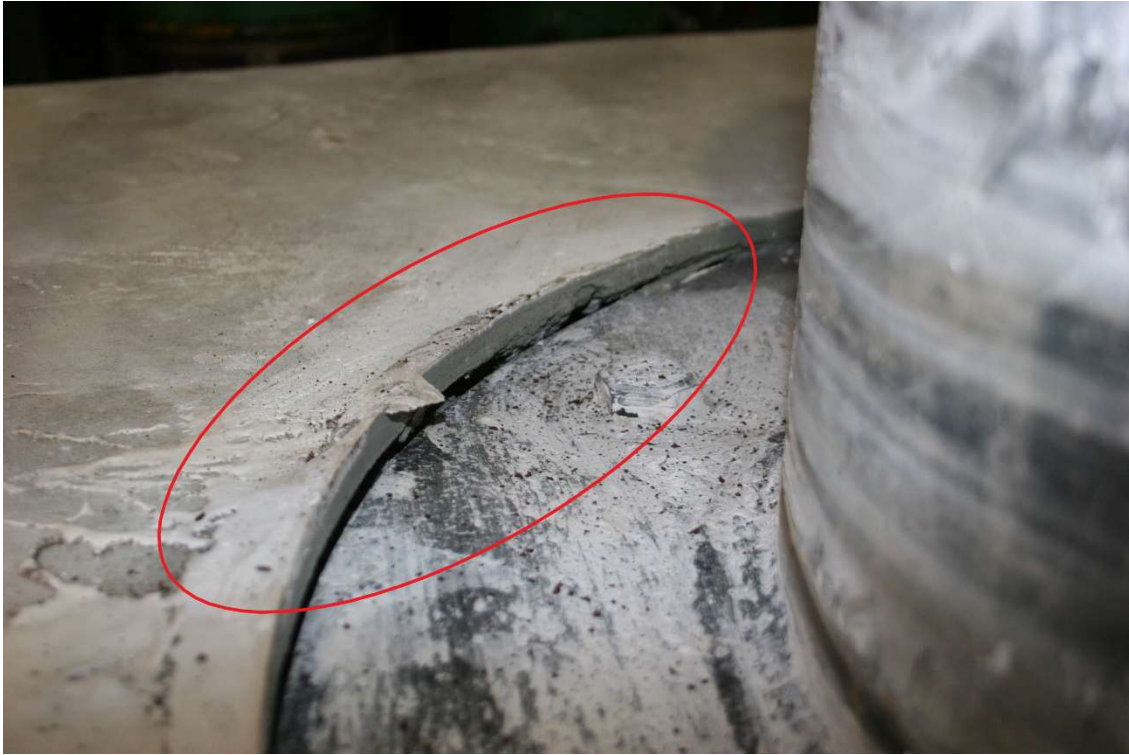
Figure 6.11. Deformation at Ring Edge of Top Column – Post Test (PTB_4.5_1_0_P)

Beginning with the top face of the slab, the top column had noticeably sunk into the slab. The discontinuity is apparent on the northeast side of the ring in Figure 6.11. The gap between the top surface of the slab and the top of the ring show a displacement of the top of the connection that is not seen underneath the specimen. Figure 6.12 shows that the top face of the ring is flush with the bottom of the slab.

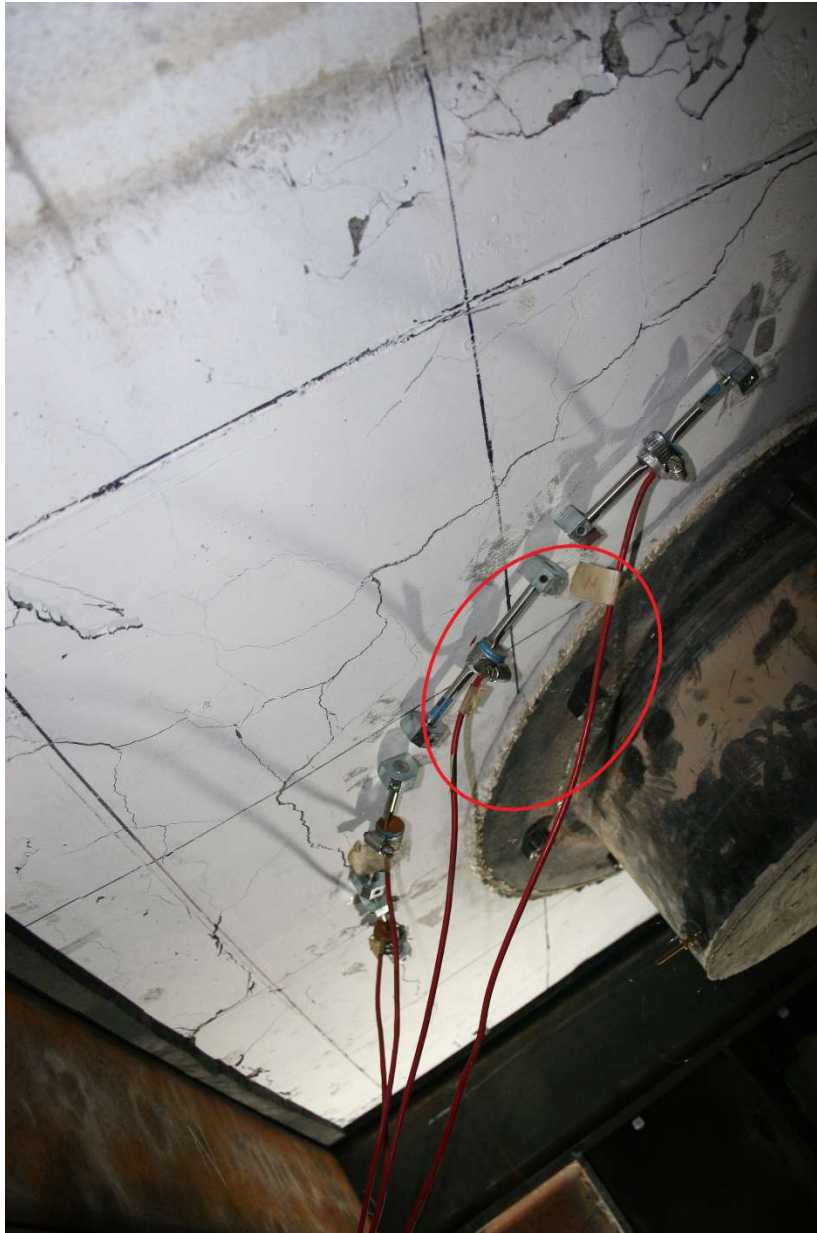
Figure 6.12. Deformation of Concrete around Ring Flange on Bottom Face – Post Test
(PTB_4.5_1_0_P)

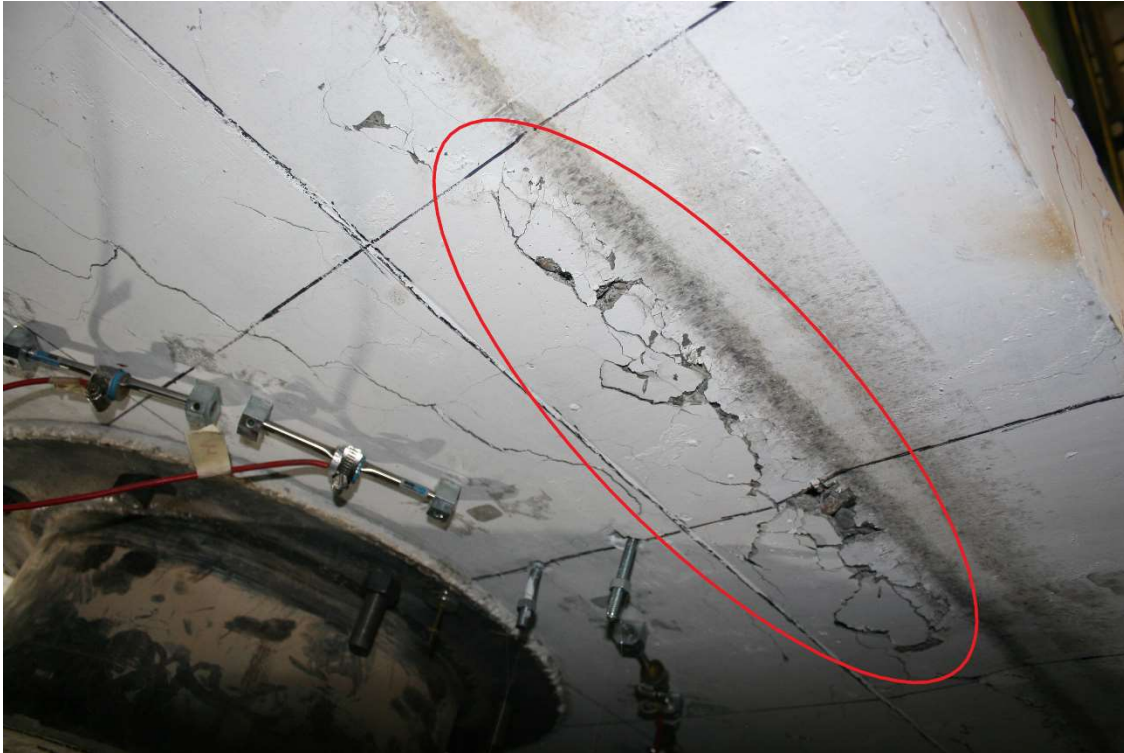
Figure 6.14. Spalling at North Support – Post Test (PTB_4.5_1_0_P)

From the photos during the test the spalling is approximated to have started during the final load step. During the final load step the specimen displaced approximately 0.37 in. which is 27.6% of the total test displacement. The spalling is a result of the supports restricting the displacement of the bottom face of the slab. From 470 kips post peak there is a relatively consistent rate of strength loss. Which does not indicate that the spalling was the result of a large drop in strength..

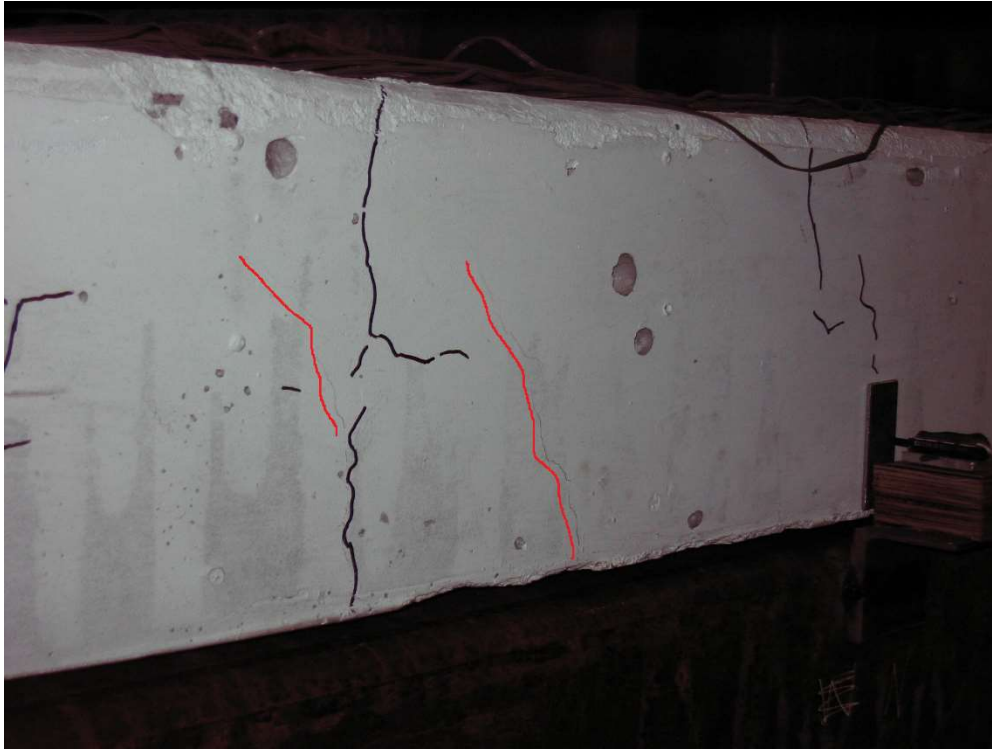
Figure 6.18. Cracking on North Face of Slab – 470 kips (PTB_9_2_0_P)

Load step 5 (400-500 kips) the cameras underneath the slab were out of focus so the development of cracking was inconclusive. Figure 6.18 shows cracking on the north edge of the slab at approximately 470 kips. The cracks highlighted in black were there before the start of testing. The cracks highlighted in red show the cracks developed during testing. In the previous test these cracks seemed to be a result of similar cracks along the reinforcement on the underside of the slab, which helps to give some information about the cracking beneath the slab, but it is not definitive. None of the strain gauges indicated yielding of the flexural reinforcement, many of the gauge readings had surpassed 50% of the yield strain. The few gauges that had strain readings below 50% of the yield strain were on bars in the east-west direction far from the ring flange, and in the north-south direction the strain gauge on the bar passing through the center of the column but at 8 in. from the edge of the ring flange.

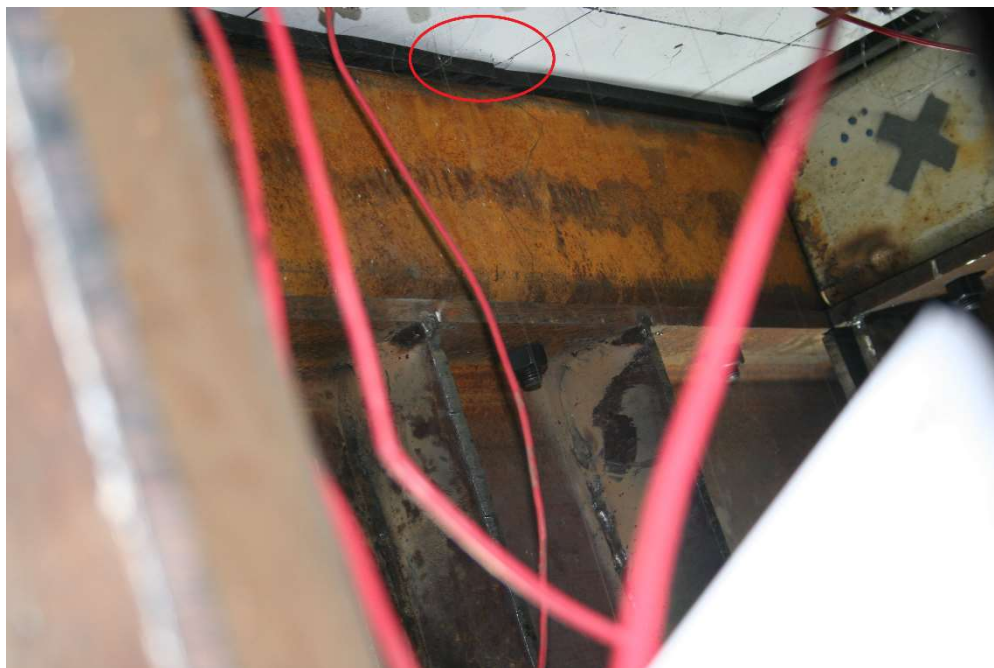
Figure 6.21. Cracking on Bottom Face of Slab near North Support – 670 kips
(PTB_9_2_0_P)

During load step 7 (600-700 kips) the stiffness continued to decrease as the load approached the peak measured load. The decrease in stiffness is attributed to yield of flexural reinforcement as well as large cracks formed on the bottom of the slab. Cracking near the middle of the north support was noticed during this load step and is shown in Figure 6.21. Figure 6.22 shows the changes in strain for the east-west bars during this load step. All of the strain gauges on the east-west bars record strains of higher than 50% of the yield strain following the similar pattern of highest strains being the bars near the column within $d/2$ from the edge of the ring flange. The strains decrease as the gauges move further away from the column. Strain gauges on the north-south bars showed increase in strain magnitudes, however there were no new instances of gauges recording strains above the yield strain.

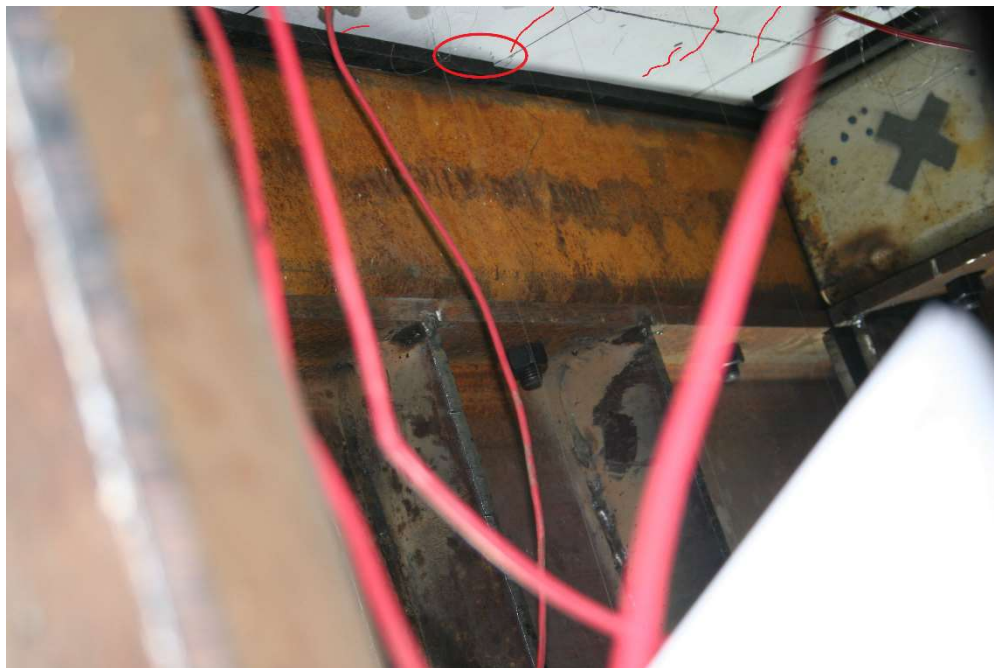
Figure 6.25. Bottom Face of Slab near North Support – 700 kips Post Peak (PTB_9_2_0_P)

During load step 9 (731-700 kips) the specimen began to gradually lose strength. The damage to bottom surface of the slab consists of cracking around the column and middle of the support with some radial cracking that extends towards the corner of the supports shown in Figure 6.25 and 6.26. Figure 6.25 shows cracking on the north edge of the slab that originated from the bottom side and aligned with the location of flexural reinforcement as well as shrinkage cracking noticed before testing. The strain gauges showed no new locations at which yield strain was reached. Strain gauges attached to east-west reinforcement continued to increase strain magnitudes with the exceptions being at the locations on the bar passing through the center of the column at the edge of the ring flange and 8 in. from the ring flange and the reinforcing bar furthest from the column. The strains on reinforcing bars in the north-south direction within the critical perimeter continued to increase in strain. The strain gauge located along the east-west bar closest to the north

During load step 10 (700-600 kips) the rate of resistance degradation decreased in comparison to load step 9. Cracks highlighted in Figures 6.25 and 6.26 continued to increase in width. The top ring flange bends upward as the top column is pressed into the top of the slab. The deformation is seen in the movement of the top column relative to the top face of the slab as the grout pad begins to crush. Figures 6.28 and 6.29 show that all of the strain gauges other than the north most gauge on the east-west bars recorded strains above yield.

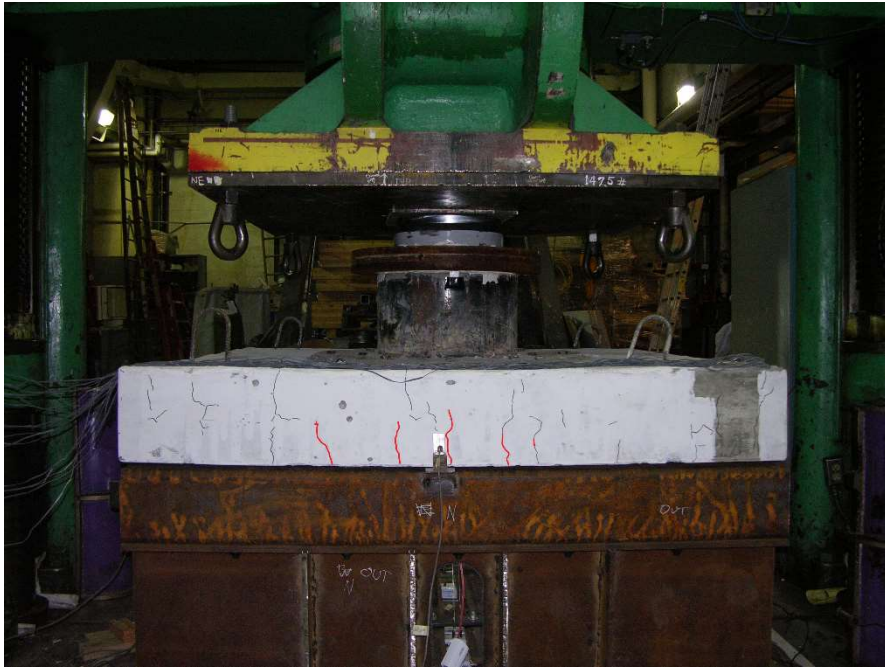
Figure 6.27. North Face of Slab – 700 kips Post Peak (PTB_9_2_0_P)

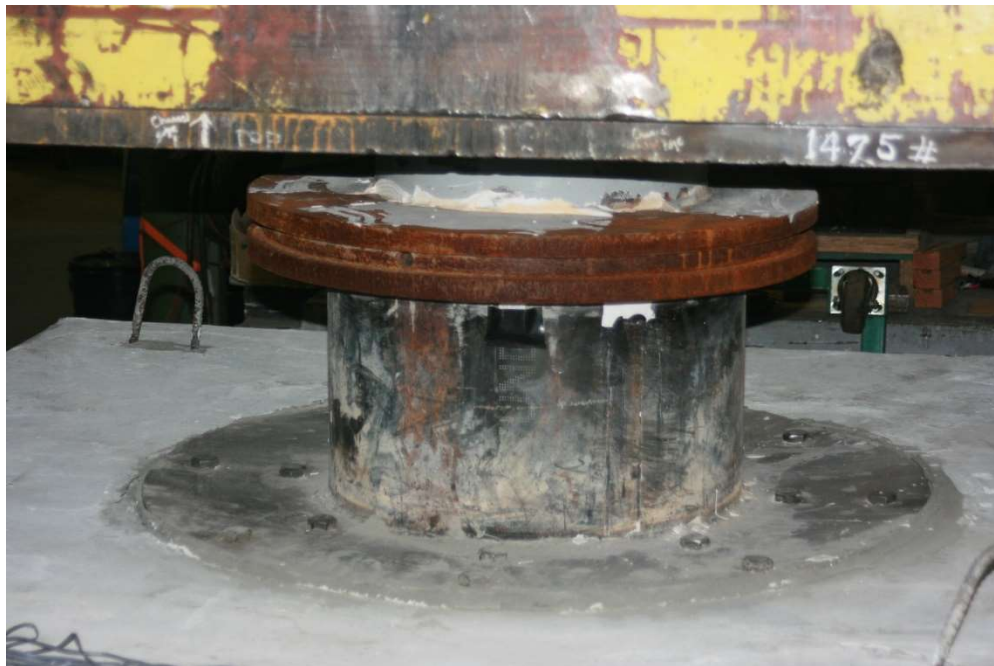
Figure 6.28. Deformation of Top Ring Flange – 600 kips Post Peak (PTB_9_2_0_P)
