Further Investigation of a New RC Slab-Column Connection for Improved Seismic Performance of Multi-Story Buildings

A dissertation

Master of Science in Civil Engineering

University of Washington

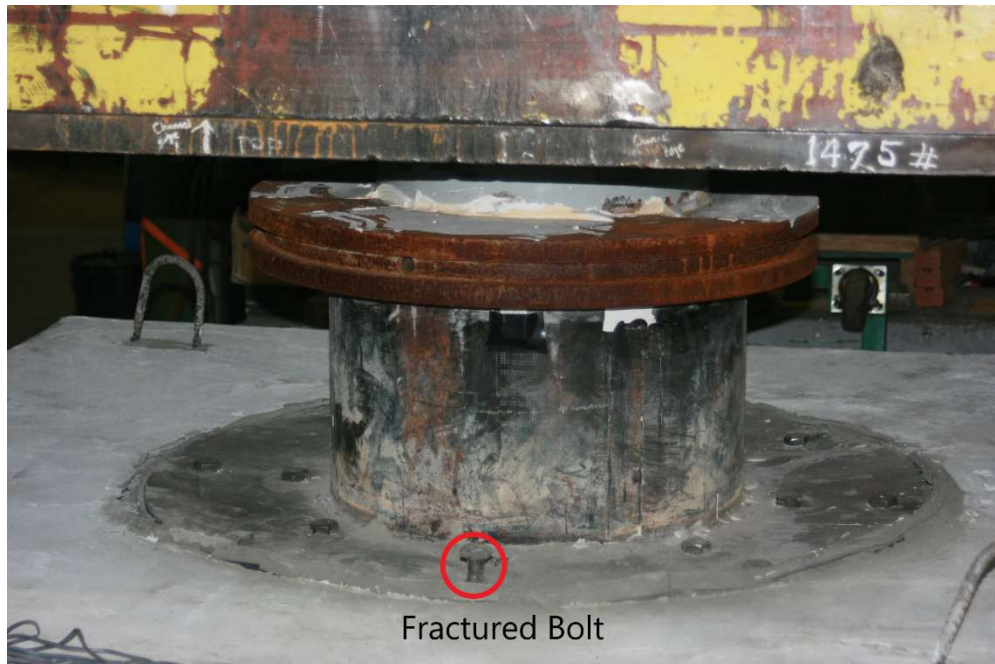
Figure 6.33. North Side of Top Column – 513 kips Post Peak (PTB_9_2_0_P)

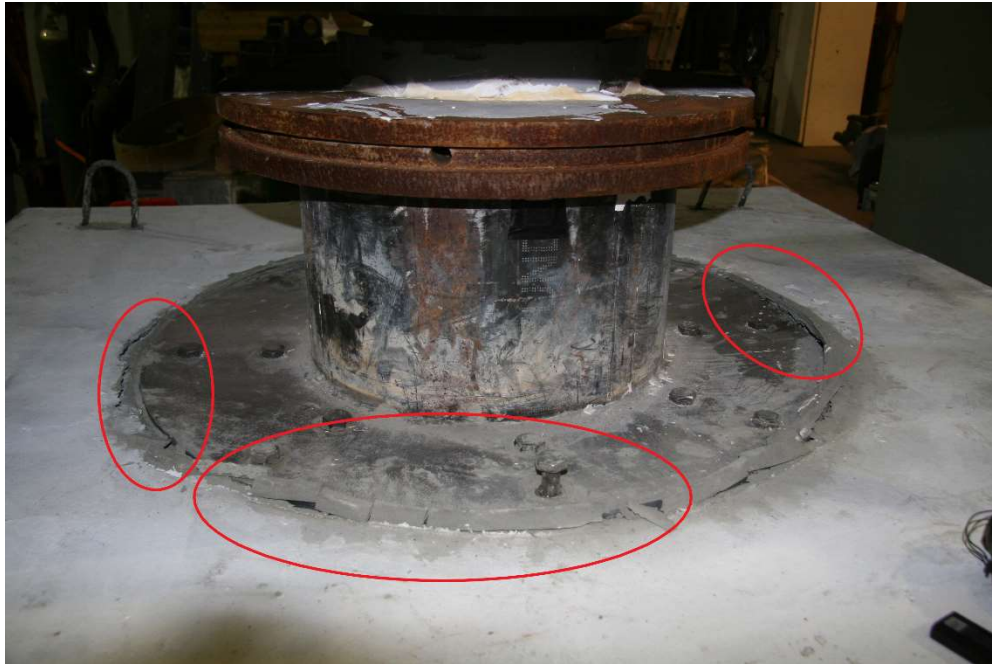
After testing was completed the Baldwin press was held at a constant displacement. Photos were taken during this configuration to observe the cracking and damage at the maximum displacement of the specimen. With the load in place it was difficult to take photos of the bottom of the specimen, so the photos were used to determine the damage to the top of the slab around the ring flange. Figure 6.34 highlights damage to the grout pad and concrete at the edge of the ring. A large crack formed at the edge of the ring flange. Figure 6.33 and Figure 6.34 show the width of the crack at different locations. The damage to the concrete around the ring flange allowed the top column to displace into the top surface of the slab. At the start of test, the bottom of the top ring flange was flush with the top of the slab. At end of test the top of the ring flange was flush with the top of the slab at a few points along the ring.

Figure 6.34. North Side of Top Column – After Test (PTB_9_2_0_P)

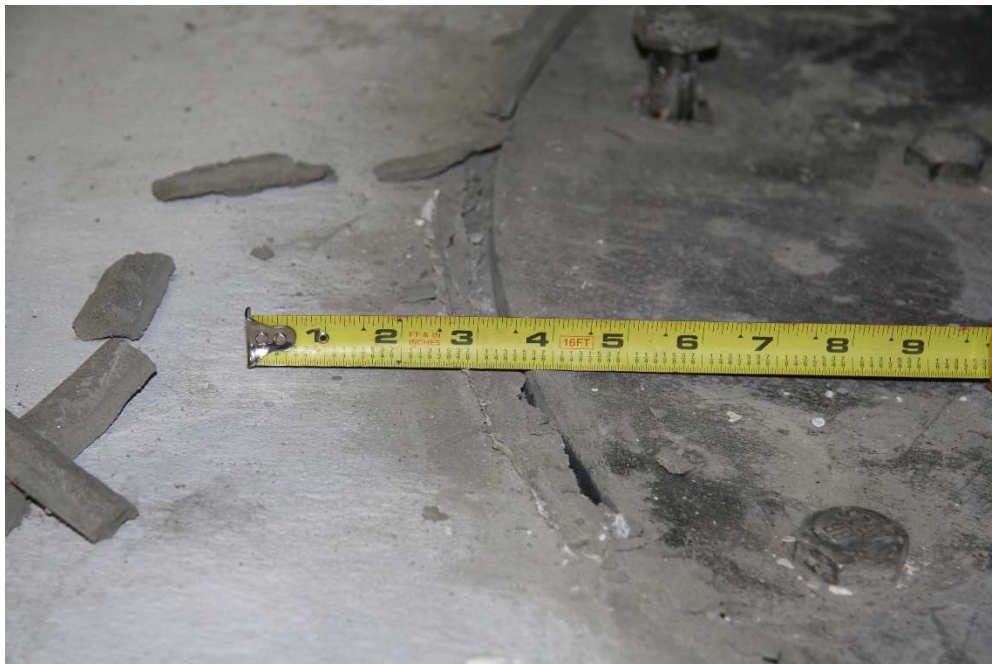
Figure 6.35. North Side of Ring Flange – After Test (PTB_9_2_0_P)

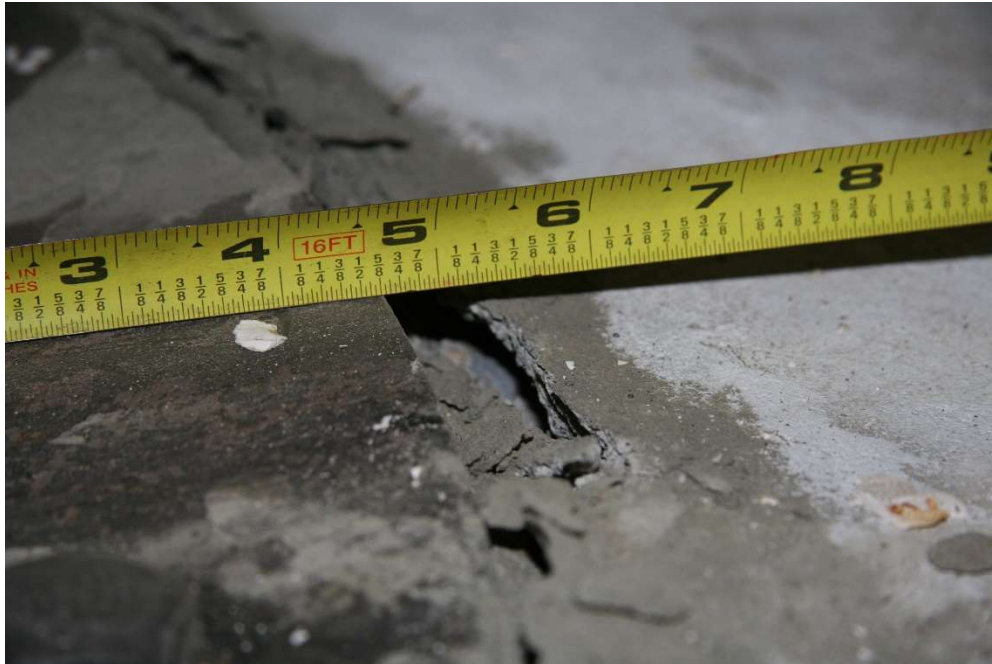
Figure 6.36. Southwest Side of Ring Flange – After Test (PTB_9_2_0_P)

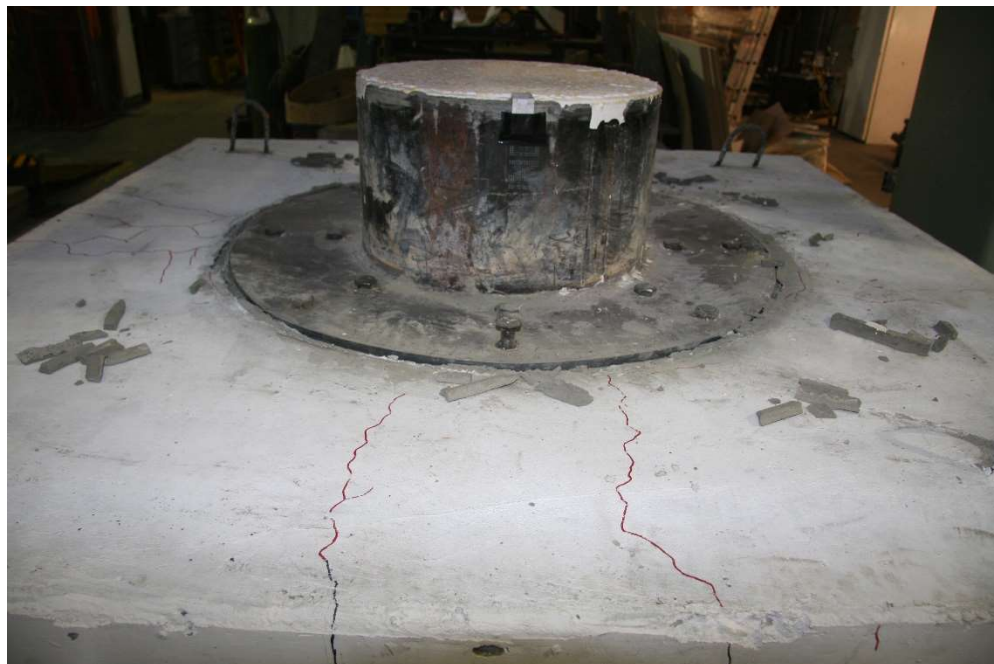
The load was then removed from the specimen to allow for easier inspection of the specimen. During inspection of the top surface of the specimen, some small cracks were found extending in the cardinal directions of the ring flange to the closest edge of the specimen. These cracks mostly aligned with the flexural reinforcement within the column region and are highlighted for the north side of the specimen in Figure 6.37. Vertical cracks were formed on the side edges of the specimens and are shown in Figure 6.38. The east edge of the slab had a small horizontal crack highlighted in Figure 6.39. Additionally there was warping of the top ring flange. The regions of the ring that were confined by the post-tensioned bolts moved to nearly level with the top surface of the slab when the column was pressed into the slab. The regions in between the bolts began to lift and the effect can be seen in Figure 6.39. The prying effect of the ring resulted in high stress on the post-tensioned bolt that caused it to fracture. The ring itself is not strong in resisting the bending due to this prying effect. The best way to increase the bending strength would be to increase the thickness of the ring.

Figure 6.37. Cracking North Side of Top Face – Load Removed (PTB_9_2_0_P)

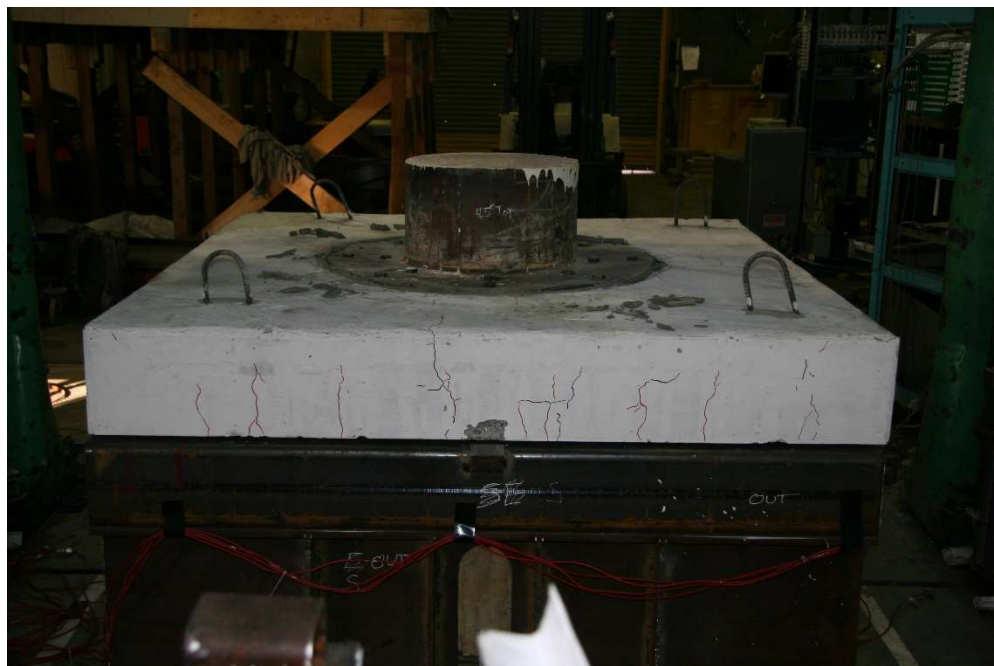
Figure 6.38. Cracking South Face – Load Removed (PTB_9_2_0_P)

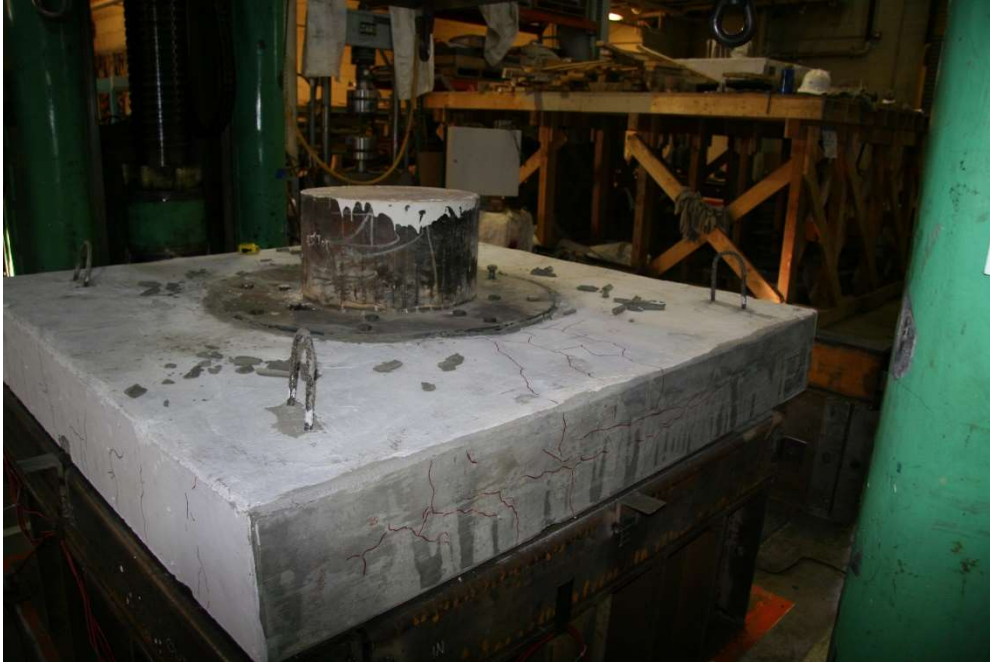
Figure 6.39. Cracking East Face – Load Removed (PTB_9_2_0_P)

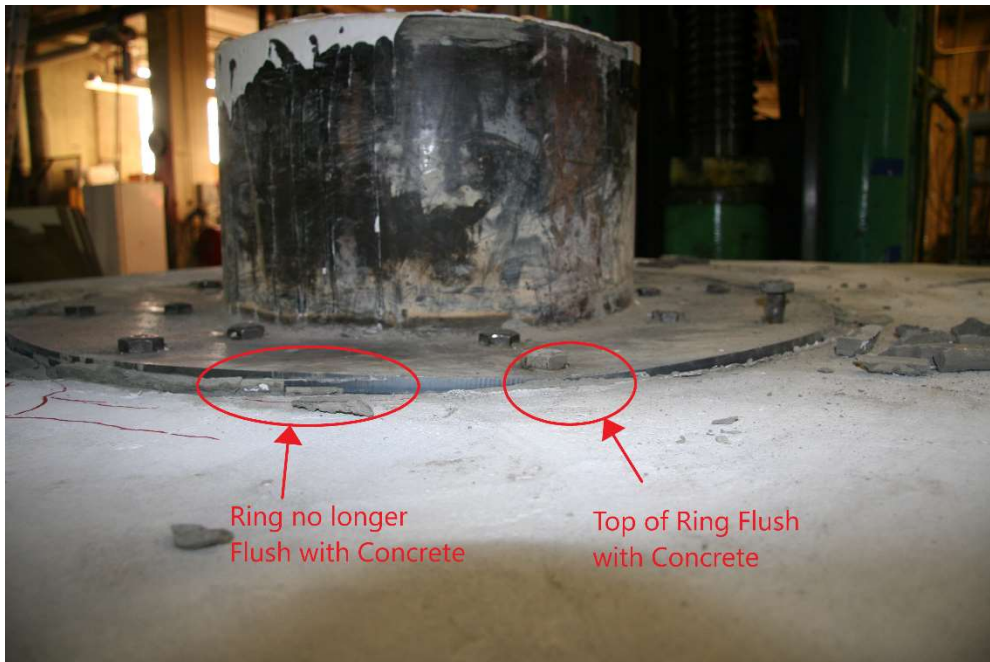
Figure 6.40. Warping of Top Ring Flange – Load Removed (PTB_9_2_0_P)
