Developing the Historical Context for Understanding Present Day Land Use-Water Quality Relationships

Julia Michalak

University of Washington

Critical Areas Ordinance Monitoring Study

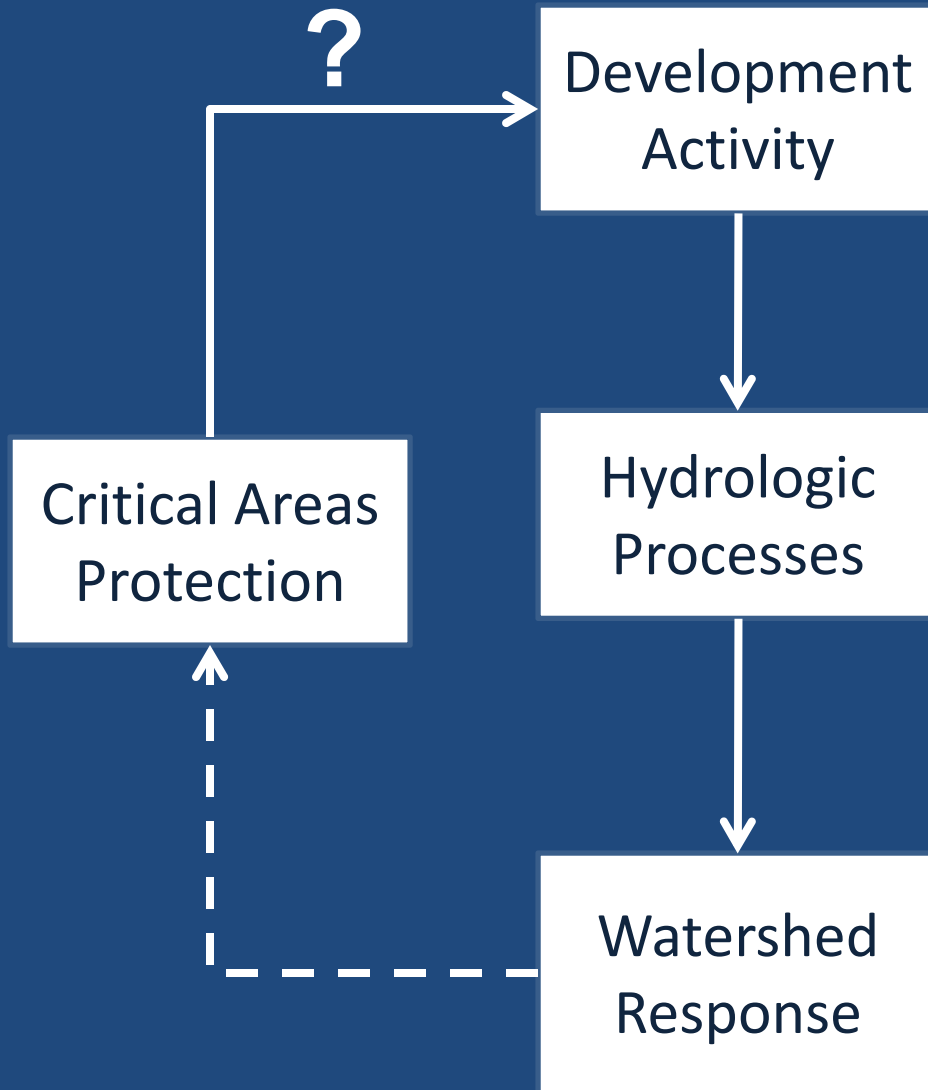
Watershed Response

Land-Cover Change:

- Impervious
- Vegetation Change
- Type of Land Use
- Location of Change

Hydrologic Processes:

- Flow
- Water quality

Watershed Response:

- Benthic Macroinvertebrates
- Physical Habitat Characteristics

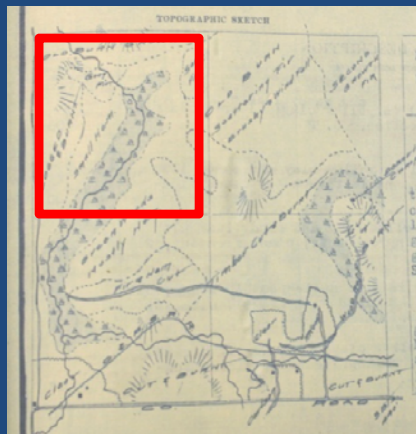
TN22 RN06 Sec 2 - Taylor

Maps:
1 Mile x 1 Mile

SW $\frac{1}{4}$ SW $\frac{1}{4}$ owner, Howard, of Seattle,
leased by Ed Hudson; house 1
story white 18 x 24 (old)
Barn 24 x 40
Orchard of 25 poor trees;

Notes: "SW $\frac{1}{4}$ SW $\frac{1}{4}$
Howard of Seattle... House
1 story white 18x24 (old) ...
Orchard of 25 poor trees"

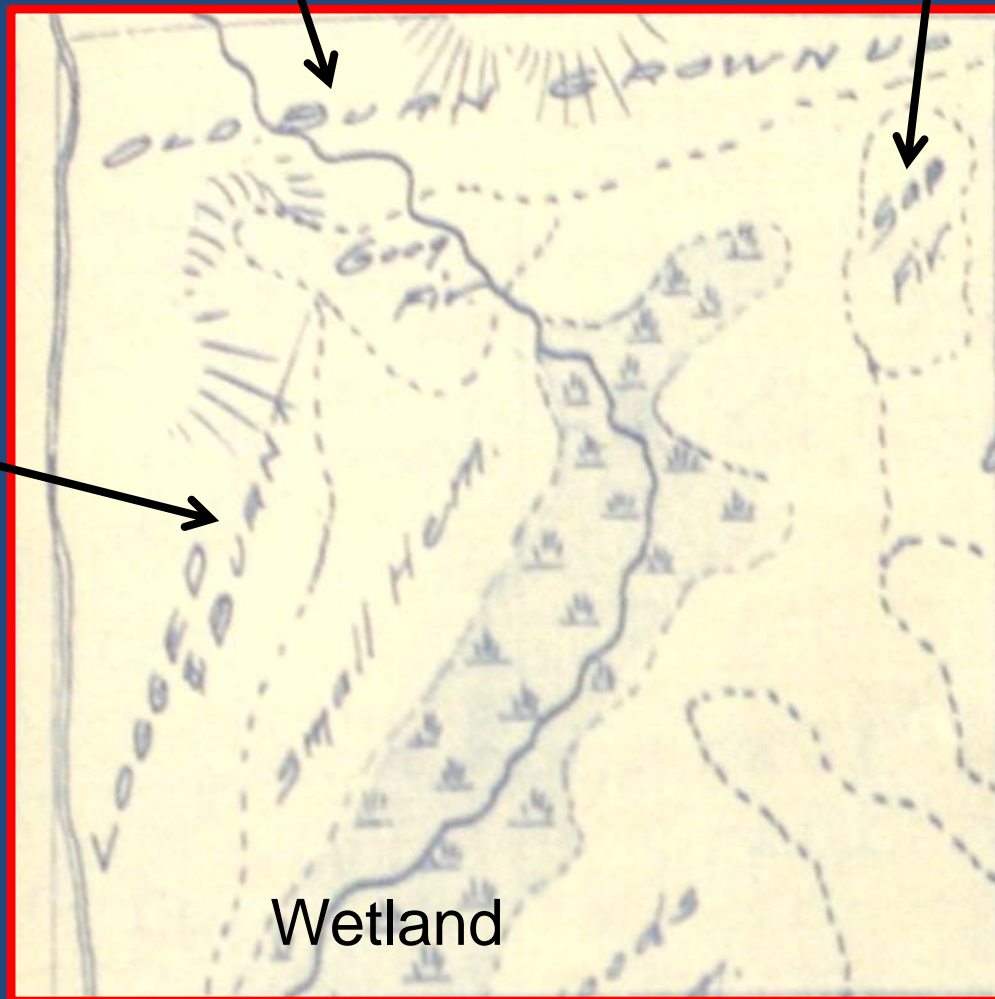
"Logged & Burnt"

"Old Burn Grown Up"

"Sap. Fir"

Wetland

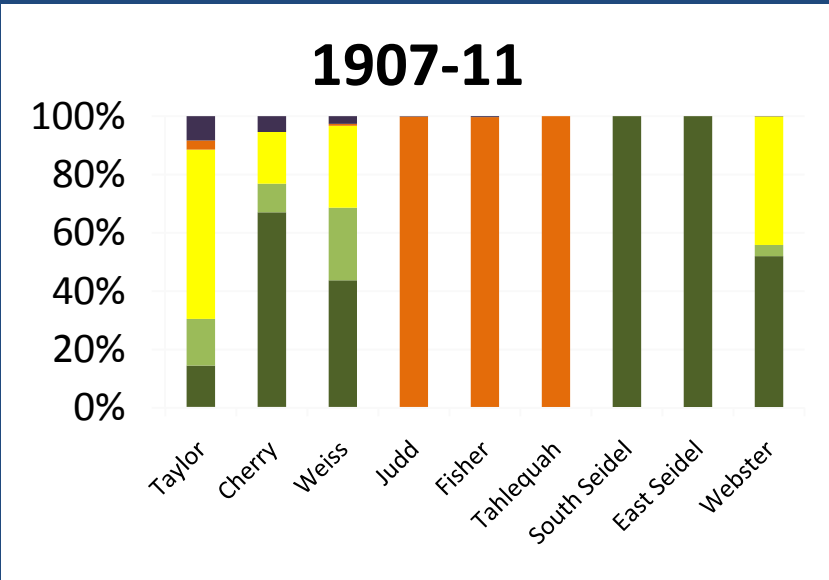
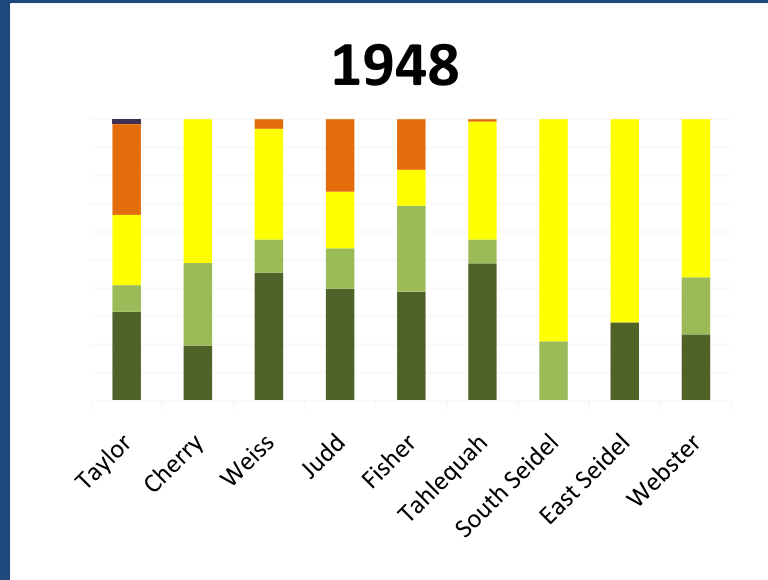
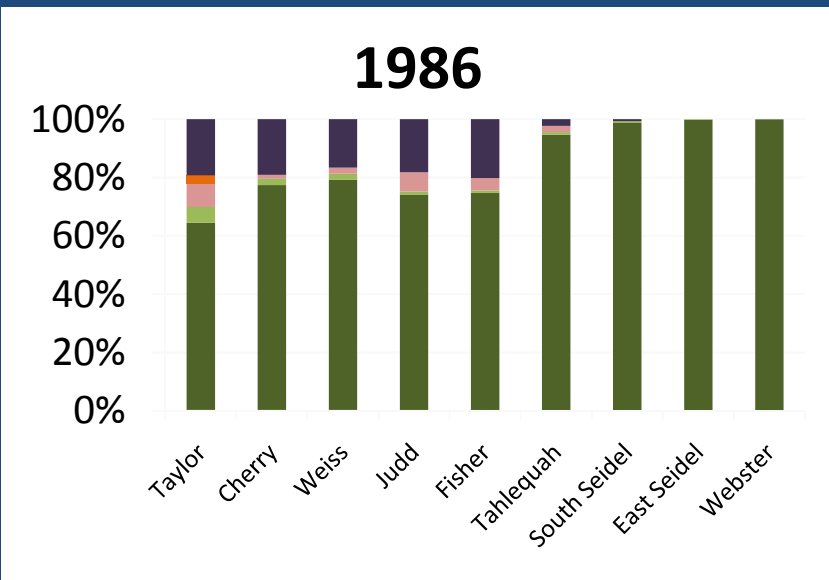
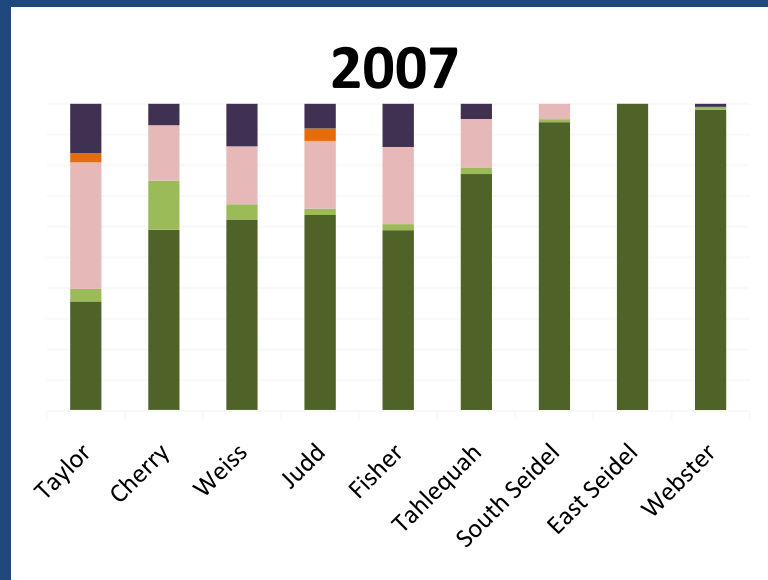
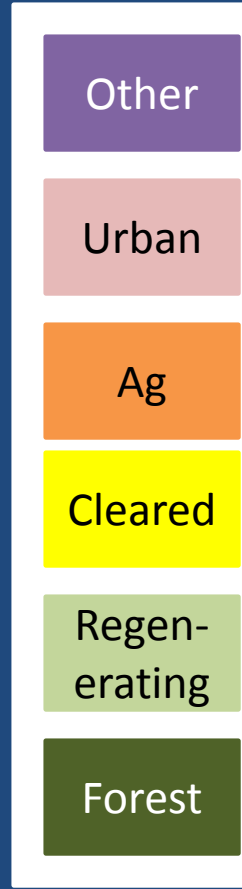
Land Cover Composition

Eastern

Vashon

Control

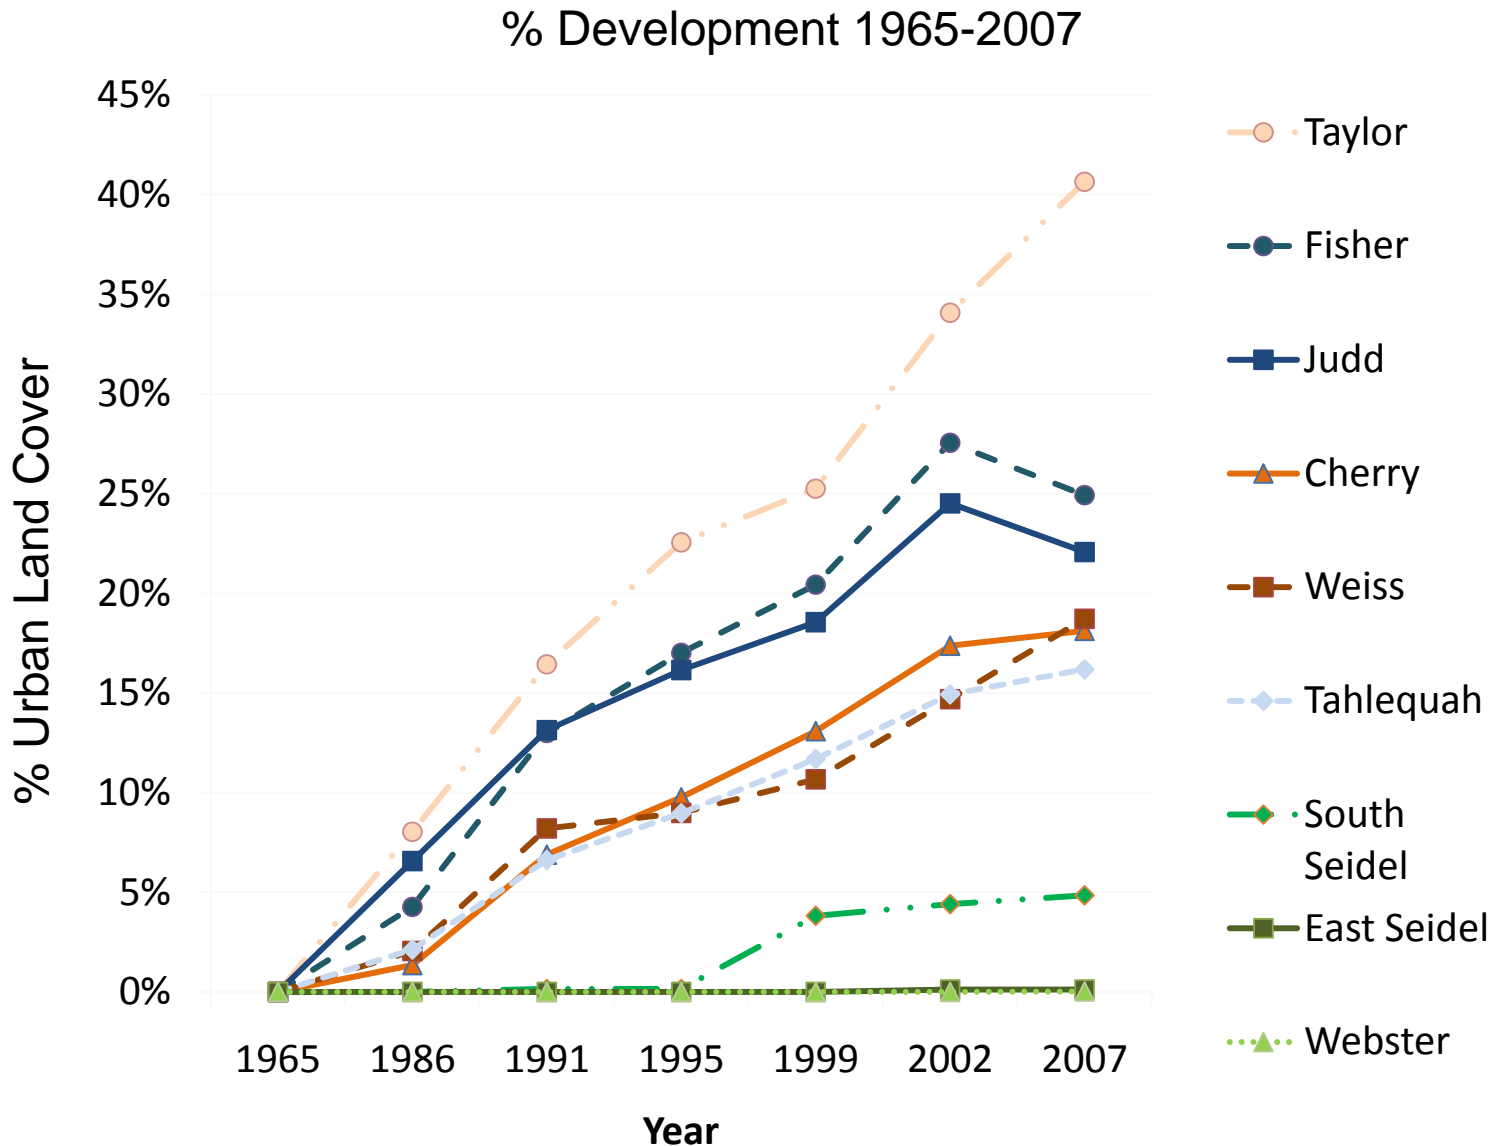
Recent Development History

**BIBI
Score:**

Data Source: UERL Land Cover

- Do the watersheds share a common history?
 - Yes, but...
 - What is the relative importance of the type, extent, duration, and time since impact?
- What are the implications of historic impacts for present day watershed condition?
 - Historic and present day landcover are not independent
 - Altered forest stand conditions
 - Woody Debris, Stream Bed Heterogeneity, and BIBI
- Can watersheds recover from significant land-cover impacts?
 - All have good to excellent BIBI scores
