Experimental Study on Steel-Concrete Composite NPS System Beam Column Joints Under Reversed
Cyclic Earthquake Loading

Master of Science in Civil Engineering

University of Washington

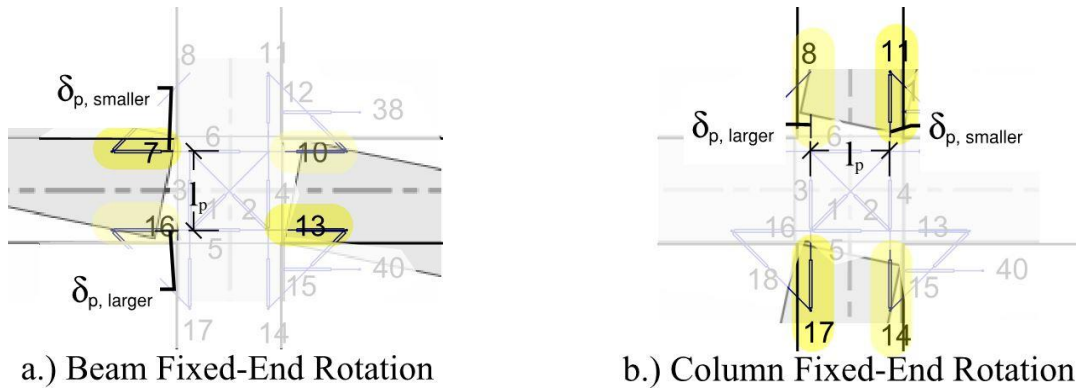
Figure 4.6: Fixed End Rotation

> The fixed-end rotation of both the columns and the beams was taken from potentiometers which spanned the interface between the joint and the member as can be seen in Figure 4.6.

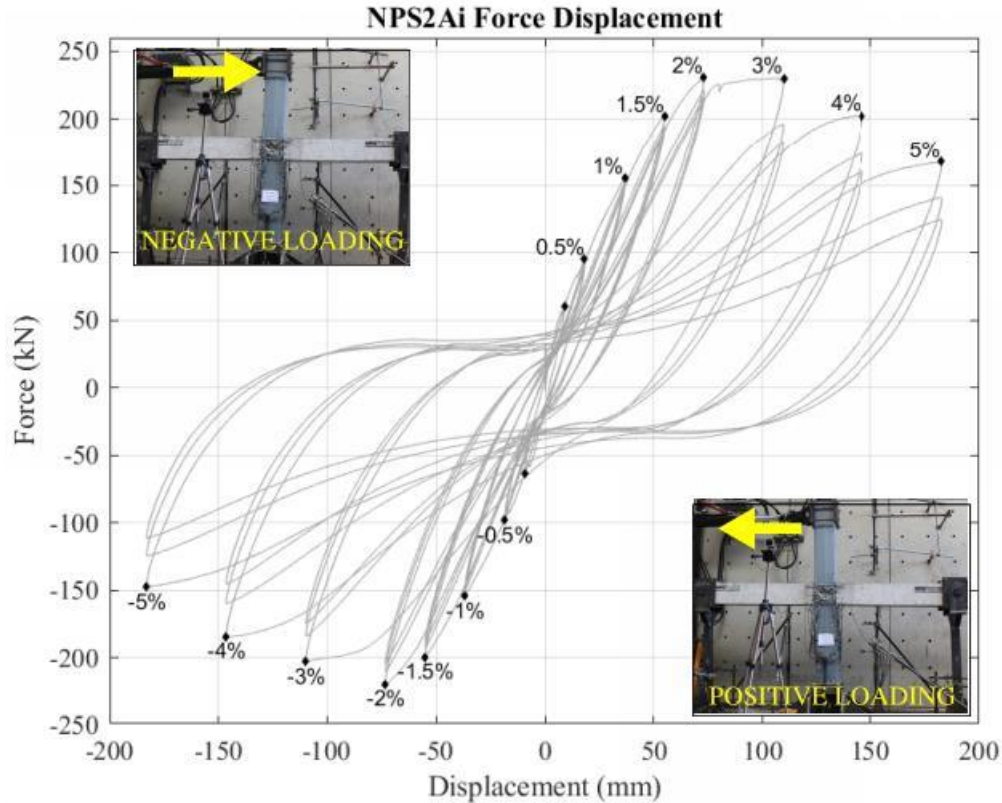
Figure 5.11: Force-Displacement Response of Specimen NPS2Ai

> The specimen was subject to the full loading protocol described in CHAPTER 3 , including three full cycles at peak drift ratio of 5%. The horizontal force-displacement response is outlined in Figure 5.11. NPS2Ai reached a positive peak strength of 231 kN and a negative peak strength of 220 kN. Both occurred during the first loading cycle to 2.0% drift ratio, in the pertinent loading direction. The hysteretic response of NPS2Ai qualitatively resembles that of the specimen REFi and, more generally, the response of a moderately ductile RC beam-column joint. It is evident that the specimen possesses a good level of ductility, but is also characterized by pinching, likely due to a combination of bond-slip and joint deterioration.

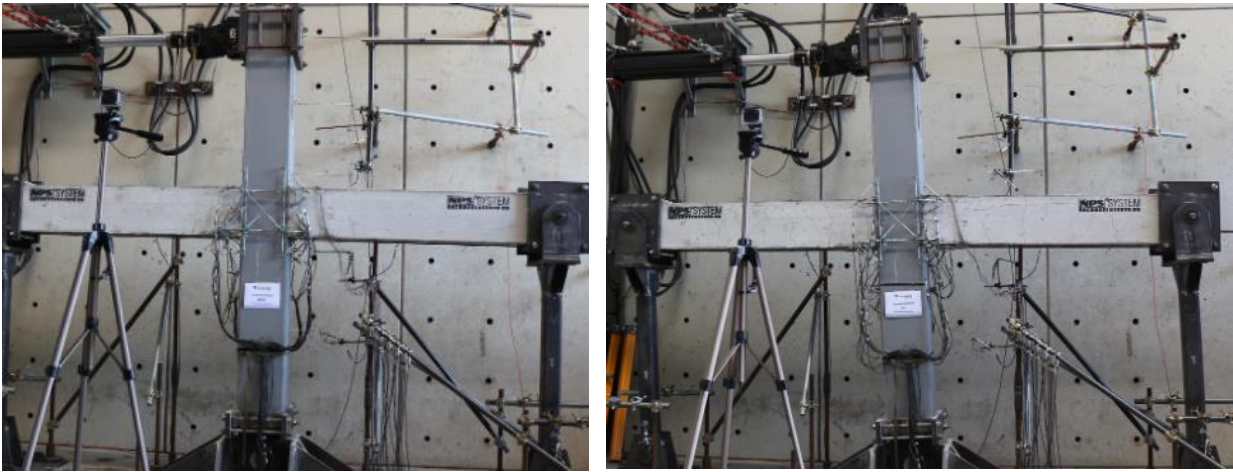
Figure 5.18: View of Specimen NPS4i Before (Left) and After (Right) Testing

> As previously discussed, this specimen was nearly the same as NPS2Ai, and the final specimen tested in the MDI Test Series, achieving moment continuity with straight deformed bars, without additional beam shear reinforcement in the critical region. The differences include (i) 150 mm shear stirrup spacing in the joint region instead of 100 mm and (ii) a steel encased joint region. A view of specimen NPS4i with the experimental setup is provided in Figure 5.18.

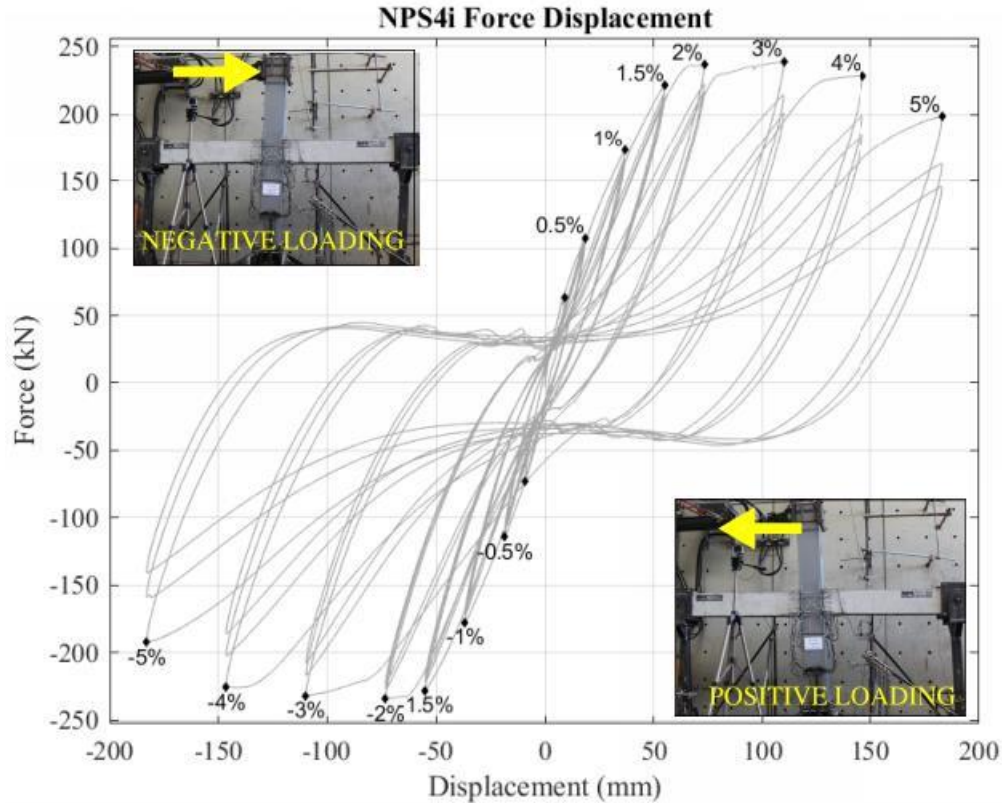
Figure 5.19: Force-Displacement Response of Specimen NPS4i

> The specimen was subject to the full loading protocol described in CHAPTER 3 , including three full cycles at peak drift ratio of 5%. The horizontal force-displacement response is outlined in Figure 5.19. NPS4i reached a positive peak strength of 239 kN during the first loading cycle to 3% drift ratio, and a negative peak strength of 234 kN at 2% drift ratio. The hysteretic response in Figure 5.19 is analogous to that of specimens NPS2Ai and NPS2Bi, but NPS4i suffered a lower extent of strength degradation as the displacement demand increased and had an overall more ductile response. However, marked pinching caused by bond-slip deterioration was still observed, beyond what might be considered acceptable levels. This is discussed in detail in CHAPTER 6

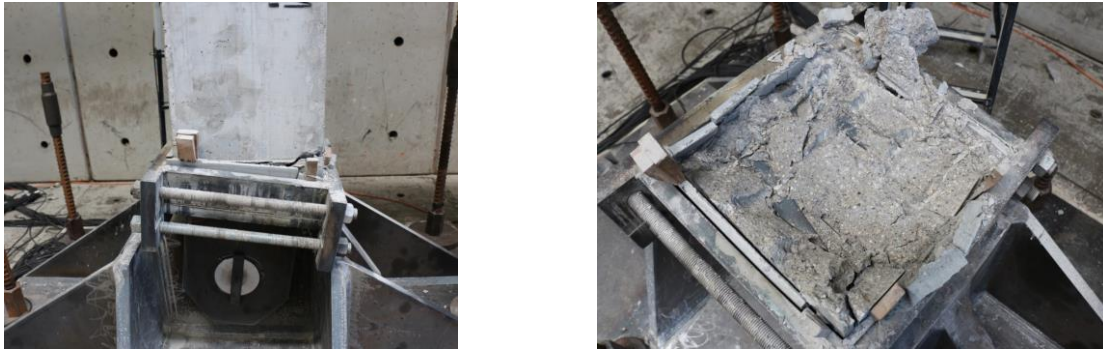
Figure 5.24: Base of the Column After Out-of-Plane Failure Occurred

> During the second cycle of the 3% loading the specimen broke at the base of the column, and testing could not be completed to the full loading protocol described in CHAPTER 3. The specimen suffered an unexpected failure at the base of the column (see Figure 5.24) due to undesired out-of-plane loads induced by the test setup.

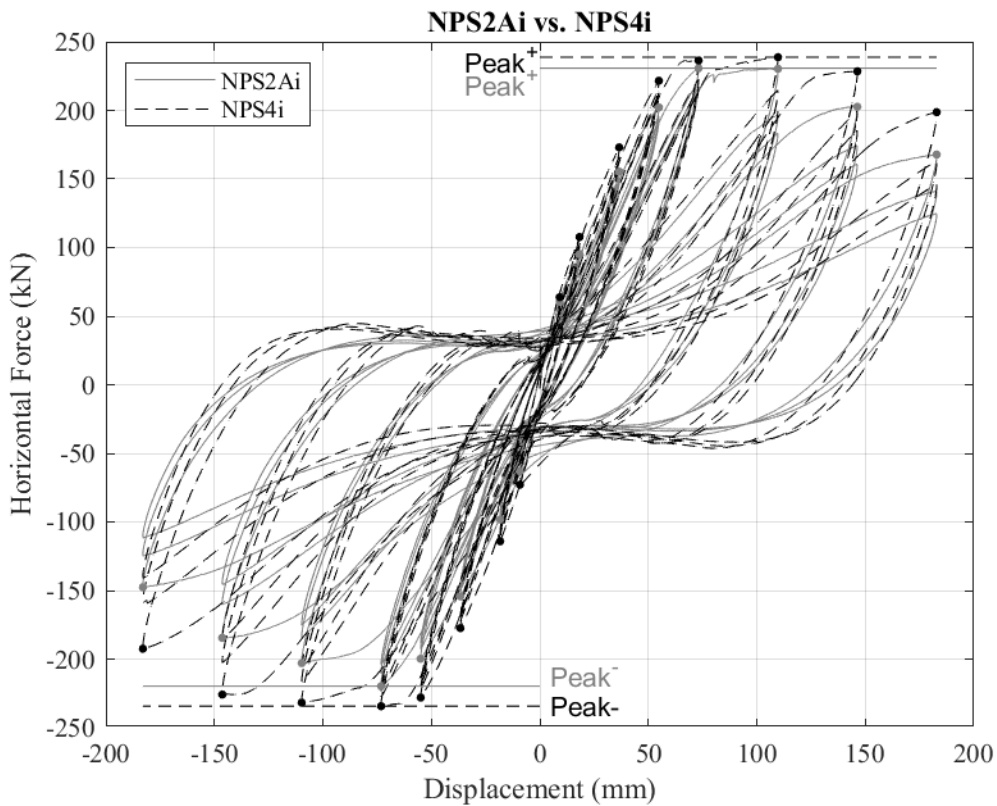
Figure 6.6: Force-Displacement Response of Specimens NPS2Ai and NPS4i

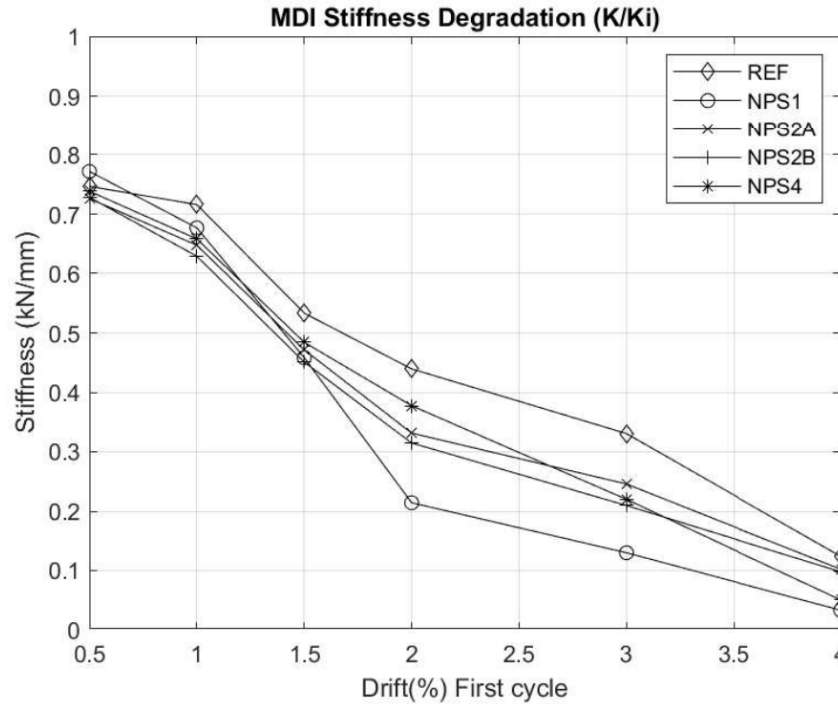
Figure 6.10: MDI Stiffness Degradation
