Development of a Lightning Strike Simulator with In-Situ Loading

A thesis

University of Washington

2025

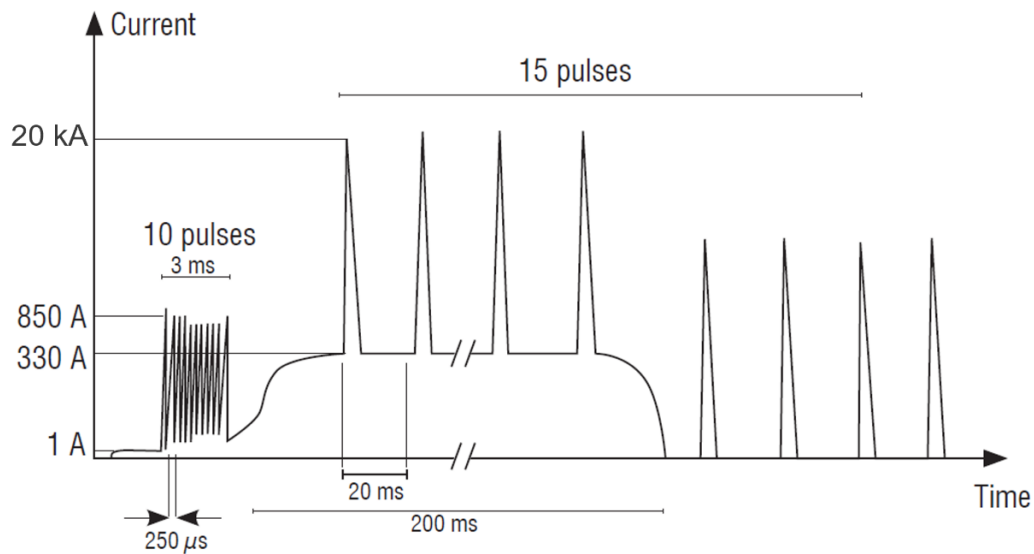
Figure 1.28. Typical Current Waveform observed during in-flight testing [36],[82]

generated by the negative leader. Subsequently, there is a continuous current with a magnitude of 330 A for about 200 milliseconds. The waveform ends with 15 pulses, which may occur either after or simultaneously with the continuous current, and it can have a peak magnitude of as high as 20 kA [36].

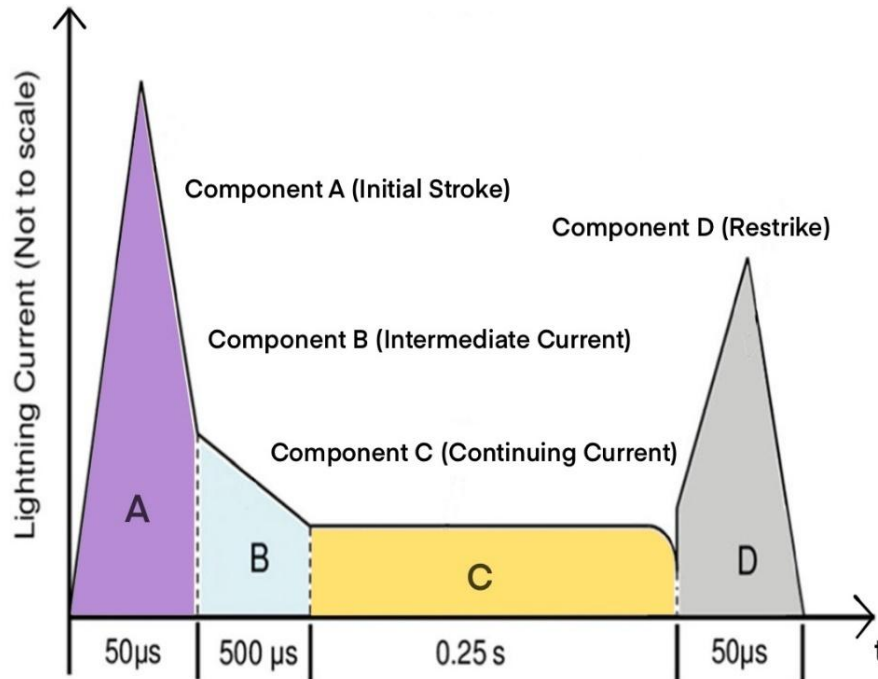
Figure 1.29. SAE ARP 5412 Standardized Current Waveform
(Readapted from [36],[82])

Figure 1.29 shows the idealized current waveform for evaluating direct effects comprising Components A, B, C, and D. Important parameters pertaining to these components are mentioned in Table 1-4. Component A encapsulates the severe parameters experienced during the first return stroke, negative subsequent strokes, and the positive return stroke, representing the pulse that an aircraft can experience when flying at lower altitudes. For testing component A waveform can be simulated as an oscillatory or unidirectional waveform. Component B is for the intermediate current that is observed after a negative return stroke. This waveform is crucial, as it has been observed to puncture thin wing skins, which are often used to cover fuel tanks. It should be plotted as a unidirectional waveform.

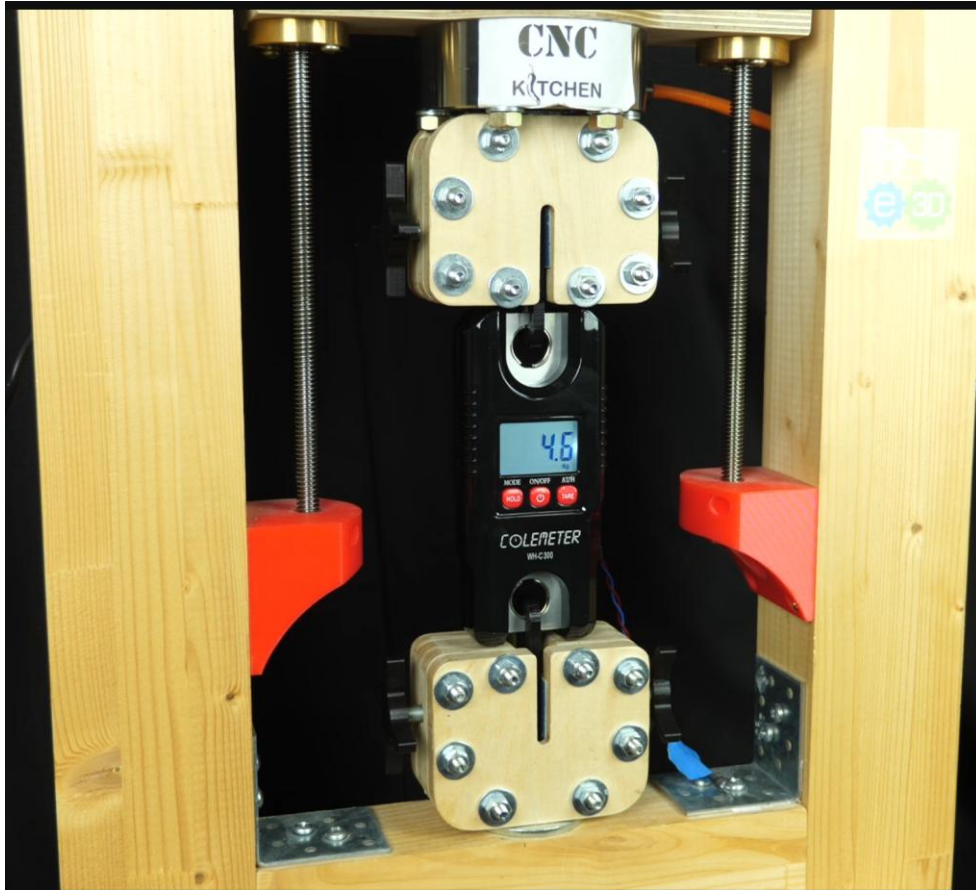
Figure 2.4. Open Source UTM by CNC Kitchen [121]

The description above essentially refers to a custom-designed universal testing machine. Further research led to the discovery of a fully open-sourced machine developed by Stefan Hermann [121], which is described here. The engineer developed a cost-effective alternative to commercial systems, capable of performing both tensile and compressive tests. This system is specifically designed to evaluate the mechanical properties of 3D-printed parts. However, it serves as a good starting point for further exploration of the idea of designing a UTM for this project. The machine is constructed from machined wood elements, 3D printed parts, screws, and linear rails. It features an integrated load cell to measure force and an optical extensometer. The system is driven by a stepper motor that can apply controlled loading to a sample with interchangeable grips, making it suitable for various sample geometries. When comparing this system to previous proposals, it offers the ability to measure force, automated operation, programmability, versatility in application, and customization options. However, the increased complexity and build time required for developing this machine may not fit within the project timeline.

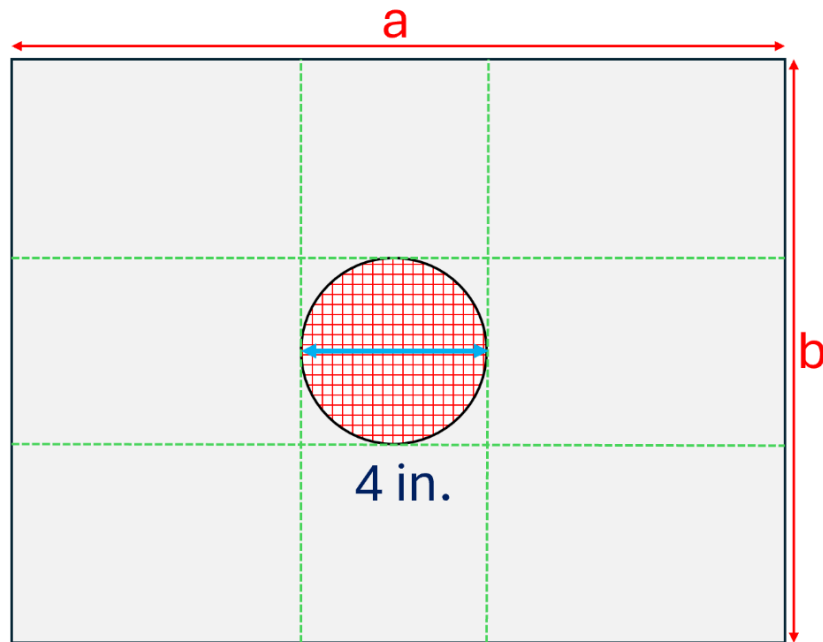
Figure 2.6. Initial Constraint

The initial constraints were to design a sample with a dedicated zone in the center that is 4 inches in diameter to account for damage due to lightning, assuming a sample with an ultimate strength of 2000 MPa.

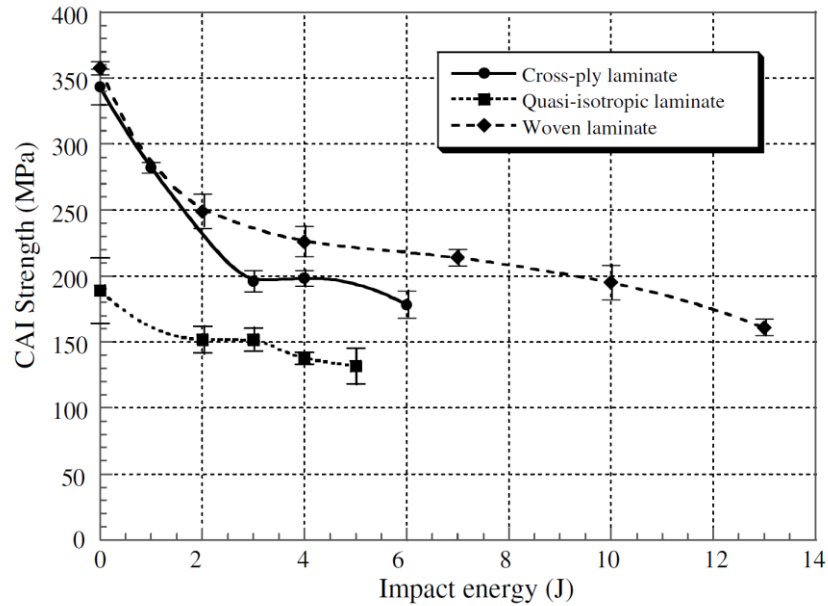
Figure 2.15. CAI Strength v/s Impact Energy [127]

The specimens measured 78 mm x 78 mm with thicknesses of 2.2 mm or 1.6 mm. Following impact tests conducted using a drop tower, the samples were placed into custom-designed compression fixtures after impact. Although the samples sustained damage, they were still able to reach high levels of force, as calculated and shown in Table 2-8.

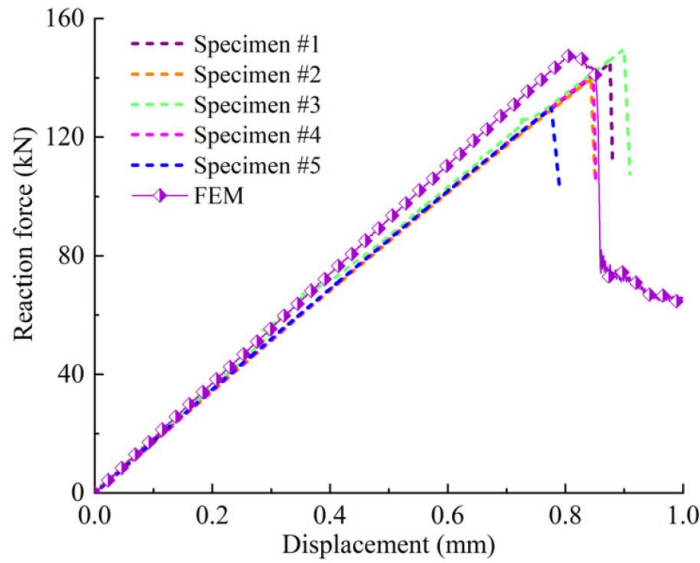
Figure 2.16. Reaction Forces and CAI Strength [128]

Figure 2.16 shows the compression after impact tests on samples measuring 150 mm x 100 mm and 4.48 mm thick. Like in the previous case, the samples can reach high enough force values.

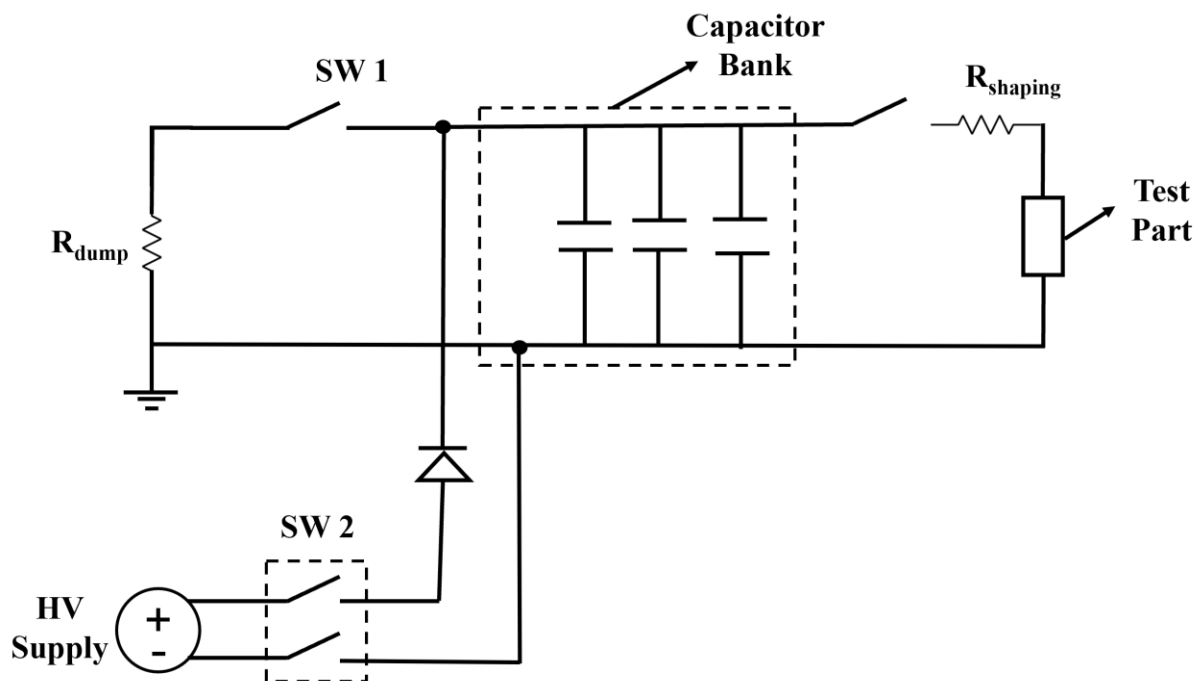
Figure 2.42. Circuit Diagram (Original Design by Dejan Nikic)

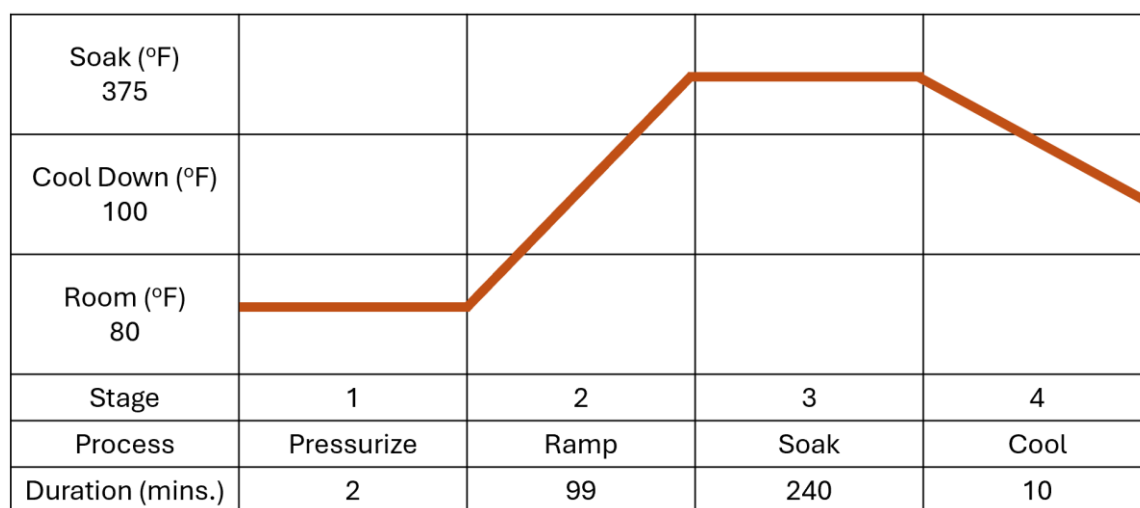
Figure 3.1. Platen Press Curing Cycle

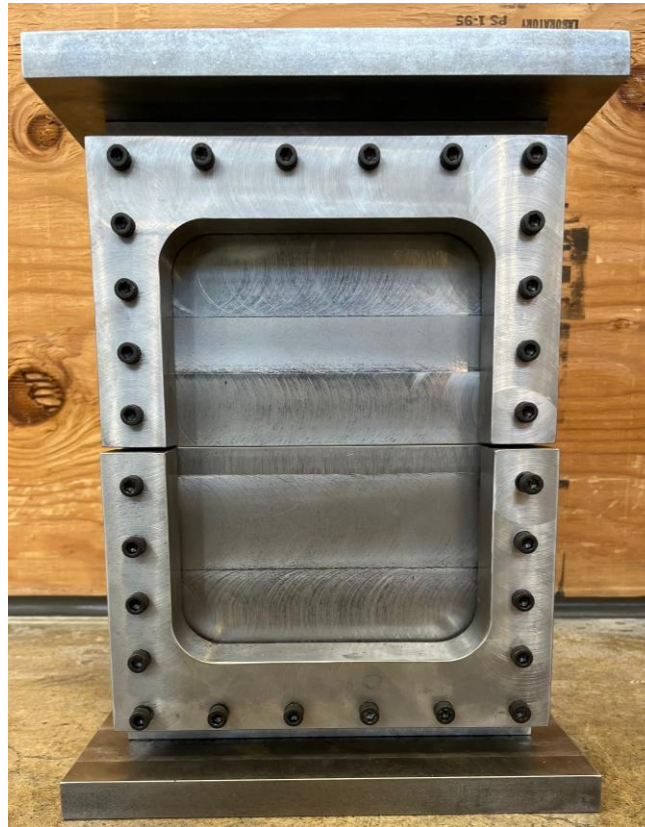
Figure 3.8. Fabricated Fixture

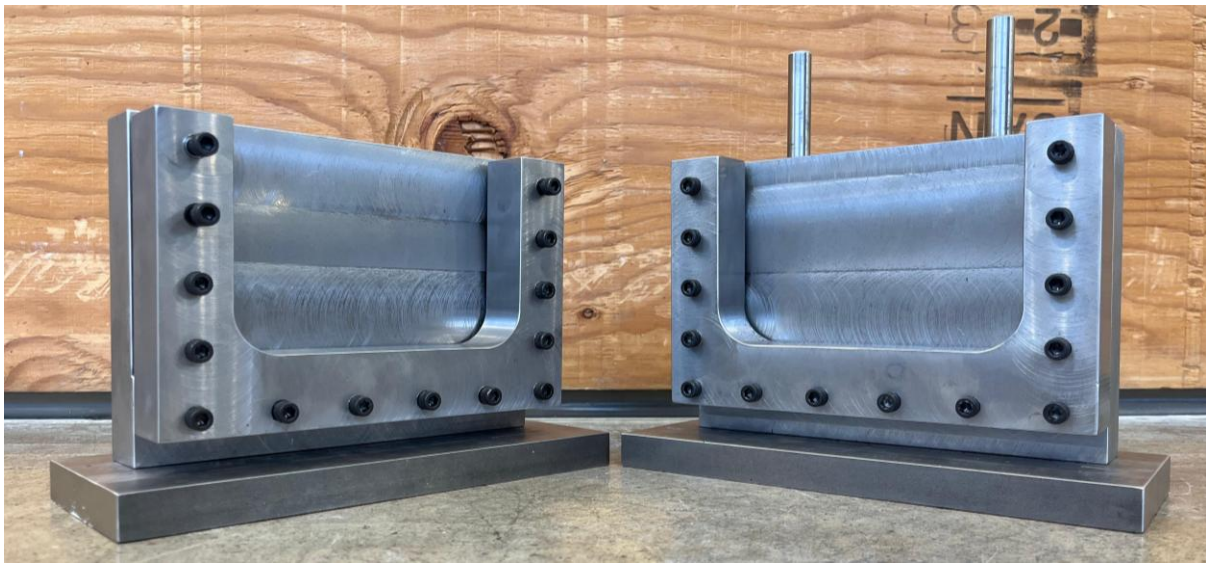
Figure 3.9. Fabricated Fixture: Top and Bottom Halves

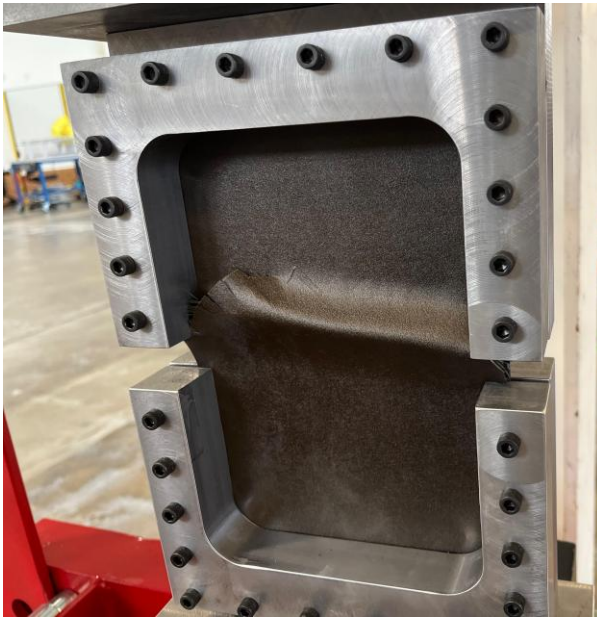
Figure 3.20. Damage Characteristics of Sample 1
