Experimental Investigation of Chevron Special Concentrically Braced Frames with
a Yielding Beam Plastic Mechanism

Master of Science in Civil Engineering

University of Washington
2018

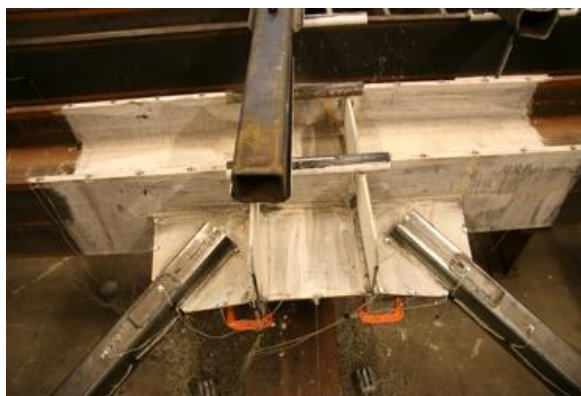
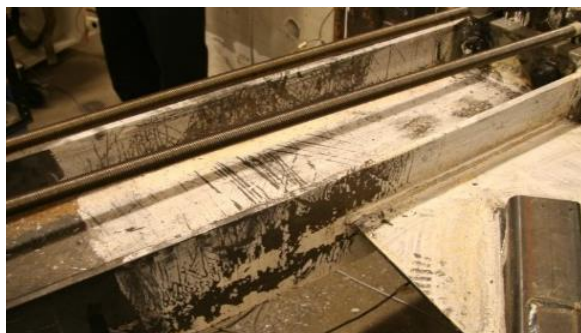
Figure 2.8 Frame damage at 2.5% story drift

Yielding Hierarchy		Drift (%)
1	Brace	0.28%
2	Gusset Plate	0.55%
3	Shear Tab	1.10%
4	Columns	1.38%
Failure mode	Brace Fracture	
Drift Range	6.3%	
Max. beam deflection	1.1 in

(a) Chevron 1 beam

(b) Chevron 1 north column

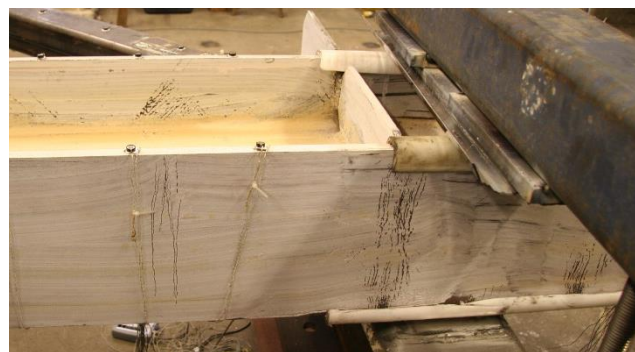
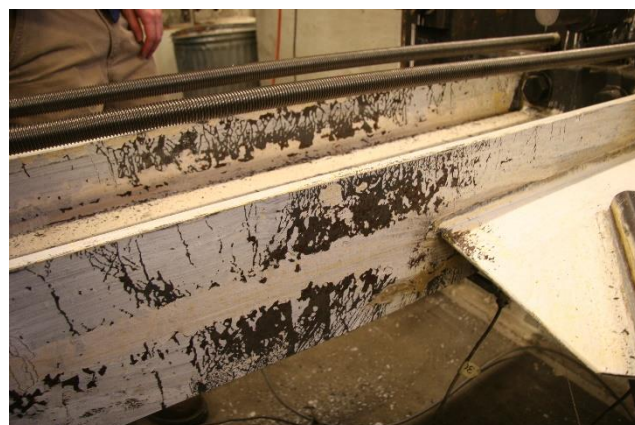
Figure 2.10 Frame damage at 2.5% story drift

Yielding Hierarchy		Drift (%)
1	Brace	0.28%
2	Gusset Plate	0.41%
3	Shear Tab	0.41%
4	Beam	1.38%
5	Columns	1.38%
Failure mode		Brace Fracture
Drift Range		6.3%
Max. beam deflection		1.8 in

(a) Chevron 2 beam yielding

(b) Chevron 2 north column yielding

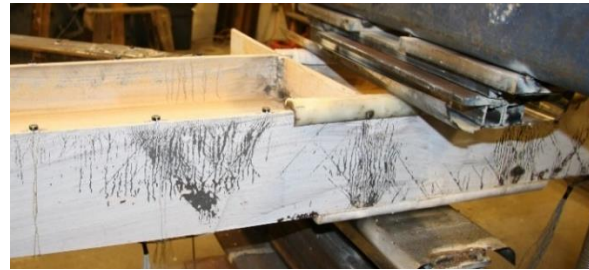
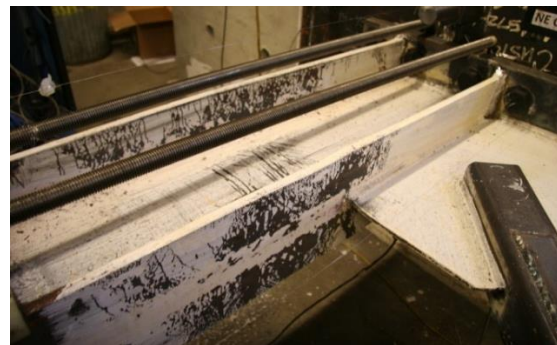
Figure 2.12 Frame damage at 2.5% story drift

Yielding Hierarchy	Drift (%)
1 Brace	0.28%
2 Gusset Plate	0.34%
3 Shear Tab	0.41%
4 Beam	0.41%
5 Columns	1.38%
Failure mode	Brace Fracture
Drift Range	7.2%
Max. beam deflection	3.0 in

(a) Chevron 3 beam yielding

(b) Chevron 3 north column yielding

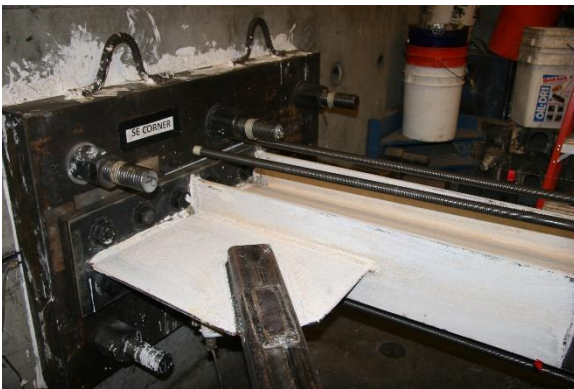
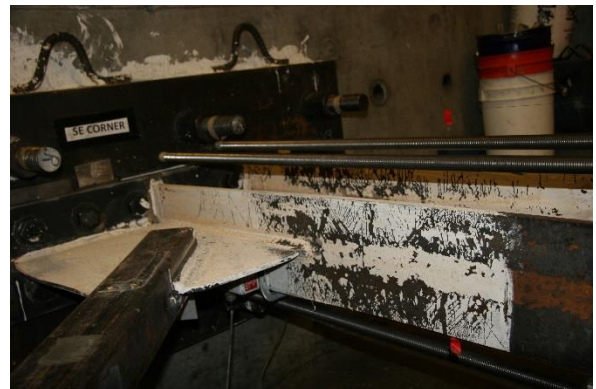
Figure 3.15 Example of whitewash on specimen

Regions of expected yielding were painted with a thin layer of whitewash, a lime and water mixture. When hot-rolled steel yields, mill scale on the surface of the member flakes off. The whitewash layer flakes off with the mill scale, permitting observation of initial and progression of yielding as shown in Figure 3.15.

a. Specimen before yielding

b. Yielded specimen

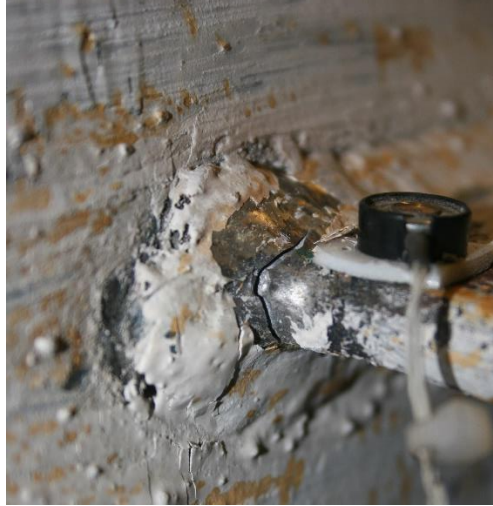
Weld damage occurred due to large OOP rotation of the gusset plate connections. The weld performance states shown in Table 4.6 are distinguished by the percentage of the weld length that has torn. At the midbeam gusset plate, the beam to gusset weld length was defined from the edge of the stiffener to the edge of the gusset plate. The weld performance states reflect fracture mechanics concepts of crack initiation (WT1), stable crack growth (WT2), and unstable crack growth (WT3). As described in Table 4.6 each of the performance states was differentiated by the crack length that defines each performance state. A clear example of the observed weld damage is shown in Figure 4.6.

Figure 4.6 Weld crack in gusset plate-to-beam interface weld

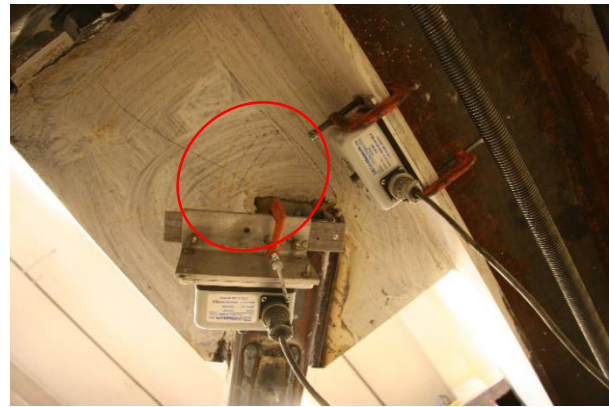
Figure 4.11 NE gusset @ -0.28% drift

- The corner gusset plates began to yield (Y1) at $\pm 0.208\%$ drift (Figure 4.10 and Figure 4.11).
- The North brace began to buckle (B1) on the first cycle of 0.28% drift.
- The South brace began to buckle (B1) on the first cycle of -0.28% drift.
- The mid-span gusset and shear plates began to yield (Y1) at $\pm 0.28\%$ drift.
- The mid-span gusset plate experience moderate yielding (Y2) at $\pm 0.70\%$ drift
- The beam began to yield (Y1) at the outer and inner flange near the stiffeners at $\pm 0.70\%$ drift (Figure 4.13).
- At $\pm 0.7\%$ story drift, the braces buckled out of plane more than twice the depth of the brace (B2)

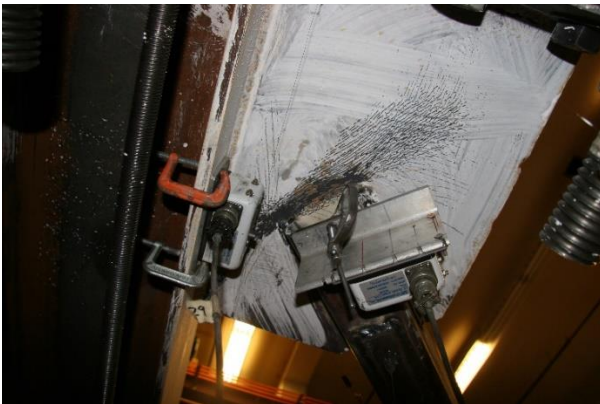
Figure 4.14 SE corner gusset @ +1.1%

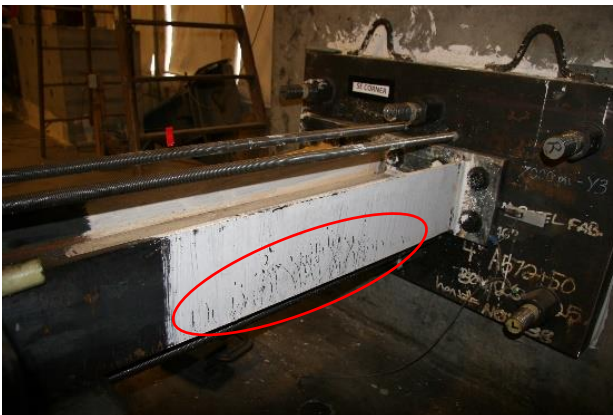
Figure 4.16 S column yielding @ -1.4% drift

- At $\pm 1.1\%$ story drift, the inside beam flange began to yield (Y1) (Figure 4.15).
- At $\pm 1.1\%$ story drift the columns began to yield (Y1)
- At -1.4% story drift, tearing initiated at the toes of the south brace-to-mid-span gusset plate welds (WT1) (Figure 4.17)
- At $\pm 1.4\%$ story drift the corner gusset plates experienced moderate yielding (Y2)
- At -1.7% story drift, beam began to twist out of plane slightly at midspan
- At $\pm 1.7\%$ story drift the beam experienced moderate yielding (Y2) in the plastic hinge region (Figure 4.19)
- At $+1.7\%$ story drift, crack initiated at the NE corner gusset weld (WT1)
- At $\pm 1.9\%$ story drift moderate buckling of corner gusset plate was observed (Figure 4.21)

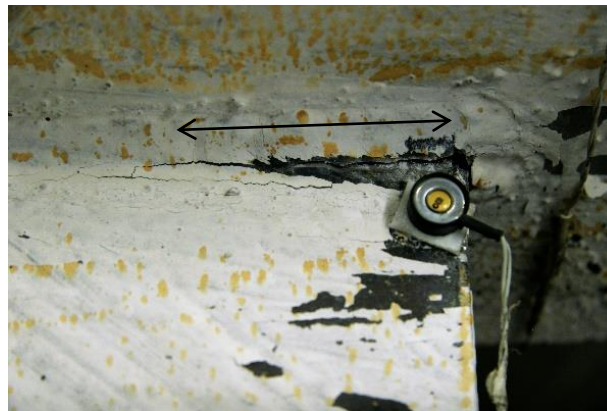
Figure 4.17 N mid gusset @ -1.4% drift

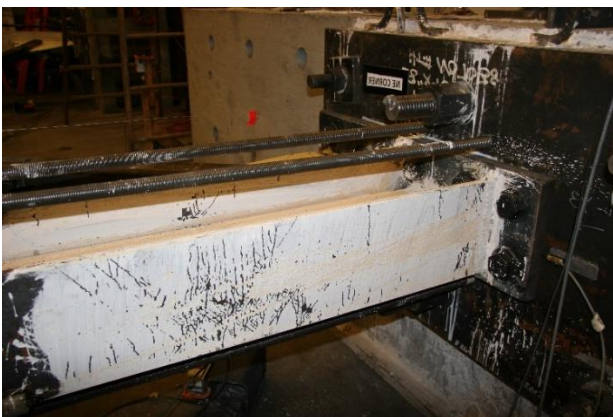
Figure 4.18 N Column @ -1.7%

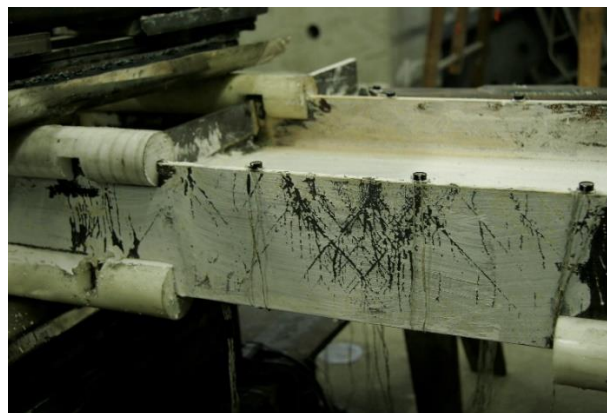
Figure 4.19 Beam yielding @ -1.7%

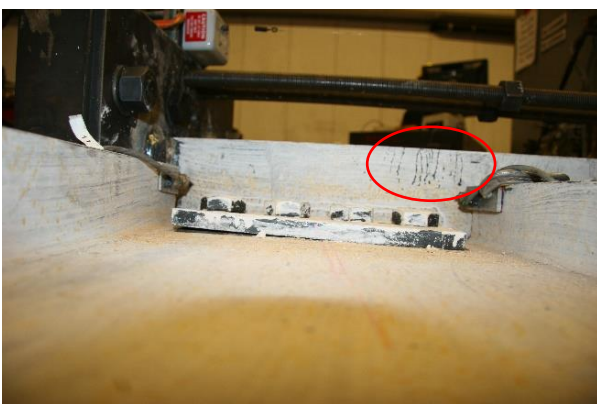
Figure 4.20 Beam end torsion @ -1.9% drift

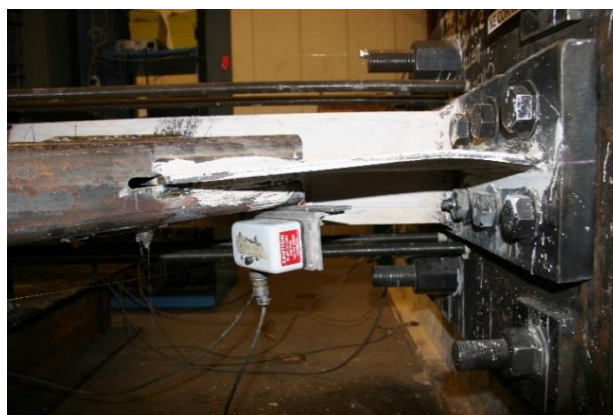
Figure 4.21 Buckling @ NE corner gusset @ +1.9%

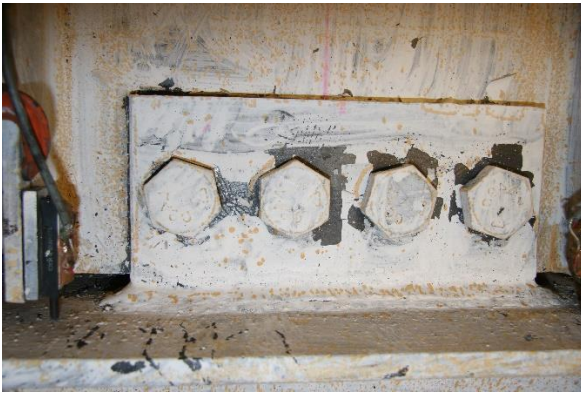
Figure 4.22 SW Shear plate @ +2.2%

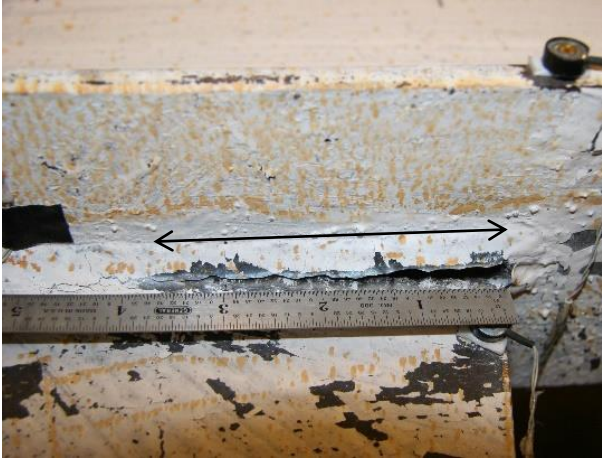
Figure 4.24 N mid gusset weld crack @ 2.8% drift

Drift (%)	N mid-span gusset-to-beam	S mid-span gusset-to-beam	NE gusset-to- column	SE gusset-to- column
1.7	1-1/8"	3/8"	1-1/8"	
1.9	2"	1-3/8"	2-5/8"	
2.2	2-5/8"	2-1/8"	3-3/4"	1-3/8"
2.5	3-1/8" (top)	2-7/8"	4-3/4" (top)	2-3/4" (top)
	2" (bot)		3.25" (bot)	1-1/2" (bot)
2.8	3-3/4"	3-1/2"	5-7/8"	4-1/4"
3.0	4-1/4"	3-5/8"	6-3/4"	4-5/8"
3.3	4-5/8"	4-5/8"	7-1/4"	6-1/2"
3.5		4-3/4"		7-1/4"
4.5	5-1/4" (top)	5" (top)	9-3/8" (top)	9-7/8" (top)
	4-1/2" (bot)	4-1/2" (bot)	9-1/2" (bot)	9-3/8" (bot)

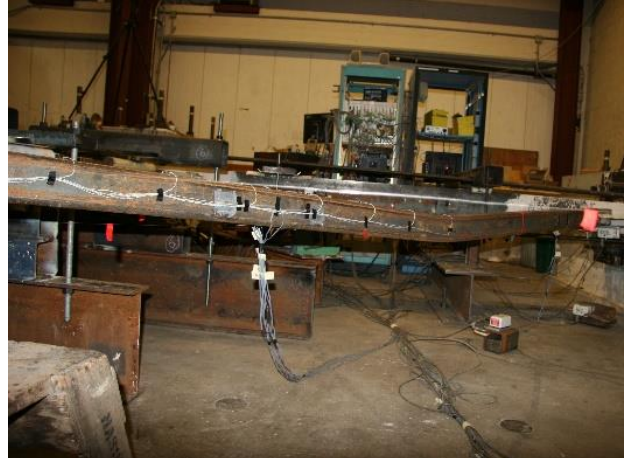
Figure 4.25 N Brace plastic deformation @ -2.8% drift

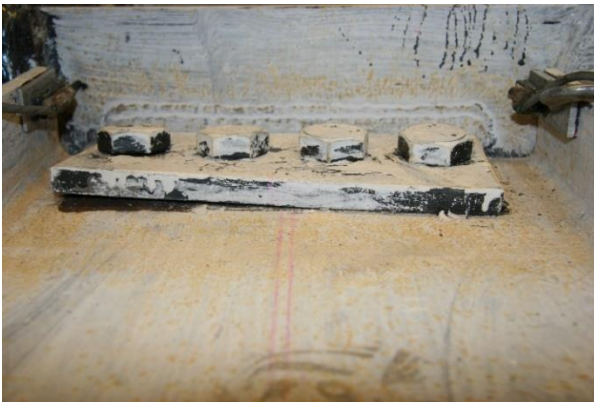
Figure 4.26 Beam end torsion @ 3.0% drift

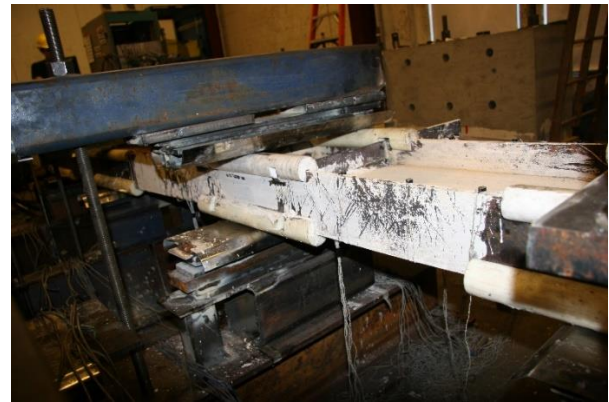
Figure 4.27 Beam yielding @ -3.0 % drift

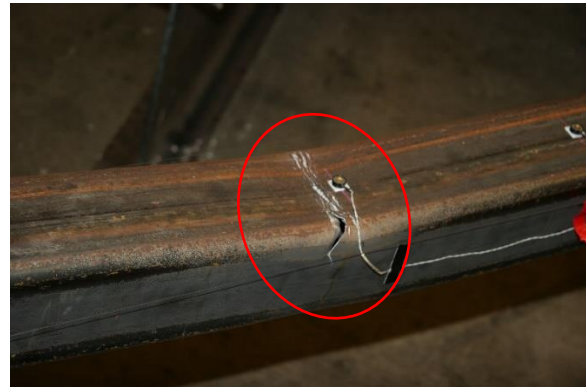
Figure 4.29 S brace @ 3.3% drift

- At $\pm 3.31\%$ drift, striation lines (B3-BT) appeared in the center of each brace
- At the second cycle of $+3.31\%$ drift S brace tore slightly (B3-BT) (Figure 4.29)

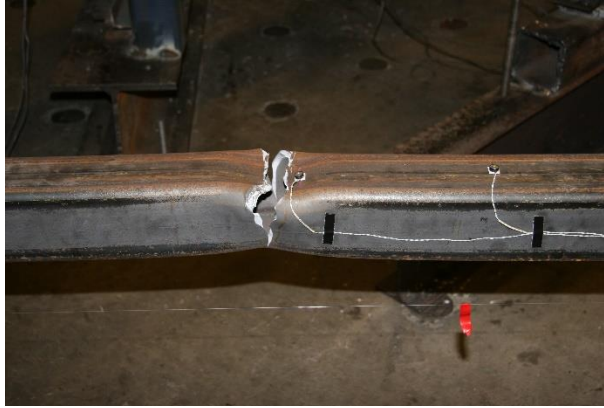
Figure 4.30 S Brace @ +3.6% drift

- At $+3.58\%$ story drift, the S brace tore $3/4$ through the cross-section (B3-BT), leaving only the bottom face of the brace intact (Figure 4.30)
- At the second cycle of -3.58% drift N brace didn't fracture so actuator was pushed to -4.4% drift to incite N brace tearing halfway through cross section (B3-BT)

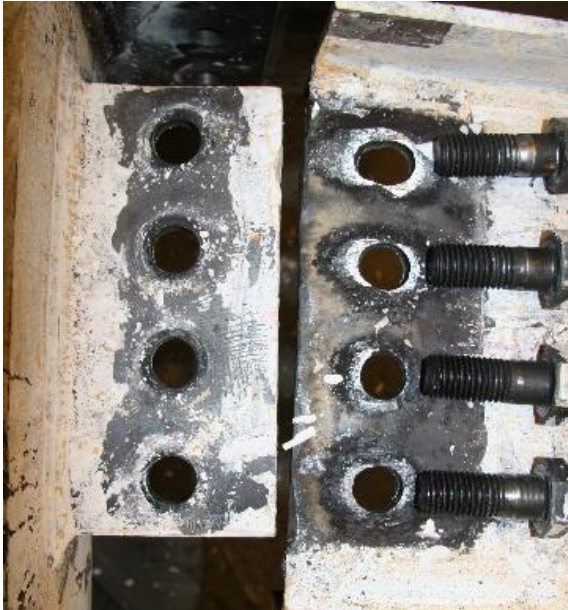
The frame was cycled to $\pm 5\%$ drift after both braces had fractured. The columns continued sustain yielding and local buckling, reaching the performance state of severe local buckling. After the test the frame was disassembled and it was noted that slight bolt-hole elongation had occurred in the top and bottom holes in the beam web, as shown in Figure 4.31 and Figure 4.32.

Figure 4.31 S Beam web bolt hole elongation

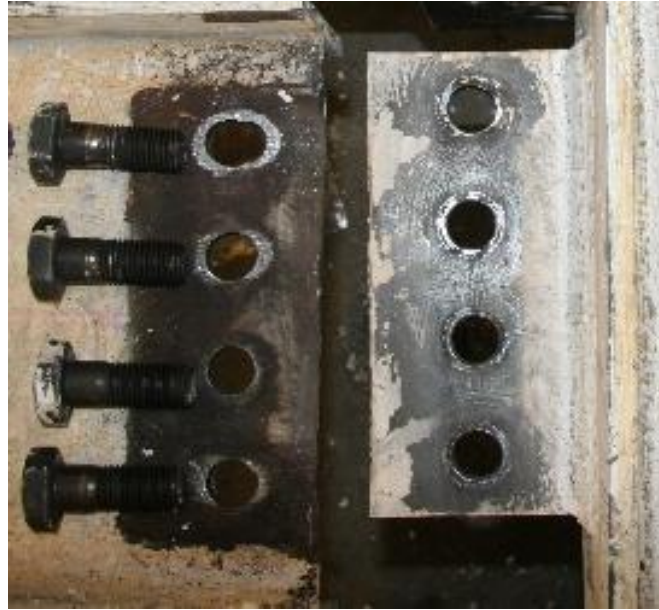
Figure 4.32 N Beam web bolt hole elongation

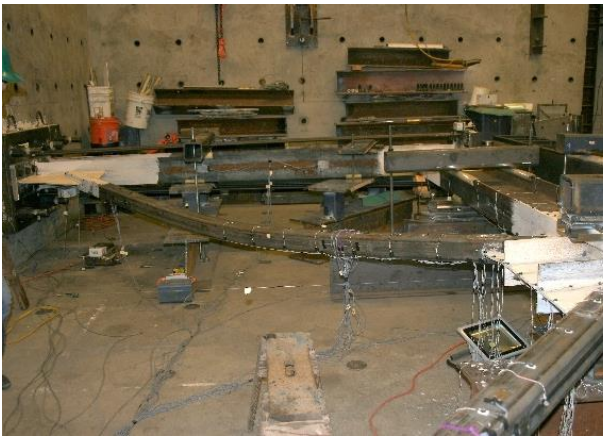
Figure 4.35 South Brace Buckling @ 0.7% drift

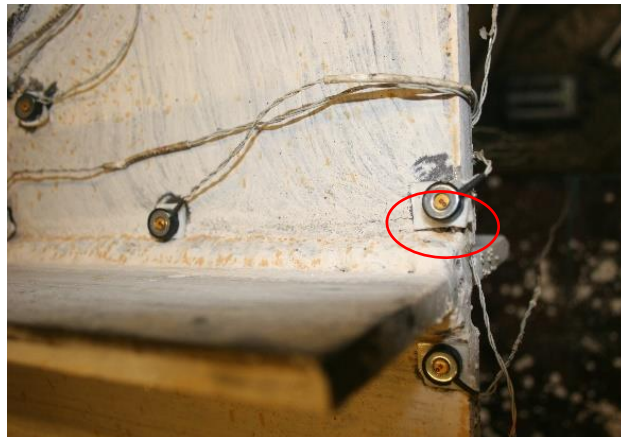
Figure 4.36 Beam Midspan Gusset Crack at Toe of Stiffener (N) 0.7%

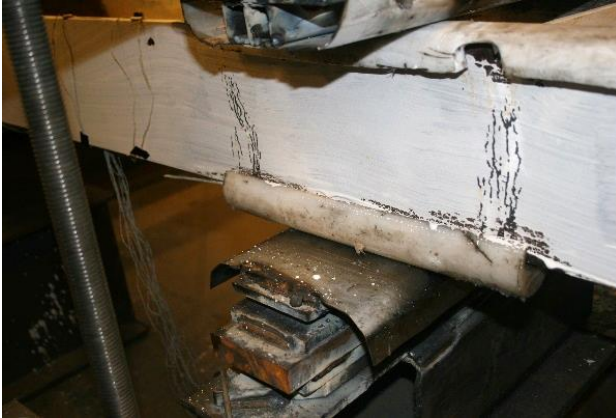
Figure 4.37 Beam Top Flange Yielding at Stiffeners 0.7% Drift

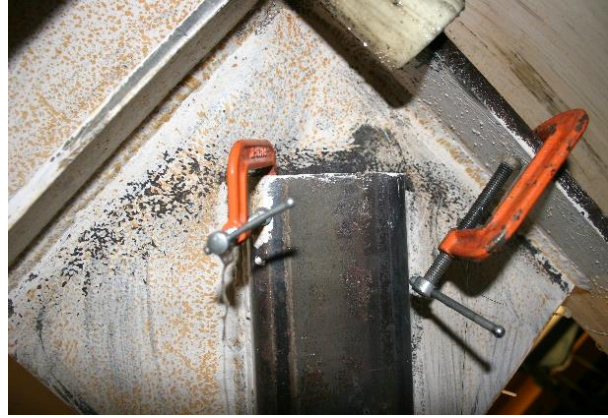
Figure 4.38 Beam Midspan Gusset Elliptical Yielding (SW) 0.83% drift

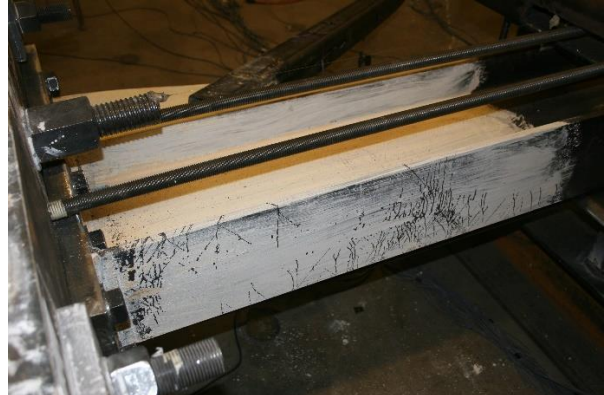
Figure 4.40 Outer Flange Yielding at Column
Base (NE) 1.4% drift

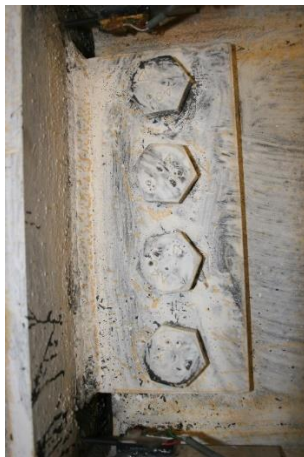
Figure 4.41 SW Shear Tab @ 1.4% drift

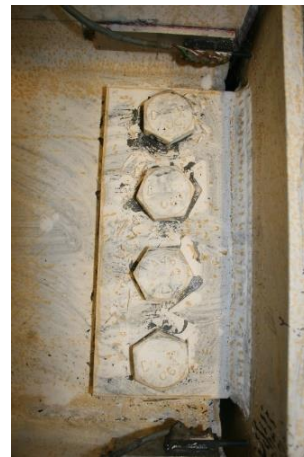
Figure 4.42 NW Shear Tab @ 1.4% drift

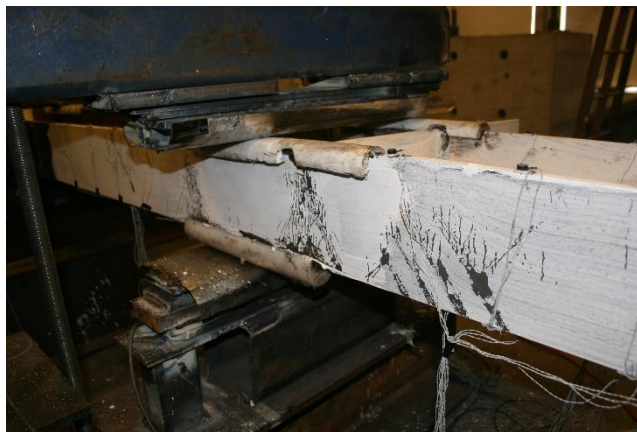
Figure 4.43 Beam Yielding Extending from Stiffeners @ 1.9%

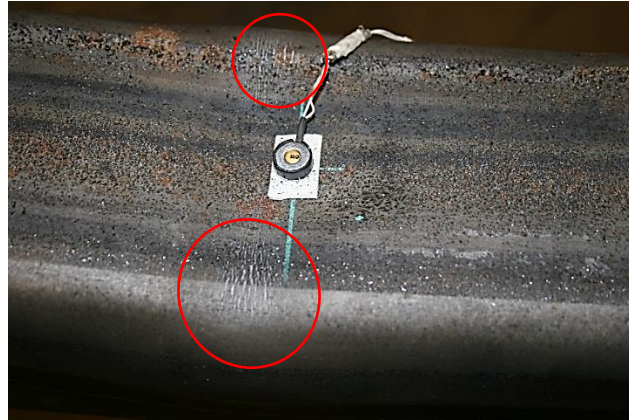
Figure 4.44 Striations in N Brace @ -2.5%

- At $\pm 2.2\%$ story drift, the braces experienced cupping (B3-BC)
- At $\pm 2.2\%$ crack initiates (WT1) in the NE corner gusset plate weld
- At -2.5% drift, striation lines appeared (B3-BT) in the center of North brace (Figure 4.44)

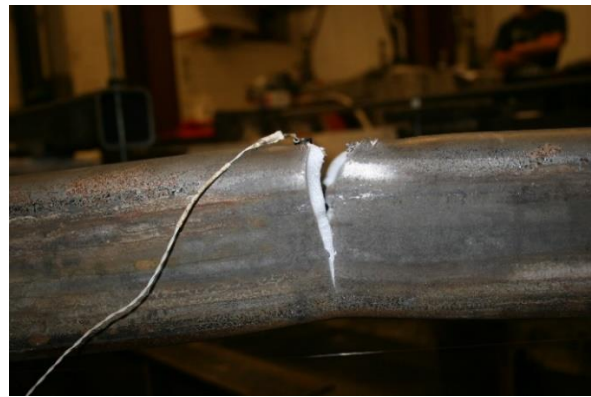
Figure 4.46 North Brace @ -2.75%

- At $\pm 2.8\%$ drift, the columns experienced moderate local buckling (LB2) of the flanges in the plastic hinge region
- At -2.8% story drift, the north brace tore partially (B3-BT) (Figure 4.46)

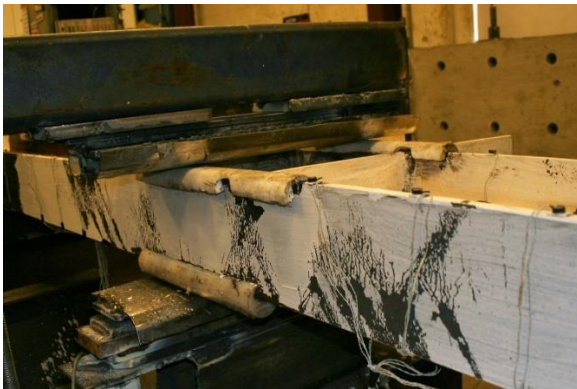
Figure 4.47 Beam @ 3.0% drift

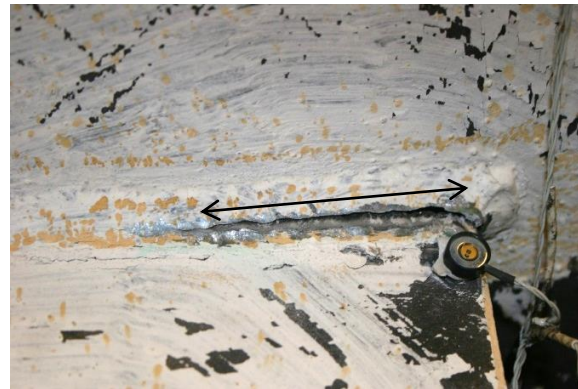
Figure 4.48 N mid gusset 3.0%

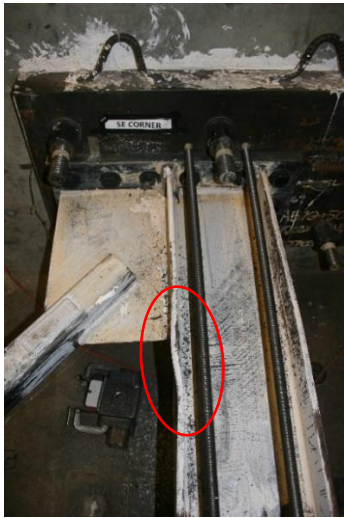
Figure 4.50 Local yielding/buckling at S Column base 3.65%

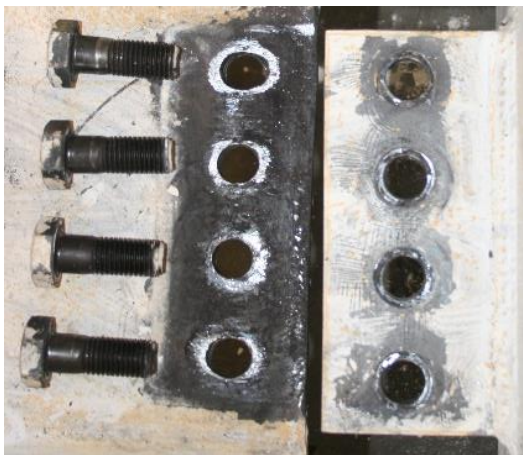
Figure 4.52 Final Condition North Beam Web and Shear Tab

The frame was cycled to $\pm 5\%$ drift after both braces had fractured. The columns continued sustain yielding and local buckling, reaching the performance state of severe local buckling. After the test the frame was disassembled and it was noted that slight bolt hole elongation had occurred in the top and bottom holes in the beam web to accommodate large rotation demands due to the large beam deflections, as shown in Figure 4.51 and Figure 4.52.

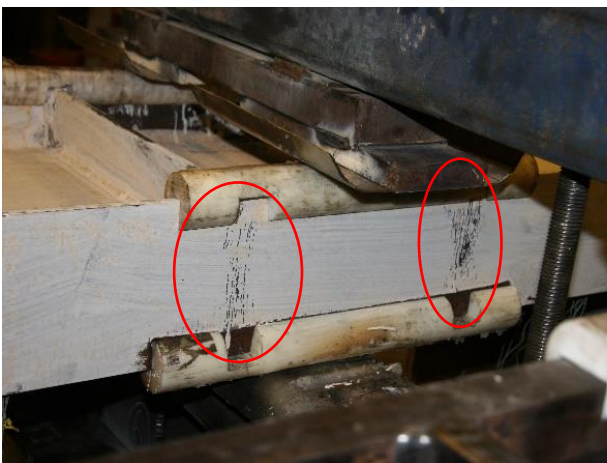
Figure 4.58 Beam OF yielding @ 1.1% drift

- At $\pm 1.1\%$ story drift, the braces buckled out of plane more than twice the depth of the brace (B2)
- At $\pm 1.1\%$ story drift, the outside column flanges started to yield (Y1)
- At $\pm 1.1\%$ story drift, the inner flange at the beam midspan began to yield (Y1-IF)
- At $\pm 1.9\%$ story drift the columns experienced moderate (Y2) yielding in the plastic hinge region

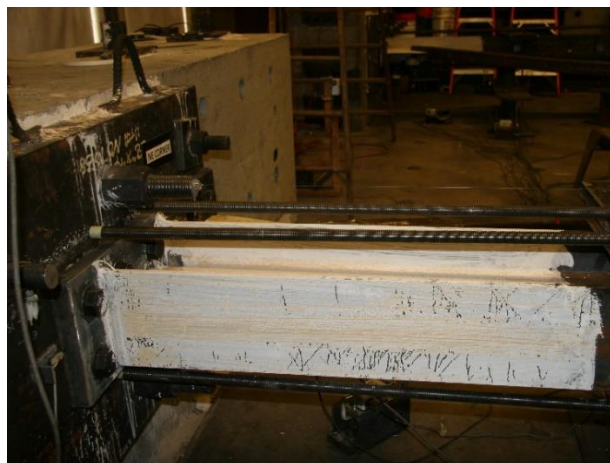
Figure 4.59 South column yielding @ 1.4% drift

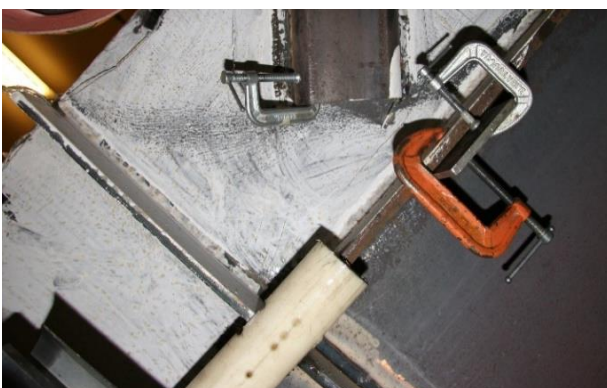
Figure 4.60 S mid gusset yielding @ 1.4% drift

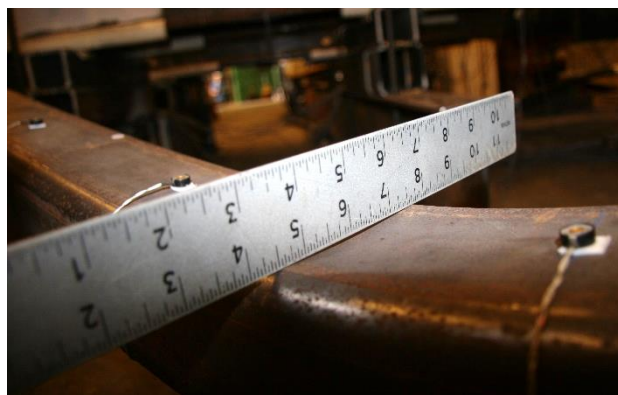
Figure 4.62 Cupping in N brace @+2.5% drift

- At $\pm 2.5\%$ story drift, the braces experienced initial cupping (B3-BC) Figure 4.62
- At $\pm 2.5\%$ story drift, a crack initiated in NE corner gusset plate weld (WT1)
- At $\pm 2.5\%$ drift, the columns experienced moderate yielding (Y2) at the plastic hinge region Figure 4.63

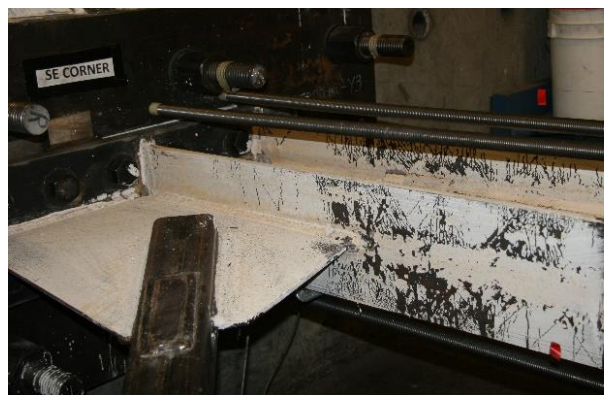
Figure 4.63 S column yielding @-2.5% drift

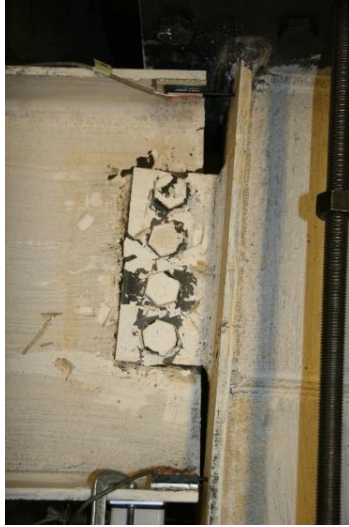
Figure 4.64 North Shear tab @ 2.8% drift

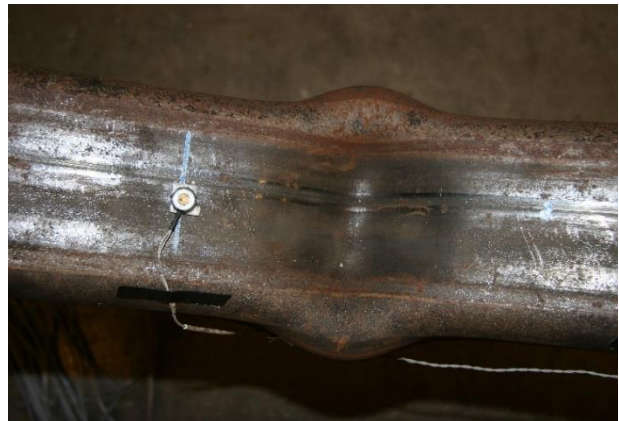
Figure 4.66 S brace @ first cycle -3.0% drift

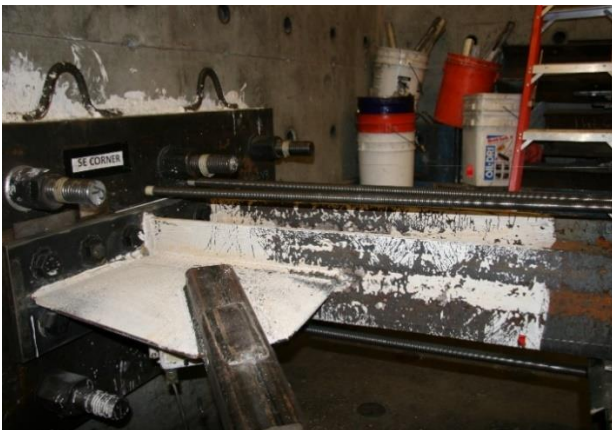
Figure 4.67 S Column @ -3.2% drift

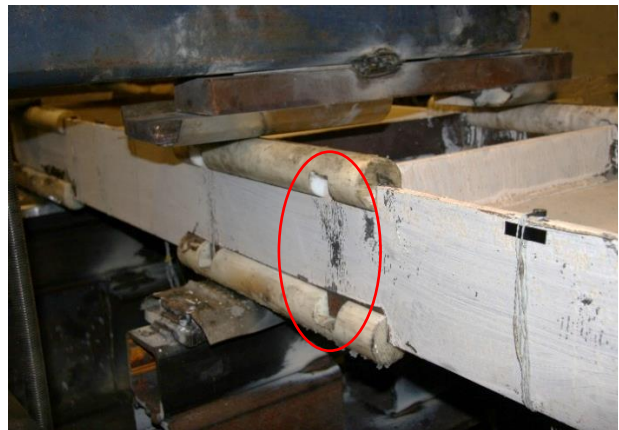
Figure 4.68 Beam yielding @ -3.2% Drift

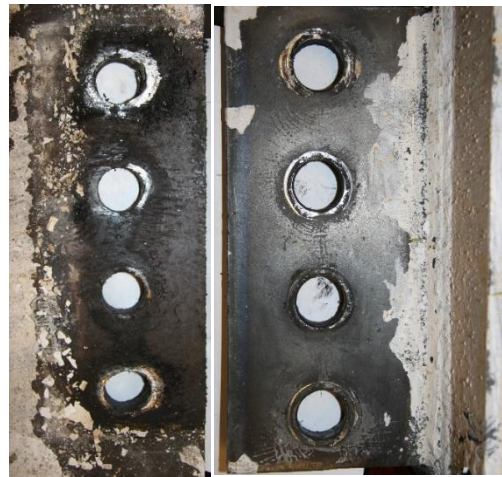
Figure 4.70 Final Condition North Beam Web and Shear Tab

The frame was cycled to $\pm 5\%$ drift after both braces had fractured. The columns continued sustain yielding and local buckling, reaching the performance state of severe local buckling. After the test the frame was disassembled and it was noted that slight bolt hole elongation had occurred in the top and bottom holes in the beam web, as shown in Figure 4.69 and Figure 4.70. There was much less bolt hole deformation in this test than in Chevrons 4 and 5.

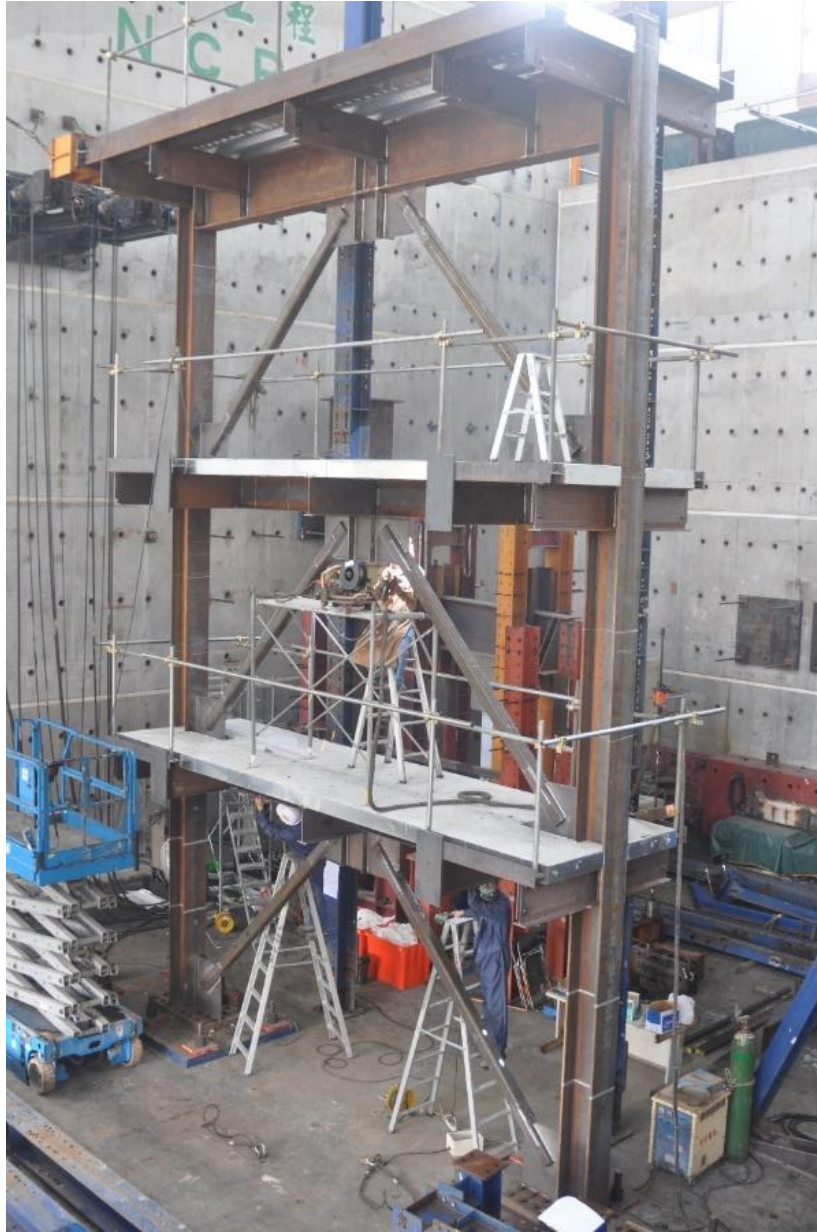
Figure 6.1 Chevron 7 overview picture (prior to testing)

This Chapter describes Part III of the experimental program which involved one 3-story chevron SCBF, Chevron 7 (Figure 6.1). Each story of the test had a chevron configuration but the top story was designed to remain essentially elastic to transfer the forces. This specimen was designed to investigate the system response of chevron braced frames with beams that yield under the brace demand. The test frame had composite slabs with gusset plates at the beam column connections; these two aspects of the configuration were expected to simulate a more realistic behavior.

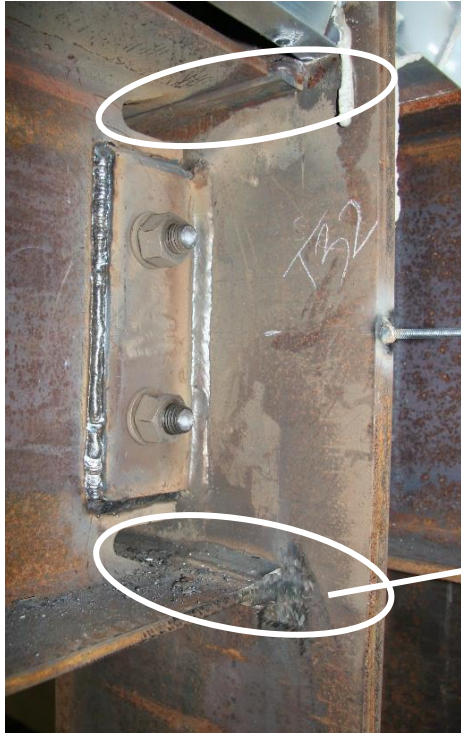
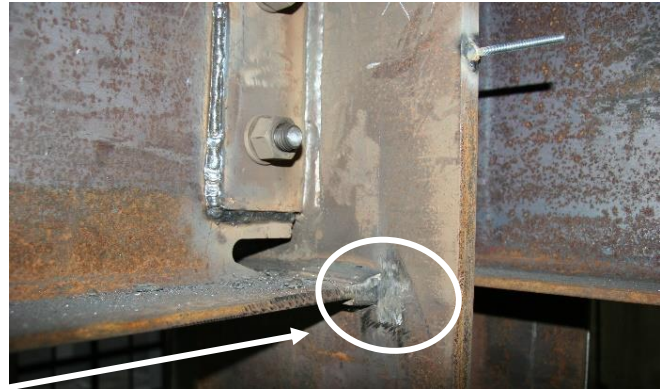
(a) backing bars on welded connection

(b) cut and ground weld runoff on bottom flange weld

Figure 6.3 Typical beam-to-column connection

Several beam to column connections were considered for Chevron 7 including variations of bolted shear plates that would meet requirement (a) as stipulated above. Additionally, results from the ABAQUS analyses mentioned in Section 6.2.1 showed that a connection of a bolted web shear tab with welded beam flanges would have provided sufficient strength and rotation. Ultimately, a welded flange welded web (WFWW) moment resisting connection was chosen for all the beam to column connection due to its preferred use by practicing engineers. The details for this connection at the first, second, and third story beams are shown in Figure 6.5 and Figure 6.6. At these beam-to-column connections, the weld runoff was cut off from the bottom flange weld and the backing bars were left in place as shown in Figure 6.3.

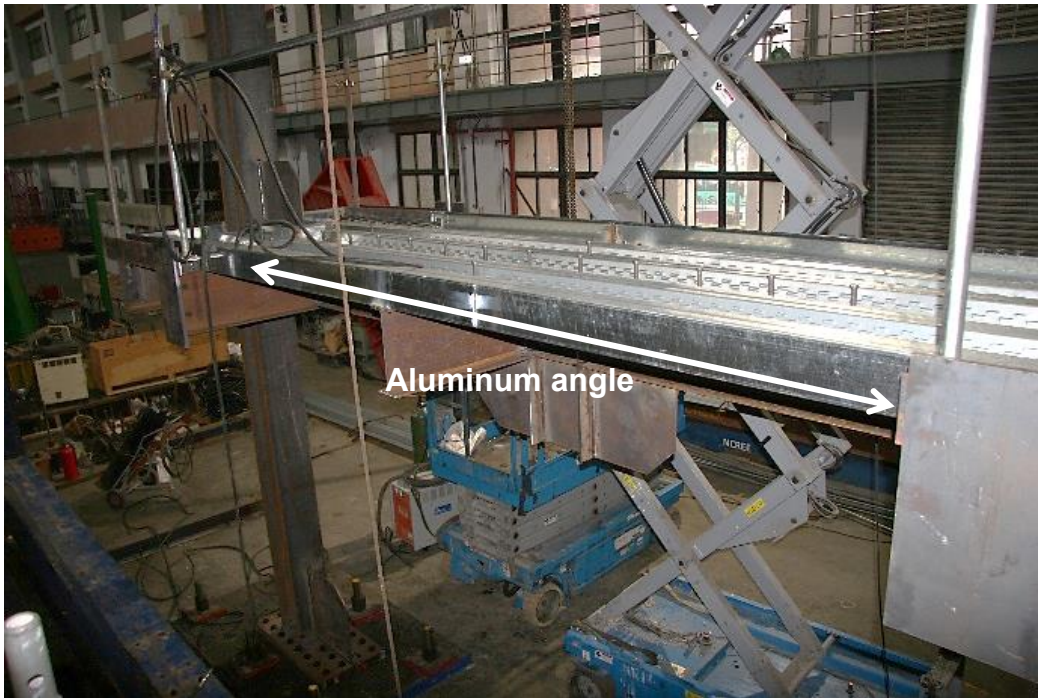
Figure 6.12 Typical metal deck for first and second story slabs

The experimental setup was designed by NCREE researchers Te-Hung Lin and An-Chien Wu. The setup was very similar to that used for the TCBF2 test series, explained in detail by Lumpkin (2009), and included the adapted modifications used for the TNCBF series explained in Sen (2014). The geometry of Chevron 7 was based on the TCBF2-HSS geometry. The two frames had equal bay width and total frame height but slightly different story heights. The modifications used by Sen (2014) as well as in this experiment included the use of only 3 – 100 metric ton actuators, a modified roller system to prevent twisting of the top beam and slab, and discontinuous edge beams at the first and second floor to prevent adding an unrealistic rigidity to the midspan of the composite beam. However, the slabs ultimately had some added rigidity from aluminum angles, as seen in Figure 6.12, used for formwork and left in place for testing.

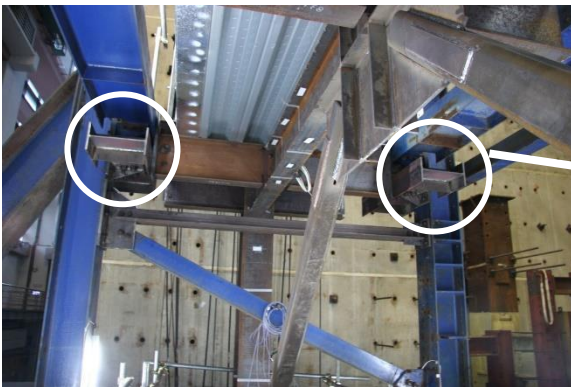
(a) First story rotational supports

Figure 6.13 Slab out-of-plane rotational restraint

It is noteworthy that the first and second story beam and slabs were restrained only at the beam quarter points, as shown in Figure 6.11. The slab rotational restraints at the first story (Figure 6.10 and Figure 6.11), consisting of two points of contact of the transverse beams with the OOP frame are pictured in Figure 6.13. This was a primary difference with Sen (2014) and Lumpkin (2009) tests as there were no slab rotational restraints over a 4 m section of the slab on the first and second stories. This absence of rotational support and edge beams in the inner portion of the beams and slab resulted in a stiff end condition between the two exterior transverse beams and a much more flexible interior section. This condition was used to accommodate the larger vertical deflections at midspan of the beam with yielding chevron beams, and it was compounded by inadvertent changes to the test setup for this test.

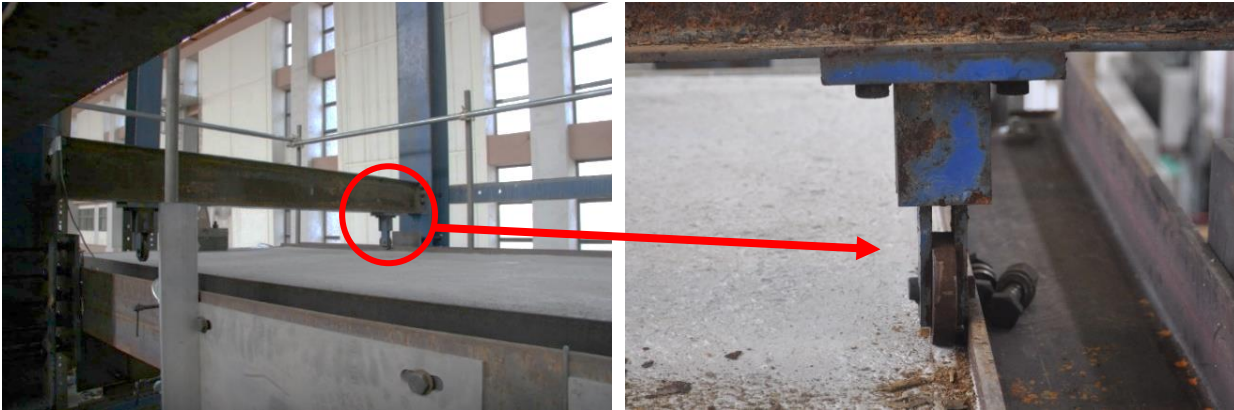
(a) Guide and roller

(b) roller

Figure 6.14 Top floor slab rotational restraint

The top slab, pictured in Figure 6.14 had rotational and lateral restraint over its entire length. At the top slab, the rollers meant to provide rotational restraint were too close to the edge beam and got stuck during testing as shown in Figure 6.14. This resulted in slight bending of the top story edge beam and movement of the OOP frame during loading. As a result, these rollers were removed halfway through the test to prevent additional OOP frame movement.

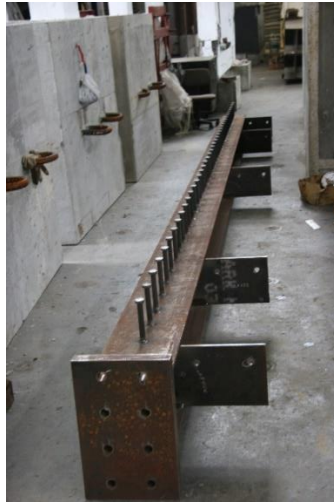
Figure 6.16 Top slab edge beam

The specimen's lateral load path is outlined in Figure 6.15. The force from the actuators was transferred through the transfer beam to the two continuous edge beams in Figure 6.10 at the third story. Then, a shear force was delivered to the slab through the shear studs spaced at 150 mm and the resulting load was transferred to the braced frame through the shear studs, also at 150mm o.c., on the third story beam. The three actuators, located on the south side of the frame, pushed out (actuators extended in compression) towards the north on the frame to incite a positive drift. As they pulled in (actuators retracted in tension) and moved the frame in the south directions, this corresponded to a negative frame drift. Of the three actuators, the center one was controlled by a preprogrammed displacement protocol, and the east and west ones were slaved to the displacement of the middle actuator.

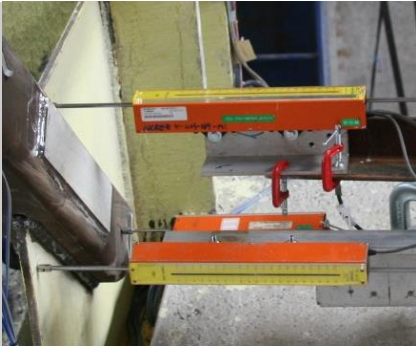
Beams Gusset plates	Mid span deflection OOP rotation
Linear variable displacement transducer (Temposonic)

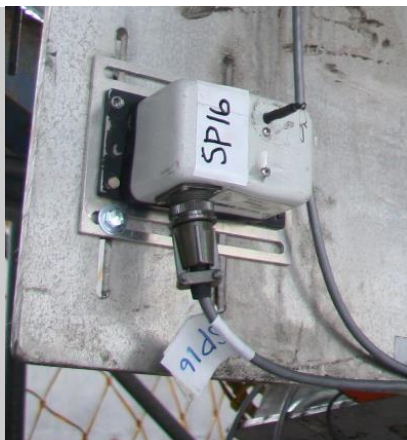
**String
potentiometer**

1F and 2F slabs	Lateral displacement
1F Braces	Elongation & shortening, OOP displacement
2F Braces	Elongation & shortening,
3F Gusset plates	OOP rotation

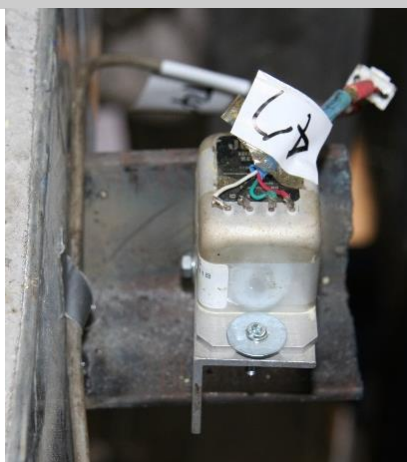
**Inclinometer
(Jewell)**

Beams	In-plane-rotation
Columns	In-plane rotation
Slabs	OOP rotation

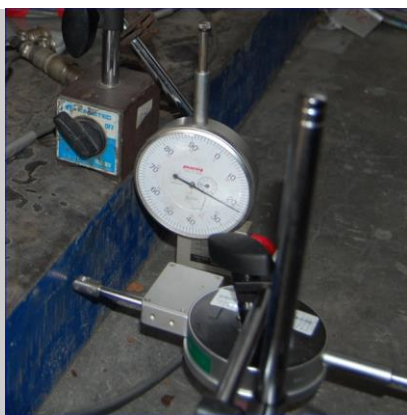
**Dial gauge
(Peacock)**

<i>Base plates</i>	Slip, uplift
<i>Anchor plates</i>	Slip, uplift

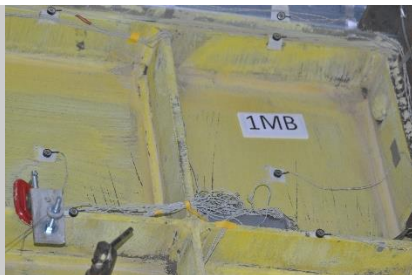
**NDI Optotrak LED
markers**

<i>1F Beam</i>	3D displacement & rotation
<i>1F Braces</i>	OOP displacement, rotation
<i>1F Mid Gusset plates</i> ..	OOP rotation

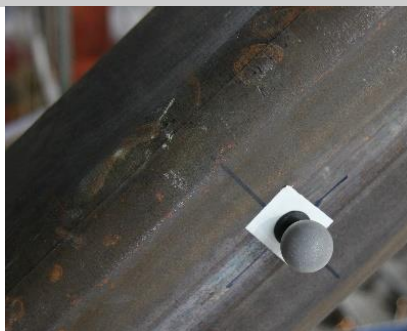
**OptiTrack
retroreflective
markers and Prime
41 cameras**

<i>2F beam</i>	3D displacement & rotation
<i>2F braces</i>	OOP displacement, rotation
<i>2F Mid gusset plates</i> .	OOP rotation

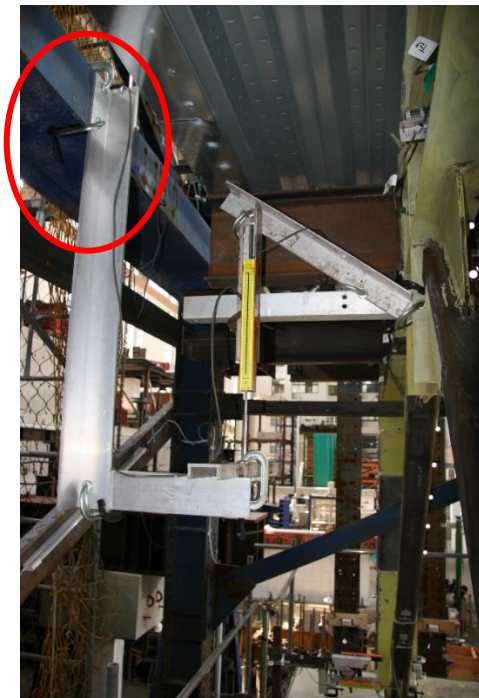
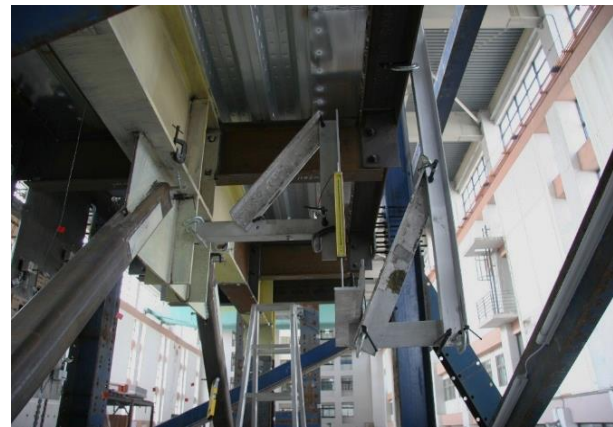
(a) Second Story beam

(b) Third story beam

Figure 6.17 Beam deflection LVDTs

LVDT's were mounted to measure the vertical deflection at the midpoint of each of the three beams as shown in Figure 6.17. However, several issues with the instruments at these three locations throughout the test rendered the data unreliable. One such issue was that the needle of the LVDT was bent due to out of plane movement of the beam and did not measure vertical displacements accurately. Thus, the reported beam deflection was determined from NDI Optotrak and OptiTrack optical sensor data for the first and second story beams respectively. The optical data was also used to calculate beam torsional rotation.
